31 PRESERVATION BRIEFS

Mothballing Historic Buildings

Sharon C. Park, AIA

U.S. Department of the Interior
National Park Service
Cultural Resources
Preservation Assistance

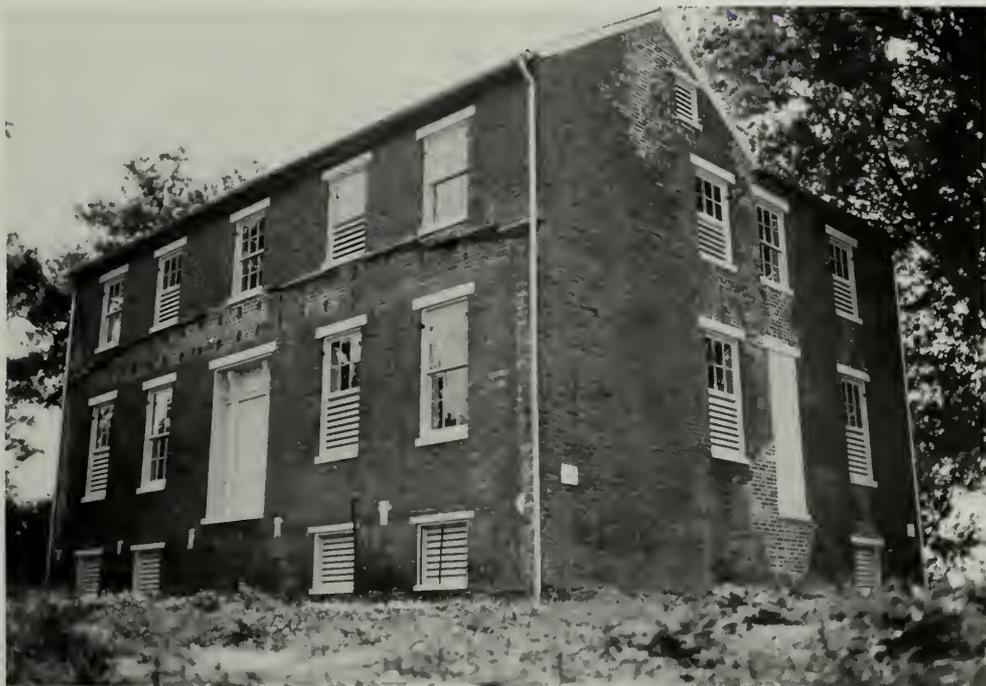
Figure 1. Proper mothballing treatment: This building has been successfully mothballed for 10 years because the roof and walls were repaired and structurally stabilized, ventilation louvers were added, and the property is maintained. Photo: Charles E. Fisher, NPS.

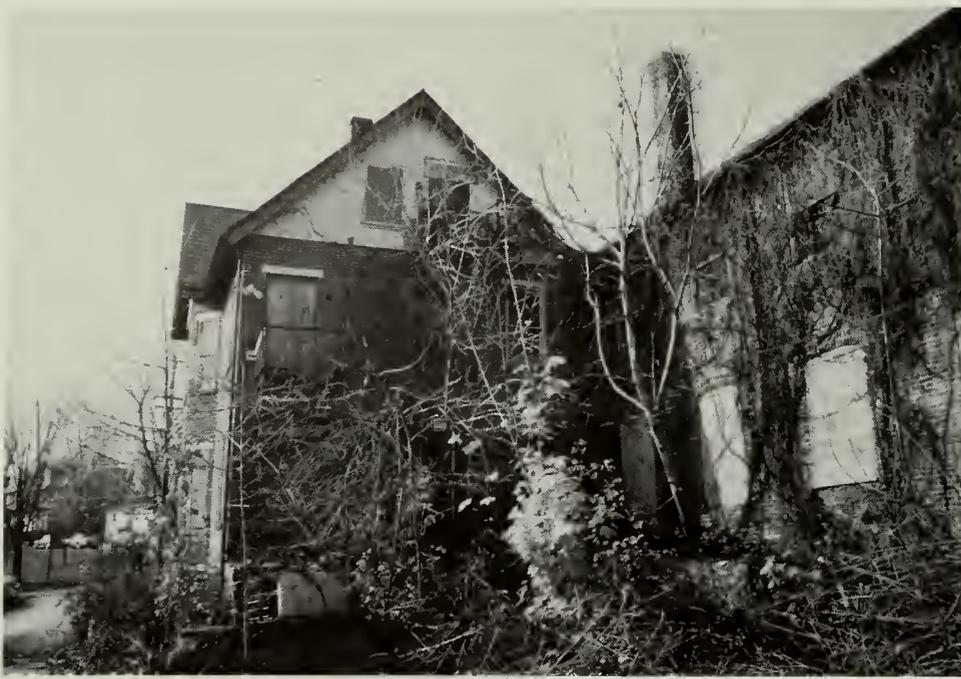
Figure 2. Improper treatment: Boarding up without adequate ventilation, lack of maintenance, and neglect of this property have accelerated deterioration. Photo; NPS file.

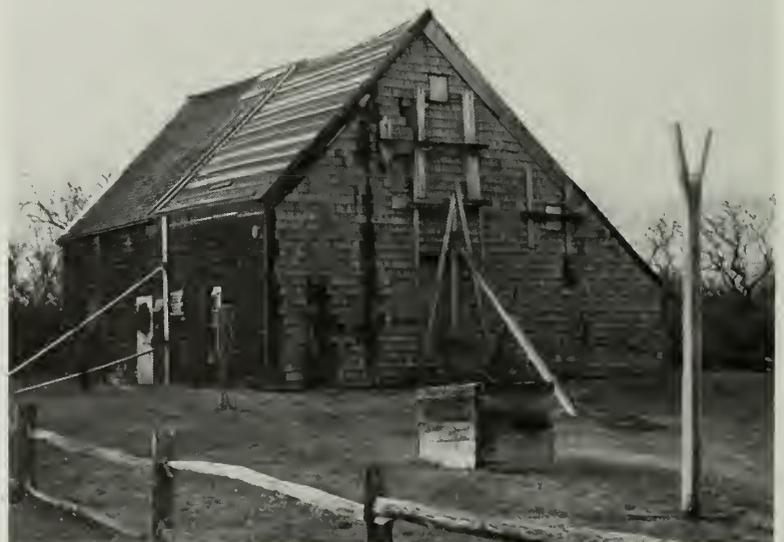
Figure 3. Buildings seriously damaged by storms or deterioration may need to be braced before architectural evaluations can be made. Jethro Coffin House. Photo: John Milner Architects.

to be structurally unsound until the condition of the structure can be fully assessed (see fig. 3). If pigeon or bat droppings, friable asbestos or other health hazards are present, precautions must be taken to wear the appropriate safety equipment when first inspecting the building. Consideration should be given to hiring a firm specializing in hazardous waste removal if these highly toxic elements are found in the building.

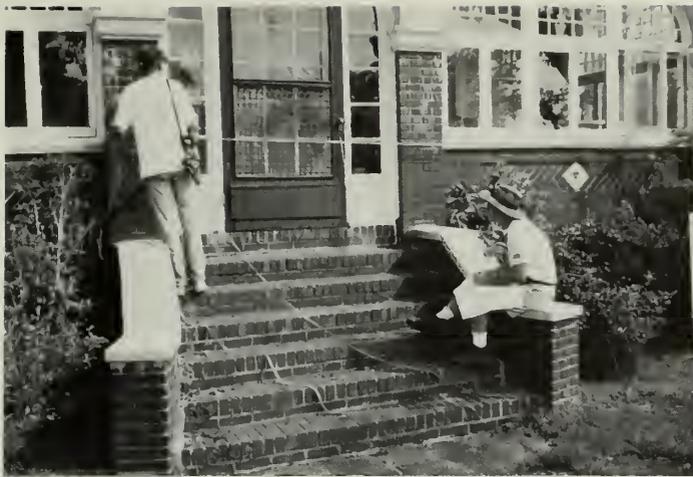
Figure 4. Documenting the building's history, preparing schematic plans, and assessing the condition of the building will provide necessary information on which to set priorities for stabilization and repair prior to securing the building. Photo: Frederick Lindstrom, HABS.

Old photographs can be helpful in identifying early or original features that might be hidden under modern materials. On a walk-through, the architect, historian, or preservation specialist should identify the architecturally significant elements of the building, both inside and out (see fig.4).

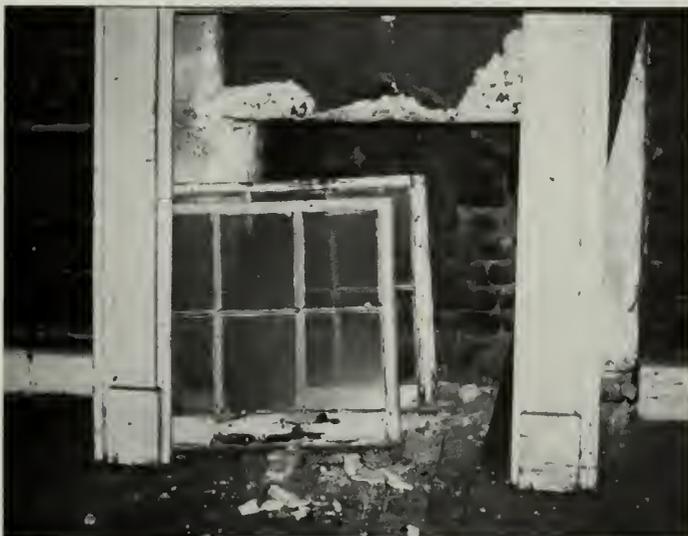
Figure 5. Loose or detached elements should be identified, tagged and stored, preferably on site. Photo: NPS files.

By understanding the history of the resource, significant elements, even though deteriorated, may be spared the trash pile. For that reason alone, any materials removed from the building or site as part of the stabilization effort should be carefully scrutinized and, if appearing historic, should be photographed, tagged with a number, inventoried, and safely stored, preferably in the building, for later retrieval (see fig. 5).

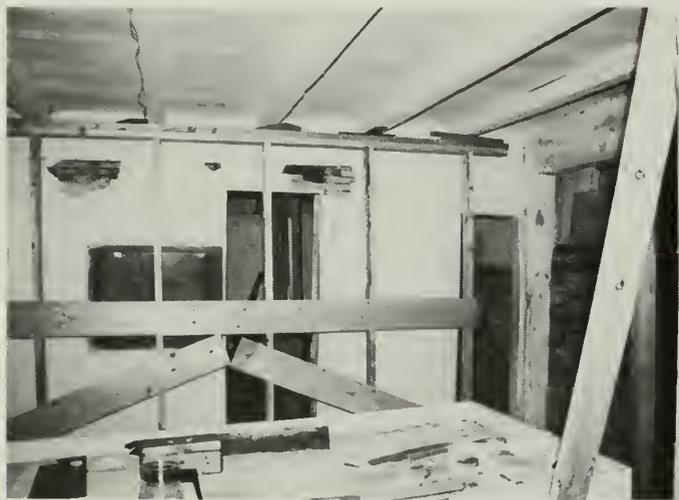
Figure 6. Interior bracing which will last the duration of the mothballing will protect weakened structural members. Jethro Coffin House. Photo: John Milner Architects.

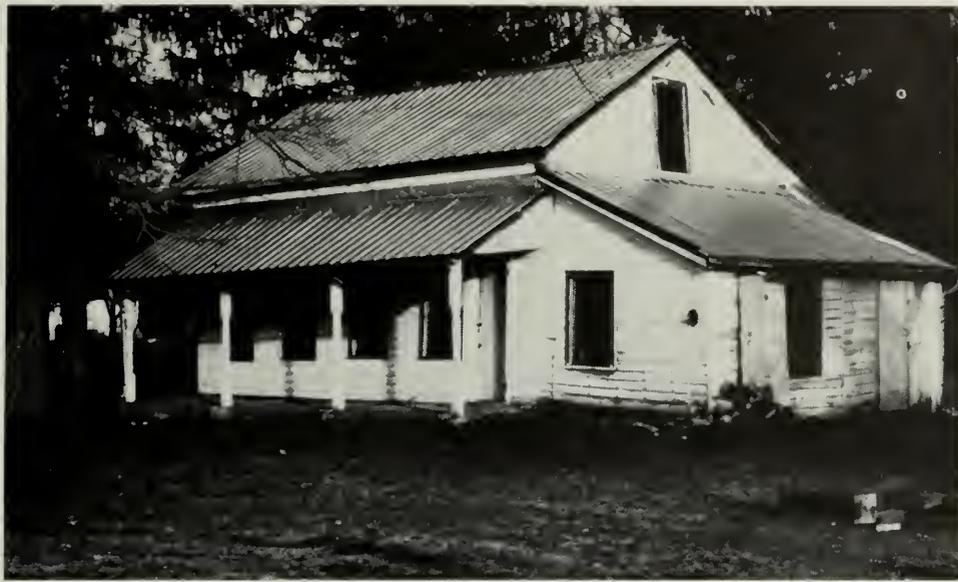
Figure 7. Non-historic materials are appropriate for mothballing projects when they are used to protect historic evidence remaining for future preservation. This lightweight aluminum channel frame and roofing covers the historic wooden shingle roof. Galvanized mesh panels secure the window openings from intrusion by raccoons and other unwanted guests. Photo: Williamsport Preservation Training Center, NPS.

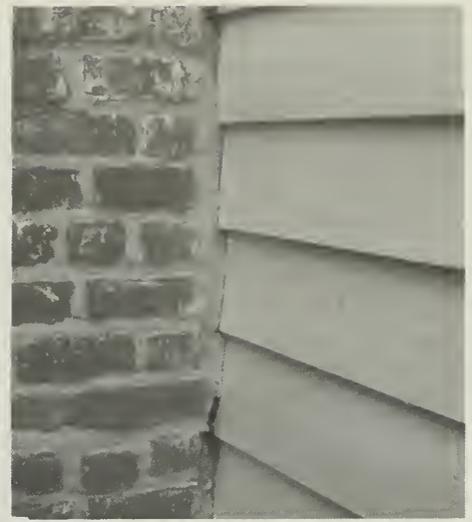
Figure 8. Appropriate mortar mixes should be used when masonry repairs are undertaken. In this case, a soft lime based mortar is used as an infill between the brick and wooden elements. When full repairs are made during the restoration phase, this soft mortar can easily be removed and missing bricks replaced.

For masonry repairs, appropriate preservation approaches are essential. For example, if repointing deteriorated brick chimneys or walls is necessary to prevent serious moisture penetration while the building is mothballed, the mortar should match the historic mortar in composition, color, and tooling. The use of hard portland cement mortars or vapor-impermeable waterproof coatings are not appropriate solutions as they can cause extensive damage and are not reversible treatments (see fig. 8).

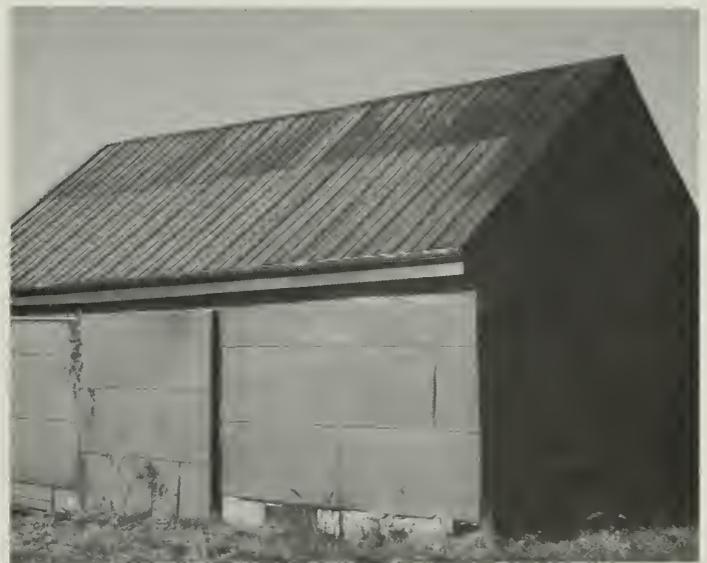
Figure 9. Severely deteriorated wooden siding on a farm building has been covered over with painted plywood panels as a temporary measure to eliminate moisture penetration to the interior. Foundation vents and loose floor boards allow air to circulate inside.

patterns or by installing panels over a frame of battens (see fig. 9). Generally, however, it is better to repair deteriorated features than to cover them over.

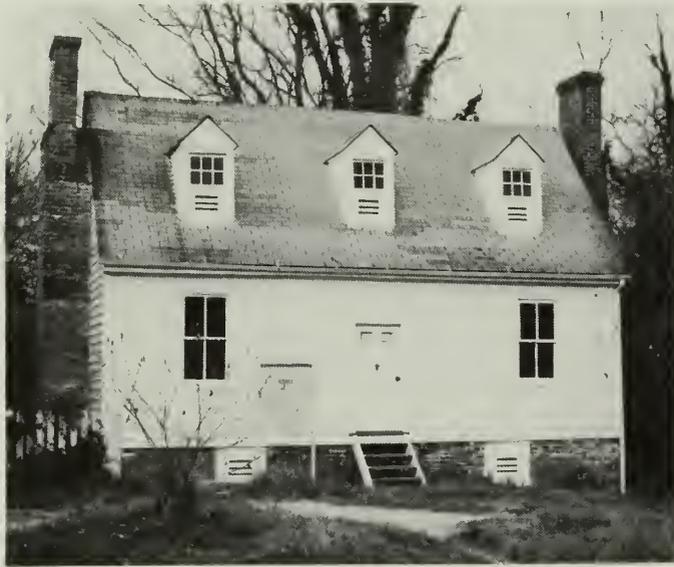
Figure 10. Regrading around the Booker Tenement at Colonial Williamsburg has protected the masonry foundation wall from excessive damp. This building has been successfully mothballed for over 10 years. Note the attic and basement vents, the temporary stairs, and the informative sign interpreting the history of this building.

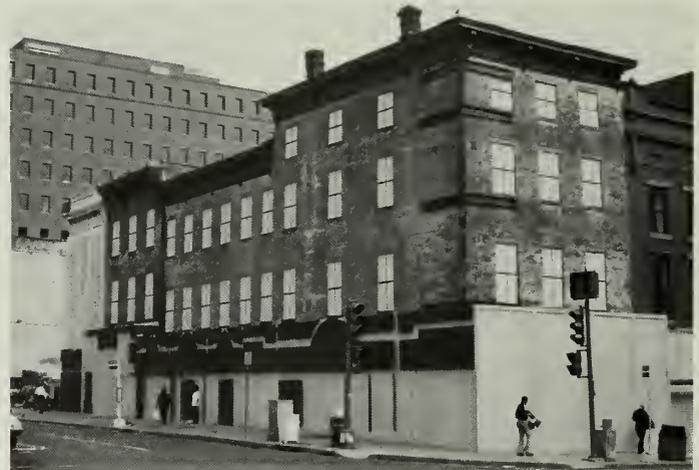
Figure 11. Urban buildings often need additional protection from unwanted entry and graffiti. This commercial building uses painted plywood panels to cover expansive glass storefronts and chain link fencing is applied on top of the panels. The upper windows on the street sides have been covered and painted to resemble 19th century sash. Photo: Thomas Jester, NPS.

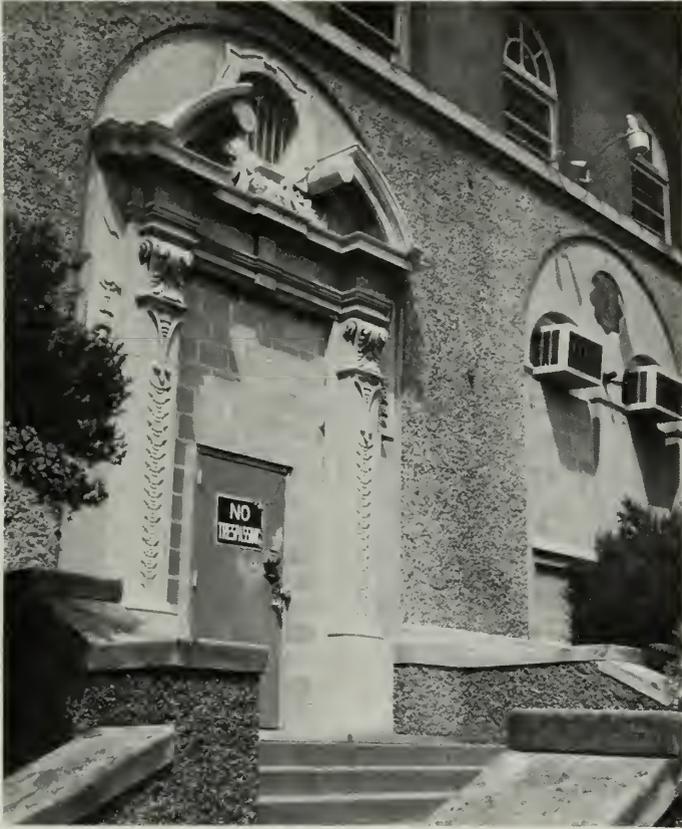
Figure 12. First floor openings have been filled with cinderblocks and doors, window sash and frames have been removed for safe keeping. Note the security light over the windows and the use of a security metal door with heavy duty locks. Photo: H. Ward Jandl, NPS.

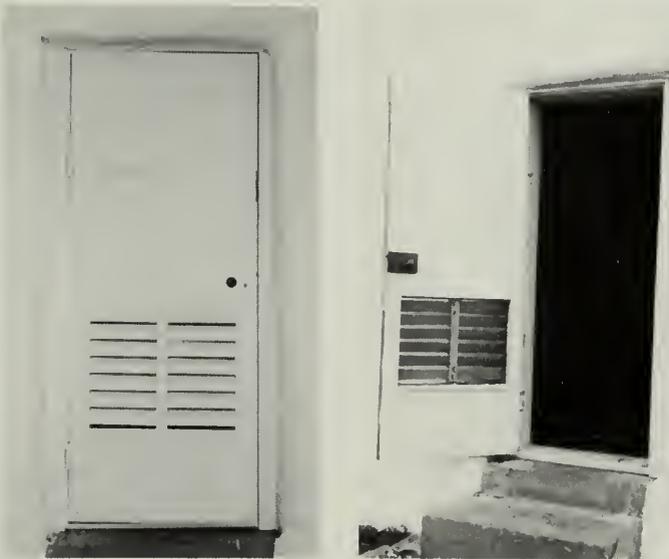
Figure 13. If historic doors would be damaged by adding extra locks, they should be removed and stored and new security doors added. At this lighthouse, the historic door has been replaced with a new door (seen both inside and outside) with an inset vent and new deadbolt locks. The heavy historic hinges have not been damaged. Photo: Williamsport Preservation Training Center, NPS.

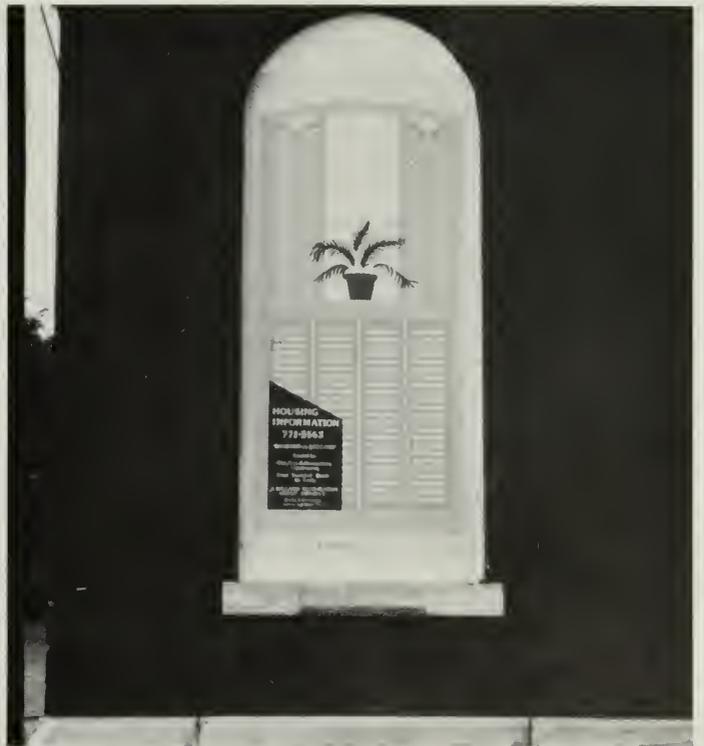
Figure 15. Painting trompe l'oeil scenes on plywood panels is a neighborhood friendly device. In addition, the small sign at the bottom left corner gives information for contacting the organization responsible for the care of the mothballed building. Photo: Lee H. Nelson, FAIA.

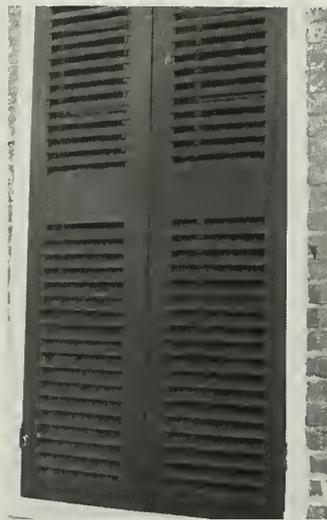
Figure 16. Historic louvered shutters make excellent security closures with passive ventilation.

If the building has shutters, simply close the shutters and secure them from the interior (see fig. 16). If the building had shutters historically, but they are missing, it may be appropriate to install new shutters, even in a modern material, and secure them in the closed position. Louvered shutters will help with interior ventilation if the sash are propped open behind the shutters.

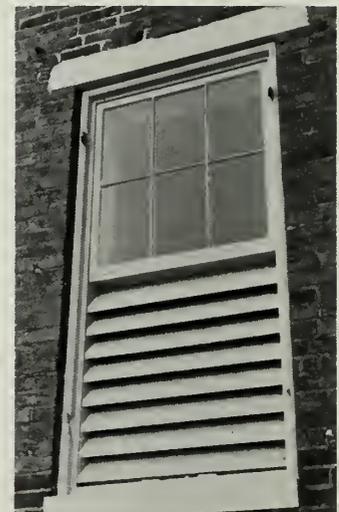
Figure 18. Heavy duty wooden slated louvers were custom fabricated to replace the deteriorated lower sash. The upper sash were rebuilt to retain the historic appearance and to allow light into this vacant historic building. Refer back to Fig. 1 for a view of the building. Photo: Charles E. Fisher, NPS. Drawing by Thomas Vitanza.

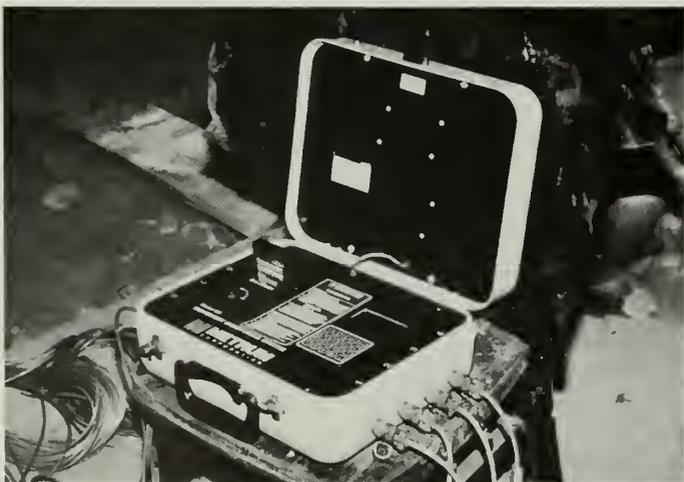
Figure 20. Portable monitors used to record temperature and humidity conditions in historic buildings during mothballing can help identify ventilation needs. This data can be downloaded directly into a laptop computer on site. These monitors are especially helpful over the long term for buildings with significant historic interiors or which are remaining furnished. If interiors are remaining damp or humid, additional ventilation should be added or the source of moisture controlled.

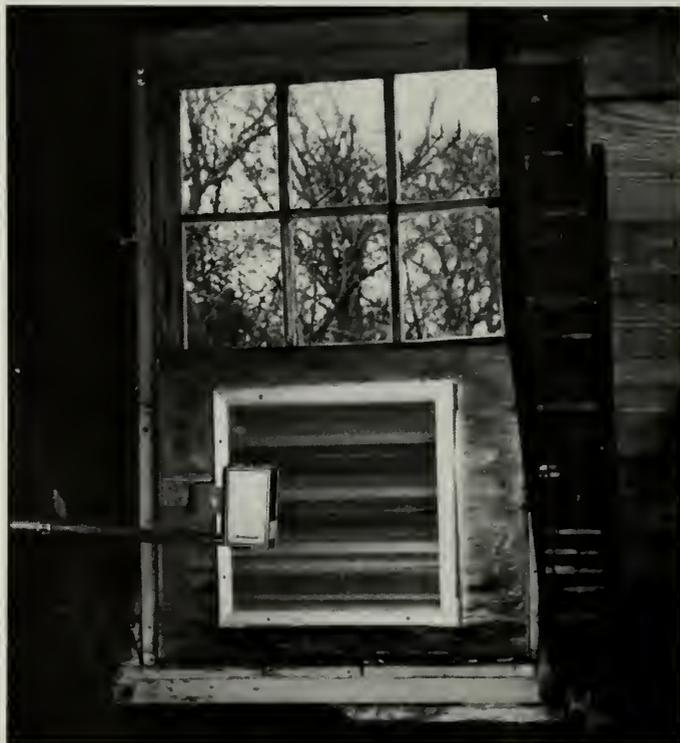
Figure 21. This electric thermostat/humidistat mounted in the attic vent controls a modified ducted air/fan system. The unit uses temporary exposed sheet metal ducts to pull air through the building and exhaust it out of the basement. For over ten years this fan system in combination with 18" x 18" preformed louvers in selective windows has kept the interior dry and with good air exchanges.

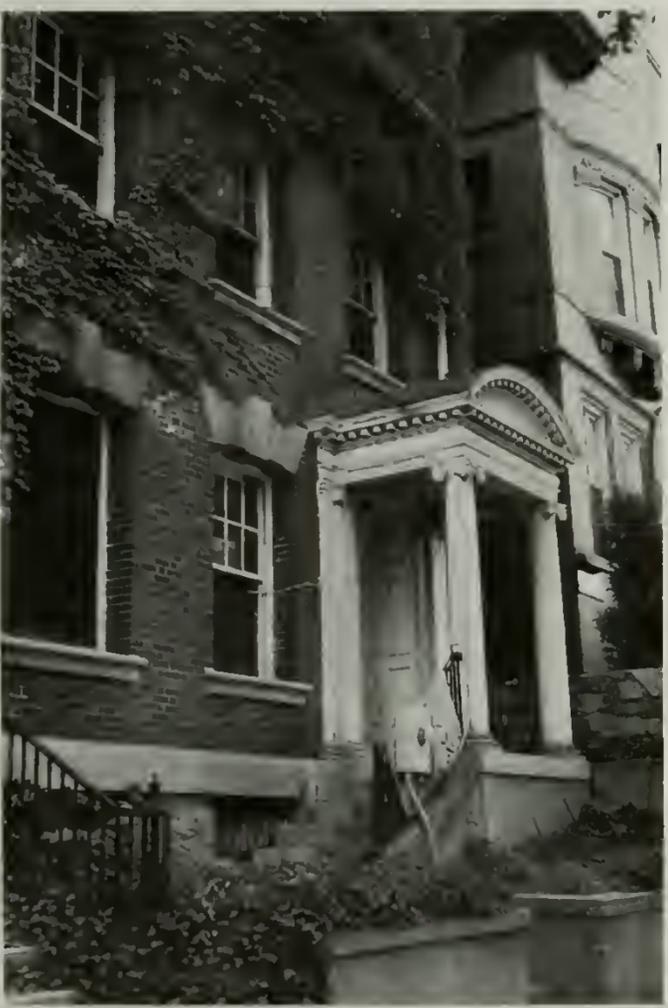
Figure 22. All systems except temporary electric have been shut off at this residence which has been mothballed over 20 years. An electric meter and 100 amp panel box have been set on a plywood panel at the front of the building. It is used for interior lighting and various alarm systems. The building, however, is showing signs of moisture problems with efflorescent stains on the masonry indicating the need for gutter maintenance and additional ventilation for the interior. The vegetation on the walls, although picturesque, traps moisture and is damaging to the masonry. Photo: H. Ward Jandl, NPS.

hazard, it is advisable to retain those which will help protect the property. Since the electrical needs will be limited in a vacant building, it is best to install a new temporary electric line and panel (100 amp) so that all the wiring is new and exposed. This will be much safer for the building, and allows easy access for reading the meter (see fig. 22).

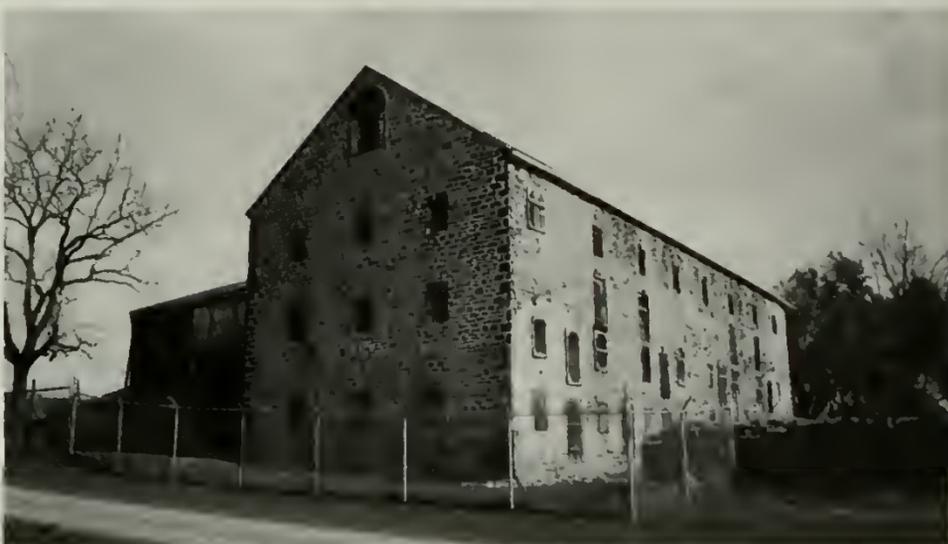
Figure 24. Once mothballed, a property must still be monitored and maintained. The openings in this historic barn has been modified with a combination of wood louvers and metal mesh panels which require little maintenance. The grounds are regularly mowed, even inside the chain link security fence. Photo: Williamsport Preservation Training Center, NPS.

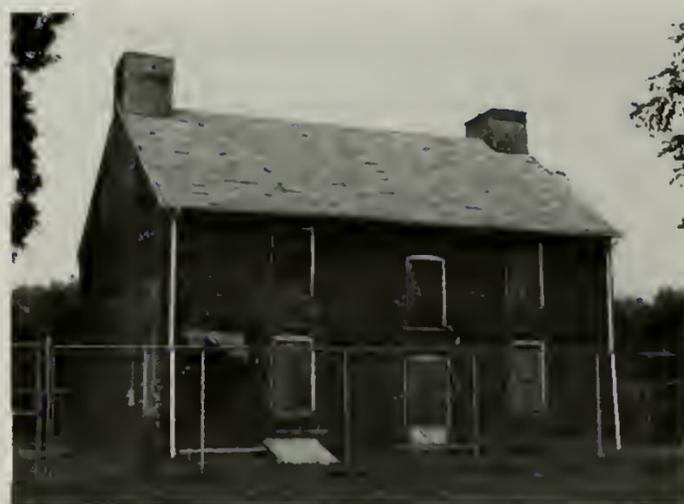
Figure 25. Above is a summary of the tasks that were necessary in order to protect this significant property while restoration funds are raised. Photographs: Michael Mills; Ford Farewell Mills Gatsch Architects.

a. A view showing the exterior of the house in its mothballed condition.

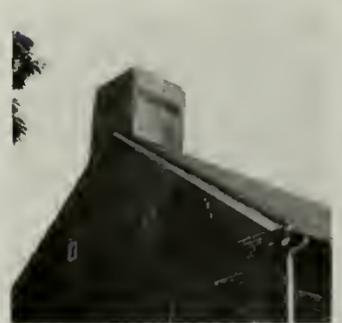
b. Plywood panels stabilize the chimneys. Note the gable vents.

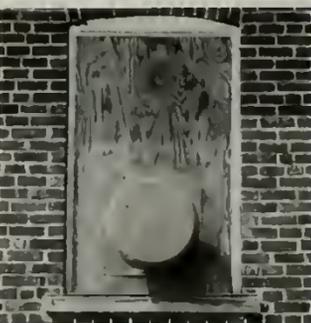
c. The exhaust fan has tamper-proof housing.

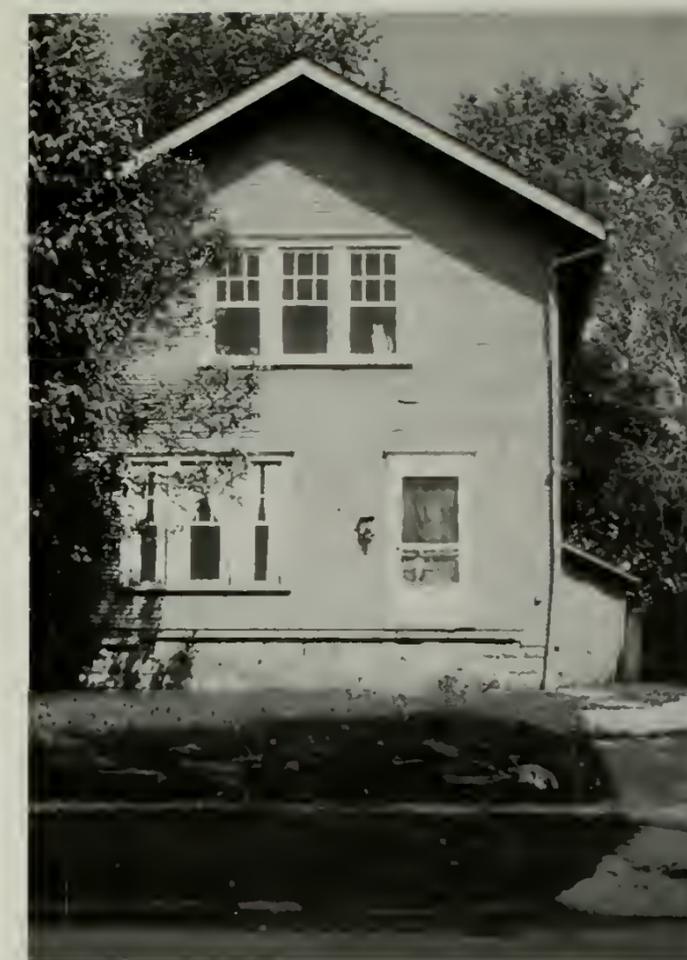
Figure 27. This residential building blends into its neighborhood even though all the windows have been covered over and the front steps are missing. The grounds are maintained and the special attention to decoratively painting the window panels shows that the property is being well cared for until it can be rehabilitated. Photo: Ohio Historical Society.
