# Yellowstone National Park

## Submerged Resources Survey

Submerged Resources Center  
Professional Reports  
Number 16

Cultural Resources Management  
Professional Paper  
Number 65

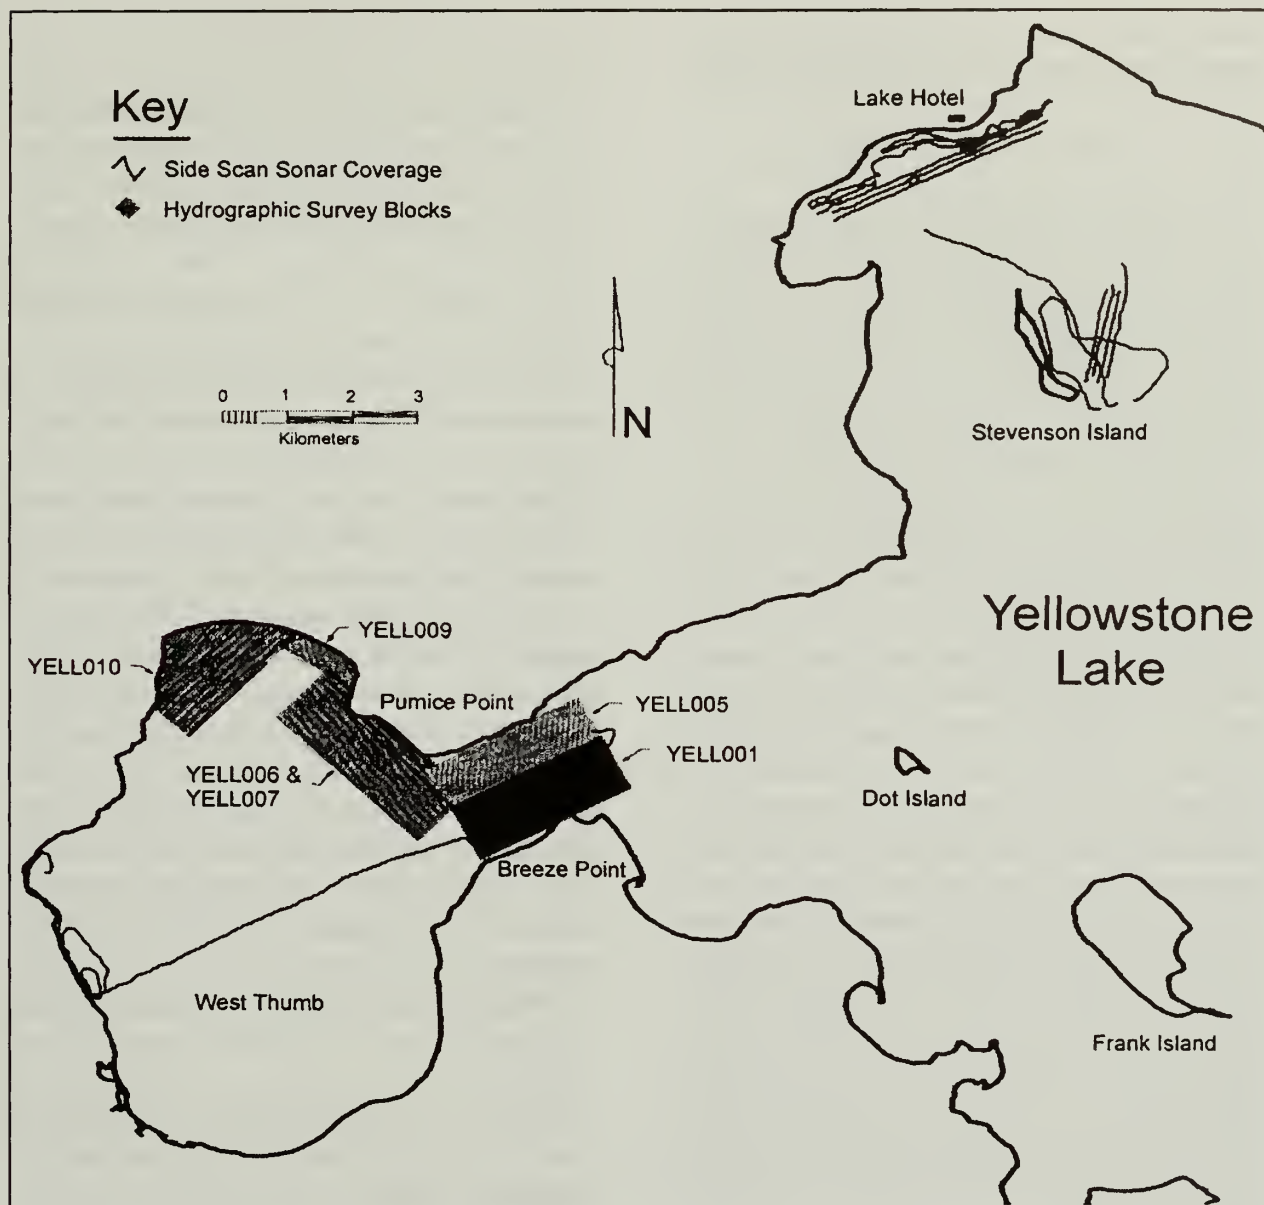
**Figure 1.** Planned survey blocks and side scan sonar coverage.

Yellowstone Lake side scan sonar coverage is presented in Figure 1. High-probability areas near the Lake Hotel revealed several interesting cultural and natural features. Although no trace of *Zillah* was observed, eight small, wooden rowboats associated with the Lake Hotel were located; three were briefly visited and documented (Figures 12–14 and Part II). In addition, unique bottom topography and geological features were also observed. For example, the probable hot water vent in Figure 15. Side scan sonar images (sonographs) of *E. C. Waters* (Figure 16) and the West Thumb docks (Figure 17) did not reveal any additional remains associated with these sites. However, the sonographs have proved useful for analytical and documentation purposes. Because the sonar towfish was damaged, no comparative data were collected in the primary RoxAnn coverage areas.

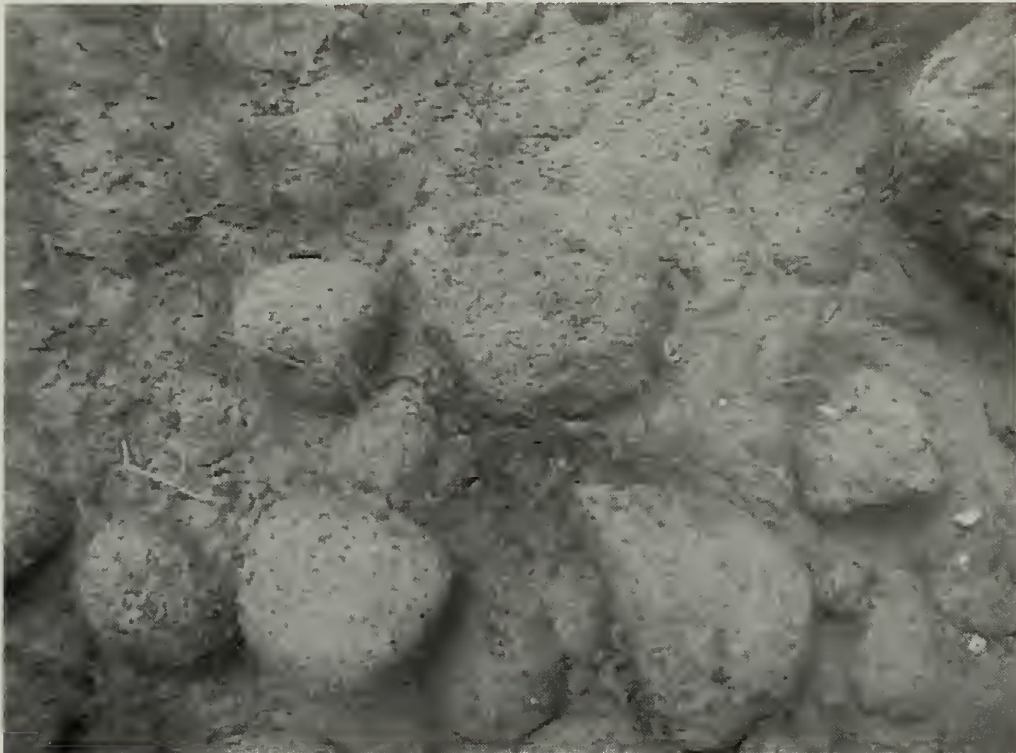
**Figure 2.** Category 1: Cobble and rubble with sand.

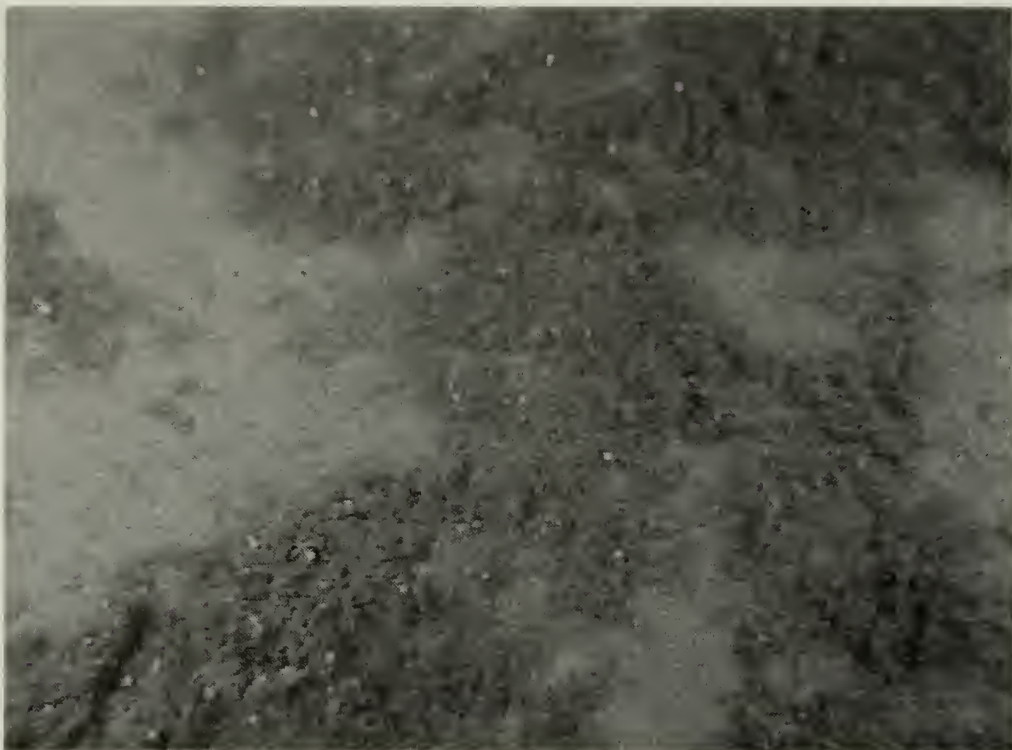
**Figure 4.** Category 3: Mud and fine sand.

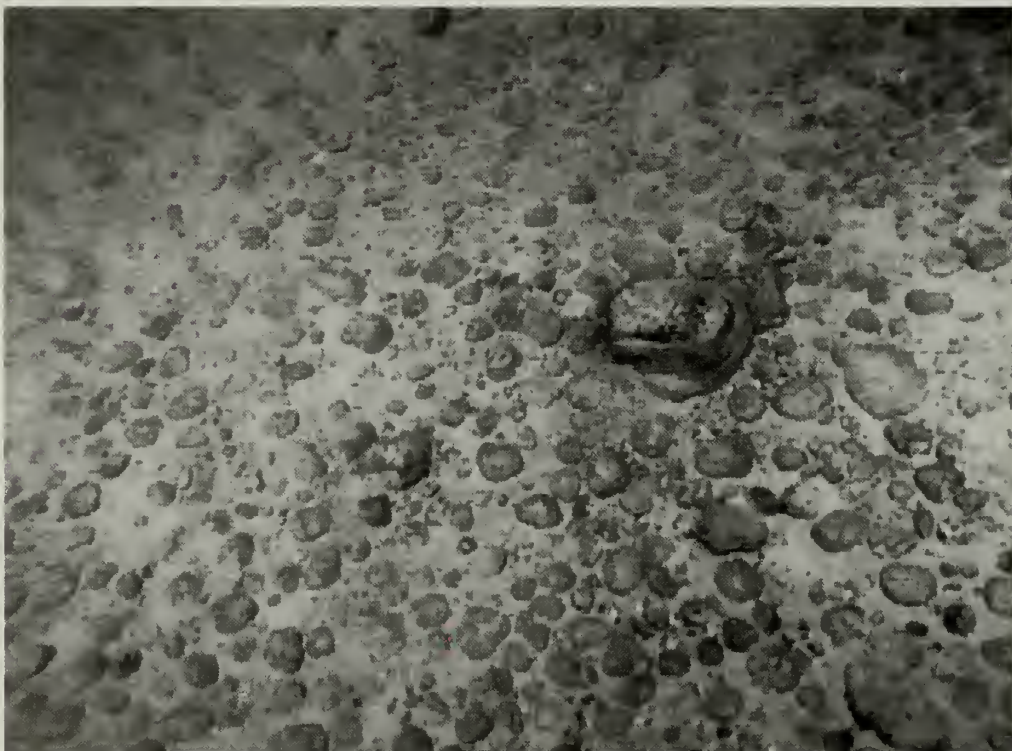
**Figure 5.** Category 5: Dispersed rubble with sand.

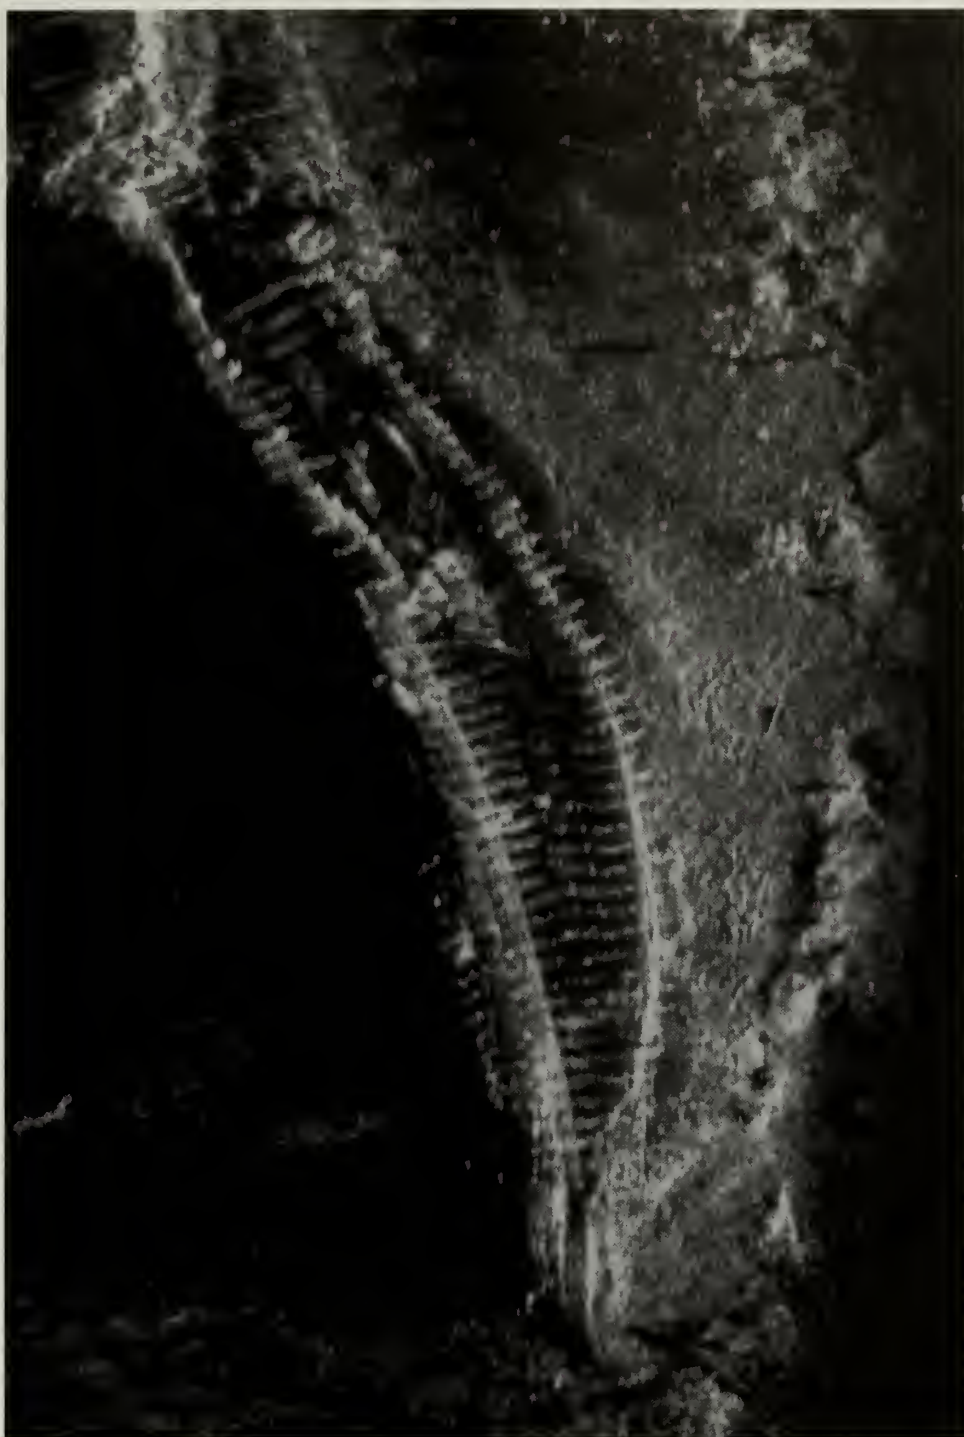
**Figure 16.** Sonograph of *E. C. Waters'* site showing hull features and surrounding bottom areas. Curvature is the result of the survey vessel's path. *E. C. Waters'* bow is at the bottom of the image.

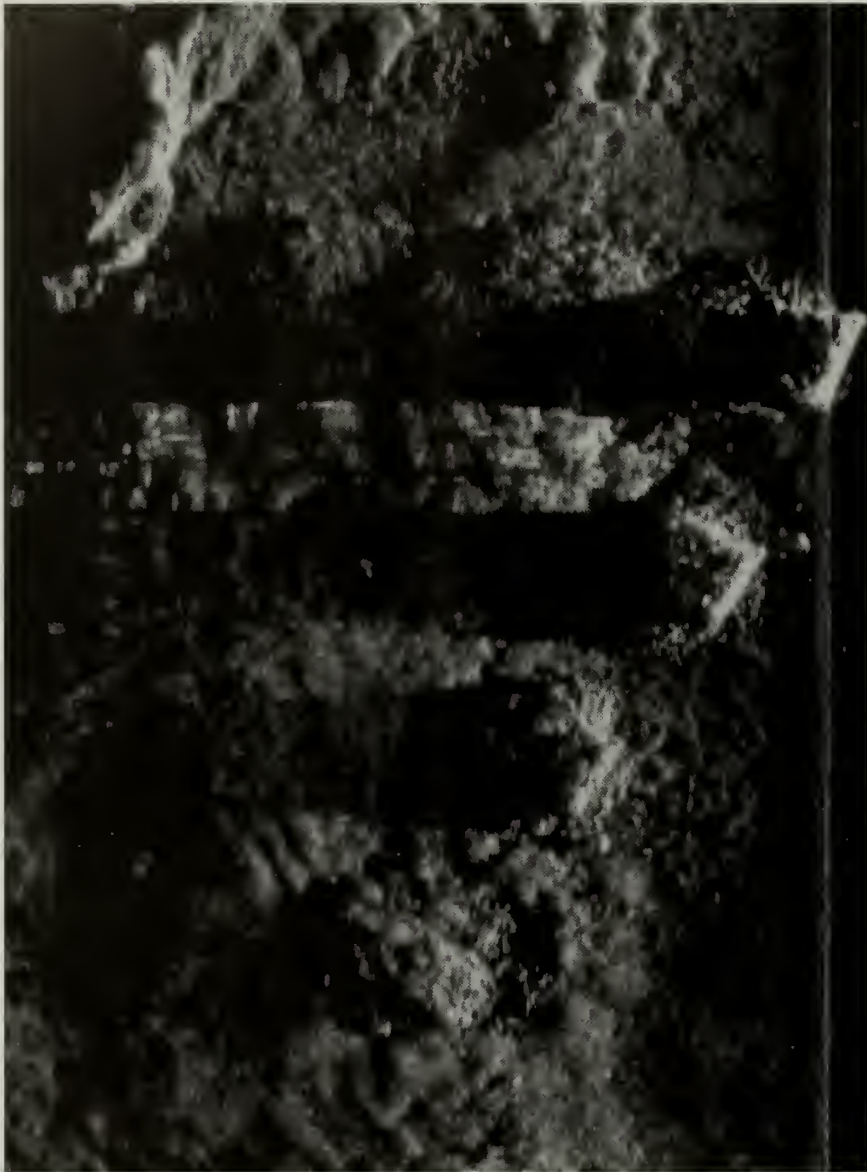
**Figure 17.** Sonograph of the West Thumb dock supports (cribbing).

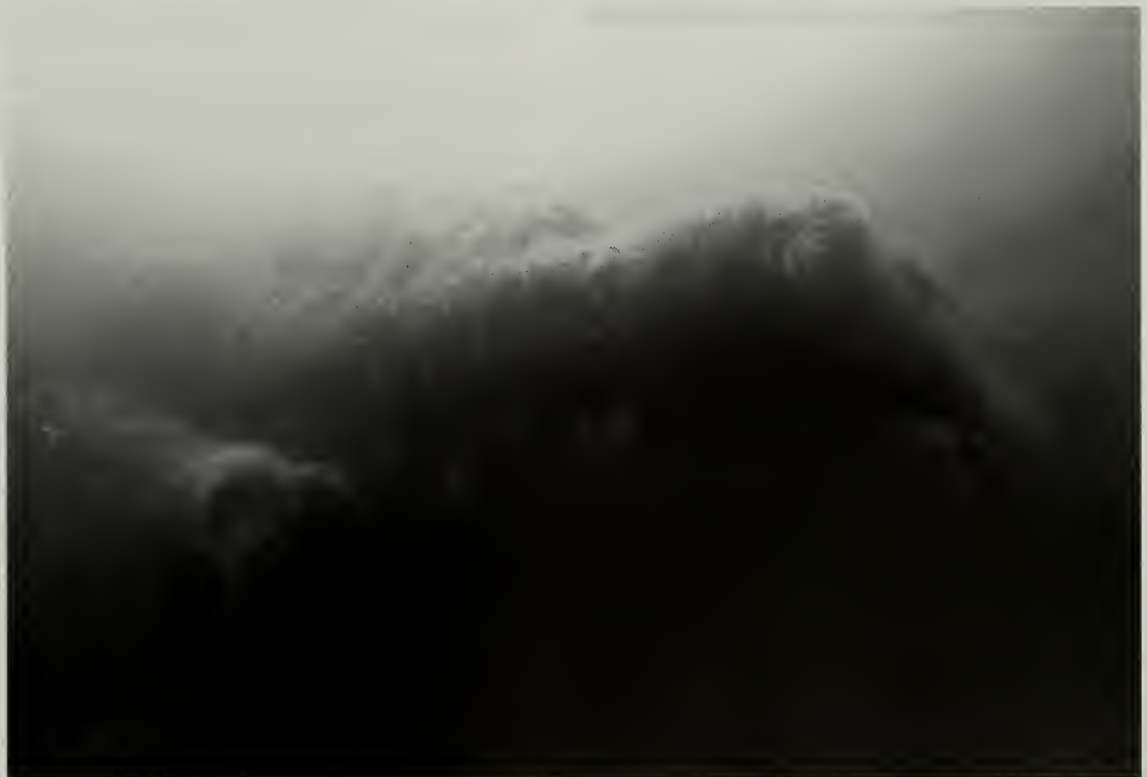
**Figure 5.3.** Algae covered dock crib at West Thumb. NPS photo by Brett Seymour.

The cribs are about 12 ft. on a side, with what appears to be an interior wall of logs dividing each crib into two parts. The cribs are made of logs ranging from 7 to 11 in. in diameter, with the majority about 8 in. in diameter. Almost solid algae growth and spilled rocks prevent complete documentation of the crib corners. Logs on all sides abut those above and below, creating a solid wall. The lower logs are shortened to accommodate the lake bottom slope, with those higher in the wall being the full 12 ft. in length or, in some cases, two logs with ends abutting to achieve the total length of a side. The crib corners are fastened with a

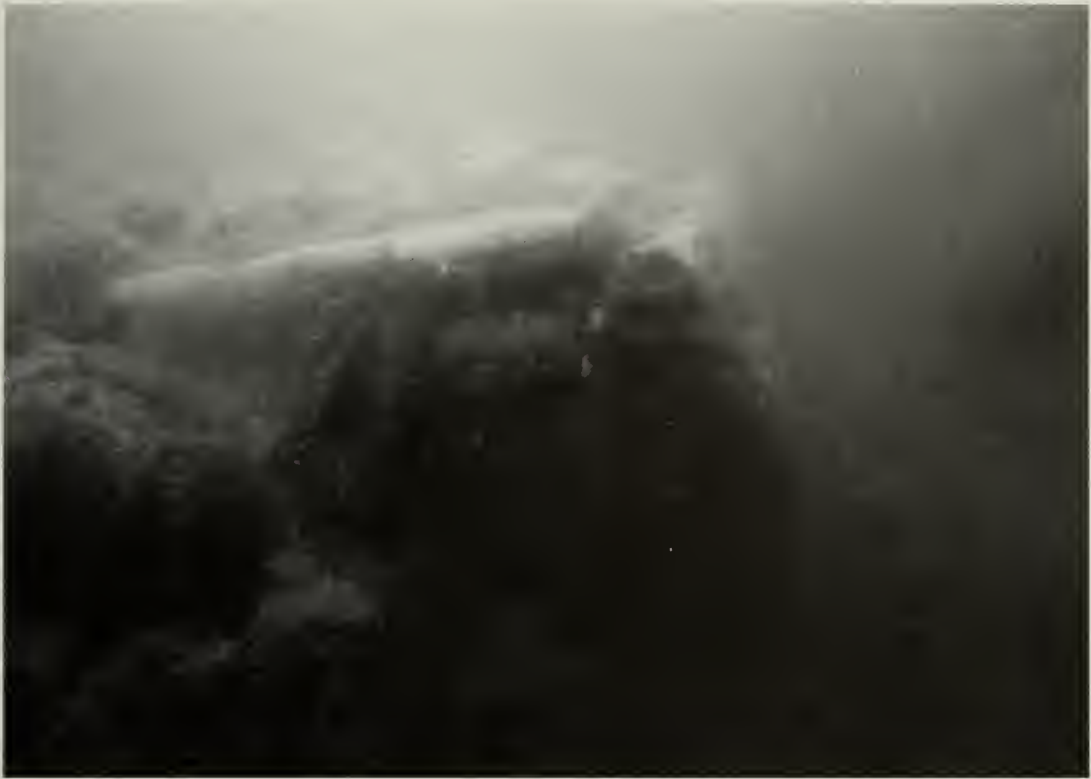
**Figure 5.8.** West Thumb dock crib. NPS photo by Brett Seymour.

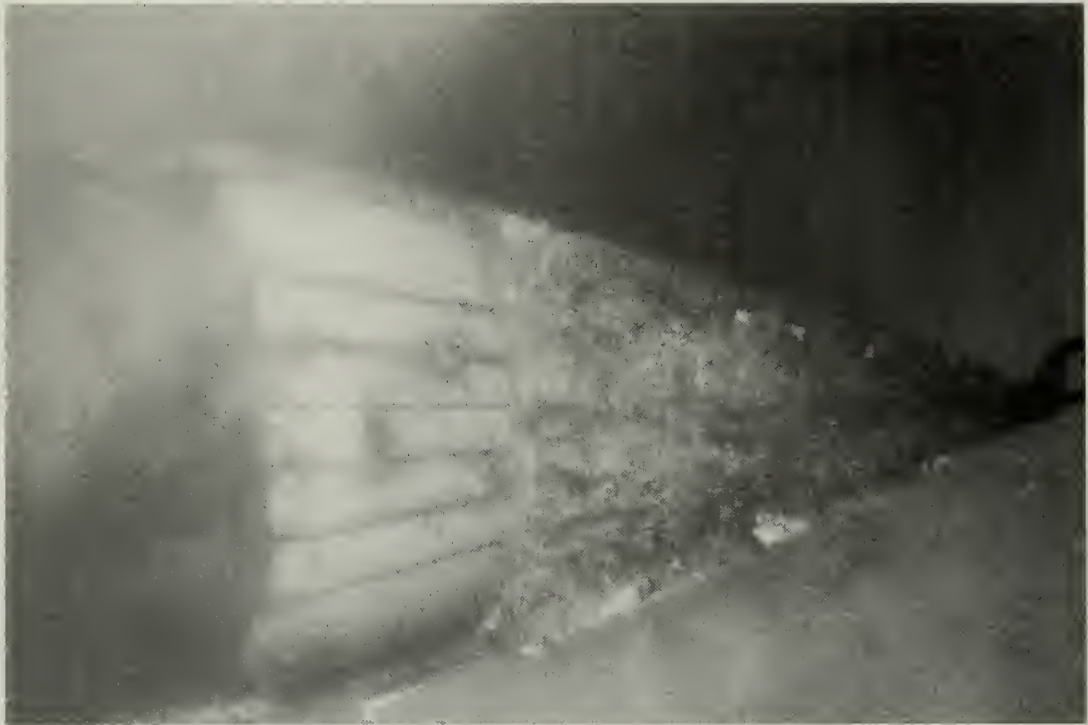
**Figure 5.17.** Small boat bow. NPS photo by John Brooks.

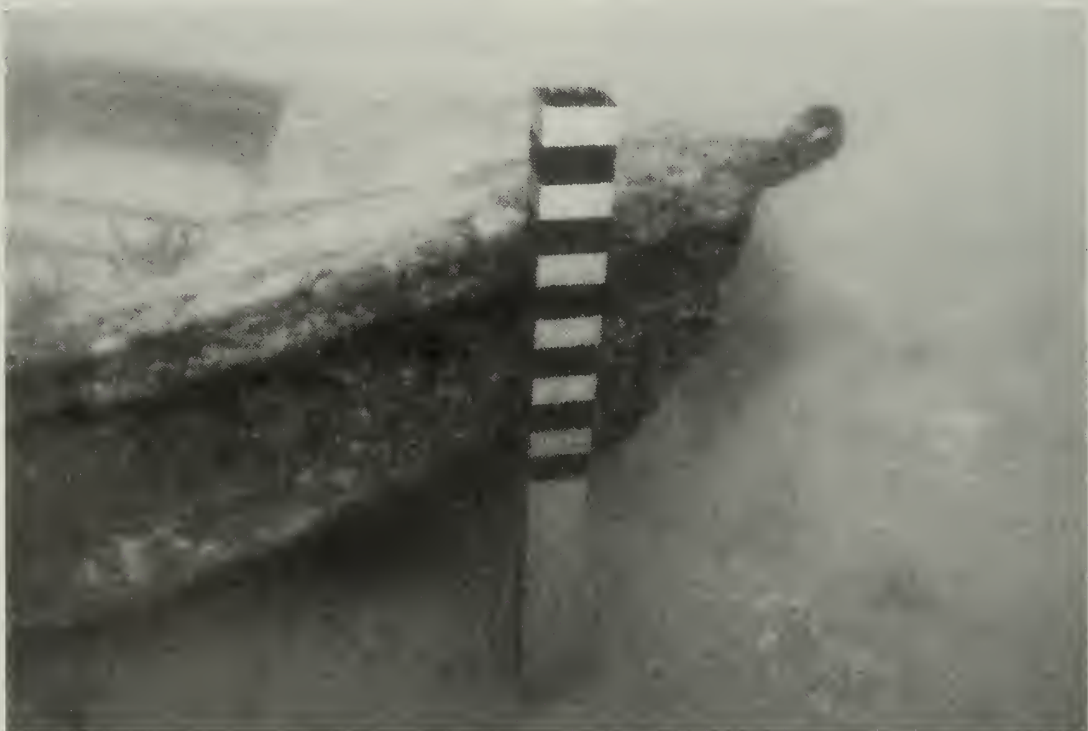
**Figure 5.18.** Small boat bow. Scale in inches. NPS photo by John Brooks.

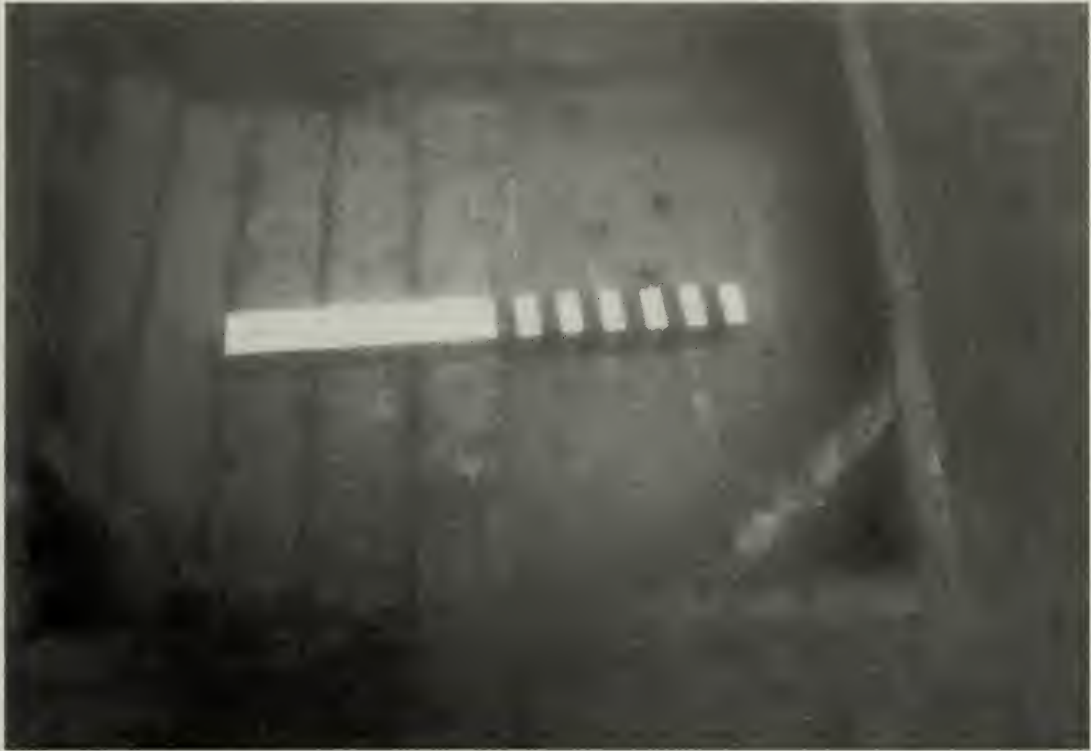
**Figure 5.19.** Small boat stern. Scale in feet and inches. NPS photo by John Brooks.

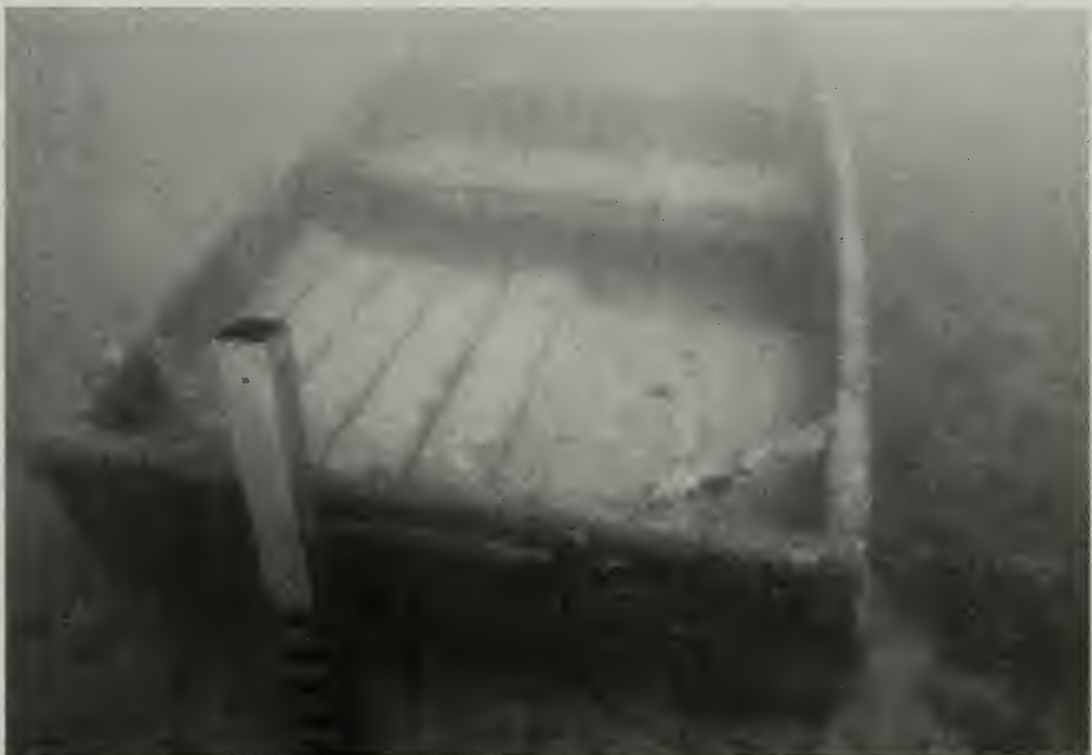
**Figure 5.20.** Small boat stern. Scale in feet and inches. NPS photo by John Brooks.

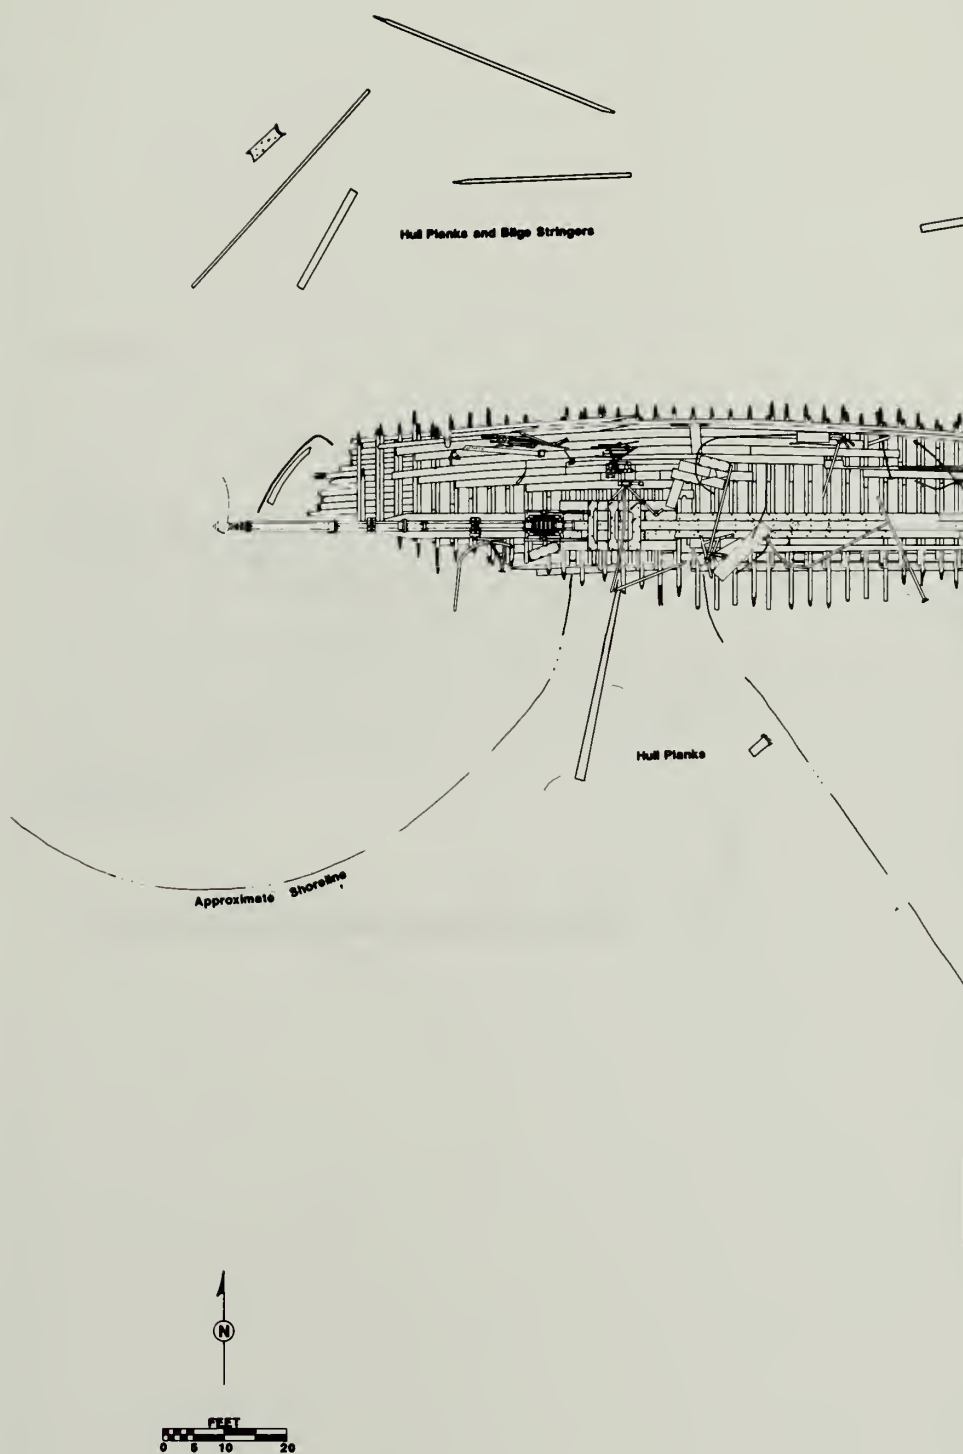
**Figure 5.27.** Plan view of *E. C. Waters'* site (48YE13). Drawing by Jim Bradford and Matt Russell.

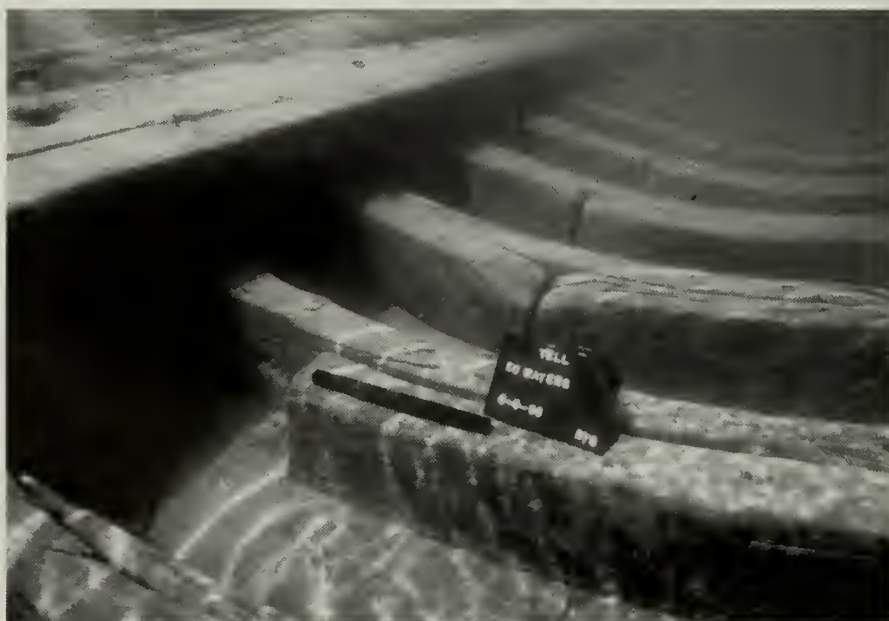
**Figure 5.29.** *E. C. Waters'* frames. View aft of paired frames with butt joints in the wreck's forward port section. The main and sister keelsons overlay the frames in the upper left. Scale = 1 foot. NPS photo by Brett Seymour.

*E. C. Waters'* framing was constructed using a peculiar combination of the long-and-short-

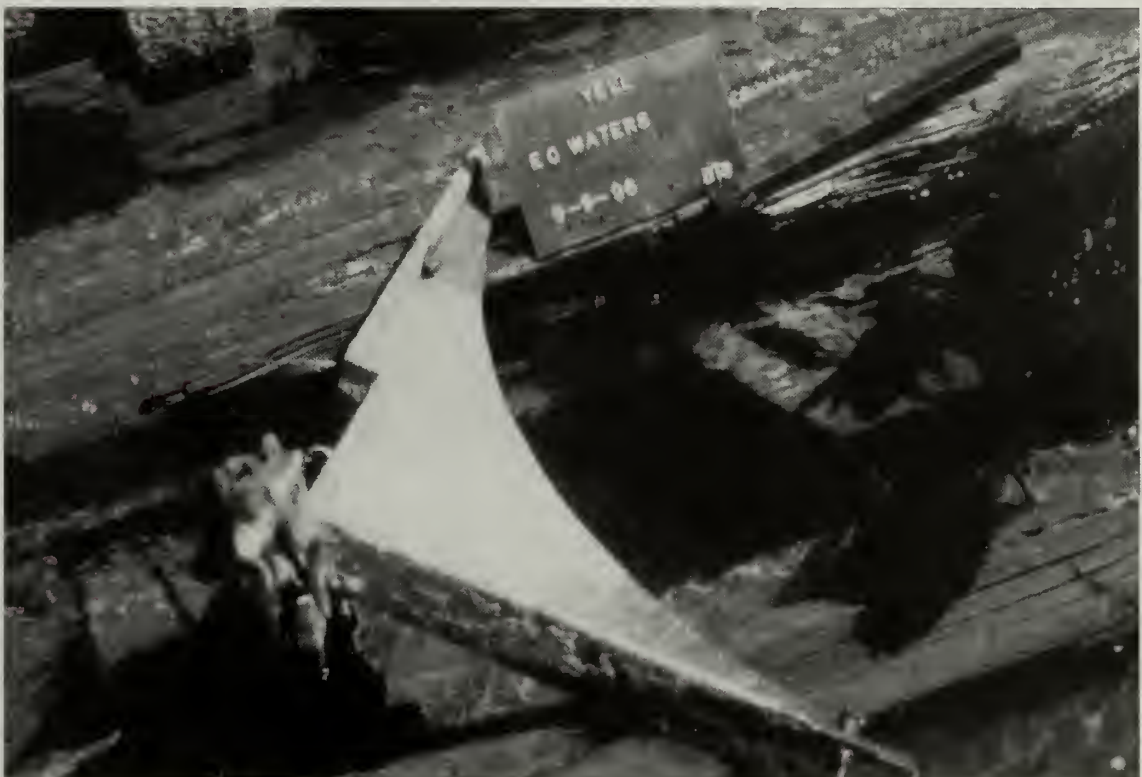
**Figure 5.33.** Boiler saddle. Scale = 1 foot. NPS photo by Brett Seymour.

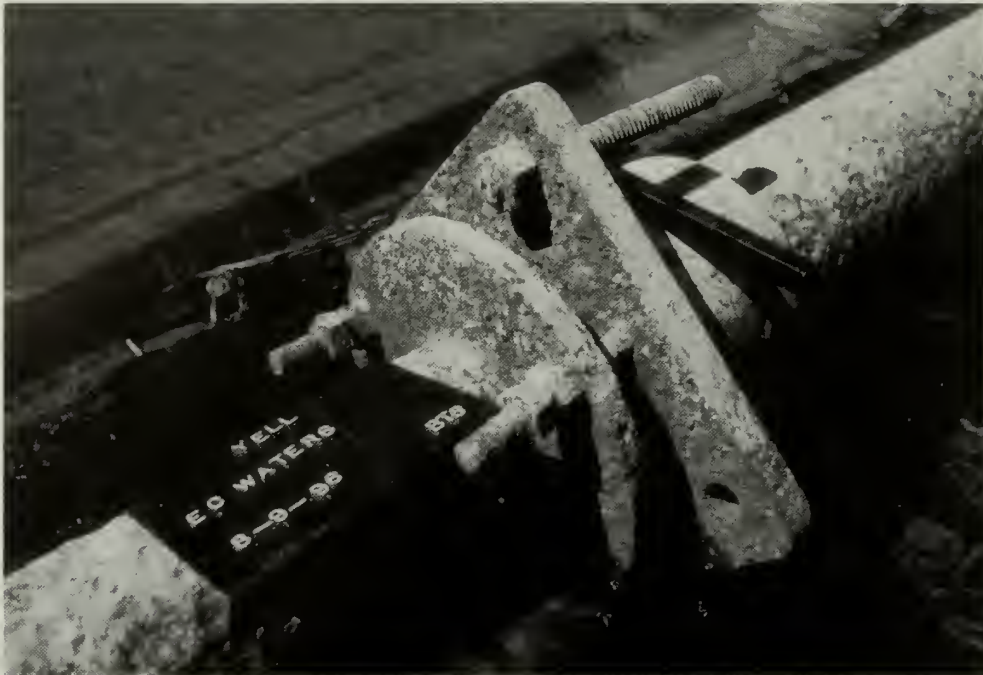
**Figure 5.39.** View southwest of forward end of stern tube stuffing box and gland. Note large bolt on top that secured the shaft to the stern deadwood (now missing) through which it passed. Marked section of scale = 6 inches. NPS photo by Brett Seymour.

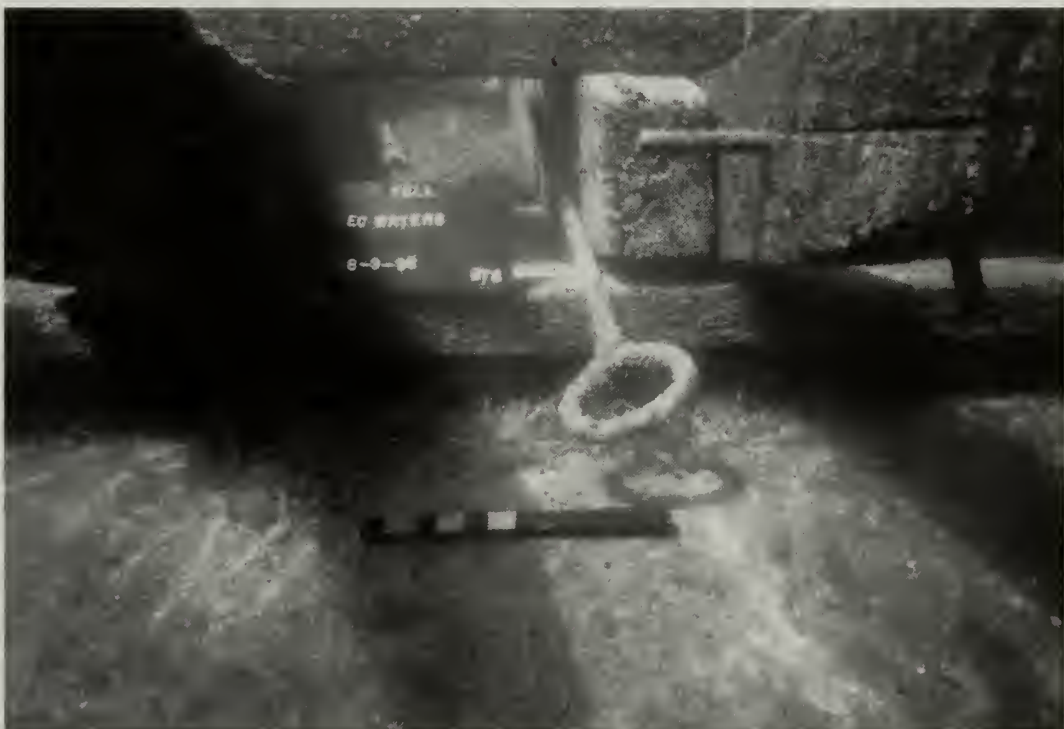
**Figure 5.50.** Metal rod handle wedged between frames on the port side turn of the bilge. Scale = 1 foot. NPS photo by Brett Seymour.
