Damaged and Threatened National Historic Landmarks 1987

National Park Service
U.S. Department of the Interior
Washington, D.C.

The report that follows, **Damaged and Threatened National Historic Landmarks for 1987** lists and describes those Landmarks which are threatened or damaged to such an extent that the nationally significant features for which the sites were designated are in danger of being irreversibly damaged or destroyed.

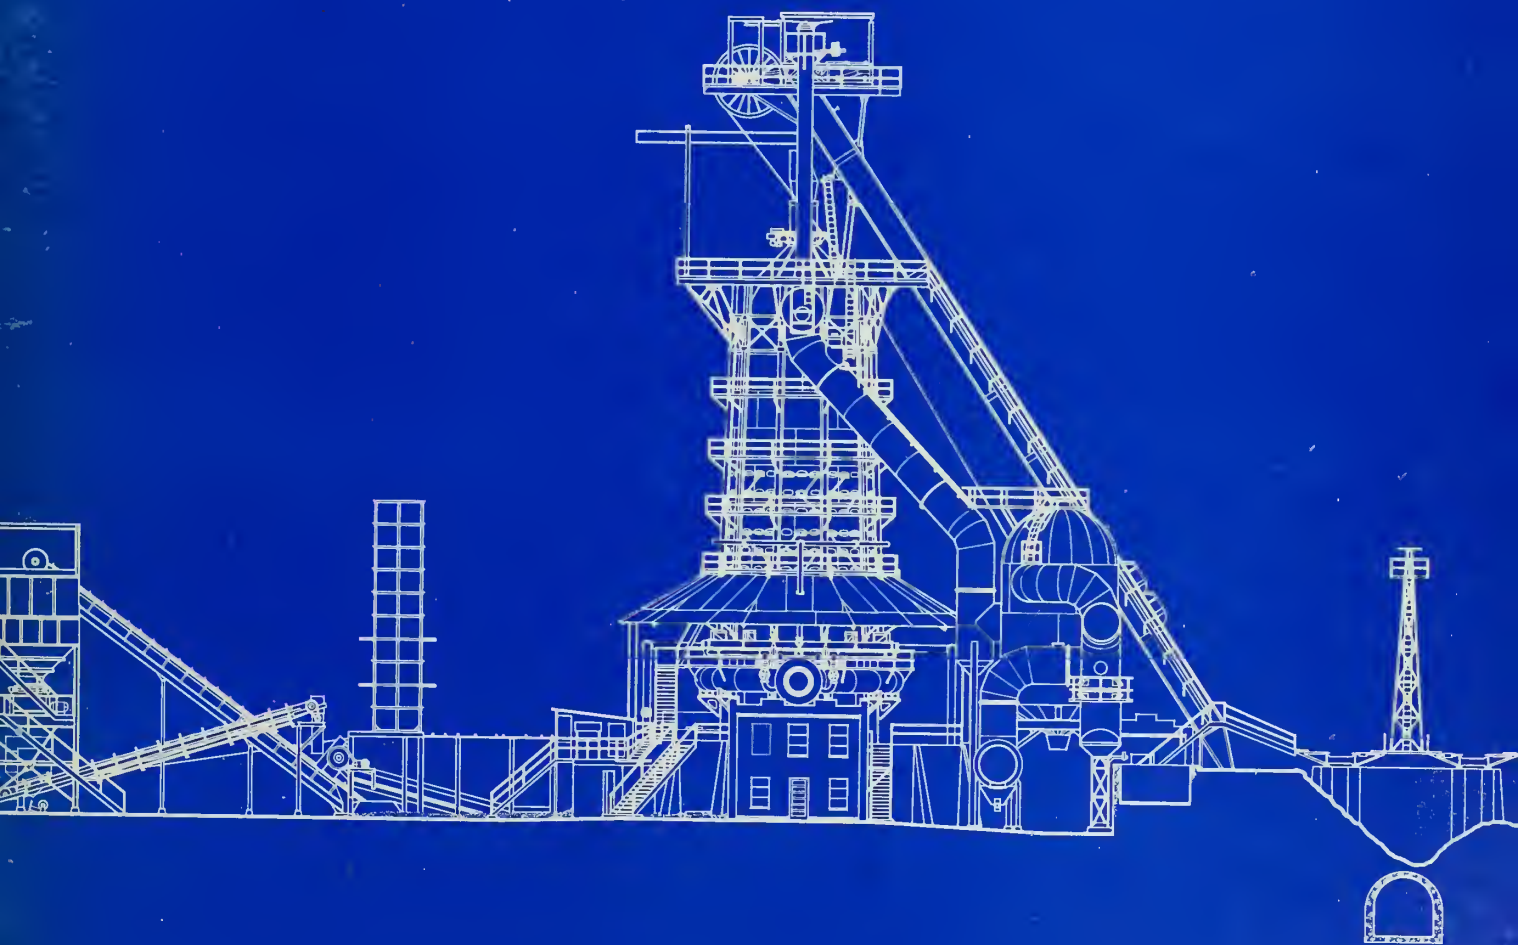
Cover: Sloss Blast Furnaces, Birmingham, AL. This landmark, which includes two blast furnaces, casting sheds, blowing engines, coke ovens and stockbins, is one of the oldest extant industrial complexes for the manufacture of iron in the Post-Civil War South. Flooding has caused extensive corrosion of the metal structural elements and foundation. Photo: Courtesy, Historic American Engineering Record, NPS.

Threat/Damage: Severe Physical Deterioration. The tunnel running underneath the stock trestle floods when it rains, causing corrosion of the metal structural elements and foundation. Remaining coke and limestone inside the furnaces mixes with rainwater to form a caustic solution which attacks paint and metal. Plants and trees growing between walls and foundations are cracking brickwork and damaging mortar.

Recommended Action: Stabilization/Rehabilitation. The site was acquired by the city for development as a museum, and some preservation work was completed; however, further stabilization and repair of the complex are necessary. An intensive program to eliminate damaging vegetation and control their regrowth should be initiated at once. Long-term preservation of the site as a museum is desirable, together with repair of key historic features.

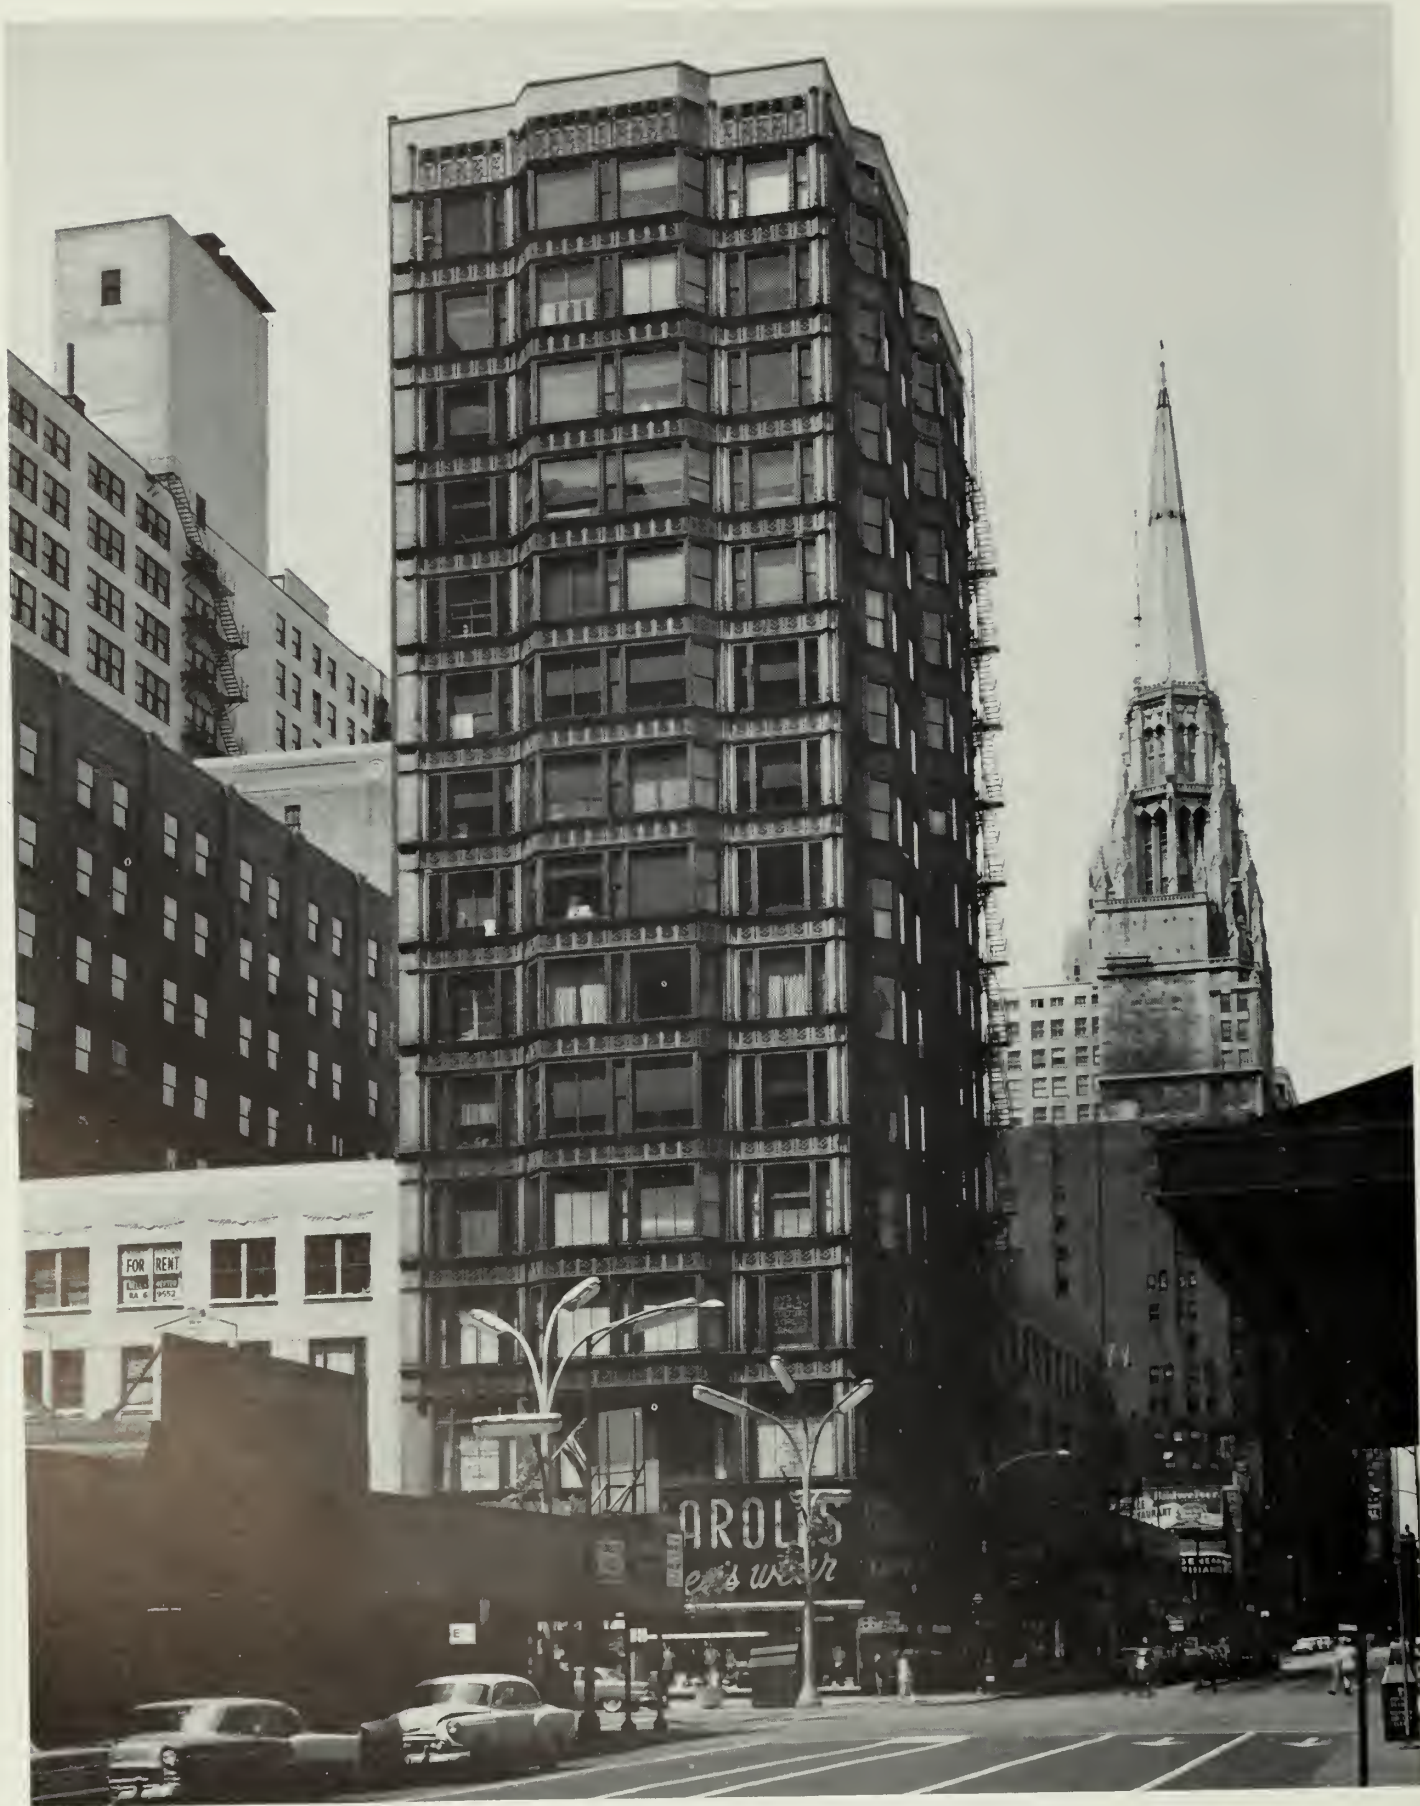
Reliance Building, Chicago, IL. This architecturally significant building is one of the key monuments in the development of modern architecture. Lack of maintenance has led to severe deterioration of the glazed terra cotta panels on the exterior. An NPS indepth inspection identified needed repair work. Photo: NPS.

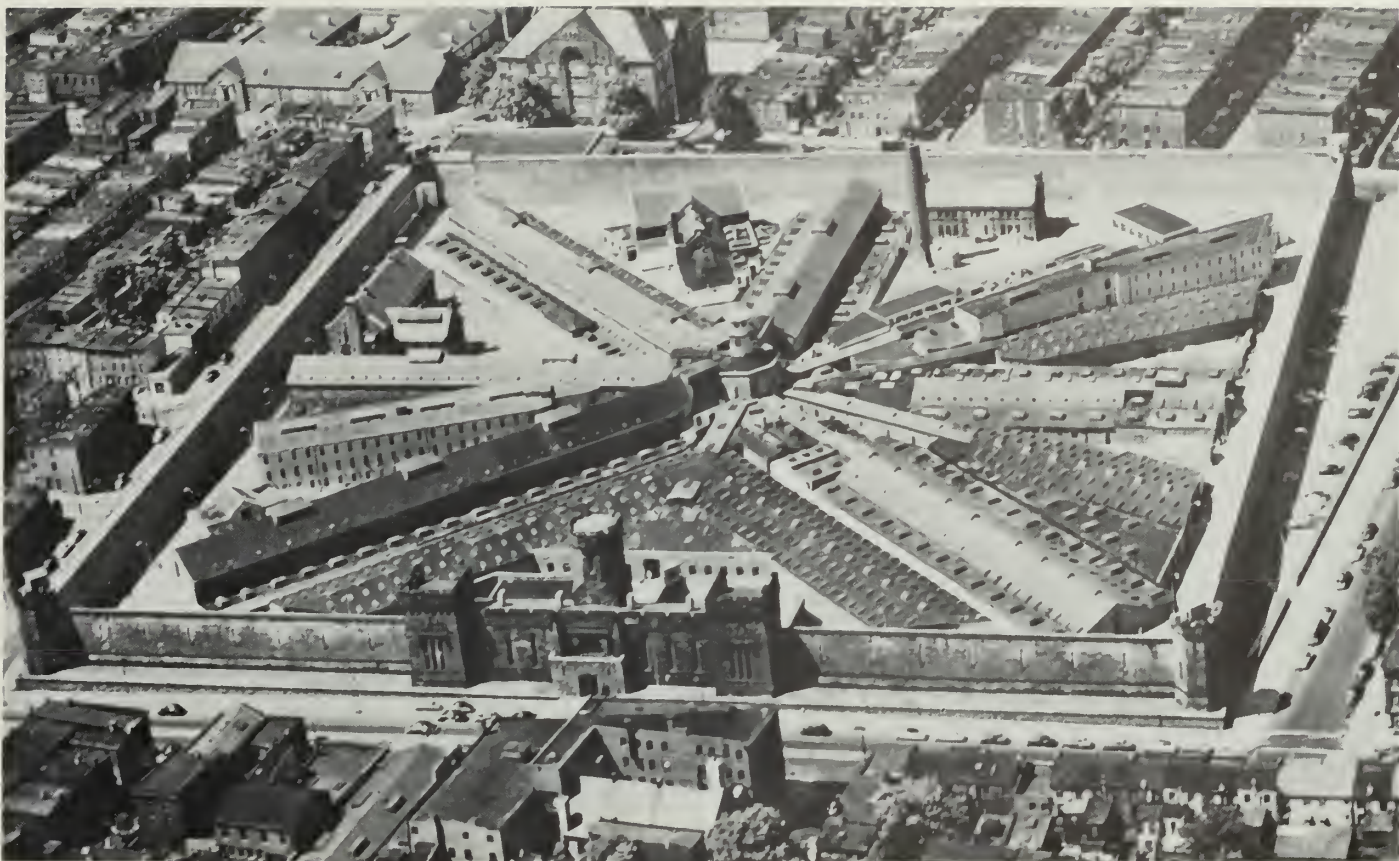
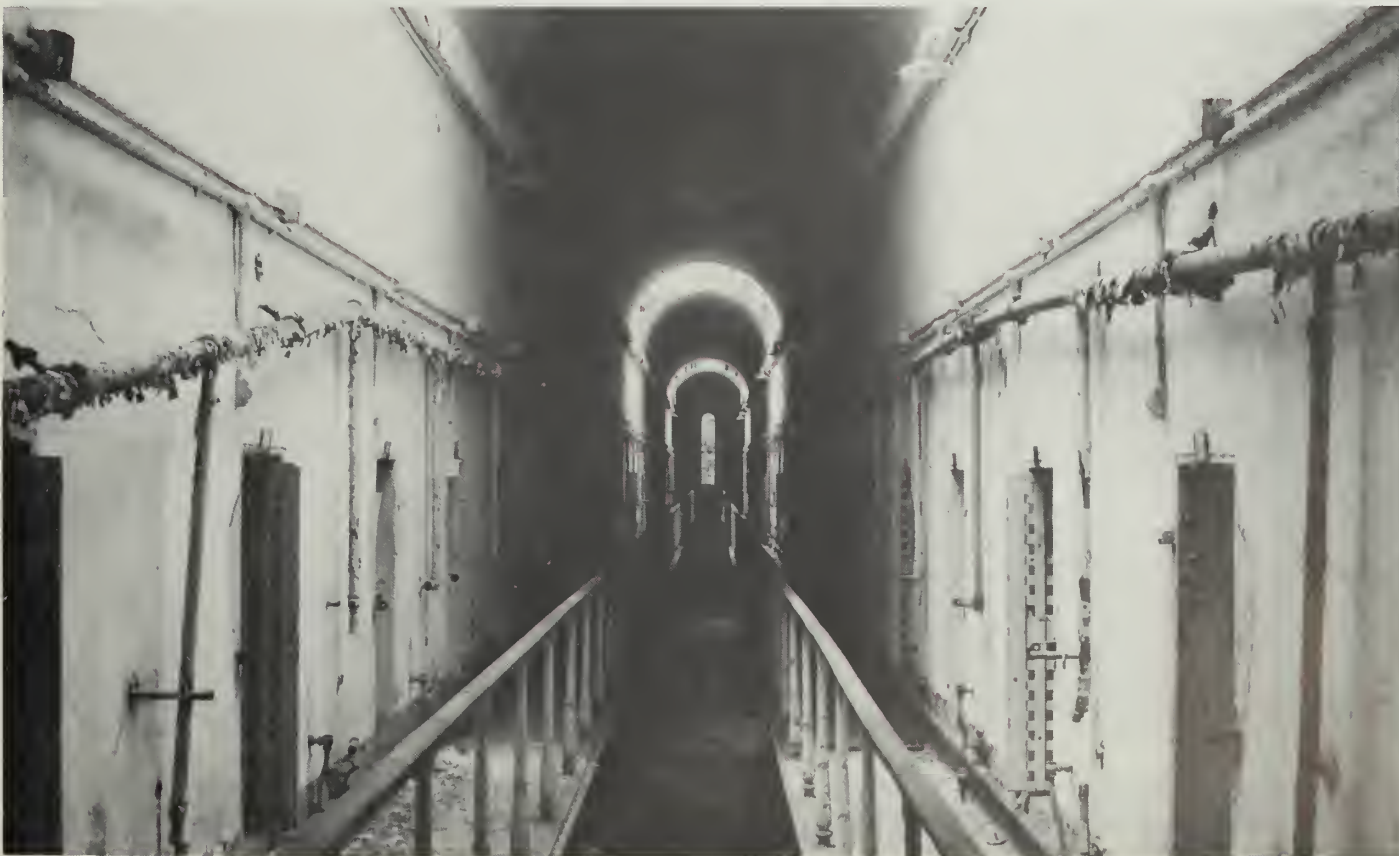
Eastern State Penitentiary, Philadelphia, PA. This stone Gothic Revival structure became an international model in prison management and design in an effort to make prison an instrument of reform rather than punishment. The structure has been vacant since 1970 and is severely deteriorated on the interior. Above: Aerial view illustrating the central rotunda from which radiate several cell blocks, seven of which were original. Photo: Courtesy, Historic American Buildings Survey, NPS. Below: Typical two-story cell block. Photo: NPS.

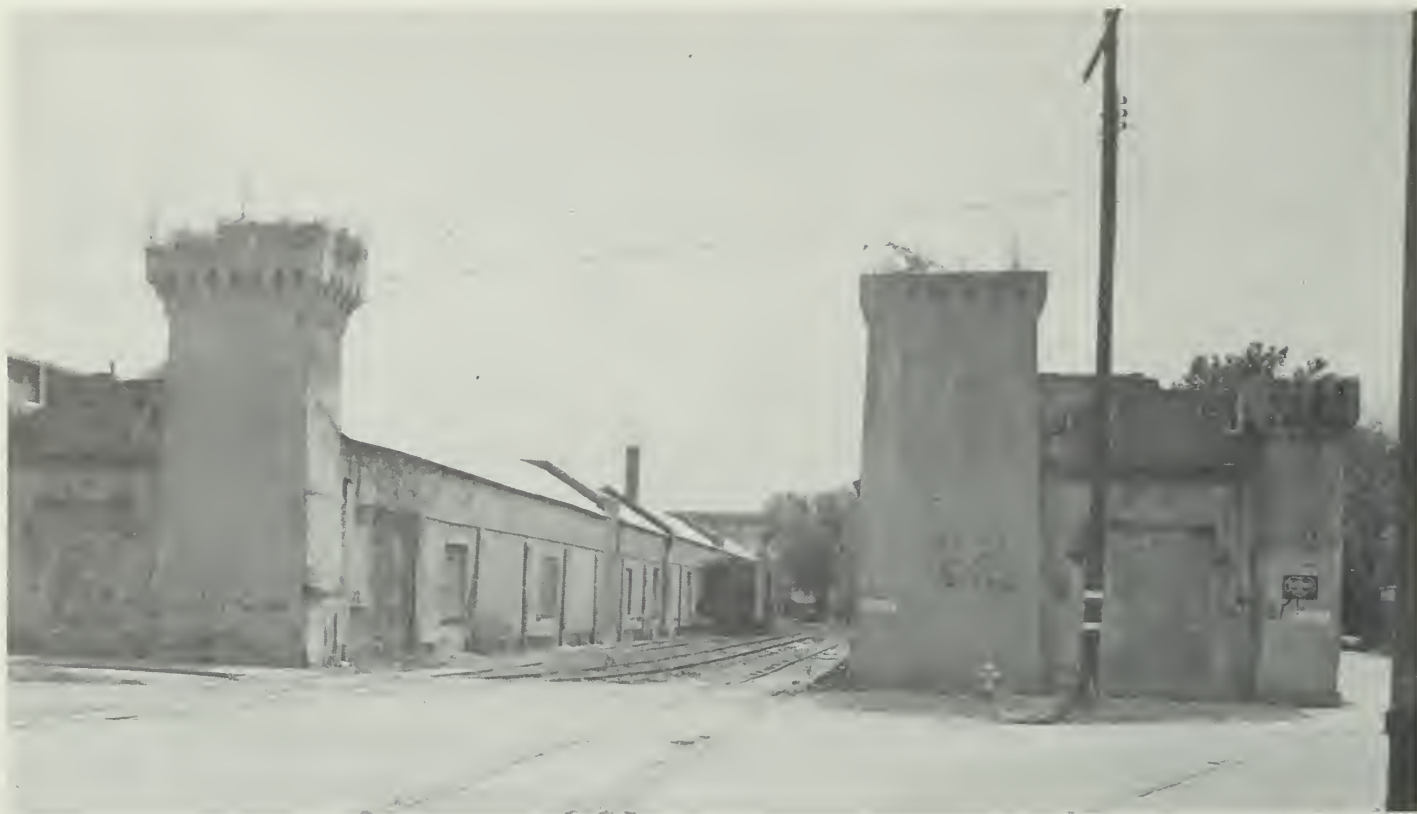
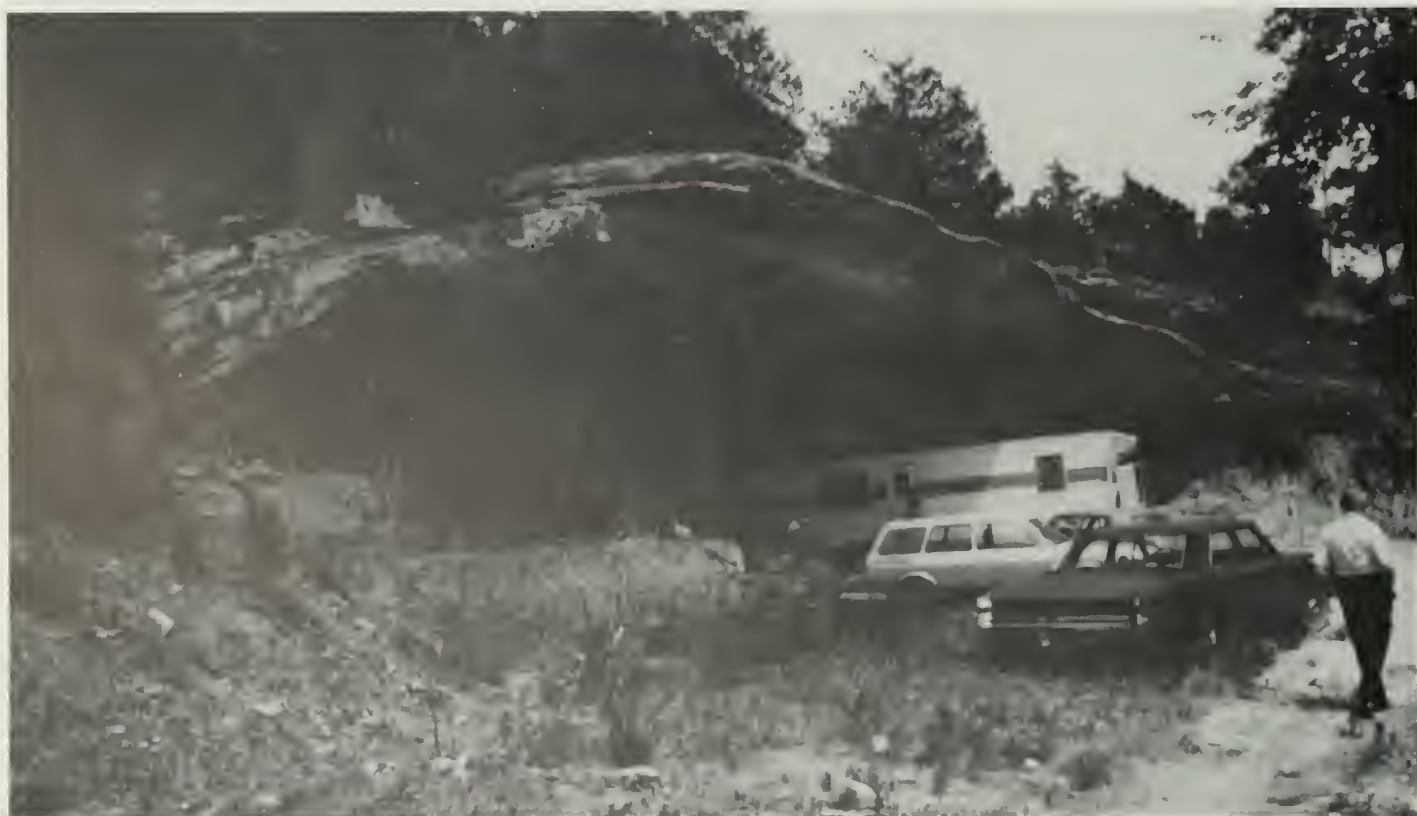
William Aiken House and Associated Railroad Structures, Charleston, SC. These railroad structures comprise the best extant collection of antebellum railroad structures in the U.S. The structures are vacant. Because no repairs have been made in years, the structures are in severely deteriorated condition. Photo: Courtesy, Historic American Buildings Survey, NPS.

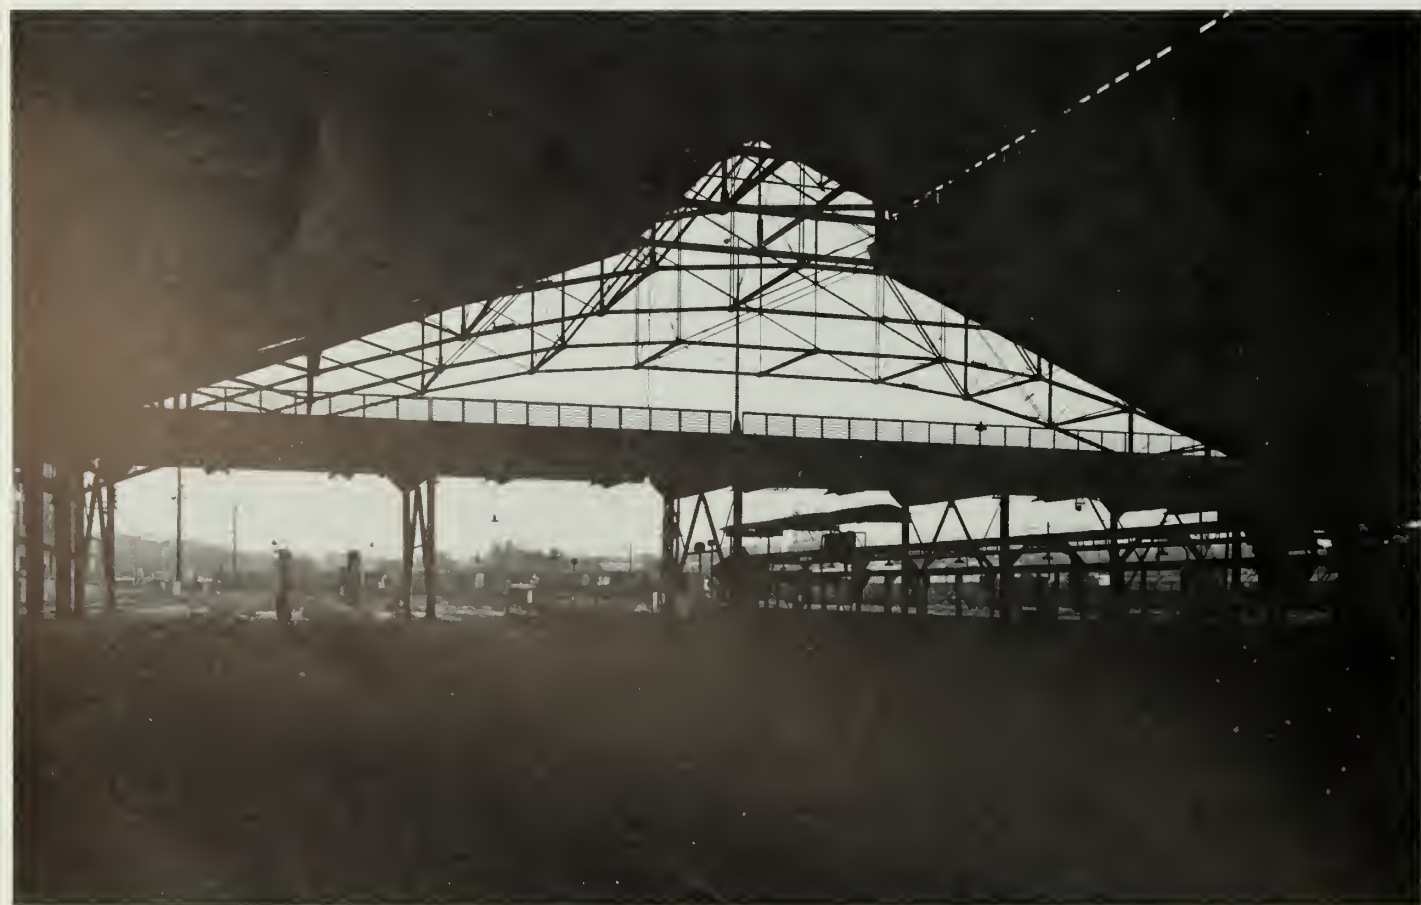
Nashville Union Station and Trainshed, Nashville, TN. The station's trainshed is the largest, single span, gable-roofed trainshed in America. The structural system developed for the trainshed made a significant contribution to the evolution of modern building methods. The trainshed has been vacant for several years, damage to the structural system is accelerating, and new owners are considering moving or tearing the structure down. Above left: Romanesque Revival train station. Above right: Trainshed. Below: Interior of trainshed illustrating steel trusses and I-beams. Photos: Courtesy, Historic American Buildings Survey, NPS.

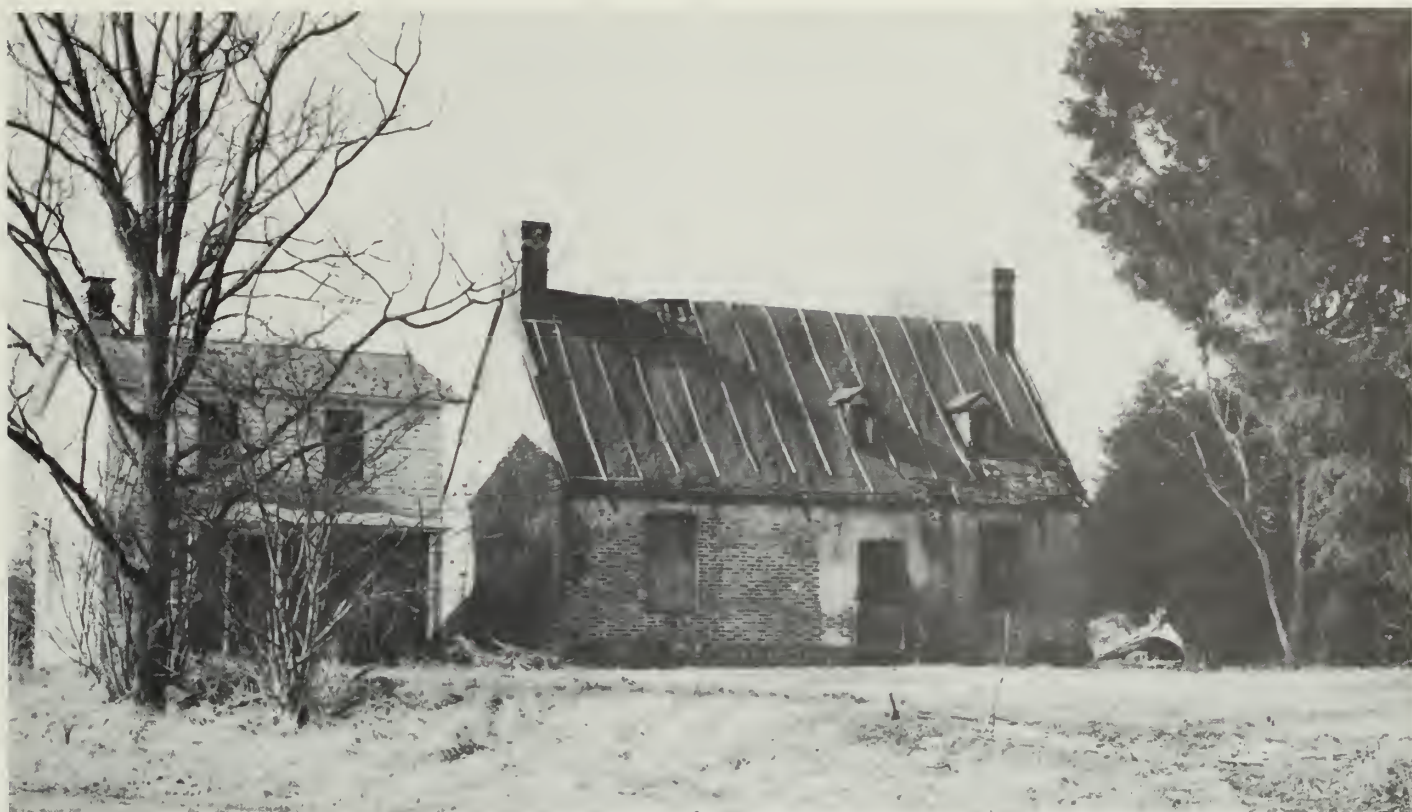
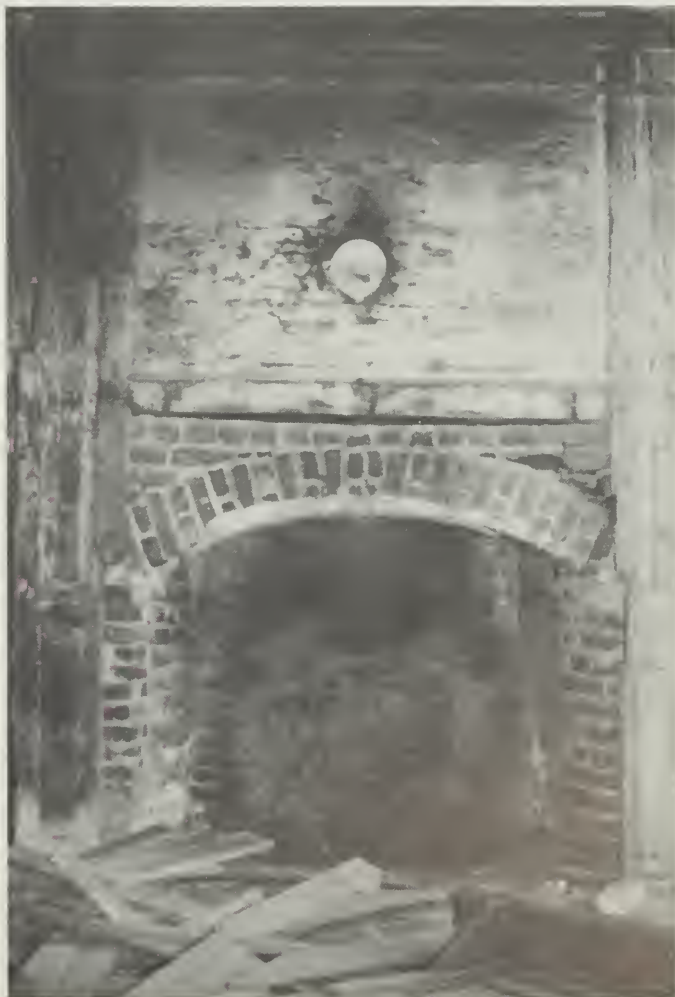
Resurrection Manor, St. Marys County, MD. This early 18th-century building is one of the earliest extant brick farmhouses in the United States. It is located on property that was one of the first manorial grants made in Maryland. The building has been listed in the Section 8 Report since 1983. Lack of repairs and maintenance have accelerated damage to the building. Holes in the roof have caused most interior features to deteriorate. To make way for residential development, Resurrection Manor may be demolished. Above: Current exterior view of Resurrection Manor. Right: Interior view of deteriorated paneled wall around fireplace. Photos: NPS.

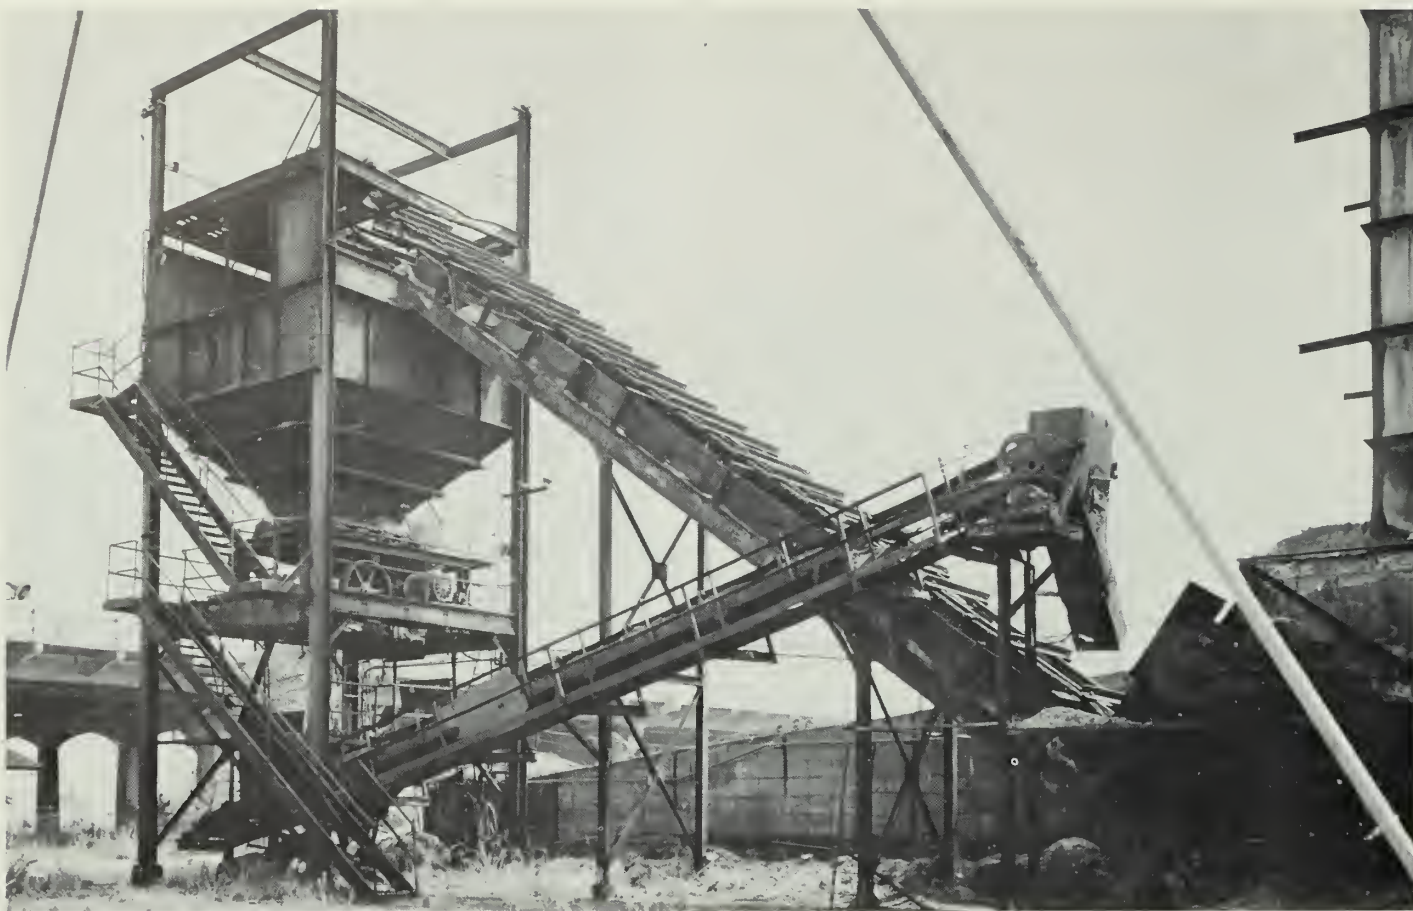
Above: Sloss Blast Furnaces, Birmingham, AL. One of ten structures listed in the 1987 Section 8 Report, this landmark is threatened by increased metallic corrosion and damaging plant growth between walls and foundations. See cover photo of entire complex. Photo: Courtesy, Historic American Engineering Record, NPS.

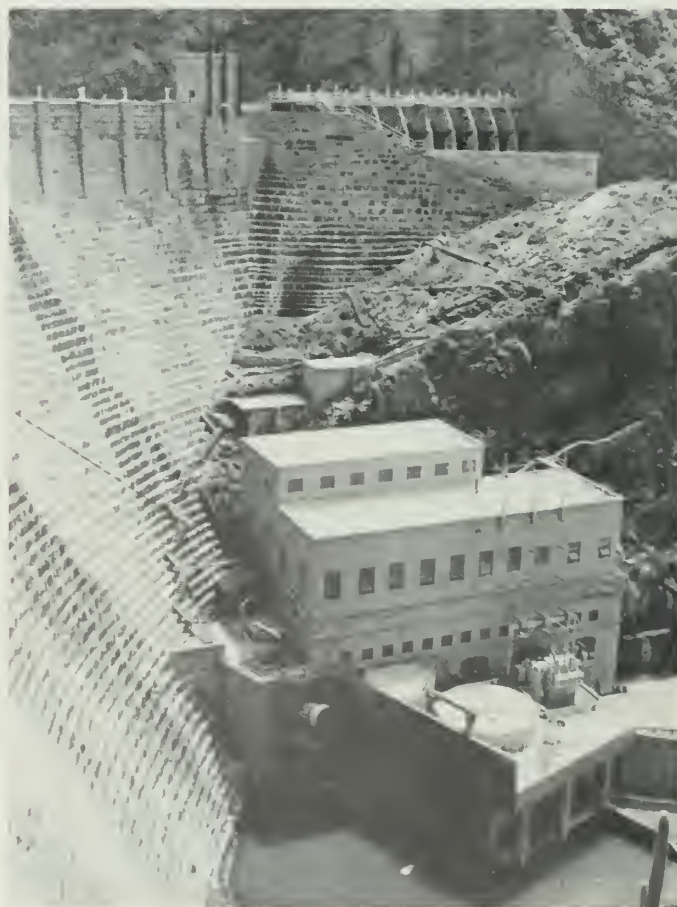
Right: Roosevelt Dam, Gila County, AZ. This dam was the first major project completed under the Reclamation Act (1902), designed to increase the agricultural productivity of this arid region. Proposed construction of a reinforced concrete addition at the top of the dam would alter its historic appearance. Photo: NPS.

Threat/Damage: Inappropriate New Construction/Alterations. A proposal to increase the emergency flood control capacity of Roosevelt Lake, raising the level of the dam by 68 feet, will require construction of a reinforced concrete addition at the top of the granite-faced dam. Such proposed new construction would radically alter the historic appearance of the landmark and irrevocably impair its integrity.

Recommended Action: Documentation. The loss of integrity of Roosevelt Dam seems certain, although the actual project work has not begun. The National Park Service is continuing to assist the Bureau of Reclamation in completing the recording of this landmark to Historic American Engineering Record Standards. If proposed construction is undertaken, dedesignation may be appropriate.
