# ACADIA TRAILS TREATMENT PLAN

## CULTURAL LANDSCAPE REPORT FOR THE HISTORIC HIKING TRAIL SYSTEM OF ACADIA NATIONAL PARK

Olmsted Center for Landscape Preservation  
National Park Service, Boston, Massachusetts, 2006

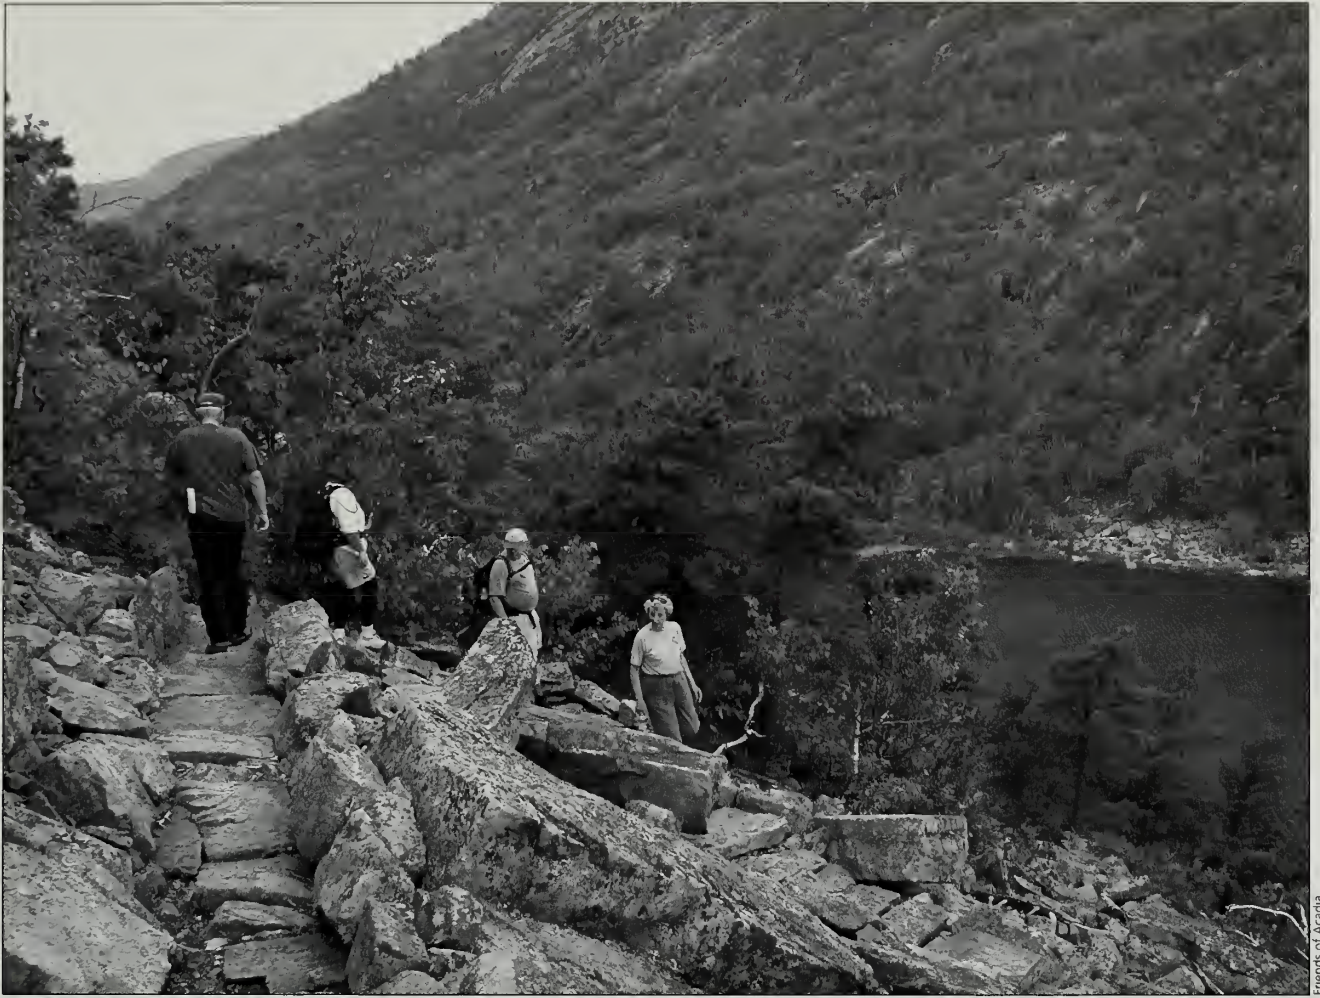
Winding steps on the Beachcroft Path, a memorial path constructed in 1915, then rebuilt and endowed in 1926.

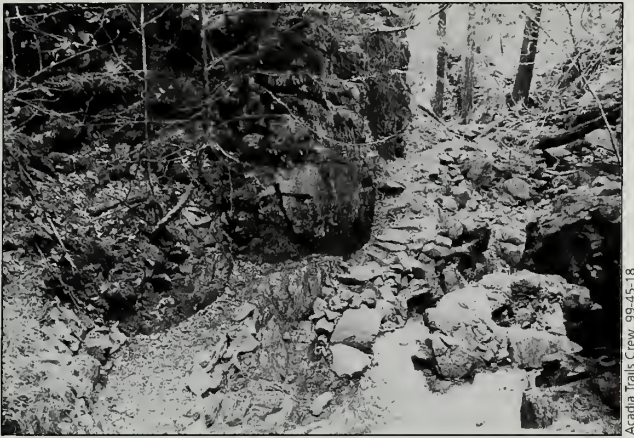
Fig. 1-2 Streamside route on Maple Spring Trail (#58).

The alignment of Acadia's trails can be further subdivided into different route types. Although a trail may include several route types, the overall trail will usually be defined by a predominant type. A **ridge-line route** is a direct alignment following the top of a ridge, usually running from the base of a mountain to the summit. Nearly all north-south-running trails at Acadia are ridge-line routes, like the Cadillac Mountain North Ridge Trail (#34). A **fall-line route** is a direct alignment ascending straight up the fall line, the line representing the flow of water. Examples include the Pemetic Mountain Trail (#31) and the southern portion of the South Bubble Trail (#43). A **sidehill route** travels perpendicular to the fall line at some elevation along the side of a hill. This type of route is usually achieved by bench construction, such as the Pond Trail (#20), and may be either a direct or designed alignment. A **switchback route** is a designed alignment

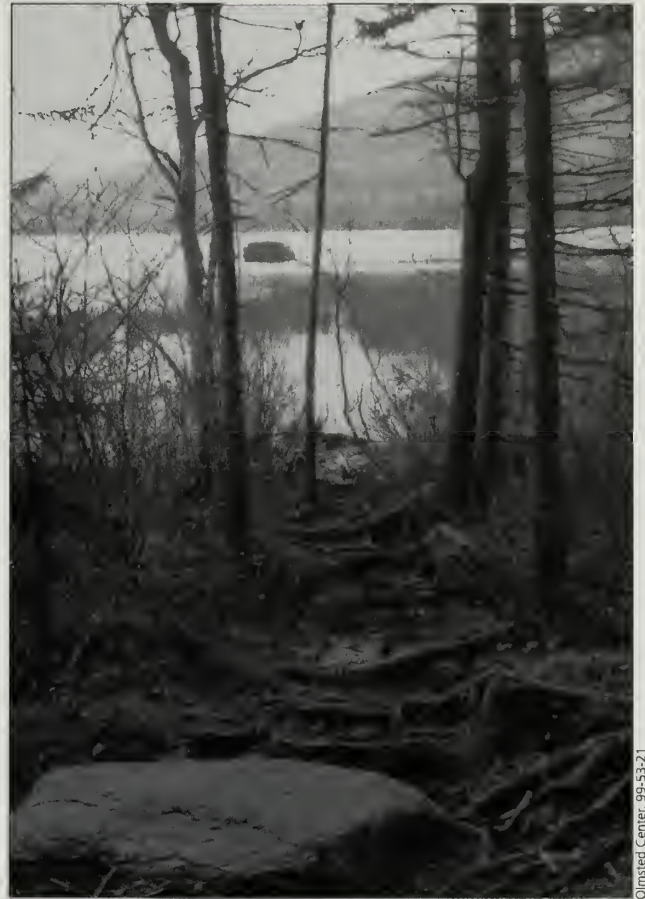
Fig. 1-3 The terminus of the Jordan Pond Carry Path (#38) at the north shore of Eagle Lake. This trail may have originally served as a portage route between water bodies.

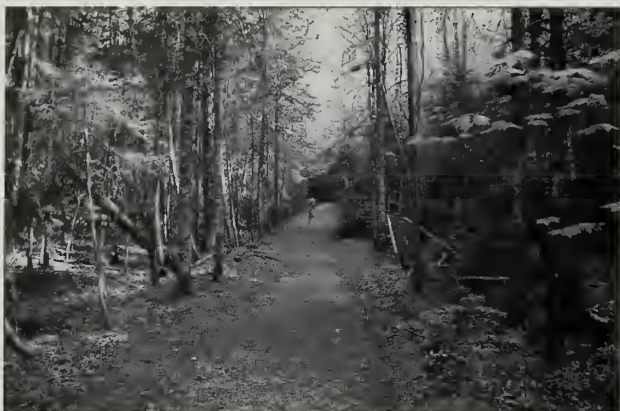
Olinsted Center, 6-97-13-6

**Fig. 1-4** Part of the Valley Trail's (#116) origin as a cart path can be seen in its width and linear character.

For the most part, Europeans settled along the coast, relying heavily on fishing, lumbering, boatbuilding, and trade for their subsistence. Inland paths were necessary for lumbering and agriculture. These routes tended to be direct, traveling along natural benches, up moderate slopes and through saddles where the grades were reasonable for a cart. Although most of these routes are now roads, some remain as part of the trail system, including the eastern half of the Valley Trail (#116) which was originally an early cart path (Fig. 1-4).

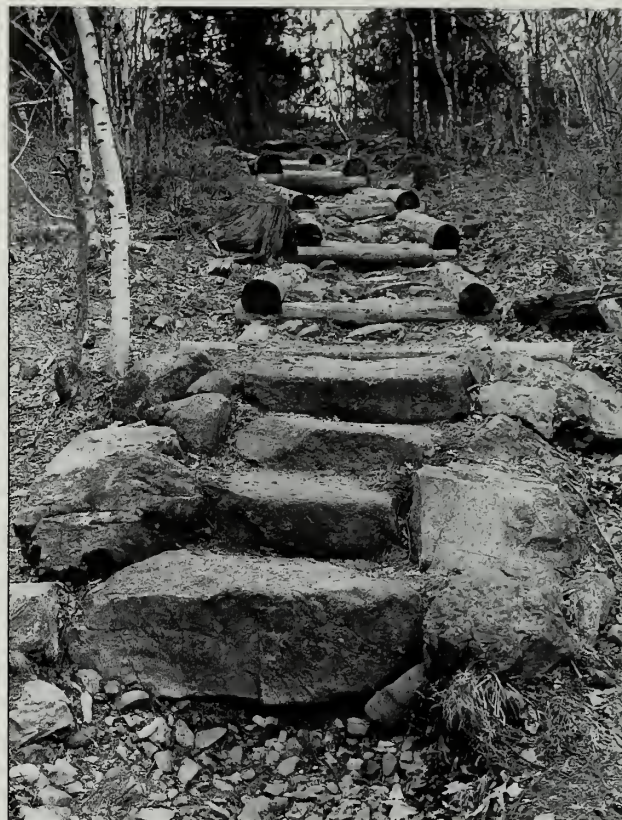
Acadia Trails Crew, 4-99-15-3

**Fig. 1-5** The Bear Brook Trail (#10) was an early route later stabilized with trail features like these stone and wooden crib steps.

Recreational travelers, artists, and writers that came to Mount Desert Island in the 1840s and 1850s were eager to ascend the mountains. They chose the most direct routes from their accommodations, mostly in Somesville and Eden [Bar Harbor]. They followed cart paths, livestock trails, drainage paths, animal paths, and scrambled across open ledges to reach the summits. Eventually, they established trodden routes and began marking them with piles of stones. The routes of the Bear Brook Trail (#10), the South Bubble Trail (#43), and the eastern half of the Beech Mountain Loop Trail (#113) are examples of early direct routes that were later stabilized and became maintained trails from the 1920s through the 1990s. Summit routes like these tended to be ridge-line or fall-line routes (Fig. 1-5).

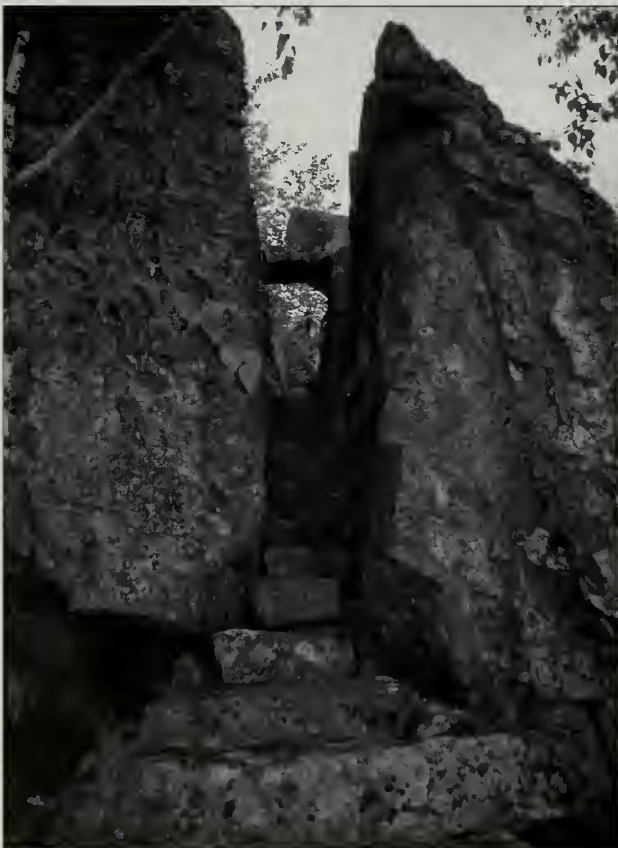
Olmsted Center, 8-00's

Fig. 1-8 The route of the Homans Path (#349) takes the hiker through this unique rock formation.

these designed alignments luxuriate in the ascent, take long, flat stretches through rock slides, switch back at stunning viewpoints, and reach for control points such as clefts in the rocks, overhangs, and waterfalls (Fig. 1-8). This was to become the standard of alignment and construction technique that later builders would struggle to duplicate.

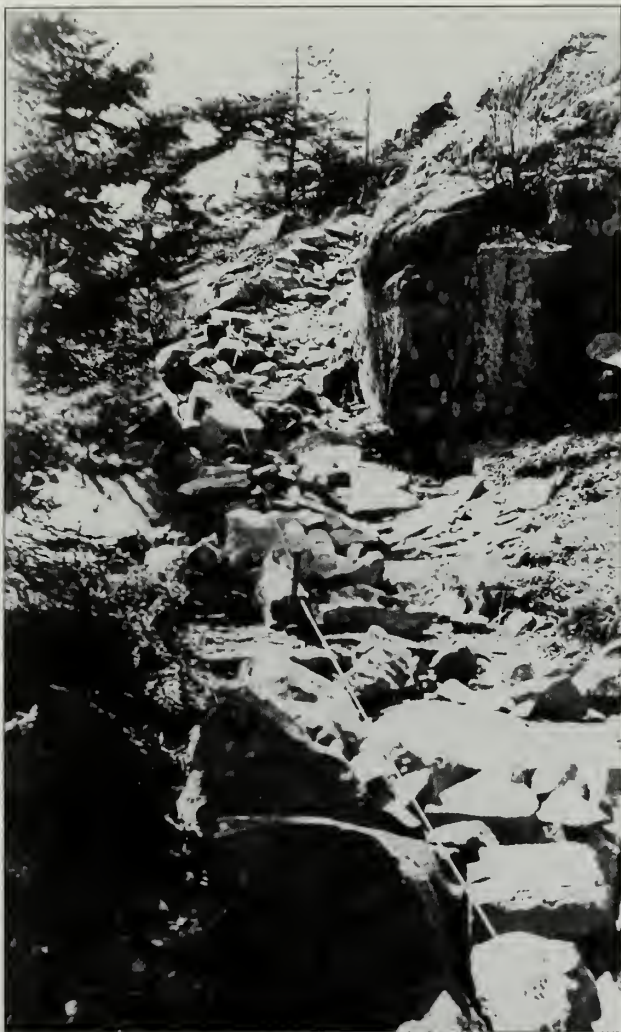
National Archives, Waltham, MA, 1930s

Fig. 1-13 The CCC used string to lay out the route and finished grade of their new trails, as shown at the construction of the Ocean Path (#3) at Otter Cliffs.

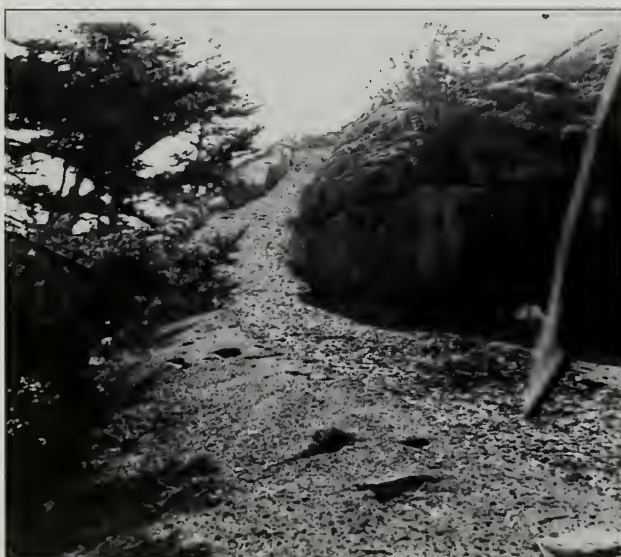
National Archives, Waltham, MA, 1930s

Fig. 1-14 Completed section of path shown in Fig. 1-13. The CCC emphasis on maintaining an even grade is evident in this newly completed section of the Ocean Path (#3) at Otter Cliffs.

Nearly all CCC trails at Acadia consist of sidehill alignments, with many containing switchback sections. Most of these trails were constructed as bench cuts in accordance with CCC guidelines. This allowed them to maintain a more consistent grade on trails like the Long Pond Trail (#118), Perpendicular Trail (#119), and much of the Ocean Path (#3) (Figs. 1-13 & 1-14). However, it is interesting to note that where the construction ends on trails such as Beech Mountain West Ridge Trail (#108), Long Pond Trail (#118), and Perpendicular Trail (#119), the alignment reverts to fall-line, otherwise avoided by the CCC. This is evidence that these trails were not intended to be left as they are today.

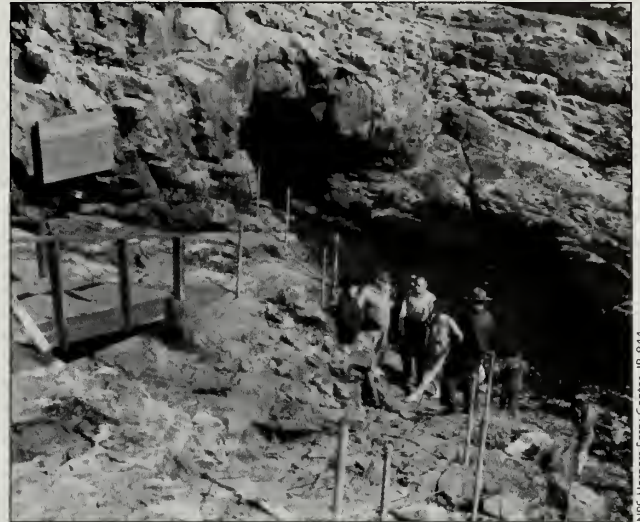
Fig. 1-15 The route of the Anemone Cave Trail (#369) provided access to the shoreline cave. Originally, the trail led directly to the cave, as shown here. However, this section has since been removed, leaving only the upper portion of the trail route from a parking area to the edge of the rocky coast. Mission 66 crews paved the trail with asphalt, thereby providing easier access for visitors and enhancing opportunities for interpretation of a significant natural feature in the park.

Mission 66 trails contained routes intended to meet the goals of increased access in interpretation. Examples include the Ship Harbor Nature Trail (#127) with its flat, wide trail corridor; the Anemone Cave Trail (#369) with its asphalt surfacing (Fig. 1-15); and the Beech Mountain Loop Trail (#113), a route over relatively easy grade that allowed access for equipment and supplies necessary to rebuild the Beech Mountain fire tower.

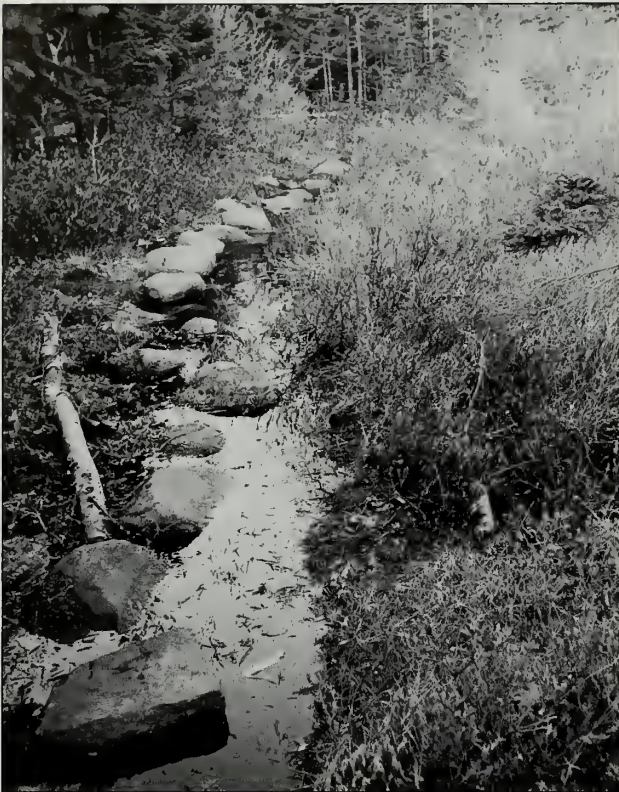
Fig. 1-16 Historic stepping stones on abandoned segment of the Bowl Trail (#6) flooded by beaver activity.

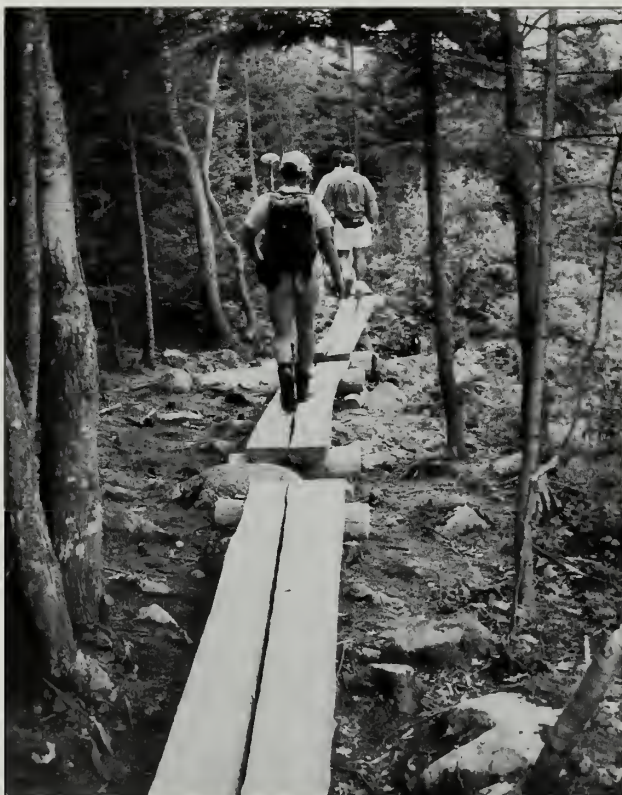
Fig. 1-17 Reroute of flooded segment of the Bowl Trail (#6) shown in Fig. 1-16 located farther away from the edge of the pond. Bogwalk was installed to traverse wet, muddy areas. However, this feature is not in keeping with the historic stepping stones that are present on other sections of this trail.

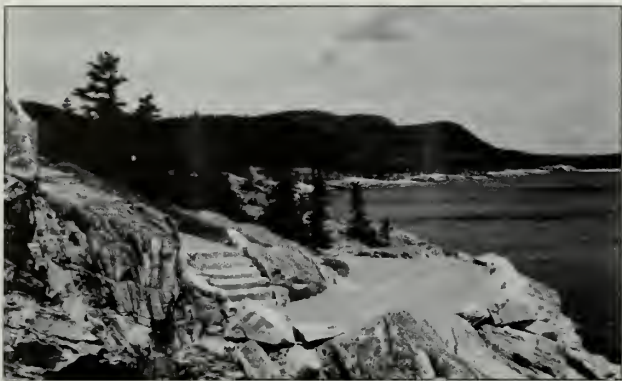
Acadia NP Archives

Fig. 1-23 The CCC used both coping and retaining walls along the stairs at the edge of the overlook at Otter Cliffs and on the Ocean Path (#3), view in 1937.

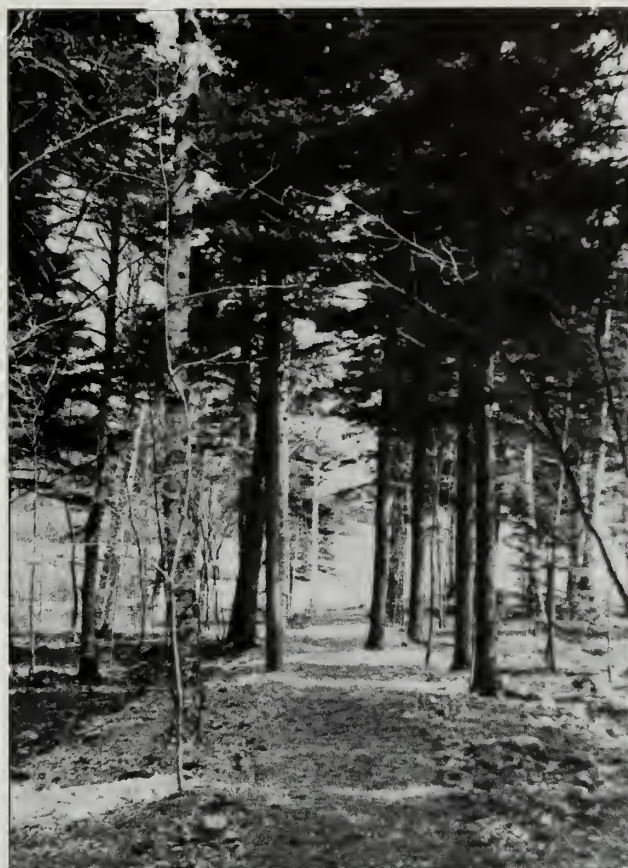
Fig. 2-3 As shown in this 1930s photo of the Anemone Cave Trail (#369), the CCC practiced vegetation clearing of understory growth along many of their trails.

Forest stand “improvement,” fire hazard reduction, and revegetation were a part of most CCC trail projects. To “improve” existing trails, stands of trees were thinned and pruned to open up views into the woods, nearby ponds, or distant valleys. This practice of woods cleaning involved removal of enormous amounts of understory vegetation, dead limbs, and ground logs (Fig. 2-3). To reduce fire hazards, most of the wood was burned in brush piles. While these forest management practices were deemed positive at the time, they were later viewed as highly disruptive to the landscape ecology of the area. It is also ironic that within ten years, the 1947 fire burned nearly a third of the forests on the eastern half of the island.

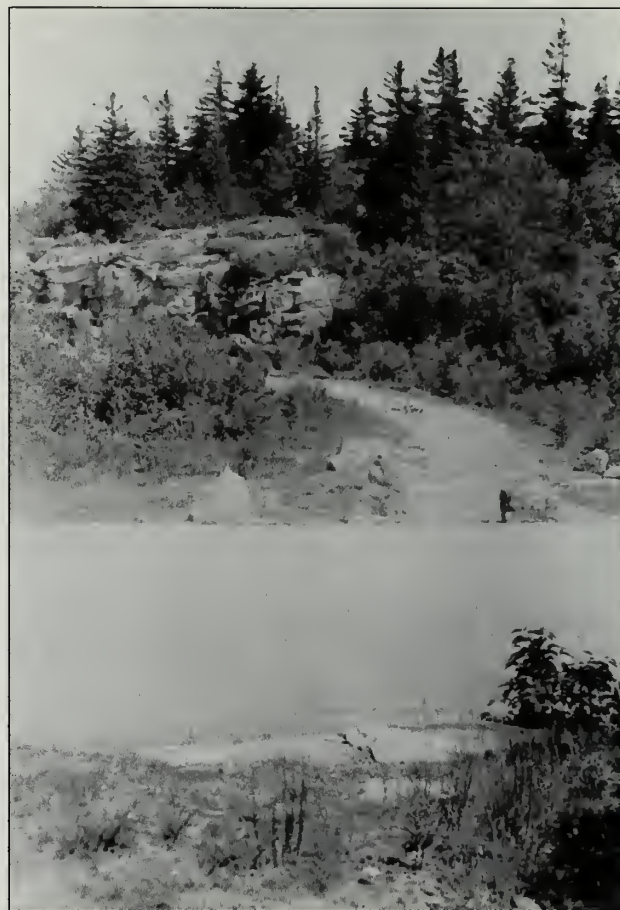
Fig. 2-5 The same trail as Fig. 2-4 on Cadillac Mountain in the 1930s after CCC revegetation and some vegetation growth.

Plants were then used to revegetate old road scars and abandoned quarries. Vegetation was also planted along new roads and trails. The CCC also covered recently constructed steps with moss and ferns to harmonize the new work with the surrounding landscape (Figs. 2-4 to 2-6).

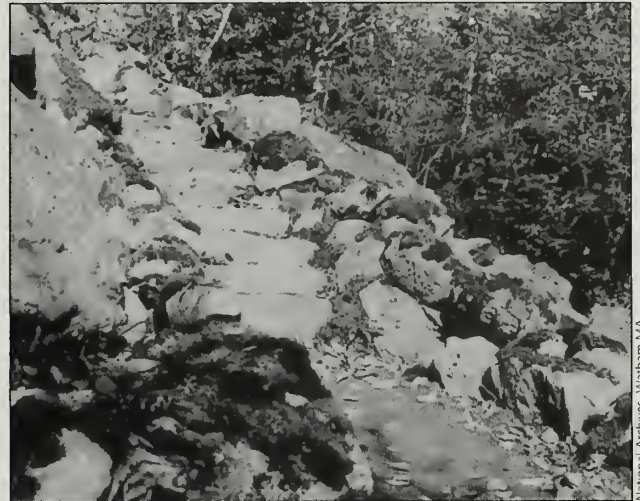
Fig. 2-6 Photograph taken by the CCC in the 1930s showing how their crews planted mosses and ferns on these newly installed steps on the Perpendicular Trail (#119) to soften the new stone work and blend it with the surrounding landscape.

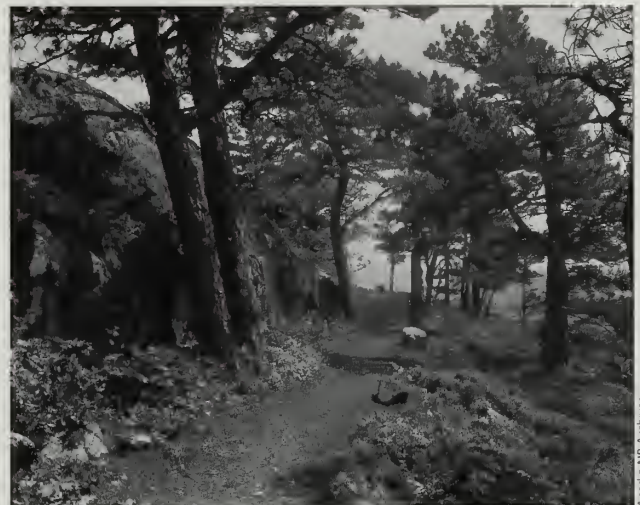
Fig. 2-7 This circa-1916 image of the Beachcroft Path (#13) shows the variety of vegetation along the trail, especially the low-growing summit vegetation, and a well-defined trail route.

One of the most significant vegetation issues faced by the NPS is the trampling and loss of vegetation in summit areas. The dramatic loss of trailside vegetation, particularly in ledge areas, can be observed by comparing old and recent photographs (Figs. 2-7 & 2-8), or by walking along one of the lichen-covered trails that is no longer marked and maintained, but within park boundaries, such as the Potholes Path (#342) (see Fig. 2-1).

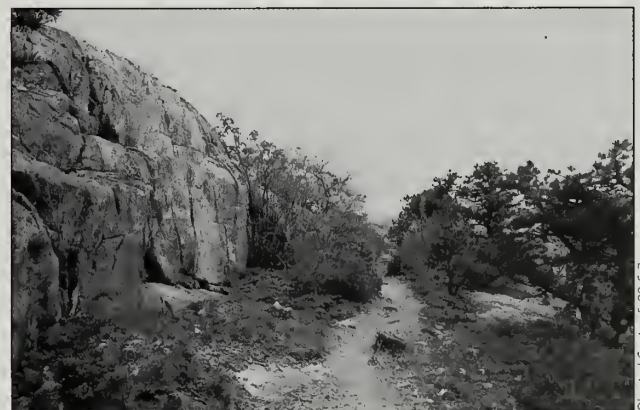
Fig. 2-8 A 1999 photograph of the same section of the Beachcroft Path (#13) as Fig. 2-7 shows the dramatic loss of vegetation, particularly the summit vegetation impacted by the 1947 fire and widening trail corridor.

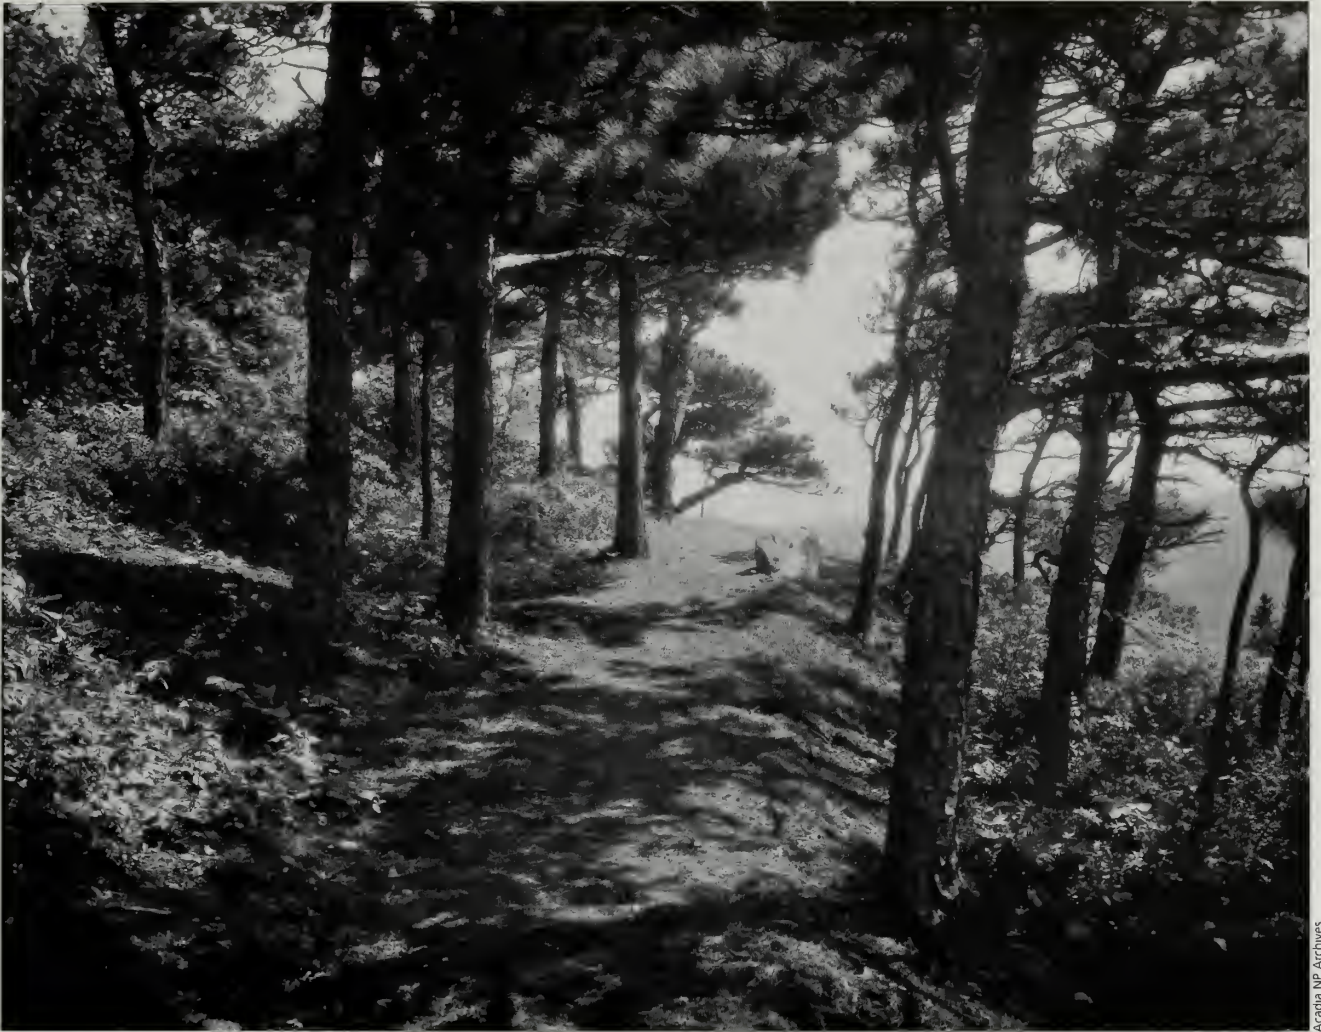
Fig. 3-1 This circa-1916 photograph of a bench cut on the Beachcroft Path (#13) illustrates how the treadway enhances the overall trail character. Near the trailhead, the trail is highly crafted with almost continuous stone pavement along its sidehill route. As it approaches Huguenot Head and winds through a grove of trees, the character changes to a woodland walk, emphasized by a treadway surfaced with pine needles and other organic material.

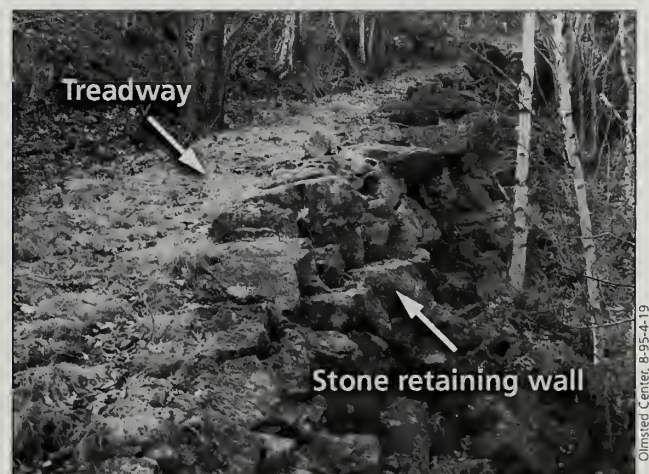
Fig. 3-3 This bench cut on the Gurnee Path (#352) is supported by stone retaining walls on the downslope side.

Nearly all the bench cuts used on highly crafted trails are retained with coping or retaining wall and surfaced with either gravel or stone pavement. For example, much of the Gurnee Path (#352) consists of long sections of bench retained with stone walls on the downslope side (Fig. 3-3). On sections of this bench work, drainage structures such as side drains and culverts are a part of the bench construction.

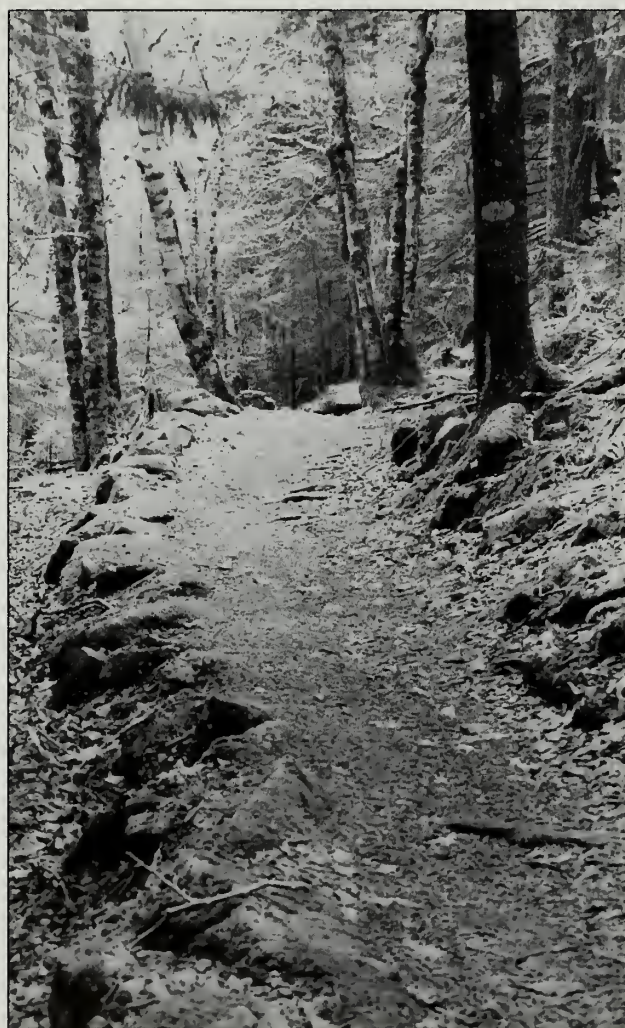
Fig. 3-5 A CCC bench cut with an outside retaining wall on the Valley Trail (#116). Note that the outslope is lost and the tread is wearing.

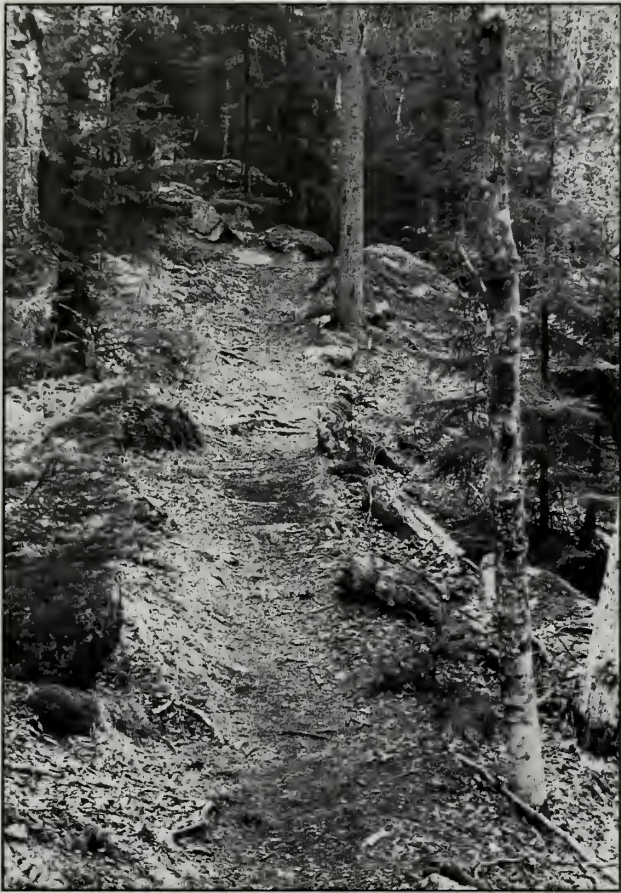
Fig. 3-7 Eroded bench on Valley Trail (#116).

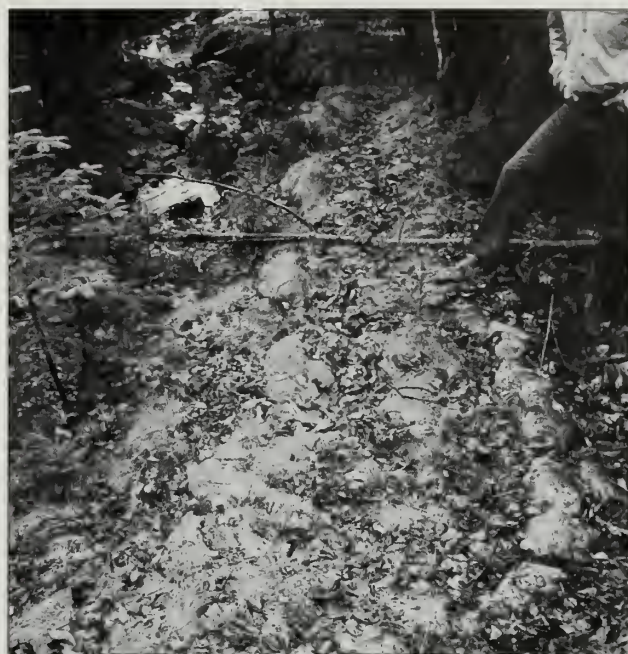
Fig. 3-12 Historic walled causeway on the Birch Brook Trail (#429).

A **walled causeway** is a raised gravel or soil treadway supported on both sides with retaining walls. This feature has been also called a turnpike. Single-tier retaining walls on the sides of walled causeways are called sidewalls (Fig. 3-12). Sidewalls may be set “toast” style—upright and on end, “cake” style—flat, or “header” style—sloping towards the center of the trail.

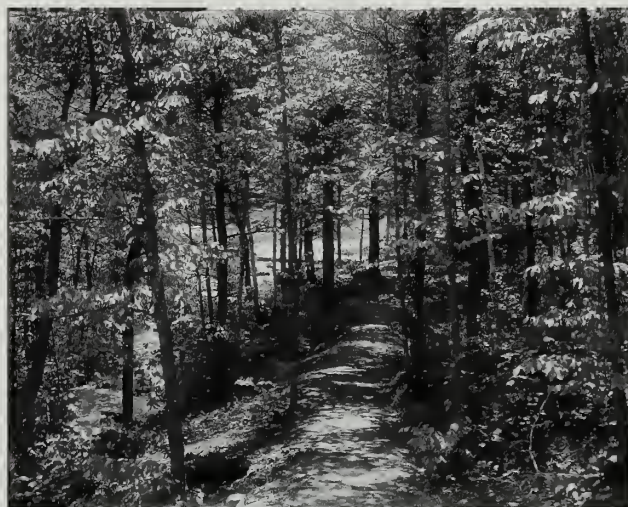
Fig. 3-13 The Jesup Path (#14), shown in circa 1916, was originally constructed with long sections of wall-less causeway.

A **wall-less causeway** is a raised gravel or soil treadway, which is constructed without retaining walls. In a wall-less causeway, the subgrade edge sloped to its angle of repose serves the retaining function. The edge is often covered with soil and vegetation (Fig. 3-13).

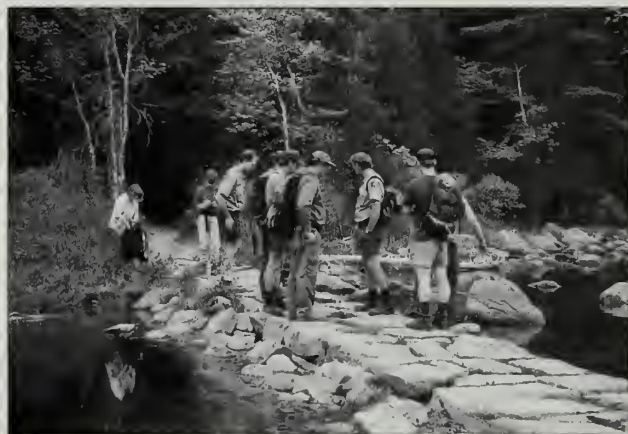
Fig. 3-14 A stone causeway at the Jordan Pond Inlet on the Jordan Pond Path (#39).

A **stone causeway** is constructed primarily of stones and has an stone pavement, rather than graveled-over, surface (Fig. 3-14).

Several historic stone causeways are extant in the trail system, including a stream crossing on the Jordan Pond Carry Spur (#40) likely built in the 1960s and a small bit of raised stone paving on the Asticou Trail (#49). The most substantial stone causeway in the system originated in about 1896, when the Bar Harbor VIA placed stepping stones across an inlet on the east side of Jordan Pond where the water is 2 to 4 feet deep.

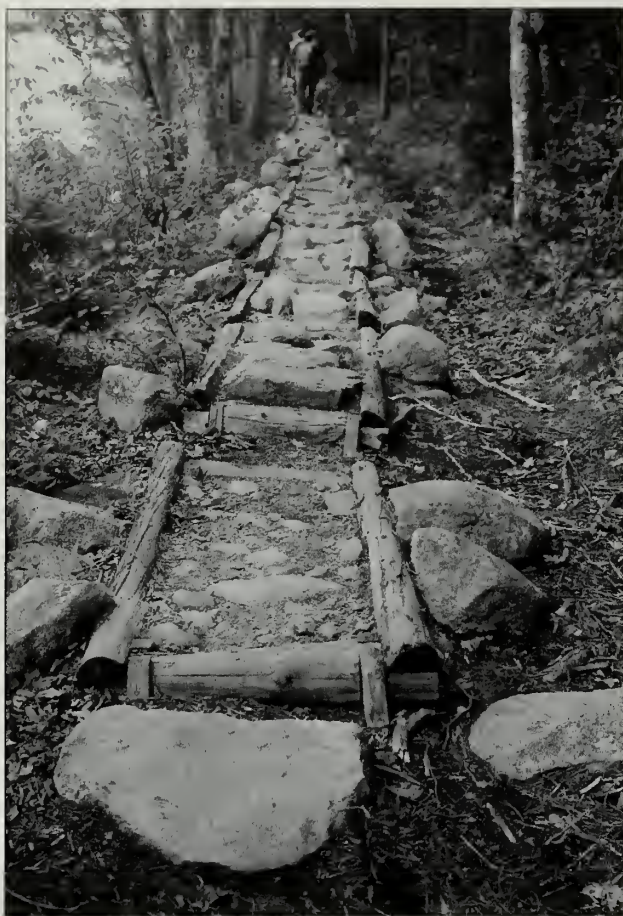
Fig. 3-15 Prior to rehabilitation, the Jordan Pond Path (#39) contained many sections of log turnpiking. Fig. 3-16 shows this same segment with the addition of new walled causeway.

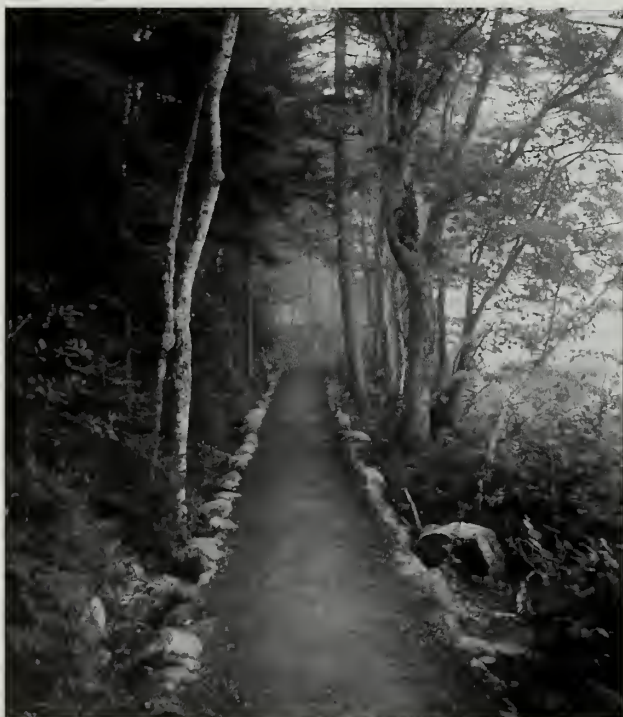
Fig. 3-16 Recently rehabilitated walled causeway on the Jordan Pond Path (#39) in section formerly treated with log turnpiking.

**Log turnpiking** is a causeway that consists of a series of gravel-filled log cribs laid continuously. Log turnpiking is not a historical feature at Acadia and is not a recommended treatment option for the Acadia trail system (Figs. 3-15 & 3-16).

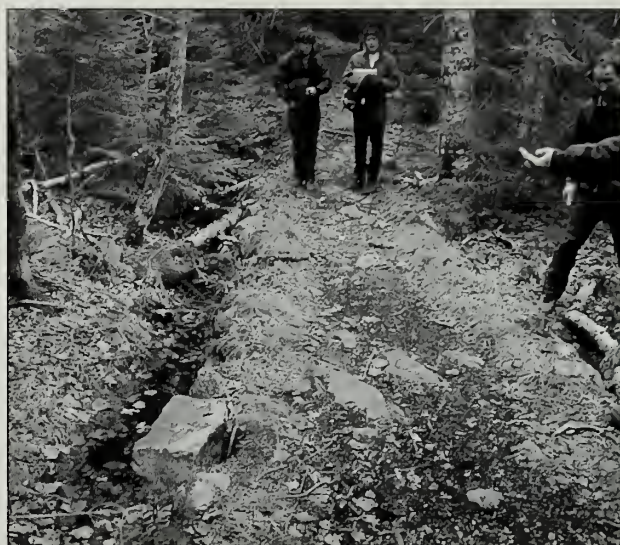
Fig. 3-17 This walled causeway on the Asticou Trail (#49) is still extant and in relatively good condition over one hundred years later.

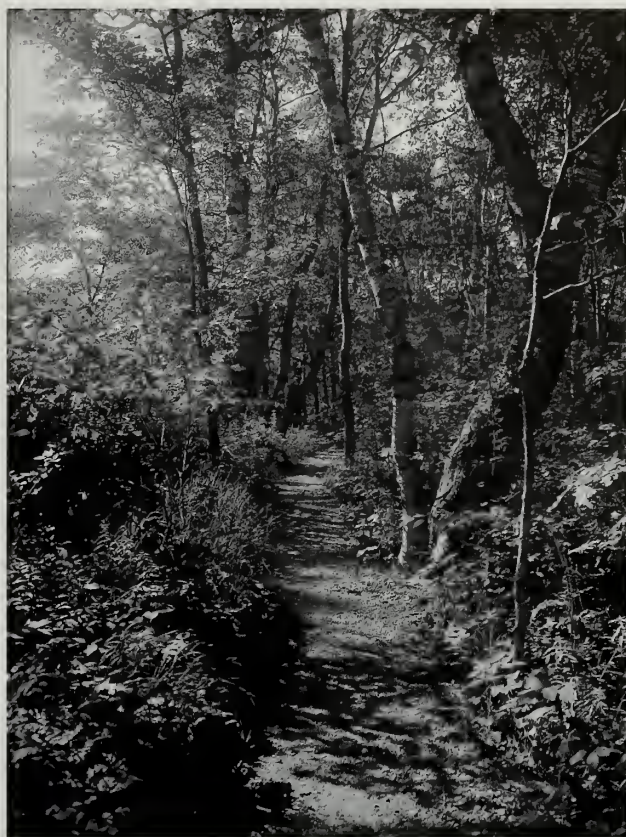
Fig. 3-18 Schooner Head Road Path (#362), shown here in circa 1916, also used wall-less causeway to traverse wet areas on the trail route.

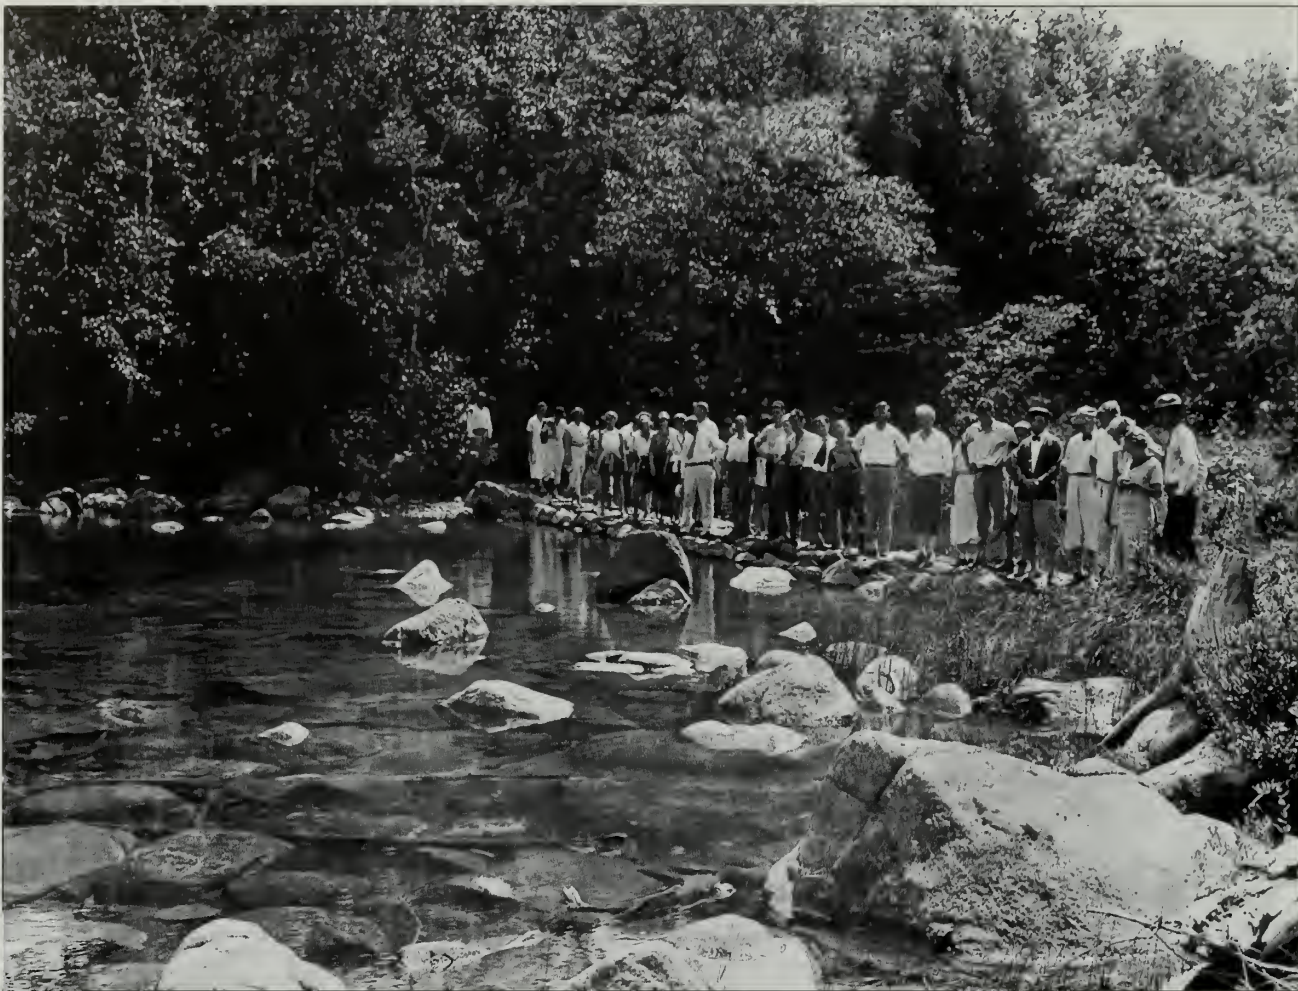
Fig. 3-20 Circa-1934 photograph of a hiking party on Jordan Pond stone causeway that shows the popularity of the area. Refer to Fig. 3-14 for a 1997 view of the causeway after NPS reconstructed and widened it.

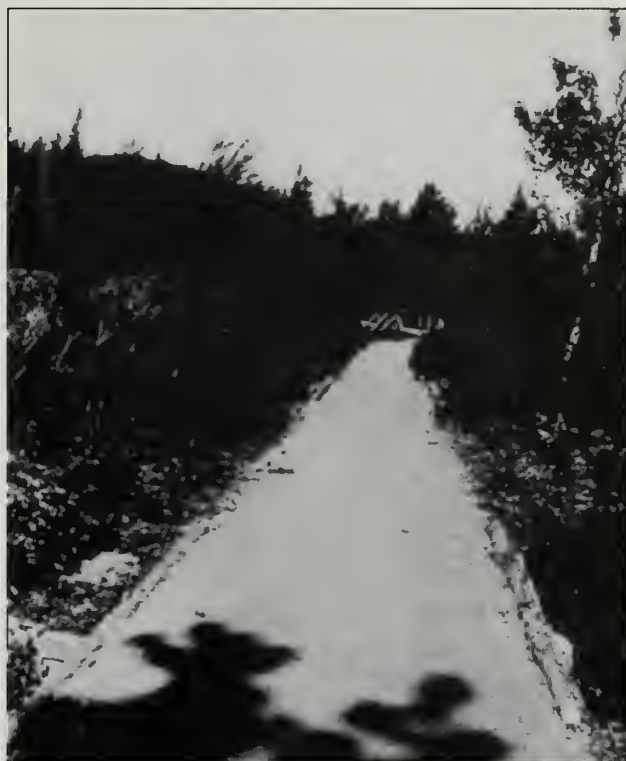
Fig. 3-21 CCC-constructed causeway on the Great Meadow Nature Trail (#365), shown in 1930s.

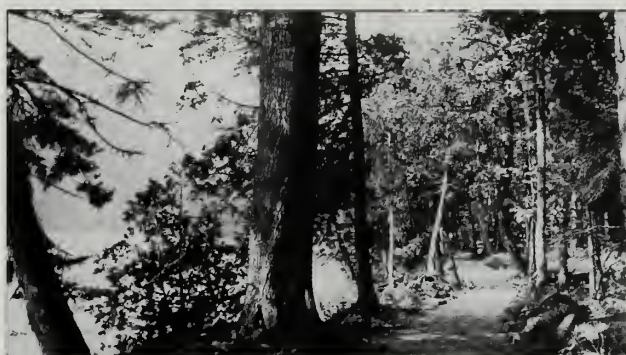
Fig. 3-22 CCC-constructed causeway on the Great/Long Pond Trail (#118), shown in 1930s.

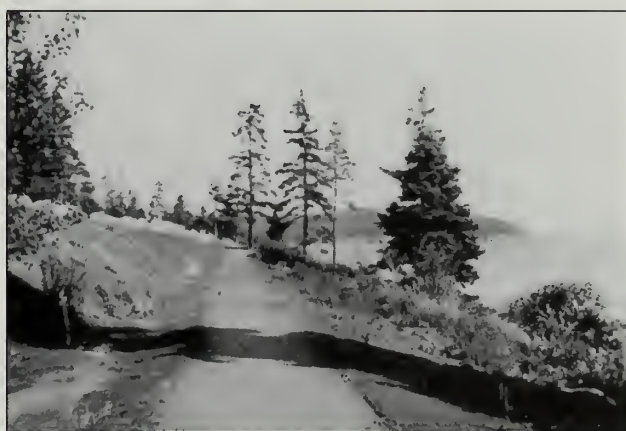
Fig. 3-23 CCC-constructed causeway on the Ocean Path (#3), shown in the 1930s.

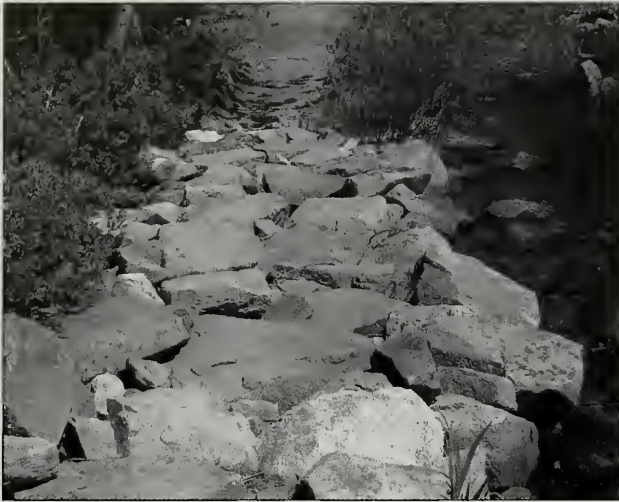
**Fig. 3-24** This stone causeway on the Great/Long Pond Trail (#118) was constructed in 1993 by the NPS; however, it is out of character for this trail and should be replaced with walled or wall-less causeway.

Between the CCC era and the late 1990s, very little causeway was built or repaired. During this period, a single causeway was completed by NPS crews in the early 1980s on a new trail connecting the Jordan Pond House to its overflow parking area. Gary Stellpflug remembers the construction as being “just mounded dirt” with no stone rubble subgrade, though this section of trail is still in good shape today. Also, as previously mentioned, the stone causeway near the southern end of the Jordan Pond Path (#39) was reconstructed in 1984 with modifications to stone size and overall width. Additionally, a new stone causeway was added to the Long Pond Trail (#118), near the southern end. However, this feature is out of character with this trail and should be removed (Fig. 3-24).

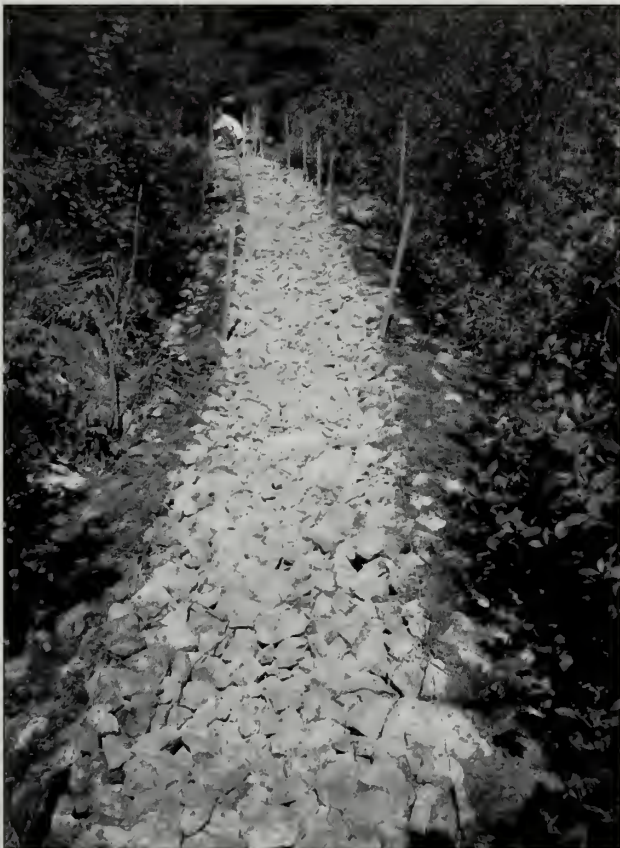
Fig. 3-26 Wall-less causeway before gravel surfacing on the Jordan Pond Path (#39) in 2002. The sides are angled and revegetated to the grade line. Note the insloping culvert lintels between first and second grade stakes.

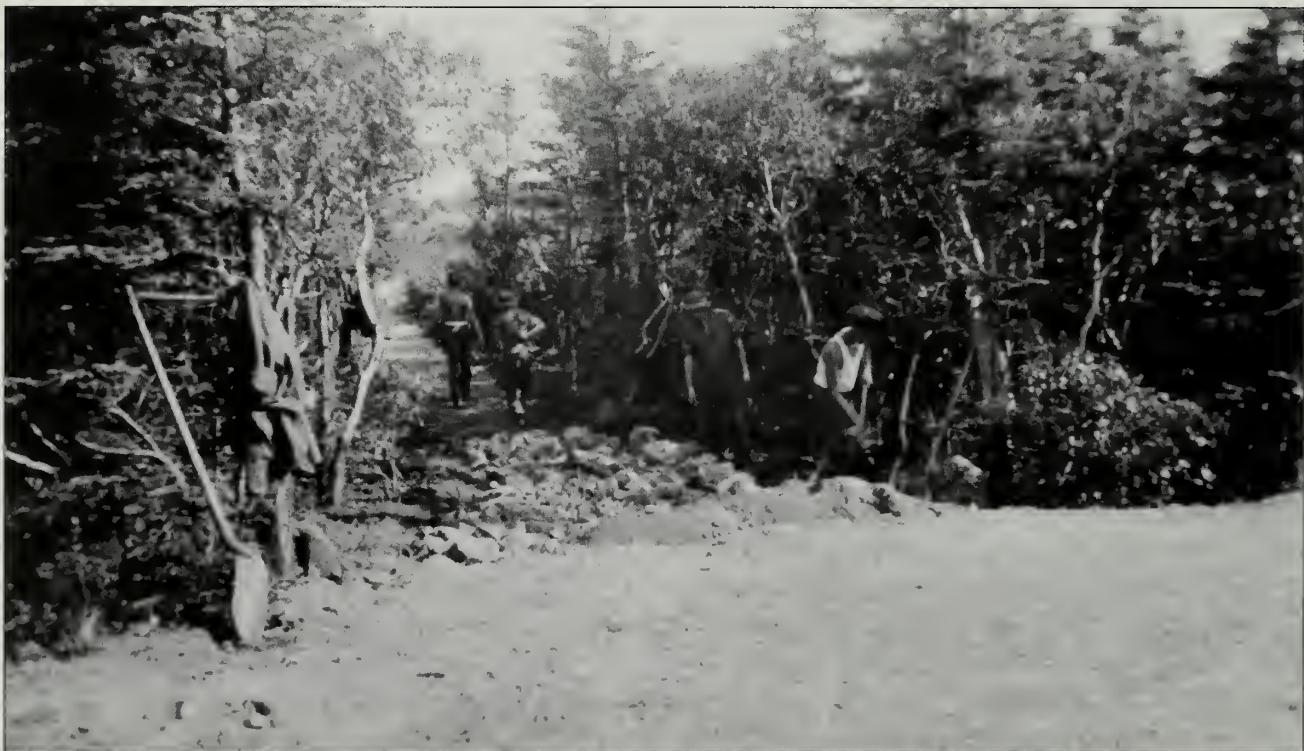
Fig. 3-29 The CCC usually installed rubble base under their gravel tread, work in progress in the 1930s.

original trail's design. The CCC provided drainage, but again, it was insufficient and/or not maintained. While some CCC gravel tread has survived, most has washed away or been seriously eroded and has not been replaced. Gravel washouts have been extensive on the Long Pond Trail (#118), Beech Mountain South Ridge Trail (#109), and parts of the Ocean Path (#3). However, as opposed to many VIA/VIS trails, much of the CCC work contains a rubble stone base. In many cases, this base is still extant and only needs resurfacing and the maintenance or addition of drainage structures or checks (Figs. 3-29 & 3-30).

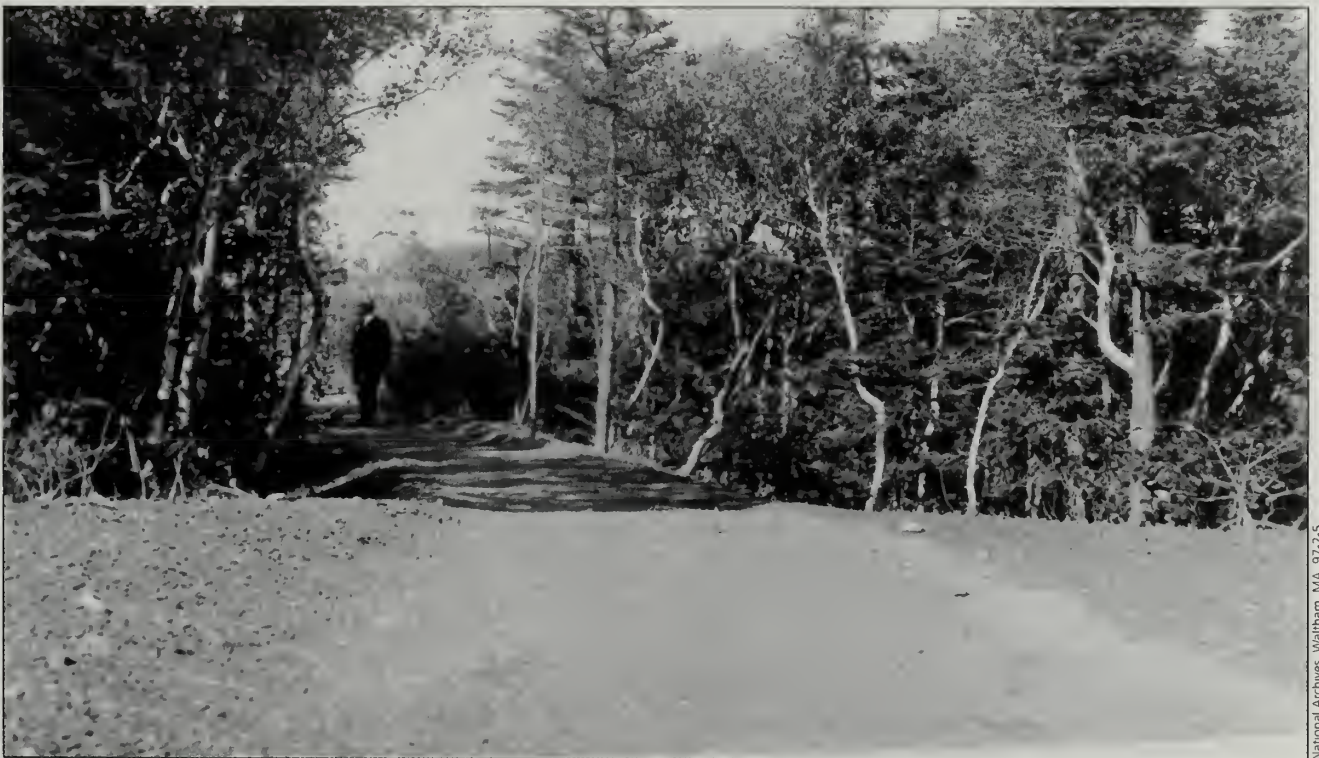
Fig. 3-30 Newly installed CCC gravel, photograph showing completed work in the 1930s.
