# ACADIA TRAILS TREATMENT PLAN

## CULTURAL LANDSCAPE REPORT FOR THE HISTORIC HIKING TRAIL SYSTEM OF ACADIA NATIONAL PARK

Olmsted Center for Landscape Preservation  
National Park Service, Boston, Massachusetts, 2006

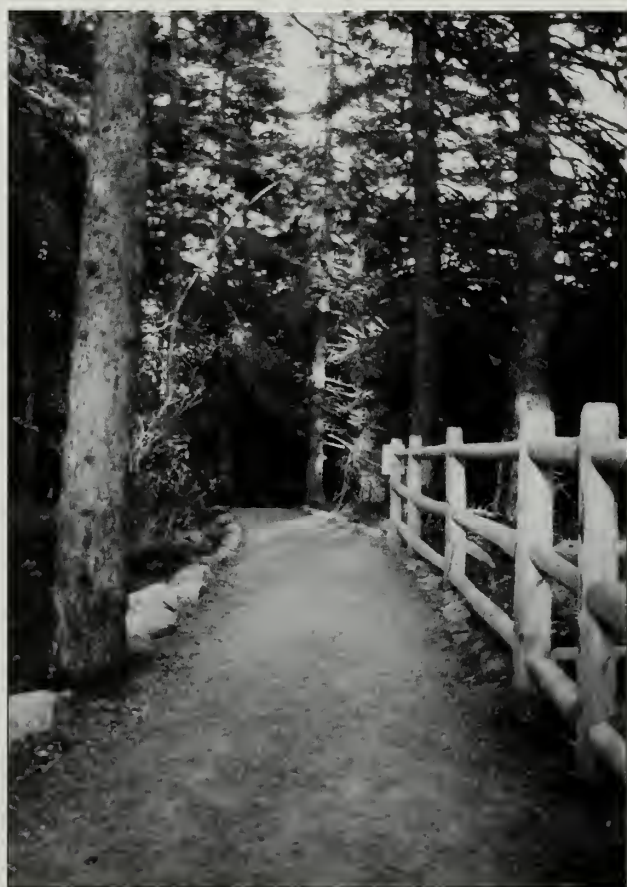
**Fig. 3-31** New gravel tread was installed by the NPS on the rehabilitated Bass Harbor Head Light Trail (#129) in 1997.

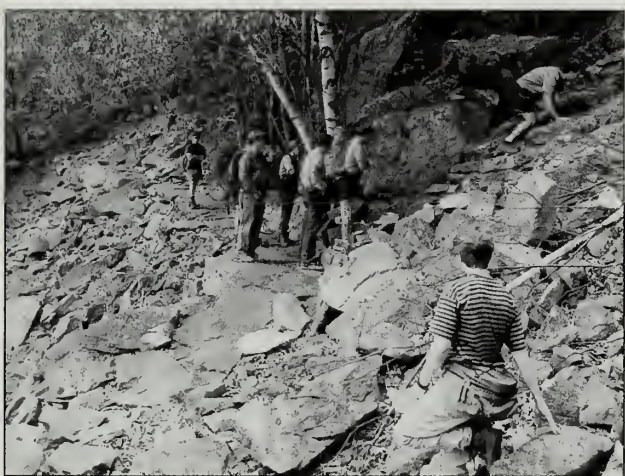
Fig. 3-32 Talus pavement on the Champlain East Face Trail (#12).

**Stone pavement** is a constructed, continuous stone treadway with individual stones, often called pavers, serving as the tread. Stone pavement used to traverse talus fields is called **talus pavement**. Stone pavement used to harden the surface of a soil treadway, typically on a woodland trail, is called **tread pavement** (Figs. 3-32 & 3-33).

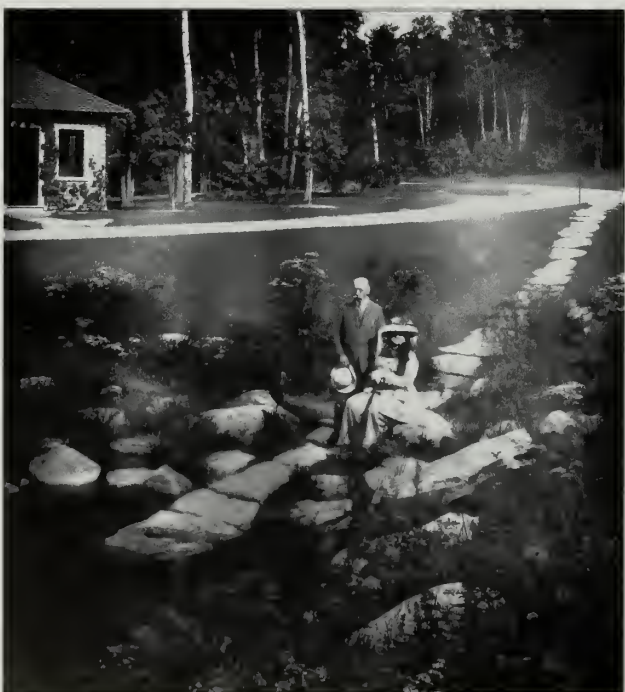
Fig. 3-33 Tread pavement at Sieur de Monts, circa 1916.

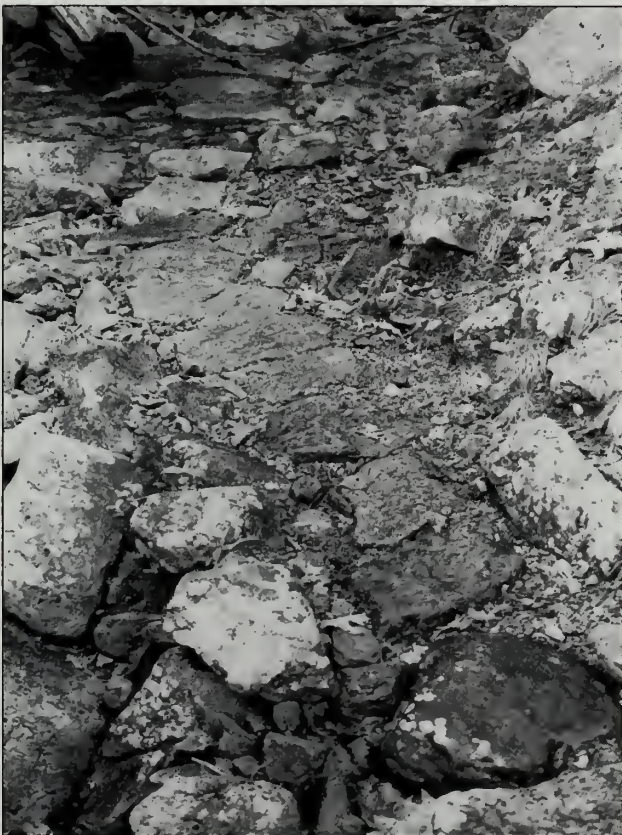
Fig. 3-34 VIA tread pavement on the Gorge Path (#28).

During this same time period, stone tread pavement was also used on several other trails, with the Gorge Path (#28) and the Canon Brook Trail (#19) containing the most extensive examples. These trails were each endowed with maintenance funds years after their initial construction. Both were built by the Bar Harbor VIA at the turn of the century and improved in the 1910s and 1920s. Each follows a streamside route and is highly crafted. They contain stone pavement of small, uncut stones in a single row, laid continuously between runs of staircases and stepping stones (Figs. 3-34 & 3-35).

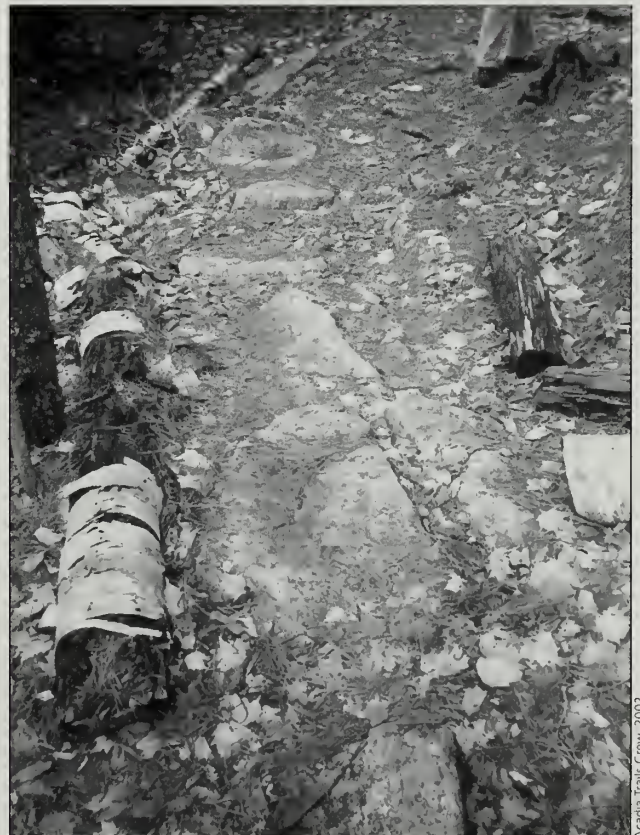
Fig. 3-35 VIA stone paving on the Eagle Lake Trail (#42).

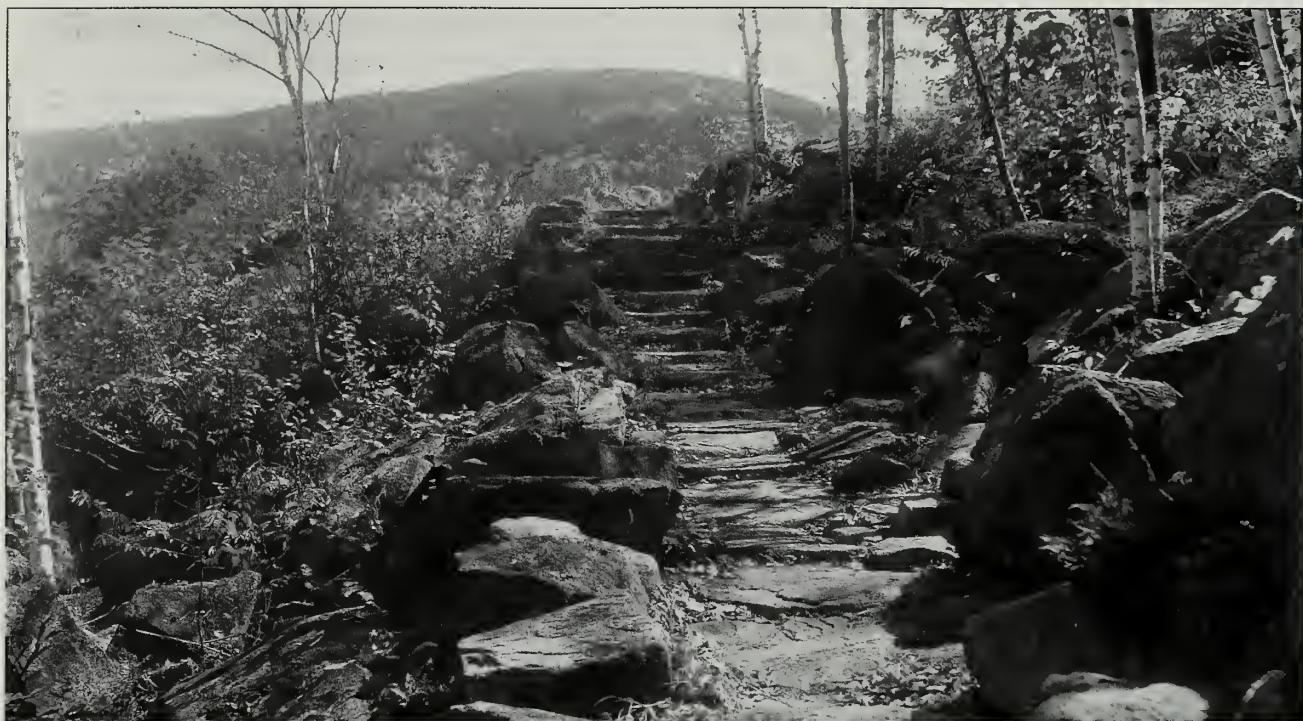
Fig. 3-36 Tread pavement leading to a set of steps on the Emery Path (#15), circa 1920.

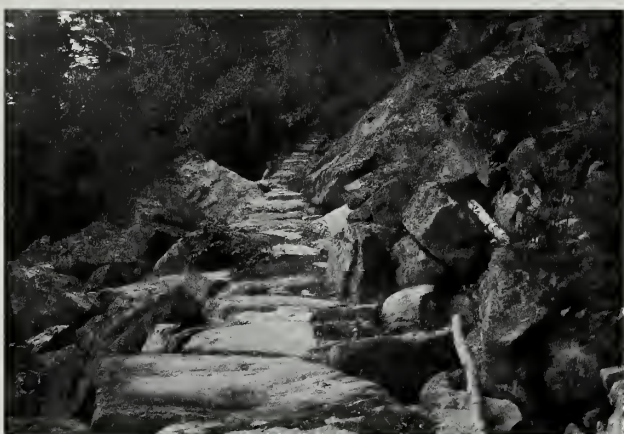
Fig. 3-37 Talus pavement on the Beachcroft Path (#13), circa 1920.

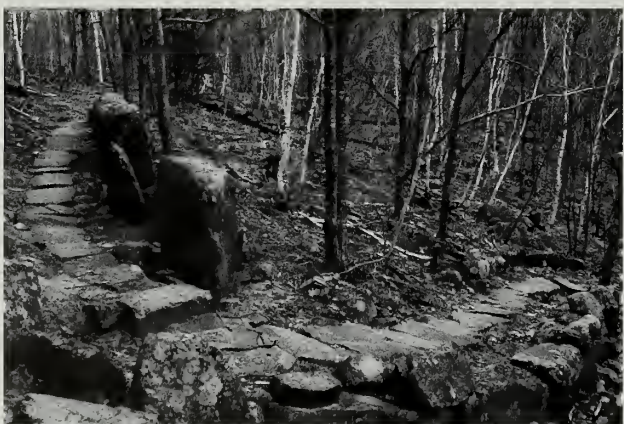
Fig. 3-38 Tread pavement through a wooded section of the Beachcroft Path (#13).

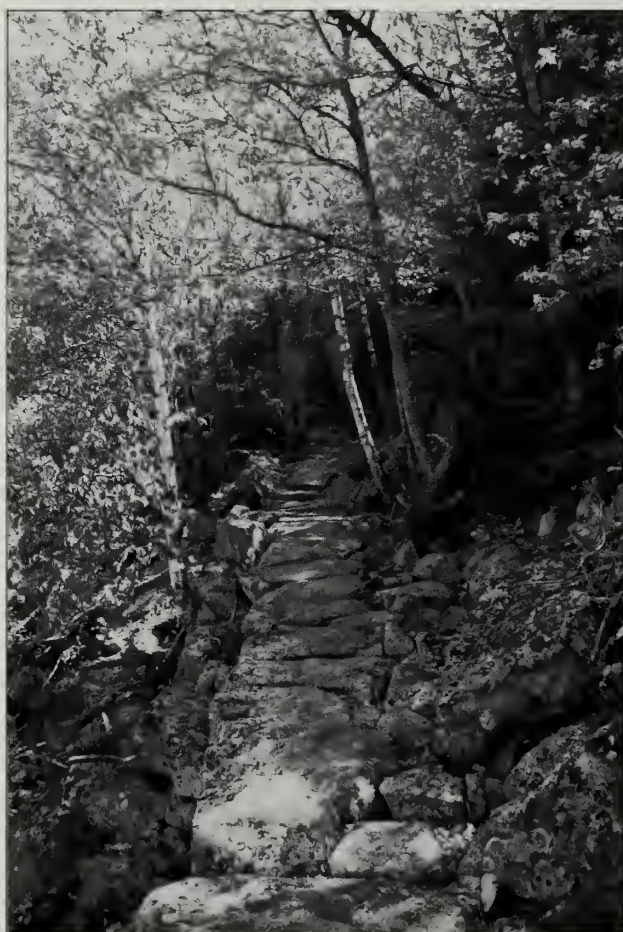
Fig. 3-39 This talus pavement on a section of Kurt Diederich's Climb (#16) is one of the fine examples of VIA/VIS stone pavement in the trail system.

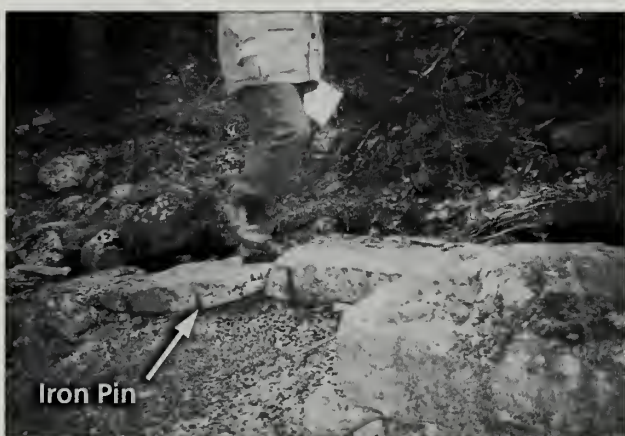
Fig. 3-40 Pinned tread pavement on the Andrew Murray Young Path (#25).

pavement contained pavers held in place with iron pins (Fig. 3-40). The circa 1930 section of the Jordan Cliffs Trail (#48) is perhaps the last major specimen of VIA/VIS stone pavement; its use of larger stones, retaining wall, and iron pins sets it apart from the earlier stone pavement on the Jordan Bluffs Trail (#457) (see Section 2, #48 Jordan Cliffs Trail).

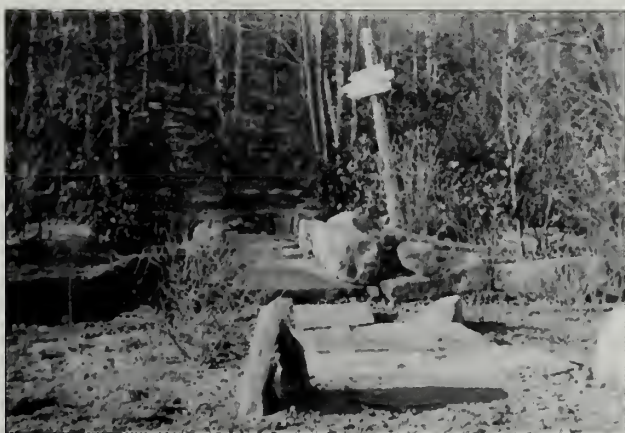
Fig. 3-41 CCC tread pavement at the trailhead for the Ladder Trail (#64) in the 1930s.

However, a few trails rehabilitated or constructed by the CCC did incorporate stone pavement. On the Perpendicular Trail (#119), there is one 40-foot stretch of talus pavement. On the Ladder Trail (#64), hundreds of feet of Dorr-style tread pavement were rehabilitated or installed by the CCC (Figs. 3-41 & 3-42). Neither exception is surprising since Dorr directed CCC work on as park superintendent. Additionally, the CCC probably improved stone pavement in the major tumbledown on the west side of the Jordan Pond Path (#39). Records show they were working in this area, and blast marks and the use of larger, cut stones point toward the CCC rather than early VIS work.

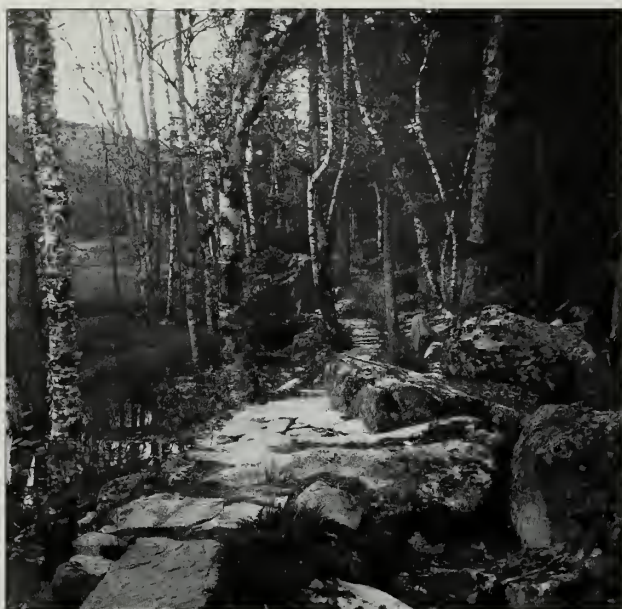
Fig. 3-43 A historic view of the talus pavement on the Kane Path (#17), circa 1916.

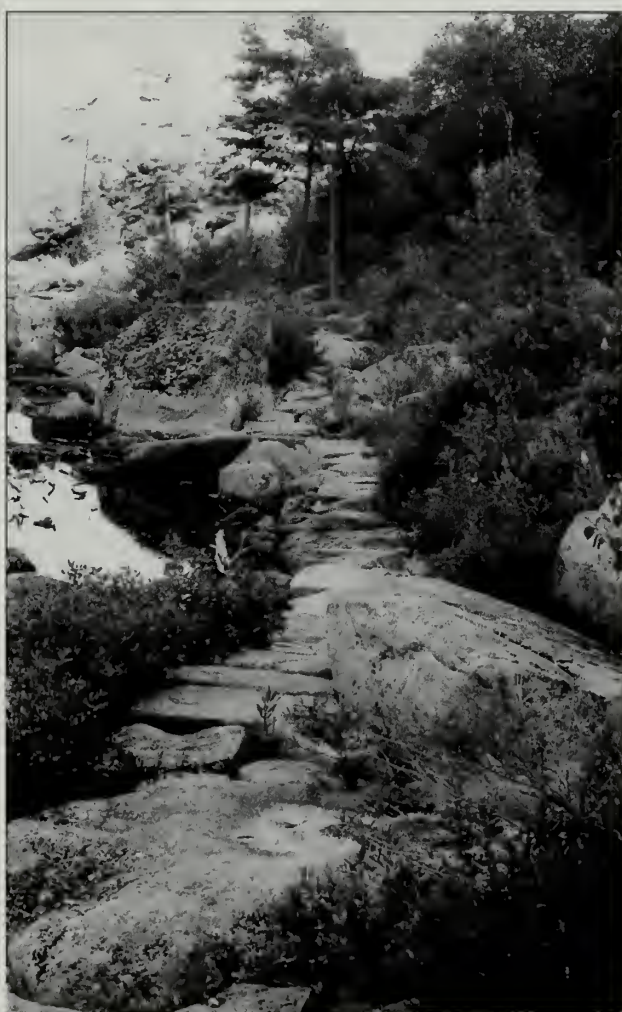
Fig. 3-44 A 1997 view of the same section of the Kane Path (#17) as Fig. 3-43. Note the change in water level and vegetation.

The most substantial, and the most appropriate addition of stone pavement was a new section of talus pavement completed by the NPS in 1994 on a reroute of the southern end of the Kane Path (#17) along The Tarn. By 1975, the original route had become swamped by The Tarn's higher water level and was in need of rehabilitation. A reroute was constructed just west of the original. It began at the southern end of the original stonework and continued to traverse the talus slope toward a section of stone pavement on the northern end that had been installed in 1917. Attempting to provide an easier walking surface while adhering to the original character of the trail, the 1994 crew constructed 262 feet of new talus pavement, the length of this reroute. The new work adheres to the old standard, using large, often cut stones set adjacent to one another with a flush tread surface along a large-gestured route (Figs. 3-43 & 3-44). (Scree was added at a later date and should be removed since it is not historically compatible with the style of pavement, and it is not integral to the pavement's construction.)

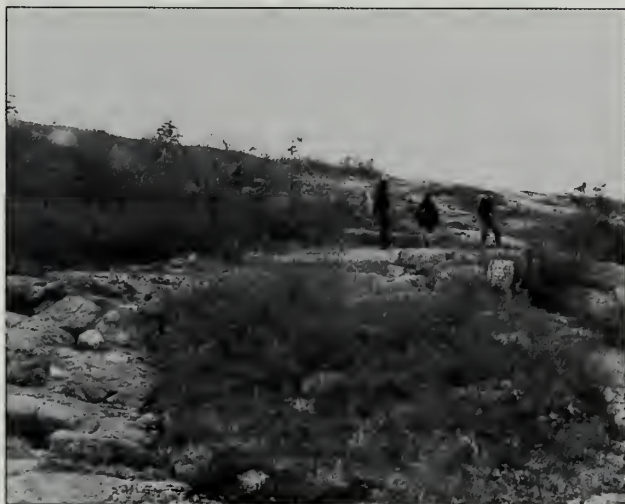
Fig. 3-47 Unconstructed tread across ledge on the Jordan Cliffs Trail (#48) near Sargent Mountain summit.

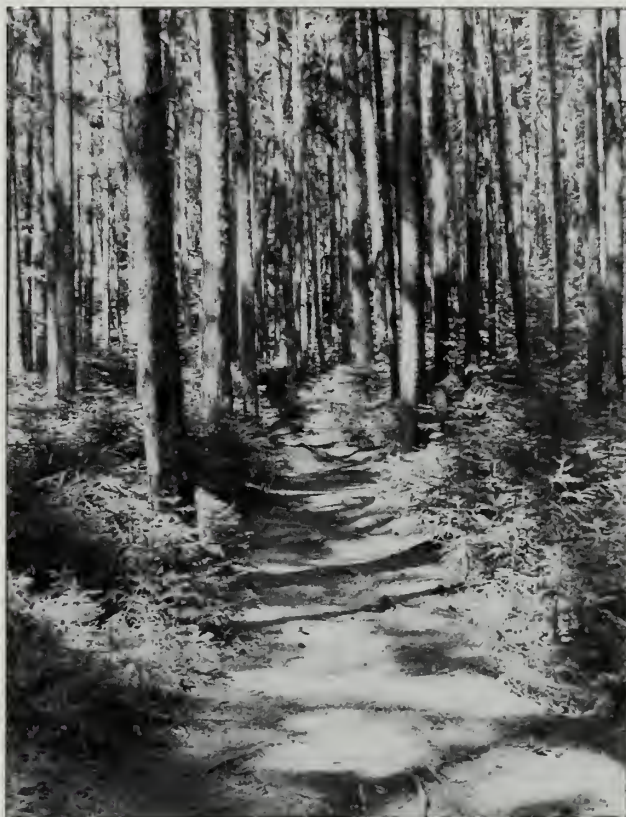
Fig. 3-48 Unconstructed tread through forest on the Norumbega Mountain Trail (#60).

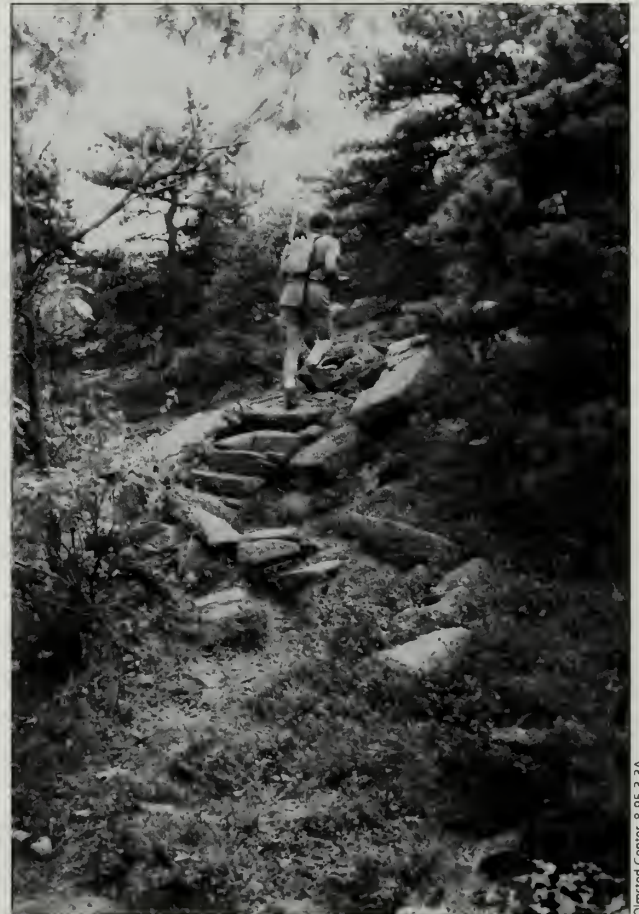
Fig. 3-50 Steps with unconstructed tread and ledge on the Upper Ladder Trail (#334).

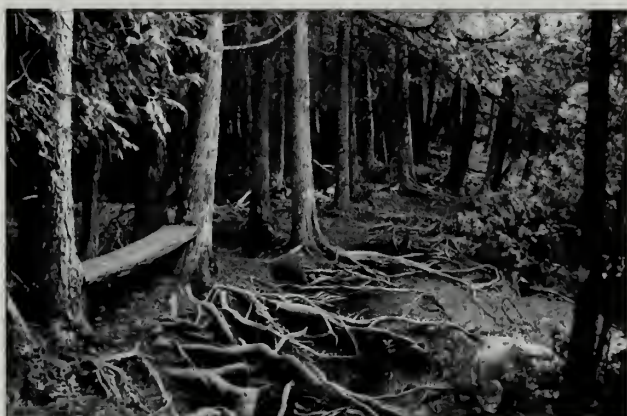
Fig. 3-51 The Lower Hadlock Trail (#502) contained unconstructed tread, and segments of it are currently in extremely poor condition.

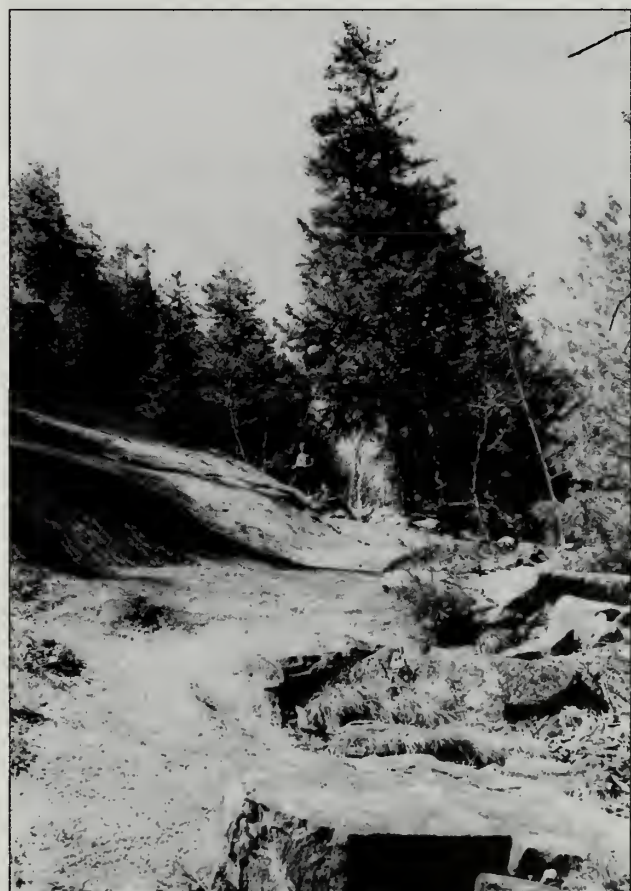
Fig. 3-52 Unconstructed tread on the Norumbega Mountain Trail (#60) has continued to erode from increased use, leaving the trail corridor more than 10 feet wide in some places.

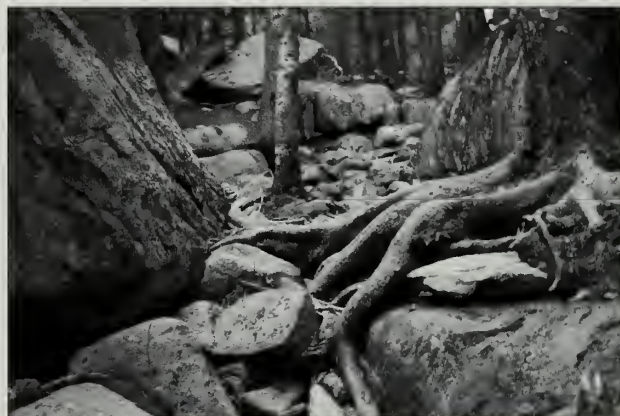
Fig. 3-53 A 1998 photograph of the upper section of the Perpendicular Trail (#119), which apparently was never finished by the CCC.

the treadway construction ends, leaving the upper quarter or so of the trail completely unconstructed. On the Beech Mountain West Ridge Trail (#108), a steep section of unconstructed trail is in poor condition with tread in a 1-foot-deep gully. It is possible that practical matters, such as distance from materials or the ending of a work project, resulted in these long sections of unconstructed treadway on otherwise highly constructed trails (Figs. 3-53 & 3-54).

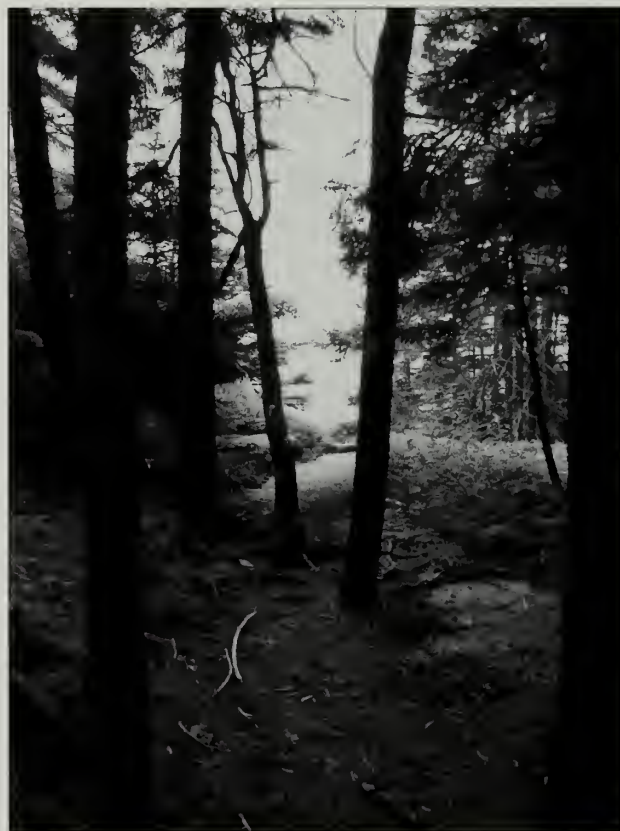
Fig. 3-54 Unconstructed tread near top of Perpendicular Trail (#119).

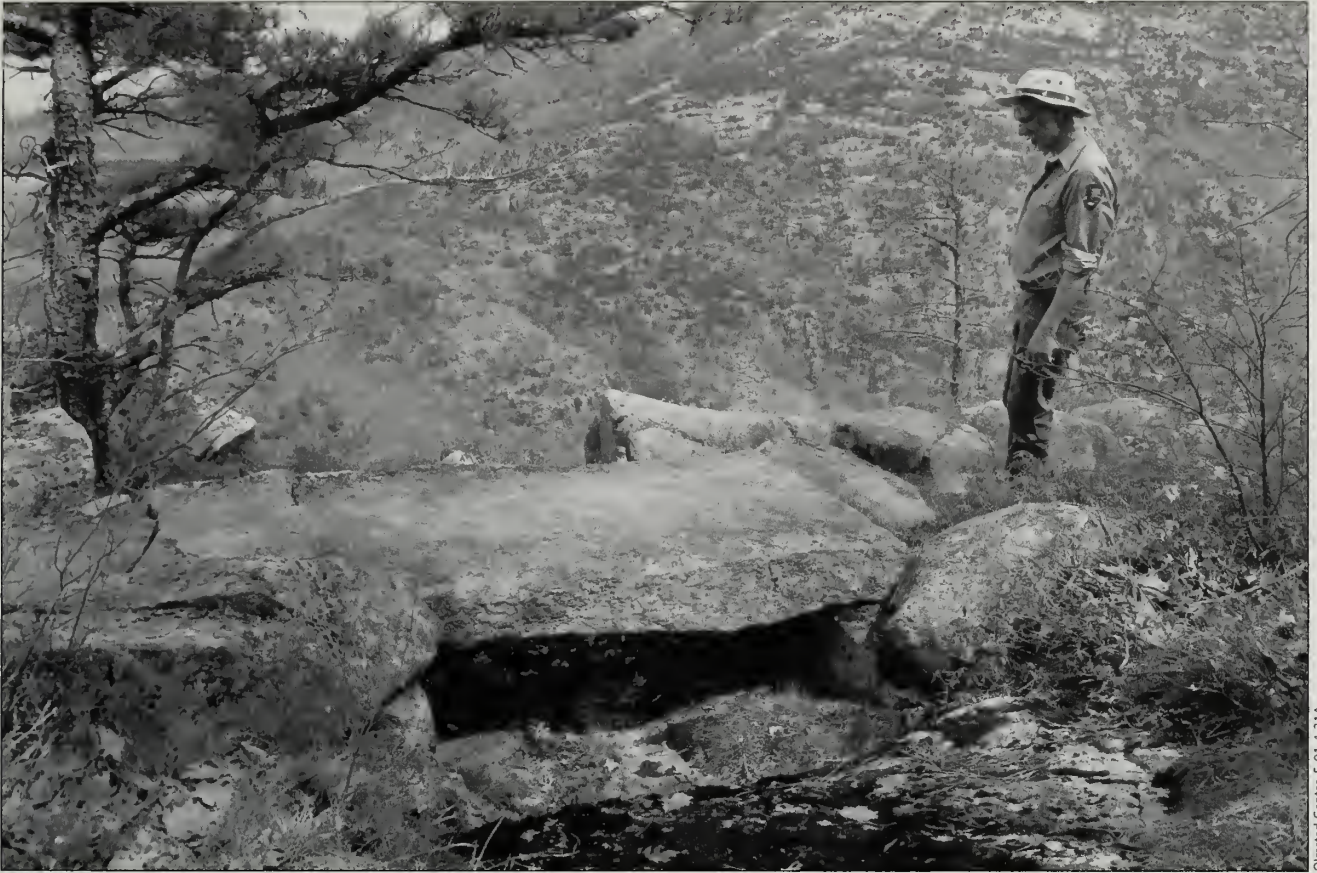
Olmsted Center, 5-01-4-21A

Fig. 4-1 A large capstone culvert on the Schiff Path (#15).

A **capstone culvert** is a closed culvert topped with one or more flat stones that also serve as the treadway (Fig. 4-1).

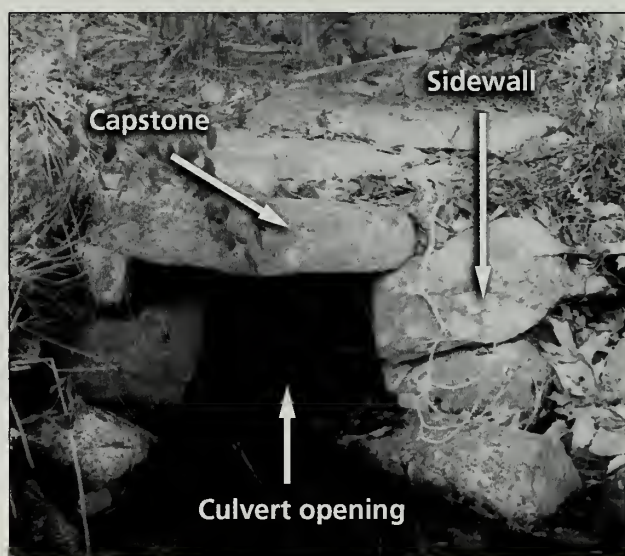
Fig. 4-2 A graveled-over culvert on the Kane Path (#17). The lintels were once completely covered with gravel and vegetation.

A **graveled-over culvert** is a closed stone culvert overlaid with a gravel treadway (Figs. 4-2 & 4-3).

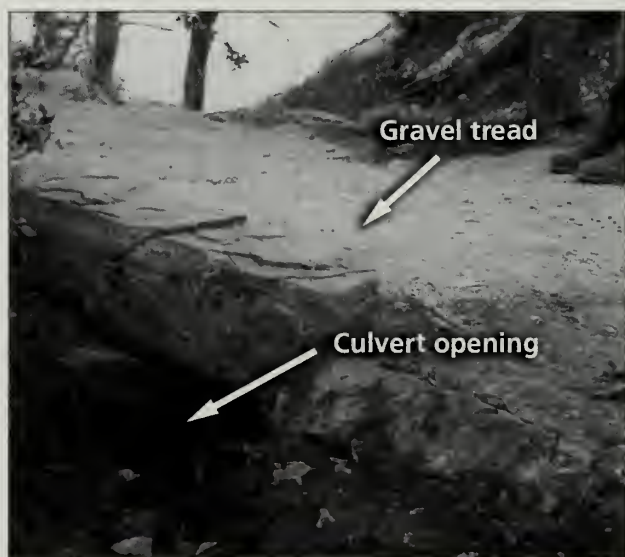
Fig. 4-3 A graveled-over culvert on the Ocean Path (#3).

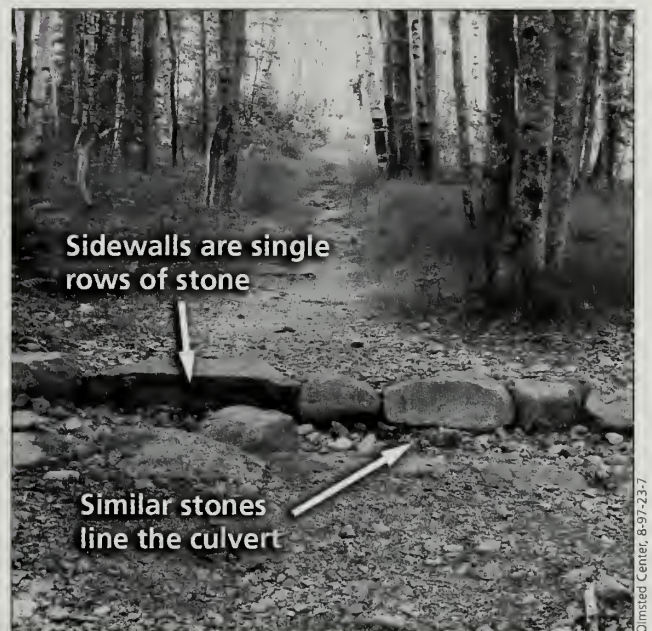
Fig. 4-5 A recently constructed open stone culvert on the Jesup Path (#14) with walls of single stones. This is not an appropriate culvert style for a trail that historically contained gravelled-over stone culverts and wooden bridges.

An **open stone culvert** is a culvert with stone sides and base whose top is open. Most open stone culverts have sides of single-tier walls, or even single stones, while some sides are small retaining walls (Fig. 4-5).

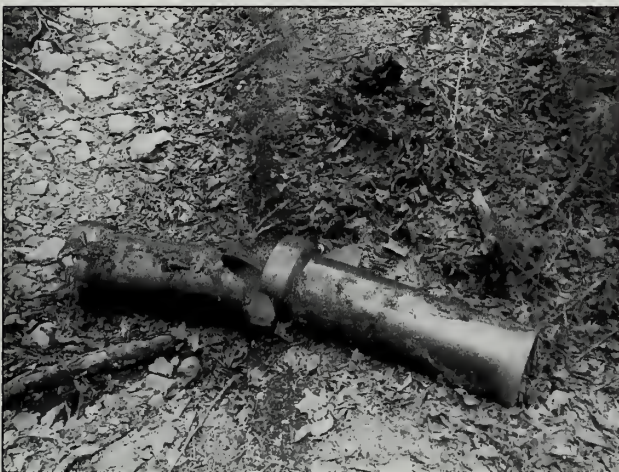
Acadia Trails Crew, 4-99-34-12

Fig. 4-8 A defunct VIA/VIS vitrified clay pipe culvert on the Seaside Path (#401), south of the Stanley Brook Bridge.

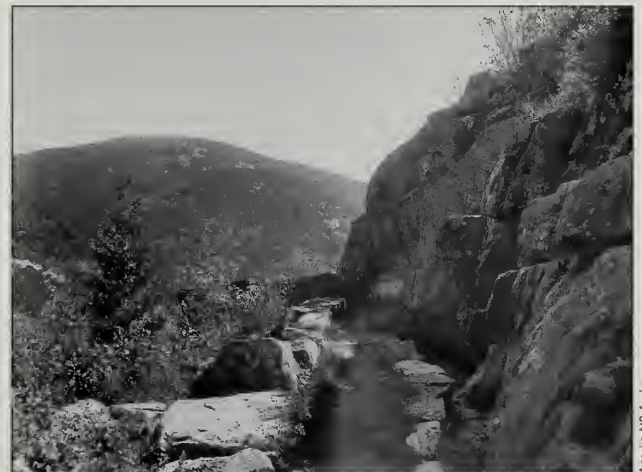
Acadia NP Archives

Fig. 4-10 A 1920 view of capstone culvert with walled side drain on the Emery Path (#15) constructed in 1916 by Bar Harbor VIA.

used to withstand cross-trail flows of water and ice. However, the trails on Dorr Mountain apparently had excellent drainage, combining use of capstone culverts (Emery Path #15), graveled-over culverts (Schiff Path, #15, Homans Path, #349), and stepstone culverts (Kurt Diederich’s Climb, #16) (Figs. 4-10 & 4-11). On the Jesup Path (#14) and Kane Path (#17) near the beginning of the Canon Brook Path (#19), small closed log culverts and large closed stone culverts were built (Fig. 4-12). These VIA/VIS culverts may have been reworked by the CCC, who carried out extensive repair work in the Dorr Mountain area. Unlike most small VIA/VIS closed culverts, the Gurnee Path (#352), completed in 1926, contains one of the largest graveled-over stone culverts in the trail system, with an opening 6 feet high and 2 feet wide, and an enormous capstone supporting the gravel tread (Fig. 4-13).

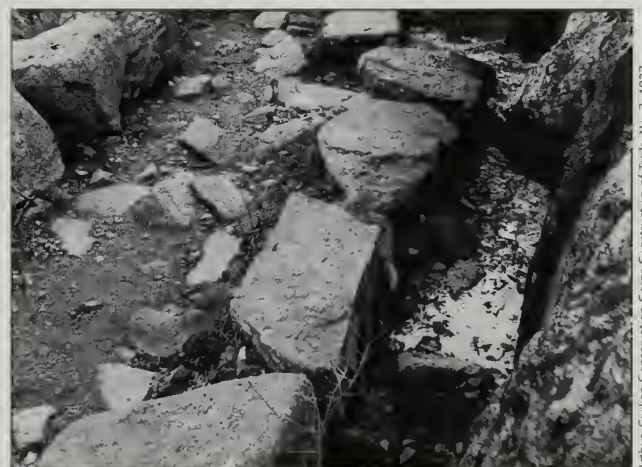
Arthur, Civilian Conservation Corps Construction of Trails, No. 7, 1937

Fig. 4-11 A VIA/VIS or CCC graveled-over road culvert near the Jesup Path (#14) between The Tarn and Sieur de Monts Spring.

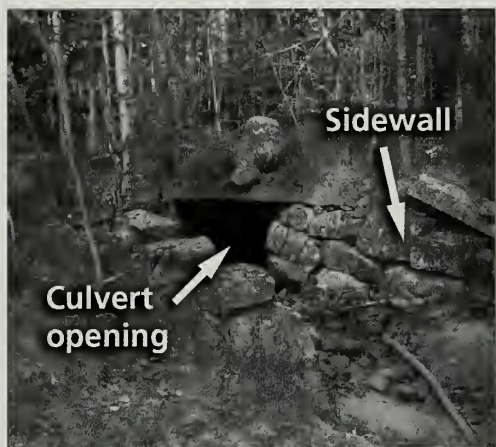
Olmsted Center, 8-95-1-16

Fig. 4-12 A VIA/VIS or CCC graveled-over road culvert near the Jesup Path (#14) between The Tarn and Sieur de Monts Spring.

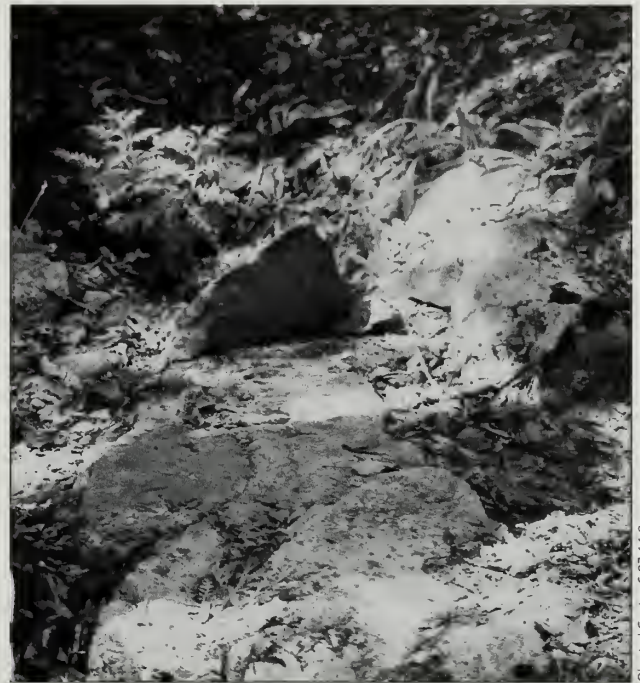
Fig. 4-16 Located near the base of the Perpendicular Trail (#119), a small CCC graveled-over culvert now has underlying capstones visible due to loss of gravel. A catch basin (difficult to discern in the photo) is in the foreground and a coping stone is visible on far side of treadway.

tied neatly into the retaining wall holding the treadway. The CCC then topped these culverts with massive, cut capstones that were left exposed as the treadway, and framed at the edges with large coping stones. These culverts were apparently modeled after the capstone culverts of the Emery Path (#15). Many of the larger CCC capstone culverts also included catch basins (Figs. 4-15 to 4-17).

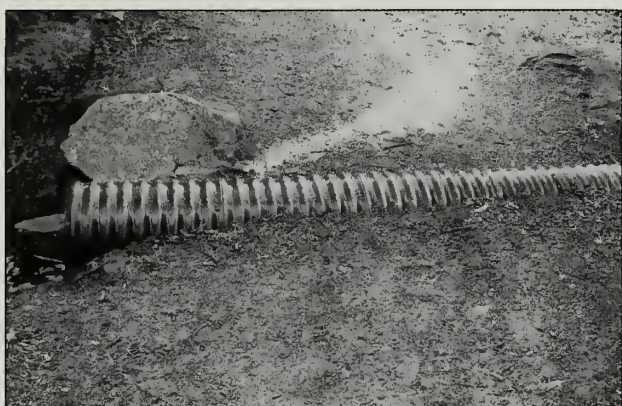
Fig. 4-18 This 10-foot-long corrugated pipe culvert, installed by Mission 66 crews on the Beech Mountain Loop Trail (#113), has been exposed by frost heave and tread loss.

(#127), and Beech Mountain Loop Trail (#113) (Fig. 4-18). Culverts on these trails were covered over with asphalt or gravel. Insufficient headwalls, tread loss, and low maintenance have allowed frost to heave many of these pipes out of the ground.

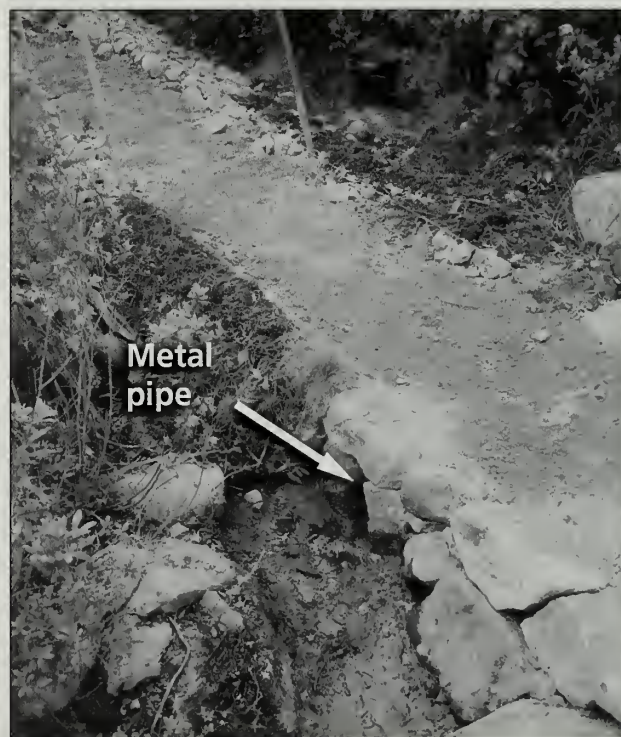
Fig. 4-21 A 2002 finished pipe culvert on the Jordan Pond Path (#39) in which pipe is obscured by insloping lintels and support rocks that are mostly covered with gravel. Lintels tie in to crush wall on one side and retaining wall on the other.

the Long Pond Trail (#118). Since the mid-1990s, NPS has focused on locating and cleaning existing closed culverts. New closed and open culverts have been built using historical prototypes, such as on the Pond Trail (#20), and using new materials like steel pipes, as seen on the Jordan Pond Path (#39) (Figs. 4-19 to 4-21).

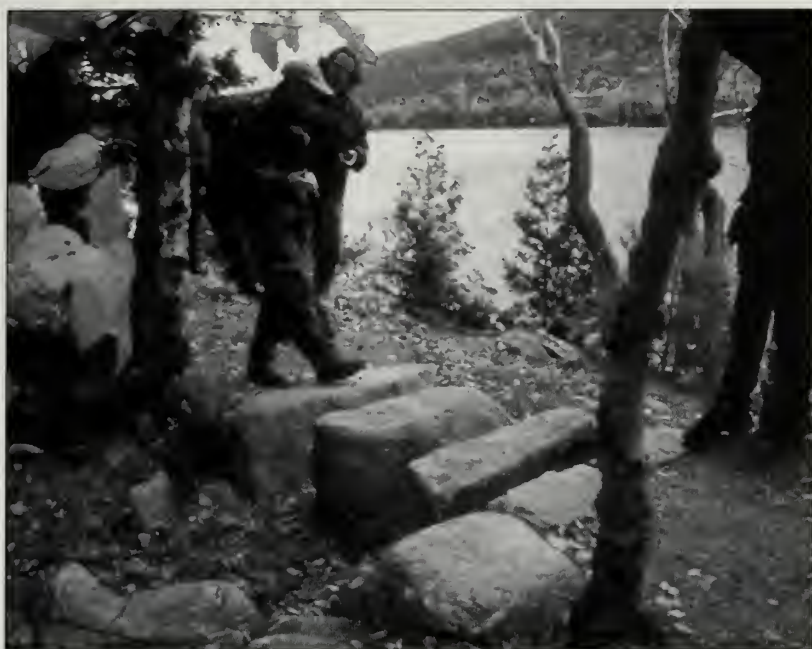
Fig. 4-27 Newly installed stepstone culvert on the Jordan Pond Path (#39).

### 5. Stepstone Culverts (Fig. 4-27)

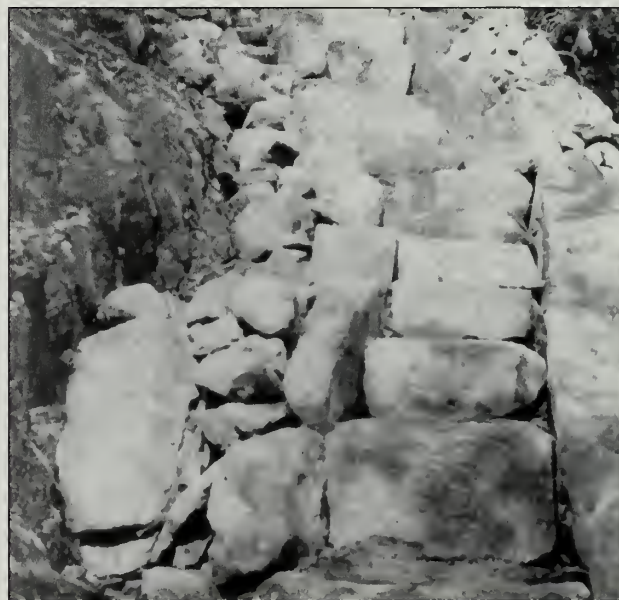
Fig. 4-29 A circa 1935 photograph of a CCC rehab of the lower section of the Ladder Trail (#64) shows a rubble French drain being installed along the side of a staircase with coping retaining wall.

### 1. French Drain (Fig. 4-29)

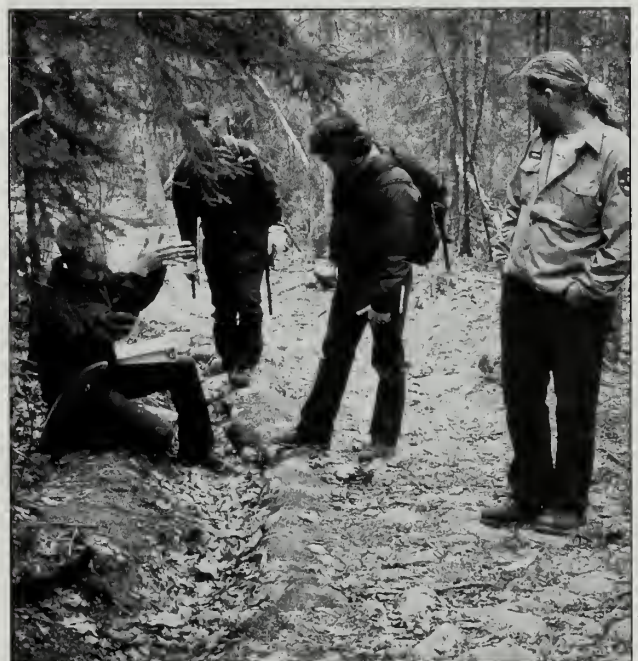
Fig. 4-31 An original VIA/VIS side drain on the Asticou Trail.

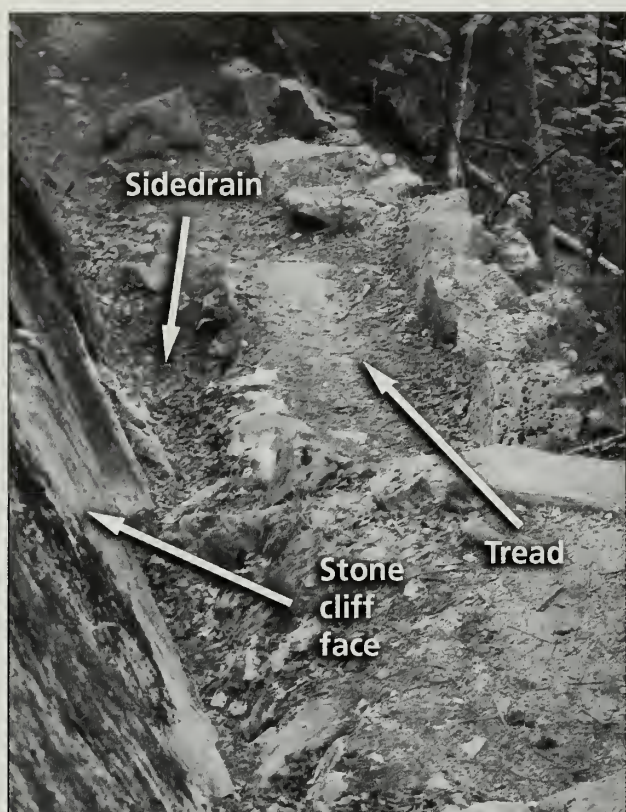
Olmsted Center, 5-98-5-4

Fig. 4-32 A walled side drain along a stone cliff face on the Perpendicular Trail (#119).

The CCC made extensive use of all types of side drains on nearly all their trails. The Perpendicular Trail (#119) uses walled side drains (Fig. 4-32). The Valley Trail (#116) and Ocean Path (#3) combine raised tread with ditching. The V-shaped drain was introduced to the system by the CCC, and the two examples of its use are on the Beech Cliff Loop Trail (#114) and the Beech Mountain West Ridge Trail (#108) (Fig. 4-33). It seems certain that the Valley Cove Trail (#105) had no side drains, or other drainage features except for two culverts. This trail and portions of the Long Pond Trail (#118) have been degraded due to the lack of drainage features, while the Perpendicular Trail (#119) has maintained its integrity thanks in part to adequate drainage.

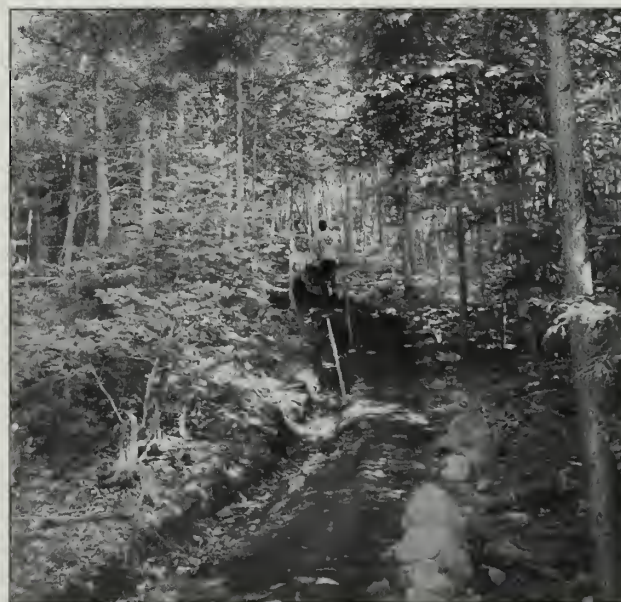
Acadia Trails Crew, 2002

Fig. 4-35 Ditch and fill on Deer Brook Trail (#51) with tread constructed of material taken from the ditch. Sides of the ditch are sloped and the ditch (in foreground) has been angled properly.

Water in the ditches is diverted away from the trail when possible, or else across the trail with stone water bars or open stone culverts. Trails rehabilitated in this way include the Western Mountain Trail (#120), the Cadillac South Ridge Trail (#26), the upper portion of the Long Pond Trail (#118), and Deer Brook Trail (#51) near the intersection with the Jordan Pond Path (#39) (Figs. 4-34 & 4-35).

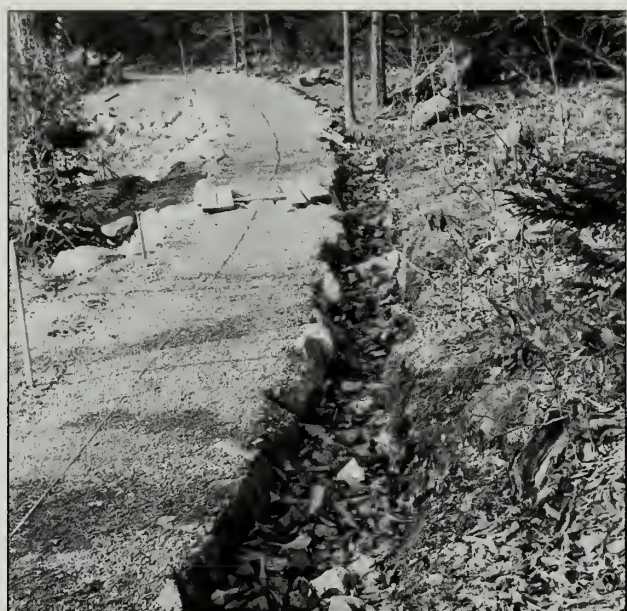
Fig. 4-36 A walled side drain installed on the Jordan Pond Path (#39) along new walled causeway in 2001. Temporary wood planks cover the new open stone culvert.

**SPECIFICATIONS FOR SIDE DRAINS****1. Walled Side Drains (Figs. 4-36 & 4-37)**

In walled side drains, the bottom is reinforced with either laid or crushed stone. If the drain is steep or carries an excessive amount of fast-moving water, checks should be added to the floor of the drainage to avoid scouring and the subsequent loss of sidewall (see Chapter 6, Section A ).

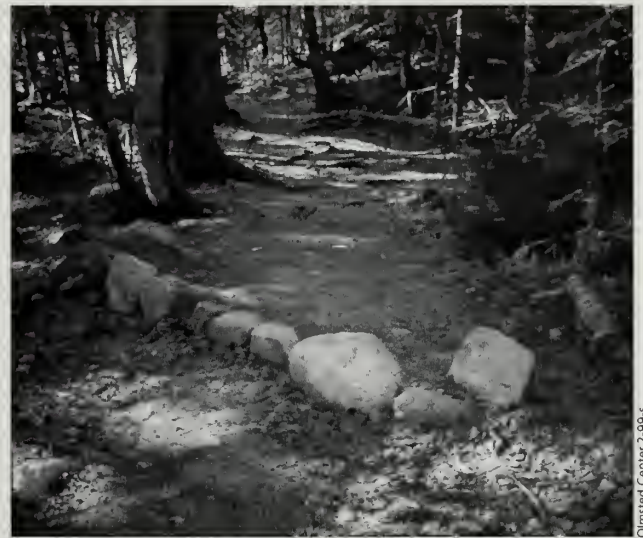
Fig. 4-39 A recently constructed stone water bar on the Pond Trail (#20), located between the motor road and the Jordan Pond Path (#39).

A **water bar** is a structure consisting of a depression crossing a treadway which is reinforced by a log or row of abutting stones on the downhill side. The main function of a water bar is to divert water that is flowing on a sloped treadway. Stone water bars consist of a row of abutting stones. Log water bars use a single log for reinforcement. A backed water bar is a water bar “backed” or held in place by steps or checks constructed below it to help retain the water bar on steep grades (Figs. 4-39 & 4-40).

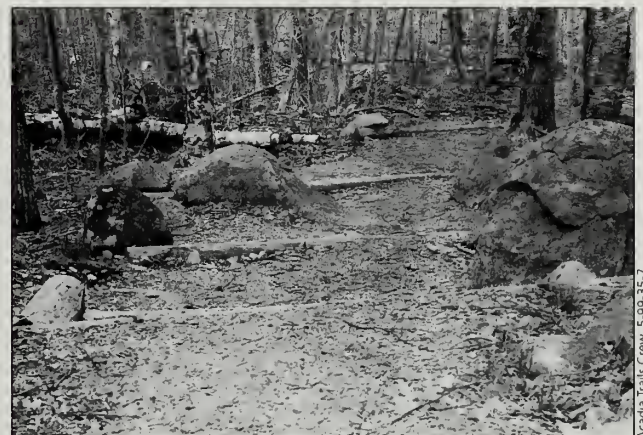
Fig. 4-40 A series of log water bars on the Jordan Pond Carry Spur (#40).

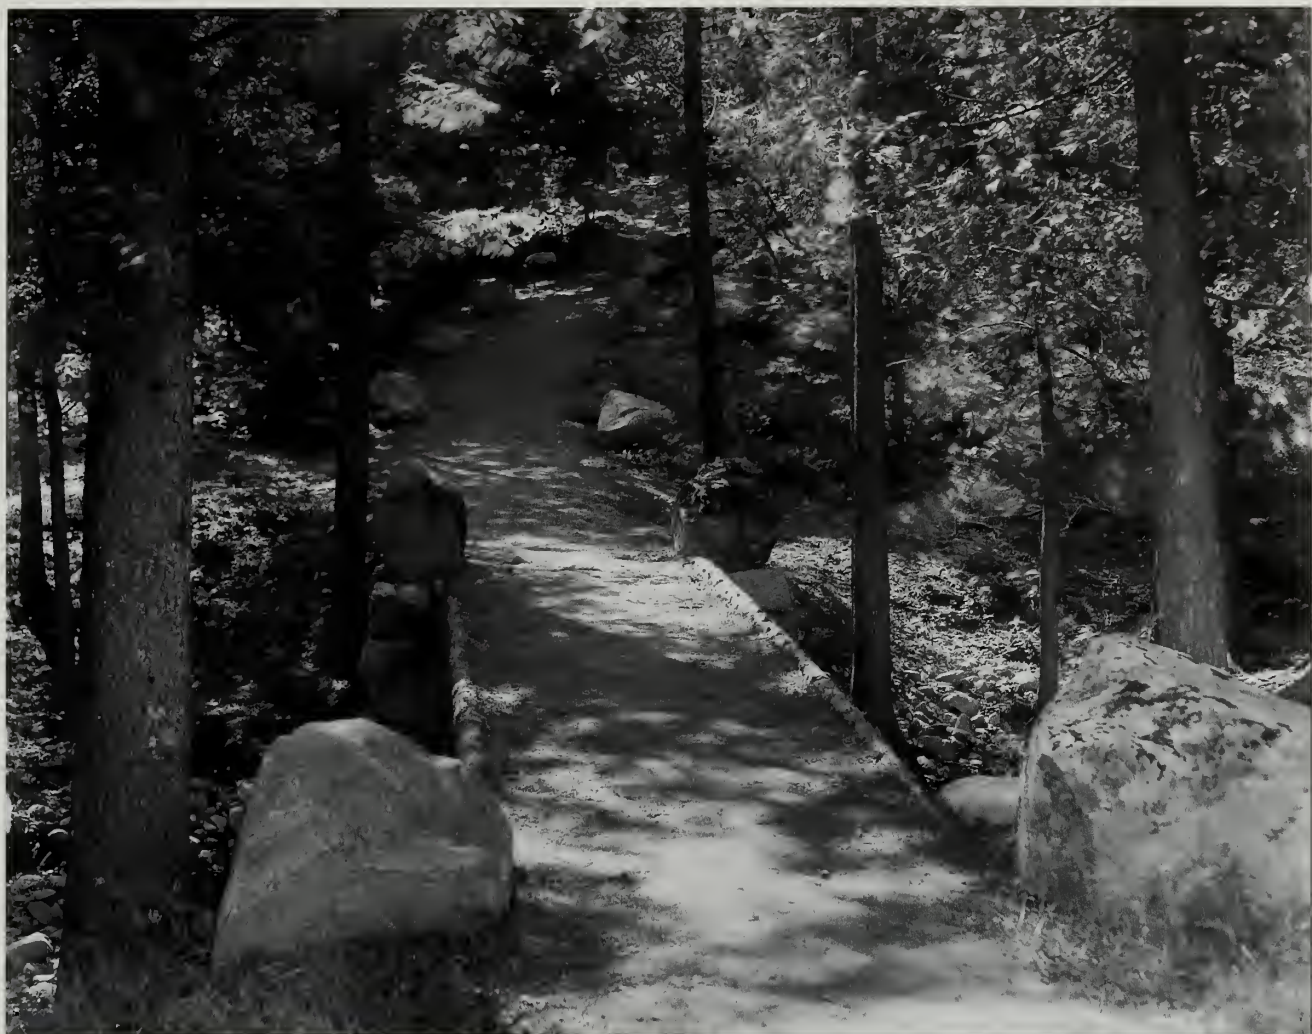
Fig. 5-1 The Bar Harbor VIA constructed many small gravel-surfaced bridges as stream crossings in the Sieur de Monts area like this one across Kebo Brook on the Stratheden Path (#24), circa 1916.

By the late teens there were a number of bridges with gravel surfacing, notably in the Sieur de Monts area (see Fig. 5-1). Some of these bridges had a span as short as 18 inches and were similar in size to culverts. Logs were either laid parallel to the treadway across the drainage, or perpendicular to the treadway on wooden stringers. The structure was then covered with gravel to match the existing tread surface. As of 2002, remnants of a few of these bridges remain in the Sieur de Monts area.

#### f. Gravel-surfaced bridges on the Stratheden Path (#24) (Fig. 5-47, also Fig. 5-1)

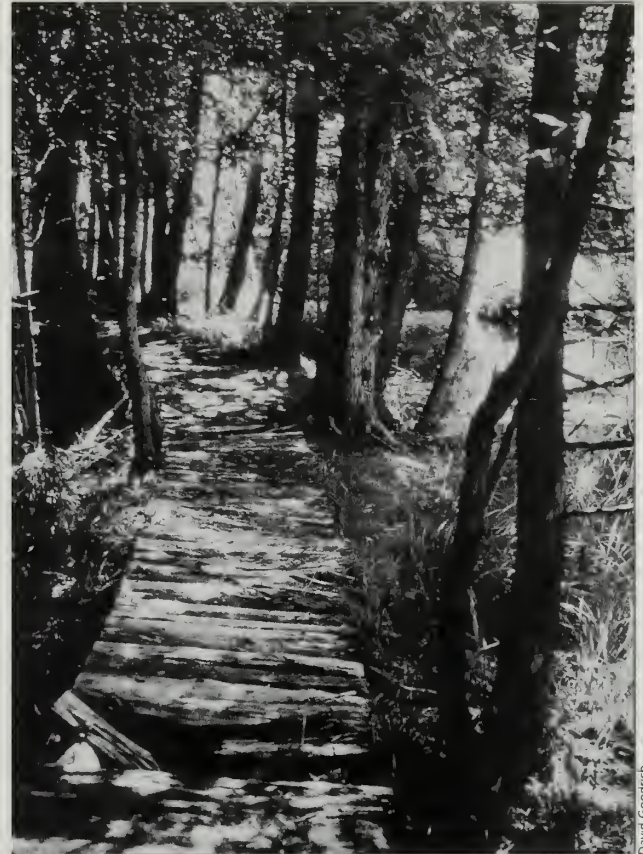
David Goodrich

**Fig. 5-3** This bogwalk on the Upper Hadlock Pond Trail (#501), shown here in 1967, was likely built by the Northeast Harbor VIS in the 1930s or 1940s. This bogwalk is more similar to a bridge, with its stringers and corduroy decking, than it is to the contemporary style of bogwalk used in Acadia.

Stream Path (#65) where planks were used by the SHVIS (Figs. 5-3 & 5-4).

These two bridges probably had the appearance of the arched and flat corduroy Northeast Harbor VIA bridges on Lower Hadlock Trail (#502) and the Asticou Brook Trail (#514), or the long corduroy bogwalk on the Upper Hadlock Pond Trail (#501). (See Figs. 5-3, 5-26, and 5-28)

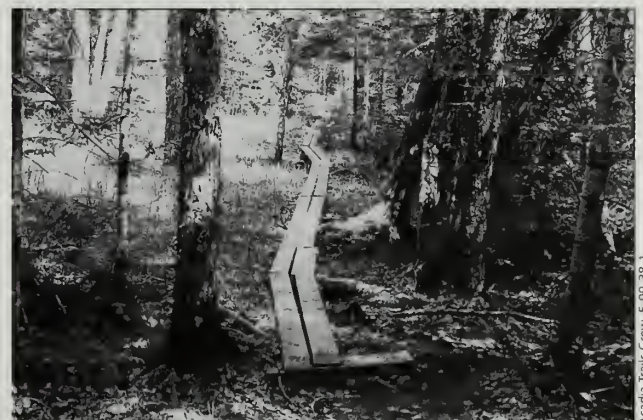
Acadia Trails Crew, 5-99-38-1

**Fig. 5-4** This 1990s plank bogwalk (possibly 2-by-6-inch lumber) on private land on the Jordan Stream Path (#65) may be Seal Harbor VIS construction.
