# ACADIA TRAILS TREATMENT PLAN

## CULTURAL LANDSCAPE REPORT FOR THE HISTORIC HIKING TRAIL SYSTEM OF ACADIA NATIONAL PARK

Olmsted Center for Landscape Preservation  
National Park Service, Boston, Massachusetts, 2006

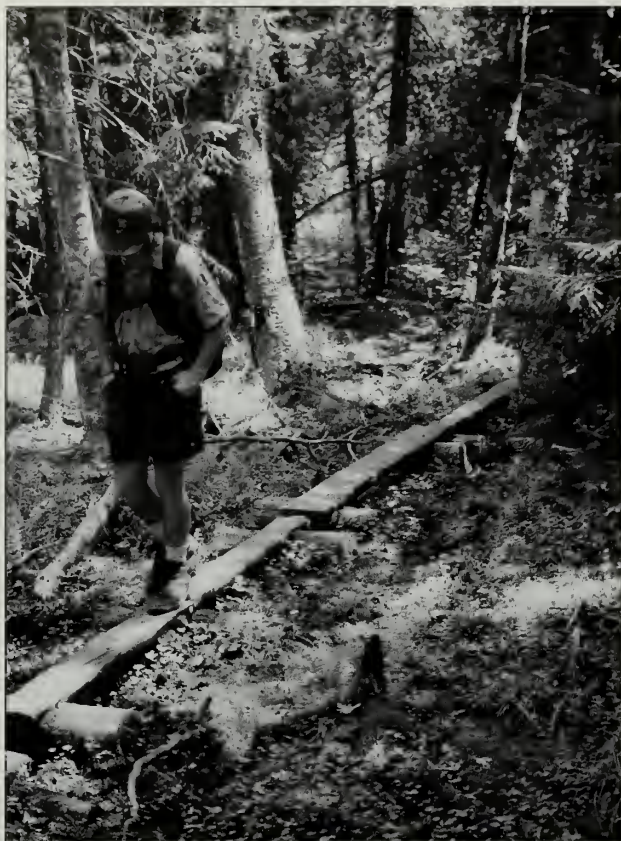
Olmsted Center, 7-97-14-21

Fig. 5-5 Log bogwalks, like these single-treadlog examples, were first introduced to the Acadia system in the 1980s to stabilize tread in wet areas on the Great/Long Pond Trail (#118).

Bogwalks as they exist within the park boundaries today were introduced to Acadia in the early 1980s by Trails Foreman Gary Stellpflug. He adapted the design from bogwalks designed by Lester Kenway in Maine's Baxter State Park. The bogwalks were first used on a reroute at the northernmost bend of the Long Pond Trail (#118). These were constructed in 1982 and were still extant at the time of this report. In 1988, extensive bogwalk construction began on the west side of the Jordan Pond Loop Trail (#39). Since the work in the 1980s, bogwalk has been used throughout the park as a solution to wet or eroded trails in flat areas and near ponds (Figs. 5-5 to 5-7).

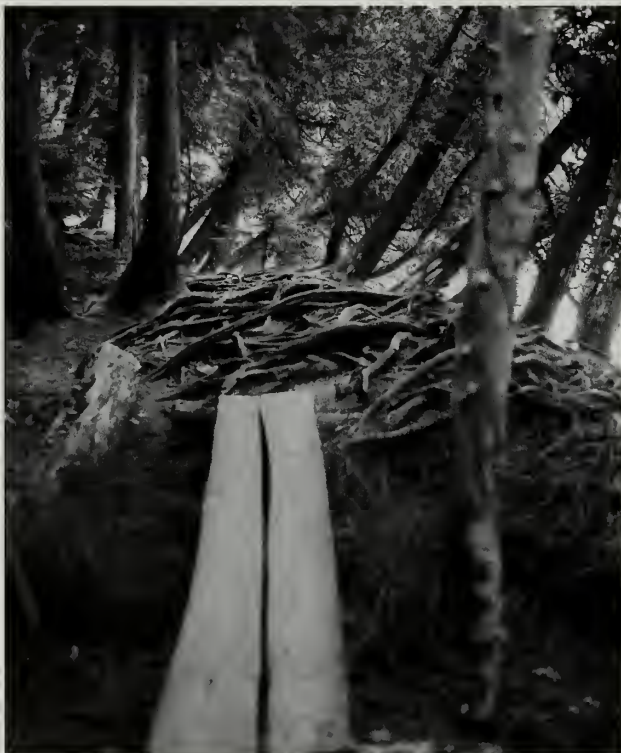
Olmsted Center, 7-97-21-12

Fig. 5-6 Bogwalks are an effective, easily constructed way to provide stable tread over wet or exposed root areas such as on the west side of the Jordan Pond Loop Trail (#39).

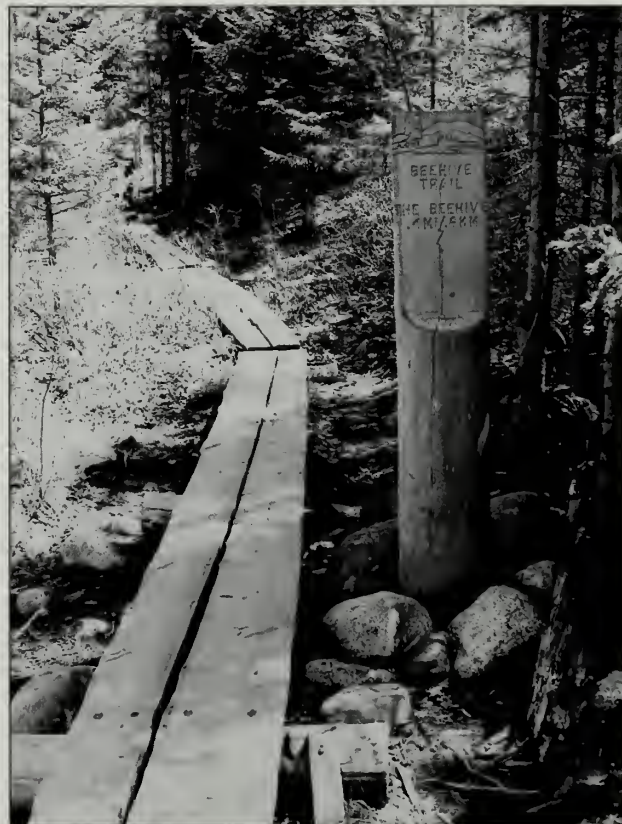
Acadia Trails Crew, Olmsted Center, 5-99-12-2

Fig. 5-7 Bogwalks are often installed to protect fragile vegetation, like this section surrounding The Bowl on the Beehive Trail, West (#8).

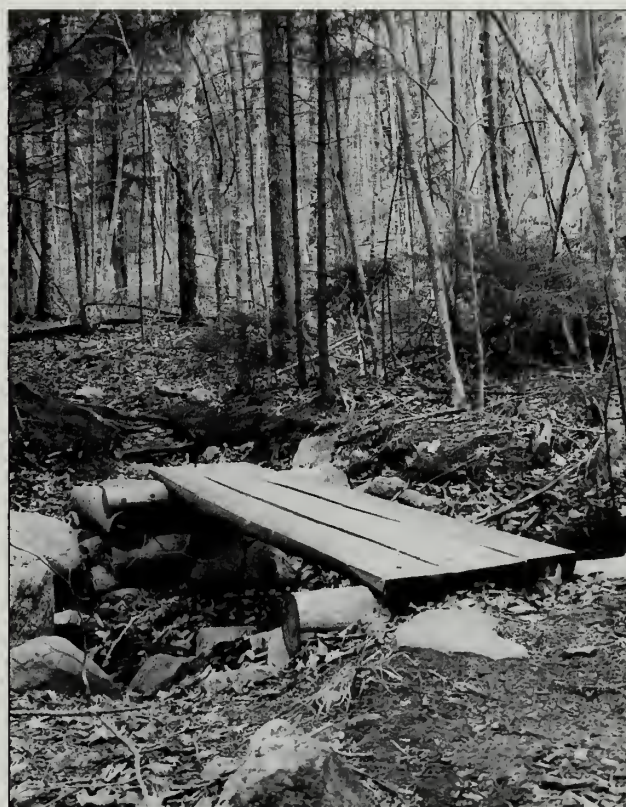
Fig. 5-9 A bogwalk bridge on the Jordan Pond Carry Path (#38).

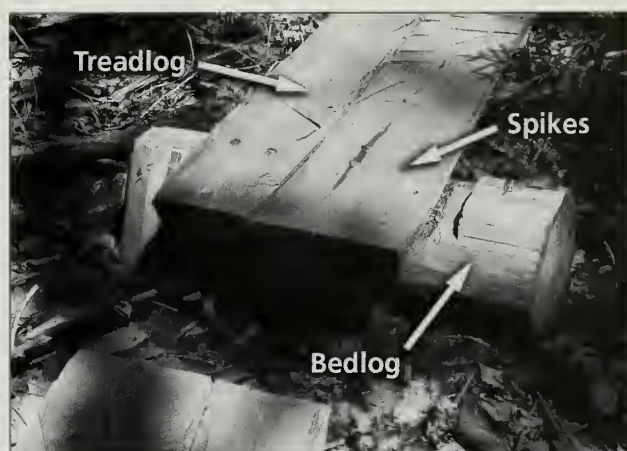
Olmsted Center, 7-97-19-15

**Fig. 5-13** Bogwalk construction detail on the Pond Trail (#20). Stakes are no longer used to anchor bedlogs due to frost heave. Bedlog notching is not needed if the treadlog and bedlog are both milled flat on two sides.

Treadlogs are spiked to bedlogs or cribs with 8-inch spikes or timber screws. Treadlogs should cantilever no more than 6 inches beyond their supports to avoid levering up or, as the wood deteriorates, breaking off.

### 2. Bedlogs or Piers (Fig. 5-13)

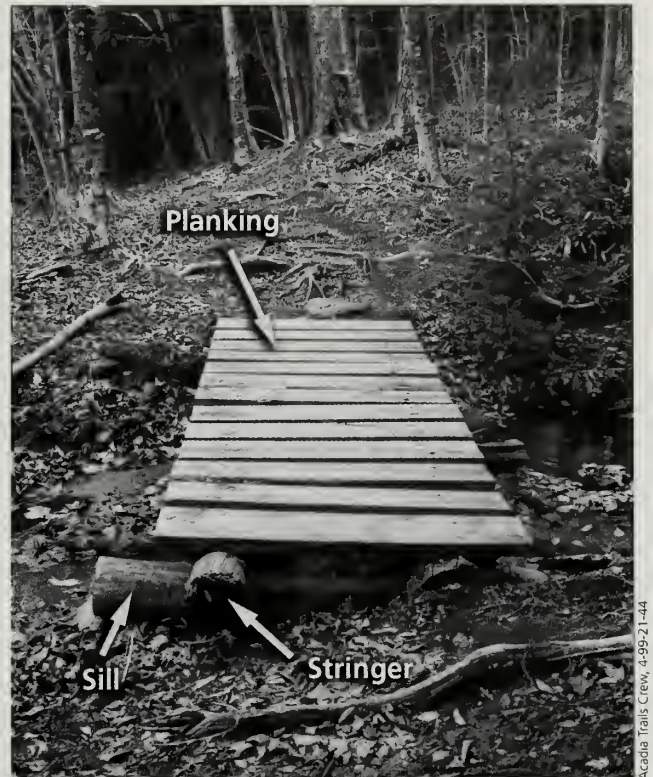
Fig. 5-14 A bridge constructed by the Youth Conservation Corps on the Jordan Pond Carry Path (#38) in 1987.

Figures 5-14 to 5-19 show a small sampling of the various bridges currently extant at Acadia. None of these examples date from the historic period of 1890–1942, but a few have features with historic precedents, like corduroy decking. Features typically associated with bridge construction are identified in the labels.

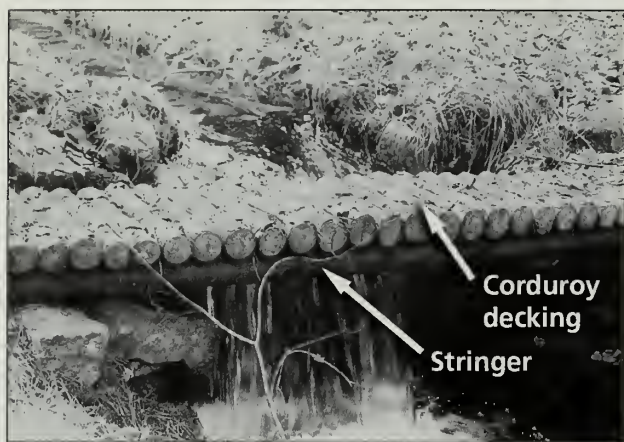
Fig. 5-16 Corduroy bridge at the Cold Brook Fish Hatchery.

**h. Cold Brook Fish Hatchery area** (Fig. 5-50, also Figs. 5-16 & 5-40). A historic corduroy bridge in the former Cold Brook at the Fish Hatchery was less than 4 feet wide. The stringers were curved cedar logs, and the deck was full or round cedar approximately 4 inches in diameter. Several other small corduroy bridges were found in this area. Typically, railings were not used with these bridges.

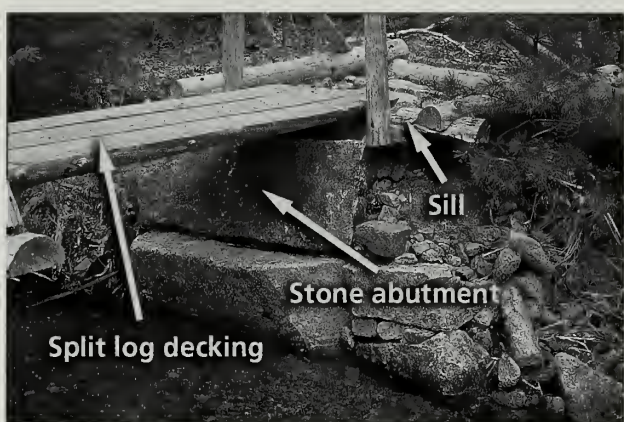
Fig. 5-17 Plank bridge over Harbor Brook on the Asticou Trail (#49).

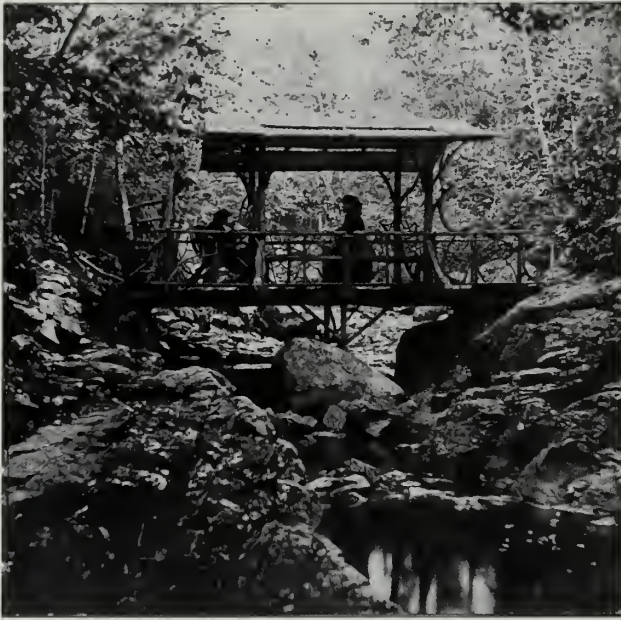
Fig. 5-20 This rustic bridge with a thatched roof and seats over Duck Brook was built by a local landowner. The bridge was erected in the vicinity of a path later marked as the Duck Brook Path (#311), photograph circa 1870s.

The earliest photographs of footbridges on Mount Desert Island date to the 1870s. A rustic bridge with shade roof and seats over Duck Brook was built by the landowner. A second bridge may have also crossed Duck Brook (Figs. 5-20 & 5-21). Though the bridges did not last long in Maine’s harsh winter climate, the photographic images were popular as souvenir postcards. These bridges were built in the picturesque style espoused by Andrew Jackson Downing’s *Treatise on the Theory and Practice of Landscape Gardening*, first published in 1841. Downing advocated for the con-

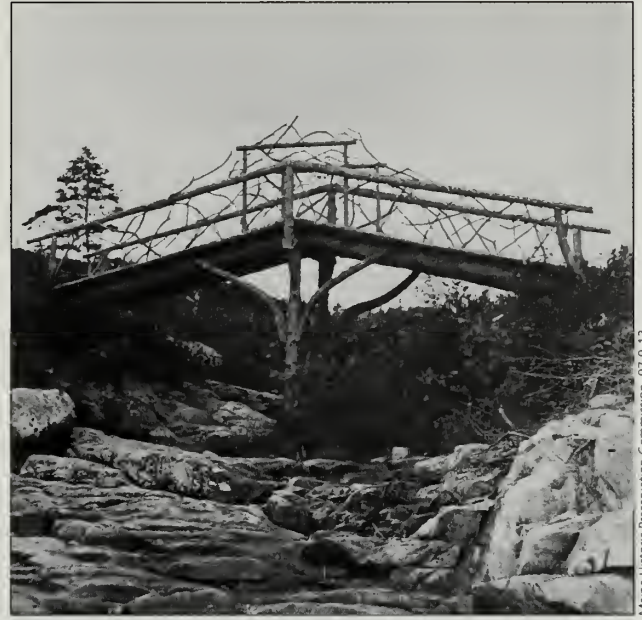
Fig. 5-21 Rustic bridge, possibly constructed over Duck Brook, photograph circa 1870s.

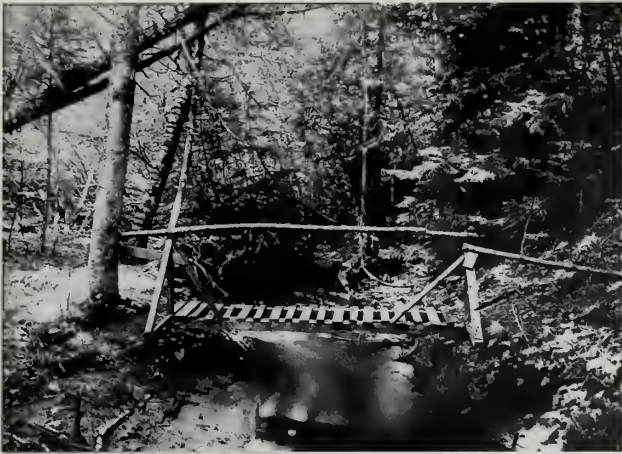
Fig. 5-22 An early footbridge over the Jordan Stream on the Jordan Stream Path (#65), photographed in 1904.

There is much commentary in the VIA/VIS path committee annual reports about the frequent need for replacement and repair of bridges. In particular, the bridges for the path along Jordan Pond Stream (#65) required constant maintenance. A circa-1904 photograph shows one of several bridges along the path (Fig. 5-22). This bridge of thin cedar logs and cut planks may have lasted fifteen years, as the 1919 Path Report indicates that five new cedar bridges were built that year. Another VIS bridge, photographed circa 1908, was also built with a combination of rough cedar logs and cut planks (Fig. 5-23).

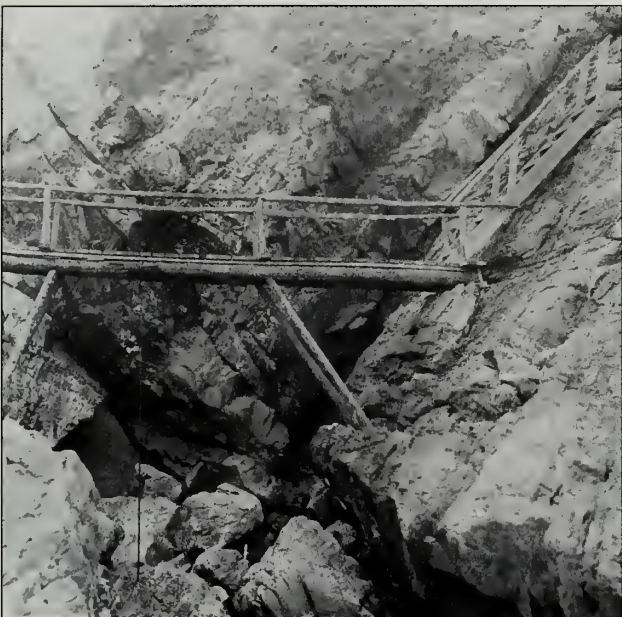
Fig. 5-23 A bridge of cut boards and rough-hewn logs, shown in 1908, along the rocks near Seal Harbor built by the Seal Harbor VIS, circa 1908.

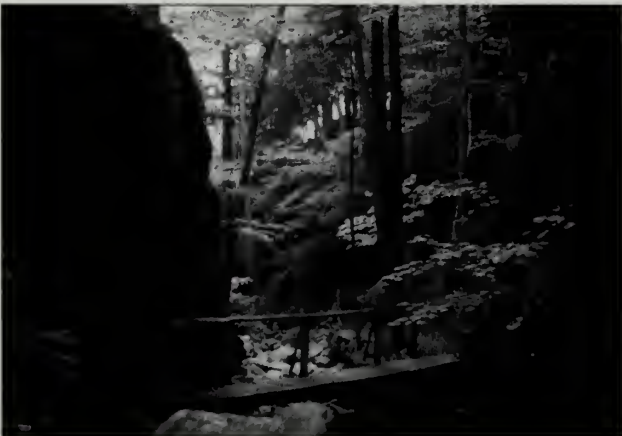
Fig. 5-24 This log bridge with a single railing, shown in 1961, was constructed possibly by the Northeast Harbor VIS over Hadlock Brook in a gorge near pulpit rock on the Maple Spring Trail (#58).

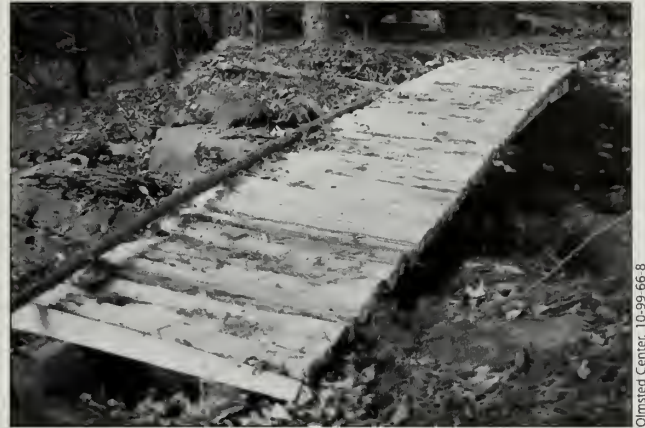
Fig. 5-25 This corduroy bridge was constructed in 1998 by the Northeast Harbor VIS below Asticou Gardens on the Asticou Brook Trail (#514). Rough split cedar decking is laid on stripped cedar log stringers and supported by stone abutments.

The Seal Harbor VIS and Northeast Harbor VIA still build and maintain bridges on trails outside of the park. Most Seal Harbor VIS bridges are constructed of cut planks, whereas the Northeast Harbor VIS continues the tradition of rustic cedar pole bridges, including arched stringers, curved railings, and thin, full round saplings for corduroy tread. Northeast Harbor VIS president Dan Falt spent several years searching for two matching arched cedar poles (of downed trees) to serve as stringers for an arched bridge on a Northeast Harbor trail (Figs. 5-25 to 5-28).

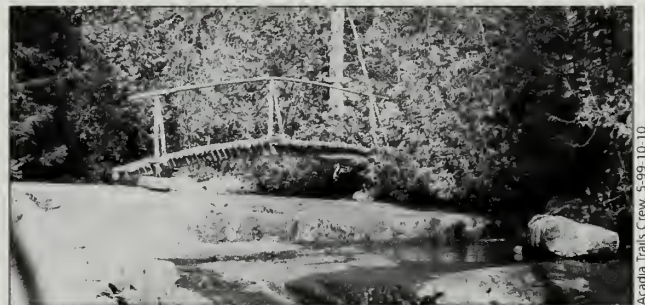
Fig. 5-26 This arched corduroy bridge with a single railing was constructed by the Northeast Harbor VIS circa 1998 on the Lower Hadlock Trail (#502). The cedar stringers are naturally curved logs, typical of trees found along pond shores or stream banks.

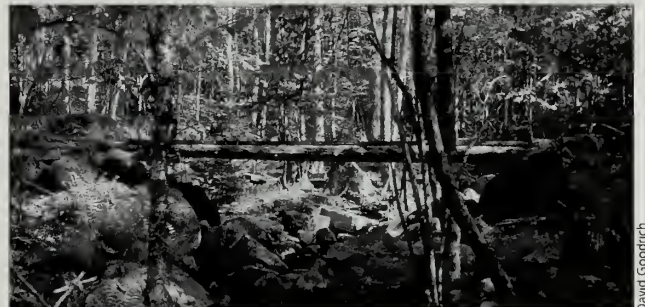
Fig. 5-27 This wooden bridge with cedar log stringers and plank decking on the Great/Long Pond Trail (#118), shown in 1968, may contain underpinnings of a CCC-era bridge.

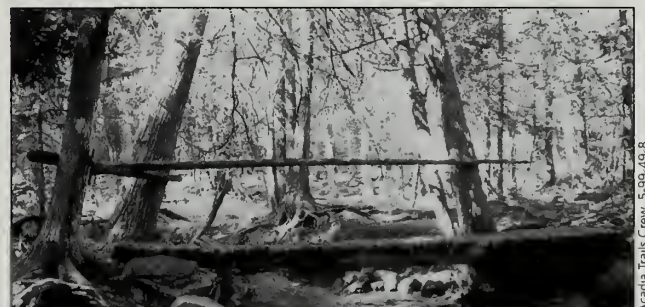
Fig. 5-28 This corduroy bridge on the Lower Hadlock Trail (#502) has a single wooden railing nailed to adjacent trees. It was constructed in the 1990s by the Northeast Harbor VIS.

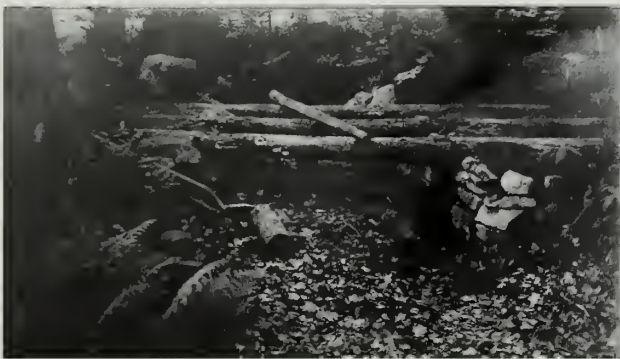
Fig. 5-29 A 1930s view of construction of a CCC corduroy bridge shows the installation of the stone abutments and three log stringers.

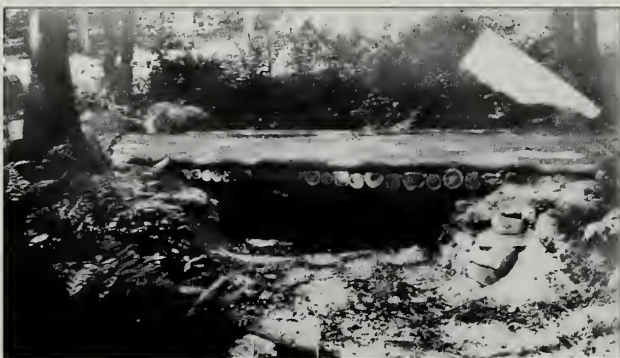
Fig. 5-30 The completed corduroy bridge with log curbs and gravel over the decking photographed in the 1930s. Its smaller scale is typical of CCC work on the west side of the island.

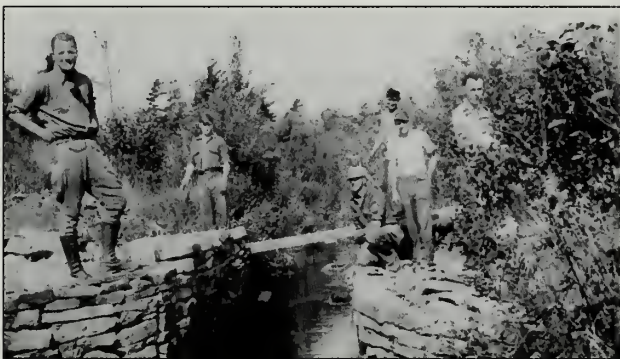
Fig. 5-31 CCC crews working on a wooden bridge in the Great Meadow, circa 1930s.

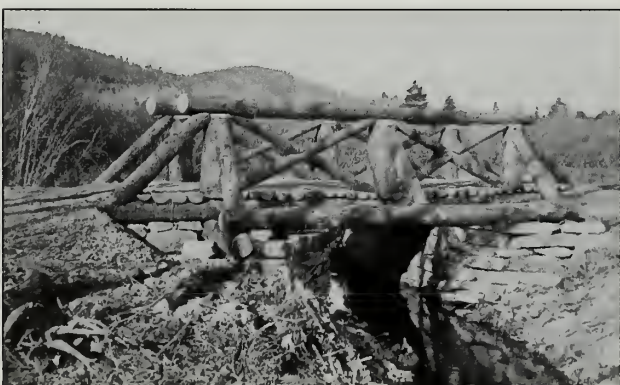
Fig. 5-32 CCC bridge in Great Meadow with stepped-down railings and outrigger bracing, 1930s.

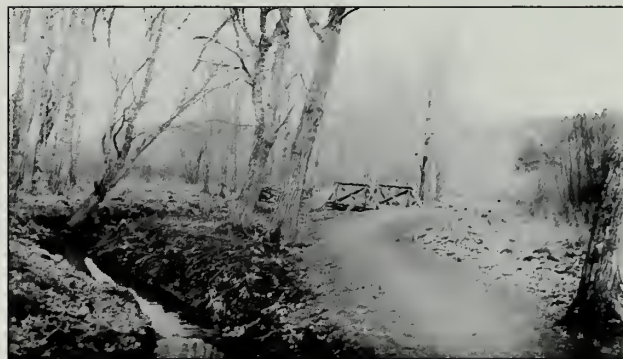
Fig. 5-33 CCC bridge near Sieur de Monts Spring with diagonal and outrigger bracing, circa 1930s.

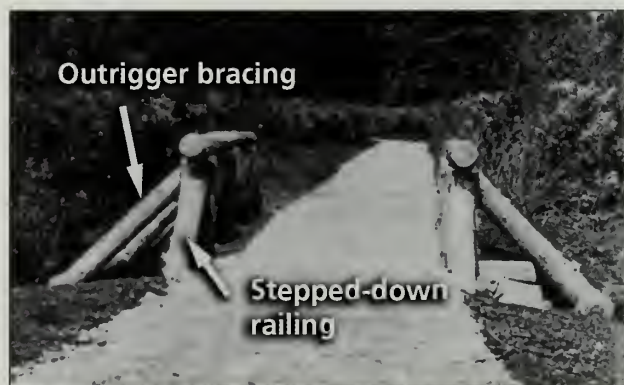
Fig. 5-34 An end view of the CCC bridge on the Great Meadow Nature Trail (#365) shows continuous gravel surfacing, circa 1930s.

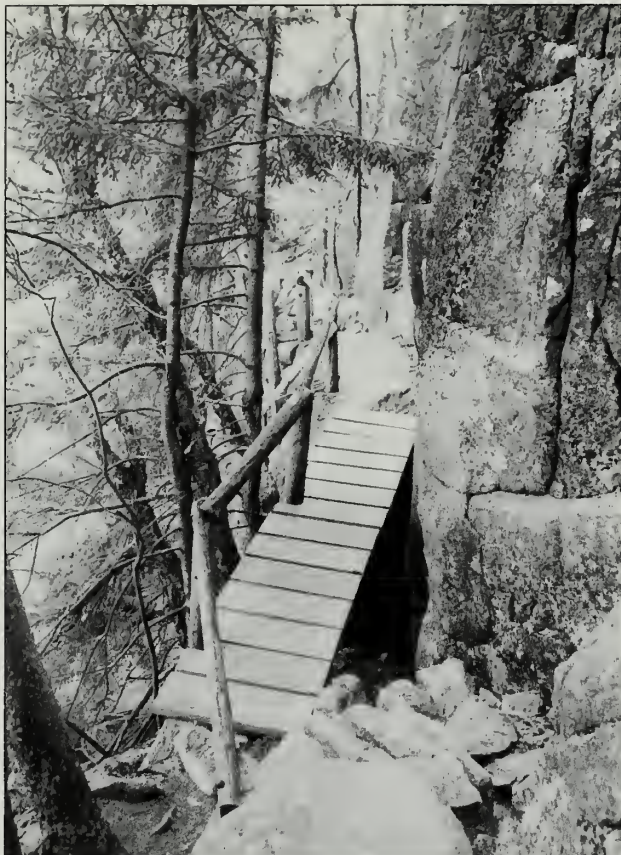
Fig. 5-35 Bridge with railing built by NPS in the 1990s along the Penobscot Mountain Trail (#47).

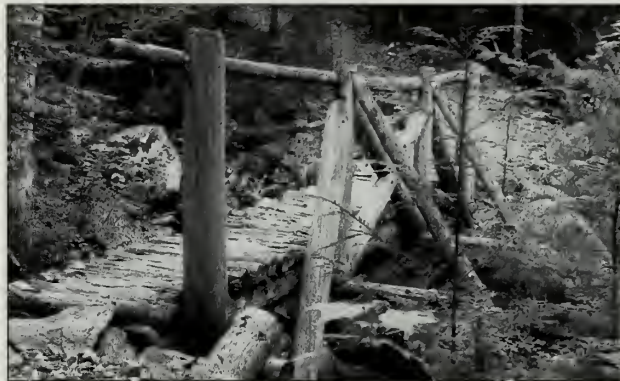
Fig. 5-37 This corduroy footbridge on the Great/Long Pond Trail (#118) was constructed in 1982, replacing an earlier CCC bridge. This new bridge is 23 feet long, 30 inches wide, and has a 3 foot railing.

In 1982, NPS crews replaced a CCC bridge on the Long Pond Trail (#118). The CCC bridge was 5 feet wide and had no railings. The new bridge was constructed in the CCC style of bridges historically used in the Sieur de Monts area. The treads for the new bridge were split cedar logs approximately 8 inches in diameter, flat side down (Fig. 5-37).

**i. Long Pond Trail (#118 )** (Fig. 5-51, also Fig. 5-37). Two pre-1970s bridges were documented in the 1980s on the Long Pond Trail (#118) and have since been replaced. The first bridge, across the Great Brook, had substantial log abutments, a width of 5 feet, and 2-inch-thick decking. A smaller bridge was only 4 feet wide and probably also had 2-inch decking. It was supported by small stones. By the 1970s, neither of these bridges had handrails, although handrails may have been an original feature. Gary Stellpflug remembers both of these bridges being extremely rotted and hazardous prior to their 1982 replacement. There is an assortment of other small bridges on this trail, many constructed over original CCC stone abutments.

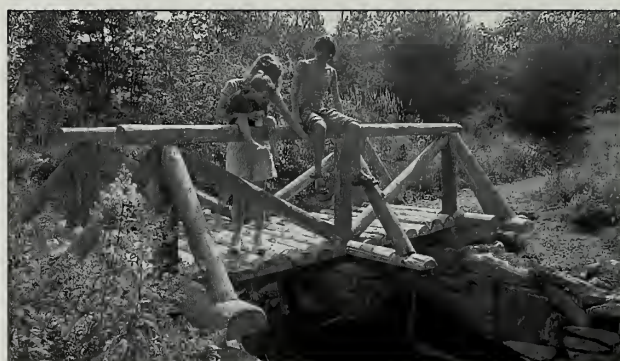
Fig. 5-38 This CCC-influenced log bridge was constructed in 1999 on the Great Meadow Loop. A side view of the bridge is shown in Fig. 5-19.

The most recent bridge constructed in the CCC large-scale style was built in 1999 on the Great Meadow Loop, a new connector trail between Bar Harbor and the park. This bridge was constructed using CCC photographs as a guide and incorporates split log decking, round-side up, and handrails on each side. The finished construction generated discussion as to whether the tread surface is too uneven. Original CCC bridges of similar design contained a gravel surfacing over the log decking, with curbrails on each side to keep the gravel in place, resulting in a smoother walking surface. This detail was not incorporated into the new bridge, and a few other items, such as bracing, differ from CCC work, but overall, the CCC character is retained in this modern addition to the trail system (Fig. 5-38).

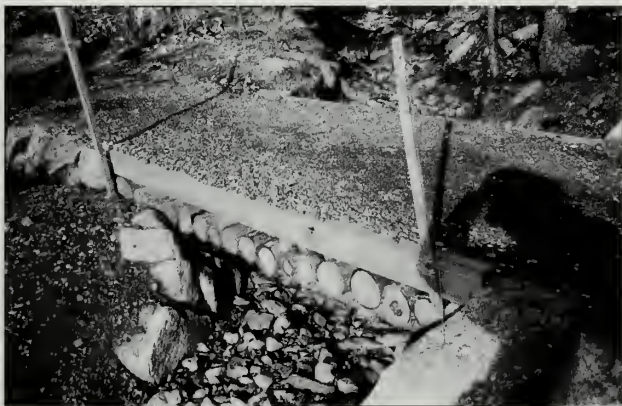
Fig. 5-39 Gravel-surfaced bridge on Jordan Pond Path (#39), constructed in 2001.

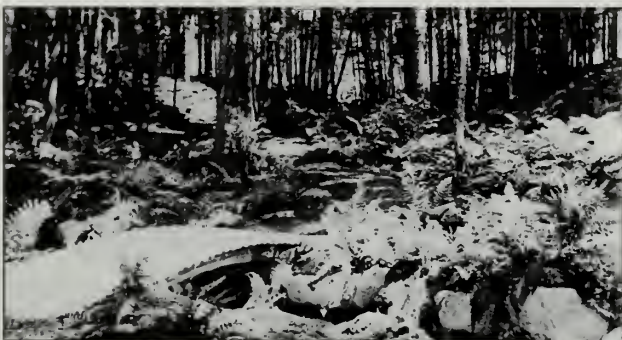
Fig. 5-40 This historic image shows an arched CCC corduroy bridge near the Cold Brook Fish Hatchery on the Great/Long Pond Trail (#118) soon after construction in 1935.

For example, a trail that primarily reflects VIA/VIS features should contain bridges built to be compatible with the VIA/VIS style. Generally these types of bridges will contain rustic construction materials and maintain a relatively delicate or graceful appearance, as seen currently seen in the Northeast Harbor VIS District and Jordan Pond Path (see Fig 5-26 & Fig. 5-39). On a CCC trail, bridges should generally have a heavier feel, with larger members and more substantial construction, particularly on the eastern side of MDI. The bridge recently constructed on the Great Meadow Loop is a good example (see Figs. 5-19 & 5-38). CCC bridges on the western side of MDI tended to be smaller in scale, and more similar to the VIA/VIS style. Examples of this can be seen in the extant (though extremely decayed) bridges at the former Cold Brook Fish Hatchery near the outlet of Long Pond, as well as in historic photographs of the many small CCC bridges constructed on the Long Pond Trail (#118) (Fig. 5-40).

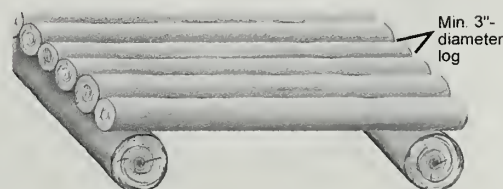
Fig. 5-44 Details of various decking options.

#### 6. Decking (Fig. 5-44)

Where decking runs perpendicular to tread, decking ends must be cut to uniform length. With milled plank decking, bridge treads must be smooth with an even height, to prevent hazard.

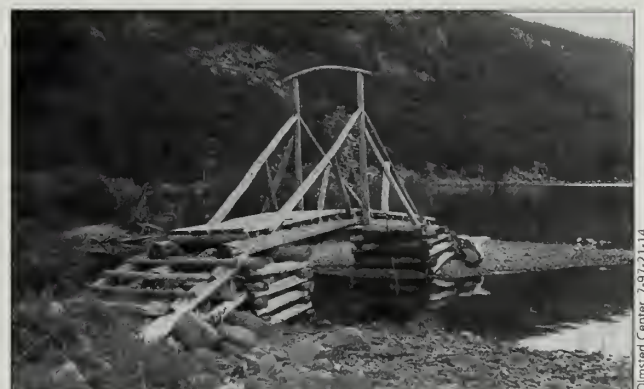
**Fig. 5-46** This wooden bridge was constructed in 1983 by NPS crews on the Jordan Pond Loop Trail (#39) at the north end of the pond.

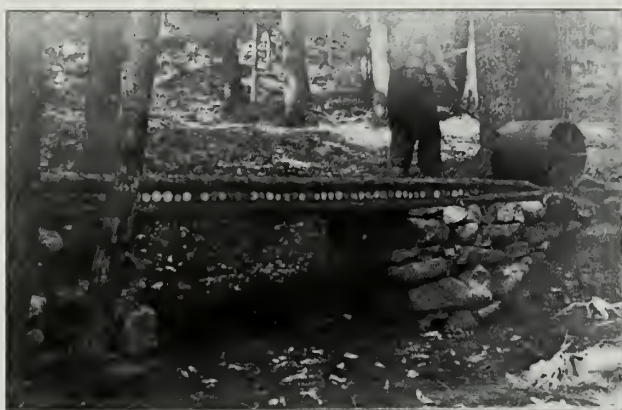
Fig. 5-47 A CCC worker rolls gravel tread on a corduroy bridge on the Stratheden Path (#24) in the 1930s. Notice the stone abutments, corduroy decking, and curbrails, common features on many of the gravel surfaced bridges.

#### f. Gravel-surfaced bridges on the Stratheden Path (#24) (Fig. 5-47, also Fig. 5-1)

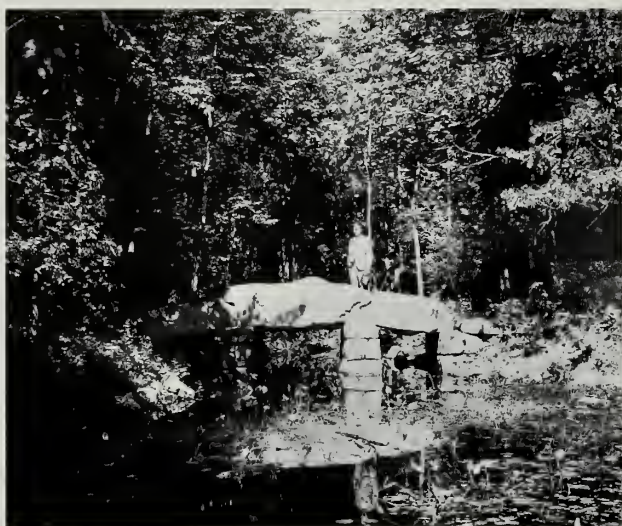
Fig. 5-48 The Kane & Bridgham Memorial Bridge was constructed between 1926 and 1929 at the outlet of Lakewood in Bar Harbor. Designed by noted landscape architect and summer resident Beatrix Farrand, the bridge consisted of large stone slabs set on stone piers. Photograph circa 1932.

In 1926 construction began on a large stone “rustic” bridge over the outlet on the north end of Lake Wood.<sup>27</sup> The bridge was designed by noted landscape architect and summer resident, Beatrix Farrand and was built during the latter period of endowed and memorial trails, as a memorial bridge. The bridge was dedicated in 1929 as the “Kane & Bridgham Memorial Bridge.”

**g. VIA/VIS Stone Bridge (Figs. 5-48 & 5-49).** In the 1920s, landscape architect Beatrix Farrand designed a granite bridge for the outlet of Lake Wood. Constructed between 1926 and 1929, the bridge consisted of granite block abutments and piers, topped with granite block decking and curbrails. Though collapsed, most of the bridge pieces remain, and it could be reconstructed using some of the original materials. If the bridge is rebuilt, further research should be conducted to locate the original design drawings and specifications. This is the only known bridge of this

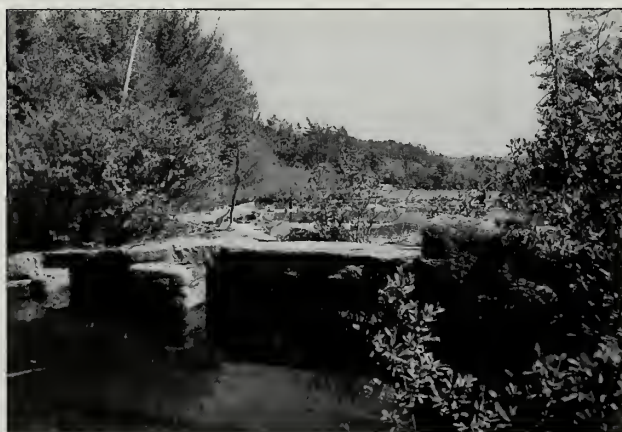
Fig. 5-49 A 1997 view of the Kane & Bridgham Memorial Bridge showing the remaining pieces of the bridge. Rising waters from beaver activity along with ice damage have taken their toll on this structure, and at times it is almost completely submerged.

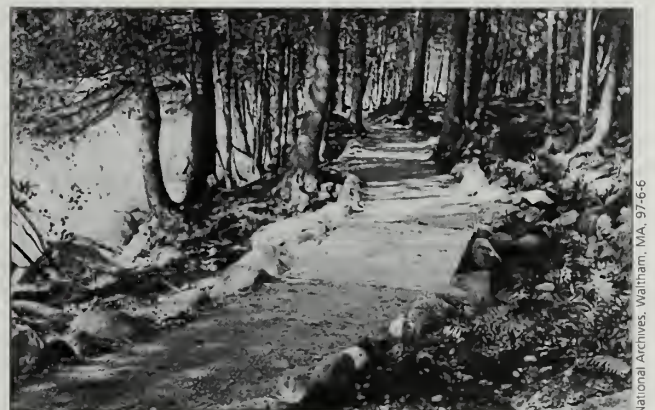
Fig. 5-51 Small CCC corduroy bridge on the Great/Long Pond Trail (#118) in 1935. The delicate style, similar to earlier VIA/VIS work, complements the gravel tread and coping stones.

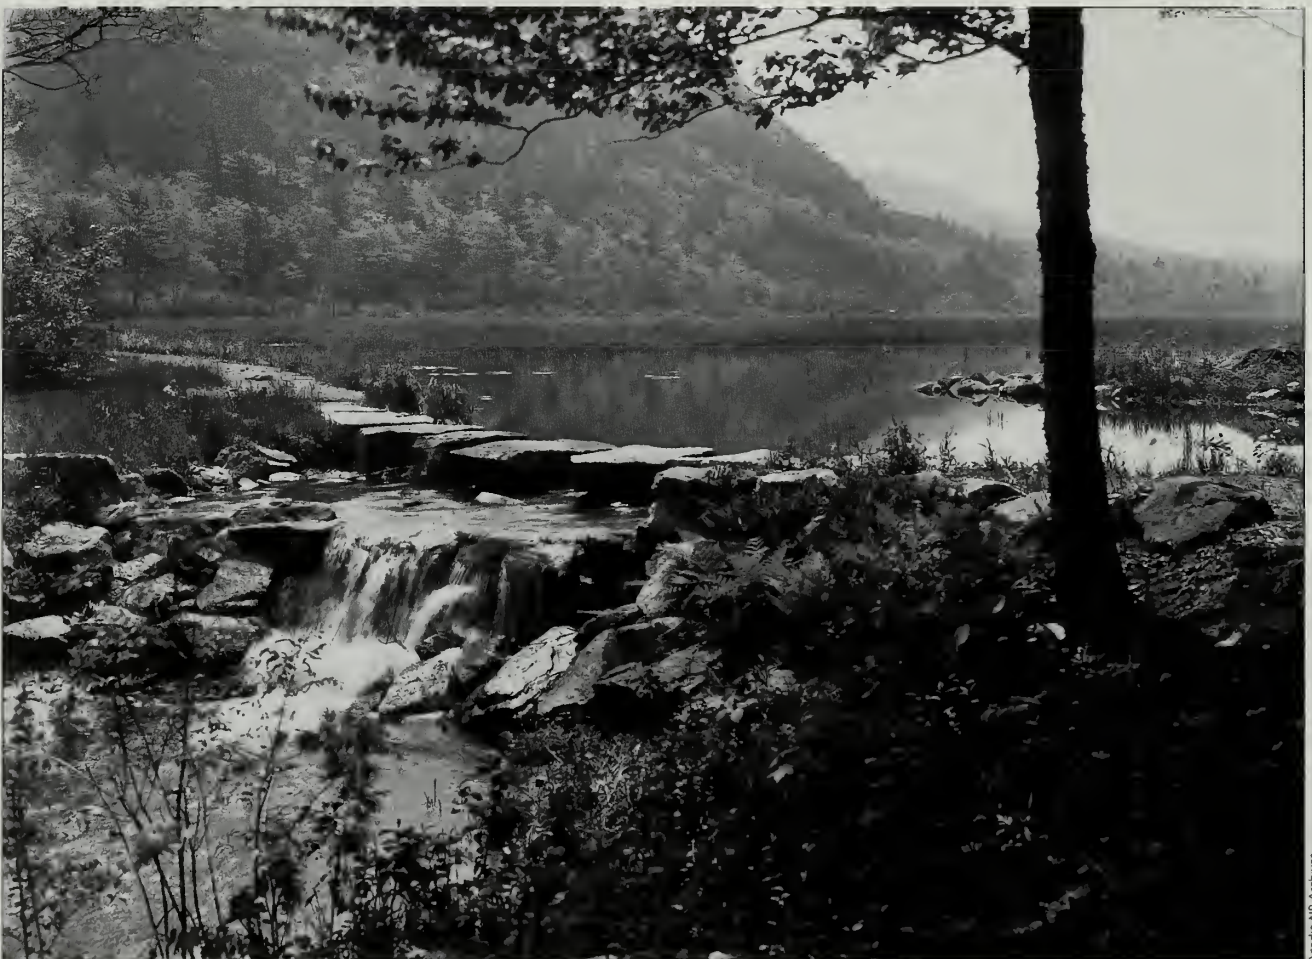
Fig. 5-52 A stream crossing was a typical location for stepping stone use by the early VIA/VIS trail builders. Shown in circa 1916, the stones cross a shallow stream over the dam at the outlet of The Tarn. These stream-style stepping stones proved to be a more durable option than a bridge, as they are still extant nearly ninety years later.

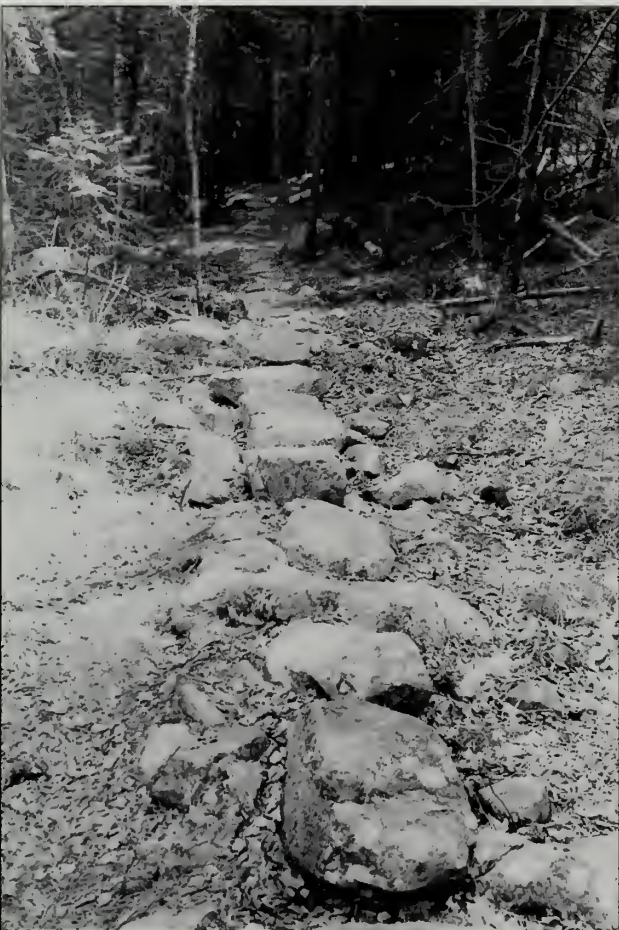
**Fig. 5-53** It is unknown whether these stepping stones on the Eagle Lake Trail (#42) are original VIA/VIS work, but they reflect the style of VIA/VIS stepping stones used in boggy areas.

**Bog-style stepping stones** are used to traverse low, wet areas with standing water. They are defined structurally by smaller, more irregularly shaped and set stones. These stones are usually elevated slightly by setting them into a causeway of crushed or piled stone. Because water need not pass quickly through them, smaller stones are often used to fill the spaces between the stepping stones, and sometimes two or more stepping stones in a row abut. Examples can be found the Eagle Lake Trail (#42), the Jordan Pond Carry Path (#38), and the Canon Brook Trail (#19) (Fig. 5-53).

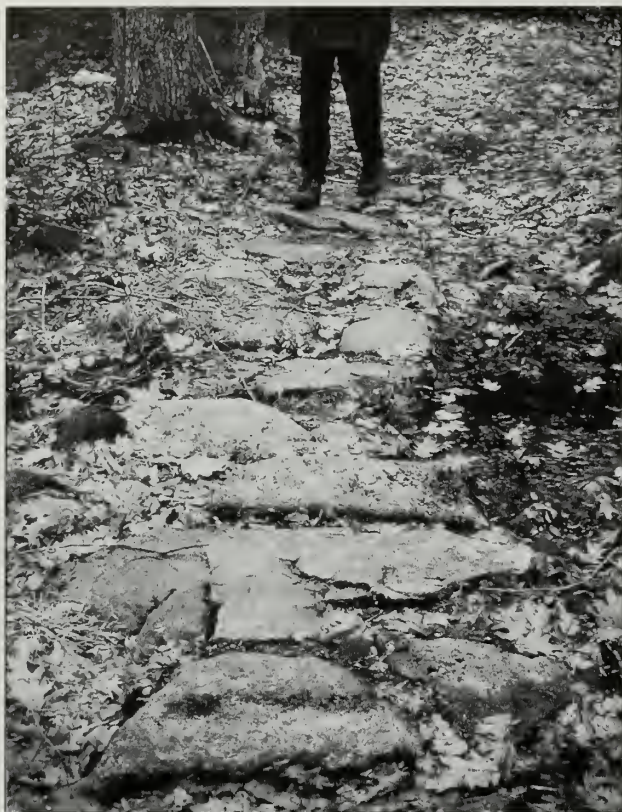
Fig. 5-54 Although these original VIS bog-style stepping stones on the Asticou Trail (#49) have settled into the ground, the irregularity of stone sizes can still be discerned.

Both styles of stepping stones were used. Examples of bog-style stones can be found on several trails, including the Asticou Trail (#49), Gorham Mountain Trail (#4), and the Bowl Trail (#6), Canon Brook Trail (#19), and Eagle Lake Trail (#42). Additionally, many stepping stones added during later periods closely resemble this style of VIA/VIS work (Figs. 5-54 to 5-57).

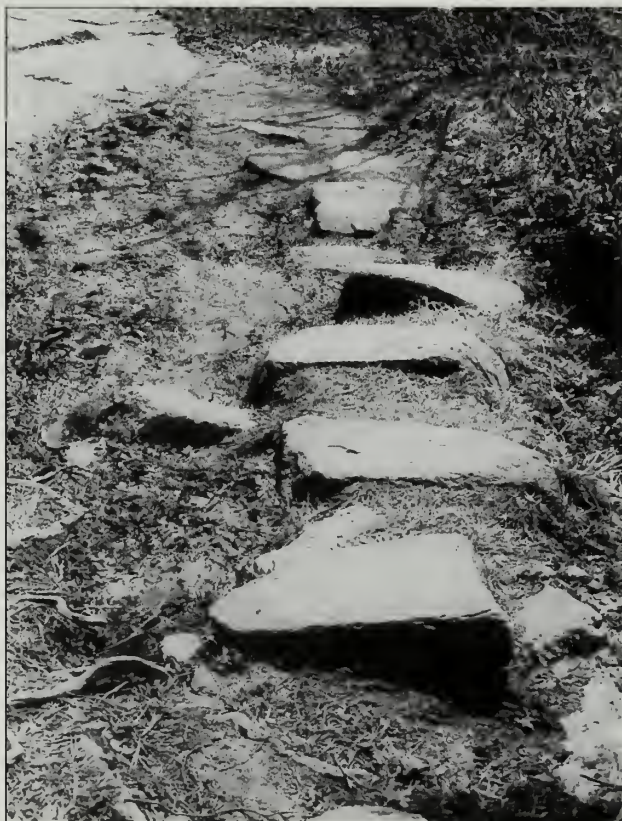
Fig. 5-55 These VIA bog-style stepping stones are located on the Gorham Mountain Trail (#4).

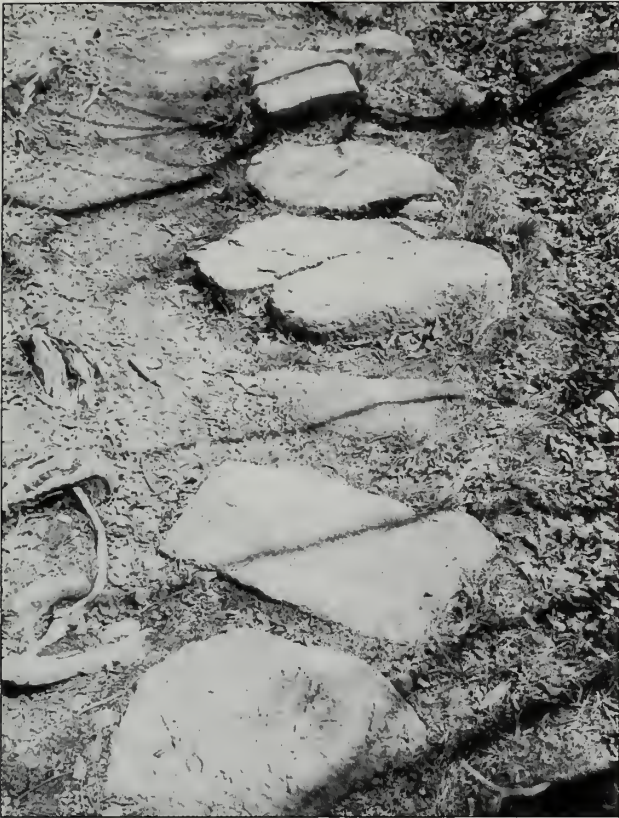
Fig. 5-56 These bog-style stepping stones on the Bowl Trail (#6) may be original VIA work.

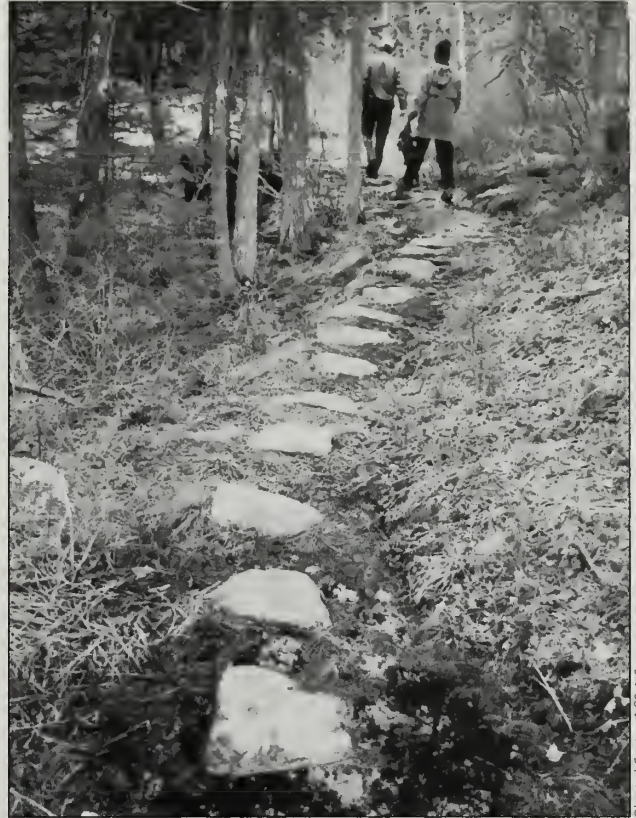
Fig. 5-57 These bog-style stepping stones on the Canon Brook Trail (#19) are in the VIA/VIS style, but it is not known if these are original trail features.

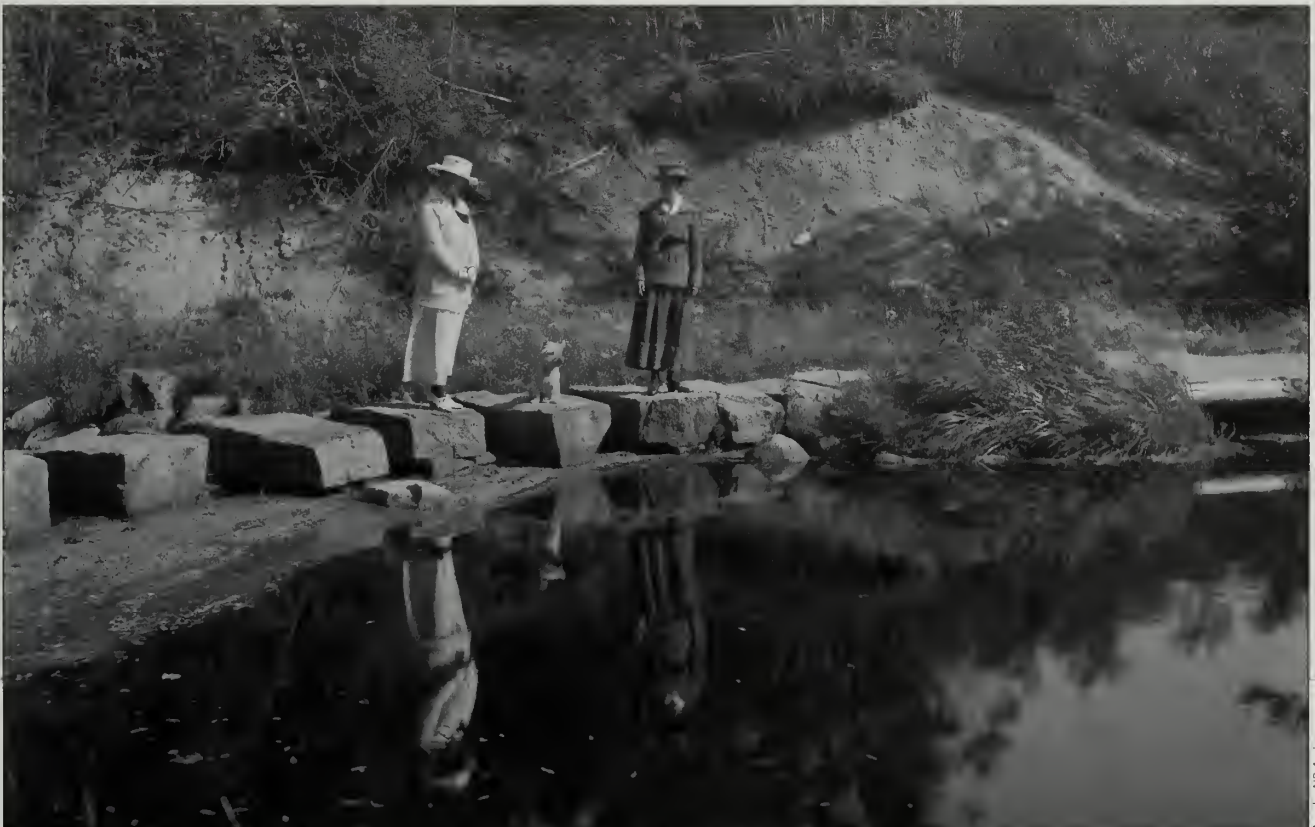
Fig. 5-58 Miss Cottoriet and Miss Grant stroll on the Tarn stepping stones near the entrance to the Kate Path a year or so after the the stones' installation in ca. 1916. The water level is down slightly, revealing the actual size of the stones.

This style of stepping stone was used on many of the endowed and memorial paths. One outstanding example was constructed circa 1915 at the outlet of The Tarn on the Kane Path (#17). These stepping stones are still in relatively good condition, but as the water level has risen, the stones have become less exposed than they were historically. Several other examples of this style of stepping stone can still be seen throughout the trail system. There are several on the Asticou Trail (#49), where some stones remain in place and others have been dislodged over time. A set can also be seen on the Andrew Murray Young Path (#25), although some of these stones have settled below the water level of the stream (Figs. 5-58 to 5-65).

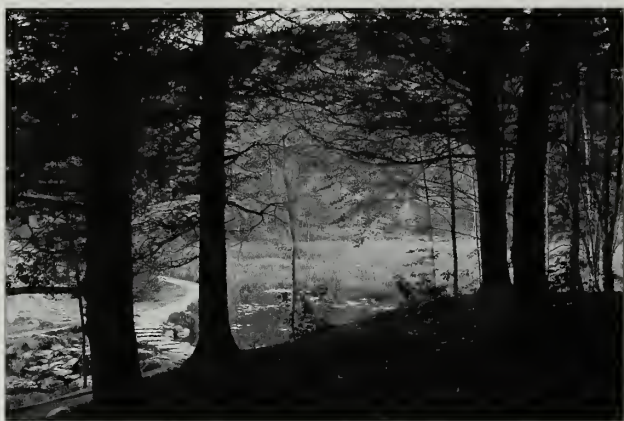
Fig. 5-59 A circa 1916 view of the VIA large-scale stepping stones across the Tarn outlet. Note the even curve of the layout, and that the stones are equal to the width of the trail.

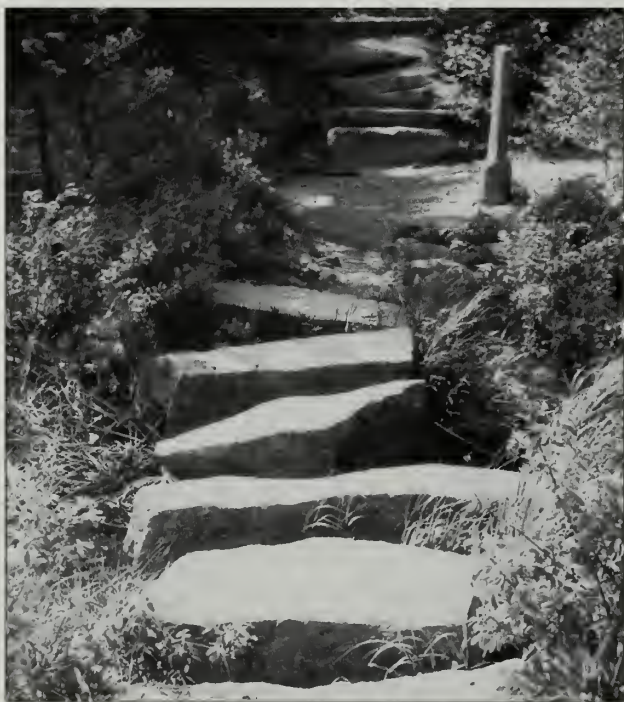
Fig. 5-60 A contemporary view of the Tarn stepping stones, looking west toward trailhead of Kurt Diederich's Climb (#16).

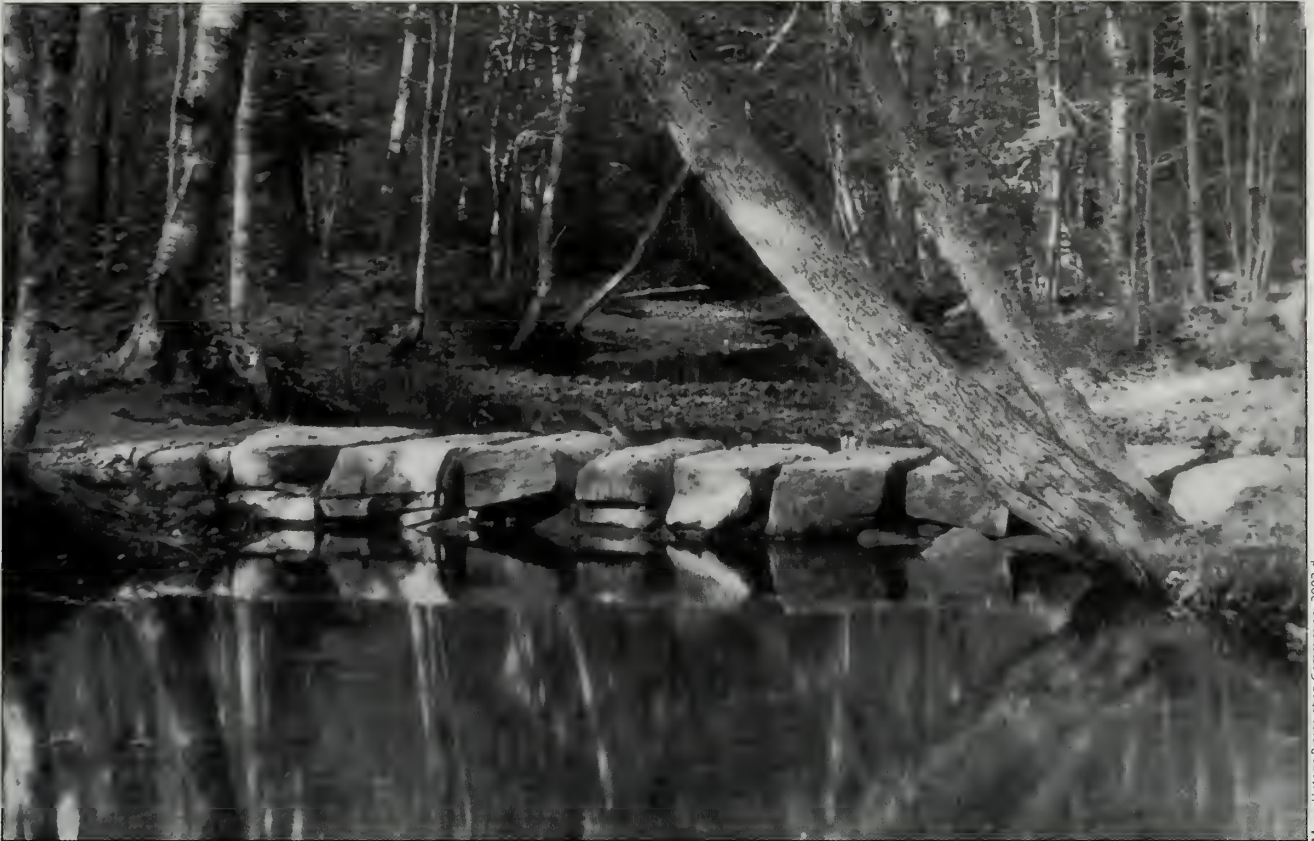
**Fig. 5-61** This circa 1920 postcard view shows original stream-style stepping stones on the Asticou Trail (#49) crossing Harbor Brook. These stones probably date to the trail's improvements by the Northeast Harbor VIS and Seal Harbor VIS in the early 1900s.

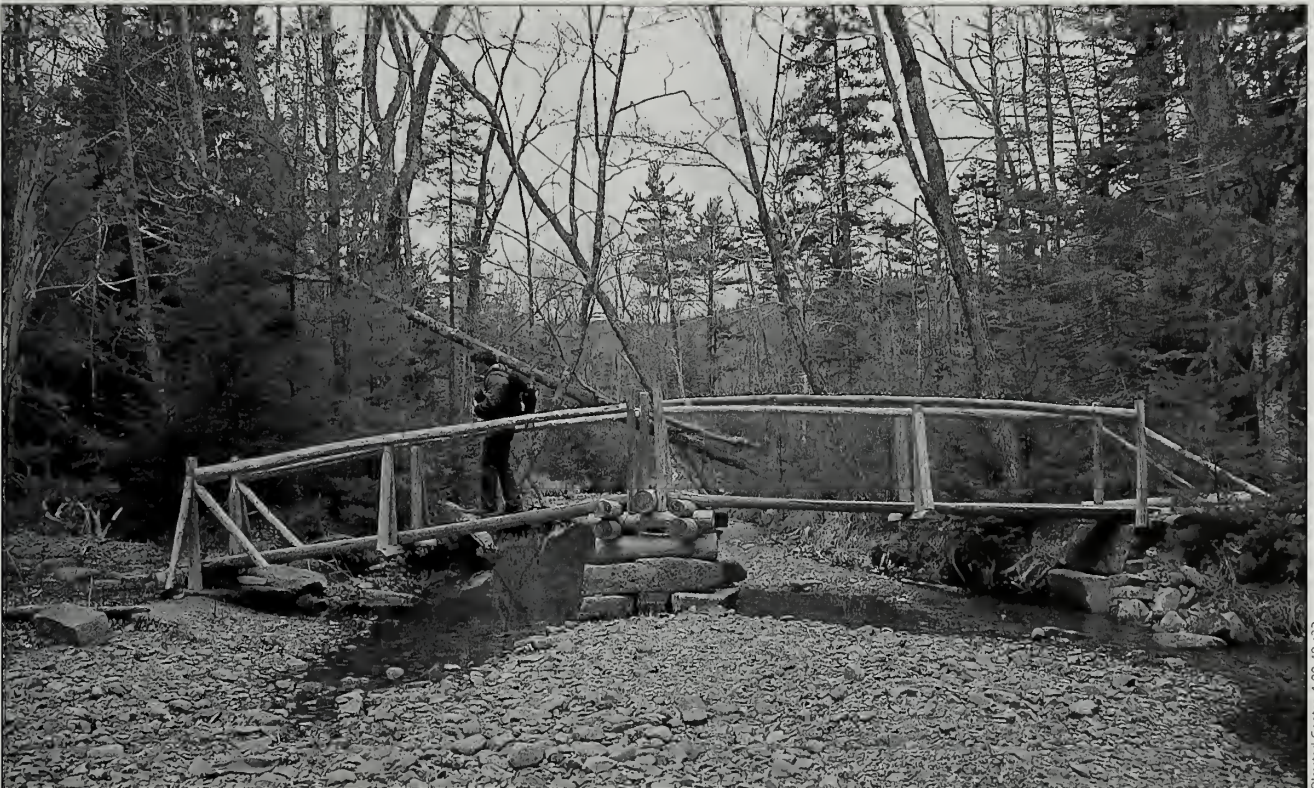
Olmsted Center, 4-99-49-s23

**Fig. 5-62** By the 1990s, the set of VIS stepping stones shown in the previous image had been dislodged and were no longer in place. However, some of the stones were recovered from downstream and incorporated into piers and abutments for this recently built bridge. Ideally, the bridge should be removed and the stepping stones reset as they were originally.
