# ACADIA TRAILS TREATMENT PLAN

## CULTURAL LANDSCAPE REPORT FOR THE HISTORIC HIKING TRAIL SYSTEM OF ACADIA NATIONAL PARK

Olmsted Center for Landscape Preservation  
National Park Service, Boston, Massachusetts, 2006

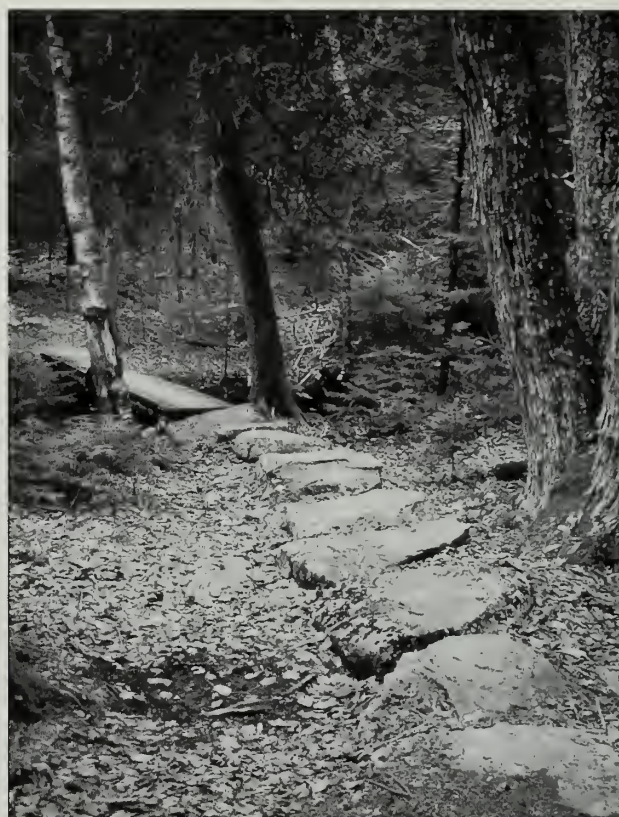
Olmsted Center, 4-99-49-516

Fig. 5-64 This set of VIS stepping stones on the Asticou Trail (#49) is one of the longer sets on the trail. Originally, the stones likely spanned the entire stream, but now a recently built wooden bridge crosses the water channel.

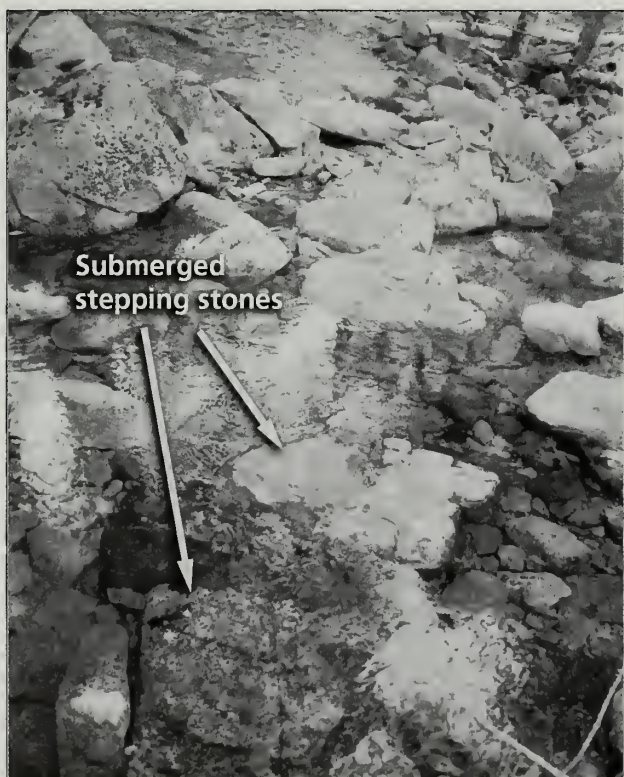
Olmsted Center, 4-99-1-18

Fig. 5-65 Some of the original VIA stream-style stepping stones at this stream crossing on the Andrew Murray Young Path (#25) have sunk below the water level.

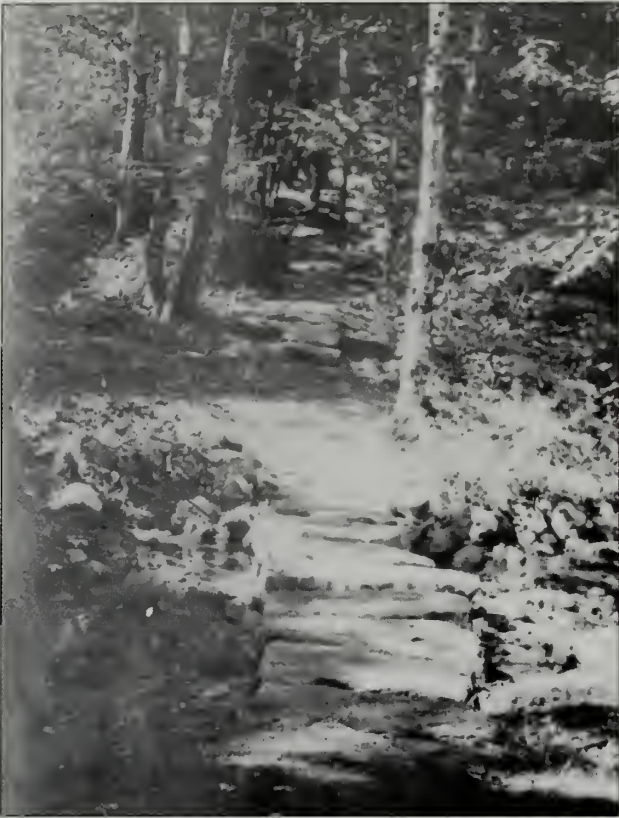
National Archives, Waltham, MA

Fig. 5-67 A 1930s CCC photograph of a set of stepping stones installed across a small stream near the Ladder Trail (#64) trailhead during the CCC rehabilitation of the trail.

work included the installation of stepping stones over a small stream near the trailhead (Figs. 5-67 to 5-69).

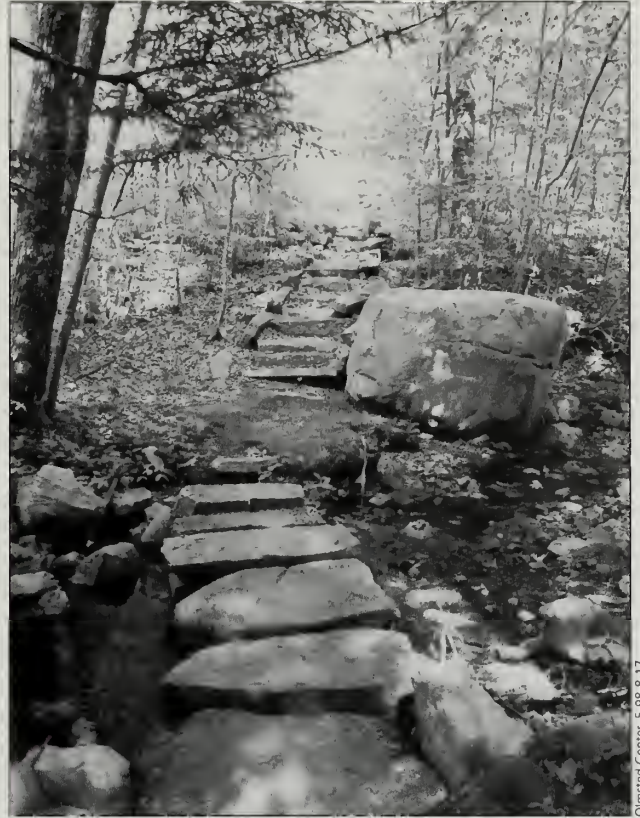
Olmsted Center, 5-98 8-17

Fig. 5-68 The CCC stepping stones on the Ladder Trail (#64) shown in Fig. 5-67 as they appear today.

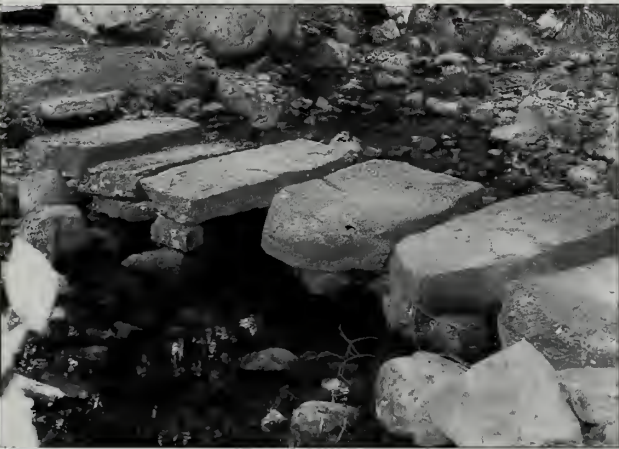
Olmsted Center, 8-97-25-14

Fig. 5-69 A side view of the CCC stepping stones shown in the previous two figures.

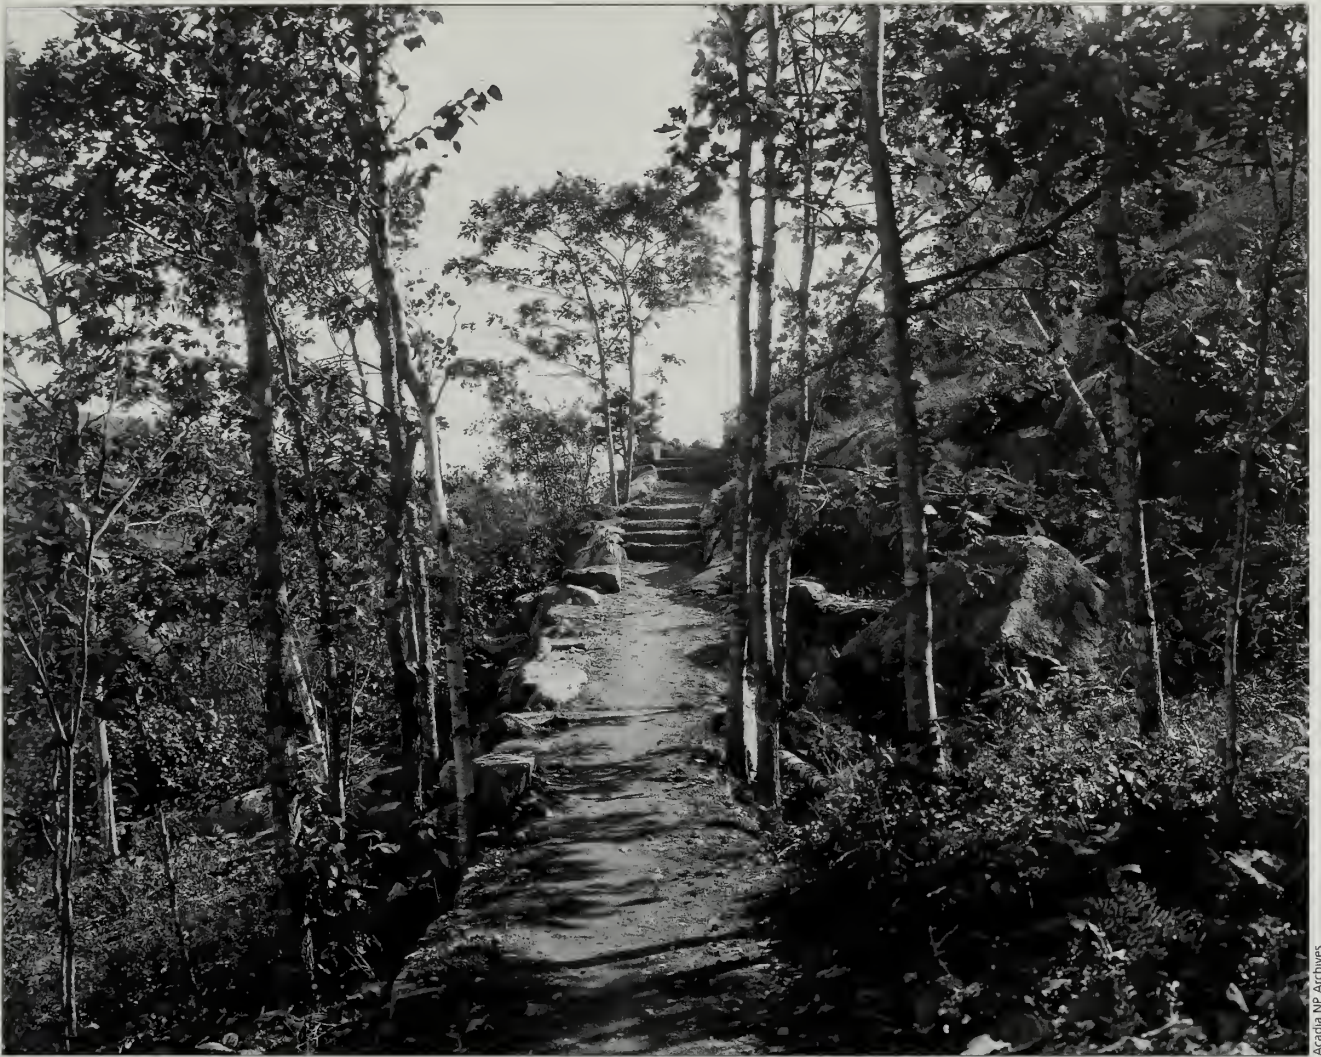
Acadia NP Archives

Fig. 6-1 Retaining features on this section of the Schiff Path (#15) include retaining walls and coping stones. These elements hold the tread and steps in place, and provide guidance for the hiker, perhaps preventing a misstep off the trail. Photograph circa 1920.

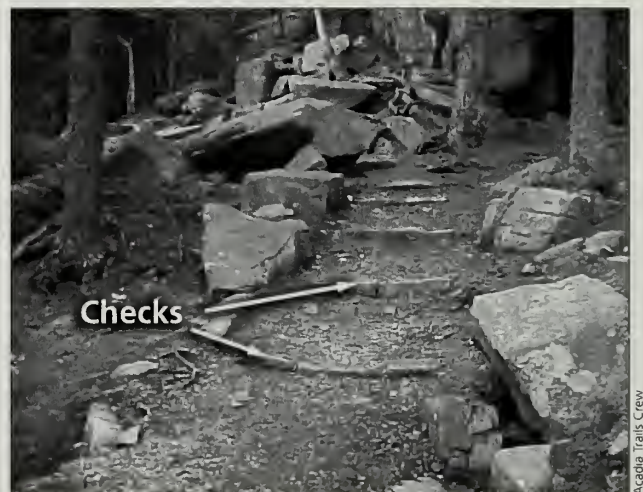
**Fig. 6-2** Although a standard feature in other trail systems, particularly in the Western parks, checks have only been used at Acadia since 1995 when these were first installed on the Ocean Path (#3). The slope at this location is approximately 15 percent, and after five years there has been a loss of approximately 3 inches of tread material.

**Checks** are rows of stones used to retain the treadway from moving in the direction of the trail on graded slopes. They are often used to rehabilitate an eroded area where the original trail surface has washed away and a gully has formed. The rows of stones are set perpendicular to the trail with high contact between them. The checks are backfilled with rubble and then covered with a top coat of tread material, or left exposed at the top. To prevent failure of the checks due to continued erosion or a lack of maintenance, the bottom of each check stone is placed at an elevation below the top elevation of the preceding downhill row of check stones. The checks act as “hidden steps” underneath the tread surface, holding back, or “checking” the uphill fill material. In worst-case scenarios where tread material wears away and is not replaced, checks hold the remaining treadway in a series of flat terraces (Figs. 6-2 & 6-3).

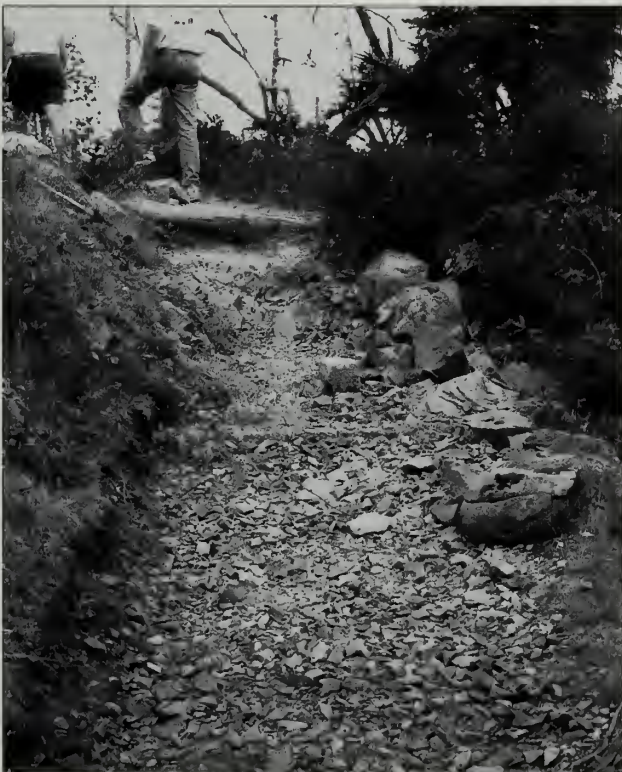
Fig. 6-5 Eroded trail section on the Ocean Path (#3) before check installation.

Figures 6-5 to 6-8 show the installation process for checks and rehabilitation of an eroded tread on the Ocean Path (#3). The eroded tread is excavated to allow installation of the checks. A retaining wall is constructed, and the checks are installed with tight and

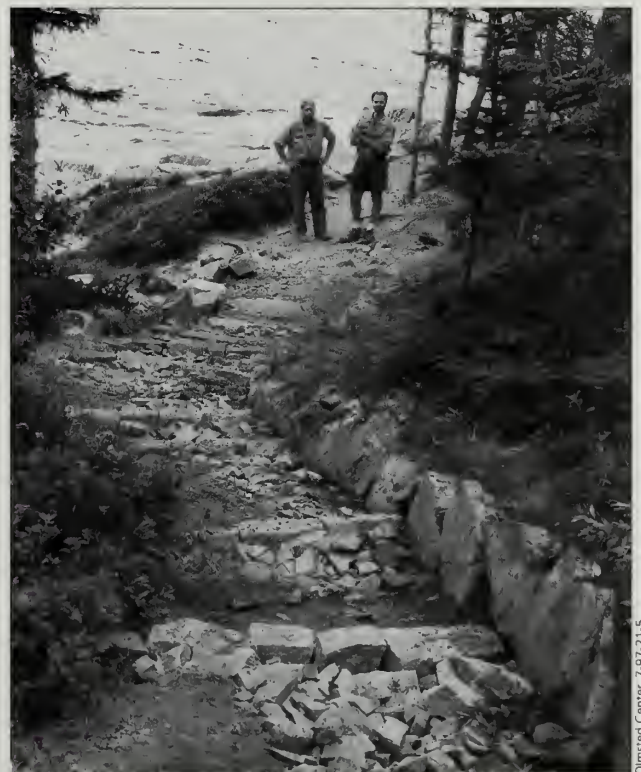
Fig. 6-6 Checks, wall, and rubble infill in place.

high contact points, at the original grade. The checks are backfilled with rubble, and the tread surfacing is installed to cover the checks and establish the desired new grade.

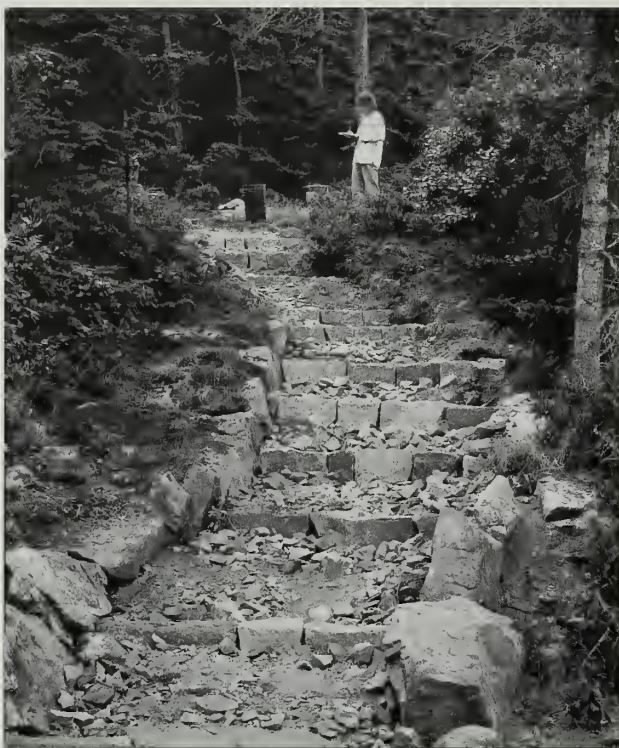
Fig. 6-7 Checks, wall, and rubble infill in place.

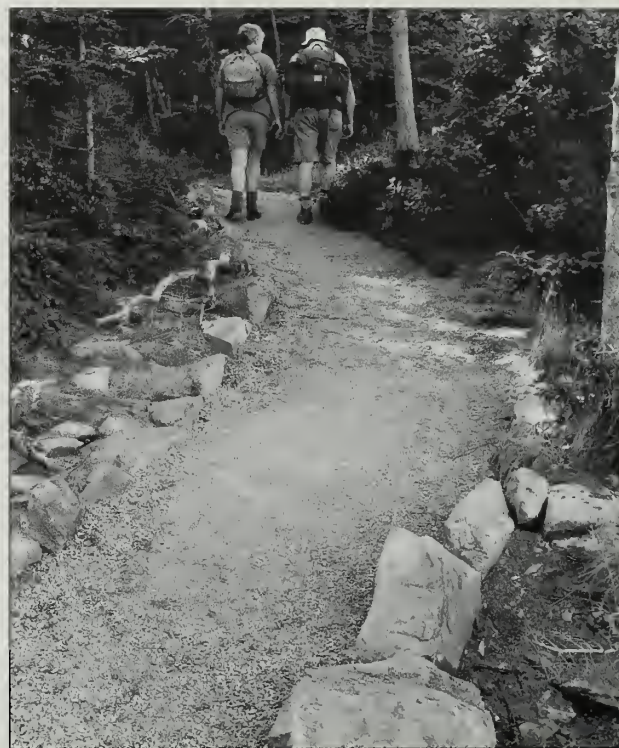
Fig. 6-8 Rehabilitated section of the Ocean Path (#3) with new tread.

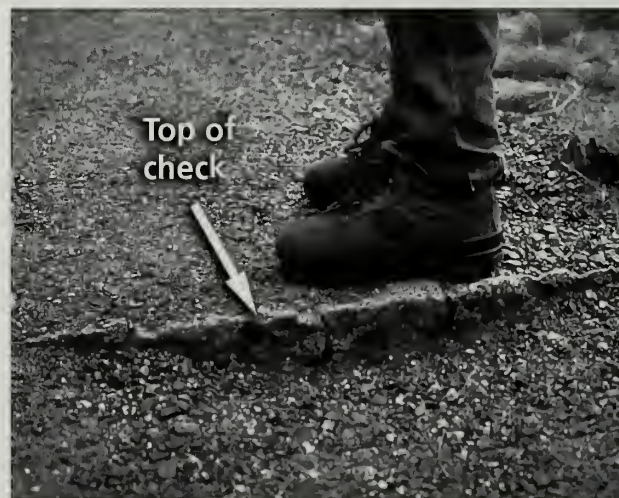
Fig. 6-10 After approximately three years, there is slight erosion of the tread, but no gullying is present on the Ocean Path (#3).

As shown in Figures 6-9 & 6-10 after approximately three years of use, the checks on the Ocean Path (#3) are becoming exposed as the gravel begins to wear away from the surface of the trail. Eventually, if left alone, this situation will create a series of terraced

steps along the trail. This may be avoided by a periodic application of gravel on the trail's surface to cover the checks and maintain the grade. However, even if this maintenance is not performed, these features will continue to serve their intended function of preventing gullying, since material will erode no lower than to level with the check retaining it and the check stones, being locked in behind each other (if well built), cannot work out of place.

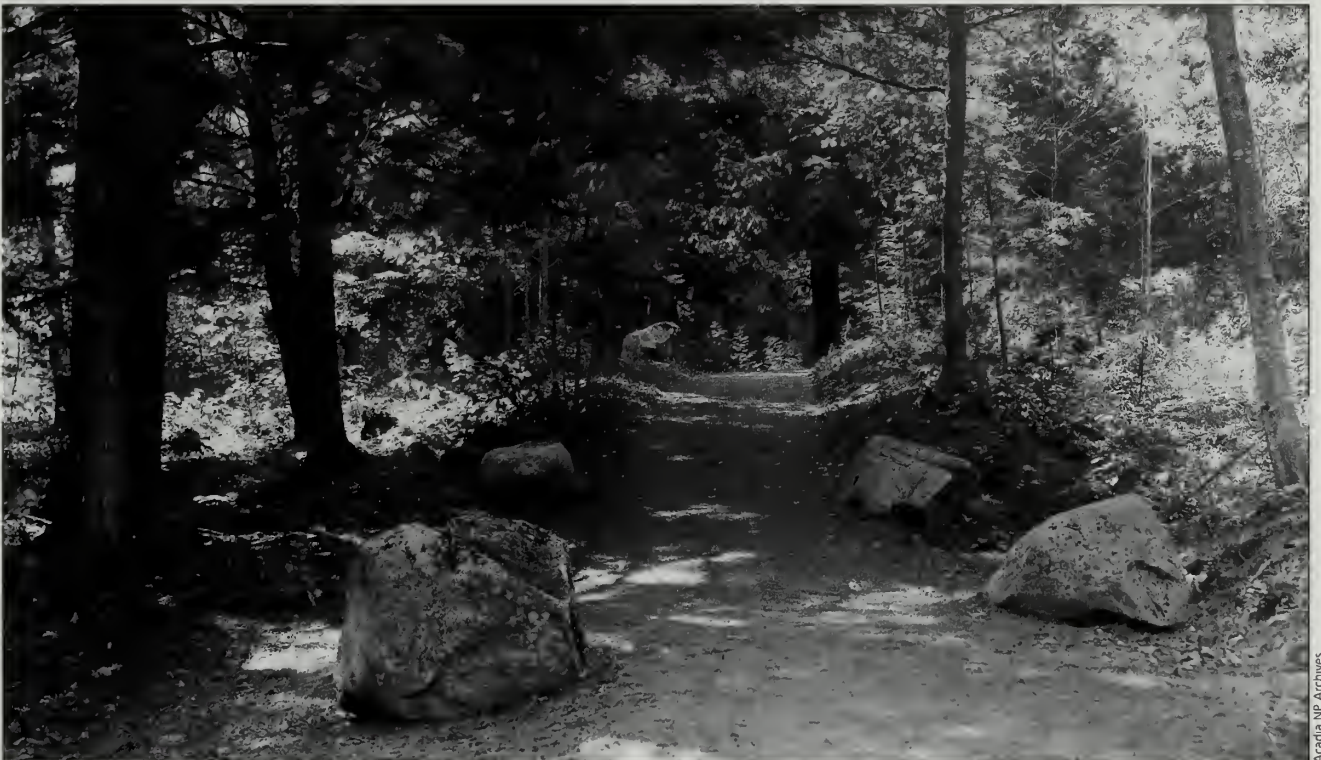
Fig. 6-11 Large and medium-sized coping stones defining the edges of the Stratheden Path (#24), circa 1920s.

**Coping stones** are set along the edge of a treadway and protrude above the height of the tread surface. These stones may be laid on the top course of a wall or set partially into the ground. Coping stones are usually gapped, but sometimes abut. Coping defines the edge or edges of the tread, provides guidance to hikers, assists the integrity of retaining walls, and in some cases supports tread material, stone paving, or steps (Fig. 6-11).

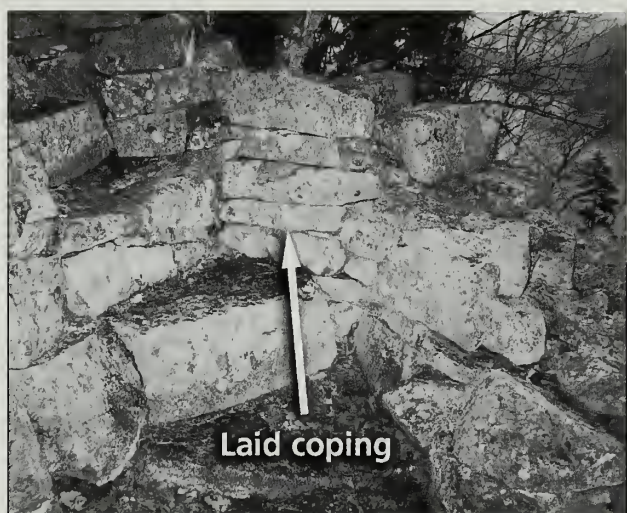
Fig. 6-12 Laid coping wall on the Perpendicular Trail (#119).

**Laid coping** is a laid wall built along the trail above the level of the tread. Laid coping is similar to a stone fence (Fig. 6-12).

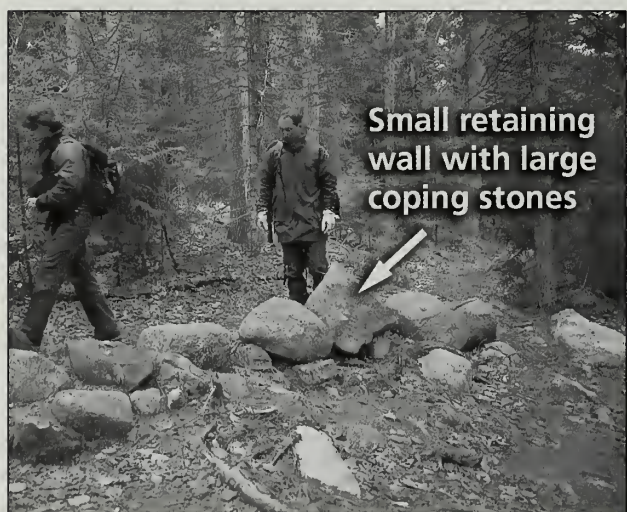
Fig. 6-13 This section of coping retaining wall has larger coping stones atop a relatively small wall on the Asticou Trail (#49).

**Coping retaining wall** refers to a coping wall that aids in the retention of the tread material, holding the tread higher than the ground on the other side of the coping. A coping retaining wall may retain gravel, stone pavement, or soil (Fig. 6-13).

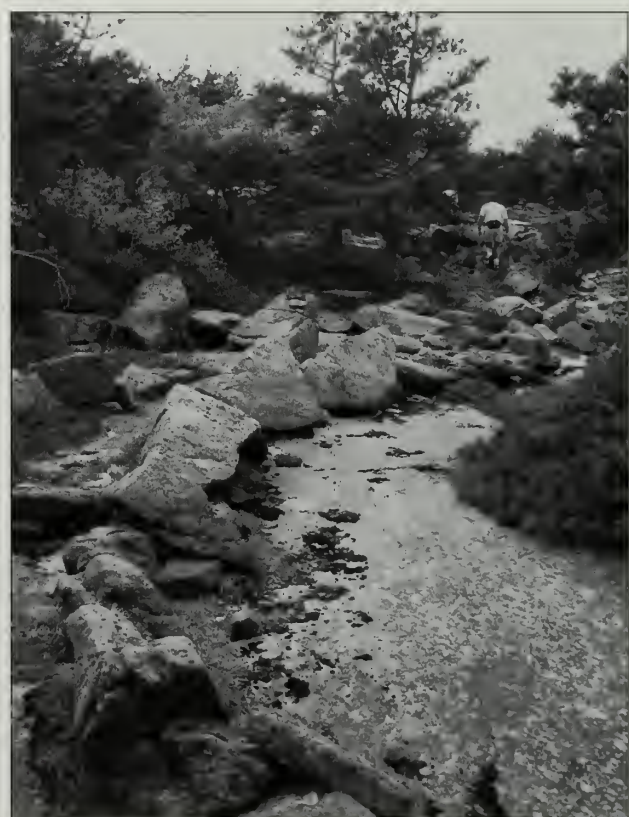
Fig. 6-14 This coping along ledge on the Upper Ladder Trail (#334) was likely constructed by Bar Harbor VIA in the late 1800s.

Many of the staircases built by the VIA/VIS contain remarkable use of coping retaining wall. On the Upper Ladder Trail (#334), built circa 1896, coping retaining wall, with stones as tall as 3 feet, are set on ledge to retain steps, which are small in comparison (Fig. 6-14). Some of the coping stones are cut blocks. These may have been added by the CCC when the trail was improved in the 1930s. Smaller, less crafted coping was used with stairs on many other trails, including the lower portion of the Penobscot Mountain Trail (#47), which was improved in 1919, and the Asticou Trail (#49), improved in the 1890s and thereafter.

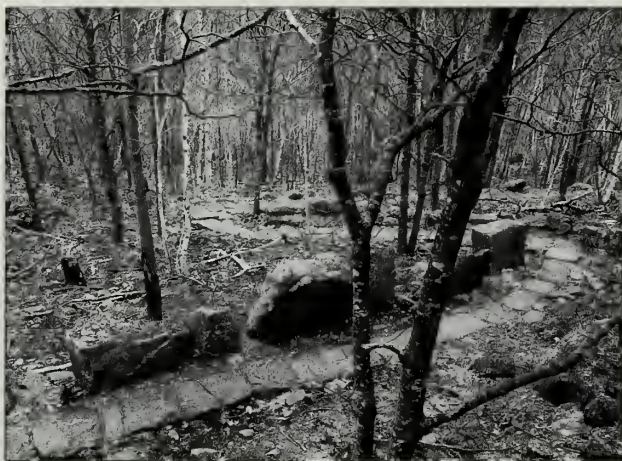
Charlie Jacobi, Acadia NP, 4.99.53.5

**Fig. 6-16** Large coping stones are used along the lower section of the Beachcroft Path (#13) to help define the trail sides.

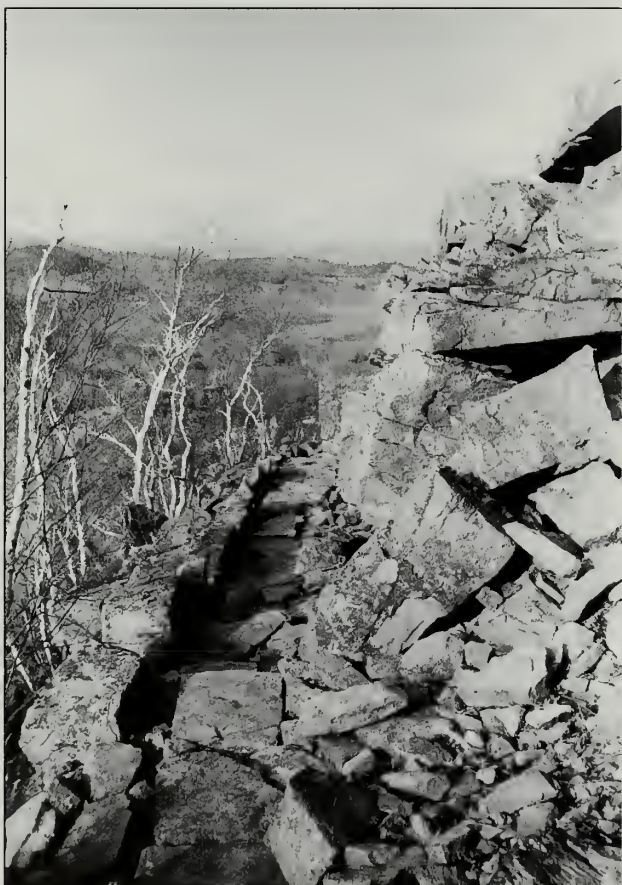
Acadia Trails Crew, 2001

**Fig. 6-17** Evenly spaced coping stones on the Beachcroft Path (#13).

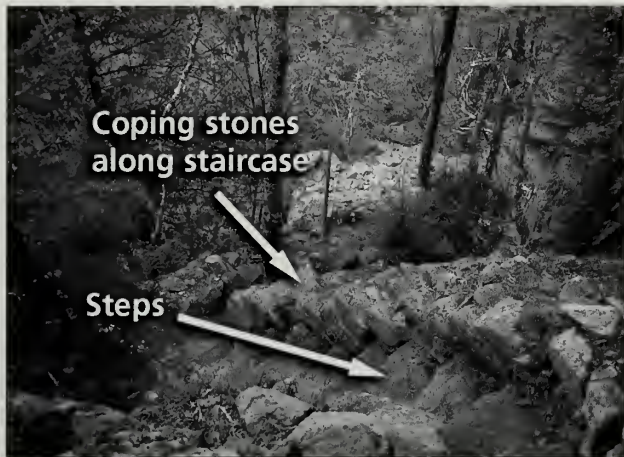
Olmsted Center, 5-98-5

Fig. 6-19 The CCC regularly used coping stones along stairways on the Perpendicular Trail (#119). They serve several purposes, including adding structural stability to the staircase and providing a definitive boundary for the trail edges.

As in the VIA/VIS period, the decision to use of coping by the CCC was determined on a site-specific basis. On CCC summit trails built in the 1930s, coping is used extensively with steps on the Perpendicular Trail (#119), but not on the Beech Cliff Ladder Trail (#106) (Figs. 6-19 & 6-20). Coping was also used on sections of the Valley Trail (#116) and the beginning of the Beech Mountain Loop Trail (#113) (Fig. 6-21). Of the

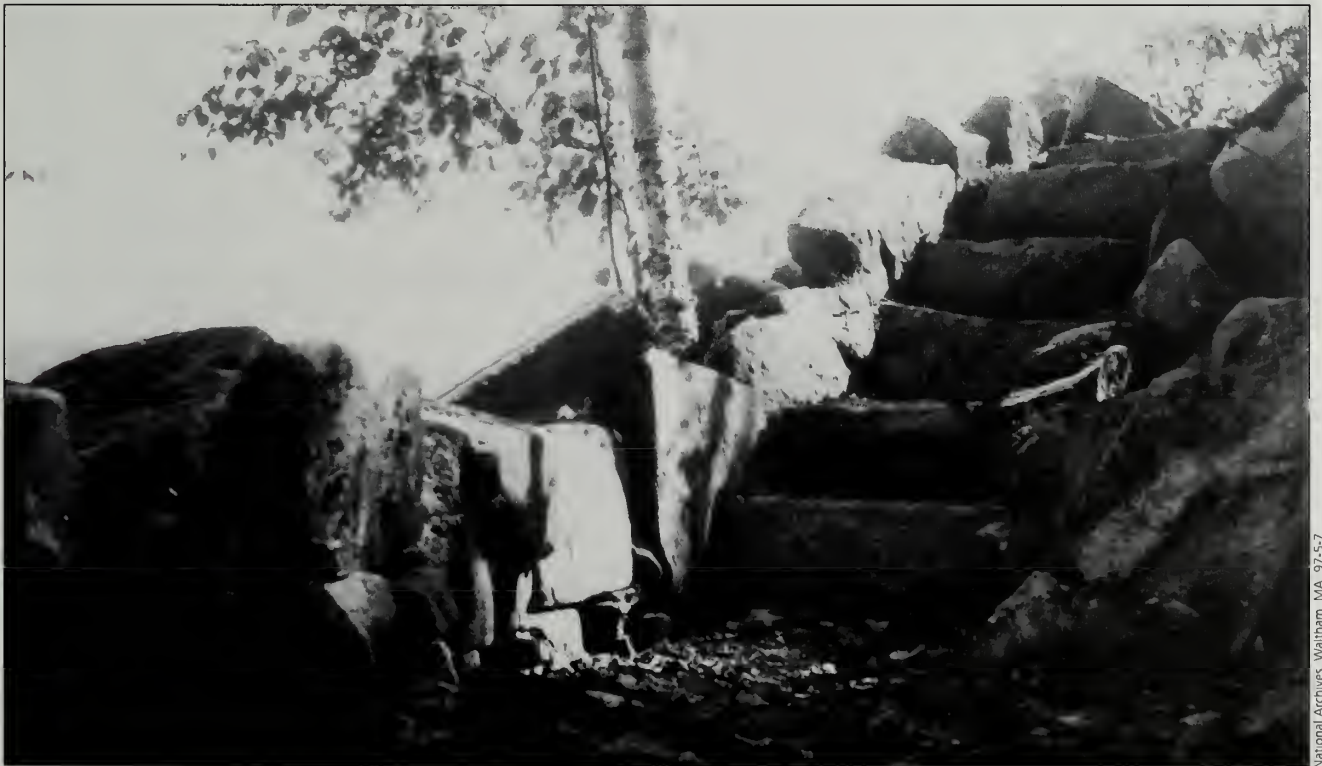
National Archives, Waltham, MA, 97-5-7

Fig. 6-20 Coping stones define the edge of this small CCC staircase on the Perpendicular Trail (#119), circa 1934.

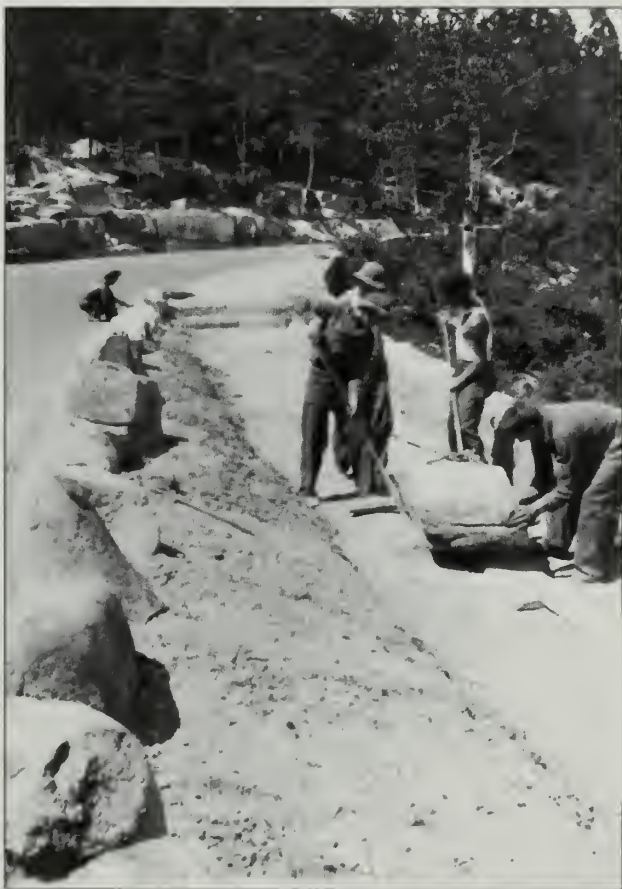
National Archives, Waltham, MA, 97-1-10

**Fig. 6-22** Coping stones newly installed by the CCC and Rockefeller's road crew between Ocean Drive and the Ocean Path (#3), circa 1934.

graveled shoreline paths, the CCC work on the Ocean Path (#3) has the most extensive use of coping. Along different segments of the trail, coping stones were installed on the roadside as the trail parallels Ocean Drive, or on the ocean side of the trail (Figs. 6-22 & 6-23). In contrast, the Long Pond Trail (#118) has almost no coping on the mile and a half section of smooth gravel walkway along the pond. The CCC also added coping to earlier VIA trails. For example, they rebuilt the Ladder Trail (#64) and added coping.

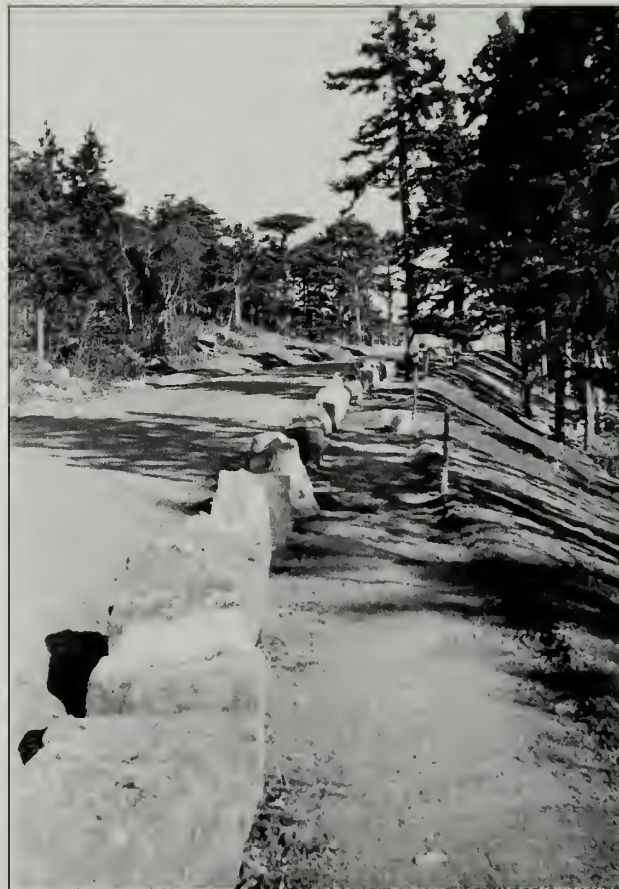
National Archives, Waltham, MA, 97-2-9

**Fig. 6-23** Coping stones were also installed between the Ocean Path (#3) and the shoreline, photograph circa 1934.

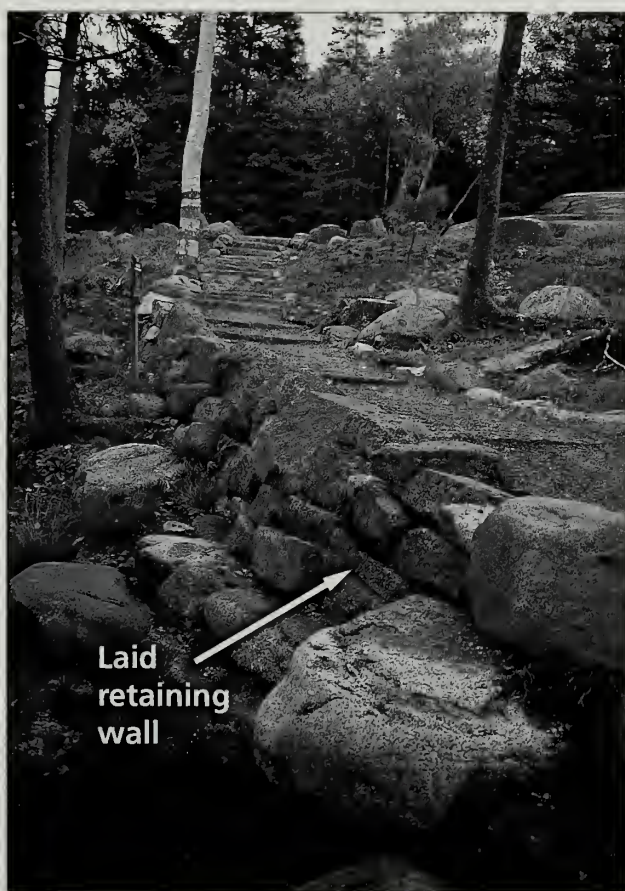
Olmsted Center, 10-00-s

Fig. 6-24 A recently constructed laid retaining wall on the Ocean Path (#3) at Otter Point.

A **laid wall** contains stones set beside and on top of one another to create a vertical or substantially vertical face (Fig. 6-24). The construction of laid walls uses established dry-laid stonework methods like maintaining tight contacts between stones, breaking the joints, and filling the core of the wall. The face of a laid wall may be smooth or rough. A laid wall with the stones set in even, horizontal rows is called a **tiered wall**. Laid walls are the strongest and most durable retaining walls, but also the most difficult to build properly.

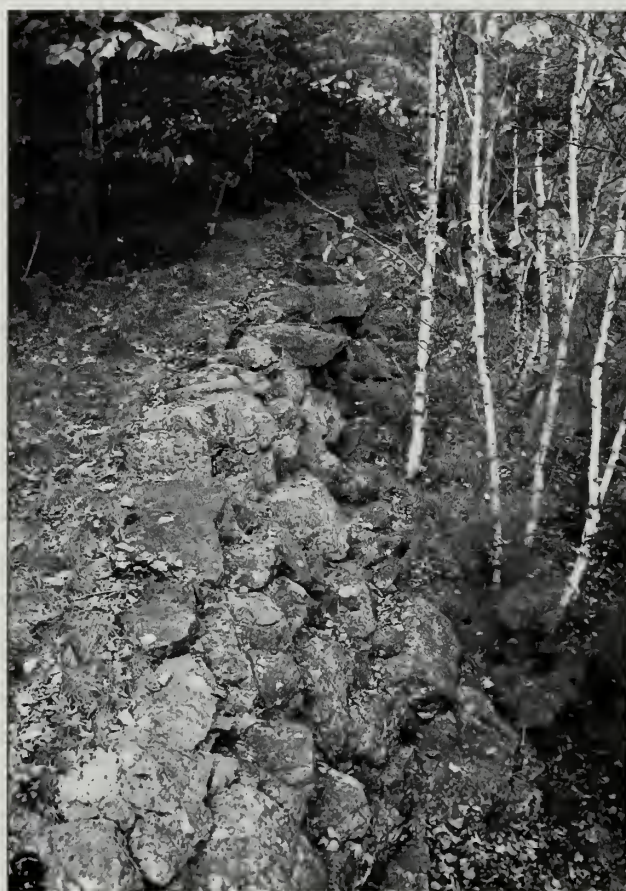
Olmsted Center, 8-95-4-17

Fig. 6-25 An original rubble-laid retaining wall on the abandoned Gurnee Path (#352).

A **rubble wall** uses stones that are set less carefully than in a laid wall. The joints in a rubble wall are not always broken and the face is irregular and contains gaps. A rubble wall depends on large stones and shallow batter for durability (Figs. 6-25 & 6-26). **Batter** is the slope, or relationship of rise to run in the face of a wall. A wall that rises 2 feet tall and slopes back 1 foot from its foundation has a 2:1 batter. The steepest batter is vertical, whereas a very shallow-batter rubble wall

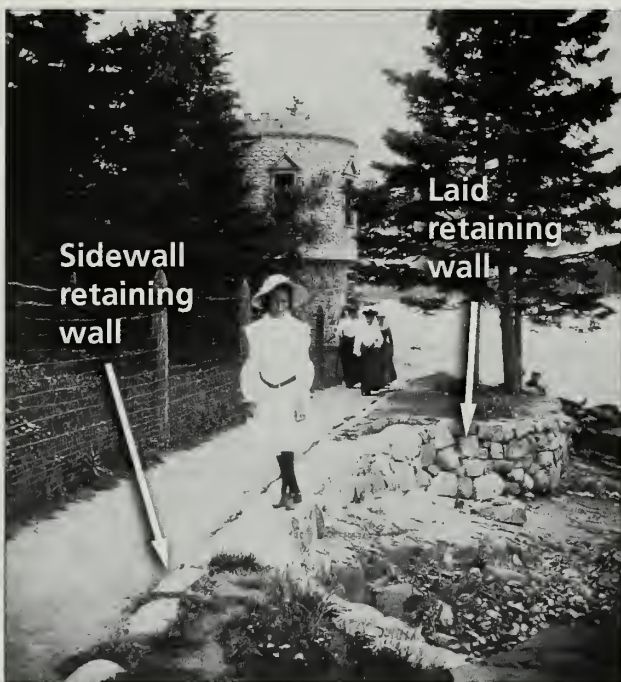
Fig. 6-27 This circa-1890 image of the Shore Path in Bar Harbor (#301) shows the early use of both sidewall and laid retaining walls.

A **sidewall** is a low, single-tier retaining wall that retains a gravel treadway. It is the type of wall used in conjunction with causeways (see Chapter 3, Section B) (Figs. 6-27 & 6-28).

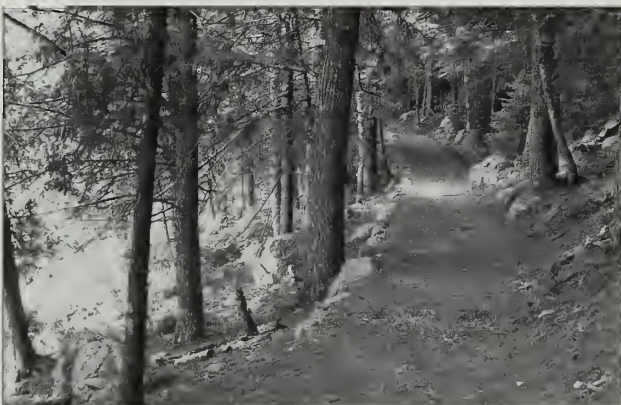
Olmsted Center, 7-97-20-22

Fig. 6-28 CCC side wall on the Long/Great Pond Trail (#118).

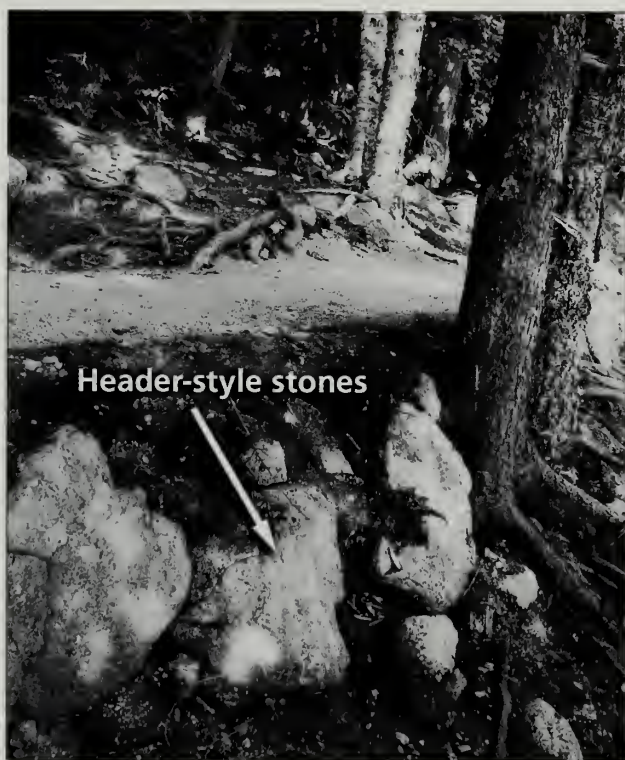
Fig. 6-30 New crush wall constructed by NPS in 2002 through heavily rooted area on the west side of the Jordan Pond Path (#39).

A **crush wall** is a retaining feature that combines a foundation similar to that of a retaining wall with a top course like the edge of a wall-less causeway, including a cover of vegetation. This hybrid style is also called “root wall” because it is a way of retaining trail without destroying all the roots in an area. Crush wall is not an historical technique; however, because crush wall usually restores material to an eroded area and because it is largely obscured with vegetation, it has the appearance of historic bench cuts (Fig. 6-30).

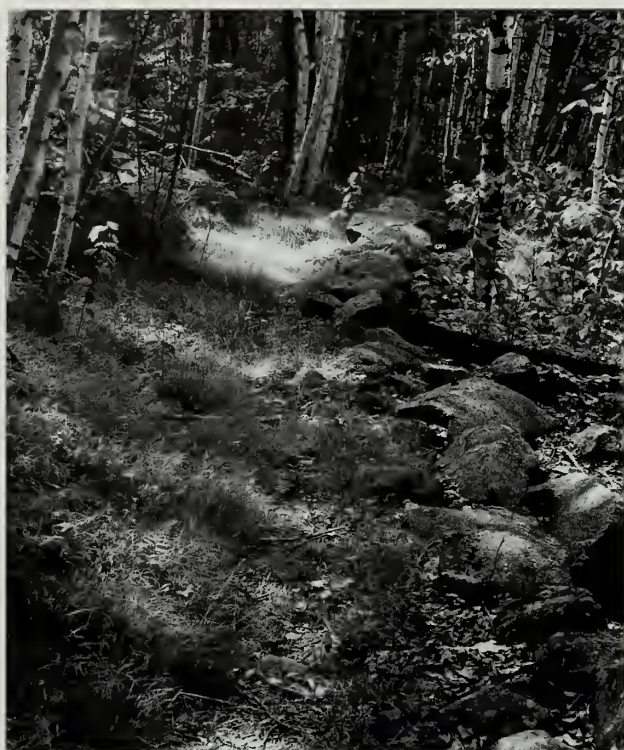
Fig. 6-31 A classic example of original coping retaining wall on the Wild Gardens Path (#354) using large single boulders for retention.

In the few cases where more substantial retaining walls were required to achieve a route, the early builders preferred the use of single, large stones set as coping retaining wall over the use of multi-tiered wall. On the Wild Gardens Path (#354) a bench is retained on the steeper sections using a row of boulders up to 6 feet

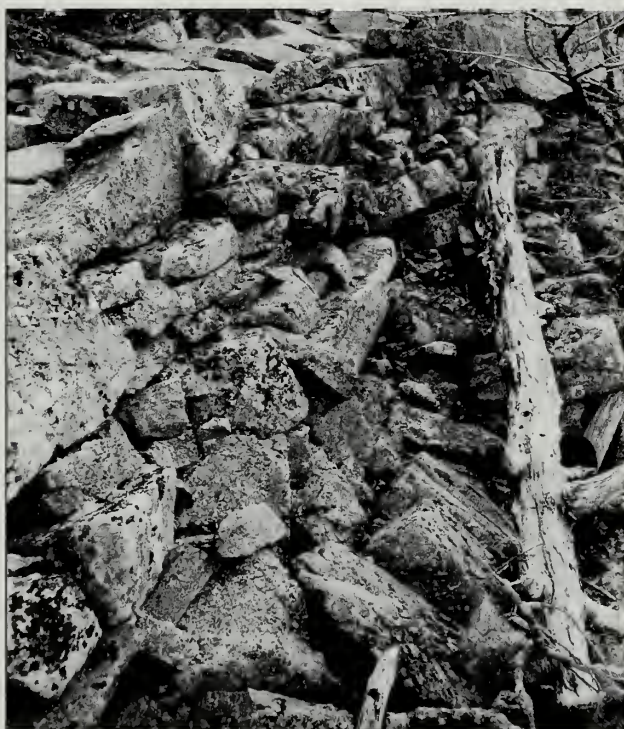
Fig. 6-32 VIA/VIS laid wall on the Beachcroft Path (#13). Stones have shifted due to "stack bonds" (unbroken, or "running joints") and areas of the wall in which three or more rocks are stacked on top of each other without overlapping the abutting stones. The weight of larger rocks on top as a coping layer is probably holding the wall together. The rough face, with some rocks jutting out, others inset, is a typical characteristic of walls on this trail as opposed to the Emery (#15) or Gurnee Path (#352) on which the walls have relatively smooth, uniform faces.

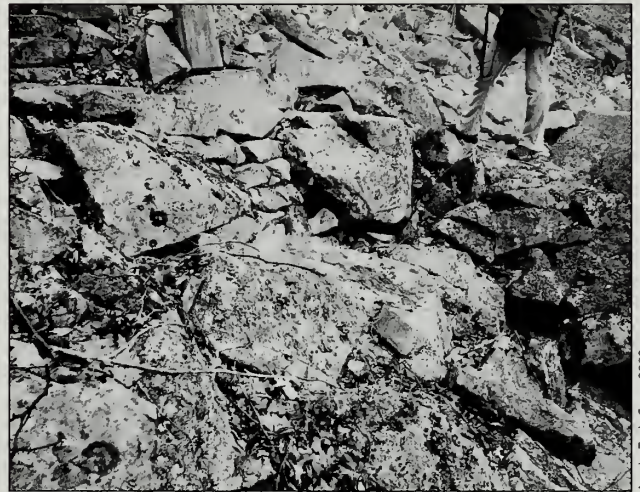
Fig. 6-34 Fitted retaining wall built into the talus slope on the Champlain Mountain East Face Trail (#12).

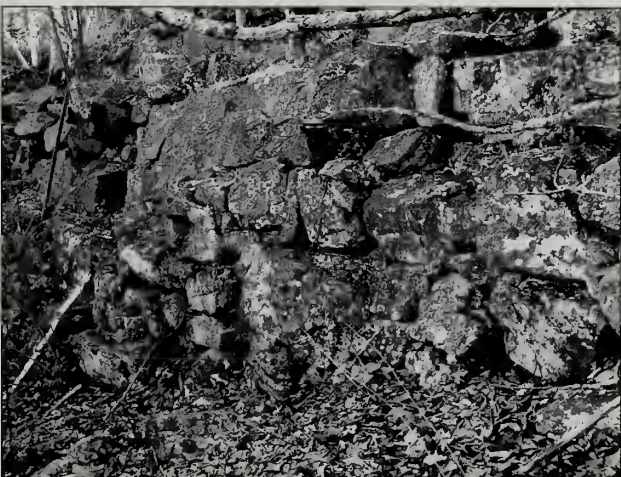
Fig. 6-33 This retaining wall on the Gurnee Path (#352) is rubble at the bottom and laid at the top.

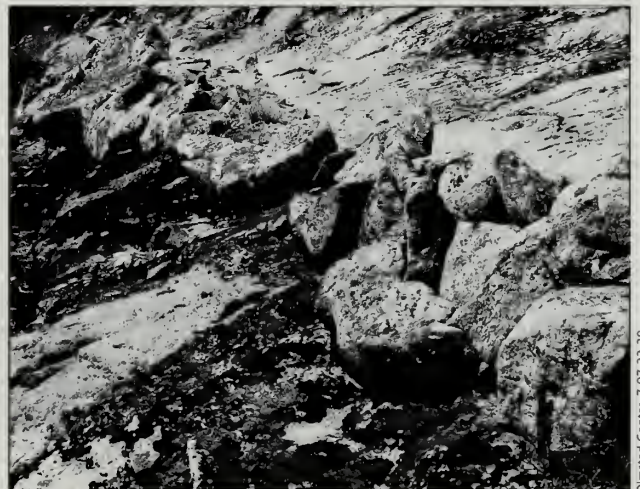
Fig. 6-35 Original VIA/VIS piled wall on the Beachcroft Path (#13).

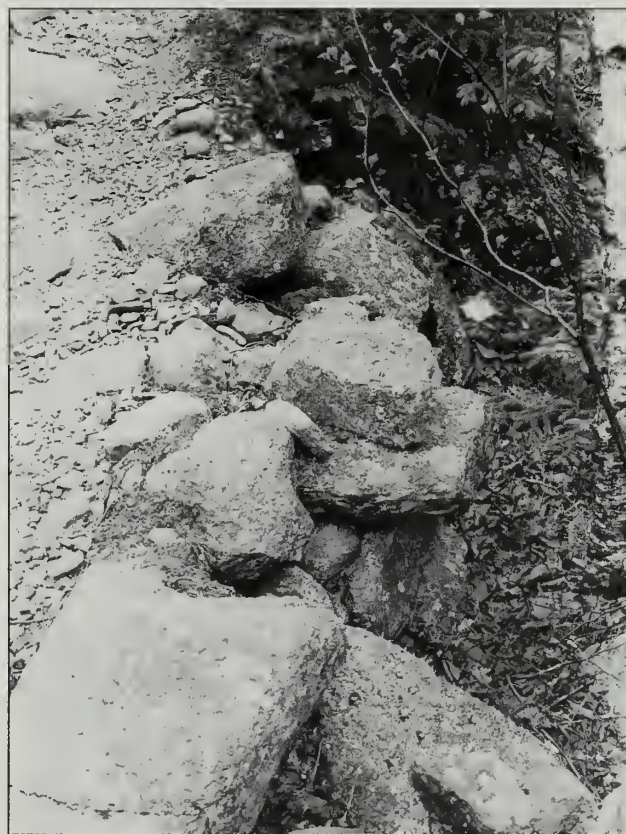
Fig. 6-38 Original Mission 66 rubble retaining wall on the Beech Mountain Loop Trail (#113).

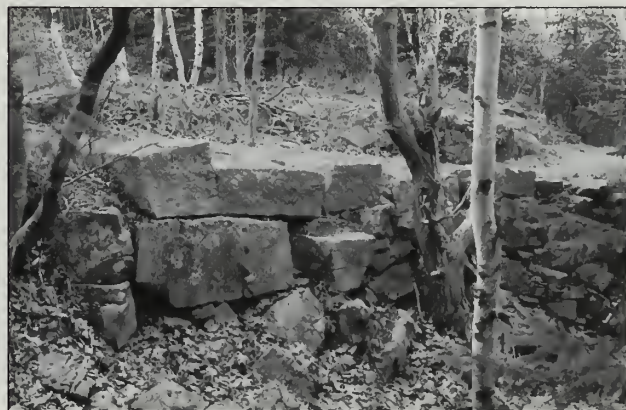
Fig. 6-39 This Mission 66 retaining wall on the Anemone Cave Trail (#369) consists of laid wall upon a rubble wall base.

Retaining walls constructed during Mission 66 followed specifications for earlier CCC work. However, relatively few trails were added during the Mission 66 period that required retaining walls, and the walls that were constructed by Mission 66 crews are generally lower in quality than work from previous eras. Some work remains; however, it is typically in a poor state of repair. Extant work includes sidewall retaining walls on the Ship Harbor Nature Trail (#127) and rubble wall on the Beech Mountain Loop Trail (#113) (Figs. 6-37 & 6-38). On the Anemone Cave Trail (#369), a 20-foot-long by 6-foot-high section of laid wall sits atop a rubble wall, recalling the style of the walls on the Gurnee Path (#352). Though not well constructed, this Mission 66 work remains in good shape. It contains a top course of large coping stones, up to 6 cubic feet in size. The weight of these stones has probably kept the wall intact (Fig. 6-39).

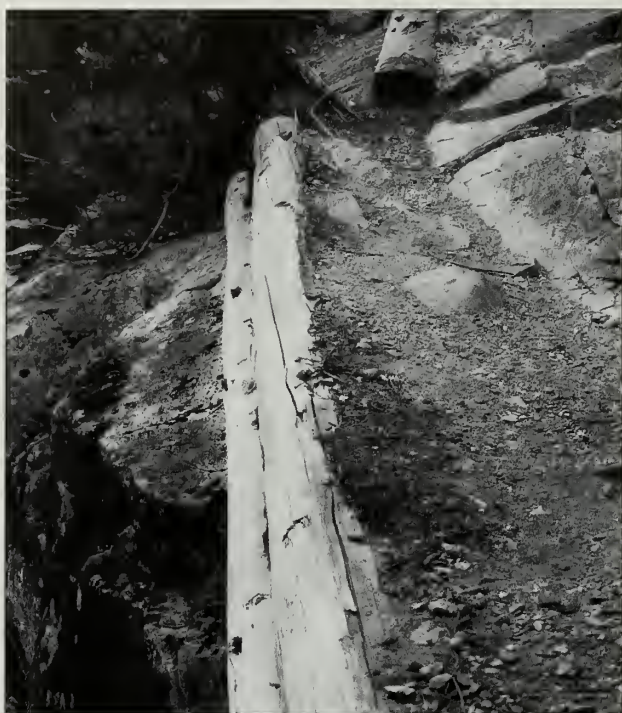
Fig. 6-40 Log features, like this log retaining wall on the Long/ Great Pond Trail (#118), have been introduced as a quick and cheap alternative to stone retaining walls, although they are not historically appropriate for the system.

historical accuracy. Most repairs consisted of resetting or replacing toppled coping stones. Log cribbing and log retaining walls were introduced as an expedient alternative to stone retaining walls (Fig. 6-40). New stone wall construction and repairs used only near-vertical, tiered laid wall of varying quality, regardless of surrounding work or historical precedent. Untiered, rough-faced, laid wall on the Beachcroft Path (#13) was replaced with tiered, smooth-faced laid wall in 1995, while a 6-foot-high vertical, tiered wall was built on the otherwise unconstructed Great Head Trail (#2). The majority of the retaining walls in need of repair were neglected.

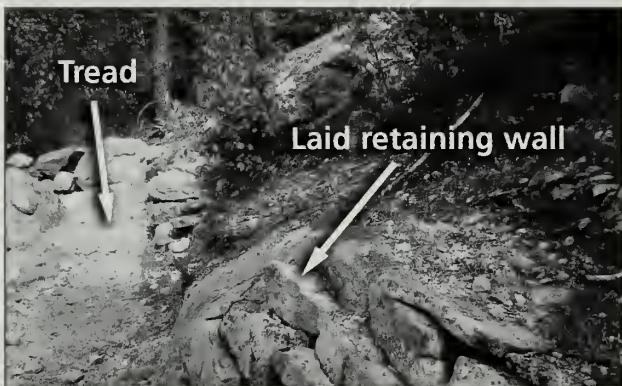
Fig. 6-41 This laid retaining wall on the Beachcroft Path (#13) was rehabilitated by the Acadia trails crew in 1999.

work sites to trade knowledge and skills with other crews. To date, thousands of square feet of retaining wall have been constructed or rehabilitated in the appropriate style by the trails crew. The majority of these efforts have involved laid retaining wall, but work completed in 2001 included rehabilitating rubble and laid retaining walls on the Jordan Pond Path (#39) as well as constructing new crush walls (Figs. 6-41 to 6-44).

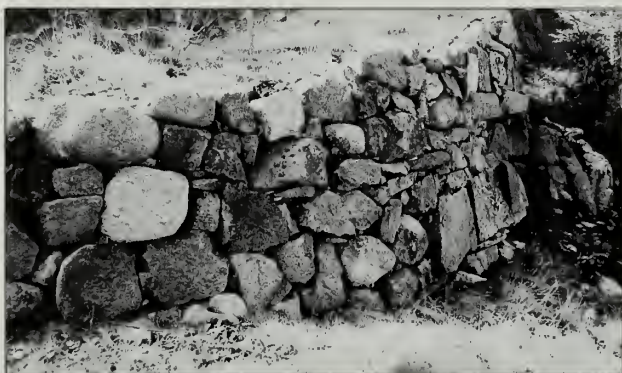
Fig. 6-42 This rehabilitated laid stone retaining wall on a section of the Ocean Path (#3) was completed by the Acadia trails crew in 2000.

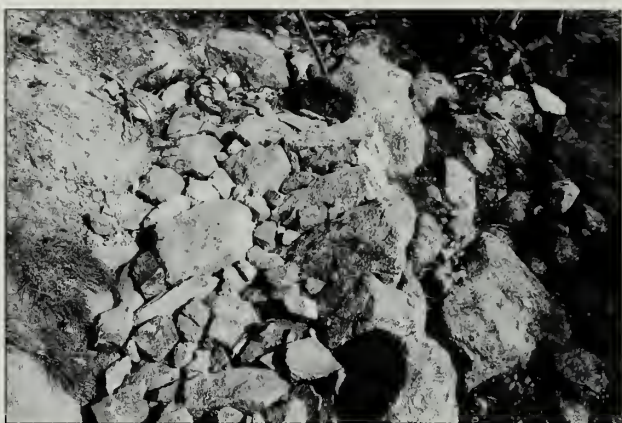
Fig. 6-43 Stone retaining wall construction on Jordan Pond Path (#39). The top course of stones are sloped in and set header-style with high contact, and the core is properly blocked.

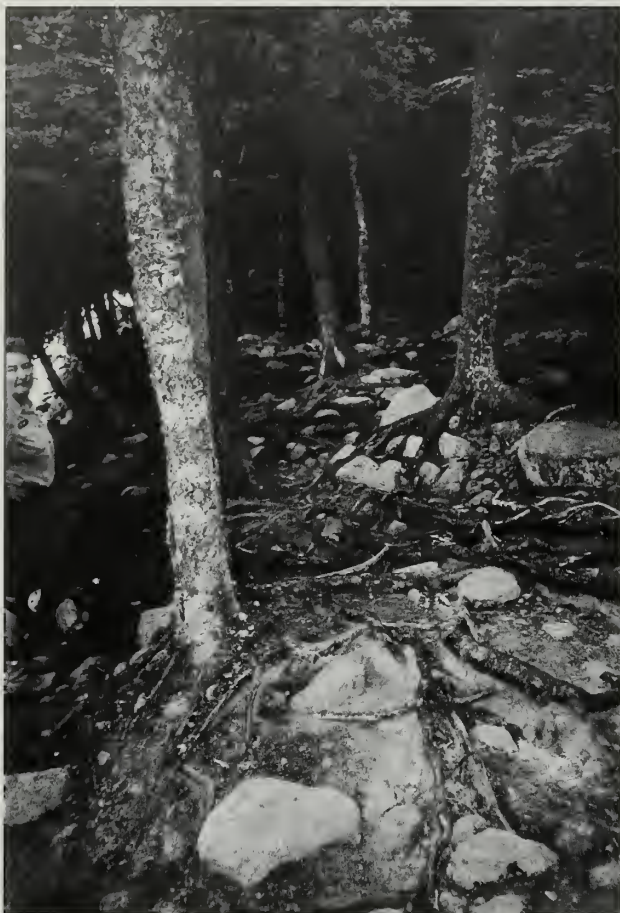
Fig. 6-48 Heavily rooted area on west side of the Jordan Pond Path (#39) before construction of crush wall.

## 4. Crush Walls (Figs. 6-48 & 6-49)
