# ACADIA TRAILS TREATMENT PLAN

## CULTURAL LANDSCAPE REPORT FOR THE HISTORIC HIKING TRAIL SYSTEM OF ACADIA NATIONAL PARK

Olmsted Center for Landscape Preservation  
National Park Service, Boston, Massachusetts, 2006

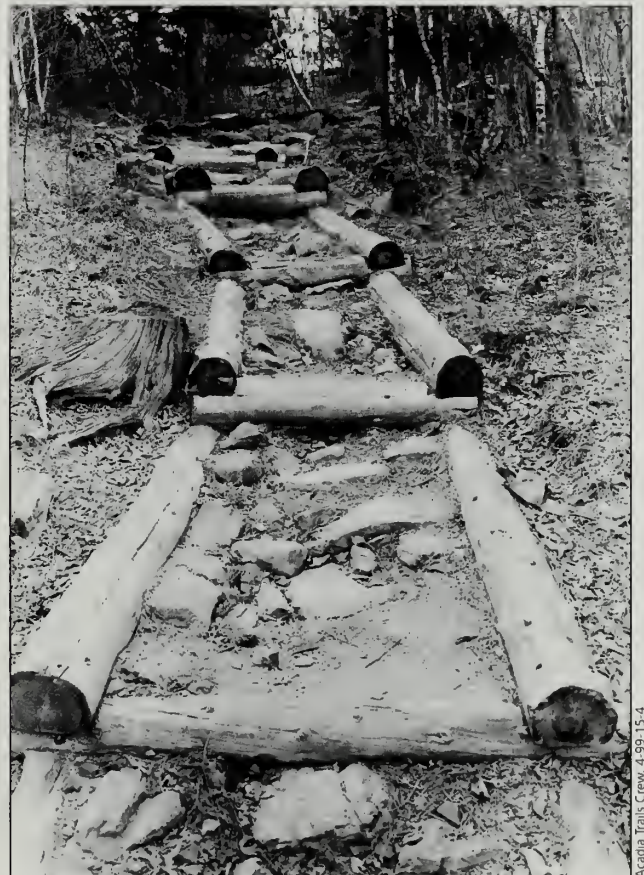
Fig. 6-54 Treadway cribs on the Bear Brook Trail (#10).

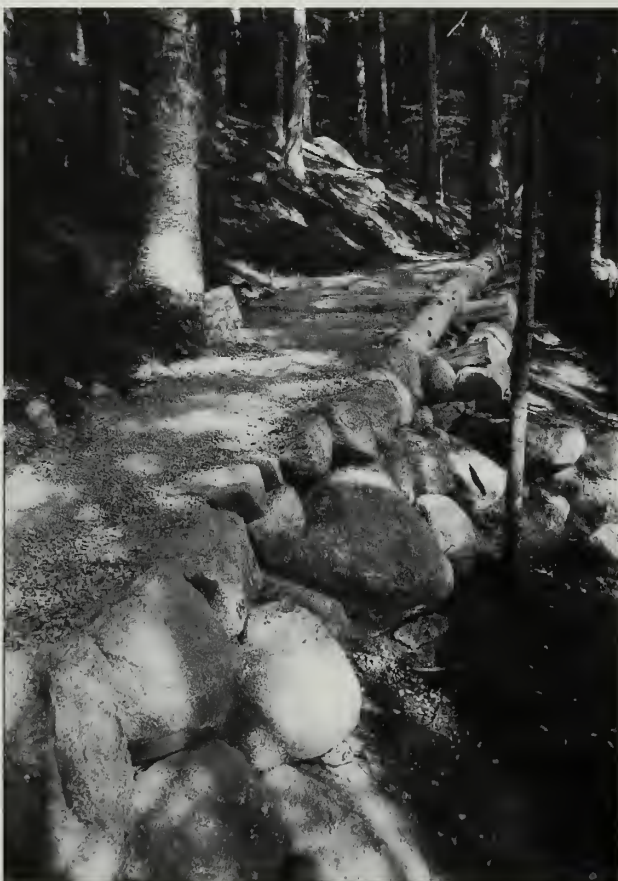
Fig. 6-55 Wall crib on steepest west-side section of the Jordan Pond Path (#39) built in conjunction with stone retaining wall.

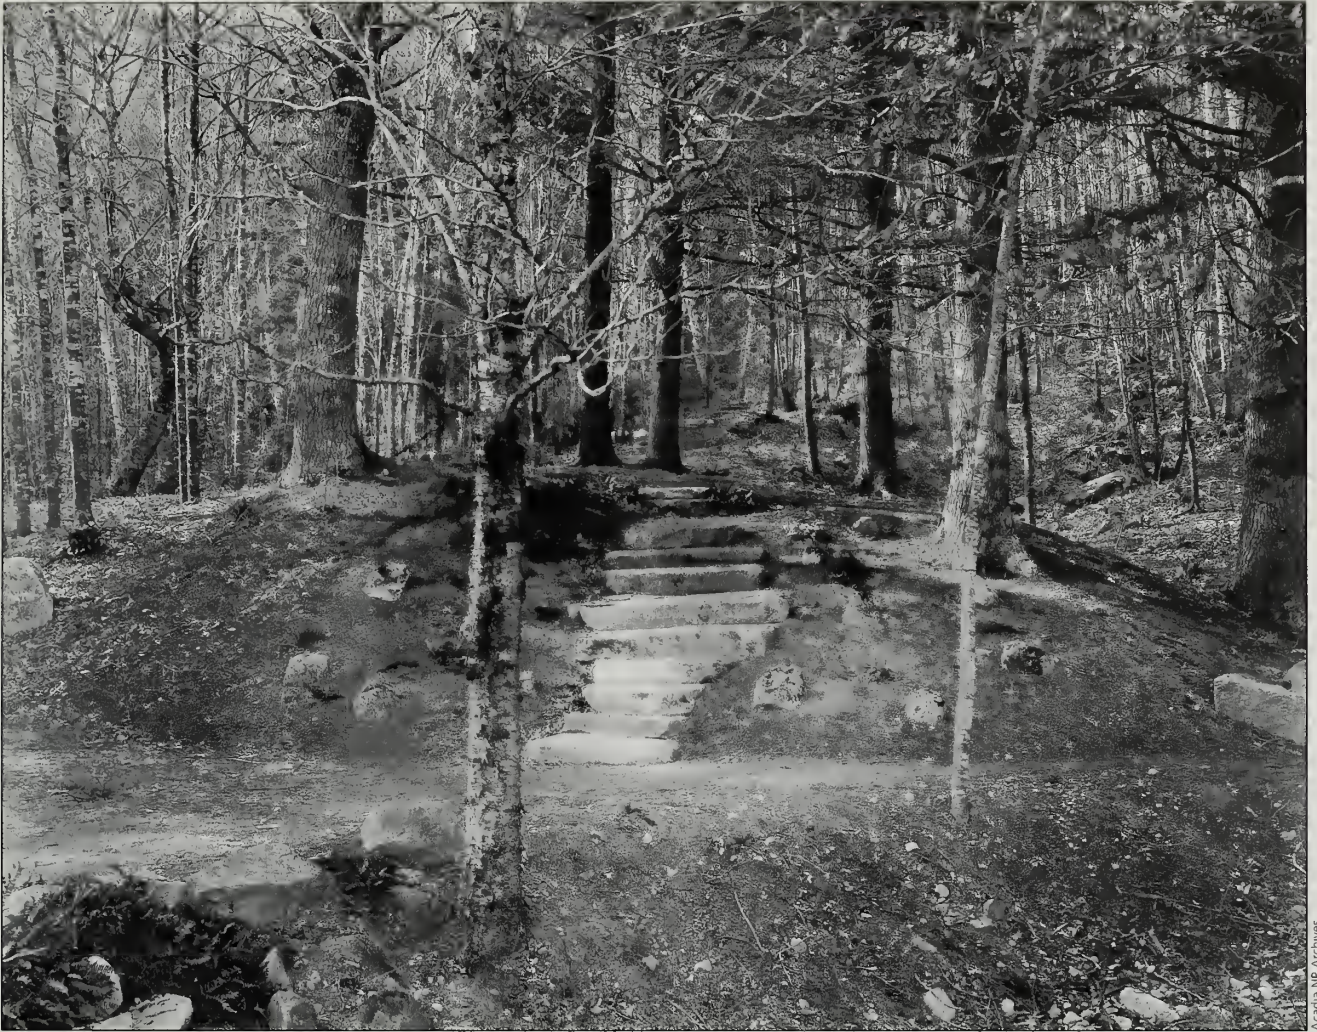
Fig. 7-1 This staircase at the trailhead of Kurt Diederich's Climb (#16), circa 1916, is one example of the highly crafted stone step work that exists on Acadia's trails.

Most steps and staircases at Acadia were historically constructed of stone, and in keeping with this tradition, stone steps are preferred for continued use in the park (Fig. 7-1). Log steps, including log checks and log cribbing, may be used as short-term solutions, but are not recommended for long-term use. They deteriorate in Acadia's extreme climate, and they do not complement the historical building style of Acadia.

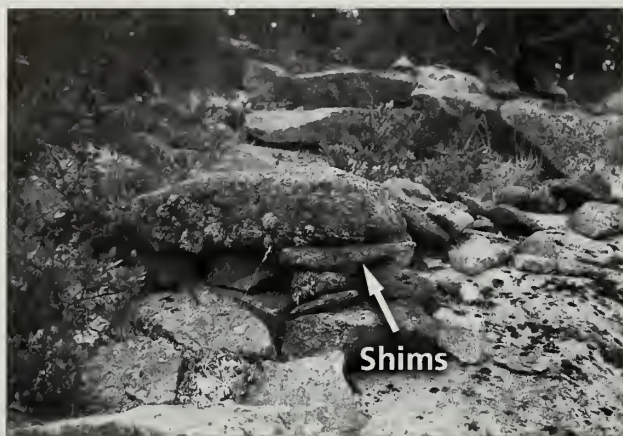
**Fig. 7-5** These steps on the Upper Ladder Trail (#334) contain exposed shims. Their use may have contributed to the deterioration of these Bates-style steps since shims are generally not locked in place and are often dislodged.

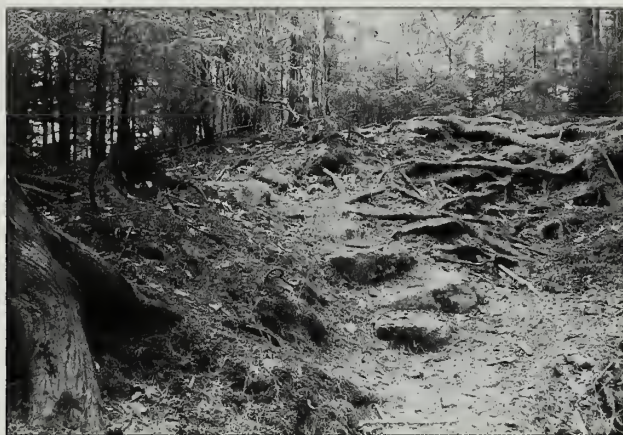
**Fig. 7-6** Deteriorated steps on the Giant Slide Trail (#63).

The first stone steps were most likely built in the 1890s either by or under the direction of Waldron Bates. Defined by economy and simplicity, these early steps were flat, uncut, slab-laid stones, constructed in short flights. The size of stones used was generally smaller than in later work. In some locations, especially over sections of ledgerrock, the steps functioned more as guidance features (see Chapter 9) than as a way of providing a durable tread over changing topography. Examples of these early VIA/VIS “Bates-style” steps (Fig. 7-45) can be found on the Upper Ladder Trail (#334), Potholes to Eagles Crag Trail (#343), Cadillac Cliffs to Thunder Hole (#345), Goat Trail (#444), and Giant Slide Trail (#63) (Figs. 7-6 to 7-8).

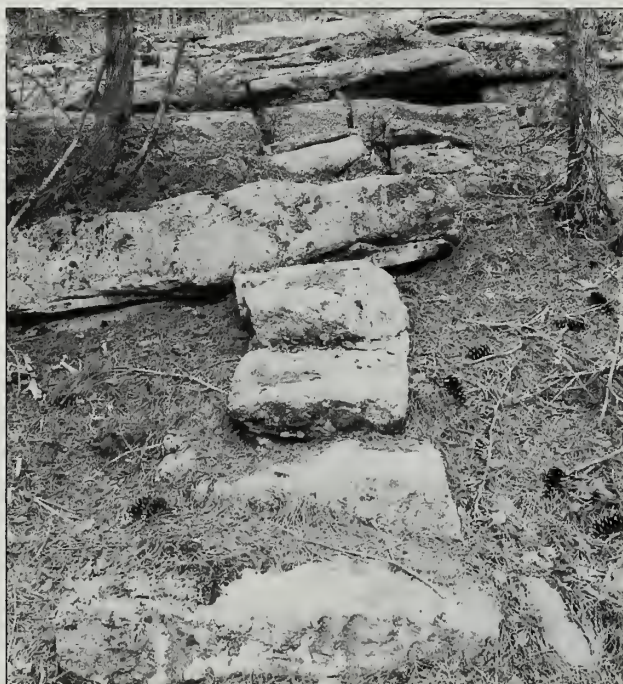
**Fig. 7-7** Bates-style steps on the Potholes to Eagles Crag Trail (#343).

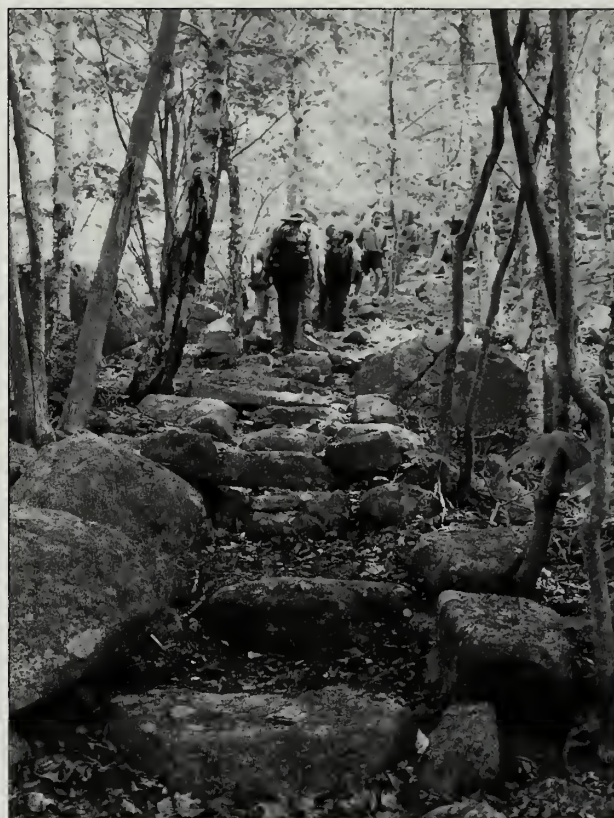
**Fig. 7-8** Bates-style steps on the Goat Trail (#444).

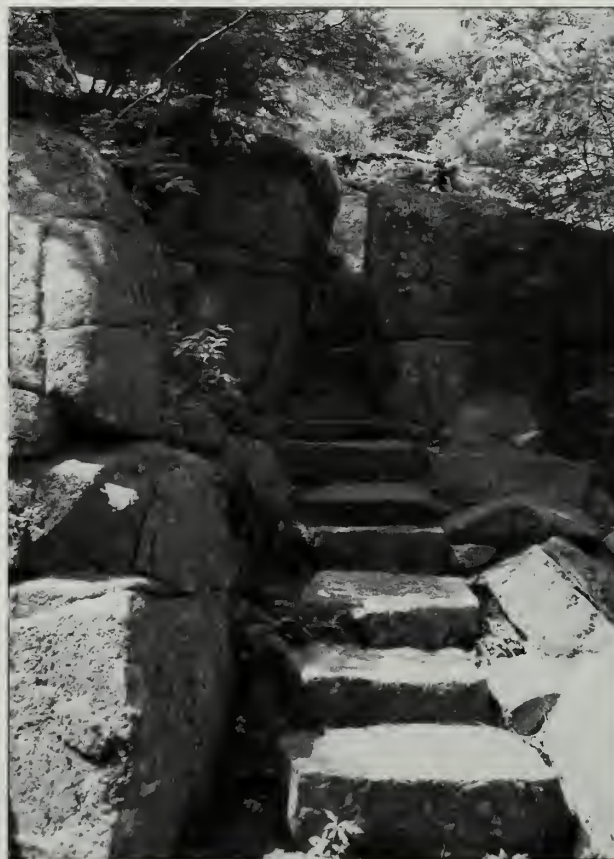
**Fig. 7-9** Dorr-style stone staircase on the Emery Path (#15).

The memorial and endowed trails built under the direction of George Dorr in the 1910s represent some of the most ingenious stair building in the park. Many of these trails were engineered to provide walkers with a continuous stone tread, using large cut blocks set with even runs and risers (see Fig. 7-46). Added components of the “Dorr-style” stairs were coping stones, large boulders used as coping retaining walls, and iron pins. Dorr staircases exhibit straight runs and pleasing curves. They make use of both slab-laid and set-behind steps. Dorr was also the first to use drainage in conjunction with staircases, making steps the capstones of capstone culverts (used on the Emery Path, #15) and using subgrade drainage beneath his steps and side drains beside them. An interesting feature of some of Dorr’s slab-laid steps is that they “belly” down, or rounded side down, behind the step on which they sit, locking in the stone and providing extra protection against slipping forward. Primary examples of steps in the Dorr style are extant on the Emery Path (#15), Kurt Diederich’s Climb (#16), and the Homans Path (#349) (Figs. 7-9 to 7-15).

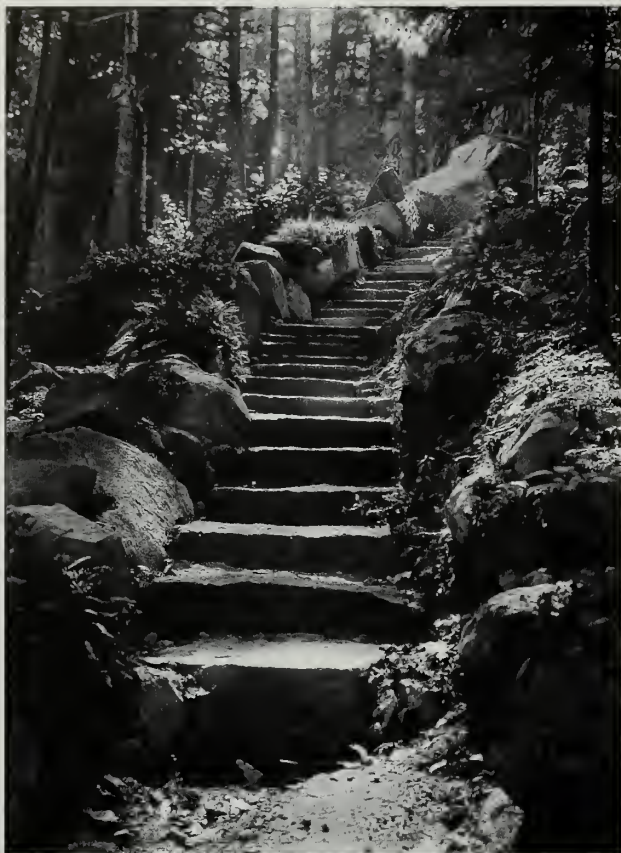
Fig. 7-10 Coping is used with stairs on the Emery Path (#15), circa 1920. There is also an obscure culvert under this staircase.

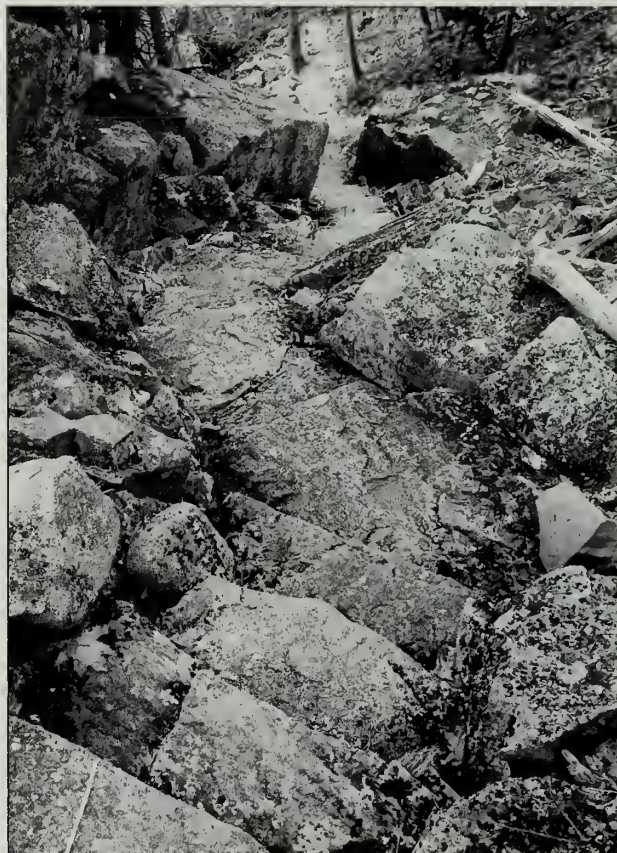
Fig. 7-12 A curving section of steps on Kurt Diederich's Climb (#16).

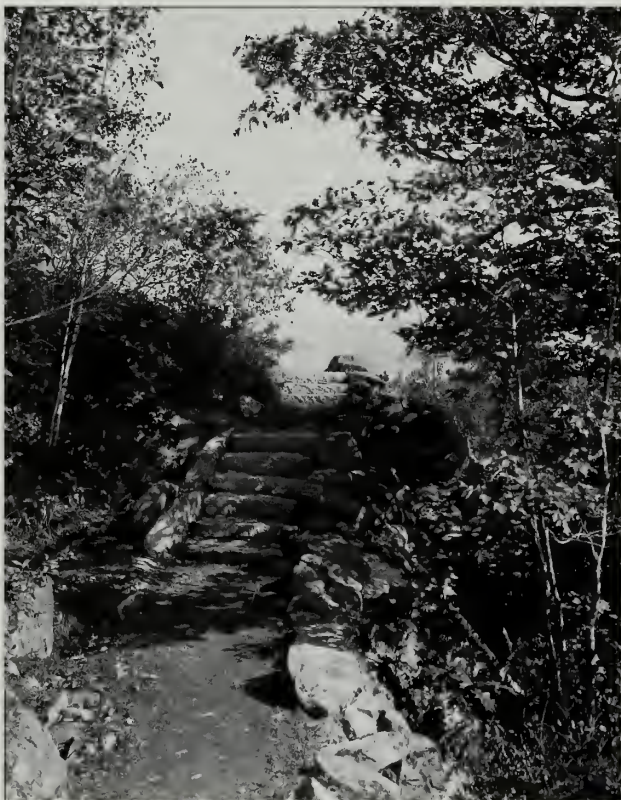
Fig. 7-11 Dorr-style stone staircase on Schiff Path (#15), circa 1916.

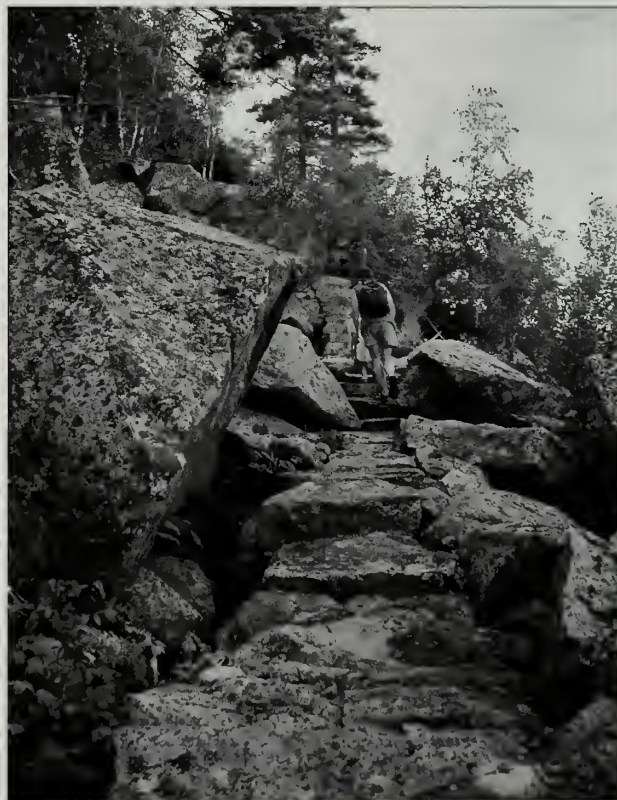
Fig. 7-13 Stone steps on the Homans Path (#349) are interspersed with sections of stone "patio."

**Patio** refers to a wide section of stone pavement, often found between sections of steps (see Figs. 7-13, 7-43).

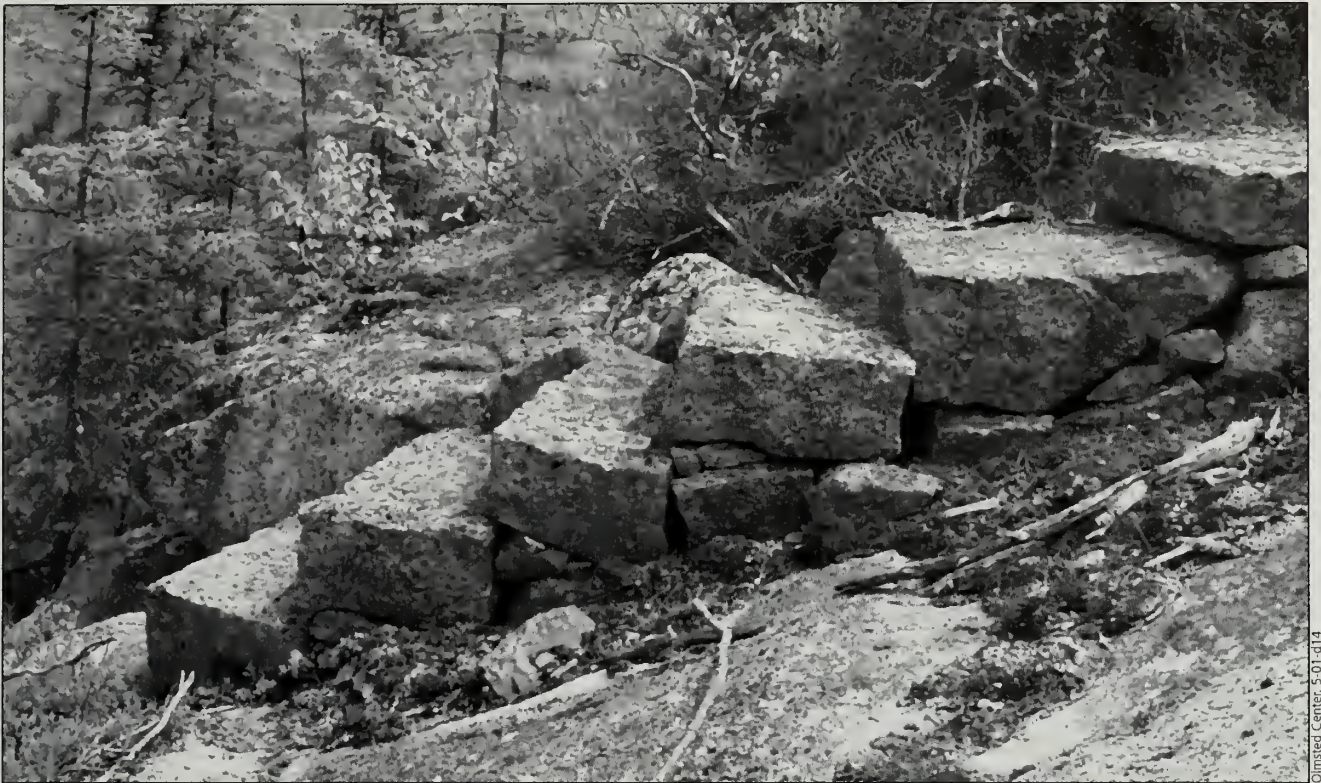
Fig. 7-14 Dorr-style stone staircase on ledge rock on the upper section of the Homans Path (#349).

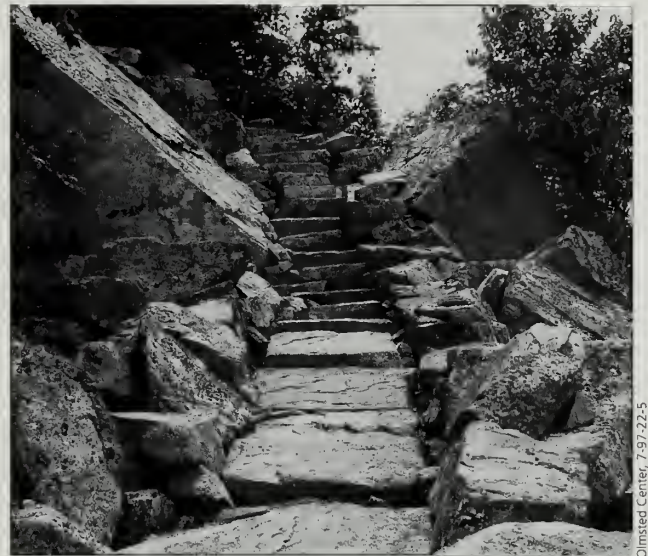
Fig. 7-17 A narrow stone staircase between sections of stone pavement on the Beachcroft Path (#13).

Later memorial paths, such as the Beachcroft Path (#13), Schiff Path (#15), and Andrew Murray Young Path (#25), had a tendency to use stairs that were smaller in overall scale and height of risers than the earlier paths, but often set in long runs of steps. Very few of the larger stairs on these later paths were as big as the stairs commonly used on their predecessors. The reason for this is unknown. Oddly, coping stones used on the Beachcroft Path (#13) are as large as any steps or paving stones on the early memorial paths, but the steps are smaller (Figs. 7-16 & 7-17).

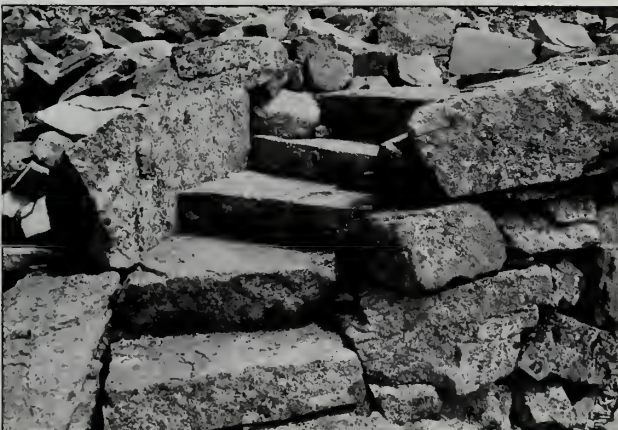
Fig. 7-16 This curving staircase on the Beachcroft Path (#13) is typical of the smaller-sized steps generally found on this trail.

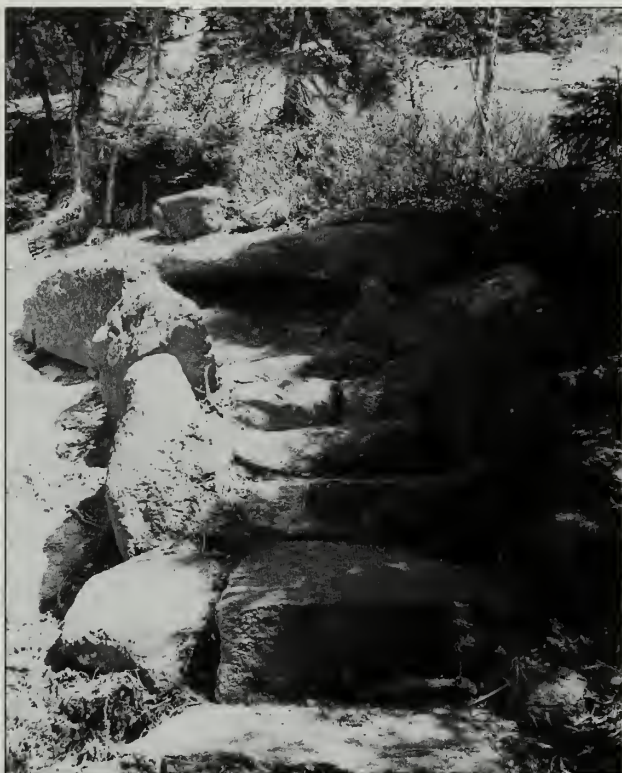
Fig. 7-18 This small curving stone staircase on the Van Santvoord Trail (#450) is typical of many of the steps on this trail.

The sporadic, distinctively curved staircases of the Van Santvoord Trail (#450) represent another variation. Constructed between 1915 and 1917 under the direction of Joseph Allen, Seal Harbor VIS path committee chairman, the trail contains large stone steps on steep climbs, between long stretches of trail with no other built features. Some short staircases were constructed on open ledgerrock, reminiscent of some of the earliest Bates-style step work (Figs. 7-18 & 7-19).

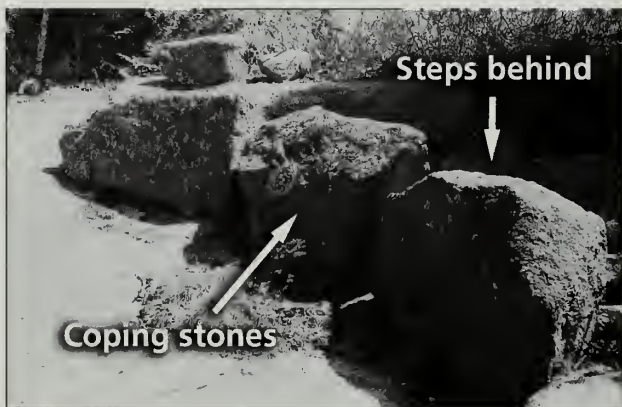
Fig. 7-19 The stone steps on the Van Santvoord Trail (#450) were often located on ledgerrock where there is no apparent need for a set of steps. These steps functioned more as a route guide than an aid to traversing the slope.

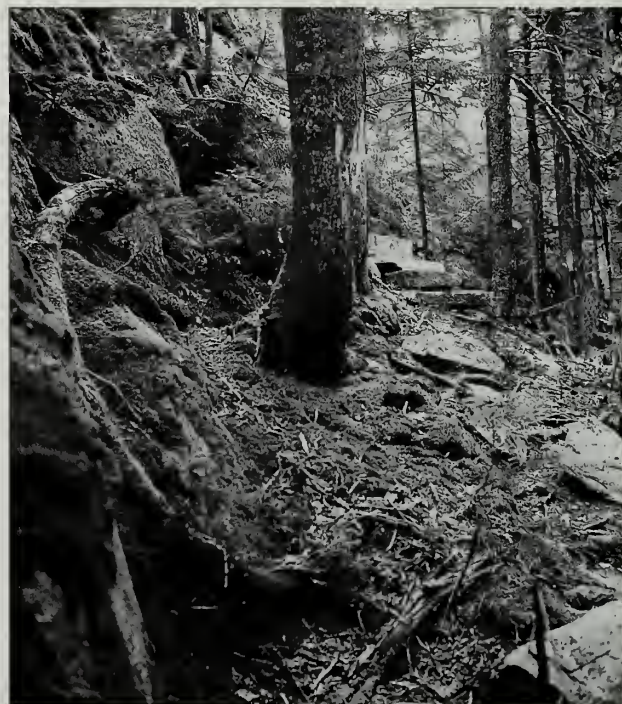
Fig. 7-20 Historic view of classic SHVIA slab-laid steps on the Moss Trail, part of the Bernard Mountain South Face Trail (#111). Steps are square, uncut stones with even runs and risers, no coping, and shimmed under the first step. The staircase is now obliterated, perhaps due to a weak foundation.

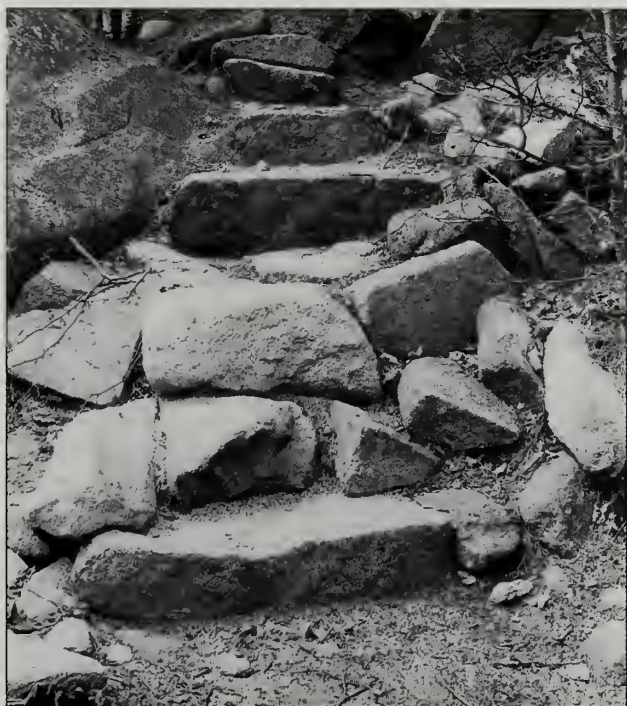
**Fig. 7-21** A partially reconstructed stone staircase on the Beehive Trail (#7). The rehab is misfitting, as the odd-shaped stones of random sizes on the lower part of the staircase do not resemble the historic, evenly laid rectangular stones on the upper part of the staircase.

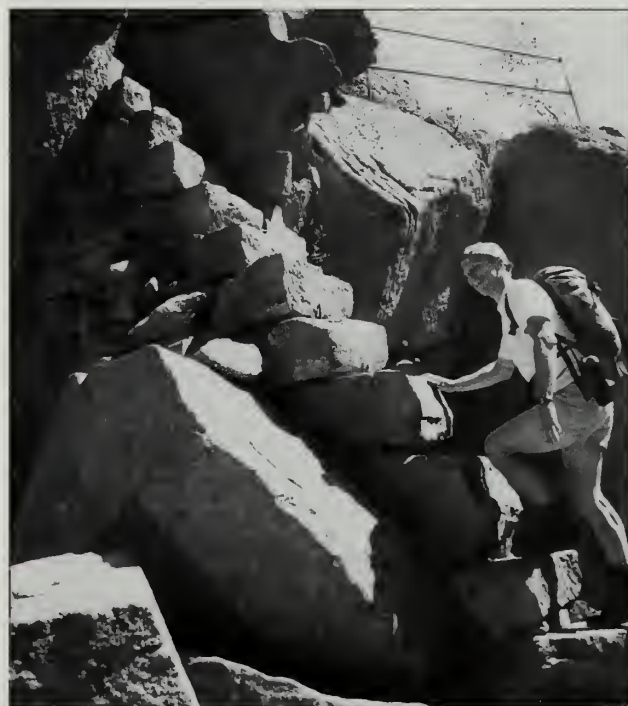
**Fig. 7-22** Brunnow's “Hanging Steps” on the Orange and Black Path (#348). Steps are pinned in the front and middle. Note the exposed retaining wall under the upper steps.

During the 1910s and 1920s, significant step work was being performed in every major area of the park. On the island's west side, the Southwest Harbor VIA added steps to the Bernard Mountain South Face Trail (#111) using typical VIA/VIS construction techniques including square, uncut stones, slab-laid construction with even runs and risers, and no coping. On the east side, Rudolph Brunnow's crew built numerous staircases on the Orange and Black Path (#348), the Precipice Trail (#11), and the Beehive Trail (#7) (Fig. 7-21). These staircases exhibit a unique style in which the steps are the top course of a retaining wall which is constructed completely under them of relatively small, carefully laid stones. The stairs do not use coping, and the blocking is exposed. The "Hanging Steps" on the Orange and Black Path (#348) are the most dramatic example of this Brunnow style (Fig. 7-22).

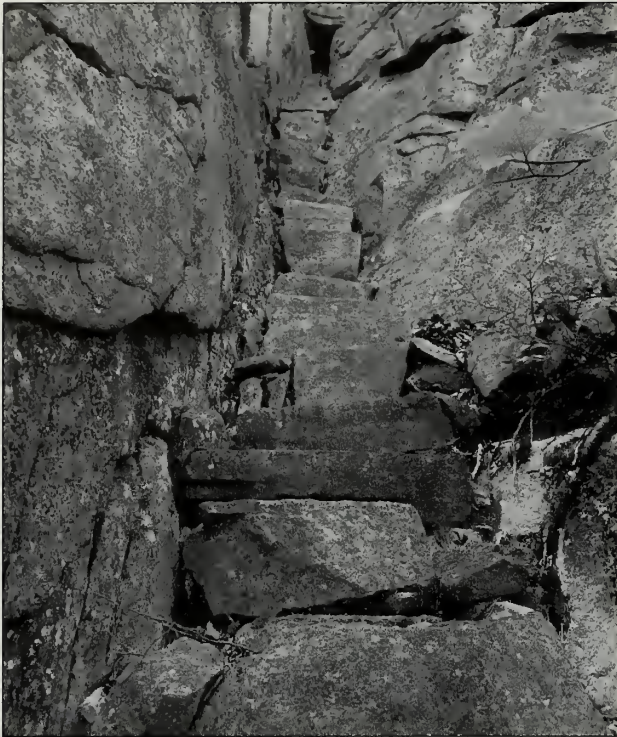
**Fig. 7-23** Brunnow-style stone steps on the Champlain East Face Trail (#12).

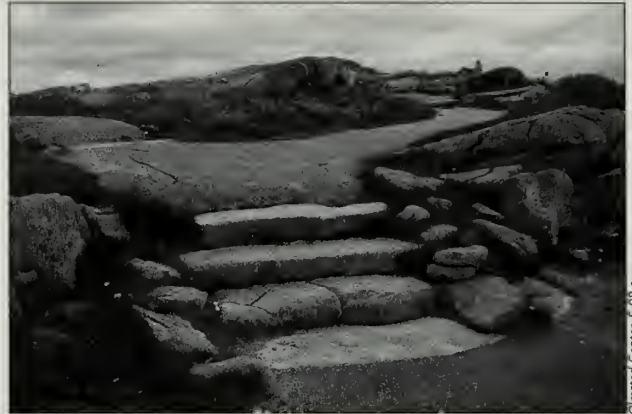
**Fig. 7-24** Stone steps and asphalt pavement on the Cadillac Summit Loop Trail (#33).

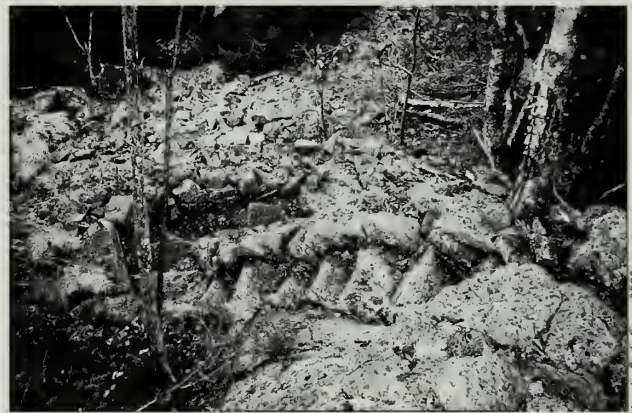
**Fig. 7-26** Highly engineered CCC switchbacks of uniform steps cutting through a talus slope on the Perpendicular Trail (#119).

This level of detail and attention to craftsmanship in the construction of CCC steps, as well as other contributing features like drainage and retention, remains especially evident on the Perpendicular Trail (#119). This trail was one of the few complete trails added to the park by the CCC, and much of the route consists of continuous staircases. On this trail, sections of a talus field were reconstructed and engineered in order to accommodate a series of even switchbacks of uniform steps (Figs. 7-26 & 7-27). While perhaps not as highly engineered, or as well constructed as the Perpendicular Trail (#119), the Valley Cove (#626) portion of the Flying Mountain Trail (#105) is the other major

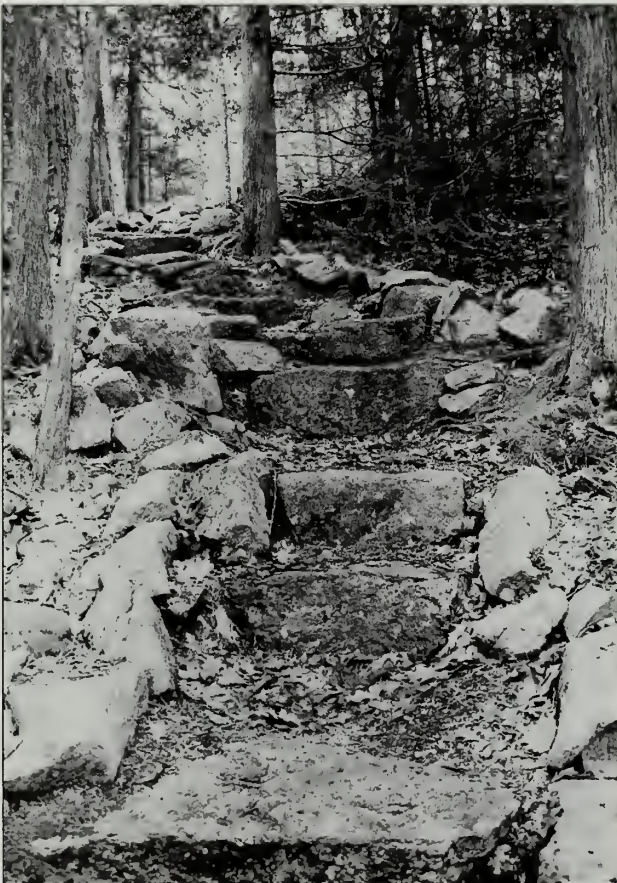
**Fig. 7-25** These CCC steps on the Acadia Mountain Trail (#101) contain consistent sizes of stones. The AMC scree installed later along the trail edges has altered the historic character.

uniform in size and shape (Figs. 7-25 and 7-46). The treads and “risers” were consistent throughout a run of steps, creating stairs that were comfortable for the hiker. Also, CCC steps were often wider than VIA/VIS steps, some over 4 feet wide, to handle more use. And to make the stairs blend in with the natural surroundings, CCC crews would plant mosses, ferns, and other vegetation in the crevices of staircase after they were finished with construction.

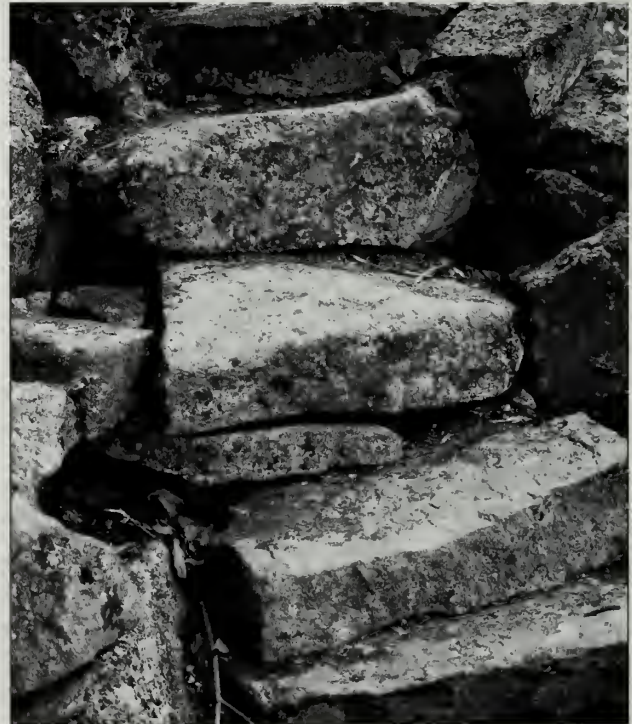
**Fig. 7-27** Details of CCC steps with shims on the Perpendicular Trail (#119).

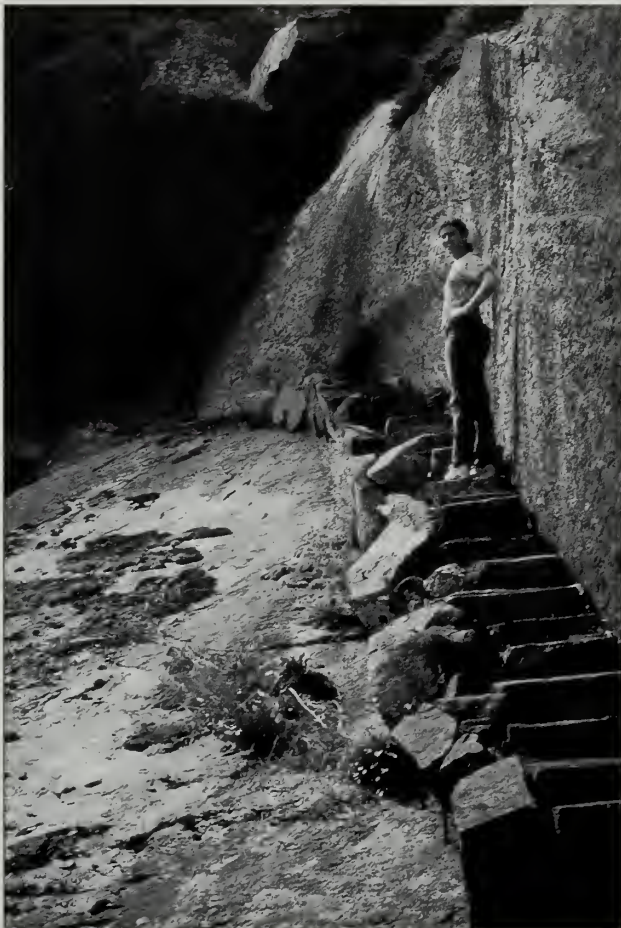
Fig. 7-28 CCC steps across ledgerrock on the Valley Cove Trail (#626), shown in 1969.

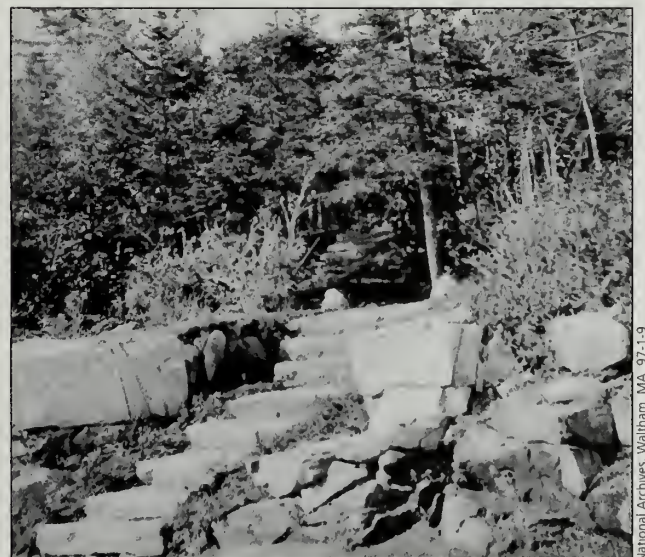
Fig. 7-29 CCC steps connecting Ocean Path (#3) with a parking area along Ocean Drive, soon after construction, circa 1937.

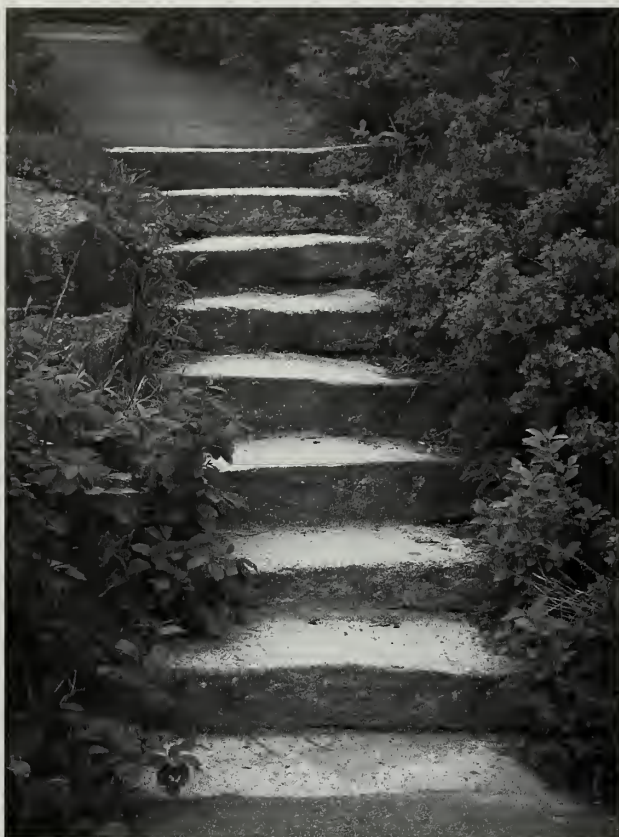
Fig. 7-30 CCC steps at Thunder Hole parking along the Ocean Path (#3).

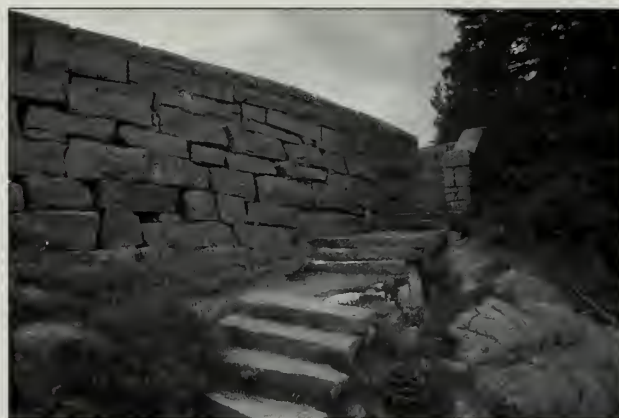
Fig. 7-31 CCC steps at Otter Cliffs on Ocean Path (#3) adjacent to motor road grade separation.

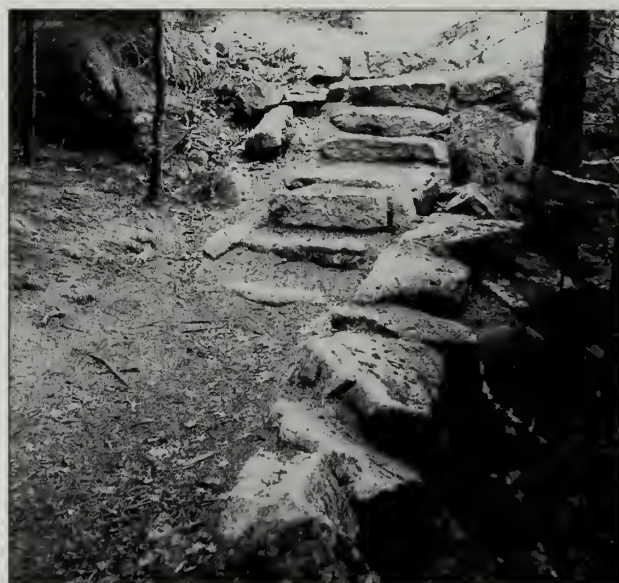
Fig. 7-33 CCC stone wall and steps on the Beech Mountain South Ridge Trail (#109).

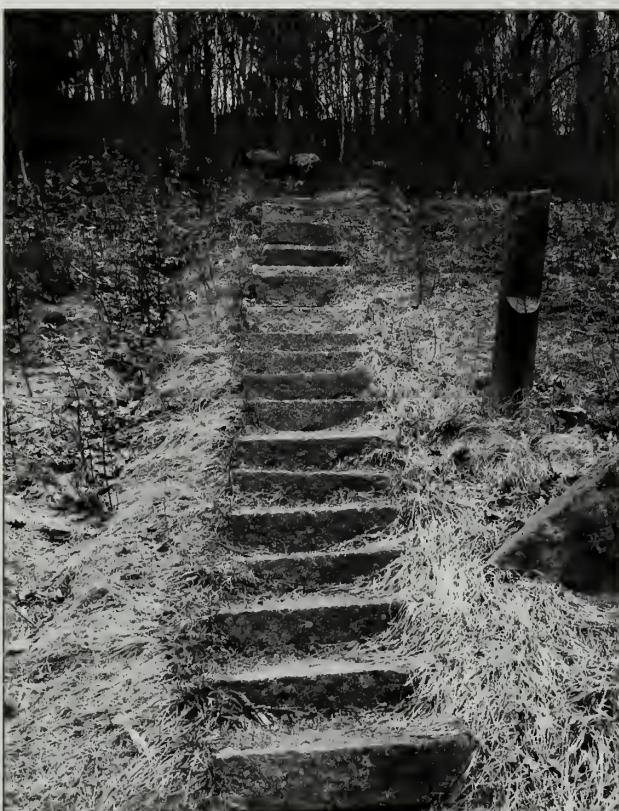
Fig. 7-32 These stone steps were added by the CCC at the newly established trailhead for the Beachcroft Path (#13).

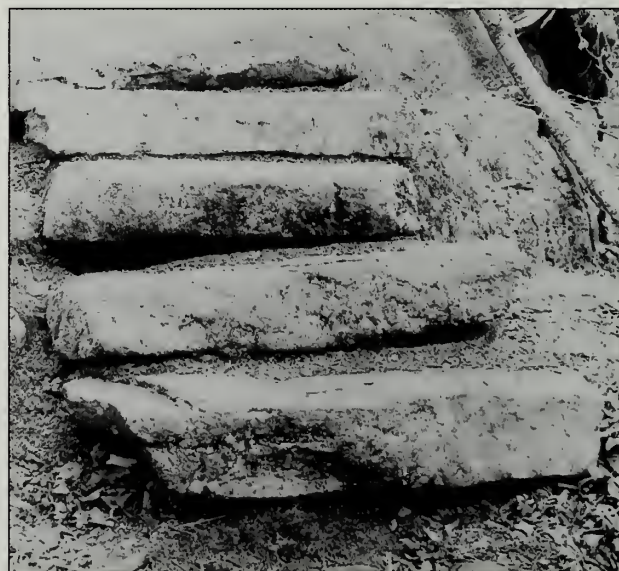
Fig. 7-34 A CCC stone staircase on the Valley Trail (#116).

the road from the newly established trailhead (Fig. 7-32). Other trails where the CCC completed step work include the Beech Mountain South Ridge Trail (#109) and the Valley Trail (#116) (Figs. 7-33 & 7-34).

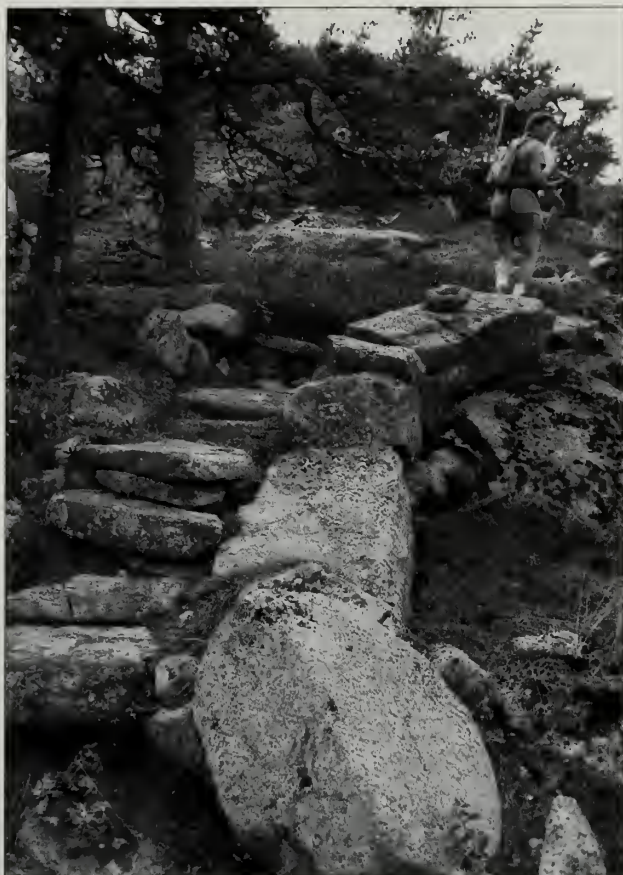
Fig. 7-35 VIA/VIS Bates-style steps on the Upper Ladder Trail (#334).

**Issue:** Unpinned steps and walls constructed directly on ledgerrock have slid out of place over time, while work held by iron pins has generally lasted as long as the pins’ useful life of over fifty years. However, iron pins are not historically accurate on all trails, including early VIA/VIS work like the deteriorating steps of the Upper Ladder Trail (#334).

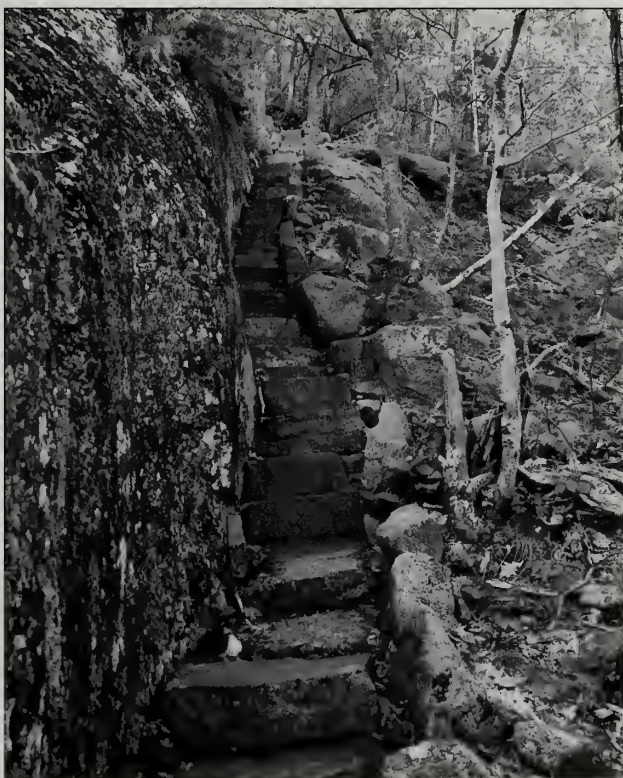
Fig. 7-36 CCC steps along cliff face on the lower section of the Ladder Trail (#64).

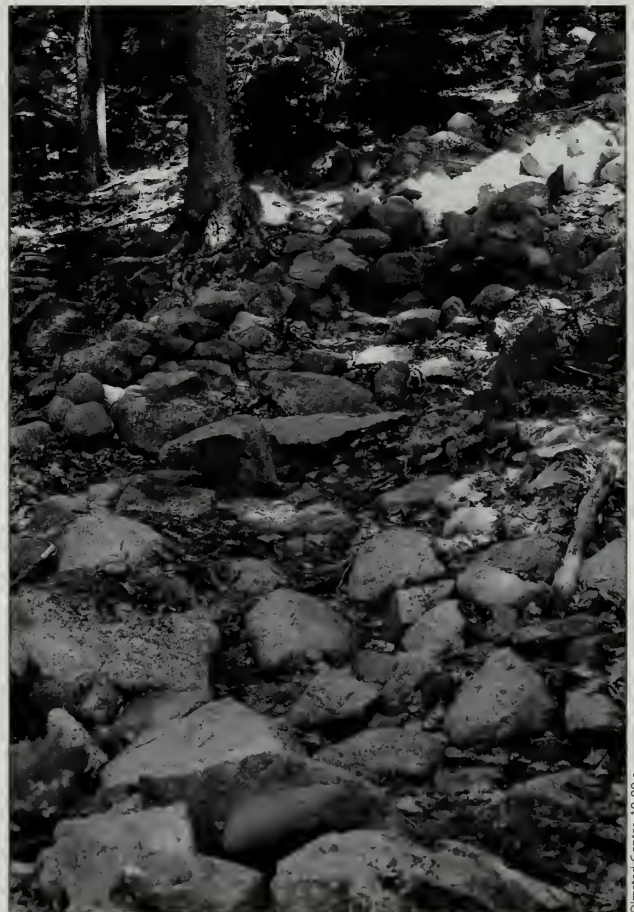
Fig. 7-39 These AMC-style steps on the Pond Trail (#20) were built according to AMC handbook. However, this style of step work, with uneven, slanted steps and the heavy use of scree, is not appropriate for the Acadia trail system.

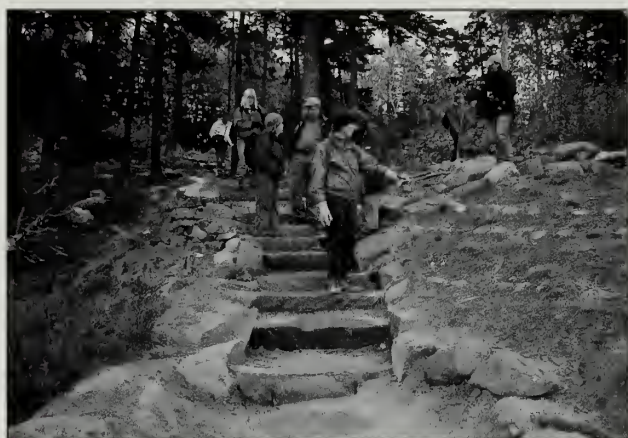
Fig. 7-40 These stone steps at Otter Point on the Ocean Path (#3) were constructed in 2000.

cal precedents for step construction have been used in both the rehabilitation of old steps, as well as in the addition of new steps to the trail system. Some examples of recent step rehabilitation include work on the Pond Trail (#20) and the Ocean Path (#3) at Otter Point (Fig. 7-40).

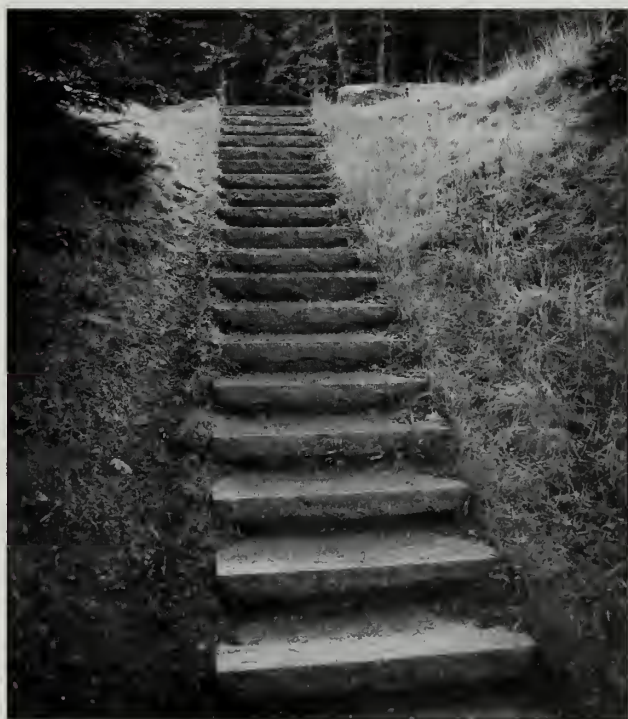
Fig. 7-41 These stairs from the Park Loop Road to Western Point, south of Blackwoods Campground, are too uniform and are out of place in the Acadia trail system.

Repairs were made to staircases of all eras, both in-character and out-of-character (Fig. 7-41). New work varied considerably. New styles were introduced, including AMC steps, wooden steps, riprap, and set-behind steps as a substitute for slab-laid steps. From the late 1990s on, close attention has been paid to rehabilitating and constructing steps in the proper style, such as in the 2002 rehabilitation of Bates-style steps on the Jordan Pond Path (#39) (Figs. 7-42 & 7-43).

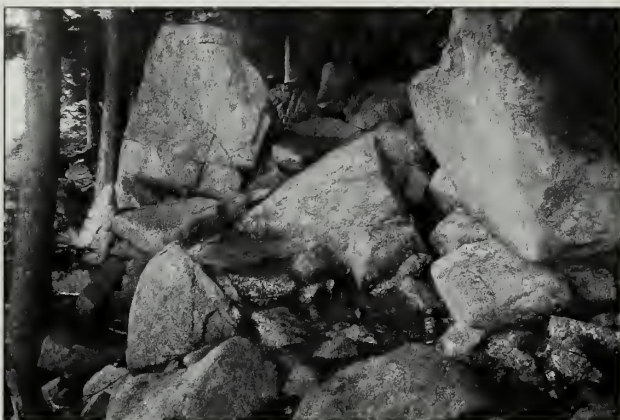
Fig. 7-42 Dilapidated Bates-style steps on the Jordan Pond Path (#39) before NPS rehabilitation, see Fig. 7-43.

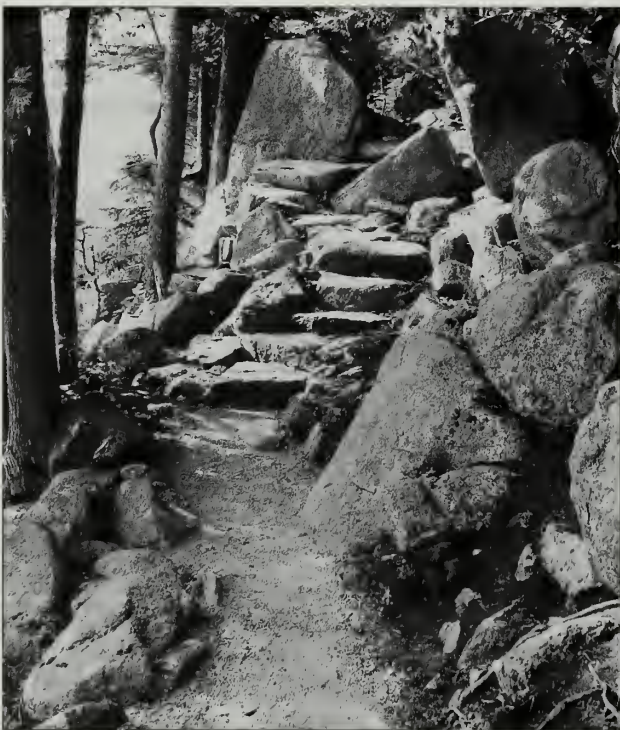
Fig. 7-43 NPS rehabilitation of Bates-style steps on the same section of the Jordan Pond Path (#39) in 2002. Note varying sizes, flat "patio" above the fifth step, and use of both slab-laid (top step) and set-behind (front steps). Steps also conform to boulders in the landscape.

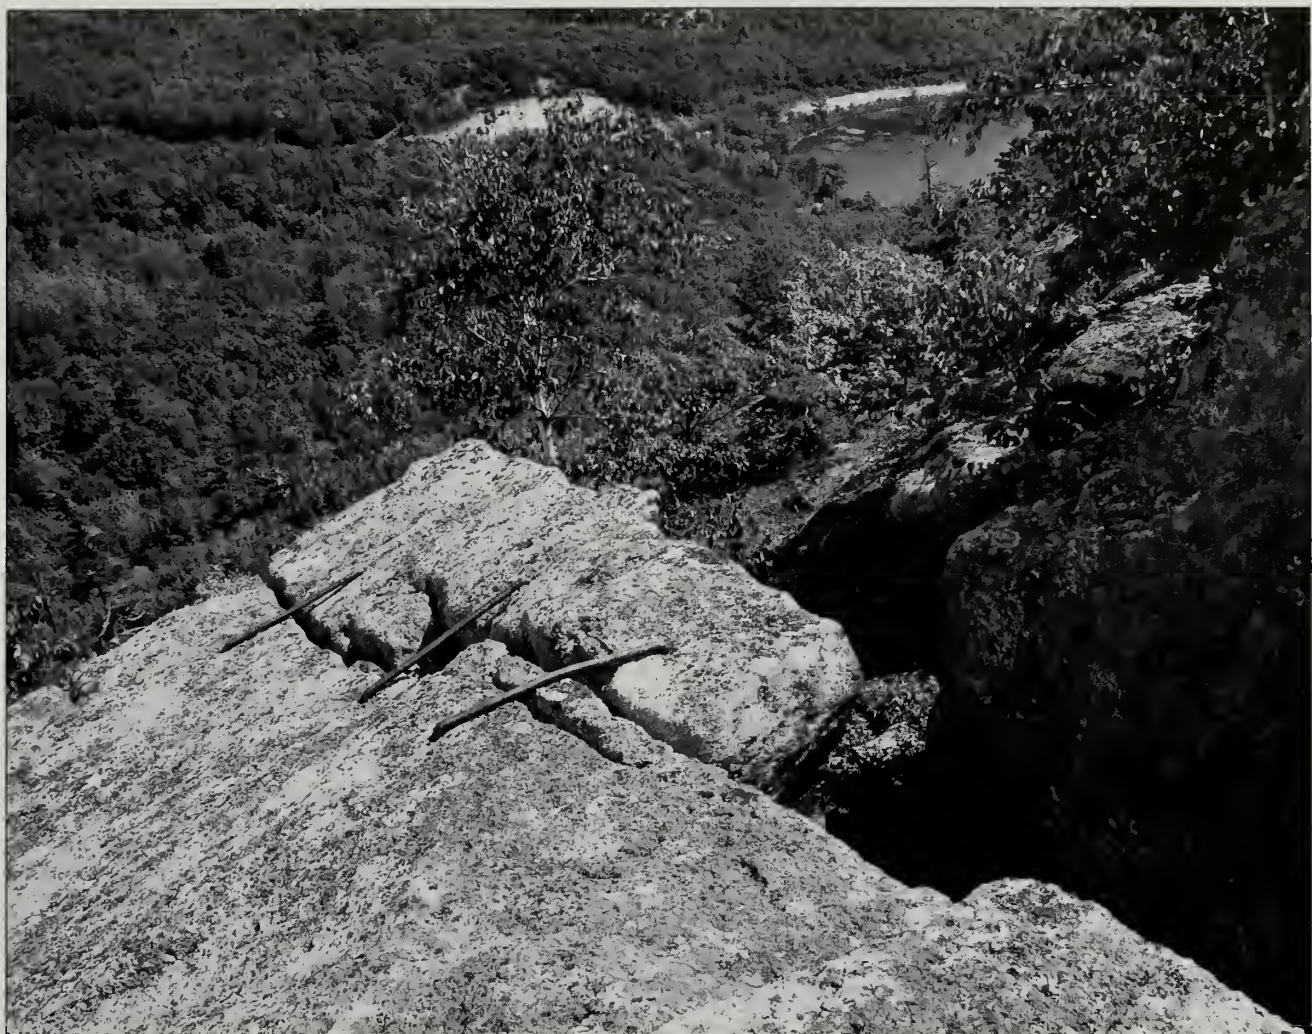
Fig. 8-1 Iron pins hold an overhanging boulder at Sieur de Monts Crag on the Emery Path (#15).
