# ACADIA TRAILS TREATMENT PLAN

## CULTURAL LANDSCAPE REPORT FOR THE HISTORIC HIKING TRAIL SYSTEM OF ACADIA NATIONAL PARK

Olmsted Center for Landscape Preservation  
National Park Service, Boston, Massachusetts, 2006

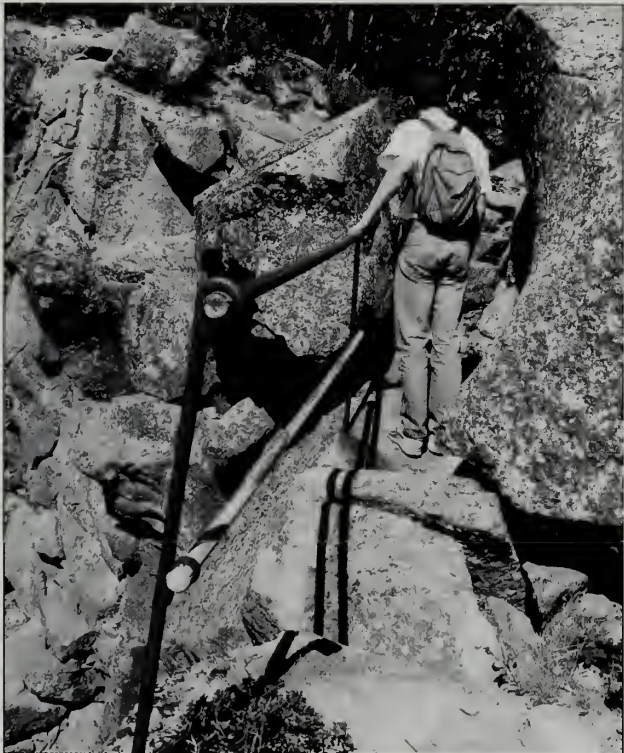
Fig. 8-4 Railing supported on stanchions on the Orange and Black Path (#348).

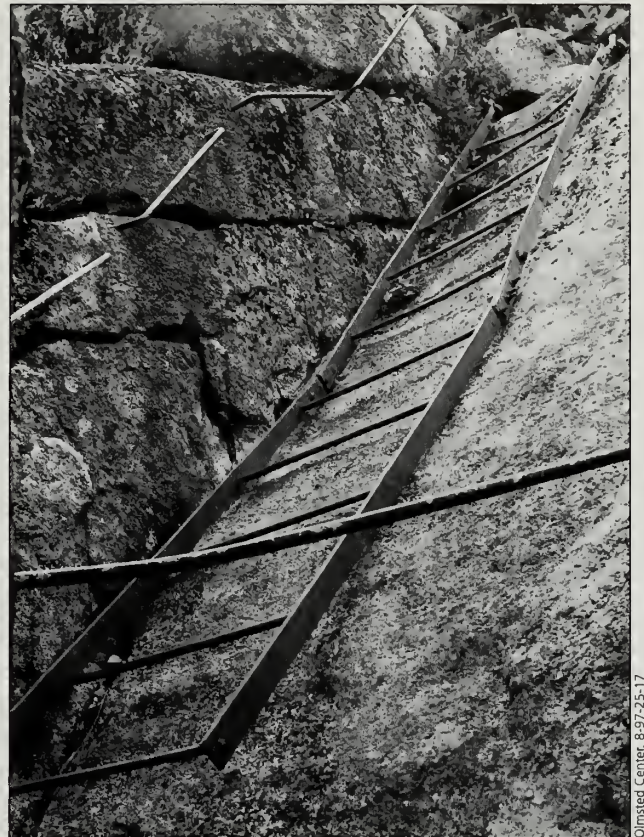
Fig. 8-5 Rung handrails and ladder on the Ladder Trail (#64).

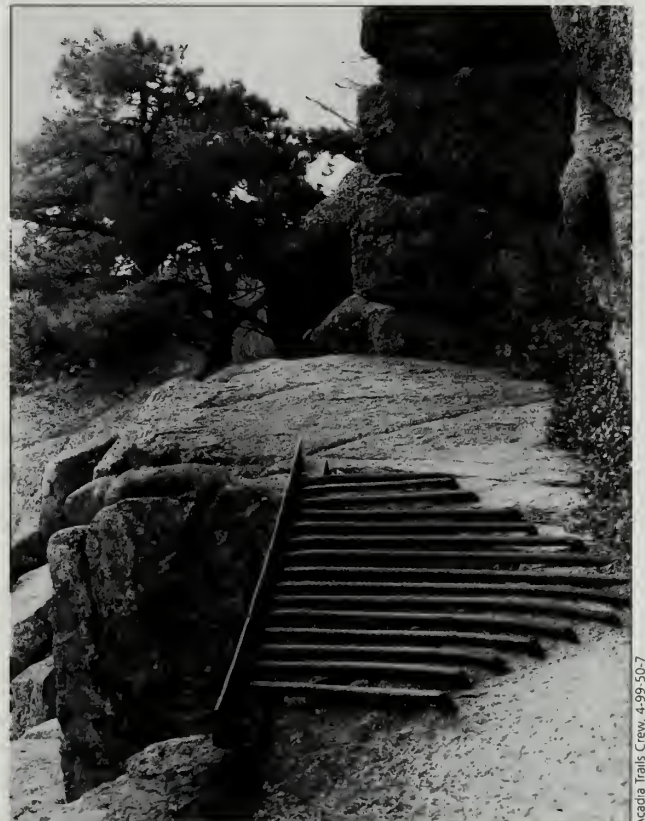
Fig. 8-6 An iron bridge on the Beehive Trail (#7).

An **iron bridge** is a series of bars, perpendicular to the tread and supported by angle iron, used to span gaps between ledges.

(Figs. 8-11 & 8-12). The 1928 Path Guide refers to a sign at the base of the trail: “Precipice Trail, which is steep and dizzy: for experienced climbers only.” Long sections of iron handrails were installed along the most exposed sections of the trail. These were built in combination with a wooden bridge connecting two ledges (Fig. 8-13). The Beehive Trail (#7) contains extensive pins, rungs, rails, and a small iron bridge that spans two ledges (Figs. 8-14 & 8-15, also Fig. 8-6). On the Cliff

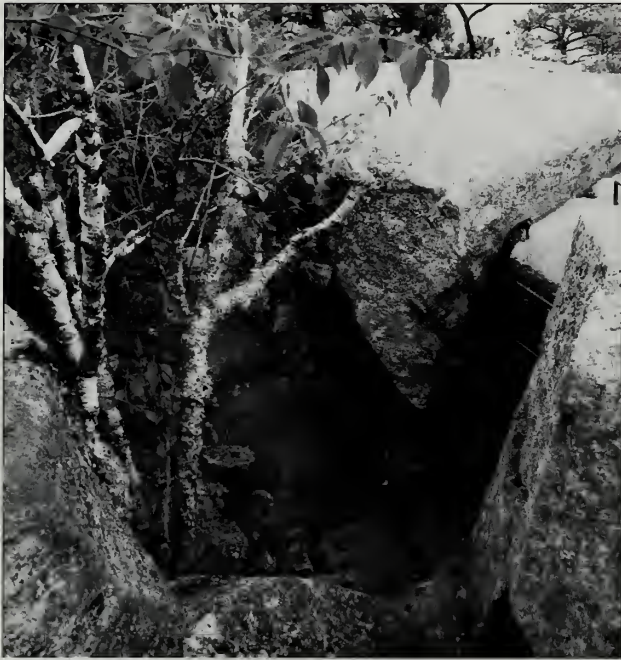
Fig. 8-7 Ladder on the Ladder Trail (#64).

The Ladder Trail (#64), which was described as a new route in 1896, shown on the 1896 path map, and labeled on the 1901 path map, may be the first trail to use ironwork: "This latter [*sic*] path down the eastern slope of Dry is quite steep and needs to be followed with caution" (Fig. 8-7). It is possible its name was derived from the iron ladders used on the trail. The Goat Trail (#444) on Pemetic Mountain has a small amount of ironwork of varying types. It is mostly round iron, with a few square pieces, and primarily consists of rungs and step pinning (Figs. 8-8 & 8-9). The Shore Path (#427) along ledges near Seal Harbor (#427) and the Ingraham Rocks Path (#445), both shown on the 1896 path map, traversed the cliff tops and their initial construction likely included iron stanchions, iron railings, or iron bridges. Remnants of this ironwork, including a rod-and-turnbuckle anchor, are visible and definitively dated in a 1908 photo of a bridge along the path. Portions of these paths and their iron are still present today (Fig. 8-10).

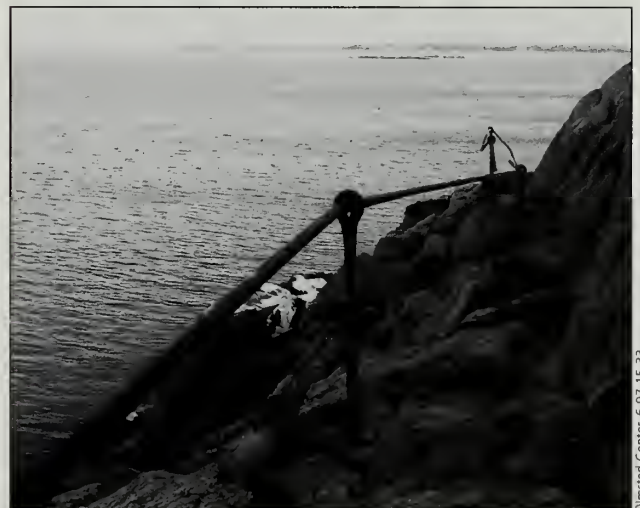
Fig. 8-10 Iron railing with stanchions on Shore Path (#427) in 1999.

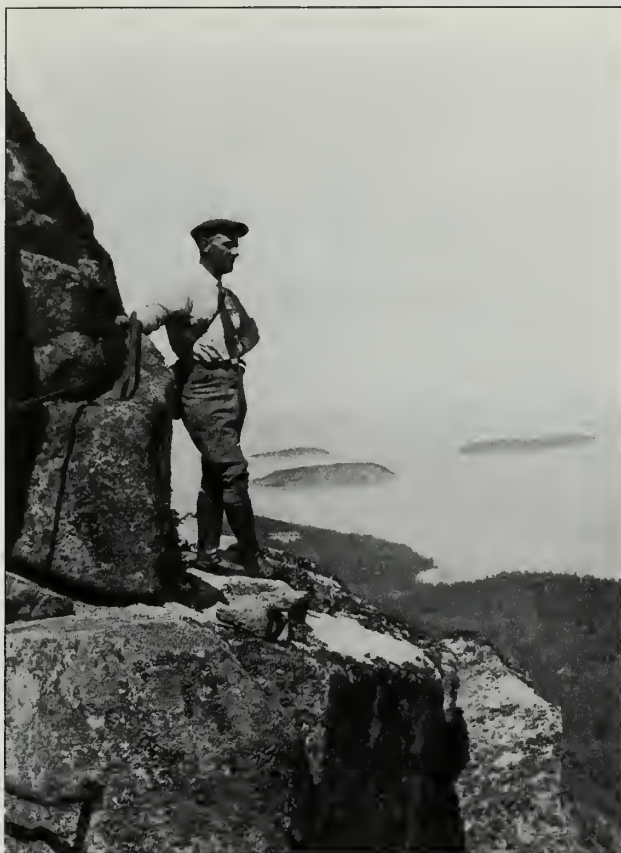
Fig. 8-11 Rungs and handrails on Precipice Trail (#11), circa 1920.

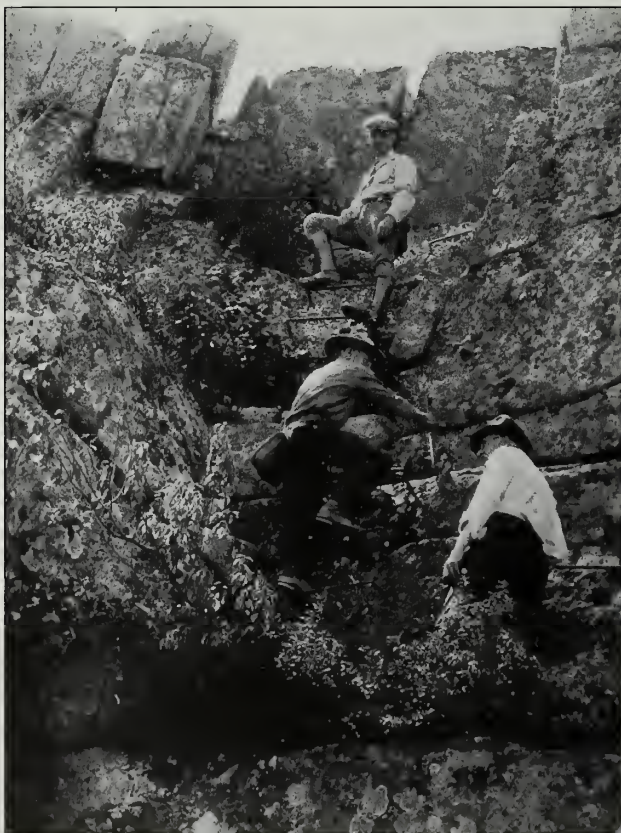
Fig. 8-12 Climbers ascend the Precipice Trail (#11) with the assistance of iron rungs, circa 1920.

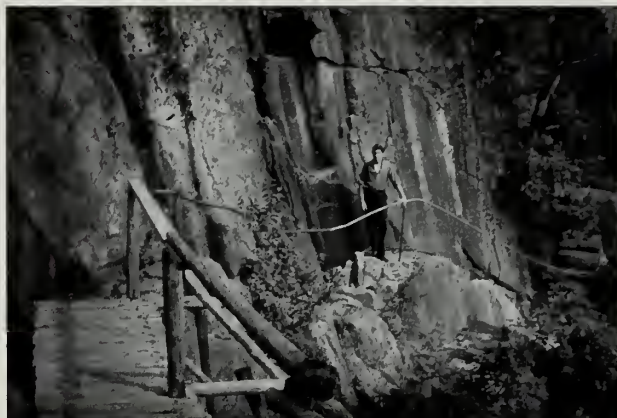
Fig. 8-13 A view in 1958 of the wooden bridge and iron handrail along the Precipice Trail (#11) ledges. The bridge was later destroyed by a rockslide.

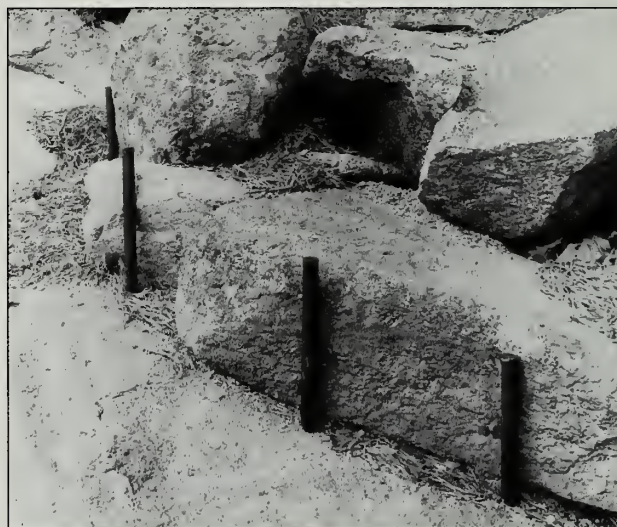
Fig. 8-14 These pins on the Beehive Path (#7) are too long and can be seen by hikers on the trail.

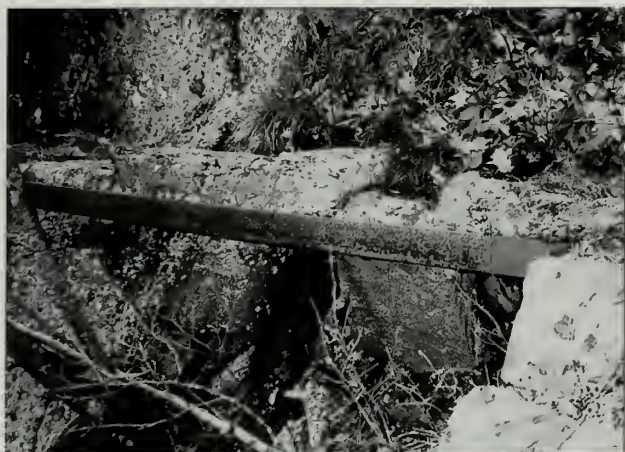
Fig. 8-16 Side view of iron bridge surfaced with flat stones on the Cliff Path (#347).

Path (#347) iron supports stone paving over a ravine (Fig. 8-16). On the Orange and Black Path (#348) iron pins were set in the front center of each step to hold together a staircase (see Chapter 7, Fig. 7-22).

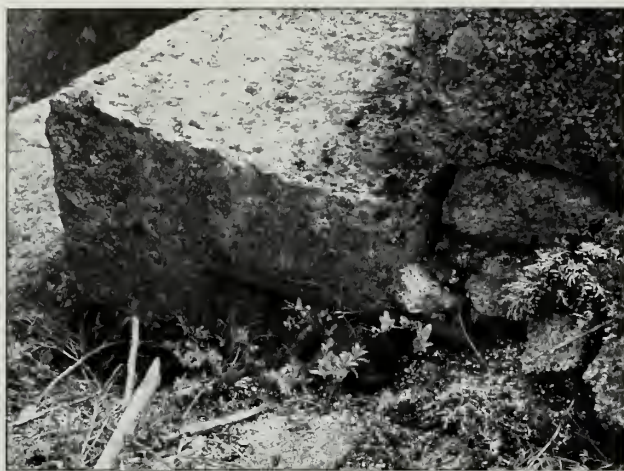
Fig. 8-19 Pin supporting steps on the Homans Path (#349).

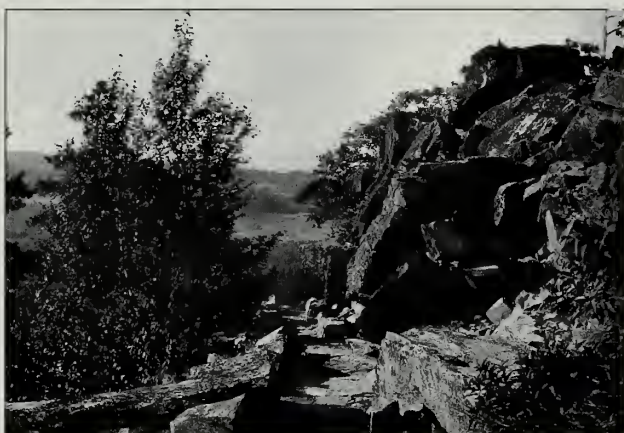
Fig. 8-20 Trail builders used iron pins to hold many coping stones along ledges and steep slopes, such as seen here on the Emery Path (#15) in a 1920 photo.

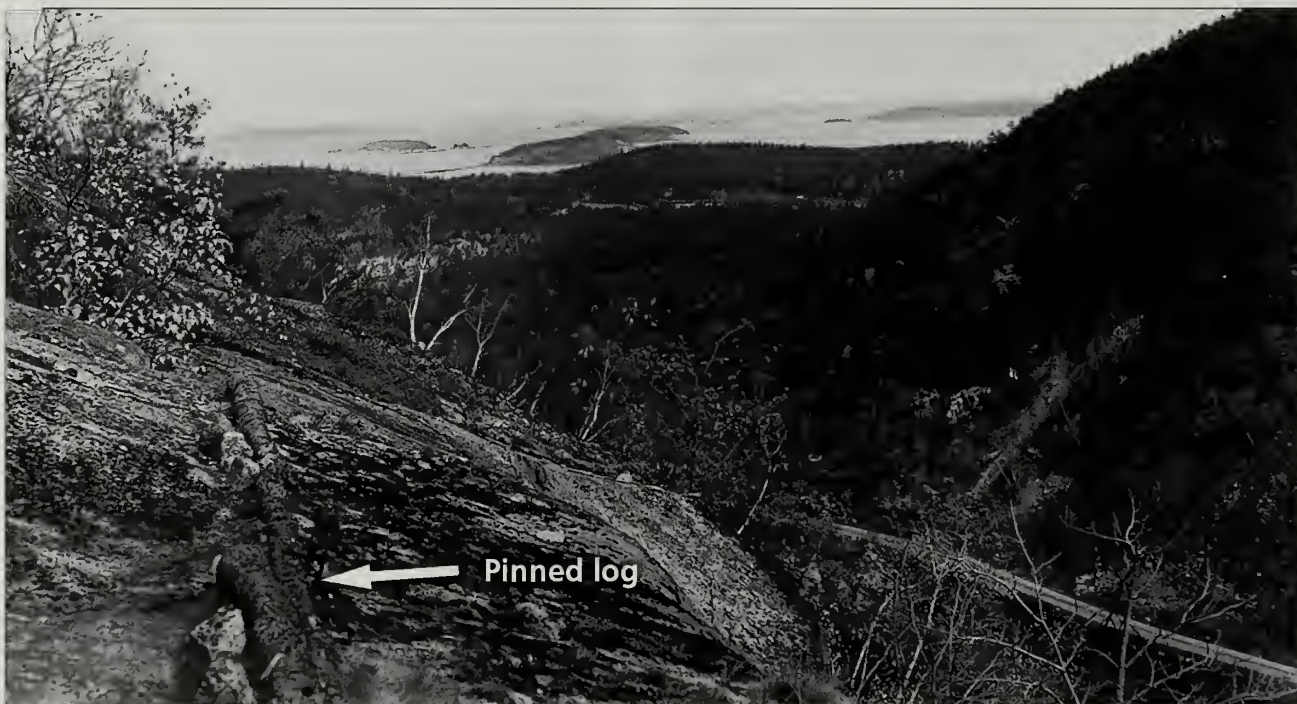
Fig. 8-22 A pinned retaining log on the Ladder Trail (#64) shown in the 1920s.

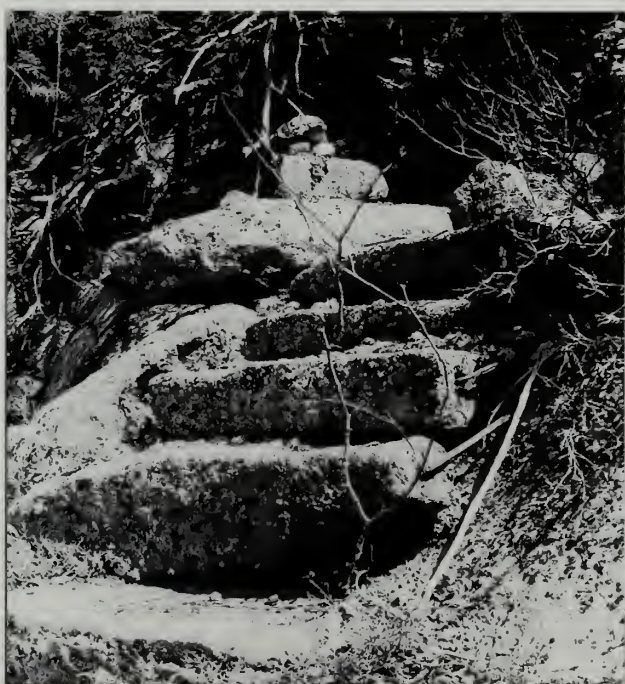
Fig. 8-23 An unusual placement of pins holding steps on the Van Santvoord Trail (#450).

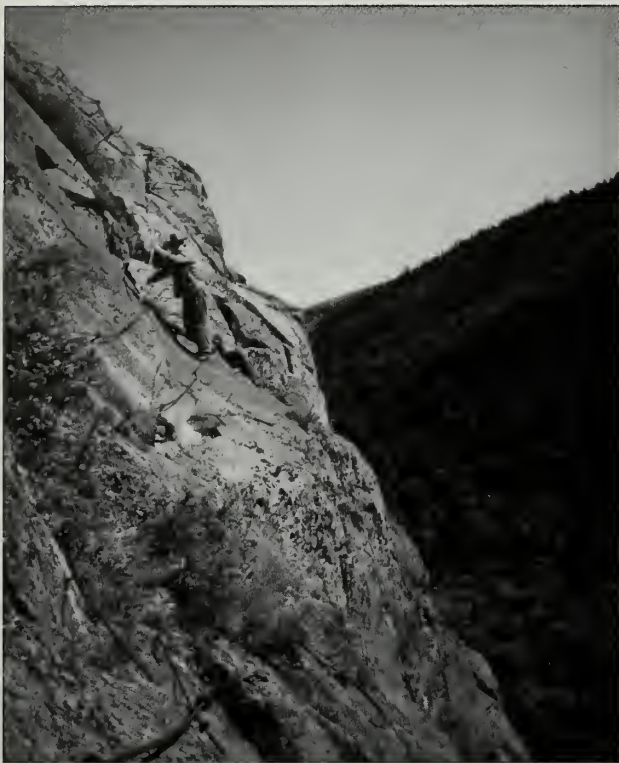
Fig. 8-25 Climber using hand and foot rails on the South Bubble Cliff Trail (#451) in 1955.

pinned to ledge. Comparable pinned log construction was used on the North Bubble Cliff Trail (#459) in 1929. Despite the addition of iron steps and rails in 1931, the dramatic South Bubble Cliff Trail was considered too dangerous by some hikers. The trail was not maintained during the 1940s and was eliminated by the NPS in the 1950s by removing some but not all of the iron. Skeletal traces of this marvelous example of the bygone trail system remain rusting and broken (Figs. 8-25 to 8-28).

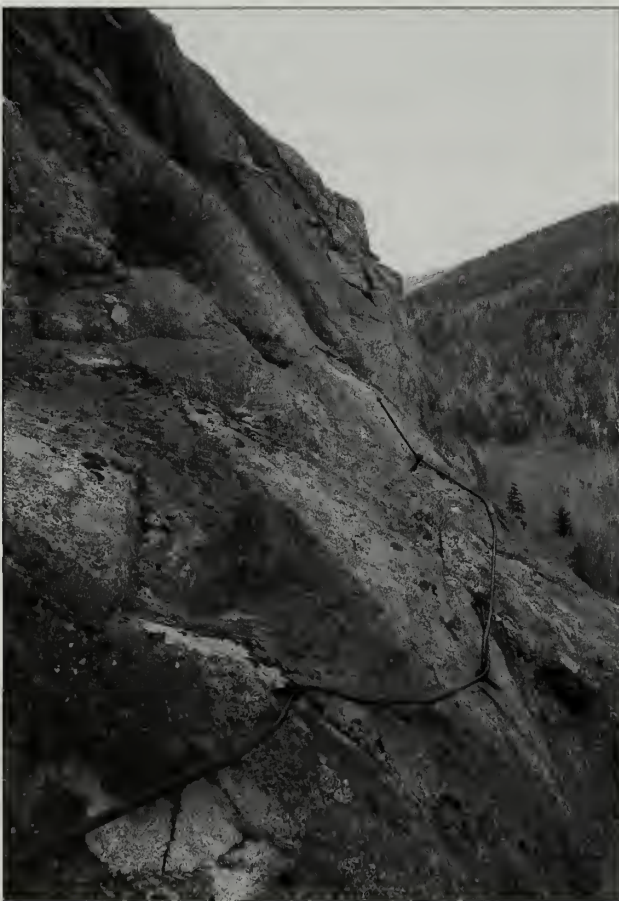
Fig. 8-26 Remnant railings on the South Bubble Cliff Trail (#451) in 1999.

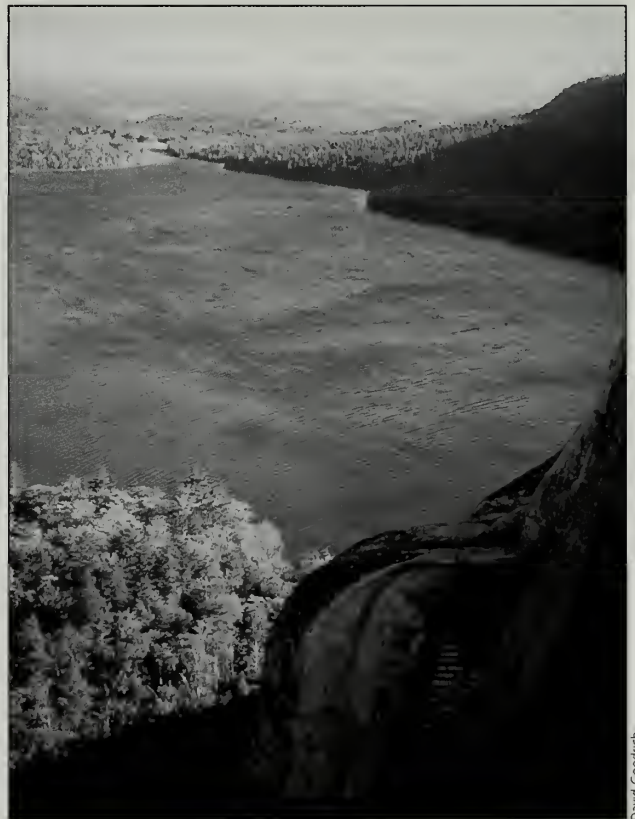
Fig. 8-27 Iron bridge across ledges on the South Bubble Cliff Trail (#451) in 1963.

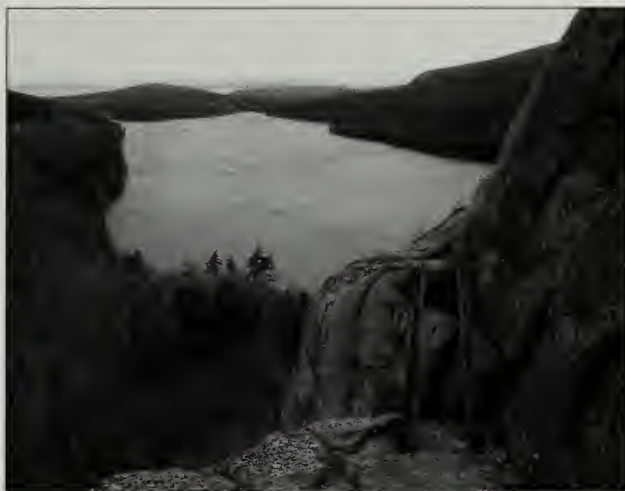
Fig. 8-28 Remnant iron bridge on the South Bubble Cliff Trail (#451) in 1999.

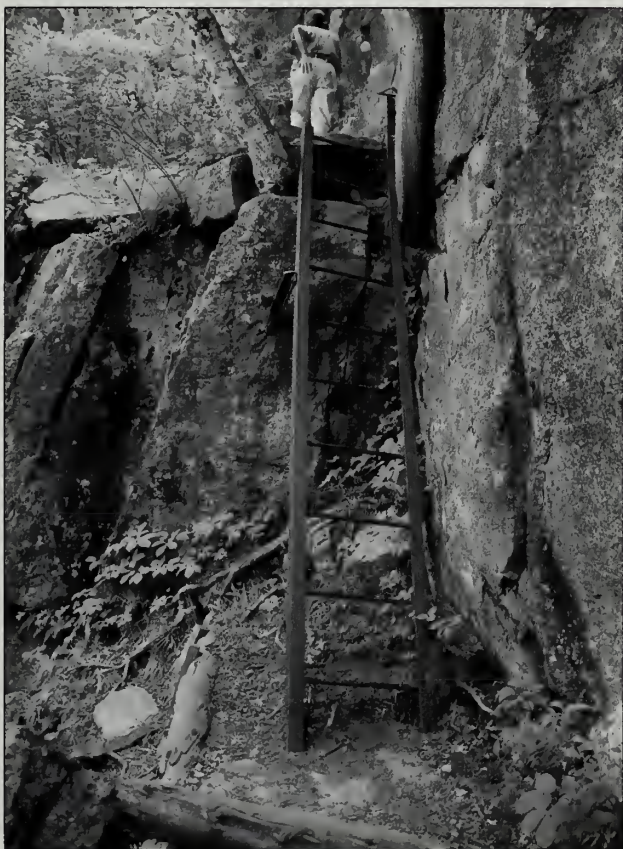
Fig. 8-29 Ladder on the Beech Cliff Ladder Trail (#106).

The CCC installed iron ladders on the Beech Cliff Ladder Trail (#106) in the 1930s. One rung and four different ladders guided hikers up the cliff face. For comparison, on the Brunnow trails of Champlain Mountain, ladders usually consisted of individual rungs in series. The Beech Cliff ladders, however, incorporated rolled steel crosspieces fitted and welded to angle iron sidepieces with 110 feet of ½-inch wire rope cable providing safety railing for hikers. This type of railing, with 2-inch square metal stanchions and eyebolts for support, is unique among Acadia's trails (Figs. 8-29 to 8-32).

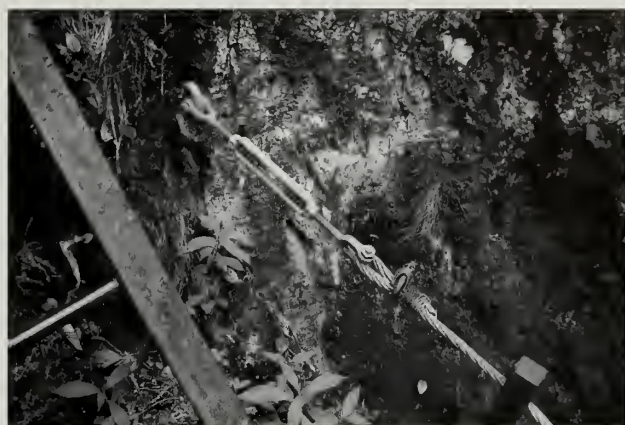
Fig. 8-30 End of rope cable on Beech Cliff Ladder Trail (#106).

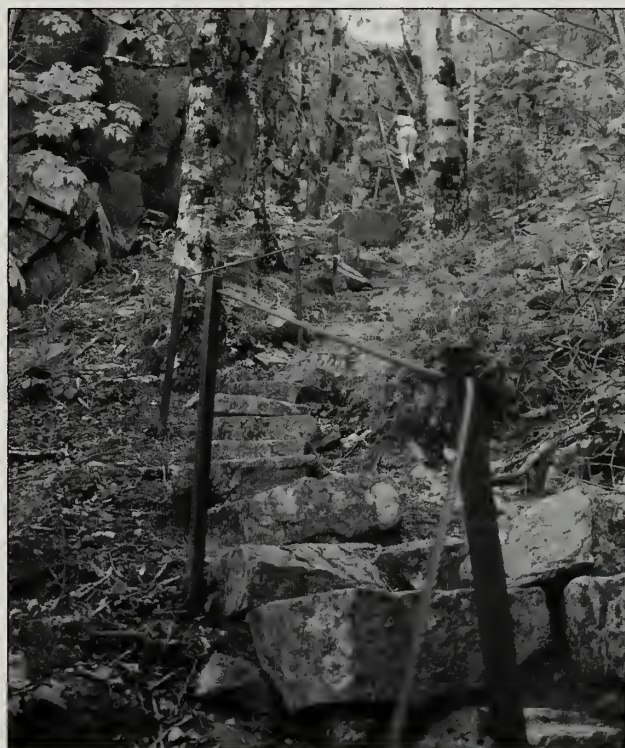
Fig. 8-31 Cable on stanchions on the Beech Cliff Ladder Trail (#106).

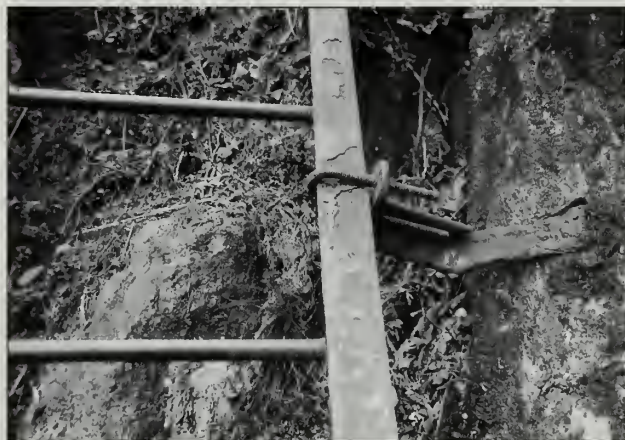
Fig. 8-32 Fastener for ladder on the Beech Cliff Ladder Trail (#106).

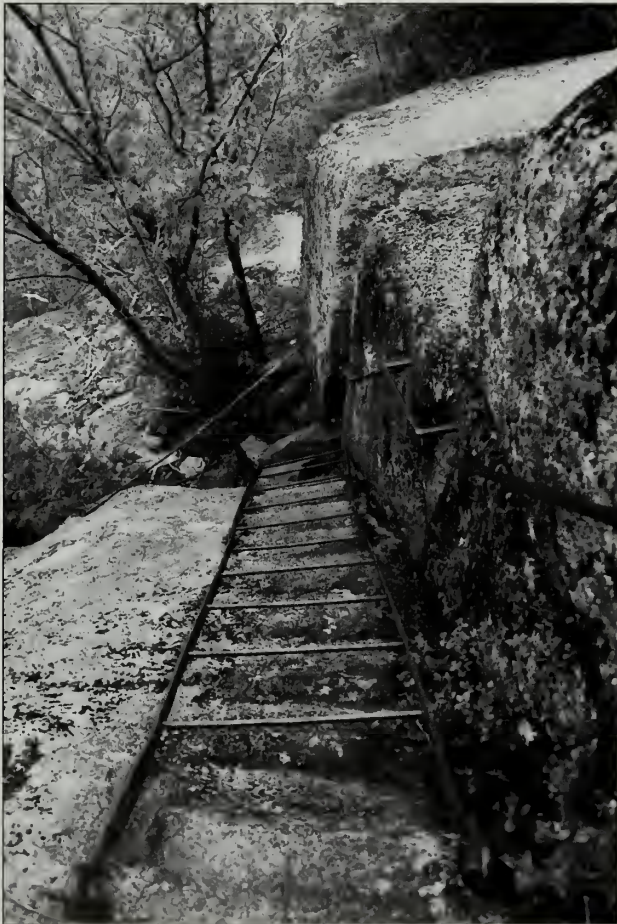
Fig. 8-33 Ladder on Ladder Trail (#64), a VIA trail, similar to the CCC type.

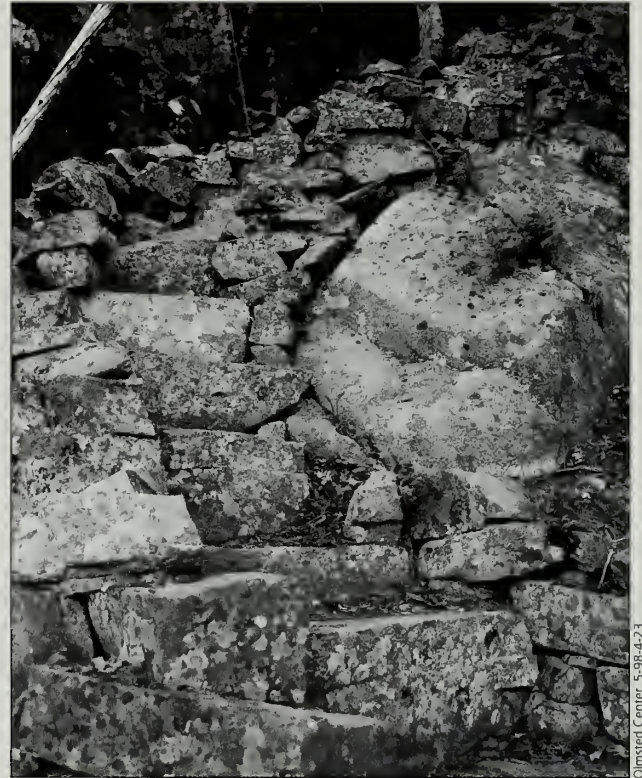
Fig. 8-34 This section of coping and retaining wall along a staircase on the Perpendicular Trail (#119) is held in place with iron pins that are expertly hidden among the stone. It is typical of the type of ironwork used by the CCC on this trail.

On the Perpendicular Trail (#119), 160 feet of walled tread and switchback is secured with pins. Most of these are ½ inch diameter, and only 2 to 3 inches tall. They are barely discernible, with no detrimental effect on the overall view of the intricate stonework (Fig. 8-34). There are also pins throughout the Valley Cove section of Flying Mountain Trail (#105). One section, though, reveals a most remarkable use of iron in the form of a pinned rock walkway. This tread runs 60 feet across open ledge. Two dozen steps are secured in place with eighteen pins, with evidence of five to seven other pins rusted away. Perhaps these pins were not as visible when first installed. Possibly, vegetation in the area concealed these pins. With subsequent vegetation loss over the years, they are now highly visible (Fig. 8-35). In contrast to the extensive use of iron on some CCC trails, the highly crafted Valley Trail (#116) contains extensive walls and stonework steps with no ironwork.

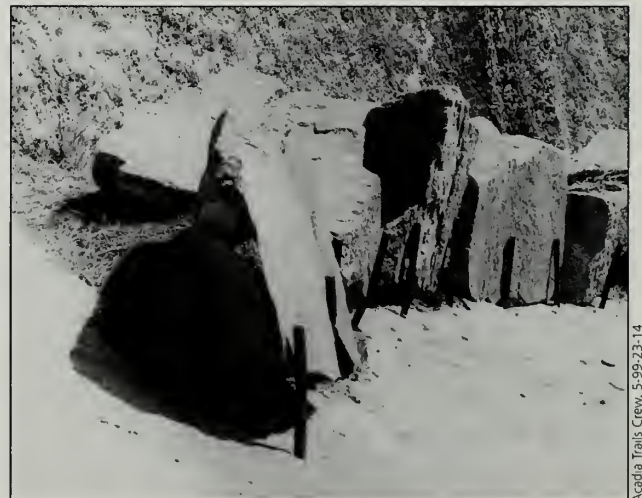
Fig. 8-35 Increased pin visibility resulting from vegetation loss on the Flying Mountain Trail (#105).

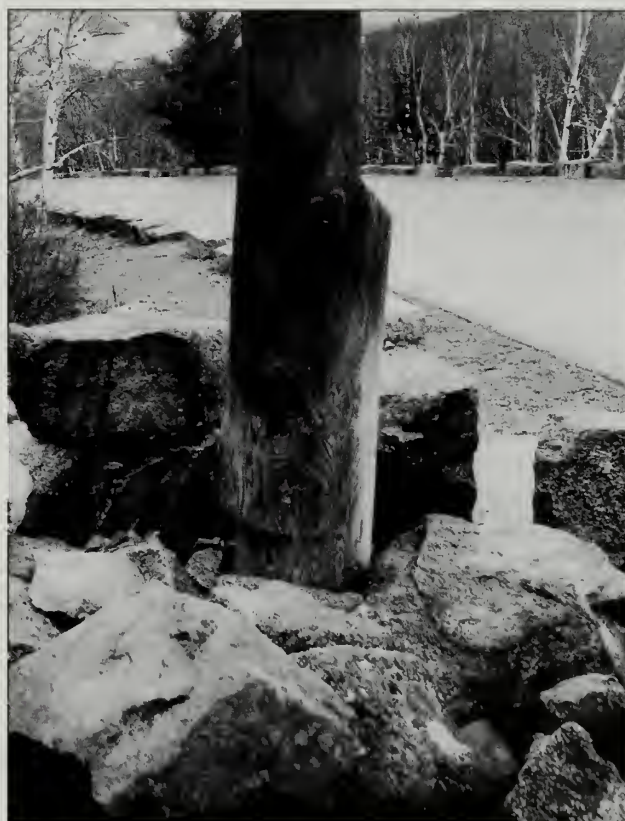
Fig. 8-37 Pinning technique used to deter sign vandalism on signpost at the Bear Brook Trail trailhead (#10).

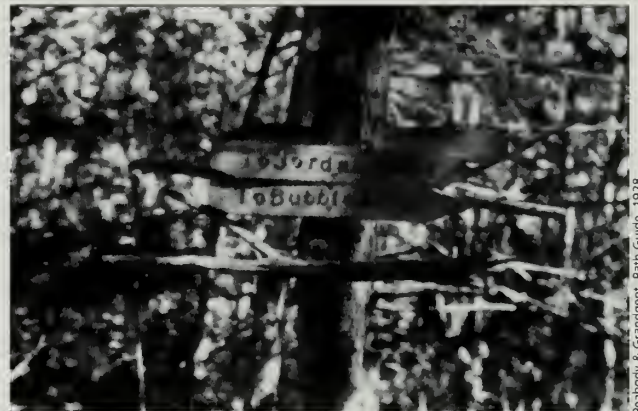
Fig. 9-3 These wooden signs and pointers were early forms of trail guidance recommended by Waldron Bates.

Arrows were straight branches, with tapered ends, nailed to trees to indicate trail direction (Figs. 9-2 & 9-3). Specifications for pointers were described in 1906 by Waldron Bates, BHVIA path committee chairman from 1900 to 1909:

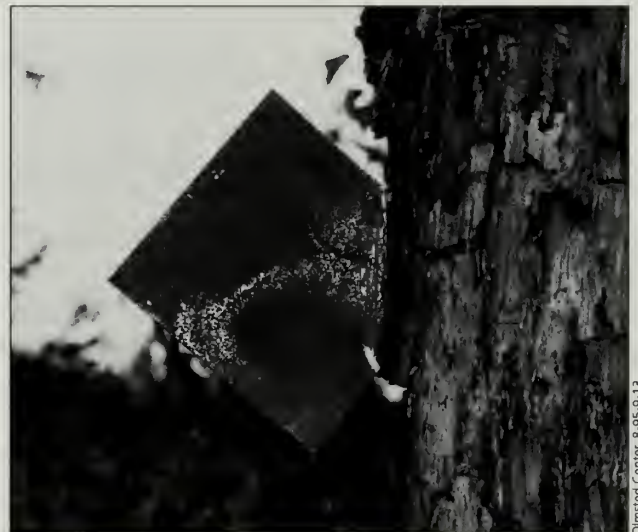
Fig. 9-4 VIA/VIS metal marker, approximately 4 inches square, painted red, on the Green and Black Path (#358), origin unknown.

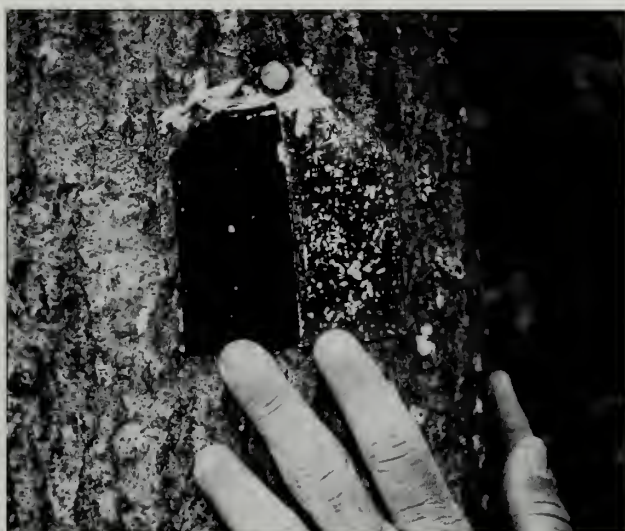
Fig. 9-5 VIA/VIS metal marker, approximately 4 inches square, painted half green and half black, on the Green and Black Path (#358), origin unknown.

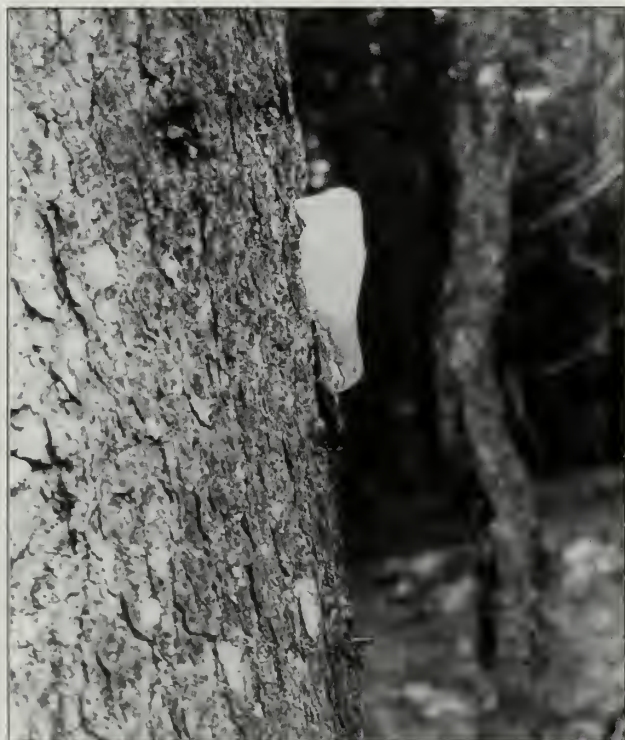
Fig. 9-6 Bird-shaped metal marker on the Ledge Trail (#103).

removed from the marked trails (except for a few overlooked examples). In the mid-1970s, however, some trails were marked with bird-shaped metal blazes, approximately 4 inches long (Fig. 9-6). These blazes were difficult and time consuming to cut, and their use was discontinued in 1977, though a few still remain in the trail system. Within the Acadia National Park land on Schoodic Peninsula, some bird-shaped blazes also remain on open trails.

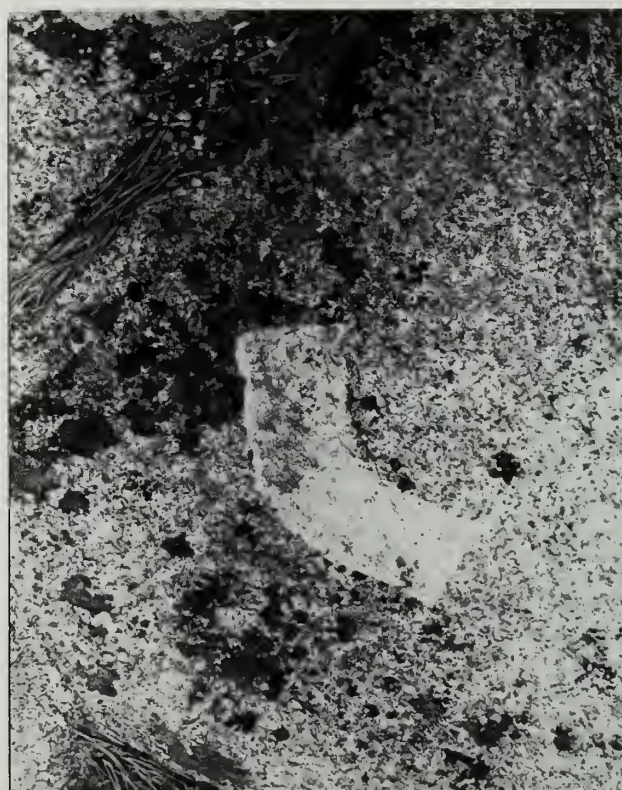
Fig. 9-7 This blue painted blaze on the Ledge Trail (#103) is curved to indicate a turn in the trail. Most trail blazes are rectangular.

The orange blazes, however, were considered too intrusive by some, so in the early 1990s an AMC study group recommended a change in blaze color. Acadia trails foreman Don Beal painted a stone with several test colors, and a committee chose sky blue as the blaze color that was most pleasing to the eye, the least intrusive, and was still easily spotted from a distance. Throughout the 1990s, the system of orange rectangular paint blazes was replaced with blue blazes (Fig. 9-7).

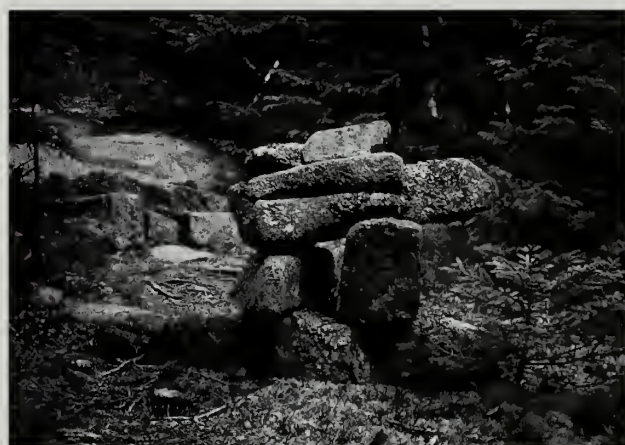
Fig. 9-9 Bates-style cairn at the summit of Eliot Mountain, on the Asticou Ridge Trail (#520).

**Bates-style cairns** are a historic Acadia style of cairn dating from Waldron Bates’s chairmanship of the Bar Harbor VIA. They are constructed of two base stones set apart with a lintel across them, creating an opening in the direction of the trail, and topped by a pointer stone (Figs. 9-13 & 9-23). Some Bates-style cairns consist of two or more tiers constructed in this manner (Fig. 9-9).

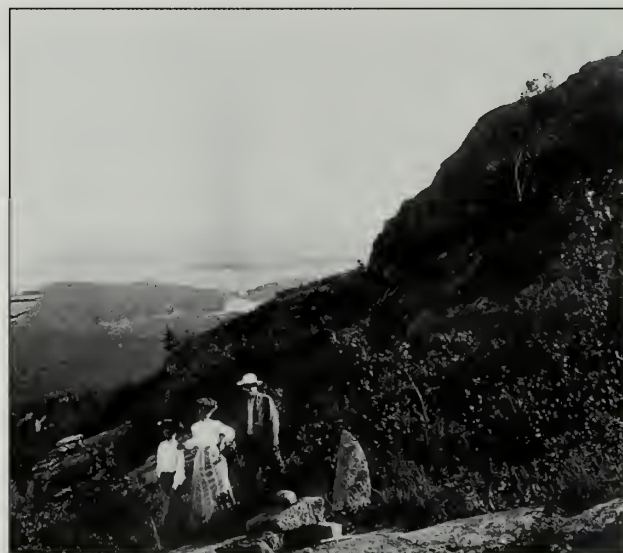
Fig. 9-11 This 1907 view, possibly located near Jordan Bluffs, shows two early cairn styles. The large upright stone may be the first style of cairn to mark recreational walking routes. In 1855, Charles Tracy described a “sat-up” boulder on the summit of Sargent. The smaller Bates-style cairn represents an early VIA/VIS style of cairn building.

The first description of a stone trail marker dates to 1855 when Charles Tracy noted a “sat up” boulder (an upright single stone) and pile of stones on the summit of Sargent Mountain (Figs. 9-11 & 9-12). Benjamin F. DeCosta’s 1871 guidebook indicates that the Bear Brook Trail (#10) (originally called the Path up Newport Mountain) was marked with piles of stones.

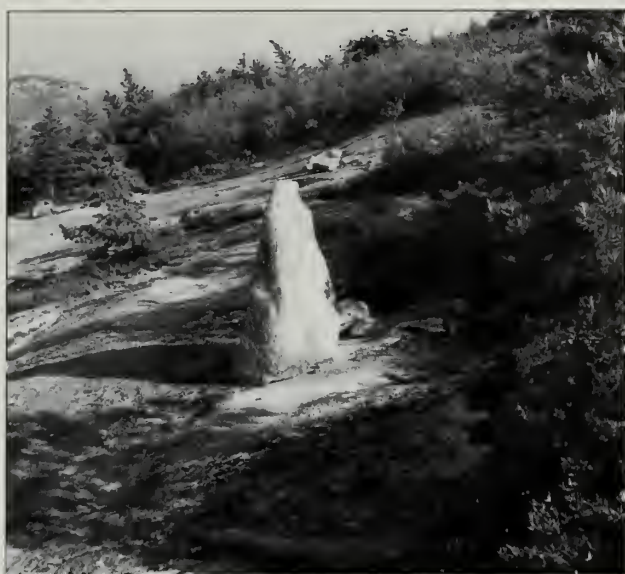
Olmsted Center, 5-98-9-17

Fig. 9-12 A "sat-up" or upright stone marking the trail across exposed ledge rock on the Dorr Mountain East Face Trail (Emery Path/Schiff Path, #15).

**Upright single stones** are large individual stones or boulders standing on end and acting as cairns (Fig. 9-12). They were used historically at Acadia.

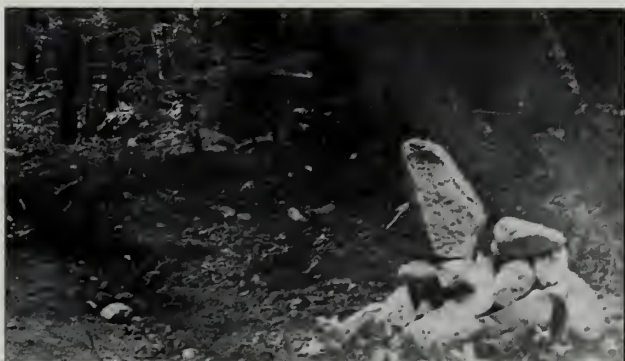
Maine Historic Preservation Commission, Dana Family Collection

Fig. 9-14 Stone cairn with large upright stone on the Seaside Path, circa 1910.

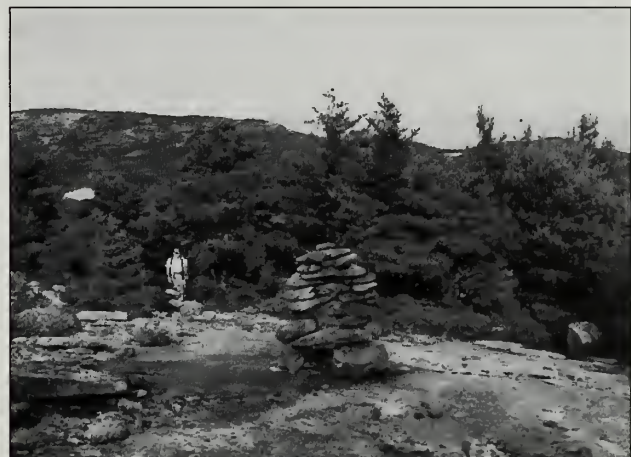
Olmsted Center, 8-95-6-204

Fig. 9-16 Large cairn on the Potholes Path (#342) photographed in 1995.

Cairns were used extensively on some ledge trails; however, construction varied. Many cairns constructed under Bates are still extant. On the mountain summits, piles of stones, first described in 1855, have continued to grow to large mounds (Figs. 9-15 to 9-22).

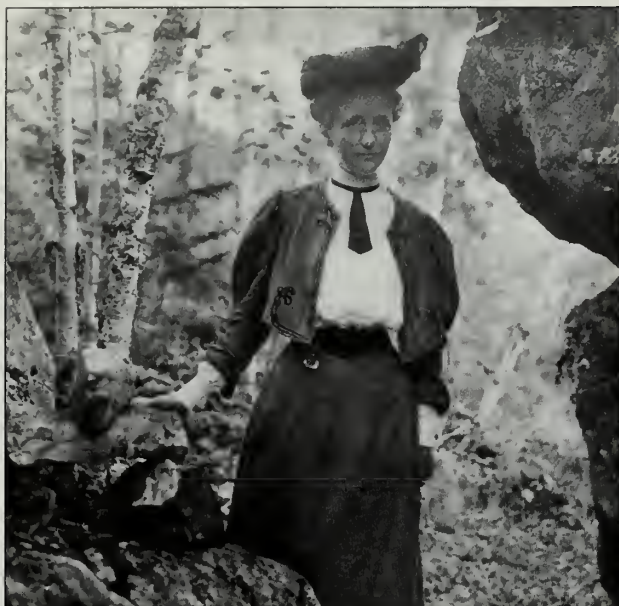
Maime Historic Preservation Commission, Dana Family Collection, 97-10-12

Fig. 9-17 A 1906 photo of a small Bates-style cairn, exact location unknown, but most likely near Seal Harbor.

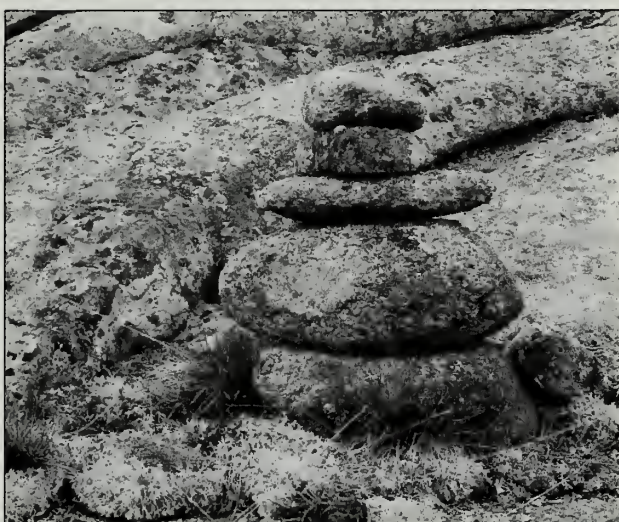
Charlie Jacob, Acadia NP 5-99-60-7

Fig. 9-18 VIA/VIS stacked cairn on the Van Santvoord Trail (#450).

**Stacked cairns** are a historic Acadia style of cairn consisting of stacked stones of diminishing size, from largest on bottom to smallest on top (Figs. 9-10 & 9-18).

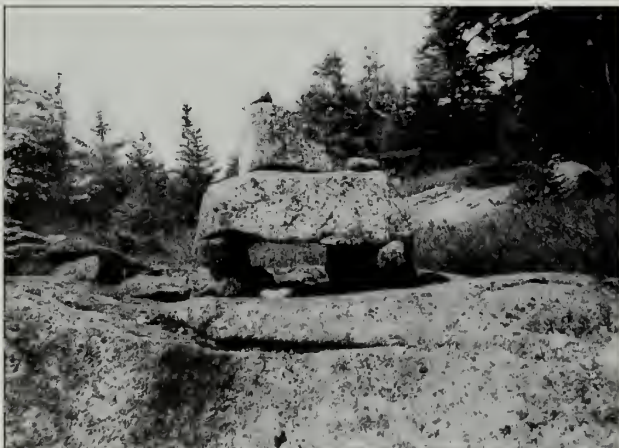
Acadia Trails Crew, 5-99-39-23

Fig. 9-19 This Bates-style cairn on the Sargent Mountain South Ridge Trail (#52) in 1999 may have survived in this open location because of its extra large lintel stone.

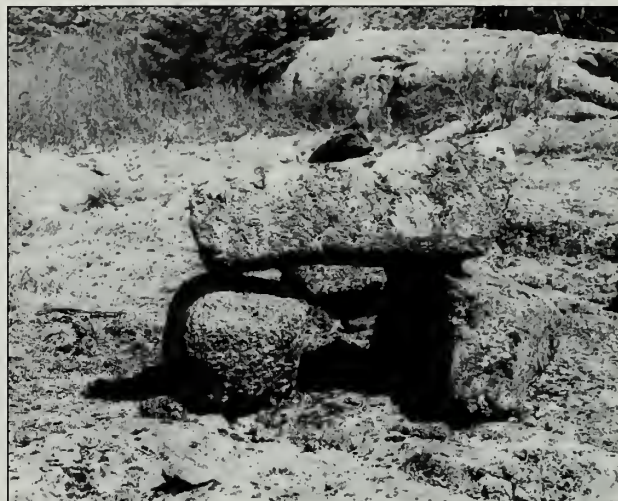
Charlie Jacob, Acadia NP 5-99-60-5

Fig. 9-20 Bates-style cairn on the Van Santvoord Trail (#450).

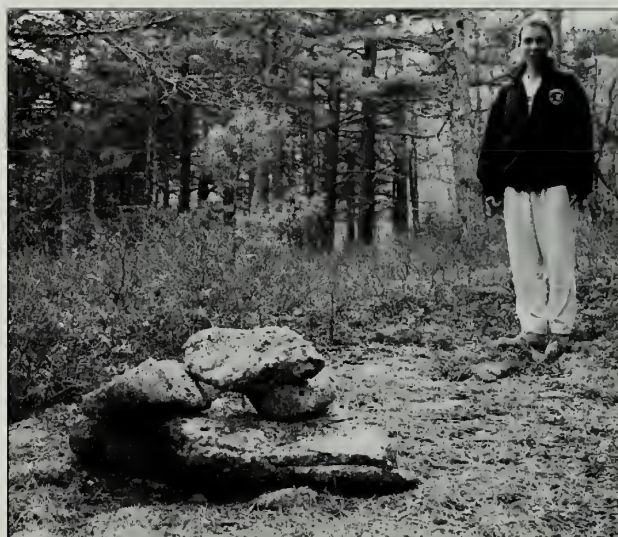
Olmsted Center, 4-98-1-4

Fig. 9-21 Bates-style cairn on the Potholes to Eagles Crag Trail (#343).

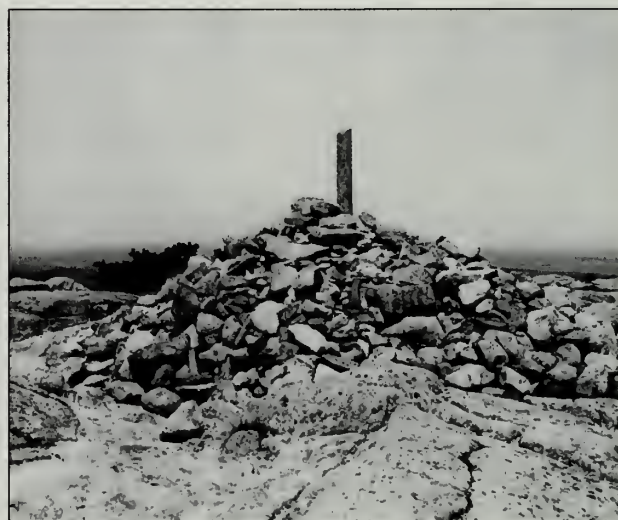
Acadia Trails Crew, 5-99-43-17

Fig. 9-22 A large pile of stones marking the summit of Dorr Mountain.

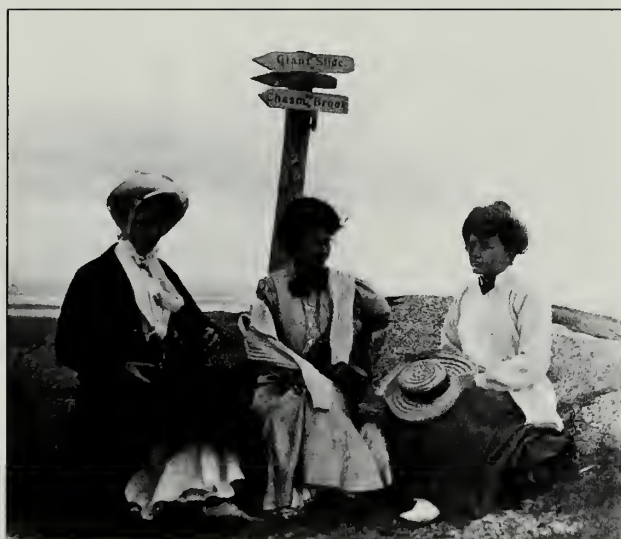
Maine Historic Preservation Commission, Dana Family Collection, 95-10-28

Fig. 9-25 On this signpost at the summit of Sargent Mountain, the sign in the center is the oldest of the three and directs walkers to "Somes Sound." The upper and lower signs were likely installed under the direction of Waldron Bates, who recommended "burned-in" lettering. Both the Giant Slide Trail and Chasm Brook Trail were laid out by Bates in 1903, thus the signs were relatively new in this 1907 photograph. Note the point on one end and the slight taper on the "cut-off" end.

Beginning in 1890 the Bar Harbor VIA marked trails with signs, arrows, pointers, cairns, maps, and regulatory signs. The group marked “paths and trails...at their entrances and crossings by signs suitably inscribed.”<sup>43</sup> Specifications were described in 1906 by Waldron Bates (Figs. 9-25 to 9-27, also Fig. 9-3):

Fig. 9-58 These signs on the summit of Sargent Mountain, shown in 1907, marked trails by the natural features found on the route, like the Giant Slide, Chasm Brook, and Somes Sound (enlargement of Fig. 9-25).

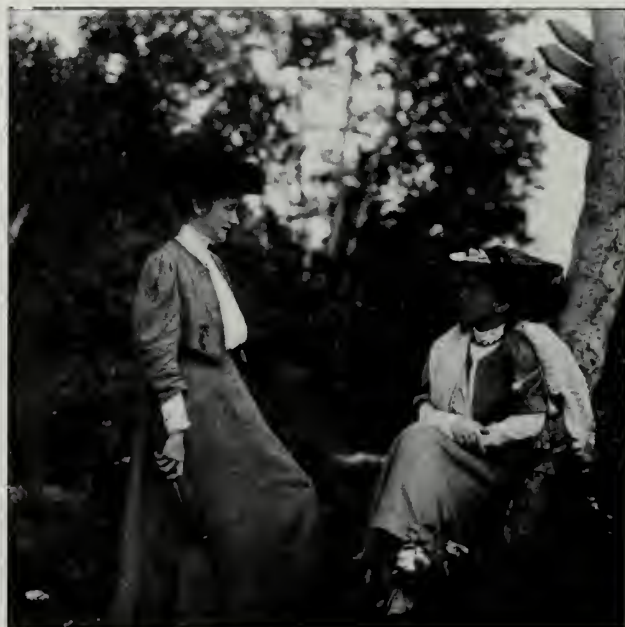
Maine Historic Preservation Commission, Dana Family Collection, 95-10-14

Fig. 9-27 This 1906 image shows several early VIA/VIS signs near Seal Harbor. The individual signs were mounted on a tree at a height of approximately 6 feet.

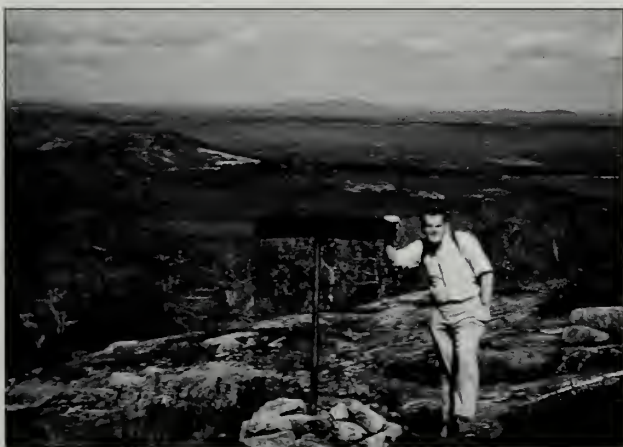
David Goodrich

Fig. 9-28 This steel post with signs, shown here in 1965, was located on the Sargent Mountain North Ridge Trail (#53) and dated to the VIA/VIS period. The signs read: Aunt Bettys Pond, Chasm Brook, Sargent Mt., and Giant Slide. They were removed circa 1970, but the spot where the angle iron support was cemented into the rock is still visible.

- The use of standardized signs—wooden varnished signs with letters cut in and painted red, referred to as “Bates” signs—at most locations (excepting summits).
- The placement of steel signs on summit and ridge trails to eliminate the need for their annual replacement (Fig. 9-28).
- A numbering system for trails to be marked on trail signs, maps, and guides.

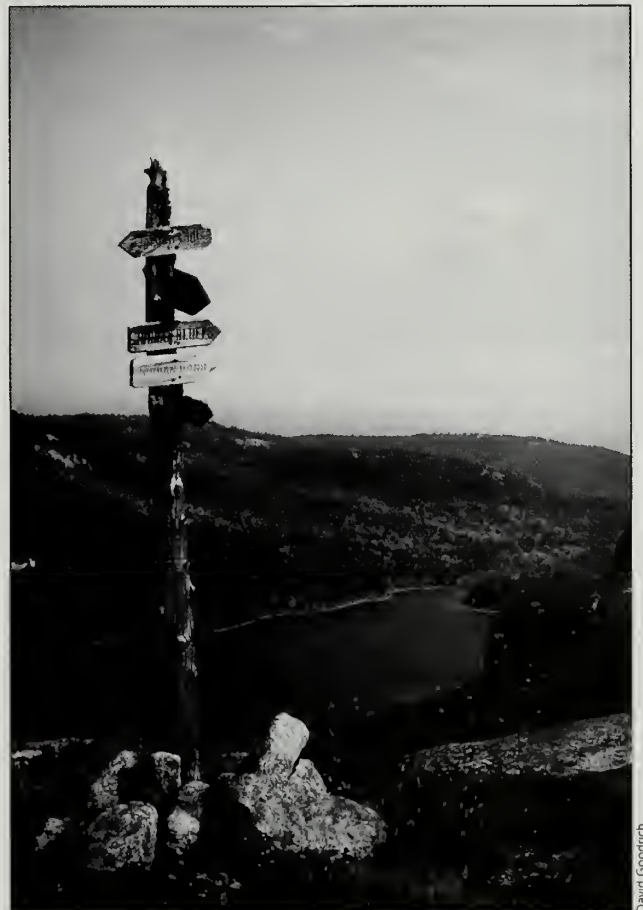
David Goodrich

Fig. 9-29 One of the last remaining early VIA/VIS signs pictured in 1961 with lower-case letters at the top of post. Later VIA/VIS signs with upper-case letters on lower post located on the Jordan Cliffs Trail (#48).

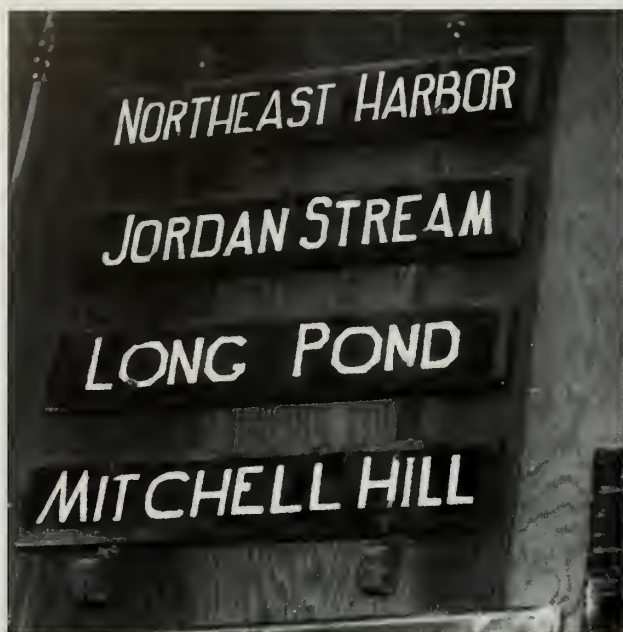
Fig. 9-30 CCC-style carriage road trail markers in the NPS sign shop.

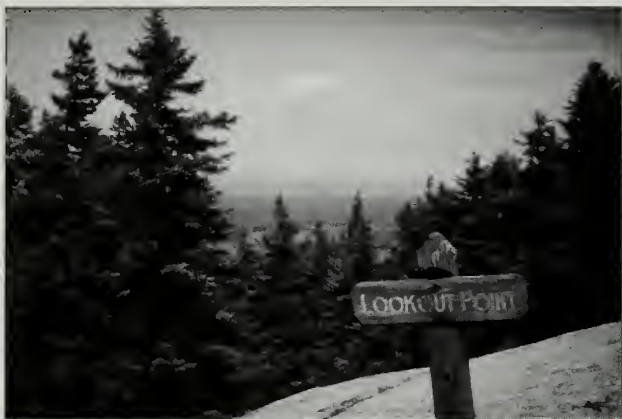
Fig. 9-31 A 1958 photo of a 1930s CCC trail sign at Lookout Point on the Mansell Mountain Trail (#115). The sign is nailed to a notched post that was stained brown and cut with a conical top. The sign had tapered ends and was also stained brown with chiseled letters painted yellow.
