# ACADIA TRAILS TREATMENT PLAN

## CULTURAL LANDSCAPE REPORT FOR THE HISTORIC HIKING TRAIL SYSTEM OF ACADIA NATIONAL PARK

Olmsted Center for Landscape Preservation  
National Park Service, Boston, Massachusetts, 2006

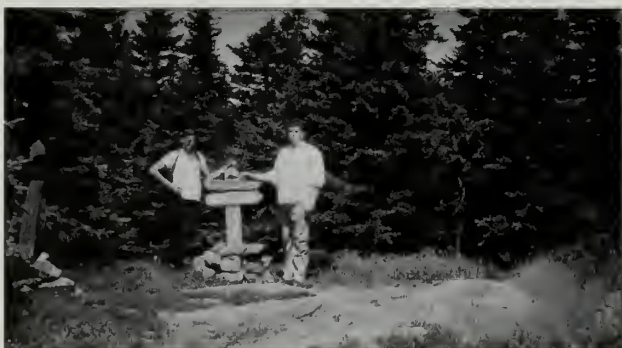
Fig. 9-32 Two different styles of CCC signs are shown in this 1958 photograph. The sign on the left was stained brown with yellow painted letters. The sign in the center was left natural, weathered wood with painted letters. Although different colors, these signs all contained one pointed and one beveled end, and were mounted on round posts with conical tops, though blunter than those in the Bar Harbor district.

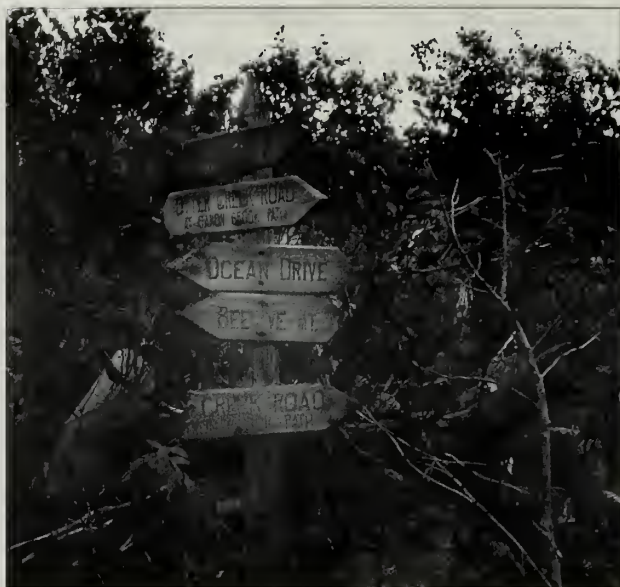
Fig. 9-33 This CCC sign, photographed in 1964, was one of the last remaining CCC signs. It was located at the intersection of the Green and White Path (#327) with the Black Path (Gorham Mountain Trail, #4) on Champlain Mountain near the outlet of The Bowl. The signs read from top to bottom: Black Path to Champlain Mountain; Otter Creek Road at Canon Brook Path (pointing to the Green and Black Path, #358, which forked off a little up the ridge); Ocean Drive; Beehive Mt.; Otter Creek Road at Canon Brook Path (may have been reattached and not an original sign on this post). CCC-type signs such as this were used in the Bar Harbor district, and were slightly different than signs on the west side of the island. Bar Harbor district posts were taller, had pointed tops, and could accommodate more signs. The use of a second line in smaller letters only occurred in the Bar Harbor area. This type of sign became extremely rare, as most burned during the 1947 fire. Note the very pointed conical post top.

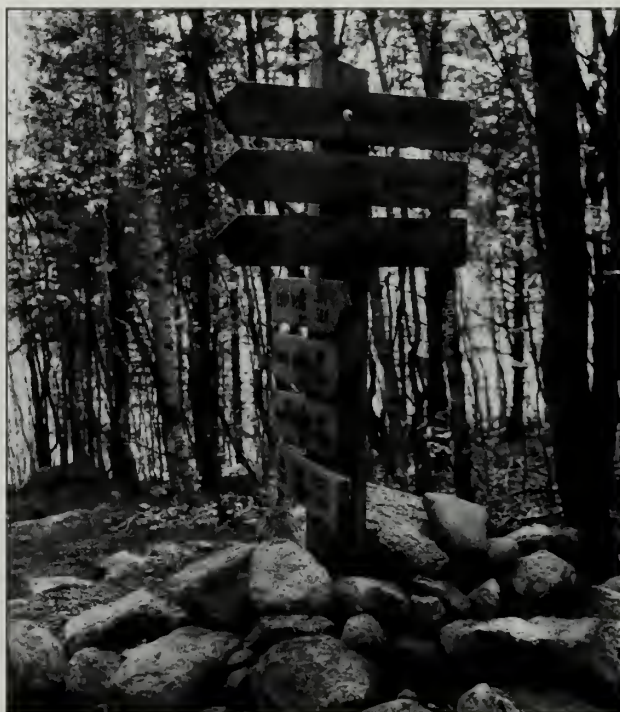
Fig. 9-34 NPS signpost on the South Bubble Trail (#43), in the saddle between the North and South Bubble Trails.

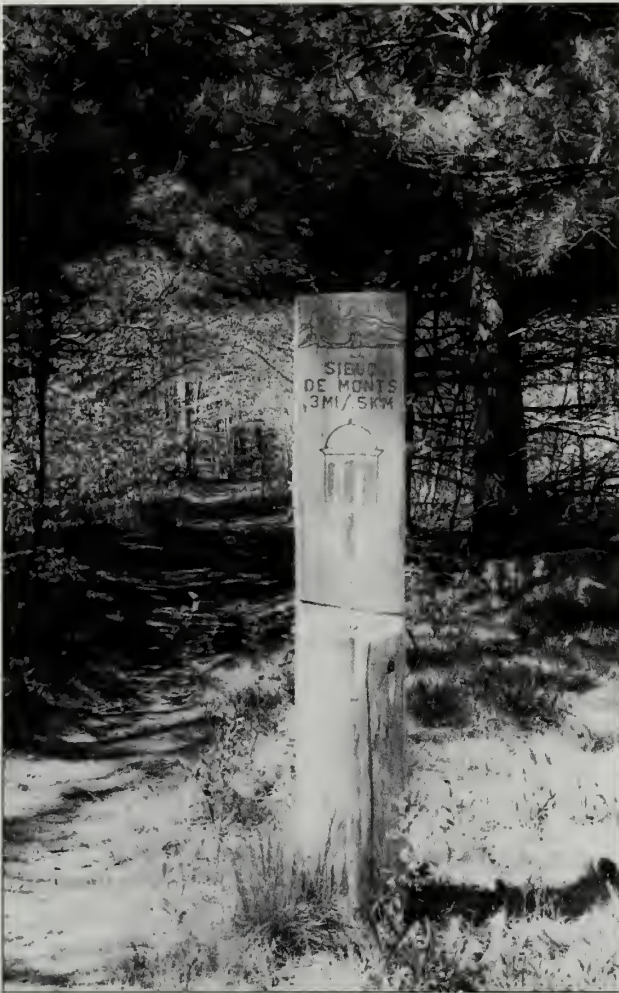
Olmsted Center, 99-43-23

Fig. 9-35 Trailhead sign on the Kane Path/Tarn Trail (#17) marking the way to Sieur de Monts Spring.

this flat face includes trail and destination names and directional arrows (Fig. 9-35, also 9-42 & 9-43). Gary Stellpflug developed this style of signage for Acadia in 1980.

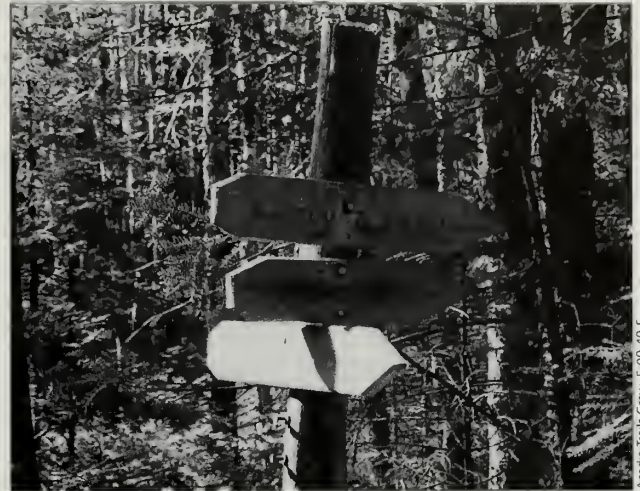
Acadia Trails Crew, 5-99-49-5

Fig. 9-37 Within the park, near Northeast Harbor, are signs made by the current Northeast Harbor VIS that retain the VIA/VIS style (pointed on one end, tapered on the other, chiseled letters) but are slightly more crafted (edges are slightly beveled, thus not "cut off" in the field. These signs are on the Norumbega Lower Hadlock to Goat Trail (#69).

Throughout the years, some characteristics of VIA/VIS signage have persisted. As of 2002, VIA/VIS-style signs are used by the Seal Harbor VIS (tapered ends, painted letters), Northeast Harbor VIS (tapered ends, chiseled letters, similar dimensions, and in some locations red-painted letters), and a phantom signmaker in the Bar Harbor VIA district (tapered ends) (Figs. 9-36 to 9-39).

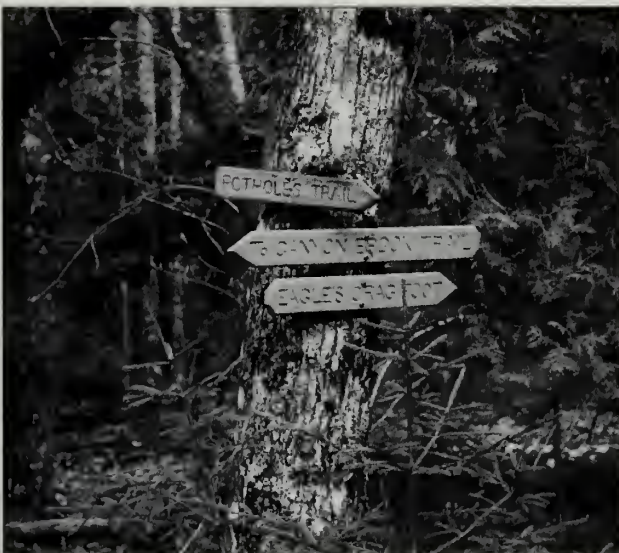
Olmsted Center, 4-98-1-2

Fig. 9-36 Within the former Bar Harbor VIA district are contemporary signs of unknown origin (i.e., by a phantom), located within the park on unmarked trails. These signs mimic the VIA/VIS style (pointed on one end, tapered on the other) but with alterations (beveled edge, routed rather than chiseled letters.) The center sign "To CANYON BROOK TRAIL" was installed in about 1997.

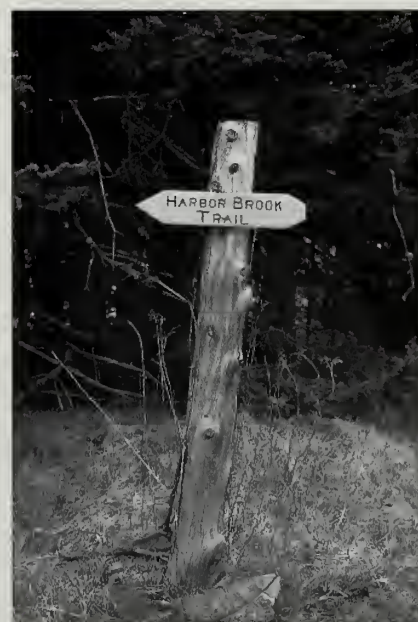
Olmsted Center, 4-99-5

Fig. 9-39 Signpost on the Little Harbor Brook Trail (#55) at the Route 3 trailhead. The sign is stained gray with red painted letters, in the Northeast Harbor VIS style.

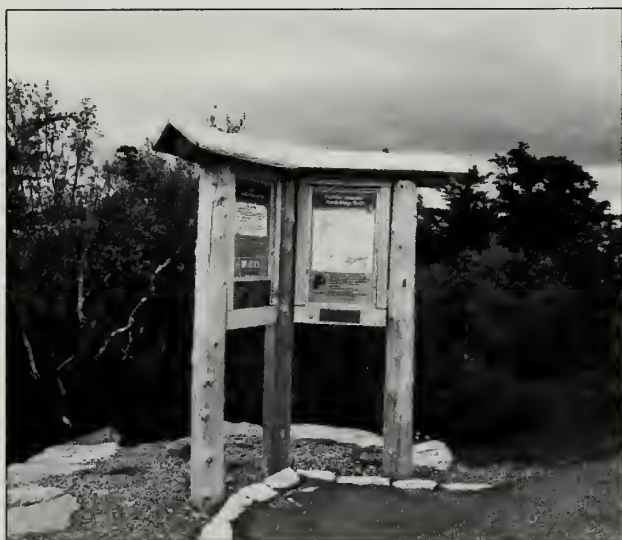
Olmsted Center, 5-98-3-19

Fig. 9-44 A trailhead exhibit at the Cadillac Mountain North Ridge Trail (#34) located on the summit of Cadillac Mountain.

**Trailhead exhibits** are located near popular trails. Each consists of two embedded fiberglass panels that provide the trail name, a map, "Leave No Trace" and/or other resource protection messages, and safety information. An example of a trailhead exhibit is located at the summit of Cadillac Mountain (Fig. 9-44).

The most recent sign was a new design for trailhead exhibits developed in the late 1990s. Composed of three cedar posts, a small roof, and two display panels, the kiosks display maps, trail mileage, rules, and safety considerations (see Fig. 9-44). The maps are generated through the park's Geographic Information System database. Information about the terrain is provided only for the ladder trails. Additionally, the self-guided trails at Jordan Pond and Ship Harbor are actively used by individuals and ranger-led tours. A self-guided nature area is also maintained within the Wild Gardens at Sieur de Monts Spring.

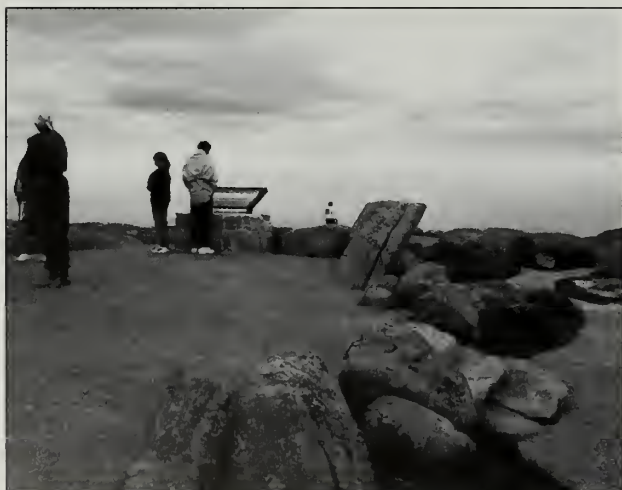
Olmsted Center, 5-98-3-18

Fig. 9-45 Interpretive signs on the Cadillac Summit Loop Trail (#33) discuss the surrounding viewsheds.

**Interpretive signs** are located at scenic overlooks, such as Cadillac Summit; at cultural features, such as Bass Harbor Head Light; at natural features, such as Thunder Hole; and at the several trailheads, such as the Ship Harbor Nature Trail (#127) or the Shore Path (#301) in Bar Harbor. Numbered posts along nature trails corresponding to self-guided trail brochures are also considered interpretive signs (Figs. 9-45 to 9-48).

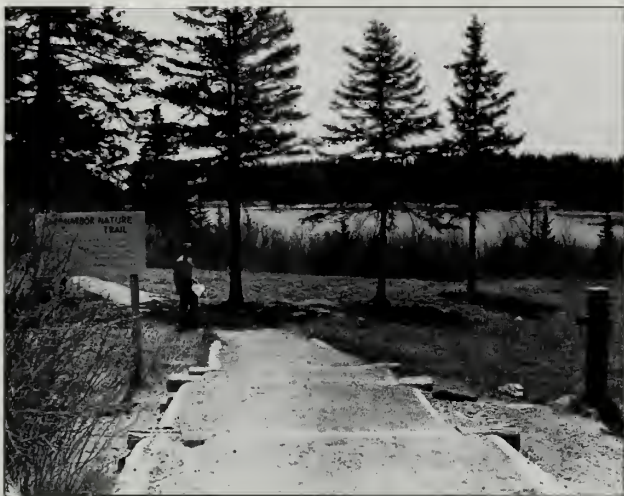
Fig. 9-47 An interpretive sign at the start of the Ship Harbor Nature Trail (#127).

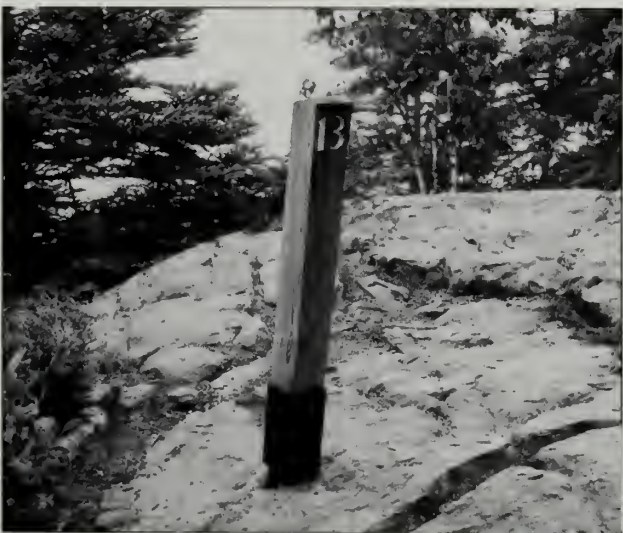
Fig. 9-48 Numbered markers such as this one on the Ship Harbor Nature Trail (#127) are often used with self-guiding trail brochures.

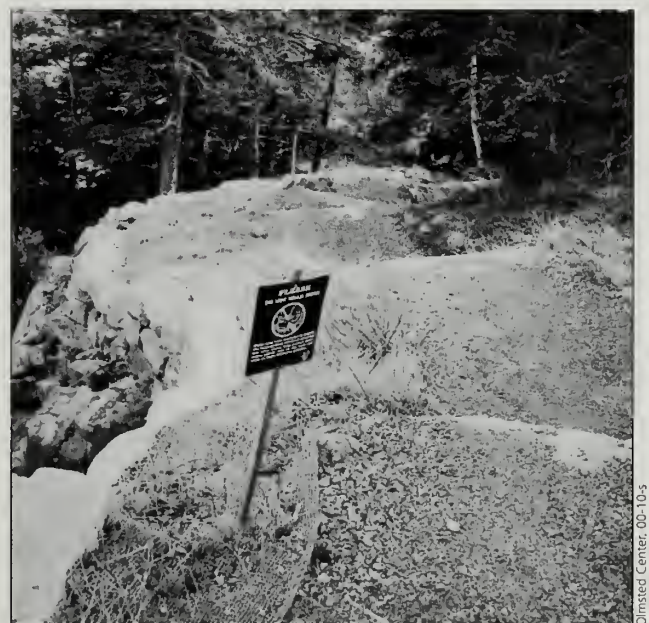
Fig. 9-49 This regulatory sign reminds hikers to stay off a newly vegetated area on the Ocean Path (#3).

**Rules and regulatory signs** with wording and/or symbols are also posted where necessary. Examples include signs explaining trail closures due to nesting peregrines or signs prohibiting certain practices, such as “No Camping” or “No Fires” (Figs. 9-49 & 9-50).

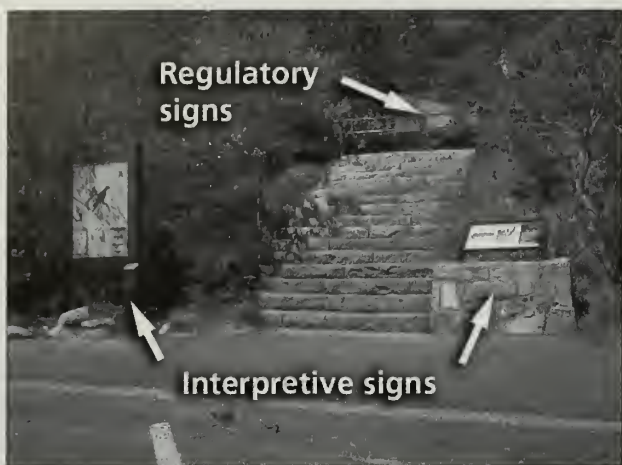
Olmsted Center, 5-98-5

Fig. 9-50 The trailhead to the Precipice Trail (#11) contains both interpretive signs and regulatory signs informing hikers of trail closure during peregrine falcon nesting season.

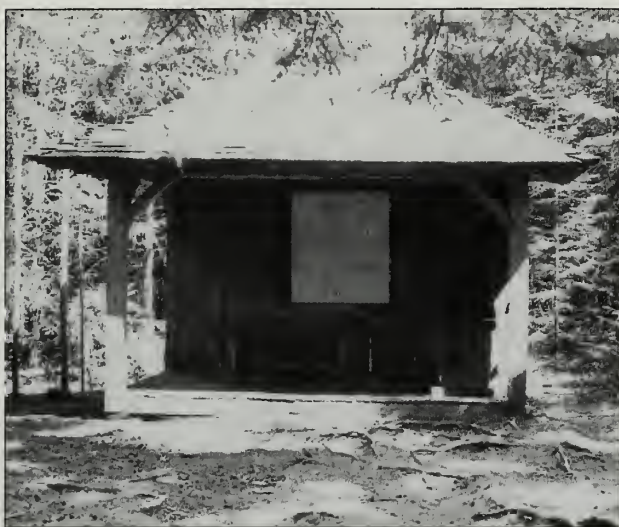
Acadia Trails Crew, 5-99-38-3

Fig. 9-51 Eliot Mountain map hut on the Asticou Trail (#49).

Finally, **map signs** are posted both as part of the trailhead exhibits and in the one map house, located on Eliot Mountain, near Northeast Harbor (Fig. 9-51). Historically, more map signs were posted in the park than are currently present.

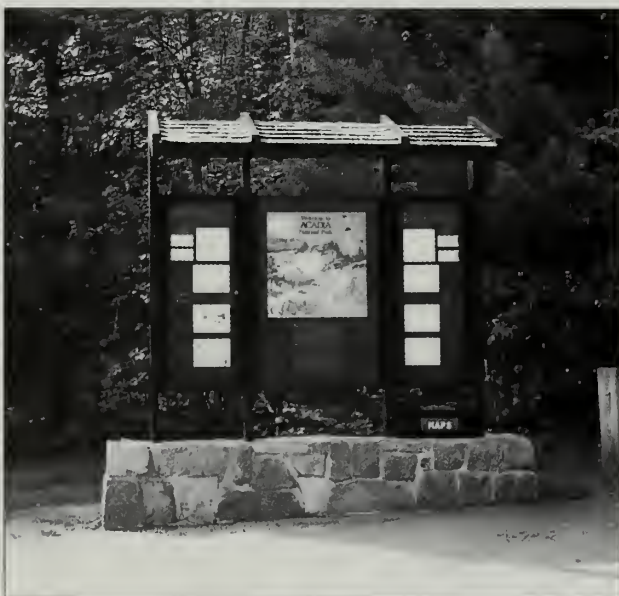
Olmsted Center, 5-98-5-17

Fig. 9-52 This interpretive sign was installed during the Mission 66 era at the Halls Cove Visitor Center.

brochure for the trail circa 1959, which corresponded with fourteen numbered posts along the trail route. The walk and brochure are still actively used. Mission 66 may have also built a similar trail near the Jordan Pond House (#45). Mission 66 crews also paved the trail to Anemone Cave (#369), and a photograph taken in 1961 shows an informational sign at the end of the trail. The park's visitor center at Hulls Cove was also constructed during this period. This new facility offered interpretive information, though it was detached from the trail system (Fig. 9-52).

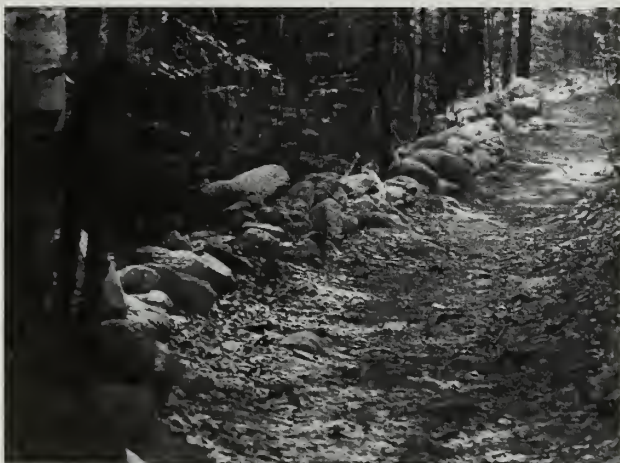
Mane Historic Preservation Commission, Dana Family Collection, 97-11-10

**Fig. 9-54** A 1907 photograph showing the early Seal Harbor VIS trail construction of the Seaside Path (#401). Stones and roots were removed from the treadway and stacked along the trail, acting as scree. However, this technique contributed to increased trail erosion, and widening of the path.

During the early period of VIA/VIS trail construction, stones and roots were removed from trails to create a smooth walking path. The result was often a path lined with stones acting as scree (Fig. 9-54). This technique was used on the most heavily traveled graveled paths, such as the Seaside Path (#401), a popular walk from

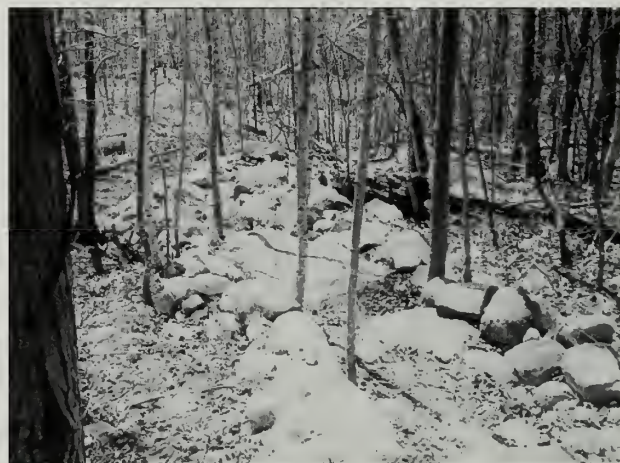
**Fig. 9-55** Scree installed on the South Bubble Trail (#43).

Despite its widespread use on other trail systems, Acadia trail crews have chosen to refrain from installing large amounts of rock scree because of its impact on trail aesthetics. This is especially true on summits, where scree-lined trails appear road-like and detract from the natural appearance of the surrounding environment. However, some rock scree has been used recently at Acadia, primarily on woodland trails (Fig. 9-55). Typically, this scree is out of keeping with historical scree used in the park. Recent scree has a haphazard quality, is usually higher (a foot or greater), and has been used on trails where historic builders would not have used scree, like woodland paths. Little rock scree has been placed on Acadia's summit trails. Log scree has been introduced on woodland paths to define the treadway.

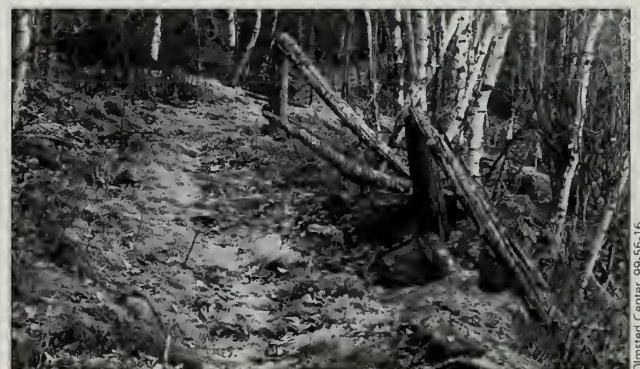
Fig. 9-56 Extant VIA/VIS railings on the abandoned Gurnee Path (#352).

Examples of VIA/VIS railings were present on the ledges of the Penobscot Mountain Trail (#47, formerly the Spring Trail, #621, from 1911), the connection from the Maple Spring Trail (#58) to the Hadlock Brook Trail (#57), the Northeast Harbor Skidoo Trail (#509) and Steep Trail (#508), and the Thuya Lodge trails (including #519). Examples of historic railings can still be found on the abandoned Gurnee Path (#352) (Fig. 9-56)

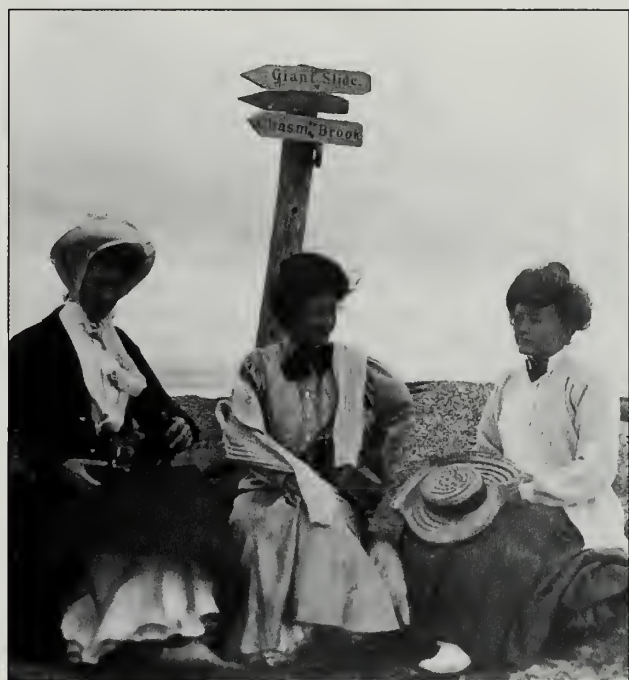
Fig. 9-58 These signs on the summit of Sargent Mountain, shown in 1907, marked trails by the natural features found on the route, like the Giant Slide, Chasm Brook, and Somes Sound (enlargement of Fig. 9-25).

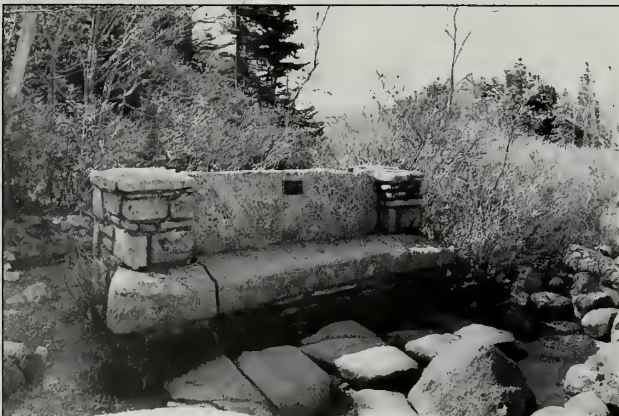
Fig. 10-28 This stone memorial bench located on the Jordan Pond Nature Trail (#45) is dedicated to Sarah Cushing.

Two existing stone benches may date to the VIA/VIS period. The first is a memorial bench located on the shore of Jordan Pond on the Jordan Pond Nature Trail (#45), approximately 50 feet south of the boat launching area (Fig. 10-28). While the commemorative plaque on the bench is typical of those placed by the VIA/VIS, no documentation has been found in the annual reports of the Bar Harbor VIA or Seal Harbor VIS to document the bench's construction. The second bench sits along the Penobsot Mountain Trail (#47) on the first bluffs west of and overlooking Jordan Pond. The location and orientation of this large rectangular block suggest it was more than likely arranged as a stone bench.

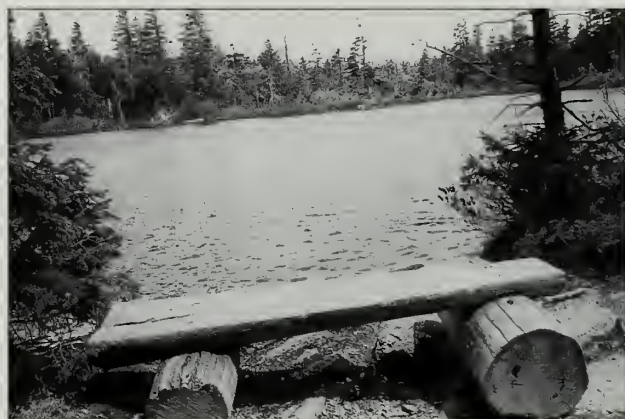
Fig. 10-34 This log bench, installed by the NPS in the 1990s at the water's edge on the Penobscot East Trail (#50), is similar in construction to CCC-style benches.

Although no CCC benches are extant in the park, a bench installed by the NPS in the 1990s is similar in style to CCC benches described in *Park and Recreation Structures*. It is located on the Penobscot East Trail (#50) at Sargent Mountain Pond (Figs. 10-33 & 10-34).

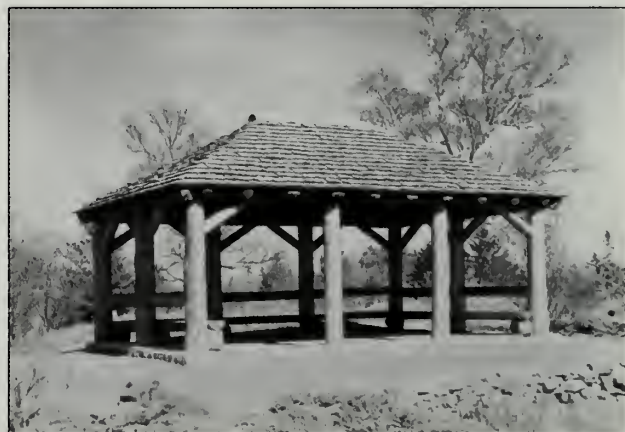
Fig. 10-35 The picnic shelter shown in this 1937 photograph was constructed by the CCC at the Oak Hill picnic area. A trail led visitors from the parking area the site overlooking the marsh. Only the foundation of the structure remains.

In the second volume of *Park and Recreation Structures*, Good describes the desired characteristics of trailside shelters and overlook structures as having “an ingratiating lack of pretentiousness.”<sup>57</sup> Of the CCC outlook shelters built on Mount Desert Island, only those at Pretty Marsh remain, though the viewshed and the associated trail are now overgrown. At Oak Hill, only the foundation of the shelter remains (Fig. 10-35). The

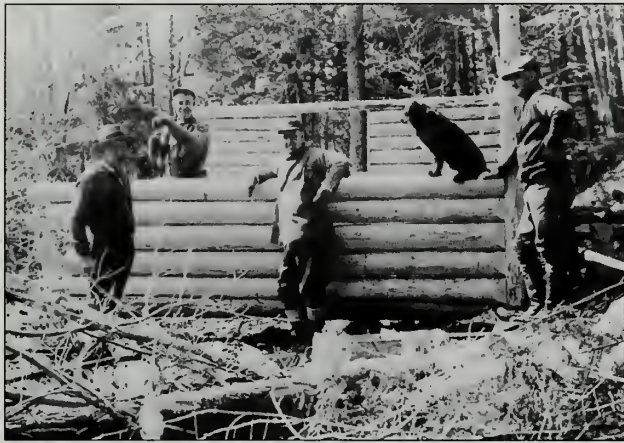
Fig. 10-36 Construction of a ranger cabin on McFarland Hill by the CCC in the 1930s.

CCC also constructed ranger cabins with trails on Bernard Mountain, McFarland Hill, and Youngs Mountain, but none of these structures are extant (Figs. 10-36 & 10-37). However, there are still a few rotted logs, boards, and shingles at the Bernard Mountain site.

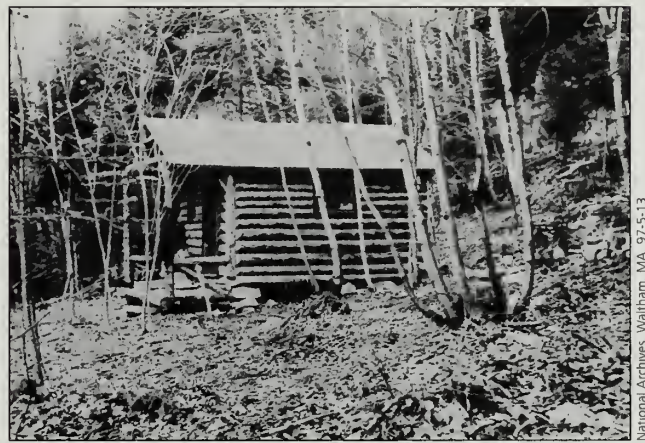
Fig. 10-37 A ranger cabin on Youngs Mountain shown in the 1930s after construction by the CCC.

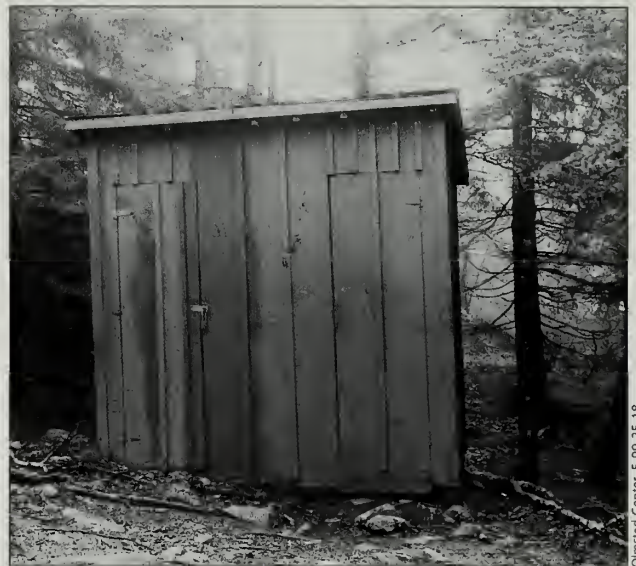
Fig. 10-42 Privy on the Beech Mountain Loop Trail (#113).

Examples of other associated structures added by the NPS include a privy on Beech Mountain Loop Trail (#113), and an observation platform and steps on the Bass Harbor Head Light Trail (#129). The construction of features like these provides both visitor comfort and safety. However, they generally do not complement the historic character of the trail system. These types of features have typically been generic in style and construction and are often not representative of the historical precedents at Acadia (Figs. 10-42 & 10-43).

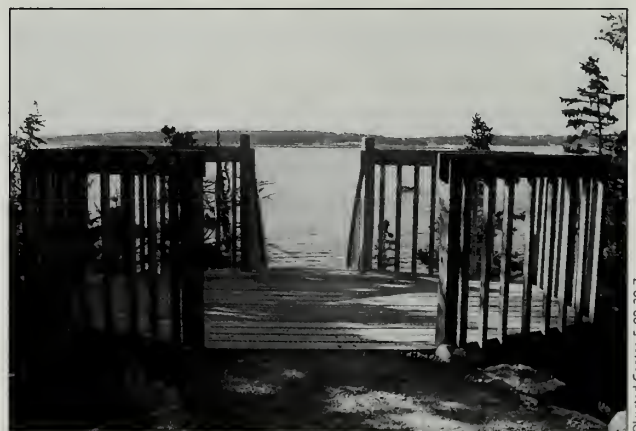
Fig. 10-43 Observation deck on the Bass Harbor Head Light Trail (#129) built in the 1990s.

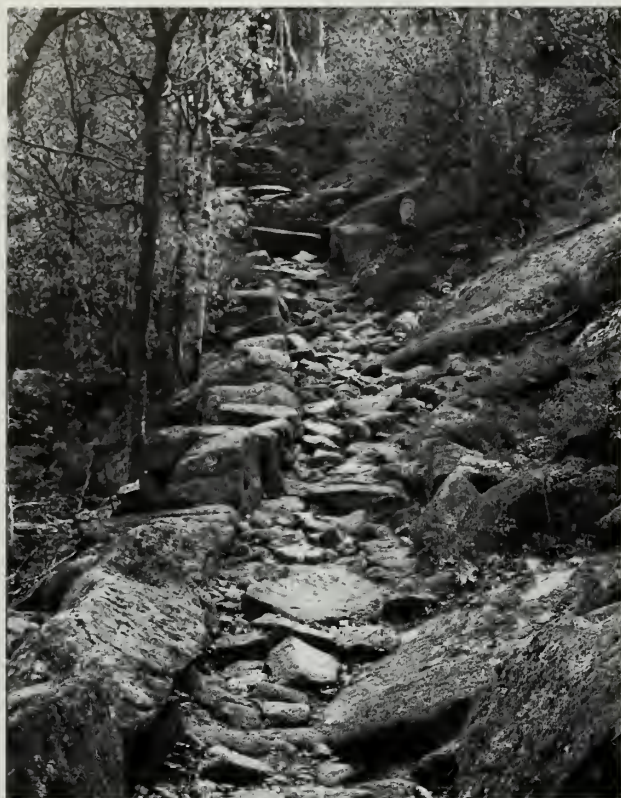
Fig. 15-5 Gravel surface has washed away, exposing rubble base.

- B. Causeway:** None.
- C. Gravel Tread:** Many sections of trail were once surfaced with soil and gravel over rock rubble. Most of this gravel has washed away (Figs. 15-5 & Fig. 15-6, compare with Fig. 15-1). Because this is a highly crafted memorial trail, imported crushed stone and gravel would diminish the historical character of the trail. Borrowing enough gravel and soil to resurface all sections may be difficult and not sustainable. Thus, rock rubble may continue to be the surface for many sections. These sections can be repaired with stone pavement similar in appearance to other sections of trail. In places where gravel surface remains, drainage should be repaired or maintained to prevent erosion of remaining material.

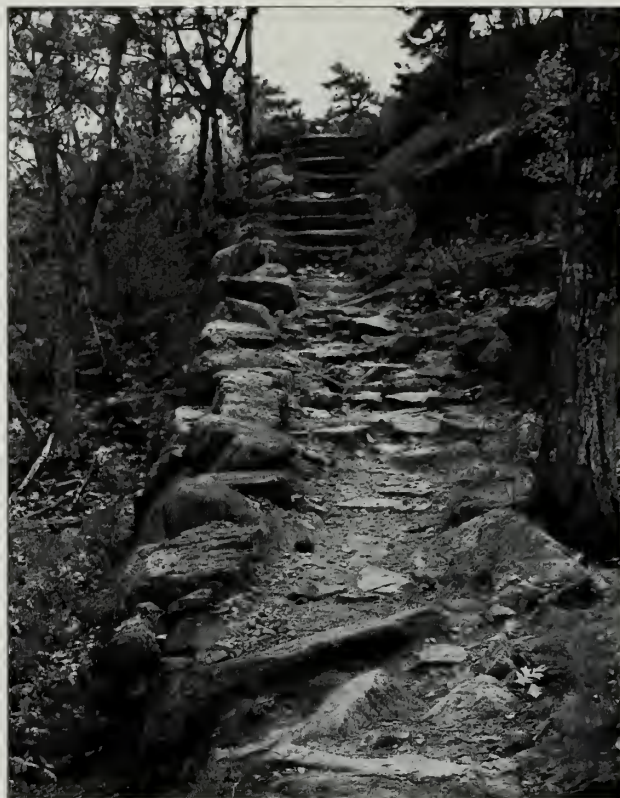
Fig. 15-6 The same view in 2001 as Fig. 5-1 in the 1920s, but with gravel surface washed away.

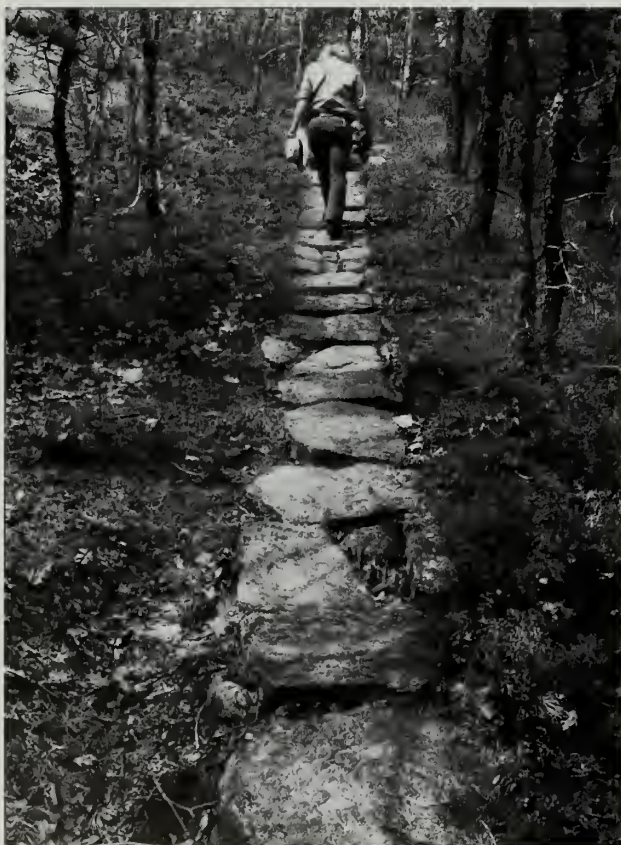
Fig. 15-7 Stone paved trail in good condition.

- D. Stone Pavement:** The trail contains long sections of stone pavement that provide durable and comfortable walking tread (Figs. 15-7 to 15-10). In some locations erosion and/or loss of stone pavement has occurred, possibly because of a broken or clogged culvert nearby. Culverts associated with stone pavement should be repaired and stepstones reset. Compatible new stone pavement may be added to highly eroded sections of trail.

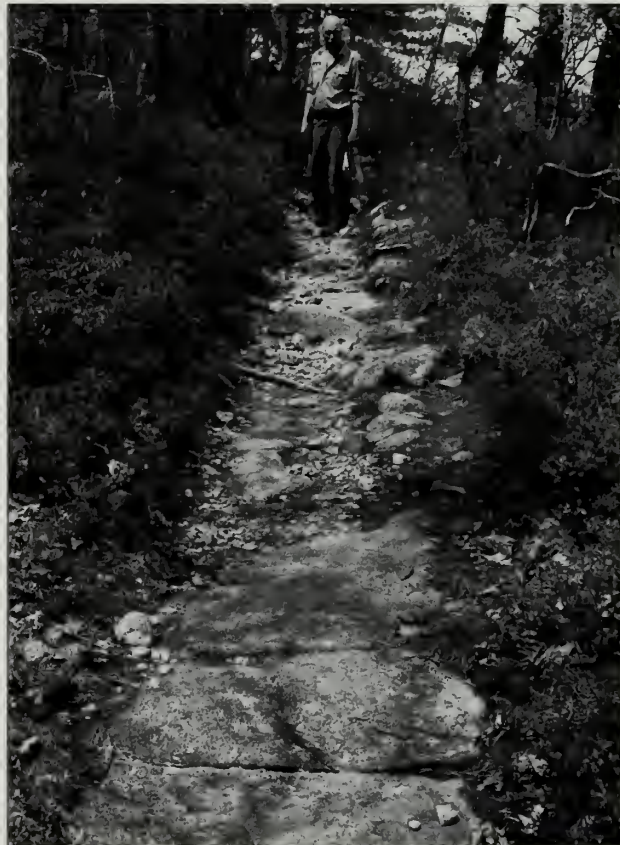
Fig. 15-8 Stone paved path with some erosion.

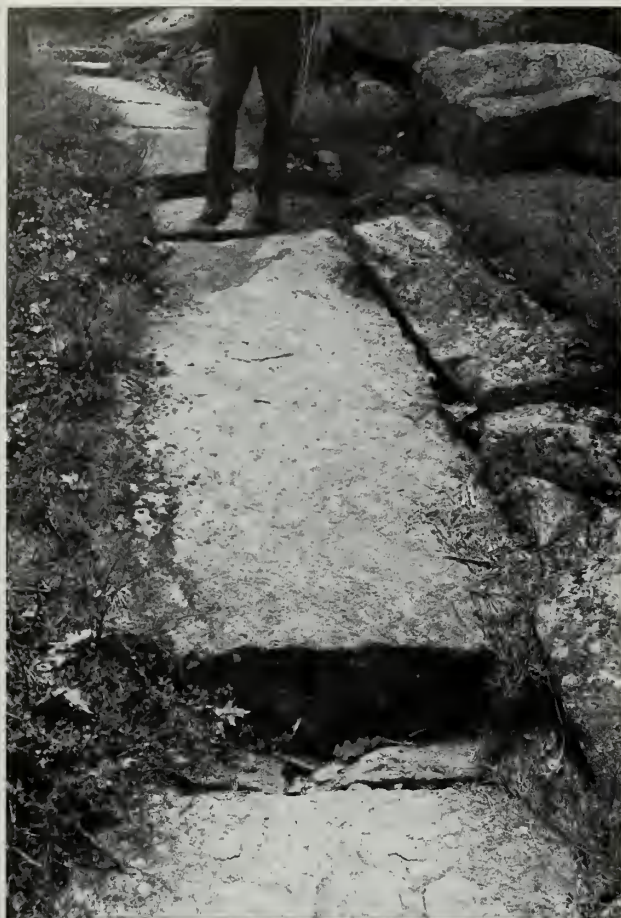
**Fig. 15-9** Stone paved trail with capstone culvert in good condition.

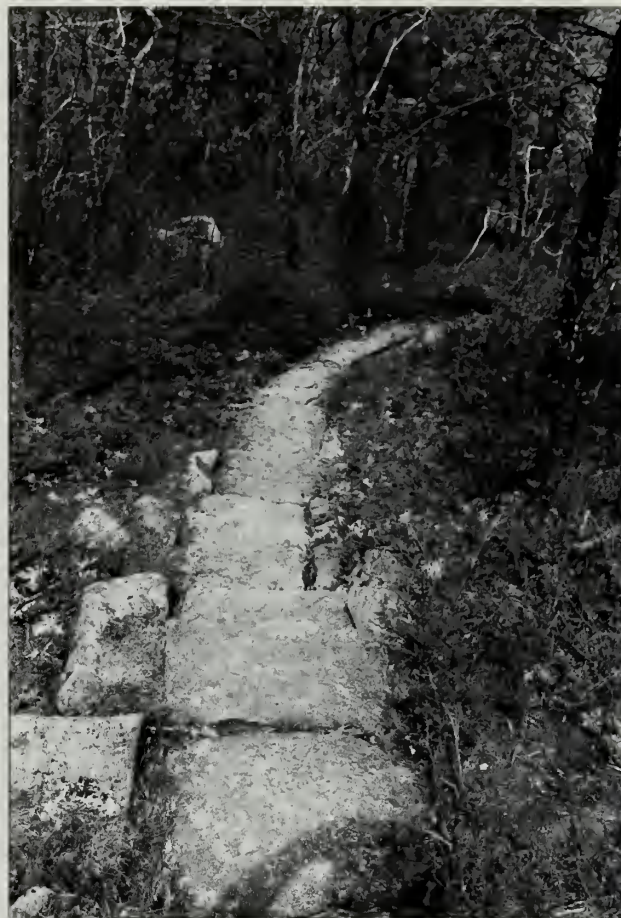
**Fig. 15-10** Stone paved trail and steps in good condition.

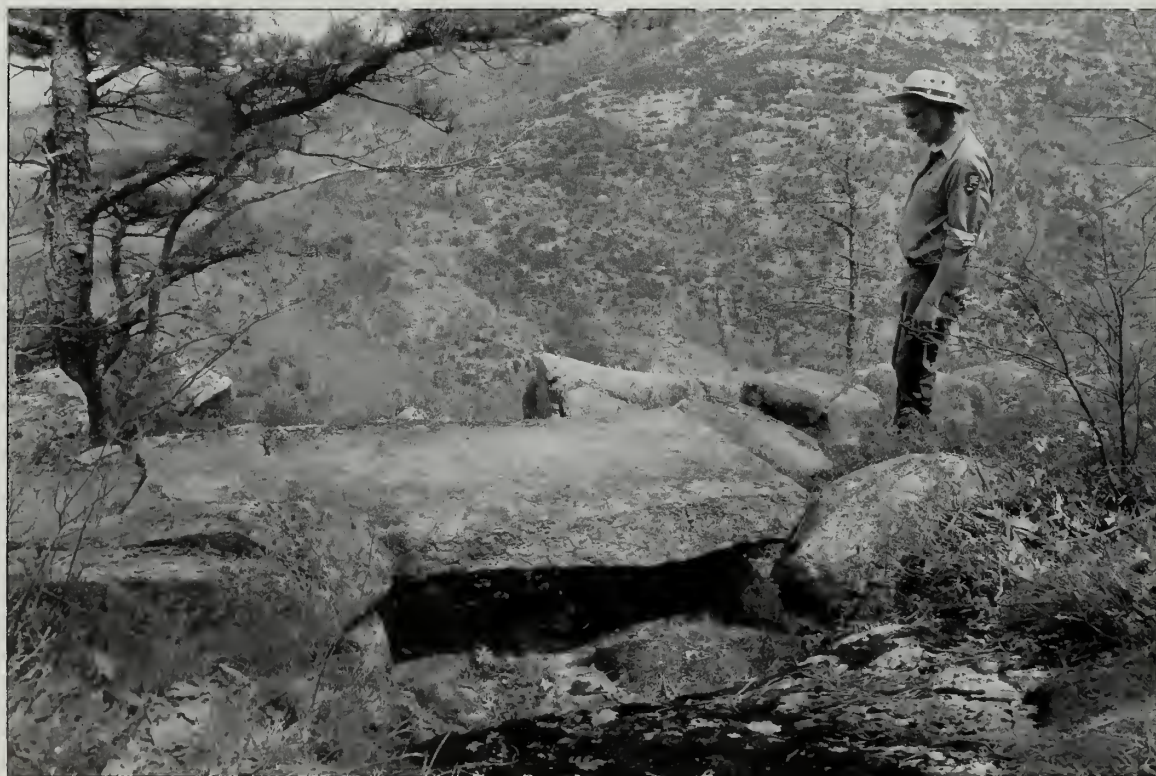
**Fig. 15-11** Massive capstone culvert.

- A. **Culverts:** The trail contains extensive culverts. These include capstone culverts and graveled-over culverts that have lost their gravel. Many culverts need to be rebuilt or cleaned out. Culverts should be rebuilt with the same stones if possible and in the style of historic closed culverts on the trail (Fig. 15-11).
- B. **Subsurface Drains:** None.
- C. **Side Drains:** There is some evidence of side drains. Extant side drains should be rehabilitated in conjunction with closed culverts, but installation of new side drains should be avoided.
- D. **Water Bars:** None. Bars should not be added.
- E. **Water Dips:** None. Dips may be added as needed.

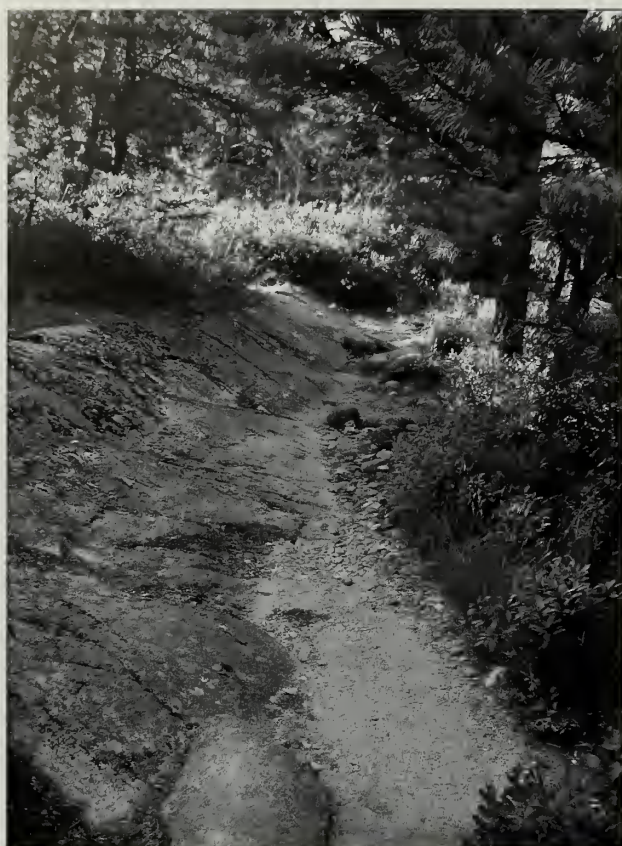
Fig. 15-12 Eroded upper trail.

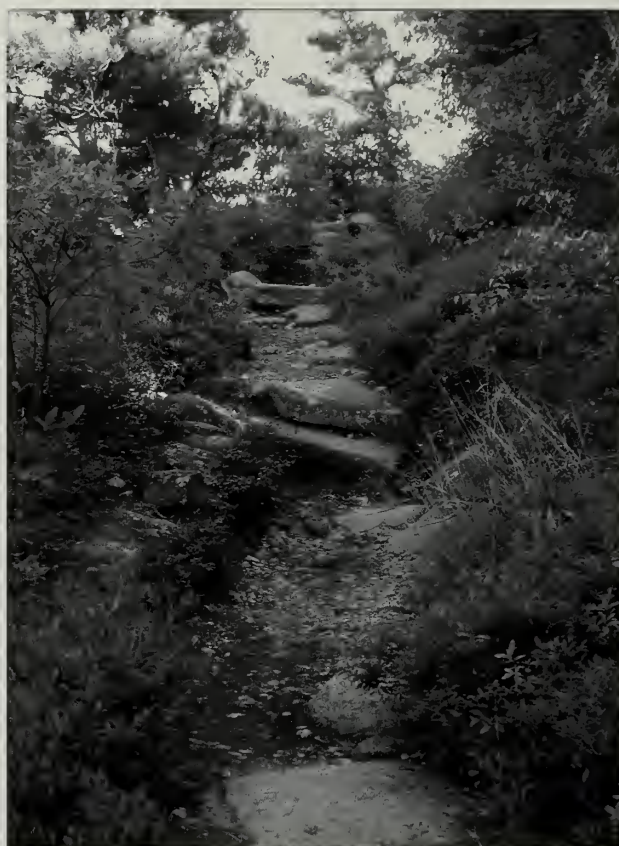
Fig. 15-13 Eroded section with collapsed steps that need to be rebuilt.

Like other memorial trails, the Schiff Path ascends the mountainside with staircases of stone. There are about 350 steps of various styles. Some are placed through boulder fields. Most are built in association with retaining walls and stone pavement (Fig. 15-18). And, most are slab laid and cut (Fig. 15-19). Some are set behind, but in some cases this may be a result of slipping. Some are placed with drill marks visible. Many sections alternate between stone steps and stone paving. One step is cut out of ledge (Fig. 15-20). In several places, extensive erosion is undermining the bottom step of a staircase, thus jeopardizing the structural stability of the entire run. All steps that have slipped should be reset and secured with extant coping stones. Sources of erosion should be corrected by the construction of closed culverts or other appropriate drainage solutions. Eroded sections (see Fig. 15-13) should be repaired using steps, stone pavement, or checks.

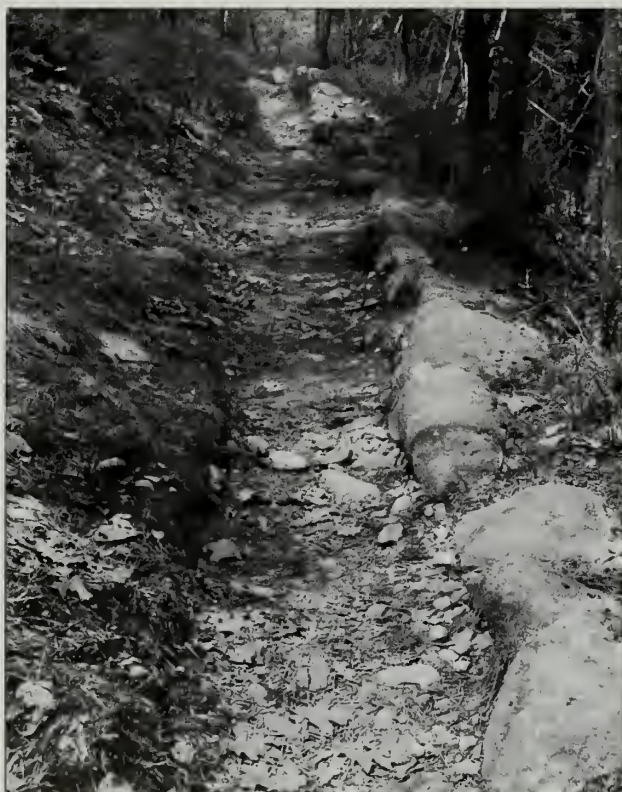
Fig. 15-14 Low coping wall holding water on tread.

Some coping stones have slipped and need to be reset (Figs. 15-14 & 15-15). Extant coping should be retained. Where coping is slipping along ledge, concealed pins may be added. Compatible new coping may be added as needed.

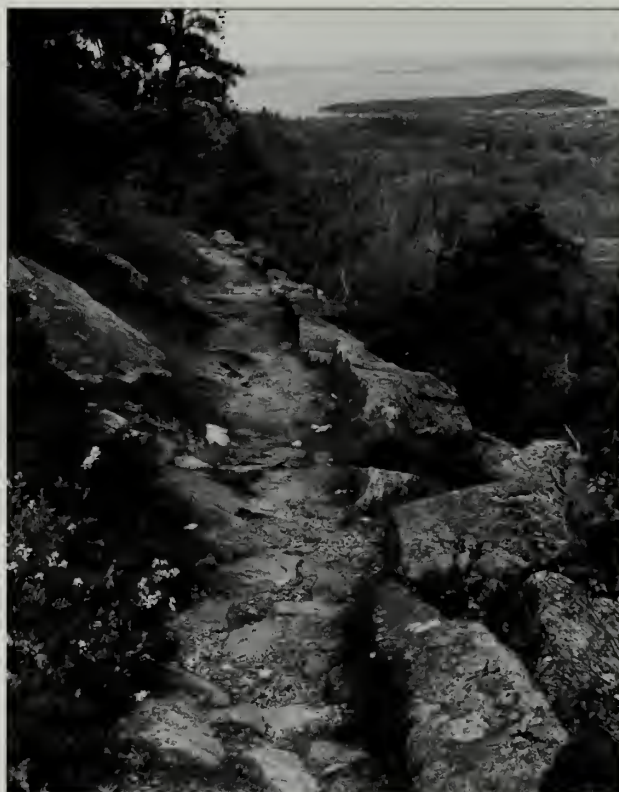
Fig. 15-15 Very large coping stones are used along this area of exposed ledge rock to retain the tread. Some of the stones have slipped.

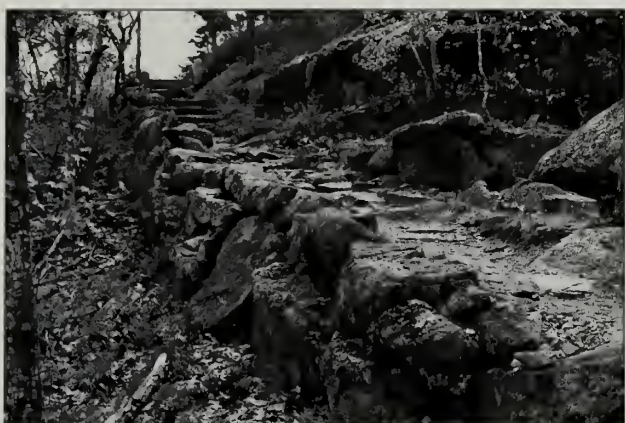
Fig. 15-16 Retaining wall at lower end of trail.

- C. **Retaining Walls:** The Schiff Path contains almost 2,000 linear feet of retaining wall. Wall height ranges from 1 to 6 feet. Most of the wall is in good condition (Fig. 15-16). Damaged sections should be repaired or reset and compatible new sections may be added as needed.

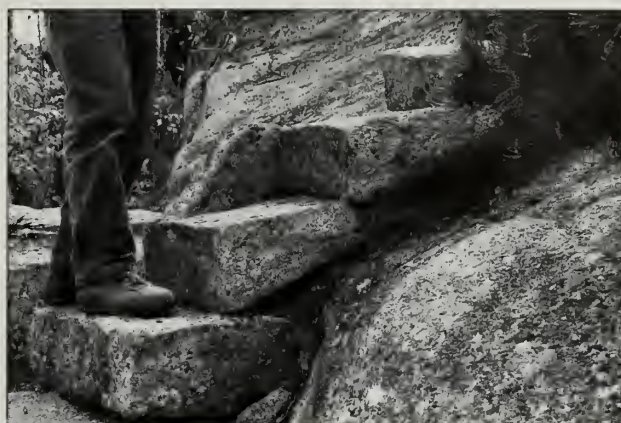
Fig. 15-19 Slab-laid steps.

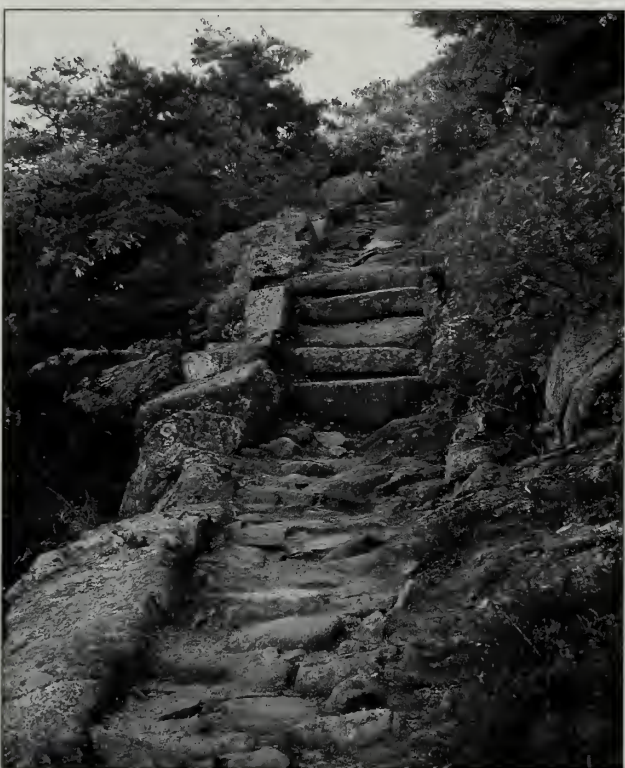
Fig. 15-17 Stone steps with coping, some steps and coping stones have slipped.

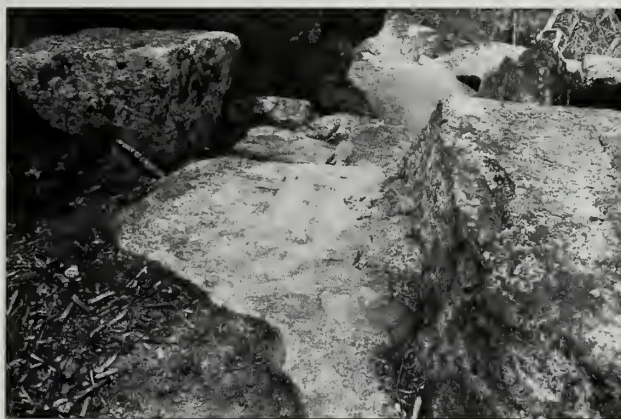
Fig. 15-20 Step cut out of ledge.

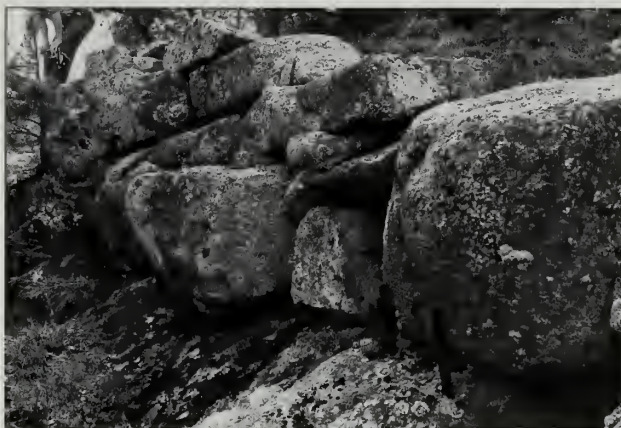
Fig. 15-21 Iron pins securing stone in retaining wall.

There are two trail sections with iron. Iron is used to pin rubble retaining walls along the first 600 feet of trail (lower end). About 600 feet beyond is another section of iron used to anchor wall and steps (Fig. 15-21). Extant ironwork should be replaced as needed. Additional iron may be added to sections of the trail where it is currently extant, but excessive use of new iron should be avoided.

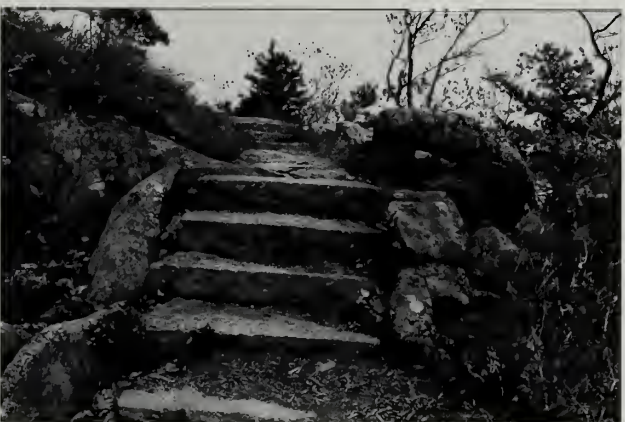
Fig. 15-18 Stone steps with coping stones and retaining wall behind.

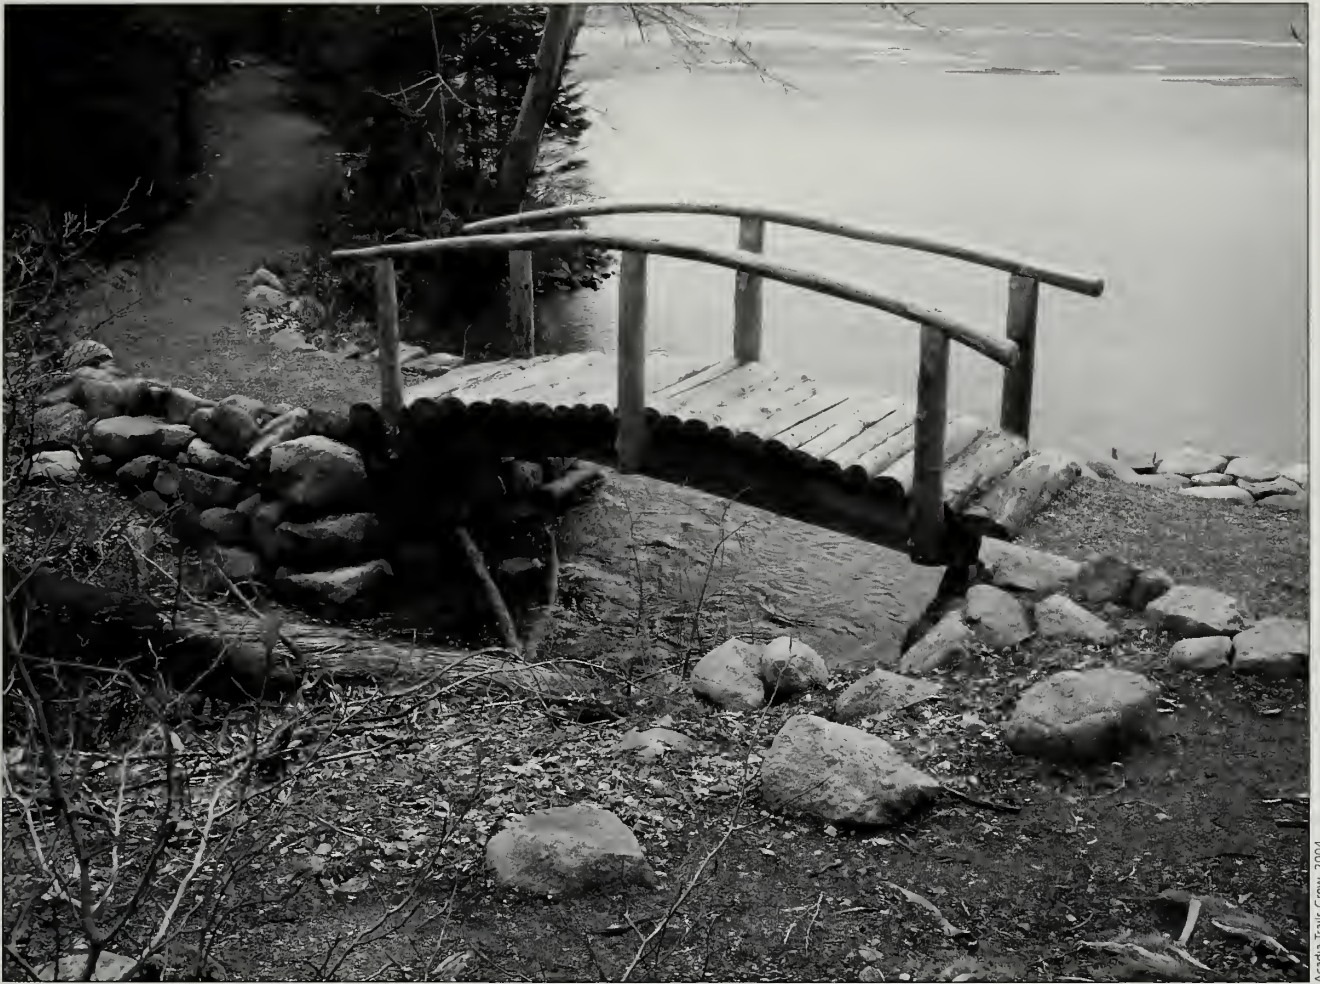
Fig. 39-1 Corduroy bridge built in 2004 on the Jordan Pond Path near the Jordan Pond Carry Path.

For over 100 years, the Jordan Pond Path has been one of the most heavily traveled walking paths on Mount Desert Island. Located in the pristine interior, along the reflective shores of Jordan Pond and leading to the Jordan Pond House, the trail offers a leisurely stroll for all generations (Figs. 39-1 & 39-2). The trail has suffered, however, from this heavy use. Erosion, compaction, widening, and exposed roots have created an unattractive and undesirable trail. Rehabilitation work must preserve the character of this late-nineteenth-century trail but also provide a durable tread.
