# ACADIA TRAILS TREATMENT PLAN

## CULTURAL LANDSCAPE REPORT FOR THE HISTORIC HIKING TRAIL SYSTEM OF ACADIA NATIONAL PARK

Olmsted Center for Landscape Preservation  
National Park Service, Boston, Massachusetts, 2006

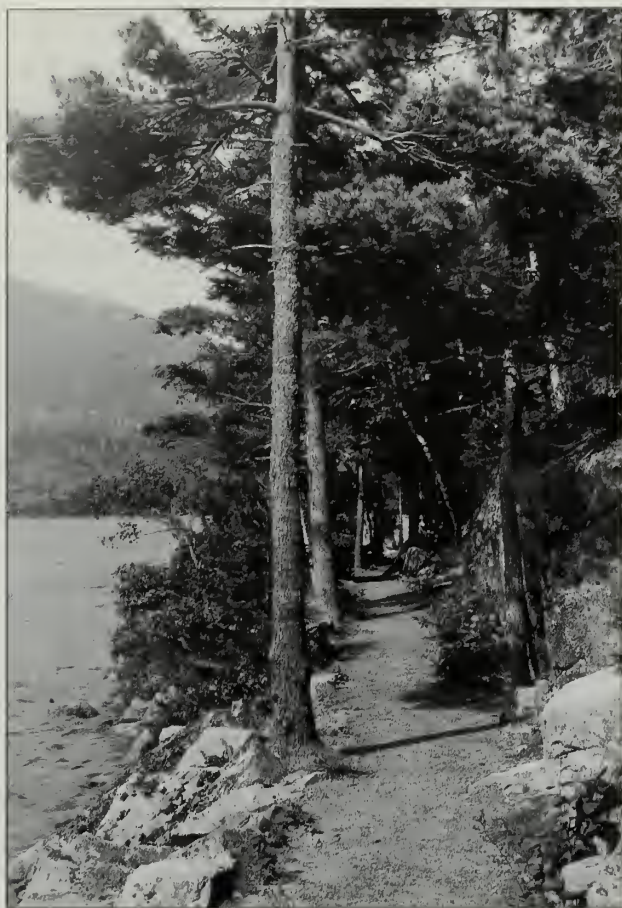
Fig. 39-5 An early photograph showing the recently rehabilitated gravel tread, circa 1920.

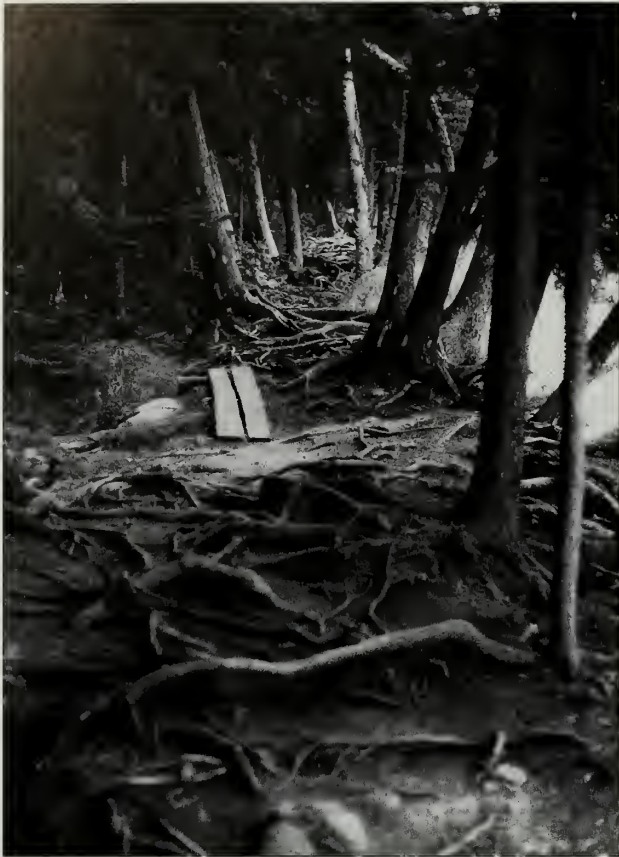
Fig. 39-10 Eroded trail and bogwalk on the western side of the pond.

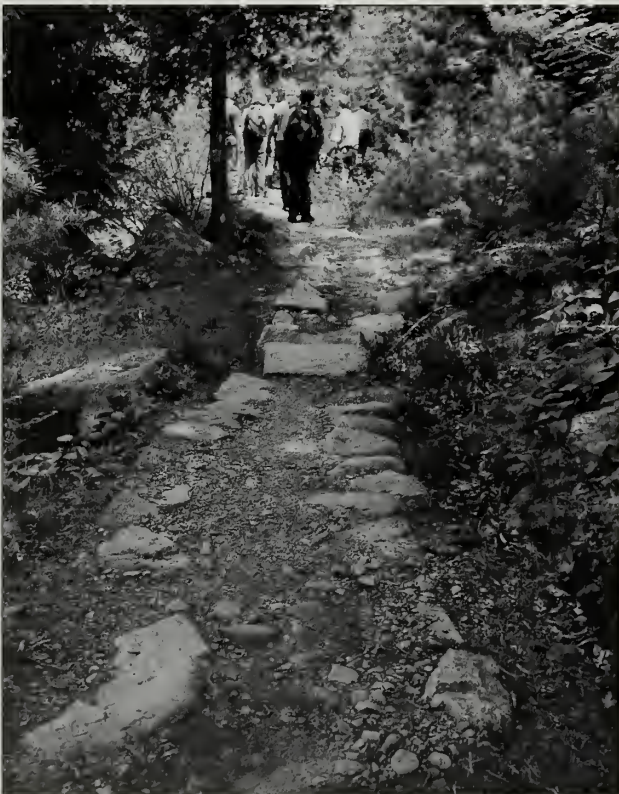
Fig 39-11 Eroded (not original) walled causeway on east side of pond.

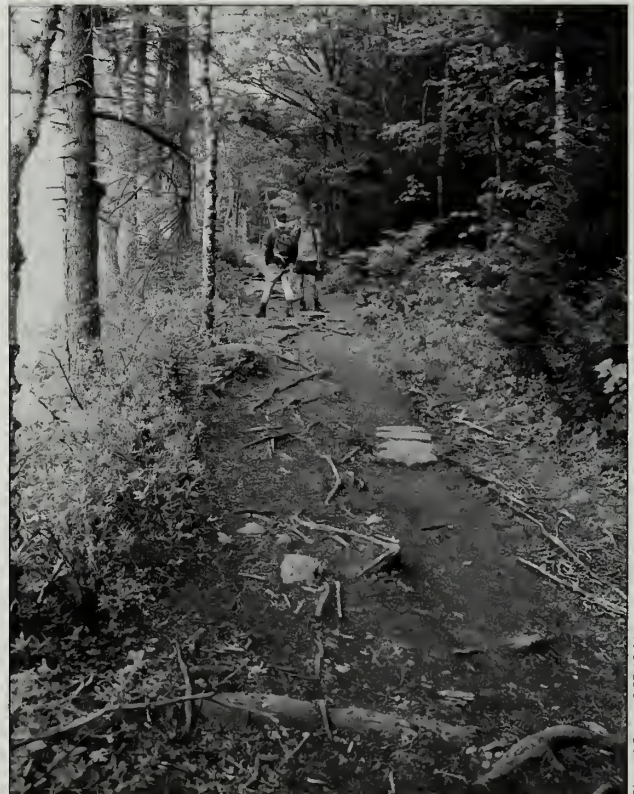
Fig 39-13 Gullied section on east side of pond.

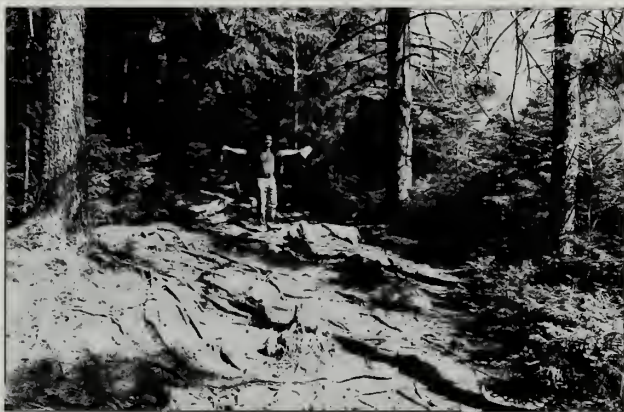
Fig. 39-14 Eroded portions of the trail on the western side of the pond are in need of rehabilitation, including narrowing the trail corridor.

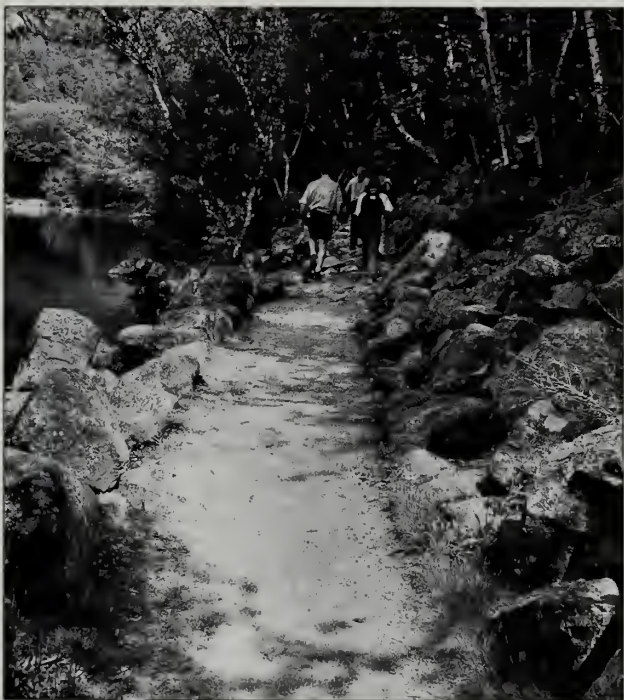
Fig. 39-15 This section of the trail at the bottom of a talus slope is in excellent condition.

Prior to current rehabilitation efforts, most of the trail was in need of extensive maintenance, with only one section trail remaining in good condition as the bottom of a talus slope (Fig. 39-15). As of 2004, has been rehabilitated (Fig. 39-16, also see Fig. 39-1).

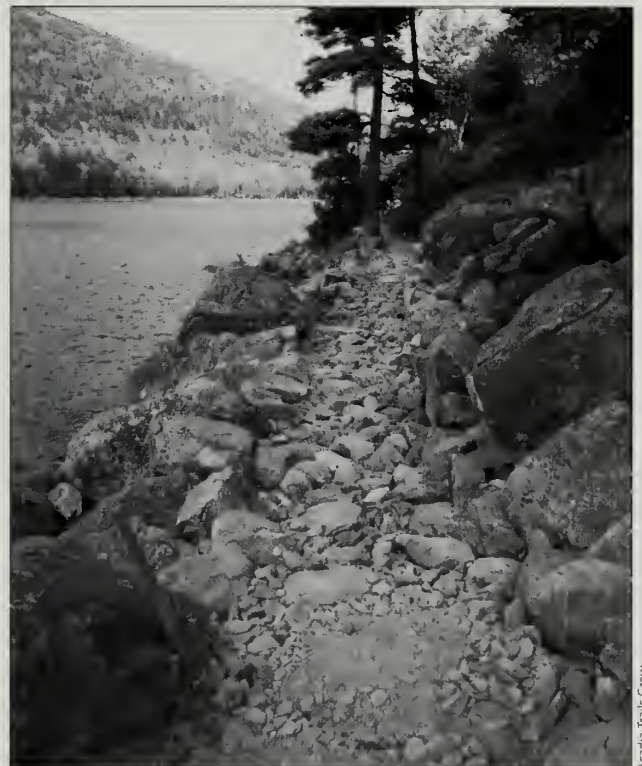
Fig. 39-16 The same view as Fig. 39-5 taken in 2001 showing NPS rehabilitation in progress. The base is in place, but the final application of gravel tread has not been completed.

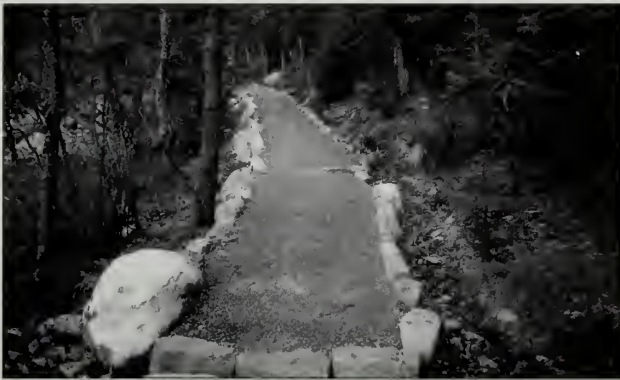
Fig. 39-22 Newly installed gravel tread on the eastern side of the pond.

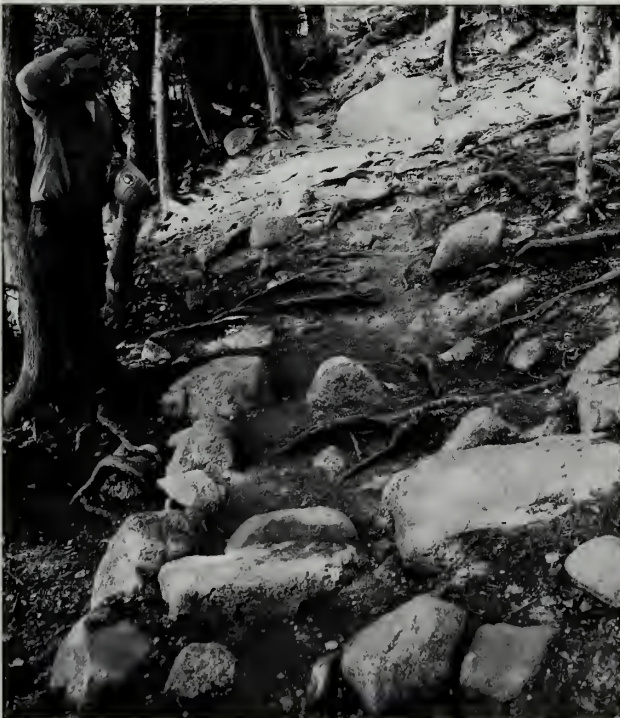
Fig. 39-23 Heavily rooted area and deteriorated tread on the west side of the pond.

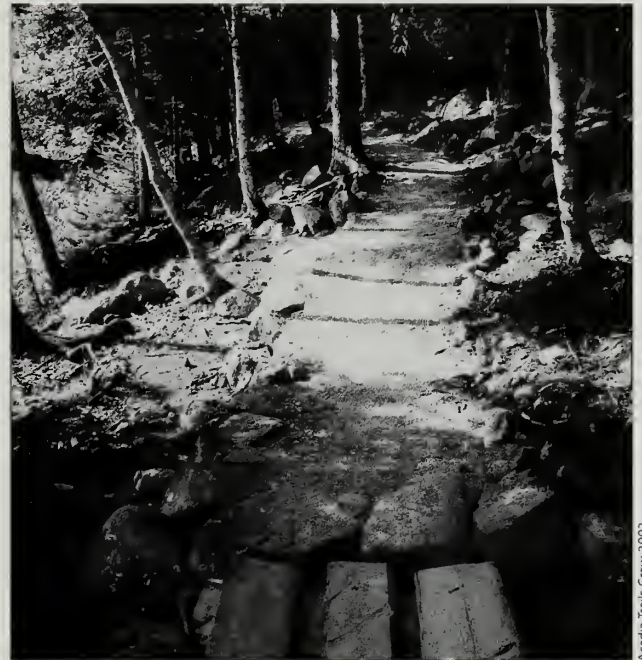
Fig. 39-24 2002 NPS new stone sidewall, gravel, open stone culvert (with temporary wood planks) on west side near section pictured in Fig. 39-23.

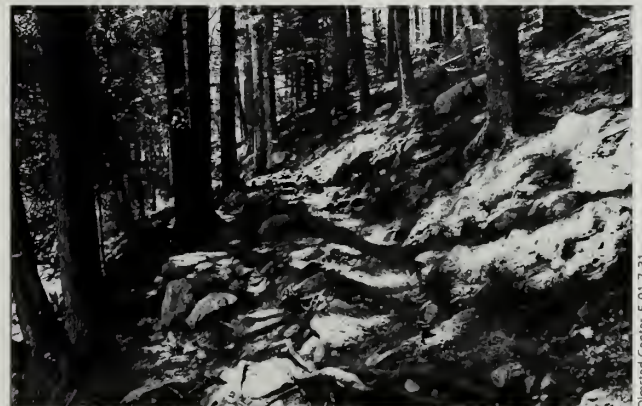
Olmsted Center, 5-01-7-31

Fig. 39-25 Erosion on the steepest slope at northern end of the west side of the pond.

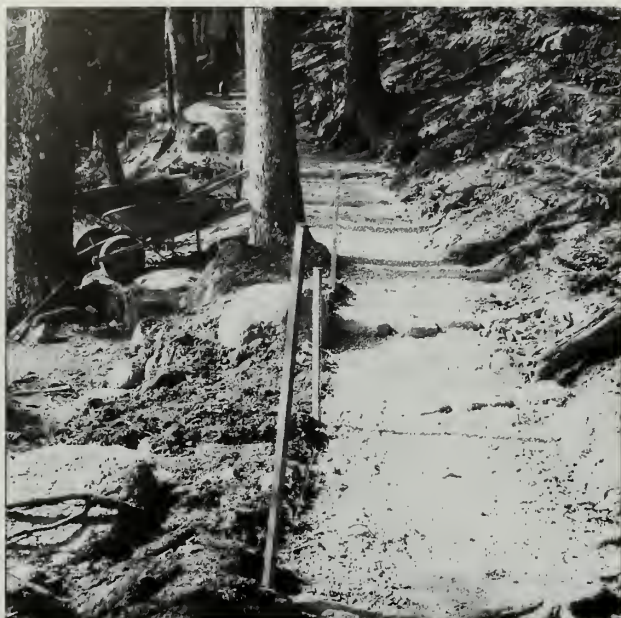
Acadia Trails Crew 2002

Fig. 39-26 Wall crib and checks installed by NPS in 2002 in same section shown in Fig. 39-25.

**C. Retaining Walls:** Historically, most of the trail was constructed without the use of retaining walls. However, substantial laid and rubble retaining walls were constructed midway along the eastern shore and in the tumbledown area on the northeast corner of the pond. Small rubble walls are also extant along the west side of the pond. Some extant walls are up to 6 feet high and continuous over hundreds of linear feet. Coping, iron, and cut stone were all used. The majority of the square footage of retaining wall was in need of repair, which was accomplished in 2001 and 2002. Much of the work is featured in examples in Chapter 6.

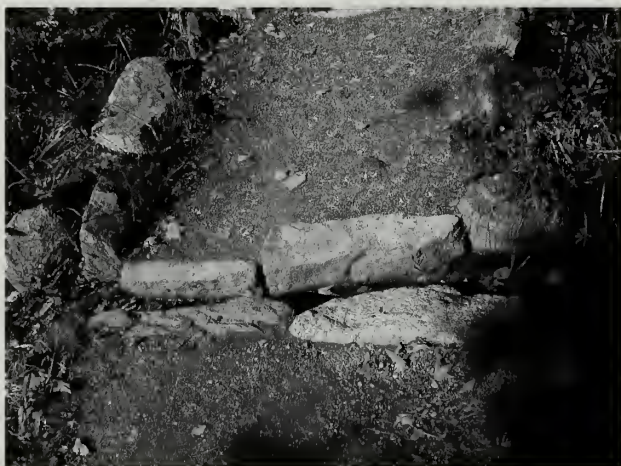
Friends of Acadia

Fig. 39-27 A medium flow of water should be handled with a small open culvert. Closed culverts, although providing better visual consistency to the trail tread, would likely clog and fail regularly due to ice dams and organic debris, requiring increased maintenance.

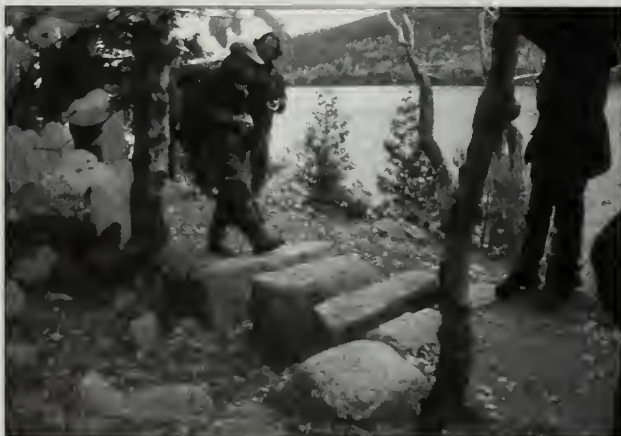
Olmsted Center, 10-00-d

Fig. 39-28 This step stone culvert was installed on a newly rehabilitated section of trail to handle a heavy water flow.

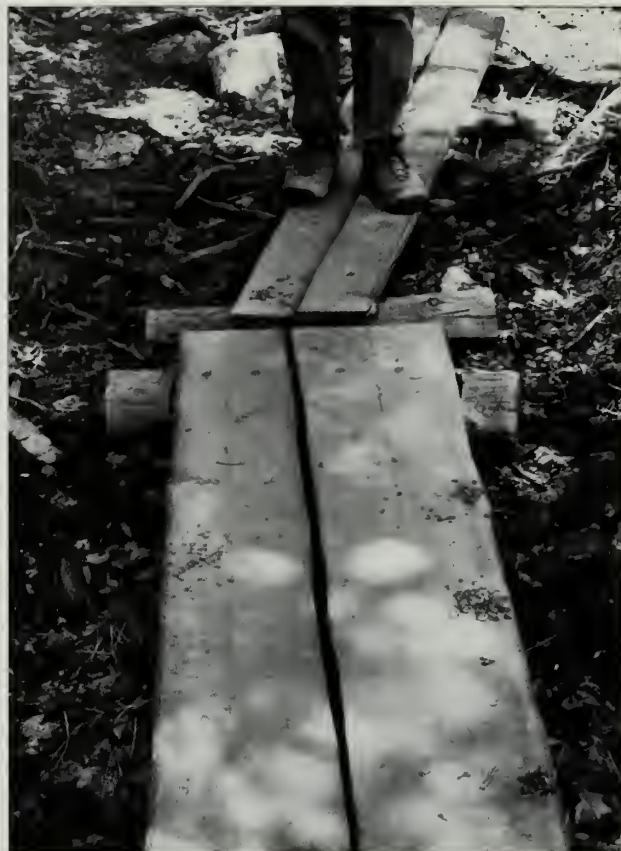
Olmsted Center, 5-01-7-19

Fig. 39-29 Bogwalk should be uniform in length and width. For example, this bogwalk on the western side of Jordan Pond is not of uniform width at the joint, making it more difficult for hikers to walk along safely.

- A. Bogwalks:** The trail contains extensive bogwalk on the western side. Although not a historic feature, the high use, large amount of standing water, exposed roots, and fragile pondside ecosystem require this treatment. Sections of bogwalk should be built with a uniform length and width (as specified in Chapter 5, Section A) and repaired as needed, so walkers can establish a comfortable rhythm and safely enjoy the pondside scenery (Fig. 39-29).

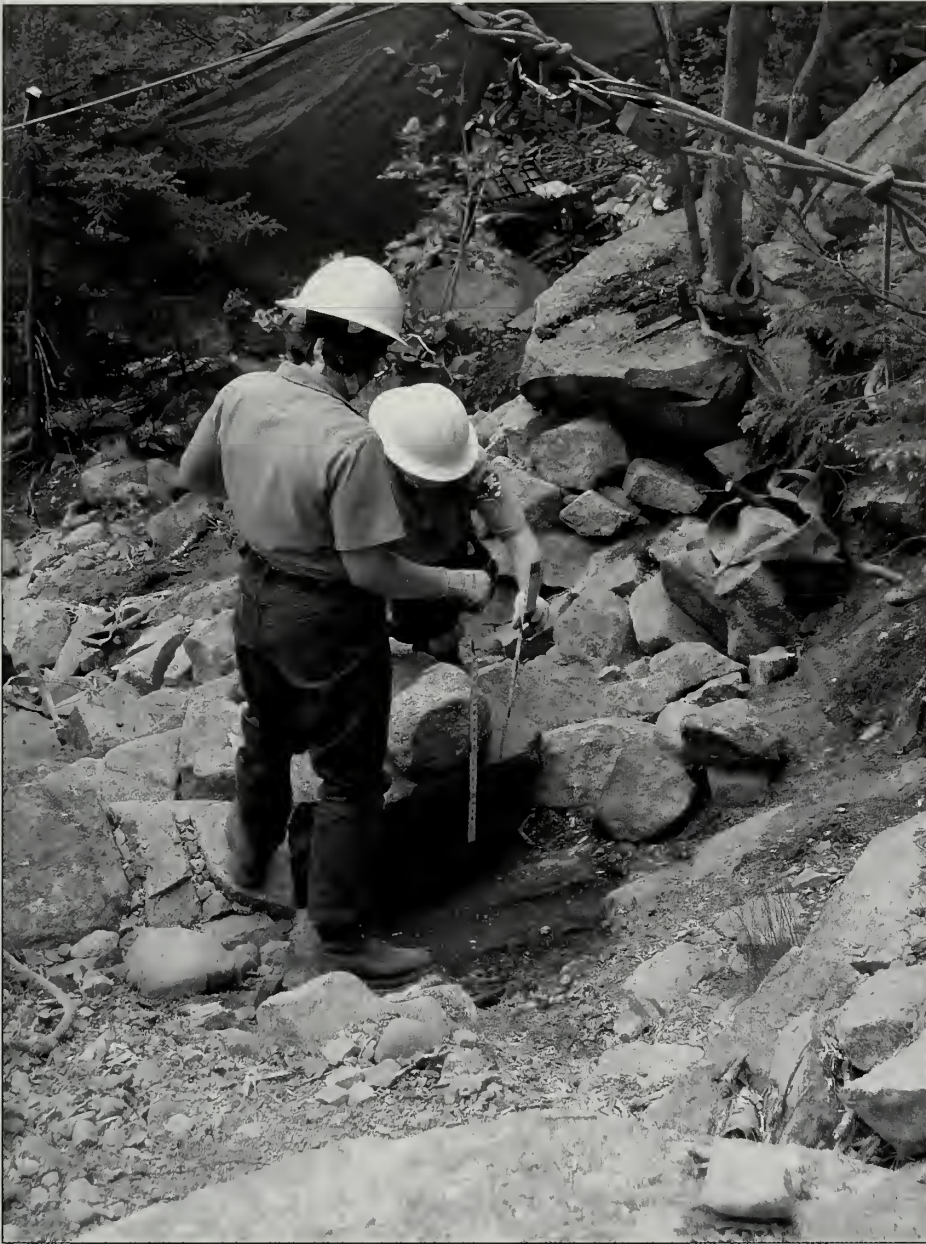
Acadia Trails Crew, 2004

Fig. 48-1 Repair work on the steepest section of the Jordan Cliffs Trail.

Characteristic of VIA/VIS summit trails, this challenging route winds along the ledges of Jordan Bluffs, then ascends to the north by a steep ravine to the open ledges and summit of Sargent Mountain (Figs. 48-1 & 48-2). A lack of built features, however, on the northern section has resulted in substantial erosion and unsafe conditions. Rehabilitation efforts must focus on the addition of features, which are in keeping with the VIA/VIS style, to ensure durable and safe tread.

On the section of trail north of Deer Brook, there are several sections in poor condition that may have contained steps. Steep eroded sections in poor condition should be repaired with a combination of checks, retaining wall, and steps constructed to be compatible with the general VIA/VIS style. This would include step work in the Bar Harbor VIA, Northeast Harbor VIS, and Southwest Harbor VIA districts. In Bar Harbor, this would include step work on the relocated Curran Path (#315) and several 1920s endowed trails, including the Andrew Murray Young Path (#25), Gurnee Path (#352), Beachcroft Path (#13), Gorge Path (#28), Brigham Path (#366), and Canon Brook Path (#19). The repaired section should be winding rather than straight. The challenge is to create a durable treadway without making this trail appear like the highly constructed endowed trails (Fig. 48-16). Figure 48-1 shows trail rehabilitation with steps in progress.

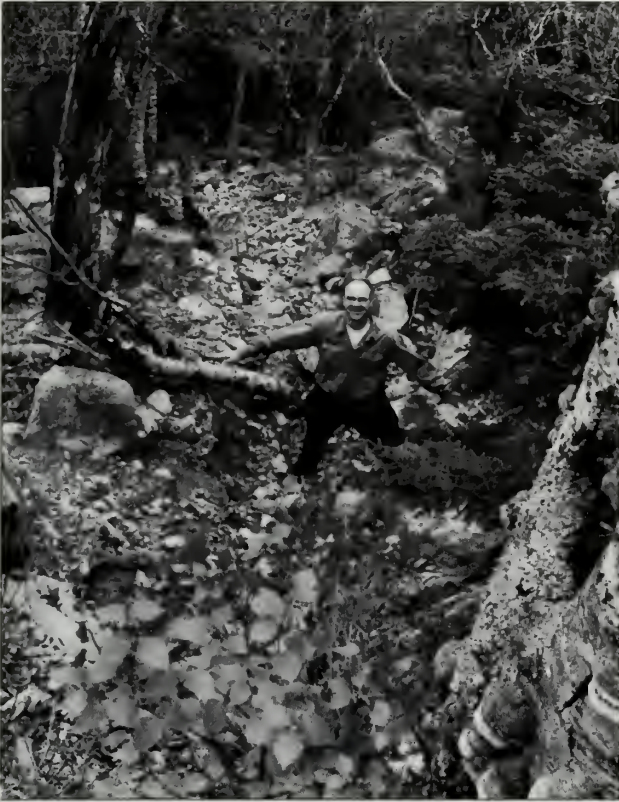
Olmsted Center, 5-01-03

Fig. 48-7 Steep eroded section of trail that has been closed for several years.

By 1941 several other trails were added to the Bluffs area, creating a labyrinth of trails (Fig. 48-5). Several trails were subsequently closed by the NPS. In a 1952 path inventory the northern half of the trail, from Deer Brook to the summit of Sargent Mountain, was referred to as the Sargent Summit Cutoff. By the late 1950s, however, the trail was again named the Jordan Cliffs Trail. Since about the 1980s, the southern half of the trail has been closed from early spring to late summer to protect peregrine falcons, which nest on the Bluffs not far from the trail (Fig. 48-6). In the 1990s, the northern half of the trail was closed due to unsafe trail conditions in a steep section of trail with loose rock (Fig. 48-7).

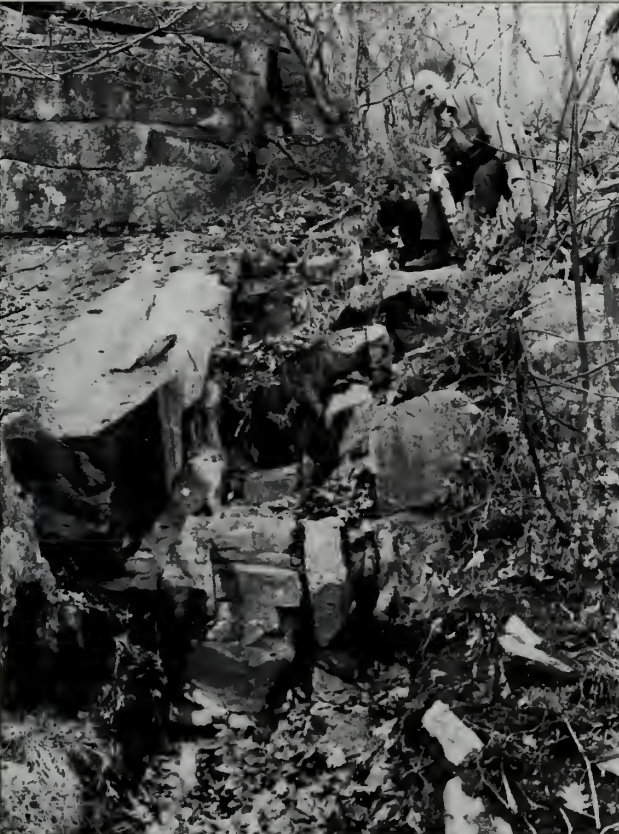
Olmsted Center, 5-01-16

Fig. 48-8 Ascending ledges below shoulder of Sargent Mountain. Section in poor condition needs steps and checks.

On the section of trail north of Deer Brook, the trail winds up through talus and along ledges. Once above treeline, there are spectacular views from the ledges (Figs. 48-8 to 48-10). The trail ascends to the shoulder of Sargent Mountain and travels fairly directly to the summit (Fig. 48-11). A steep and eroded section located in a talus area above Deer Brook is currently unsafe due to loose falling rocks. This straight section should be rebuilt to wind up through the talus area. The new route should be flagged prior to construction and rejoin the original route above and below the damaged section.

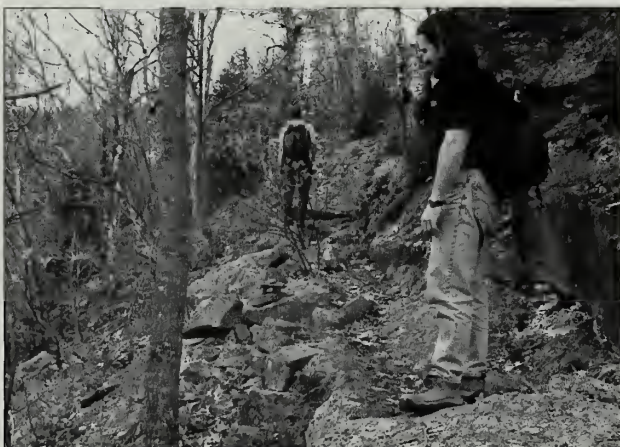
Olmsted Center, 5-01-1-10

Fig. 48-13 Section of tread along ledge, a natural bench, with retaining wall.

On the section of trail north of Deer Brook, there are several low retaining walls to provide comfortable tread along ledges. There is also some coping (Figs. 48-13 to 48-15). Additional or new retaining walls and/or checks are needed in sections that are eroded and washed out. The most eroded sections of trail need checks, coping stones, retaining walls, and steps.

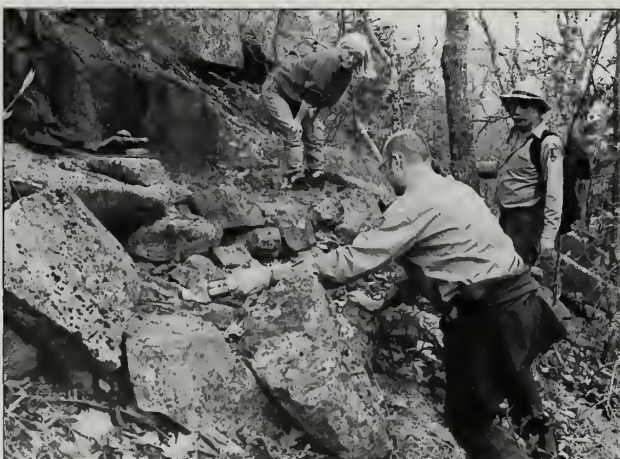
Olmsted Center, 5-01-d4

Fig. 48-14 The same retaining wall as above, viewed from the side of the trail.

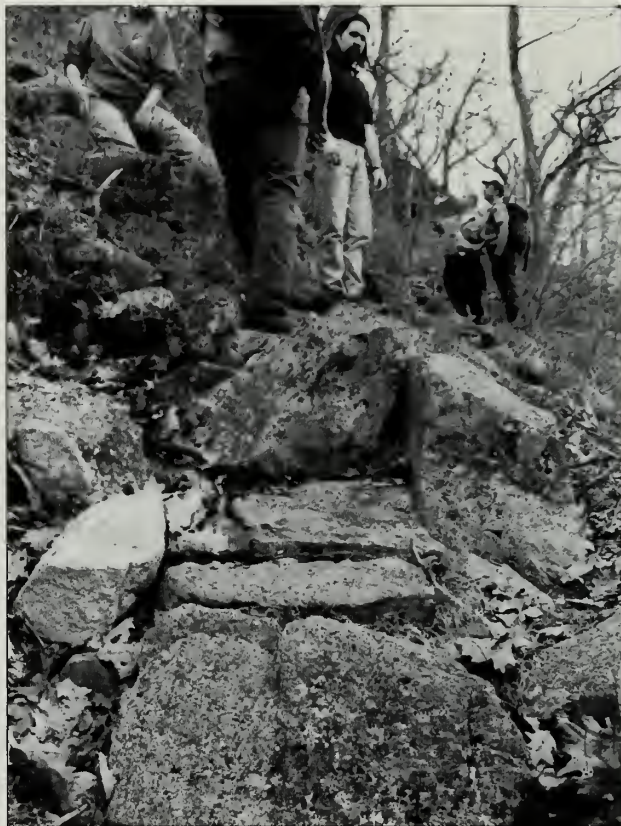
Olmsted Center, 5-01-1-13

Fig. 48-15 A short run of coping stones, steps, and stone pavement on ledges in poor condition.

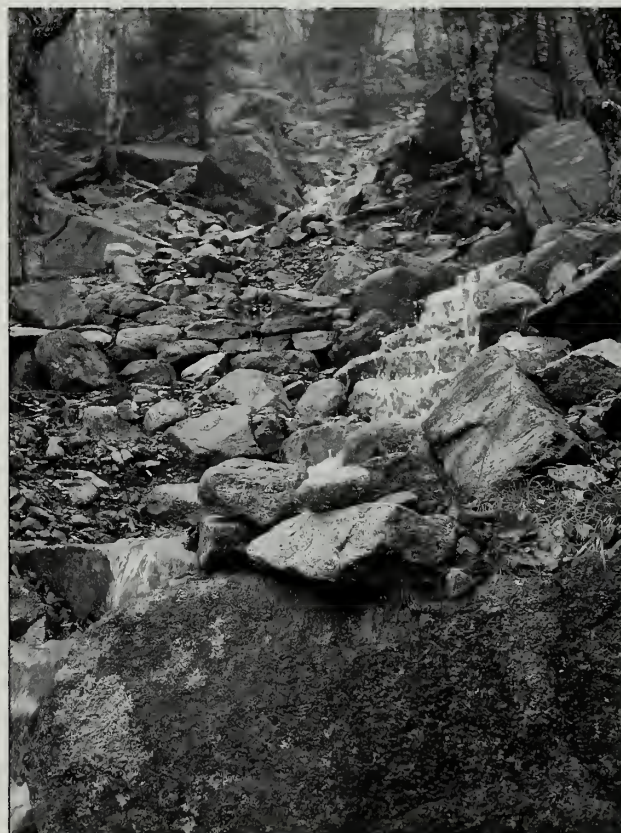
Acadia Trails Crew, 2004

Fig. 48-16 Tread and slope stabilization in progress in 2004 using winding steps built in the VIA/VIS style.

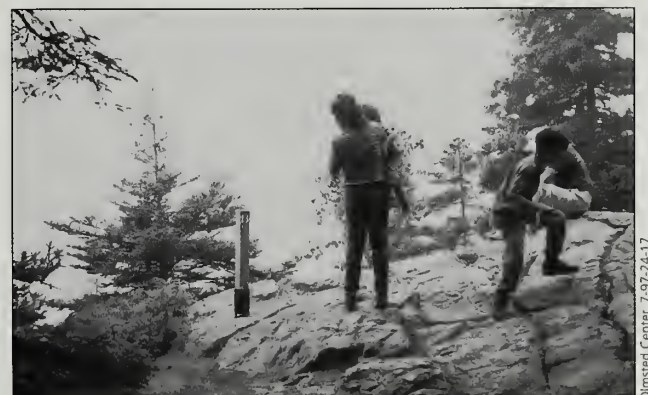
Fig. 127-4 Self-guided trail post on ledge overlooking Ship Harbor.

D. **Informational Signs:** At the trail entrance is a brochure box and an iron tube with a money slot. Nearby is a large sign with the trail name, map, and quote. There are fourteen numbered posts for the self-guided nature trail (see Figs. 127-4 & 127-5). A redwood interpretive sign describing shipwrecks was located at the southern end of the trail, but the NPS removed the sign after it was vandalized.

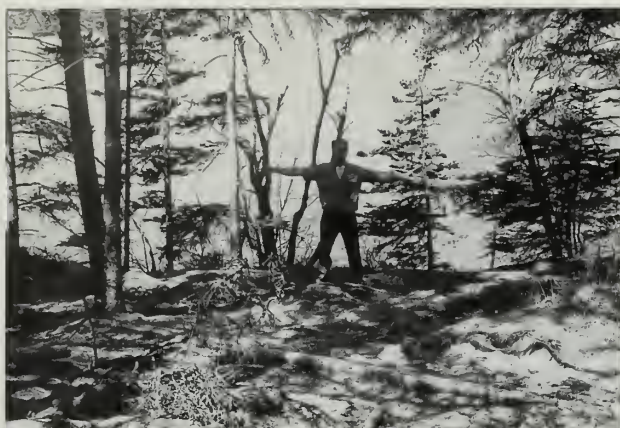
Acadia Trails Crew, 4-99-33-1

Fig. 127-7 Eroded section of trail that is approximately 30 feet wide.

The trail winds through an old orchard and thick coniferous forest, past interesting trees with burls and snake-like trunks, and along the rockweed-strewn coast. In thick forested areas, much of the trail is undefined and widened due to a lack of understory vegetation (Fig. 127-7 & Fig. 127-8). This variety in vegetation character should be maintained along the trail by keeping the original route. Trail widening should be addressed with coping stones and/or the placement of fallen logs sporadically along the trail edges.

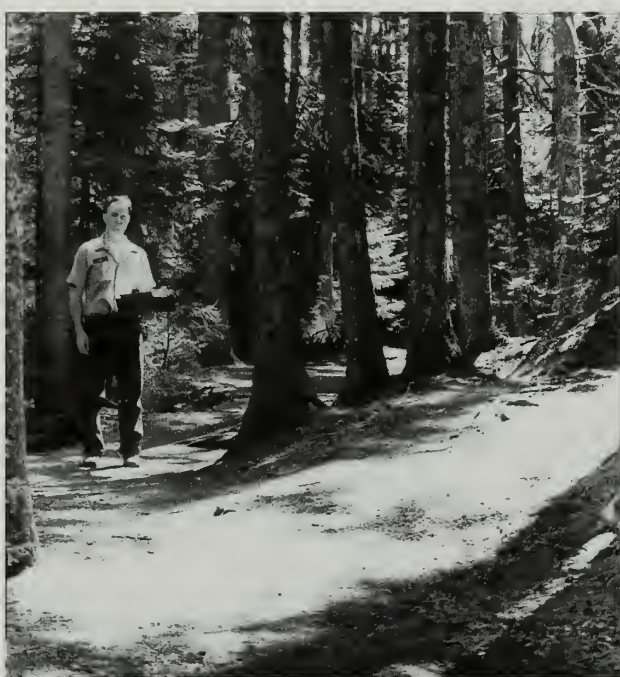
Acadia Trails Crew, 4-99-33-5

Fig. 127-8 Undefined woodland tread.

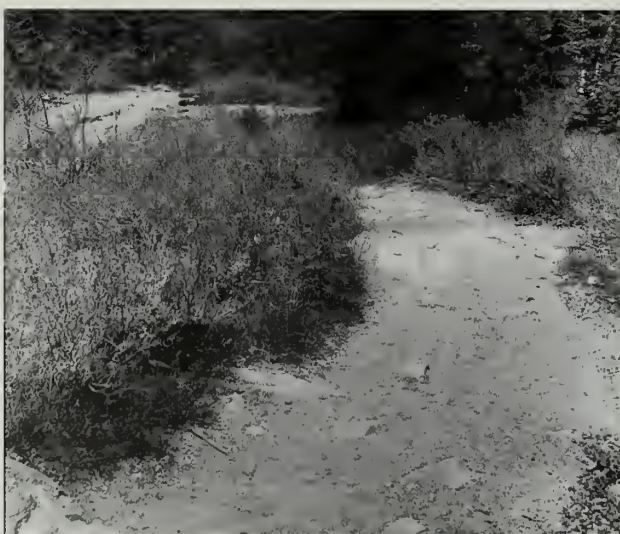
Acadia Trails Crew, 4-99-33-9

Fig. 127-9 Typical 5-foot gravel treadway.

- A. Bench Cuts:** About one-third of the original trail was constructed with half bench cut. Subsequent erosion makes it difficult to identify bench cuts. New bench cuts may be constructed, if needed, to stabilize the trail.
- B. Causeway:** Many eroded sections should be improved with causeway.
- C. Gravel Tread:** The original trail was 5 feet wide and gravel-surfaced by Mission 66. Much of the gravel has washed away and the eroded surface has exposed roots. Once drainage problems are dealt with, new gravel tread should be applied (Fig. 127-9).

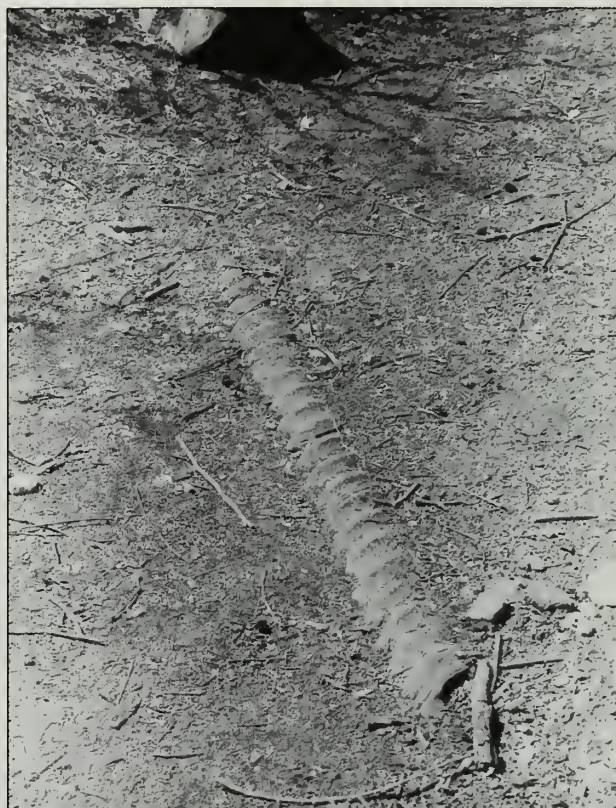
Acadia Trails Crew, 4-99-33-1

Fig. 127-10 This original pipe culvert is in poor condition. It is exposed and clogged with no side ditches available for outlets.

Side drains and ditches have silted-in and become ineffective, so water remains on the trail. Pipes should be replaced and reset for positive drainage. Associated side drains need to be re-dug and maintained (Fig. 127-10).

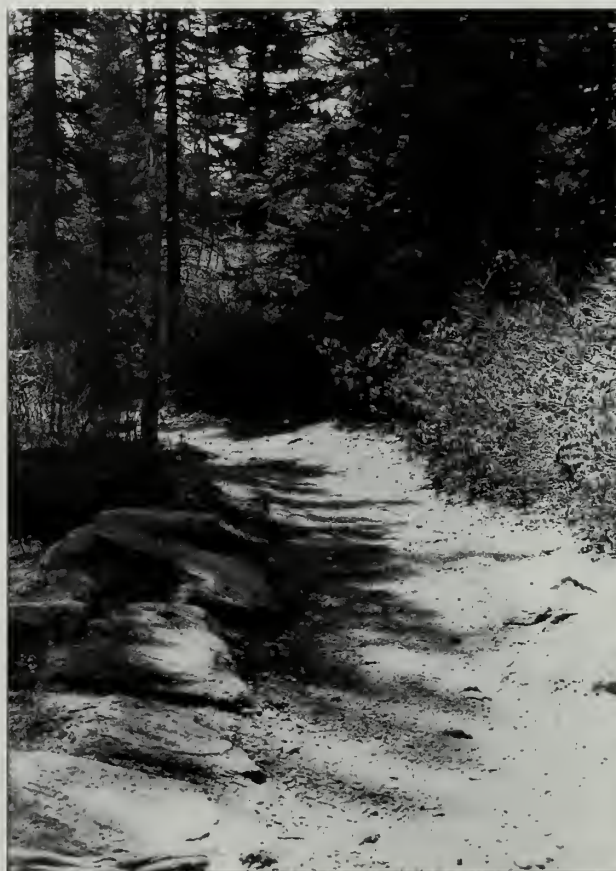
Acadia Trails Crew, 4-99-33-8

Fig. 127-11 Original coping.

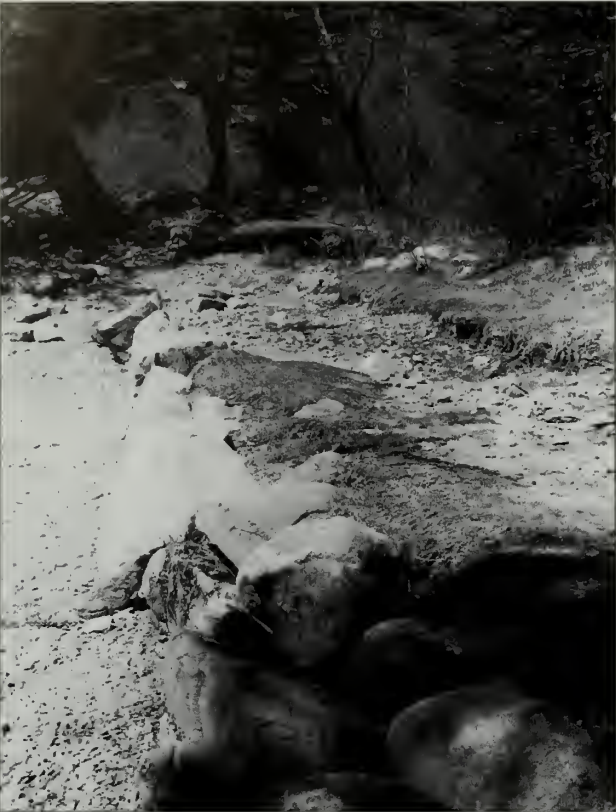
Acadia Trails Crew, 4-99-33-16

Fig. 127-12 Retaining wall constructed by YCC in 1993.

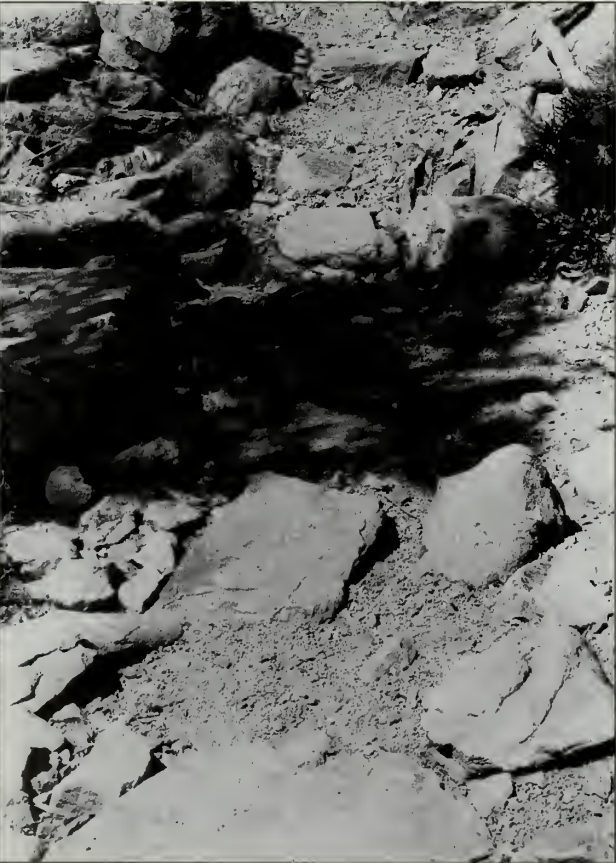
Acadia Trails Crew, 4-99-33-12

Fig. 127-14 Portion of a 50-foot section of step stones serving as stone pavement in gravel, lined with scree, constructed in 1992.

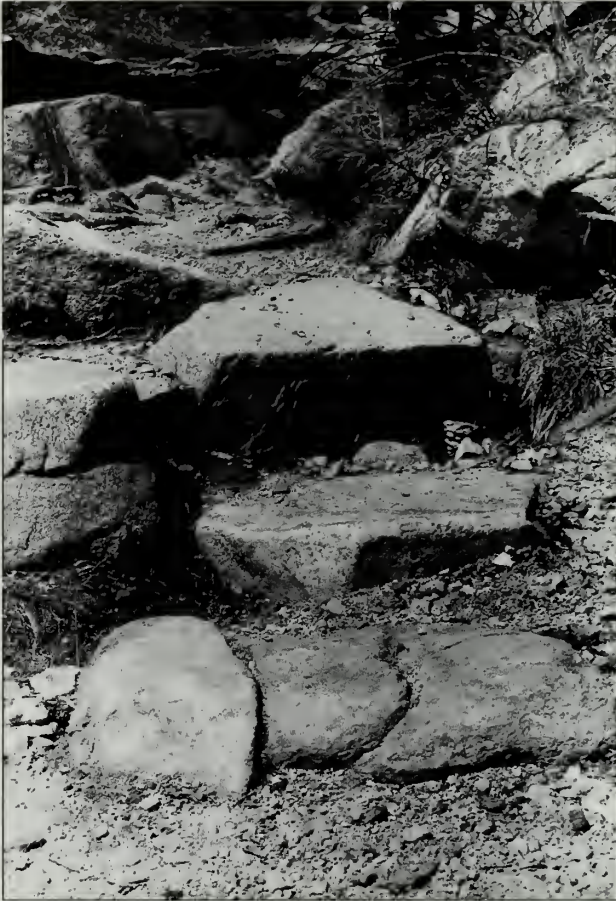
Acadia Trails Crew, 4-99-33-14

Fig. 127-13 Slab laid steps built in 1991 of local basalt.

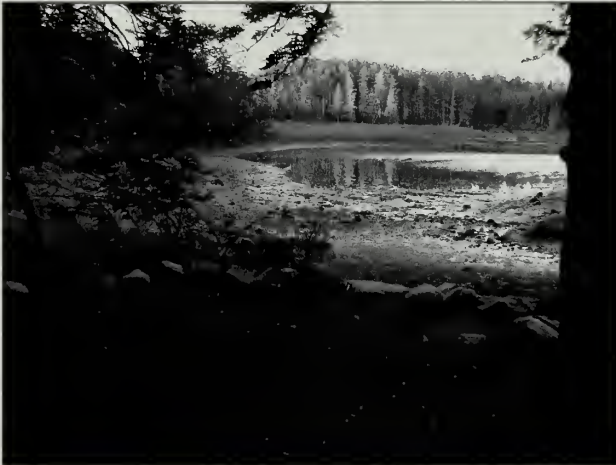
Friends of Acadia

Fig. 127-15 ADA-accessible section of trail completed in 2003.

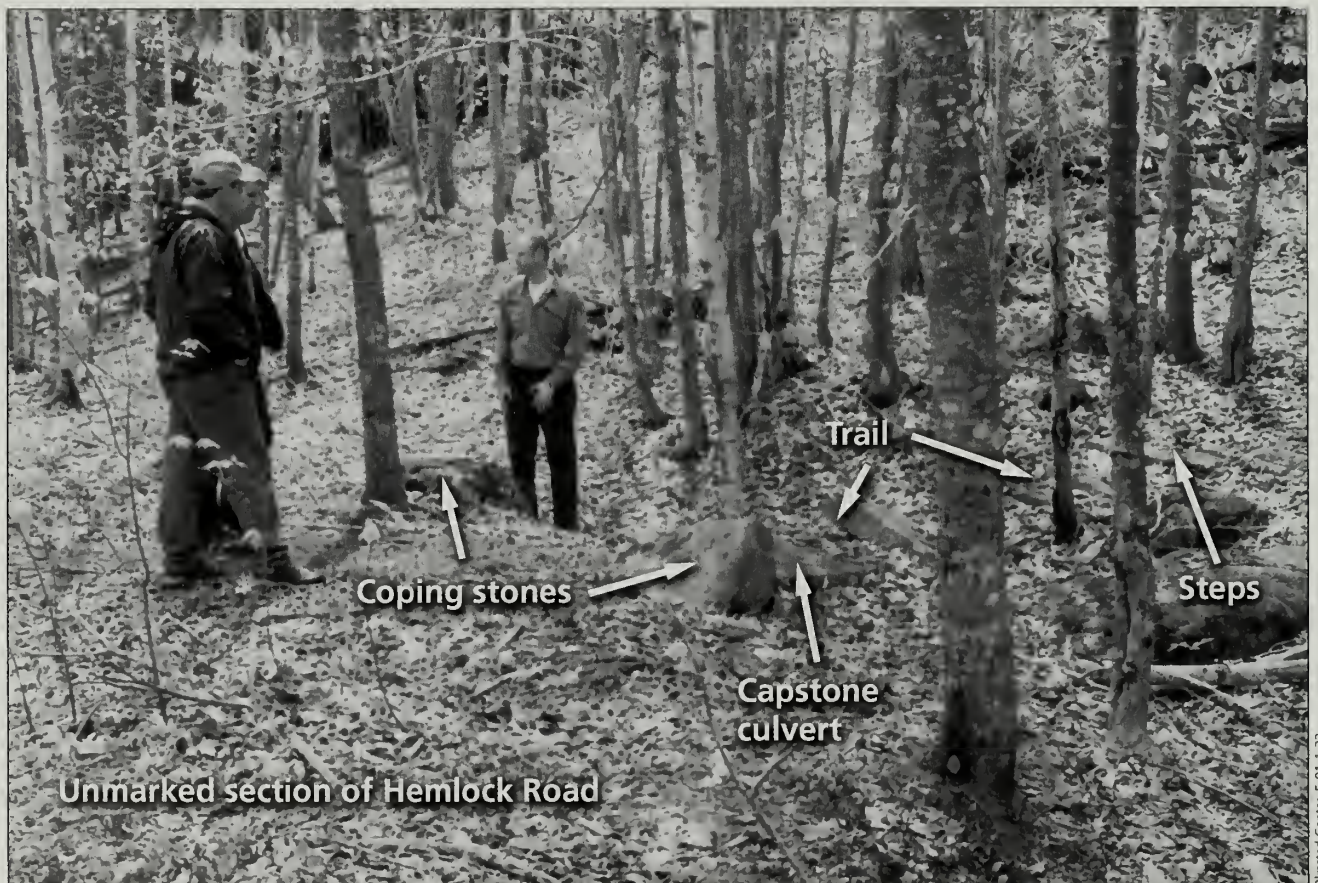
Fig. 349-3 The entrance to the Homans Path is on an unmarked section of Hemlock Road (#377), marked by two large coping stones. Constructed VIA sonework is prevalent along the trail, and the first features at the trailhead include a capstone culvert over the road's drainage ditch, and followed by a series of steps.

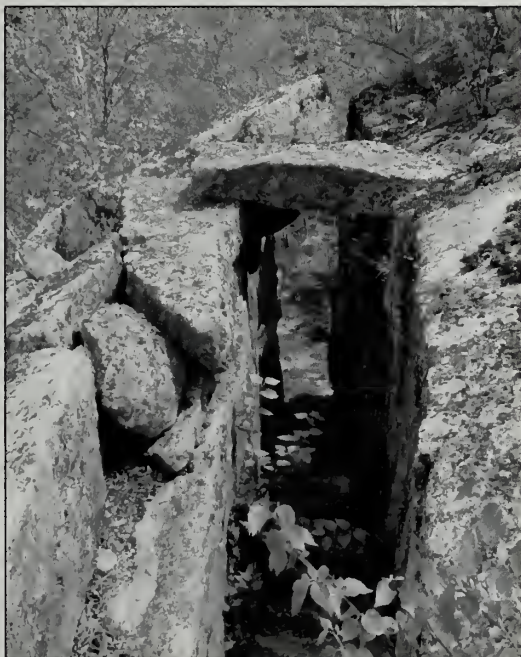
Olmsted Center 5-01-d9

Fig. 349-5 This stone was placed during trail construction to create an interesting feature along the route. It is the same location as shown in Figure 349-1, but viewed from above.

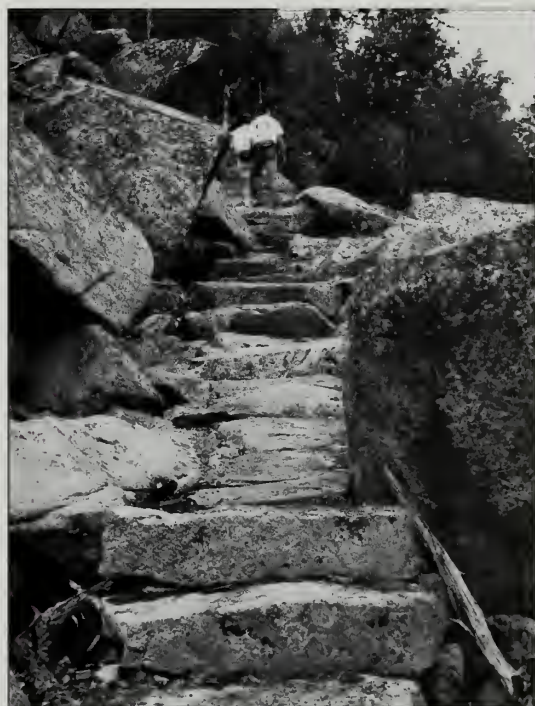
Olmsted Center 8-95-2-5A

Fig. 349-6 Stone steps and stone pavement through talus slope.

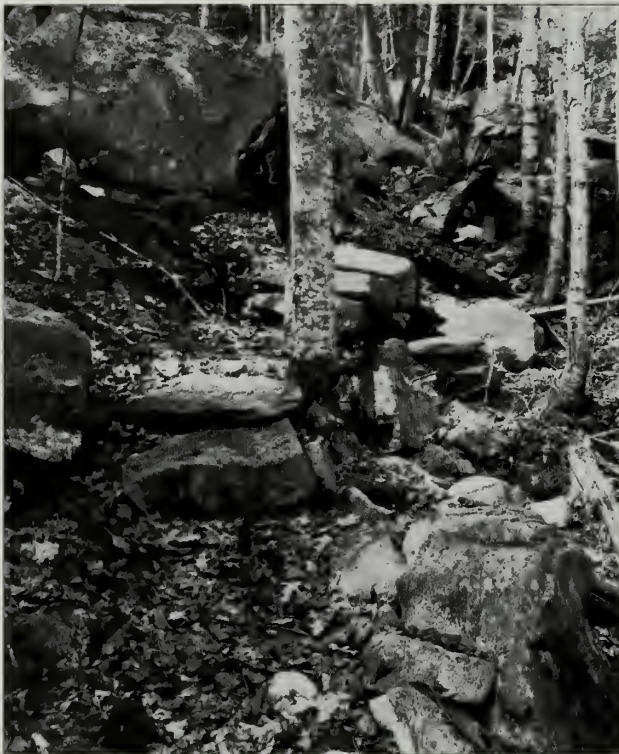
Olmsted Center, 5-01-2-10

Fig. 349-7 Approximately 230 feet from entrance, a 24-foot section of collapsed tread and uprooted trees shows the abandoned condition of some trail segments.

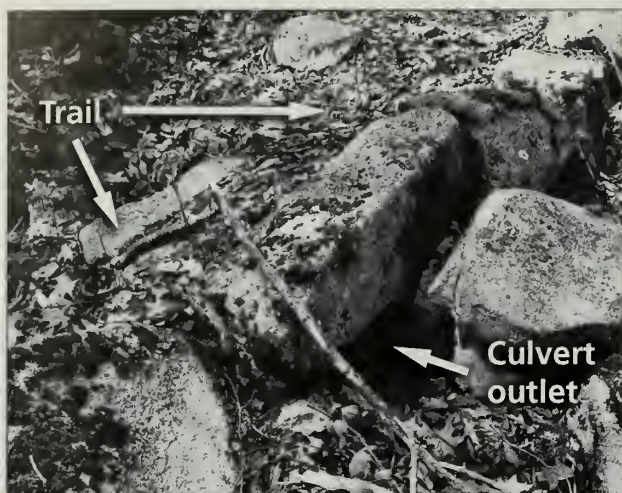
Olmsted Center, 5-01-2-4

**Fig. 349-12** Graveled-over culvert located 60 feet from the trail beginning.

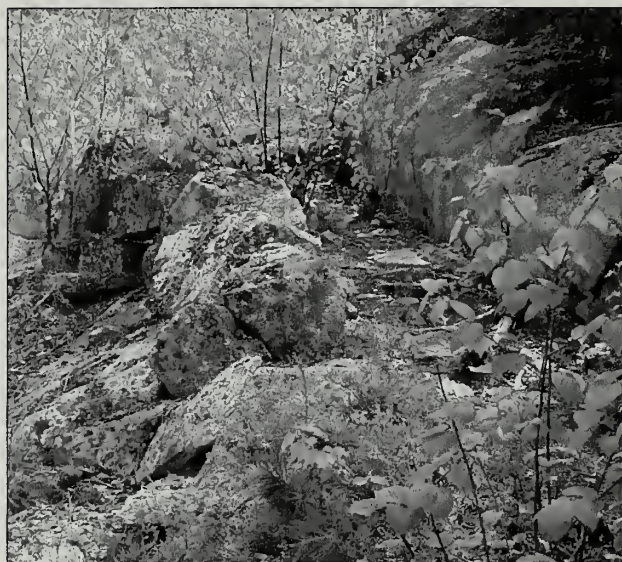
Olmsted Center, 5-01-d10

**Fig. 349-13** Irregular coping stones are often located along the lower edge of the tread.

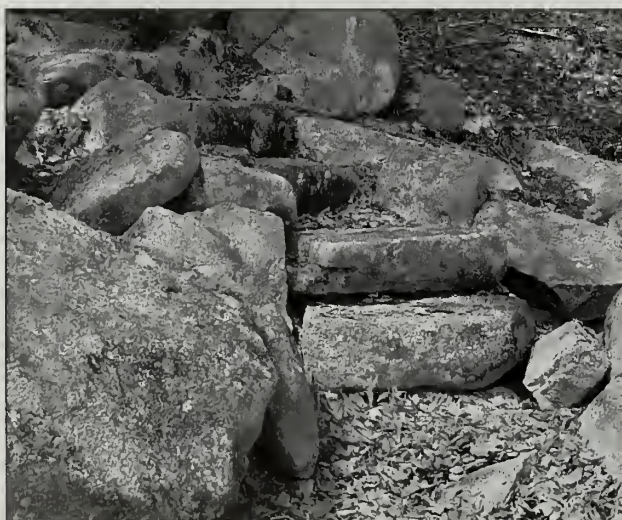
Olmsted Center, 5-01-d1

**Fig. 349-14** Retaining wall, coping and curved steps at about 270 feet up the trail.

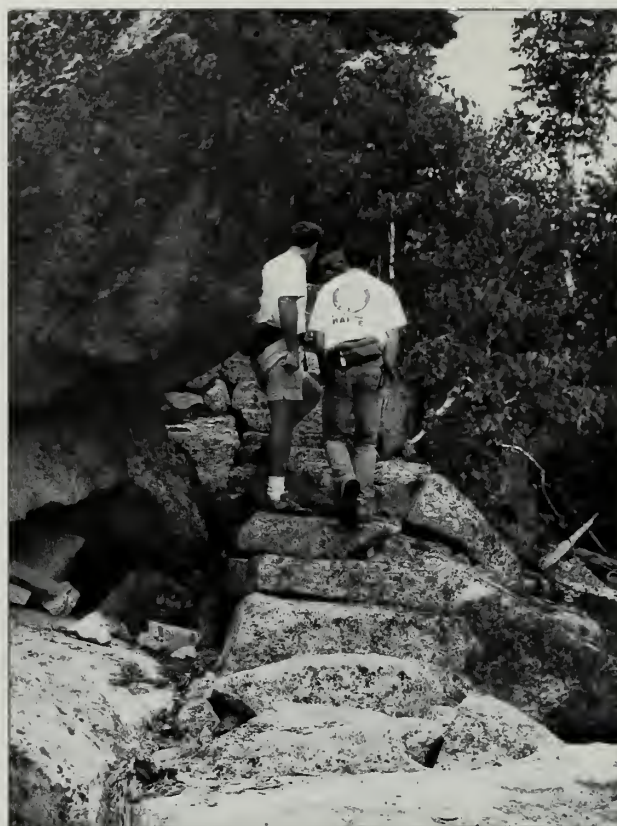
Olmsted Center, 8-95-2-6A

**Fig. 349-15** Path passing beside jutting boulder, raised with retaining wall and blocking.

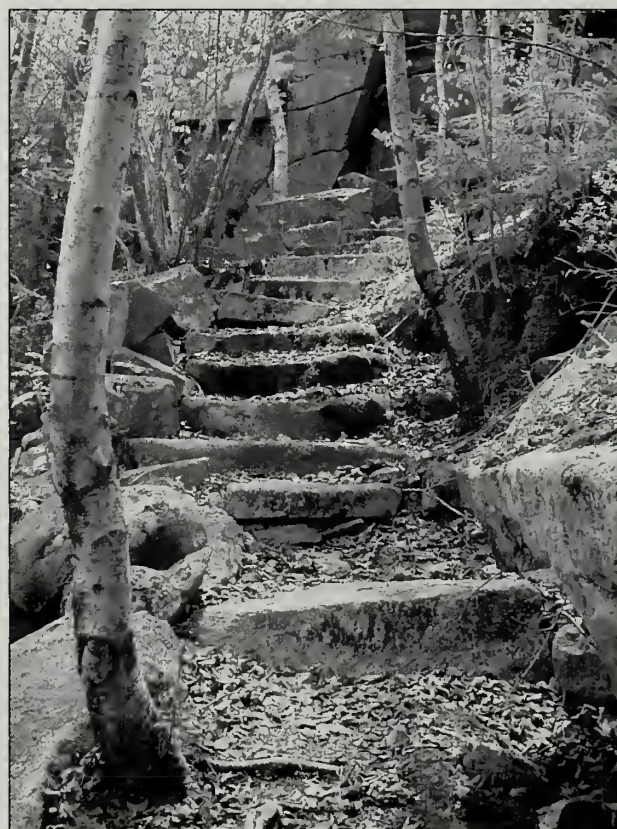
Olmsted Center, 5-01-d4

**Fig. 349-16** Large stone steps.

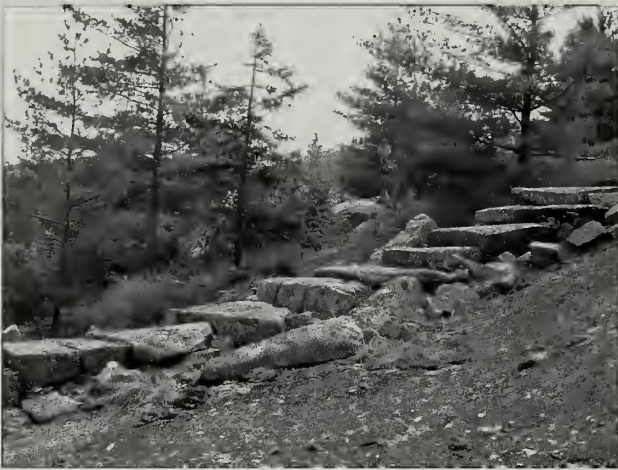
Fig. 349-17 Steps on ledge near upper end of trail.

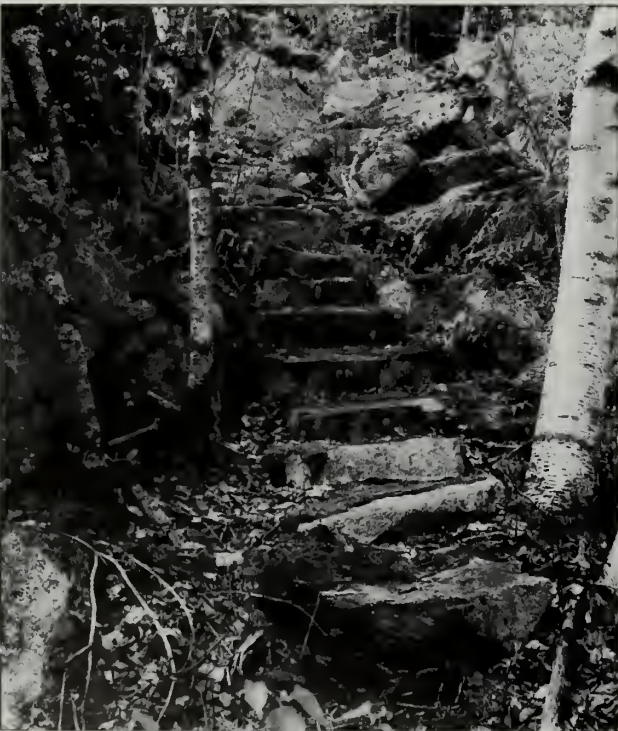
Fig. 349-18 Several runs of smaller steps without coping and covered with moss are located about 550 to 600 feet up the trail.

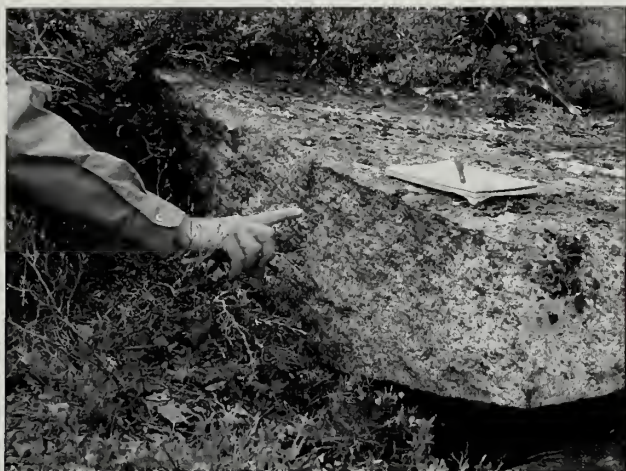
Olmsted Center, S-01-d17

Fig. 349-19 Hand showing drill marks on a nearby ledge where steps were quarried.

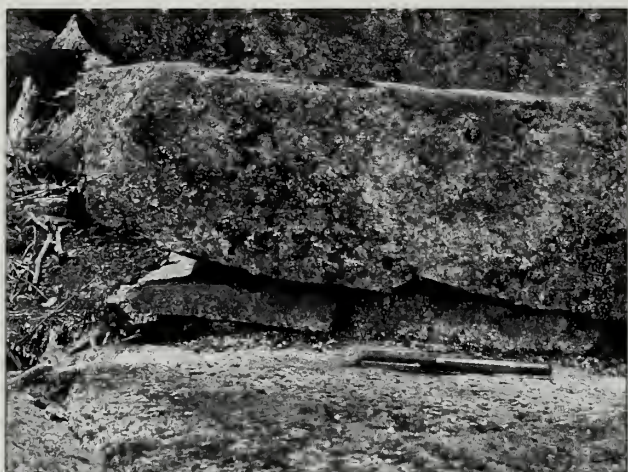
Olmsted Center, S-01-d8

Fig. 349-21 Stone step with shims.
