# ACADIA TRAILS TREATMENT PLAN

## CULTURAL LANDSCAPE REPORT FOR THE HISTORIC HIKING TRAIL SYSTEM OF ACADIA NATIONAL PARK

Olmsted Center for Landscape Preservation  
National Park Service, Boston, Massachusetts, 2006

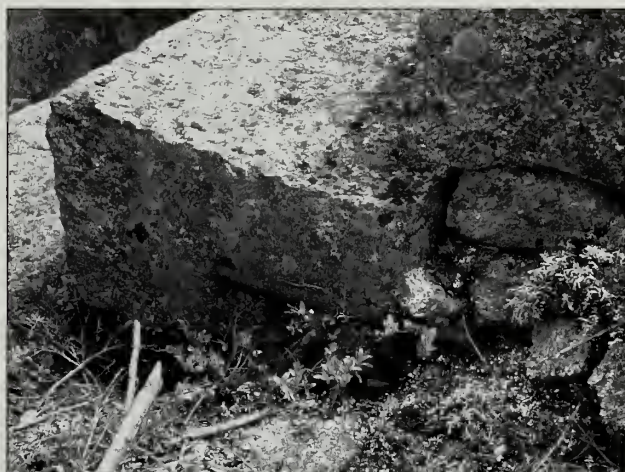
Olmsted Center, S-01-d13

Fig. 349-22 Detail of a pinned step on the Homans Path.

There is minimal iron on the trail. The circa-1915 construction of the trail places it during a period when iron use was increasing. The existing iron is used to support slab-laid steps and coping stones on ledge

at approximately 850 and 930 feet up the trail (Figs. 349-22 & 349-23). Additional concealed pins may be added to help hold steps in place. For example, a pin may be added to hold the bottom step of a run of steps to ensure that the staircase does not collapse with increased use. Pins should be added to secure stone-work prior to reopening the trail where high use will cause the steps to slip. Annual inspections may locate additional locations for pins. Use of concealed pins is preferred, rather than adding stone retaining walls or coping, to avoid altering the character of the trail.

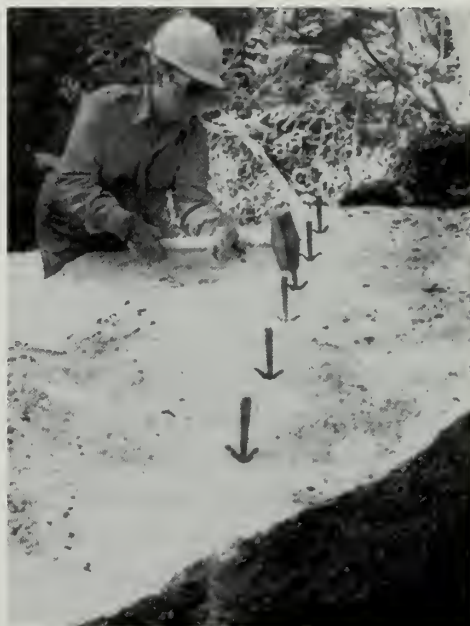
L. C. Kenway

- a. All wedge sets are placed in the holes oriented so they all push in the same plane in order to push the halves of stone apart.
- b. All wedges are driven with a hammer until they are “loaded.” This is indicated by each wedge emitting a tone or ringing sound. When all wedges are loaded, the stone is allowed to react to the pressure for 1 to 3 minutes.
- c. Wedges are driven equally, a little bit at a time. The sound of the tone of each wedge, when it is struck, can indicate the relative tightness of each wedge. If the wedges seem to be going hard, more scoring can be done between the wedges.
- d. Eventually, a crack will begin to show along the scored line. At this point, drive only one wedge so other wedges can be retrieved. You can then drive a lone wedge into the crack and retrieve the remaining wedge set. The two halves of stone can be separated with pry bars.

**Deb Hofford, SCA-BSP crew of '97 pounds 6 inch wedges to begin splitting a 10-ton slab of granite.**
