Moisture Problems in Historic Masonry Walls

Diagnosis and Treatment

by *Daird M. Smith, AIA*

*U.S. Department of the Interior
National Park Service
Preservation Assessment Division*

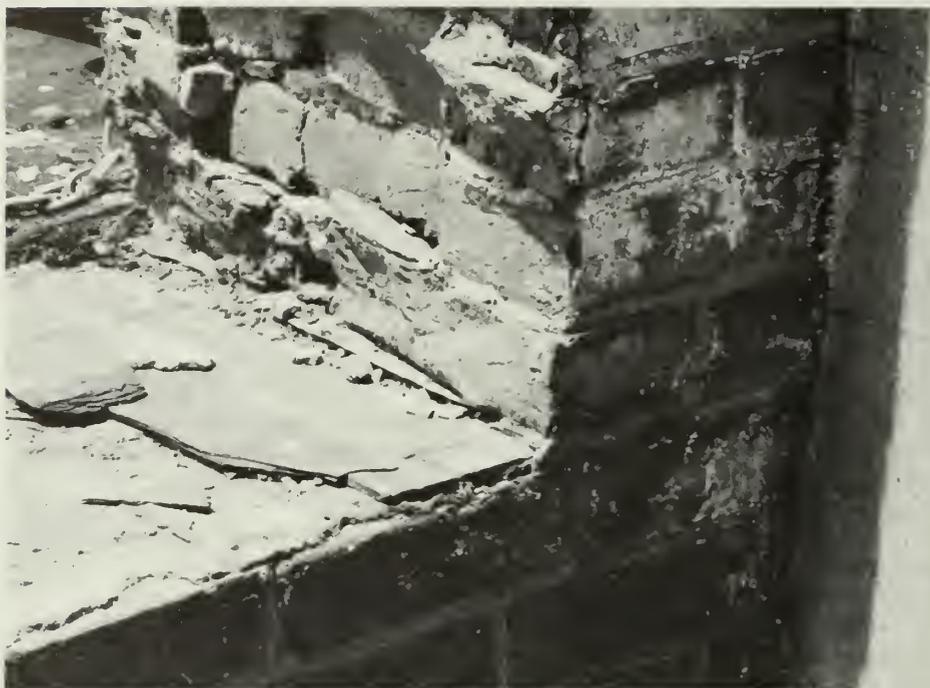
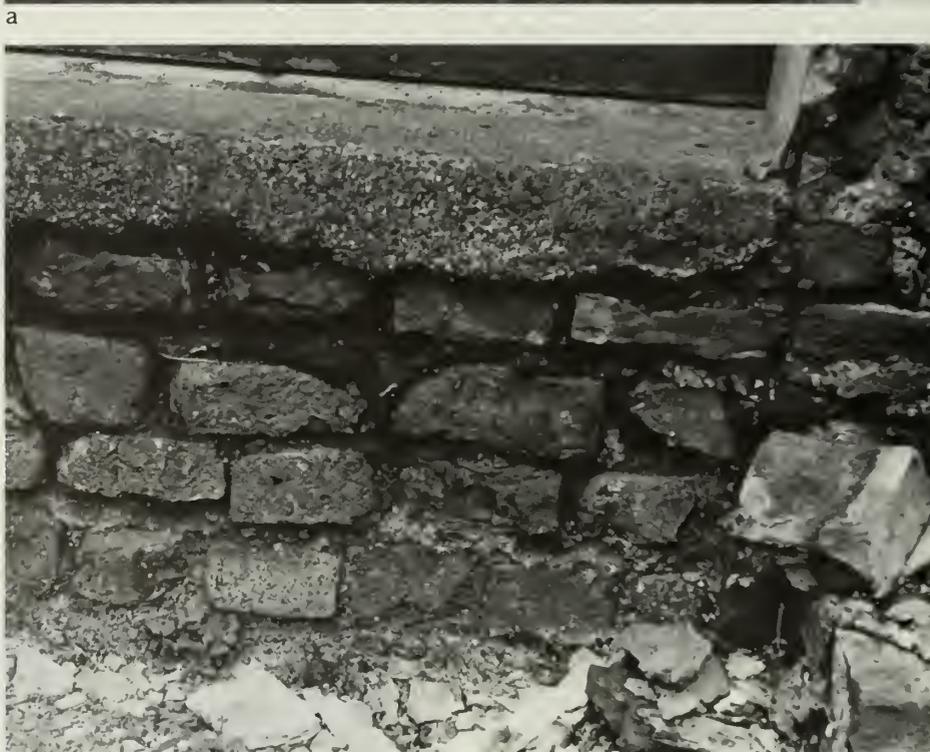
figure 2

Typical physical damp courses.
 (a) partially dismantled brick wall with exposed slate damp course. This Washington, D.C. building dates from about 1890. (b) Cavity wall with the outer brick wythe removed exposing a tar damp course (note that the tar, when poured, overflowed slightly into the cavity).
 Photographs: Baird M. Smith.

In the second half of the century a flurry of patented inventions followed, as architects and builders sought to capitalize on the newly discovered virtues of damp proof courses. Some patented courses were made of brick, fired at high temperatures, and often glazed, in order to render them impervious to moisture.⁸ Other common damp courses included double courses of slates; a single sheet of lead or zinc set in cement; a layer of tar and sand; or a layer of bituminized building paper.⁹ (Figure 2 shows two examples.)

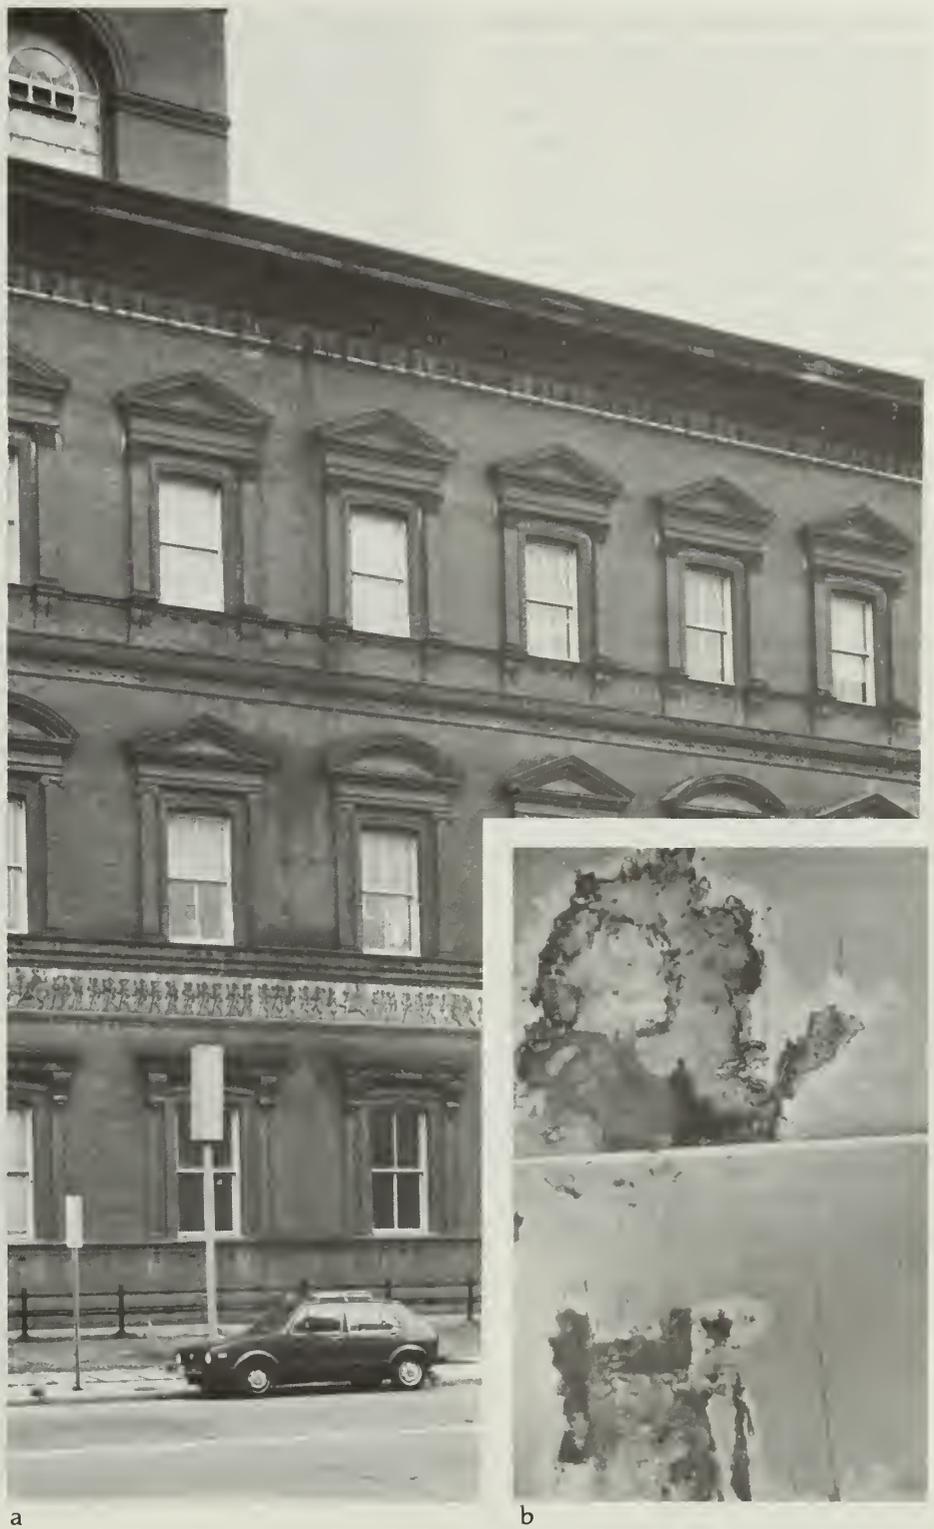
figure 3

(a) The stain shown here is caused by overflow from a clogged rain leader (a 4 inch diameter cast iron pipe set within the masonry wall).
(b) Extensive damage to the interior wall plaster opposite the rain leader also resulted. Photographs: (a) Baird M. Smith. (b) Susan Dynes.

interior and exterior damage resulted (see figure 3).

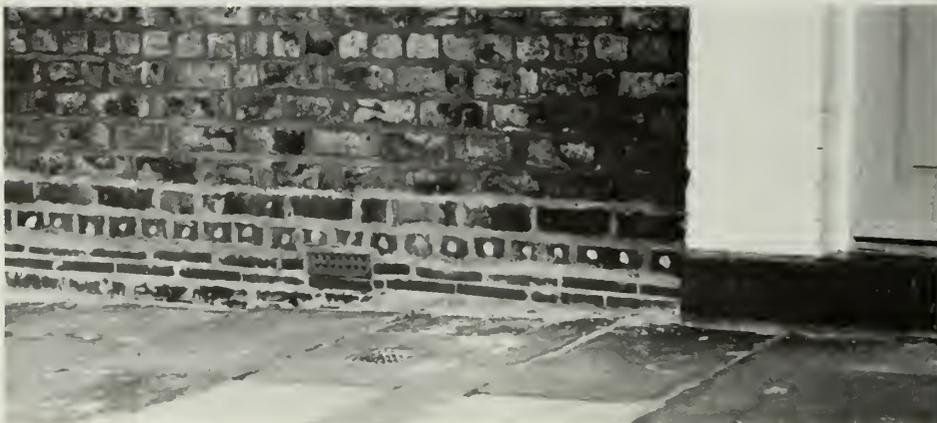
figure 5

Evidence of an injected chemical damp course. Each header brick has been drilled, injected, and subsequently patched. Note that the injected damp proof course is above an existing damp proof course of two courses of high fired brick. Photograph: Baird M. Smith.

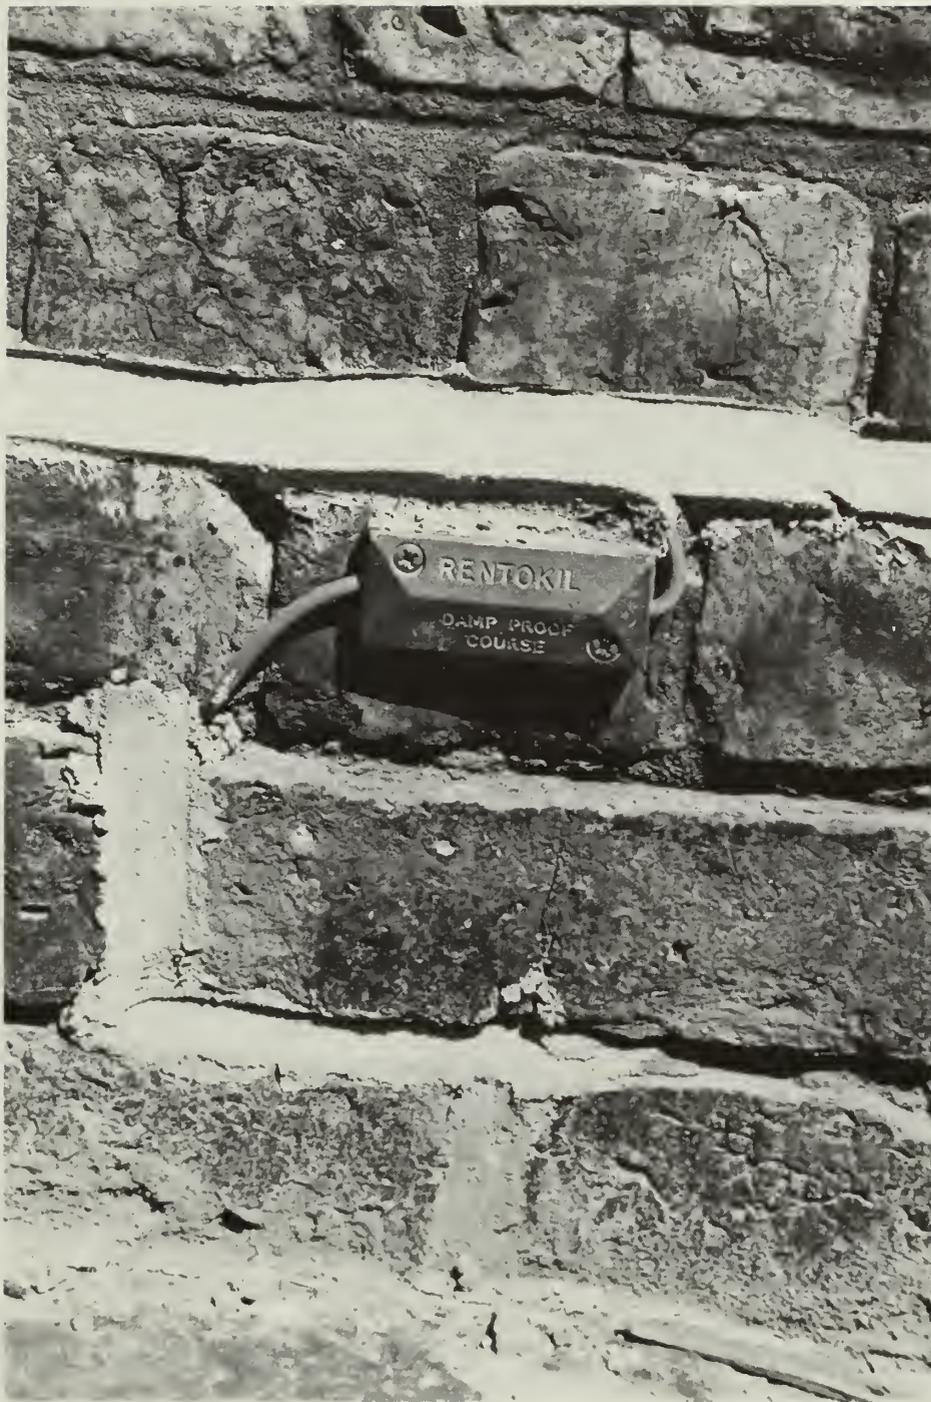
figure 6

A passive electro-osmotic system. The thickened mortar joint holds the copper strand, which is grounded to the earth. In theory, an electrical potential difference is established that halts the migration of moisture above the copper strand. In practice, however, there is little proof that the passive systems work. Active systems do work, but are subject to rapid corrosion of system parts and hence are not considered appropriate for long-term moisture problems. Photograph: Baird M. Smith.

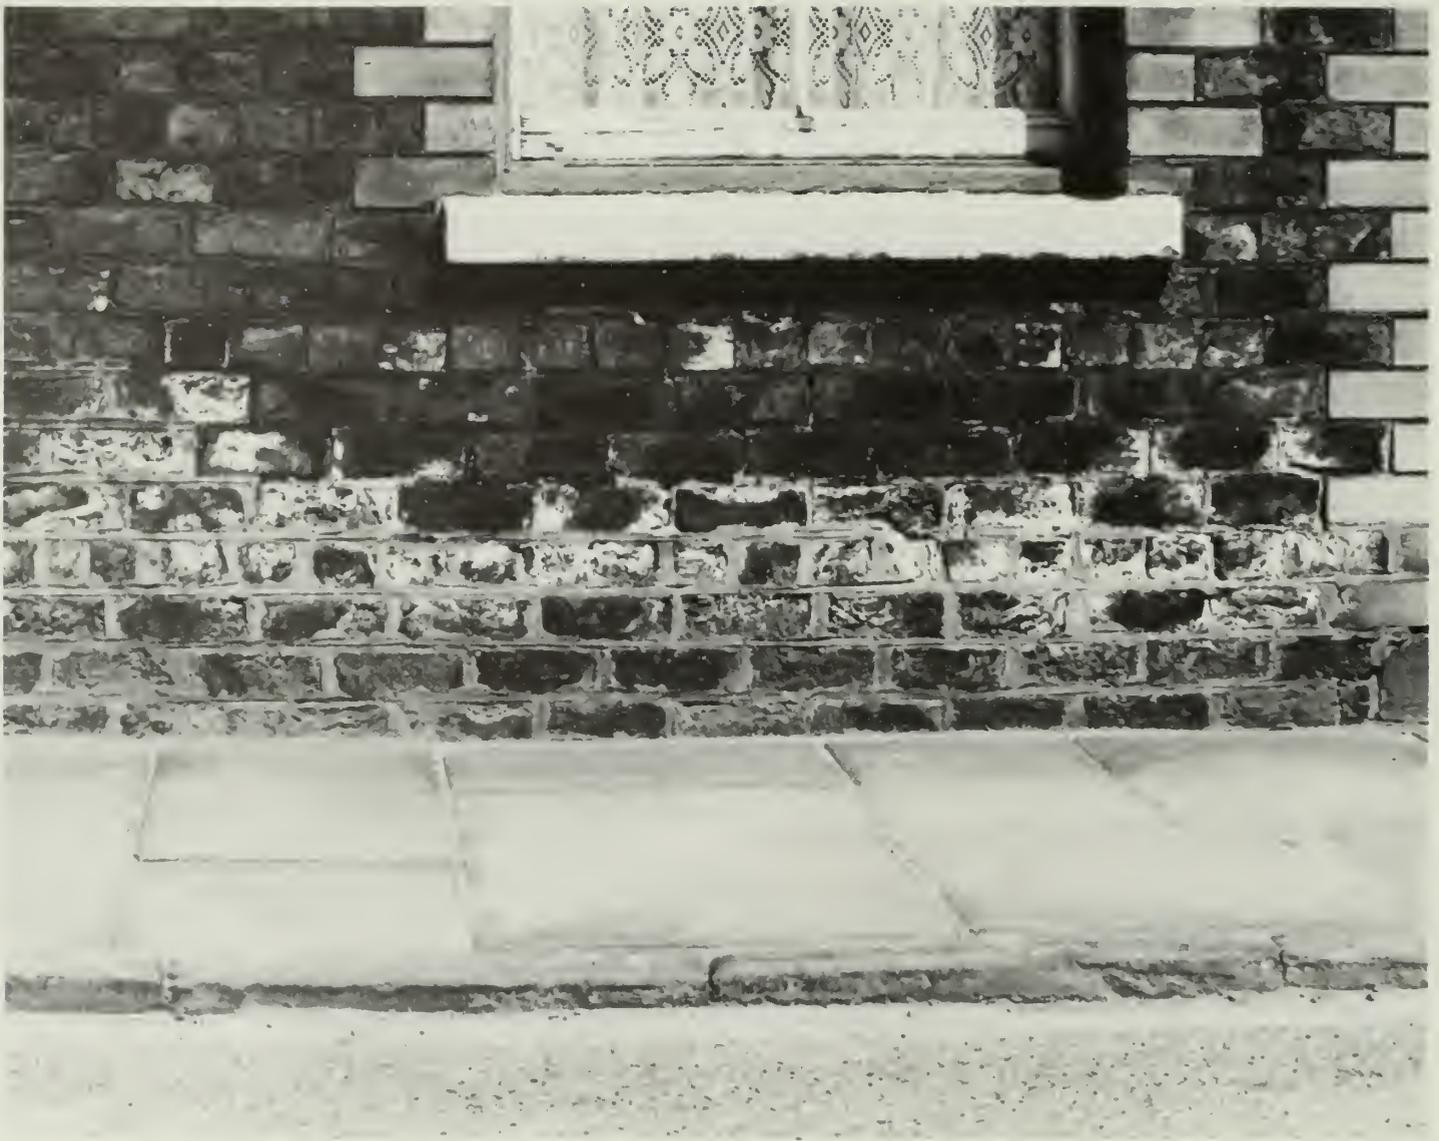
figure 10

Typical horizontal tide mark. The efflorescence gradually disappears above the tide mark. Photograph: Baird M. Smith

is generally identifiable by a horizontal stain or "tide mark" on the wall. The tide mark is formed at the point where equilibrium has been reached between capillarity and evaporation, thus leaving large, visible accumulations of crystallized salts, called "efflorescence." Below the tide mark, moisture is rising through capillarity. This area often appears damp. Efflorescence is unusual below the tide mark because the high moisture content retains the salts in solution, although there is continual evaporation. Above the tide mark, the

moisture content in the wall can vary as the equilibrium changes with the weather. In this transition area, the moisture content is sometimes high enough to support capillarity; at other times only water vapor is present. In the transition area, salts are brought to the surface, leaving a band of salt crystals above the tide mark.

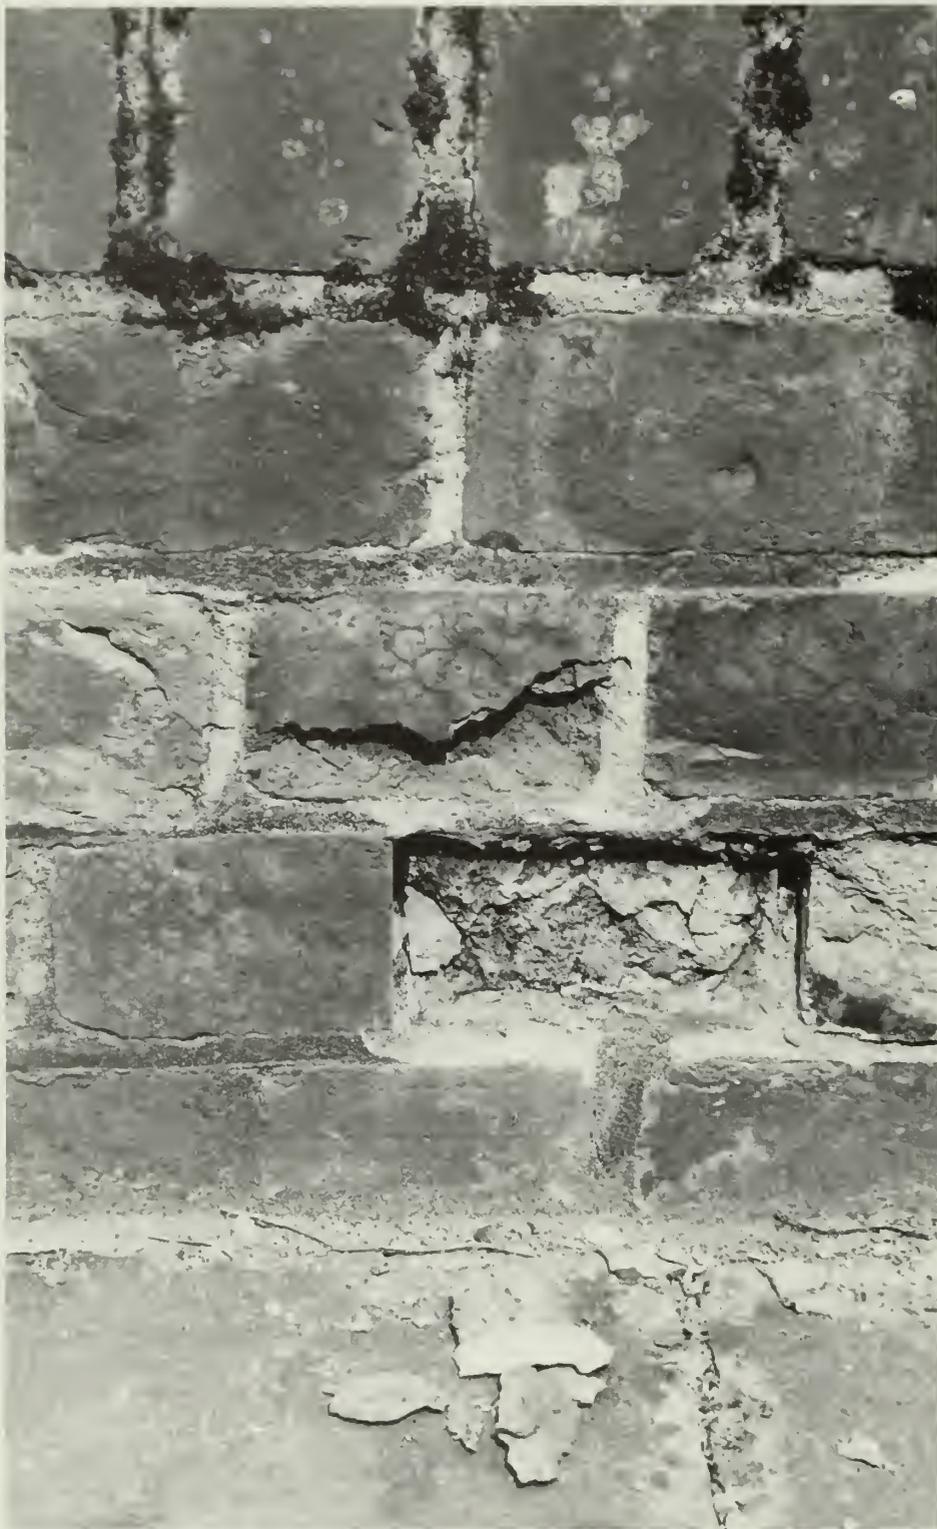
figure 16

Typical freeze damage to brick. Since the damage has occurred at the base of the wall, rain splash-up would be suspected as the source of the moisture. Damage from freezing moisture in porous materials is very common. Photograph: Baird M. Smith.

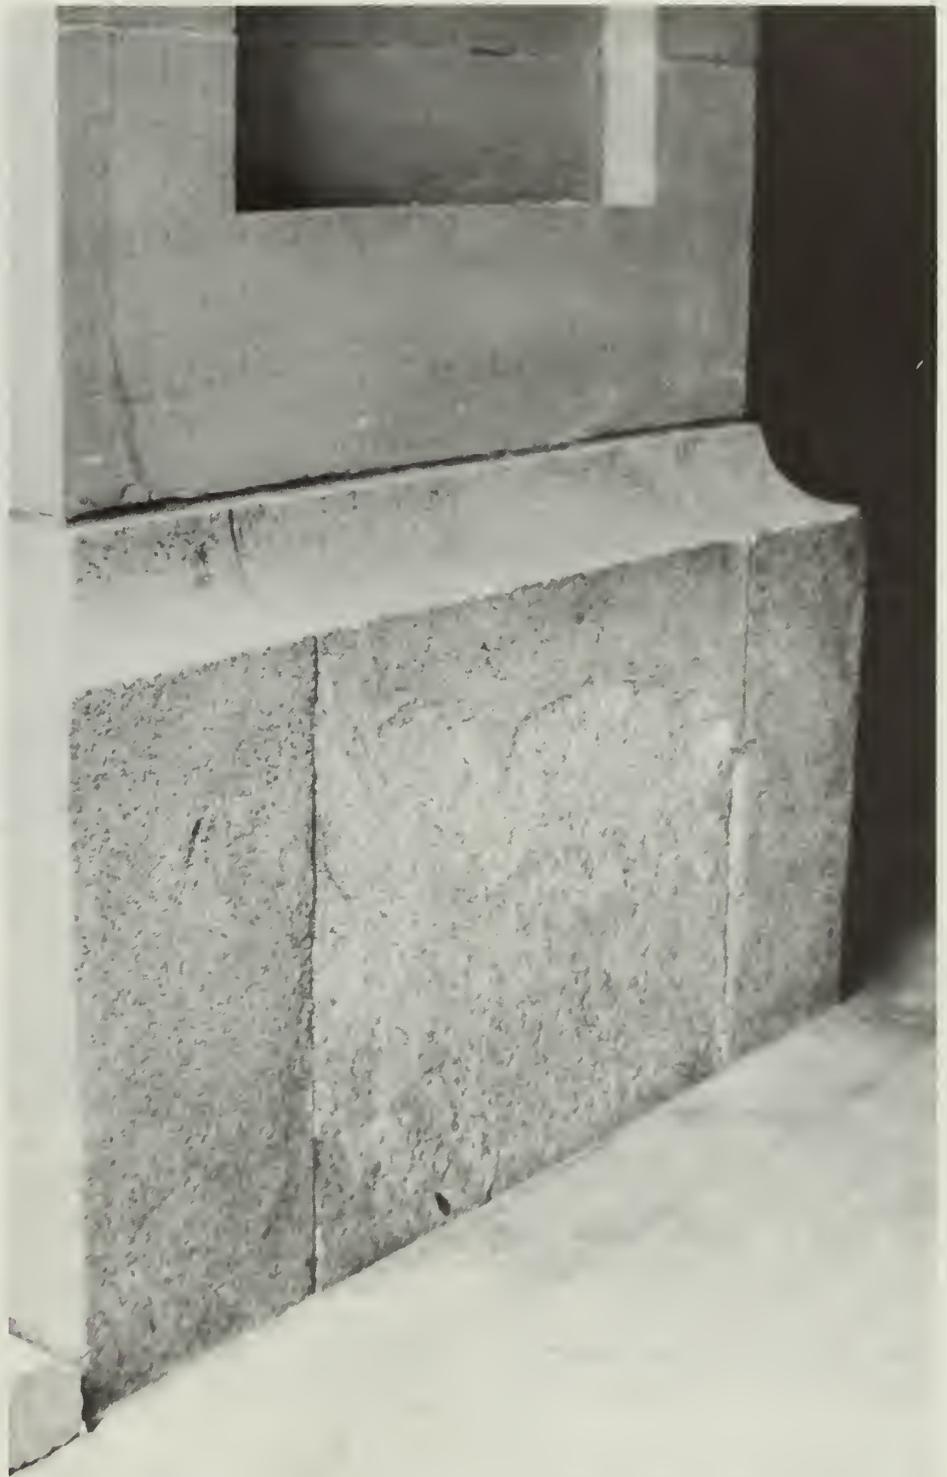
figure 17

Freeze damage to granite. Granite is a very hard stone and generally very durable, but internal pressure from freezing water within the very tiny pore structure of the stone can cause fracturing.

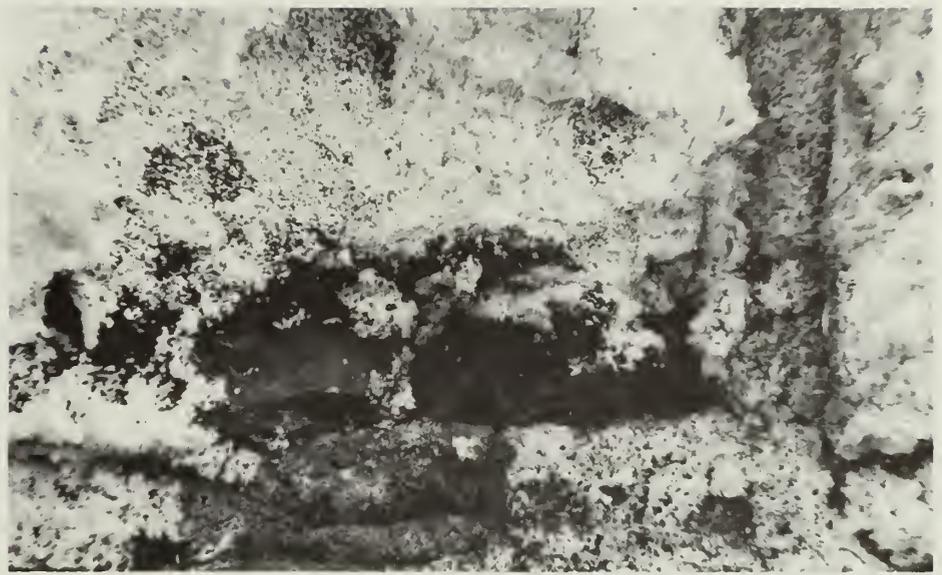
figure 19

Close-up view of efflorescence (scale: approximately full size). Identification of the types of salt in a patch of efflorescence by sight or taste is unreliable. Laboratory tests should be considered to identify the type of salt, and therefore, possibly the source of the moisture.

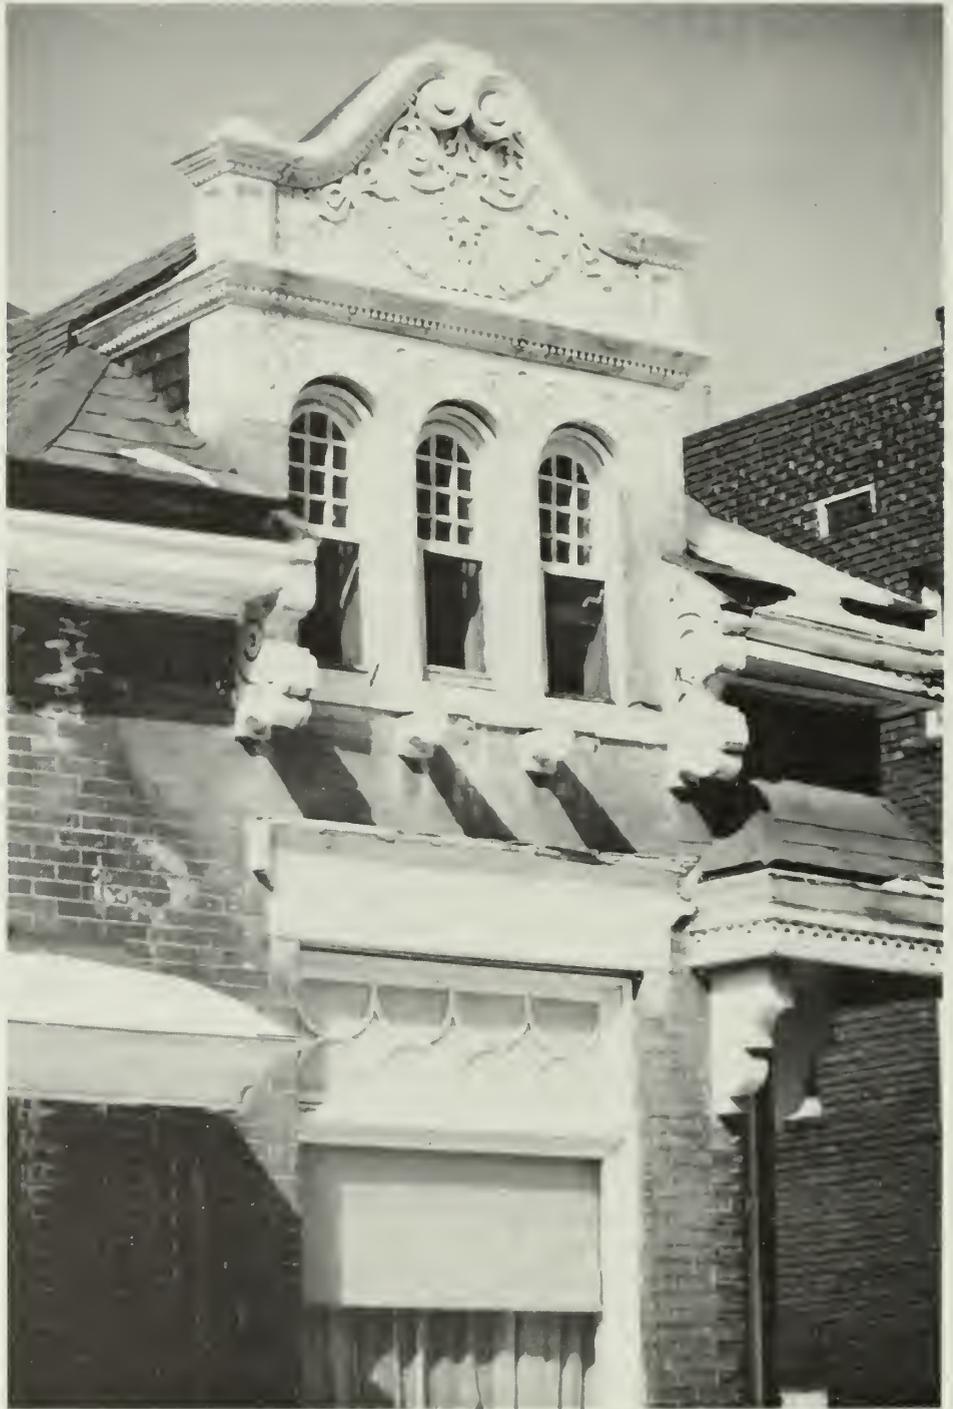
figure 28

Typical evidence of moisture problems. Investigation would record location, extent, and nature of moisture staining and condition of all metal gutters, downspouts, and flashings. This would in turn be correlated with evidence collected during interior inspections to determine if water is gaining access.

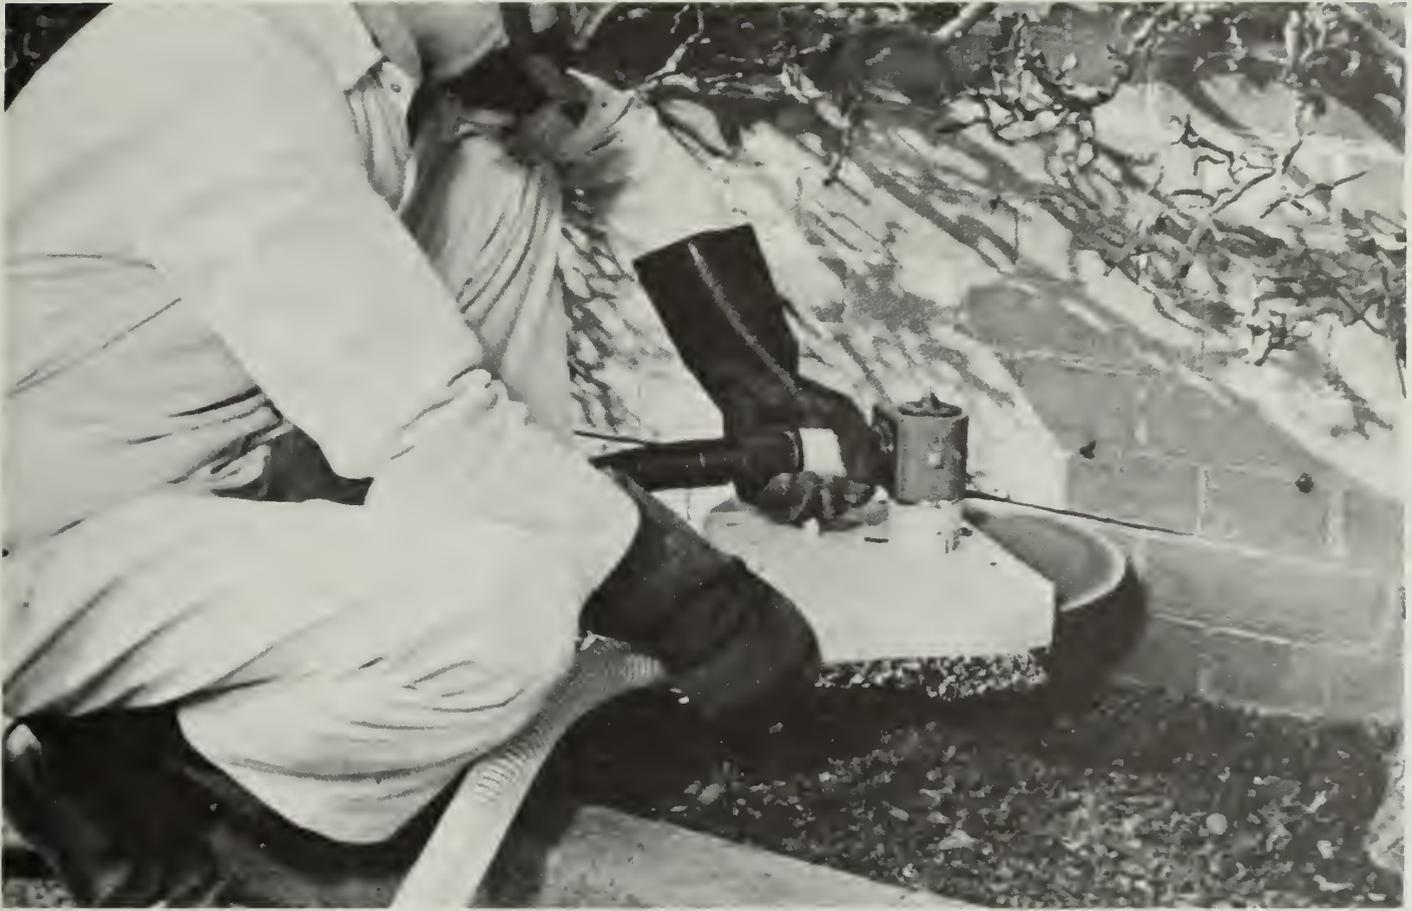
figure 30

Masonry saw with dust extractor. This saw is used to cut a narrow slot in a continuous masonry joint to allow the insertion of a physical damp course. When it is accessible from both sides, a wall up to 13 in. thick can be cut with this equipment.

Another type of physical damp course involves the use of damp proof ("flashing") materials inserted into a cut-out mortar joint. The flashings generally come in three-foot wide rolls (which are then cut down to the width of the wall) and consist of semi-rigid sheets of bituminized felt, impregnated

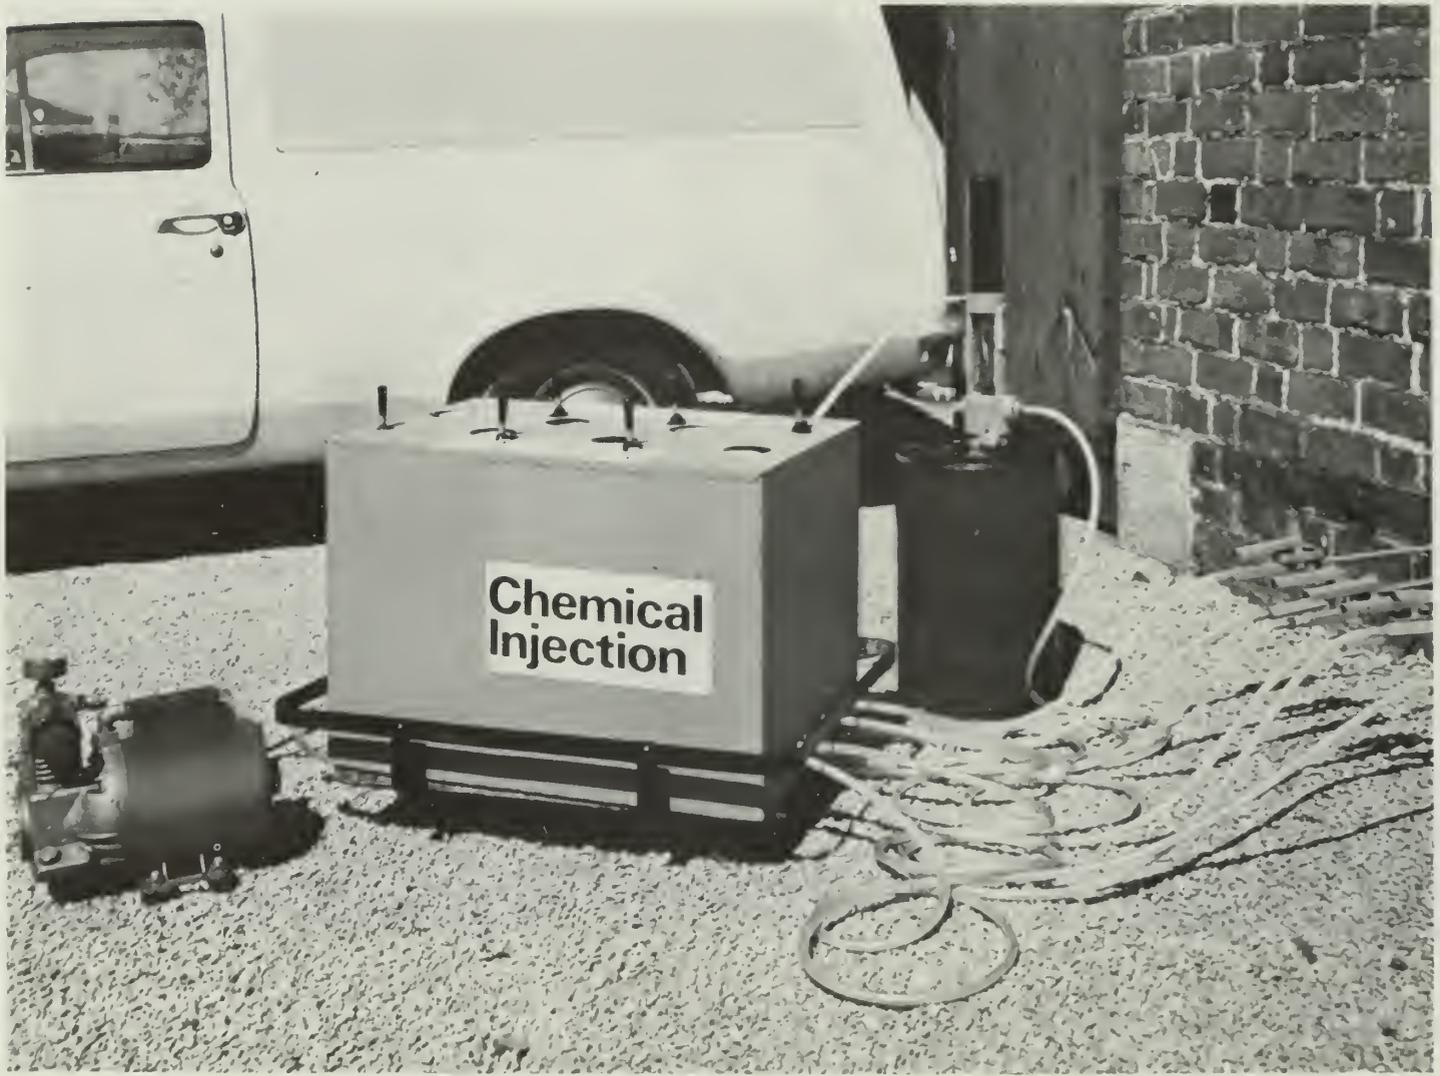
figure 31

Chemical injection process. Solutions are injected under pressure into pre-drilled holes. The process is complete when the brick surfaces appear wet. The chemicals then cure into a waterproof horizontal zone. Photograph: SPI Chemical Injection, Inc.
