# Damaged and Threatened National Historic Landmarks 1988 Report

**Damaged and Threatened  
National Historic Landmarks  
1988 Report**

Compiled by  
Camille M. Martone

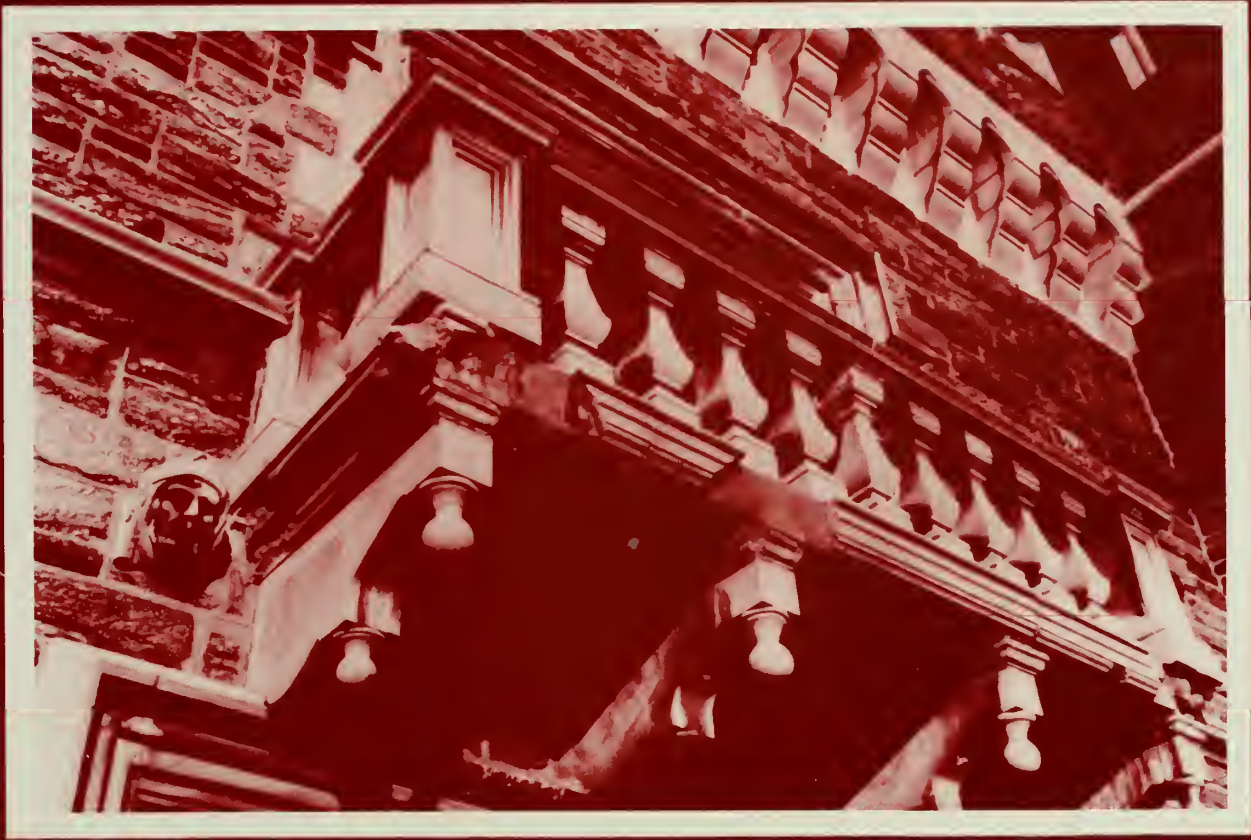
*Cover: Grey Towers, Glenside, PA. Built in 1893 for a wealthy sugar refiner, Grey Towers is an outstanding example of an American medieval "castle." This limestone balcony is cracking and spalling, and will need to be repaired and restored to prevent further damage. Other exterior features are also in need of repair. Listed as a Priority 2 landmark in the Section 8 Report, Grey Towers exhibits potentially serious damage and over \$577,000 is needed for preservation work. Photo: John Milner Associates.*

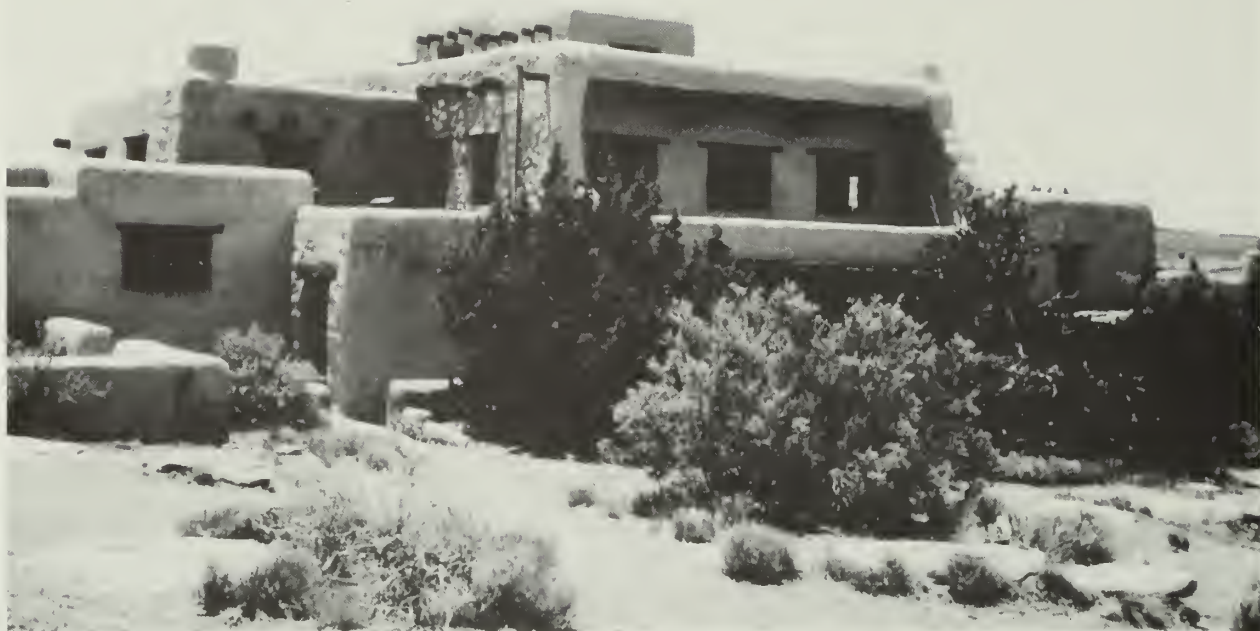
*Painted Desert Inn, Petrified Forest National Park, AZ. This Landmark, built in 1937, is a Pueblo Revival style structure with highly notable interior features. Water penetration in the roof has caused structural damage and is beginning to damage significant interior murals. Photo: H. Ward Jandl.*

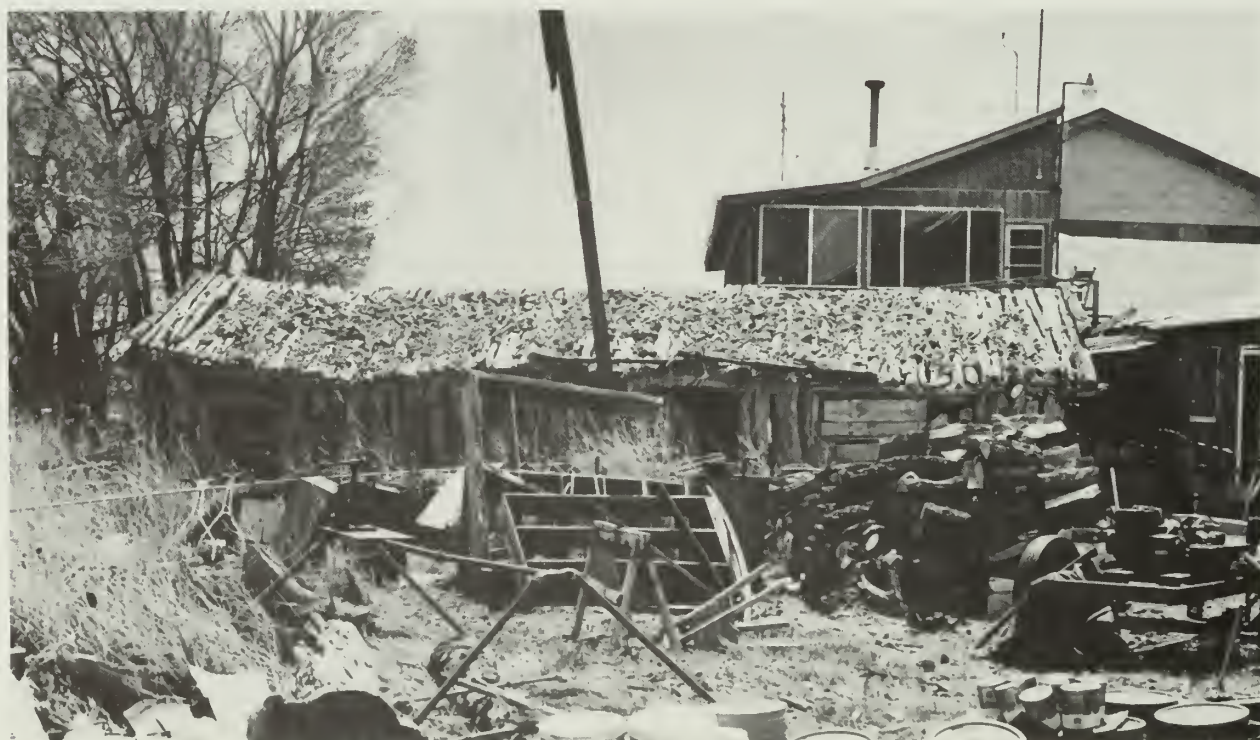
*Fort Ruby, White Pine County, NV. This structure is the former Fort Ruby Headquarters and one of the only four extant pre-1870 log structures in Nevada. It is a rare example of palisade log construction. The structure has not been maintained and is in poor condition. New construction close to the historic log structures has altered their archeological and visual integrity. Photo: Holly Dunbar.*

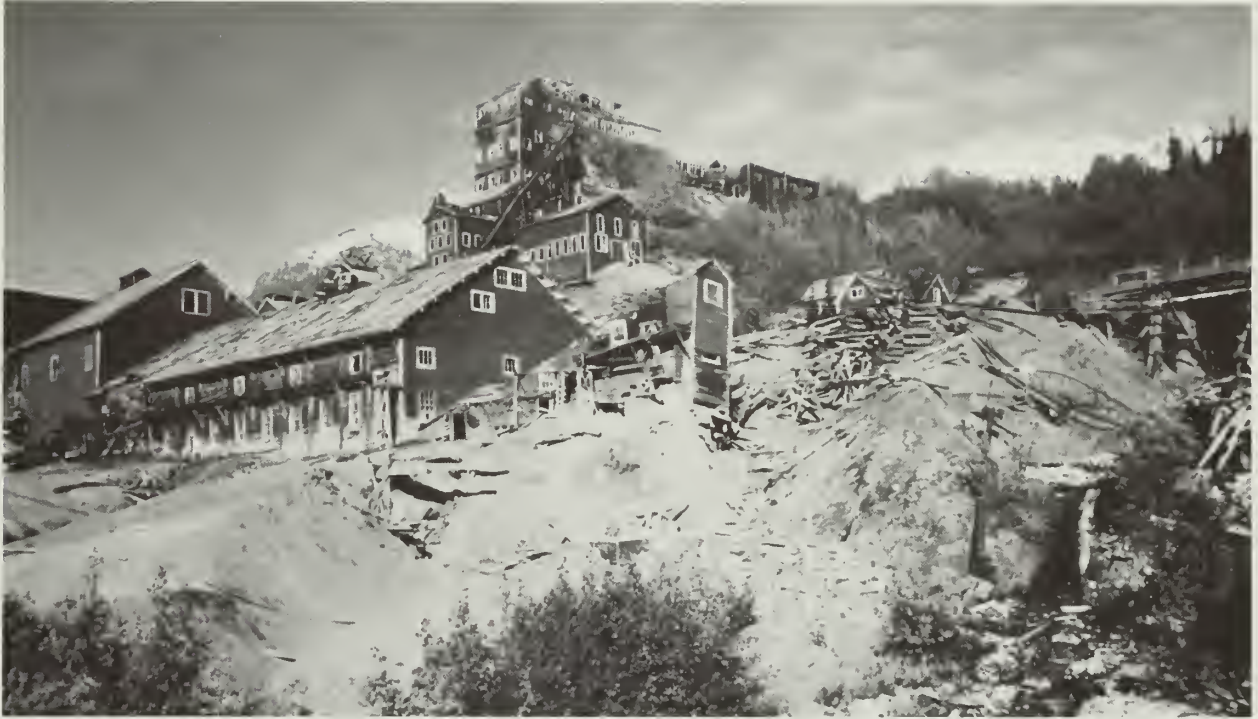
*Kennecott Mines, Kennecott, AK. This complex is the best remaining example of an early 20th-century copper mining camp in the nation. The Landmark includes the mill town, mine camps, and a tramway system. The major industrial structures have not been maintained since the complex's closing in 1938. This photo of the leaching plant and mill illustrates the extensive deterioration. Photo: NPS Files.*

**Threat/Damage: Severe Physical Deterioration.** The threats or damages to this landmark include deterioration of structures and lack of maintenance. The major industrial structures, buildings at the mine entrances, and the mines themselves have not been maintained for 50 years. Many are at a critical point beyond which preservation will not be possible. Others, while in better condition, have been damaged by previous attempts at salvage of building materials and made more vulnerable to weather-caused deterioration. The roof of the mill building was removed in such an attempt. Many windows are broken. For many years the Kennecott Mines complex could be reached only by travel over a seldom maintained road or by air. Sale of individual lots within the complex has recently increased visitation. It is only a matter of time until the increased human presence at Kennecott results in destruction of one or more buildings by fire or vandalism.

**Recommended Action: Repair Damage/Deterioration, Education and Technical Assistance.** Damage to the structures should be repaired. Public education of the resource's significance as well as technical assistance to the owners in carrying out suitable preservation actions are necessary. HABS/HAER recording that documented the industrial buildings was completed in 1985.

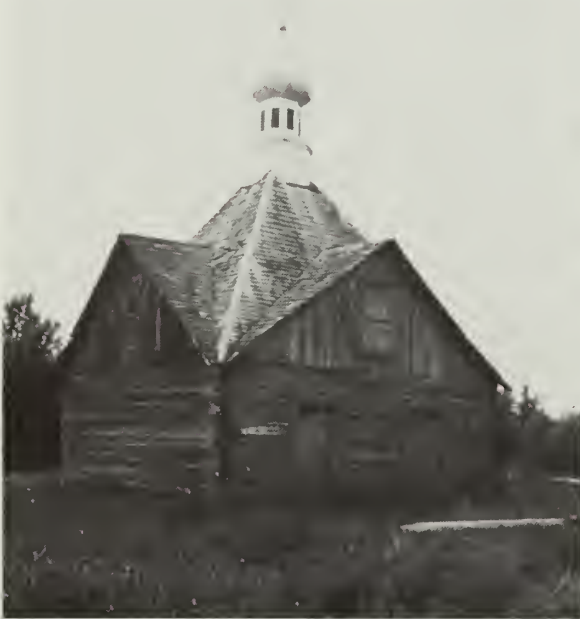
*Chapel of St. Nicholas at Holy Assumption Orthodox Church, Kenai, AK. This Landmark which includes the church, rectory, cemetery, and chapel, has been the principal and most enduring representative of Russian culture in south central Alaska from 1841 to the present. The Chapel of St. Nicholas is an outstanding example of Russian log construction. The structure is minimally used and maintained, one wall is collapsing, and doors and windows are missing. Photo: NPS Files.*

**Threat/Damage:** Severe Physical Deterioration. The south wall of the chapel is collapsing and doors and windows are missing. Limited funds available to the parish have been used to maintain the main church building only. There is strong interest in preserving the chapel, but insufficient funds to do so. In 1985, an indepth inspection of the church and chapel was sponsored by the National Park Service as part of the Service's expanded technical assistance to endangered NHLs.

**Recommended Action:** Stabilization. Repairing the damage and deterioration identified in the National Park Service condition assessment report and making the building secure is recommended. Sources of funding need to be identified and

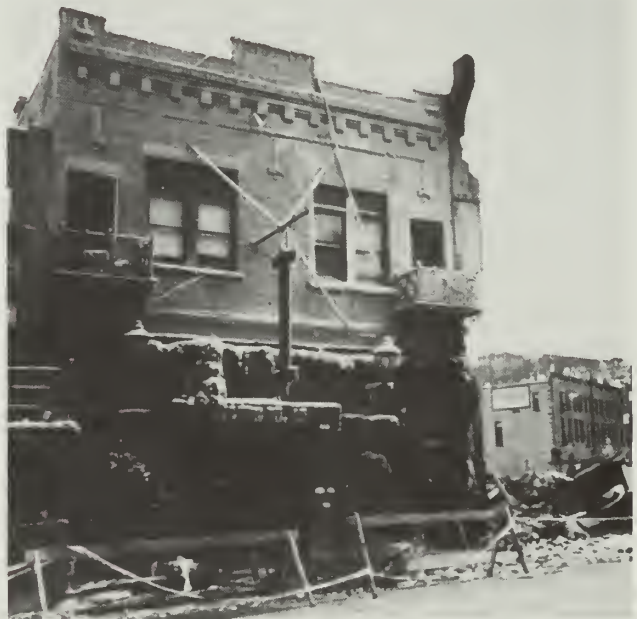
*Deadwood Historic District, Deadwood, SD. Deadwood is significant as the site of a rich gold strike in 1875. The historic district contains commercial and residential structures of the mining town. Many structures in the district are being radically altered by inappropriate renovation work. Other structures are deteriorated and abandoned. A fire destroyed two commercial structures adjacent to Saloon #10 as seen in this illustration. Photo: Ken Loeschke.*

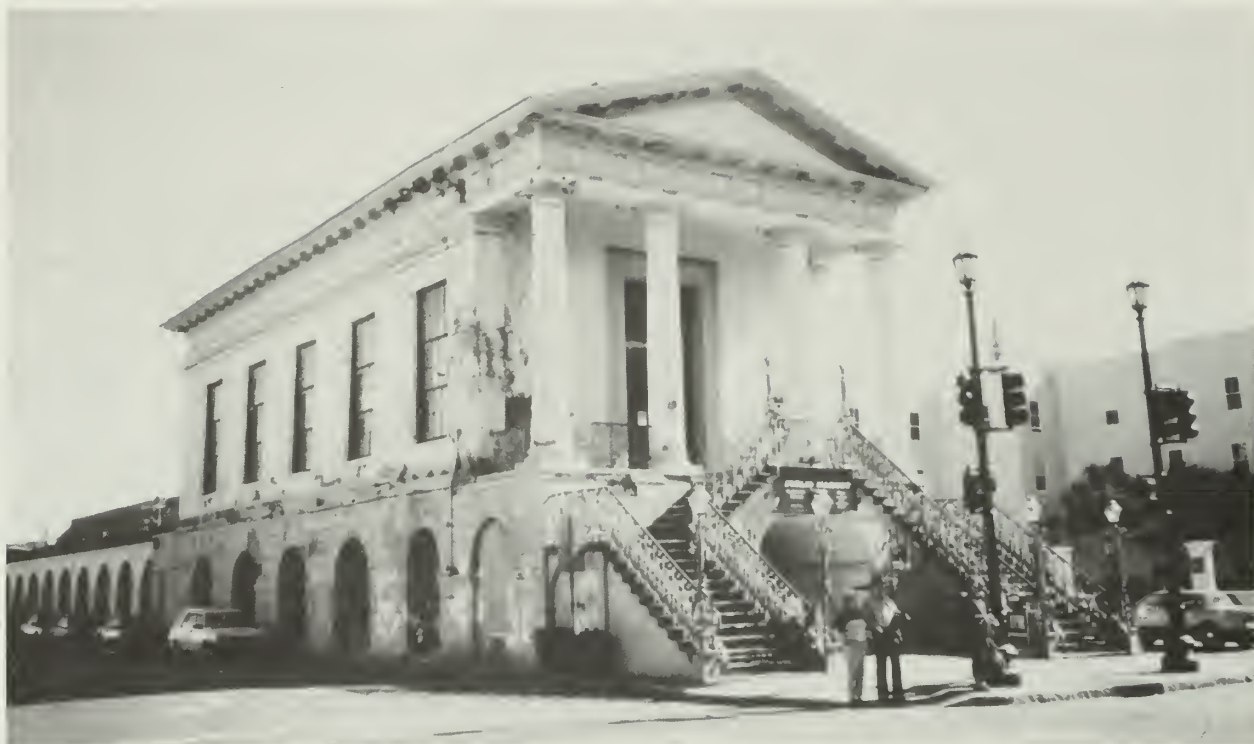
*Market Hall and Sheds, Charleston, S.C. This Landmark, built in 1841, is an excellent example of Greek Revival Architecture and is one of the few remaining 19th-century market complexes in the U.S. Moisture problems are causing severe deterioration to the building's exterior. Photo: Lee H. Nelson, FAIA.*

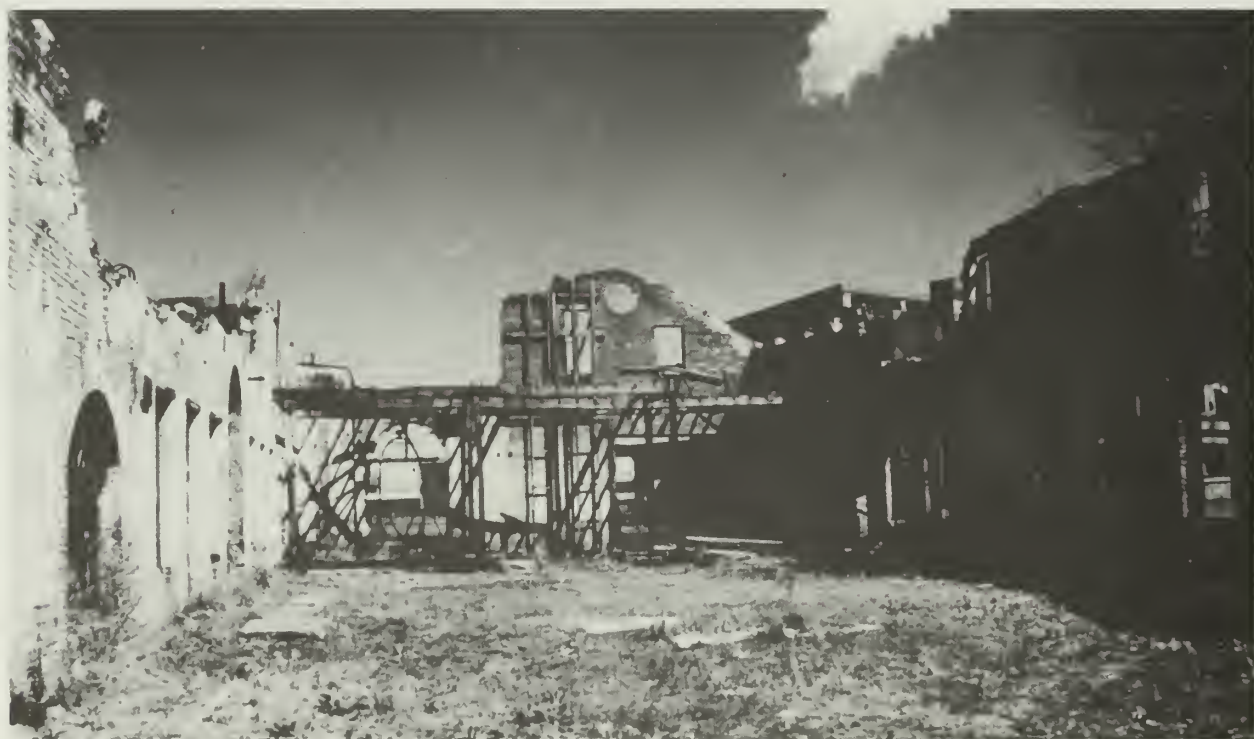
*Central of Georgia Railroad Shops and Terminal, Savannah, GA. This Landmark is the oldest and best surviving example of a mid-19th century integrated railroad shops complex in the U.S. Although the head house and trainshed are in good condition, shop structures, as these illustrated, are vacant and severely deteriorated. Fires have gutted some shops, and in some cases destroyed large roof sections. Photo: Paul Hawke.*

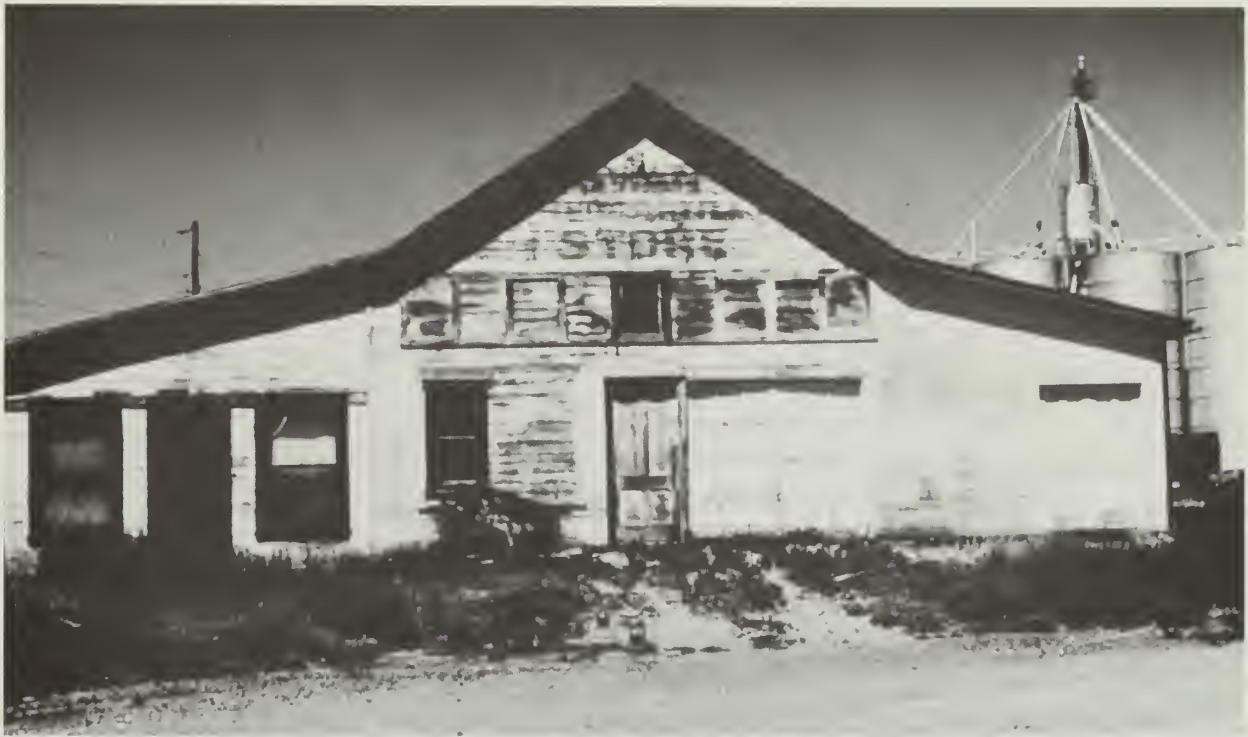
*Swan Land and Cattle Company Headquarters, Platte County, WY. The Swan Land Cattle Company was organized in Scotland and was one of the foreign concerns that flourished in the west when the range cattle industry was profitable. This illustration is of the general store, one of the surviving ranch structures. Structures are largely abandoned and are deteriorating. Photo: NPS Files.*

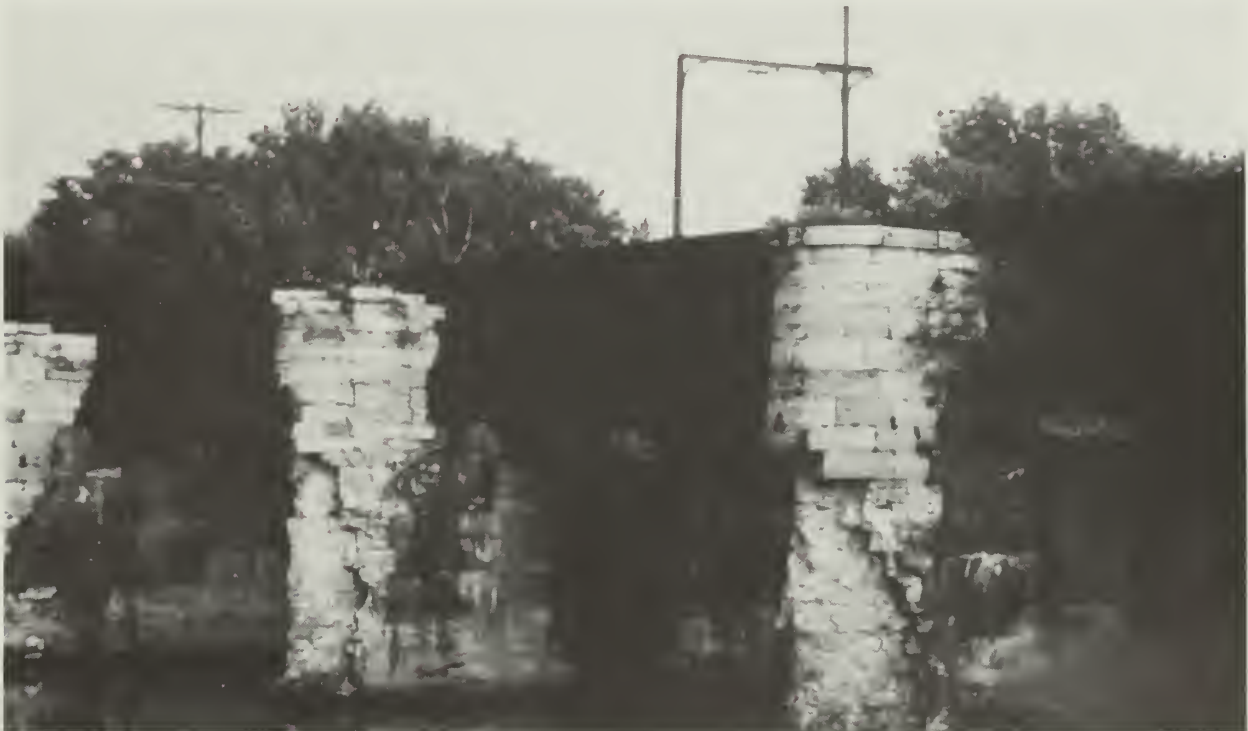
*Illinois and Michigan Canal Locks and Towpath, Will County, IL. The canal linked Chicago to the Mississippi River, and completed a continuous waterway to New York City making Chicago a leading grain market and meat packing center. The canal encompasses locks and other engineering structures associated with the operation of the Canal. This illustration is of the Fox River aqueduct, the most seriously threatened structure. The structure is spalling, there are voids in the limestone, and it is in danger of collapsing. Photo: NPS Files.*

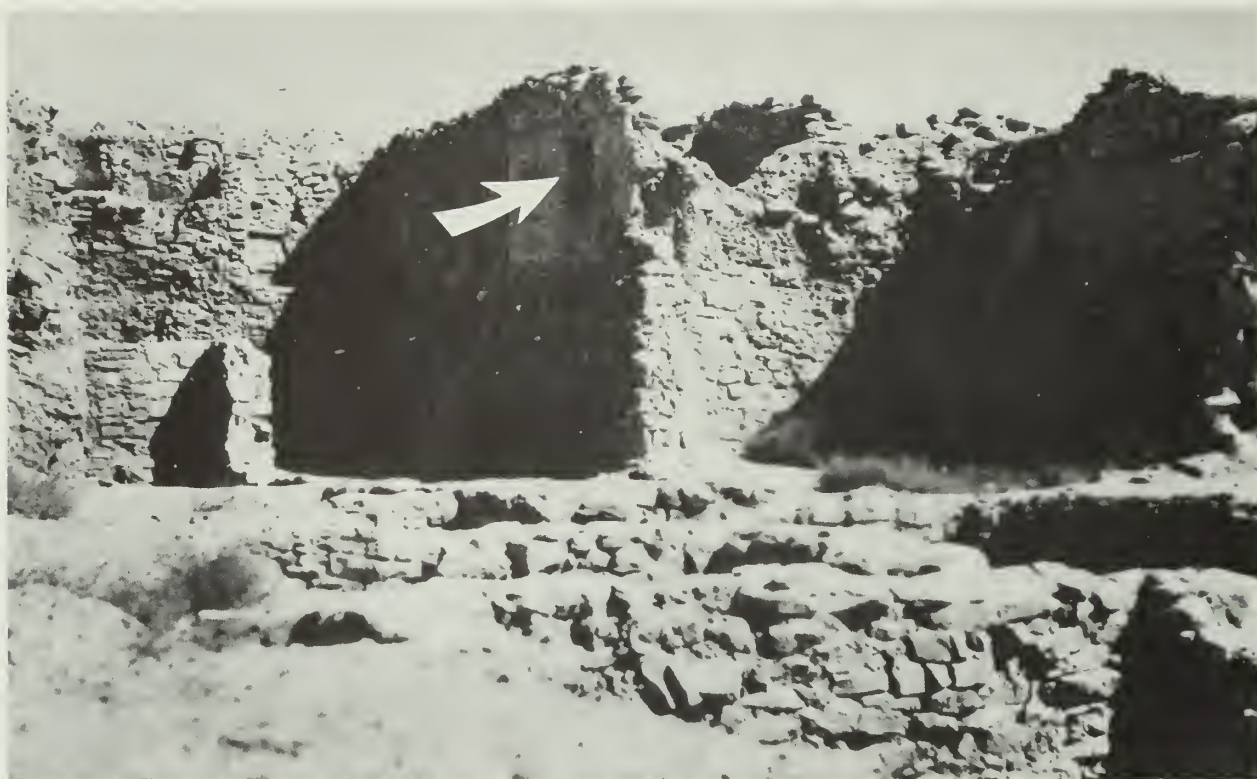
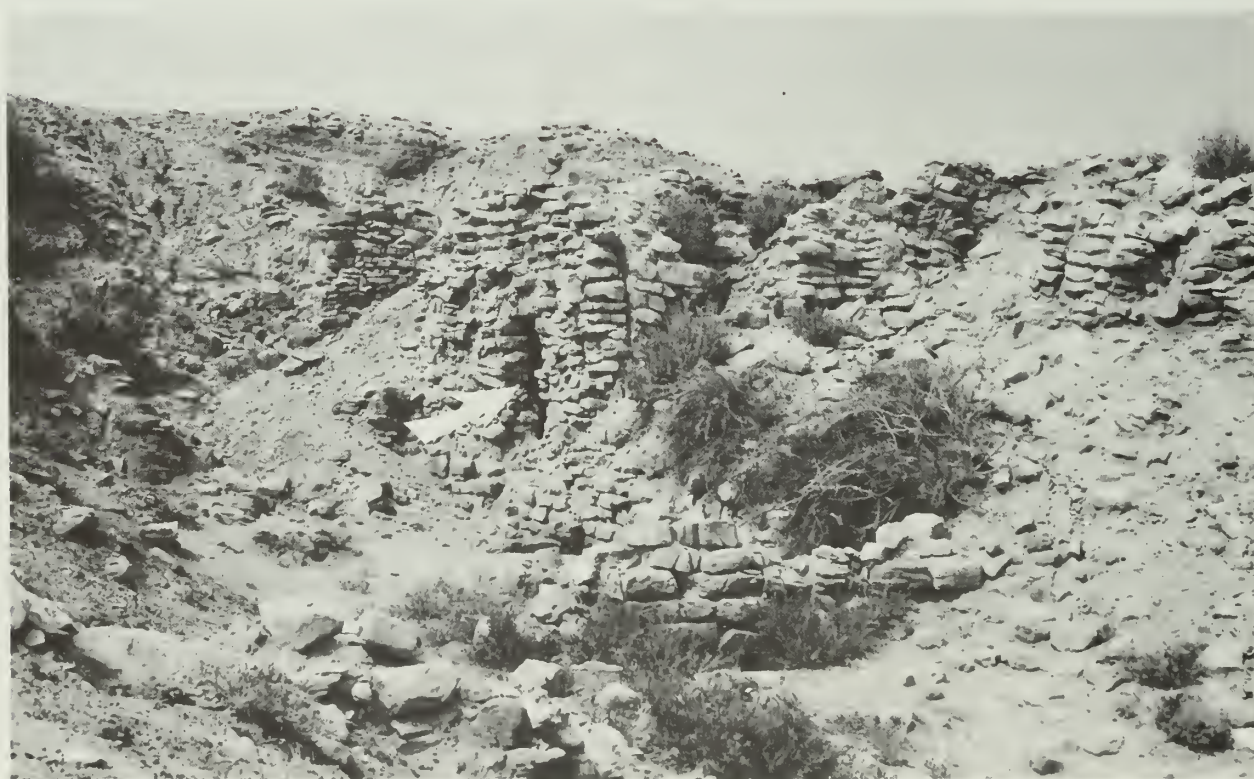
*Awatovi Ruins, Antelope Mesa, AZ. Awatovi Ruins is the site of one of the most important Hopi Indian villages, encountered by Coronado's men in 1540. It includes the remains of the pueblo and a 17th-century Spanish mission complex. Excavations conducted in the 1930's by the Peabody Museum left much of the pueblo uncovered. The site is eroding, and vandalism is occurring. Above: View of a prehistoric Western room block taken immediately following the clearing of this section of the Western mound by the Peabody expedition in 1937. Below: Same view taken from the same vantage point in 1988. The exposed ruin has deteriorated due to weathering and slumping, and walls have been lost or displaced. Arrows indicate displacement of wall opening from 1937 to 1988. Photos: Sally Dean.*

**Threat/Damage:** Severe Physical Deterioration and Inappropriate Construction/ Alterations. Deterioration of the pueblo accelerates yearly. A combination of factors contribute to its deterioration, including natural erosion, abandonment, neglect, new construction, alteration of existing buildings, recycling, and vandalism. In addition, intrusive concrete block repairs and additions, power lines, and television antennae have damaged historic materials and altered the historic appearance of the pueblo.

**Recommended Action:** Preservation and Stabilization. A preservation and stabilization program is needed to prevent further physical deterioration and to provide technical assistance and education to residents on stabilization, compatible rehabilitation, and modernization techniques. HABS/HAER recording of the existing pueblo, an indepth site inspection to assess contributing elements, and assistance to the Hopi Tribe in developing a management plan are also recommended.

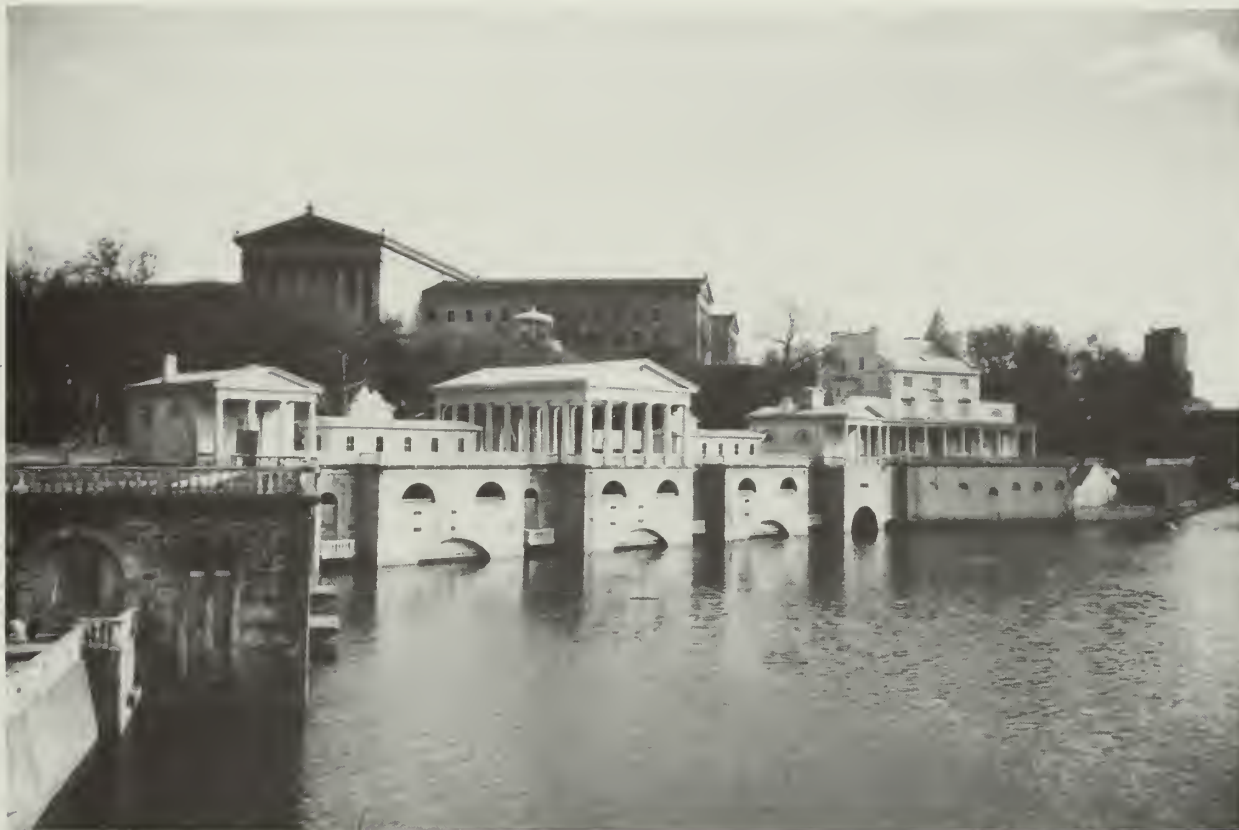
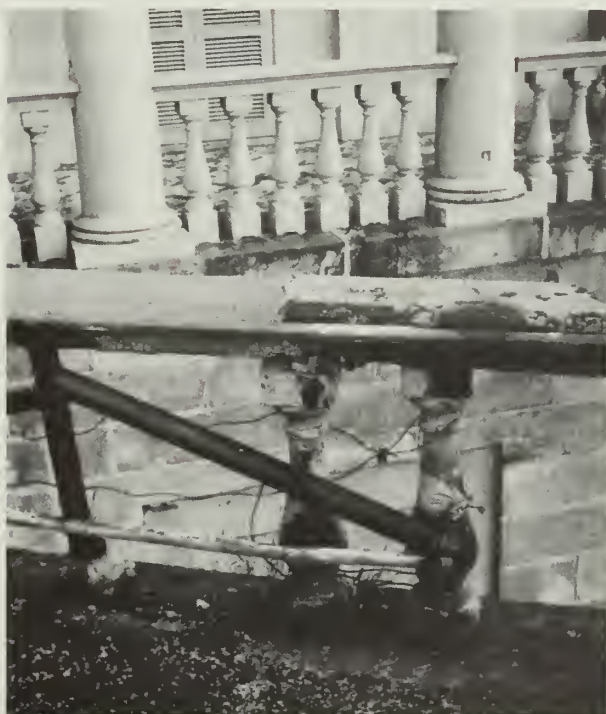
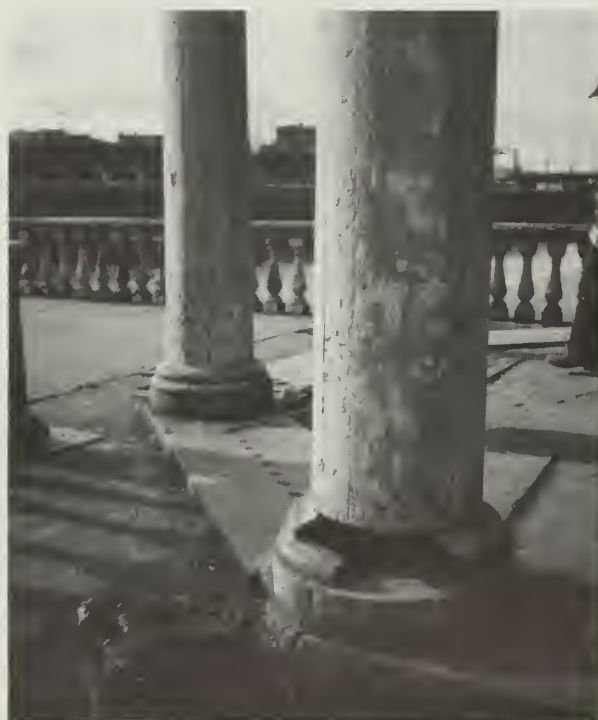
*Fairmount Waterworks, Philadelphia, PA. These mid-19th century waterworks were the first municipal waterworks to use paddle wheels to pump water and the first to replace them with turbine engines. Above: Overall view of the waterworks. Most of the historic structures are being repaired or rehabilitated, however, the ca. 1860 mill house, in the left foreground, is sustaining extensive damage to its iron supports. Below left: Deteriorated ballustrade above the ca. 1860 mill house. Below right: Deteriorated columns at the Little Pavilion (not pictured in overall photo). Photos: Camille Martone.*
