Cultural Landscape Report Manzanar National Historic Site

National Park Service
Pacific West Region
2006

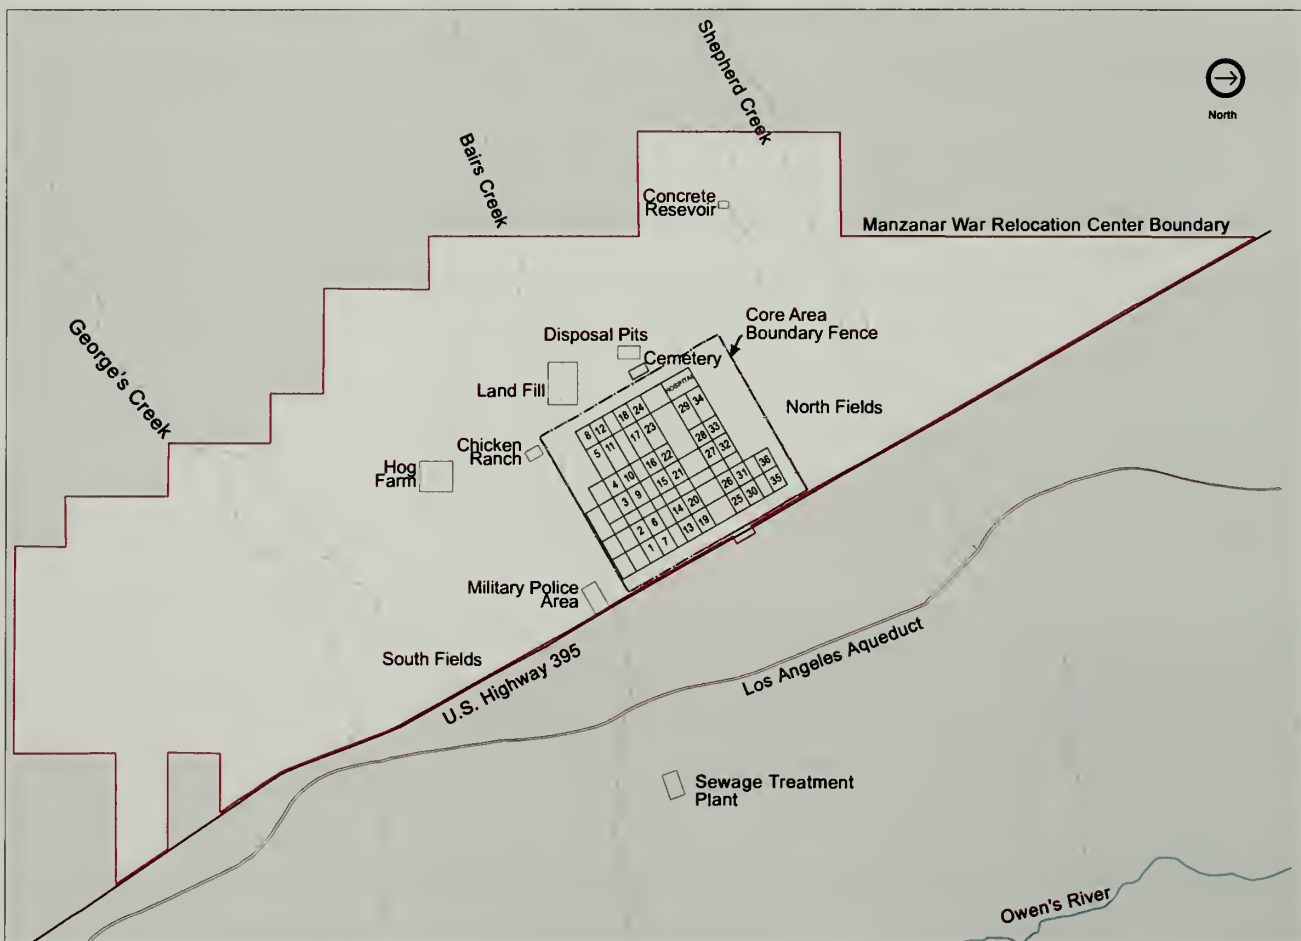
Figure 1. Study Boundary (Adapted from *Three Farewells to Manzanar*, WACC, 1996)

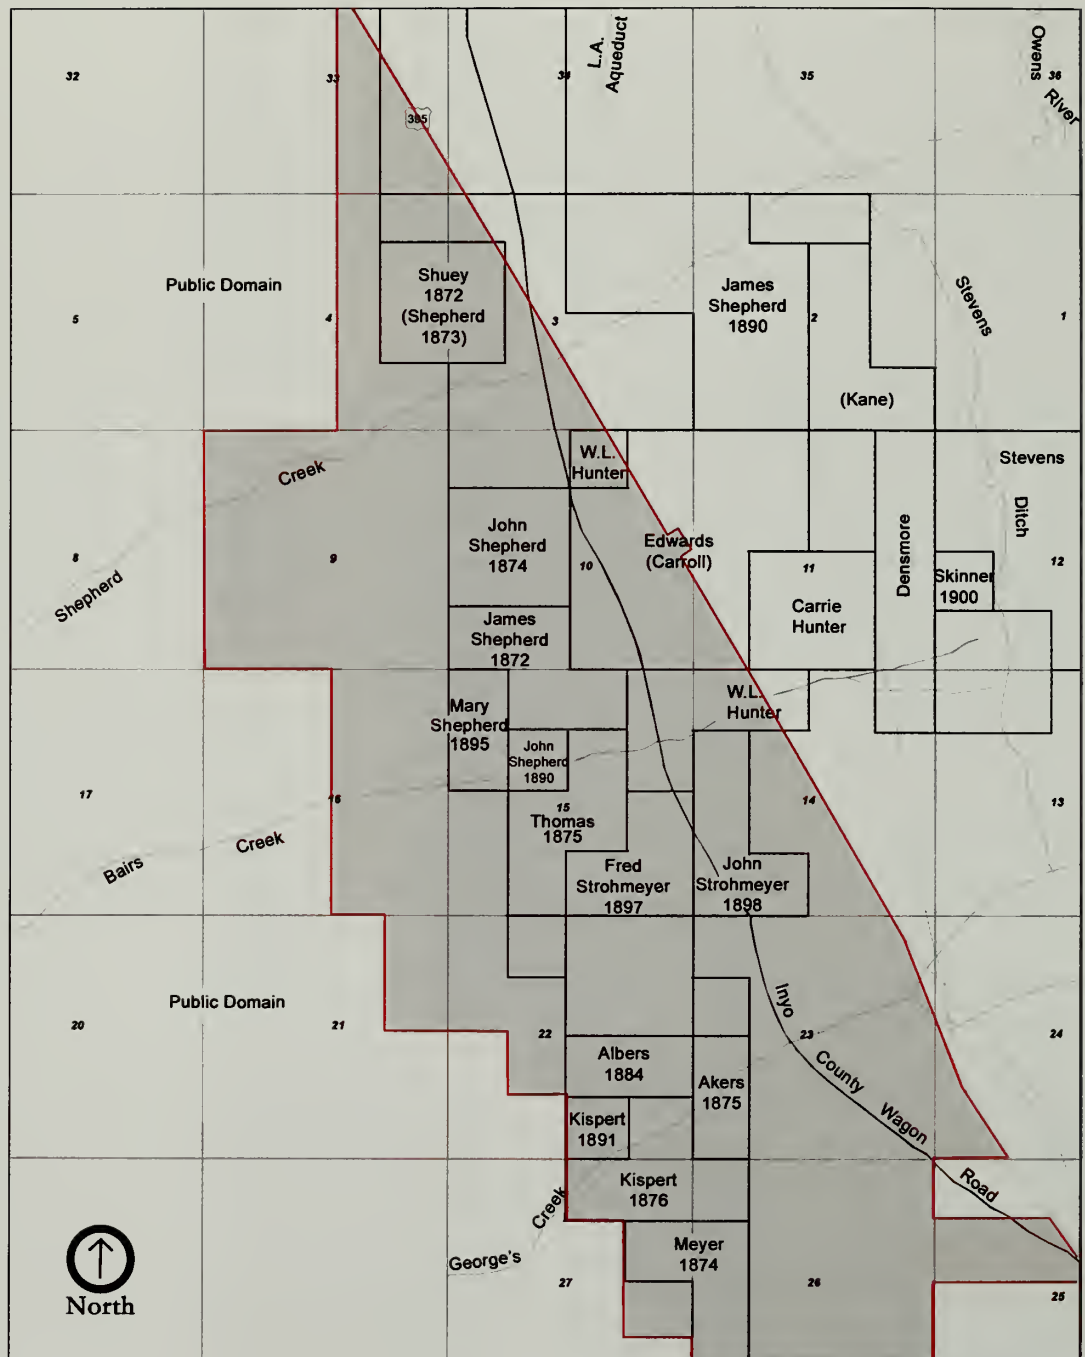
Figure 5. Map depicting land ownership in the Manzanar area, Owens Valley, ca. 1900. Shaded area shows the future boundary of the Manzanar War Relocation Center. (Adapted from *Three Farewells to Manzanar*, WACC 1966)

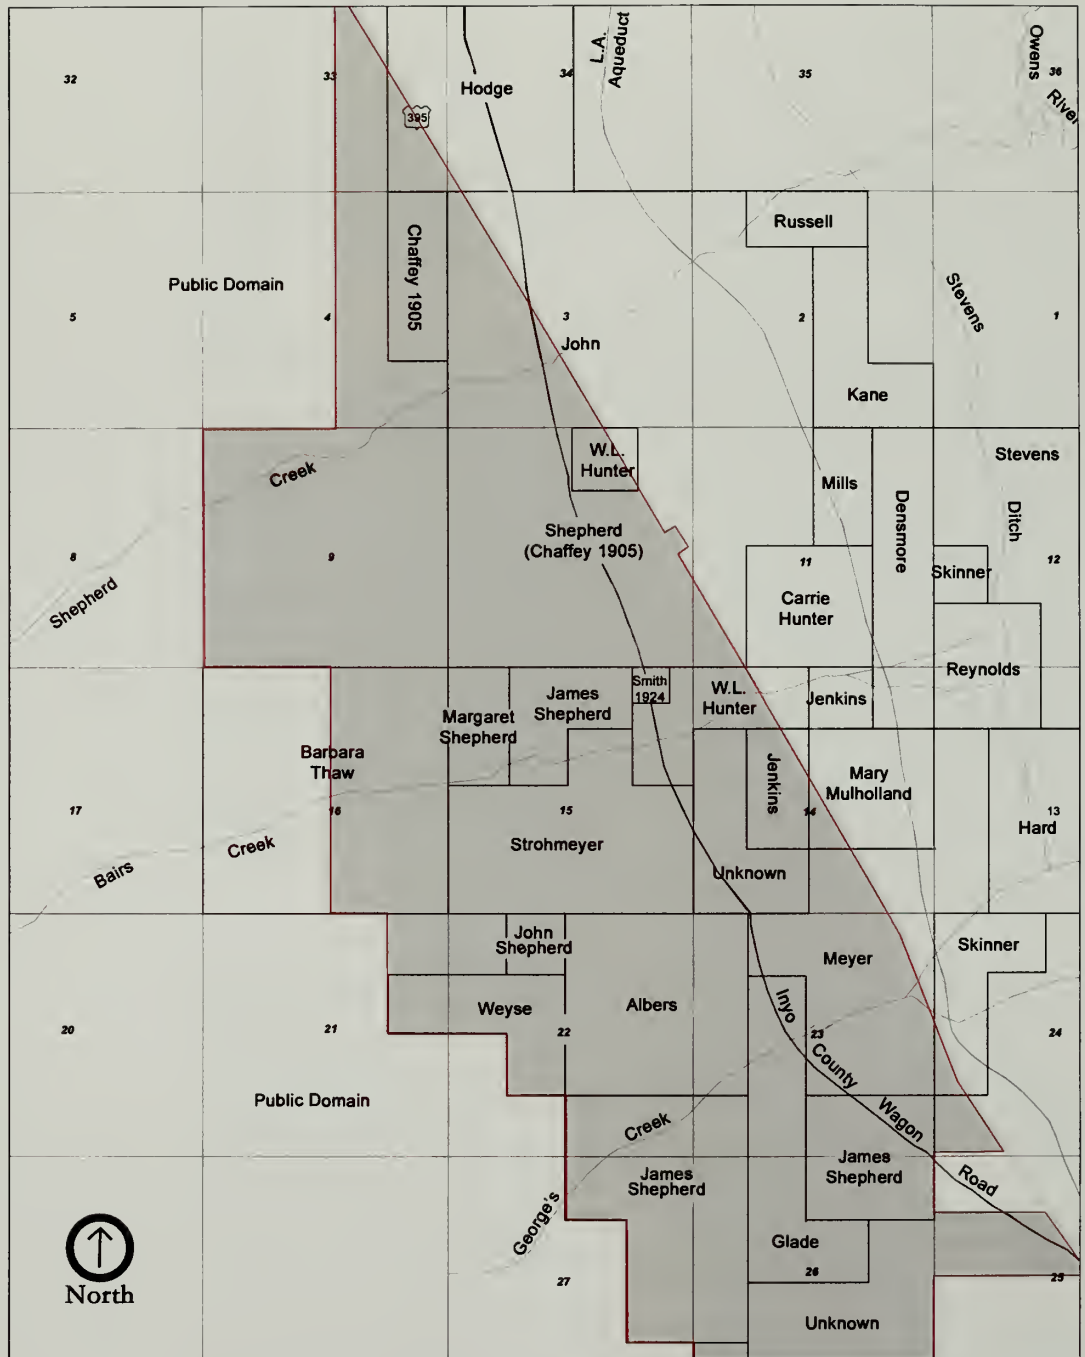
Figure 6. Map depicting land ownership in the Manzanar area, Owens Valley, ca. 1905. Shaded area shows the future boundary of the Manzanar War Relocation Center. (Adapted from *Three Farewells to Manzanar*, WACC 1996)

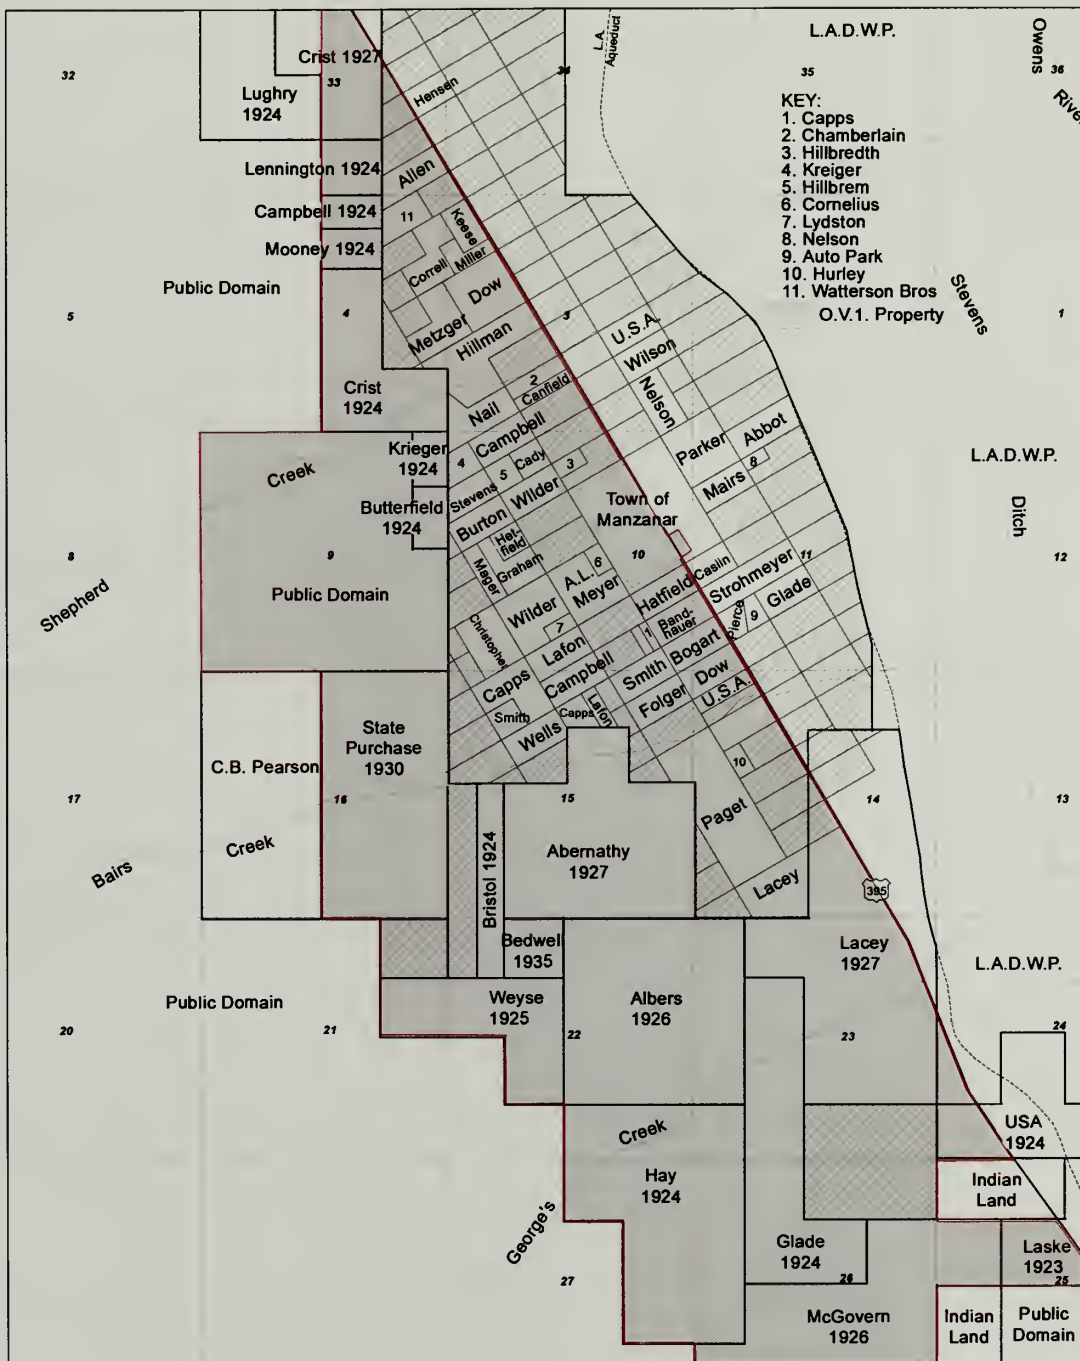
Figure 9. Map depicting land ownership for the town of Manzanar, 1927. (Adapted from *Three Farewells to Manzanar*, WACC 1996)

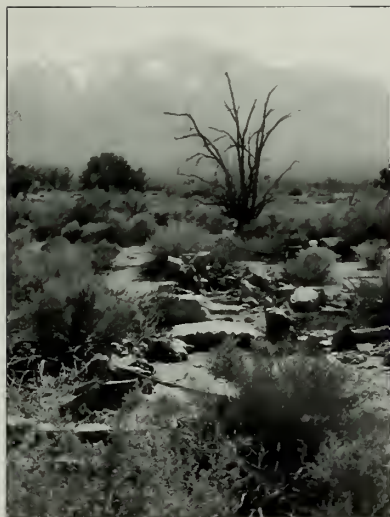
Figure 38. View of scrub vegetation spreading across a remnant rock and water garden in Block 35, barrack 2. View looking west. (NPS 2003)

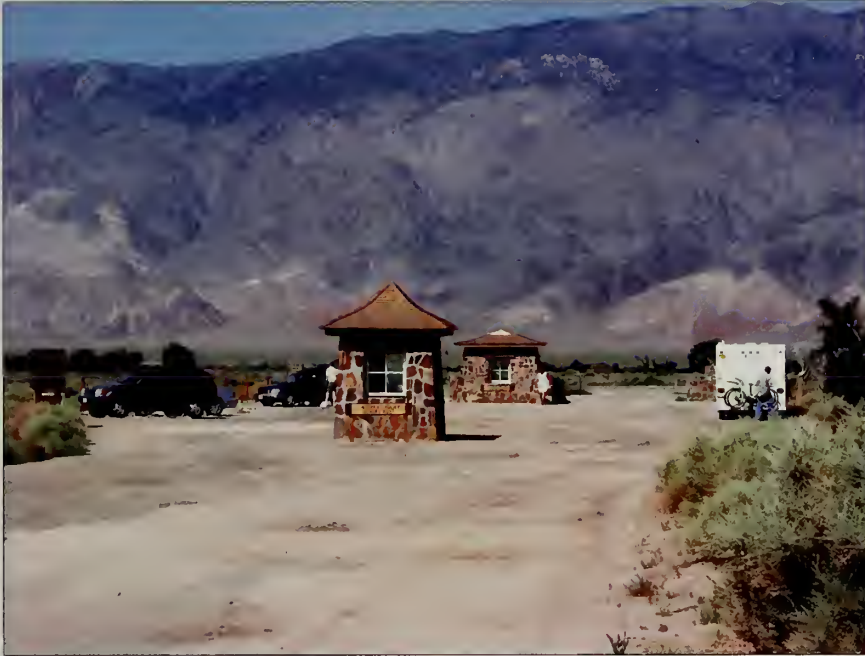
Figure 39. Internal Police Post (foreground) and Military Police Post at the entrance after restoration work. (NPS 2001)

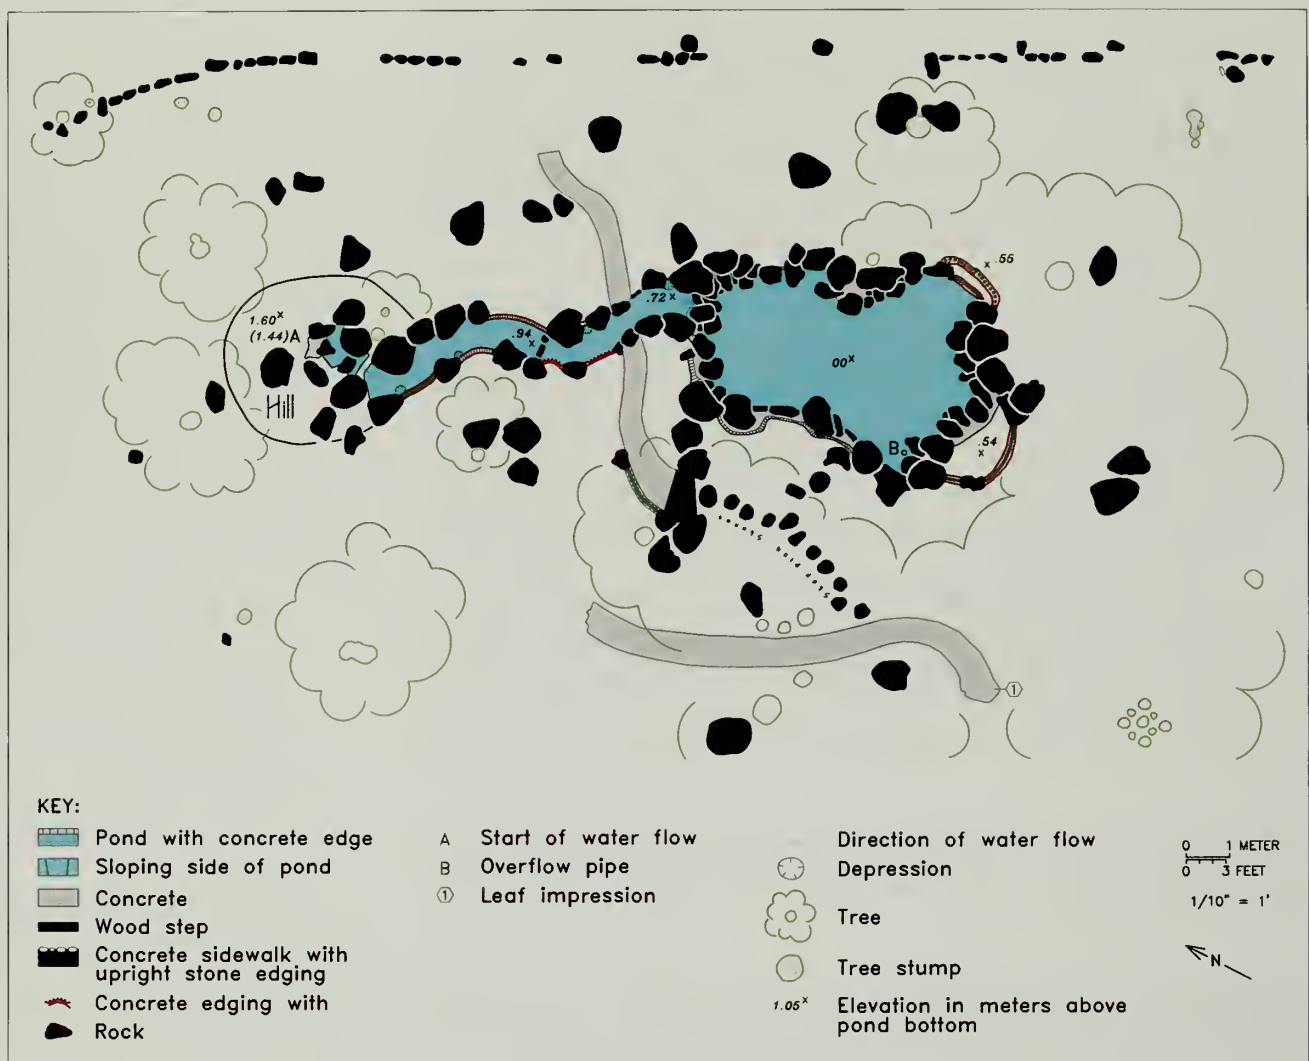
Figure 51. Archeological base map, Hospital Garden (Adapted from *Three Farewells to Manzanar*, WACC 1996. Drawing revised and updated by R. Beckwith, 1999)

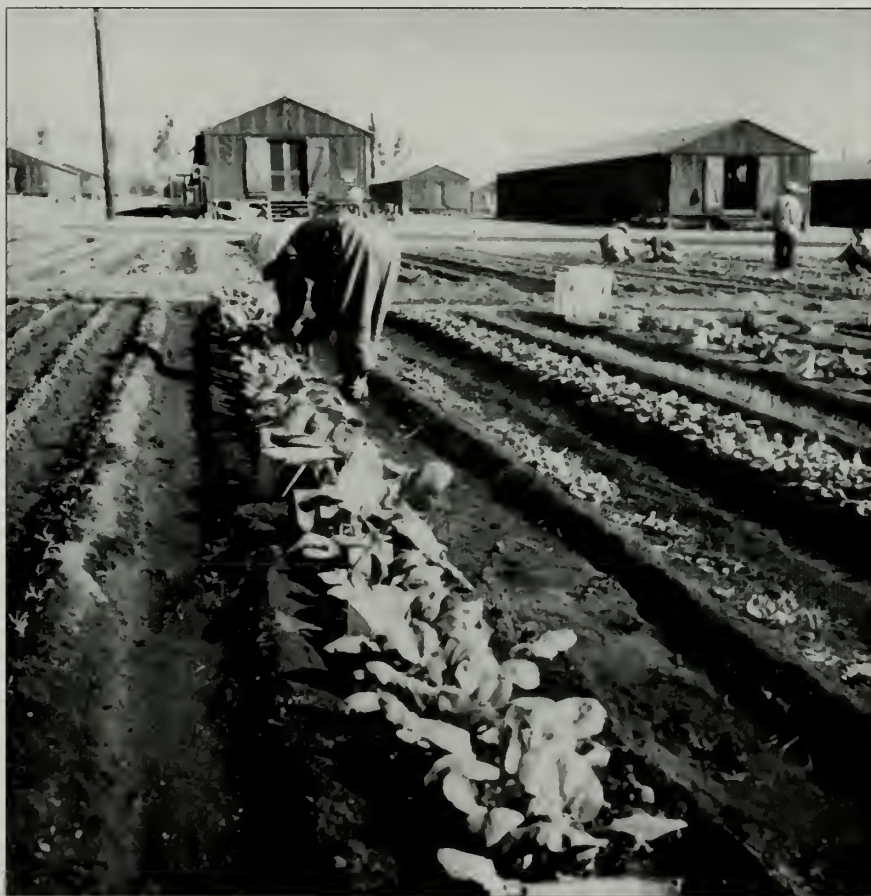
Figure 69. A system of earthen ditches and runoff from rain and snowmelt provided irrigation for the vegetables grown in the Victory gardens. The internees dug the ditches and established the watering schedules using gates to control the supply of water. (Courtesy of the National Archives and Records Administration)

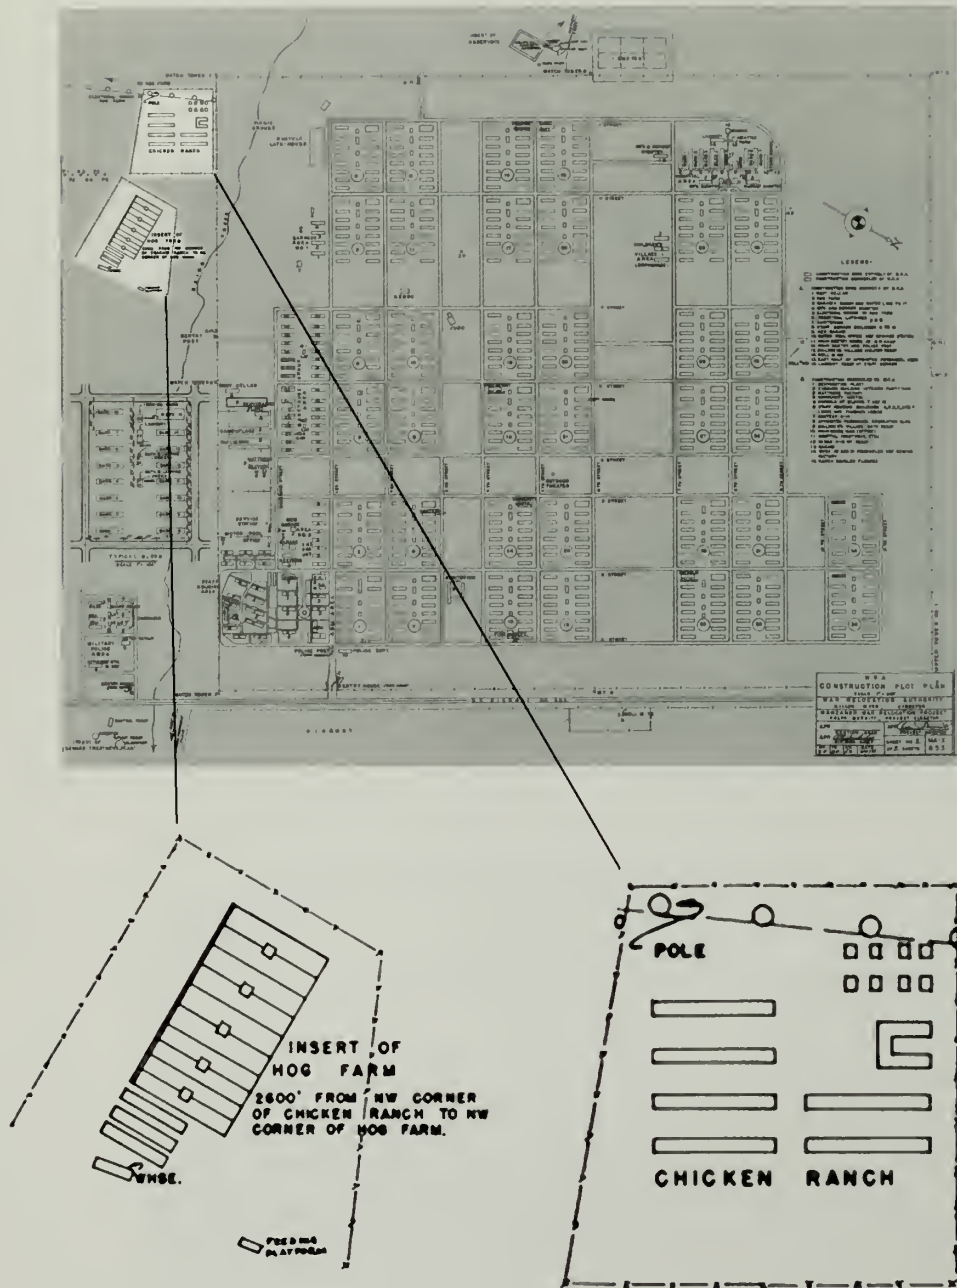
Figure 80. Agricultural buildings were located outside of the perimeter fence and included both a chicken ranch and hog farm. (Adapted from WRA Construction Plot Plan, 1942)

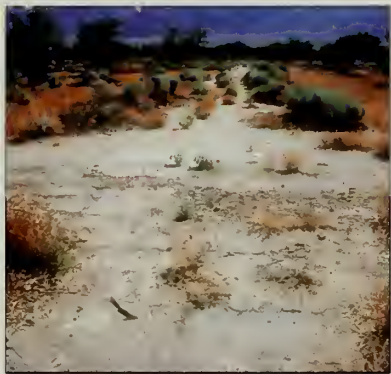
Figure 88. Native vegetation and exotic vegetation encroaching on historic road. (NPS, 2002)

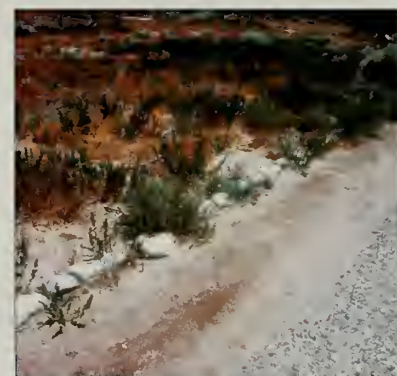
Figure 90. (above) Many features, like this stone curb, are obscured by accumulated soil along historic roads throughout the site. (NPS 2002)

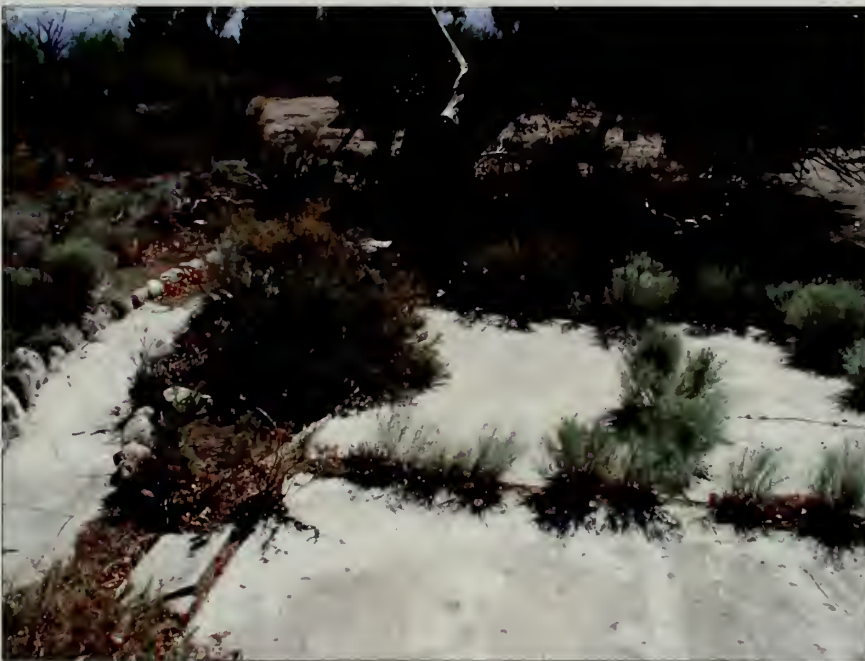
Figure 100. Non-historic vegetation obscures the historic foundations and can damage garden features if left unmanaged. (NPS, 2002)

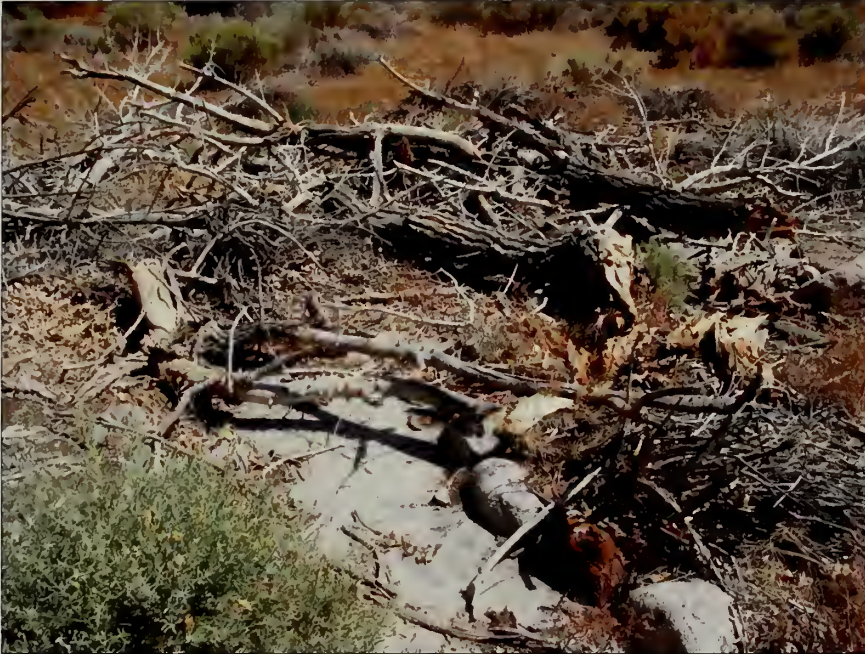
Figure 102. Accumulation of woody debris increases fuel loads, which threaten historic resources. (NPS, 2002)

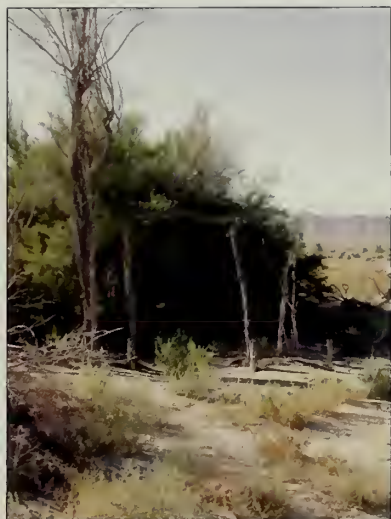
Figure 104. Active control of some non-historic invasive species, such as tamarisk, is required. (NPS, 2002)

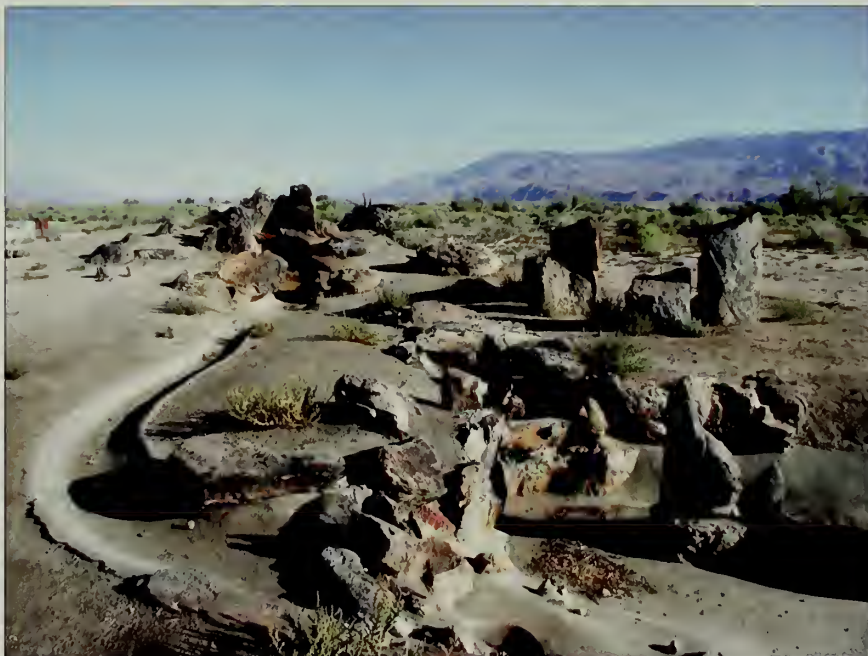
Figure 108. Stabilize eroding historic features, such as the berms and watercourse in the block 34 mess hall garden. (NPS, 2002)

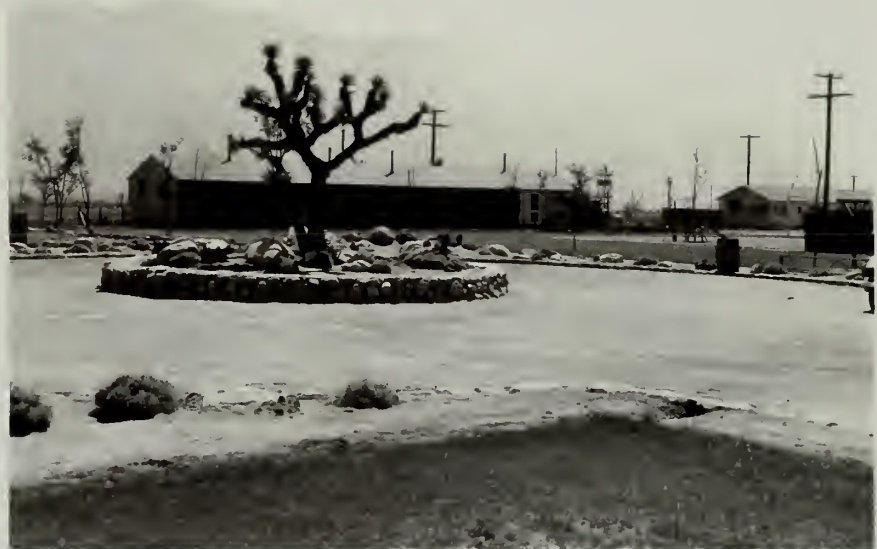
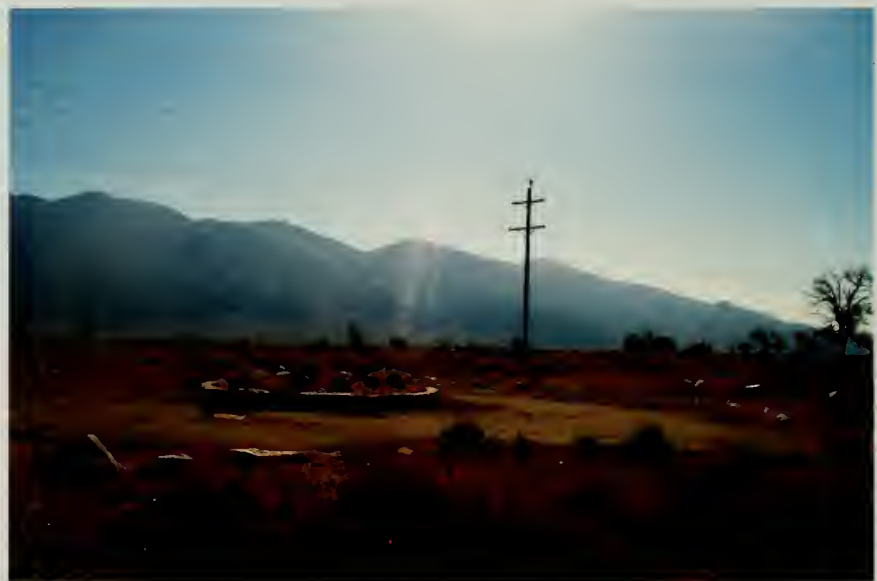
Figure 110. Restoration of missing vegetation, like the Joshua tree in this traffic circle, should be based on careful examination of historic documents. (Top: Courtesy UCLA Special Collections; bottom: NPS, 2002)

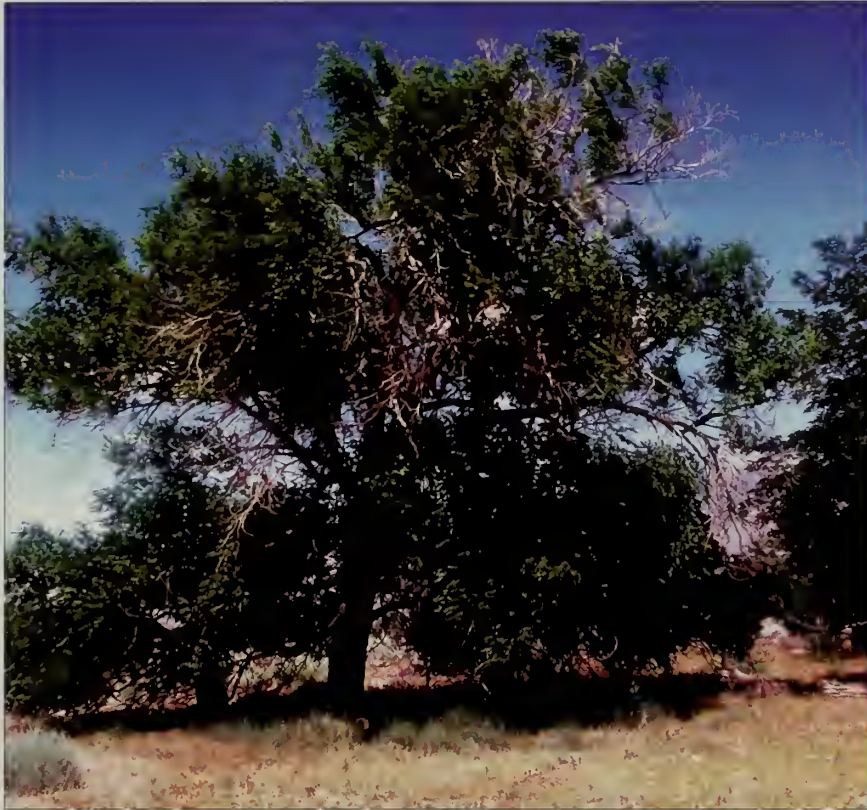
Figure 112. Removing dead wood from historic trees will help improve tree health and reduce fuel loads and hazards. (NPS, 2002)

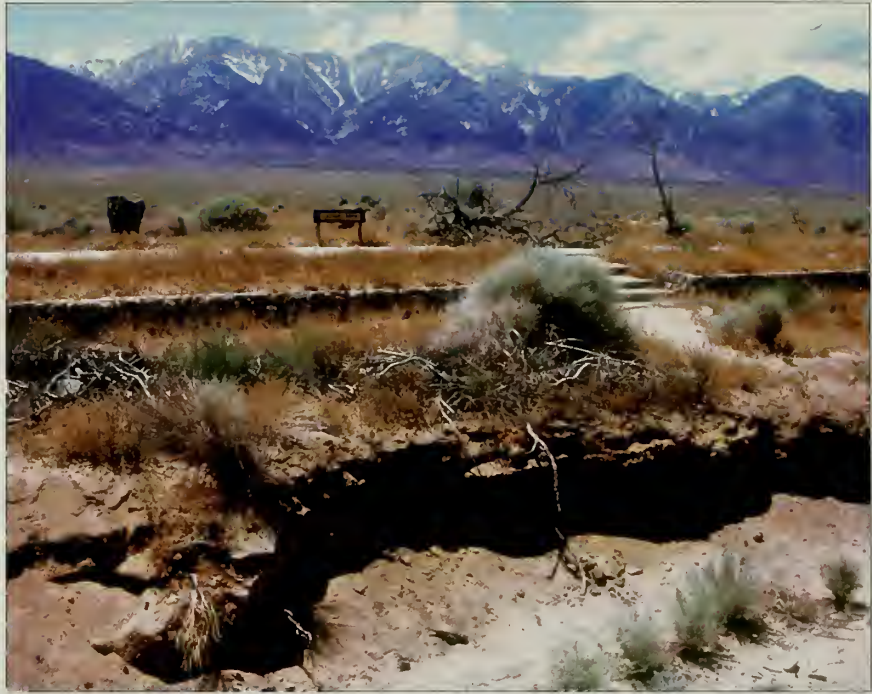
Figure 113. Stabilize eroding soil that threatens site features. (NPS, 2002)

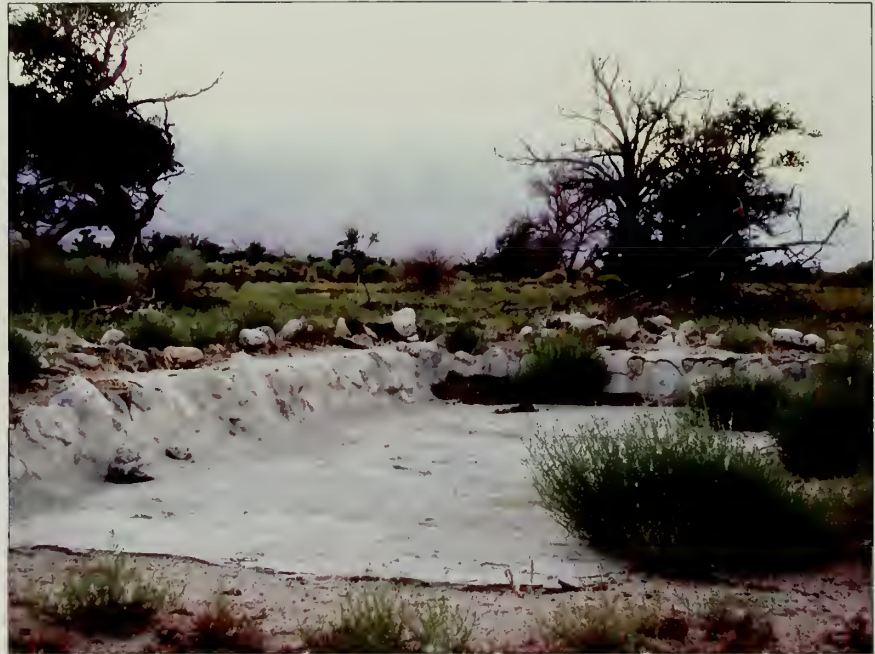
Figure 123. Stabilize and interpret unique historic features like the wading pool in the demonstration block. (NPS, 2002)
