40 PRESERVATION BRIEFS

Preserving Historic Ceramic Tile Floors

Anne E. Grimmer and Kimberly A. Konrad

U.S. Department of the Interior
National Park Service
Cultural Resources
Heritage Preservation Services

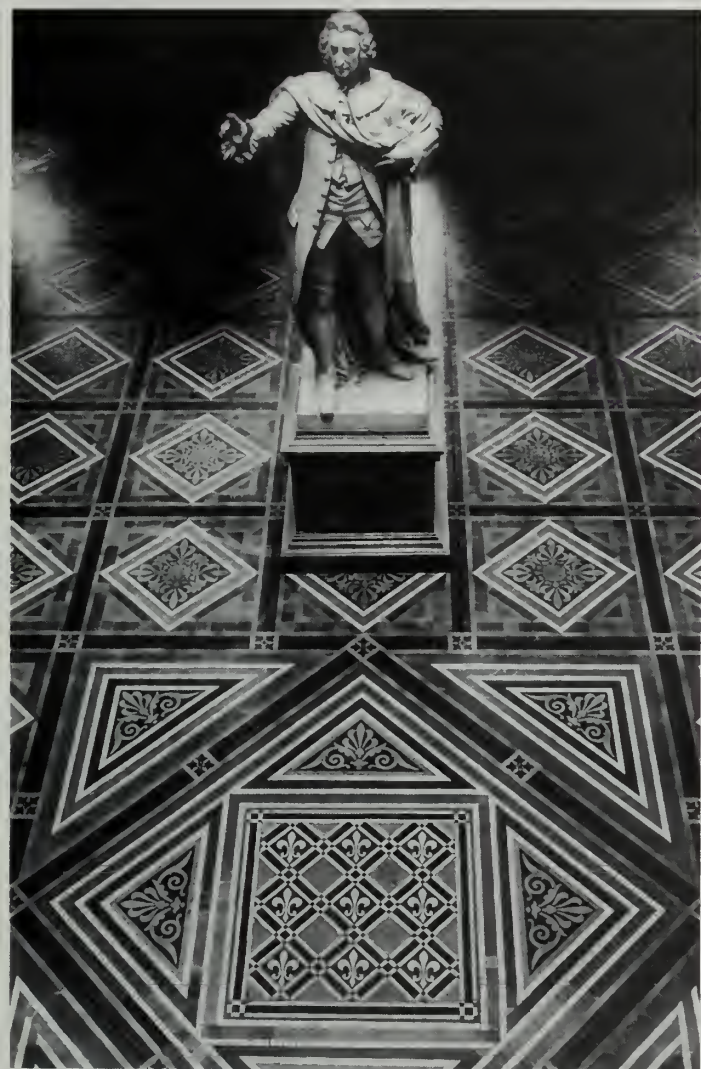
Figure 1. Minton encaustic tile floor, 3rd floor, Patent Office Building (now the National Portrait Gallery), Washington, D.C. Originally constructed between 1836-40 under the supervision of Robert Mills, the upper floors of this portion of the building were restored and redecorated in 1877 in the "Modern Renaissance style" by Cluss & Shulze, Architects, after a disastrous fire. Photo: Jack E. Boucher, HABS Collection.

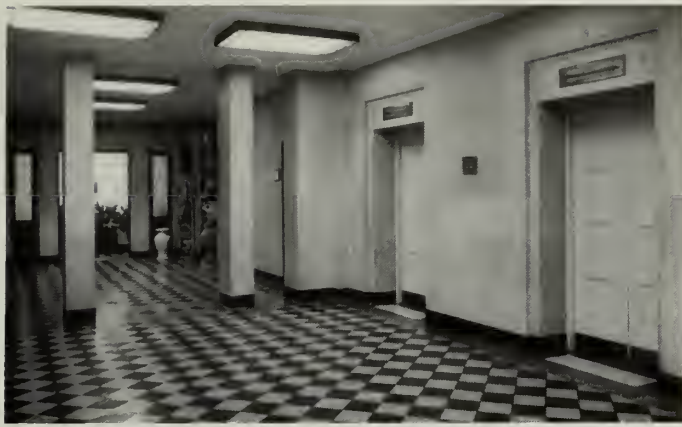
Figure 13. Quarry tiles were used in the corridors on many of the upper floors of the U.S. Department of the Interior Building (1935-1936). They were laid in a pattern identical to the more expensive marble floor tiles that were used in the public spaces. Photo: Brooks Photographers, HABS Collection.

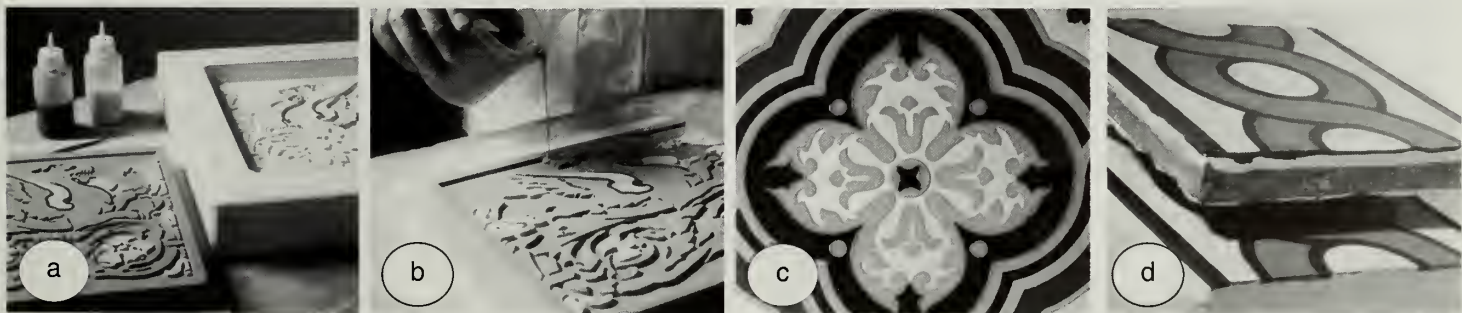
Figure 14. **Making encaustic tiles.** When finished, a reproduction encaustic tile resembles a historic tile, but the reproduction process is quite different from the traditional method. Designs for reproduction tiles are recreated by a computer from drawings of the original tile. (a) The computer image of the design is transferred to, and machine-cut into, a Plaster of Paris mold. Plastic, buff-colored clay is pressed into the mold to form the main body of the tile, and left to dry for 24 hours. (b) Colored slip, or liquid clay, is poured into the indented portions of the tile to create the pattern. (Each color of slip must dry before another color can be poured.) (c) After drying, and before firing, excess slip is scraped off, leaving the surface of the tile smooth, but the slip-filled areas still slightly recessed. (d) A side view of the 19th-century tile at the top of the photograph clearly shows the 3-layer clay "sandwich," as well as the 2 colors of slip that form the inlaid design. The new tile, below, is slightly thinner and is made from only 1 layer of clay. Photos: (a-b) H&R Johnson Tiles Ltd.; (c-d) Wayne Firth, Office of the Architect of the Capitol.

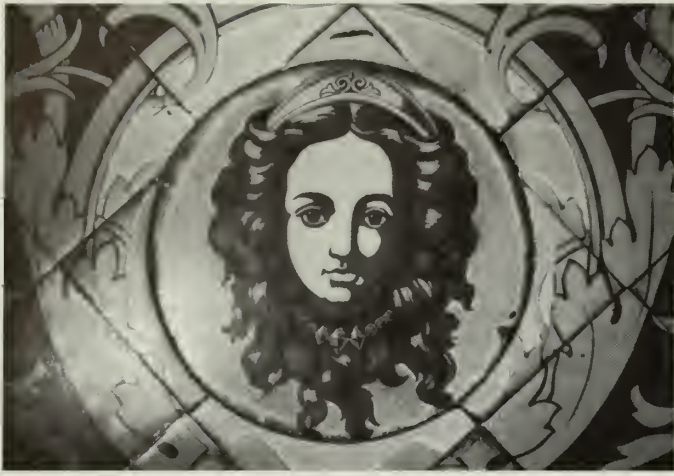
Figure 15. The detailed features of the portrait on this round tile in the U.S. Capitol were painted on the surface of the tile rather than inlaid. Photo: David W. Look, AIA.

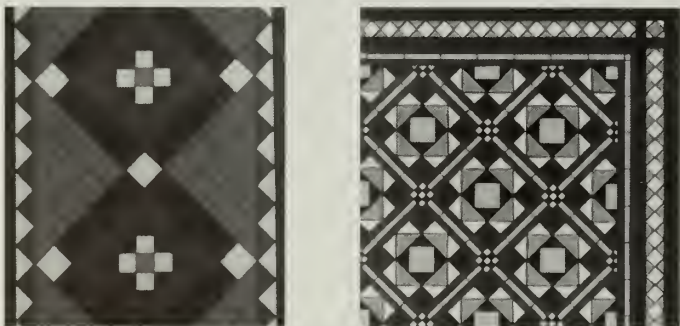
Figure 17. Shown here are typical geometric tile patterns popular in the late-19th century, as illustrated in *Decorative Tile Designs in Full Color*. Selected and arranged by Carol Belanger Grafton. NY: Dover Publications, Inc., 1992, pp. 73, 83.

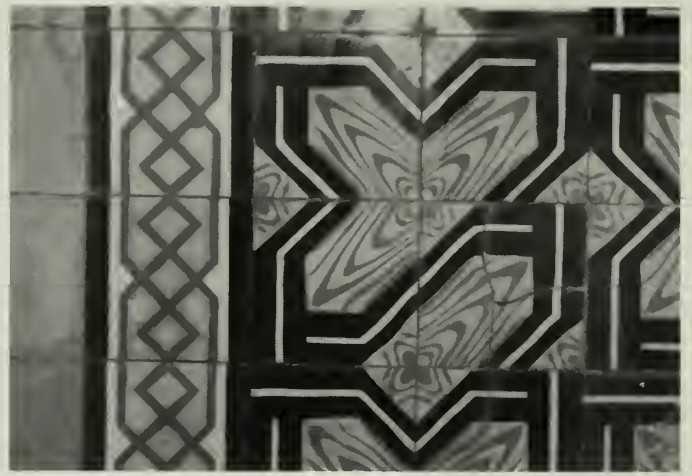
Figure 16. Historic cement floor tiles in a house at 103 Calle San Jose, Old San Juan, Puerto Rico, feature a design intended to resemble wood parquet. (Note the mismatched repair.) Photo: Jack E. Boucher, HABS Collection.

resembled those commonly found on encaustic tiles but applied as a transfer printed pattern, or using a multi-color lithographic or silkscreen process. These are still manufactured and popular in many parts of the world (Fig. 16).

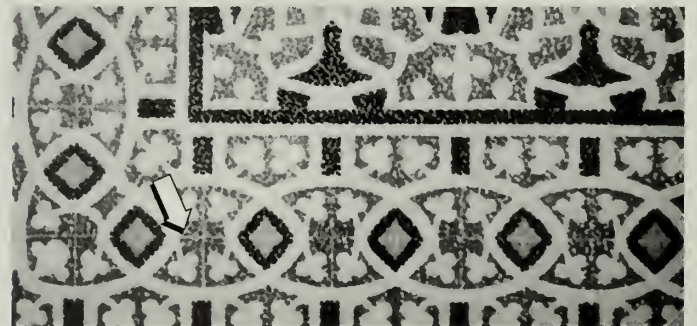
Figure 18. One-piece tiles were made with a mold that created the appearance of mortar joints and individual mosaics, as illustrated in *Decorative Tile Designs in Full Color*. Selected and arranged by Carol Belanger Grafton. NY: Dover Publications, Inc., 1992, p. 87.

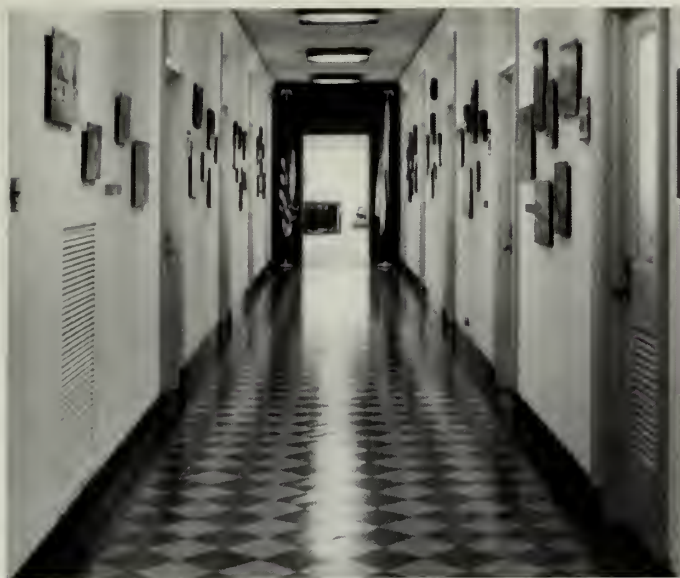
Figure 19. Regular maintenance treatments for the historic quarry tile floors in the U.S. Department of the Interior, shown here in a side corridor, include: stripping and waxing once a year; weekly spraying and buffing with a commercial "floor finish revitalizer/cleaner" that is slip resistant; and dust mopping or damp mopping 4 times a week. Photo: Brooks Photographers, HABS Collection.

Regular maintenance of a ceramic tile floor should always begin with vacuuming to remove loose dirt and grit. Then, a mild cleaning solution may be applied and left on the floor for 10-15 minutes, without letting it dry on the tiles. Heavily soiled areas may be scrubbed with a natural bristle or nylon brush to loosen dirt from the tile surface. Finally, the floor should be thoroughly rinsed with clean, clear water, preferably twice, and dried with terry cloth towels, if necessary. Any proprietary cleaning product should always be used in accordance with the manufacturer's directions (Fig. 19).

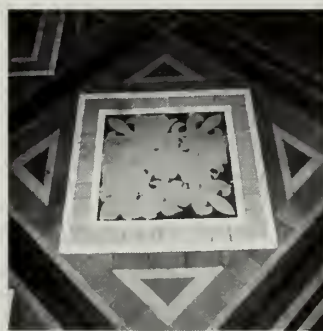
Figure 20. The surfaces of these late-19th century encaustic tiles have become worn and much of the pattern has been lost after more than 100 years of use. Photo: Anne Grimmer.

Loss of Tile Surface and Pattern. Ceramic tiles are among the most durable of historic flooring materials, but natural wear and a certain amount of deterioration or damage is inevitable. Some tiles, such as dense, close-textured quarry tiles and ceramic mosaic tiles, resist abrasion and stain absorption very well. But many others, especially patterned encaustic and geometric tiles, are extremely susceptible to abrasion. Heavy traffic can also result in uneven wear, or even cupping, in certain areas of tile floors that get more use than others, such as doorway entrances. The particular clay mix, or the dye or pigment used to color the clay, can also affect the hardness and durability of individual tiles or an entire ceramic tile floor (Fig. 20).

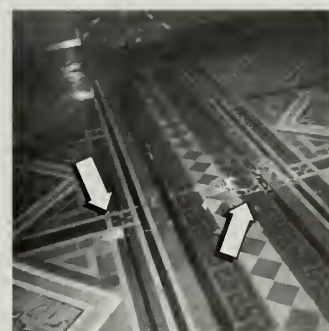
Figure 21. These cracked geometric tiles may have been damaged by the repeated passage of heavy equipment over the floor. Photo: Anne Grimmer.

Tile Breakage. Ceramic floor tiles are very susceptible to damage and breakage caused when something heavy is dropped. Repeated passage of heavy objects, or carts, over a floor can also crack and break ceramic tiles, as well as heavy vibration from outside traffic (Fig. 21).

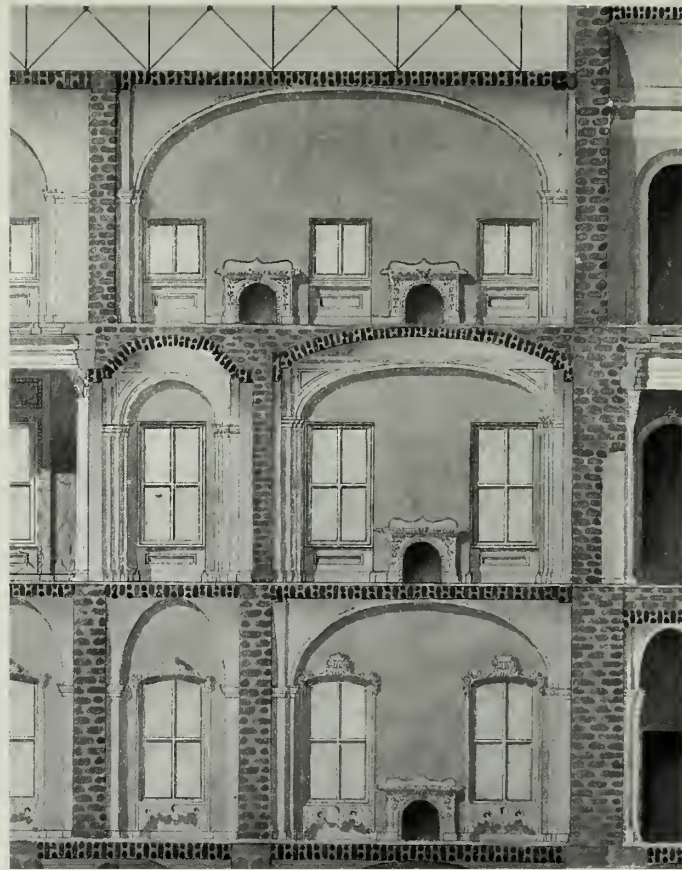
Figure 22. Original section drawing of the 2nd and 3rd floors of the House of Representatives Wing of the U.S. Capitol shows how Montgomery C. Meigs ensured the durability of the encaustic tile floors that were laid in the 1850s. He specified that the 3/4" tiles be laid on top of 1/2 to 3/4" mud (or mortar), which, in turn, was to be laid over a coal tar membrane on top of 3" of brick over an air space of 4-6". Photo: Wayne Firth, Office of the Architect of the Capitol.

Traditionally, a layer of asphalt (replaced by a layer of plastic or building paper in more modern construction) was inserted to separate the base and the bedding underneath (Fig. 22). This prevents bonding between the base and the bed, and allows for some “relative” movement. It is intended to prevent the ceramic tile floor from arching or ridging, a condition in which single or entire rows of tiles can pop up to relieve tension and separate completely from the bed. When this happens, the condition will probably require taking up and relaying many or all of the tiles.

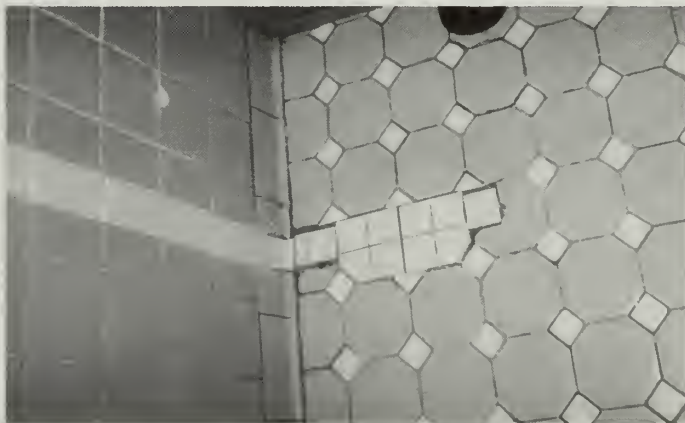
Figure 23. These non-matching tiles are inappropriate replacements for original tiles that were damaged during bathroom remodeling. Photo: Anne Grimmer.

Tile Damage or Loss caused by Systems Update. The installation of new plumbing, electrical and HVAC systems, or the attachment of new fixtures and furnishings, may be one of the most common sources of damage to an historic ceramic tile floor. Earlier remodeling projects to remove old pipes or to replace “out-dated” bathroom fixtures may have resulted in the loss of floor tiles (Fig. 23). Different shapes and sizes of new fixtures, equipment or pipes may have exposed previously untiled areas that have been inappropriately patched with cement. Careless workers and insensitive installations can also result in damage, breakage or removal of historic floor tiles. All of these conditions will require matching replacement tile.

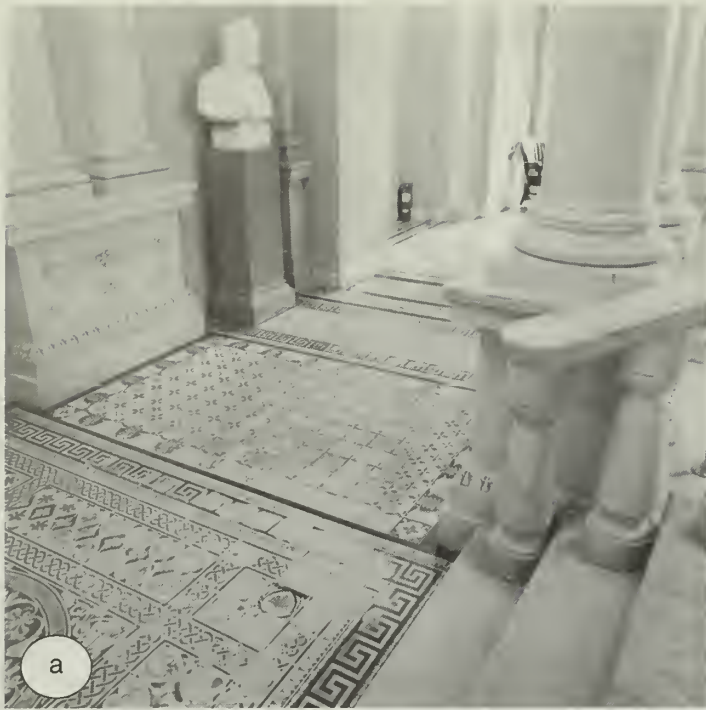
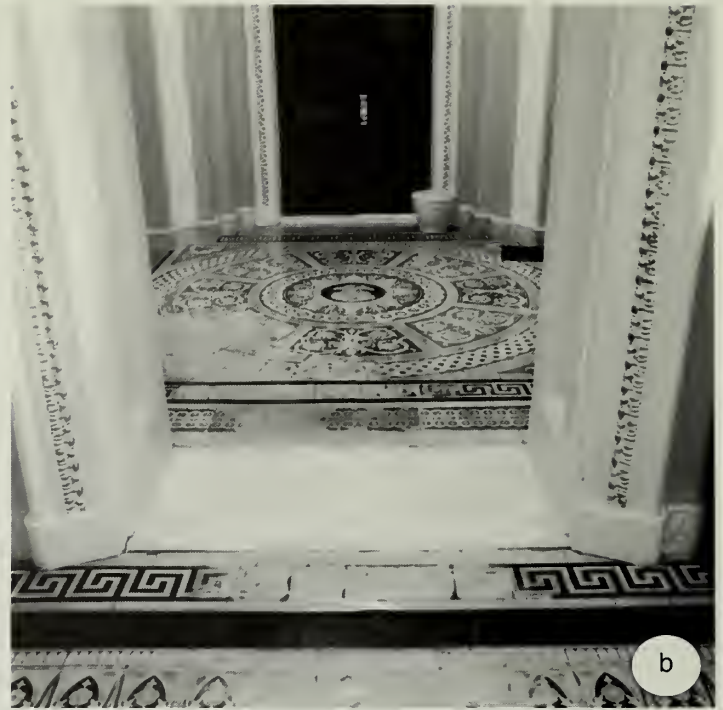
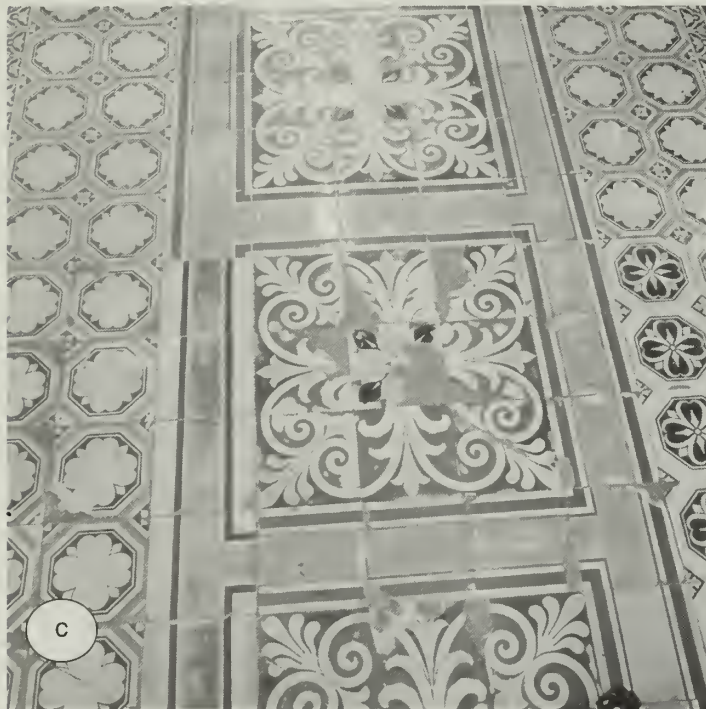
(a-b) Above: By the mid-1970s, many of the patterns in the encaustic tile floors had become faint, and some had completely worn off in the most heavily trafficked areas. (c) Below left: Damaged areas of the floor had been patched with salvaged pieces of tile that fit, but did not match. Photos: Wayne Firth, Office of the Architect of the Capitol.

Figure 24. U.S. Capitol Restoration Project. Restoration of the historic ceramic tile flooring at the U.S. Capitol is one of the most extensive ongoing undertakings of this kind in the U.S. When the Office of the Architect of the Capitol contacted H&R Johnson-Richards, the manufacturer of Minton Hollins tiles, regarding restoration of the tile floors in preparation for the American Bicentennial, the company was unaware of the extent of original Minton encaustic and geometric floor tiles in the U.S. Capitol building. Montgomery C. Meigs, Supervising Engineer, and Architect of the Capitol Extension, Thomas U. Walter, specified Minton encaustic tiles for the floors in the two wings that were added to the Capitol. The tiles were ordered from the factory in England through Miller & Coates, a Minton supplier in New York City, and installed in the 1850s.

When the project was initiated, the intent was to replace only those tiles that were severely damaged or worn. Removing and replacing selected sections of the tile floor in their entirety was determined to be a better approach because of the difficulty of removing one tile without damaging adjacent tiles in good condition, in addition to the difficulty of matching new and old tiles which are slightly different in color, pattern and thickness. This means that sometimes tiles in good condition may have to be removed, but they are salvaged and stored for future reuse.

Before ordering the reproduction tiles, each section of the Capitol floor was drawn and photo-documented. The condition of all the tiles was evaluated based on a rating of one to four (excellent, good, damaged, or, in need of replacement), and color-coded accordingly. Every tile that needed to be replaced was individually numbered and photographed with dimensional, color and grey scales.

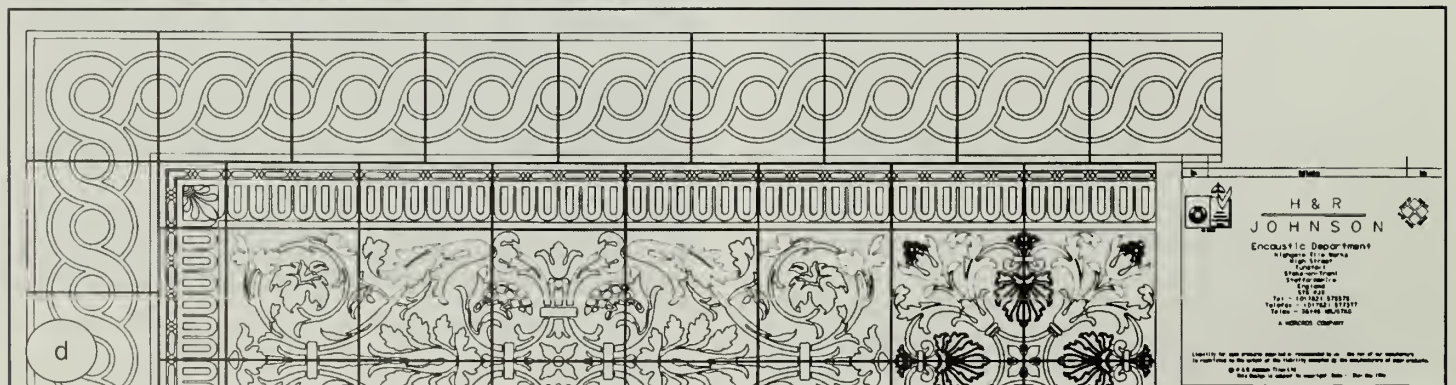
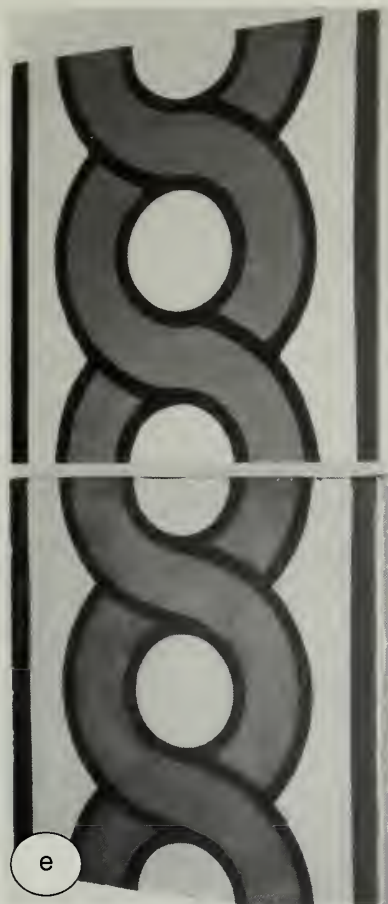
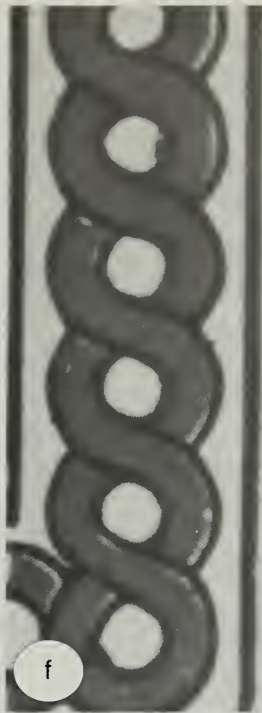
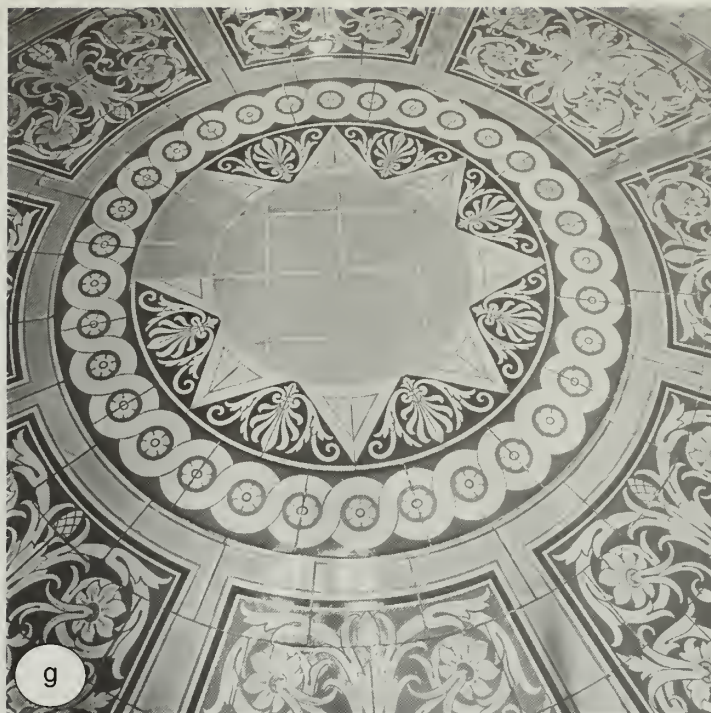
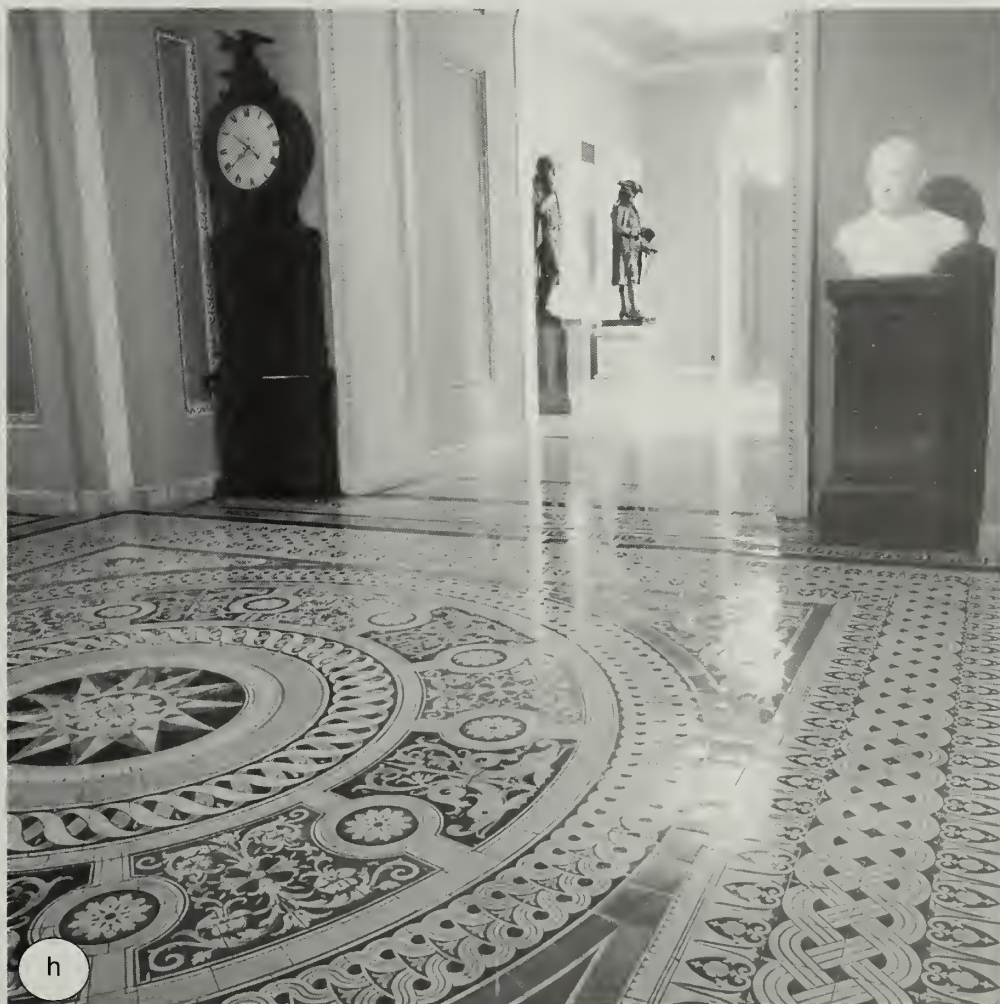
(e) The top tile is a new reproduction of the historic tile below. (f) This design is identified as No. 84 in Miller & Coates' Minton Tile Catalogue (detail Figure 2). (g) What might appear to be an inappropriate repair with non-matching modern tile in the center of the star is, in reality, a neatly executed patch to serve as temporary in-fill for the reproductions that have been ordered. (h) Shown below is a restored section of the Capitol floor. Photos: (e,g,h) Wayne Firth, Office of the Architect of the Capitol; (f) David W. Look, AIA.

(d) Since the early-20th century, making encaustic tiles had, again, become a lost art. Thus, H&R Johnson-Richards not only had to learn how encaustic tiles had been made historically, but, also, how to reproduce them. After studying old records of the early tile manufacturers, the company began reproducing tiles using modern-day computer-assisted technology (CAD/CAM). Drawing: H&R Johnson Tiles Ltd.; Photo: Wayne Firth, Office of the Architect of the Capitol.

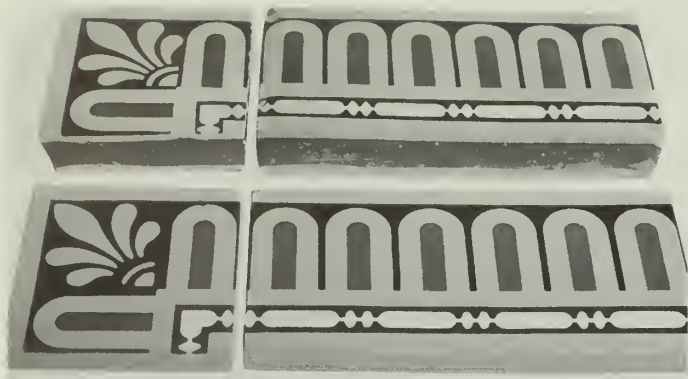
Figure 25. This comparison of an original, historic encaustic tile (top) with a reproduction encaustic tile (bottom) reveals an obvious difference in thickness, but only a slight difference in the design. Photo: Wayne Firth, Office of the Architect of the Capitol.
