Damaged and Threatened National Historic Landmarks 1989 Report

**Damaged and Threatened
National Historic Landmarks
1989 Report**

**National Park Service
U.S. Department of the Interior
Washington, D.C.**

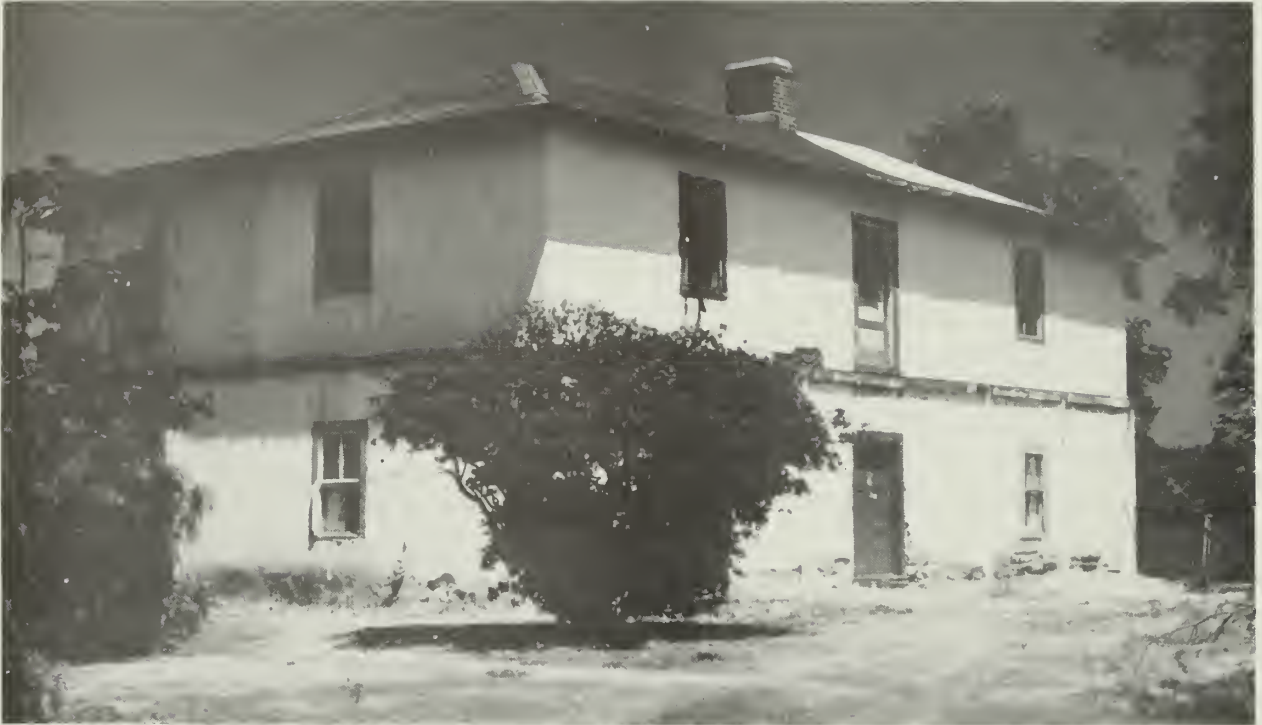
Las Flores Adobe, Camp Pendleton, CA. This ranch house is a prime example of a two-story 19th century Monterey Colonial style residence, a popular building type unique to California during the mid-19th century. The house is in a very deteriorated state. Adobe is crumbling, floors are damaged, and a veranda was removed due to termite damage. Photo: Ann Huston.

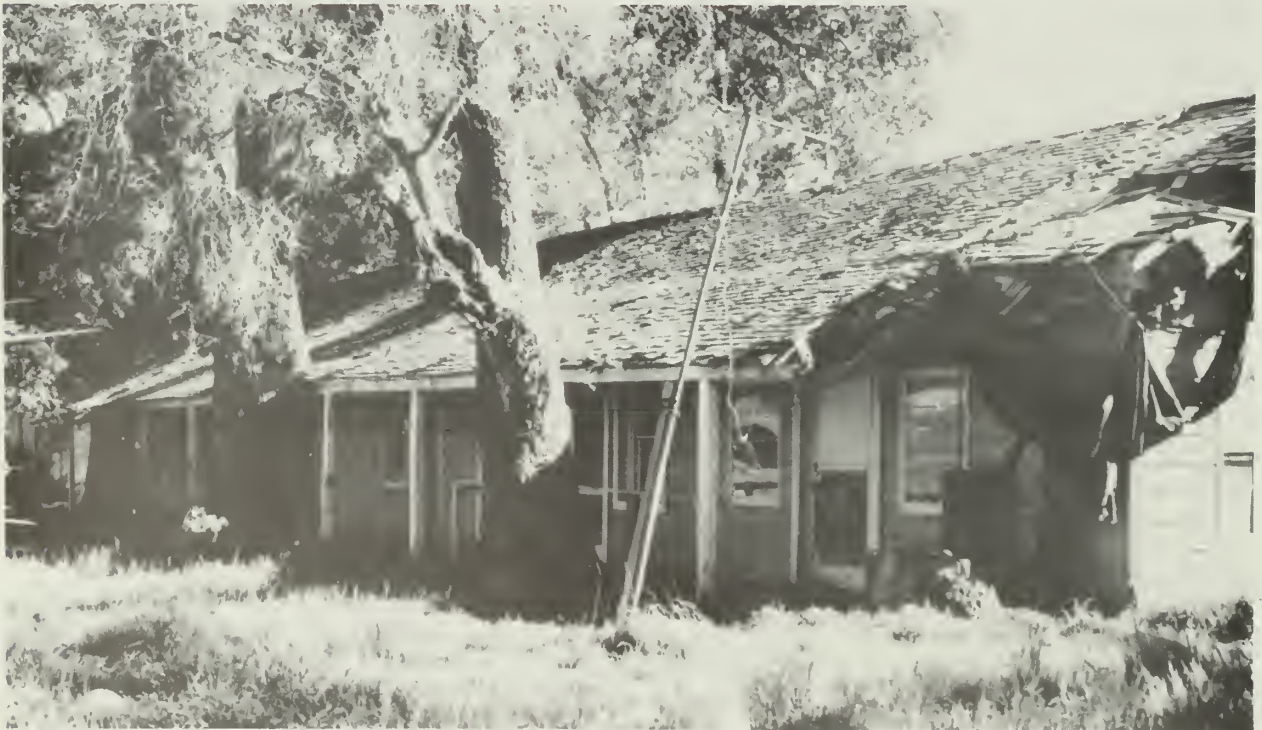
Oak Grove Butterfield Stage Station, Aguanga, CA. This stage station is one of the only remaining stations on the Butterfield Overland Mail Route which operated between San Francisco and two eastern terminals from 1858 to 1861. The building has been vacant and without maintenance for several years. The roof has partially collapsed and adobe is crumbling. Photo: Ann Huston.

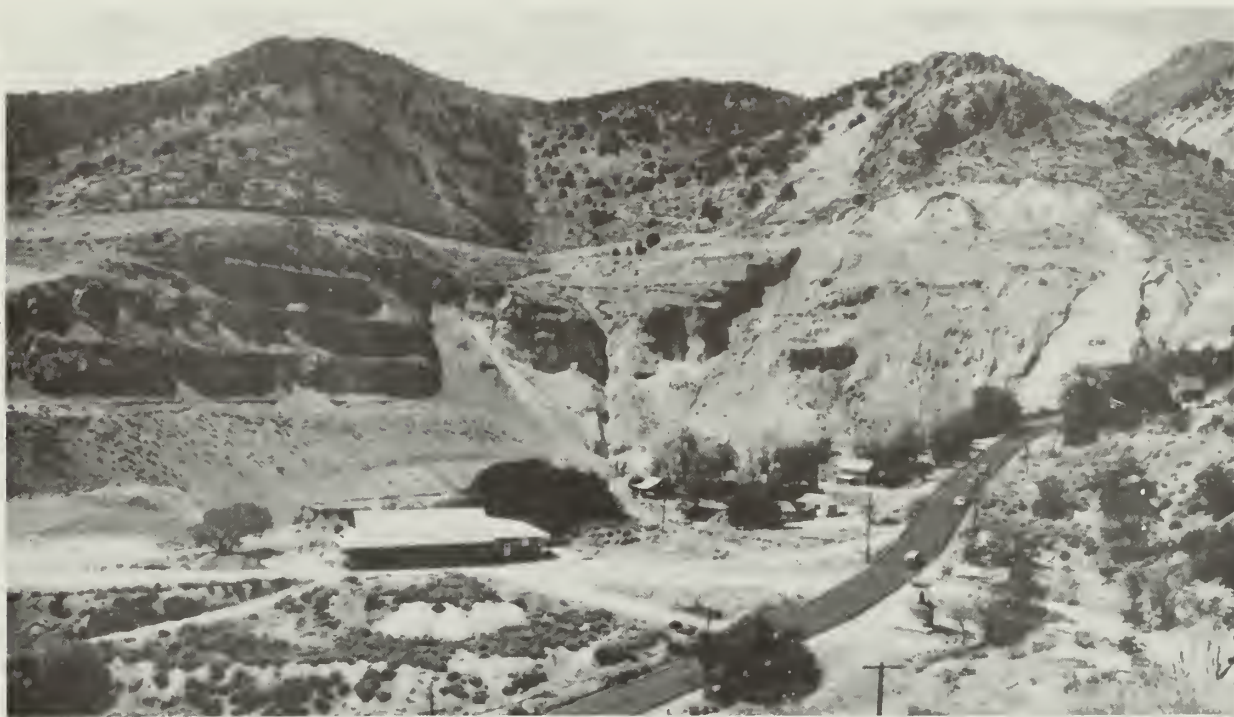
Virginia City Historic District, Virginia City, NV. Virginia City was a noted frontier mining boom town, owing its success to the 1859 discovery of the Comstock Lode. Several buildings in the town of Gold Hill, the mountainside adjacent to Virginia City, and a portion of the historic Greiner's Bend Rd. (at right side of photo) are in danger of sliding into an inactive mine pit which runs from just left of the railroad station (in the left foreground of this photo) to the right where the road disappears at Greiner's Bend. Photo: Leo Barker.

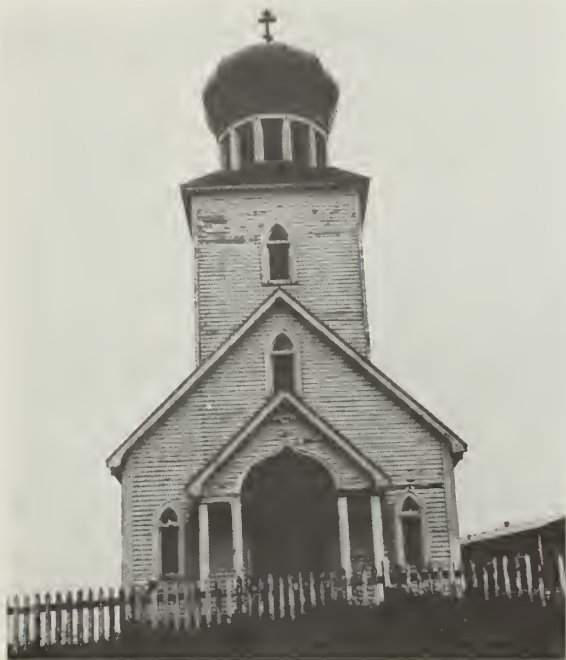
St. George the Great Martyr Orthodox Church, Seal Islands NHL, St. George Island; Pribilof Islands, Alaska. A good example of a classic Russian Orthodox church design, the church was the center of the Aleut people's community life. Due to harsh climatic conditions and poor maintenance, the church suffers from roof leaks and extensive water damage to the interior. Photo: Steve Peterson.

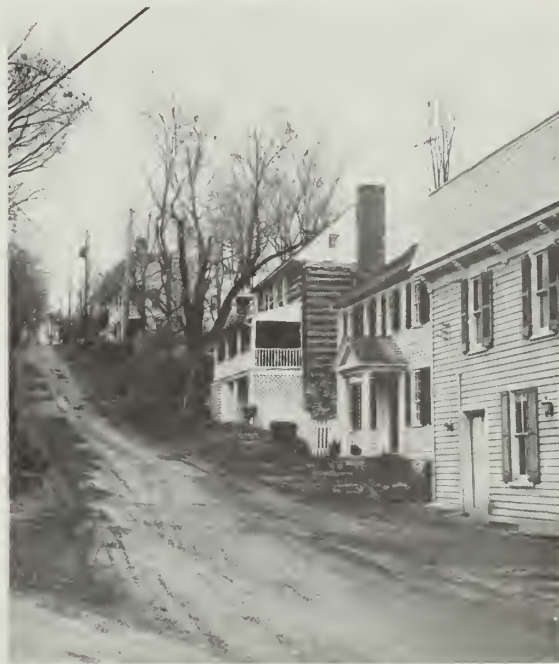
Waterford Historic District, Waterford, VA. Waterford is an intact example of an early-19th century rural village with several historic vernacular brick, log, stone, and wood structures, surrounded by historic farmland and pristine landscapes. The historic agricultural land surrounding the village is threatened with suburban growth. Photo: NPS files.

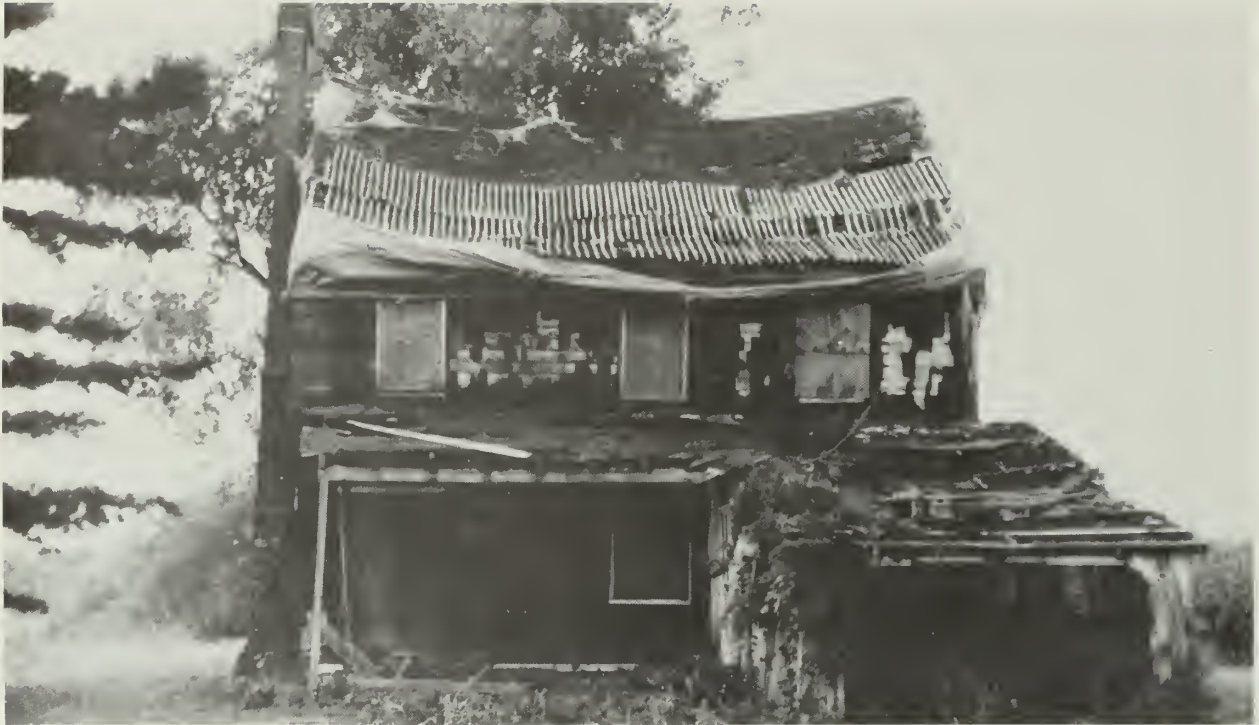
Rhea-Gordon House, Monmouth Battlefield, Monmouth County, NJ. Monmouth Battlefield was the site of the last major battle fought between American and British forces in the north during the War for Independence. The Rhea-Gordon House, which dates to before the battle, is vacant and deteriorated. Windows are boarded up, the roof is sagging, and there is extensive water damage. Photo: Bill Bolger.

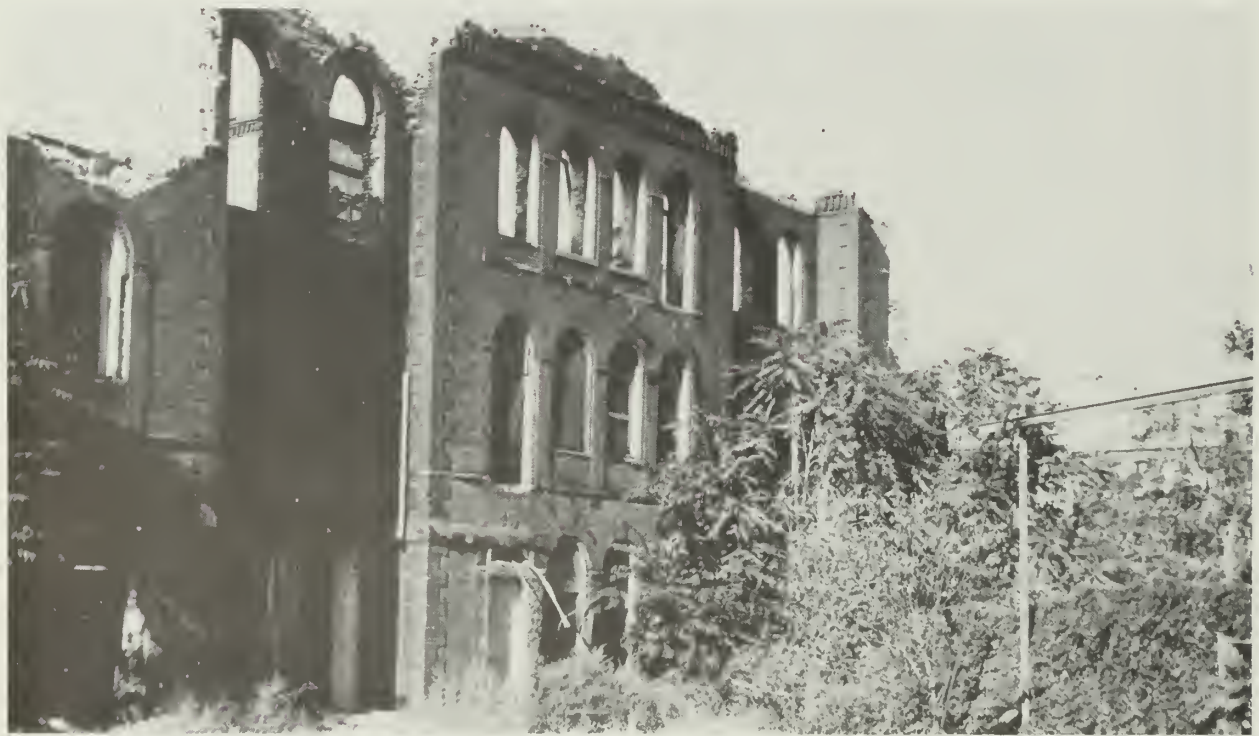
Waverly Mill, Great Falls of The Passaic Historic District, Paterson, NJ. The district is the site of the first attempt in the U.S. to harness the entire power of a major river for industrial purposes. The Waverly Mill, located along the Passaic River, in the heart of the district, has suffered extensive damage. There has been no stabilization or rehabilitation of this structure. Photo: Bill Bolger.

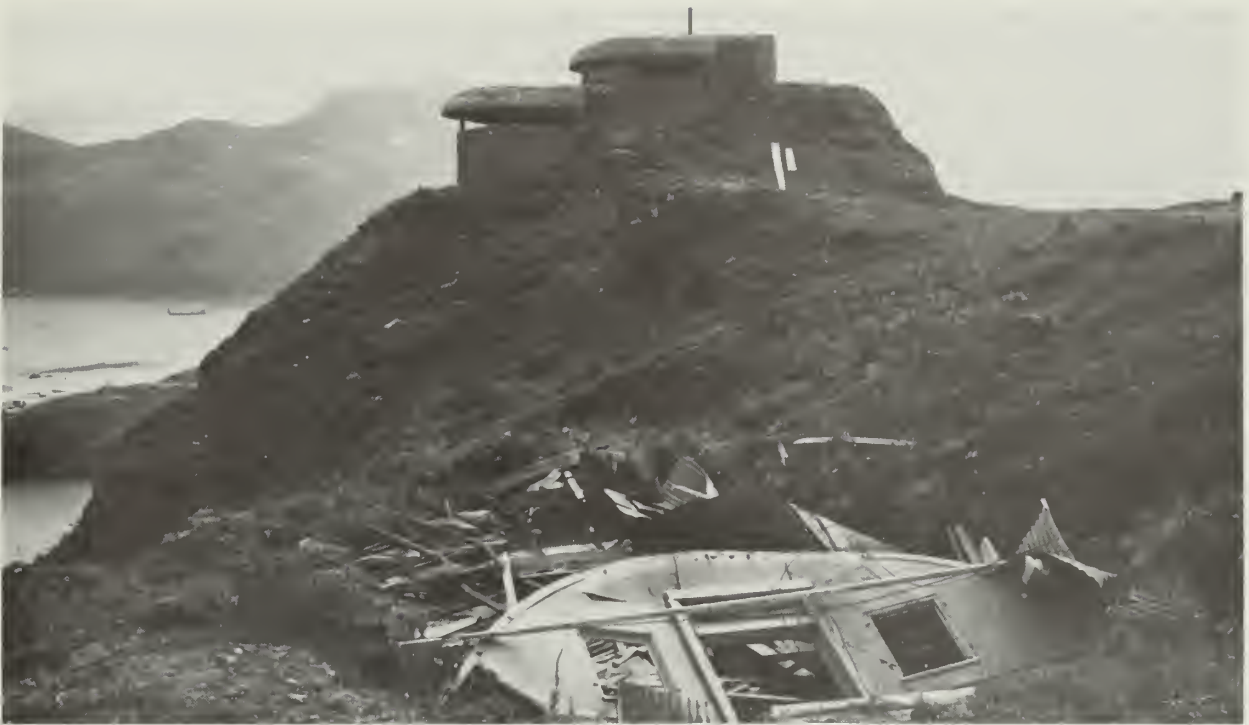
Dutch Harbor Naval Operating Base & Fort Mears, U.S. Army, Amaknak Island, AK. This naval base and army post was significant as a coastal defense during WWII. It represents Alaska's tactical and strategic contributions to the war. The collapsed quonset hut in the foreground of this photo is one of the many damaged or vacant structures that have deteriorated or been demolished. Photo: Sande Faulkner.

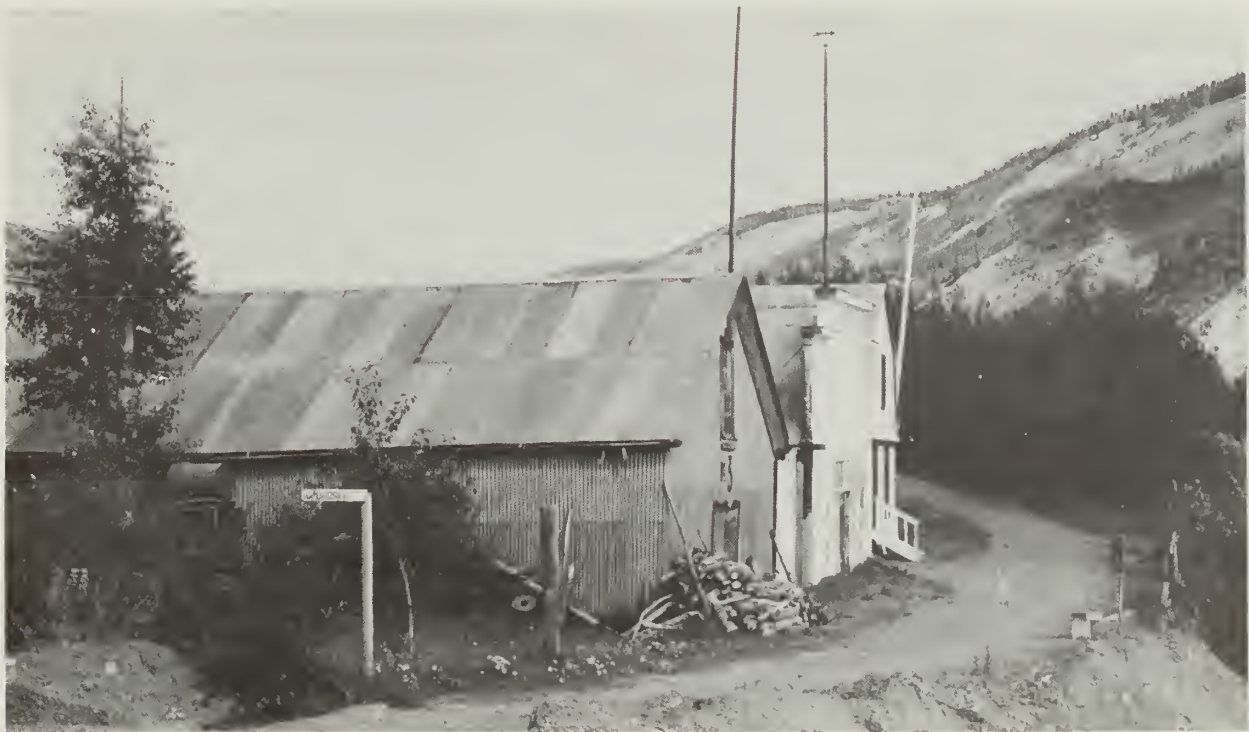
Eagle Historic District, Eagle, AK. Eagle was the judicial, military, transportation and communications center for interior Alaska during the gold rush. River erosion is threatening three historic waterfront buildings on Front street pictured above. Photo: Bill Hanable.

Threat/Damage: Severe Site Erosion. Run-off water from higher ground and the scouring action of ice on the Yukon River have combined to undercut the riverbank to the point that three of the historic waterfront buildings are threatened. One of the buildings is city-owned and two are privately-owned. The two privately-owned buildings are unoccupied. Culverts and ditches to abate run-off have been constructed close to the historic structures without archeological testing or recovery. The situation is becoming more acute every year, and funds have not been identified to mitigate the erosion problem. Plans have been approved to move the city-owned building, (although this move is not completely funded), while the threat to the two others remains unaddressed.

Recommended Action: Stabilization of the river bank and alteration of drainage patterns are essential to correct the problem before irreparable damage occurs.

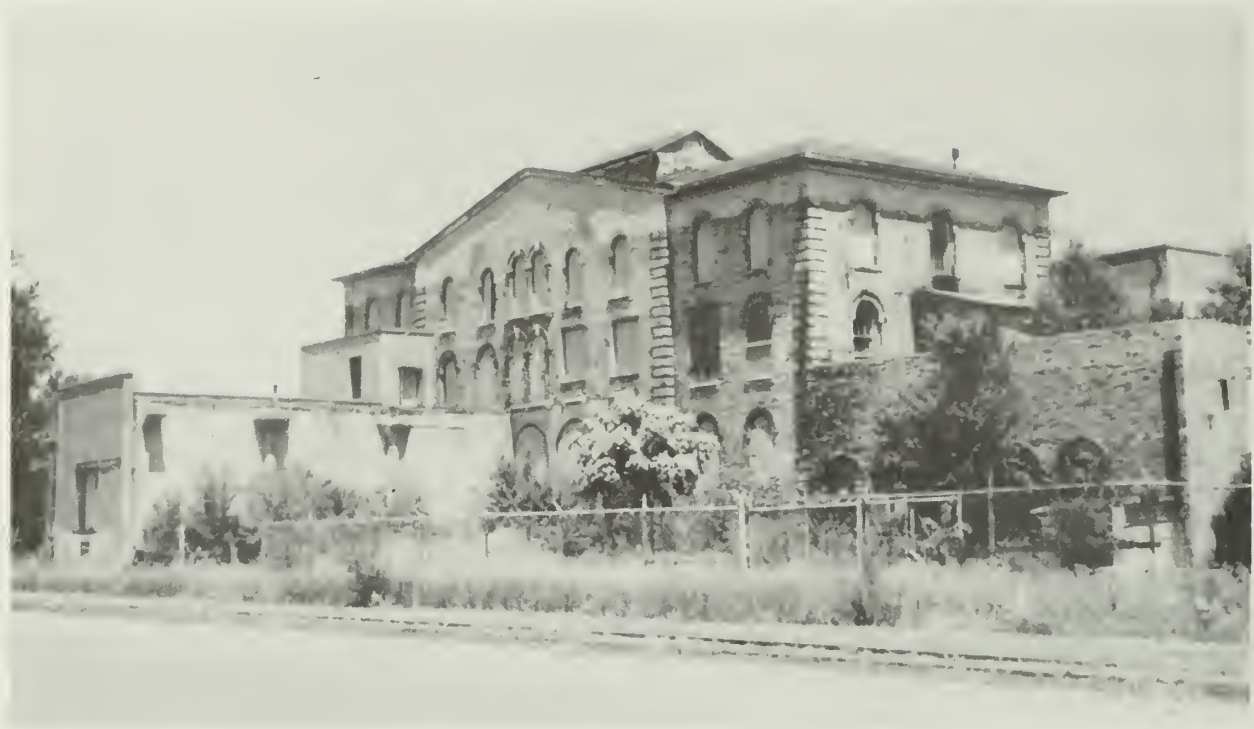
Dousman Hotel, Prairie du Chien, Wisconsin. Built in 1864, the hotel served travelers when Prairie du Chien was a railroad center. It was used as a stopping point by thousands of immigrants to the West after the Civil War. The building has been vacant with no maintenance or repair for several years. Deterioration continues to accelerate. Photo: NPS files.

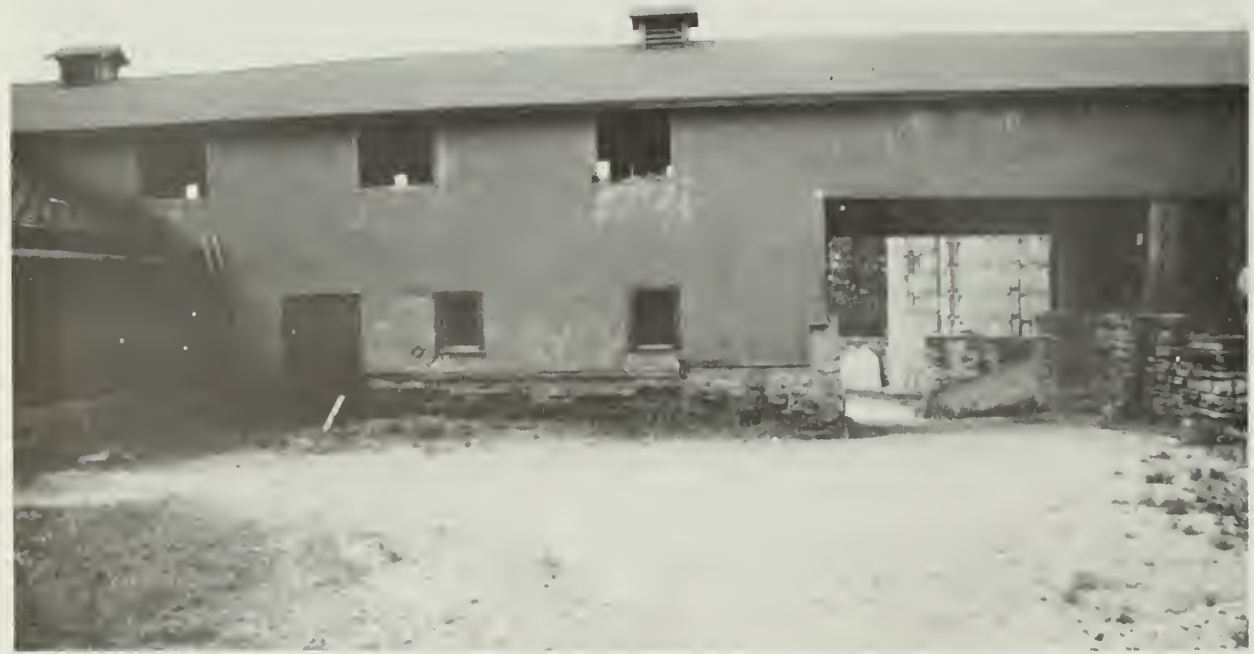
Taliesin, Iowa County, LA. This complex, which was built as home, school, workshop, and laboratory for Frank Lloyd Wright includes superb examples of this "organic" architecture, developed out of his Prairie School work. The barn building pictured above is located in the Midway Farm complex and suffers deterioration due to leaky roofs and lack of maintenance. Photo: NPS files.

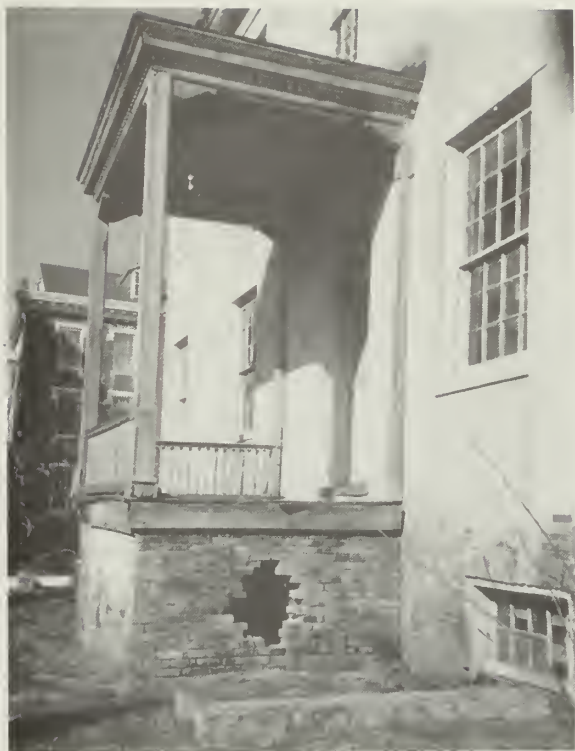
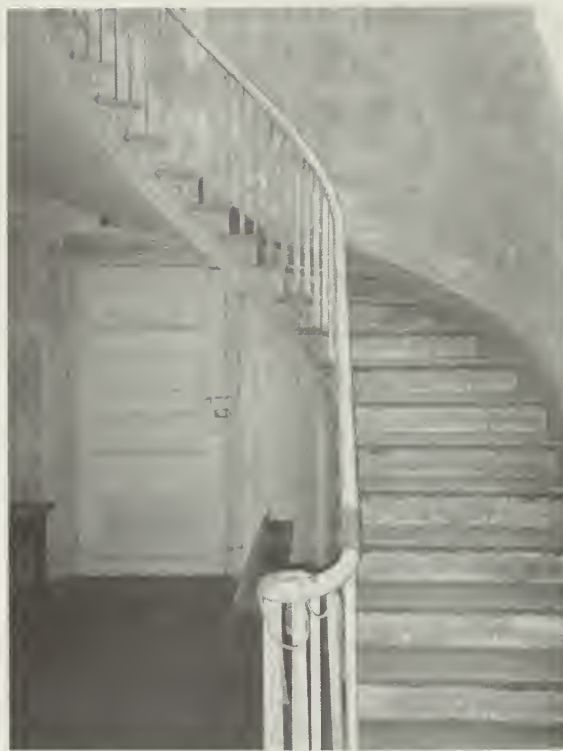
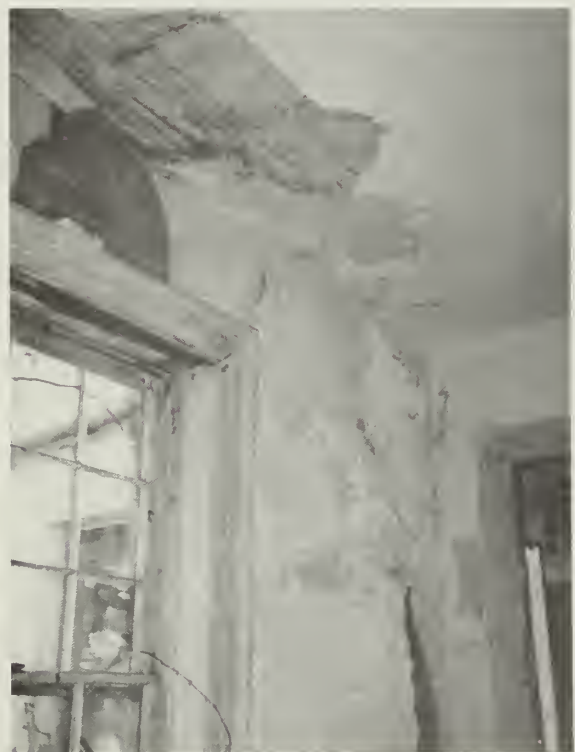
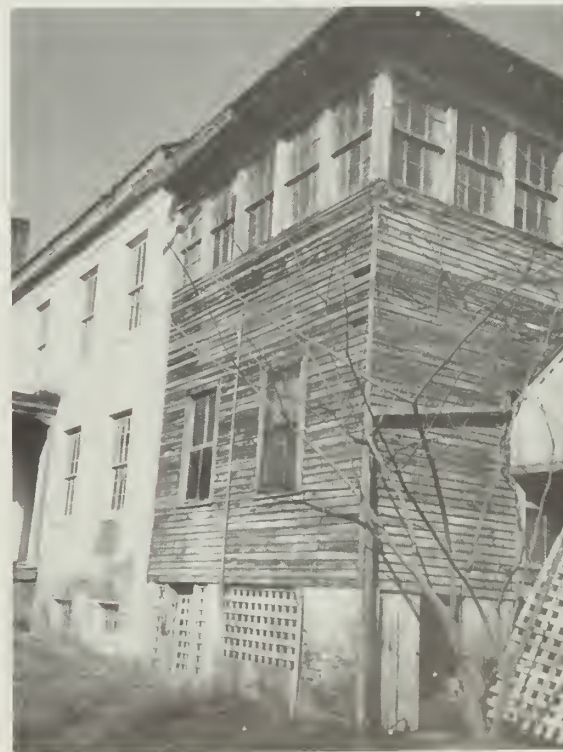
Pemberton's Headquarters, Vicksburg, MS. This house was the headquarters of Confederate Commander Lieutenant General John C. Pemberton during most of the siege of Vicksburg, and the place where the decision to surrender the city was made on July 4, 1863. The building is severely deteriorated and has suffered considerable water damage. Above left: West facade with missing bricks and mortar. Above right: Circular stair with rotting woodwork. Below left: Damaged plaster walls and ceilings. Below right: Southwest corner with rotting siding and damaged roof. Photos: Paul Hawke.
