GEOMORPHIC HISTORY OF THE VIRGIN RIVER IN THE ZION NATIONAL PARK AREA, SOUTHWEST UTAH

U.S. GEOLOGICAL SURVEY OPEN-FILE REPORT 95-515

*Prepared in Cooperation with the
National Park Service*

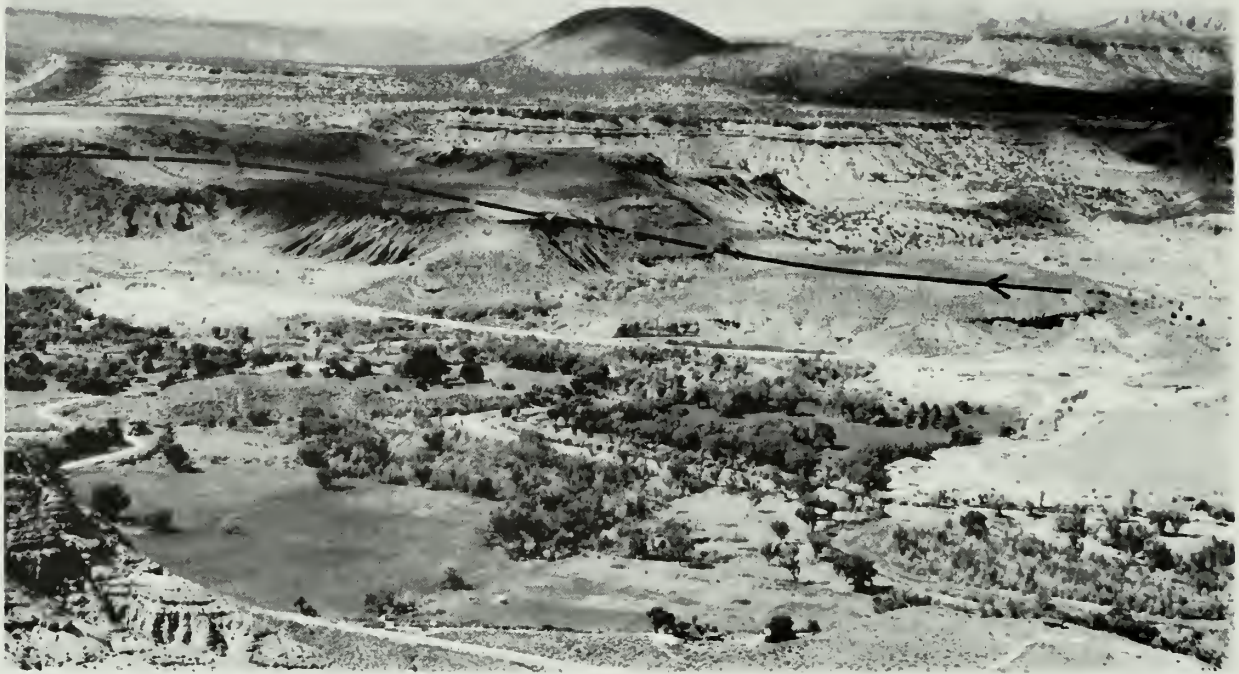
Figure 2. Photograph of Crater Hill volcanic field and Virgin River valley. Dark hill in upper center is Crater Hill. Basaltic lava flows are dark, smooth, and flat areas above river. Base of youngest lava flow is 20-30 m (66-98 ft) above channel of Virgin River. Line indicates axis of ancestral Virgin River, dashed where covered by lava flows.

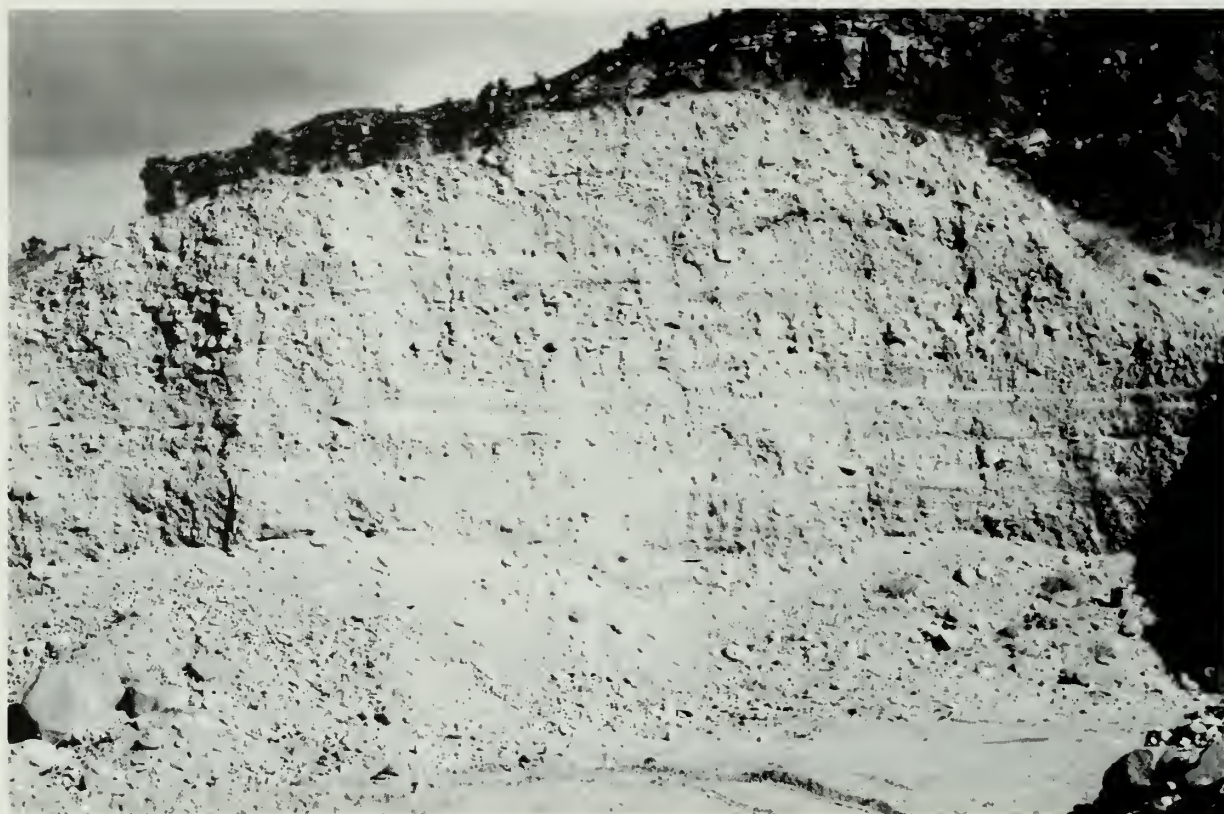
Figure 4. Photograph showing late Pleistocene gravel with interbedded sand in quarry south of Rockville. Note scale on left, 1.4 m (4.6 ft) long with 20 cm (5.08 in) divisions. This is topographically the lowest and youngest gravel.

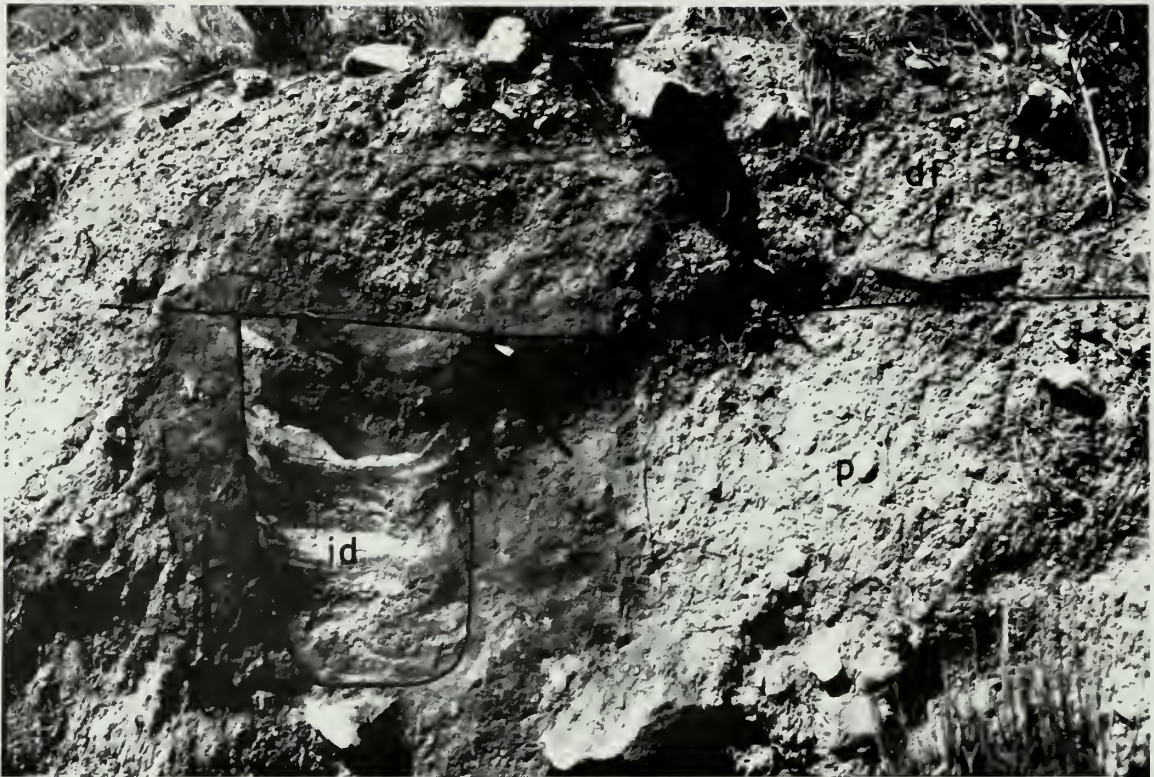
Figure 6. Photograph showing irrigation ditch filled with sediment and overlain by debris-flow deposits. id = cross-section of irrigation ditch; df = debris-flow deposits; p = prehistoric alluvium interbedded with debris-flow sediment.

The north-side ditch is well exposed in a gully near survey control point 1215.07 m (fig. 5); figure 6 is a cross-section of the ditch exposed in the west side of the gully. The light-colored sand beds outline the perimeter of the ditch, which extends vertically from the base of the collapsible shovel to the trowel. Deposits in the ditch are light-colored mainstem alluvium interbedded with dark-

colored tributary deposits. The mainstem deposits accumulated when streamflow was diverted into the ditch; the tributary deposits resulted from sheetwash originating on the nearby bedrock hillslope. The present physical setting of the ditch demonstrates the rapid and extensive changes that affected the alluvial valley. Sometime after 1862 and before at least 1903, the top of the ditch, which corresponds with the prehistoric terrace, was covered by 2 m (7 ft) of debris-flow sediment; enlargement of the tributary channel then eroded through the debris-flow sediment, irrigation ditch, and terrace; this erosion was probably coincident with entrenchment of East Fork between 1883 and 1893.

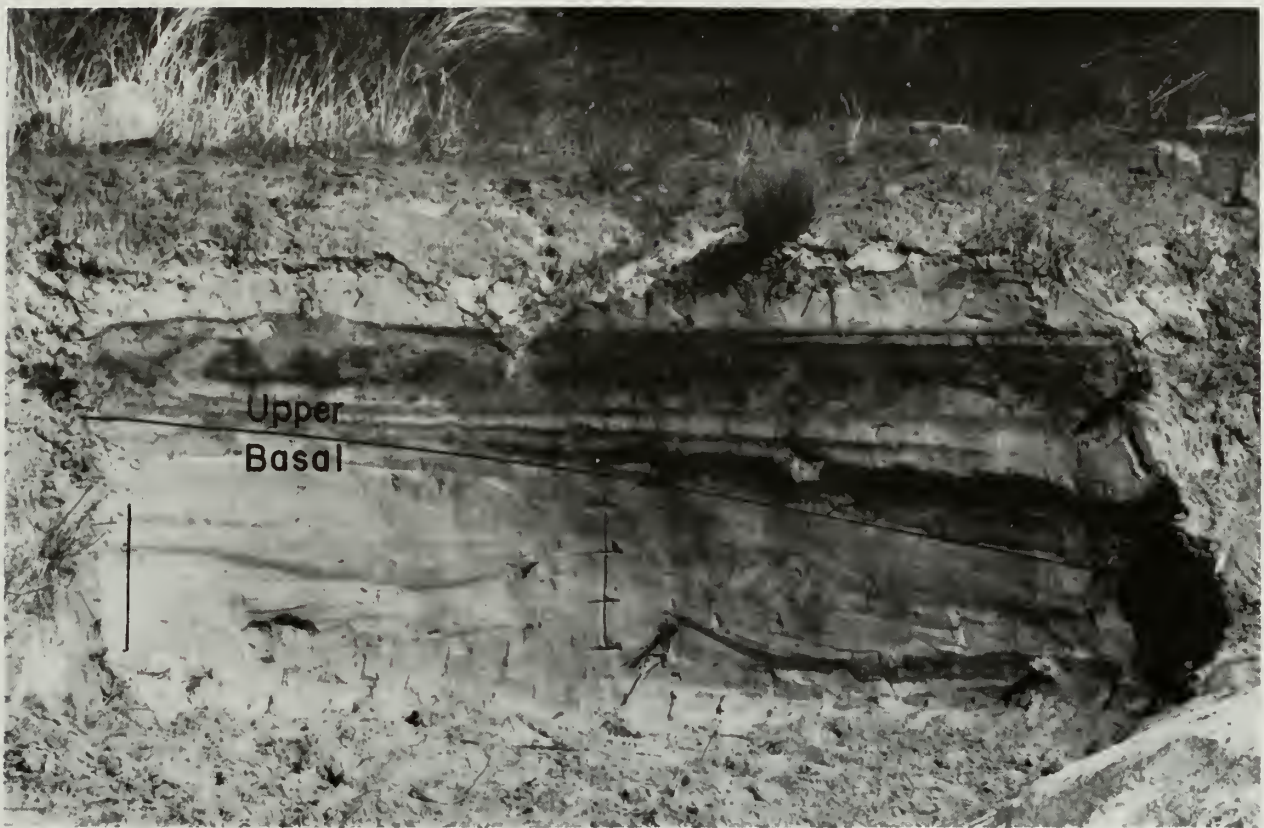
Figure 8. Photograph showing exposure of basal and upper unit of modern alluvium in East Fork. Vertical bar is 30 cm long. Light-colored beds are mainstem deposits; dark-colored beds are sheetwash deposits of clay, silt, and sand.

Alluvium of the modern terrace is well exposed in the cutbanks of the active channel and floodplain. Figure 8 shows the alluvium on the south side of the river just upstream of a large rockfall clast southeast of spot elevation 1202.0 m (fig. 5). The alluvium consists of two units, a basal sand about 50 cm (1.6 ft) thick and an upper stratified sand. The basal unit is massive without distinctive stratification, largely the result of fluvial reworking. A cottonwood tree resembling those on the modern terrace that date between 1940-1963 is rooted on the top of the basal unit, suggesting that the unit predates 1940-1963. The upper unit in the right side and upper portion of the exposure (fig. 8), consists of yellowish-gray beds of very fine to fine-grained sand of mainstem origin with interbedded dark-reddish brown silty and clayey sand derived from erosion of nearby hillslopes. The deposits are extensively bur-

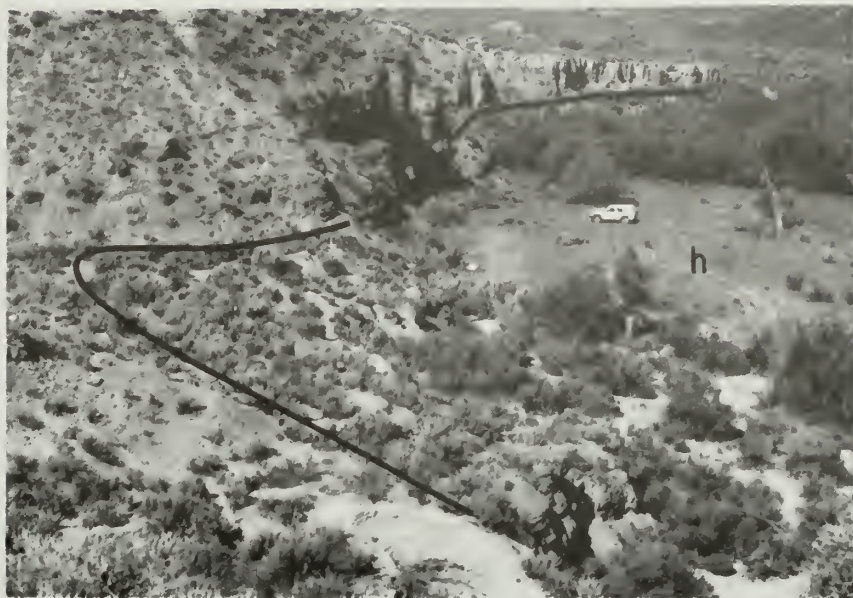
Figure 11. Photograph illustrating erosion of bedrock (Moenkopi Formation) associated with historic arroyo cutting west of Grafton. Line shows trace of irrigation ditch. Dashes show eroded ditch and bedrock. h = historic terrace; m = modern terrace.

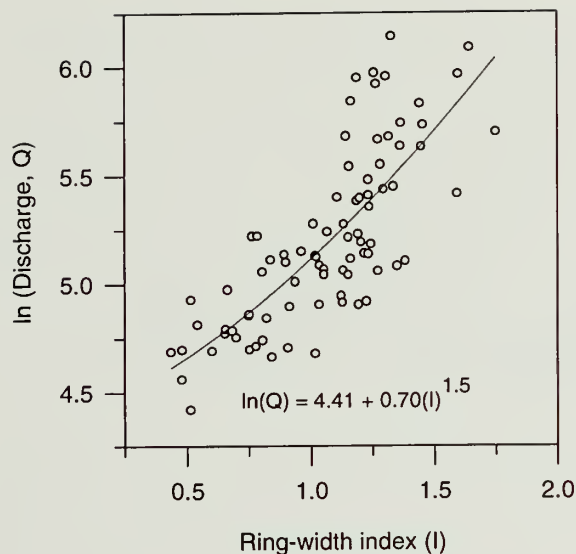
Figure 23. Natural logarithm of average-annual daily discharge (Q) as a function of ring-width index (I).

The independent variable of the calibration regression is standardized ring width averaged between the two tree-ring study sites, and the dependent variable is log-transformed average daily discharge for the water year. Standardized ring widths, or ring-width indices, were calculated from the raw-width measurements to remove systematic changes of ring width related to the age of the sampled trees. The discharge data were transformed to reduce the positive skewness caused by large values. Water years 1972-1978 are missing from the gaged record; these missing data were estimated by using annual flow rates from the North Fork gage near Springdale (gage 09405501). Discharge of North Fork is highly correlated with the Virgin River downstream of the forks such that 95 percent of the annual variation of Virgin River discharge is explained by discharge of North Fork.

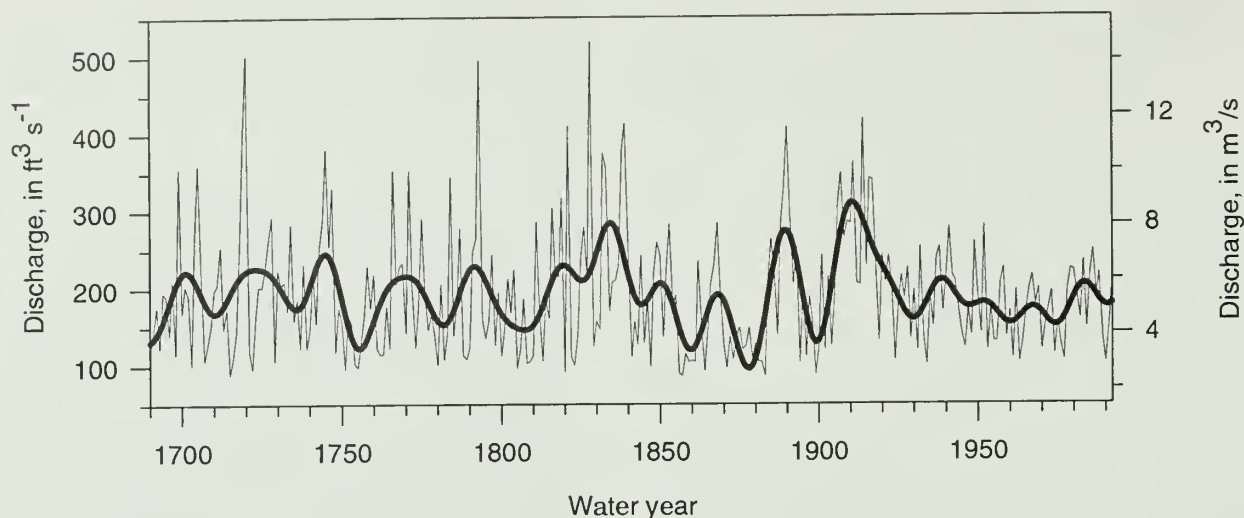
Figure 25. Reconstructed average daily discharge by water year, 1690-1992. Heavy line is discharge smoothed with fourier transform algorithm, smoothing level 35 percent.

Streamflow reconstructed with equation (1) from the full tree-ring chronology is shown in figure 25. This reconstruction is qualitatively verified from the flood history listed in Table 1, from an independently derived reconstruction in the lower Virgin River basin (Larson and Michaelsen, 1990), and from a tree-ring chronology in Kanab Creek basin (Webb and others, 1991).

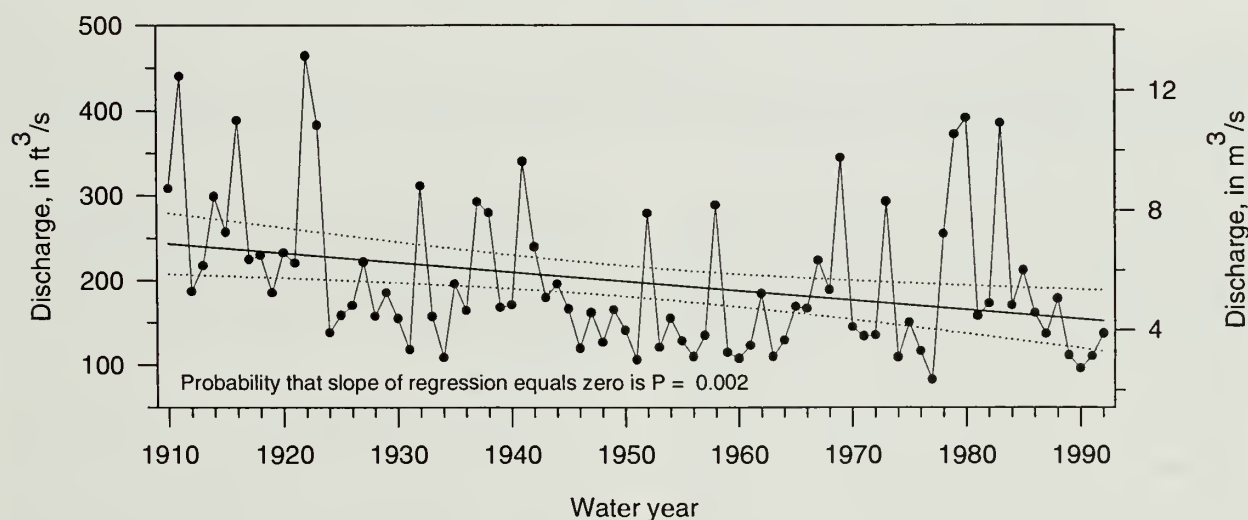
Figure 26. Time series of average daily discharge, 1910-1992. Regression line shows long-term, linear decline of annual discharge, dotted lines are 95 percent confidence interval of regression.

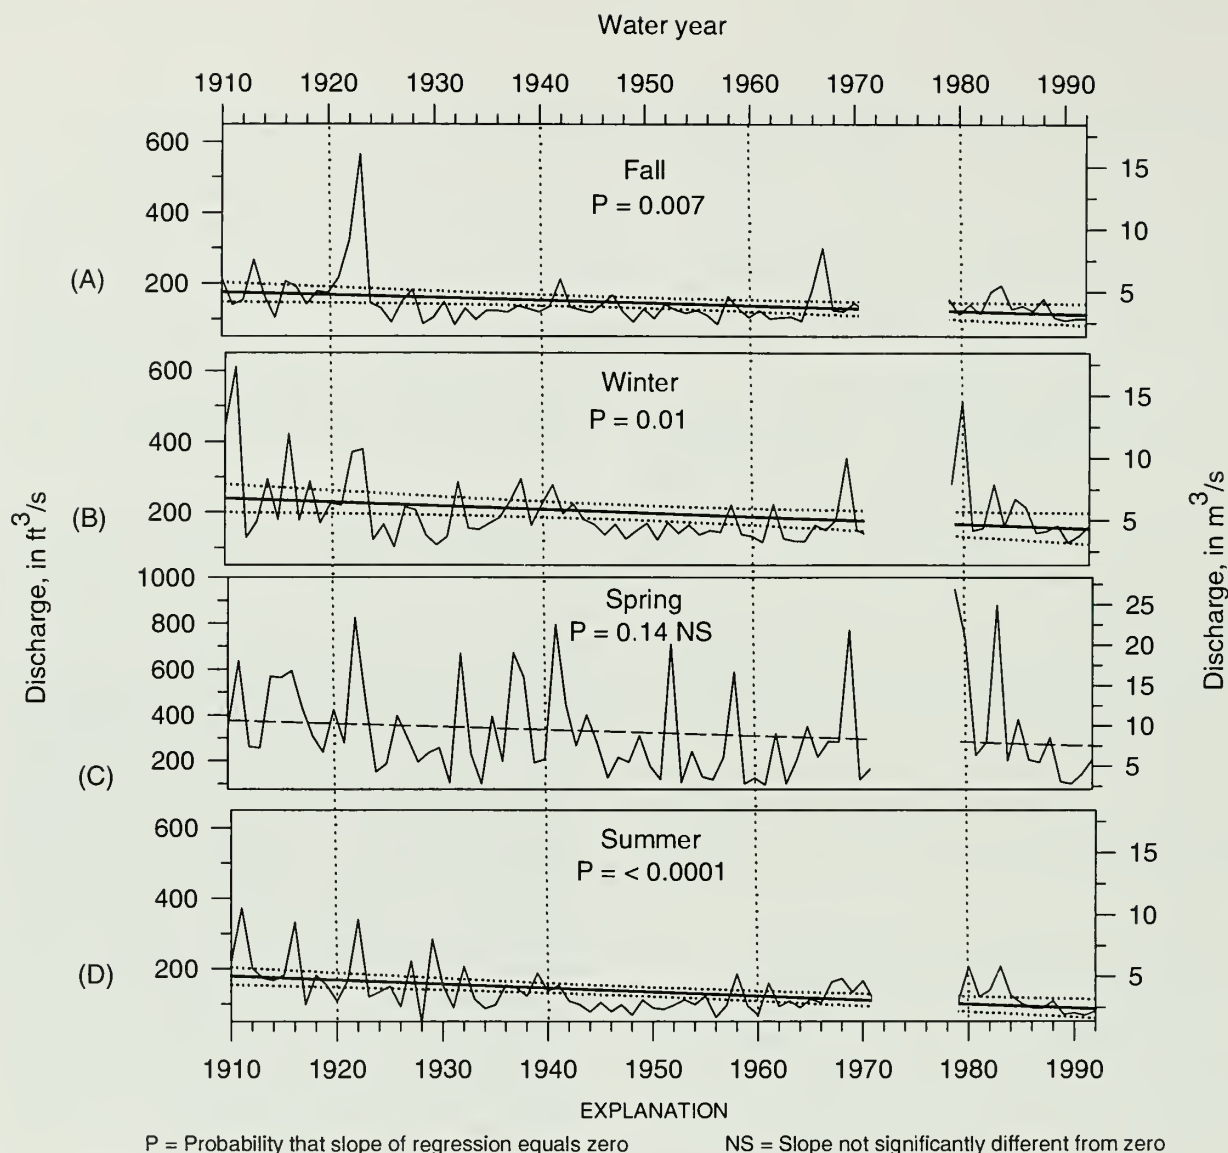
Figure 27. Time series of A) fall, B) winter, C) spring, and D) summer average daily discharge, 1910-1992. Data for 1972-1978 are missing. Regression line shows long-term, linear decline of discharge, which is not statistically significant for spring (dashed line), dotted lines are 95 percent confidence interval of regression.

The decline of annual discharge results largely from variation of seasonal streamflow. Figure 27, shows average daily discharge by water year for fall (October-December), winter (January-March), spring (April-June), and summer (July-September). Spring is clearly the dominant streamflow season, having average daily discharge nearly twice as large as the other seasons. Over time, spring discharge has remained essentially constant, without a significant trend toward either higher or lower discharge (fig. 27c). Fall, winter, and summer discharge have decreased over time, however, and the trend is statistically significant (fig. 27a-b,d). The large annual streamflow from 1910-1923 (fig. 26) resulted from high streamflow during the latter three seasons combined with spring streamflow.

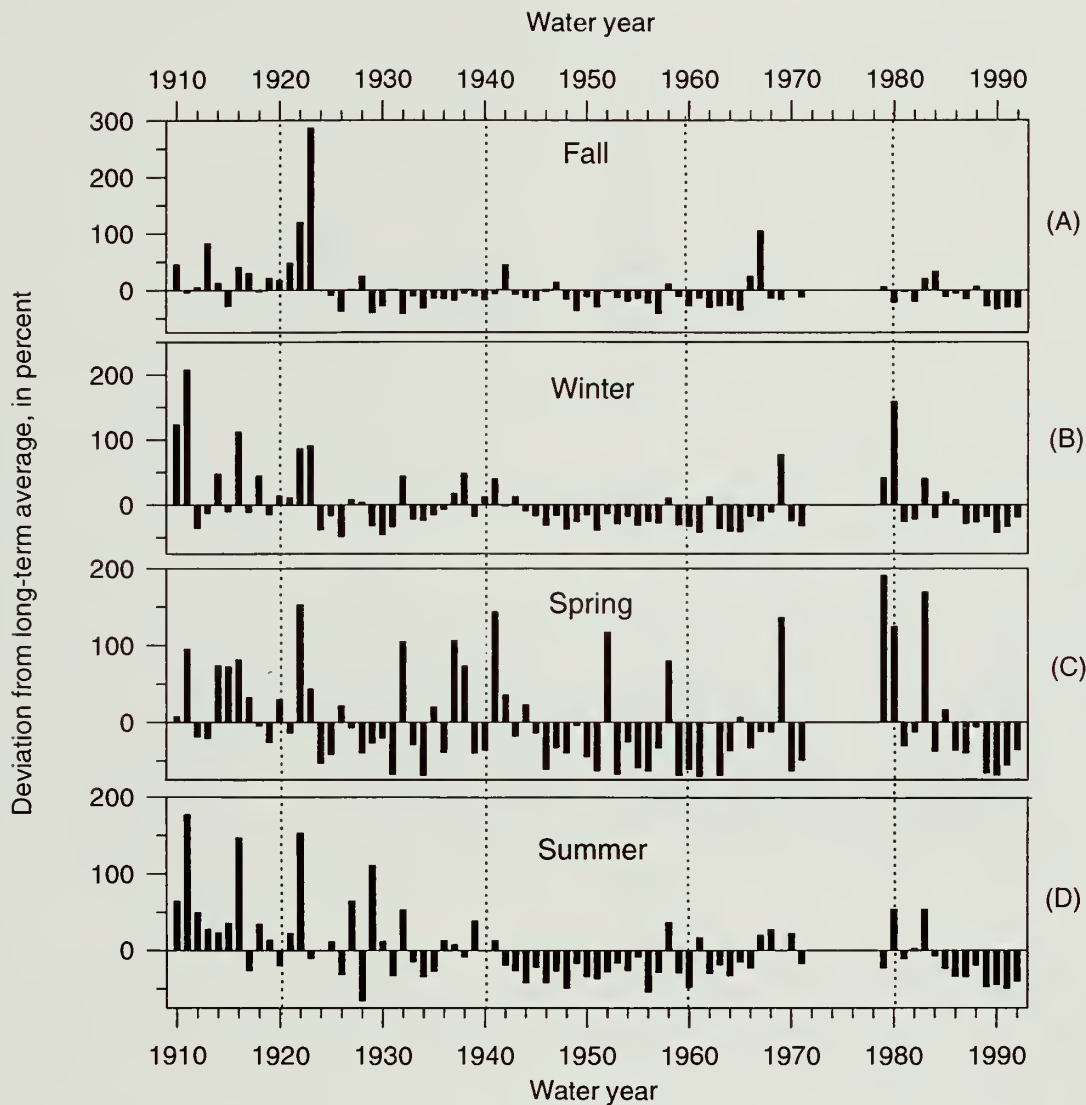
Figure 28. Time series of deviation in percent from long-term average flow rates, 1910-1992. A) fall, B) winter, C) spring, and D) summer. Data for 1972-1978 are missing.

produced most of the annual streamflow since about 1930. Only one year, 1980, approached the earlier conditions of large spring, winter, and summer flow rates (fig. 28b-d).

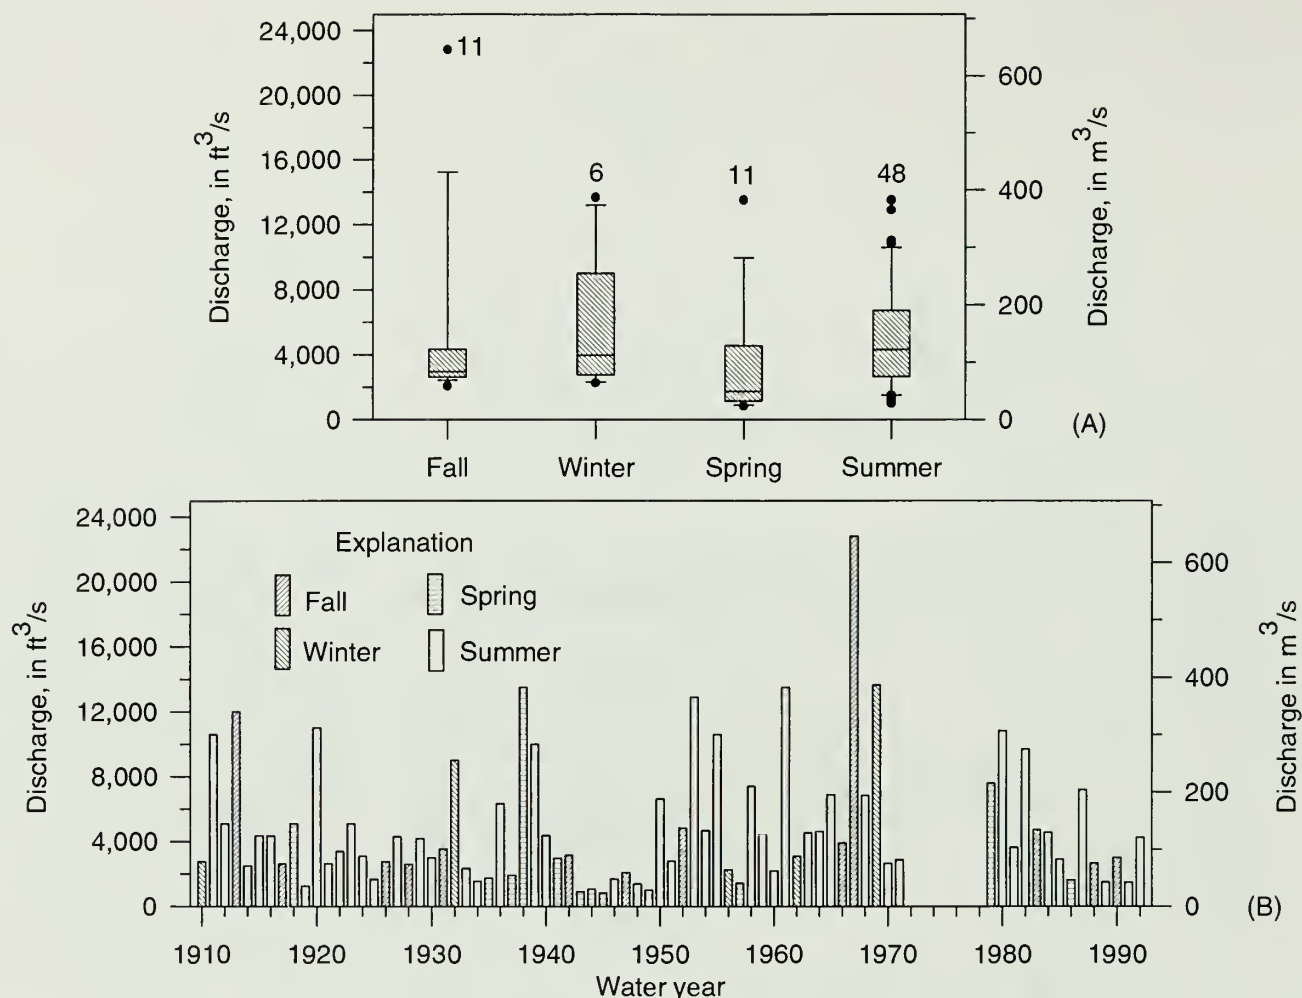
Figure 29. Discharge of the annual flood. A) Statistical summary of the annual flood by season; box shows median and 25-75th percentile, vertical line is range of 10-90th percentile, and solid circles are values less than 10th and greater than 90th percentiles, respectively. Number of floods shown at top of upper vertical line. B) Times series of annual flood, 1910-1992. Data for 1972-1978 are missing.

annual peak flood by season (fig. 29a) and a time series of the annual flood classified by season (fig. 29b). The annual peak flood occurs in every season, but is most frequent in summer. These summer flood peaks have little affect on average summer streamflow because of short duration, which is substantially less than average spring streamflow (fig. 27). Annual flood peaks in spring are infrequent, although the largest spring flood is close to the largest winter and summer peak flood. The largest annual flood was in fall and was almost twice the size of the largest flood of the other seasons (fig. 29a).

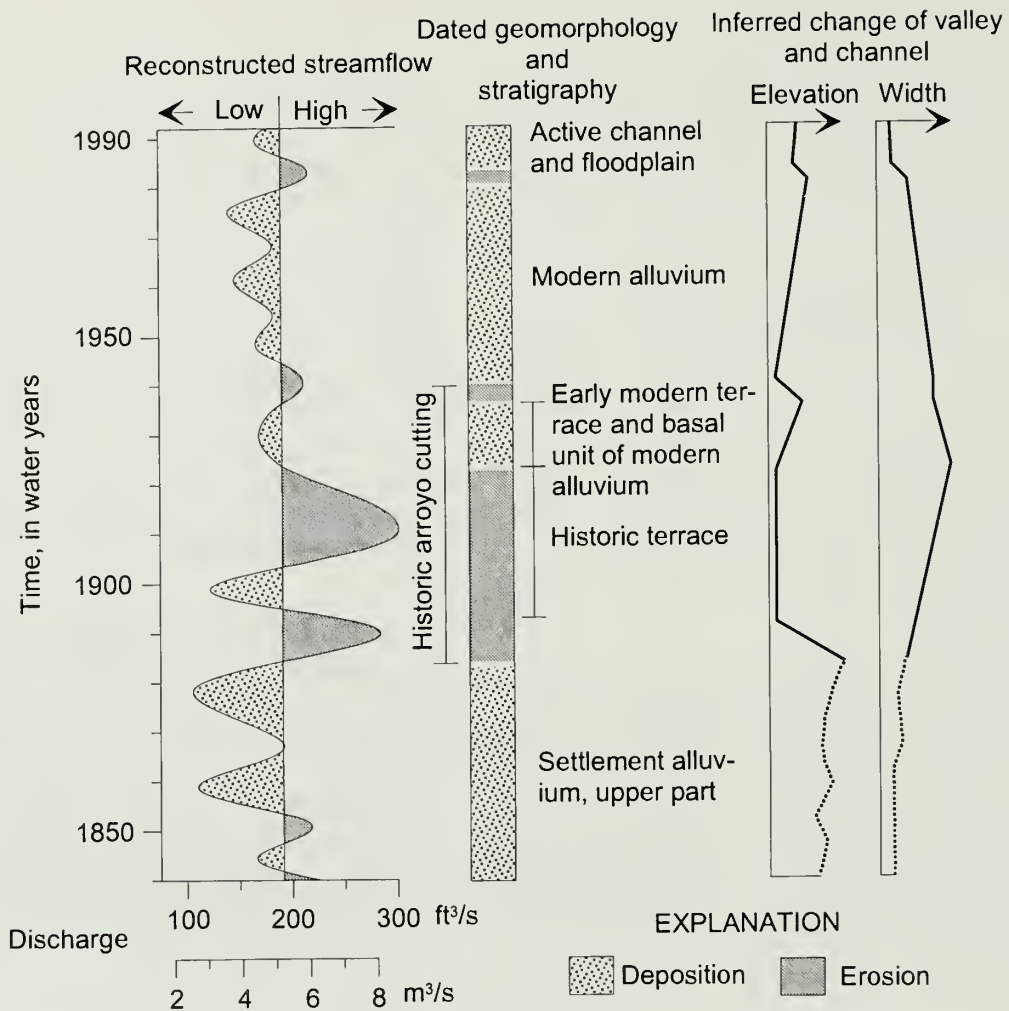
Figure 30. Reconstructed streamflow, dated geomorphology and stratigraphy, and inferred change in width and elevation of valley and channel, respectively, 1850-1992. Streamflow data smoothed with fast fourier transform algorithm, smoothing level 32 percent.

The early modern terrace and basal unit of the modern alluvium developed in the flow regimen of the mid-1920s to late-1930s. The terrace and deposits apparently record incipient deposition in the historic-age channel (figs. 19, 22) during a period of relatively low streamflow (fig. 26). This flow regimen developed after a drop in fall, winter, and summer
