Historic Furnishings Report
Scotty's Castle: An Interior History of Death Valley Ranch

HISTORIC FURNISHINGS REPORT

**SCOTTY'S CASTLE: AN INTERIOR HISTORY OF DEATH VALLEY RANCH
DEATH VALLEY NATIONAL MONUMENT
CALIFORNIA/NEVADA**

by
Linda Wedel Greene
Denver Service Center

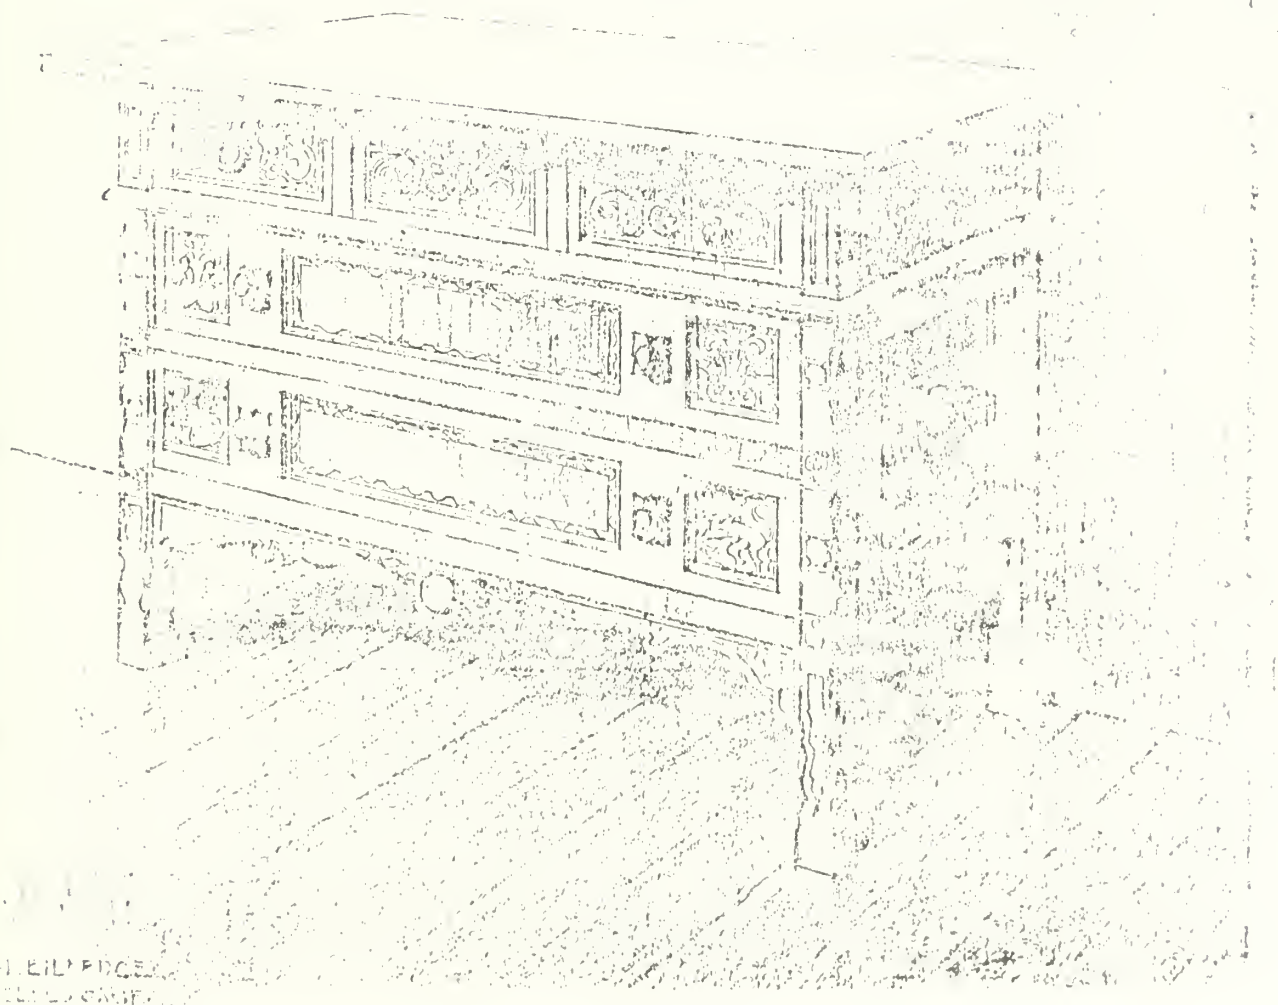
Drawing 10. Mrs. Johnson's bureau.
Copy drawing, DEVA 17004 (no. F-1009), n.d.

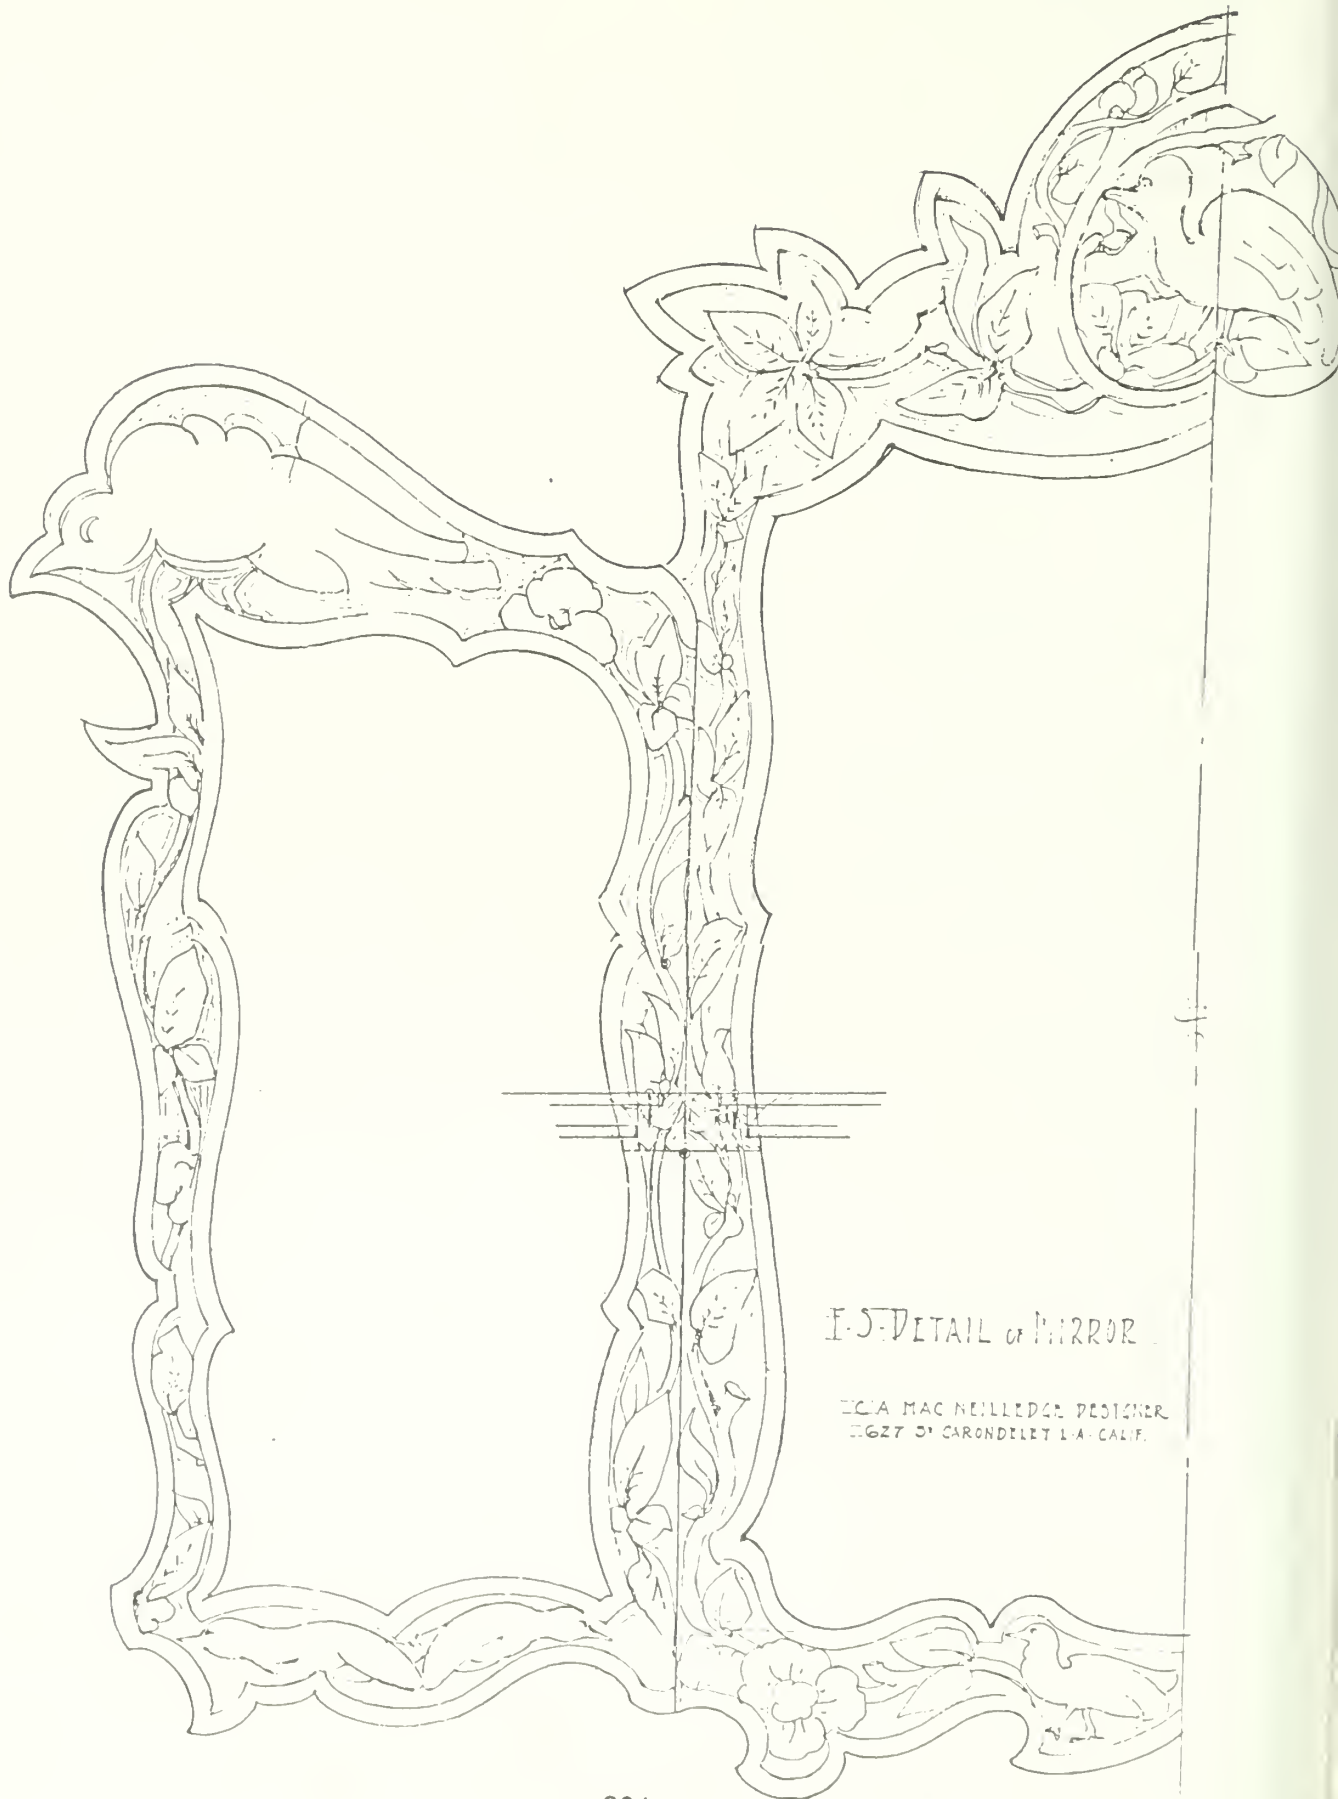
F.S. DETAIL of MIRROR

Drawing 13. Full-size detail of mirror above dressing table in west guest suite bedroom.
DEVA 17041.

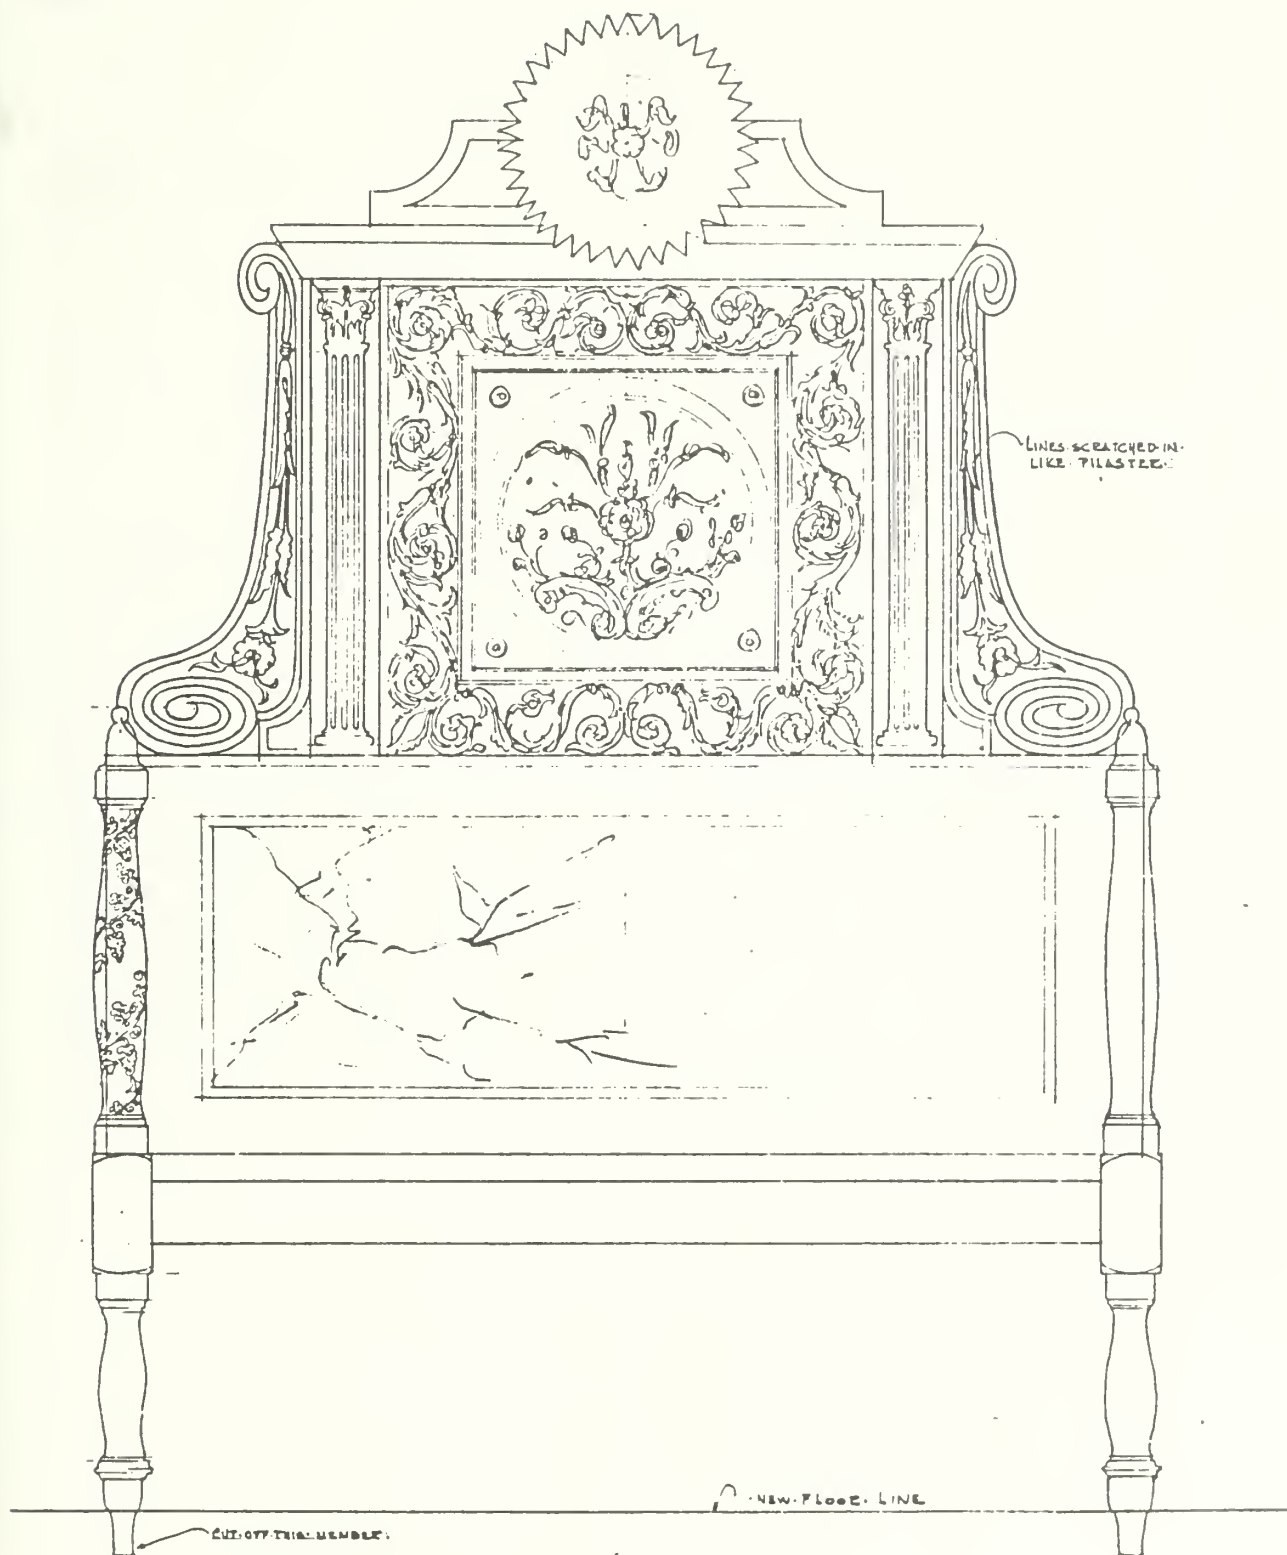
REBUILT SPANISH BED. 3" 11'0"
DEATH VALLEY RANCH JOHNSON & SCOTT CALIF.

Drawing 14. Italian bed in second overnight guest room (Bokhara room).
DEVA 17054.

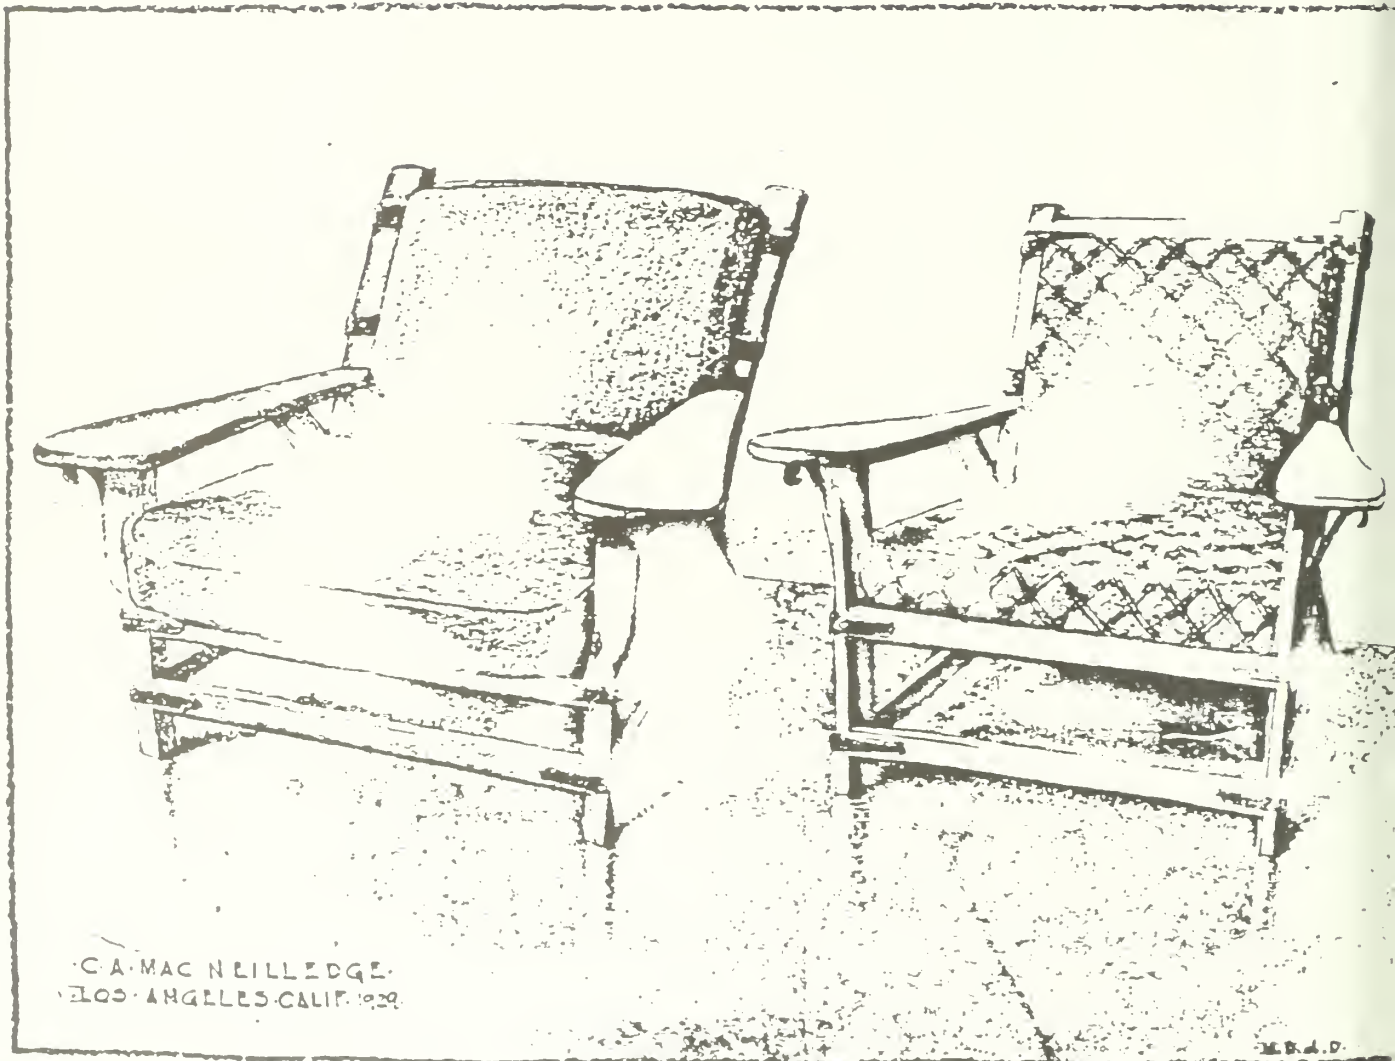
Drawing 15. Renderings of armchairs. Note de Dubovay's initials as the artist in the lower right corner.
DEVA 17002.

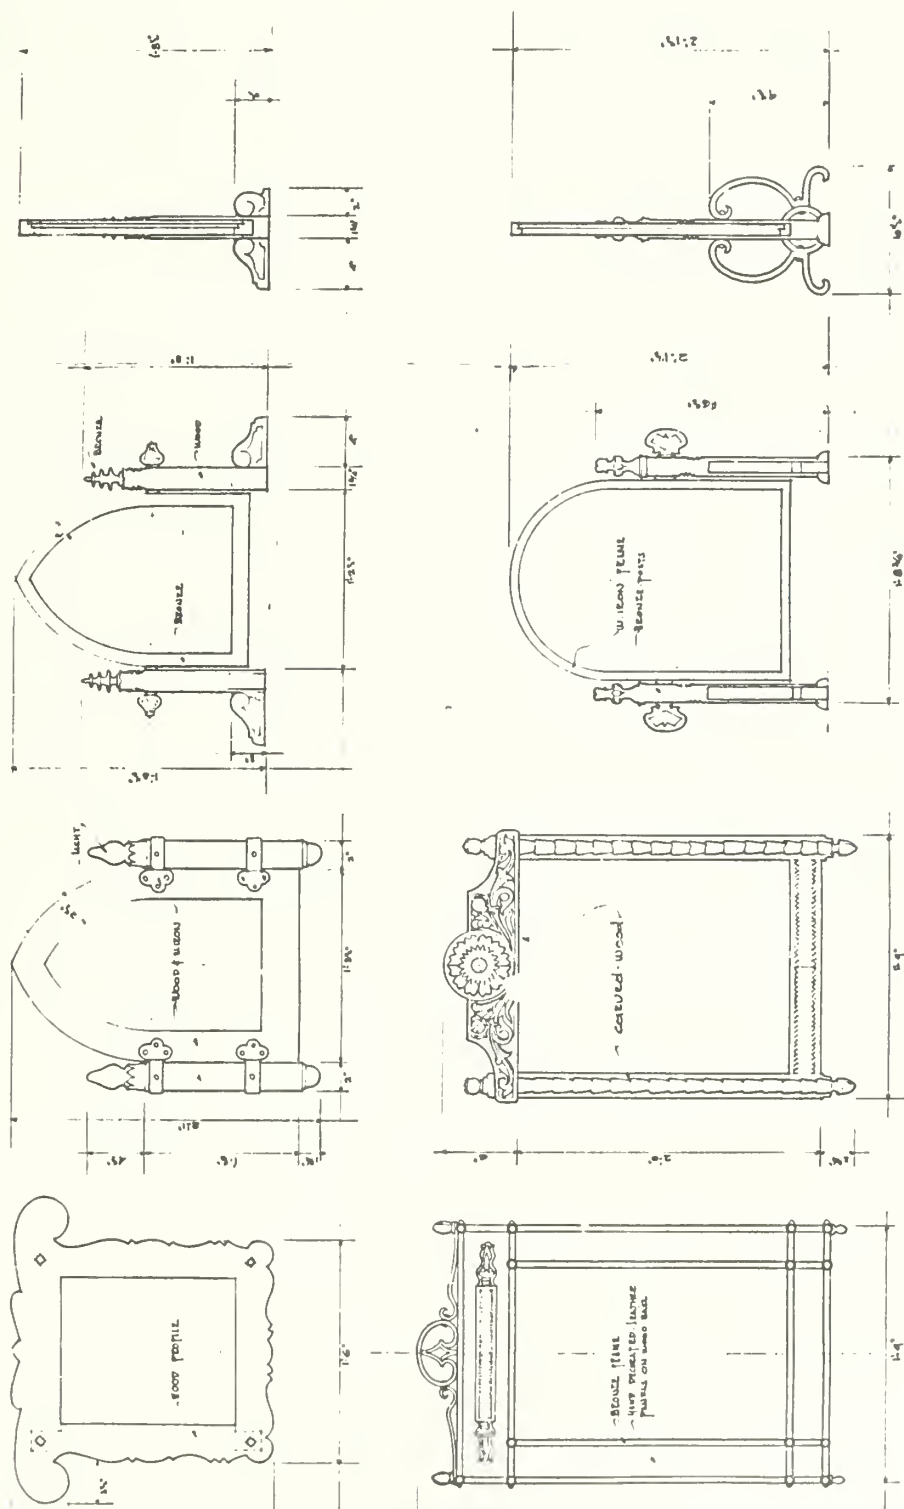
Drawing 16. The mirror on the bottom row, second from the left, hung in 1987 in the second overnight guest room (Bokhara room). The top right-hand mirror is now in the stable storage area. The mirror in the bottom right-hand corner is in Mr. Johnson's bedroom on the chest of drawers.
DEVA 17055.

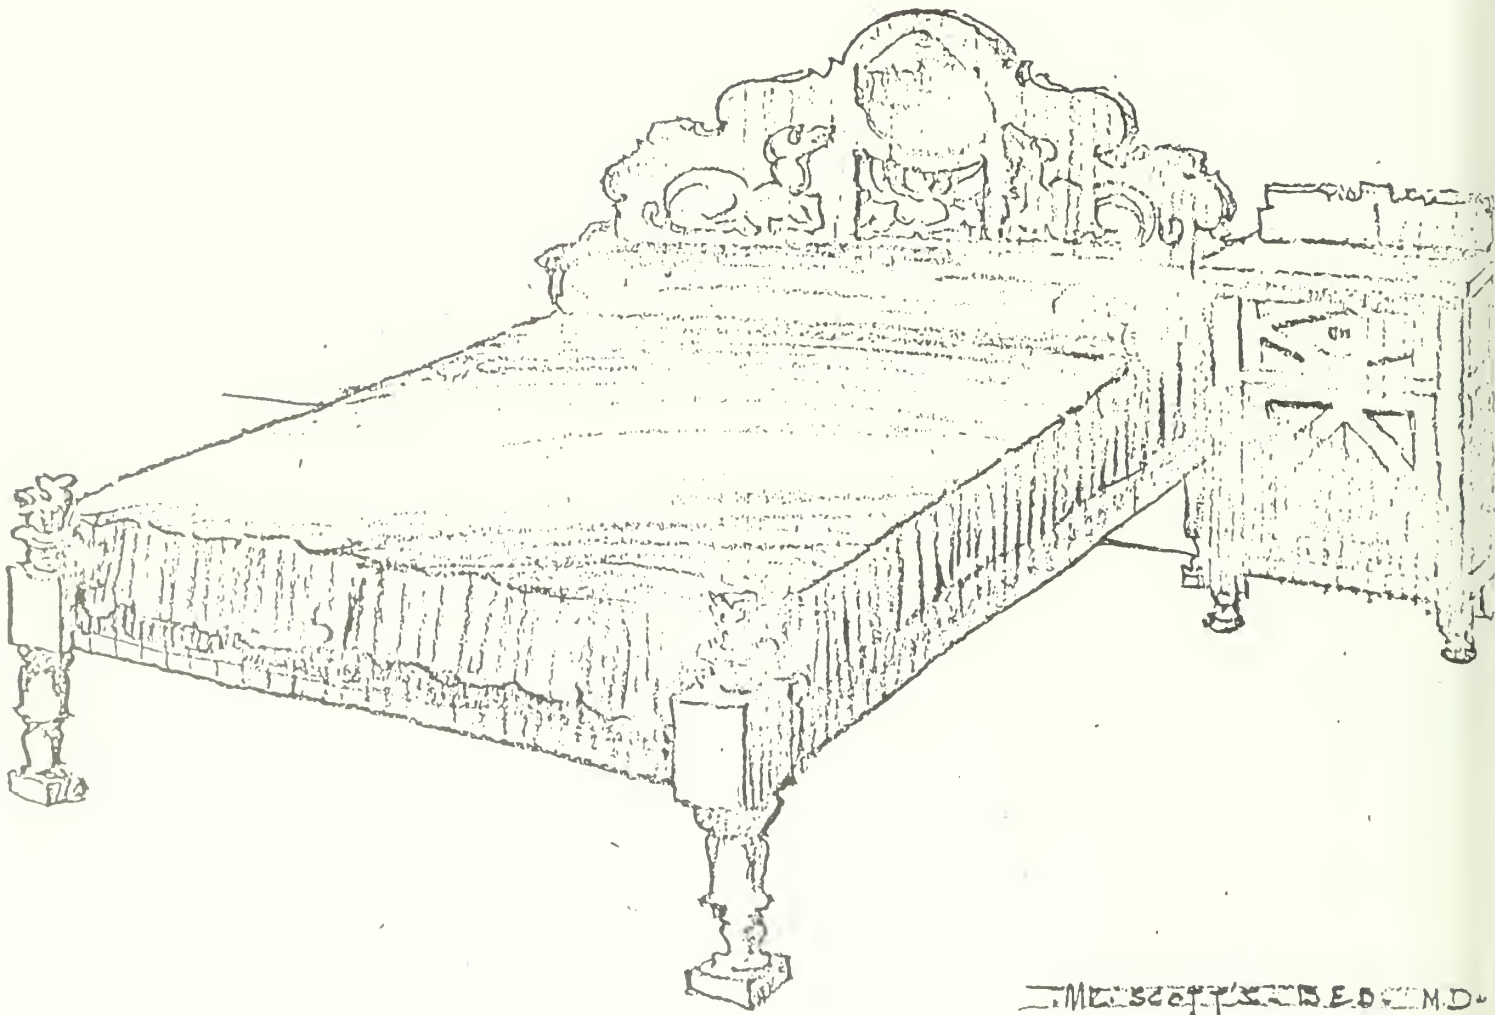
Study for "Mr. Scott's bed," but not the design finally decided upon.

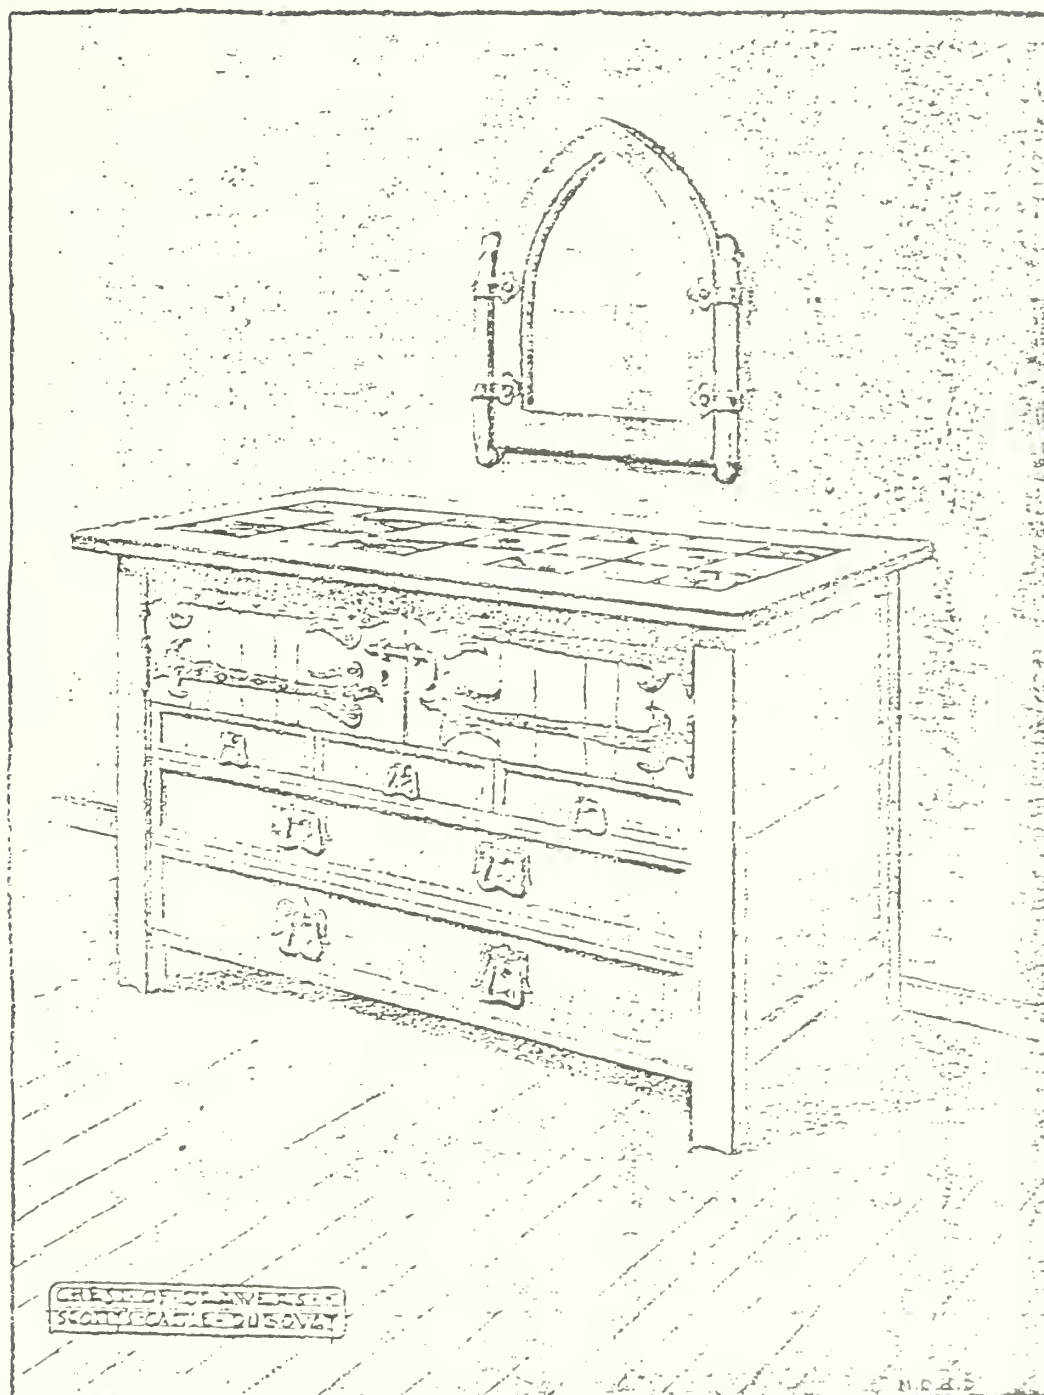
Drawing 2.

Chest of drawers as built for Scotty's bedroom on the north wall.

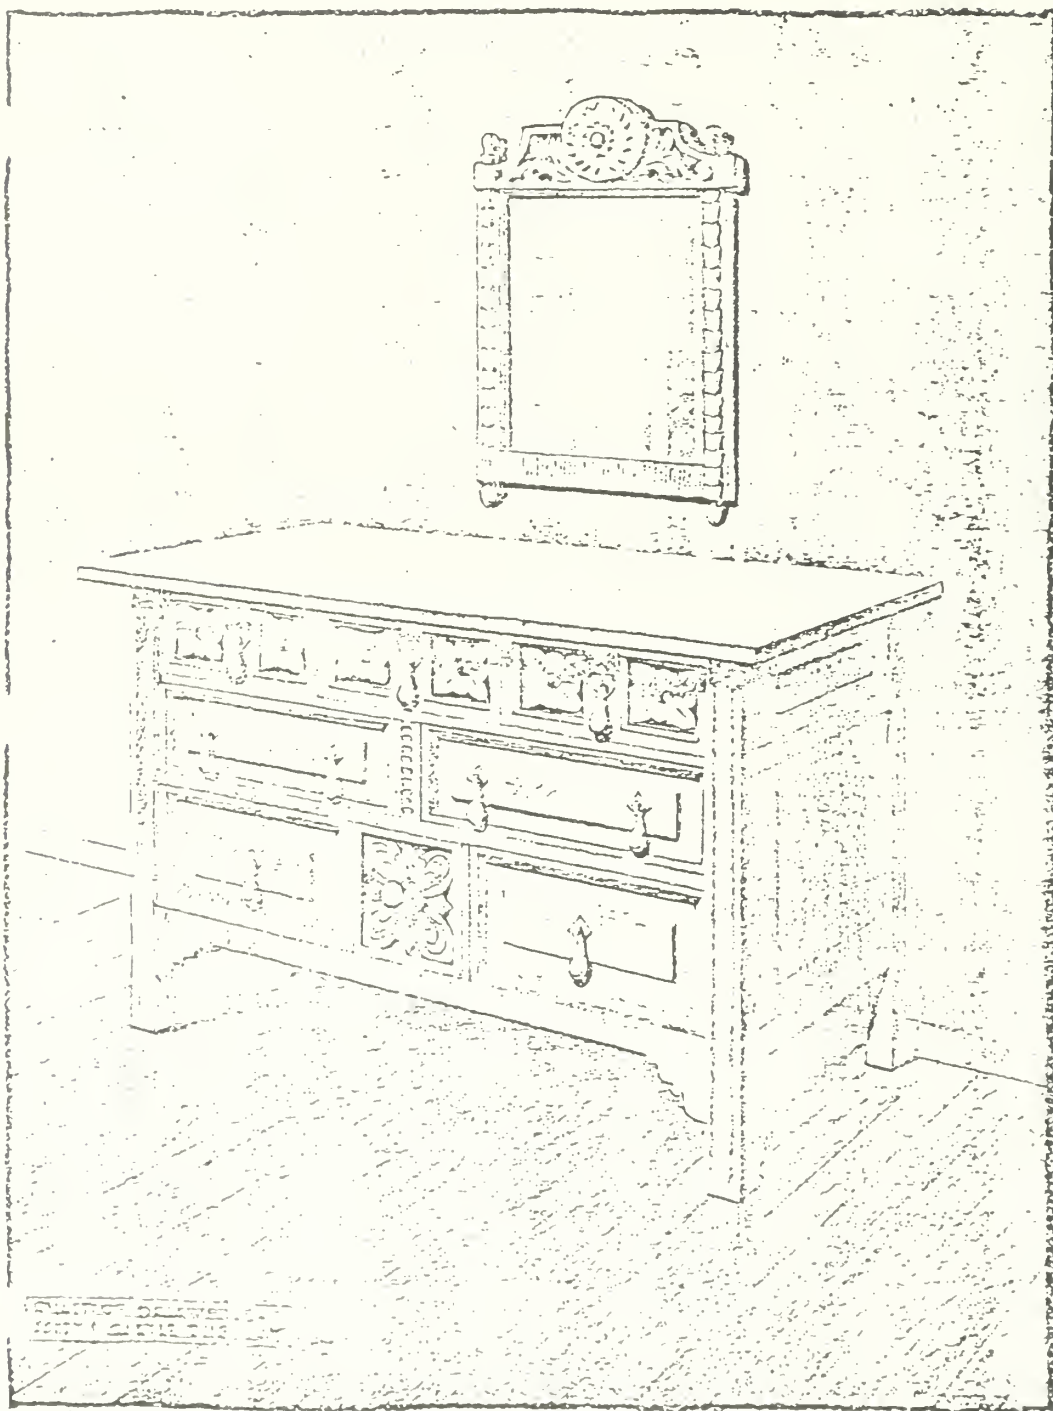
Drawing 3.

Chest of drawers on west wall of Mr. Johnson's bedroom.
