## CULTURAL LANDSCAPE REPORT FOR SPRINGWOOD

HOME OF FRANKLIN D. ROOSEVELT NATIONAL HISTORIC SITE

VOLUME II: TREATMENT

Olmsted Center for Landscape Preservation  
National Park Service, Boston, Massachusetts 2009

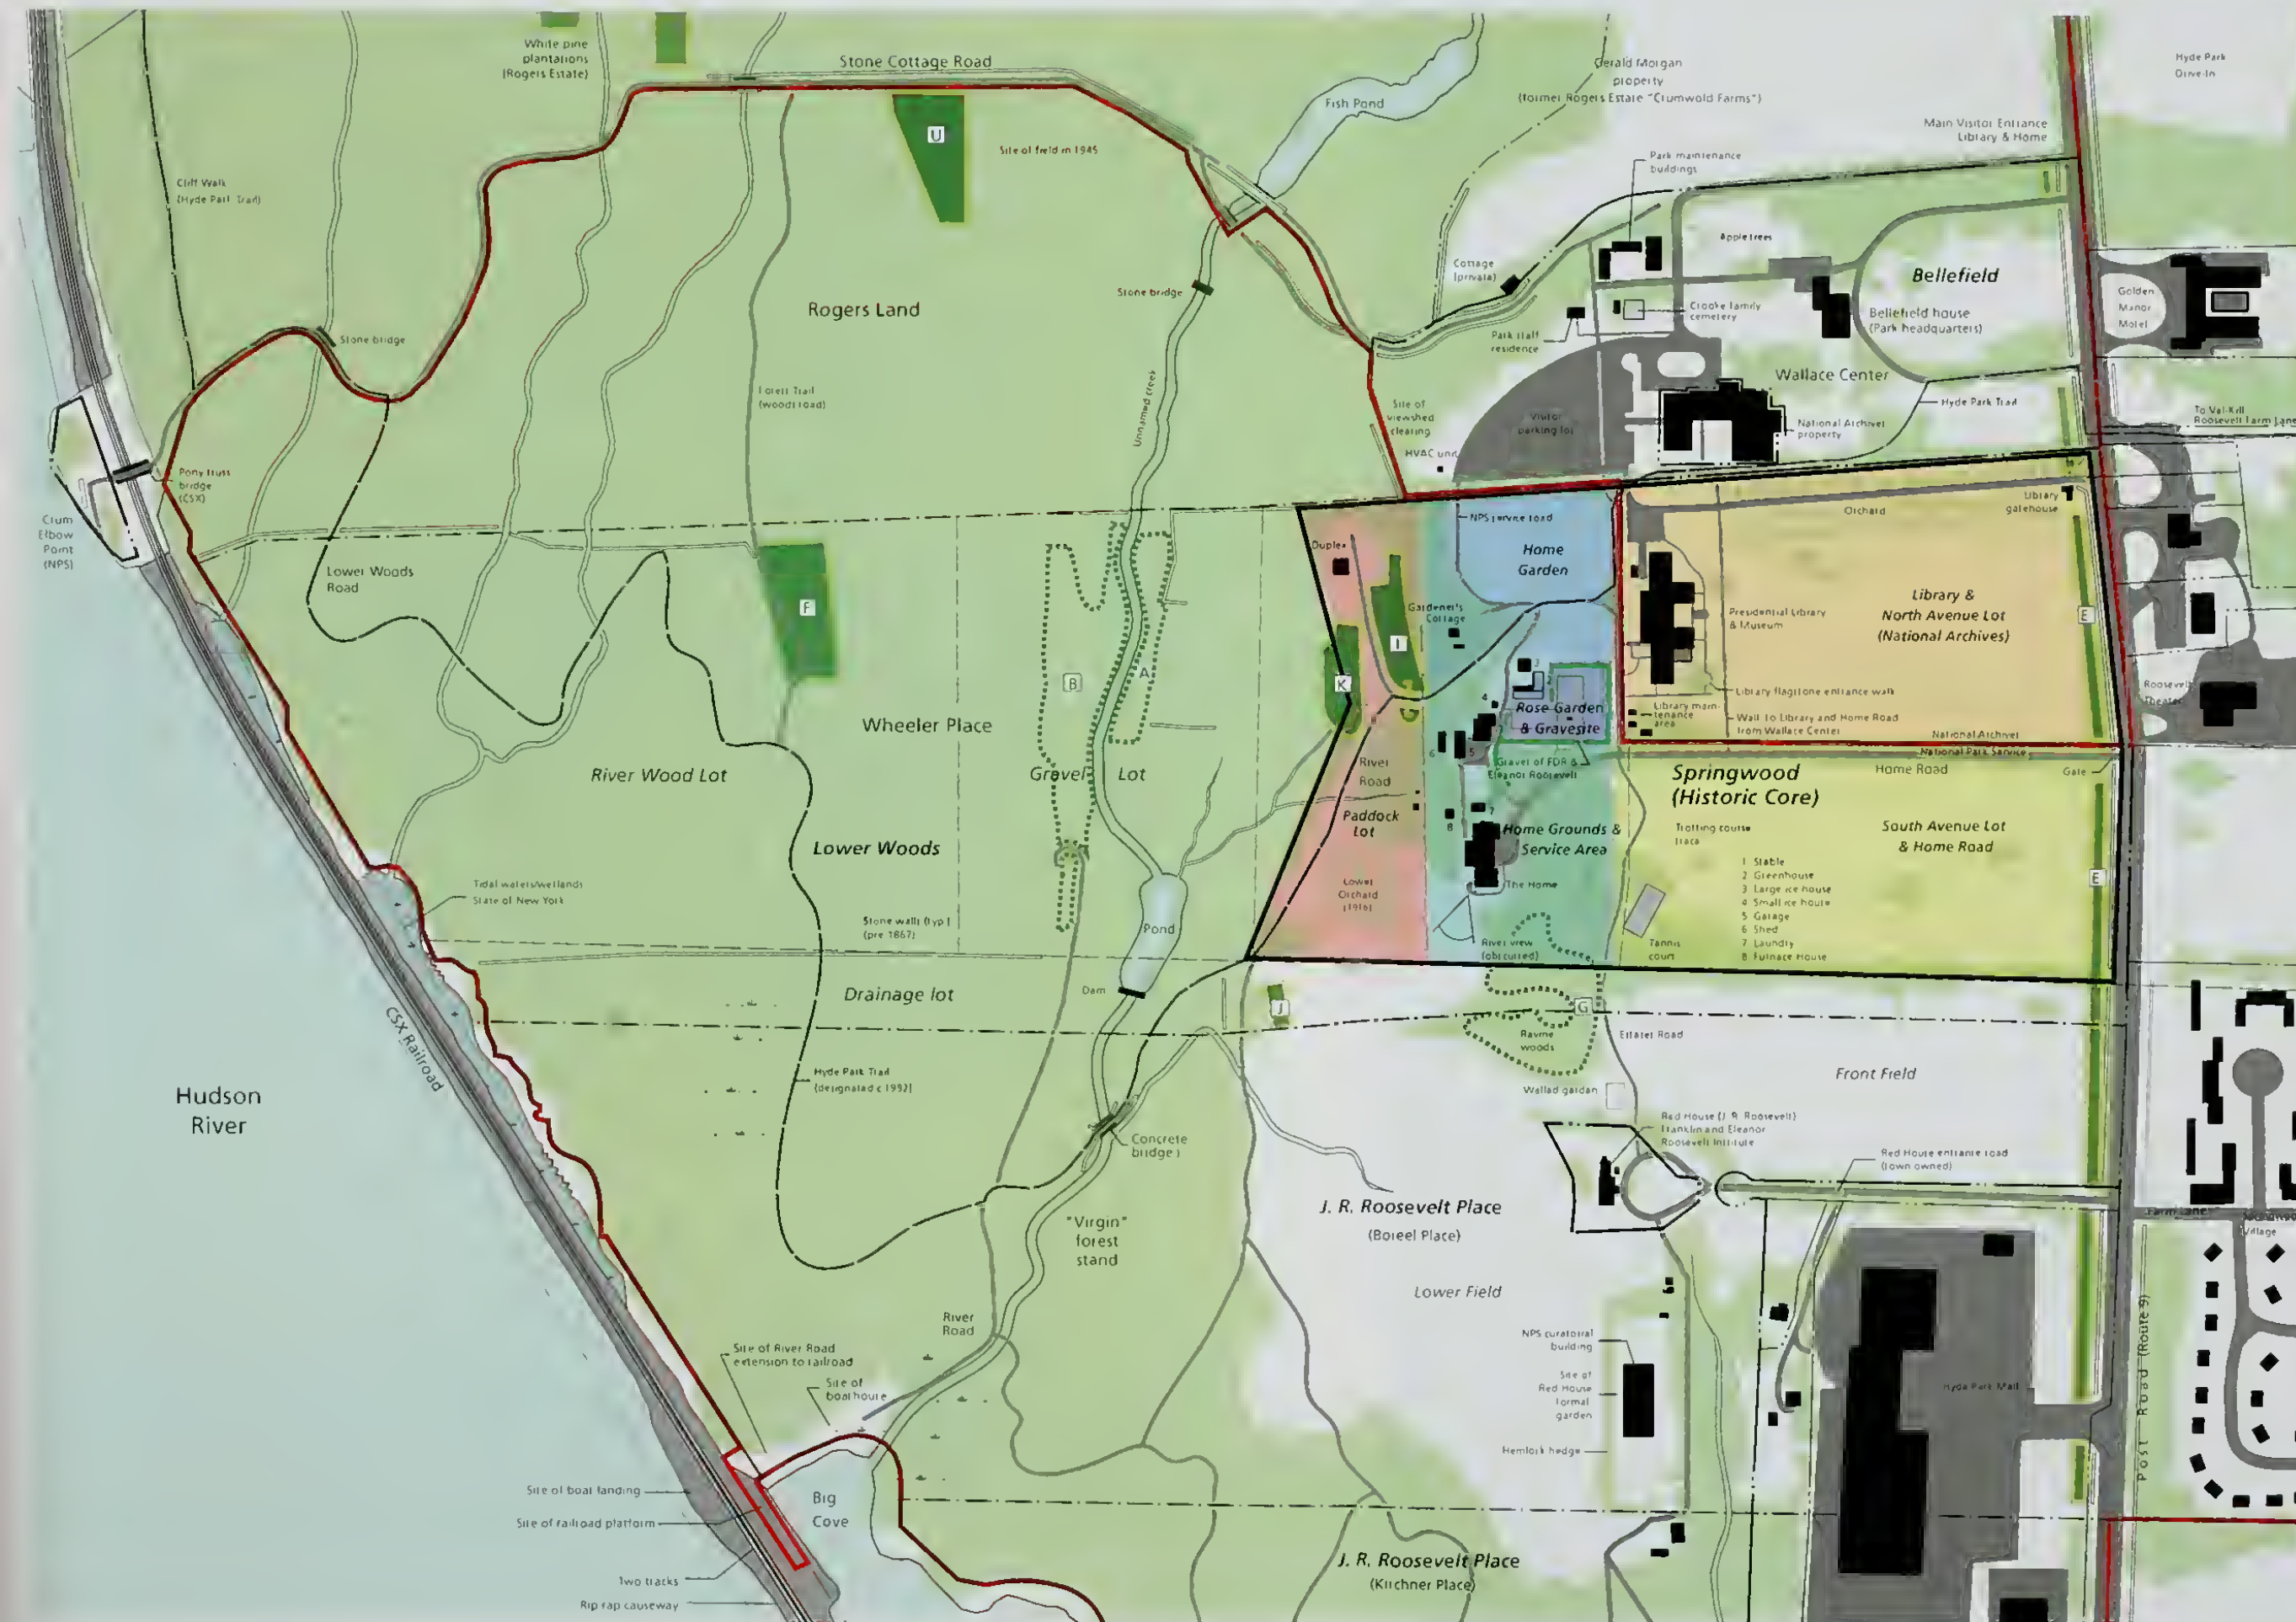
Drawing 1

1. All features shown in approximate scale and location.
2. Plan provides overview of existing (2009) conditions within the historic core (original 33-acre area surrounding the Home), with less detail in adjoining areas.

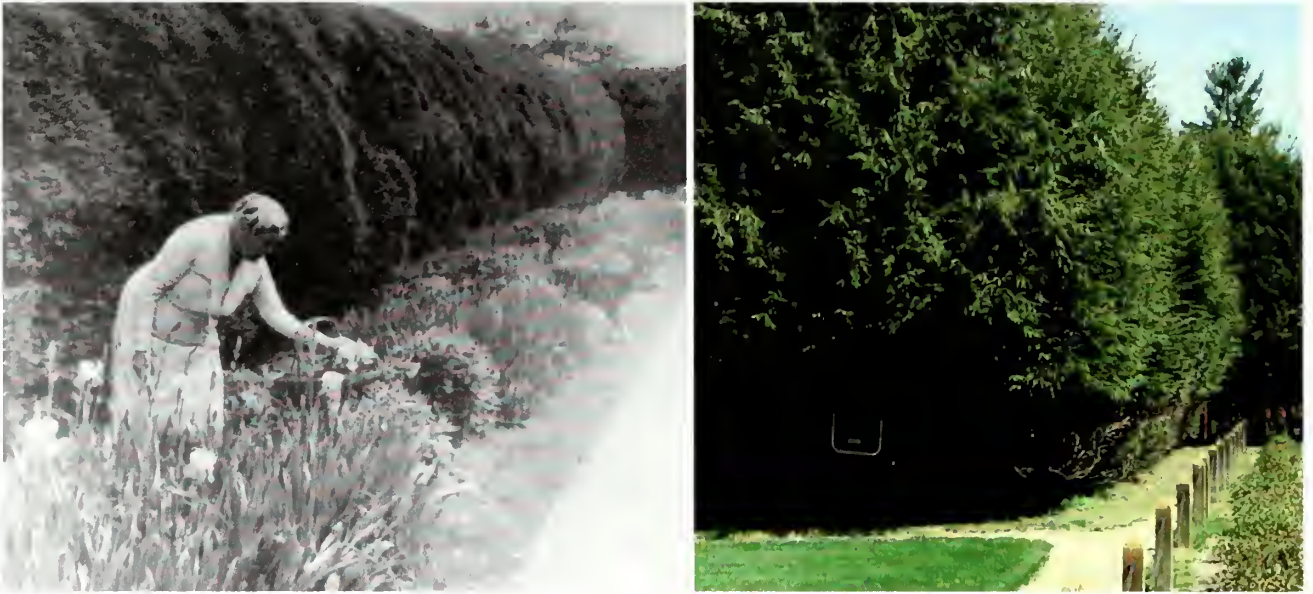
Figure 1: View in the Rose Garden in c.1935 looking north showing Sarah Roosevelt tending to the well-maintained border along the west side of the garden, compared with recent view of the same area. Note change in character of walks, turf, and hedges. Recent replacement of the hedge has allowed the bed to be restored. (Photograph NPx 50-104:13, Franklin D. Roosevelt Library and Museum.)

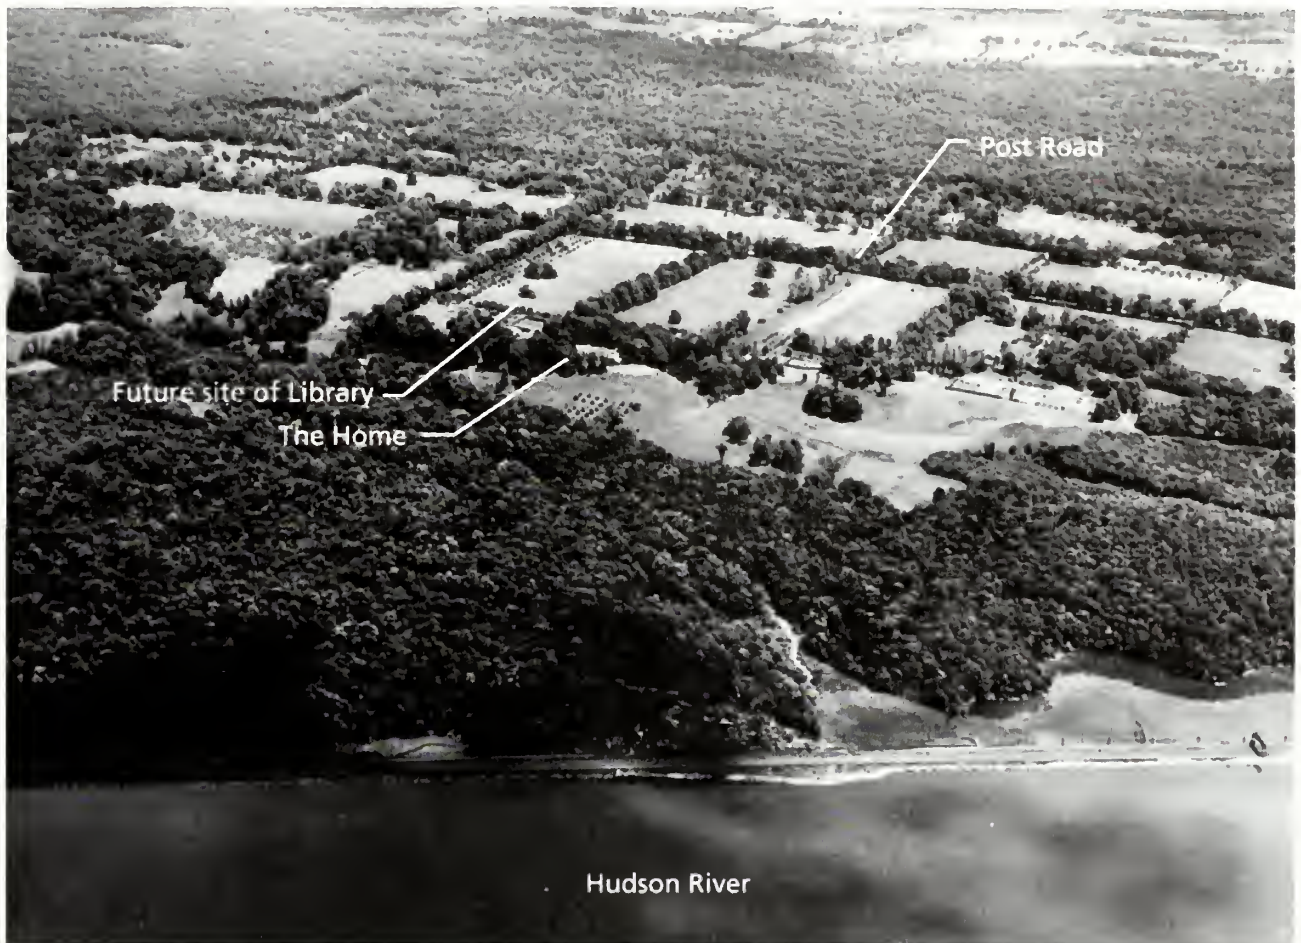
Figure 3: Aerial view looking east from the Hudson River over the historic core in 1932 illustrating the rural setting. The long line of trees running horizontally across the upper part of the photograph is the Post Road. (Photograph Px48-2213837, Franklin D. Roosevelt Library and Museum, annotated by SUNY ESF.)

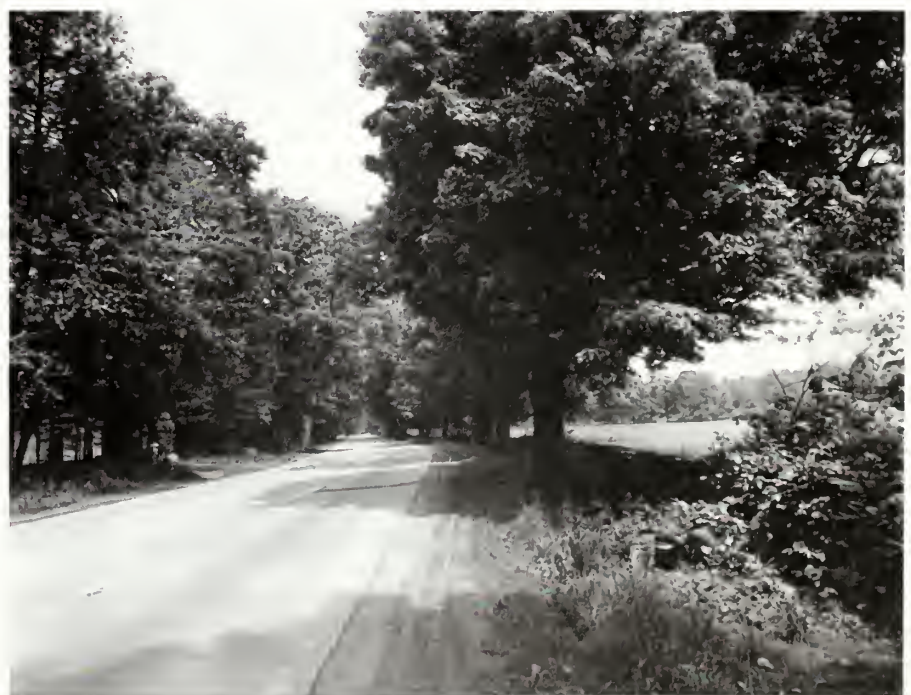
Figure 4: View looking north along the tree-lined Post Road through the Roosevelt estate in c. 1946 with the Home Farm at right and Home Road entrance gate at left. Today, commercial development occupies the field at right, the road has been widened, and most of the roadside trees have been lost. (Photograph R-378, Roosevelt-Vanderbilt National Historic Sites.)

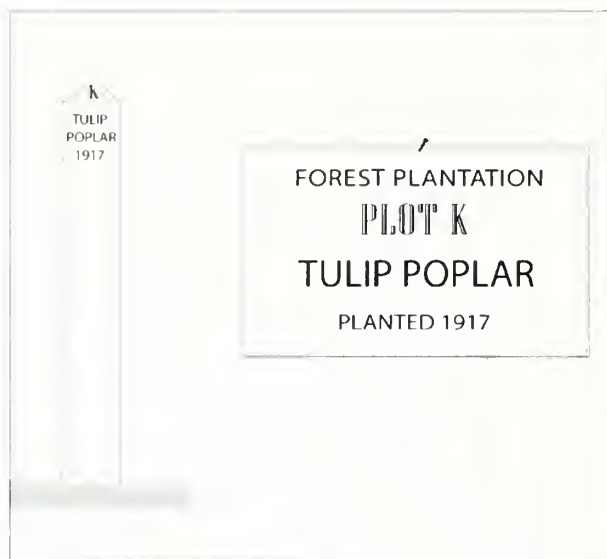
Figure 5: Suggested design for post (boundary) and signboards to identify the forest plantations. Signs should be attached with fasteners that do not damage trees. Not to scale. (SUNY ESF.)

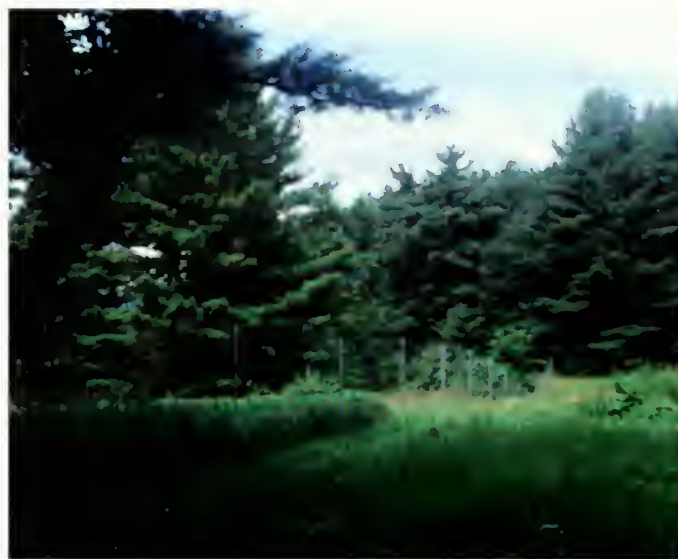
Figure 6: Recent photograph of site-wide deer fencing at The Mount, Lenox, Massachusetts showing inconspicuous design that visually recedes through open field conditions. (SUNY ESF.)

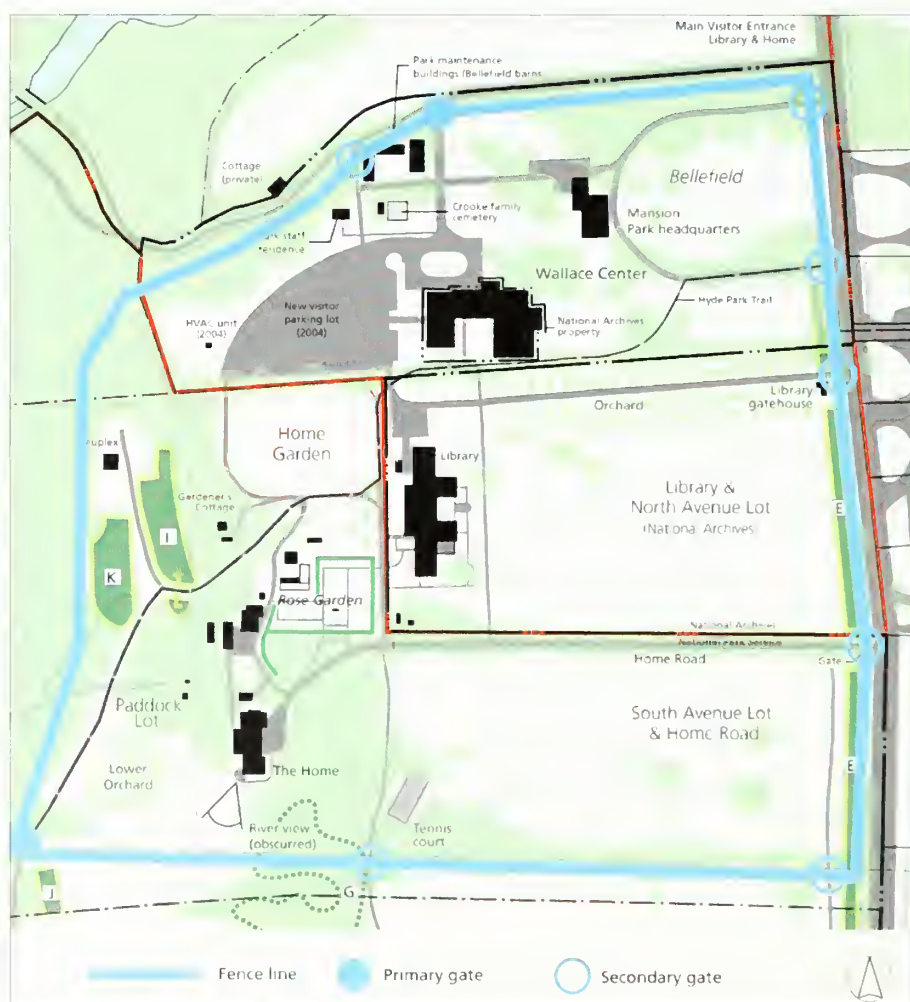
Figure 7: Plan showing possible location of site-wide deer fencing to protect the historic core and Bellefield. The plan includes two primary fence gates and seven secondary gates. (SUNY ESF.)

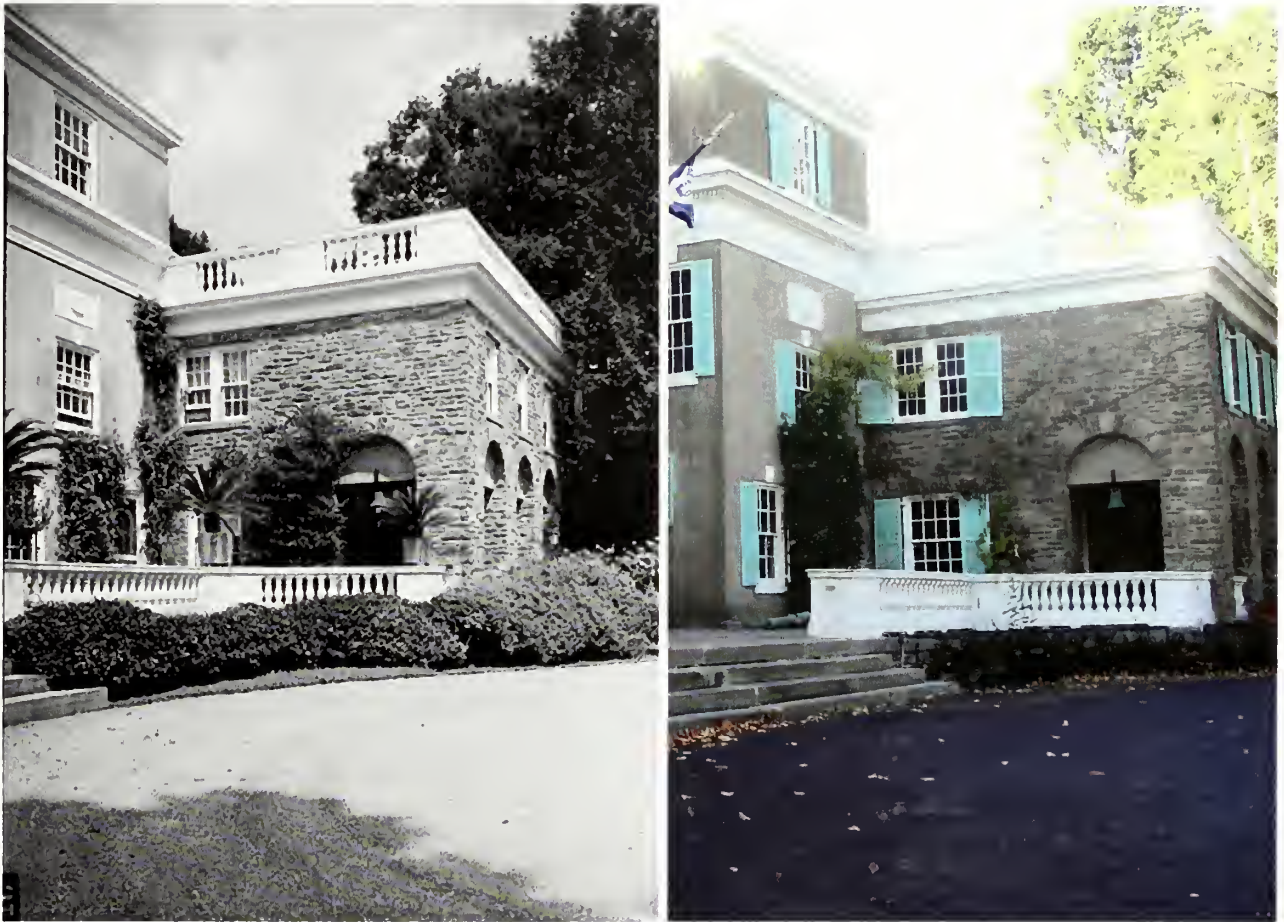
Figure 8: Comparison of paving character showing gravel-surfaced turn-around in July 1941 and the existing black asphalt that replaced it. These images also changes to the foundation shrubs. (Left: Digital image 115847pr, Historic American Building Survey, Library of Congress American Memory Collection; right: SUNY ESF, 2005.)

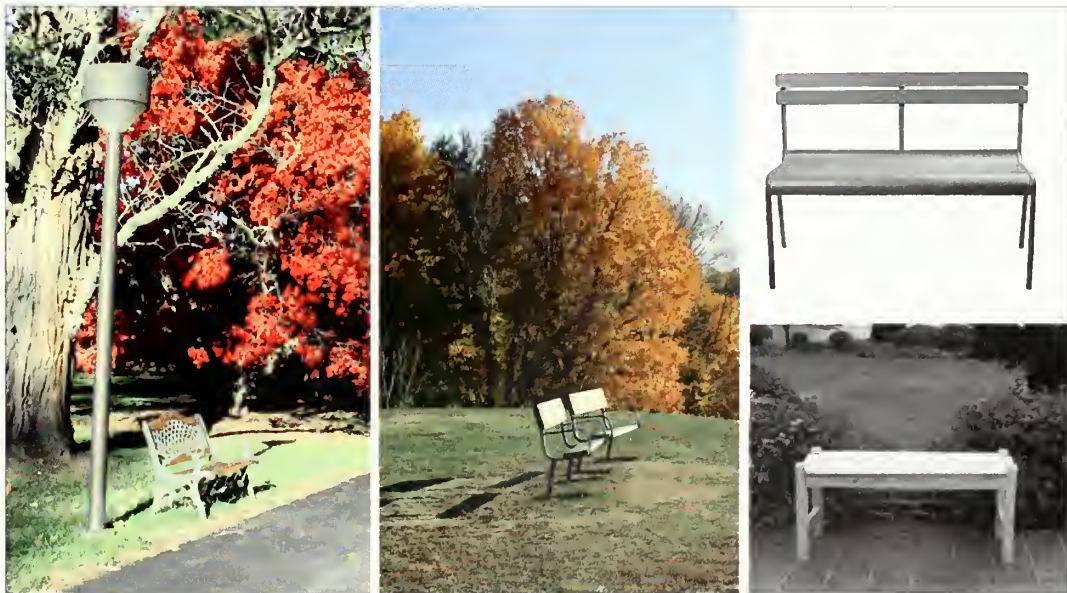
Figure 9: Existing park furnishings showing light standard and two styles of benches (left and center), and suggested bench styles that would be compatible with the historic character of the landscape. (SUNY ESF, 2005; right, bottom: WoodenBench.us, <http://www.woodenbench.us>; right top: Luxembourg Verbena Bench, <http://www.conranusa.com>.)

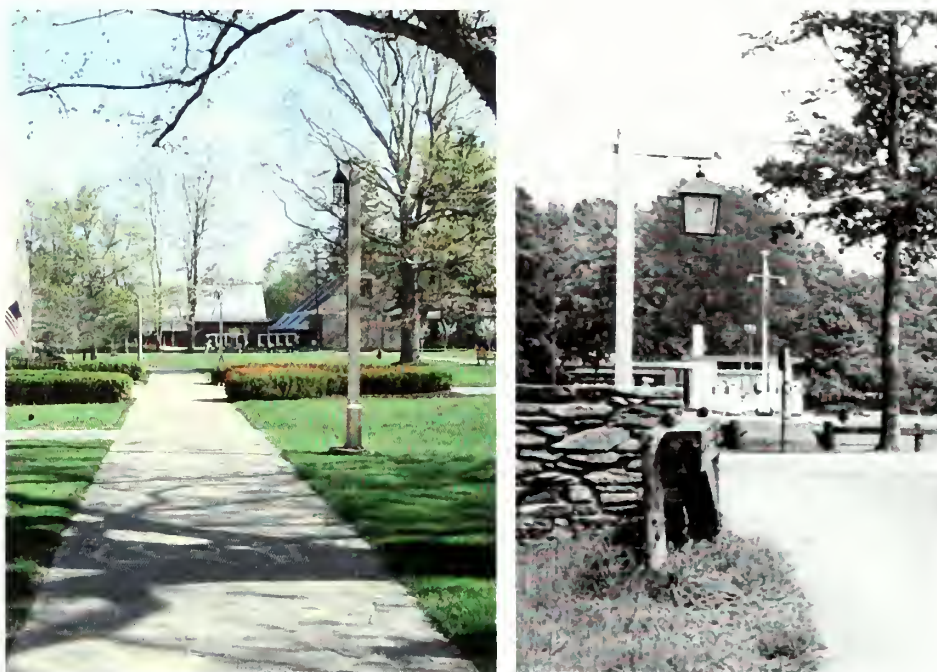
Figure 10: Recently installed light standards along the Library entrance walk (left) and historic light standards at the Library entrance. (Right: Photograph R78B, c.1946, Roosevelt-Vanderbilt National Historic Sites; left: SUNY ESF, 2007.)

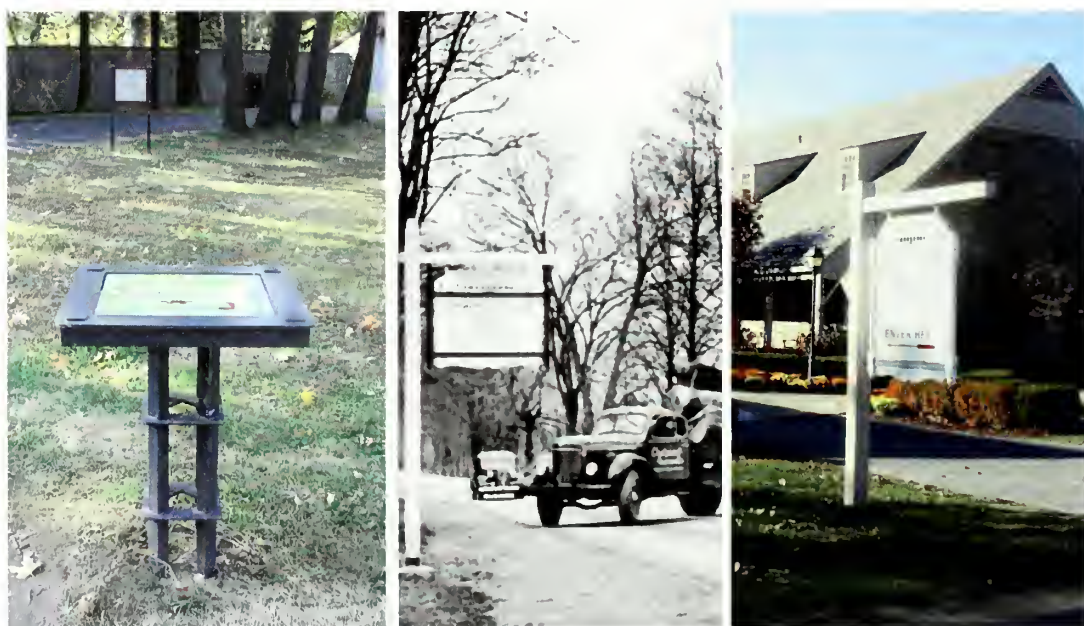
Figure 11: Example of current National Park Service directional sign, historic Library entrance sign on the Post Road, and existing entrance sign in front of the Library. (Left and right: SUNY ESF, 2005; center: detail of photograph Px61-294129, c.1944, Franklin D. Roosevelt Library and Museum.)

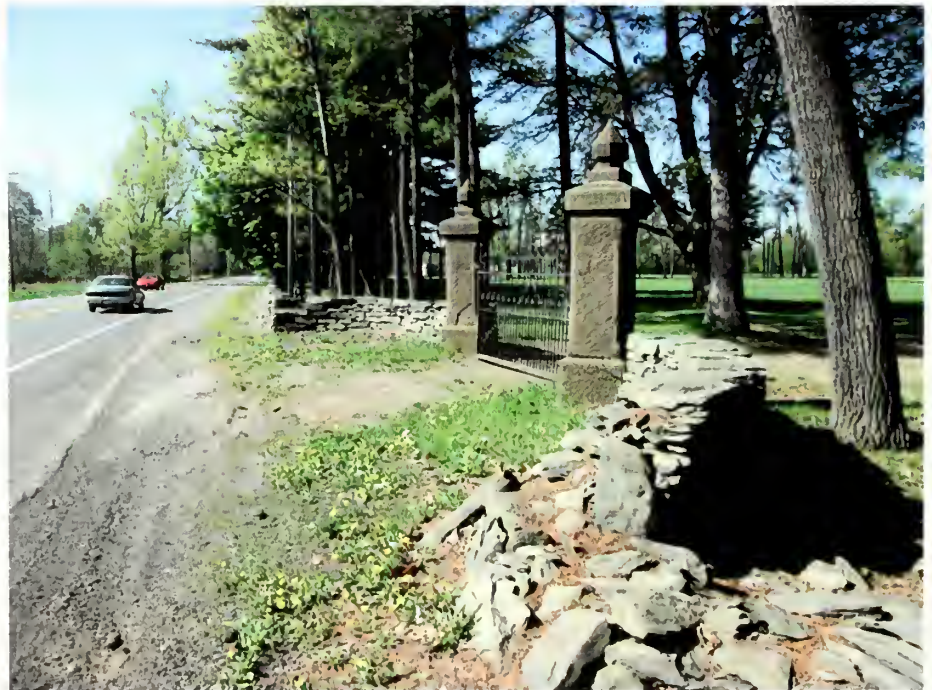
Figure 12: Recent view of the Home Road entrance looking south along the Post Road showing deteriorated condition of road shoulder, earthen roadbed, and stone wall. (SUNY ESF, 2007.)

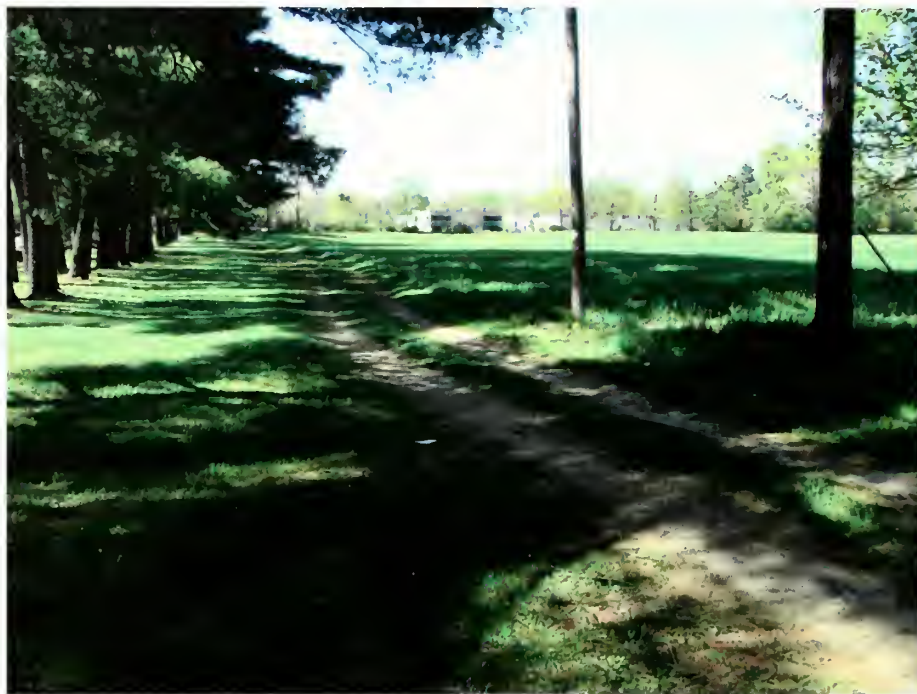
Figure 16: Recent view along the South Avenue Lot farm road looking south from the Home Road with the white pine screen (Plot E) at left. The Red House front field shown in figure 15 is visible in the background. (SUNY ESF, 2007.)

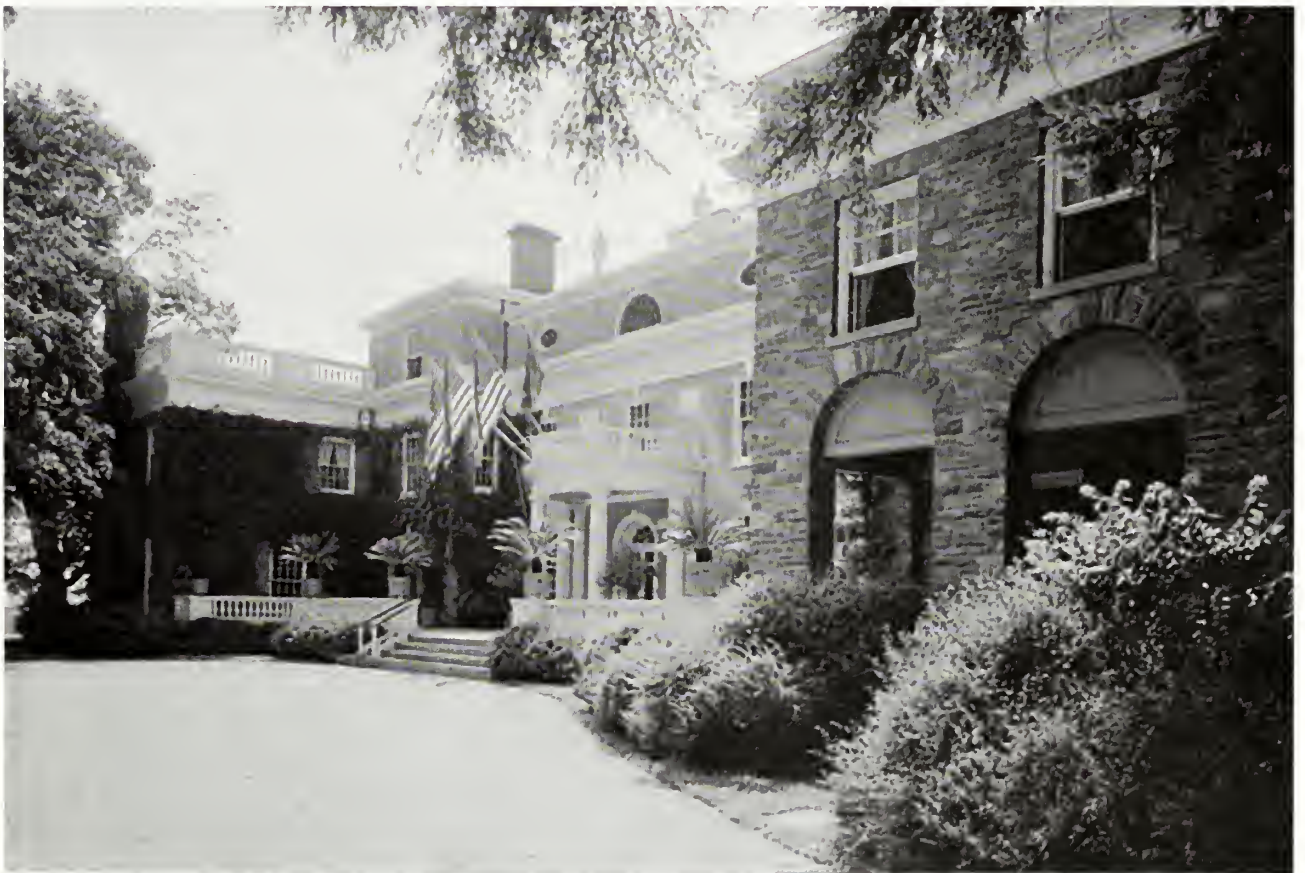
Figure 19: Historic view of the foundation plantings along the front of the Home as photographed in July 1941 showing euonymus (along terrace balustrade) and mixed spirea-barberry-mock orange (larger shrubs in front of the north and south wings). See figure 8 for a close-up view of the euonymus. (Digital image 115842, Historic American Building Survey, Reproduced on Library of Congress American Memory Collection.)

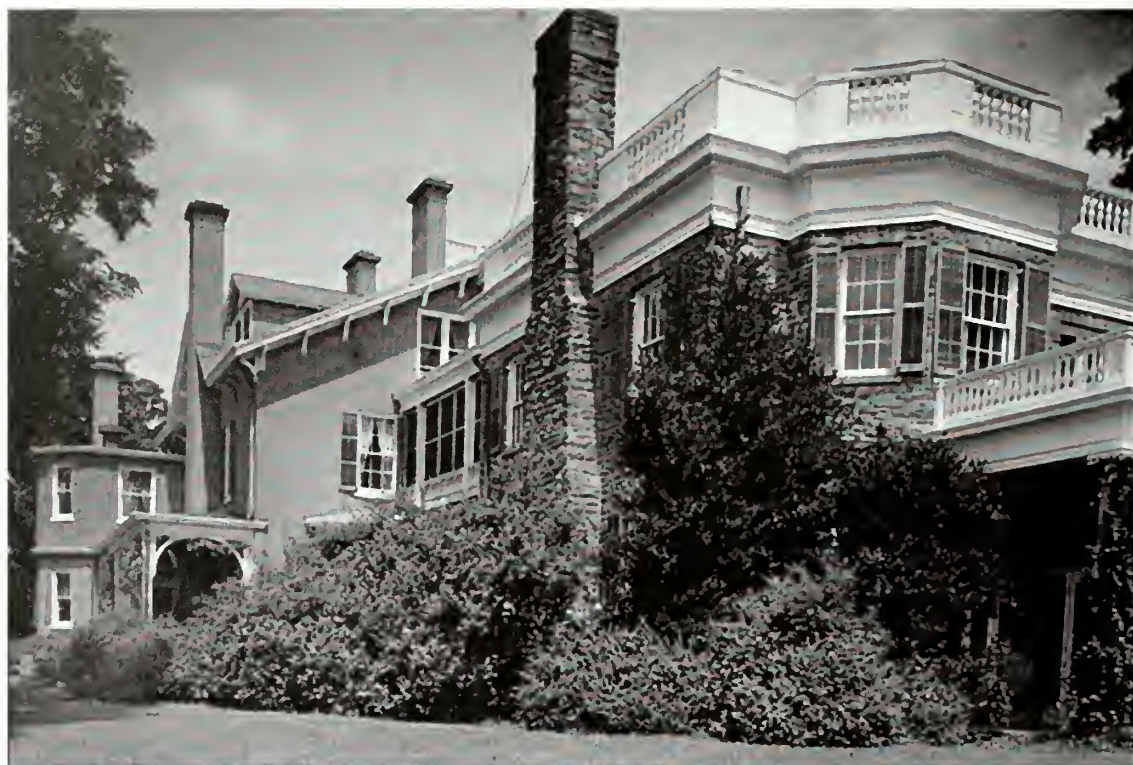
Figure 20: Historic view looking north at the foundation plantings at southwest corner of the home, July 1941 showing informal massing of spirea and barberry accented by taller holly. Also note the vines on the south and west porch columns. (Digital image 115849pr.Historic American Building Survey, Library of Congress American Memory Collection.)

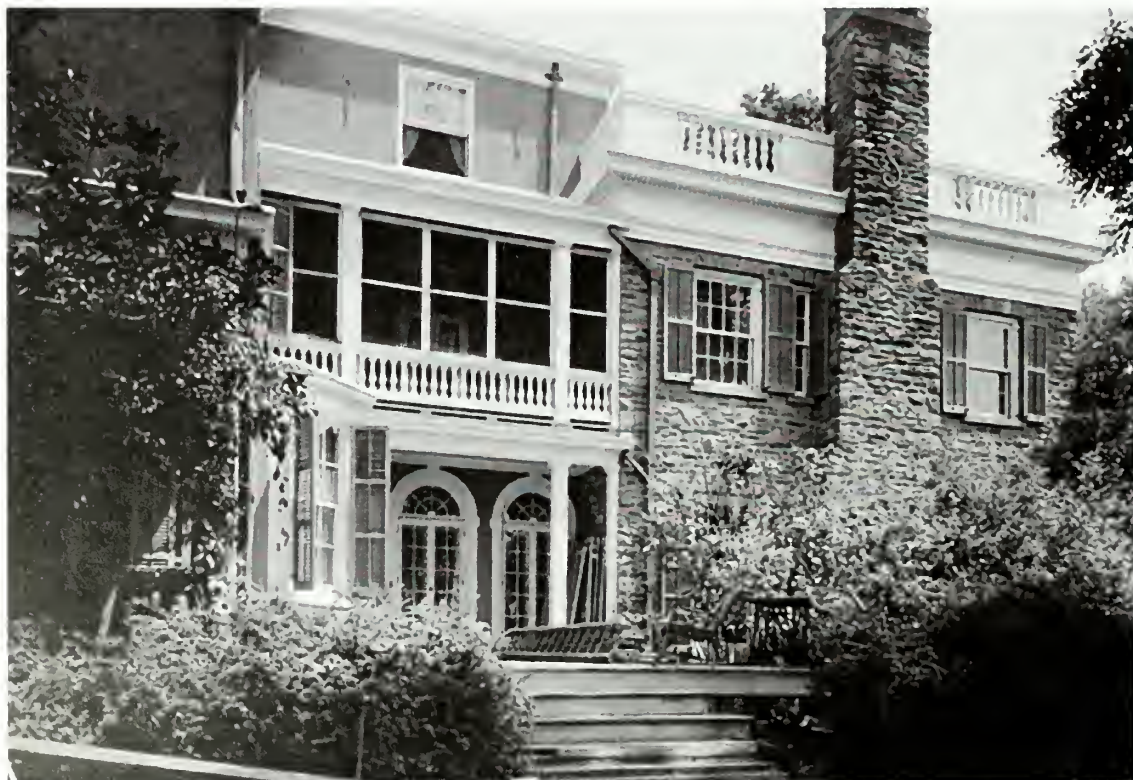
Figure 21: Historic view looking east at the plantings along the west deck, July 1941. To the left of the steps is a clipped spirea hedge; to the right is a mass of barberry and spirea. Honeysuckle is growing on the west porch column at left. (Digital image 115850pr, Historic American Building Survey, Library of Congress American Memory Collection.)

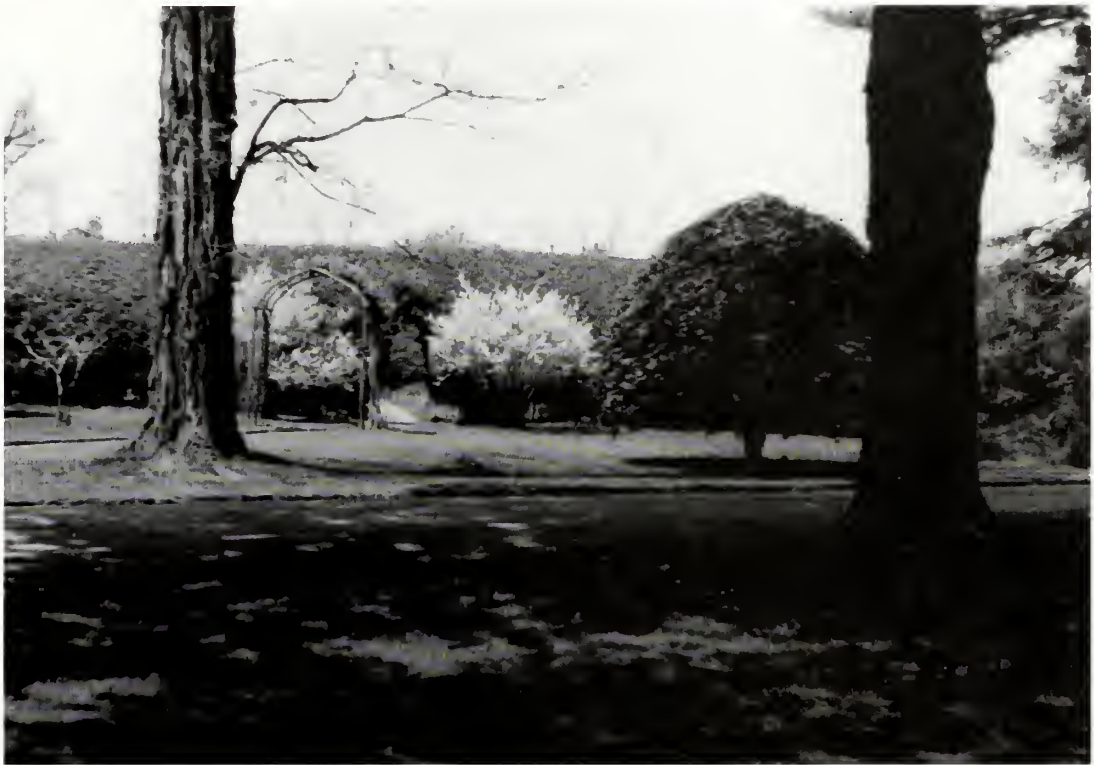
Figure 22: Historic view looking north toward the Rose Garden from the main lawn, c.1935. Note the edged unpaved roads and walks, and the arched rustic rose arbor. Hemlock shrubs may have been planted to either side of the arbor by 1941. The clipped tree at right is the existing Japanese red maple. (Photograph NPx 80-165 10, Franklin D. Roosevelt Library and Museum.)

The two walks from the Home Road turnaround to the Rose Garden were probably surfaced in a stone dust matching the surface of the walks within the Rose Garden, and were carefully edged into the lawn (fig. 22). At some point after 1946, the park paved these walks in asphalt, together with the connecting walk within the Rose Garden, apparently to provide a clean and durable walking surface that was easier to maintain. A connecting walk parallel to the Rose Garden hedge was removed at the same time. Most of the connecting walks in the Rose Garden, which receive a comparable amount of traffic, are surfaced in gravel.

A rustic arched rose arbor located in the north lawn outside the Rose Garden was replaced with a wider, flat-arched design by the park after 1954, probably when the walk was paved in asphalt. Junipers were planted to either side of the arbor, probably at the same time, replacing hemlocks.<sup>12</sup> Replace the existing rose arbor with a new arbor that matches the design of the historic arbor (see fig. 22). Plant climbing roses to either side of the arbor using a variety that existed in 1941 (historic variety is unknown). Remove the existing overgrown junipers that are located to either side of the arbor and replace with a pair of evergreen shrubs south of the arbor. Plant two hemlocks, as indicated on the 1946 USGS survey (see Appendix A), such as Sargeant weeping hemlock (*Tsuga canadensis* 'pendula') pruned to maintain a small size approximately 4' wide. If deer browsing cannot be controlled, then substitute Fortune's euonymus (*Euonymus fortunei* "radicans")

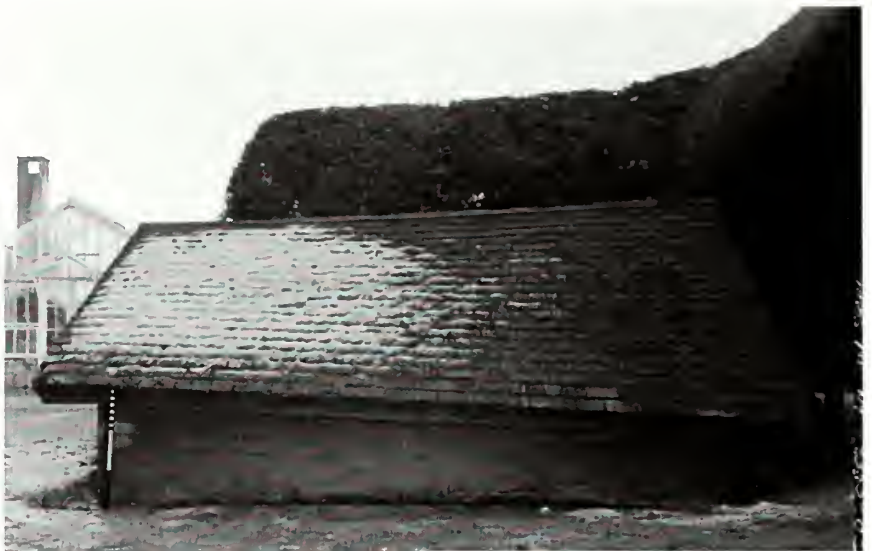
Figure 26: Historic view of the hemlock hedge along the Service Road looking south from River Road, April 1945. Note the clipped profile matching other hemlock hedges in the service area and Rose Garden. (Detail of a photograph by William C. Shrout of FDR's funeral, LIFE photograph archives, copyright Getty Images.)

- Section 4 (West side of Service Road, Stable to River Road, approximately 310'): This hedge section provided an edge to the service area along the woods and drop-off to the west (fig. 26). The historic hemlocks remain as trees along the edge of the woods between the Stable and greenhouse tool shed, but have been recently replaced between the tool shed and River Road with widely-spaced hemlocks. To reestablish this hedge section, remove the existing hemlock trees (overgrown hedge) between the Stable and tool shed. Plant a new hemlock hedge in their place and plant additional hemlocks between the recently planted hemlocks north of the tool shed to fill out the planting as a hedge. The adjoining woods may require thinning and pruning to allow sufficient light to reach the hemlocks.

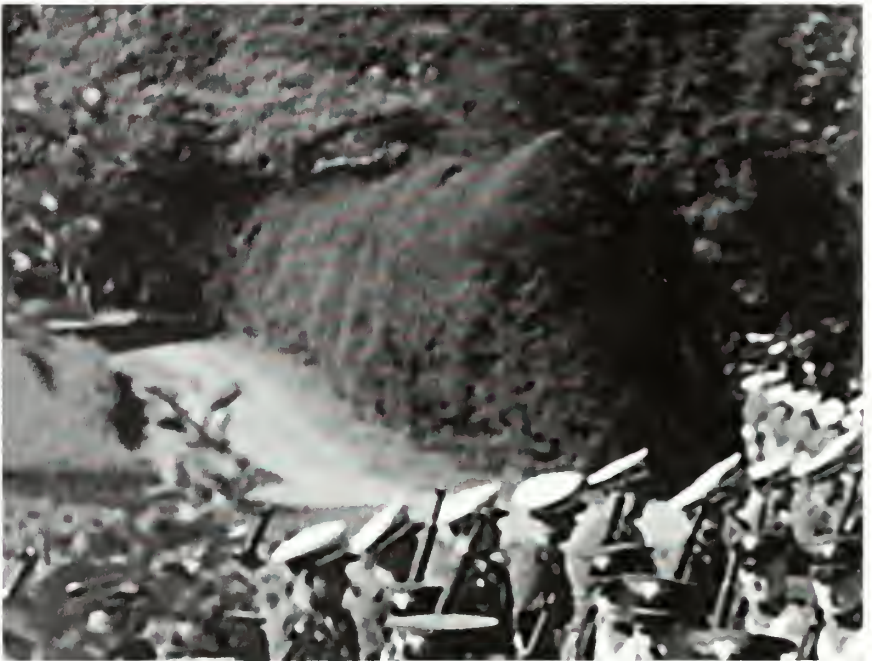
Figure 27: Photograph of the Large Ice House hotbed looking north taken soon after the end of the historic period in c.1946. Note the glazed sash in an open position. (Negative R-147, Roosevelt-Vanderbilt National Historic Sites.)

The concrete-frame hotbed on the south side of the Large Ice House was historically covered with glazed wood sash. This was apparently a single large sash that was supported by the concrete frame of the hotbed and intermediary rails (fig. 27). Reinstall this sash if it still exists in park storage. If it no longer exists, fabricate a new sash based on historic photographs and evidence in the existing concrete frame. Further research may be necessary to determine the historic specifications of the sash. Return of this sash will aid interpretation of the hotbed's historic use and allow it to function once again for forcing plants.

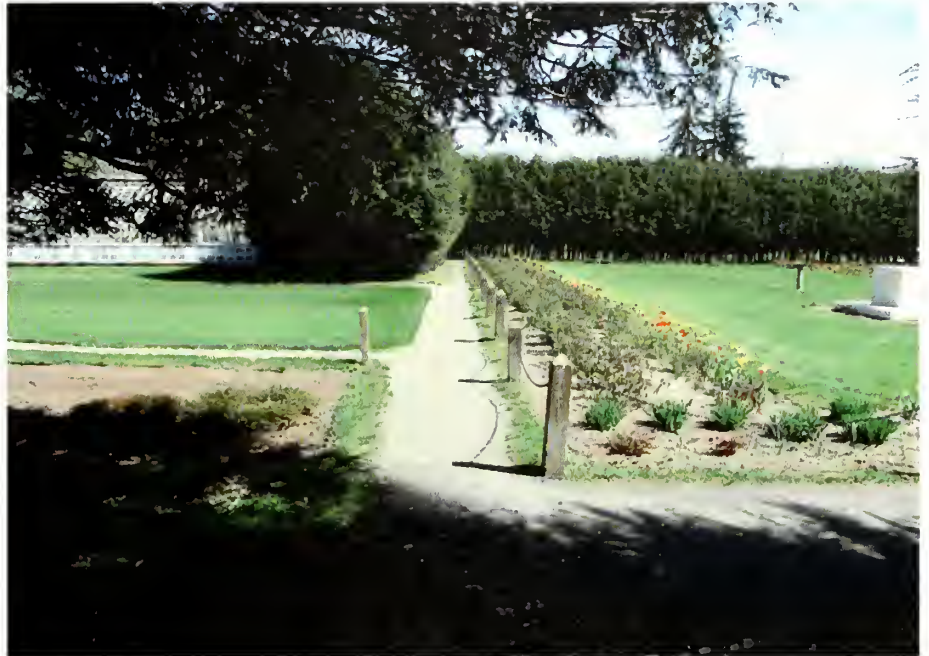
Figure 28: Recent view of the Rose Garden hedge looking north prior to replacement in fall 2008 showing overgrown and browsed conditions. Compare with same view in figure 29. Also note the changes in the walks, which are today surfaced in asphalt and coarse gravel, and lack the well-defined edges that existed historically. The narrow turf border between the walks and the flowerbeds has also eroded. (SUNY ESF, 2007.)

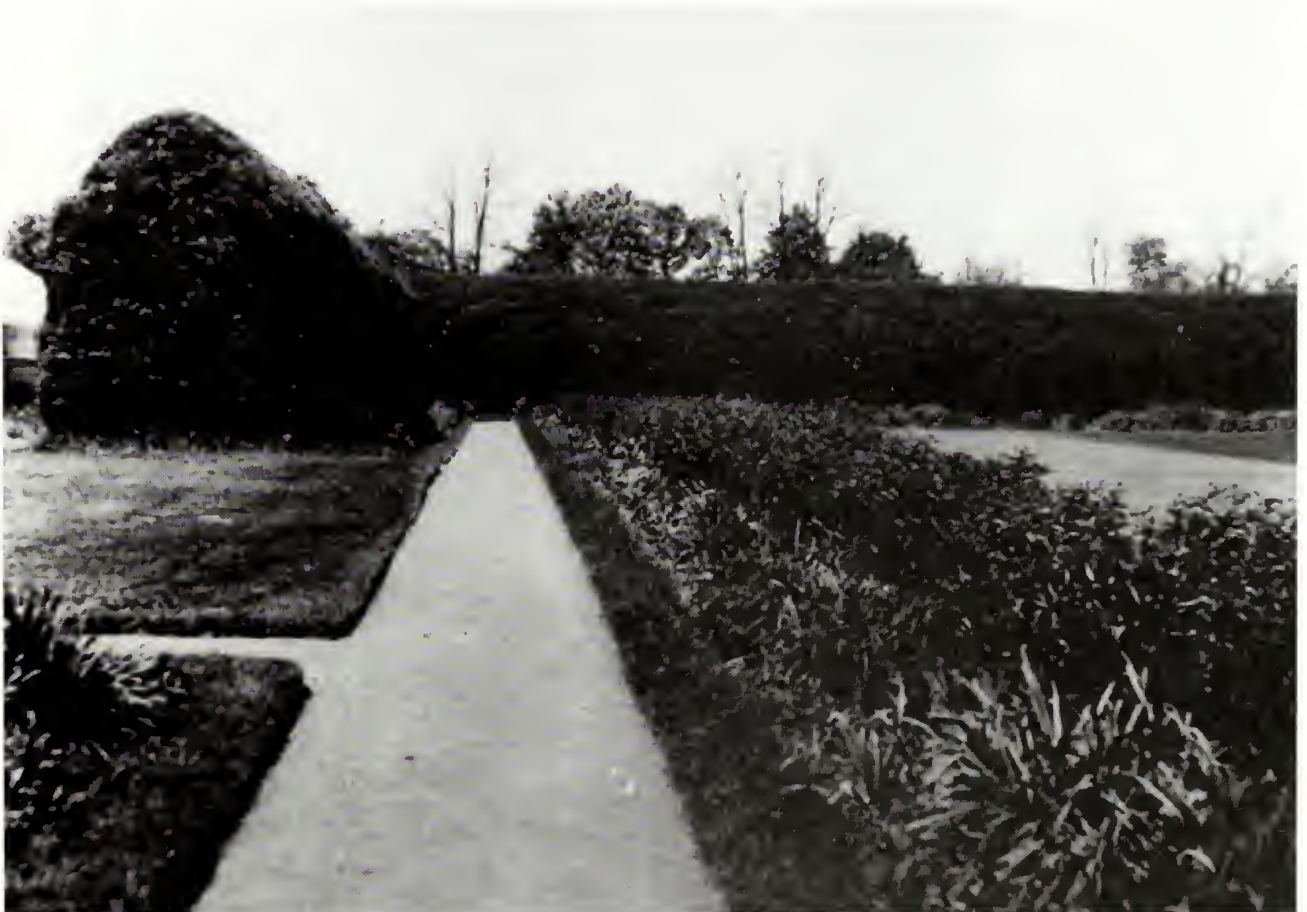
Figure 29: Historic view of the Rose Garden hedge in c.1942 looking north showing straight sides and battered top. Also note stone dust surface of walks, neatly edged into the lawn; and narrow turf strip between the herbaceous borders and the walks. (Photograph NPx 80-165 9, Franklin D. Roosevelt Library and Museum.)

The eastern hemlock (*Tsuga canadensis*) hedge that encloses the Rose Garden was replaced in fall 2008. The old overgrown and browsed hemlocks extended over walks and garden beds, and no longer enclosed the garden as they did historically (figs. 28, 29). The new hemlocks were planted within a mulched bed on the alignment of the historic hedge using 6'-tall stock on a contemporary 4' spacing. Two openings were maintained at the walks from the north lawn, and the opening at the former walk to the Library was reintroduced. The project included installation of a 6'-tall black-mesh deer fence on the perimeter of the hedge. This fence replaced an earlier one and is intended to serve as the outer clipping edge as the hedge matures.

- Clip the hedge to produce straight sides on the lower two-thirds, and a rounded batter on the top third, as shown in historic photographs (fig. 29, see also diagram in fig. 23). A battered profile is optimal for enhancing light levels and reducing snow-load stress.
- Allow the hedge to grow to a height of approximately 10' to 12', and a width of approximately 6'.
- At the three walkways, clip the hedge when it reaches a sufficient height into arched openings, approximately 7' high.
- Maintain the hedge with a full canopy to the ground level on both sides, and prune out deadwood.
- Maintain the understory free of weeds and with a dark brown (natural color) mulch or compost neatly edged into the adjoining turf.
- Prune adjoining trees that may heavily shade the hedge (such as at the southeast corner of the garden) to ensure adequate light levels and consistent growth.

The Rose Garden walks were historically surfaced in stone dust and were neatly edged into the adjoining lawn (see fig. 29). Today, the walks are either black asphalt or courser gravel, and in areas have narrowed and lost well-defined edges, while the asphalt-paved sections have been widened (see fig. 28). The viewing walk at the south end of the garden was added in 1945 along with the grave and therefore should be retained. In 1946, the walk at the northeast corner of the garden, which FDR used to access his office in the Library, was removed for better visitor control. Replacement of the hedge in 2008 opened walks that had been overgrown by the old hedge.

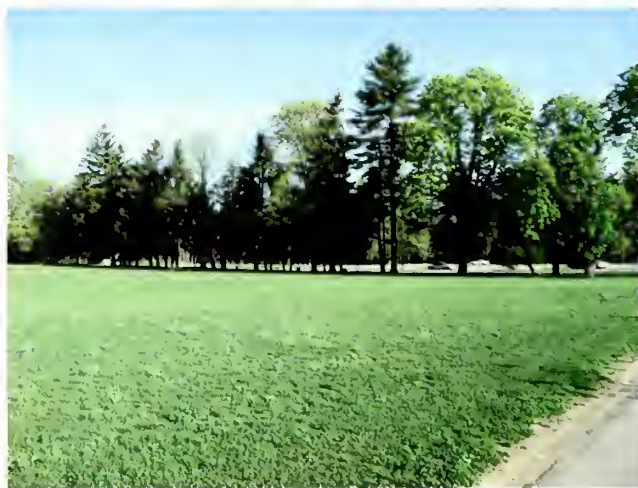
Figure 38: Recent view looking northwest across the site of the large vegetable garden at the north boundary trees, with their open understory allowing view of the Wallace Center visitor parking lot. (SUNY ESF, 2007.)

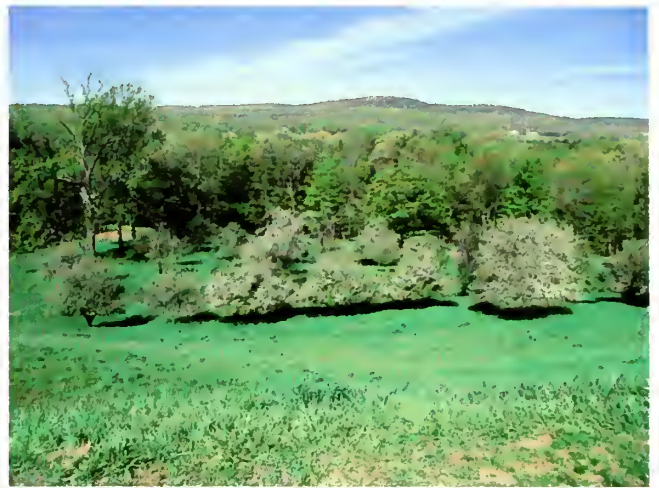
Figure 43: Recent view of the lower orchard looking west from the south lawn at the Home. Note missing trees and lack of uniform pruning. (SUNY ESF, 2007.)
