## CULTURAL LANDSCAPE REPORT FOR SPRINGWOOD

HOME OF FRANKLIN D. ROOSEVELT NATIONAL HISTORIC SITE

VOLUME II: TREATMENT

Olmsted Center for Landscape Preservation  
National Park Service, Boston, Massachusetts 2009

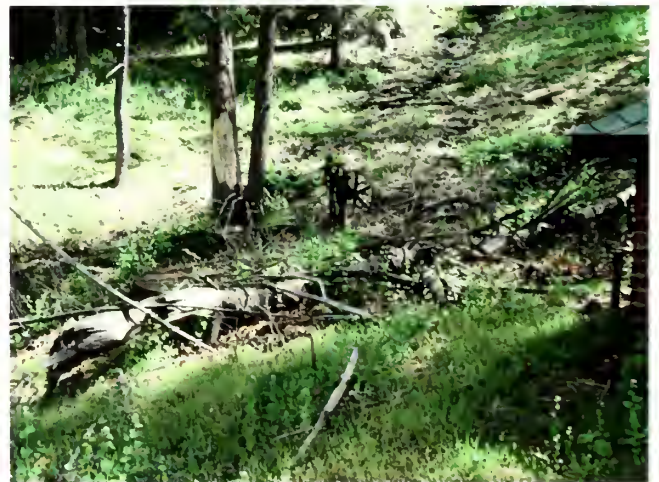
Figure 46 (right): Current view looking northeast uphill at the old reservoir showing its rusted gears and debris-strewn condition. At right is the corner of the pump house. (SUNY ESF, 2007.)

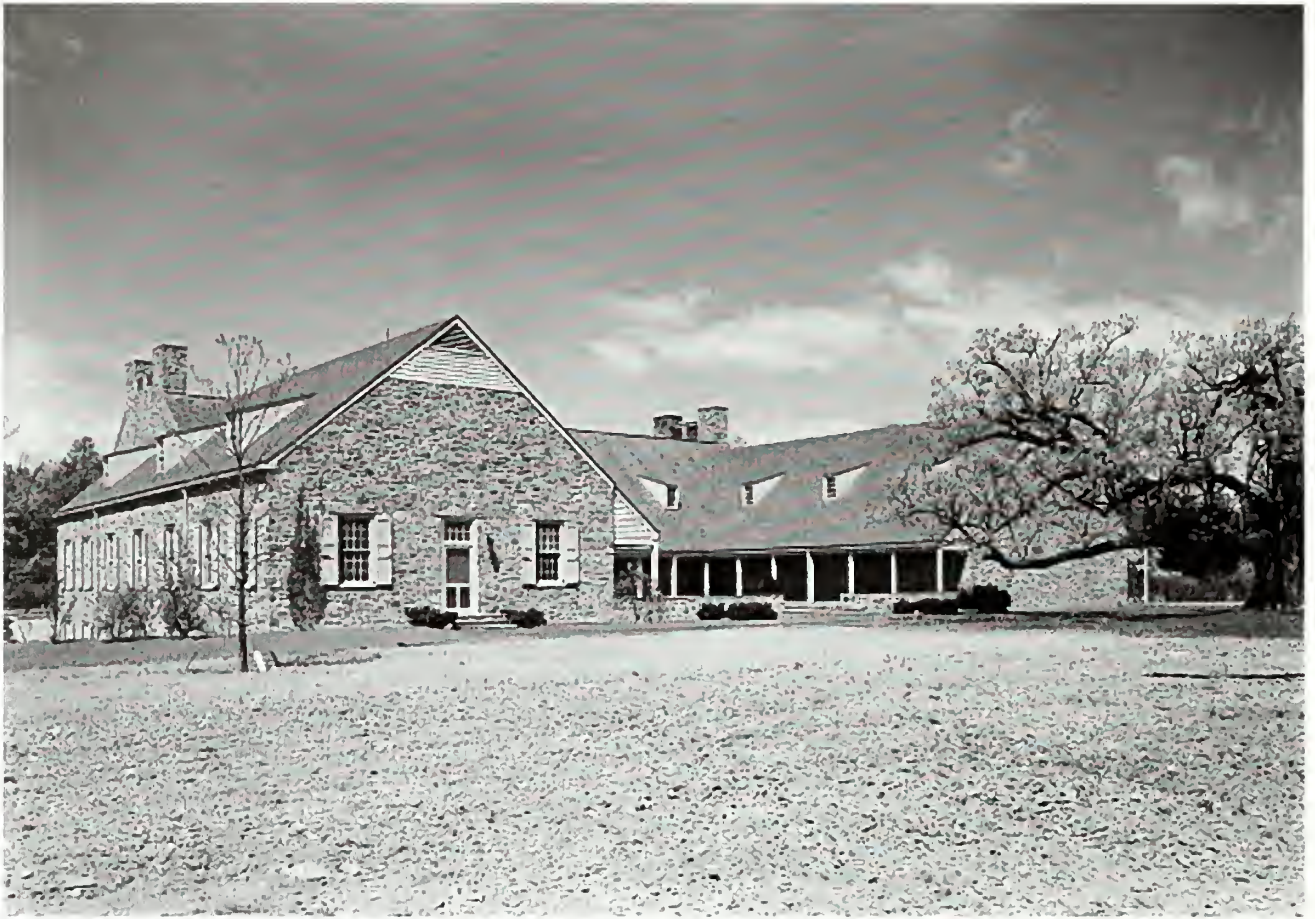
Figure 47: Historic view of the Library looking northwest, 1941. Note relationship to the cultivated field, simple foundation plantings, open character of the courtyard, aged white oak to the right of the entrance, and the recently planted red oak at left. (Digital image 5a07074r, Historic American Building Survey, Library of Congress American Memory Collection.)

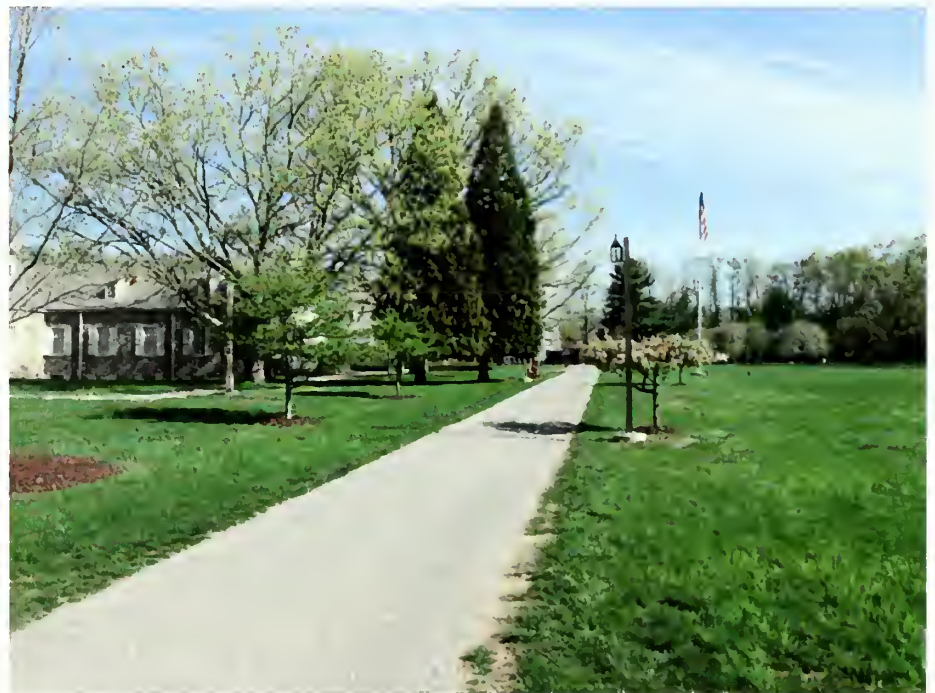
Figure 48: Recent view looking north along the recently built new Library entrance walk showing ornamental fruit trees and cedars. Compare with figure 47. Much of the mown lawn was historically maintained as agricultural field. (SUNY ESF.)

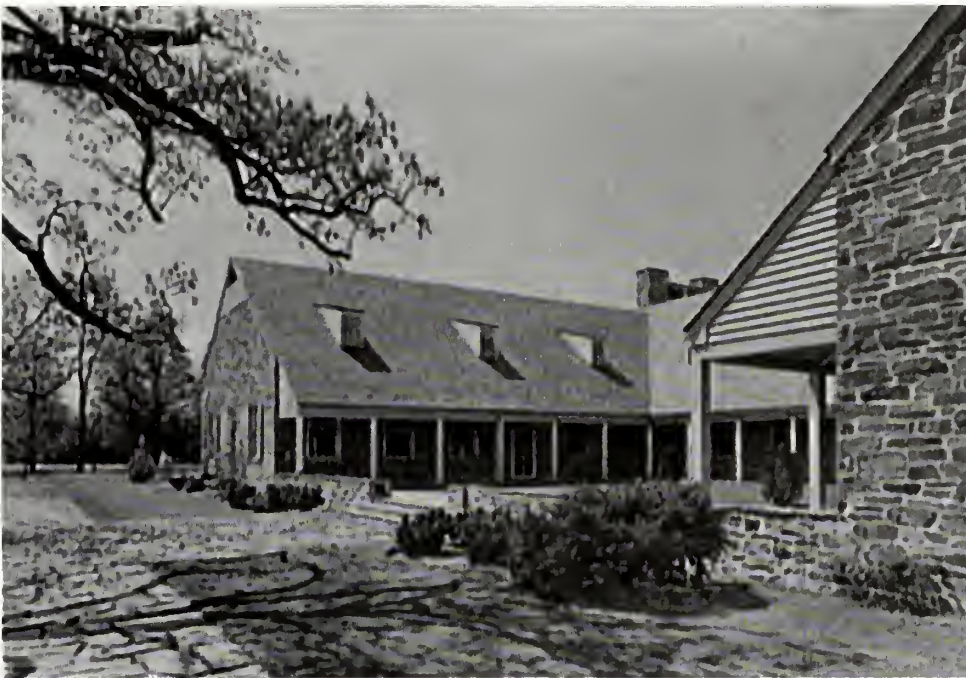
Figure 49: Historic view of the Library entrance plantings and courtyard lawn looking southwest, 1941. Also note flagstone walk and simple treatment of courtyard. (Digital image 5a07078r, Historic American Building Survey, Library of Congress American Memory Collection.)

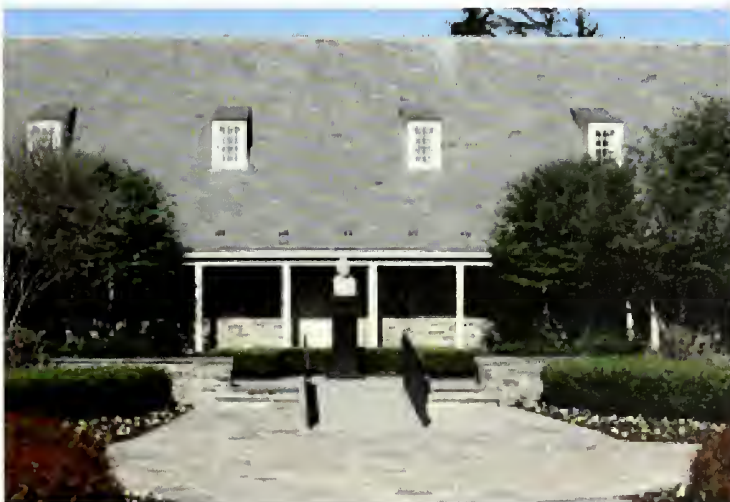
Figure 51: Recent view into the Library courtyard showing plantings made after 1971. (SUNY ESF, 2007.)

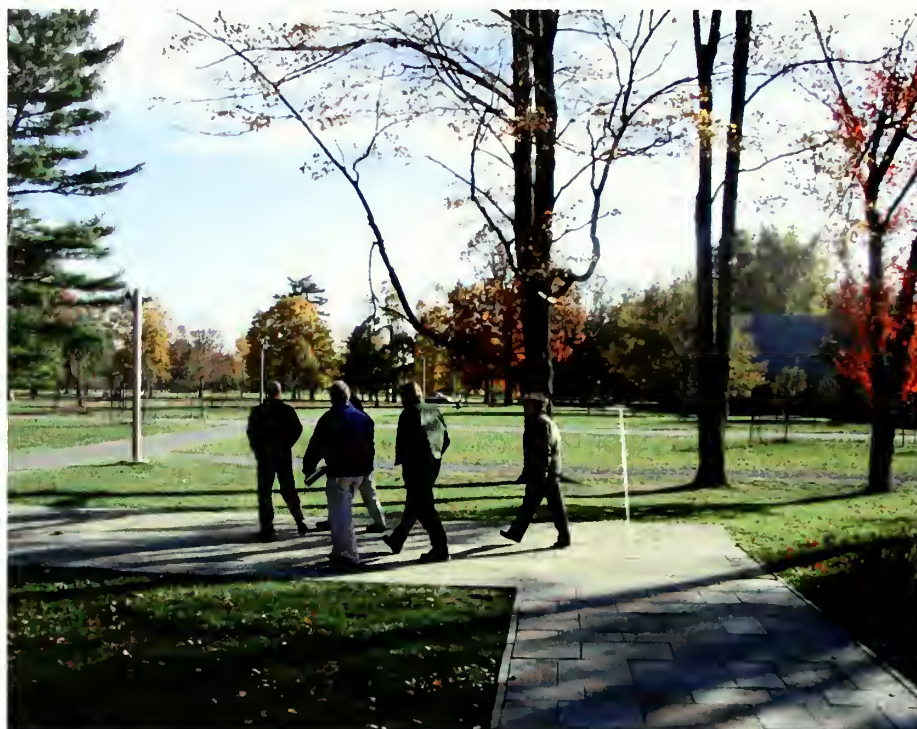
Figure 52: Recent view of the new Library entrance walk (foreground and at left) looking south from the Wallace Center showing alignment with the historic Library entrance walk in the distance indicated by the white line. This is the alignment recommended for extension of the old Library entrance walk. (SUNY ESF, 2005).

The new entrance walk to the Library was constructed in 2004 as the primary visitor access to both the Library and the Home from the Wallace Center (fig. 52). The stone chip asphalt walk parallels the old Library entrance walk along the former edge of the North Avenue Lot field. The old flagstone walk was built along with the Library in 1939-41 and was extended in 1948 and 1971.<sup>23</sup> The location of the new walk location paralleling the old walk was selected to revive the historic arrival sequence to the Home via the Home Road, to give visitors an improved view of the Library, and to align with a pre-existing opening in the Library fence near the Home Road.<sup>24</sup>

A more historically appropriate solution for visitor circulation from the Wallace Center to the Library and the Home would follow the old Library entrance walk by extending it north to the Wallace Center (it is aligned with the south entrance, see fig. 52), and south to the Home Road. These changes would enhance the historic setting of the Library, allowing visitors to experience the historic approach to the building and returning the historic limits of the North Avenue Lot field. This realignment would require minor creation of a new opening in the Library fence and removal of two trees along the north boundary. In designing this change in circulation, the following issues should be considered:

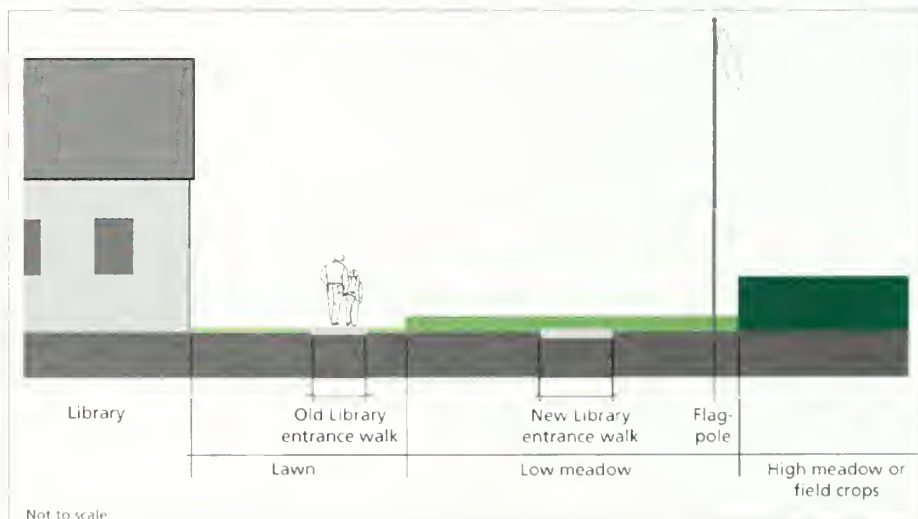
Figure 54: Section perspective looking north from the Library to the flagpole illustrating relative heights of proposed lawn-meadow conditions. (SUNY ESF.)

A distinctive aspect of the Library landscape was its integration with the North Avenue Lot field. Historically, the existing flagpole marked the edge of the high meadow/cultivated field, with low meadow extending to the old Library entrance walk (figs. 53, 54). Manicured lawn was limited to a narrow band around the building. Over the years, the limits of the lawn have been extended out from the building. Today, only the east half of the field is maintained as high meadow (hay field).
