UNDERGROUND STORAGE TANK
INITIAL SITE CHARACTERIZATION
CUMBERLAND ISLAND NATIONAL SEASHORE

ST. MARYS, GEORGIA

Technical Report NPS/NRWRD/NRTR-90/01

October 1990

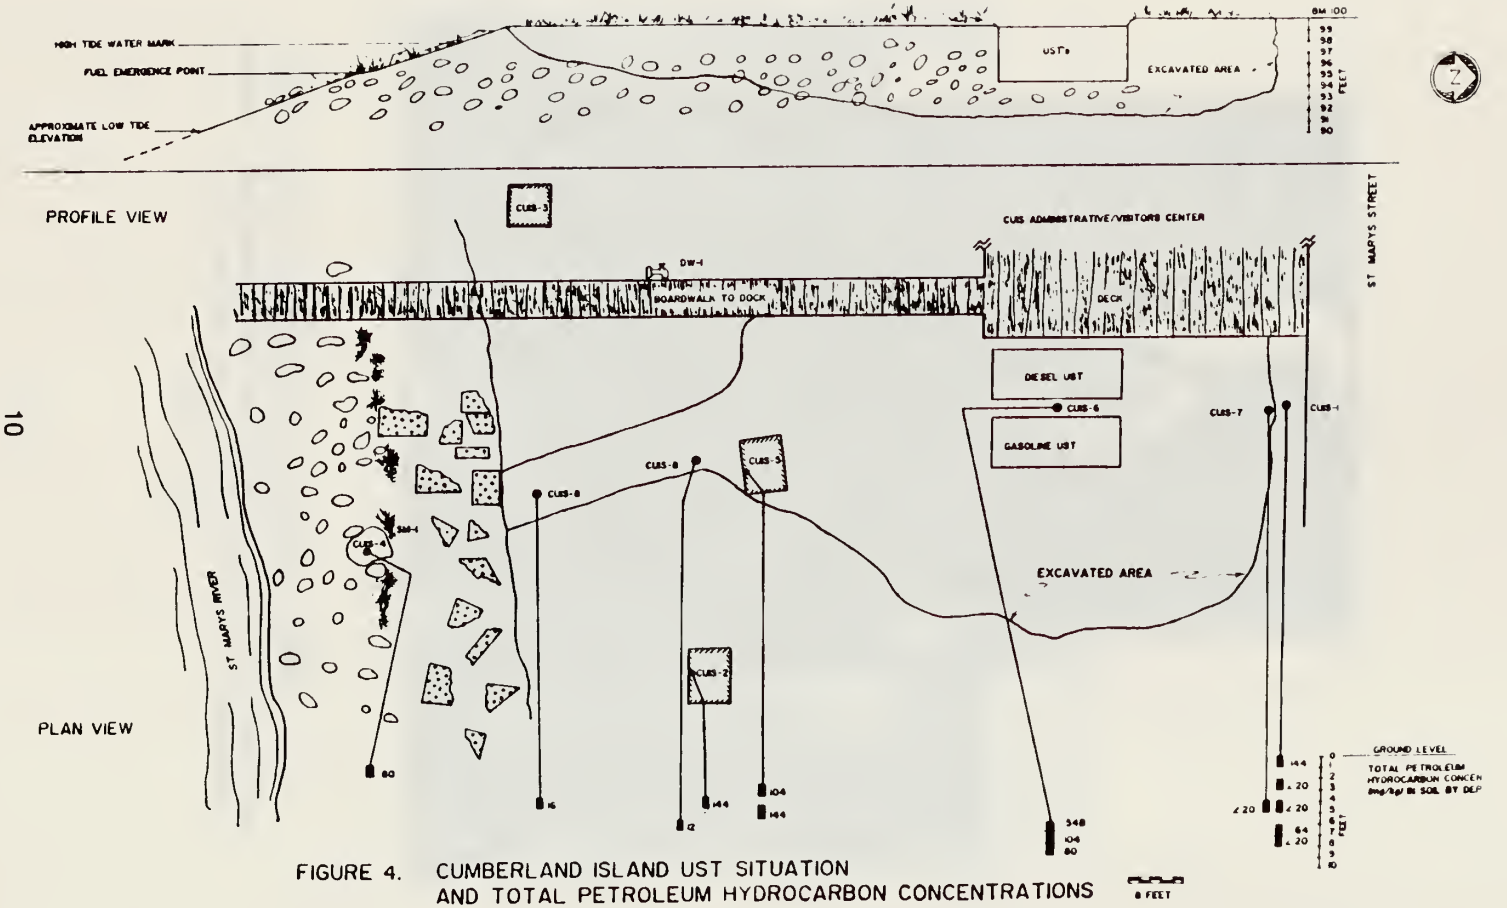
FIGURE 4. CUMBERLAND ISLAND UST SITUATION AND TOTAL PETROLEUM HYDROCARBON CONCENTRATIONS

After both USTs were removed, efforts were initiated to remove the soil that was obviously contaminated by hydrocarbons. The existing UST pit was excavated to about a depth of about 8 feet below ground surface level. The excavation was then expanded to the north, south, and east directions for a distance of about 10 feet. A wooden deck, which serves as a congregating point for park visitors, prevented a full westward expansion of the excavation. The excavation then continued through sampling pit CUIS-5. The excavation was then narrowed to form a trough which was excavated to a depth of about 5 feet from CUIS-5 to the St. Marys River bank. The final limits of the excavated area is depicted in Figure 4.

The fuel emergence point and much of the remaining hydrocarbon contamination in the soil was above the bottom-most portion of the USTs and their leak causing holes. Examination of Figure 4 (profile view) reveals that the lowest most portions of the USTs were below the maximum high-tide water mark observed during this investigation. Assuming that the maximum ground-water table elevation approximately equaled the high-tide elevations of the St. Marys River and that many components of the diesel and gasoline fuels floated at the ground water-soil interface--the observed zone of soil contamination and the fuel emergence point are within the potential range of ground-water table fluctuations.
