THE HEXAGON (Ephraim Shay House) Harbor Springs, Michigan

Tech Notes

In-Kind Replacement of Historic Stamped Metal Exterior Siding

Rebecca A. Shiffer
Mid-Atlantic Regional Office
National Park Service

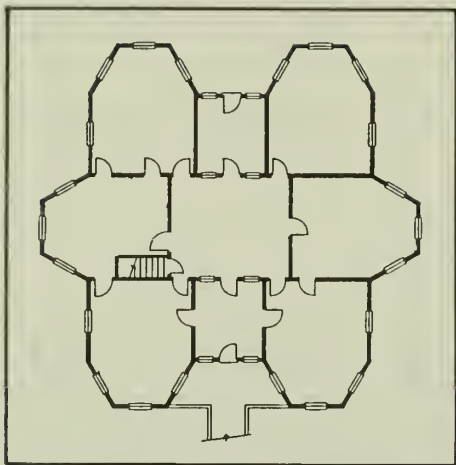
1. Windows in each elevation of the hexagonal wings offer views in every direction from the center of the house. This first floor plan of the Hexagon shows the new, post-rehabilitation uses. Drawing: Jeffrey Pascale, from plans by Richard Hiler.

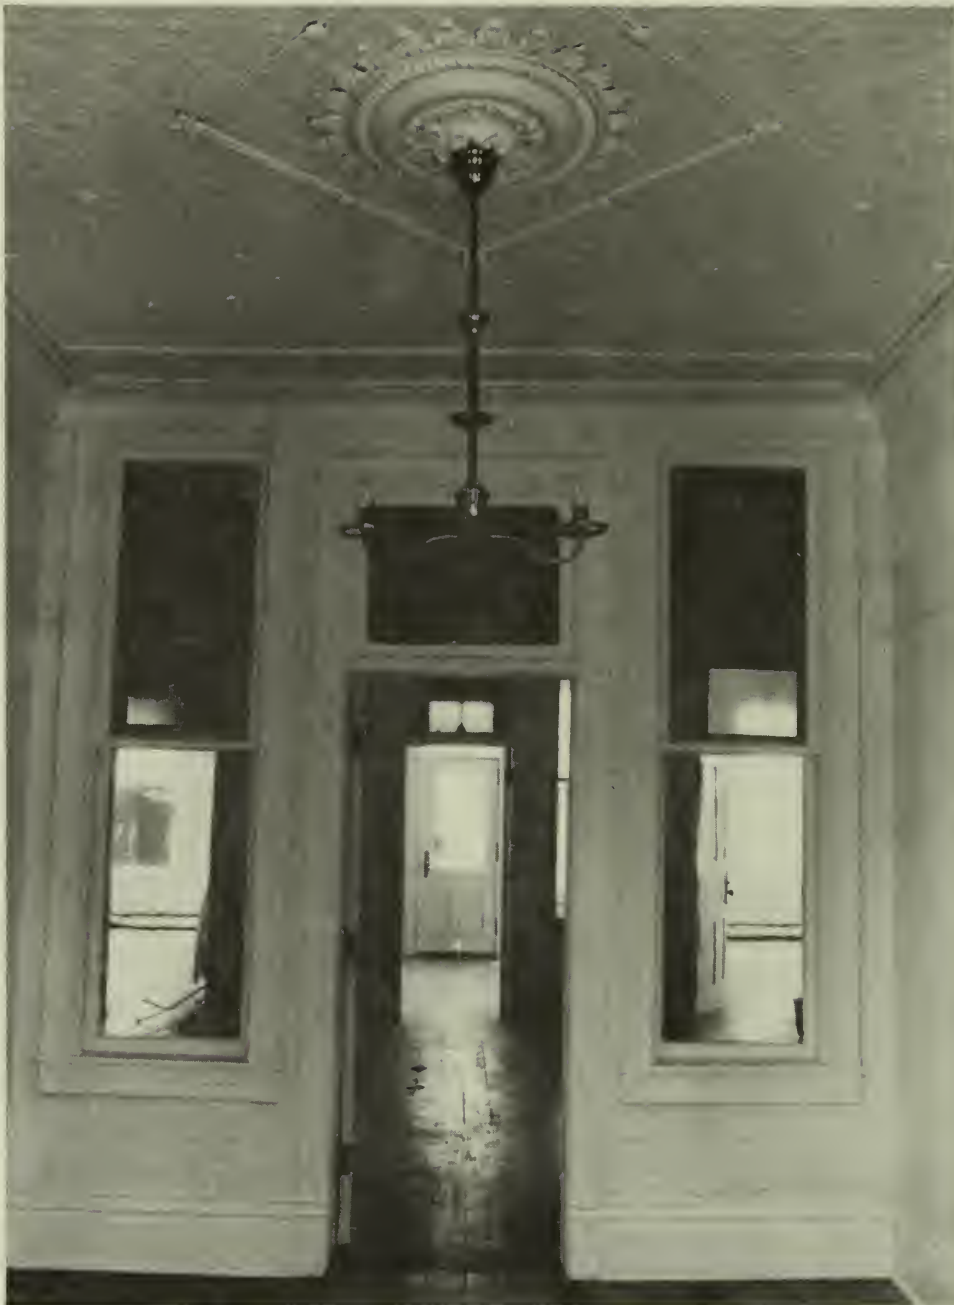
In contrast to the exterior metal siding, the interior stamped ceilings and walls remained in good condition. All of the interior metal was retained, with only isolated areas requiring patching due to minor rust. In addition, the exterior window hoods had not deteriorated like the siding and only routine repairs were necessary for their retention.

2. The walls and ceilings of each interior room are sheathed with stamped metal siding in a variety of decorative patterns. Photo: Brian Conway.

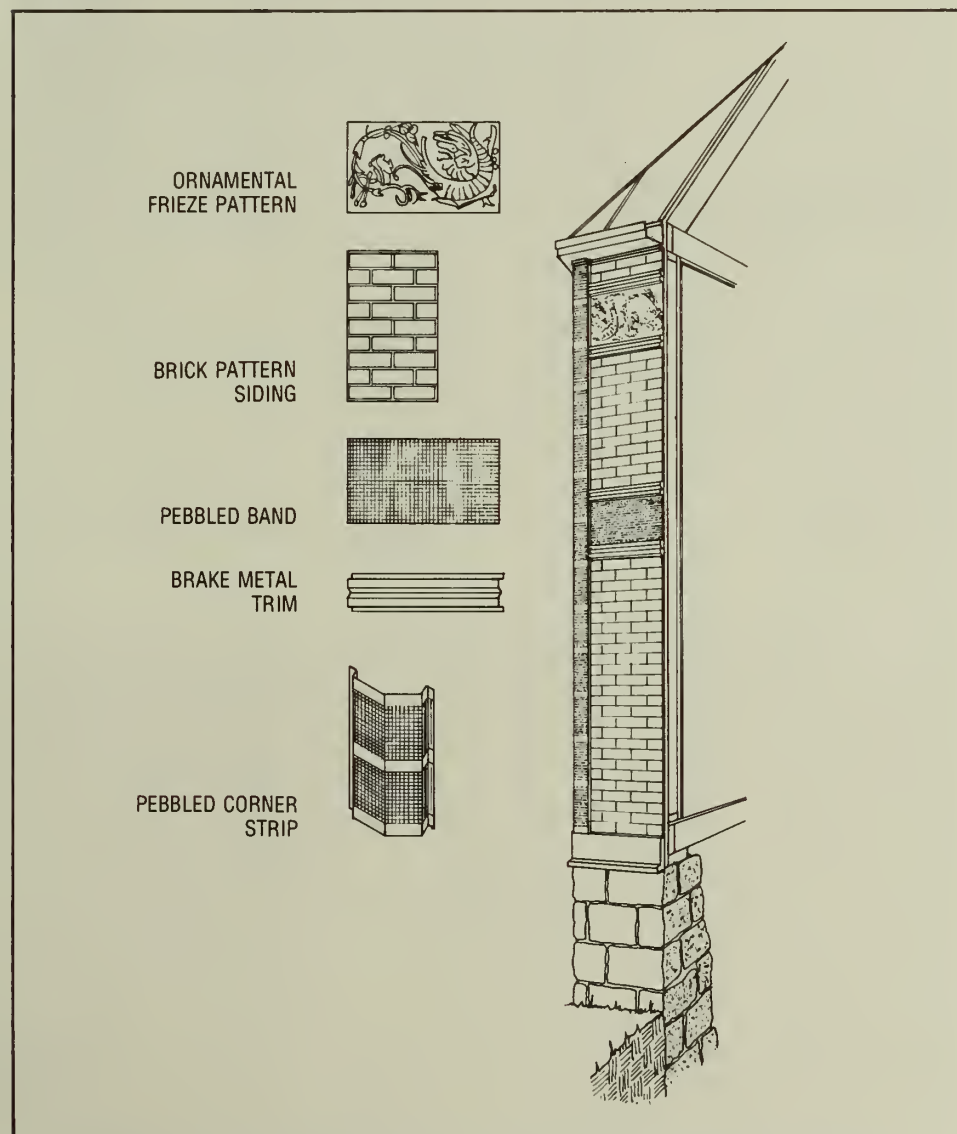
Five exterior sheet metal patterns required replacement: the brick pattern that covered more than half of the exterior, two ornamental band patterns, the wall corner pattern, and the molding that separated the ornamental bands from the brick pattern (see figure 5).

5. Five different sheet metal patterns were used to cover the exterior wall. Drawing: Timothy Buehner.

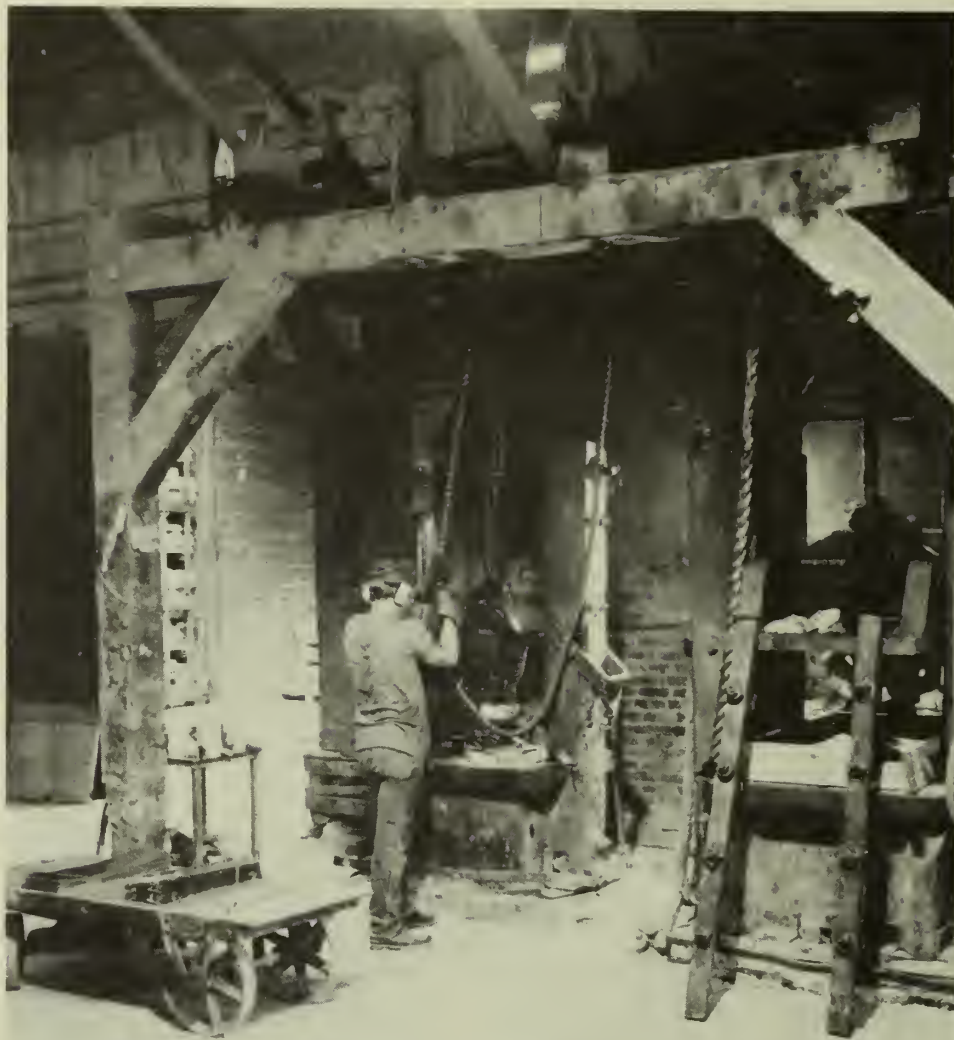
the male half attached to a large, cast-iron hammer, known as a gravity drop hammer, hanging above the press bed. A sheet of metal was then placed over the die on the cast-iron bed, and a press operator released the hammer to drop onto the bed, stamping the design into the metal by the force of the meeting of the die-set (see figure 6).

6. The stamped-metal siding was made the traditional way using gravity drop hammers and cast-iron dies. Photo: Lance Carlson.

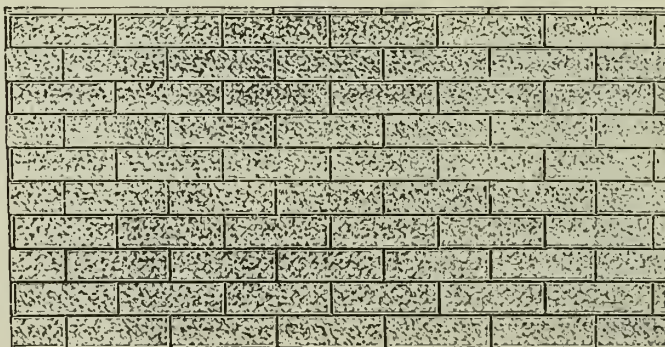
Made in all gauges No. 24 and lighter. Sheets 28 inches by 60 inches. 8 4/7 sheets required to cover 100 square feet. This siding should be applied over solid sheathing. Always lay the concave or hollowed part of the joint to the outside.

7. The brick pattern was a stock design still available from the company. The description from their 1913 catalogue is unchanged from today.

Each of the stamped designs was reproduced in the same metal used to make the original. The stock brick pattern was stamped into 28-gauge galvanized steel sheets measuring 28" by 60" (see figure 7). Galvanized steel is often used for exterior installations, due to its resistance to corrosion. Moreover, galvanized steel is strong enough to produce very stiff sheets of stamped siding in large sizes that can cover a fairly large area with minimum nailing support.

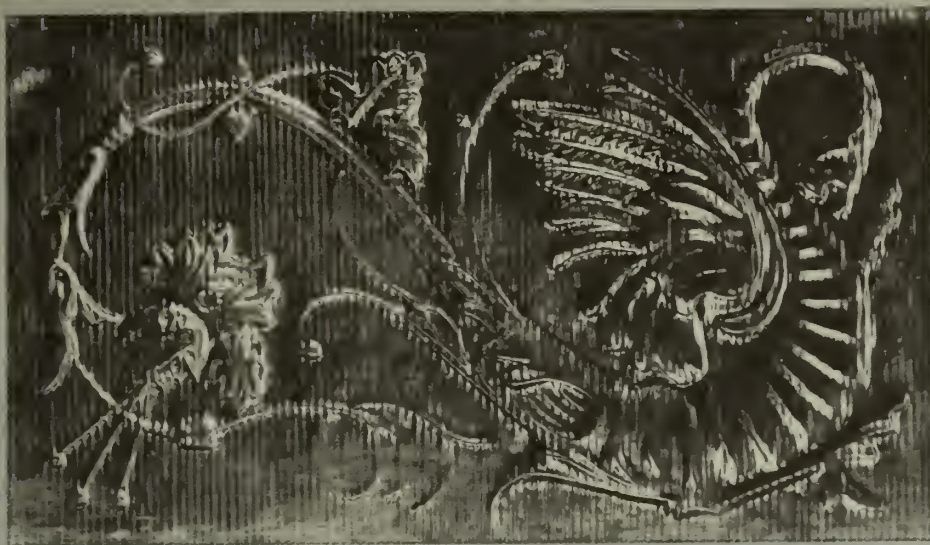
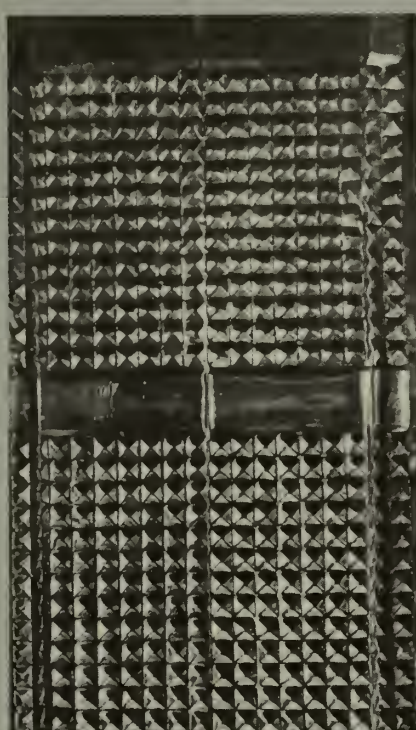
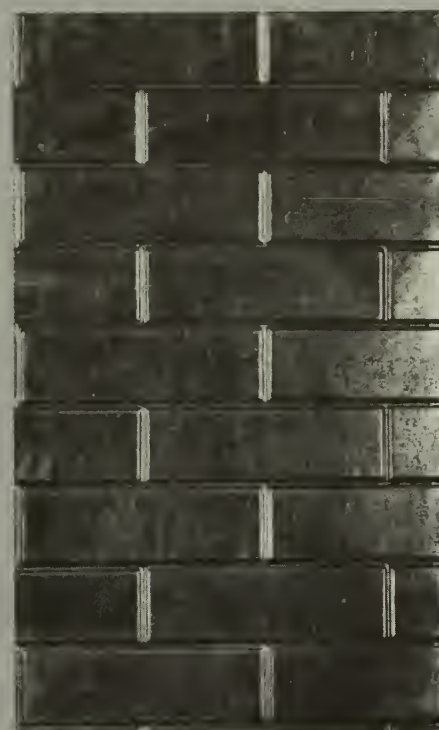
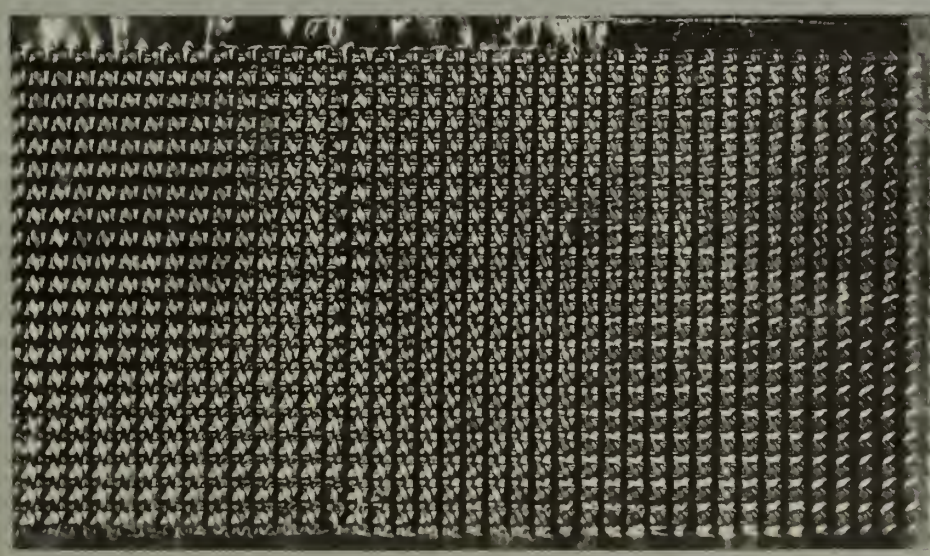
8. The four stamped patterns used at the Hexagon are shown (samples in photograph are smaller than the actual sheet size).
