A REPORT ON
NONDESTRUCTIVE TESTING
AND
STRUCTURAL ANALYSIS
ON
ELEVEN IRON CASEMATE
CARRIAGES AND CHASSIS

FORT SUMTER NATIONAL MONUMENT

Charleston, South Carolina

April 2, 1979

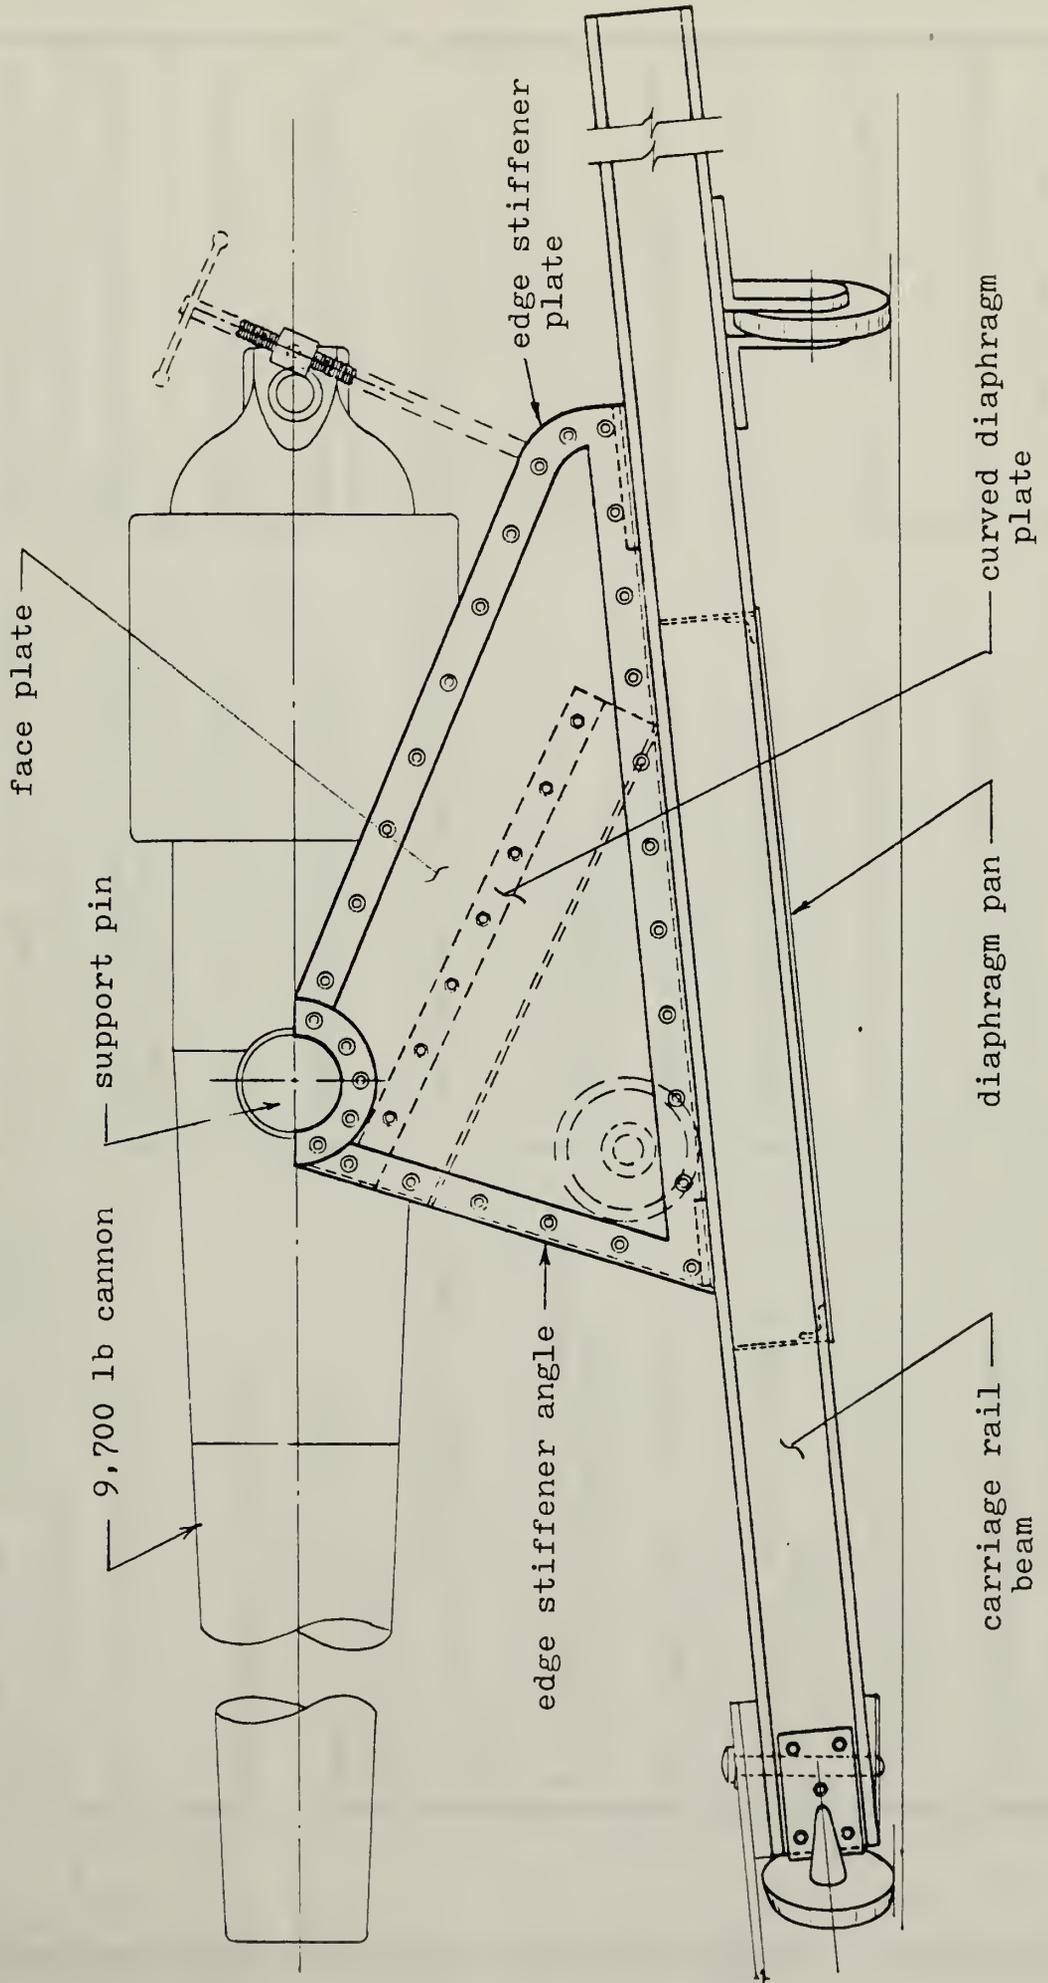
FIGURE 1. STRUCTURAL ELEMENTS

The principal structural elements are identified in figure 1. The weight of the 9700 lb cannon is supported by 8" diameter pins which in turn are supported by two 1/2" thick face plates. The face plates are edge-stiffened by plates or angles and are also mutually connected and braced by a 1/2" curved diaphragm plate. Each face plate is mounted on a 9" carriage beam. The cannon-pin-face plate assembly were movable in relation to the carriage beam. The carriage beams are supported by wheels that are travelable on concentric rails.

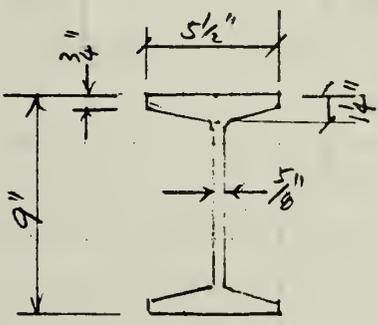
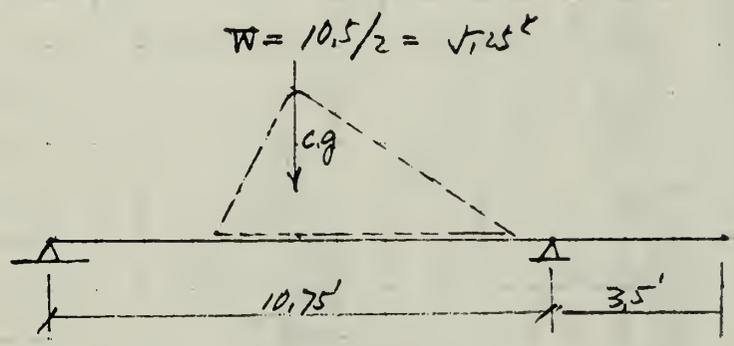
→ RUSTED TO 50% $I = 100 \text{ IN}^4$

RAIL IS OK

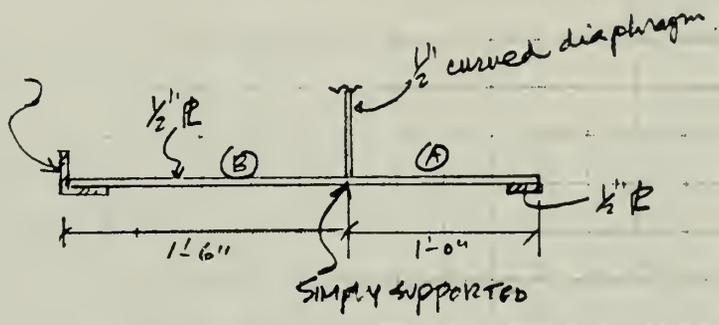
PLATE (A)

ALL MATERIAL BUSTED TO 40% $L 2\frac{1}{2} \times 2\frac{1}{2} \times \frac{1}{8}$

ONE EDGE SIMPLY SUPPORTED, ONE EDGE FREE.

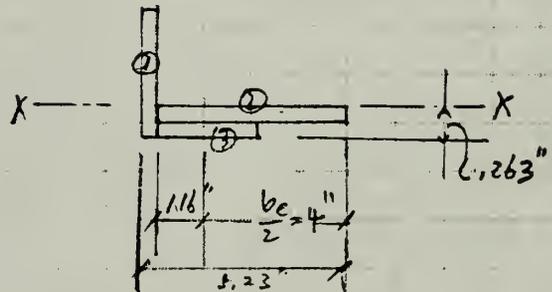
PLATE (B)

BOTH EDGE SIMPLY SUPPORTED
