16 December 2010

US Department of Interior/ National Park Service
Fort Sumter National Monument
1214 Middle Street
Sullivan's Island, SC 29482

Reference: Fort Sumter Masonry Conditions

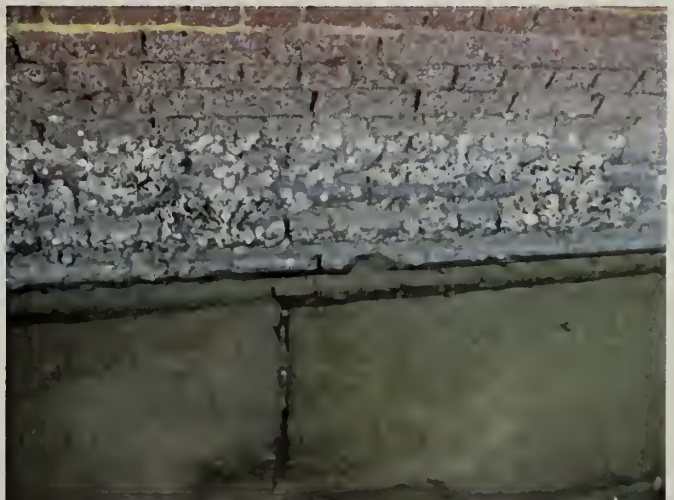
The brick and stone masonry underpinnings of Fort Sumter are literally sitting in a constant bath of salt water, while the majority of the structure remains open to the air. The generally absorbent nature of its brick construction is such that there is a natural tendency for the salt laden water to be absorbed at the structures base and travel upward via capillary action (like a wick), and then be evaporated out of the structure at a height where the capillary action can no longer draw enough water to sustain this outward flow.

Salt saturation in general should not be detrimental to the condition of the masonry so long as it remains in liquid state. However, as the evaporation occurs, the salts crytofloresce within the outer “evaporation zones” of the masonry.

Salt crystals form and expand within the internal brick matrices in-sighting failure of the internal structures of the bricks and/or mortar as there is no volumetric capacity for the crystals to grow.

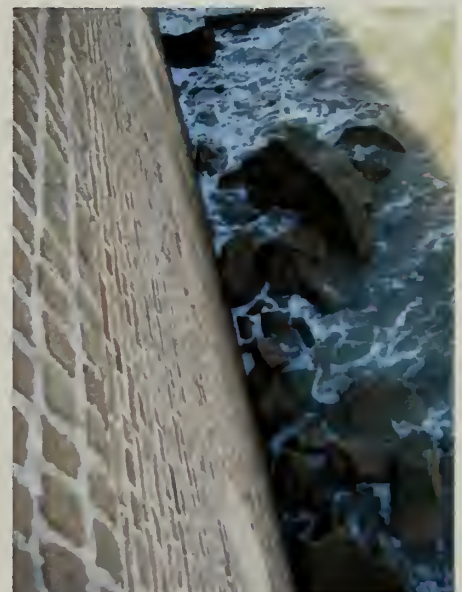
Beyond the direct scouring of waves, another effect is the shifting of rip rap stones that grind against the brick surfaces of the Fort causing them to abrade.

Fort. However, it would tend to drive sand and other airborne particles that can abrade the exposed surfaces, as will rain and seawater during storms while accelerating evaporation (and saltwater uptake) during dry periods.

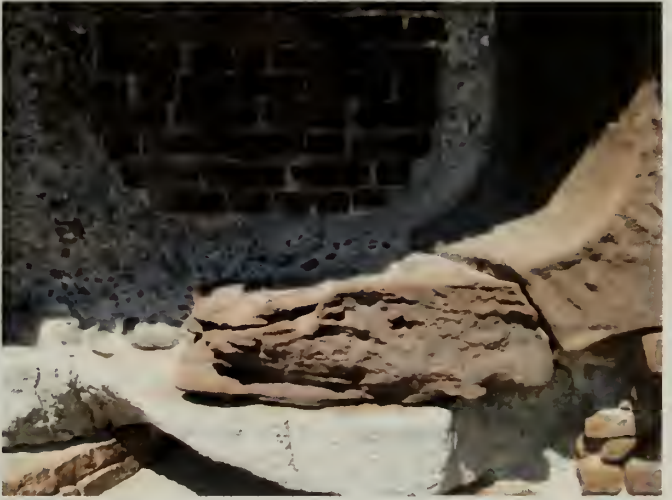
1. Red Common Brick: This comprises the majority of Fort Sumter's early to mid 19th Century construction and has been researched and well described by Prof. Brosnan and consists of four "families" of bricks that were hand molded from coastal clays and one "family" of extruded bricks. The bricks are generally weaker and more porous than bricks that would be used in such applications today. Such bricks could be, and in many cases have been, damaged by improper selection of mortar, which would need to be very breathable and relatively soft to behave compatibly with the brick.
