Submerged Cultural Resources Study

USS ARIZONA MEMORIAL

PEARL HARBOR NATIONAL HISTORIC LANDMARK

**DANIEL J. LENIHAN, EDITOR
SUBMERGED CULTURAL RESOURCES UNIT
NATIONAL PARK SERVICE**

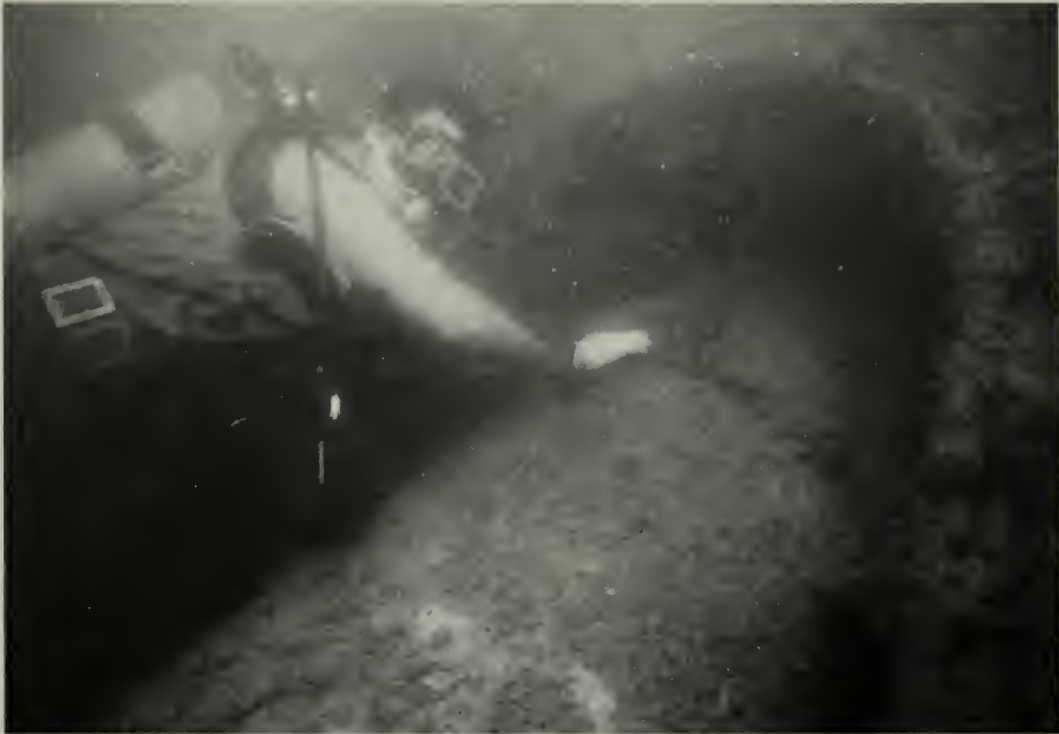
Figure 1.1. Gary Cummins, Superintendent of ARIZONA Memorial inspects embrasures of No. 1 turret. It was not known that the 14-inch guns were still in place on the ship until the underwater survey. (NPS photo by Larry Murphy)

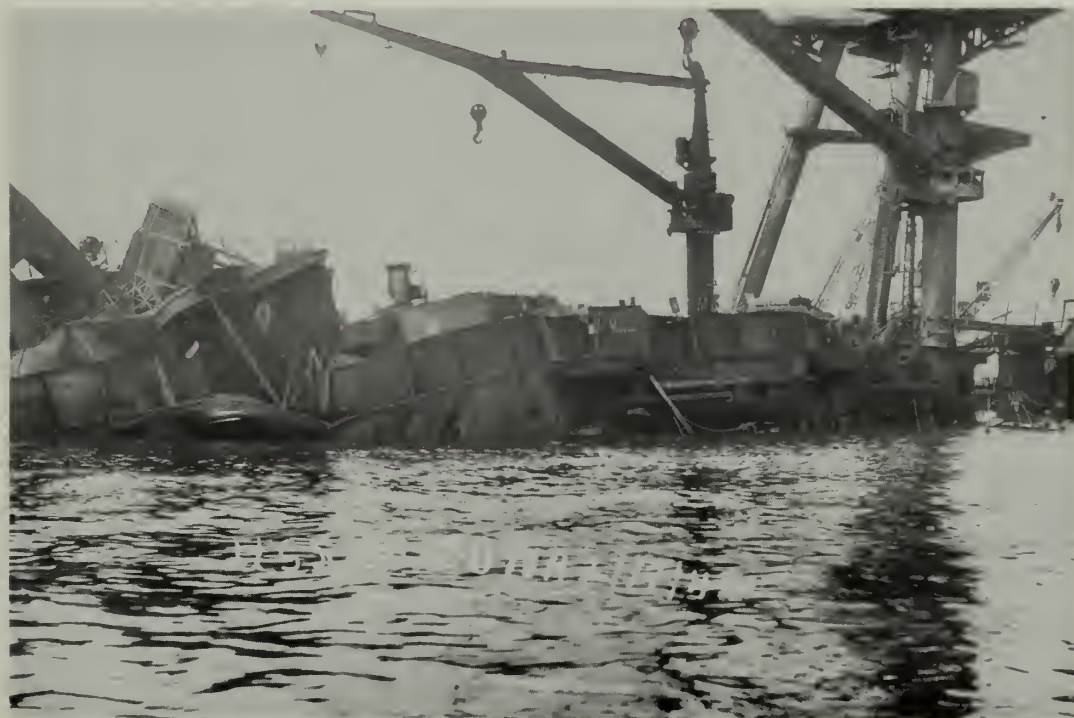
Figure 2.23. Aftermath: The USS ARIZONA midships area near boat cranes February 17, 1942. Note V for victory placed on splinter shield (center). (NPS: USAR collection)

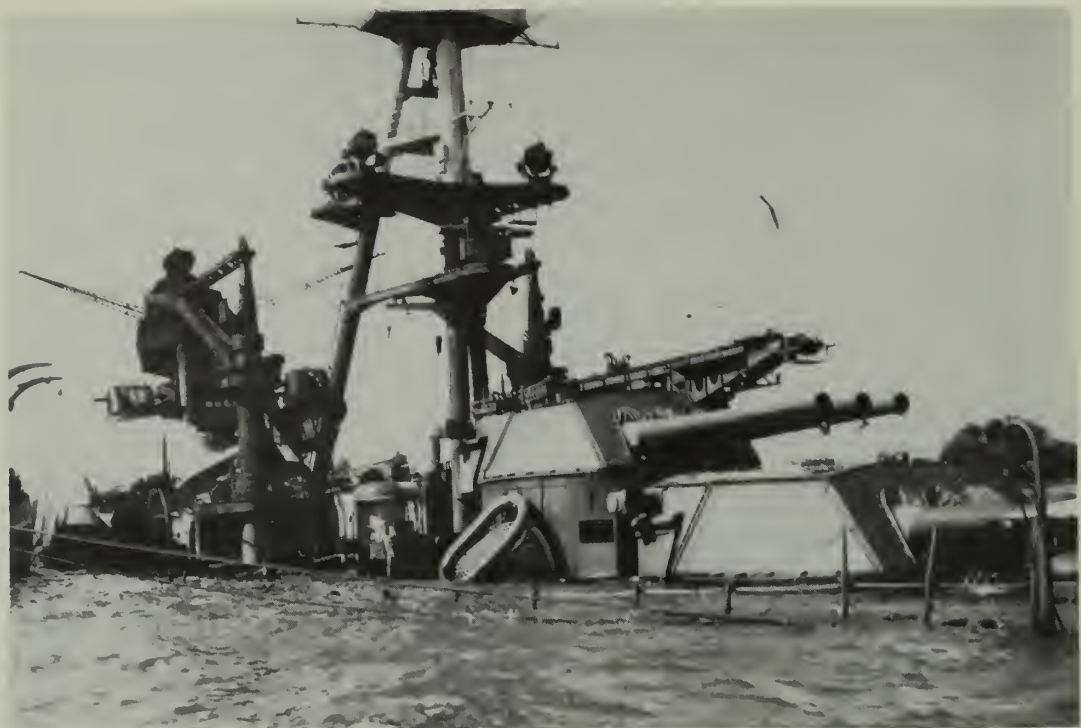
Figure 2.24. The USS ARIZONA from port stern looking forward. (NPS: USAR collection)

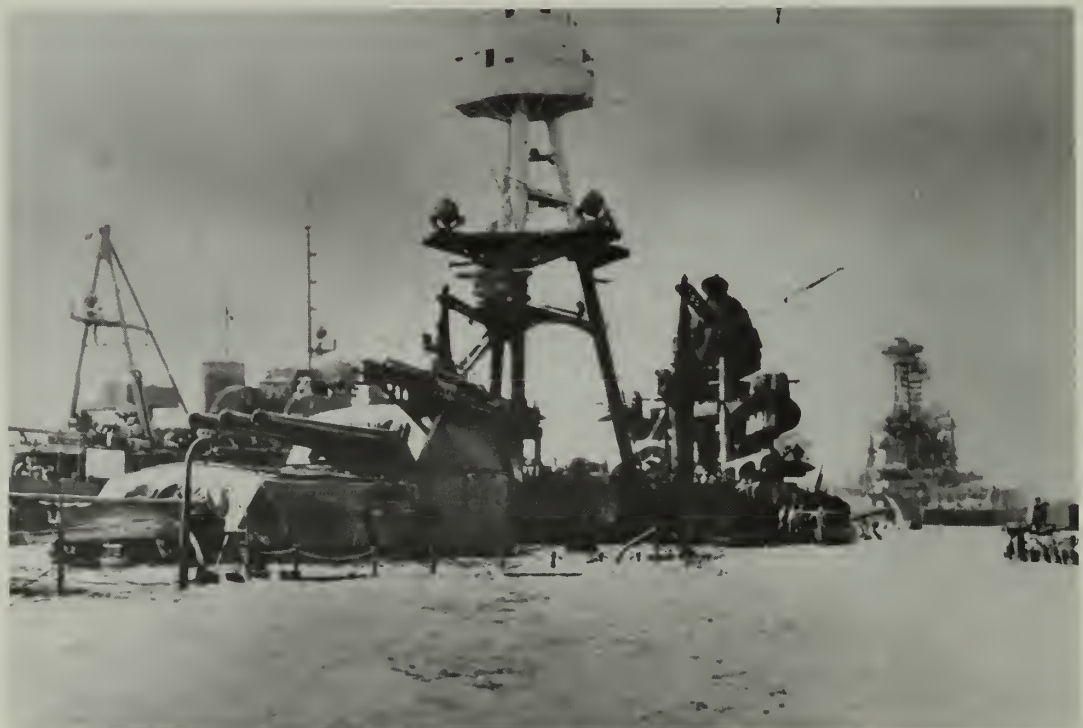
Figure 2.25. USS Arizona from starboard stern looking forward. (NPS: USAR collection)

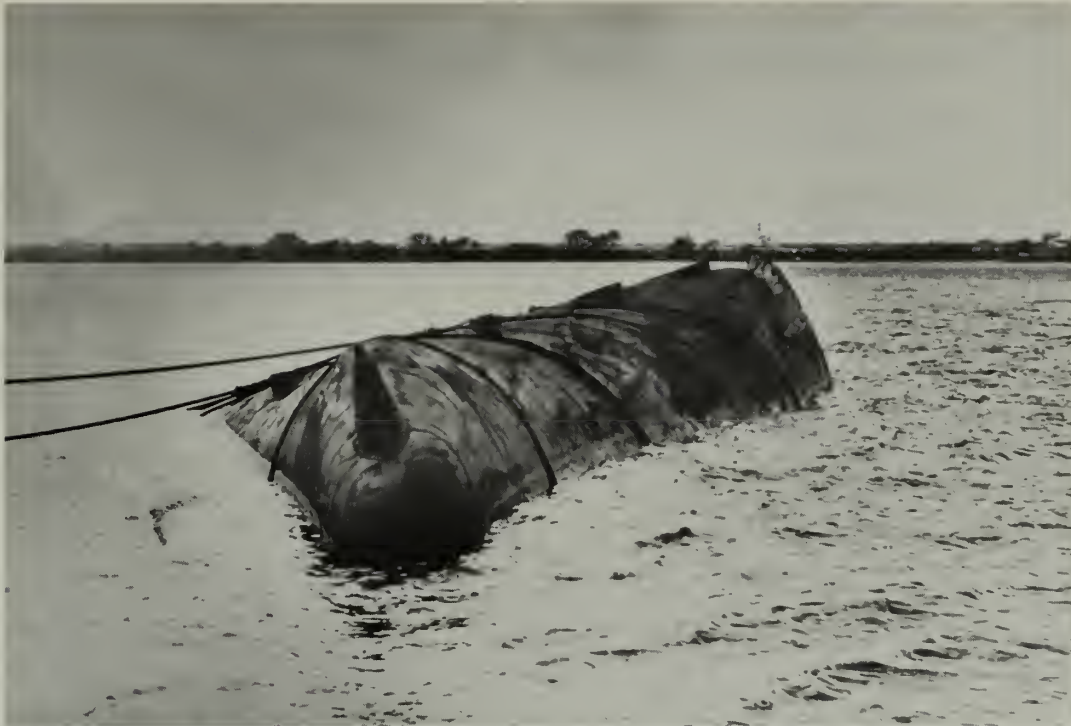
Figure 2.38. The USS UTAH turned turtle after attack. (NPS: USAR collection)

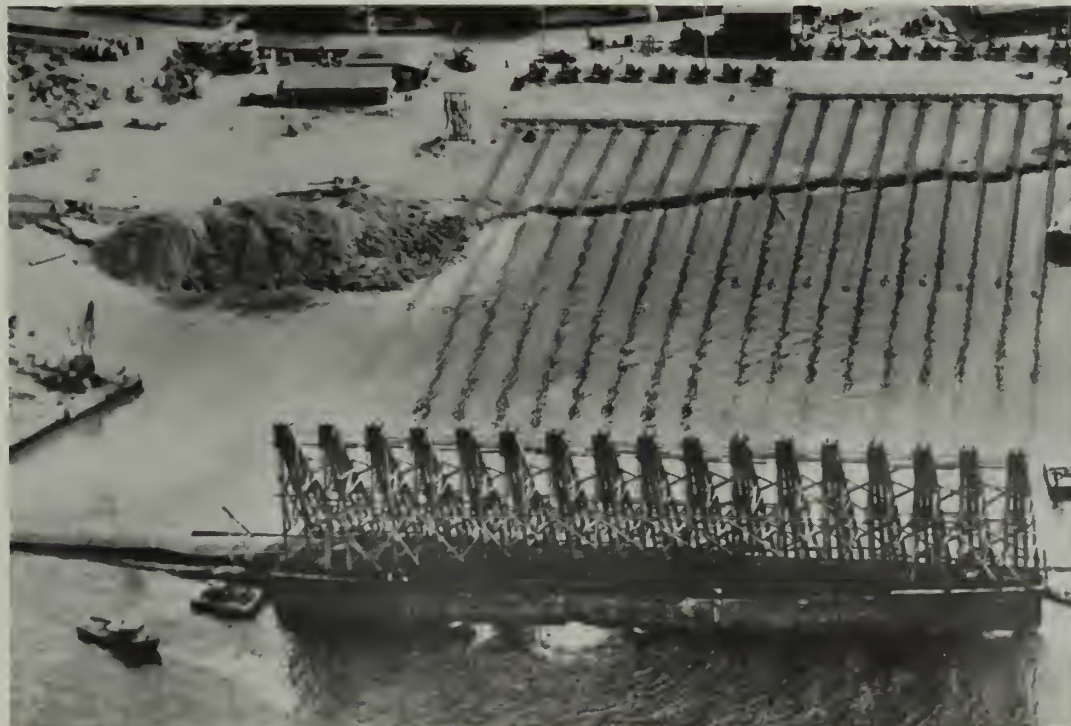
Another approach was considered. The conditions that faced the UTAH were similar to those in the righting of the OKLAHOMA. Captain Wallin and his staff decided that the OKLAHOMA's method would accomplish the task. In preparation, during the month of January 1943, workers removed ordnance material, painted frame marks on the hull, constructed a floating walkway to the F-11-N quay, installed a landing for boats, and drilled access holes to remove the ship's oil supply.

Figure 2.39. The UTAH salvage operations attempt to right the ship. (NPS: USAR collection)

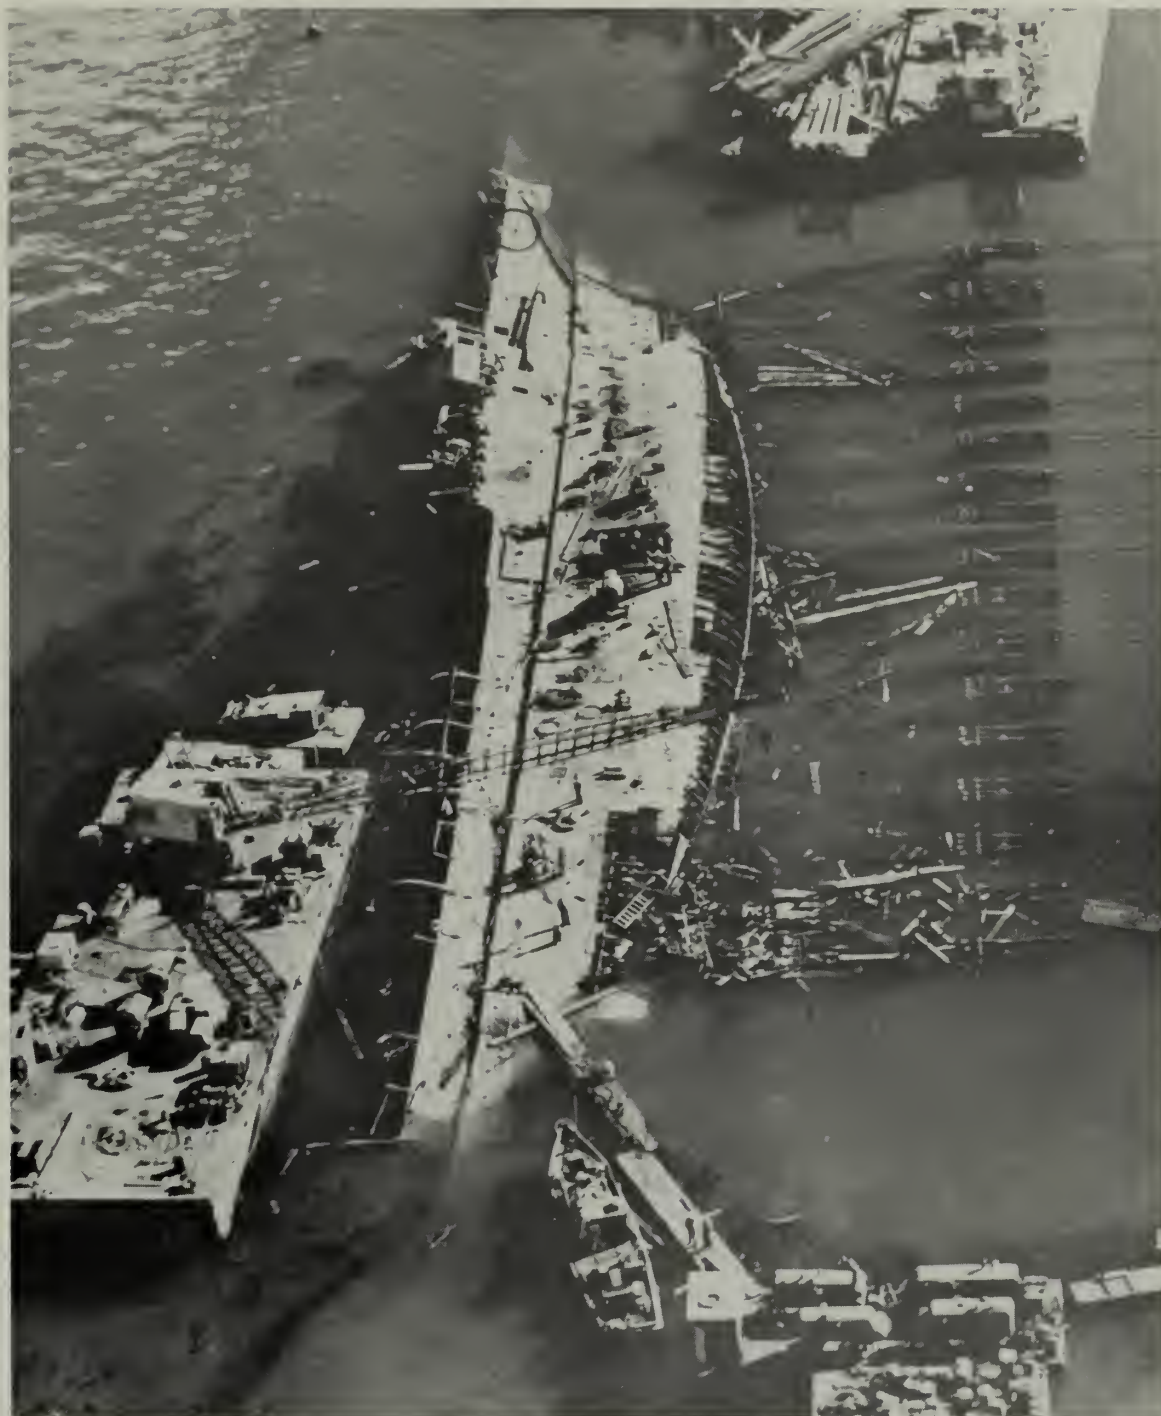
Like the OKLAHOMA, a series of 17 electric winches, cables and wooden struts was used to right the ship. Work on the UTAH proceeded slowly but effectively until early in 1944. As the ship began to roll back to an upright position, the vessel failed to grip the bottom. As the winches pulled, the vessel slid toward Ford Island. Immediately work stopped, and salvage engineers pondered the problem.

Figure 2.40. The UTAH partially righted during salvage operations. (NPS: USAR collection)

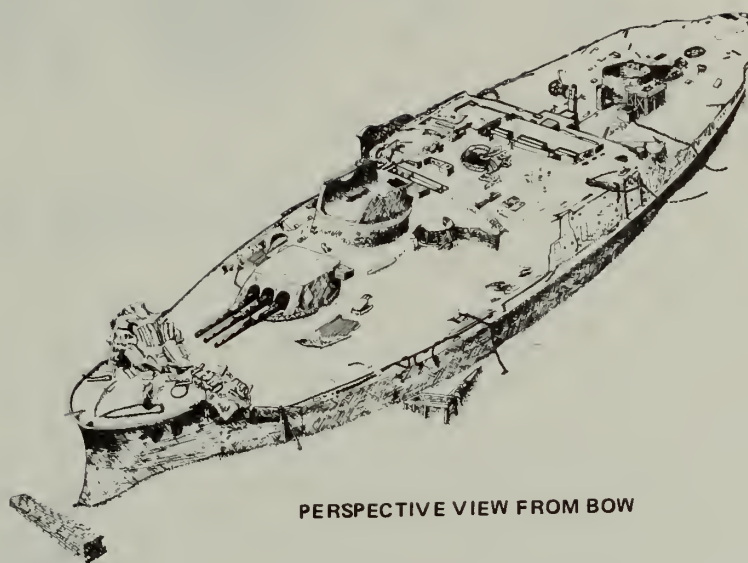
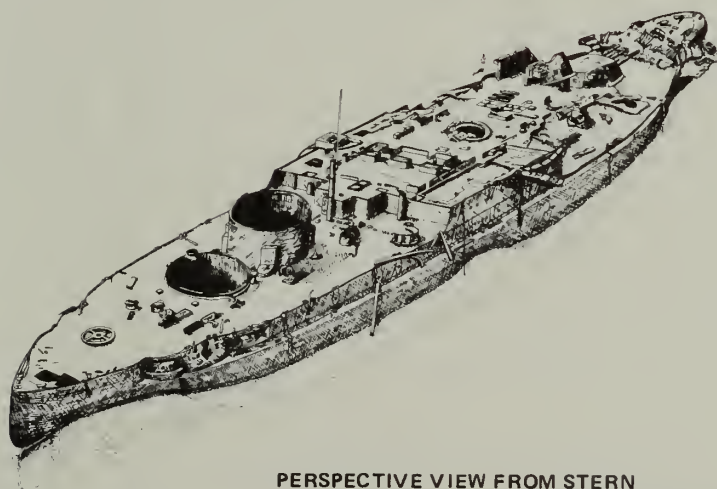
On the port side approximately 80 feet and 112 feet aft of the stem, open cracks visible in the torpedo blister continue below the silt line. These cracks in the sides above the silt probably indicate a major structural failure associated with the magazine explosion. In all probability the inner hull and armor belt are also cracked.

Figure 3.7. These artistic renderings by Jerry Livingston portray the ship remains from different oblique angles.

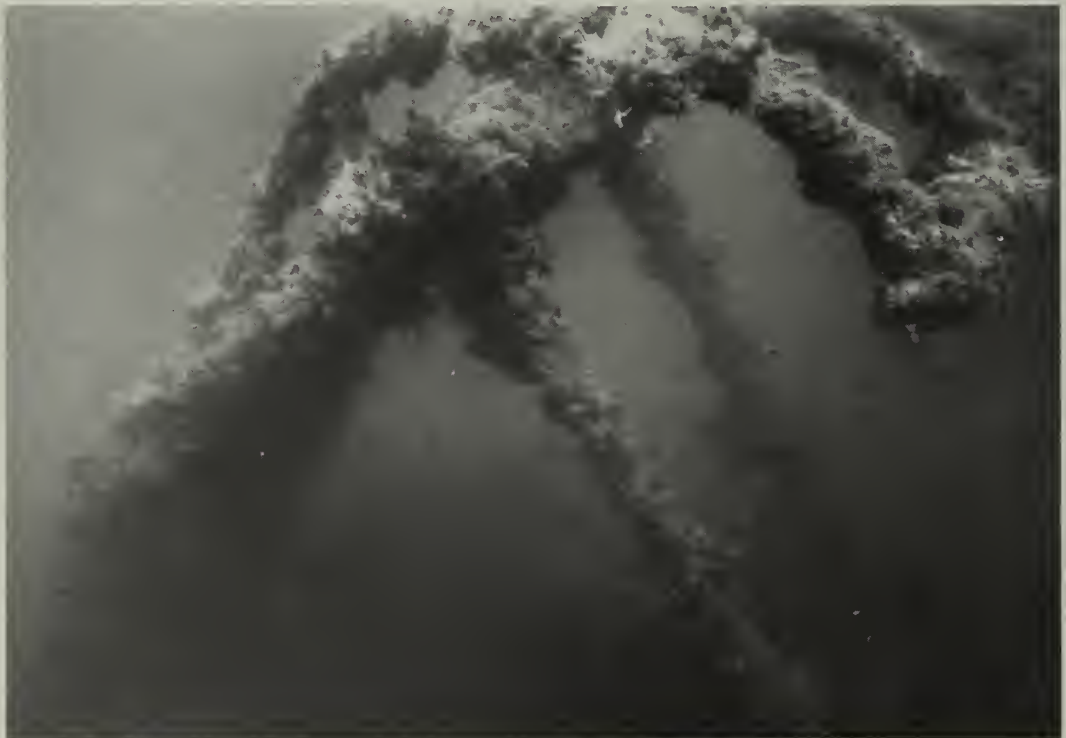
Figure 3.12. Awning cover for a hatch on aft port side of No. 1 turret. (NPS photo by Larry Murphy)

Along the sides of turret No. 1 below the range finders, teak decking -- the forward remains of the forecastle deck -- is visible after light fanning of the silt. A few feet farther aft on the port side is a hatch that has been propped open for access below decks, probably by the salvage teams (Figure 3.12). The tropical awning support is in place.

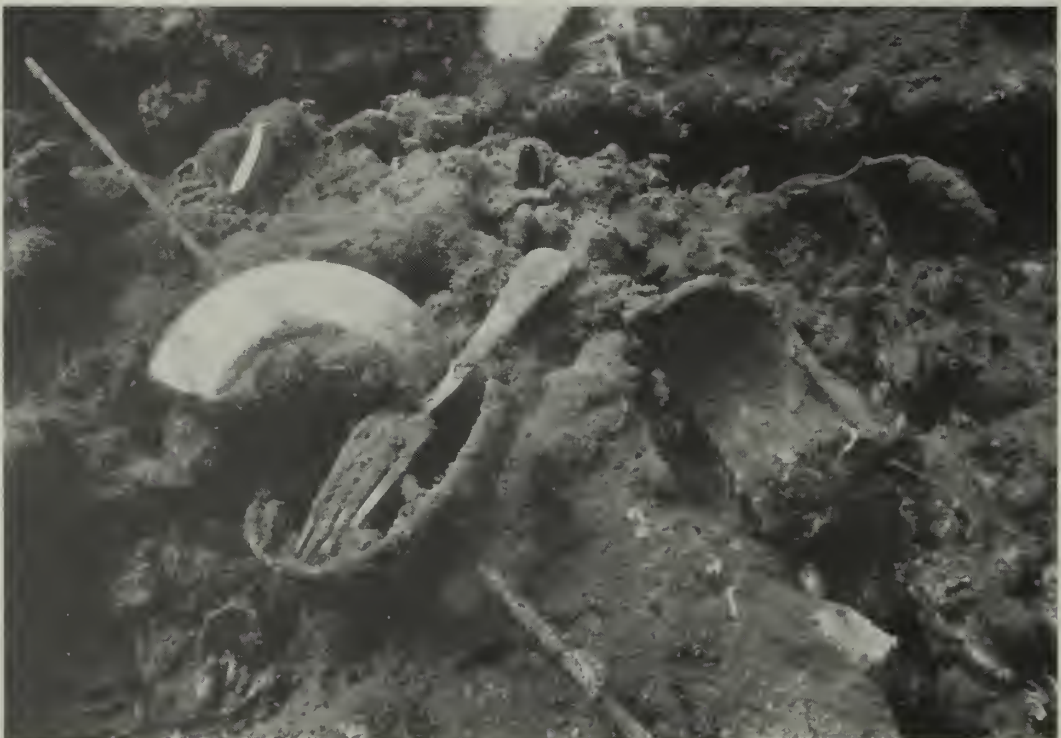
Figure 3.16. Artifacts in ship's galley area, USS ARIZONA. (NPS photo by Larry Murphy)

The remains of bulkheads and other features unmistakably define the galley area (Figure 3.15). Doorways, oven bases and what appear to be table legs are visible. The floor was covered with 2-inch hexagonal tile, much of which remains beneath the thin layer of silt. Many artifacts can be found, including coffee cups, plates and silverware (Figure 3.16). The stumps of the main mast tripod legs are discernible, as are the bases of boat cranes.

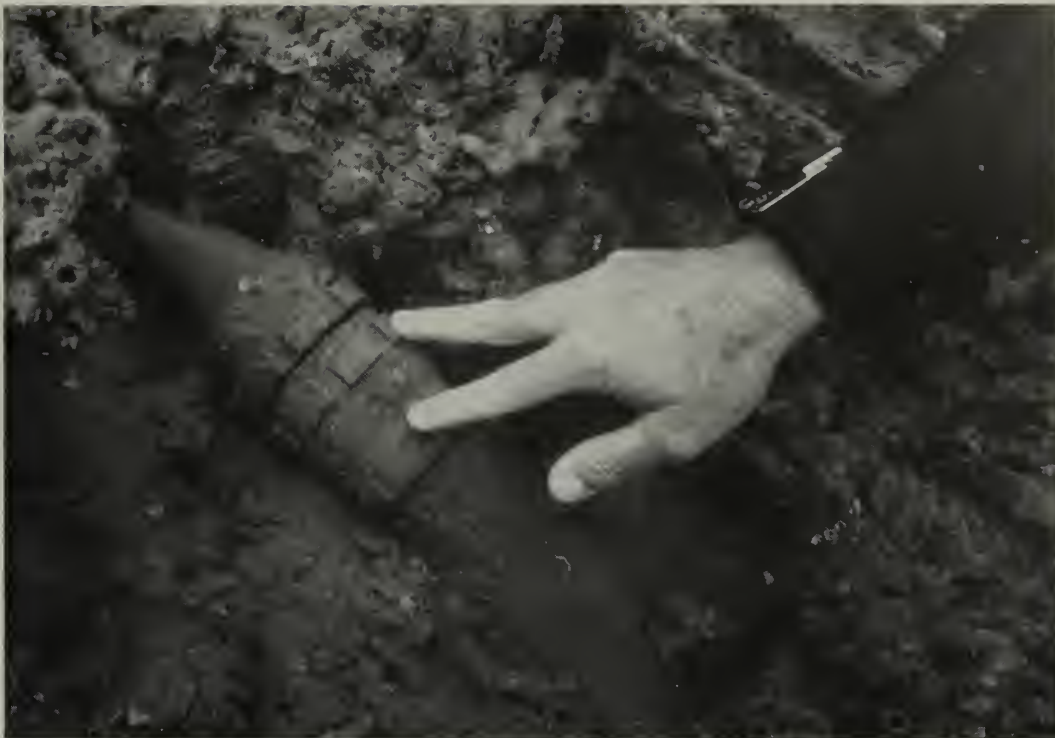
Figure 3.17. Coupling of fire hose on deck of ship protrudes through the sediment. (NPS photo by Larry Murphy)

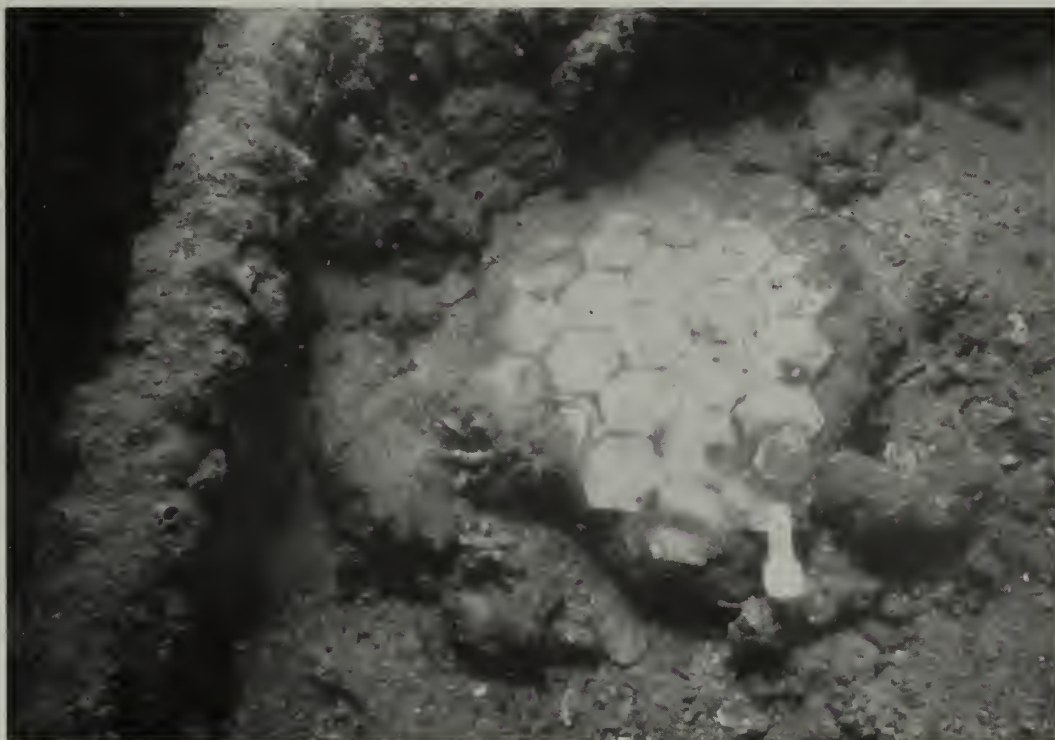
Figure 3.18. Tile floor in galley area of USS ARIZONA. (NPS photo by Larry Murphy)

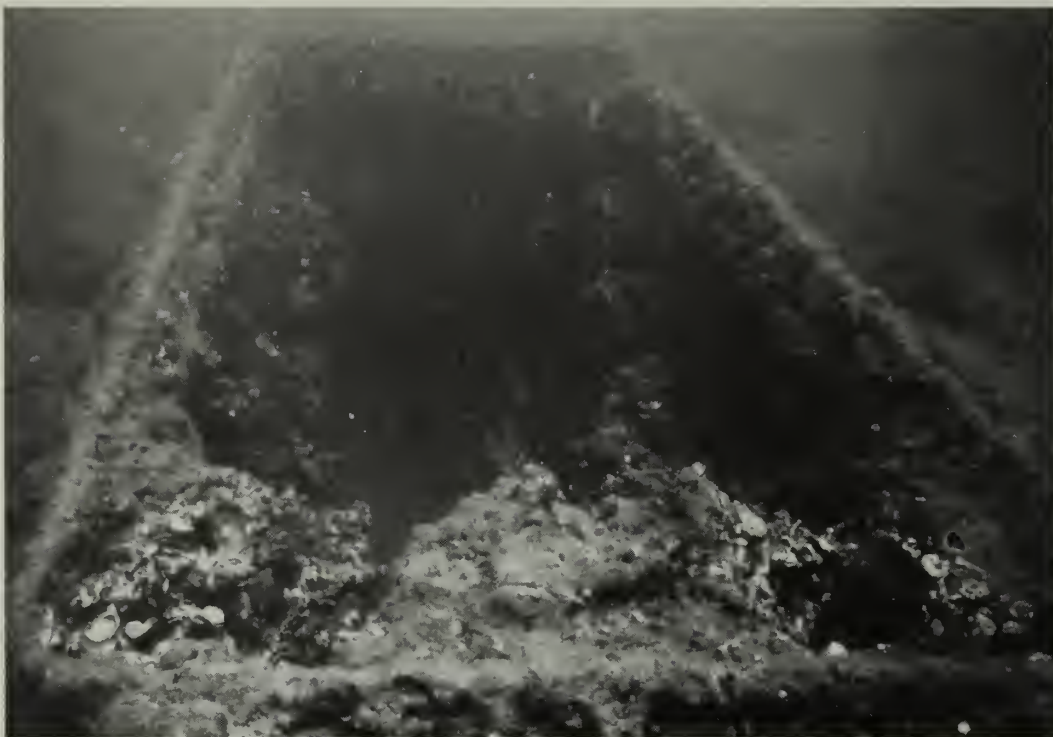
Figure 3.19. Open hatch on USS ARIZONA with stairwell heavily fouled with marine organisms. (NPS photo by Larry Murphy)

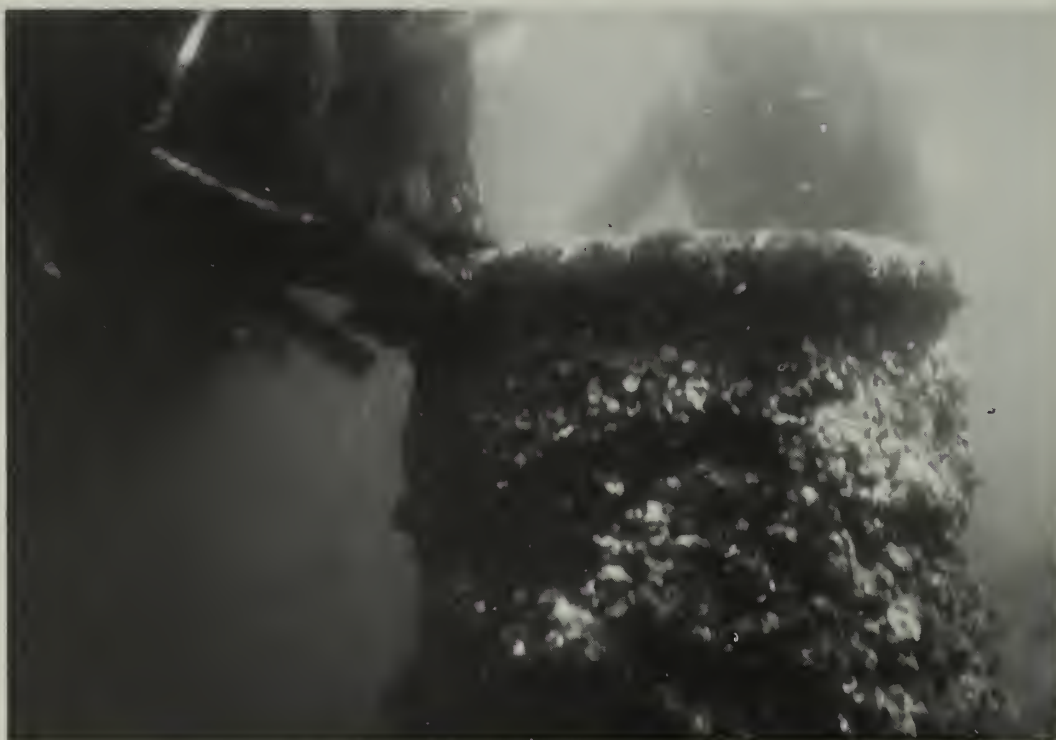
Figure 3.20. Ventilator on deck of USS ARIZONA. (NPS photo by Larry Murphy)

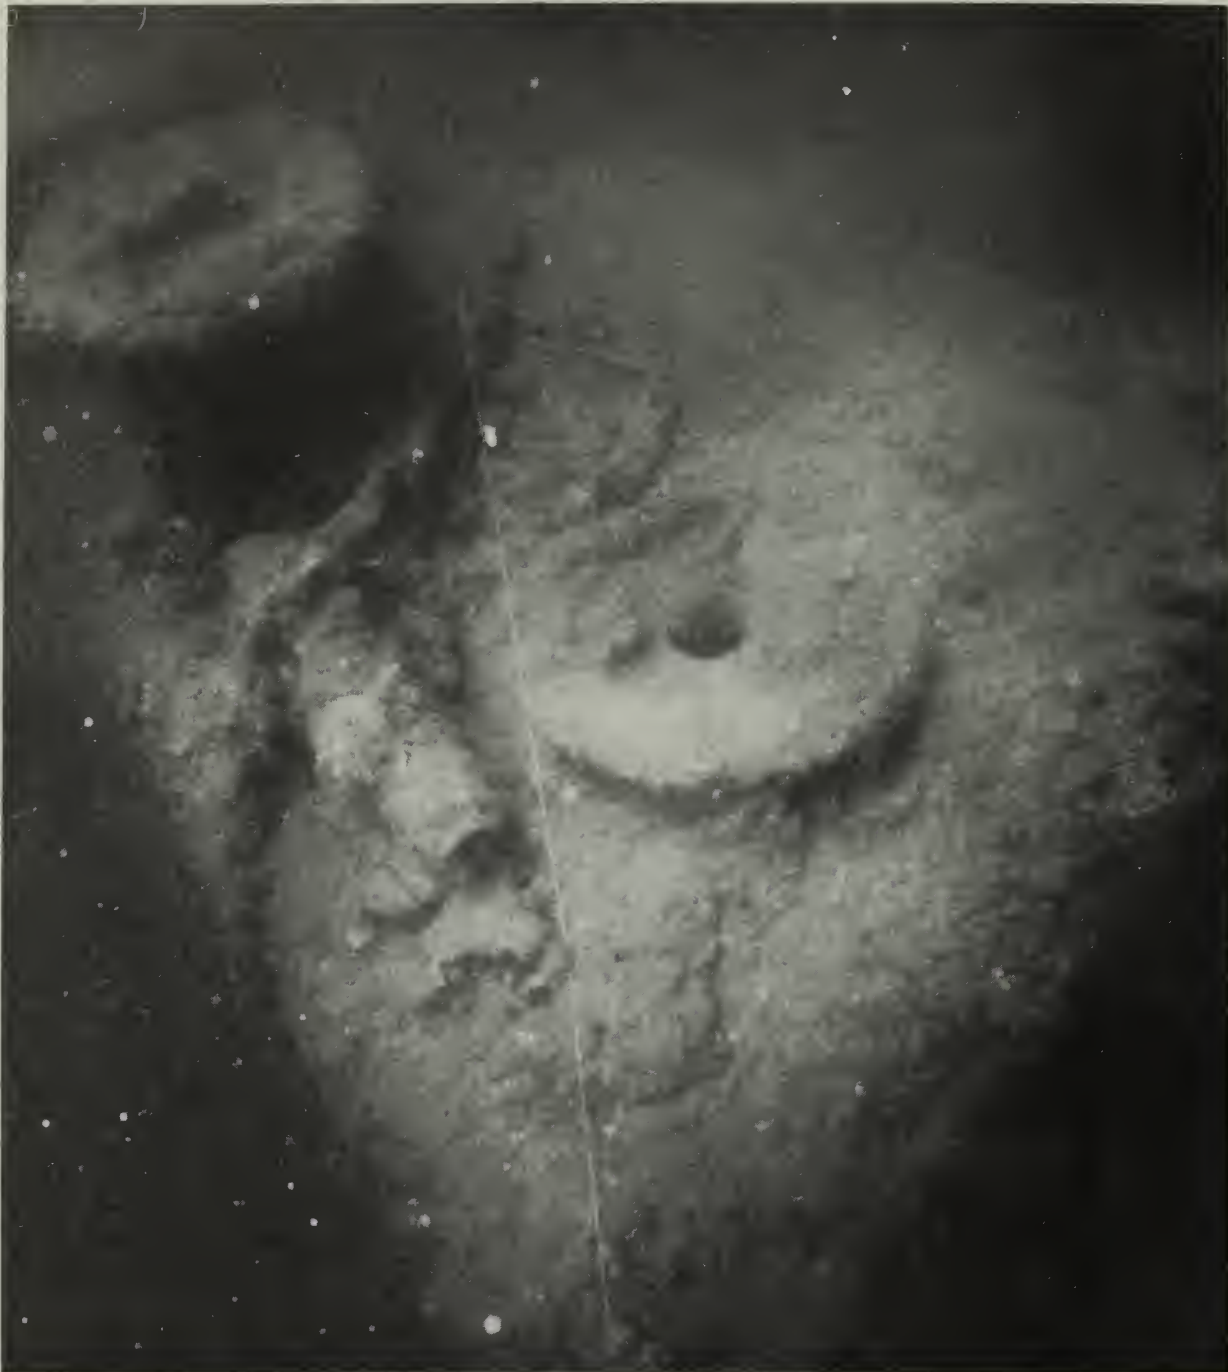
Figure 3.23. Flagstaff hole at stern of USS ARIZONA. Mooring bitts visible to left. (NPS photo by Larry Murphy)

A 12-inch-diameter cable of bundled wire strands can be seen running along the inside of both gunnels in the stern. The function of these cables is unknown, although our original guess that they had something to do with degaussing was not confirmed by military personnel familiar with degaussing technology. The airplane catapult base is visible on the stern. There is a hole in the starboard stern extending to amidships left from the salvage of the airplane recovery crane. On the port stern hull are some portholes that still hold trapped air between the blackout covers and the glass (Figure 3.21); this is the area of the admiral's cabin. The jackstaff hole at the stern is intact, although empty (Figure 3.23).

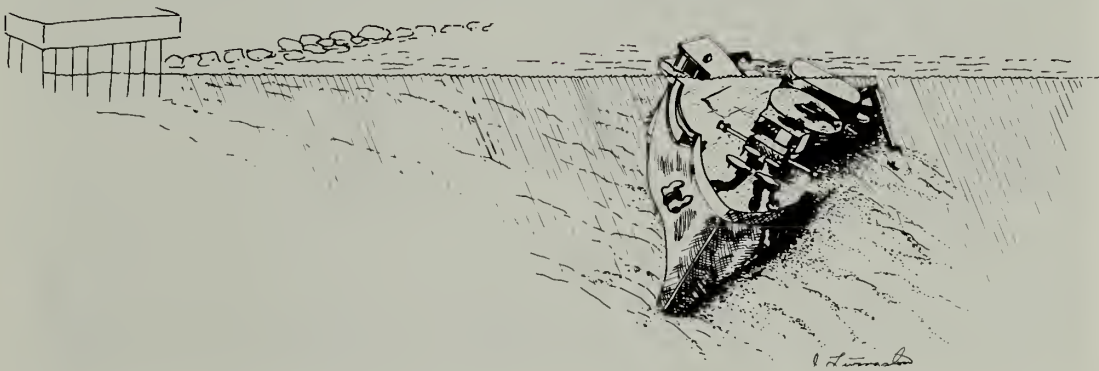
As is evident from the site map (Figure 3.27), the UTAH is lying on its port side and partially buried in the silt. A portion of the starboard side area protrudes from the water amidships and is visible from the memorial. It is interesting that some plants have been able to establish themselves on the hulk, and greenery protrudes from unlikely places on the exposed hull portions.

Figure 3.27. *Perspective of Utah from bow by Jerry Livingston.*

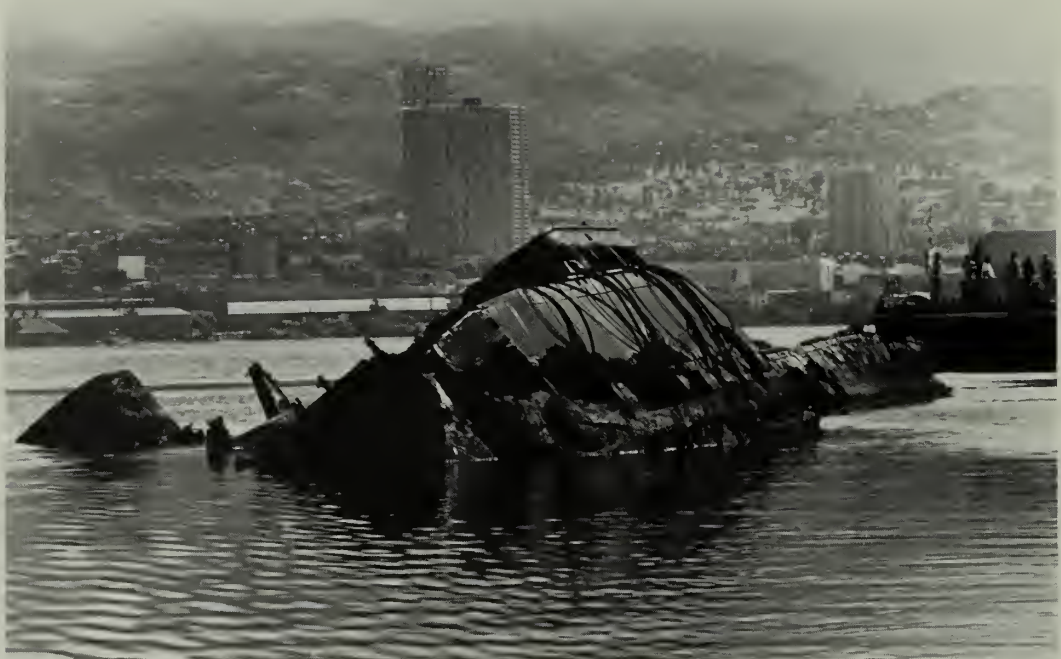
Figure 3.28. USS UTAH looking forward from stern. (NPS photo)

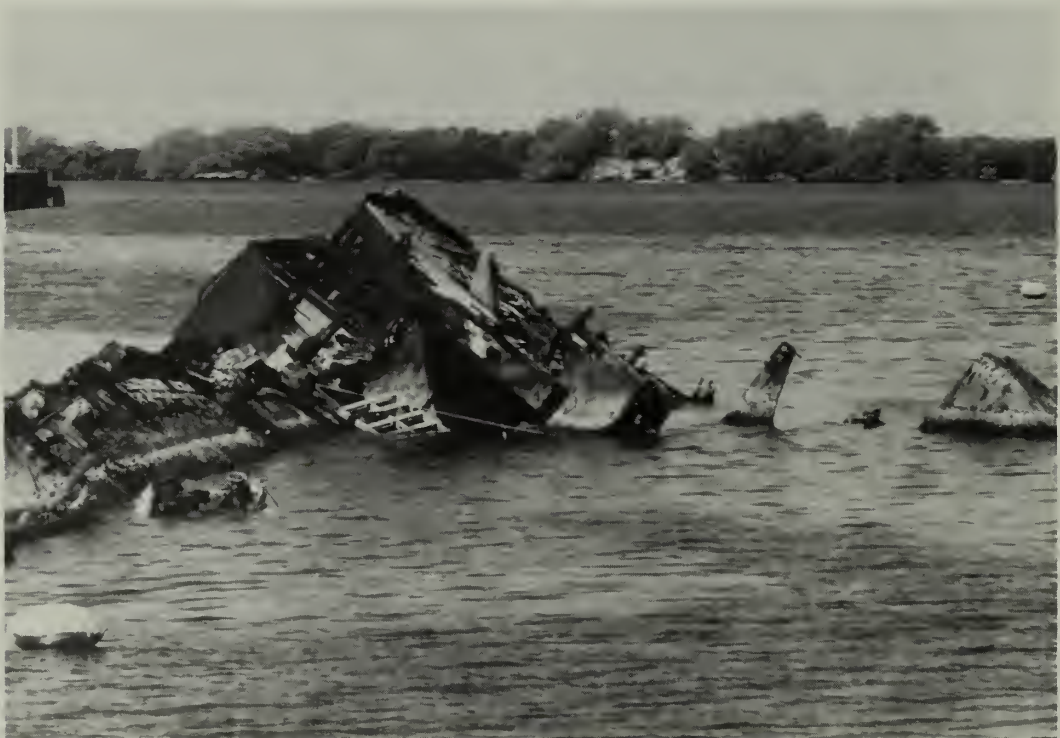
Figure 3.29. USS UTAH looking aft from the bow. (NPS photo)

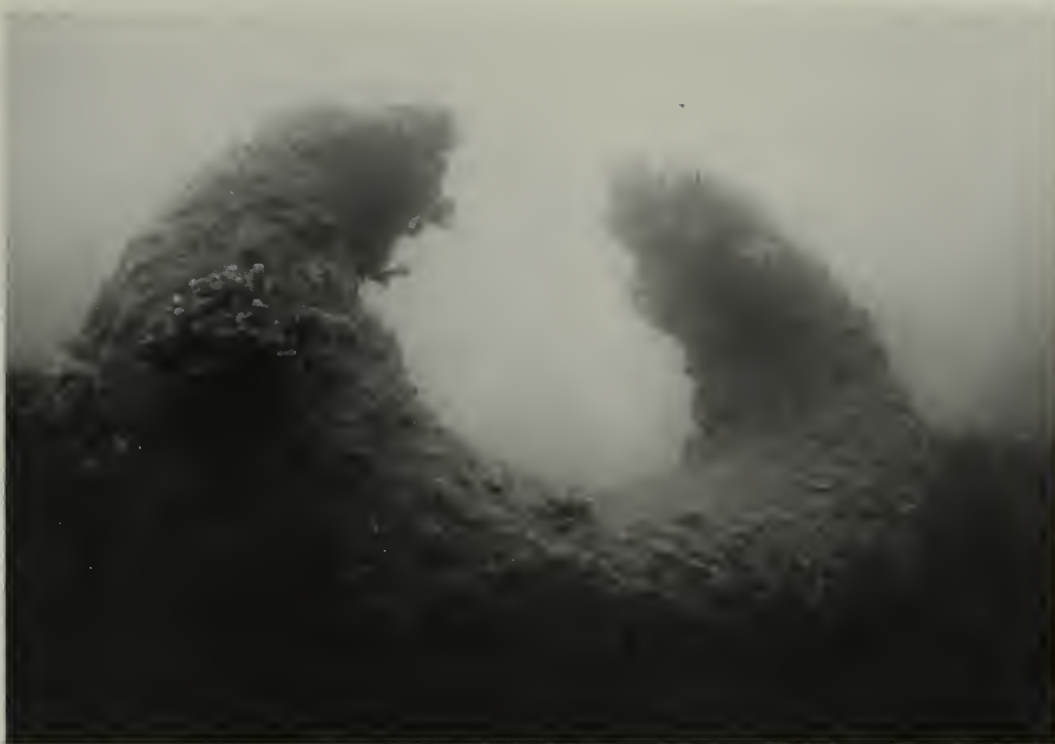
Figure 3.30. Chock on gunnel of starboard bow of USS UTAH. (NPS photo by Larry Murphy)

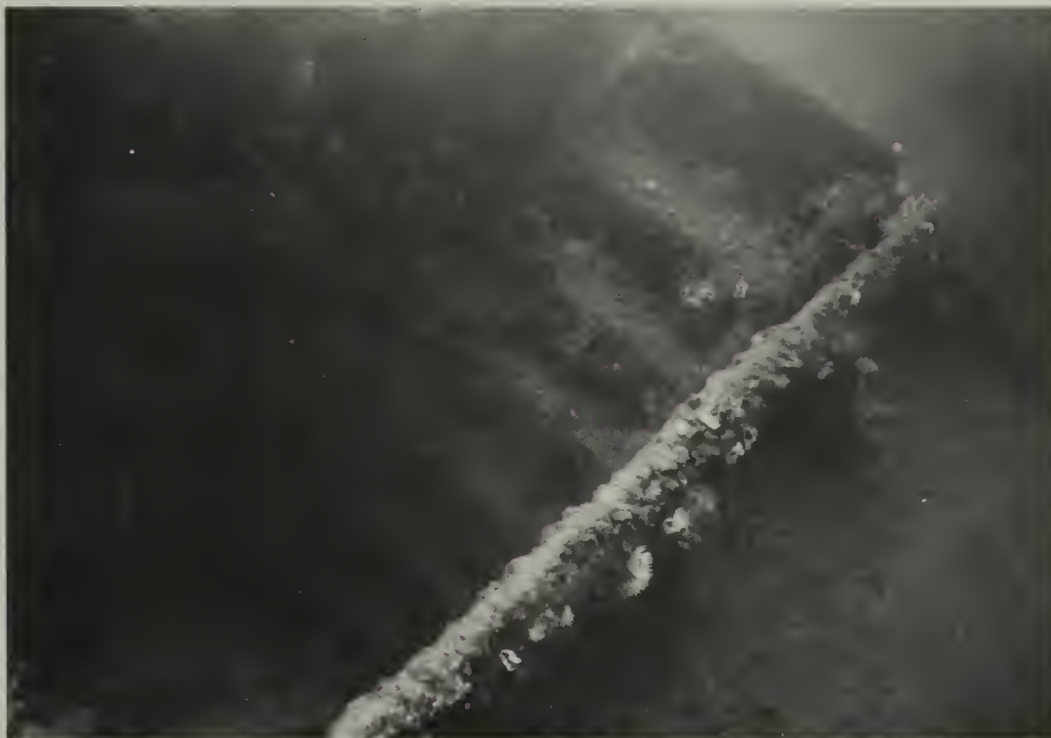
Figure 3.31. Stairs lead down into interior of USS UTAH. (NPS photo by Larry Murphy)

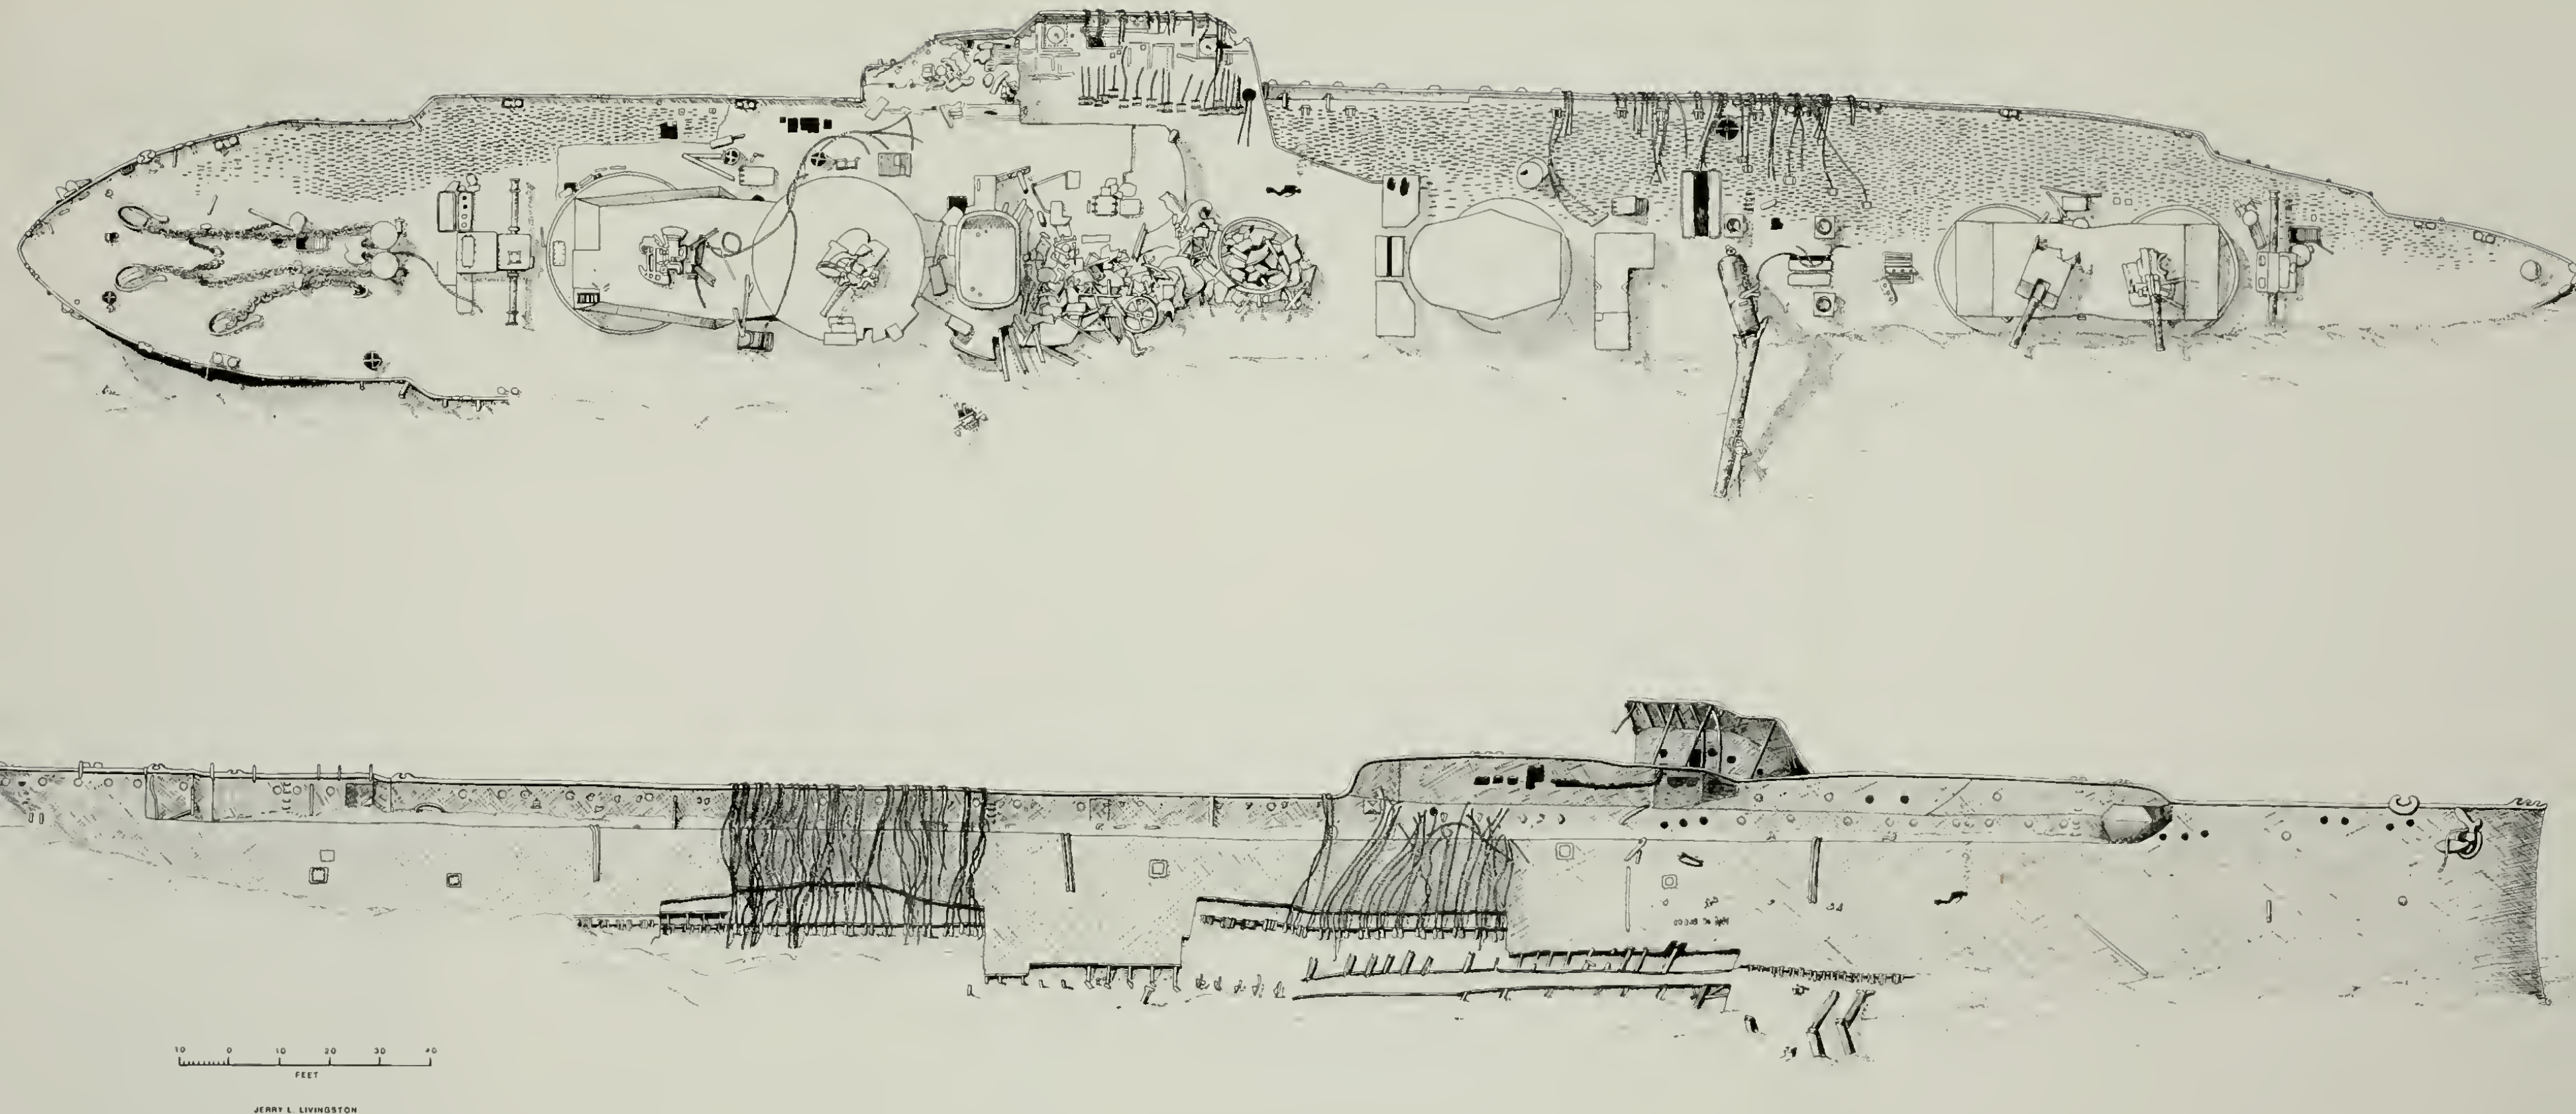
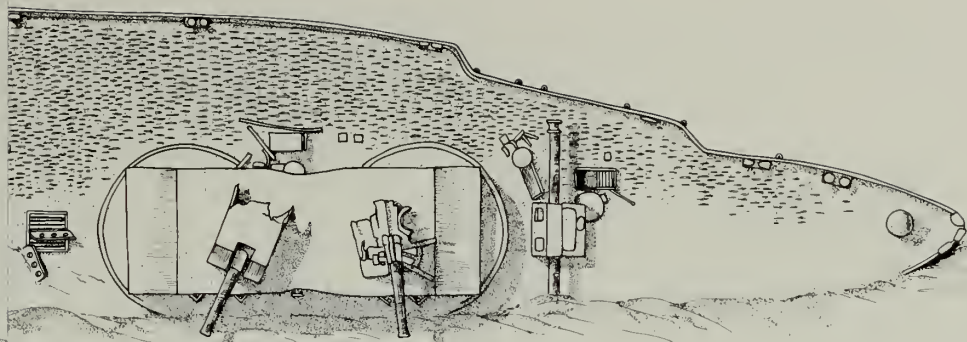
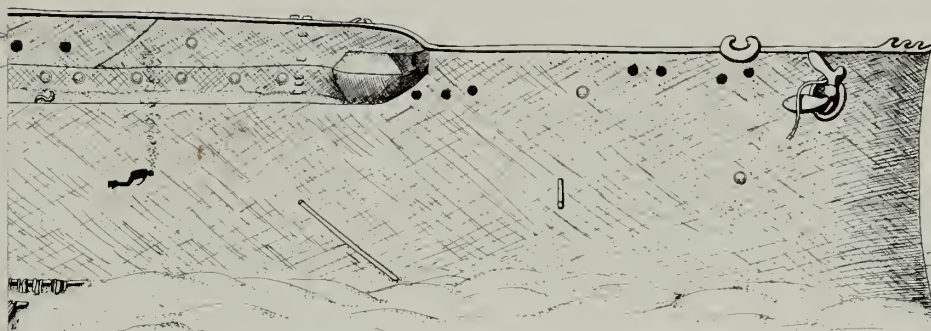
Perhaps the best way to pursue a descriptive narrative of the current condition of the UTAH underwater is to conduct an imaginary swim from bow to stern, first along the starboard side, and then along the deck (see Figure 3.33 --for reference).

Heading aft on the starboard side, one would probably first see the anchor still secure in the hawse pipe. From here aft there are very few features, except some intact portholes well above the waterline. No signs of war damage are evident, indicating that the torpedo damage on the port side that sank the ship did not vent on the starboard.

The hull is virtually complete and undistorted. Near the starboard bilge line, a hull plate has been removed. A-frame parbuckling gear (or righting headgear) was attached to the bottom of the UTAH during attempts to right the vessel. Cables attached to the parbuckles once led to huge electric winches on shore. It appears that

Figure 3.33. Two-part drawings of remains of USS UTAH. Drawn by Jerry Livingston from underwater operations conducted by SCRU and US Navy Reserve MDSU One (Det 319).

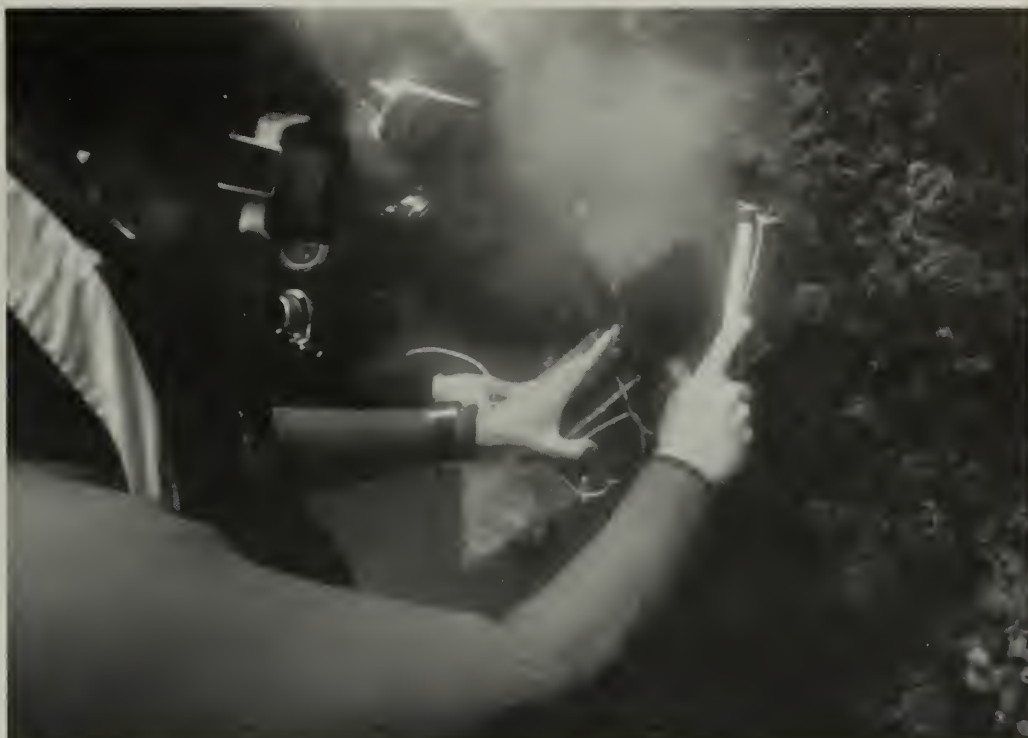
Figure 4.4. Corrosion and biofouling material being scraped into collection funnel by divers. (NPS photo by Larry Murphy)
