Submerged Cultural Resources Study

USS ARIZONA MEMORIAL

PEARL HARBOR NATIONAL HISTORIC LANDMARK

**DANIEL J. LENIHAN, EDITOR
SUBMERGED CULTURAL RESOURCES UNIT
NATIONAL PARK SERVICE**

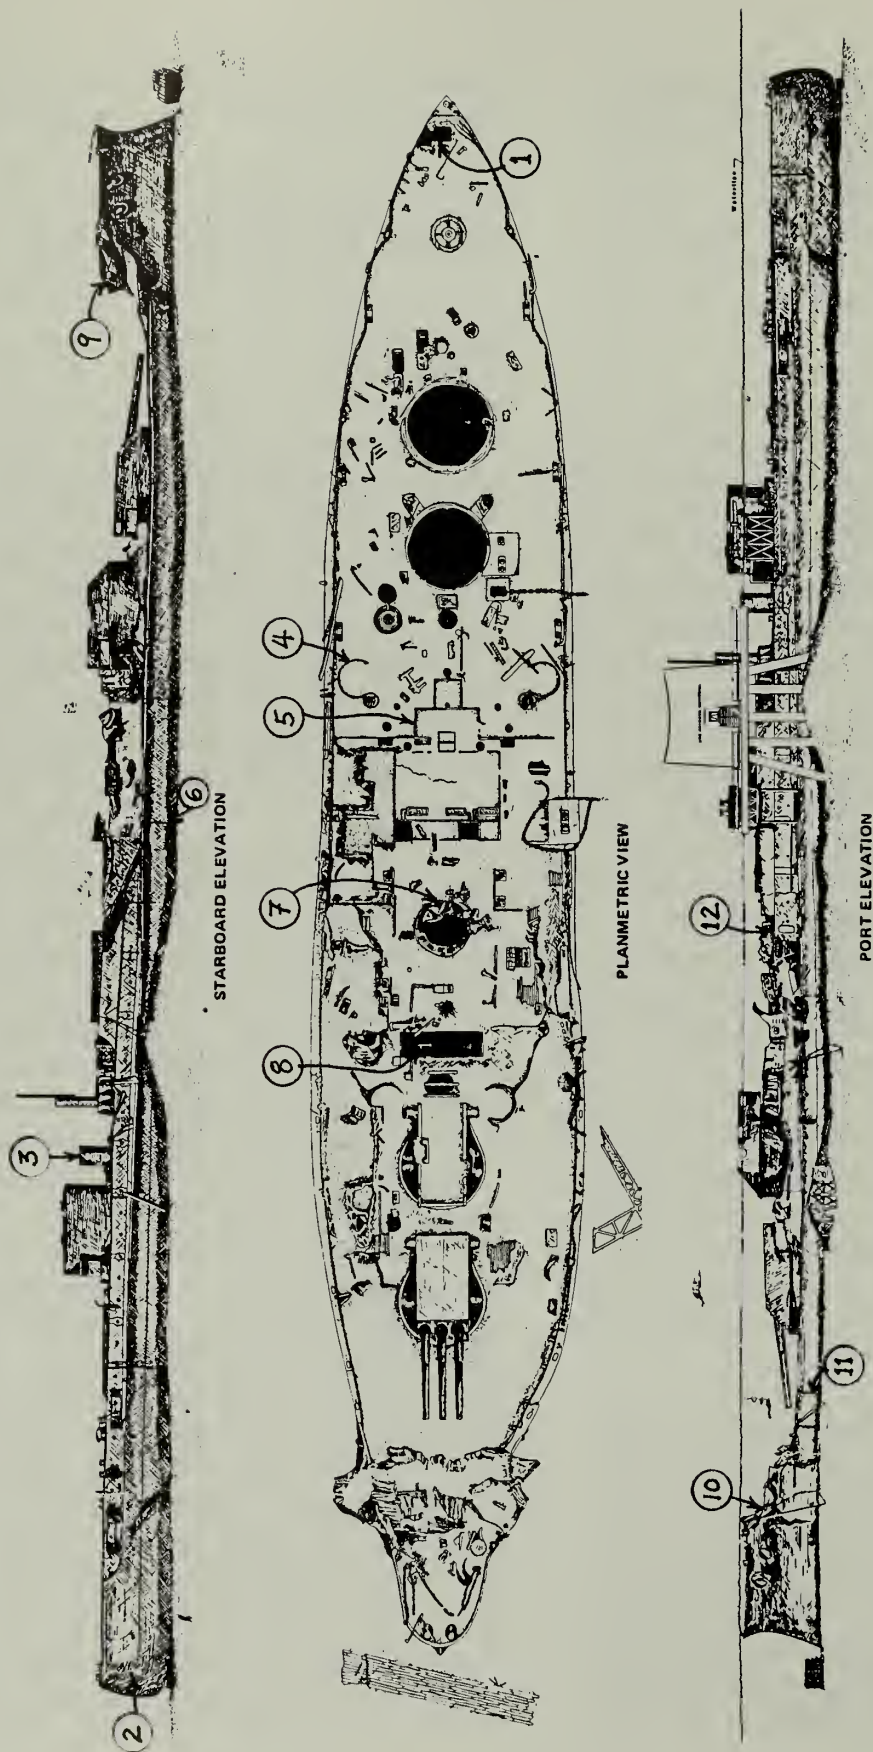
Twelve stations were selected on hull and superstructure surfaces that had access to metal edges (Figure 4.4). At each station, divers used a claw hammer to chip away a few square inches of fouling growth and corrosion from both sides of the metal edge to expose shiny metal. Observations were then made of the thicknesses of dense fouling, black and grey oxides, and shiny steel that were visible in the exposed end sections.

Figure 4.8. Locations where measurements were made of thickness of corrosion products and underlying shiny steel on edge sections of hull and superstructure fabric on the USS ARIZONA.

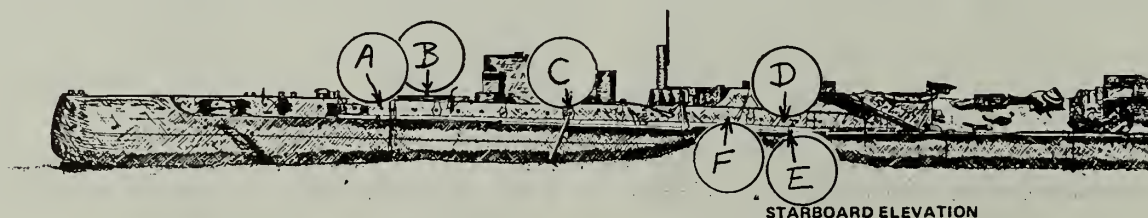
As expected, oxygen levels measured 15 to 16 feet inside interior spaces were substantially lower than ambient values (Table 4.5). At distances of 8 to 9 feet inside openings, oxygen levels were only moderately lower than ambient, indicating that water volumes within about 10 feet of hull openings are relatively well flushed. Oxygen concentrations were at or less than 1 mg/l at 15-foot distance from opening in 3 out of 6 stations, thus it would be reasonable to assume that most other enclosed volumes in the hull that are distant from openings would also exhibit sub-1 mg/l oxygen concentrations.

Figure 4.9. Locations of points of entry for water-quality measurements made in interior spaces in the USS ARIZONA.

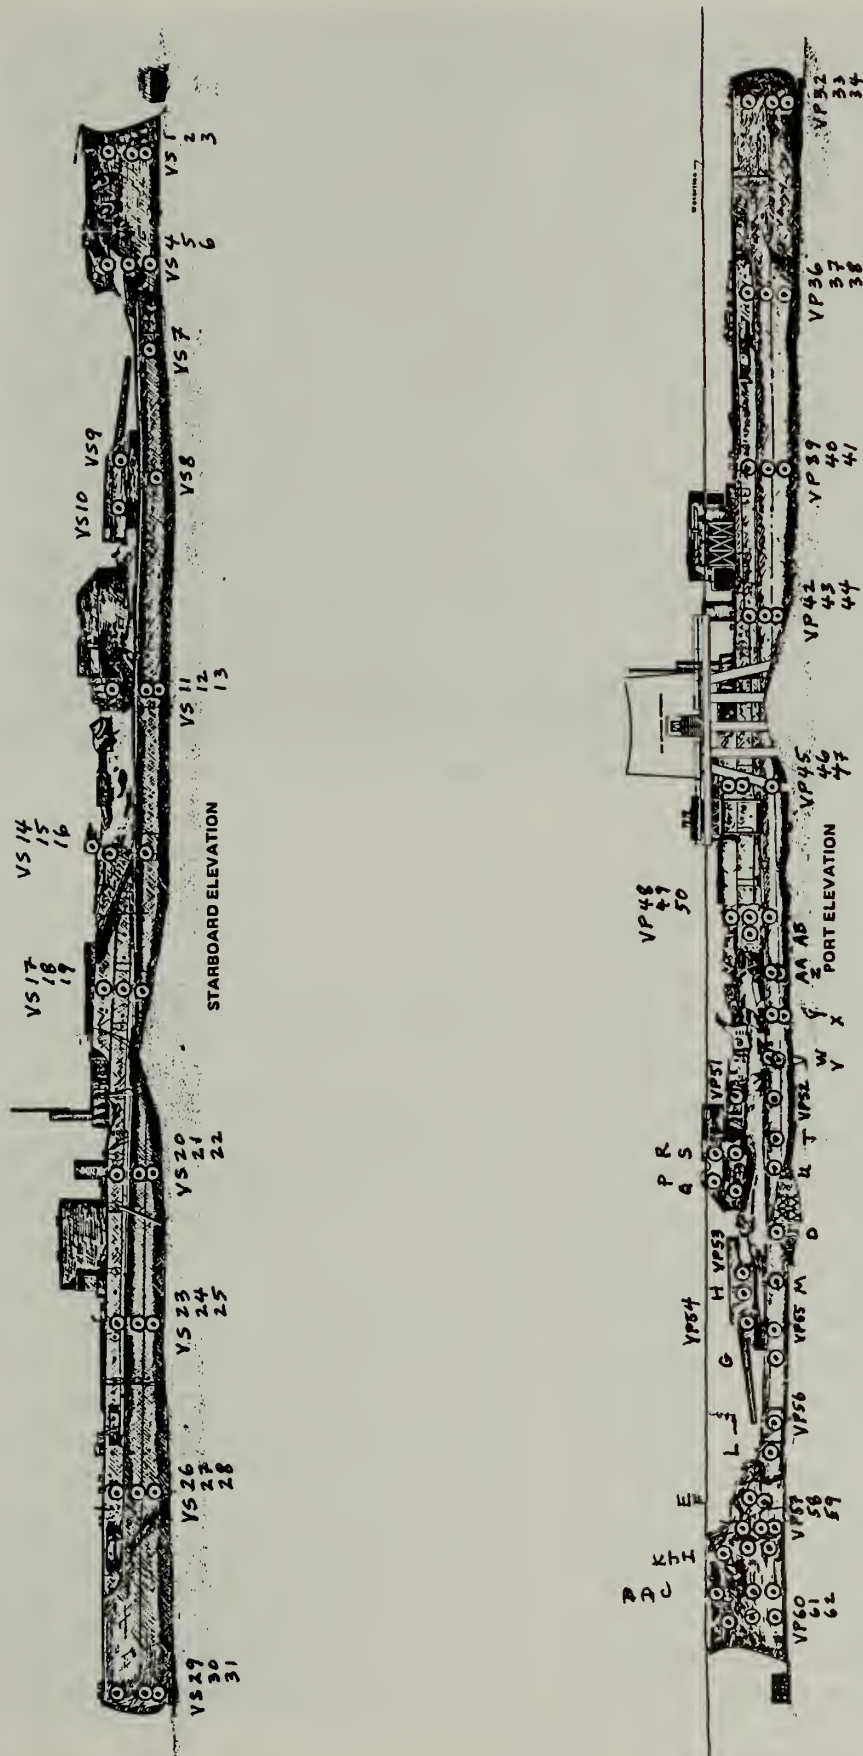
Figure 4.12. Location of bathycorrometer measurements made on the USS ARIZONA.
