REPORT  
GEOLOGIC HAZARD EVALUATION  
ALCATRAZ ISLAND  
GOLDEN GATE NATIONAL RECREATION AREA  
FOR THE NATIONAL PARK SERVICE

OCTOBER 29, 1982

JOB NO. 2050-064-03

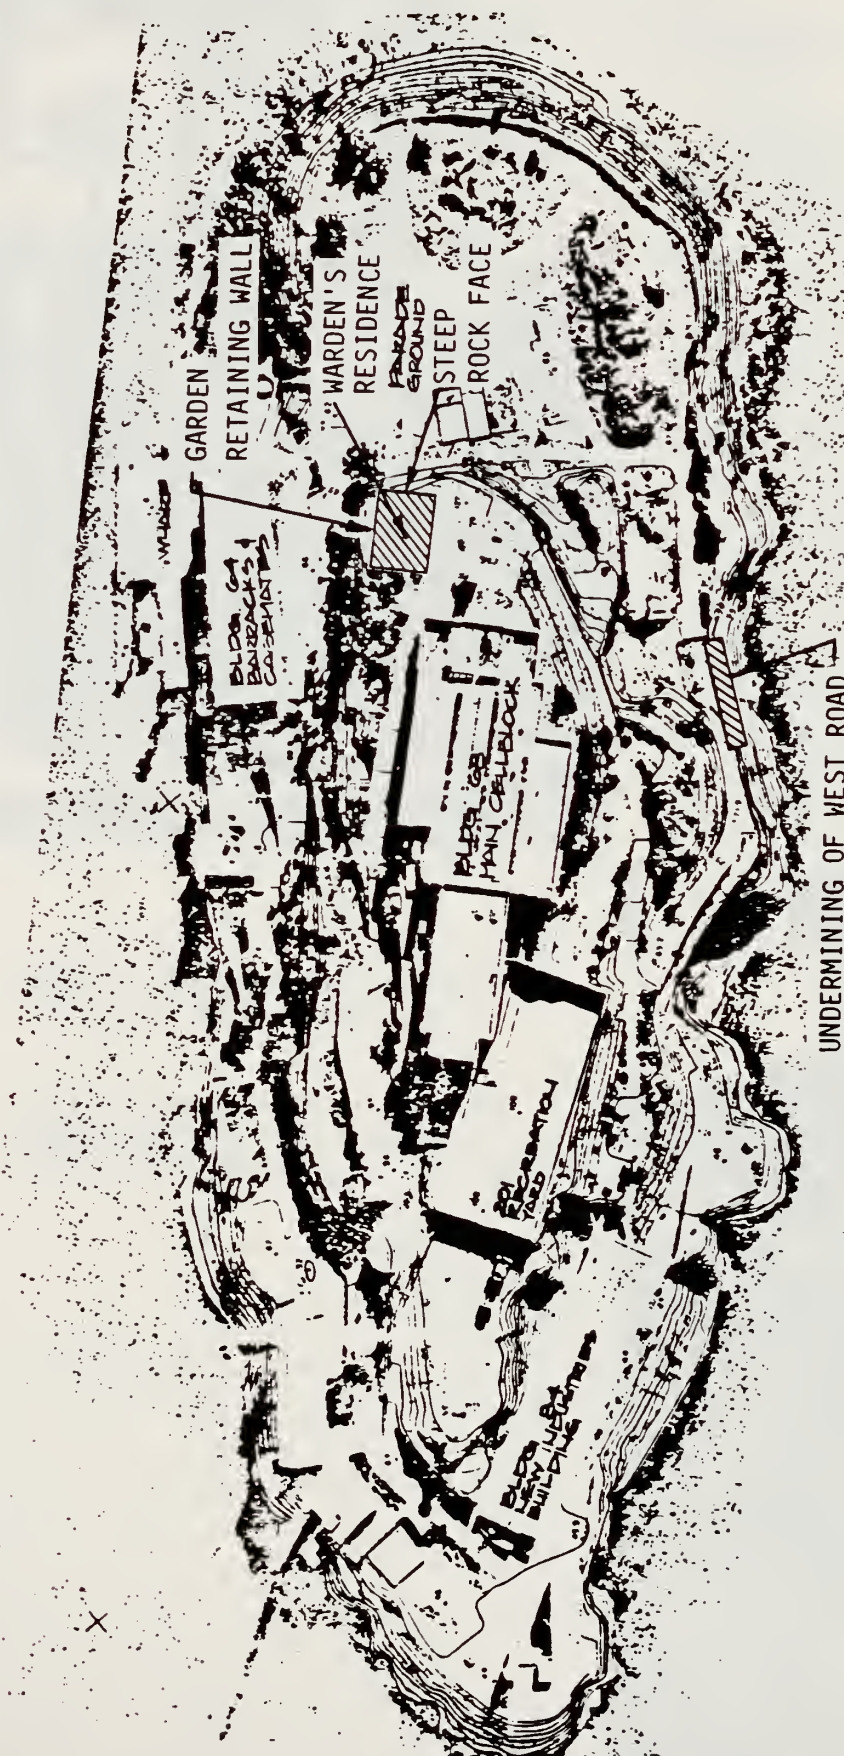
PLOT PLAN

These areas had been identified as hazardous in a study conducted in 1979\*. Their locations are illustrated on Plate 1, Plot Plan.

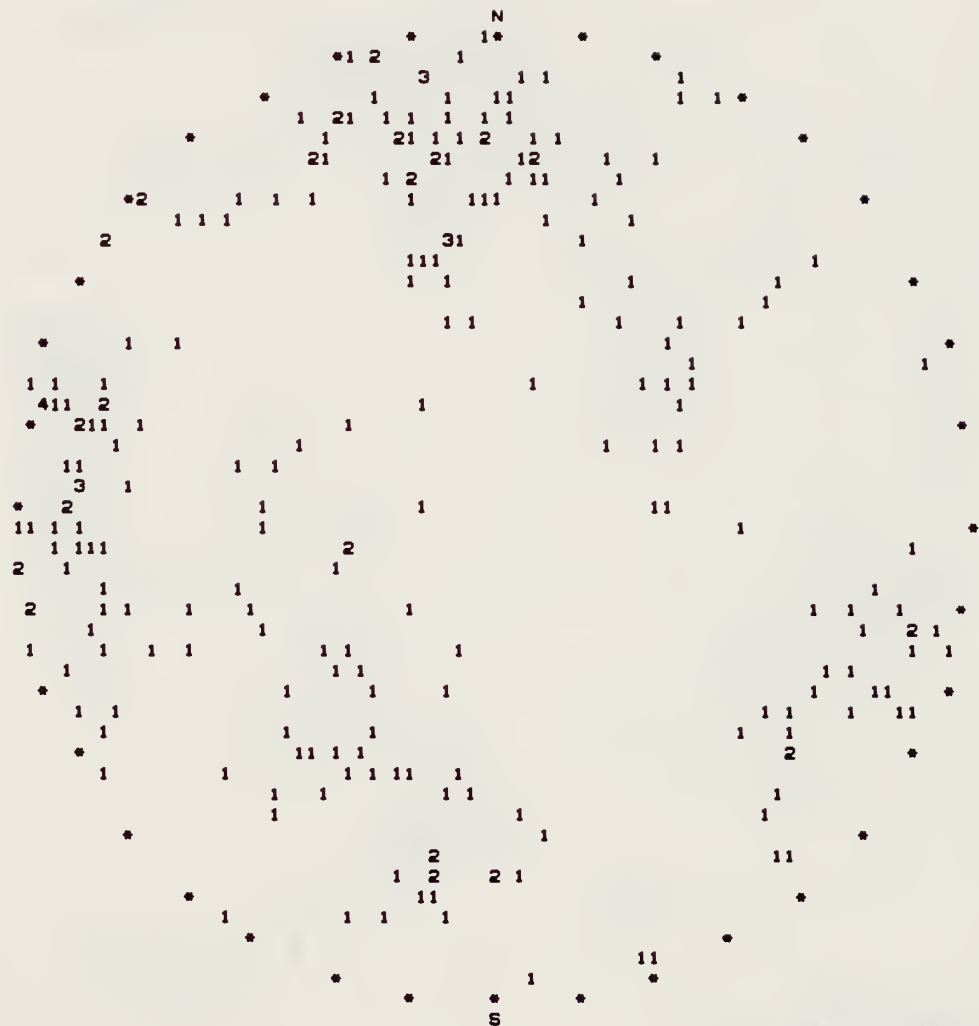
# RAW ROCK STRUCTURAL DATA

Based on these analyses and the results of field observations, the critical unstable surfaces were identified. There are two dominant joint sets whose intersections appear to be the primary location of wedge-type failure; these sets have the following orientations: 1) striking N16°E and dipping 80° E; and 2) striking N82°E and dipping 72°S; the data are synthesized on Plate 6.

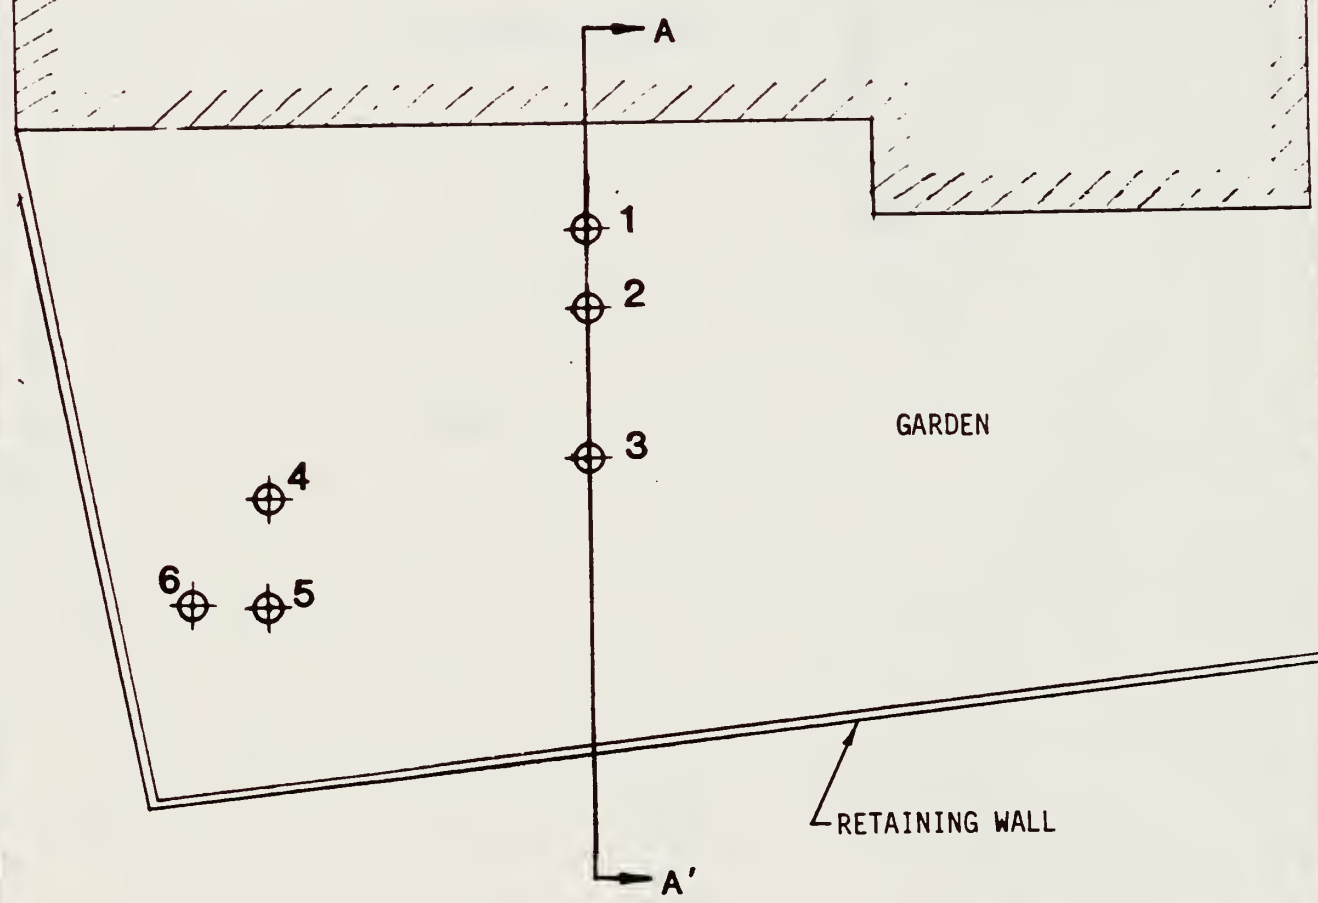
# LOCATION OF HAND AUGER HOLES

Six hand auger holes were drilled in the garden area adjacent to the Warden's Residence at the locations shown on Plate 7. Holes 1,2,3 and 5 encountered concrete at depths of 1.9, 4.1, 4.1, and 2.5 feet, respectively. These data suggest the presence of a previous platform or slab in this area. Hole 4 encountered sandstone at a depth of 4.1 feet which suggests that the older platform or slab is founded on bedrock. Hole 6 encountered brick, sandstone and concrete at a depth of 2.3 feet which may represent a wall associated with the older structure, or newer fill. A cross section through the garden and the retaining wall showing this older feature and the estimated bedrock surface is presented on Plate 8.
