# GENERAL PHILIP SCHUYLER HOUSE

Saratoga National Historical Park  
Schuylerville, New York

Historic Structure Report  
Volume I

**2003**

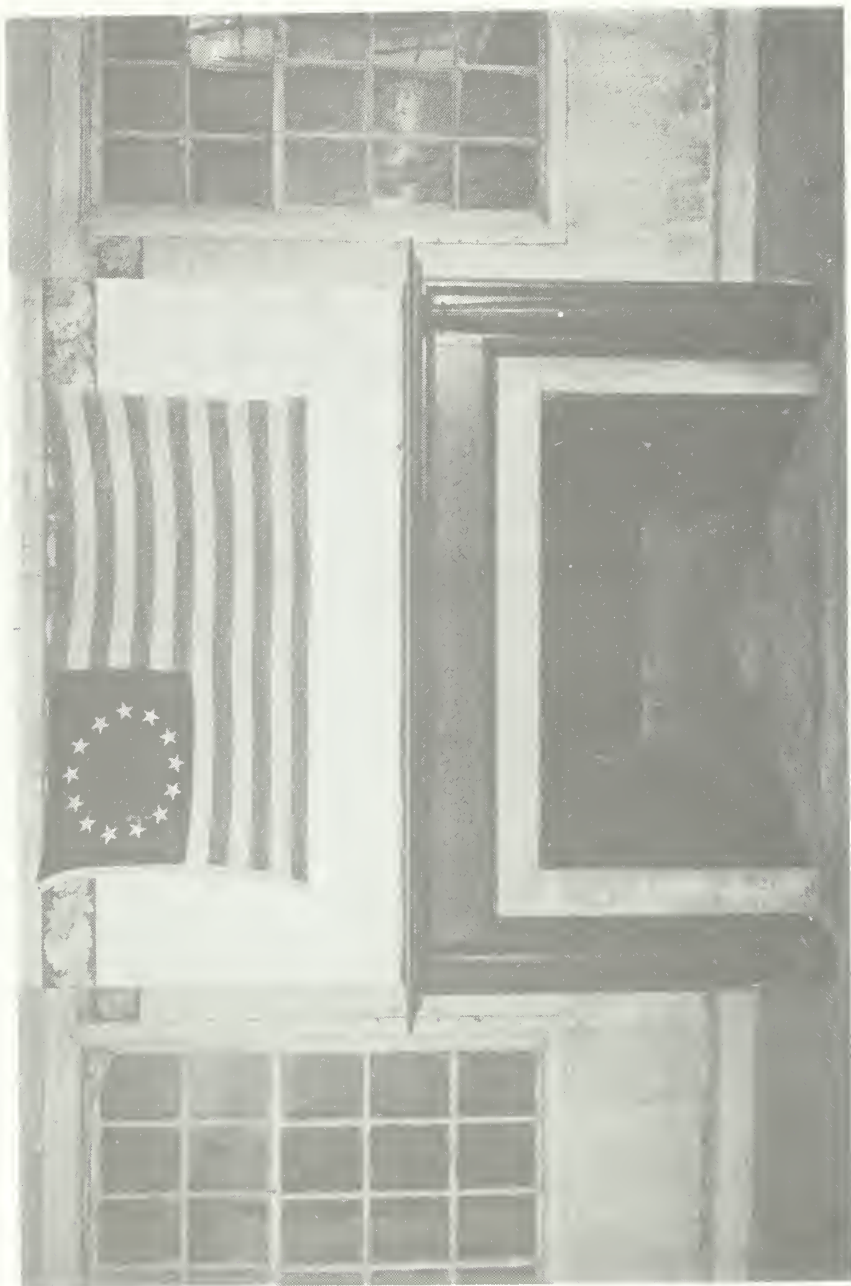
The mantelpieces that the restoration team found in the 1950s in the south bedroom and in the parlor (fig. 25) had Classical Revival details. The parlor mantel may have been new in 1815, but the south bedroom mantel was “an older mantel converted to early classic revival”; it had probably been installed in 1787 and updated during the ca.-1815 remodeling.<sup>67</sup>

Figure 25. Schuyler House: Parlor (Room 102), south wall and mantelpiece (ca. 1955).

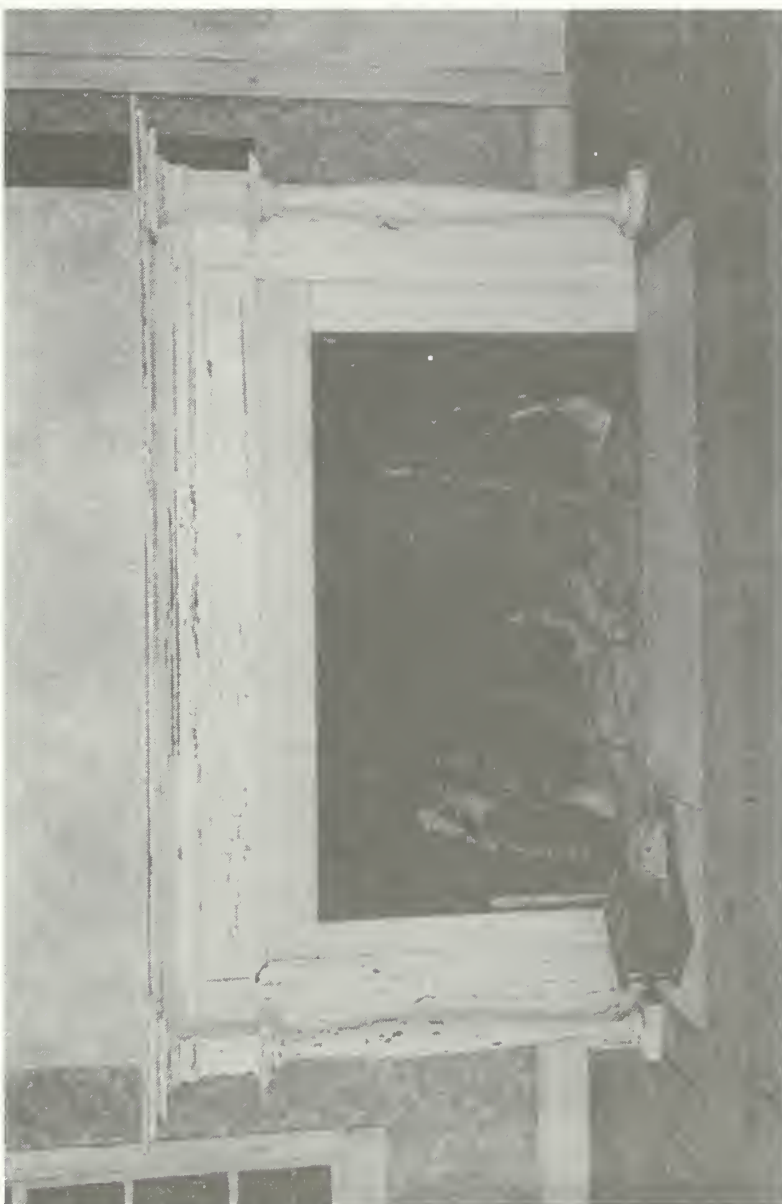
It appears that much, if not all, of the chair rail in the dining room was removed during the 1815 remodeling. No chair rail can be seen on the wall to either side of the fireplace in a ca.-1955 photograph of the north wall of the room (fig. 26). When the restoration team removed the plaster from the south wall of the room, it found a band of split-board lath (such as Judd described was used in the east tier) at the chair-rail level, with earlier sawn lath above and below it.<sup>64</sup> The chair rail may have been removed to avoid the difficulty of patching across the space where the doorway to the dining-room pantry had been located.

The extant dining-room mantelpiece was probably installed during the ca.-1815 remodeling (fig. 26). The restoration team noted that “the saw marks in the lumber, the type of nails and the method of assembly suggest that this mantel was first fabricated between 1795 and 1815.”<sup>66</sup> According to the accepted research of the 1950s, the type of nail that dated to 1795-1815 would have been a hand-headed cut nail. The current accepted chronology of the manufacture of cut nails concurs.

Figure 26. Schuyler House: Dining room (Room 103), north wall and mantelpiece (ca.1955).

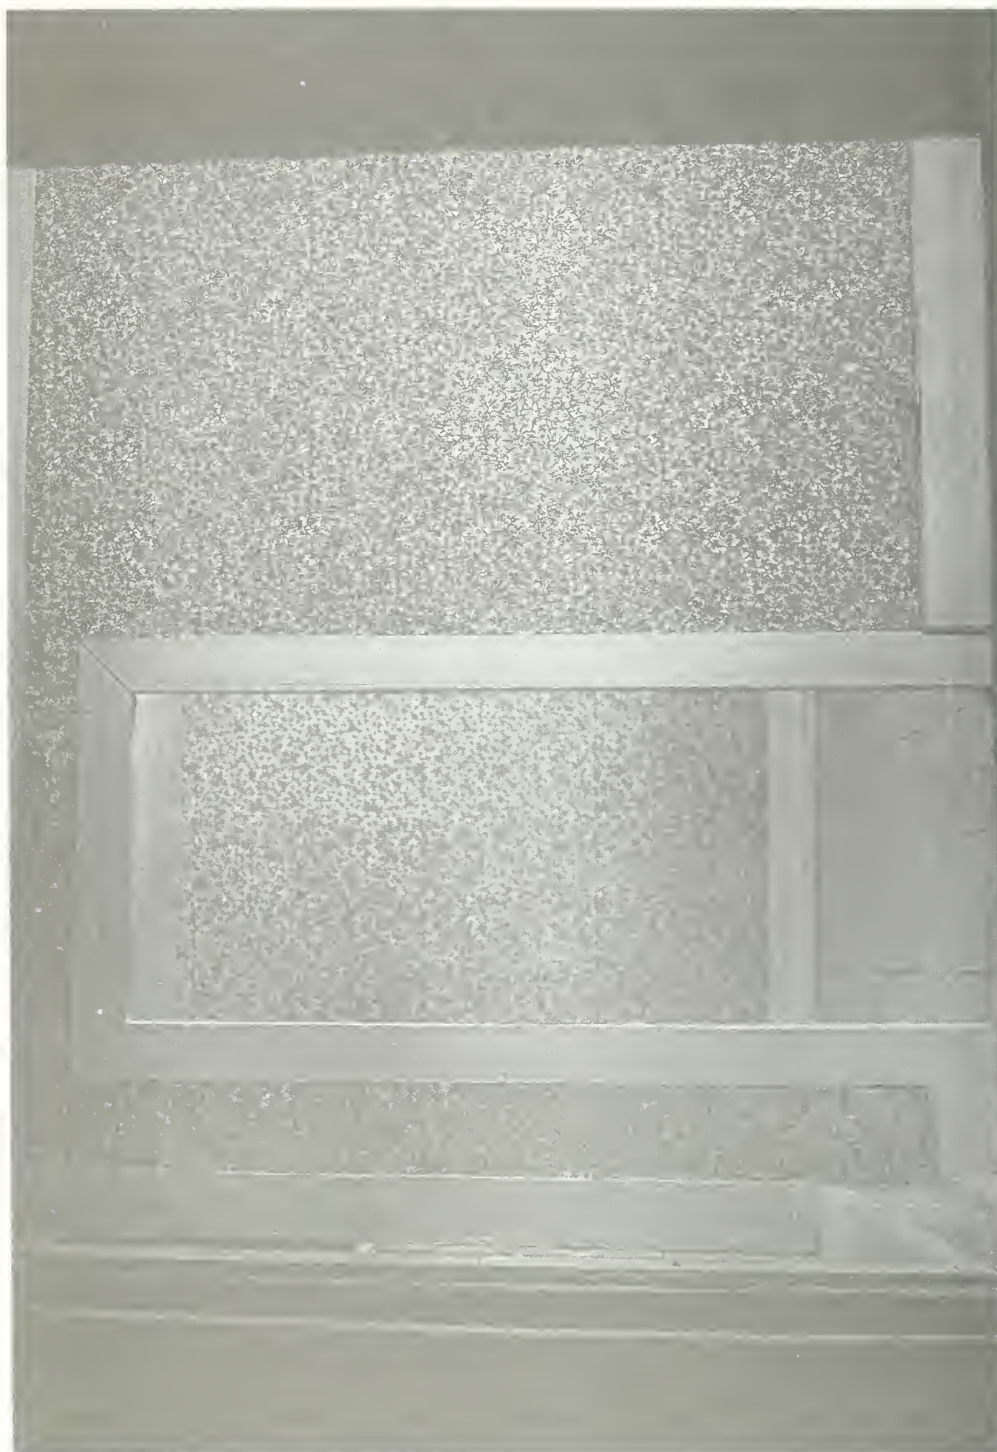
**Figure 29.** Schuyler House: View from south chamber (Room 202) through former doorway to hall chamber (Room 203) and storeroom (Room 204) beyond, ca. 1955.

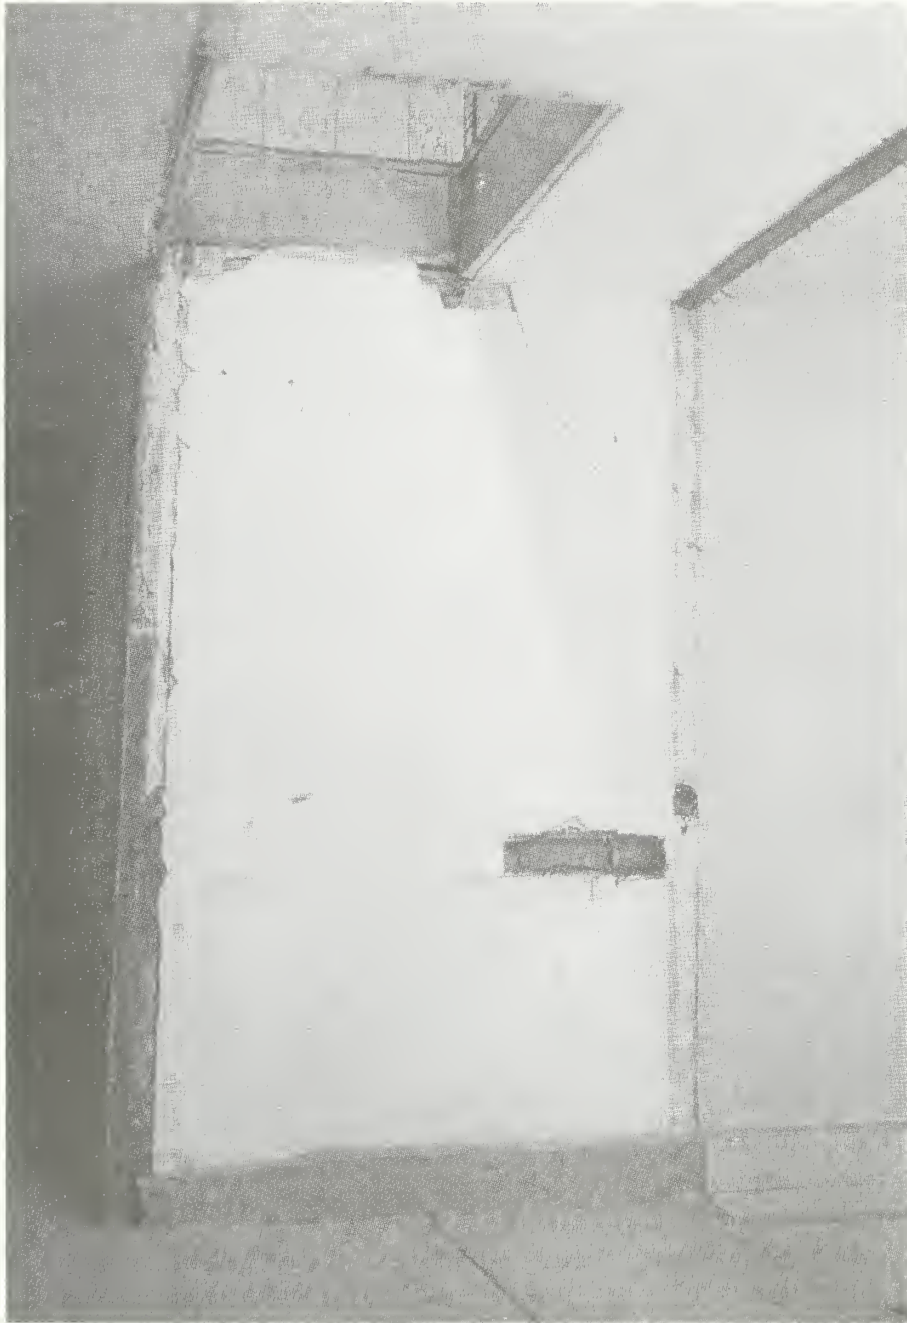
The restoration team also found a hatchway and trap door in the ceiling of the second-story hall that opened to the attic, which the team thought to be original.<sup>26</sup> The trap door extant in the opening today is a batten door constructed of wide vertical boards secured with wrought-iron nails and an antique HL hinge, also attached with wrought-iron nails. This would appear to be the original hatchway door found in the 1950s, but a photograph taken during the restoration work (fig. 30) appears to show a vertically mounted door constructed of narrow boards.

**Figure 30.** Schuyler House: Second-story hall (Room 201), view of north wall and attic hatchway after partitions removed but before stairway reconstructed (ca. 1955). Note nogging exposed on wall; also mark of handrail on wall and balusters along edge of flooring at right where ca.-1815 balustrade was located before stairway was enclosed.

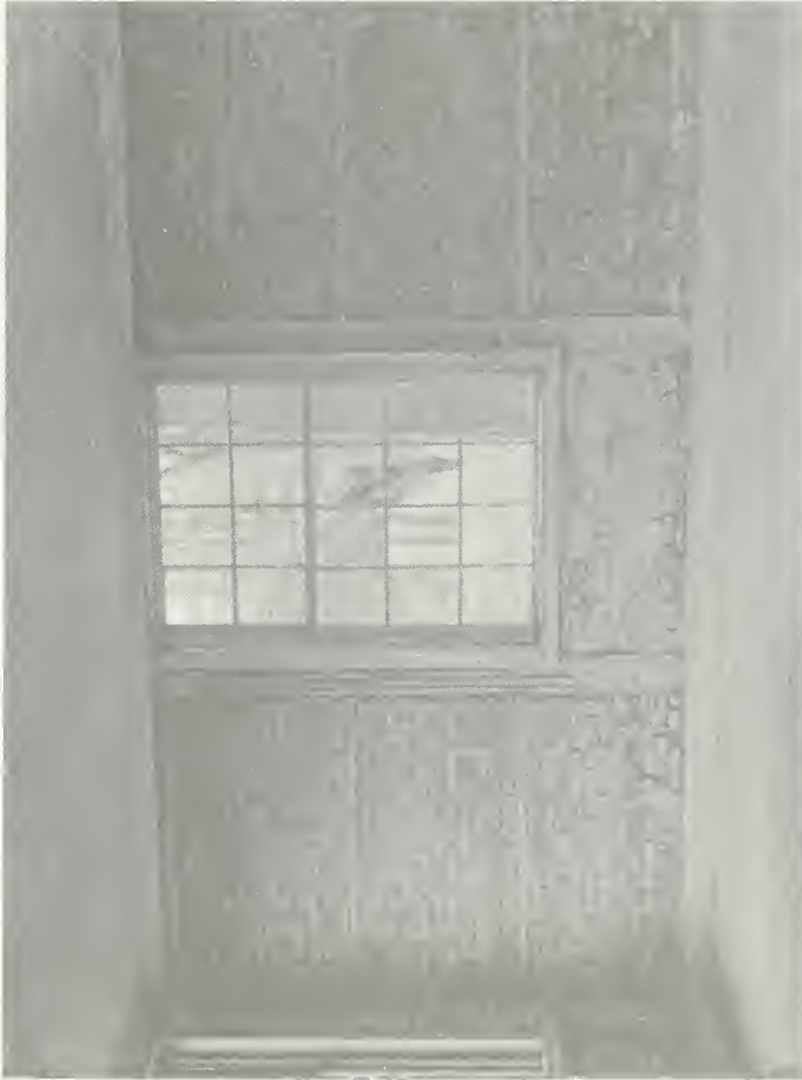
**Figure 34.** Schuyler House: Parlor (Room 102), west wall after plaster removed (ca. 1955).  
Note surviving cornice and baseboard.

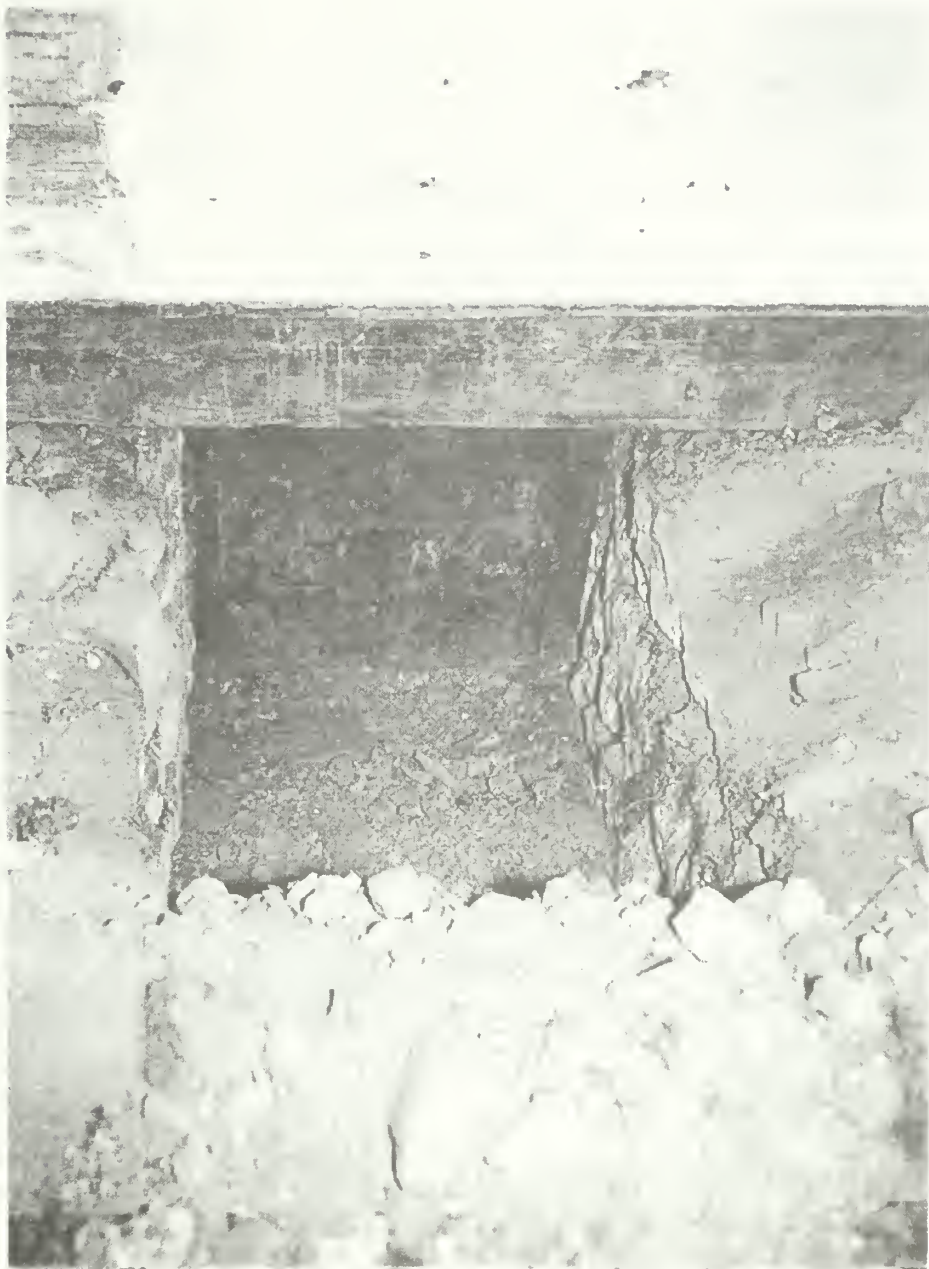
**Figure 40.** Schuyler House: West façade, opening O001 with original whitewashed areaway (1958).

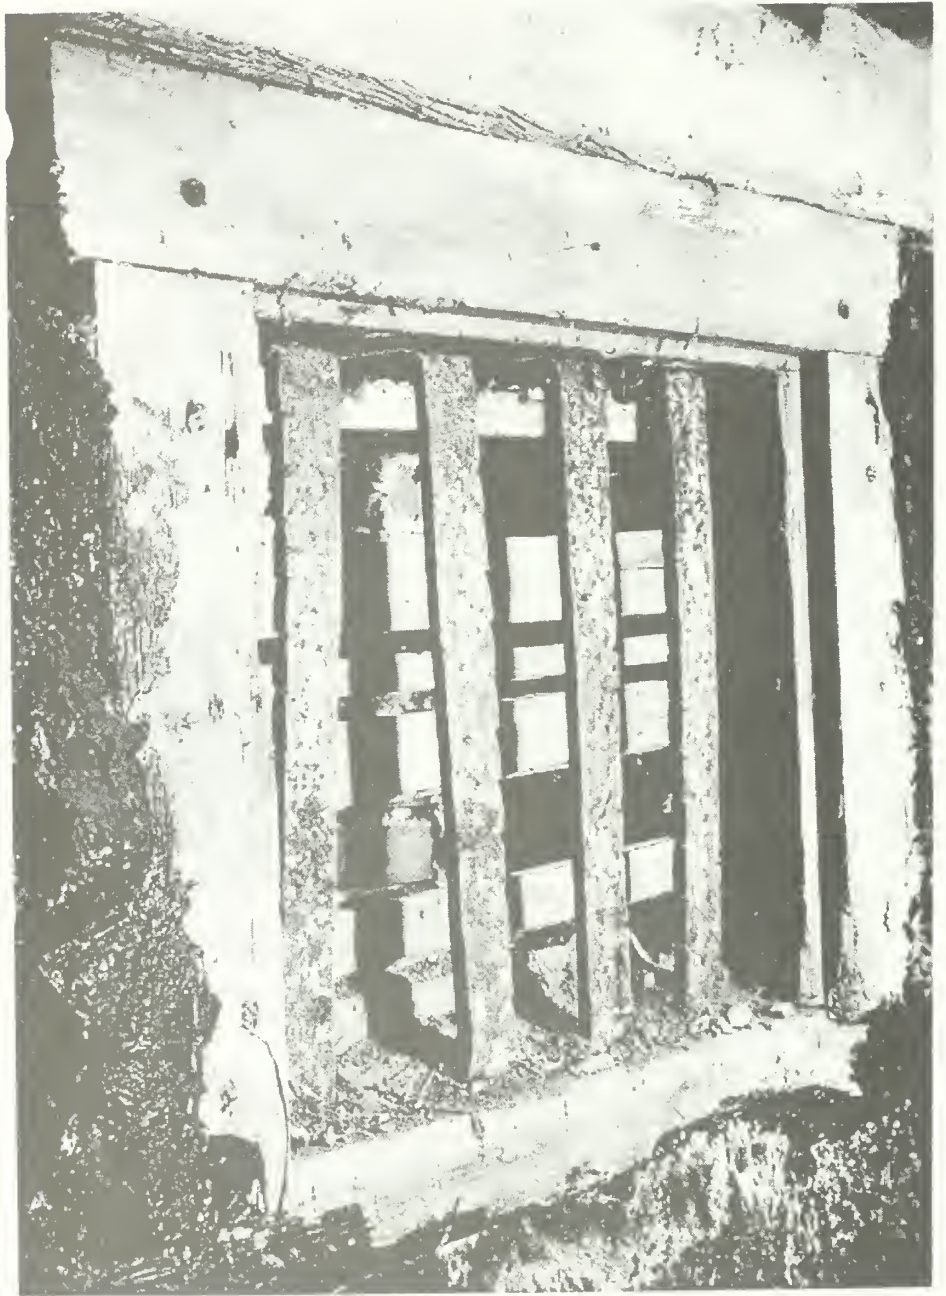
There were three windows in the cellar, all located along the west foundation wall, that dated to 1777 or earlier. (See the preceding section “Structural Features, Foundation.”) One window (W001) opened into the storage room at the north end of the cellar, and a second window (W002) opened into the kitchen at the south end. A third opening was located in the west wall of the center cellar room (the food storage room), but it is not known if it was used after 1777, since it was just to the north of the front entrance located above it. Both the north and south windows had been filled with bricks on the interior, but when the piazza floor on the exterior was removed, the restoration team found the following: an original frame and four vertical iron bars in place of the original sash in the north window (fig. 41), and the original fieldstone areaway, frame, and part of the sash in the south window. The center opening had been filled circa 1815 with stone masonry, which was not removed by the restoration team.

**Figure 41.** Schuyler House: West façade, cellar window W001 (1958).

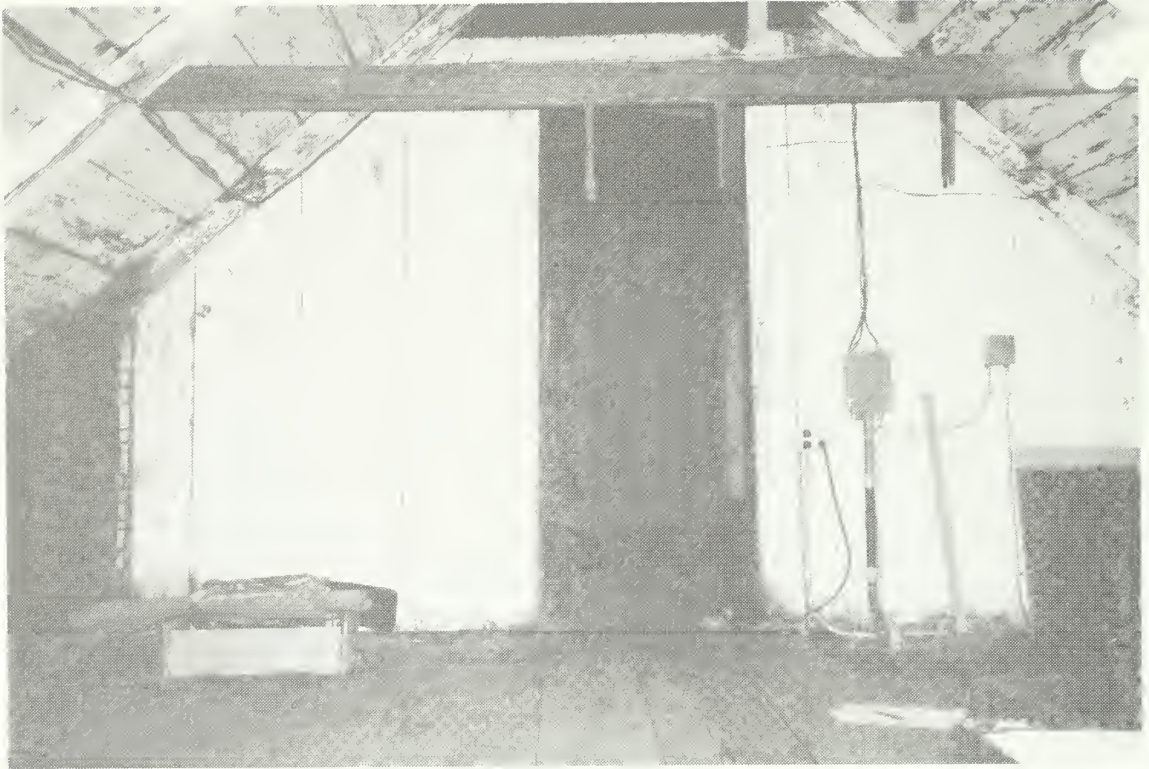
**Figure 247.** South attic room (Room 301), north wall and doorway D302.

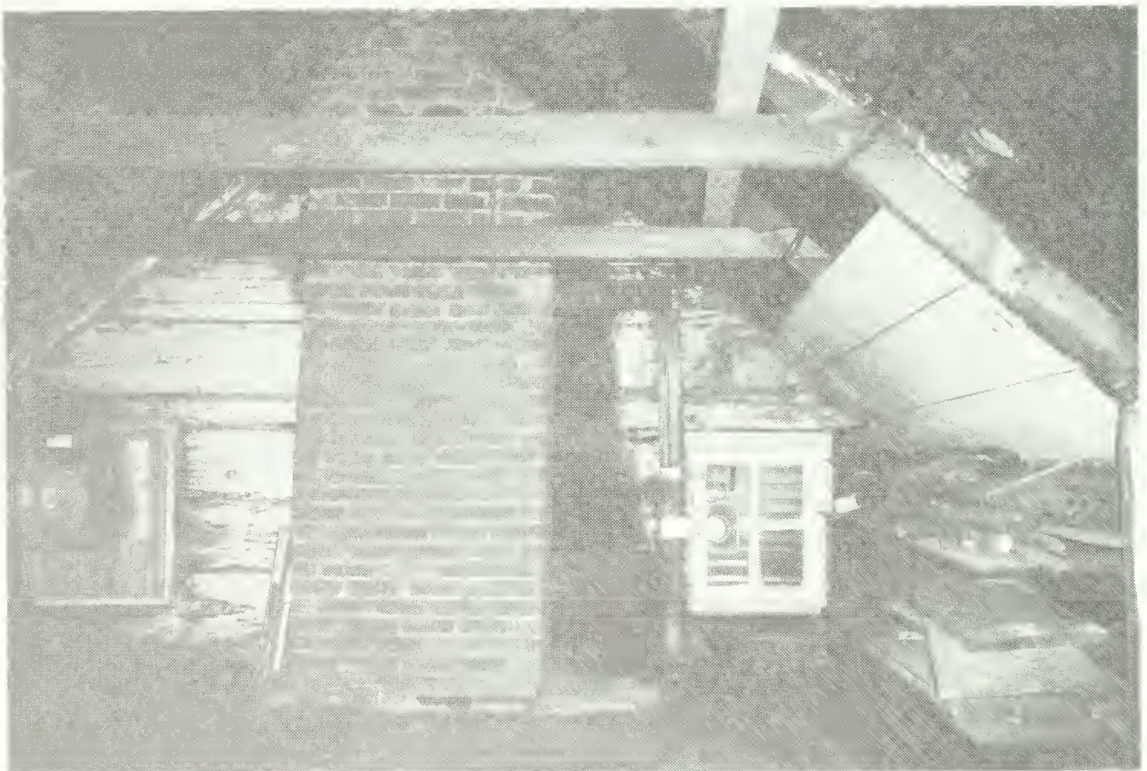
**Figure 248.** South attic room (Room 301), south wall.

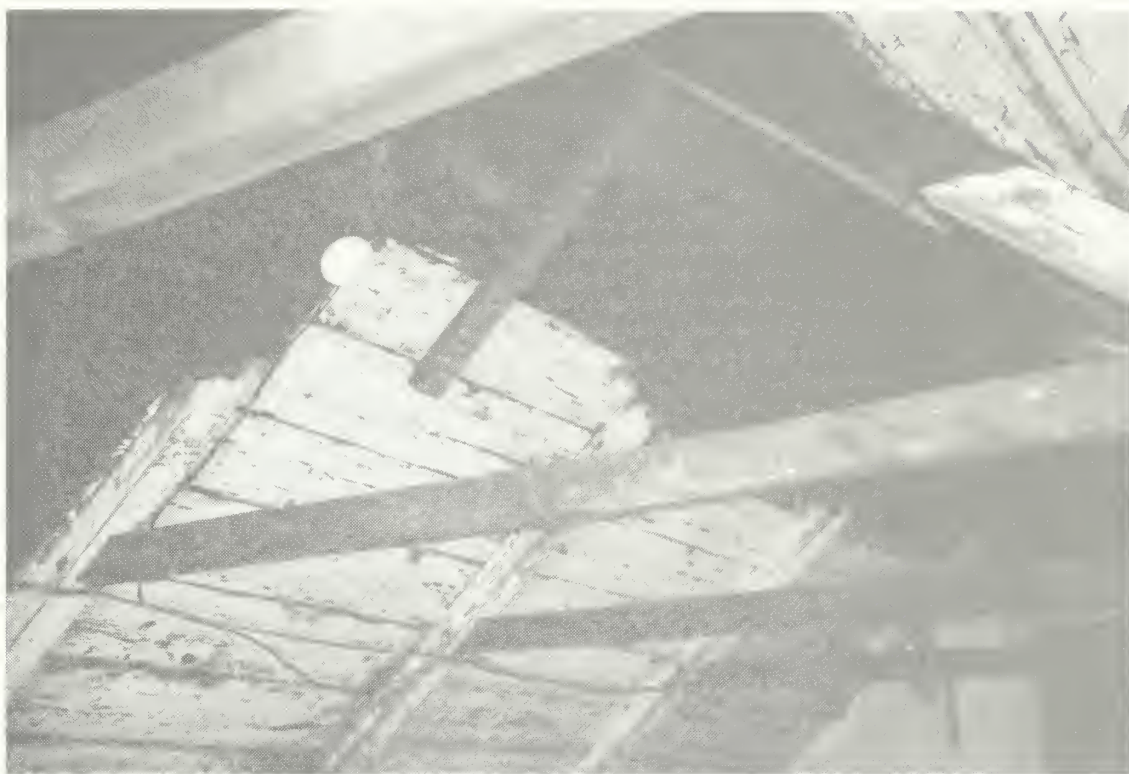
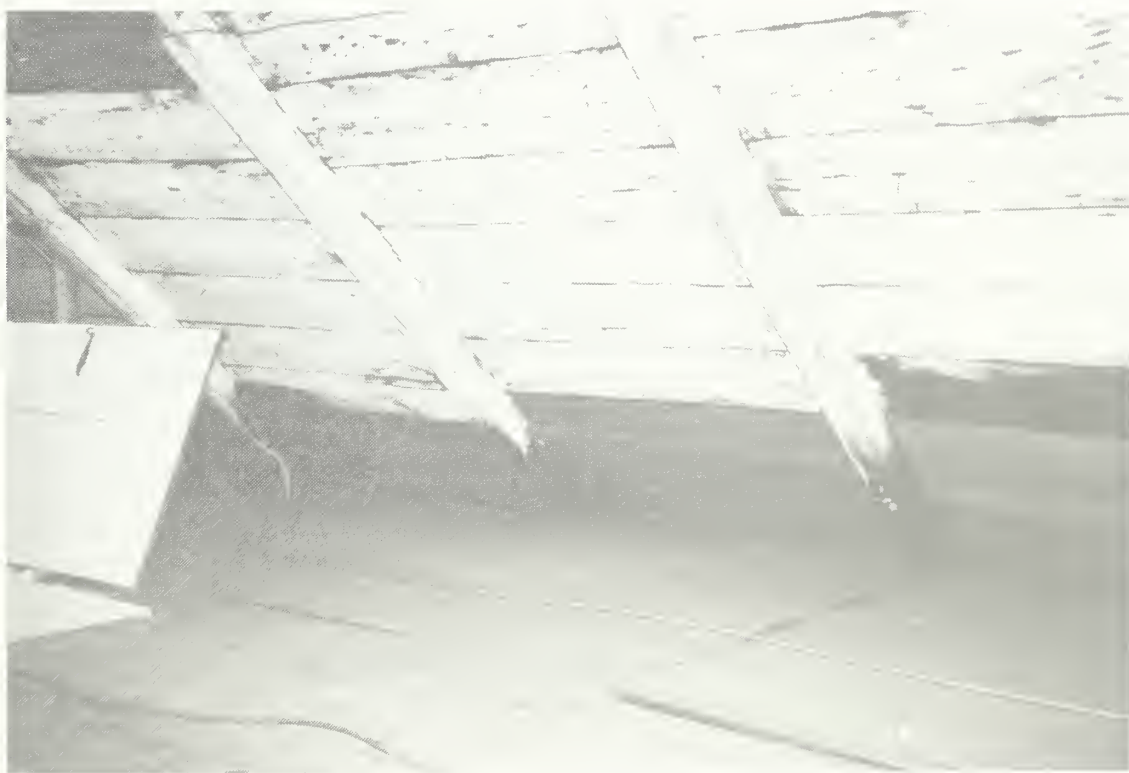
The exposed framing and sheathing in the south attic room date to the 1777 construction of the house and to subsequent repairs. The casement sashes appear to predate 1800. The vertical-plank north wall and doorway date to the ca.-1815 remodeling. Whitewash evidence of former partitions is visible on the roof framing and sheathing (figs. 249-250).

**Figure 249.** South attic room (Room 301), ceiling apex.

**Figure 250.** South attic room (Room 301), east ceiling slope and edge of hatchway D301.

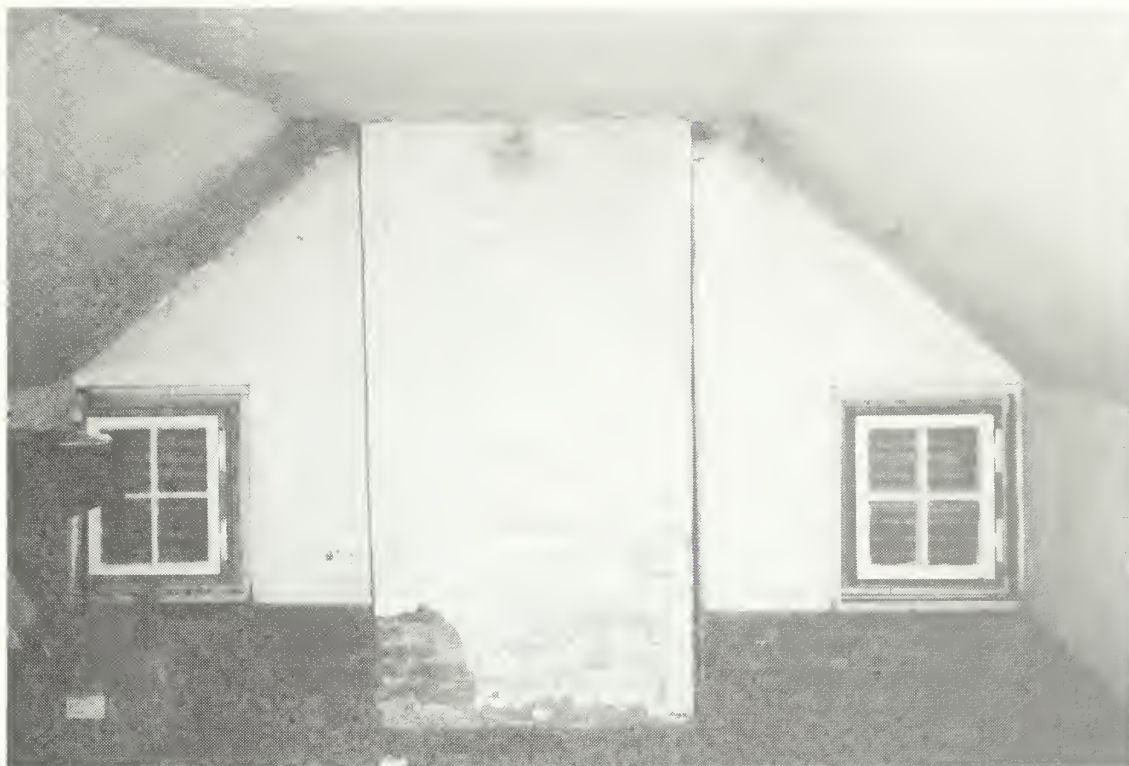
**Figure 252.** North attic room (Room 302), north wall and windows W303 and W304.

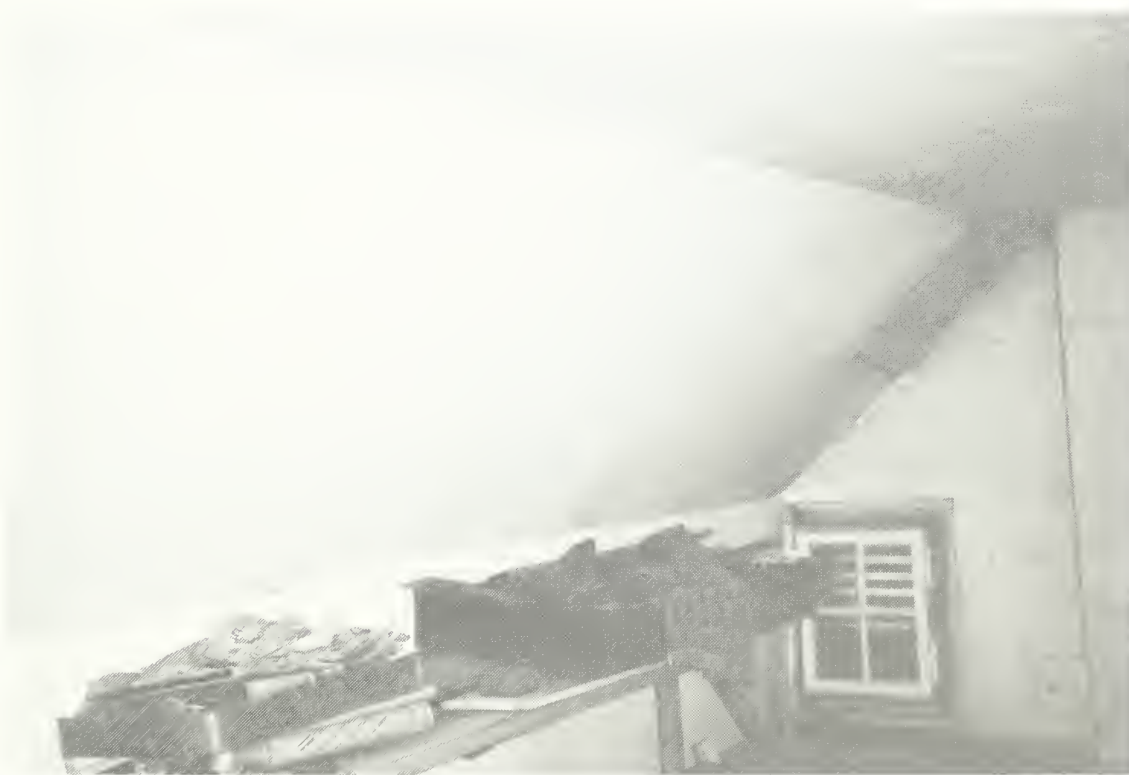
**Figure 253.** North attic room (Room 302), looking northwest.
