AN EVALUATION OF EXPERIMENTAL
REHABILITATION WORK,
REDWOOD NATIONAL PARK

TECHNICAL REPORT
JULY 1987

Redwood National Park Watershed Rehabilitation
Technical Report Number 19

National Park Service
Redwood National Park
Arcata, California
July 1987

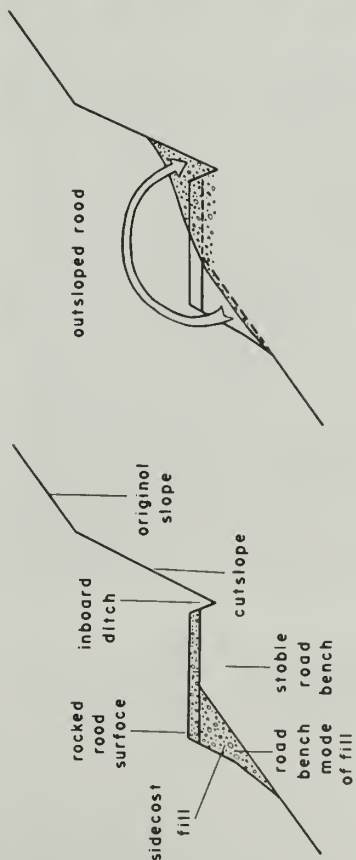
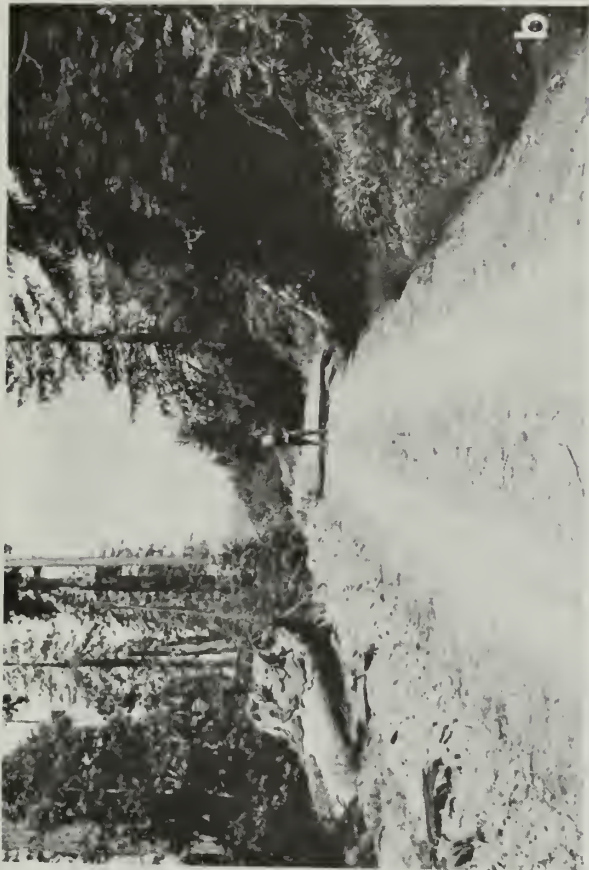
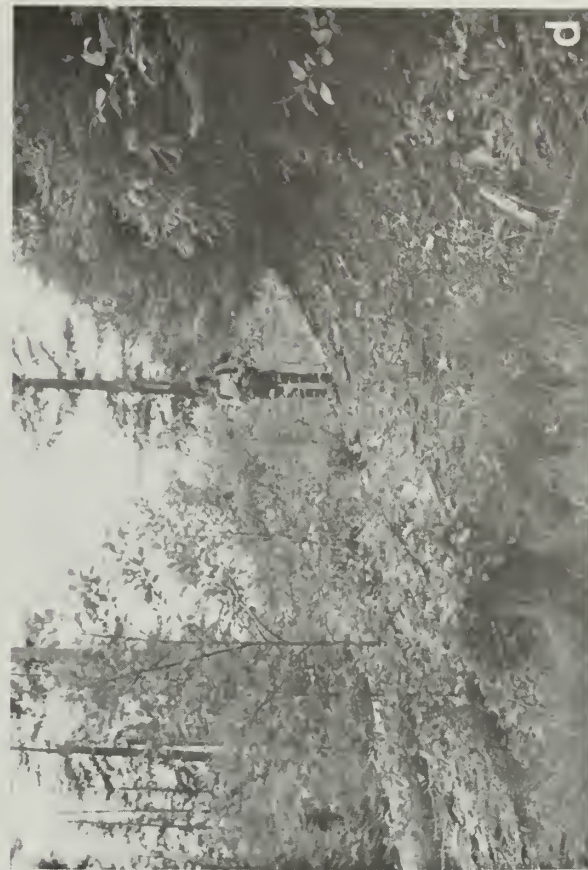
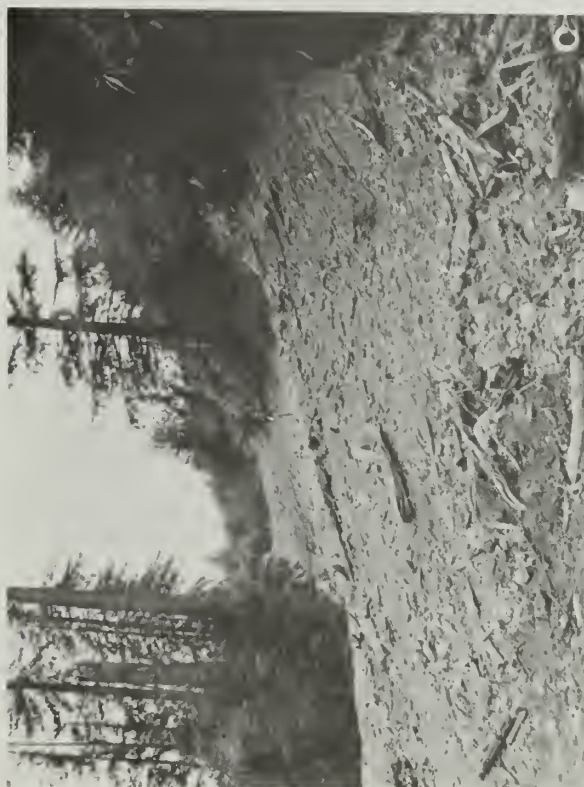
Fig. 6. Outslipping a segment of the L-1-5 road. A) diagrammatic sketch of road outslipping showing excavation of road fill and burial of inboard ditch and cutbank, B) before heavy equipment treatment (May 1979), C) immediately after outslipping and D) two year later (June 1983). All photos taken from the same viewpoint.

Several pieces of equipment were used to outslope the L-1-5 (Figure 6). Before outsloping, a blade-mounted chisel tooth on the tractor was used to decompact the western half of the road to a depth of about 12 inches. Fill material was then removed from the outside edge of the road with a drag-line crane and either loaded into dump trucks or deposited and graded uniformly up the cutbank. Because of insufficient stable storage area, dump trucks were used to end-haul much of the excavated fill to a disposal site (Figure 4). Approximately half of the total length of outsloped road required end-hauling.

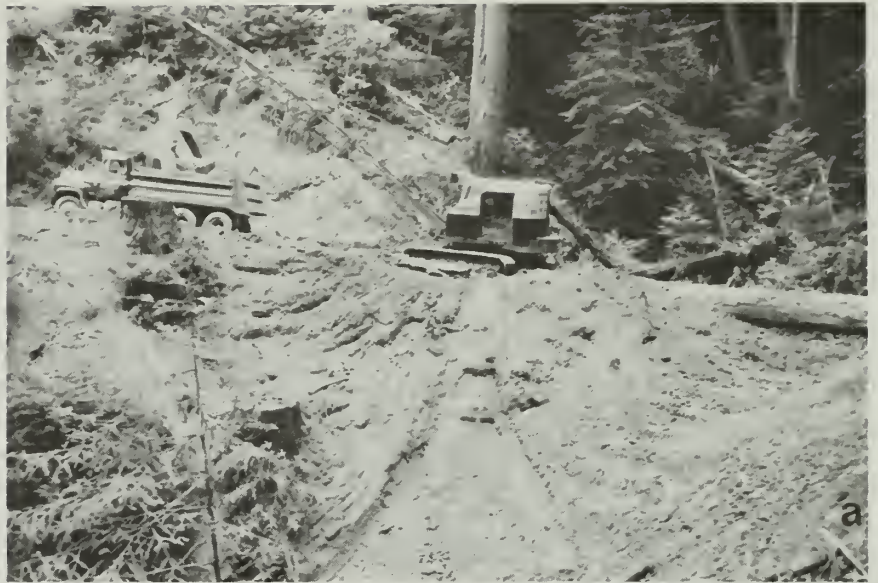
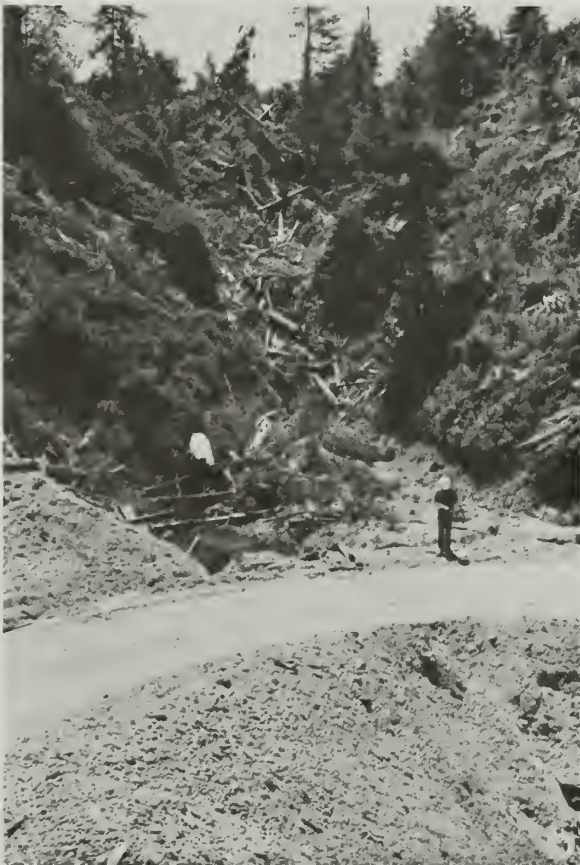
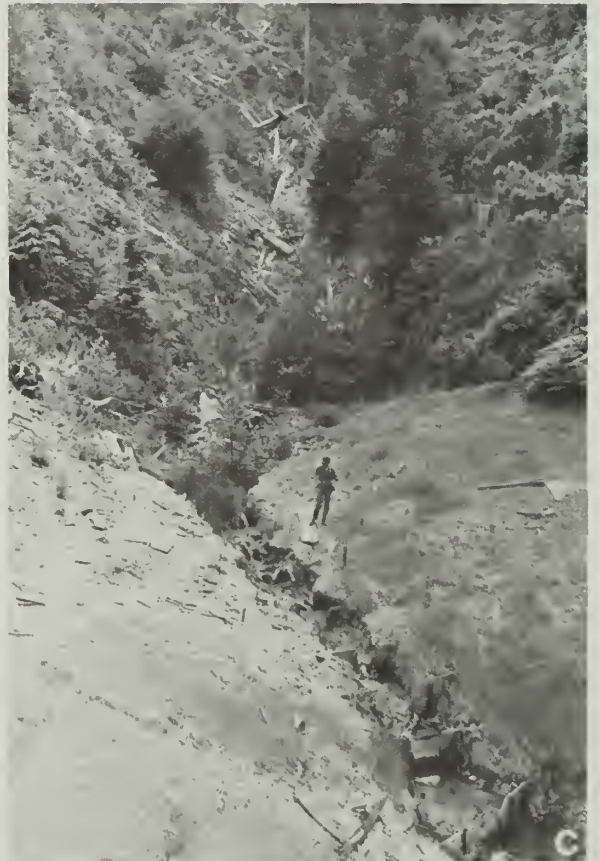
Fig. 7. Stream crossing excavation on the L-1-5 road. A) dragline crane excavates material from the crossing and places it in dump truck for endhauling to nearby storage area, B) before stream crossing excavation and C) after stream crossing excavation. Photos B and C were taken from the same viewpoint.

The four stream crossings on the L-1-5 were excavated by a drag-line crane, with finish work completed by a backhoe (Figure 7). Much of the excavated material had to be end-hauled due to insufficient stable storage area adjacent to the worksites. The amount of fill removed from the crossings ranged from 280 to 500 cubic yards. Costs varied from \$1,200 to \$1,500, averaging \$1,320 per stream crossing (\$3.80 per cubic yard of material removed) (Table 6). Total cost to excavate the four stream crossings was \$5,300.

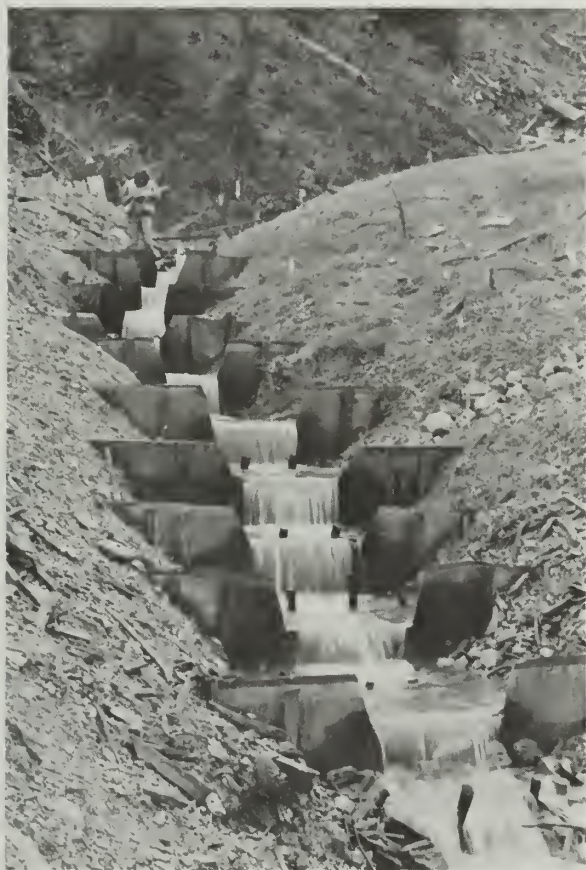
Fig. 8. Redwood board checkdams in an excavated stream crossing, L-1-5 road.

placed in six excavated stream channel crossings (Figure 8). Submerged spillways were installed at three locations. Rock armor, secured with stakes or chicken wire, was used to protect portions of three stream crossings and four drainage ditches (Figure 9).

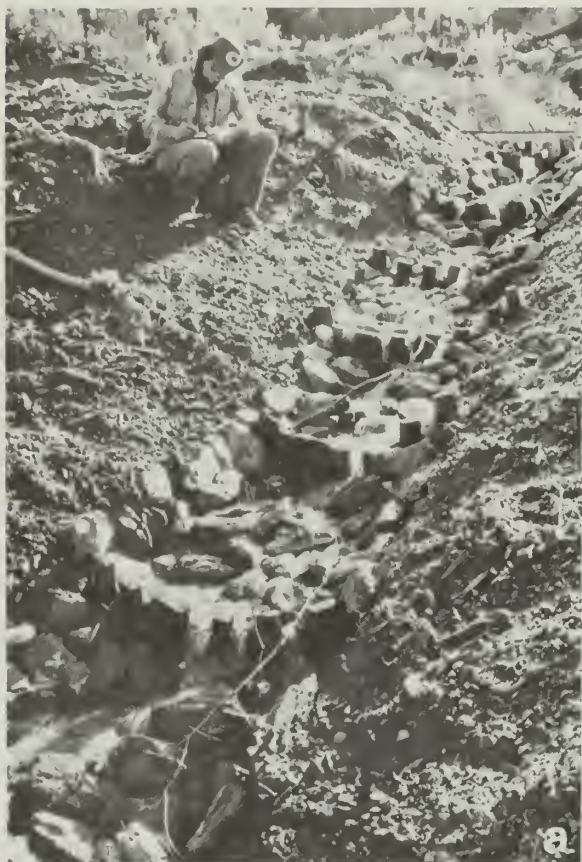
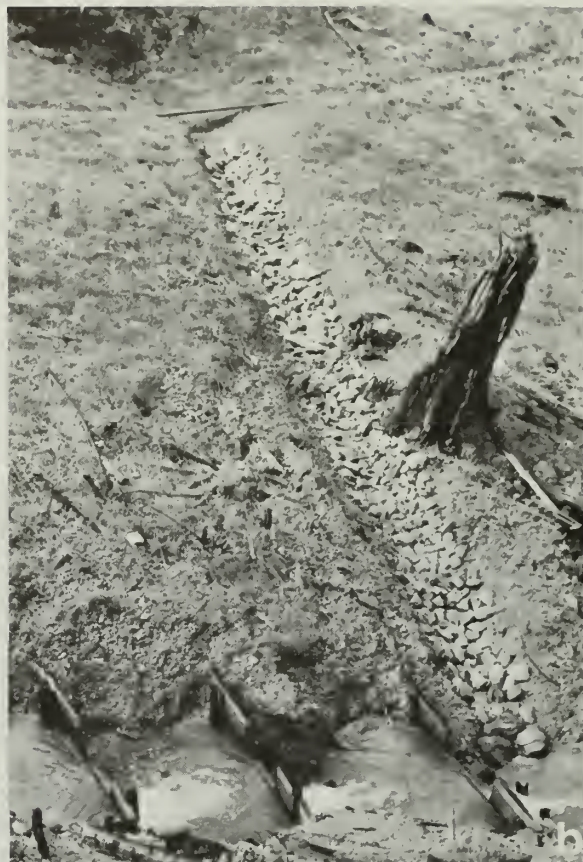
Fig. 9 (above). Hand-placed and secured rock armor in two small channels (A and B) excavated through the former L-1-5 logging road.

Rock armoring was also effective in controlling channel erosion. At two locations, R3 and R4, chicken wire used to hold rocks in place had disintegrated by April 1982, but none of the rock moved. Likewise, small sized rock armor, secured to the bed by wooden stakes, has not changed appreciably since installation. Although rocking worked well, its application in four cross-road drains seemed excessive in retrospect because of the small amount of erosion expected to occur at these locations.

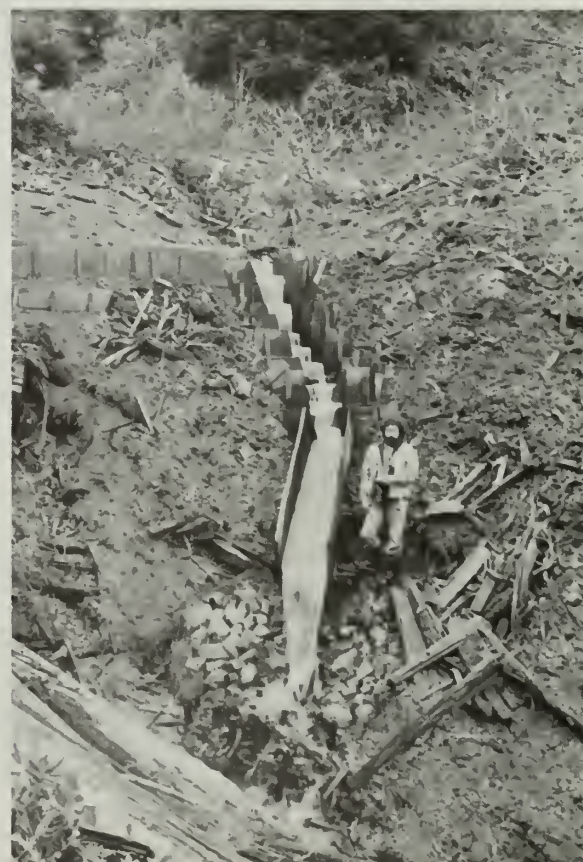
Fig. 10 (right). Water ladder, flume and rock energy dissipater constructed in incompletely excavated skid trail stream crossing.

To reduce stream channel adjustment, wood was secured in or along channel banks. Log deflection points, board deflection points, notched logs, a log energy dissipater and a log retaining wall accounted for seven percent of the total contract cost. In addition to tasks completed by the contractor, park personnel constructed a flume at worksite S2 (Figure 10) to carry water over a steep reach of excavated channel. The flume took approximately five hours (\$34.00) to build and install.

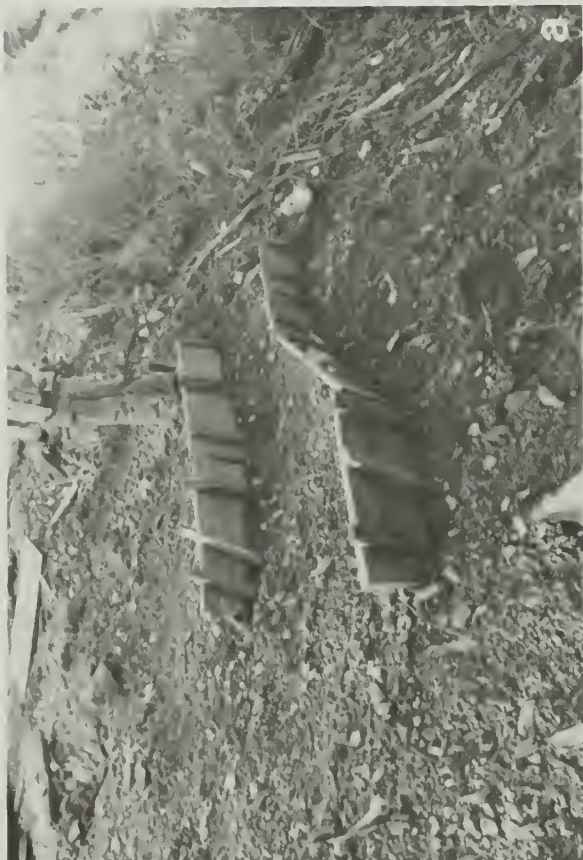
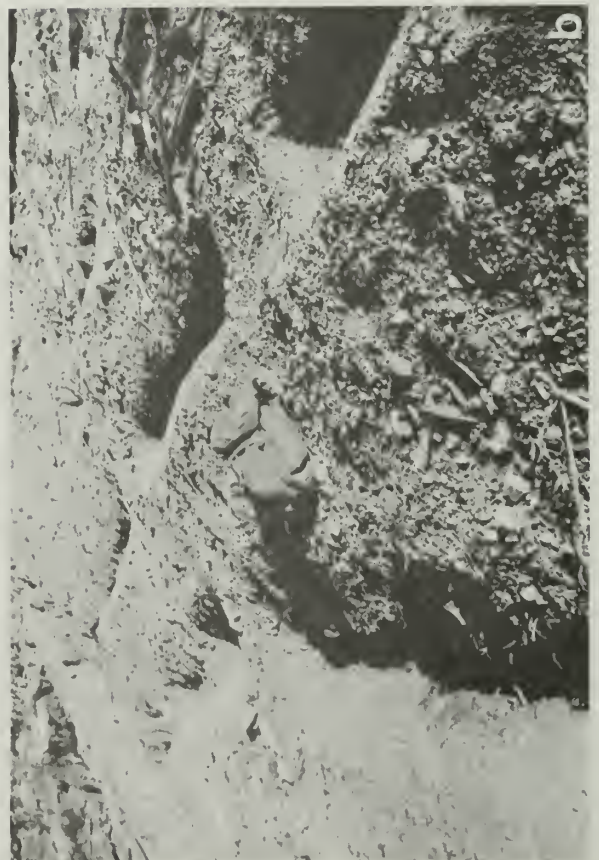
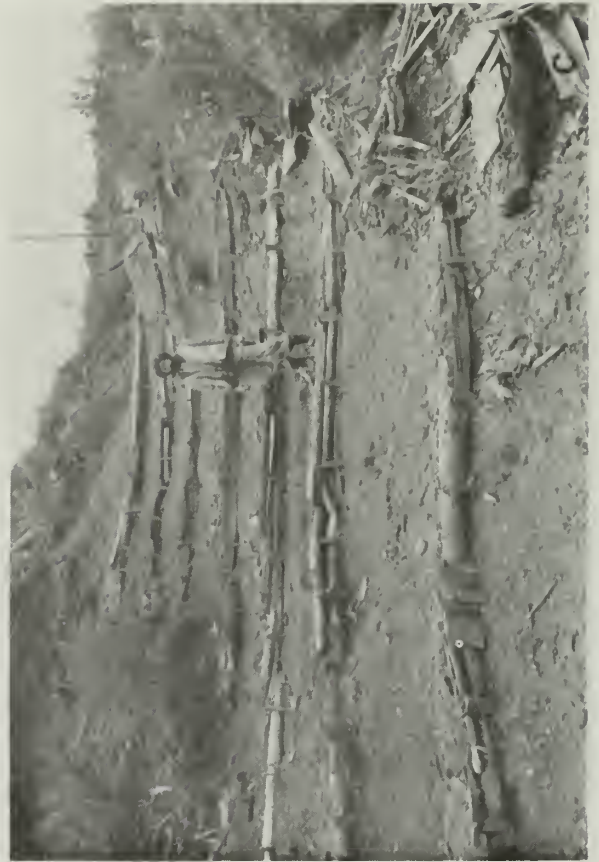
Fig. 11. Physical erosion control devices used to reduce surface erosion from bare soil areas. A) ravel catchers, B) contour trenches and C) wooded terraces.

Physical erosion control techniques used on bare slopes to retard or prevent rainsplash, sheet and rill erosion included wooded terraces, contour trenches and ravel catchers (Figure 11). Contract labor costs for surficial erosion control work were 30 percent for wooded terraces, eight percent for contour trenches and two percent for ravel catchers. The remaining 60 percent was spent on treatments which combined

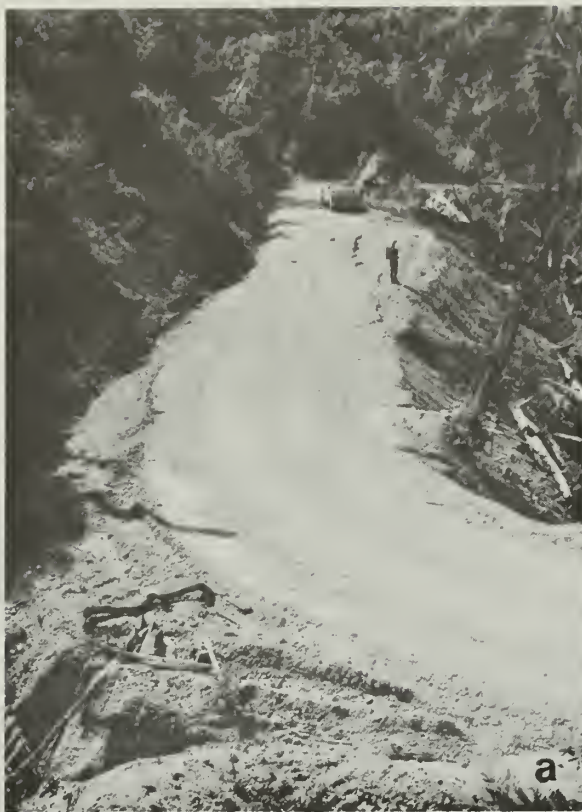
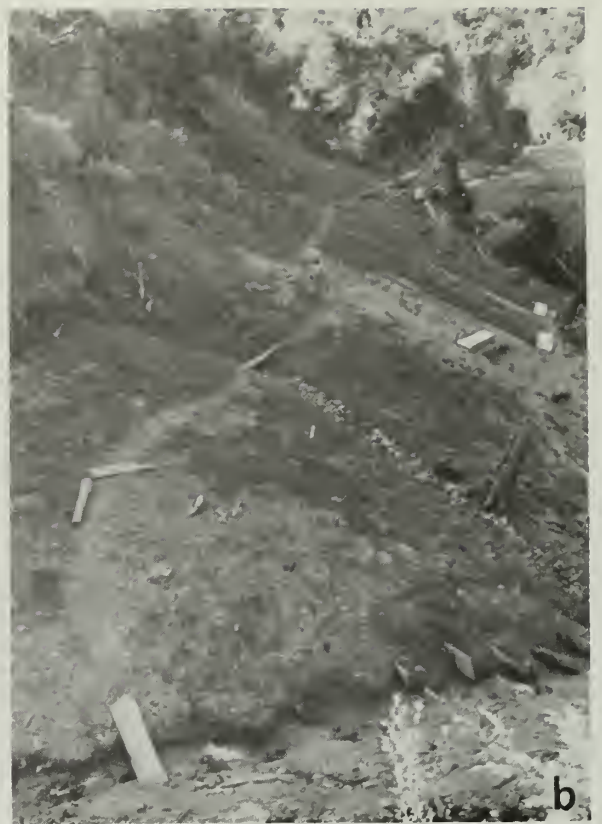
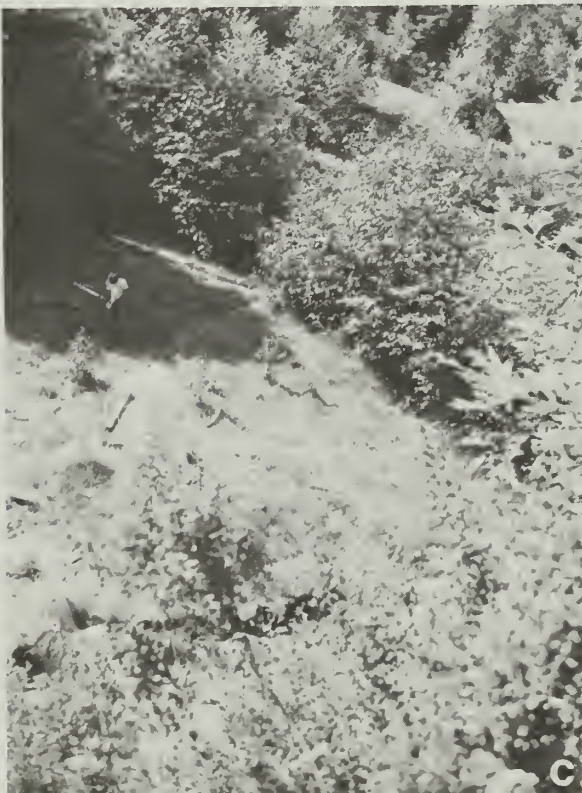
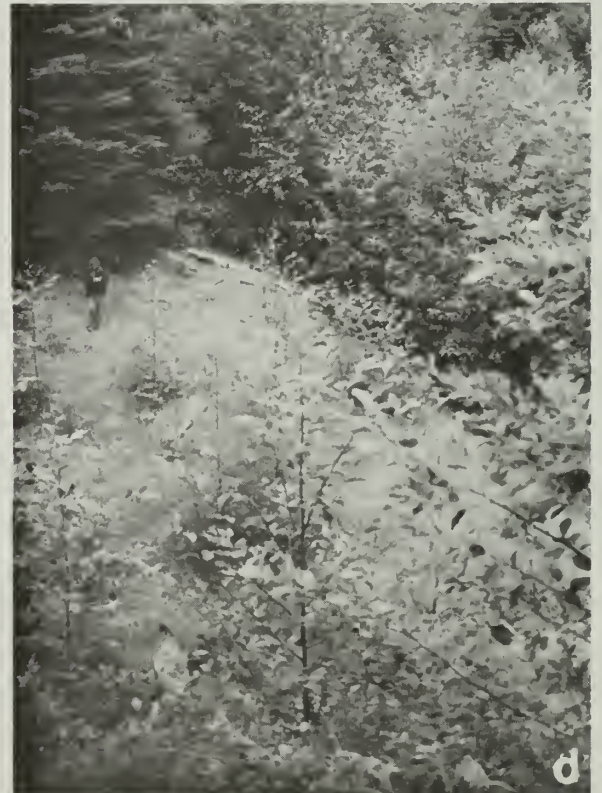
Fig. 14 Outsloping and revegetation of a portion of the L-1-5 road. A) logging road before treatment (May 1979); B) outsloped road (over half of the unstable fill and excavated material from the two stream crossings was endhauled to a nearby storage site); note the sediment trough erosion plots, grass seeded and straw mulched slopes, the hand-rocked cross road drain and the check dams in the foreground stream channel (February 1979); C) alder revegetation takes hold in the wetter areas (May 1981); D) same view in August 1982. All photos were taken from the same location.

Little change was noted in vegetation survival three years after rehabilitation. The most striking changes were in the growth of transplanted alders and in the amount of natural revegetation (Figure 14). Many transplanted alders were over 15 feet tall, while naturally seeded alders averaged five feet. Fewer alders and other naturally colonizing trees and shrubs were found in heavily grassed areas. Hundreds of volunteer hemlock, Douglas-fir, western red cedar, salal and coyote brush seedlings were growing on the rehabilitated road where little natural vegetation existed before rehabilitation.

Grass seeding and fertilization. Park personnel hand seeded and fertilized three outsloped road areas in early October following heavy equipment work (Figure 14b). The remaining areas were hand seeded and fertilized by contractors in late January. The grass seed mixture,

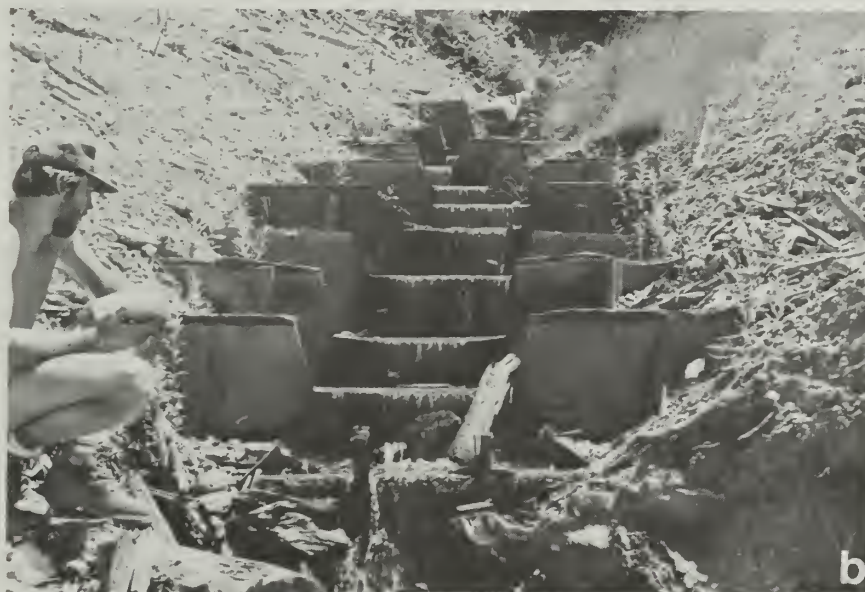
Fig. 15. The effect of checkdam construction on excavated stream crossing R2. Note down-cutting in the unprotected, excavated crossing following the first significant runoff of the 1979-80 winter (15A). A measuring tape is draped across the channel at the location of the former excavated ground surface. In 15B, the series of checkdams installed in the eroded channel caused aggradation and stabilization of the channel bed and banks.

None of the four stream crossings along the L-1-5 road were excavated to the original channel bed. Consequently much fill remained within each crossing. One stream crossing excavation (R1) was also left unprotected and measurements show that ten cubic yards of material eroded between 1979 and 1982. Downcutting in R1 was controlled by abundant organic debris within the eroding fill material. Minimal channel adjustment occurred before the stable organics were uncovered (Figure 17). Crossing R2 lost 22 cubic yards during the first few storms after excavation and eventually could have yielded perhaps ten times that much had checkdams not been installed (Figure 15). Since there was less organic debris in the fill at R3 and R4, more channel adjustment would have occurred had checkdams or rock not been installed. If each of the L-1-5 road crossings had been excavated to the original channel grade, the potential for subsequent erosion would have been considerably less and protection of the channels would not have been warranted.

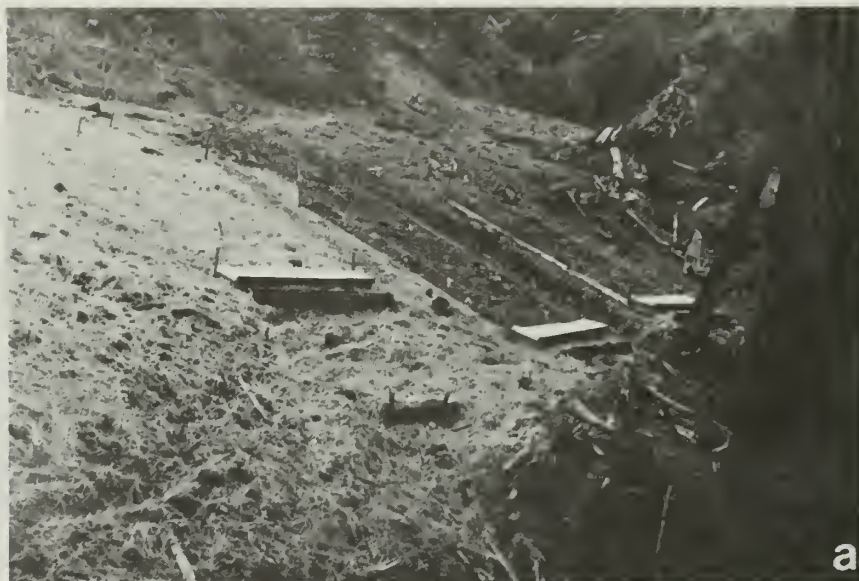
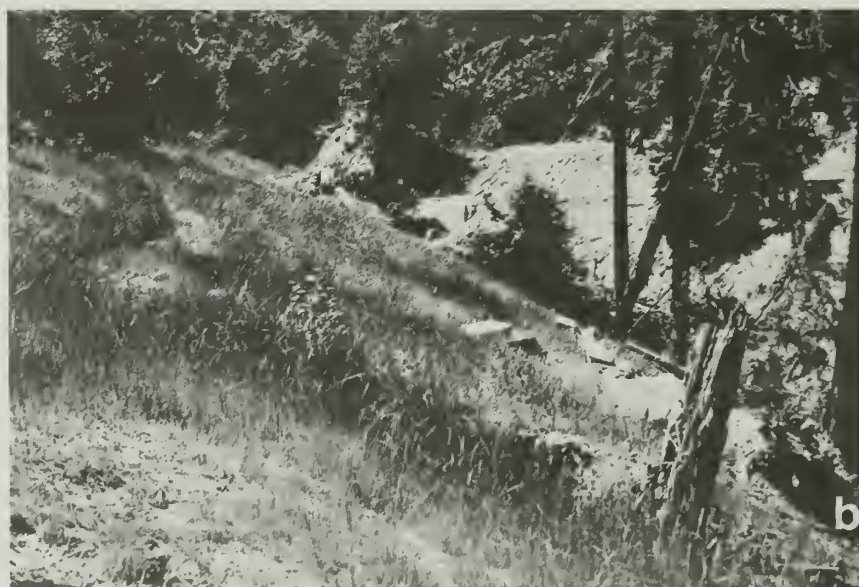
Grass seed and mulch were applied as surface treatments to prevent soil erosion. In areas where it was applied, straw mulch (2000 lbs/ac) controlled rainsplash and sheet erosion initially, but tended to become thin as the season progressed, reducing some of its protective value. Where straw was spread over an area that was initially seeded and fertilized, by the time the straw had deteriorated, the grass was established well enough to protect the ground surface (Figure 18).

Surface erosion sediment-trough plots (10 feet x 25 feet; Figure 18) were installed to compare the effectiveness of three treatments to control surface erosion (Kveton and others, 1983). The treatments and results from the sediment trough plots are listed in Table 9. In the first season, plot 2 (50 pounds per acre grass seed) yielded 1.64 tons per acre of sediment with 61 inches of rain. Plot 1 (9,000 pounds per acre straw and 50 pounds per acre grass seed) yielded 90 percent less sediment than plot 2. Plot 3 (150 pounds per acre grass seed) yielded 75 percent less sediment than plot 2.

Fig. 18. Sediment trough plots installed on a segment of the outsloped L-1-5 road between crossings R1 and R2. The plots are numbered 1, 2 and 3, from foreground to background. Note the extensive grass cover which emerged by 1981 (Figure 18B).

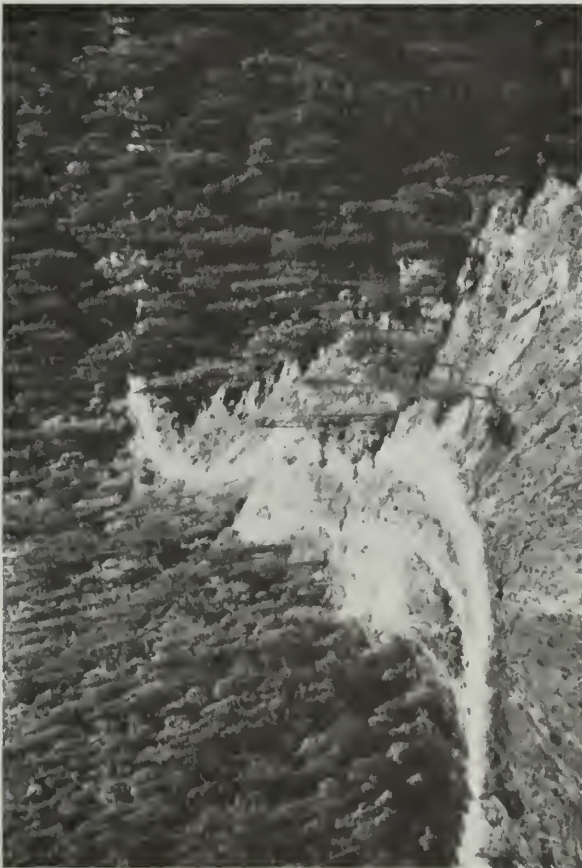
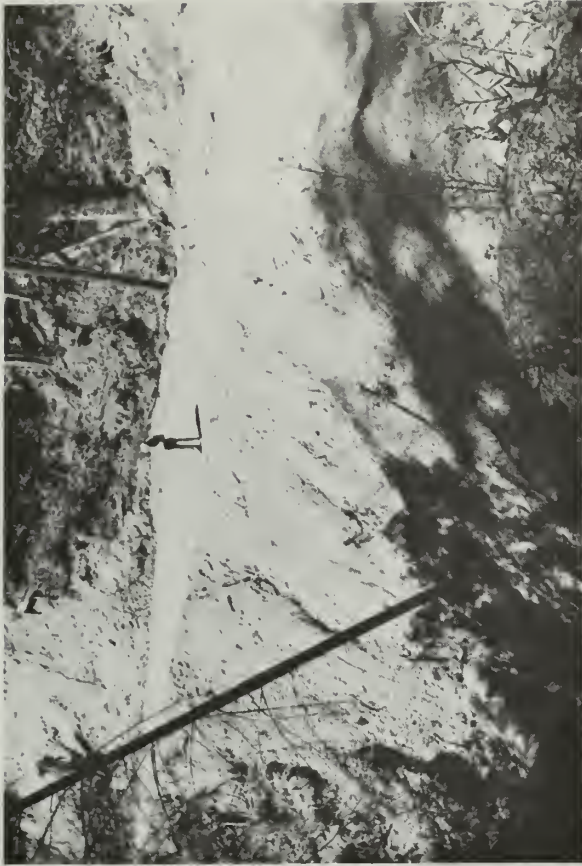
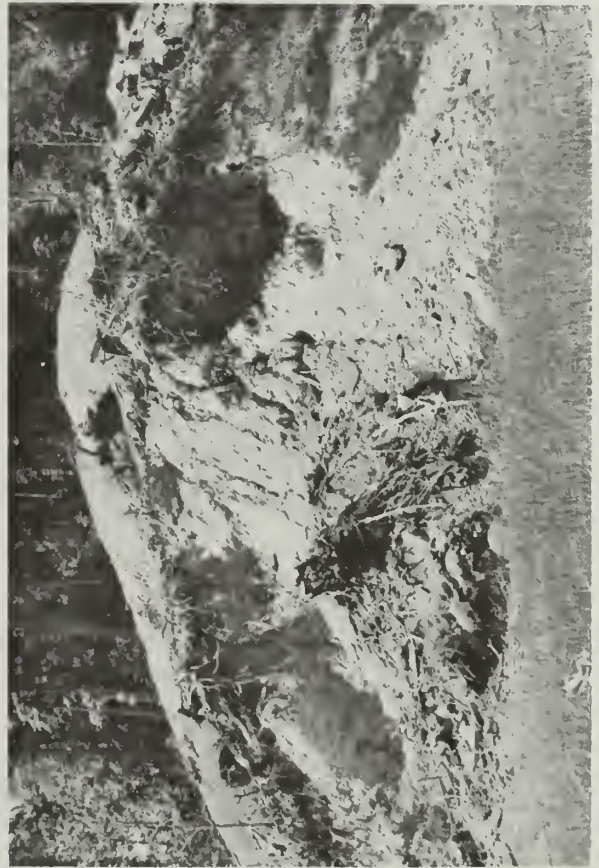
All active erosion problems within this unit were associated with the M-7-5-1 road (Figure 20). No significant erosion was noted on the cable clearcuts. Problems included erosion of roadfill (Figure 21); accelerated movement of wet, naturally unstable hillslopes undercut by road construction; mass failure of road and landing fill material (Figure 22) and minor gullying resulting from concentrated inboard ditch flow culverted onto roadfill or bare soil areas on the slope below the road (Figure 23). All of these erosion problems would have been much more severe had the area experienced average or above average rainfall during the two years between road construction and rehabilitation.

Fig. 20 (above left). Oblique aerial photograph of the M-7-5-1 road, showing 2 and the two yarder pads.

Fig. 21 (above). Gullied fill slope on a stream crossing site, M-7-5-1 road, prior to rehabilitation work.

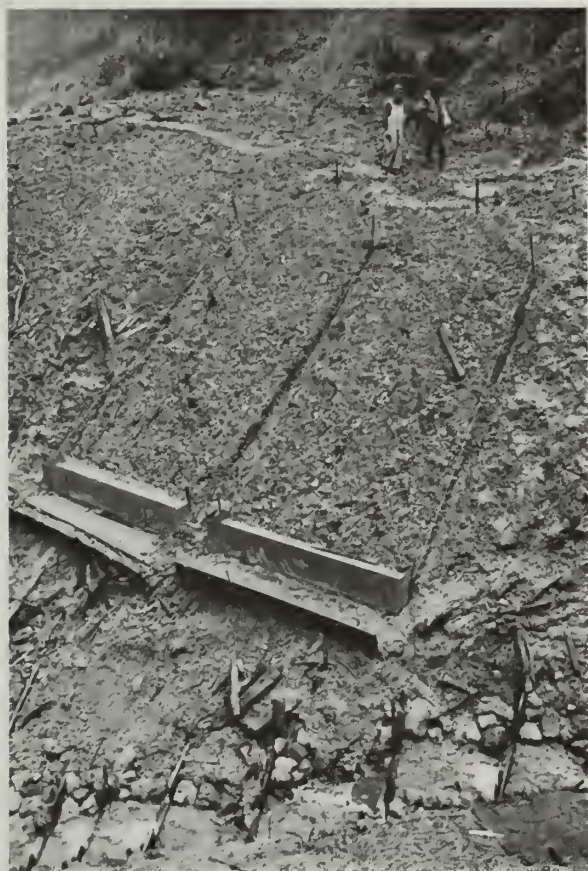
Fig. 24. Sediment trough erosion plots installed on the steep right bank of excavated stream crossing R7. The 10' x 25' plots were established to monitor sediment yield from untreated side slopes at stream crossings. Sediment accumulated in the 1' x 1' x 10' sediment trough while runoff was funneled to 50 gallon drums, and later a large tipping bucket, for measurement.

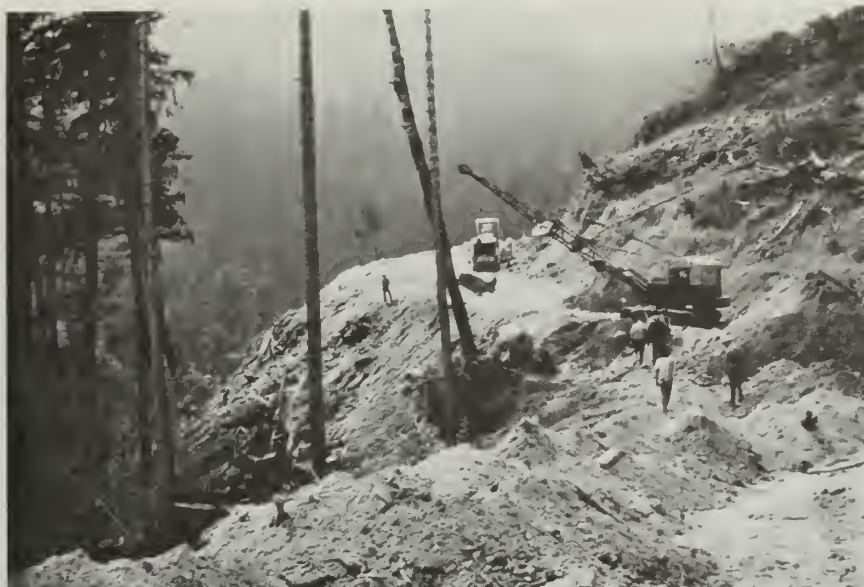
Fig. 25. Initial stages of outslowing on a segment of the M-7-5-1 road using a dragline crane and D-6 crawler tractor.

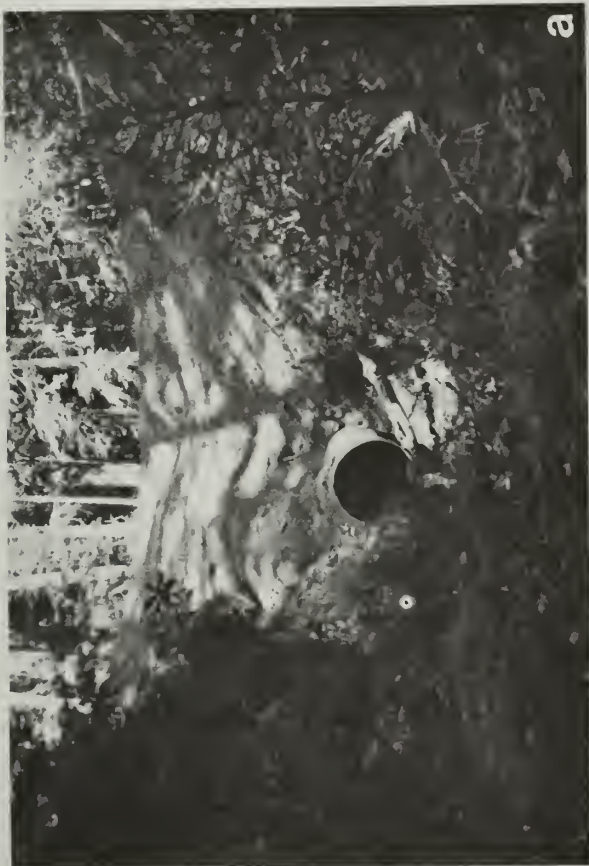
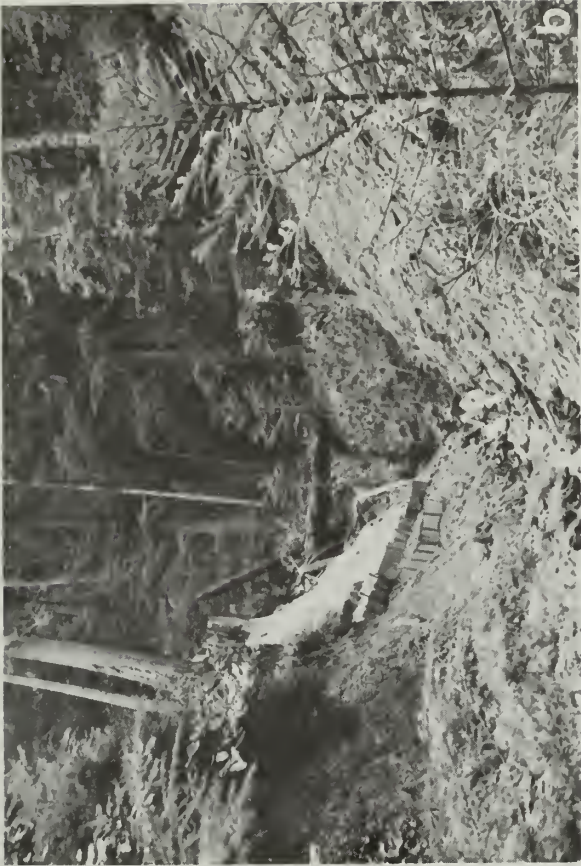
Fig. 26 (above). Excavation of stream crossing R9 at the end of the M-7-5-1 road. The fill material was primarily excavated by dragline crane. To complete the work, a backhoe was lowered to the channel bottom to finish detailed work on the stream bed. A) before treatment, (May 1979), and B) after excavation, (January 1980).

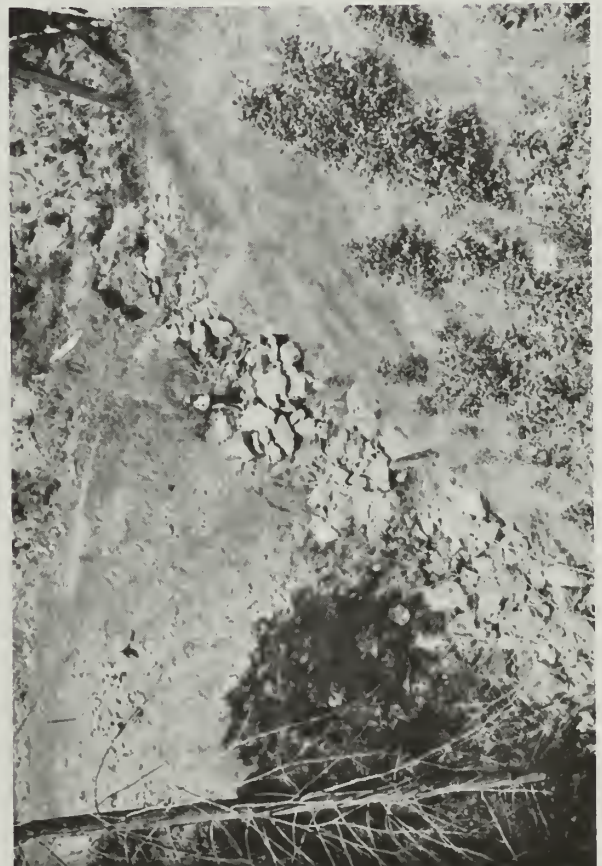
Fig. 27 (left). Heavy rock armor placed in the channel thalweg of excavated stream crossing R8. This treatment prevented subsequent erosion of the uncavated material that still remained after heavy equipment work (July 1982).

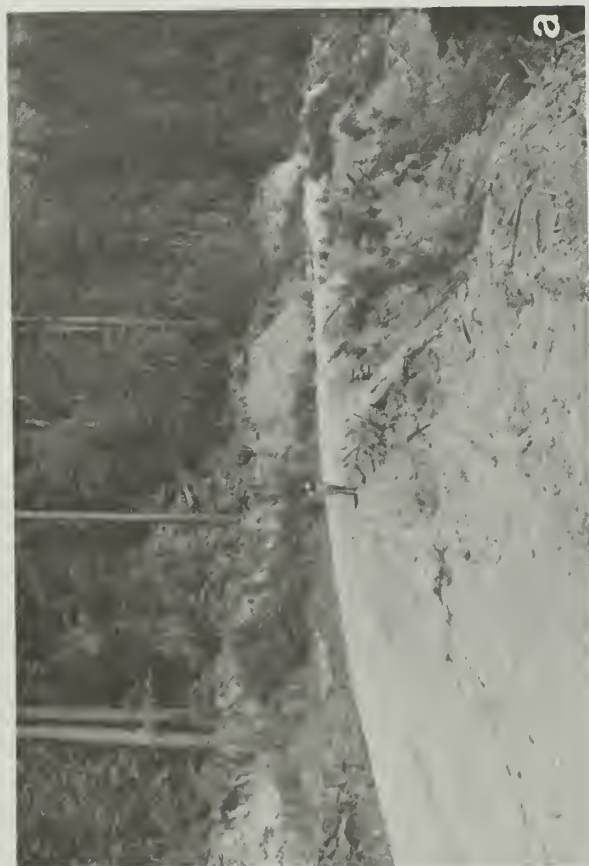
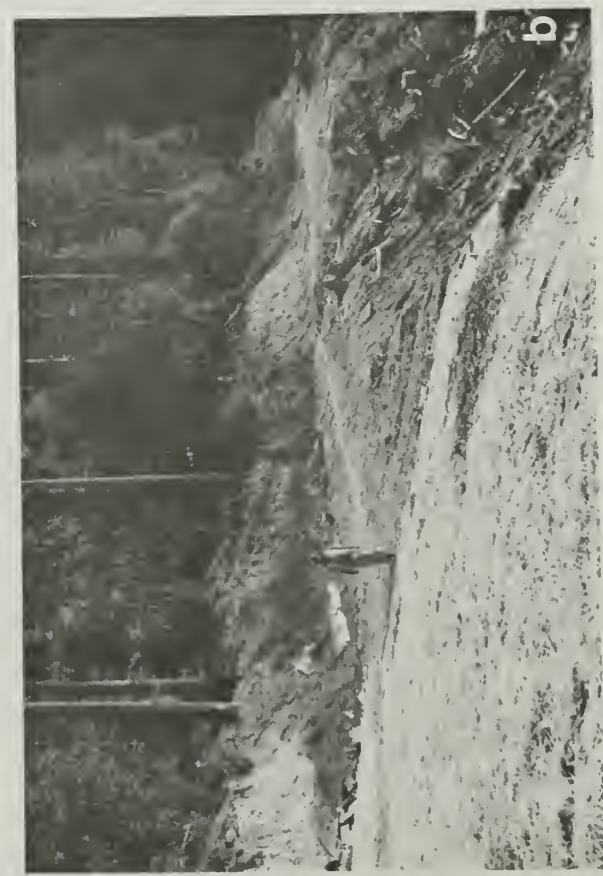
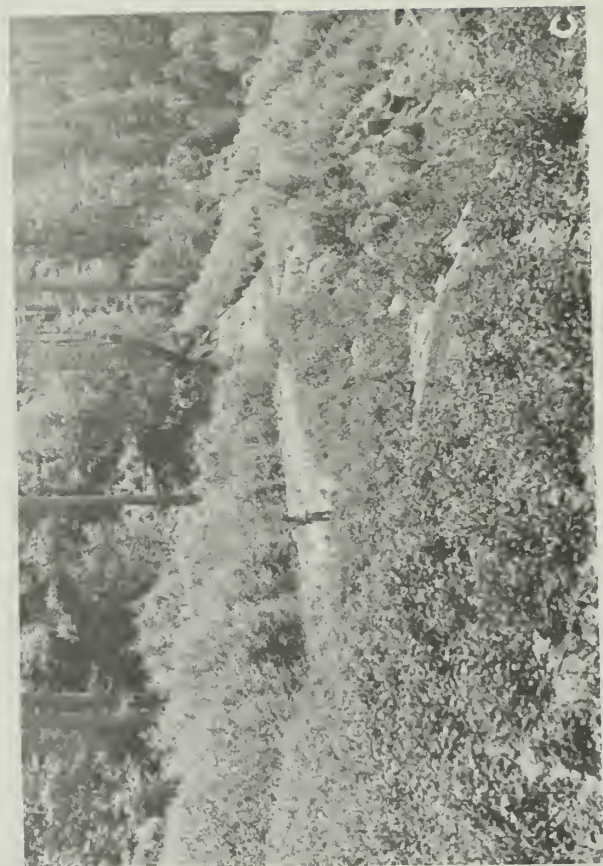
Fig. 28. Slight outcropping of a segment of the M-7-5-1 road. This was the most common type of treatment applied to logging roads on this unit. A) before outcropping (June 1979); B) after outcropping and application of straw mulch (January 1980); C) natural invasion of alder (June 1984).

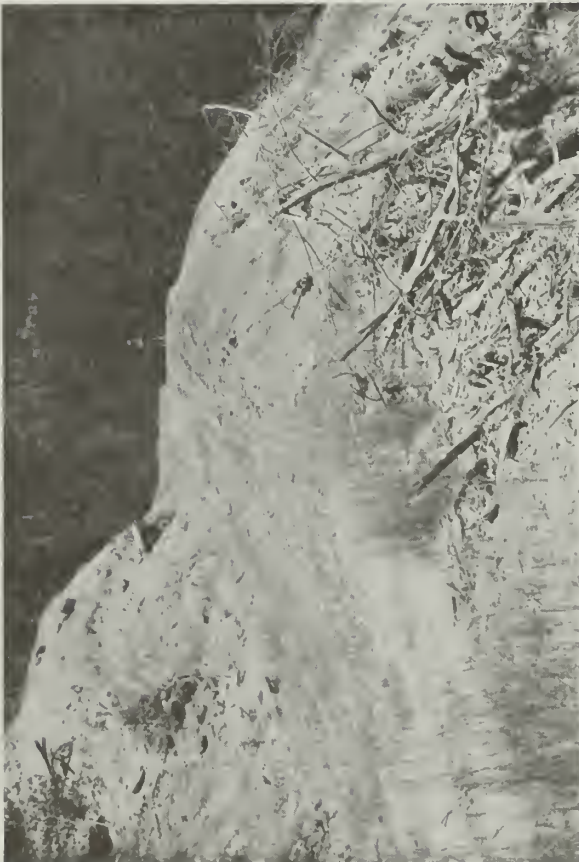
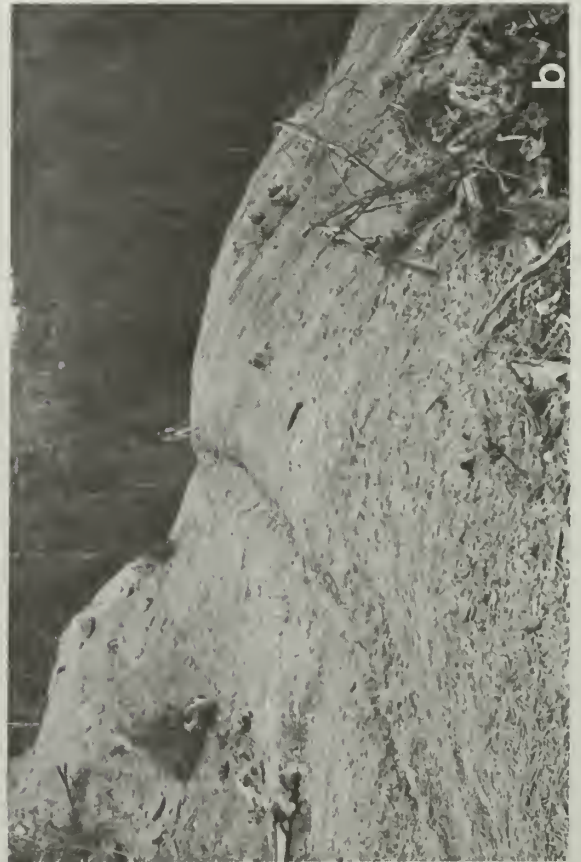
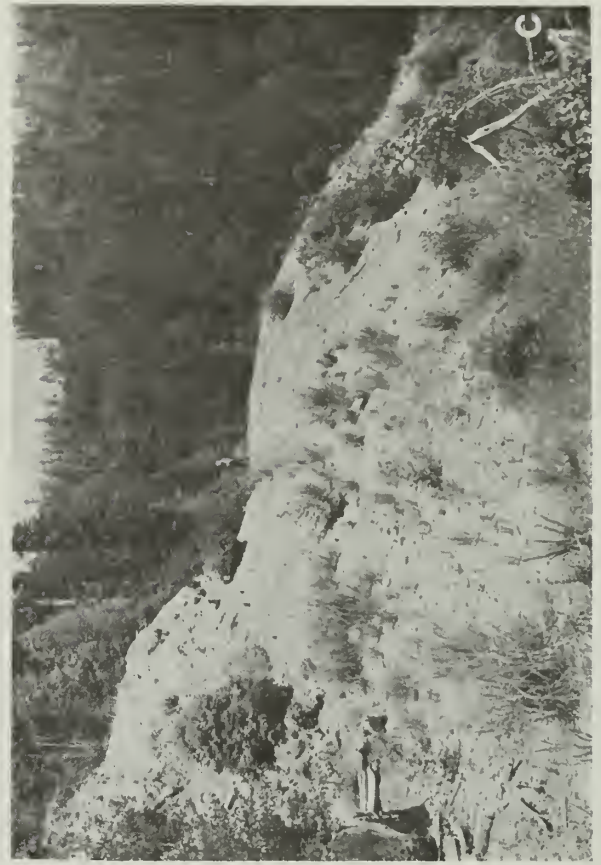
Fig. 29. Treated yarder pad above landing 2. A) before rehabilitation (note sparse revegetation) (June 1979); B) after outslping and drainage improvements (January 1980); C) natural invasion of rushes and woody shrubs (August 1983).

Three yarder pads were ripped, outsloped and drained by the crawler tractor and backhoe (Figure 29) for \$3,400. A ditch system installed between pads 2 and 3 and outsloping of approximately 0.2 miles of access road is included in the cost.

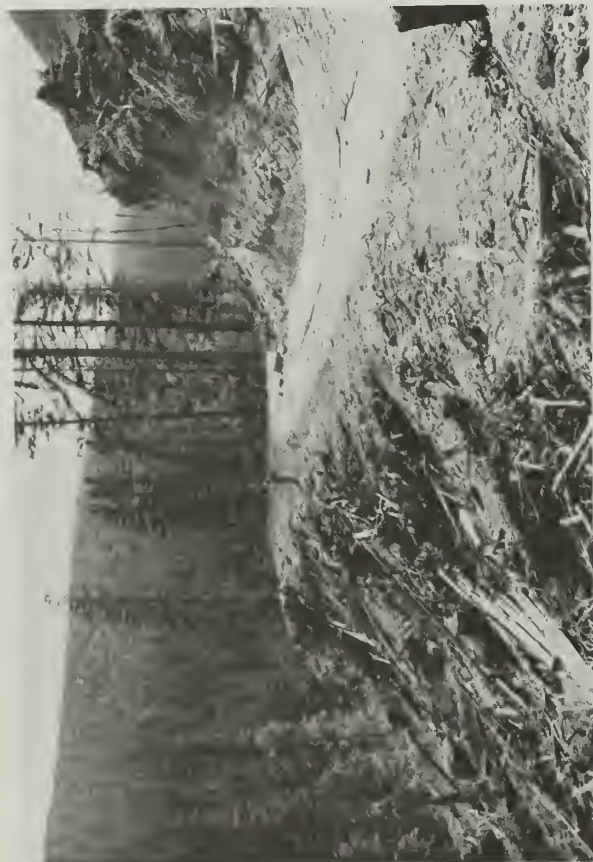
The most expensive and least cost-effective treatments were removal of fill and debris and outsloping landings (Figure 30). These totalled 45 percent of heavy equipment costs (Table 14). Without treatment, much of the landing fill would have failed, but only a portion of this material would probably have directly entered stream channels. Most of the failed material would have been deposited on hillslope benches below the landings (Figure 20). A more cost-effective treatment would have been to excavate fill material in the headwater regions of streams located below the landings and to provide a slightly outsloped surface to drain the remainder of each landing. Based on more recent rehabilitation work, a similar treatment, utilizing a crane or loader and large crawler tractor, would probably have cost about \$5,000 for each landing.

Fig. 30. Serial photographs depicting the treatment and recovery of landing 2. Outslowing and debris removal along several portions of the M-7-5-1 road was expensive but resulted in reduced erosion and rapid revegetation. A) landing 2 before heavy equipment rehabilitation treatment (June 1979); B) after debris removal, outslowing and the natural invasion of alder seedlings approximately 3 years later (July 1982); C) roughly 4 years after treatment (August 1983).

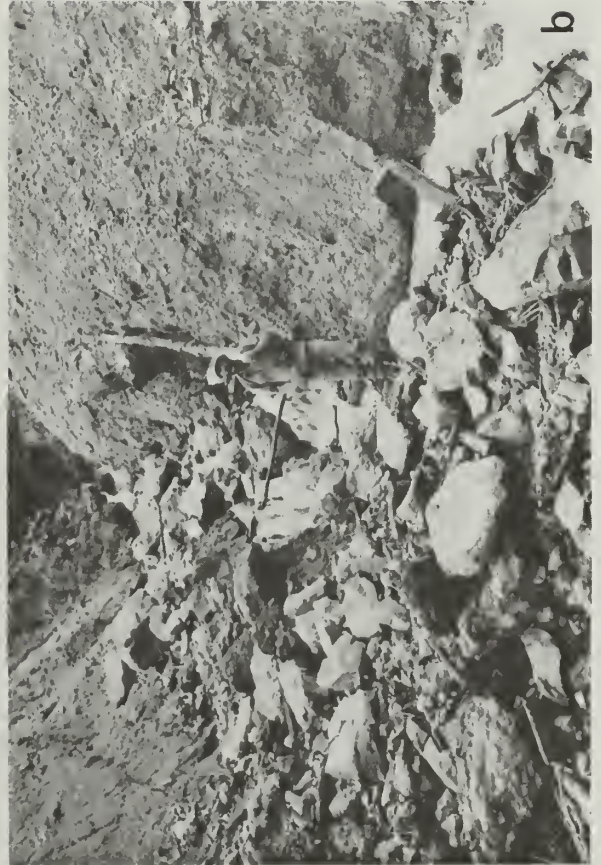
Rock armoring stream crossing excavations by heavy equipment was experimental. Three of the armored stream crossings (R4, R5 and R8) have experienced little, if any, erosion (<5 cubic yards each). Approximately 116 cubic yards have eroded from R6 since rehabilitation (Figure 31). This erosion resulted from flows which were deflected around the rock armor and into the unconsolidated material of the stream sidebank (Figure 32). Streamflow proceeded to downcut, leaving the rock armor stranded above the waterline (Figure 32B). Portions of the undercut sidebank slumped into the stream (Figure 33).

Most erosion at R6 could have been avoided by using more rock along the channel banks or by systematically placing the largest four-foot diameter boulders against the banks. When located near the channel bottom, these deflected water against the sidebanks and caused erosion. While their "random" placement was an intentional experiment, the large boulders were also difficult or impossible to reposition by manual labor during later attempts at corrective winter maintenance.

Fig. 31. Erosion of rock armored stream crossing R6. Sediment loss was caused by the presence of oversized rocks which diverted flow into and caused undercutting of the adjacent channel banks. Crossing R6 A) before heavy stream flows (October 1979) and B) after several winters (July 1982).

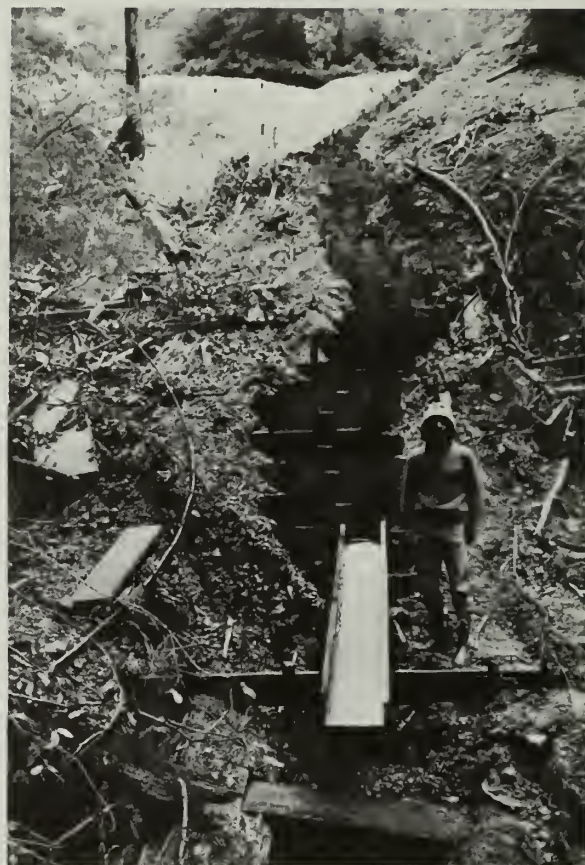
Fig. 35. Protection of a steep, rilled slope near crossing R9 using small checkdams and a flume with energy dissipater. In retrospect, this treatment was judged excessive for the comparatively small amount of runoff and erosion which would have occurred. As with this case, runoff volumes from treated areas and former springs are often difficult to predict.

were constructed to protect this spring from gullying (Figure 35). Slash and rock checkdams were also constructed to stabilize small gullies draining yarder pads 2 and 3.
