AN EVALUATION OF EXPERIMENTAL
REHABILITATION WORK,
REDWOOD NATIONAL PARK

TECHNICAL REPORT
JULY 1987

Redwood National Park Watershed Rehabilitation
Technical Report Number 19

National Park Service
Redwood National Park
Arcata, California
July 1987

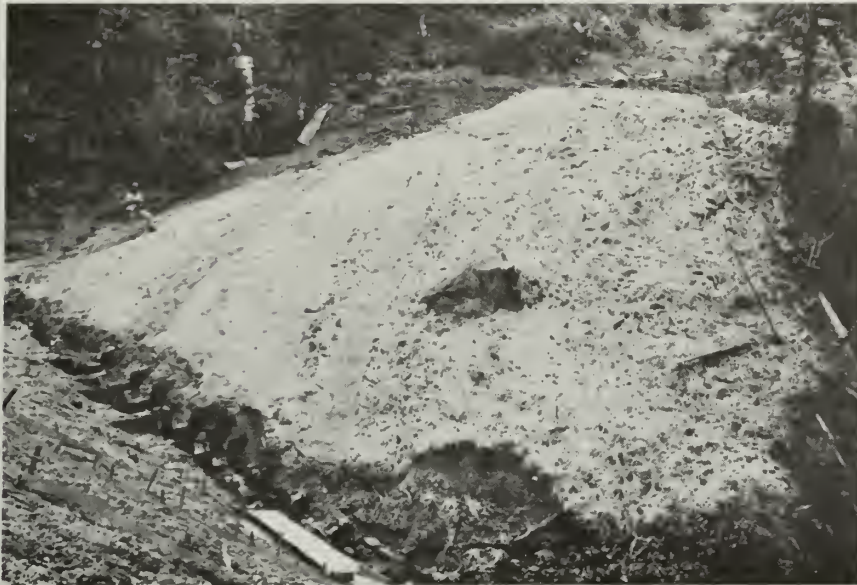
Fig. 36 (left). Surface erosion control on excavated stream crossing R7. The most cost-effective treatment for controlling surface erosion was the liberal application of straw mulch, secured by jute netting on slopes steeper than 70 percent. Photo shows same slope depicted in Figure 34.

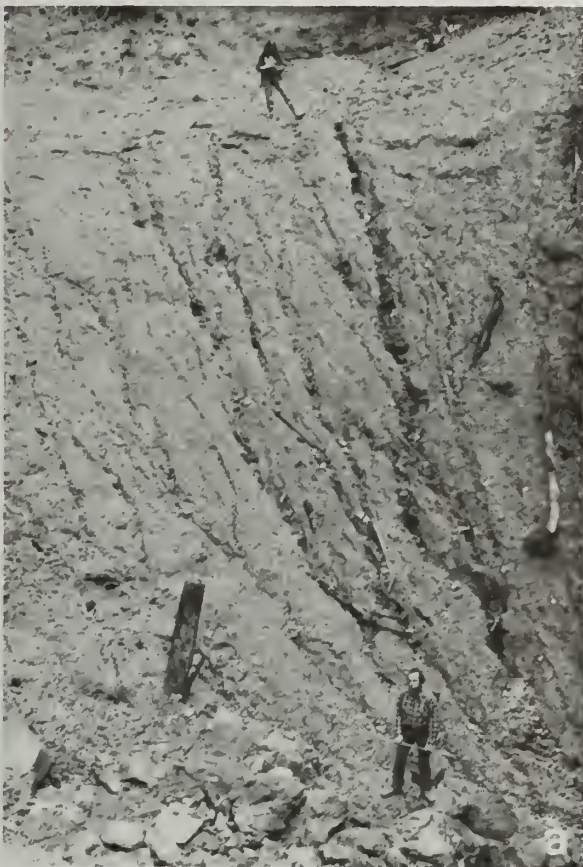
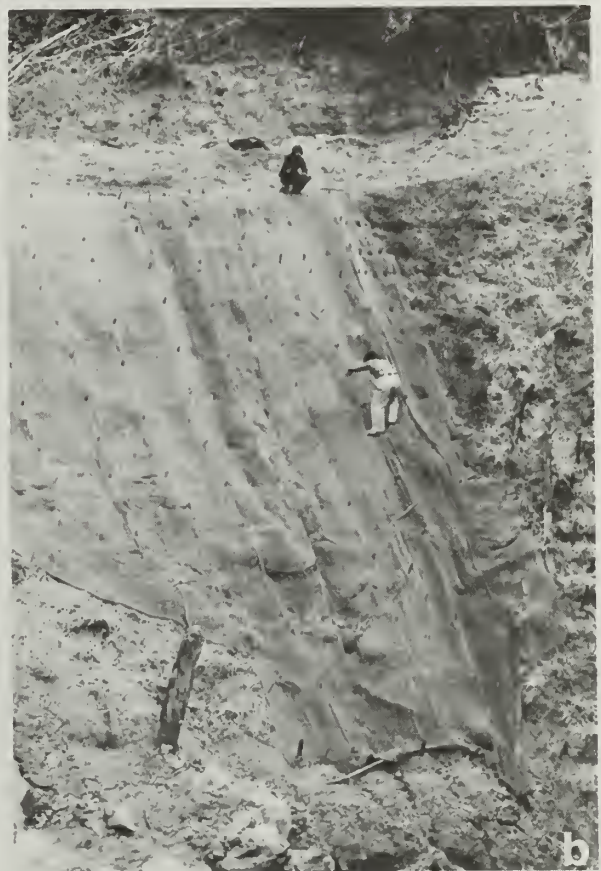
Fig. 37. Photos showing the left bank of excavated stream crossing 8A. A) after 5 inches of rainfall but prior to treatment for controlling surface erosion and B) during final stages of installation of jute netting over straw mulch. Once the original surface had rilled, it had to be manually raked (smoothed) before the jute and straw could be placed. No measureable erosion of the slope has since occurred.

Straw covered by jute was very successful in controlling rilling (Figure 37). However, the size and number of rills which developed on all treated sites were substantially reduced as compared to the same areas before treatment (immediately after the first fall rains). Following each winter, measurements showed that plots 3 and 4 (straw covered by jute and punched straw, respectively) actually trapped sediment which had been eroded from upslope areas. Plot 5 (straw mulch) reduced expected rilling by 85 percent and Plot 1 (wood chips) reduced predicted rilling by 13 percent (Table 23). There was less erosion with straw applied at 6,000 to 8,000 pounds per acre than with the 2,000 to 4,000 pound per acre rate. Wood chips prevented surface erosion on slopes less than 40 percent, but washed away and were ineffective on slopes steeper than 60 percent.

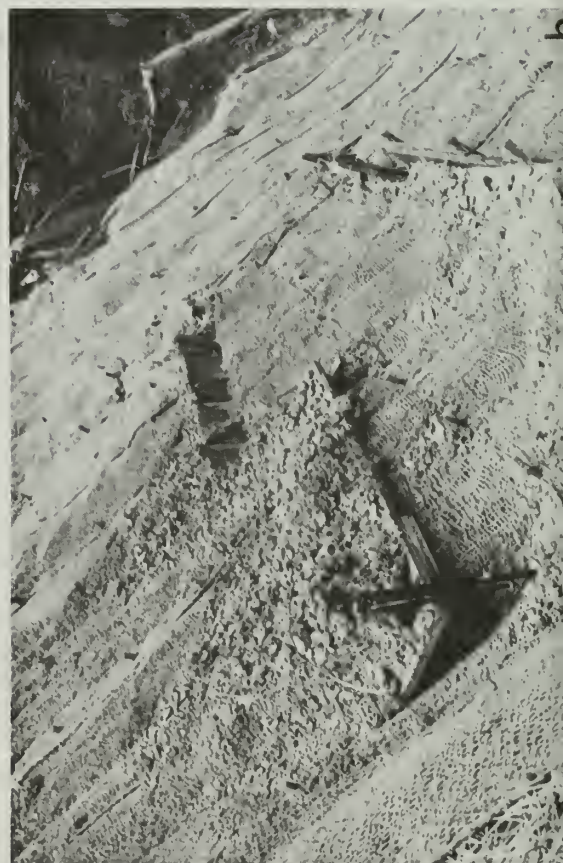
Fig. 38. Ravel catchers and jute-covered straw mulch on crossing R9. A) ravel catchers and jute-covered straw mulch were placed on the steep right bank of excavated stream crossing R9. B) following a small cutback failure on the former logging road at the top of the excavation, soil and rock passed over the jute (with no apparent damage) and either filled or toppled the ravel catchers.

was expected to be minimal, those structures were not repaired. Some rock armor at R3 was moved after streamflow had been diverted against the channel bank, but most of the material was too heavy to manipulate. Ravel catchers at crossing R9, which had been flattened by a small debris flow from a cutbank failure, were not re-built (Figure 38).

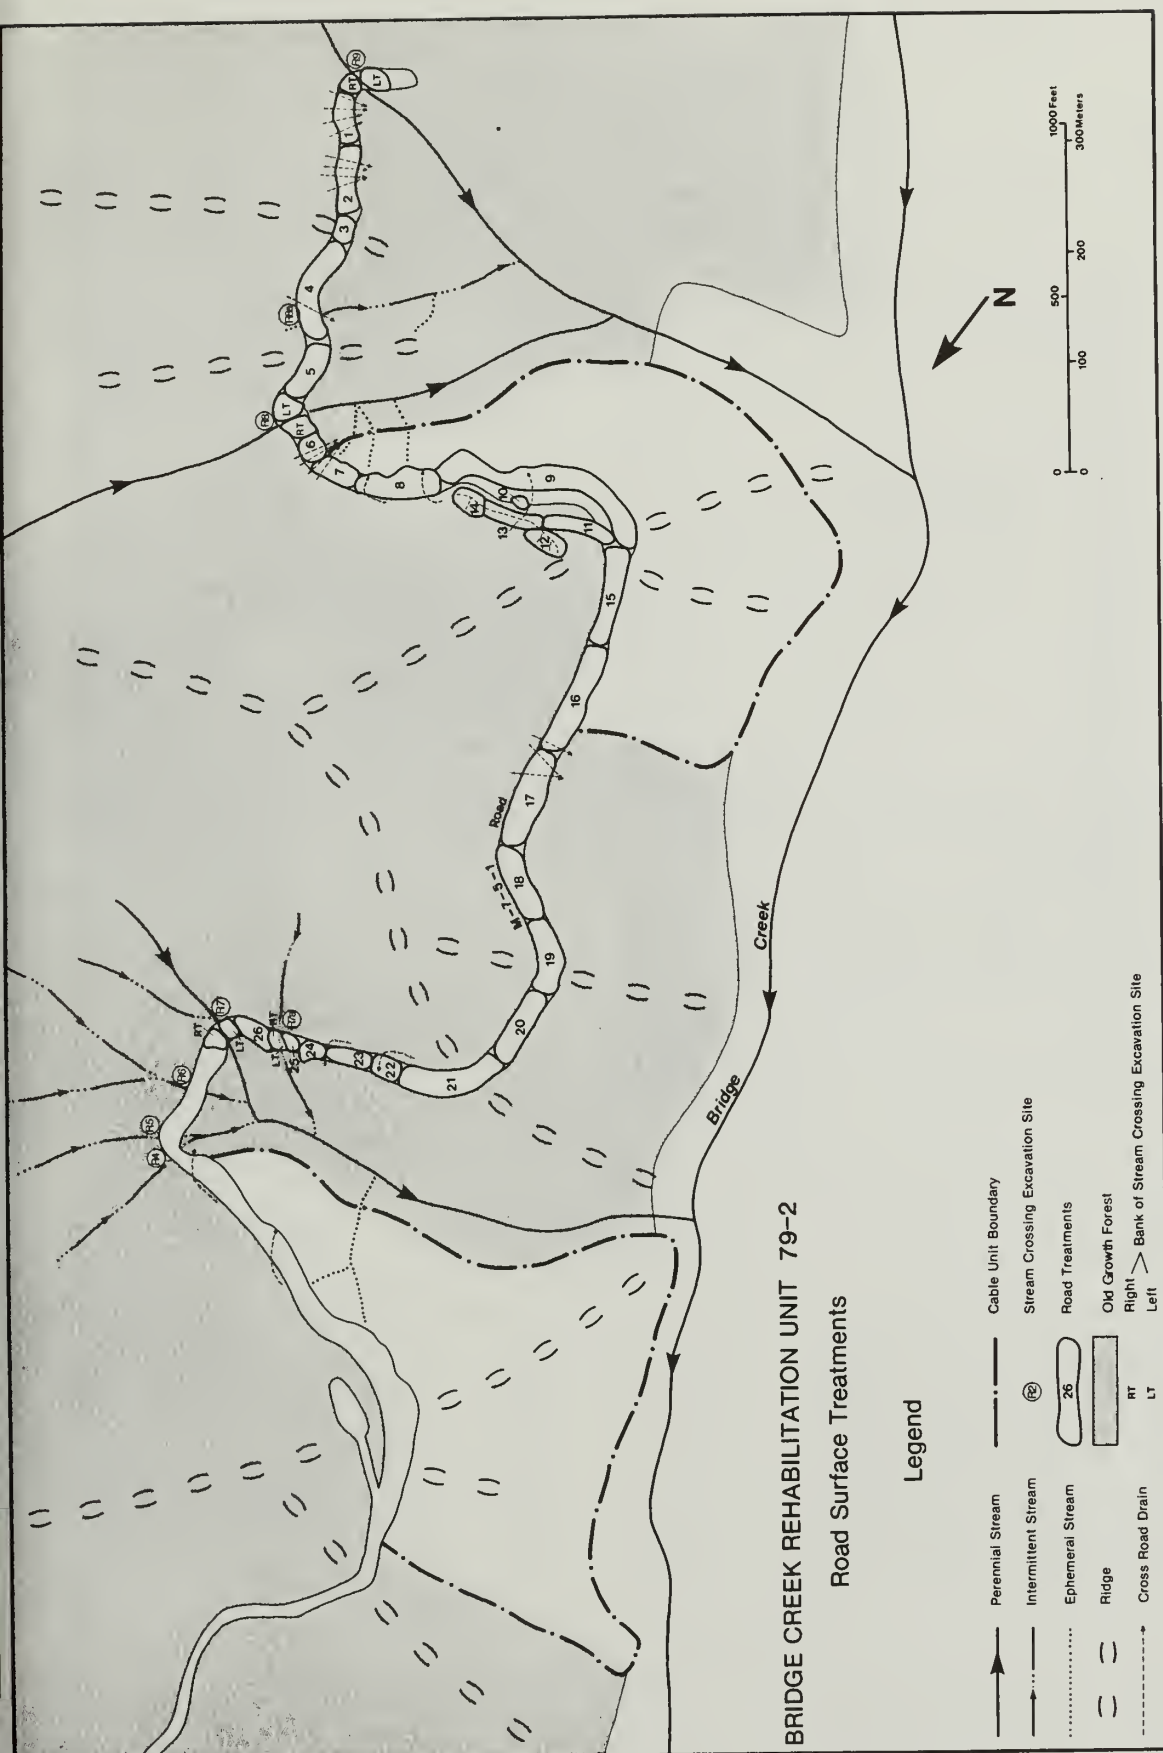
Fig. 39. Revegetation treatment plots established on the surface of the M-7-5-1 logging road following heavy equipment rehabilitation work. Surface treatments included grass, grass and fertilizer, straw mulch, wood chip mulch and untreated control plots (Table 21).

Experimental treatments of grass seed, fertilizer and straw mulch were applied to most of the road surface in November 1979 (Figure 39 and Table 21). Grass seed and fertilizer were also applied at stream crossing excavations R7, R7A, R8 and R9. The RNP grass mixture was applied at 50 pounds per acre and 16-20-0 fertilizer was applied at 250 or 500 pounds per acre.

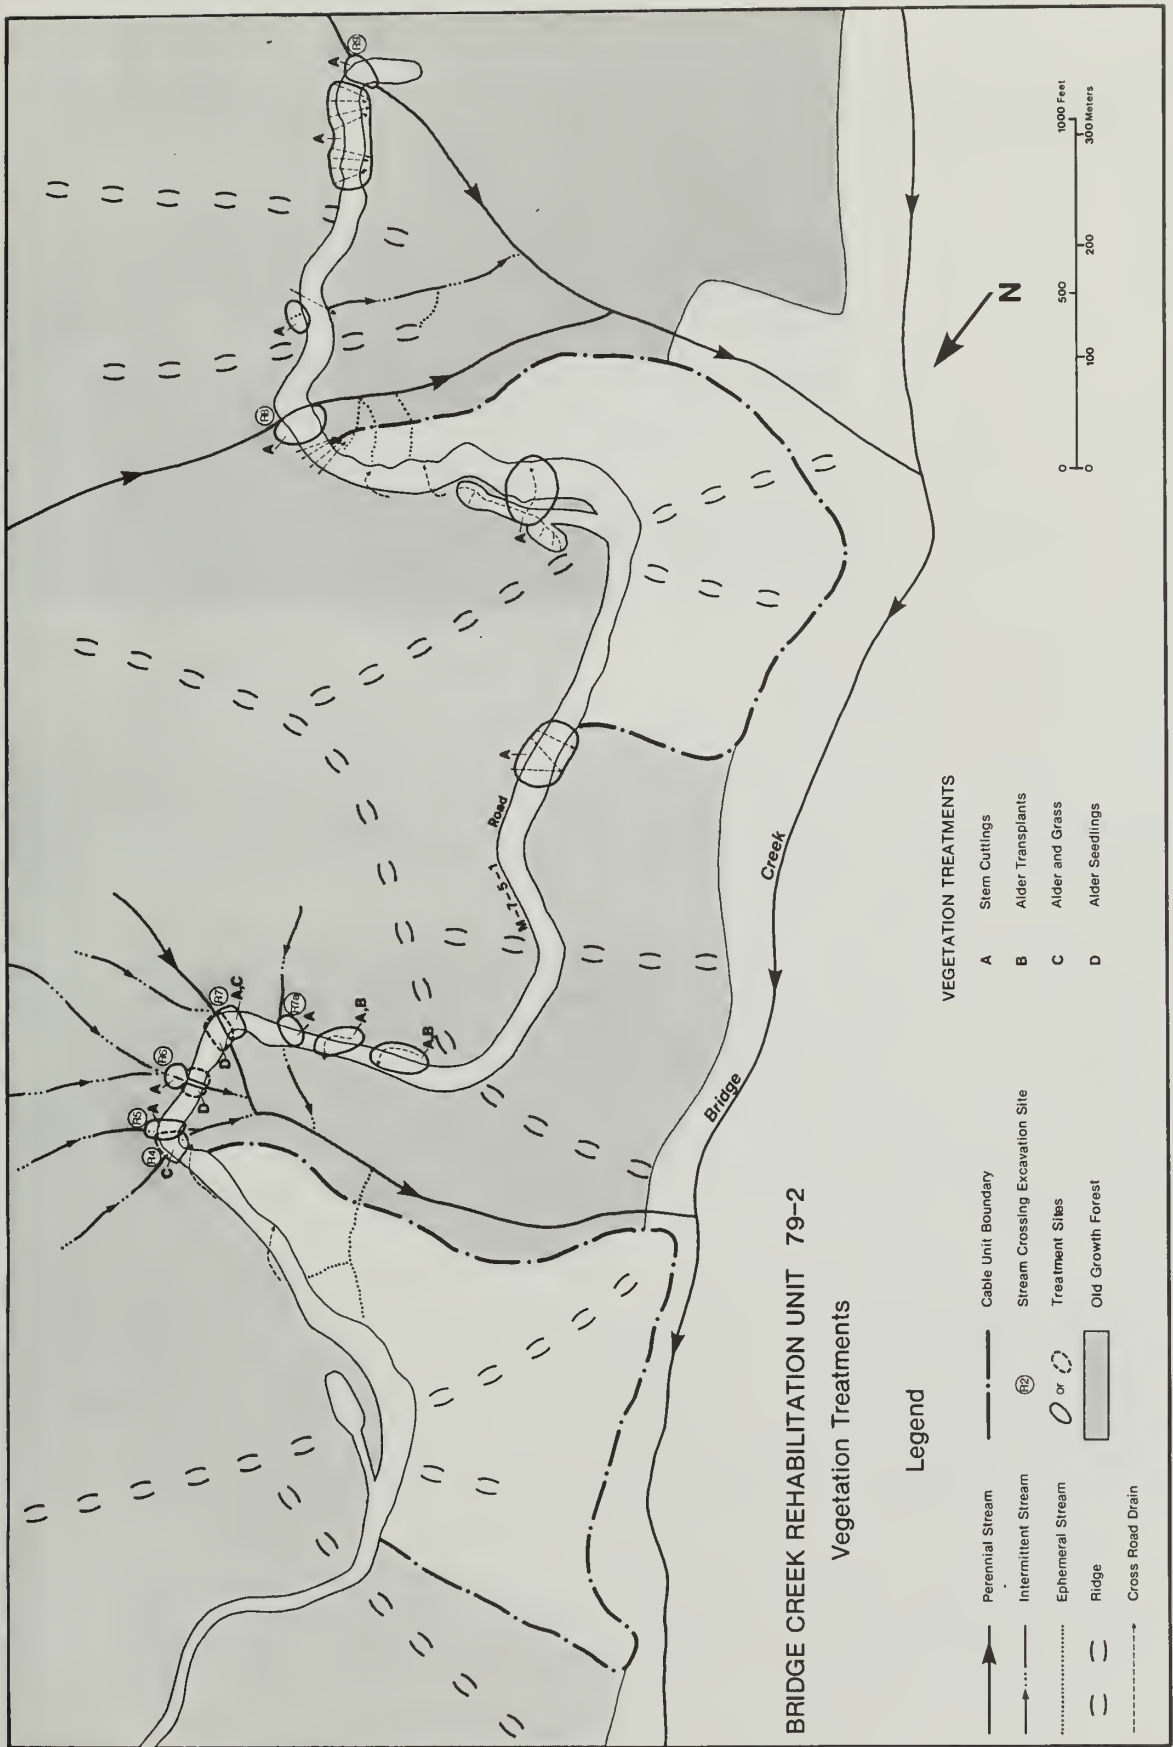
Fig. 40. Vegetation treatments, M-7-5-1 logging road.

Over one-thousand willow stem cuttings were planted at 14 moist areas (Figure 40). Source for cuttings was near the Redwood Creek trailhead at Orick. On-site alder seedlings were transplanted at two sites. One-year old containerized alder seedlings grown by Simpson Timber Company were planted at R6 and R7. Twenty-six pounds of a grass/alder seed mixture were sown at stream crossings R4 and R7 in April 1980 (Figure 41). The grass/alder seed mixture was composed of 25 pounds "RNP mix" and one pound alder seed.

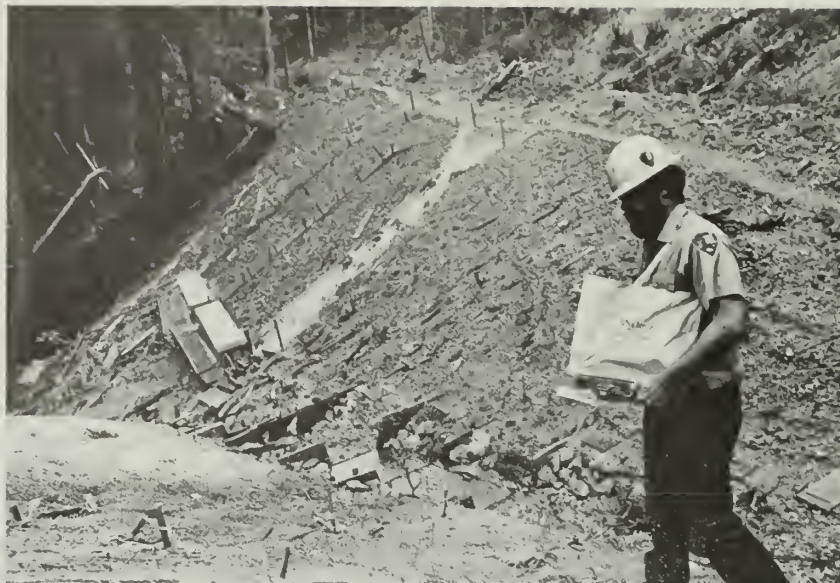
Fig. 41. Alder and grass seed being hand spread at stream crossing R7.

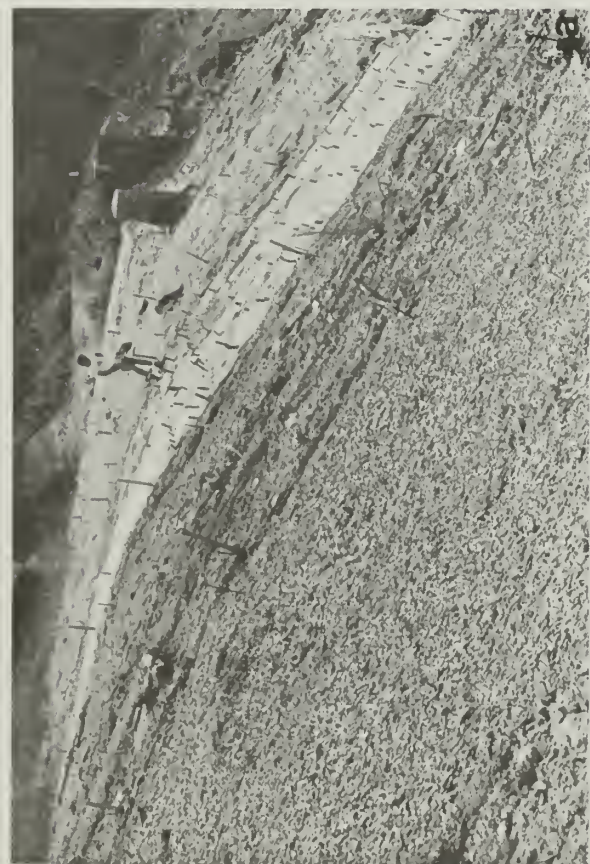
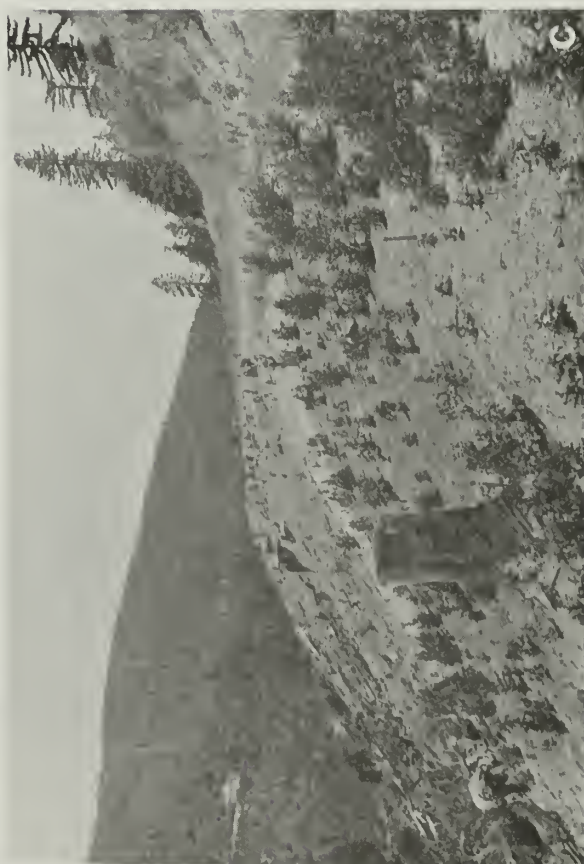
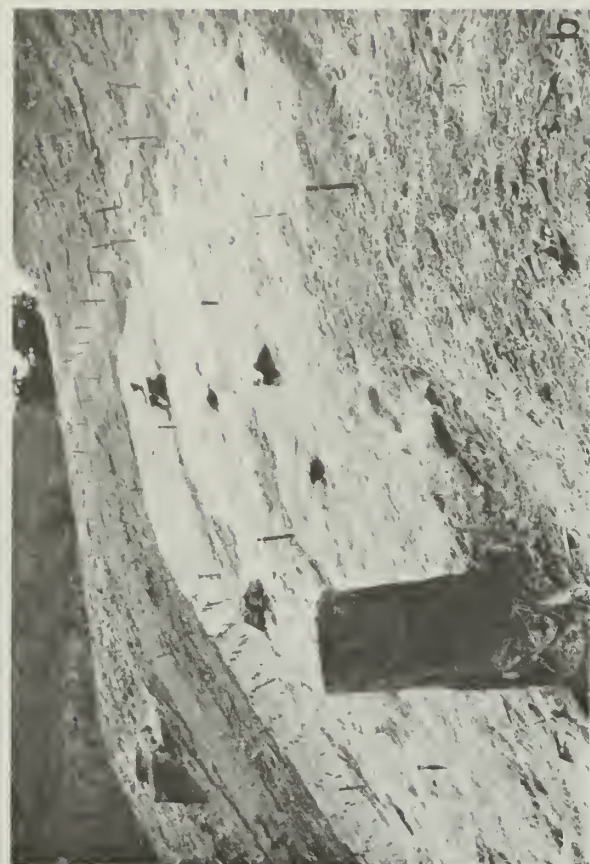
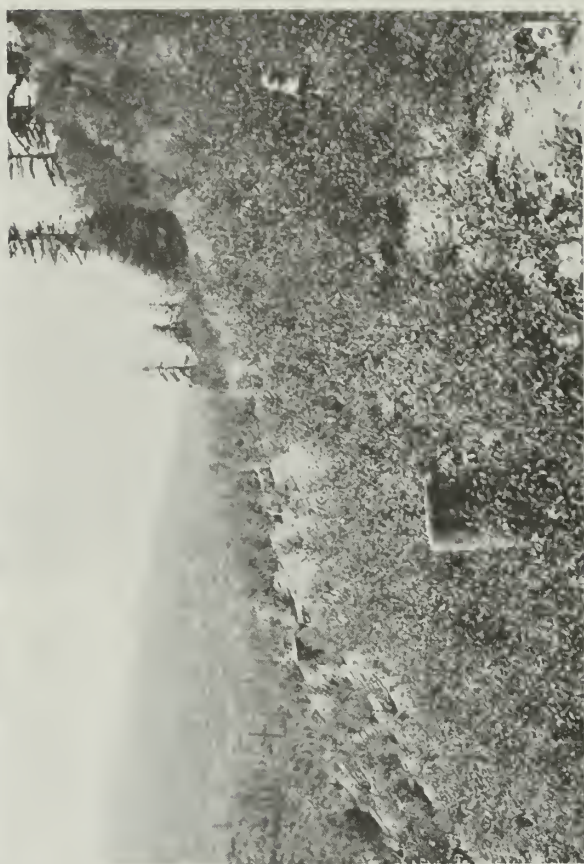
Treatments to control surface erosion included straw mulch, straw mulch covered by jute netting and wood chip mulch. Five (20 foot by 50 foot) side-by-side slope treatment plots were established to compare the effectiveness of these treatments to control rilling (Figure 42). In order of decreasing effectiveness the treatments were: straw mulch (8,000 pounds per acre) covered by jute netting; straw mulch (9,000 pounds per acre) punched into the ground surface with a shovel; straw mulch (9,000 pounds per acre); wood chips (305 cubic yards per acre) and no treatment.

Fig. 42. Slope treatment plots established on the outslipped section of landing 1. A) plots, from foreground to background, included (1) wood chip mulch, (2) control (no treatment), (3) straw mulch covered by jute netting, (4) straw mulch, punched in by shovel, and (5) unsecured straw mulch. B) closer view of the straw mulch plots, #5 (foreground, beyond stump) to #3 (beyond person sitting on ground near break-in-slope). Photos A and B taken just after application of treatments (December 1979). C) natural invasion of alder two years following treatments (June 1981); note how chip mulch (background) has inhibited alder invasion. D) same view (July 1982).

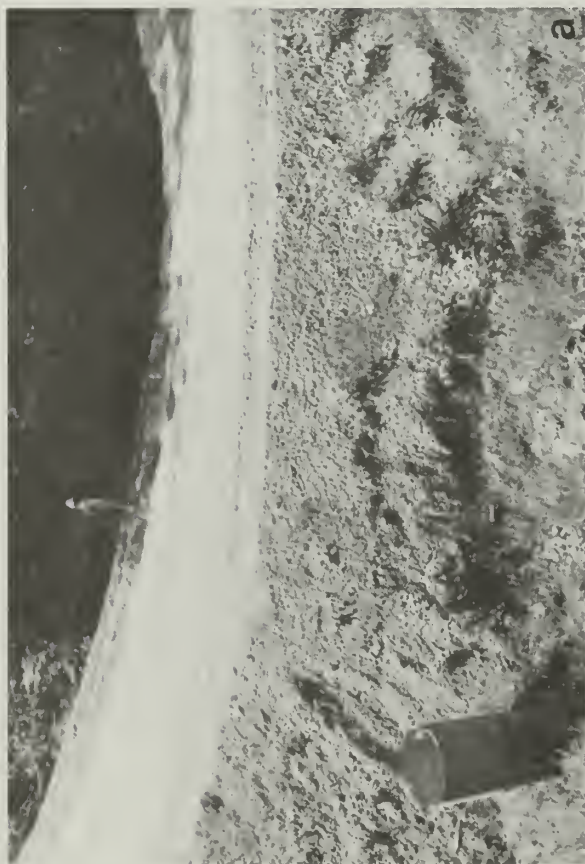
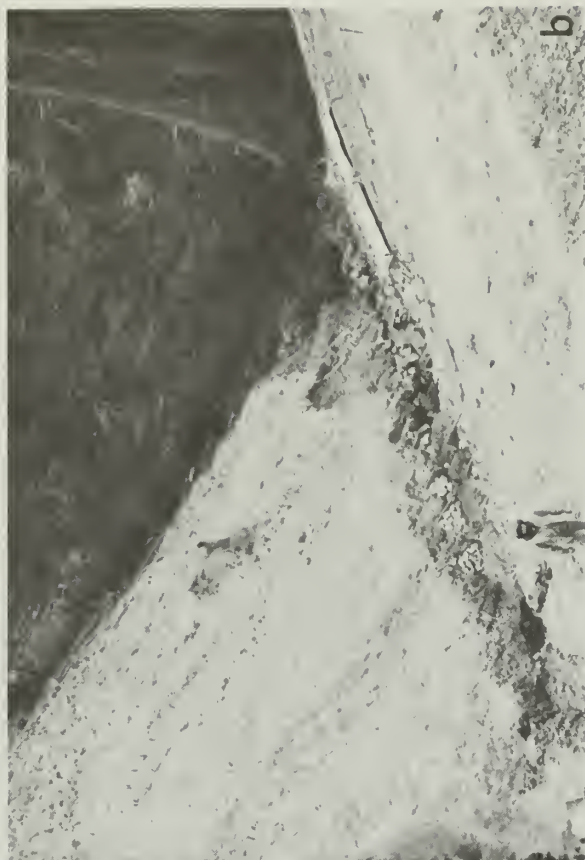
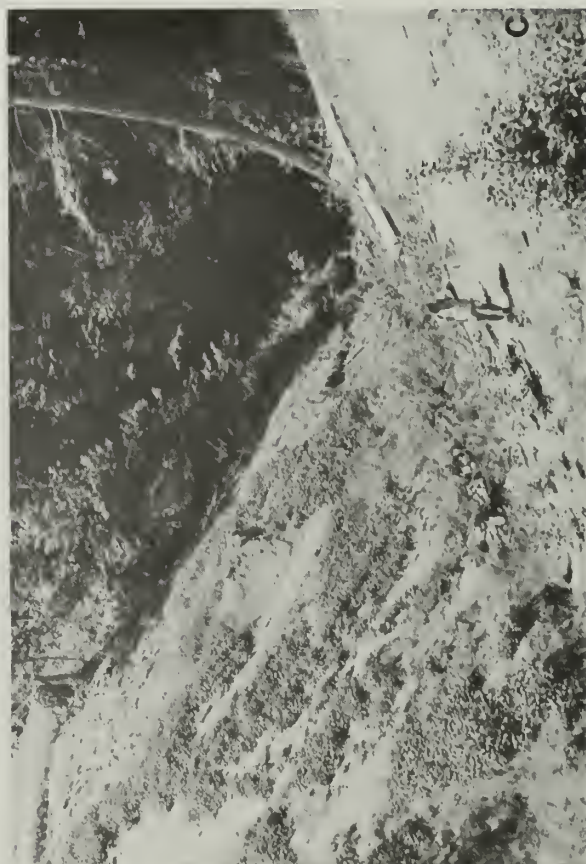
Fig. 43. View of the excavation and revegetation of stream crossing R7, M-7-5-1 logging road. A) M-7-5-1 logging road before rehabilitation and excavation of the stream crossing material (note drop inlet to culvert), May 1979; B) after channel excavation; note straw and jute netting on the left bank, sediment troughs on right bank, and checkdams in channel (January 1980); C) one year, eight months after rehabilitation, showing patchy alder growth from seeding (left bank) and growth of planted alder seedlings and grass (right bank) (May 1984); D) two years, nine months after rehabilitation, showing dramatic alder growth and essentially equal success (in both height and number) of seeded and planted alder at this locality (July 1982); E) three years, ten months after rehabilitation, showing complete closure of new canopy over excavated stream crossing (August 1983).

Grass/alder seed treatments resulted in heavy grass the first year, but alders were well-established the second (Figure 43). The grass did not persist because no fertilizer was used. Natural alder invasion in the unseeded area between stream crossings R5 and R6 resulted in similar alder cover as the seeded area between stream crossings R4 and R5. Grass sown without fertilizer in the spring-seeded areas did not exclude alders as did the fall-seeded grass sown with fertilizer in the road treatments.

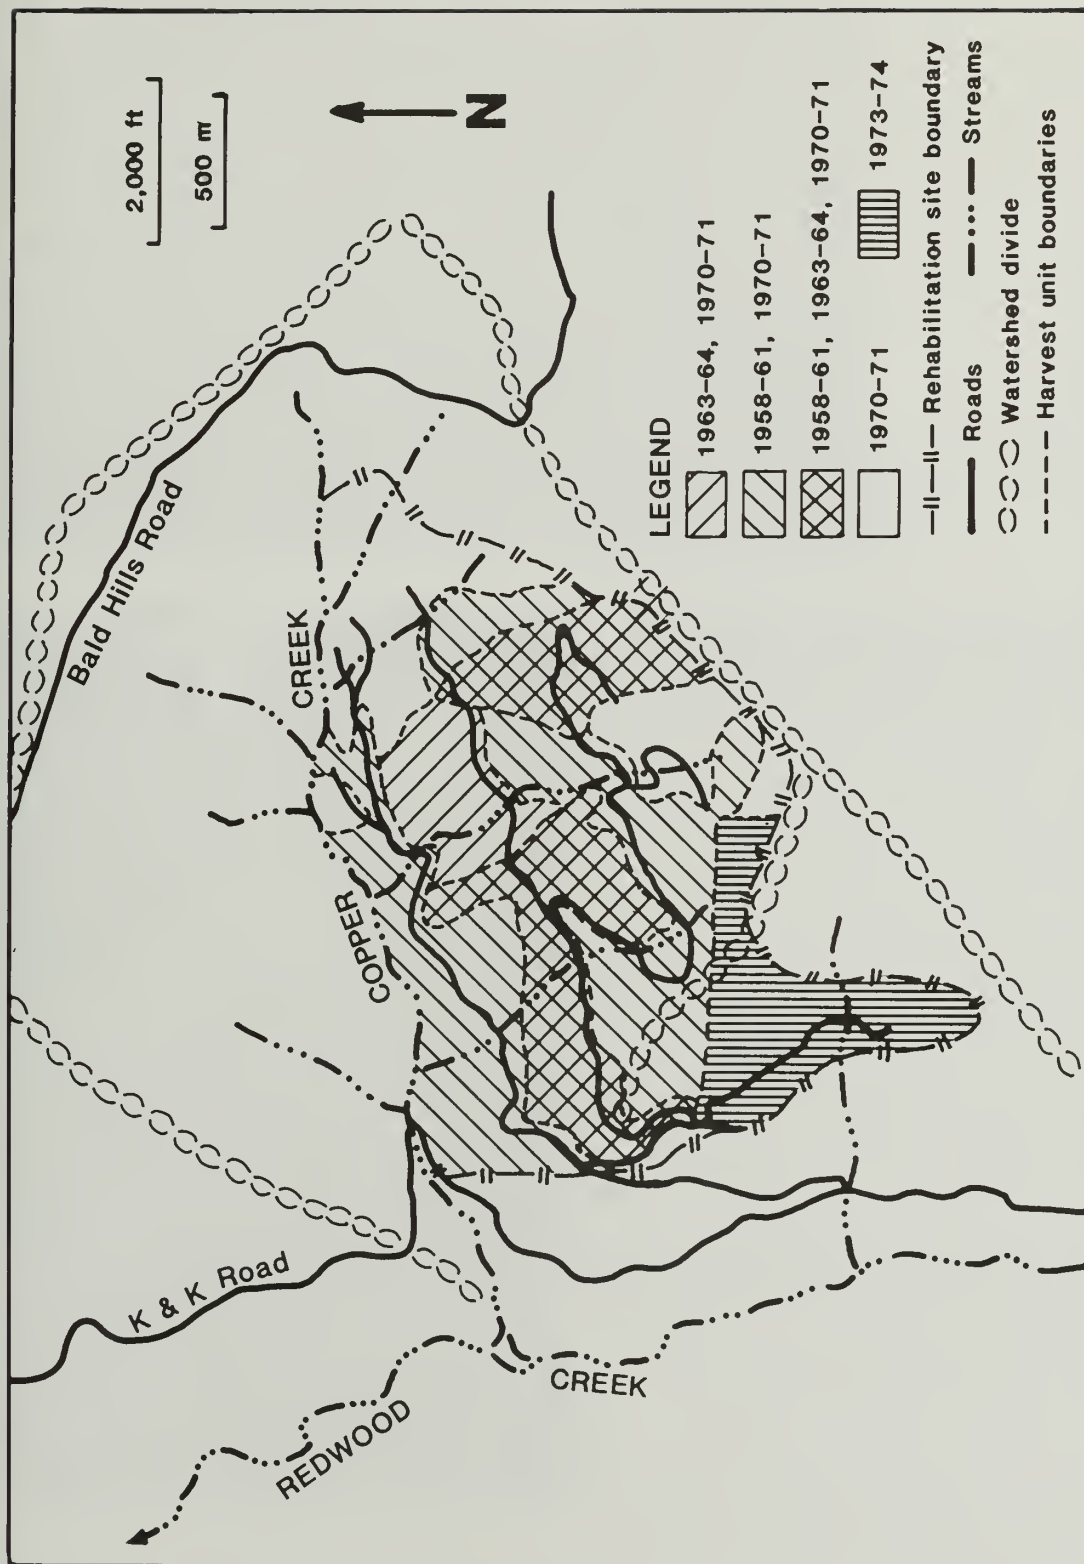
Fig. 45. History of timber harvest and road building on the Copper Creek rehabilitation unit. Note the multiple entry pattern which occurred over most of the area and the widespread clear cutting which was conducted in 1970-1971.

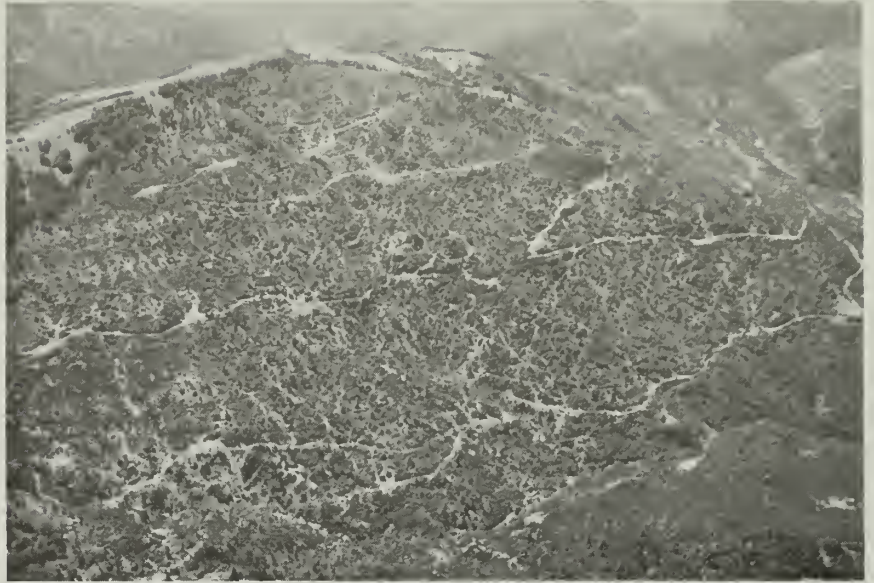
Fig. 46 (above). Oblique aerial photograph of the Copper Creek rehabilitation unit (August 1979). Most areas, except logging roads, major skid trails, landslides and large gullies have revegetated in the decade since the area was last logged.

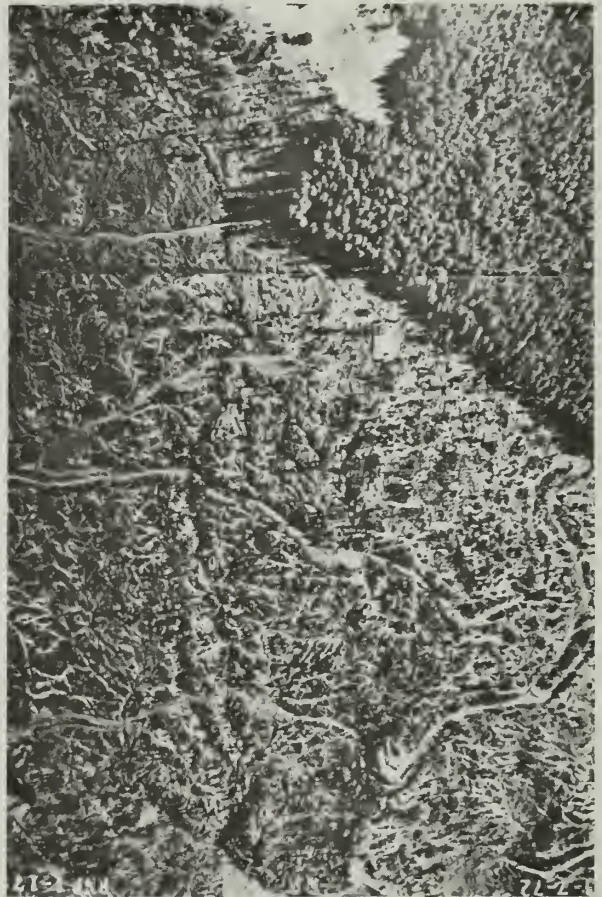
Fig. 47 (right). Vertical aerial photograph of the south west portion of the Copper Creek site just following the 1972 storm and flood. Note the high degree of ground disturbance in the tractor logged areas. The remaining forest in the upper portion of the photo was clear-cut the following year.

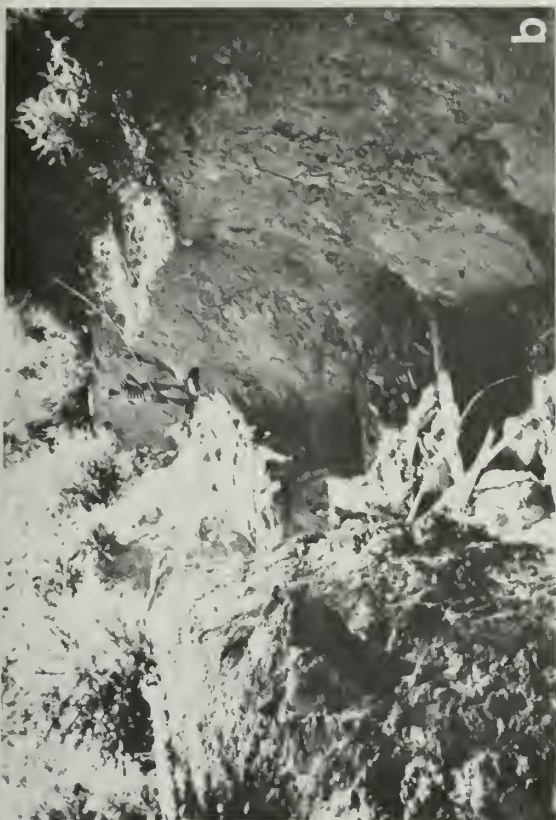
Waterbars or cross-road drains were lacking on most roads and skid trails. Many of these bare areas became severely gullied by concentrated runoff (Figure 49). By 1979, many sections of unstable roads and landings had failed into adjacent stream channels (Figure 50). Approximately 163,000 cubic yards of sediment were eroded and lost from the area between 1964 and 1979 (Weaver and others, 1982).

Fig 49. Examples of gully erosion on the Copper Creek rehabilitation unit. A) partially eroded stream crossing. B) severely gullied skid trail. C) gully headcut on hillside and D) large gully formed by stream flow diverted out of its natural channel at an upslope logging road stream crossing.

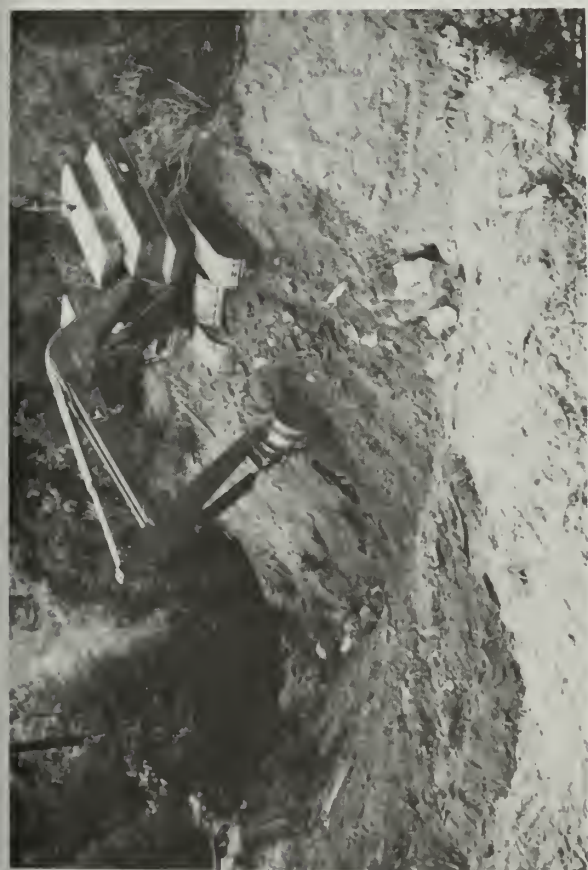
Fig. 52 (above left). Typical stream crossing being excavated by hydraulic excavator.

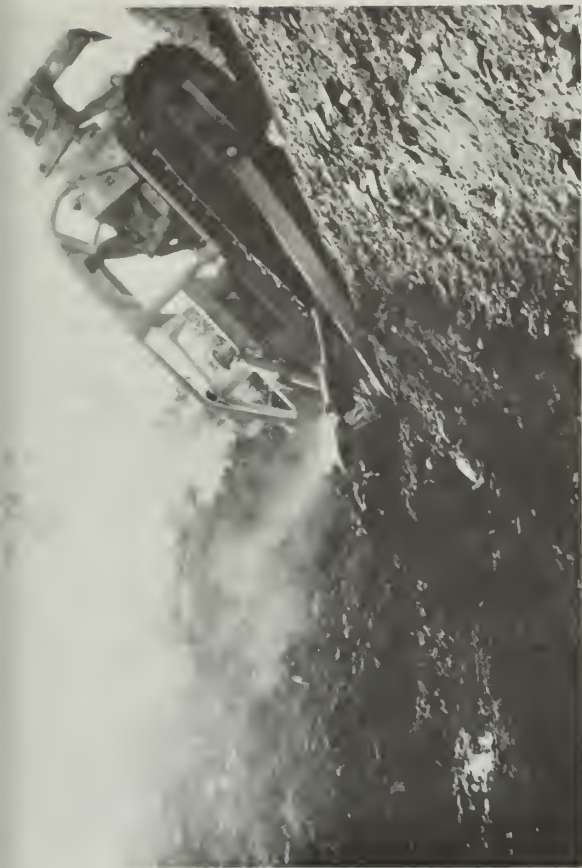
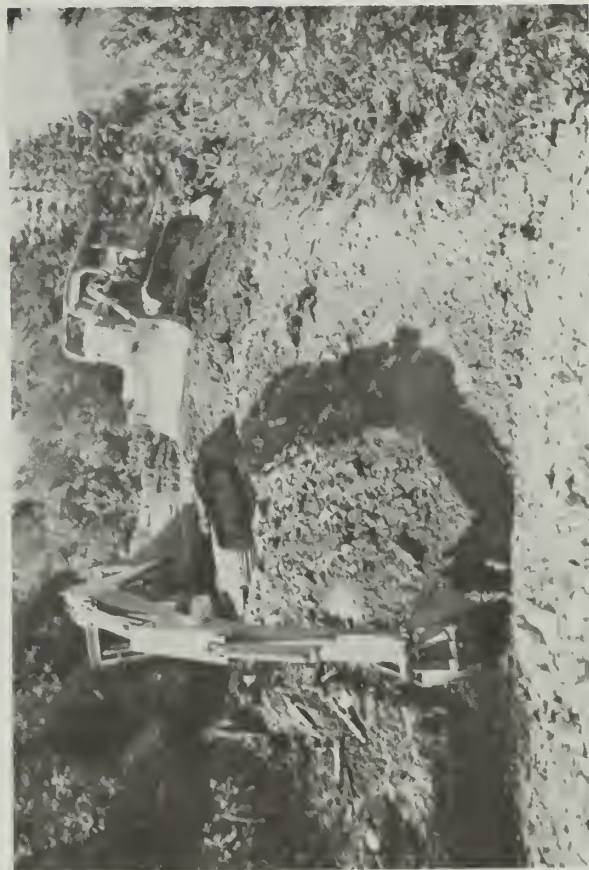
Fig. 53 (above). D-8 sized crawler tractor excavating debris from a stream crossing. As shown here, tractors were used to perform initial excavation work at a number of stream crossing sites. In recent years, many crossings have been entirely excavated using only crawler tractors to both excavate and remove material.

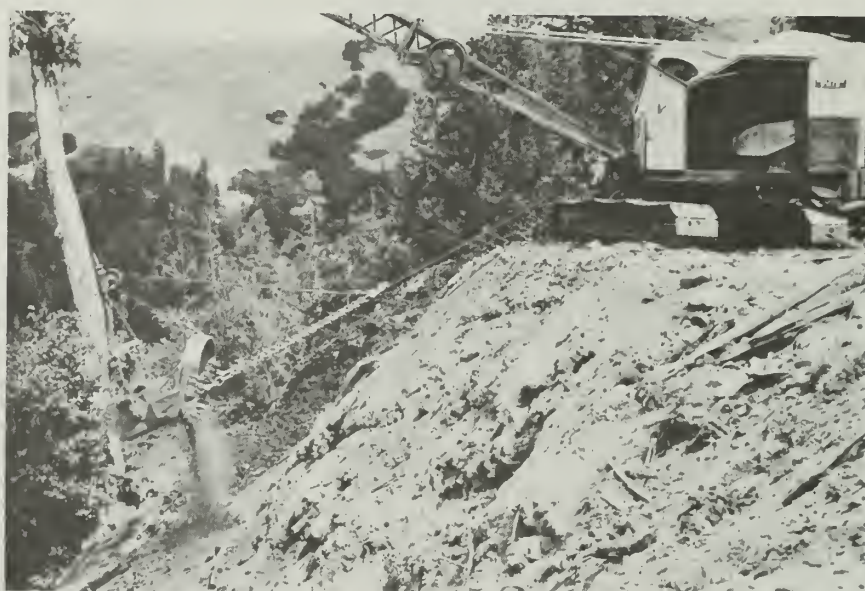
Fig. 55. Dragline crane excavating soil and organic debris from the outside edge of a log landing.

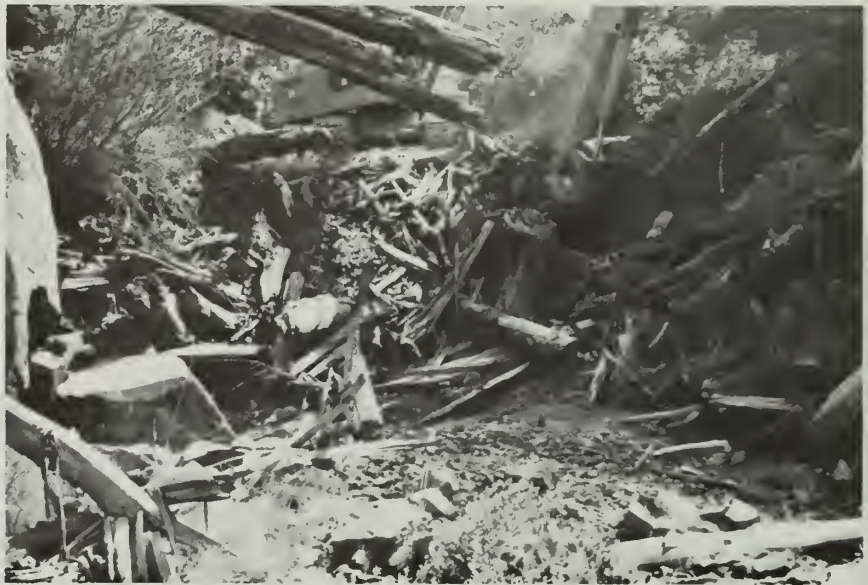
Five percent of the total heavy equipment costs were incurred in removing three log jams in Copper Creek. The log jams were composed of partially rotted saw logs (predominantly Douglas-fir) which were likely to fail and release the sediment stored behind them (Figure 56). Unstable sideslopes were also excavated and the toe of the unstable right bank between the upper and middle log jams was protected with riprap. Excavation and endhauling was done by crane, excavator, both crawler tractors, loader and dump truck (Figure 57). Figure 58 shows morphologic maps of the log jams prior to treatment and three years later.

Fig. 56. View up the Copper Creek stream channel above a three step log jam removed during rehabilitation. Most logs in the jam were cut on at least one end, attesting to their logging origin. The hydraulic excavator is shown working on top of the sediment stored above the log jam.

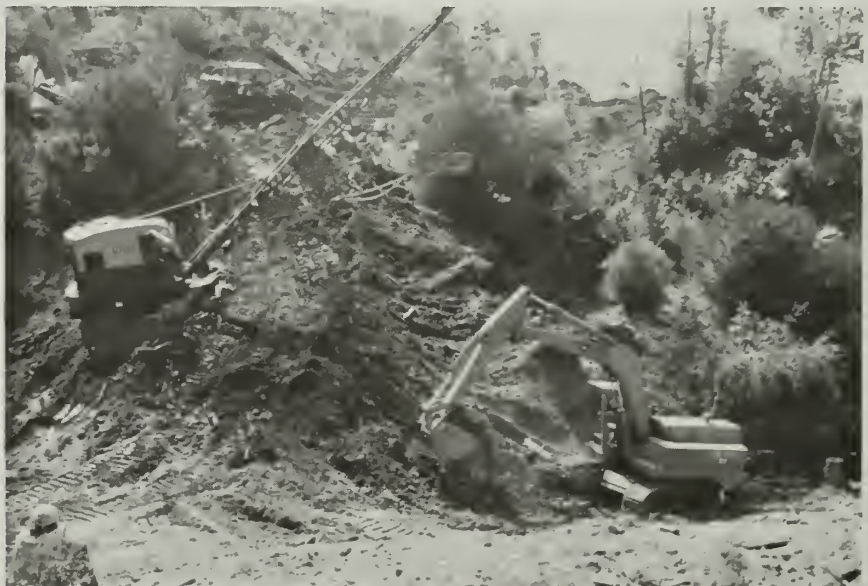
Fig. 57. Hydraulic excavator, dragline crane and crawler tractor excavating and disposing of material stored behind the log jam, Copper Creek.

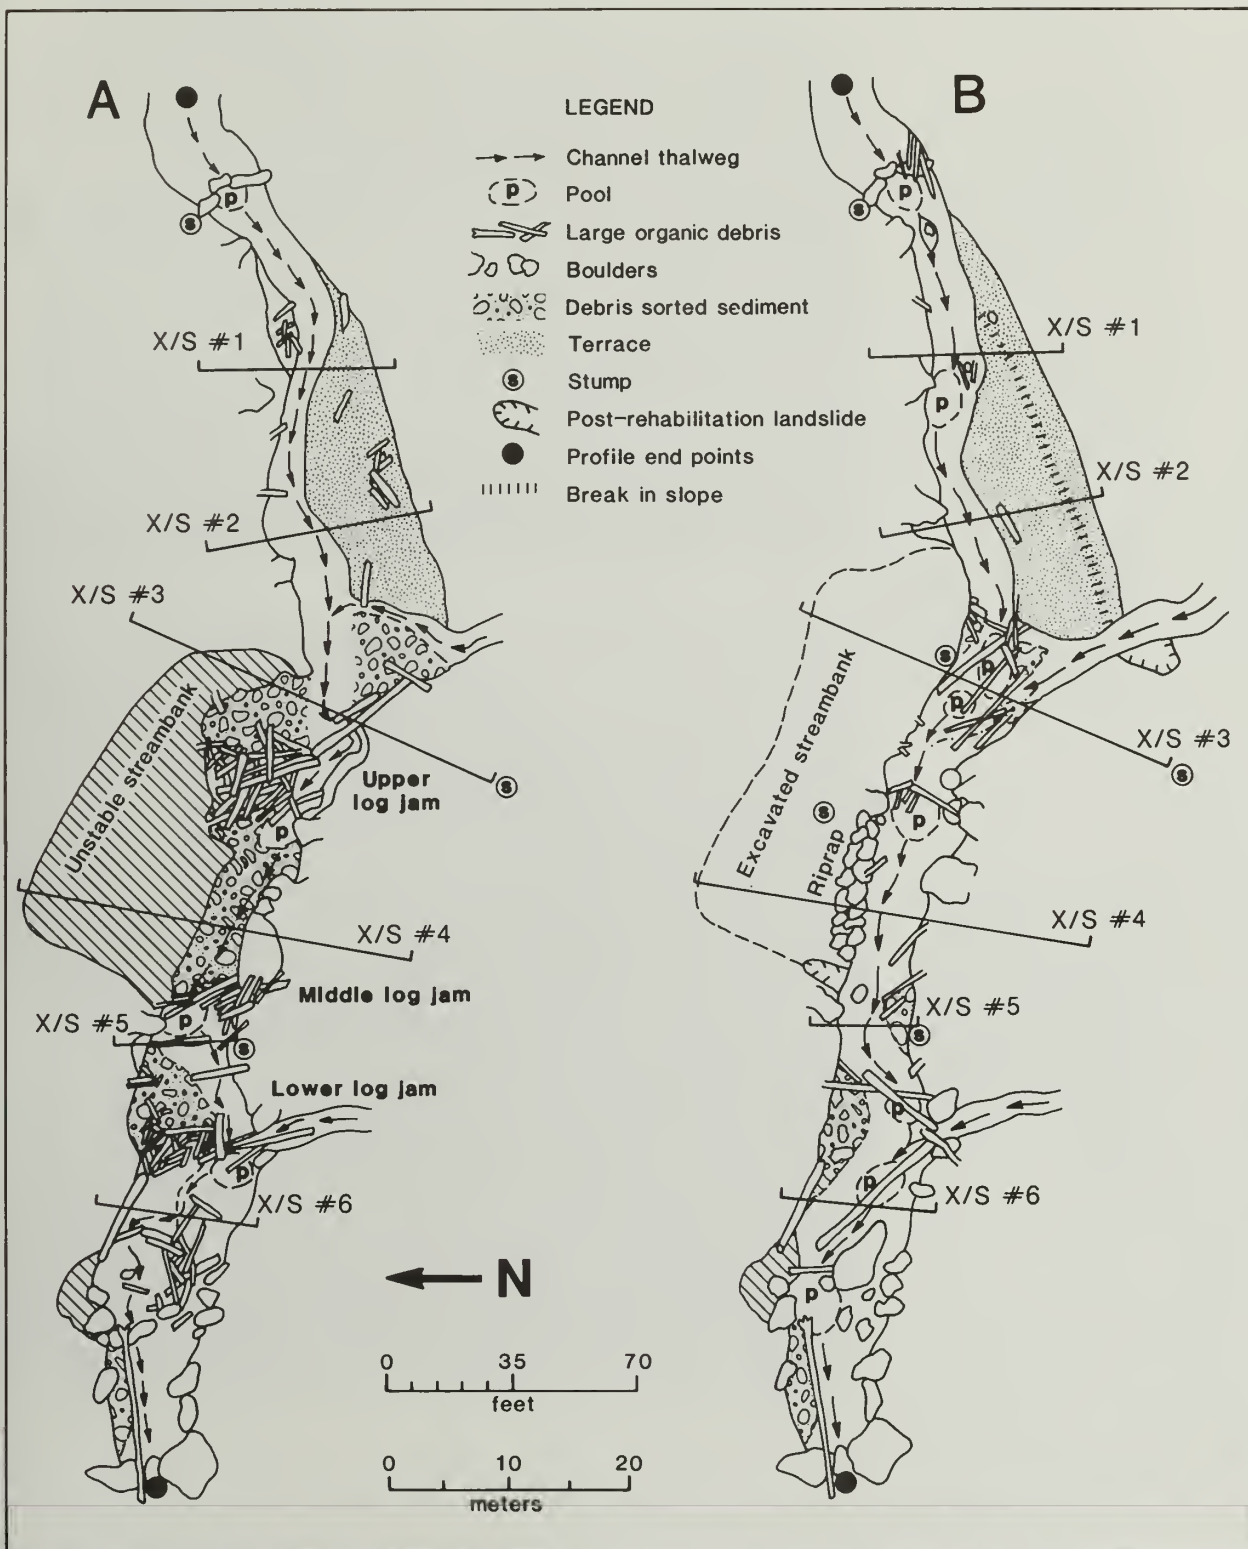
Fig. 58. Morphologic maps of Copper Creek in the vicinity of the log jam. A) before rehabilitation (September 1979), showing the distribution of stored sediment, organic debris and locations of bank erosion, B) after rehabilitation (August 1982) showing the channel adjustments which had occurred in the subsequent winter.

Organic debris and log jams commonly alter the hydraulics of a stream reach causing changes in channel morphology (Pitlick, 1981; Keller and Talley, 1979; Swanson and Lienkaemper, 1978). An abrupt step in the longitudinal profile may form at the log jam with an associated upstream decrease in gradient and increase in channel width. These effects were seen at the Copper Creek log jam worksite. The log jam also caused local hillslope failure by diverting flow into banks and undercutting the toe of an adjacent slope (Figure 58).

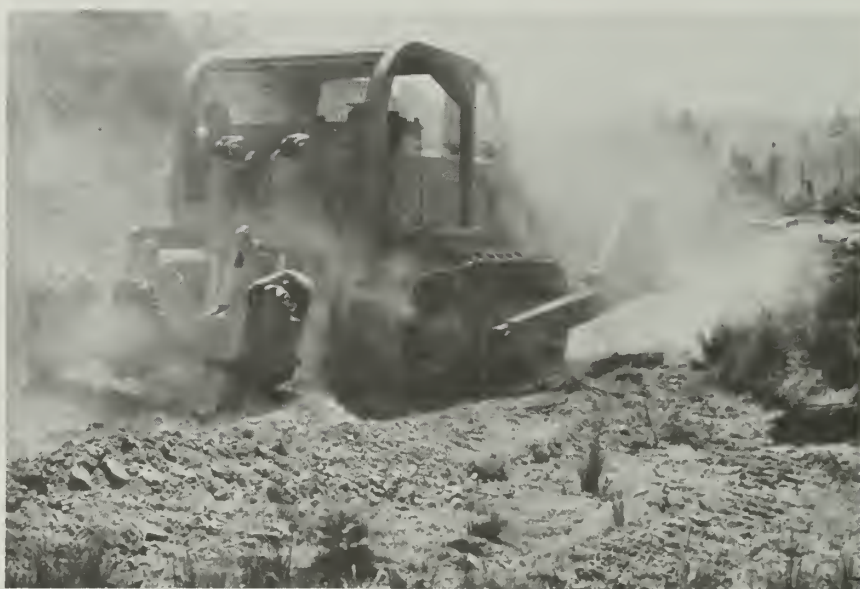
Fig. 59. A large crawler tractor with hydraulically operated three-pronged ripping attachment disaggregated compacted surfaces to a depth of approximately 18 inches. In a number of road reaches, ripping was the only rehabilitation treatment utilized.

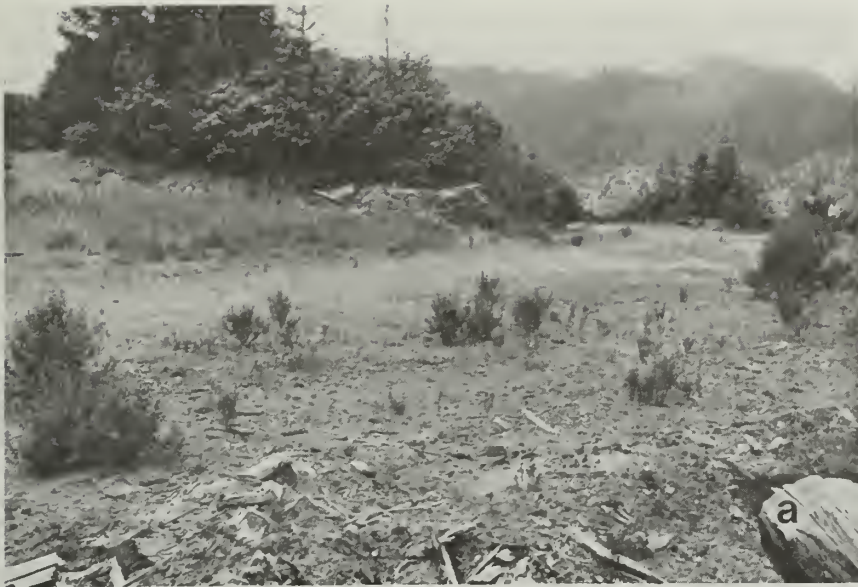
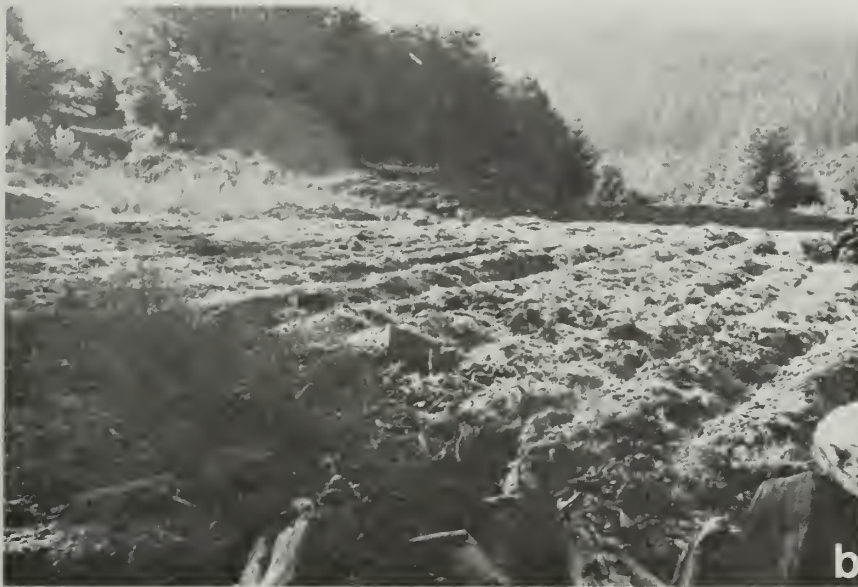
Fig. 60. Ripping a log landing on the Copper Creek rehabilitation unit. A) before disaggregation (May 1979) — note the sparse vegetation invasion of the compacted road surface in the ten years since the road had last been used; B) after ripping and the application of a straw mulch (December 1979).
