AN EVALUATION OF EXPERIMENTAL
REHABILITATION WORK,
REDWOOD NATIONAL PARK

TECHNICAL REPORT
JULY 1987

Redwood National Park Watershed Rehabilitation
Technical Report Number 19

National Park Service
Redwood National Park
Arcata, California
July 1987

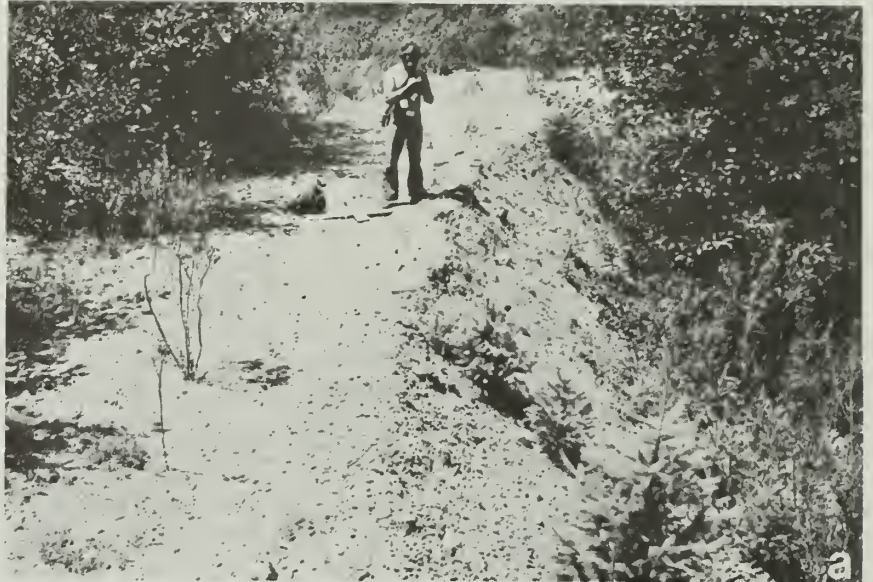
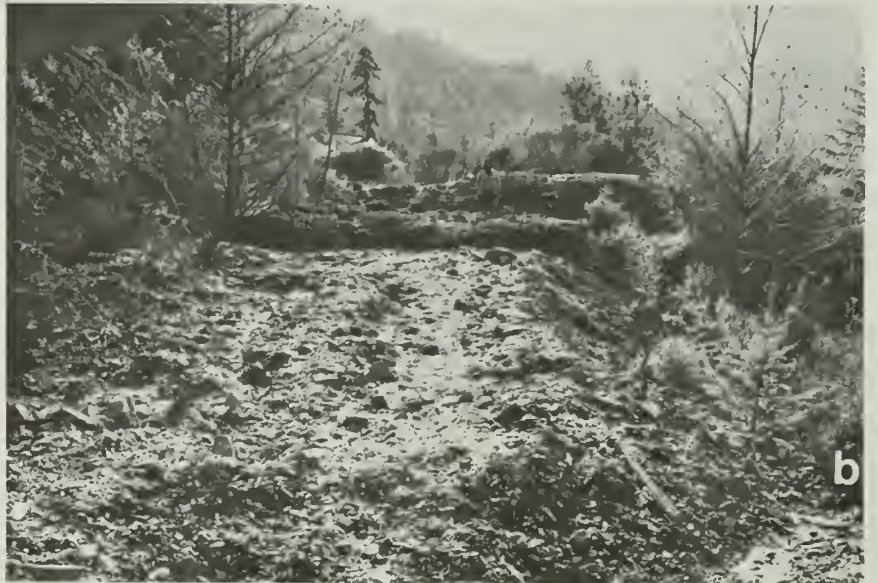
Fig. 61. Rehabilitation of a secondary logging road. A) after ten years of abandonment, but prior to rehabilitation treatments — note lack of re-vegetation on the road surface; B) immediately following road ripping and construction of cross road drains. Decom-acted road has also been lightly mulched with straw.

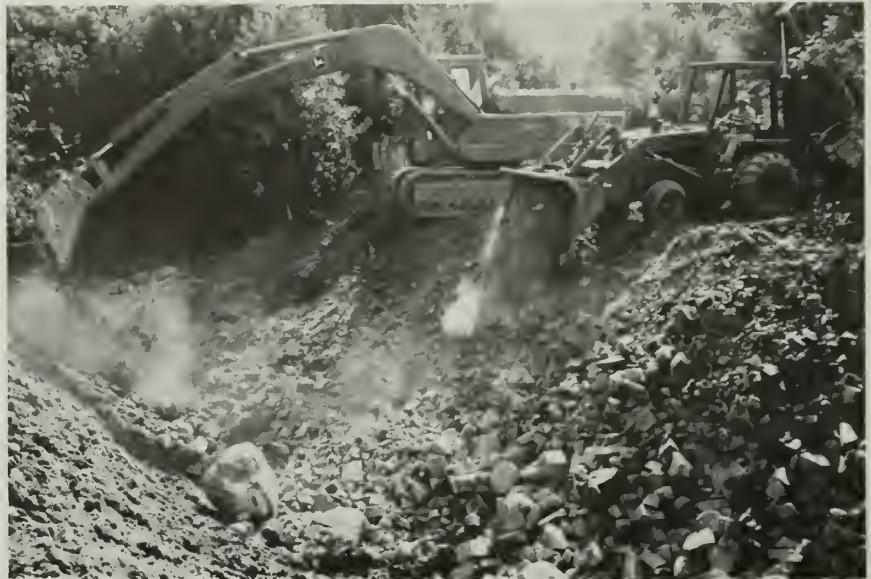
Fig. 62. Rock armor being placed in excavated stream crossing by excavator and loader. Rock used to protect newly excavated stream channels was derived locally for some crossings and from the Copper Creek rock pit for others (see Figure 51).

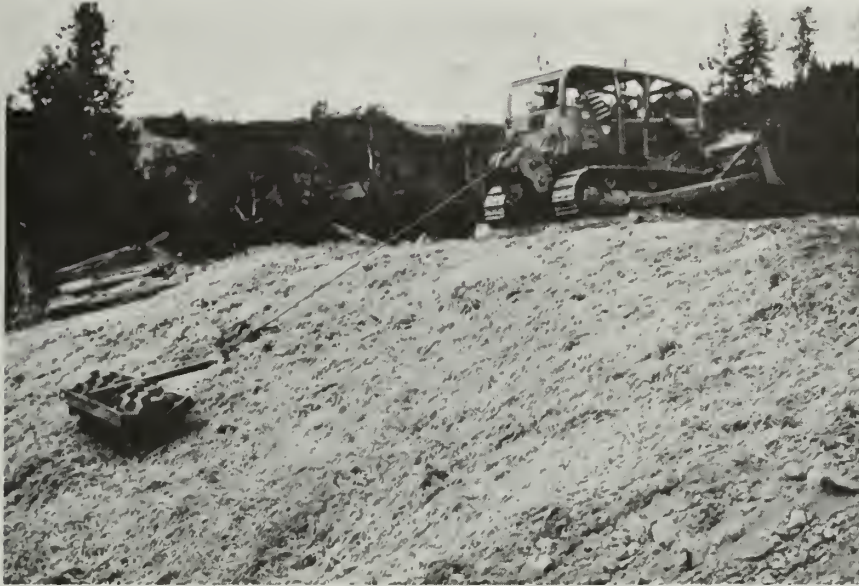
Fig. 63. Spiked roller used to punch straw into loose soil on steep, newly exposed slopes. An alternate treatment used on steep, inaccessible slopes elsewhere was the application of jute netting over the straw mulch (for example, see Bridge Creek Unit 79-2).

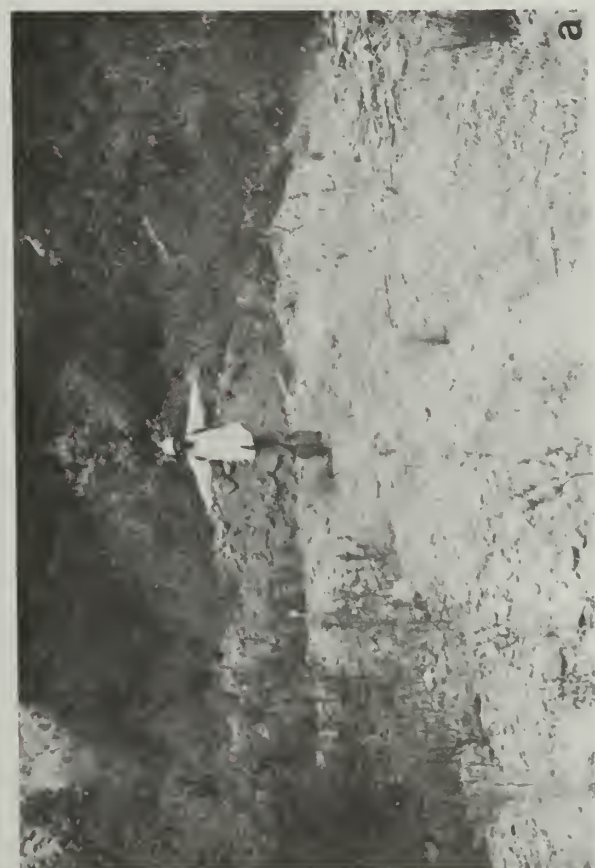
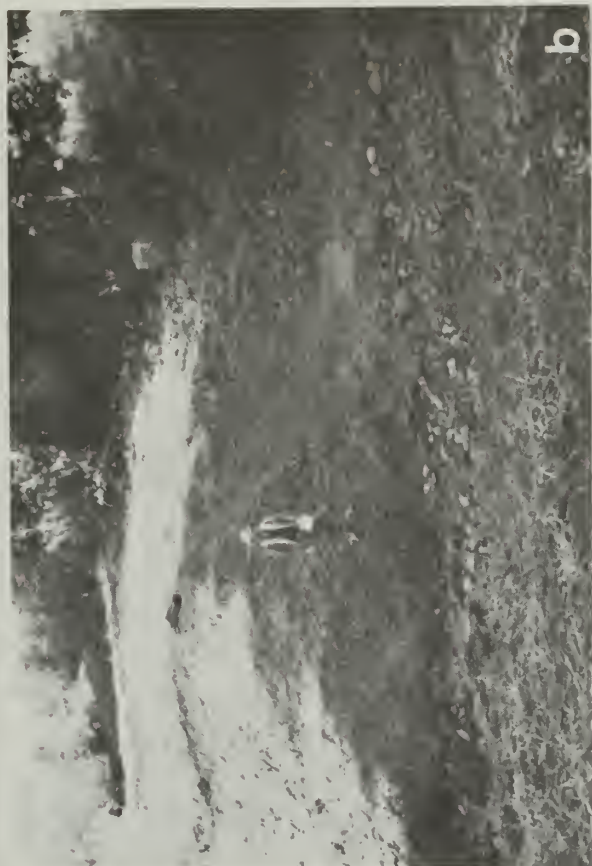
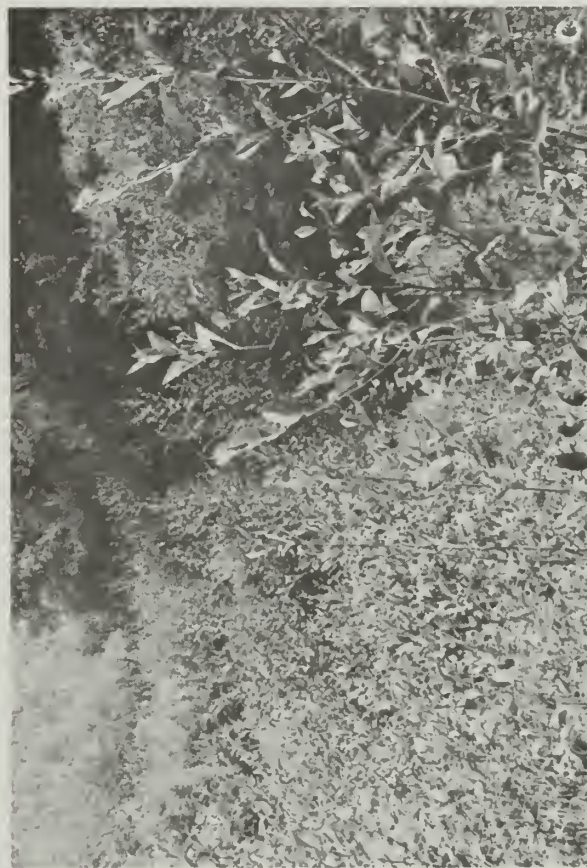
Fig. 64. Successful, minor stream crossing excavation. A) gullied stream crossing on abandoned logging road (August 1979); B) excavated crossing after several storms; note the low channel gradient, gentle side slopes and minimal widening (scour) of the channel bed (December 1979); C) same view after approximately four years, note the rapid, natural invasion of alder on the decompacted road surface (September 1983).

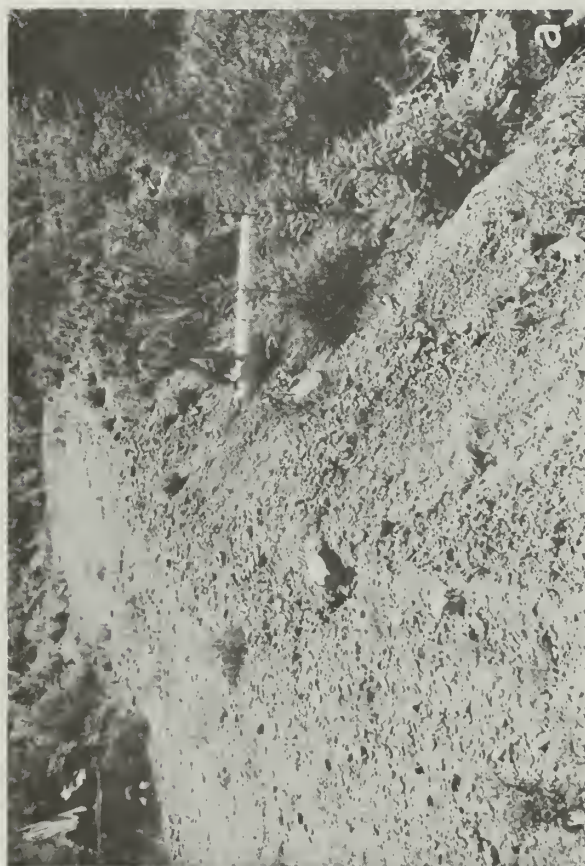
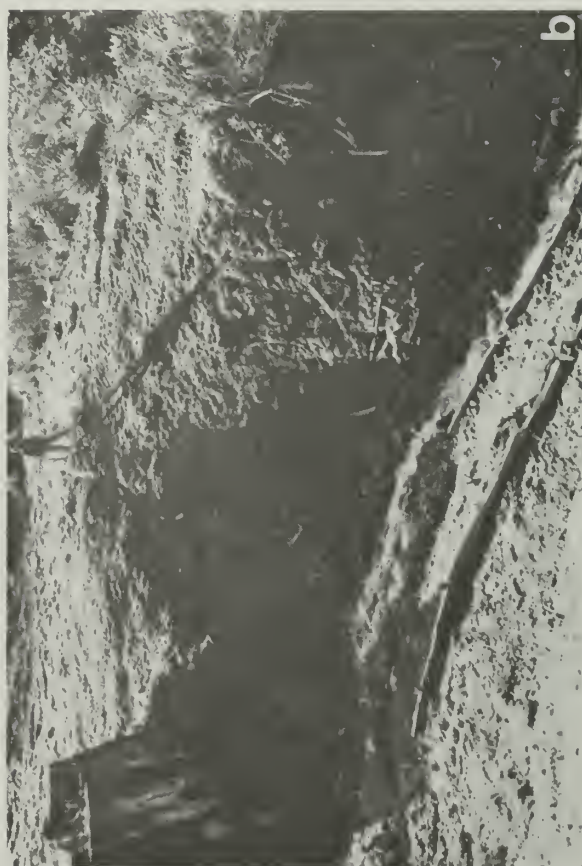
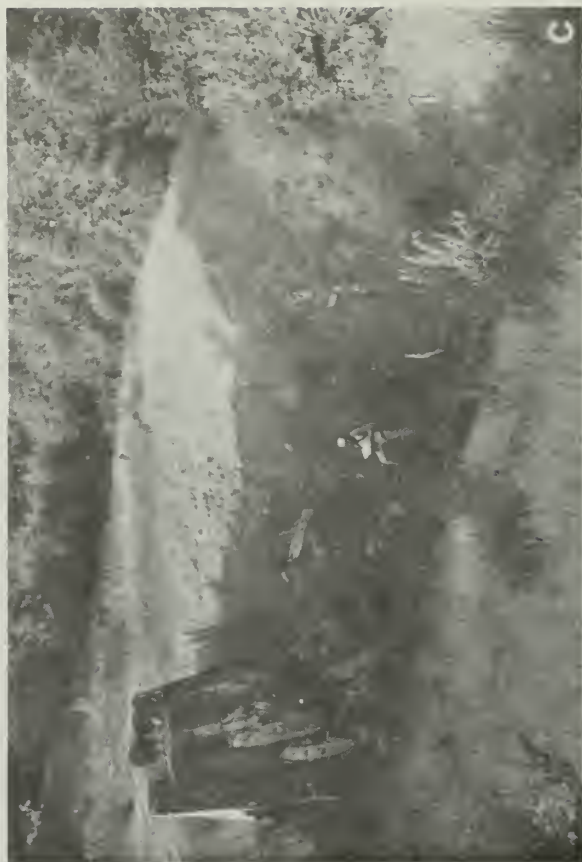
Fig. 65. Successful, major stream crossing excavation. A) intact crossing prior to rehabilitation work, note workers standing on the culvert inlet and outlet, and largely unvegetated road surface; B) same view of crossing taken immediately following excavation work; note the basal flair on the exposed redwood stump which indicates the original ground surface (stream channel bottom) was successfully exhumed; C) same crossing after three and one-half years; because the channel was excavated down to the original ground surface, there has been little erosion of the streambed following rehabilitation.

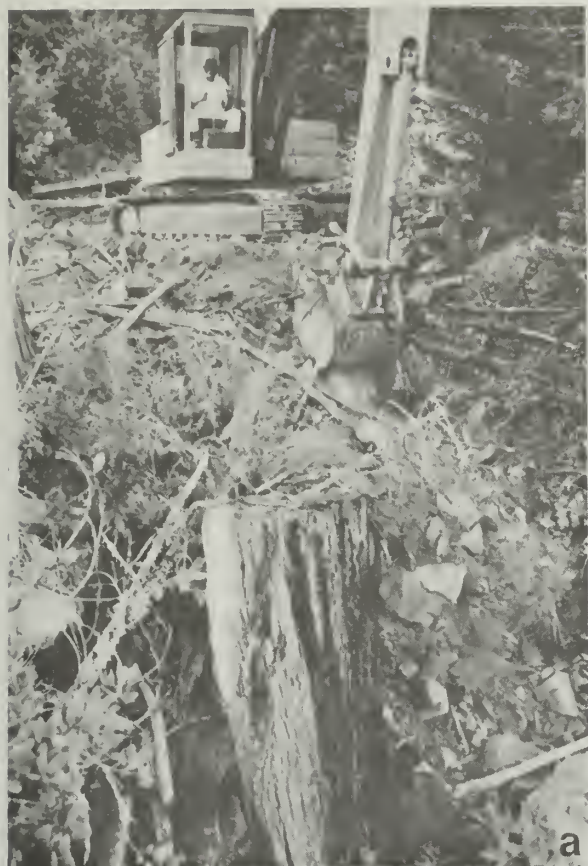
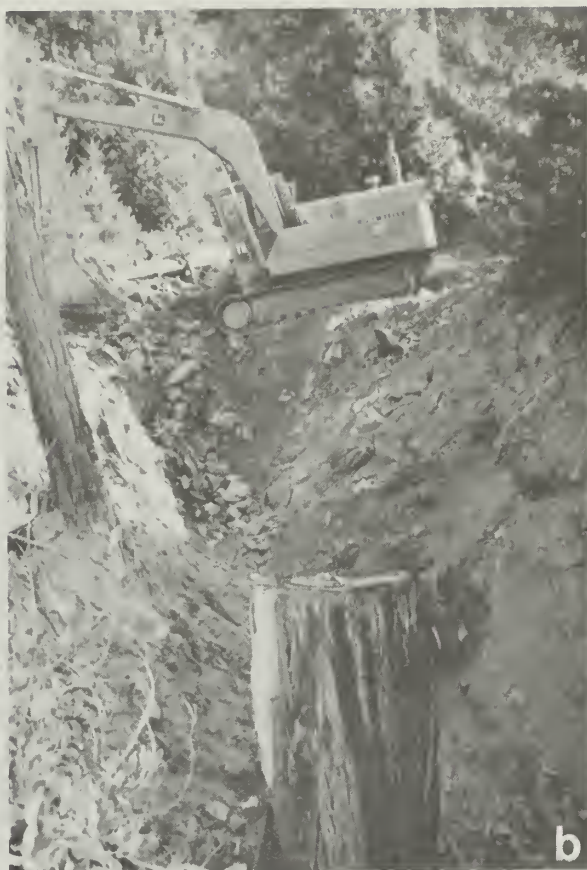
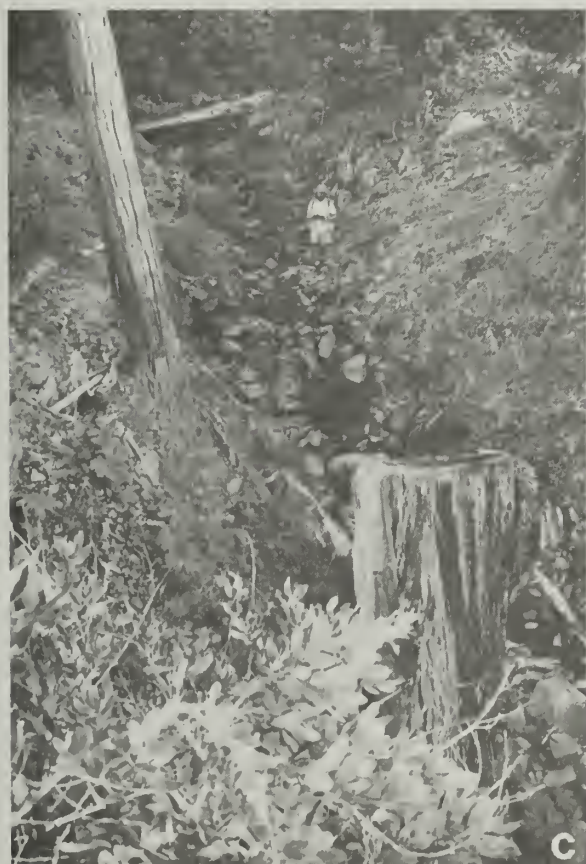
Fig. 66. Excavation of logging road stream crossings using a hydraulic excavator. A) initial excavation of the outboard edge of the crossing is done while the excavator sits on the road surface; B) as the former bed and banks of the stream channel are exhumed or reconstructed, the excavator moves to one side and passes material onto the road surface directly behind it; C) same crossing after approximately four years, note minor channel adjustment and the lag deposit of coarse rock armor which has developed in the streambed.

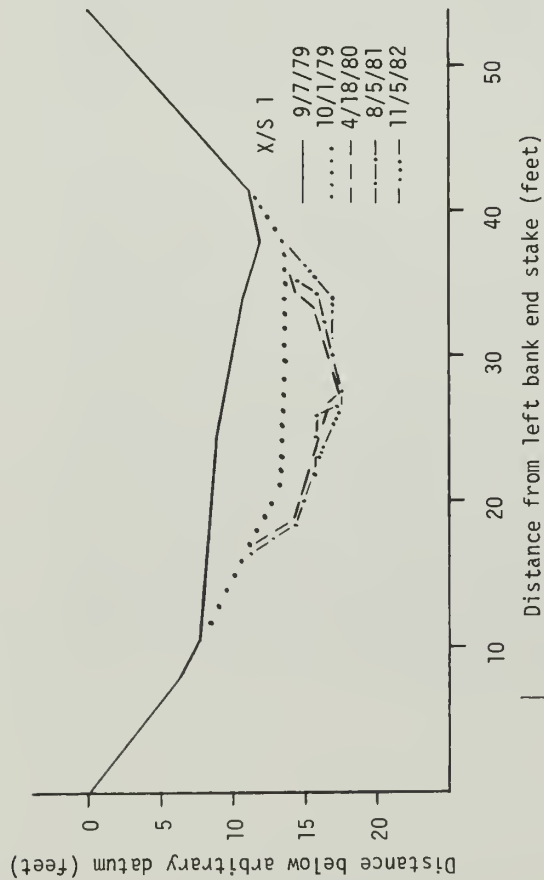
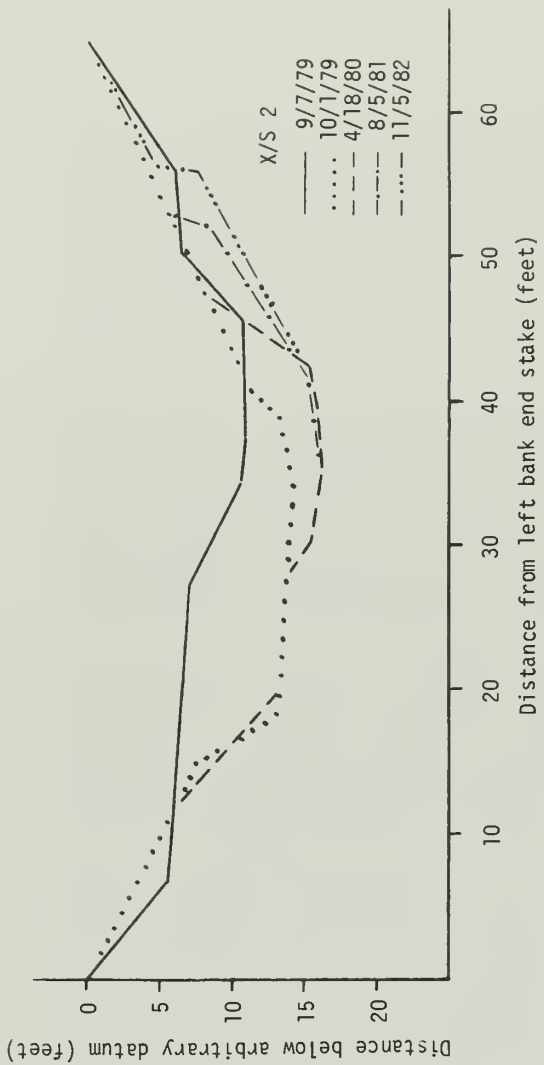
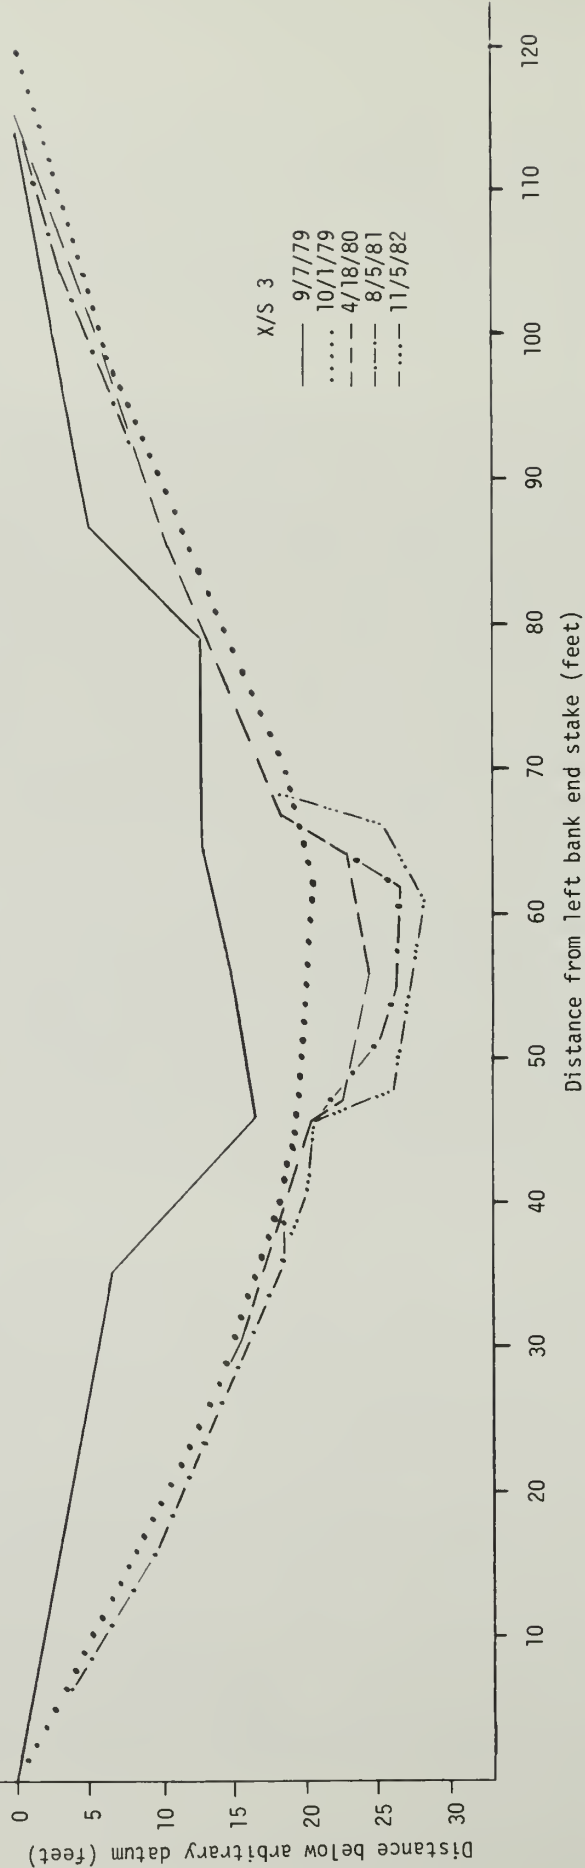
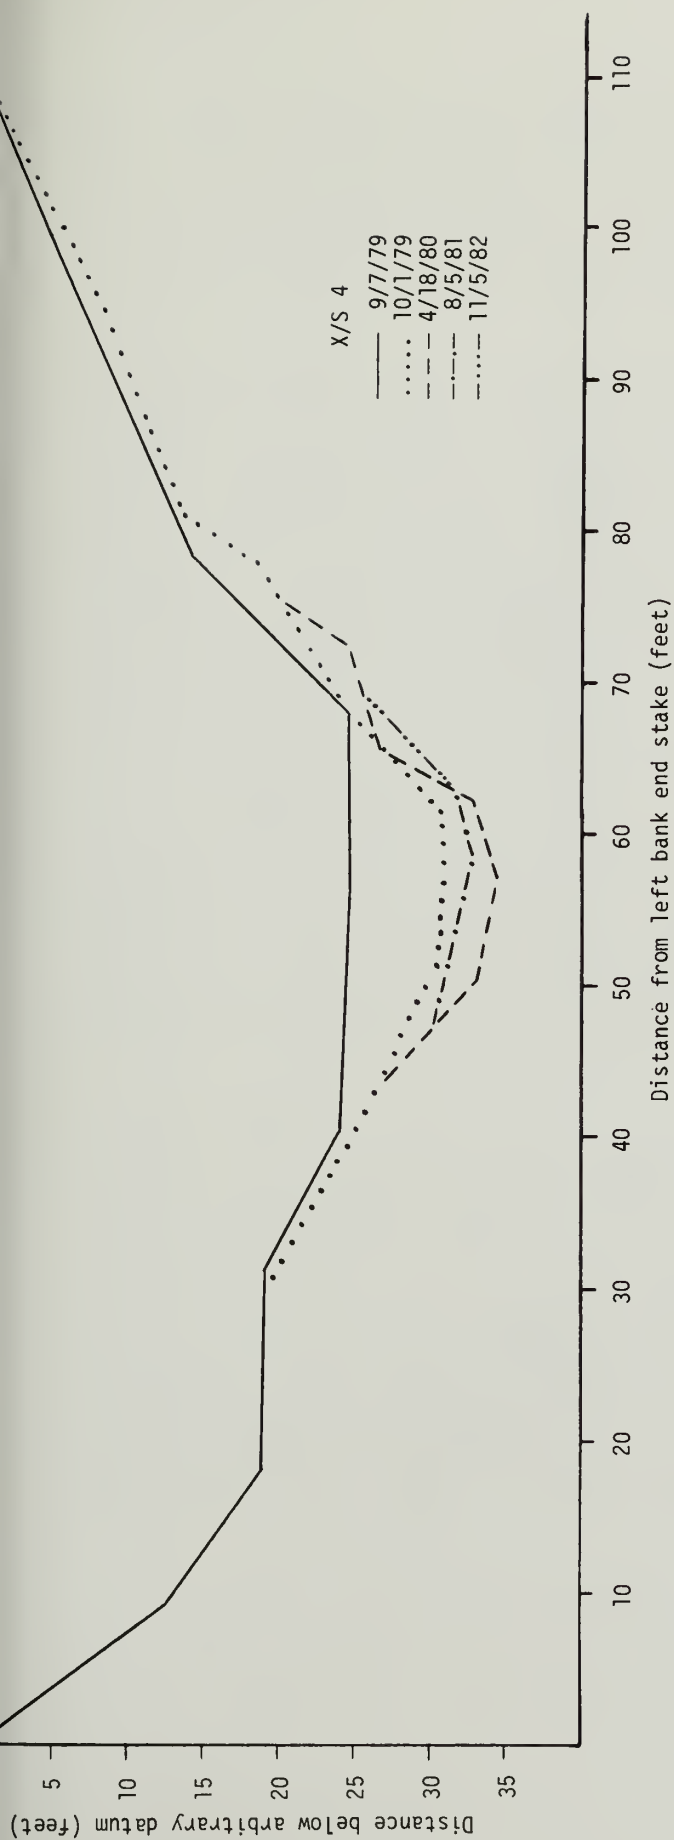
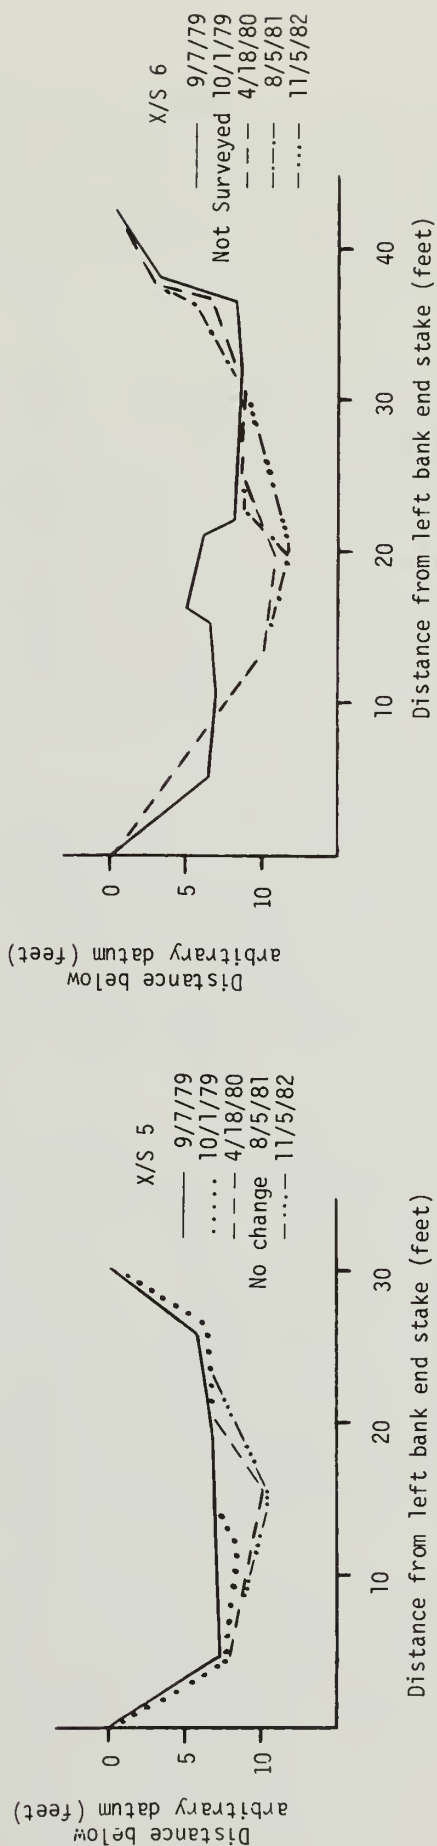
Fig. 67. Six channel cross-sections of Copper Creek at the site of the excavated log jam. Cross-sections were measured prior to log jam removal (September 1979), immediately following heavy equipment operations (October 1979) and once during each of the following three years (April 1980, August 1981, November 1982).

As a result of the 1980 winter storms, an additional 560 cubic yards were eroded from the site. Most of the bedload loss was associated with channel scour from increased flow velocities on the unprotected loose sediment within the excavated stream reach. During the following winter (1981) an additional 60 cubic yards were eroded (Figure 69). Most of this occurred near cross-sections 2 and 3 where an average of 2 - 4 feet of bank erosion was detected (Figure 67).

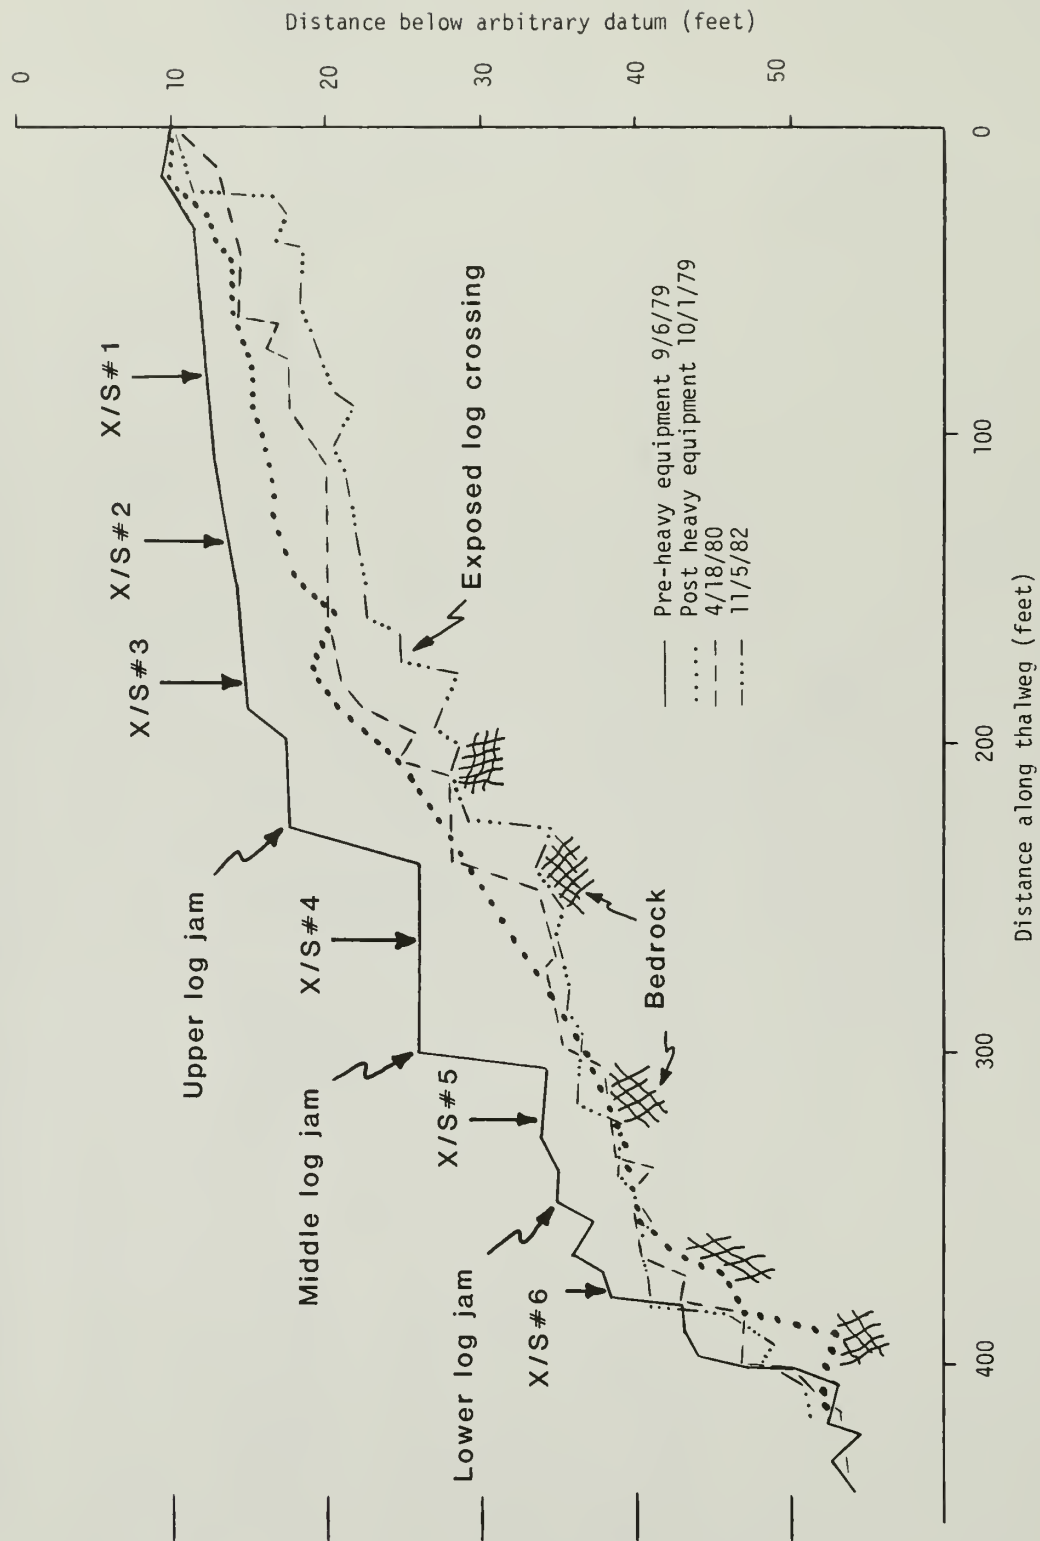
Fig. 68. Longitudinal profiles of Copper Creek at the log jam removal site. The four profiles show the trace of the channel thalweg before log jam removal, immediately following heavy equipment work and once during each of the following two years.

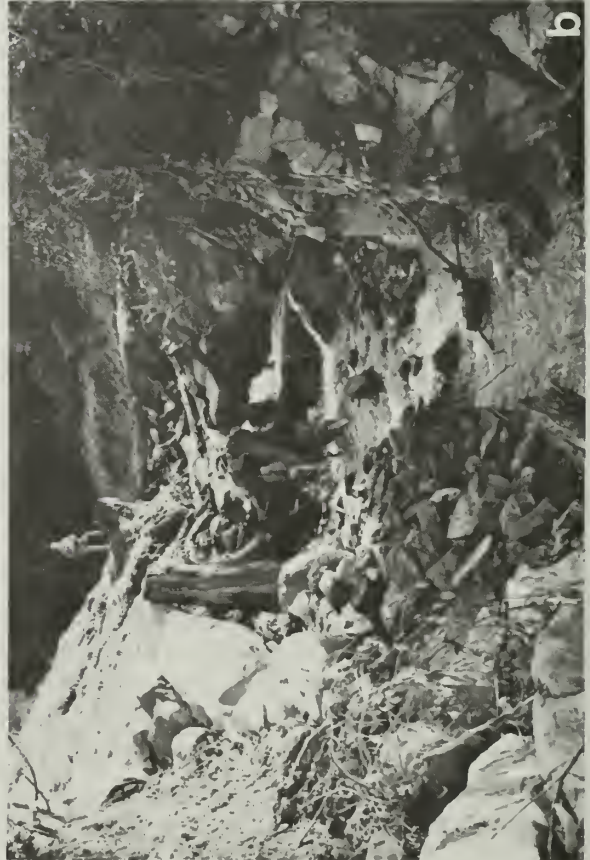
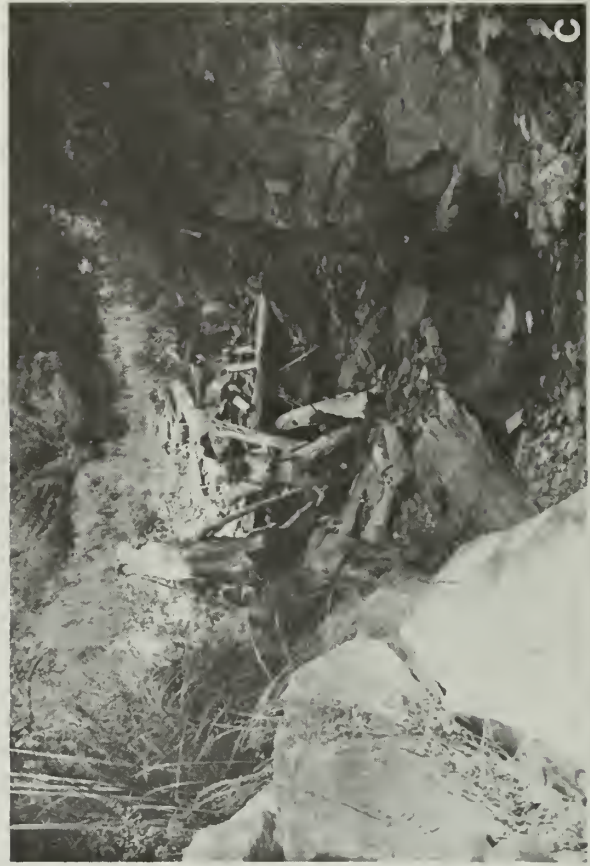
Fig. 69. Channel view from the top of the middle log jam step, looking upstream at the upper log jam step. A) before treatment, large quantities of sediment stored in the channel behind the middle step (foreground) have partially buried the base of the upper log jam; B) same view following the first winter after treatment, note the rip rap placed against the right bank (left of photo) and the nickpoint forming where additional organic debris is being exhumed; C) three years following log jam removal (September 1983) note the persistent step in the channel profile created by the remaining organic debris (this step is graphically shown at station 250 feet on Figure 68).

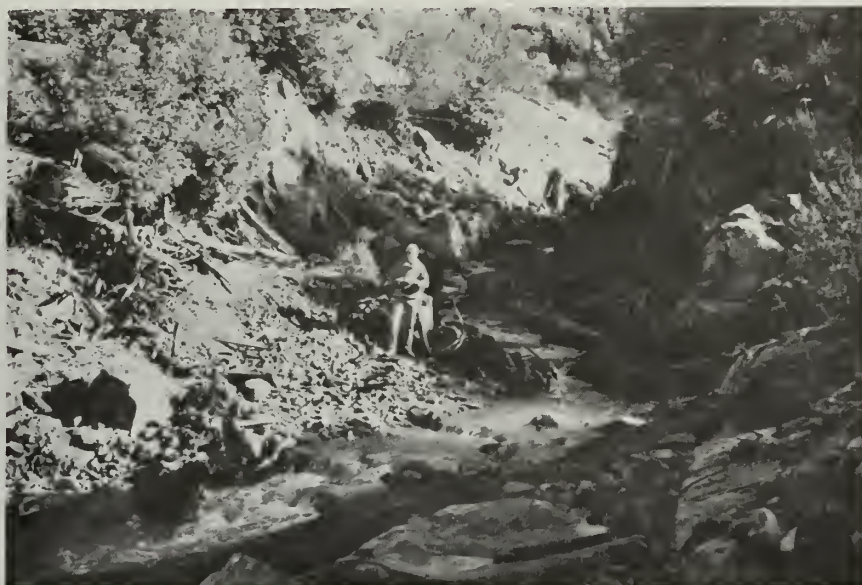
The change in erosional mechanisms from channel downcutting to channel widening was predictable. By 1982, in-place, stream-bed boulders were being exhumed throughout much of the log jam reach (Figure 70). The increase in particle size (roughness) coincided with the exposure of stumps whose basal flair indicated the stream channel was nearing its original grade. With the exception of the upstream migration of a few knick points in the channel profile (Figures 68 and 69), the dominant response to increased discharge was channel widening (Figure 67). The excavated, unstable hillslopes along the right bank (Figure 58) remained intact through November 1982. The primary objective of stabilizing the adjacent hillslopes through removal of the log jam was attained. Total cost for log jam removal including riprapping, was \$10,250, averaging \$6.00 per cubic yard of material excavated.

Fig. 70. Exhumed cobbles and boulders in the treated reach between the middle and upper log jam steps, Copper Creek. Within the first two years following channel clearance, the stream had downcut and widened several feet and exposed stable boulders in the bed of the original channel.

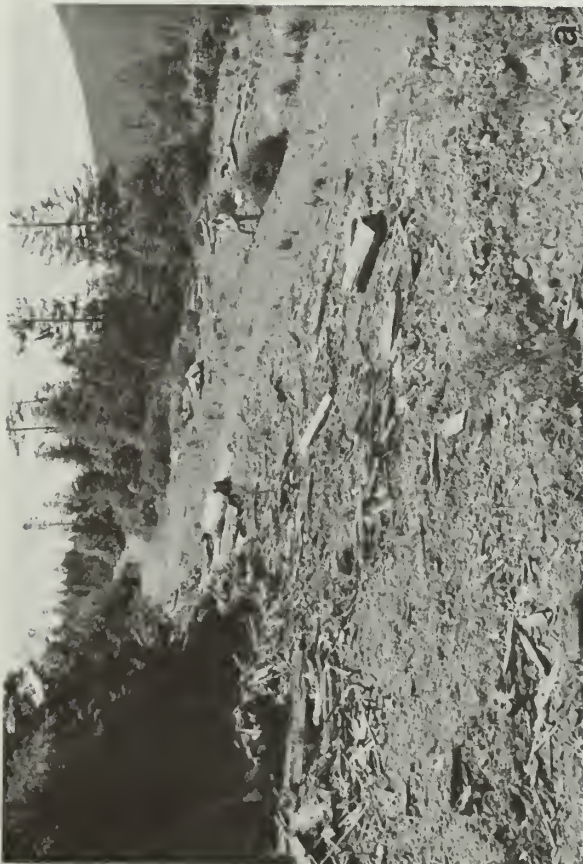
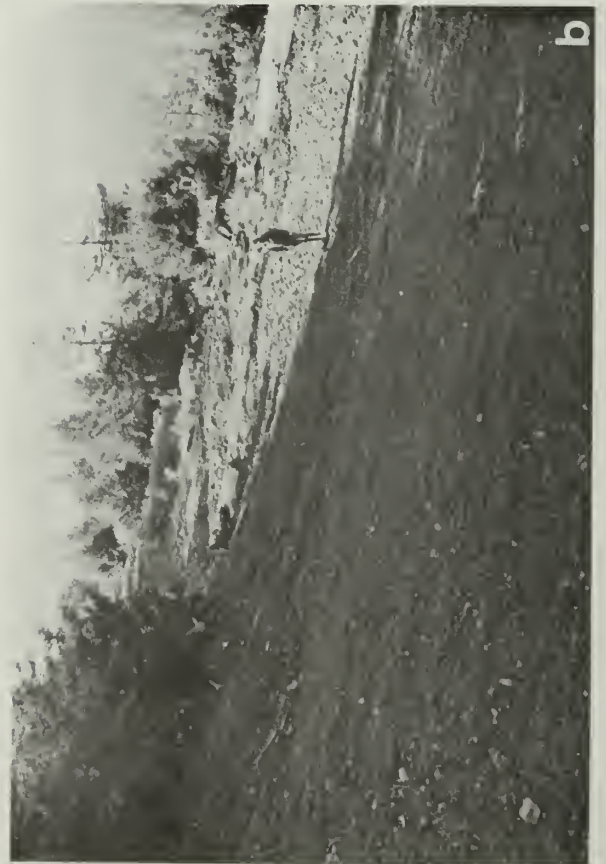
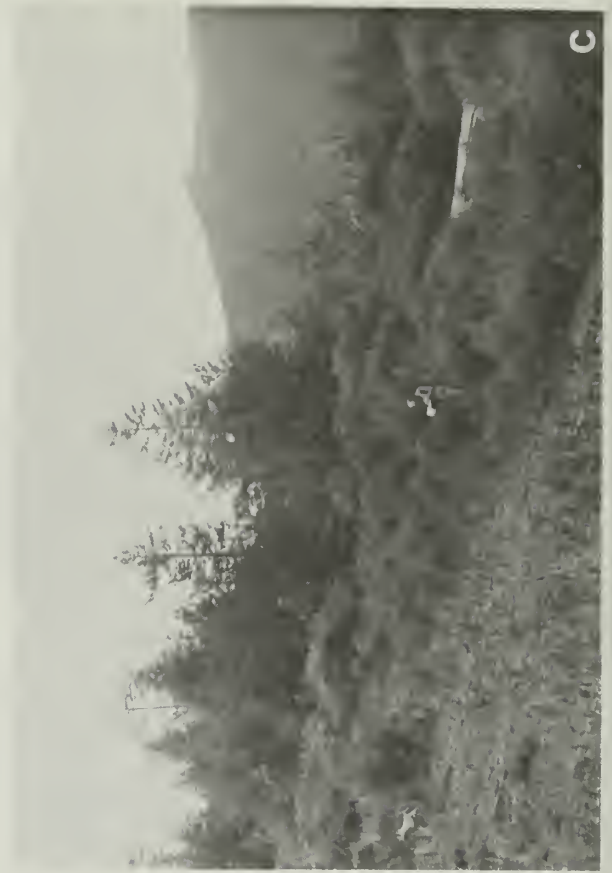
Fig. 71. Natural revegetation of a decompacted road surface. A) before rehabilitation, the former road surface showed little natural revegetation in the 10 years following its abandonment; B) same area immediately following decompaction and outslipping (November 1979); C) four years later (September 1983) the site has been covered with naturally invading coyote brush. Revegetation of this hot, dry southwest facing slope contrasts sharply with the cool moist areas in Bridge Creek (unit 79-2) which were invaded by rapidly growing alder.

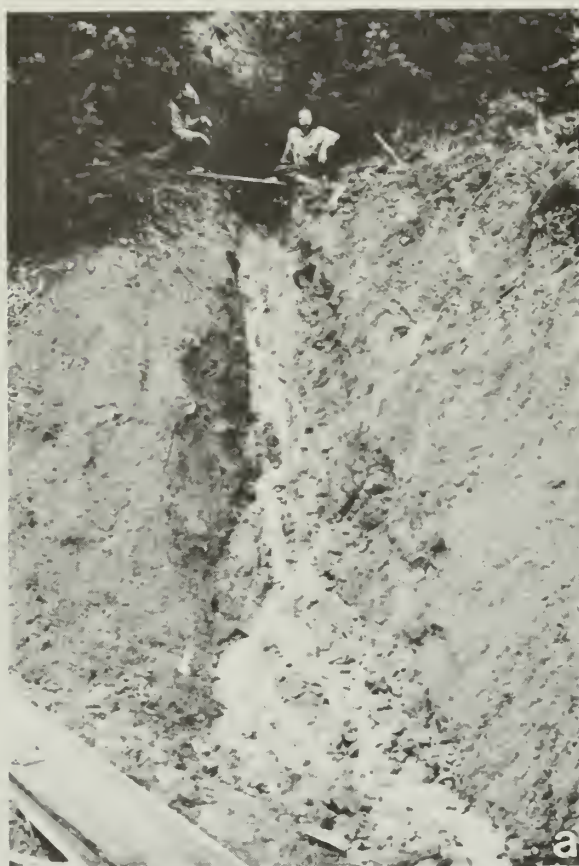
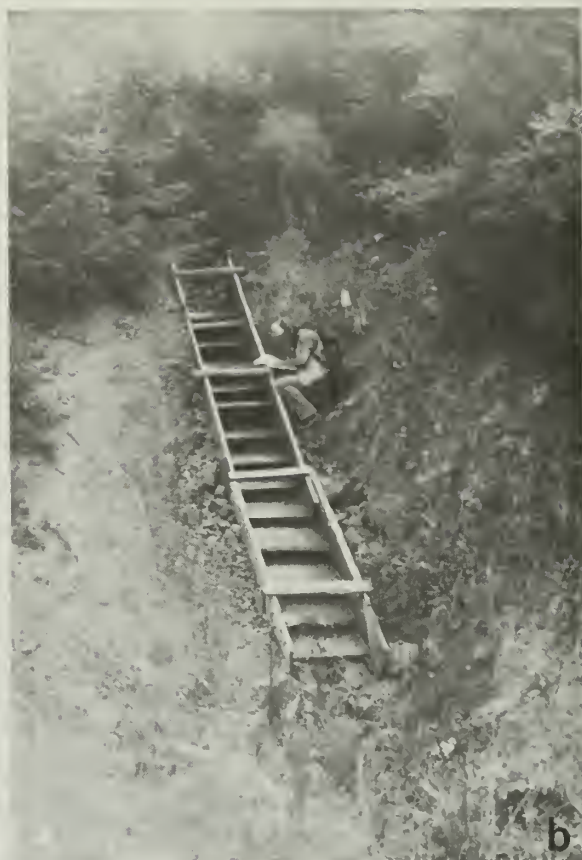
Fig. 75. Water ladder constructed at worksite 9, on the 1930 road, in the upper Copper Creek contract area (see Figure 72). A) before construction, runoff flowing down a former skid trail and over a steep cut bank was causing gully erosion and filling the inboard ditch of the abandoned logging road; B) since the water could not be diverted off the trail, a water ladder was constructed to carry the flow over the erodible bank.

Other in-channel treatments. In-channel treatments other than rock armor totalled four percent of the labor intensive costs. Notched logs, knickpoint plugs and the waterladder were still functioning properly after four winters, but all will deteriorate and eventually fail. Checkdams and waterladders are comparatively cost-ineffective (Weaver and others, 1982) for correcting erosional problems but are used as temporary measures while vegetation is becoming established.

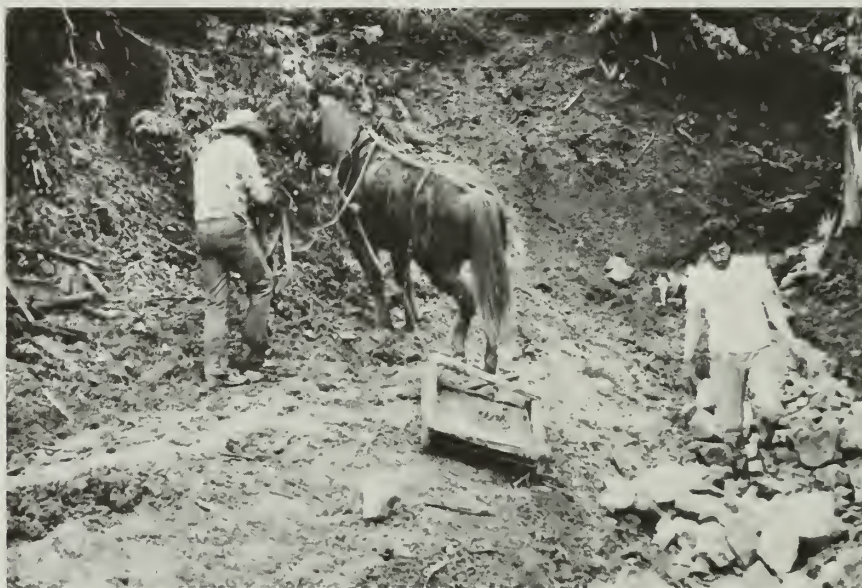
Fig. 76. Horses and sleds moving rock for stream crossing armoring in the middle Copper Creek contract area. The rocks were then placed in the channel by hand. In the smaller streams, hand-placed rock armor was generally successful in controlling post-rehabilitation erosion.

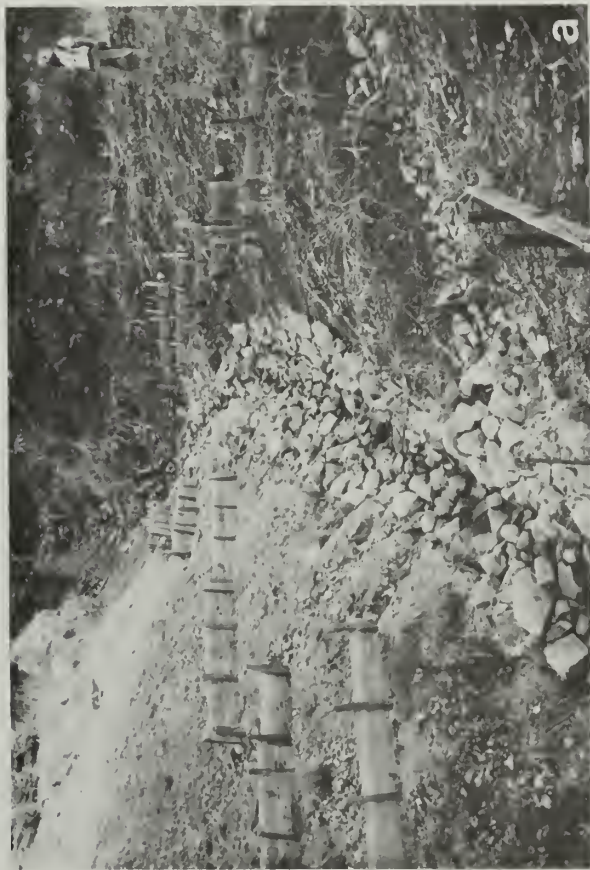
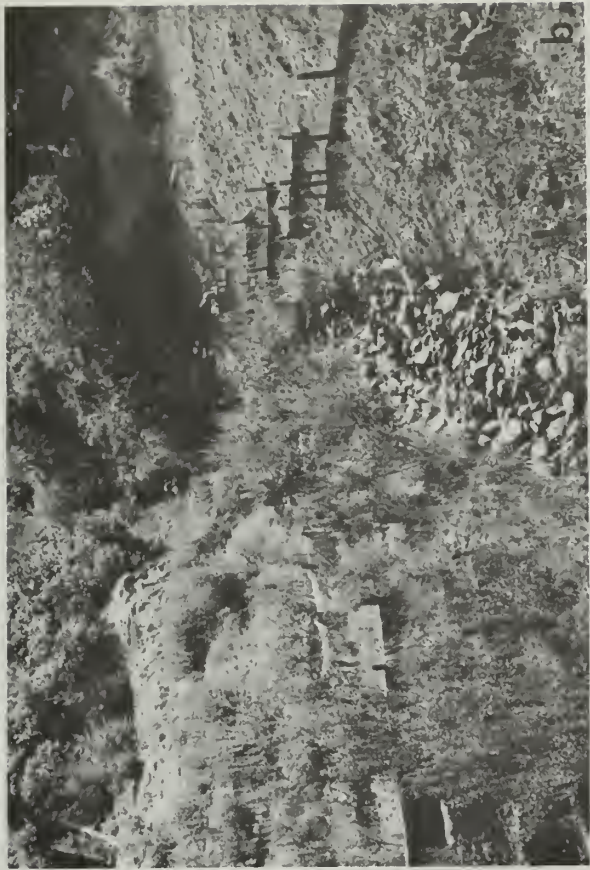
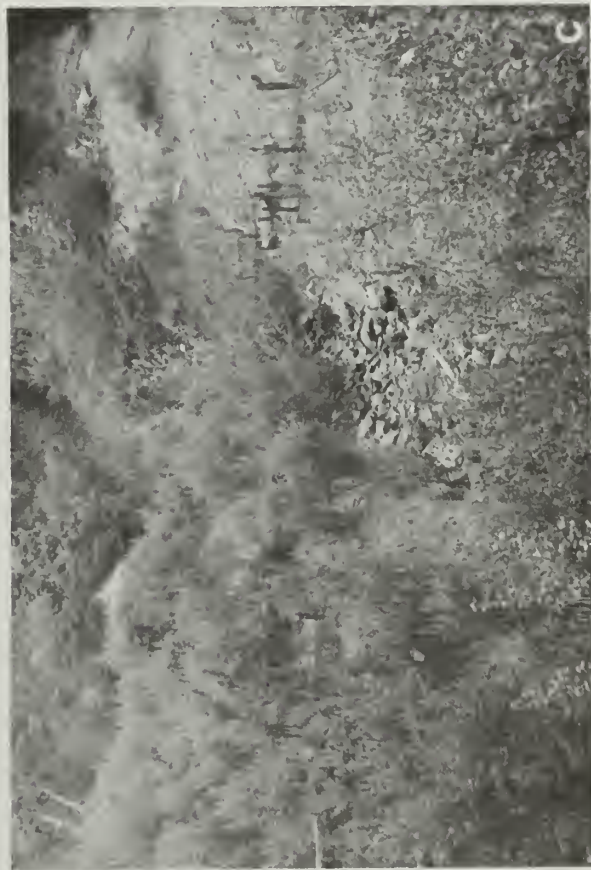
Seventy-four of the 92 crossings showed little post-treatment erosion (Figure 77). These were either excavated down to the original channel or to a stable base level, or they were adequately protected with rock armor. The remaining 18 crossings showed substantial erosion (>5 percent of the excavated volume) which could have been prevented (Figure 78). Seven of these crossings had not received any secondary in-channel protection (Table 38).

Fig. 77. Recovery of an excavated, rock armored stream crossing. A) the hand placed rock armor in this channel covered not only the channel bottom but also extended sufficiently far up the channel banks to protect the channel during higher flows; B) three years following treatment (September 1982), coyote brush has successfully invaded the site and little channel erosion has occurred; C) vegetation is now well established on the channel banks and within most of the channel bed (September 1983).

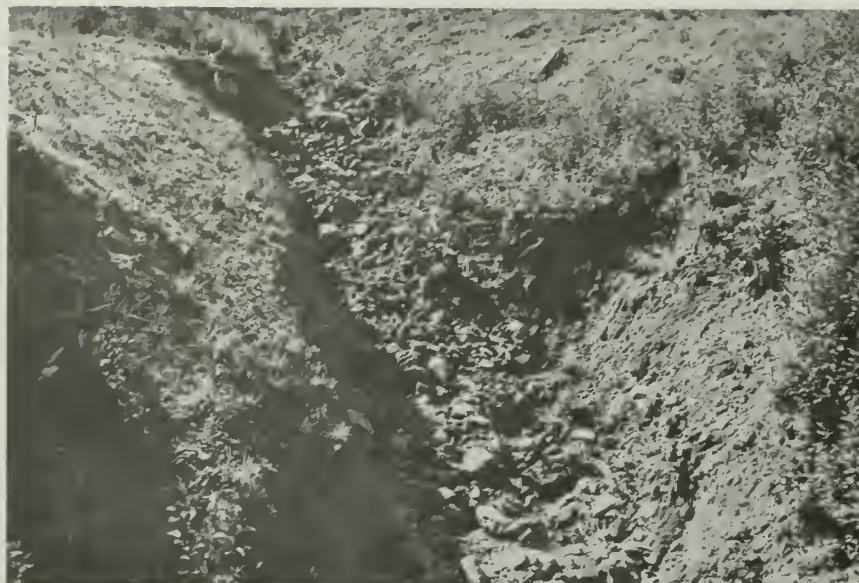
Fig. 78. Changes in an unprotected stream crossing following rehabilitation. The bed is now fairly well stabilized by the accumulation of a lag of cobbles and boulders, yet the oversteepened banks will still undergo continued adjustment as they collapse or are undercut (May 1982).

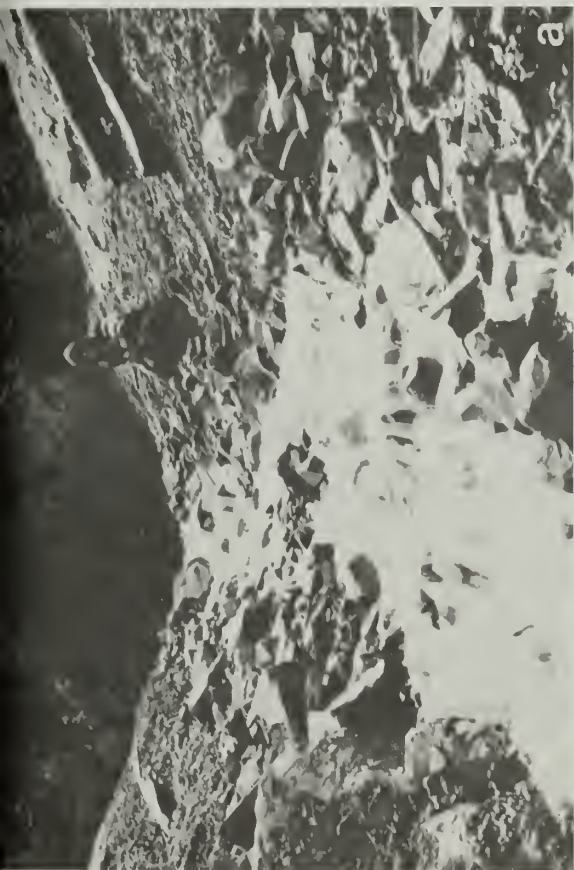
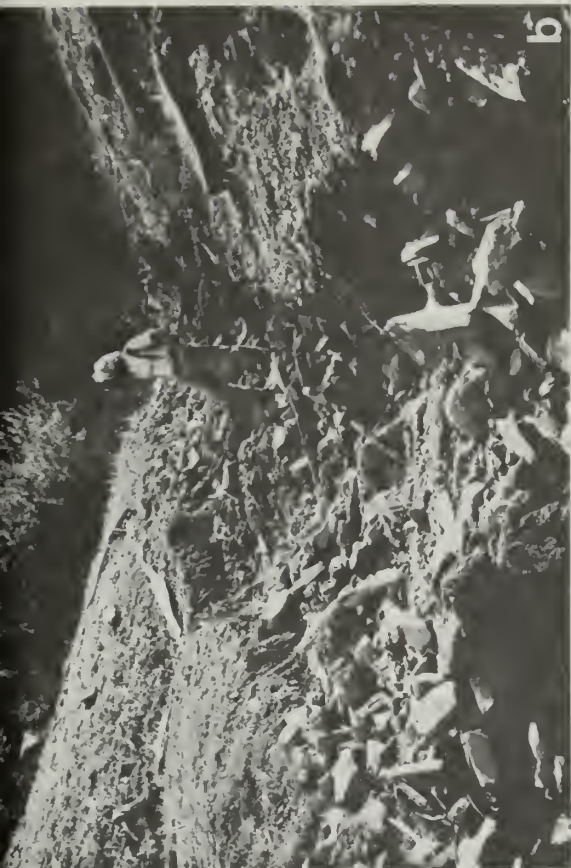
Channel widening and downcutting were the dominant forms of erosion on the eleven rock crossings experiencing scour (Figure 79). Problems included 1) rock too small to stay in place (8-12 inch mean diameter), 2) rock deflected flow into sideslopes causing bank erosion or flow channelization around rock armor and 3) stream channel gradients too steep to anchor or prevent transport of large rock (12-inch mean diameter). Rock armoring by hand was generally effective where streams drained less than 25 acres, but was not cost-effective on larger drainages. Larger rock supplied and placed by heavy equipment was found to be better for protecting channel beds. Most equipment-placed rock required some adjustment by hand after the first few major storms.

Fig. 79. Changes at an excavated stream crossing following rehabilitation. A) view upstream during the first winter flows; B) same view after first winter; note minor channel downcutting, considerable widening and the removal of under-sized rocks used in the channel armor; C) after the second year, the channel has downcut an additional foot and widened several more feet in response to sustained high flows during the winter (note the organic debris being exhumed); D) in 1983, 4 years after treatment, large boulders are now being exhumed as the stream finds its original, stable bed. Note also that widening continues to occur and young trees topple into the streambed.
