AN EVALUATION OF EXPERIMENTAL
REHABILITATION WORK,
REDWOOD NATIONAL PARK

TECHNICAL REPORT
JULY 1987

Redwood National Park Watershed Rehabilitation
Technical Report Number 19

National Park Service
Redwood National Park
Arcata, California
July 1987

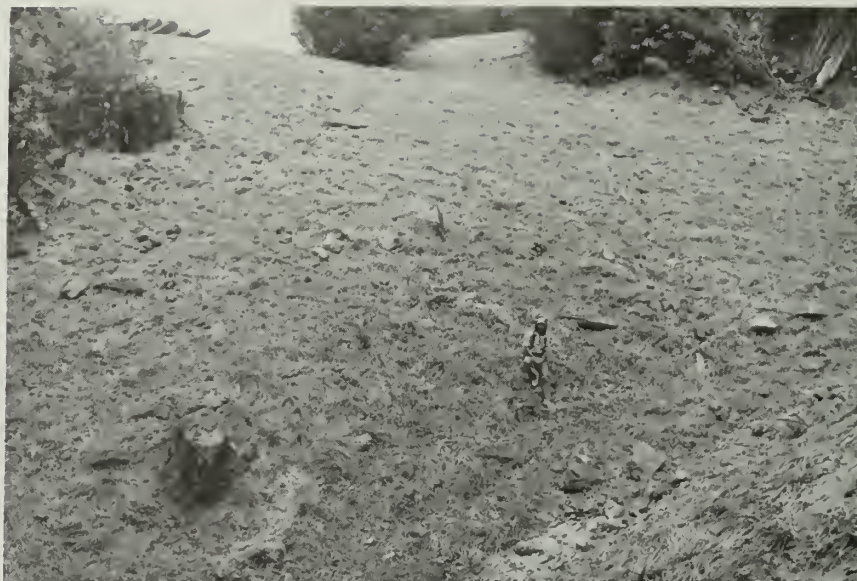
Fig. 80. Straw mulch, applied at 6000 pounds per acre, was found to be the most cost-effective treatment to control surface erosion from bare soil areas on 1979 rehabilitation units.

Straw applied at 2,000 pounds per acre on all bare areas was marginally effective in controlling most surface erosion for the first year. Decomposition rapidly reduced coverage. Straw application along flat or gently sloping segments of cross-road drained roads and landings was not necessary to control the little erosion that occurred there. At these sites, straw mulch was used more as an aid in improving micro-climate and micro-site conditions for revegetation.

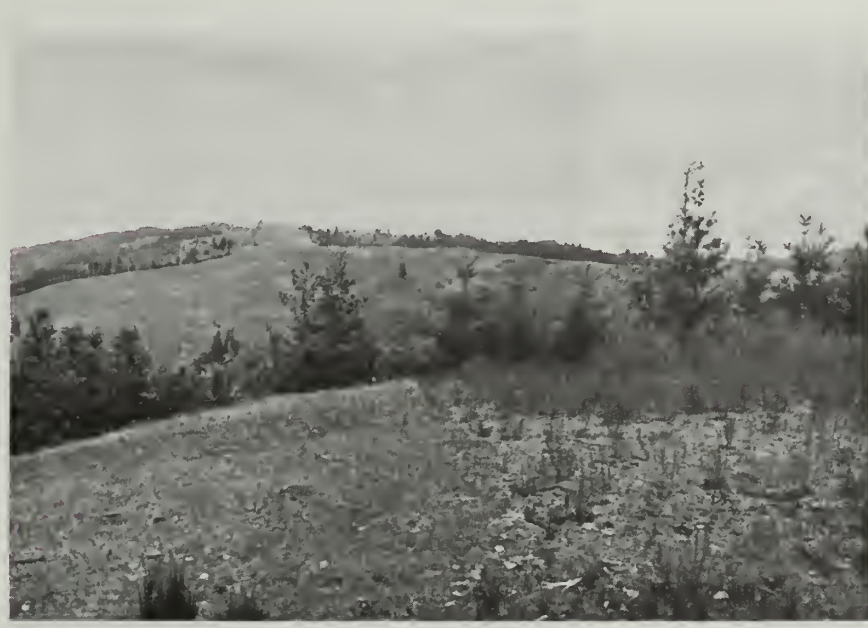
Where the RNP mix was seeded and fertilized, grass persisted with sufficient cover (>60 percent) to exclude significant natural invasion (Figure 81). Coyote brush, the main woody colonizer, was relatively sparse on areas seeded with the RNP mix but abundant in unseeded areas and areas seeded with barley. The areas seeded with barley were nearly indistinguishable from untreated areas.

Fig. 81. Shrub invasion in unseeded (right) and grass seeded areas (left) on treated landing in Copper Creek. Competition with grass on the left half of the landing totally inhibited natural invasion of coyote brush and other shrubs.

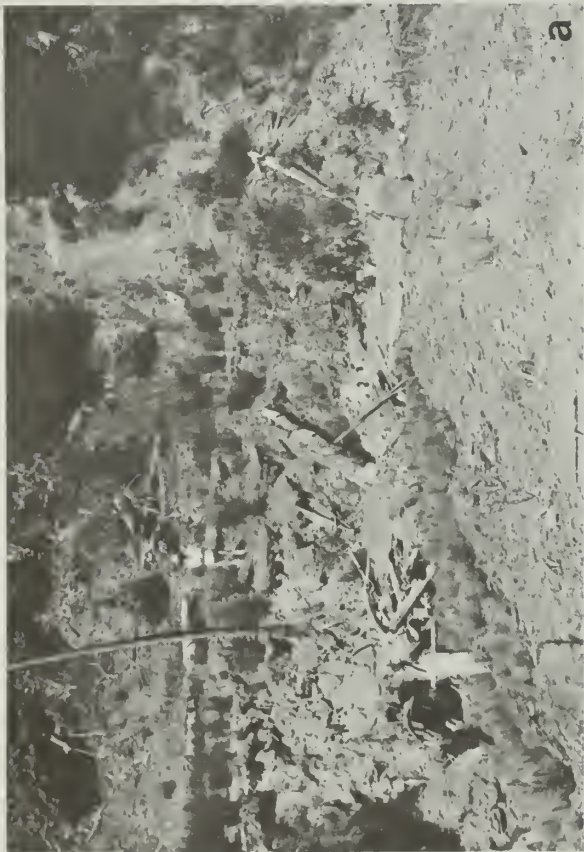
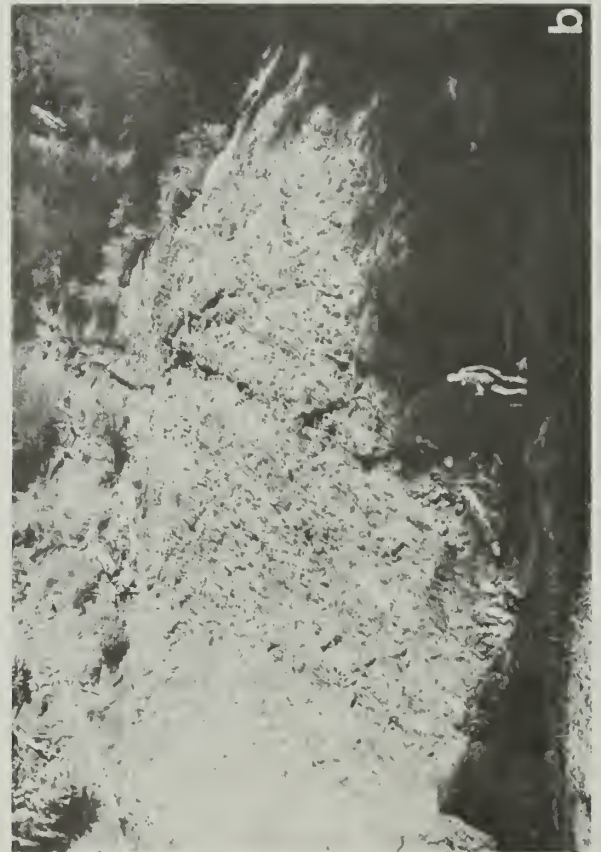
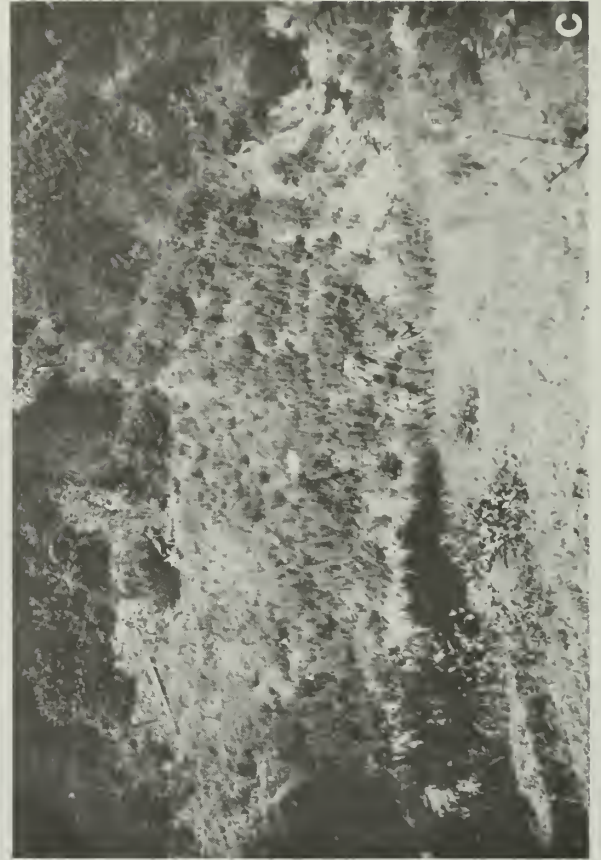
The most widely used mulch was straw. Average straw cover the first year was 90 percent, but declined to <5 percent by the third year. Heavy natural invasion by coyote brush and herbaceous species was seen on many unseeded, strawed areas (Figure 82). Several areas mulched with

Fig. 82. Natural revegetation of excavated stream crossing with straw mulched side slopes, Copper Creek. A) Partially washed out stream crossing displays unstable banks and minimal natural revegetation eight years following road abandonment (July 1979); B) several months after excavation of fill (December 1979) showing straw mulch and rilling on side slope following first winter rains; C) four years after rehabilitation (September 1983), note abundant natural invasion of coyote brush on right bank.

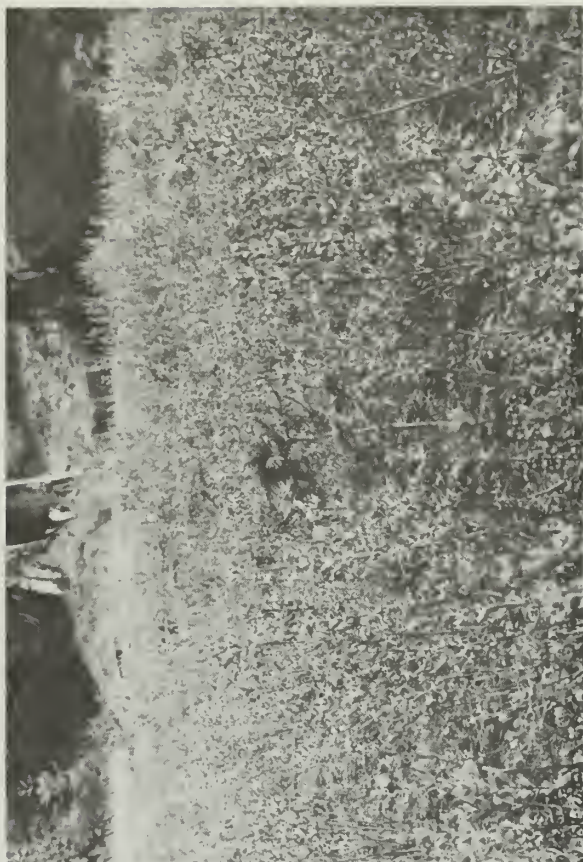
Observation of conifer seedling survival indicates species, initial size, and substrate affect the trees' health. By 1983, survival of redwood seedlings planted on the lower road was low (approximately 20 percent). Many of those surviving seedlings were stressed, but may become better established as alders shade more of the road. Observations of plantings in succeeding years indicated that two-year old bareroot stock (both redwood and Douglas-fir) have higher survival and growth rates than one-year old containerized stock. For this reason, and because the two-year stock are no more expensive than the one-year old contained seedlings, they are now preferred (Figure 83).

Fig. 83. Two-year old bareroot Douglas-fir and one-year containerized redwood seedlings were planted at Copper Creek.

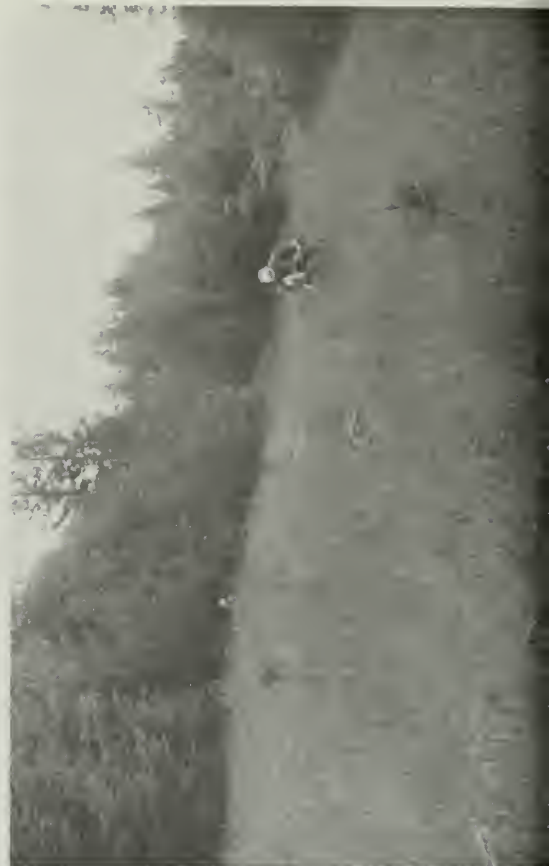
Fig. 85. Competition from grass in heavily seeded areas lowered survival and reduced vigor of outplanted conifers. Concentrations of grass also attracted elk and deer which then browsed on the planted trees.

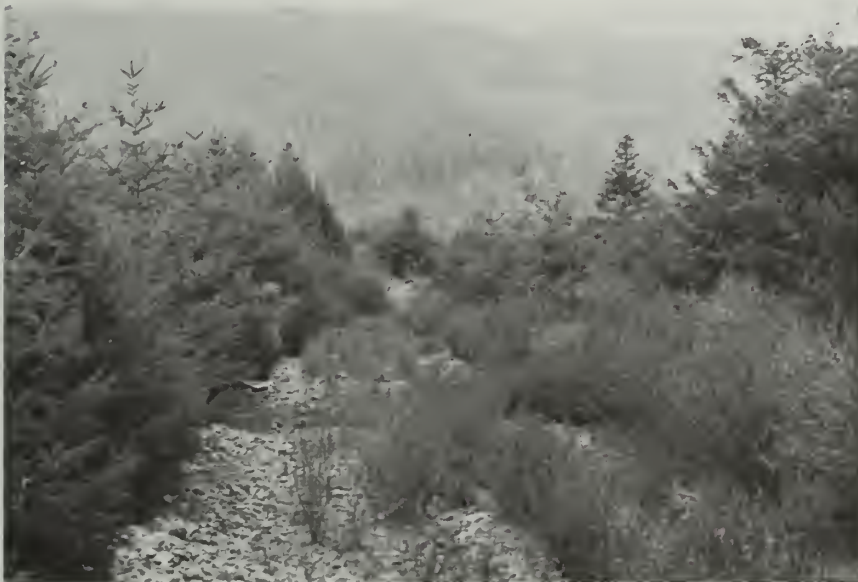
Fig. 86. Natural invasion of coyote brush. Unlike the Bond and Bridge Creek units, where alder was the principal early colonizer, the hot, dry, rocky skid trail and road surfaces of Copper Creek were quickly invaded by coyote brush.

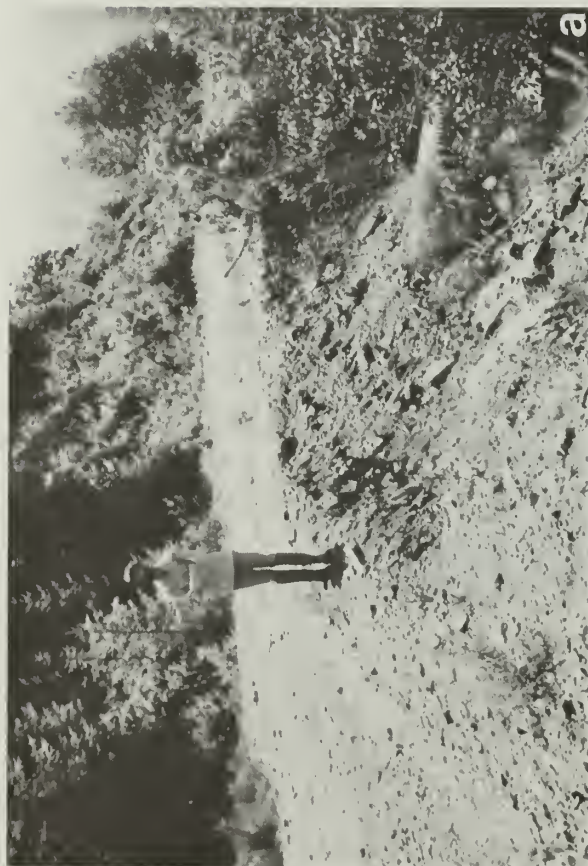
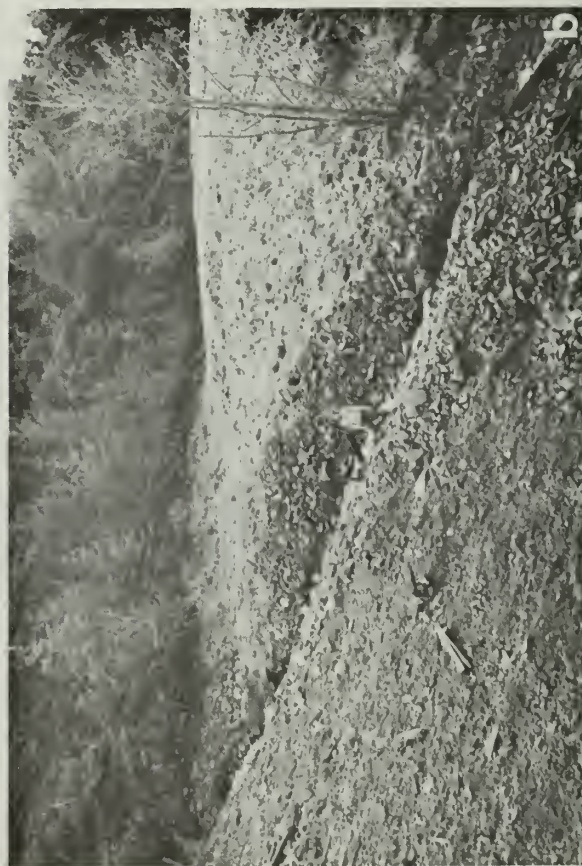
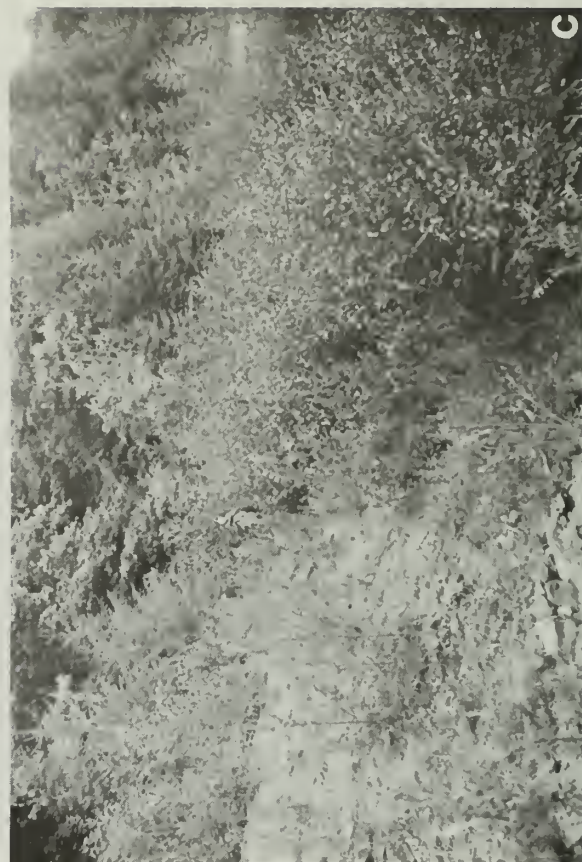
Fig. 87. Natural revegetation of an excavated stream crossing on the 1910 road. Although soils are also rocky in many of the lower hillslope areas, moister conditions favor the invasion and establishment of red alder near water-courses. A) before stream crossing excavation (June 1979). B) following excavation (January 1980; note high rock content of soils) and C) four year following rehabilitation (September 1983).
