# historic structure report

SEAWALL  
FORT McHENRY

NATIONAL MONUMENT AND HISTORIC SHRINE / MARYLAND

HISTORIC STRUCTURE REPORT  
Administrative, Historical and Architectural Data Sections  
Seawall

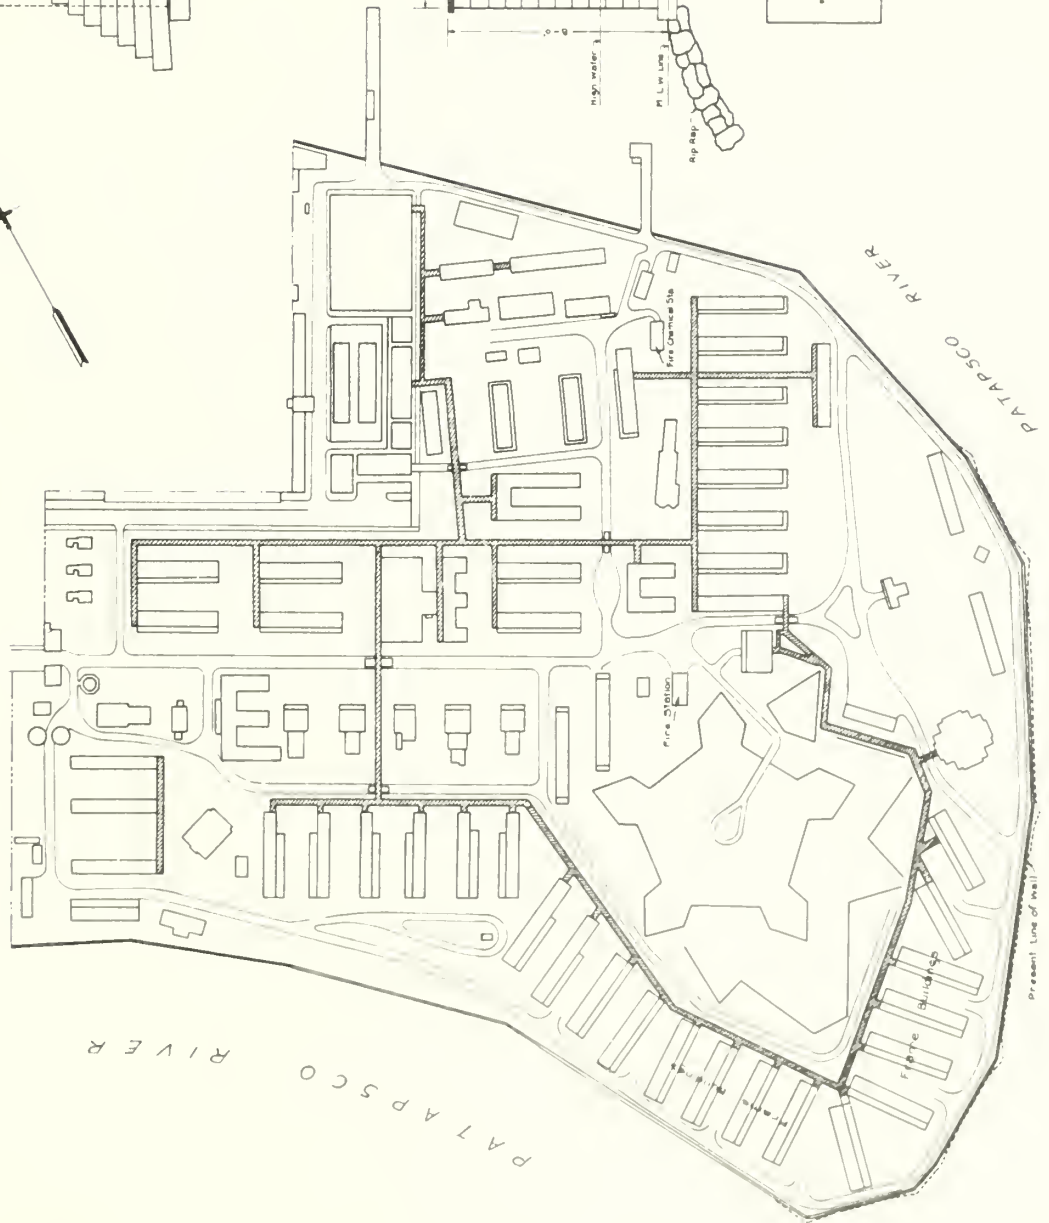
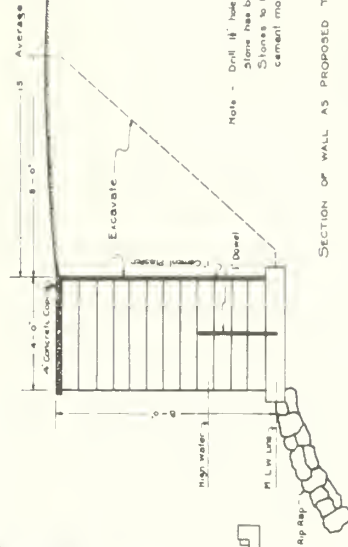
EXAMPLES OF PRESENT CONDITION OF WALL

SECTION OF WALL AS PROPOSED TO BE REBUILT

Note - Drill 1/2" hole for dowel after  
Stone has been reset  
Stones to be laid in rich  
cement mortar

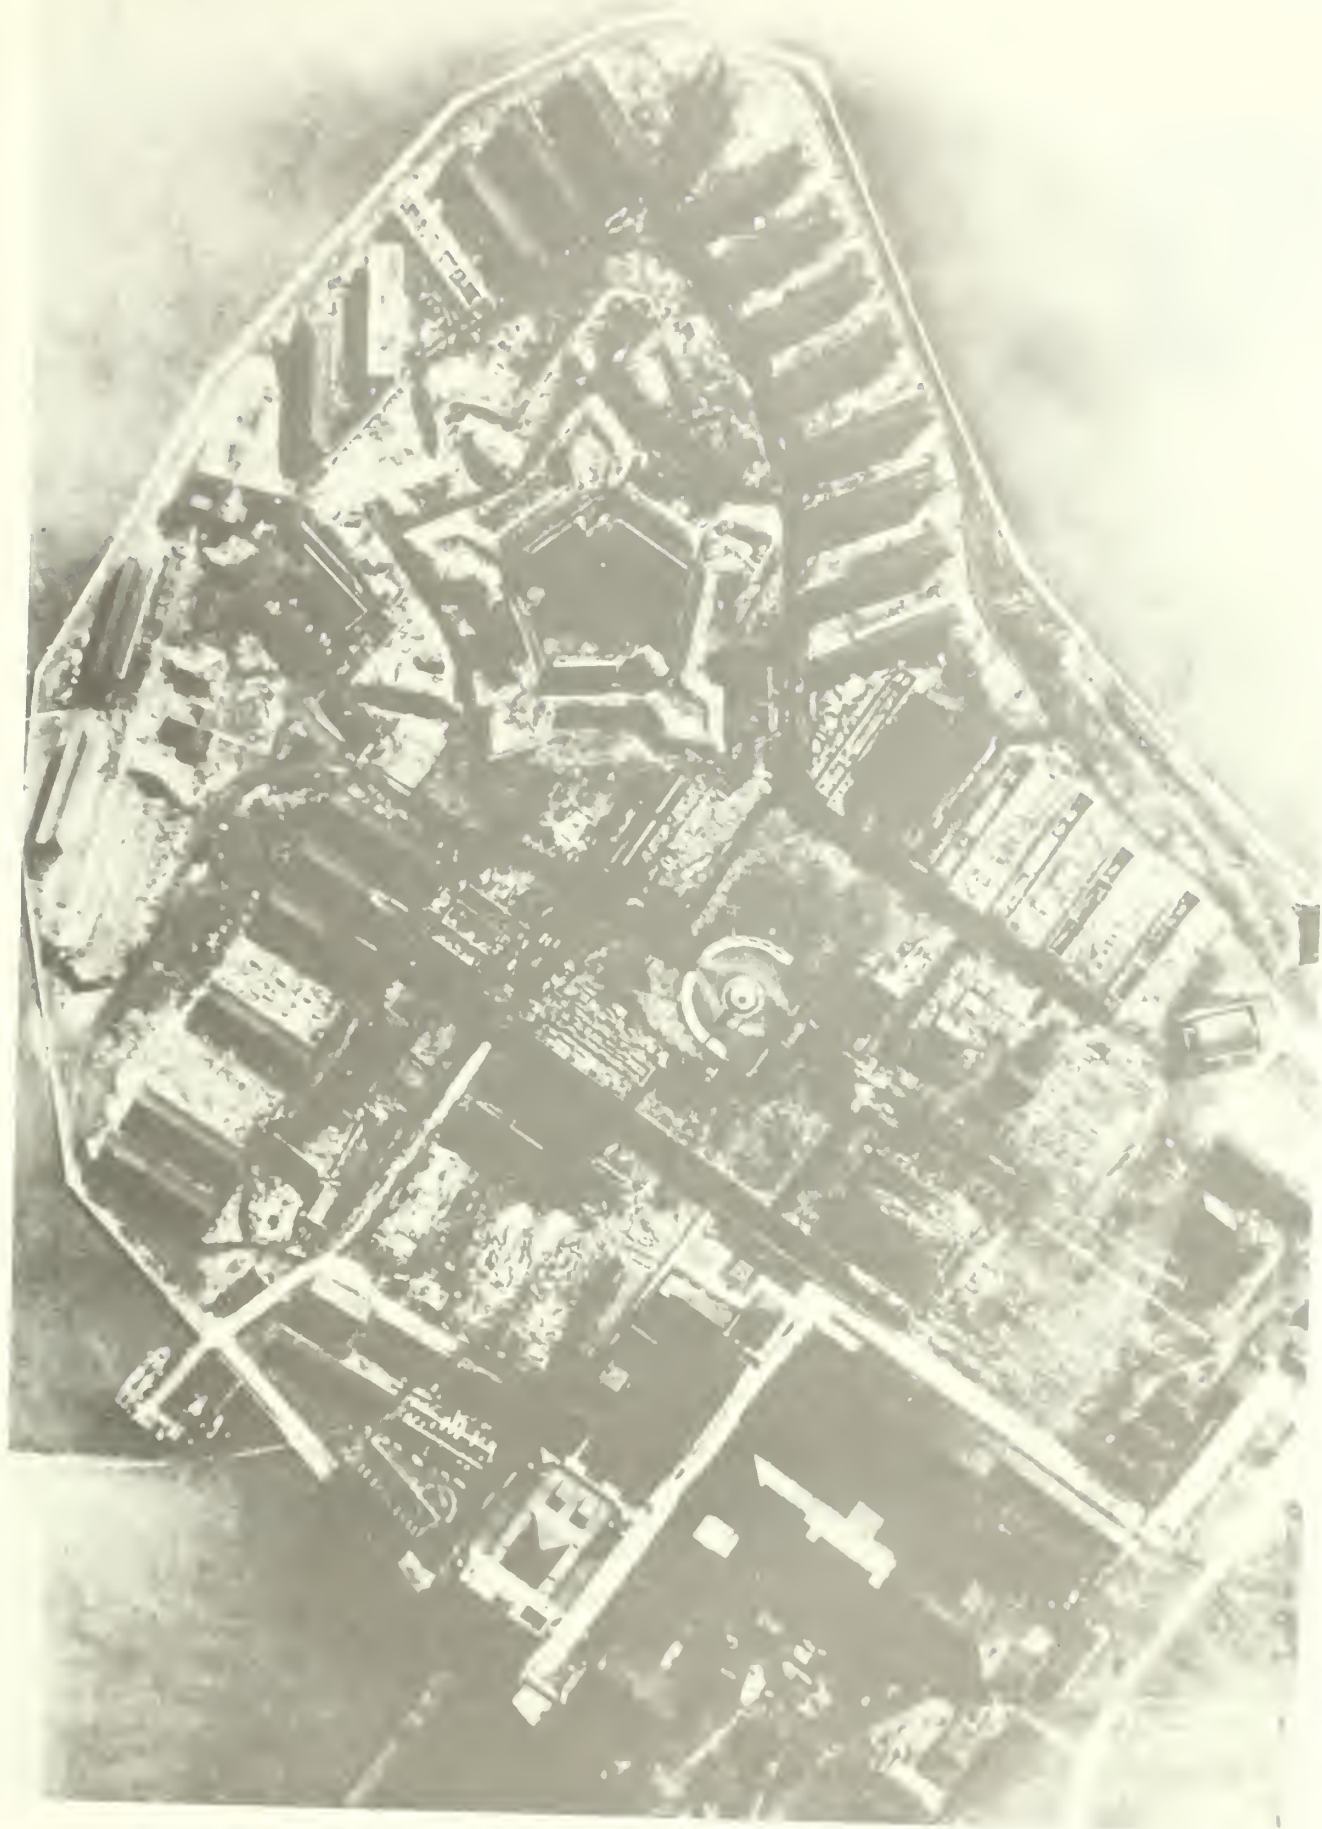
Illustration 20. Repairs--seawall, sidewalk, etc., damaged by storm, August 23, 1933

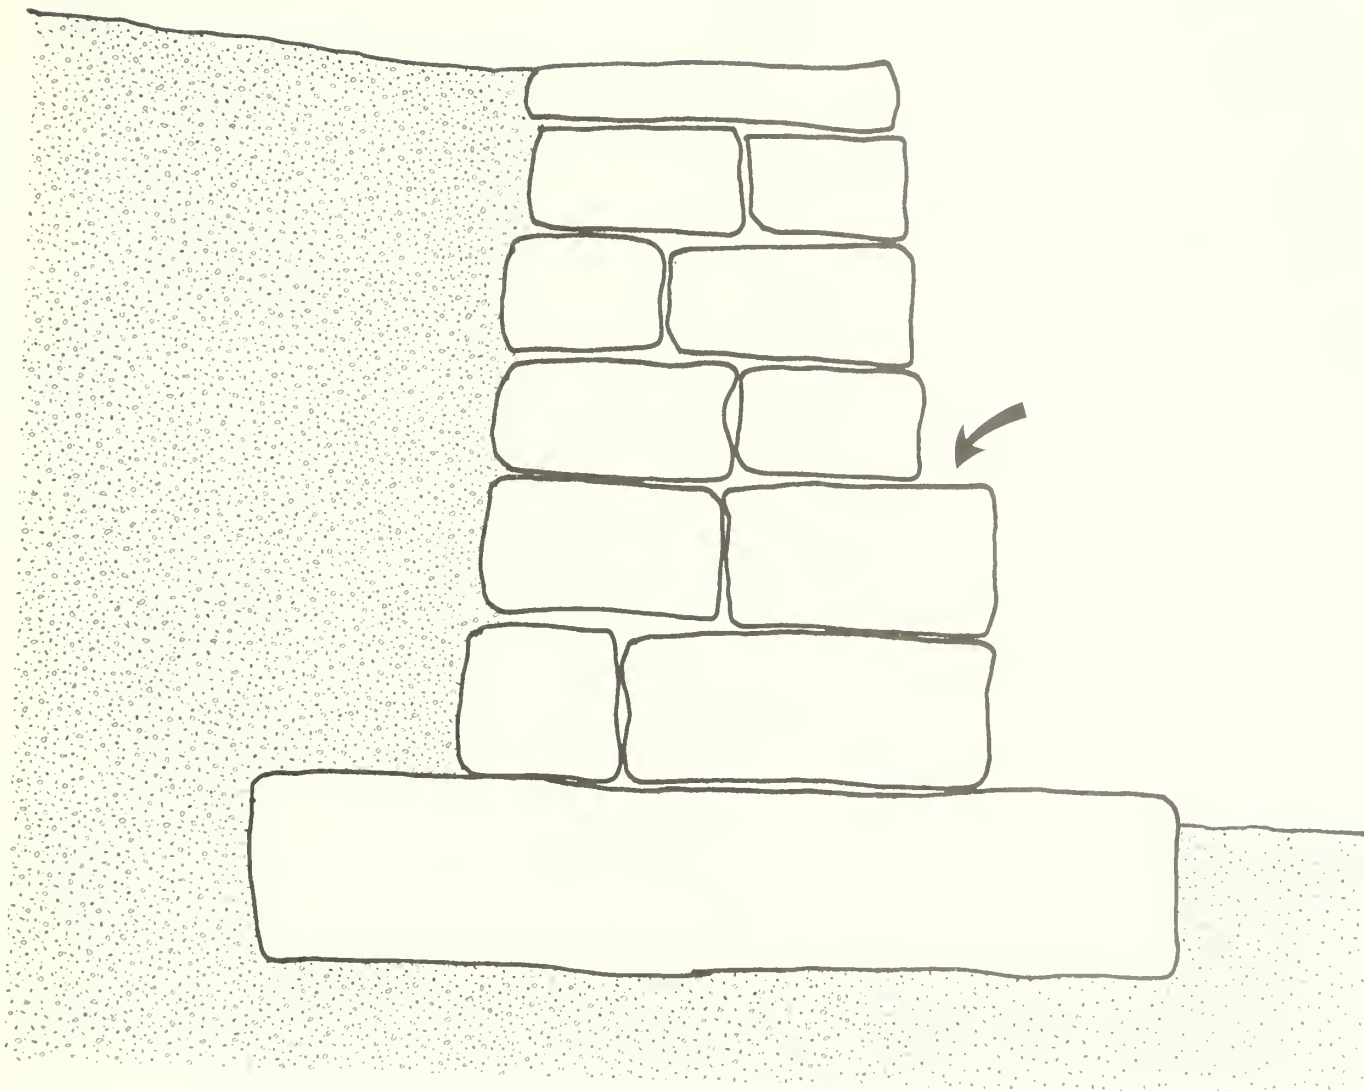
From Station 18 + 48.77 to Station 22 + 84.09 the capstones are displaced and the lower third of the wall protrudes 6 inches to 1 foot 6 inches beyond the upper portion of the wall (see photographs 5, 6, and 7). The condition of the wall at this point is unknown. Further testing should be performed to determine the profile of the wall in this section. The protrusion of the lower stones could be the historic configuration of the wall (see figure 3); however, it is more probable that it is the result of the force of water and plastic soil pushing against the wall. Thus the stones at the base of the wall are being pushed out of place, making the wall structurally unstable (see figure 4). (For amendment to this report, see Appendix A, the archeological investigations and comments.)

Figure 4: Lower third of wall displaced due to force created by water and plastic soil behind wall

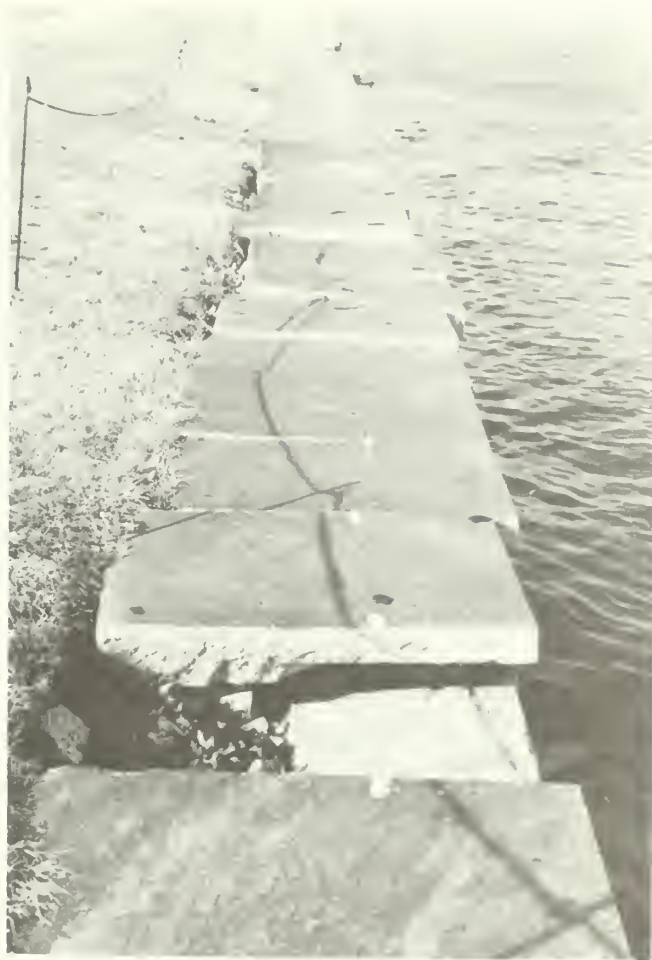
Photograph 4: Station 13 + 17.05 - Station 13 + 84.05.  
Unraveled section of wall

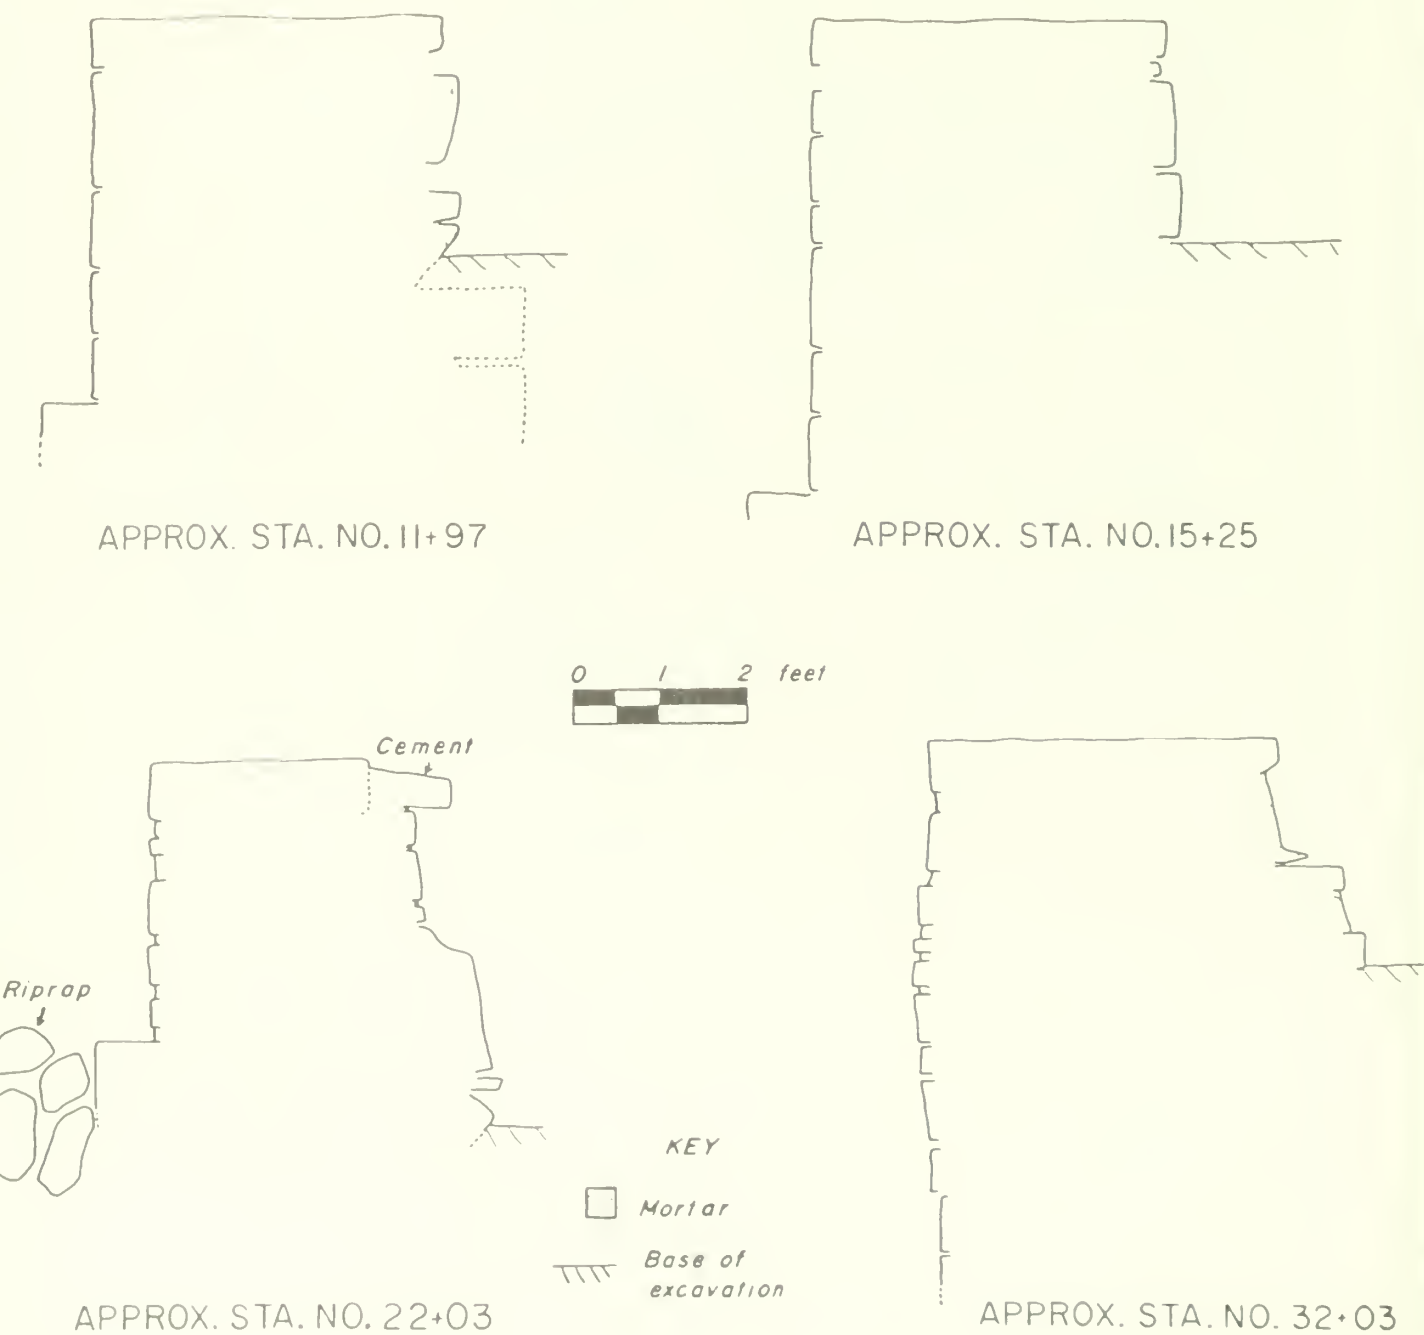
A. Architectural details of the seawall were uncovered in each test, as illustrated in Figure 2. These details indicate that the wall is not eroding but was built and repaired in the shape illustrated.

*Figure 2. Seawall cross-sections, Fort McHenry National Monument and Historic Shrine, Package 149. May 1986*

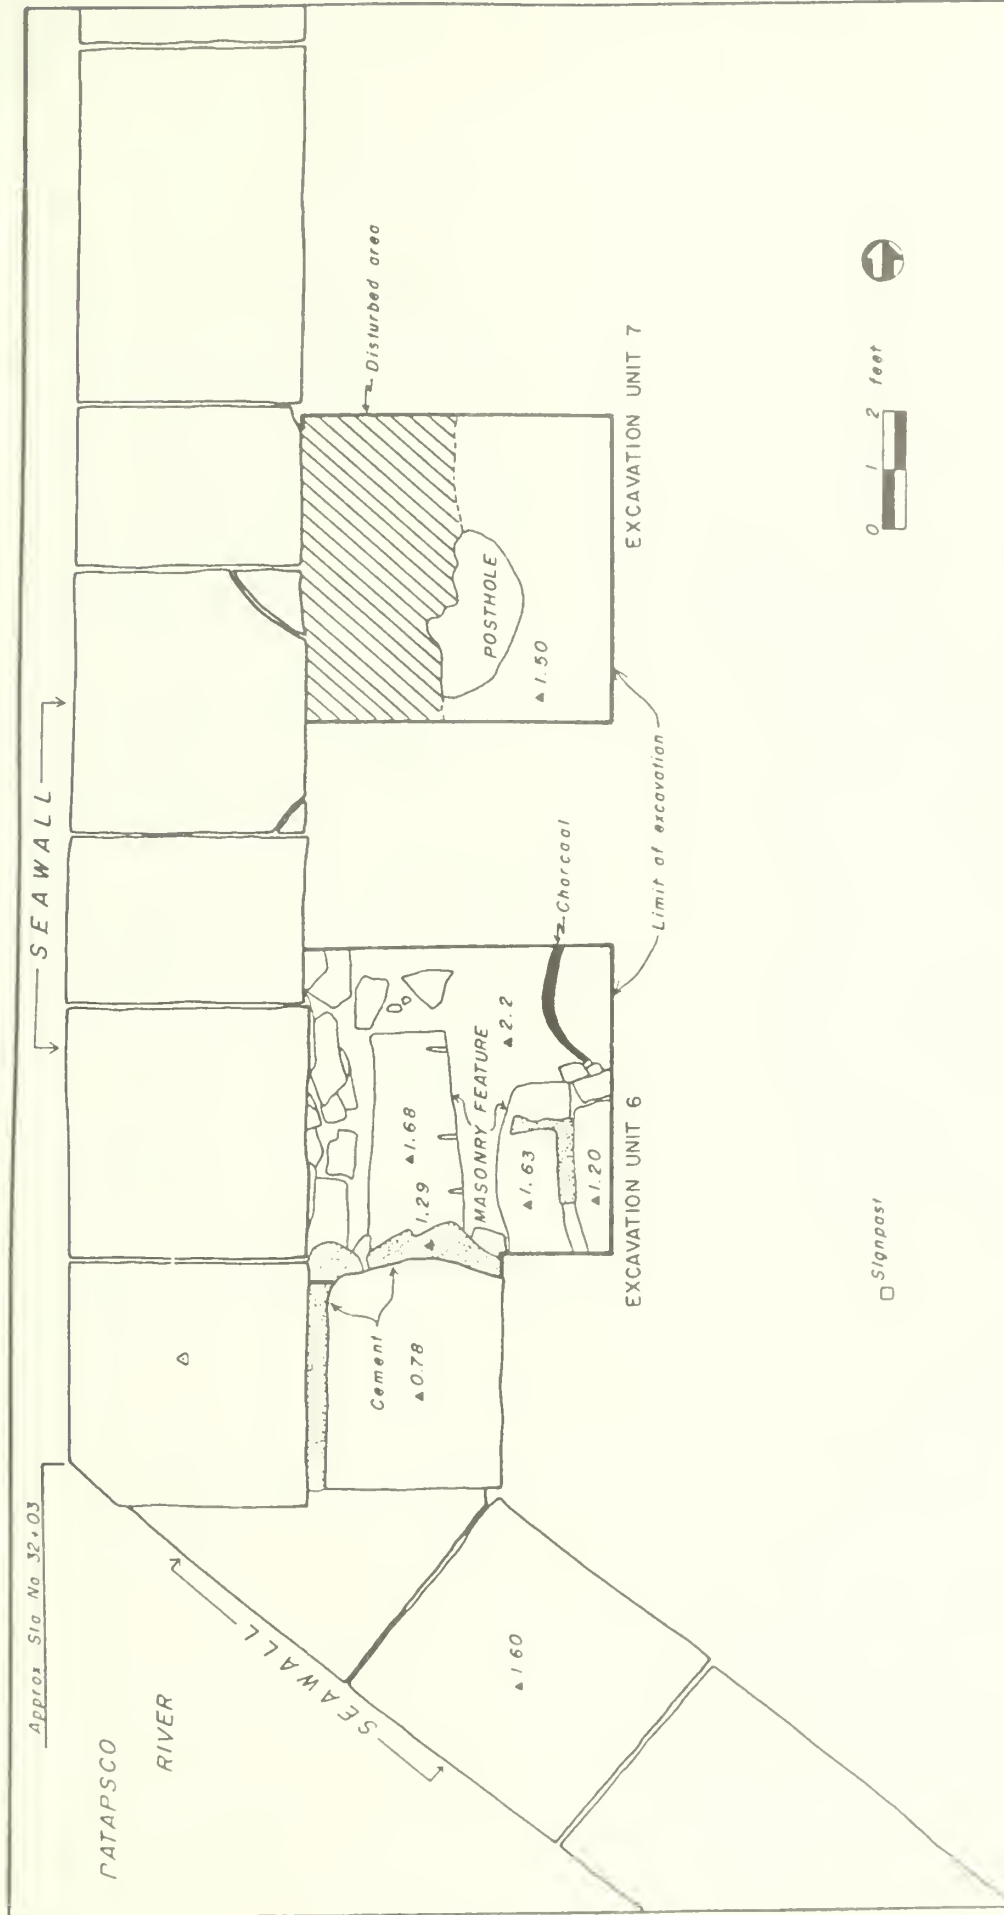
B. The location of a historically documented structure was verified in Excavation Units 6 and 7 (Figure 3). The structure was noted but not identified on the 1888 map, but in 1912 it was identified as the target area of the rifle range.

Figure 3 Plan, Excavation Units 6 and 7
