Preservation Case Studies

Main Street Historic District

Van Buren, Arkansas

Using HCRS Grant-in-Aid Funds for Storefront
Rehabilitation/Restoration Within a Districtwide Plan

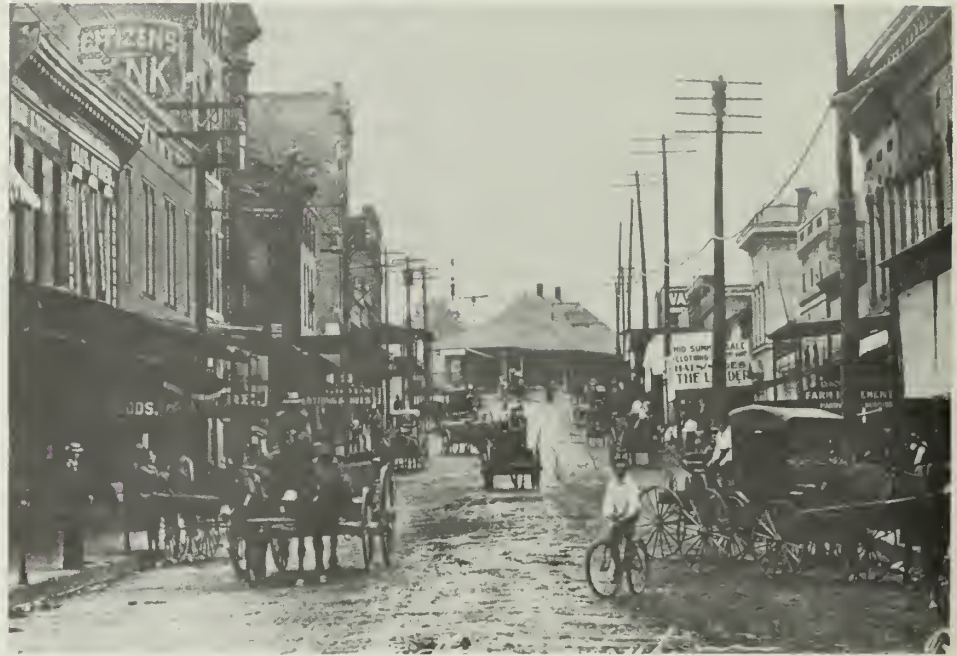
Figure 1. View of Main Street, Van Buren looking northeast toward the Frisco Railroad Depot, c. 1912. Courtesy: Ora Smith

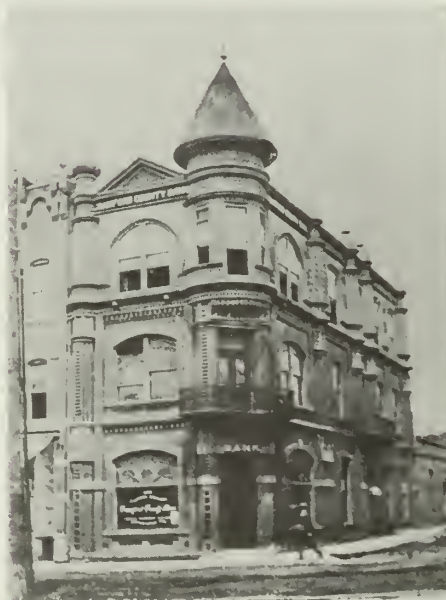
Figure 2. 629 Main Street, Crawford County Bank Building, c. 1912. One of two early Van Buren banks which remain virtually intact today (right). Courtesy: Ora Smith

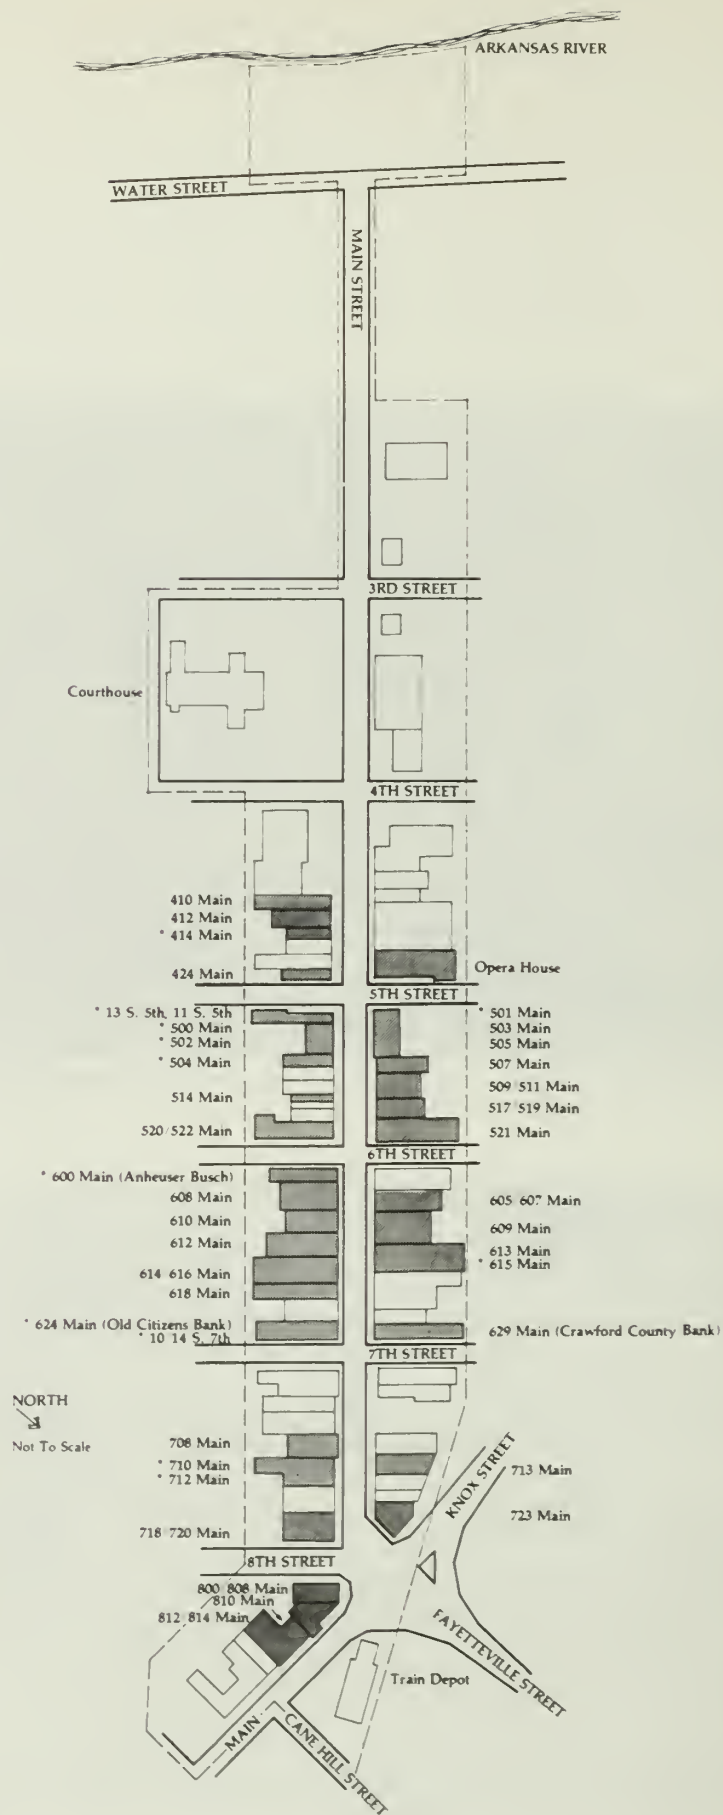
Figure 9. Plan of Main Street Historic District Van Buren, Arkansas, showing HCRS grant assisted buildings and other significant sites

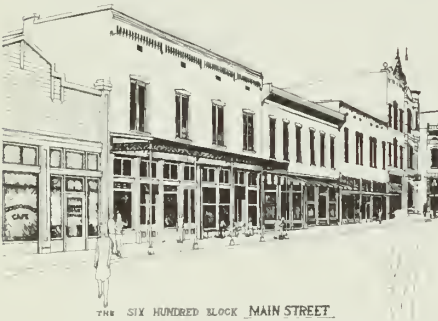
Figure 11. Rendering showing rehabilitation/restoration proposal for 600 block of Main Street. Credit: David Fitts

4. Rehabilitate/restore facades on Main Street: A matching grant program was initiated in May 1977, using HUD Community Development Block Grant (CDBG) funds (HCRS grant involvement occurred in February 1979) (see figures 10 and 11).

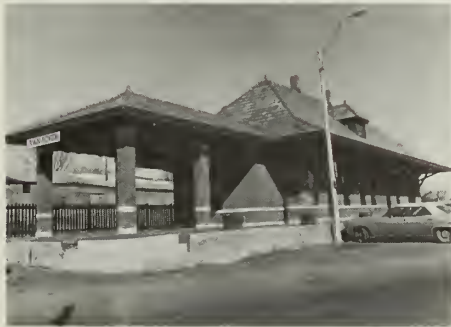
Figure 14. Frisco Railroad Depot after its acquisition and rehabilitation/restoration by the city. Credit: Bob Dunn

7. Acquire and rehabilitate/restore the Frisco Railroad Depot: In January 1978, the city acquired the Frisco Depot and in June 1978, rehabilitation/restoration work began. The city and the Chamber of Commerce entered into a lease agreement whereby the chamber would occupy the Depot and be responsible for the continuing maintenance of the building (see figures 13 and 14).

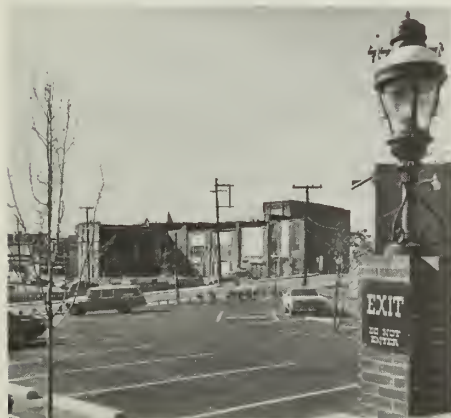
Figure 15. One of five new perimeter parking areas constructed for the Main Street Historic District. Credit: Bob Dunn

9. Provide off-street parking: Construction contracts were executed in July 1978, for the installation of three parking lots behind the Main Street buildings, outside, but adjacent to, the National Register district boundaries. The lots are accessible to vehicular traffic from the perimeter streets with direct pedestrian access to the rear entrances of the Main Street buildings. Funds were also budgeted for the installation of two additional lots, further alleviating congested parking conditions. All of the parking lots were landscaped and lighted to be in harmony with the adjacent historic district. (see figure 15).

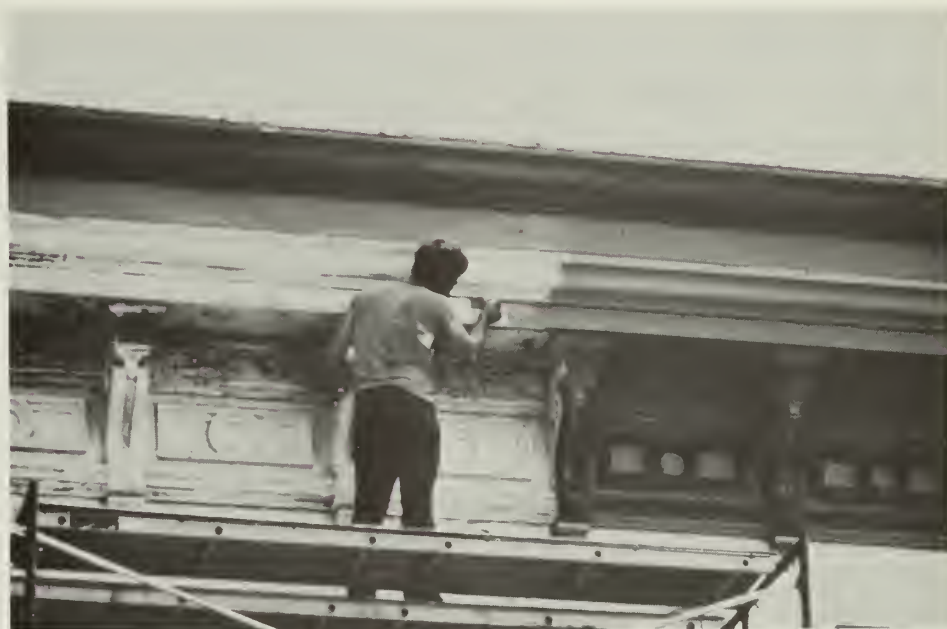
Figure 16. Facade being repainted using a Community Development Program approved color scheme. Credit: Dan Chapel

scrapings with samples of commercially available paint, a palette of colors appropriate to Van Buren's Main Street storefronts was established (see chart below). The Main Street palette offered flexibility to property owners in choosing colors for repainting their building facades, subject to approval by the Community Development Program (see figure 16). This conforms to *The Secretary of the Interior's Standards for Historic Preservation Projects with Guidelines for Applying the Standards*—specifically, the guidelines for rehabilitation and restoration—which recommend against repainting with colors that cannot be documented through research and investigation to be appropriate to the building and neighborhood.

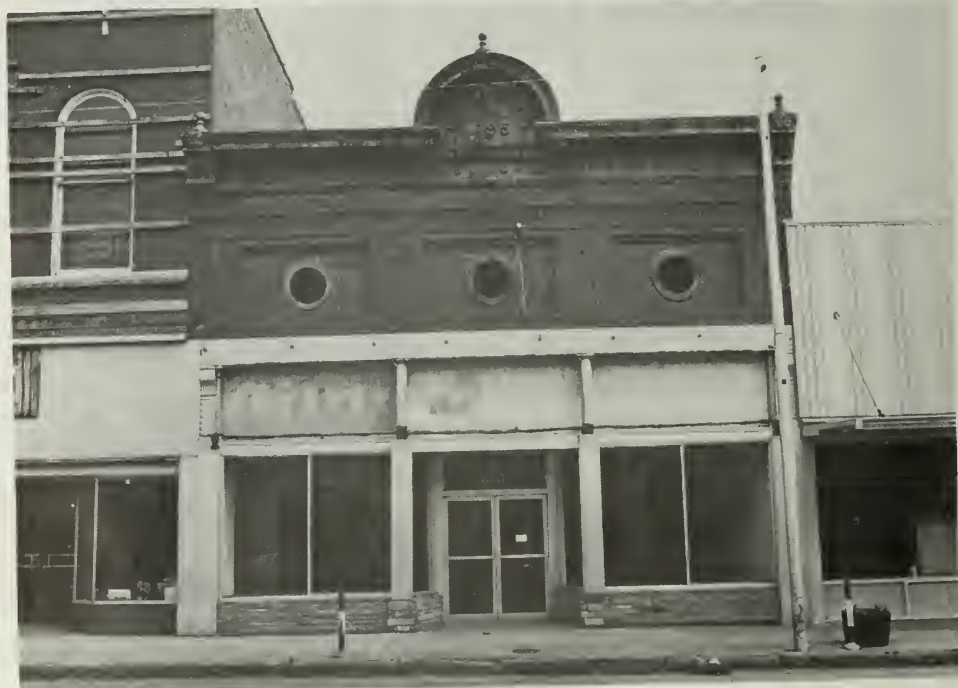
During

- Original height of storefront exposed by elimination of canopy
- Upper storefront windows reglazed
- Original storefront columns exposed
- Stone below windows replaced with appropriate wood panels
- Appropriate door and window treatment
- Projecting sign replaced with sidewalk-scale graphics

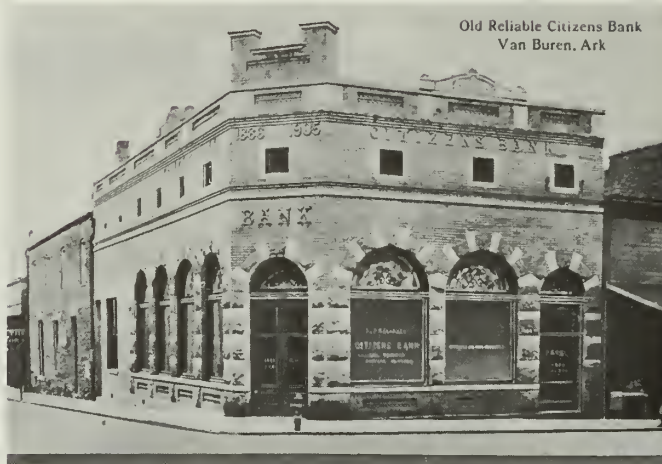
Historic

- Original scale and design of facade
- Original door and window designs
- Original stained glass design

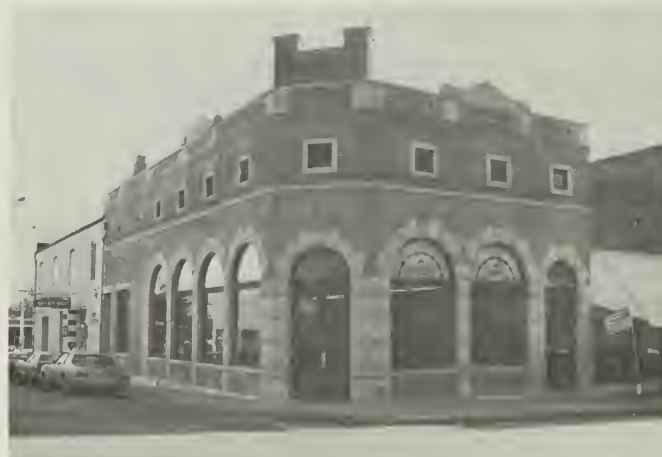
After

- Scale and design of facade changed by addition of canopy and alterations to windows and doors
- Stone and brick of facade badly discolored and stained
- Inappropriate projecting sign

- New stained glass windows reproduced and installed to match original design
- Canopy removed
- New storefront windows installed throughout to replace inappropriate glass block and plywood infill
- New doors to match original
- Projecting sign removed
- Entire facade cleaned and repointed preserving the ghosts of the original bank graphics
