## LIPPINCOTT PRESS BUILDING

# Tech Notes

### NUMBER 17

### Repair and Retrofitting Industrial Steel Windows

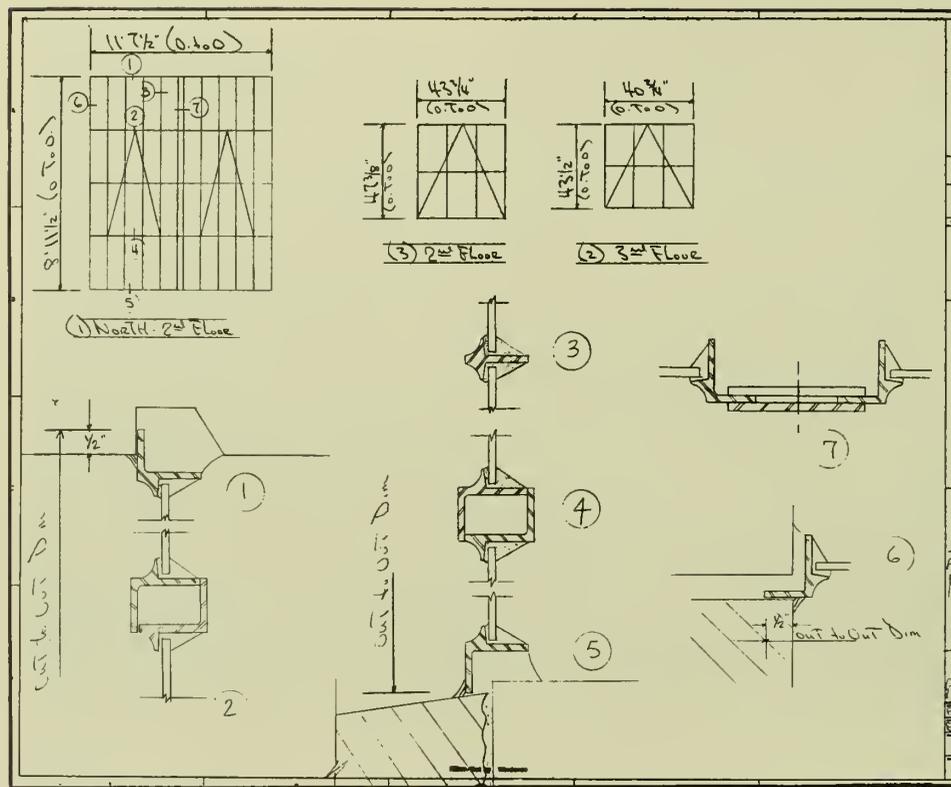
Figure 9. Sectional drawings of replacement window manufactured by A & S Window. Drawing: Winderco, Inc.

Once the muntins and mullions were set plumb, the final steps in the steel repair process began. In most of the sill areas, lengths of new steel sections were installed to replace the original corroded members. The new cavetto-shaped steel sections did not match exactly the bullnose profile of the historic windows (see figures 9 and 10). However, the original profile was no longer available and the new profile was close enough so that the overall proportions, profile, and shadow lines were compatible with the historic window appearance. The new steel sections at the sill and the lengths
