# Improving Thermal Efficiency: Historic Wooden Windows

## The Colcord Building Oklahoma City, Oklahoma

**The Colcord Building  
Oklahoma City, Oklahoma**

**Sharon C. Park AIA**

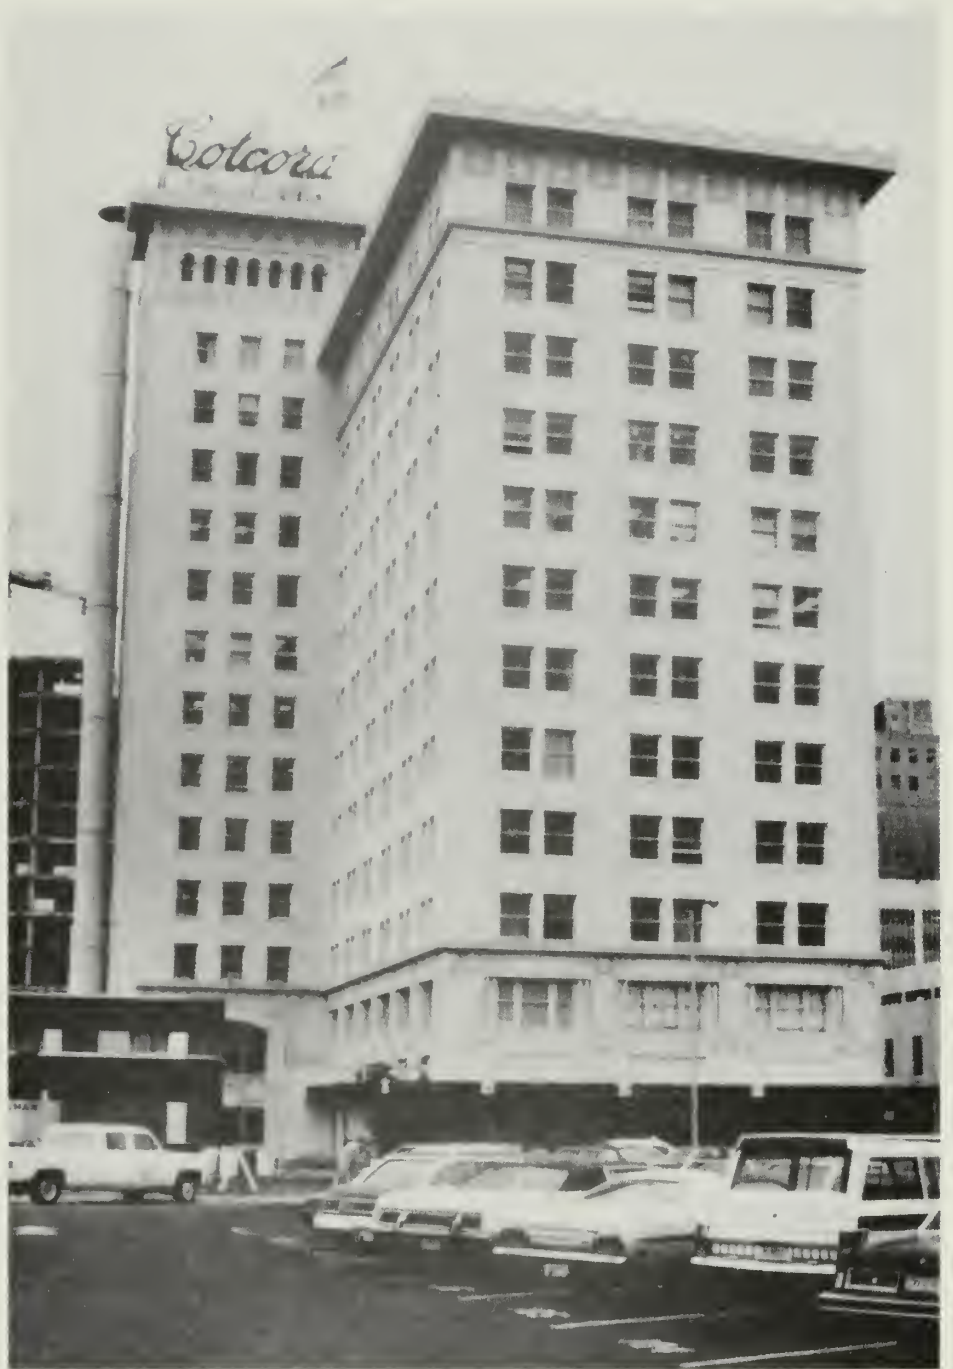
Figure 1. *The Colcord Building, Oklahoma City, Oklahoma. This 12-story poured-in-place concrete building with terra-cotta ornamentation was built in 1910 and is individually listed on the National Register of Historic Places. (Photo: H. Ward Jandl)*
