# Bathhouse Row Adaptive Use Program

The Quapaw Bathhouse: Technical Report 6

HOT SPRINGS NATIONAL PARK  
Garland County, Arkansas

June 1985

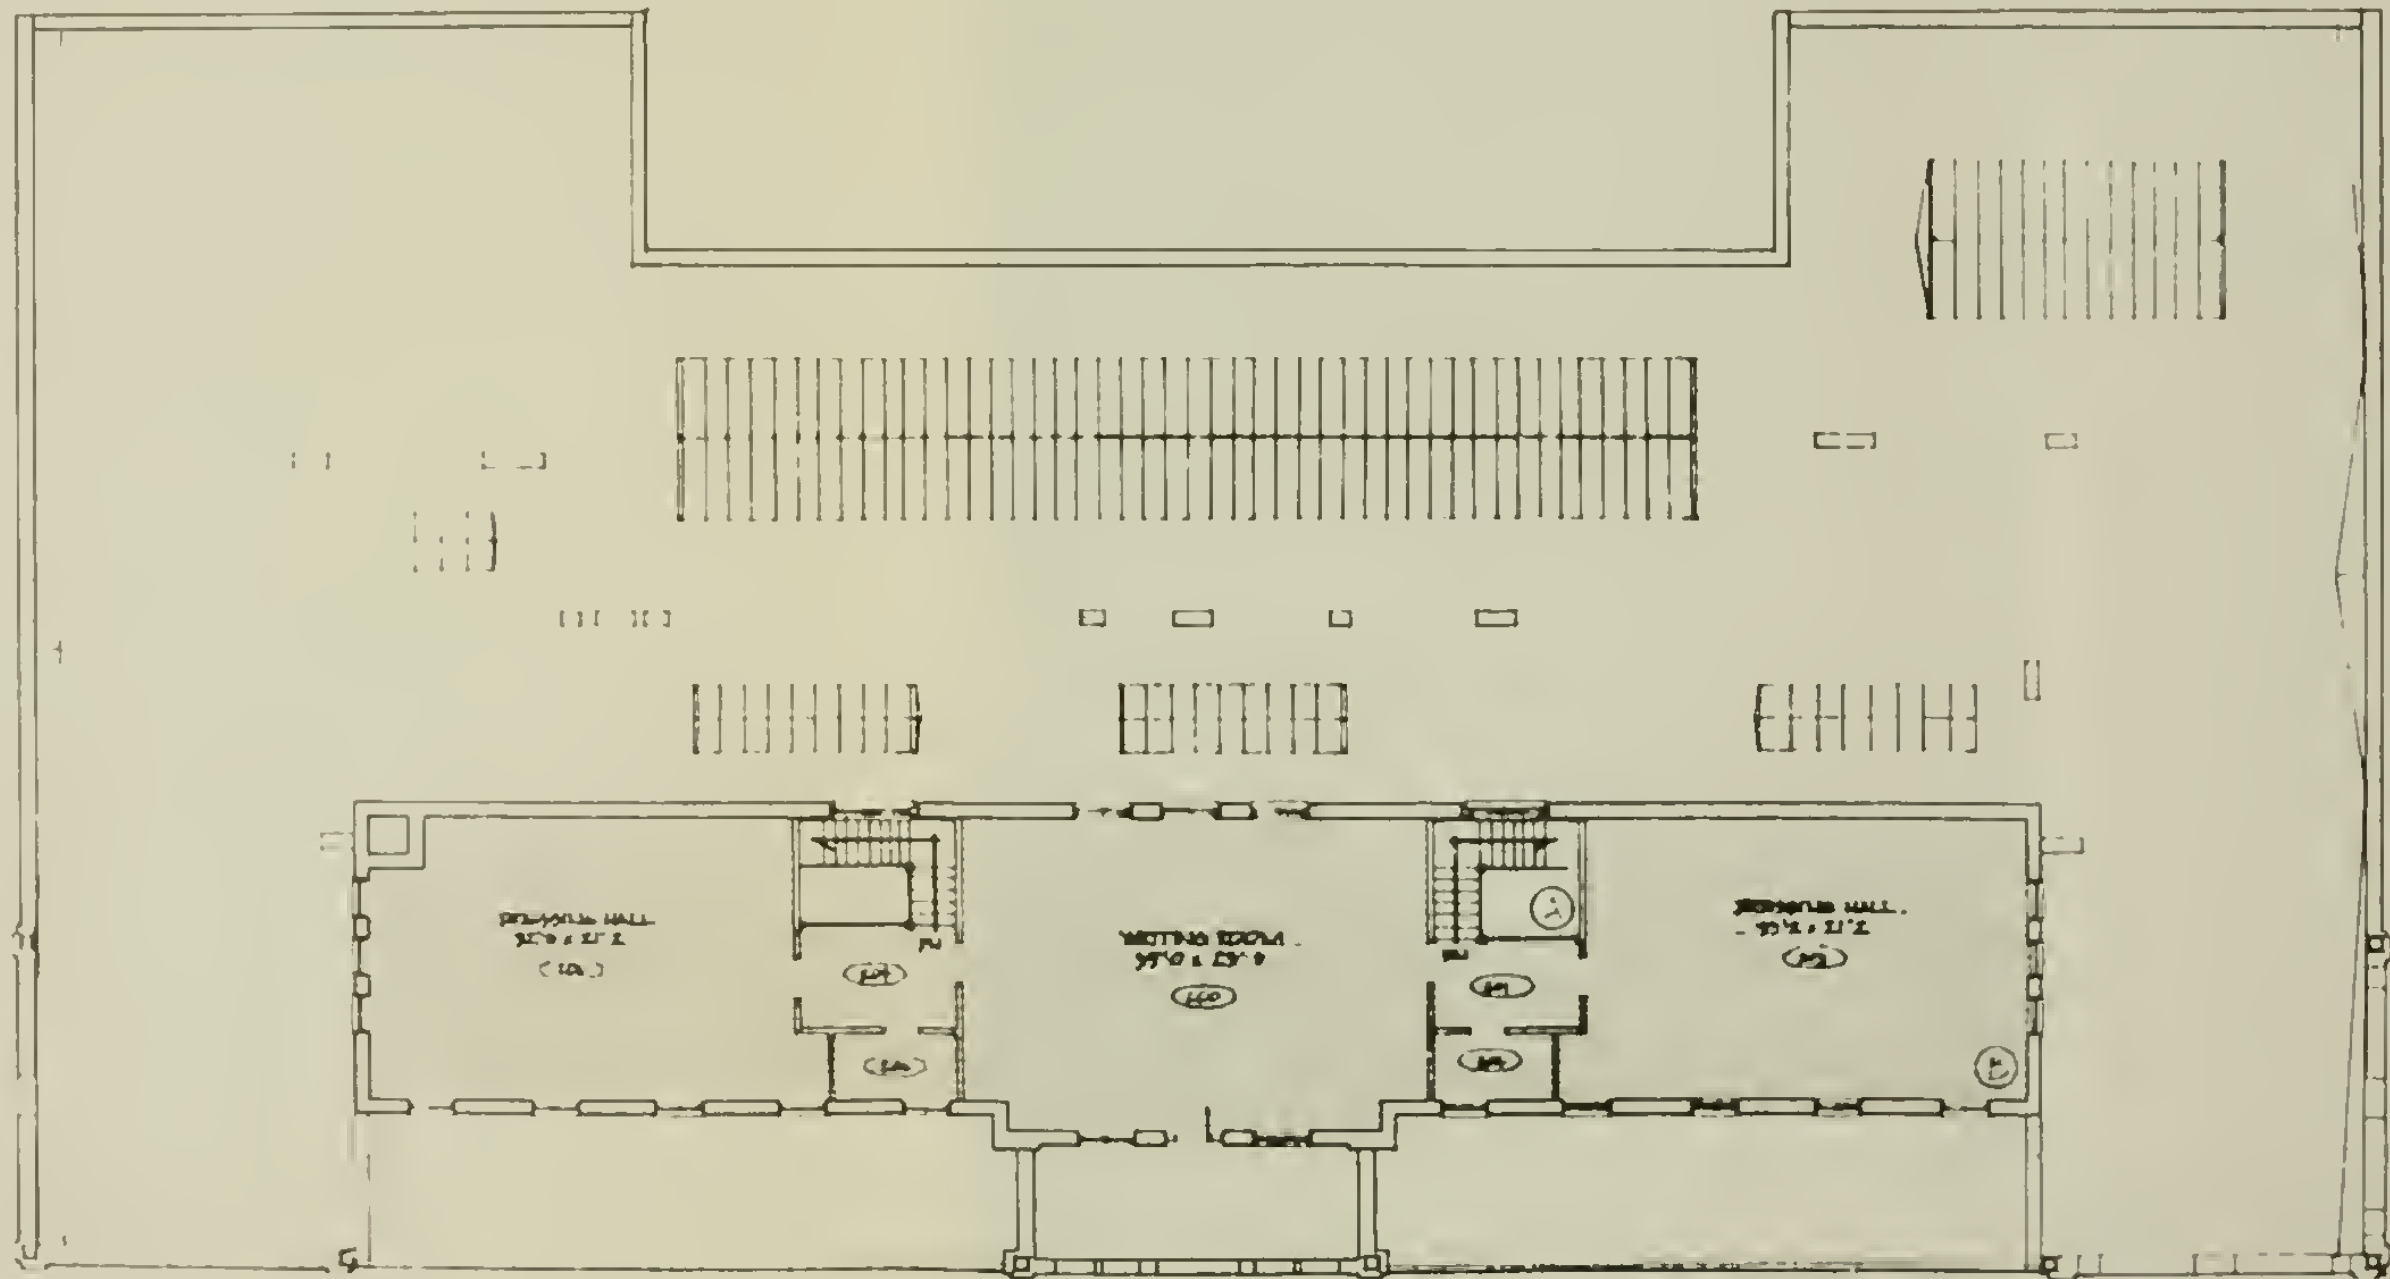
By	Description	Rev Ltr	
<b>ENGINEERING STUDY</b> <b>W BATHHOUSE</b> NO. CX702930004	Prepared <u>RSP</u> DESIGNED <u>BCK</u> DRAWN	TITLE OF DRAWING <b>2nd FLOOR &amp; ROOF STRUCTURAL PLAN</b> LOCATION WITHIN PARK <b>BATHHOUSE ROW</b>	Drawing No	
<b>ASSOCIATES ENGINEERS</b> 101 Parham Rd. Suite 4B Rock, Arkansas	RSP CHECKED <b>MAR 1985</b> DATE	NAME OF PARK <b>HOT SPRINGS NATIONAL PARK</b> REGION: <b>SOUTHWEST</b> COUNTY: <b>BARLAND</b> STATE: <b>ARKANSAS</b>	SHEET <b>Q-3</b>	OF 3

108 psf
