UNITED STATES DEPARTMENT OF THE INTERIOR
NATIONAL PARK SERVICE

OUTLINE REPORT OF
ARCHITECTURAL WORK
ON THE RESTORATION OF THE
CHESAPEAKE AND OHIO CANAL
FOR RECREATIONAL USE
(GEORGETOWN, D. C., TO SENECA, MD)

1939

Dallas D. L. McGrew
Associate Architect

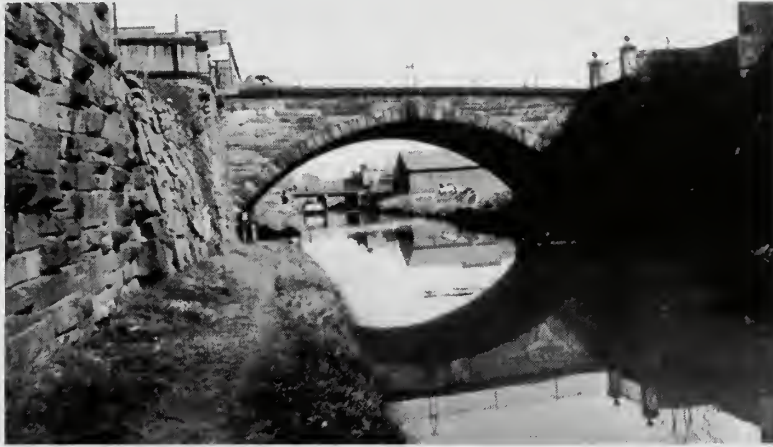
BRIDGES: In passing through Georgetown, the Canal was spanned by a series of stone arch bridges of which only that carrying Wisconsin Avenue survives. This handsome structure, completed in 1831, is in excellent condition. An inscription on its east face records the fact that Andrew Jackson was President at the time. In its northwest corner stands a marble obelisk to mark the completion of the Canal to Cumberland in 1850.

Photograph 4: Wisconsin Avenue Bridge, looking east along towpath.

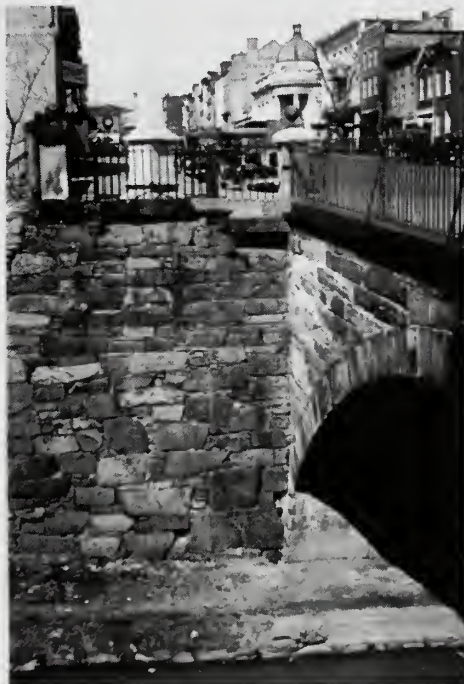
Photograph 5: Northwest corner of Wisconsin Avenue Bridge. Note character of masonry of bridge and retaining wall, the sturdy wrought iron fence, and the memorial obelisk.

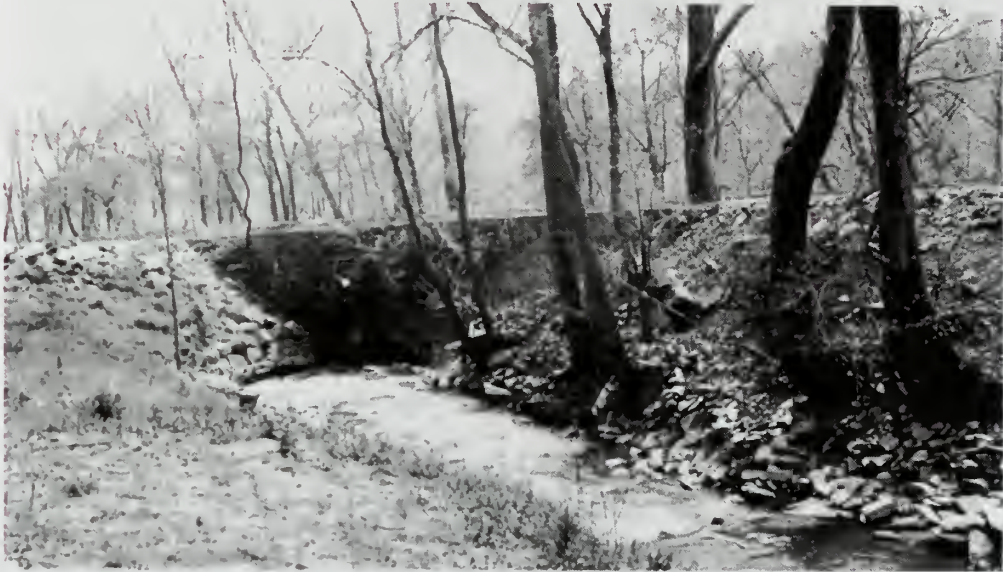
Photograph 12: Culvert below Lock No. 5.

CULVERTS: A number of culverts, structurally resembling the underpasses, carry streams under the canal. All of these have not been studied, but their character is here illustrated by photographs of two of the larger ones, the first below Lock No. 5 and the second between Locks Nos. 10 and 11, the Rock Run, and one smaller just below Lock No. 18, the masonry of which has been repointed. This particular one served to carry excess water from the Canal under the towpath.

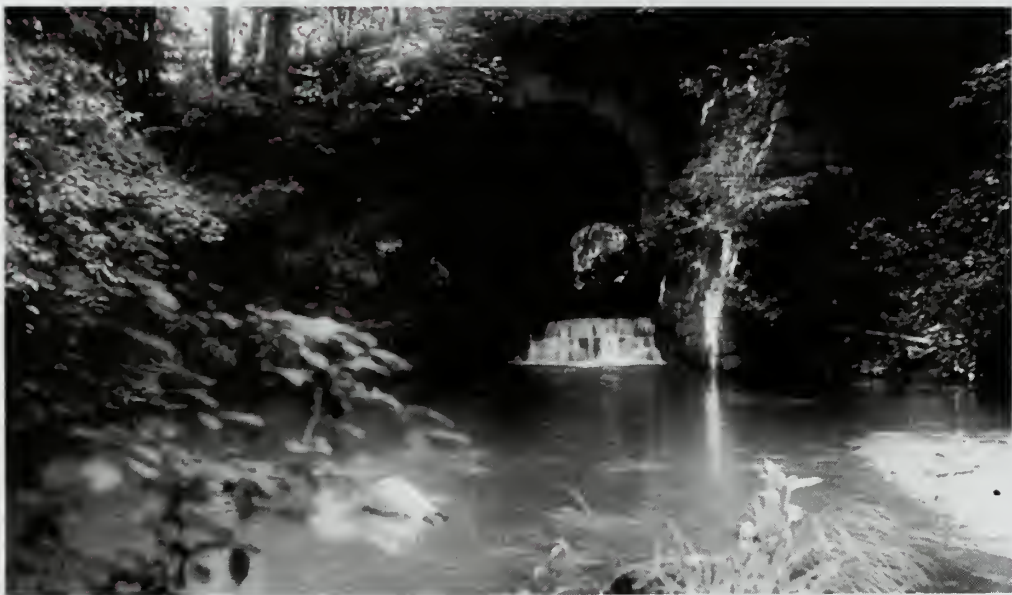
Photograph 13: Rock Run Culvert, below Lock No. 11. An excellent example of the substantial character and simple design of the canal masonry.

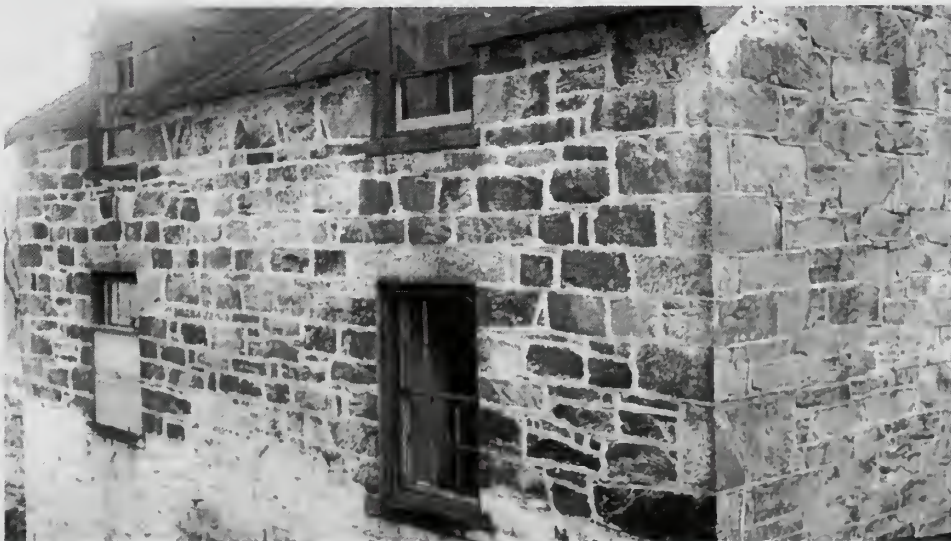
Photograph 40: The substantial character of the masonry is clearly seen in this picture, as well as the type of dormer windows.

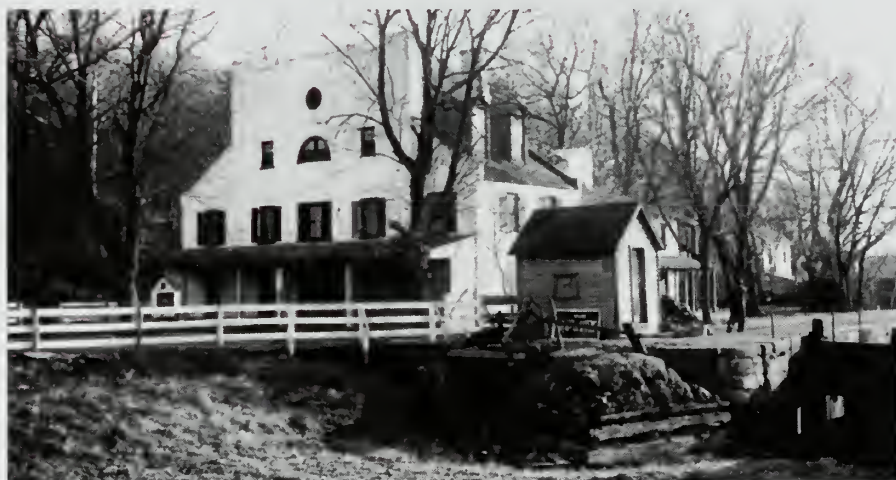
Photograph 44: The north front of the Tavern, completed in 1832, and built of brick, like the addition at the south end, completed at the same time. The porch is a comparatively recent addition and is to be removed. In the right foreground are the Lock (No. 20), gate closed, butterfly valve open, one of the slots for temporary dam, the cribbing between the lock and the opening for the spillway, and the much newer shack for the lock tender.

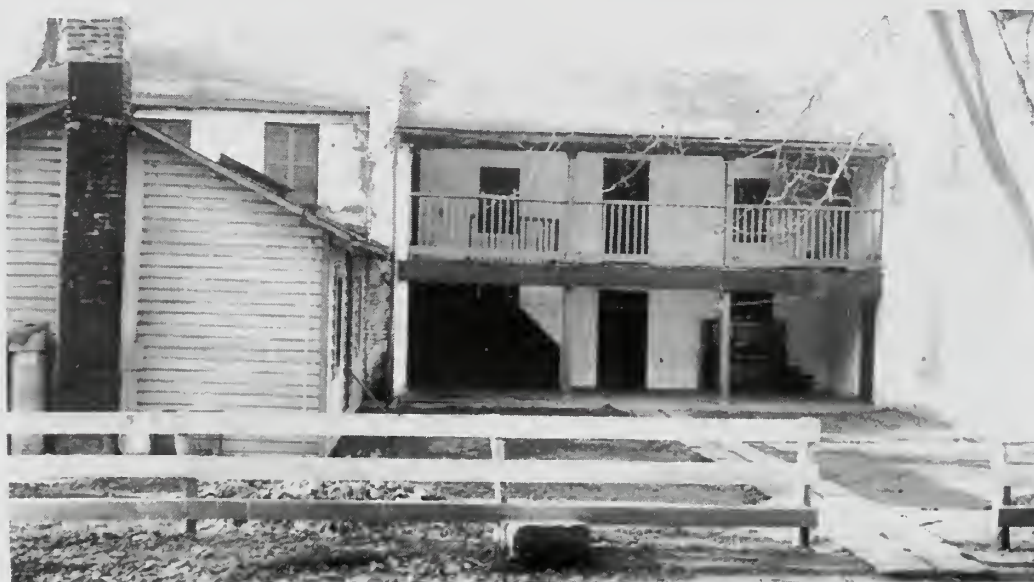
Photograph 46: The north side of the Tavern. On the left is the wooden kitchen added in 1926 to replace a similar structure. In the verandah or gallery, appears the slope of the outside stair that was the only means of communication between the ground and first floors. The central part is the 1828 building.

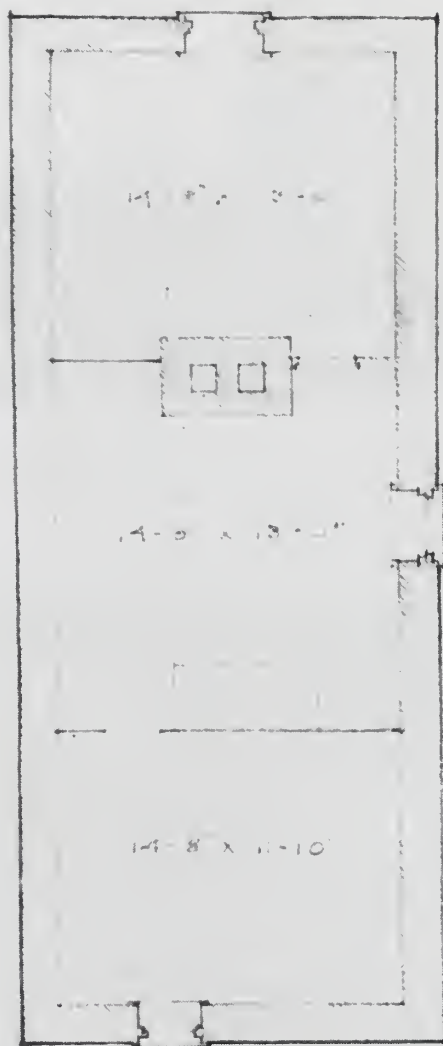
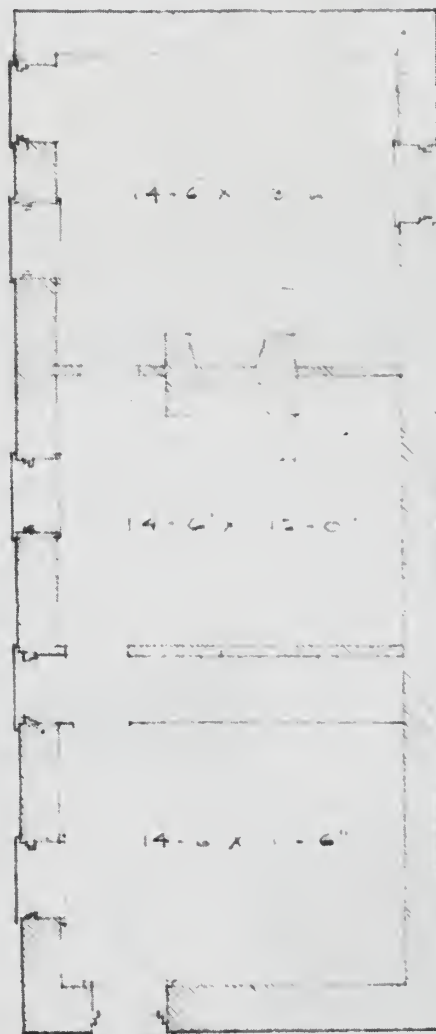
Drawing 18: Floor Plans for House at Swain's Lock No. 21.

Above Great Falls, after a stretch of several miles, is Lock No. 21 or Swain's Lock, with a stone house of still another type. This is in usable condition but needs repairs.

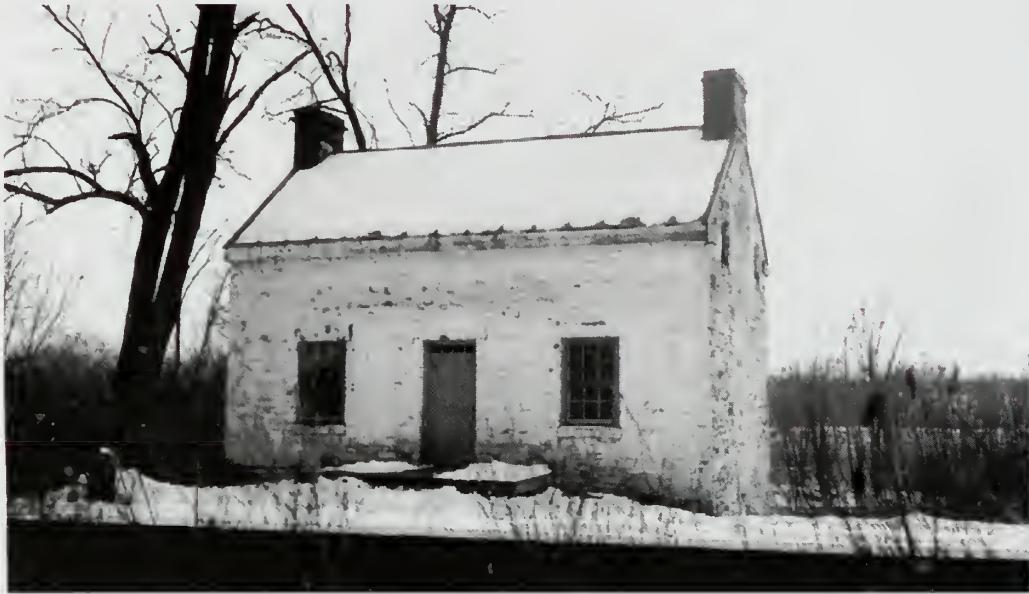
Lock No. 22 has a house of the type built from the 1836 specification, in good condition and needing little or no repair work.

Photograph 53: House at Lock No. 22, with Lock wall in foreground. These chimneys vary from type in being built of cut Seneca sandstone instead of brick. The trees here are black walnut.
