A Report on the Structural Issues at

Fort Sumter National Monument

Charleston, South Carolina

Wednesday, July 8, 2009

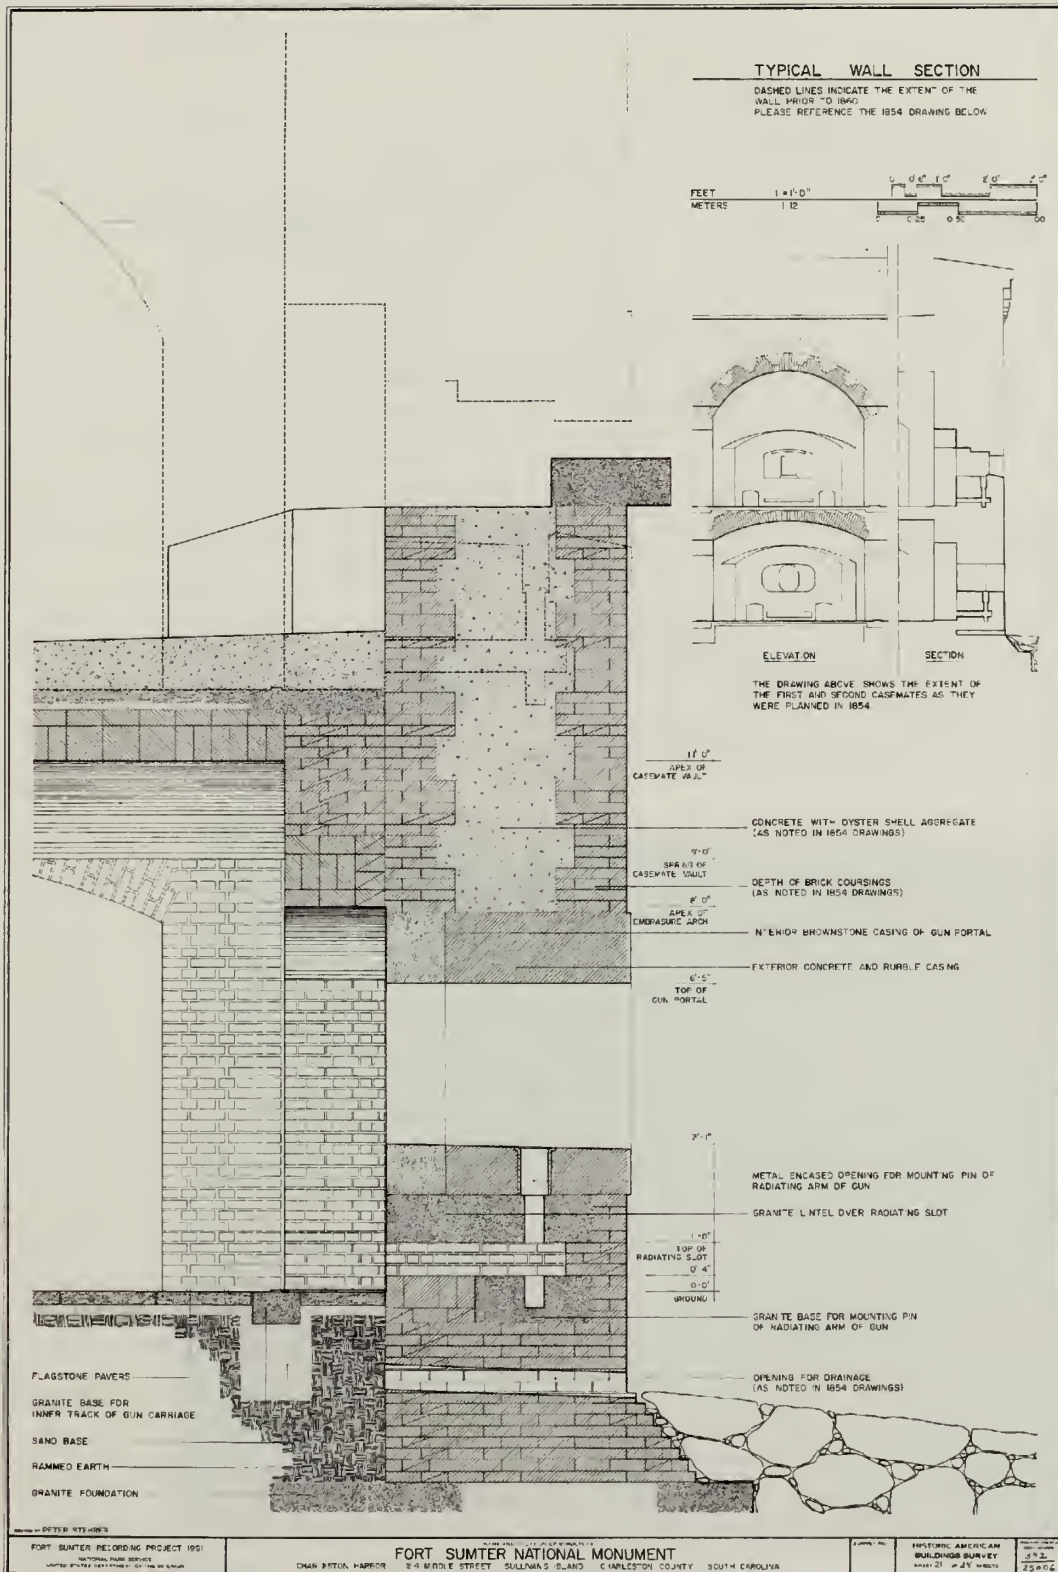
FIGURE 1: Fort Sumter Recording Project, HABS, 1991

When Fort Sumter was partially rebuilt in the 1870s, the upper casemates were eliminated (Fig. 1). The casemates along the Right Face and Right Flank were covered with earthen fill, though the interior of the Right Face was excavated in the twentieth century. The exposed vaults are now covered with a concrete roof, which was added as protection against water intrusion.

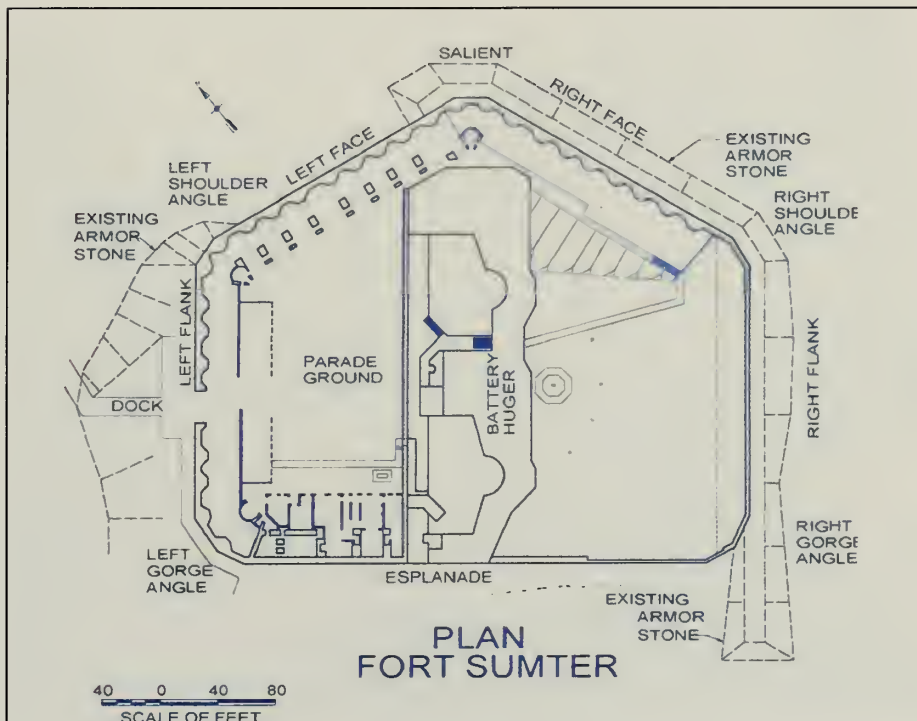
FIGURE 2: Plan of Fort Sumter, Armor Stone and Outer Wall Structural Study, 1998

Fort Sumter is an example of the design and construction typical of Third System coastal defenses (Fig. 1-2). The rampart consists of several elements. The first, a thick scarp wall, forms the perimeter of the fort. Embrasures (many now bricked in or covered) were built into the scarp to allow cannons to fire. The remainder of the rampart is formed by the casemates. These are located between the parade wall arcade and another series of arches along the interior of the scarp wall that frame each embrasure. Every casemate was originally vaulted, with the vaults resting on arched abutments that extend from the centers of the arcade piers. As shown in Figure 1, the arcades, vaults, and scarp are not tied together, but are in fact separate systems. However, loads are transferred between the structural systems through direct contact.

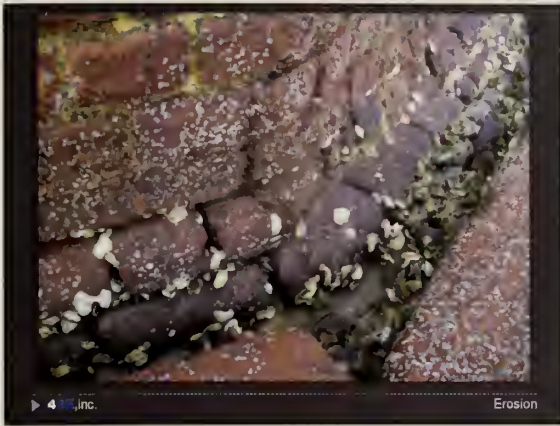
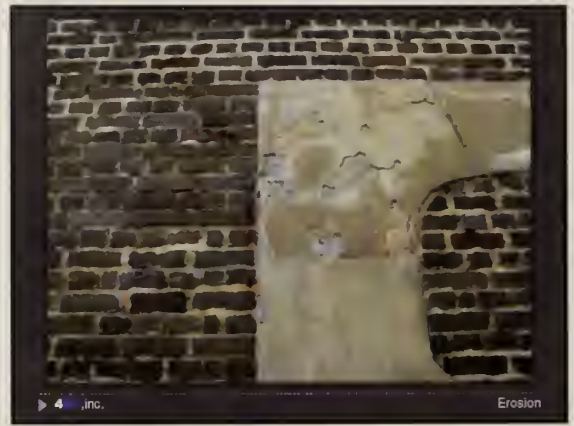
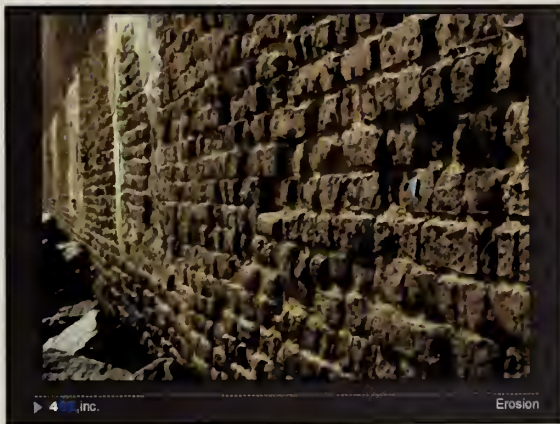
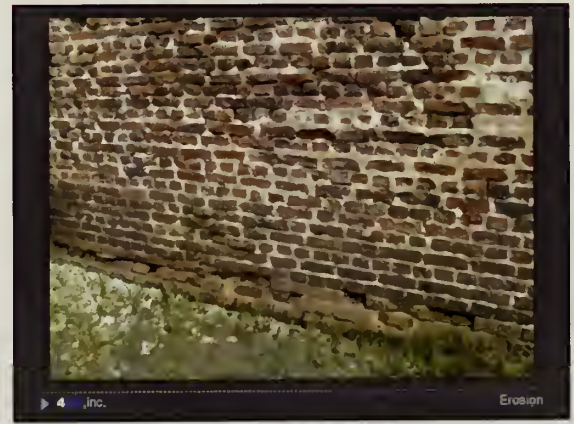
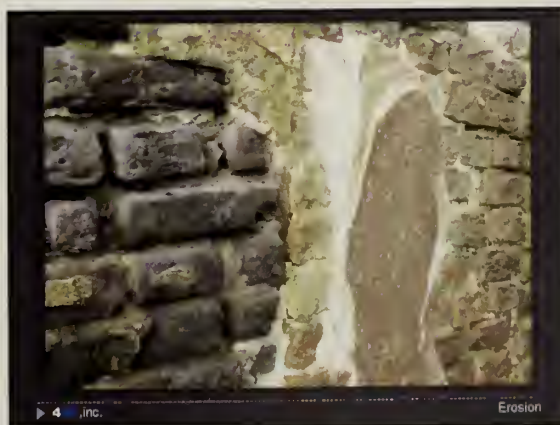
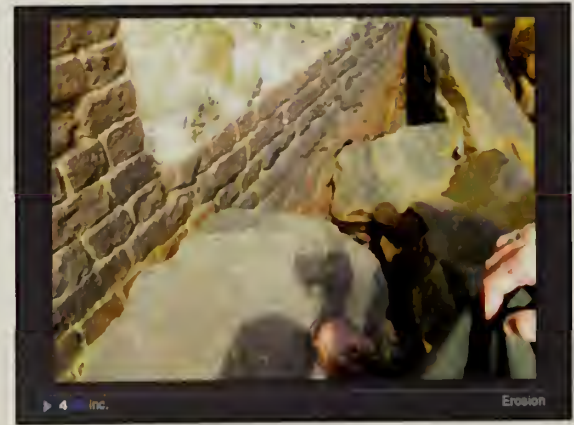
Erosion along the exterior scarp wall varies across the fort. Along the base of the wall, uniform softening and erosion of mortar has occurred below the high water mark (Fig. 3). Erosion is worst where granite revetment blocks rest against the wall (Fig. 4). Above the high water mark, erosion of the face of the wall was most severe on the Salient, Right Face, and Right Flank which face the shipping channel (Fig. 5-6). In some locations, previous repointing with Portland cement has helped to accelerate the loss of the brick face (Fig. 7). Loose bricks along the cornice were also noted along the exterior (Fig. 8).

Exterior: Surface damage, erosion

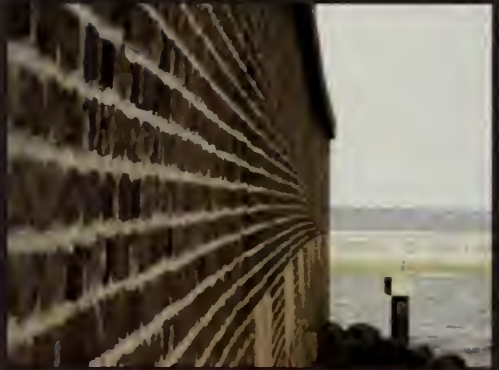
Bowing Walls

Exterior: Walls bowing as they approach corners

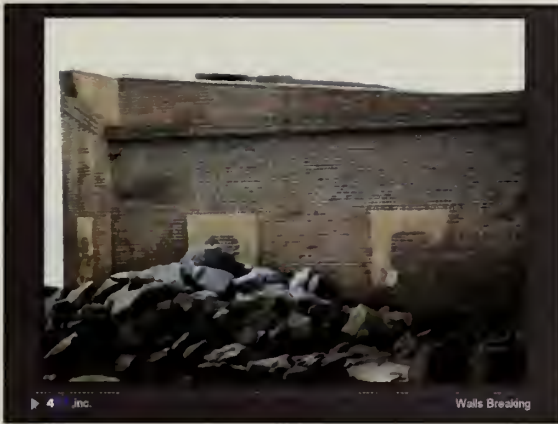
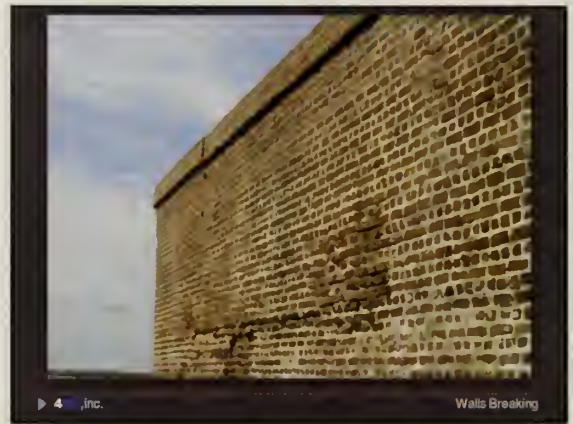
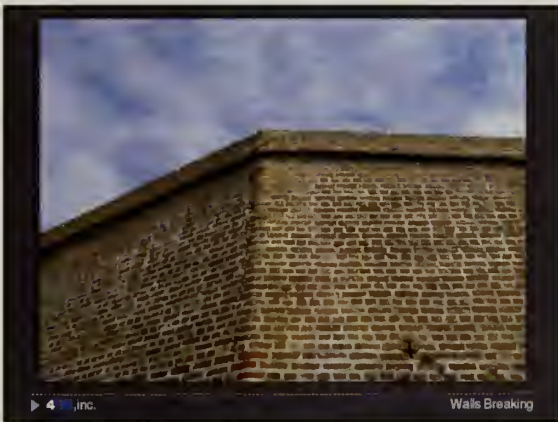
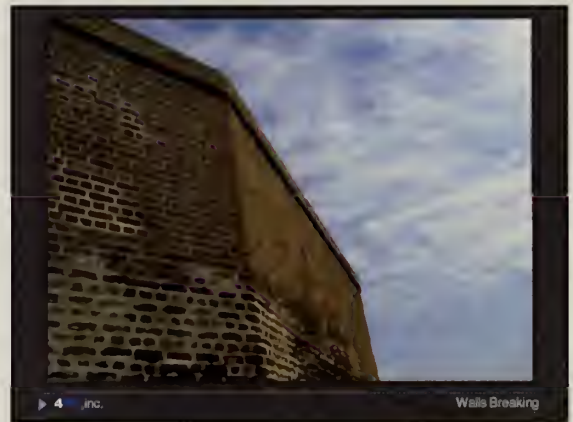
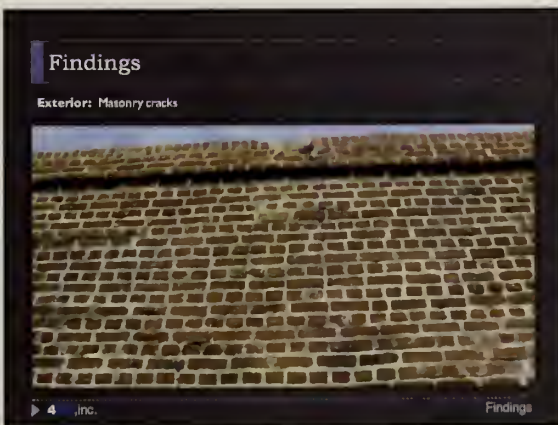
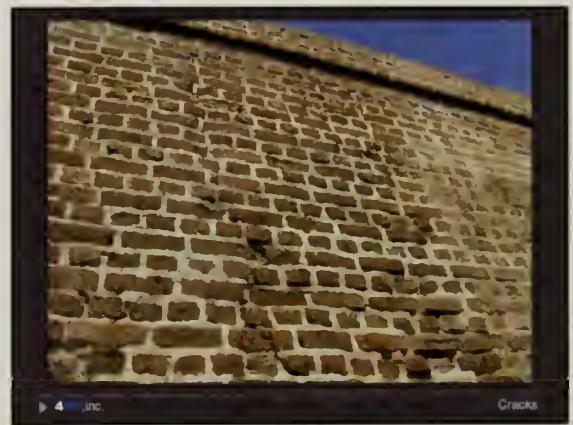
Several masonry cracks were found along the exterior of the fort. The cracks seemed to be focused towards the ends of the long walls and on the shoulders (Fig. 13-18). Several of these cracks extended from the top of the wall to below the revetment. Others started at the top of the wall and stopped at a corner before reaching the base of the wall. The Right Face and Right Flank contained the majority of the cracks noted on this site visit.

Exterior: Walls breaking at corners

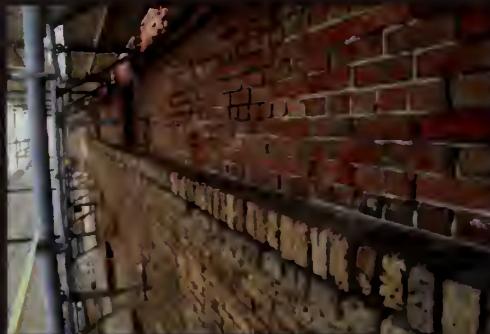
Safety Hazards

Some cracks indicate safety hazards- loose bricks that could fall out of walls, arches, or the cornice

Remove loose bricks along arches, cornice (along interior and exterior walls)

Store removed bricks for use in future repairs

Monitor areas around loose bricks, cracks, and damaged arches to watch for further loosening of material
