CHANNEL CHANGES IN THE MERCED RIVER FOLLOWING THE JANUARY, 1997 FLOOD

Mary Ann Madej (1), Vicki Ozaki (2), Carrie Jones (2), and Gregory Gibbs (1)

United States Department of the Interior
1-U.S. Geological Survey Biological Resources Division
2-Redwood National and State Parks

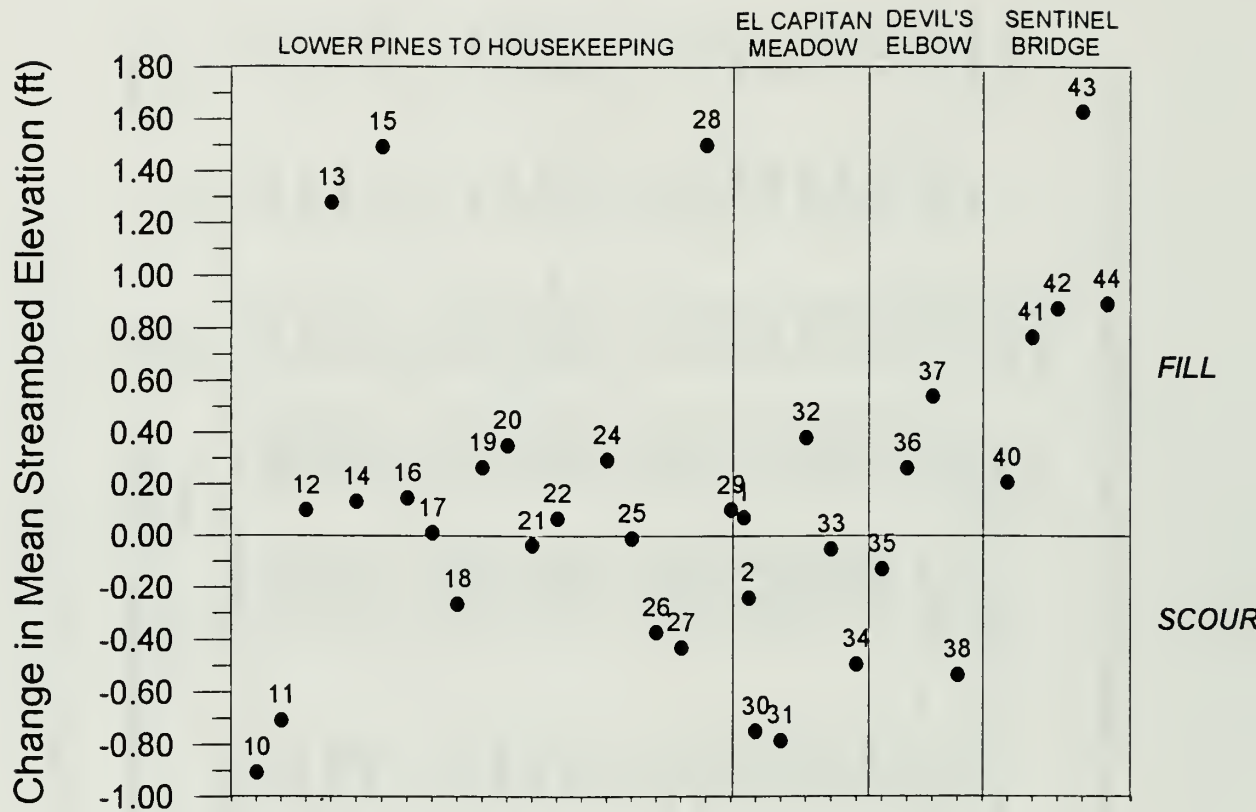
Figure 6. Change in mean streambed elevation for cross sections on the Merced River.

general, the Merced River channel filled upstream of Stoneman Bridge and near Sentinel Bridge. In the reaches of river near Sugar Pine Bridge, El Capitan Meadow, and Devil's Elbow the Merced River bed showed both scour and fill. Specific changes are discussed more fully in the following section.

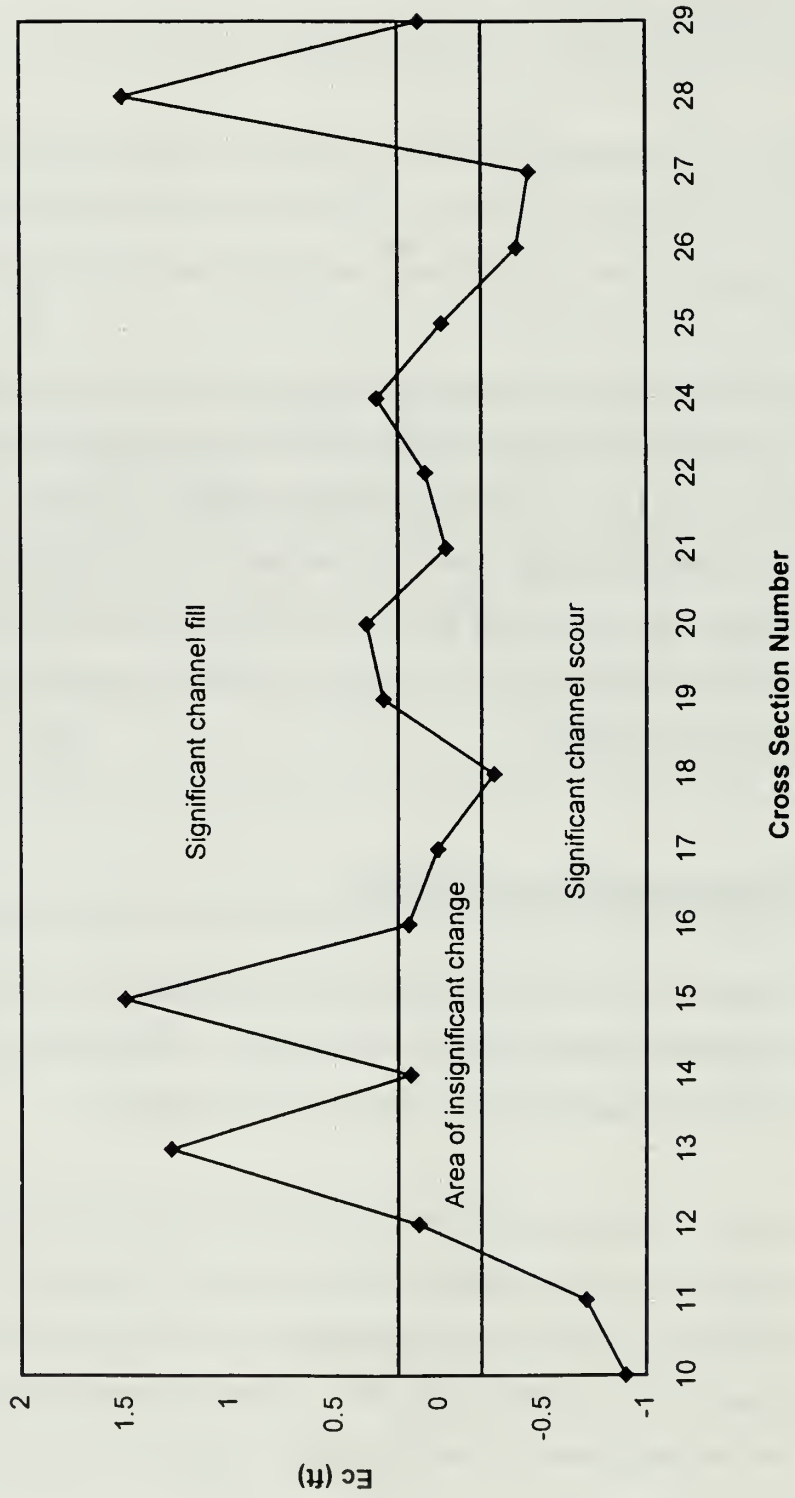
Figure 7 summarizes the changes in mean channel bed elevations at the 19 cross sections on the Merced River from upstream to downstream in this study reach. At six cross sections, the channel filled with sediment, at five cross sections the channel scoured, and at eight cross sections changes were within the survey error. When a channel aggrades (that is, fills in with sediment), the flood-carrying capacity of the channel may decrease because the area available to

Figure 7: Change in mean streambed elevation due to the January, 1997 flood in the Merced River from Cross Sections 10 to 29.

Channel response in this section was highly variable. Figure 7 is a plot of the change in mean streambed elevation, showing which cross section had net scour or fill after the flood. The lines connecting the observation points have no physical meaning, but are used to highlight the sequence of observations along the Merced River channel. The Merced River channel upstream of the Tenaya Creek confluence is wide and shallow, with low banks (Figure 8), and there is abundant evidence of past bank erosion. The cross sections upstream of the Tenaya Creek confluence show that this part of the channel scoured during the 1997 flood. Cross Section 10 and 11 scoured to a depth of almost one foot across the channel bed. At Cross Sections 12 and 14 the changes were within the survey error. At Cross Section the channel bed filled in with sediment to a depth of about three feet across much of the channel, with a mean streambed elevation increase of 1.3 ft. The channel at Cross Section 13 was influenced by the floodwaters of Tenaya Creek, and evidence for flow over the left bank was obvious at this location. This part of the channel has a more gentle gradient than the average for the study reach (discussed later). There may have been some decrease in flow velocity at this cross section, leading to deposition at this site during the flood.

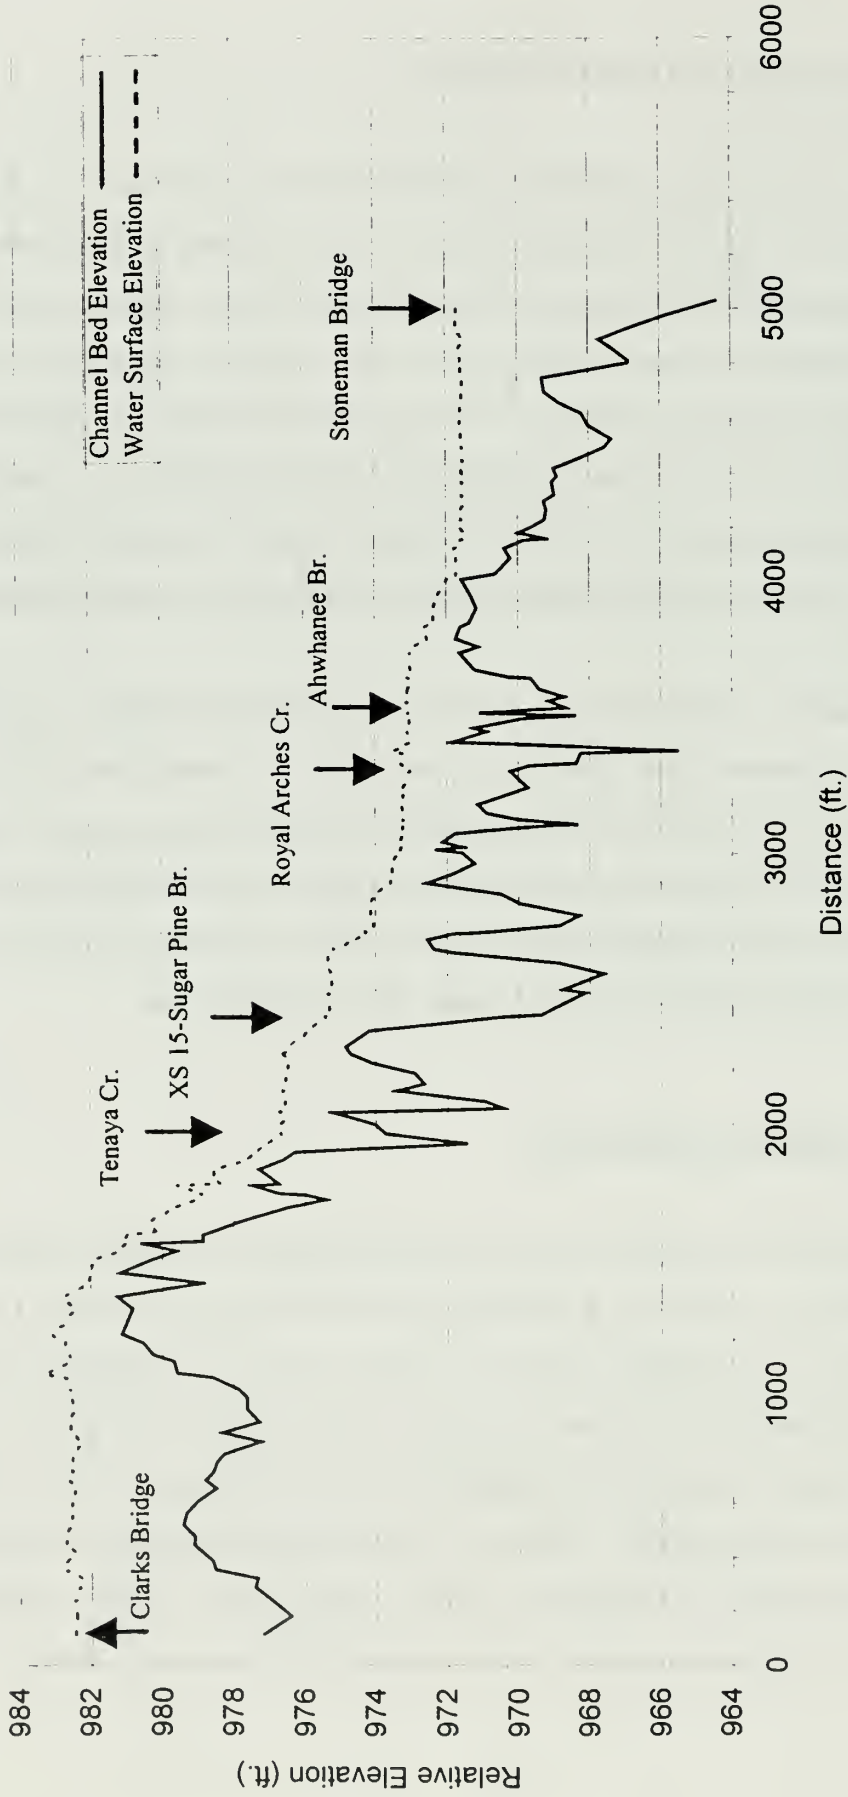
Figure 18: Longitudinal Profile of the Merced River from Clarks Bridge to Stoneman Bridge

The average slope of the river channel in the surveyed reach is 0.30 %, which represents a fall of 15.8 ft over a one-mile reach of river. In this reach 19% of the channel is classified as riffle habitat. There is a steeper section between channel distance 1300 and 2300 ft (Figure 18), with a more gentle grade near Clarks Bridge.

Although at first glance an observer may think the bed of the Merced River is smooth, the thalweg profile (Figure 18) shows there is considerable variation in the streambed profile. Some of the deepest parts of the channel are associated with man-made structures (surveyed water depths are in parentheses): Clarks Bridge (6 ft) Sugar Pine Bridge (7.6 ft), a water intake near the confluence of Royal Arches Creek (8 ft), the Ahwahnee Bridge (4.7 ft) and Stoneman Bridge (> 8 ft). Scour at the base of riprap, groins, or pieces of cement along the left and right streambanks caused minor pools (2 - 4 ft deep). Natural features also caused a few pools. A large boulder downstream of the mouth of Tenaya Creek caused a 6.1 ft scour pool, and scattered stumps along the banks were associated with pools 3 to 5 ft deep. There were few logs within the low flow channel in this reach, although farther downstream (near the El Capitan reach) instream woody debris is an important factor in pool formation.

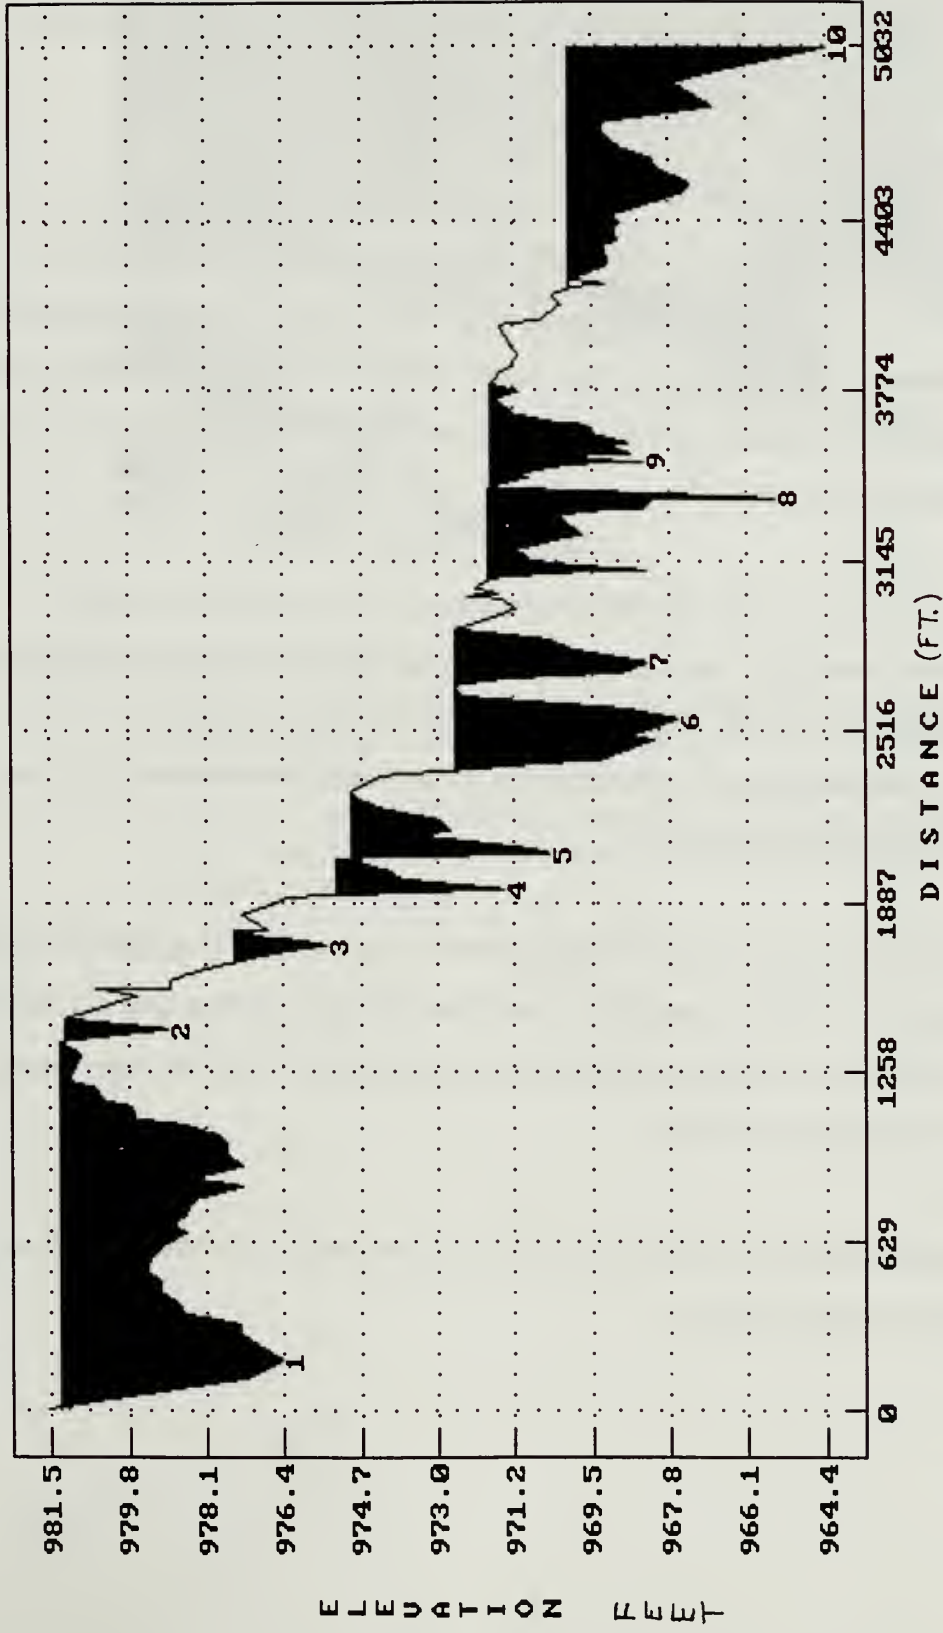
Figure 20: Distribution of pools in the Merced River. The colored areas represent pools with residual water depths > 2 ft. deep.

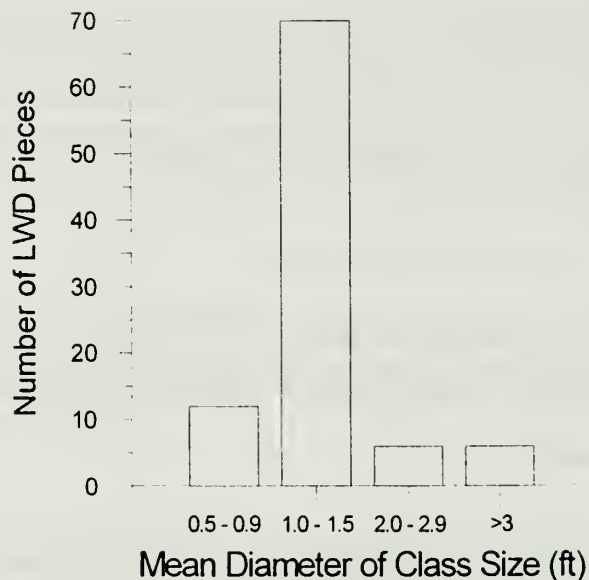
Figure 22 is a histogram of the mean diameter of wood pieces in four diameter class sizes: small (0.5-0.9 ft), medium (1.0-1.5 ft), large (2.0-2.9 ft), and very large (>3.0 ft). Class sizes were based on class sizes used by Ruediger and Ward (1996) for a large woody debris inventory for the Stanislaus National Forest, California. About 72% of the wood inventoried (68 pieces of large woody debris) had a mean diameter between 1 to 1.5 ft. Of the wood in the largest size class (> 3 ft), the largest four out of six pieces were root wads.

Figure 22: Distribution of large woody debris (LWD) by mean diameter, in the reach from Clarks Bridge to Sugar Pine Bridge.

Large woody debris did not influence sediment storage and provided little influence to channel structure in this section of the Merced River. Less than ten percent of the wood (8 pieces) was located within the bankfull channel in the reach and those pieces accounted for less than ten percent of the total volume of wood. In general, these logs were parallel to the bank and never angled more than 50 degrees from the bank in a downstream direction. Only three logs formed scour pools along the bank, with depths ranging from 3 to 5 feet. None of the wood significantly influenced sediment retention and no accumulations of sediment were observed upstream or adjacent to wood. Nearly all (>90%) of the large woody debris in this reach is only available during very large flood events; that is, when floodwaters occupy the overflow channel or flow across the floodplain.

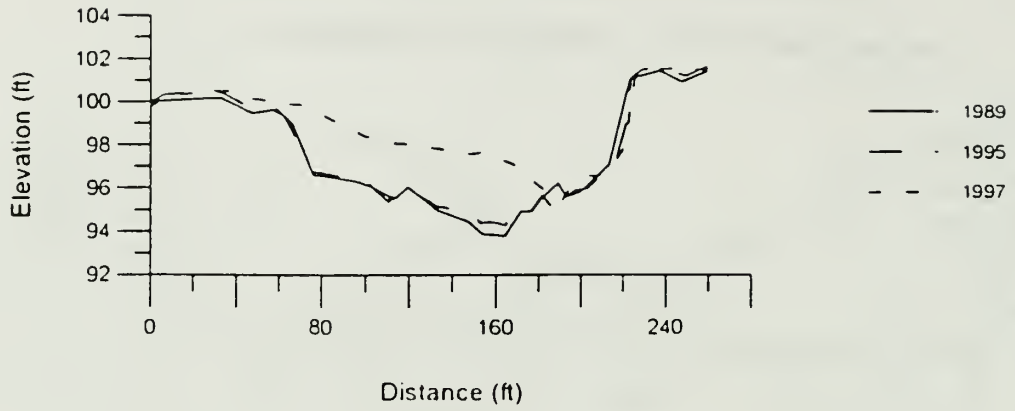
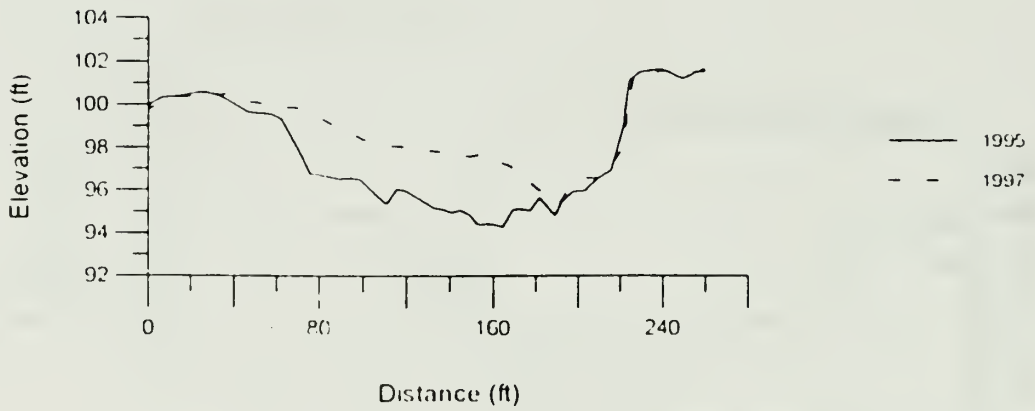
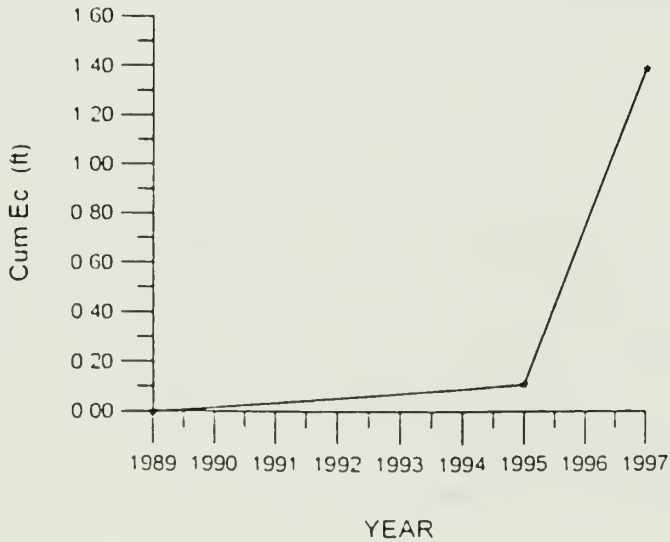
Merced River X/S 13 (Lower Pines Campground)

Changes at cross sections on the Merced River are quantified in Table 1. The net change in area, mean change in streambed elevation, and the change in thalweg (deepest part of the channel) elevation were calculated. Plots of cross-sectional changes and cumulative change in mean streambed elevation for all cross sections are included in Appendix A. Figure 6 is a summary plot of the change in mean streambed elevation at all the surveyed cross sections, and allows a comparison of the relative magnitude of change in different portions of the Merced River. The cross sections showing the largest changes from the 1997 flood are: XS 13, 15, 28 and 43. In

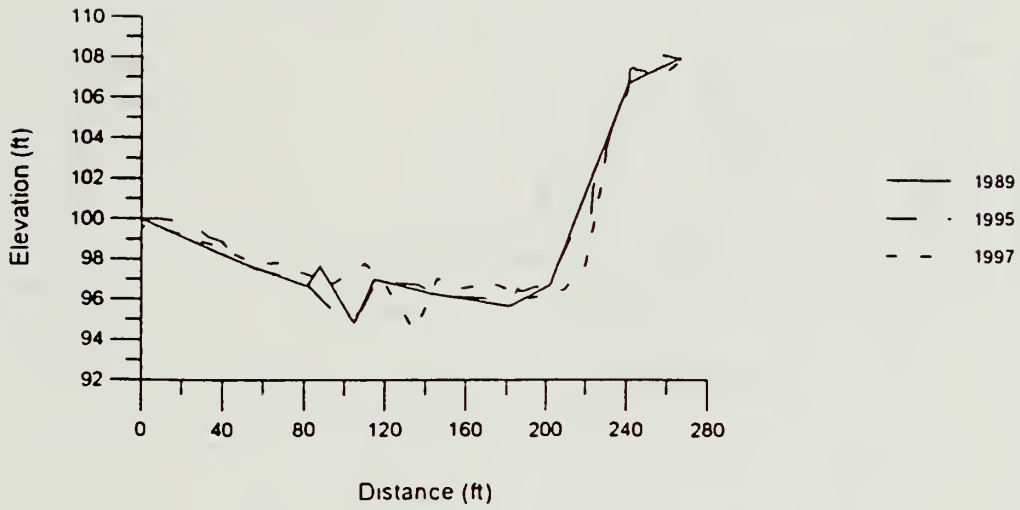
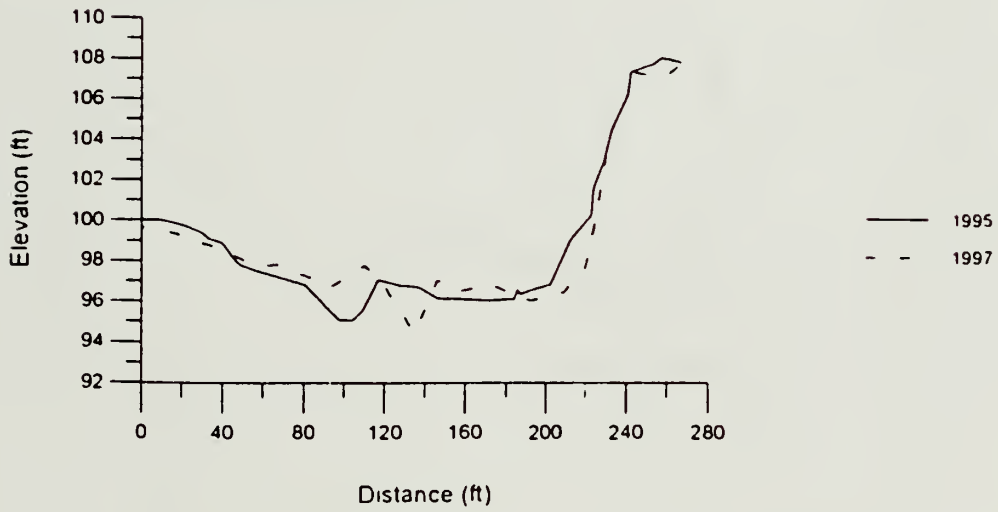
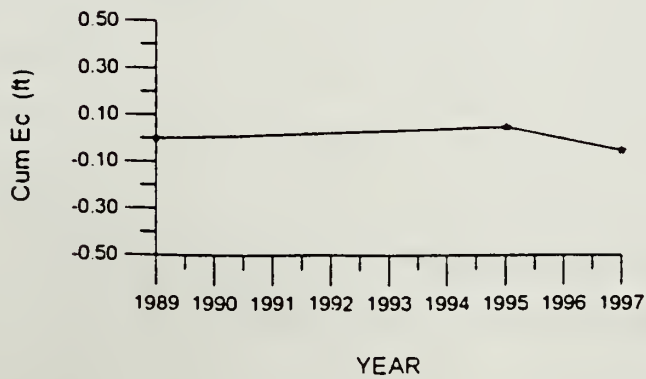
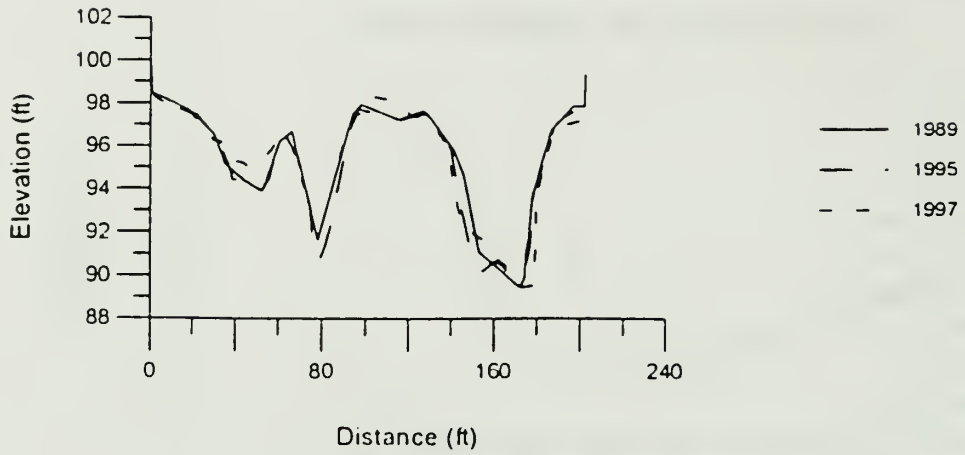
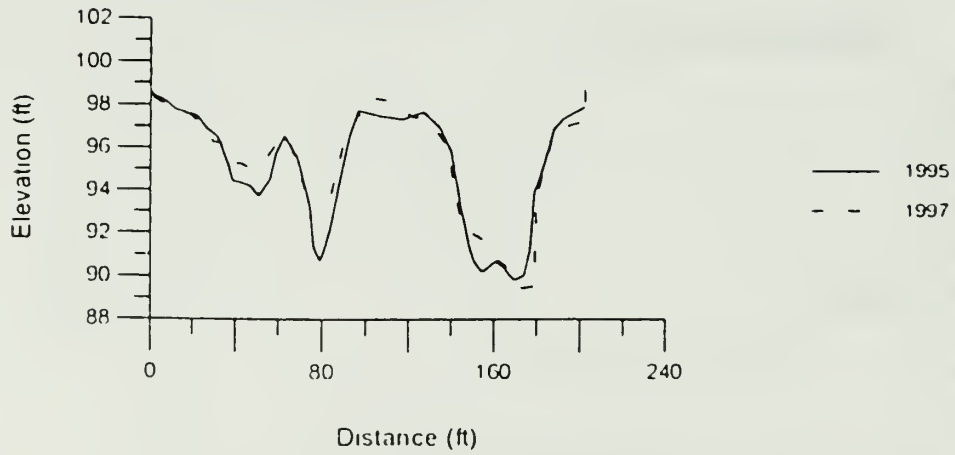
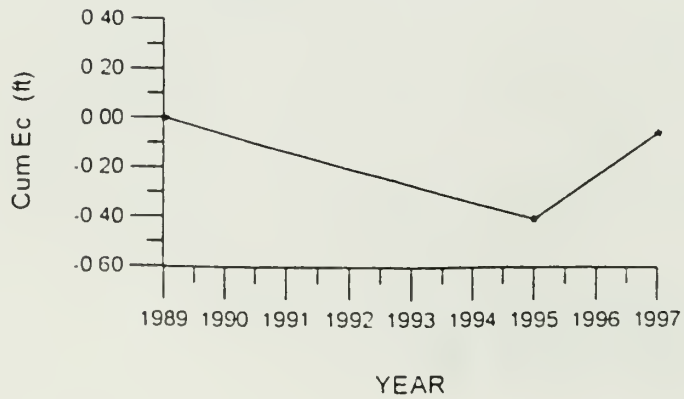
Merced River X/S 15a (Overflow Channel)

The 1997 flood caused only minor changes at Cross Sections 15a and d. Because the entire floodplain was inundated in this area, floodwaters were spread out across the valley floor, and little bank erosion occurred in the overflow channel. Large woody debris (discussed later) can cause bank erosion or channel scour, but little new debris entered the overflow channel. A large debris jam was deposited near the head of the overflow channel, but did not substantially change the flow patterns. If the woody debris had blocked Sugar Pine Bridge or had lodged directly in the overflow channel, bank and bed erosion would have been more extensive.
