TUGBOAT HERCULES

Historic Structure Report

1990

Prepared by
Tri-Coastal Marine, Inc.
200 Burrows Street
San Francisco, California 94134

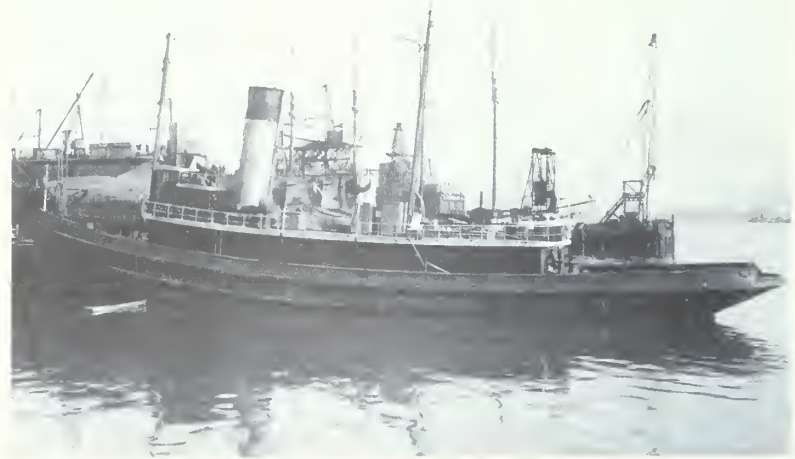
Fig. 7. HERCULES at Moore Drydock Company pier during brief period of ownership by the company, 1923. Photo: SFMNHP B4.8253

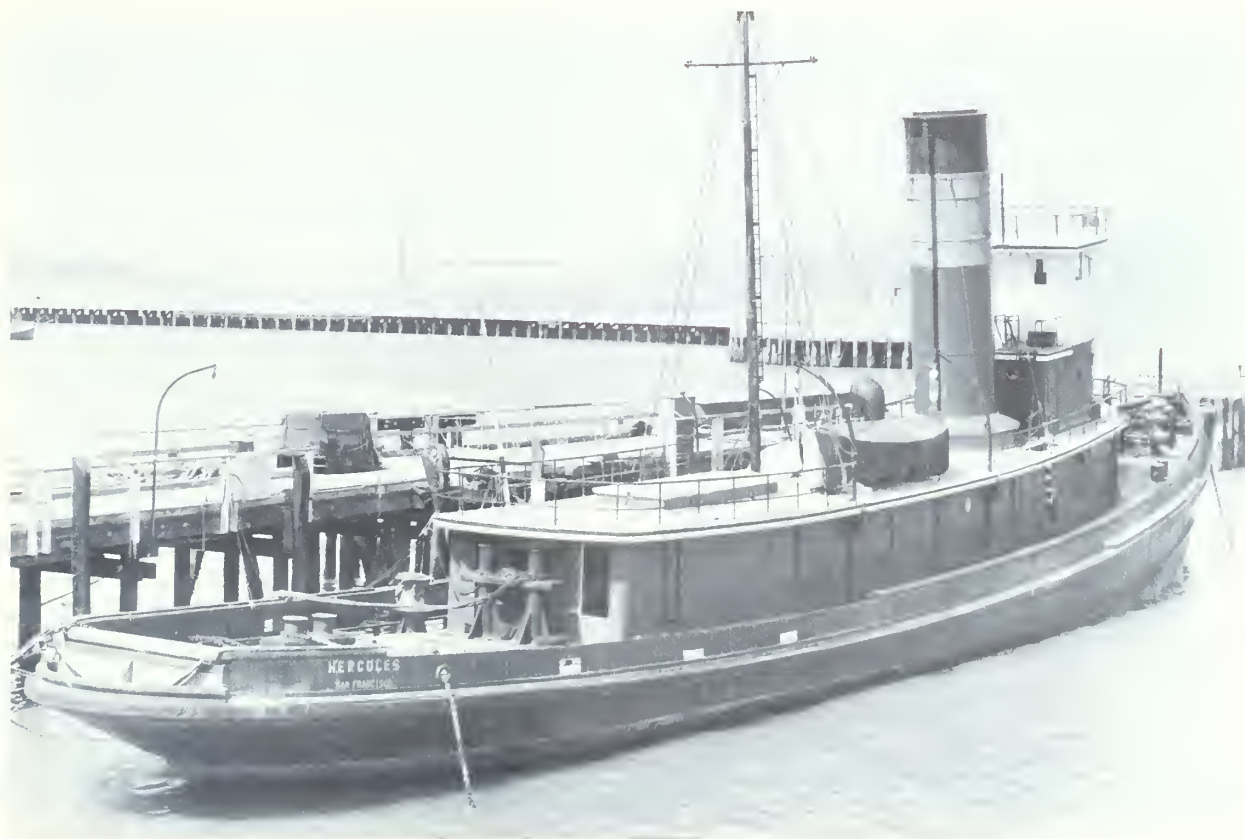
Fig. 19. HERCULES at her berth along east side of Hyde Street Pier, ca. 1981. In 1988 she was moved to Lower Fort Mason.

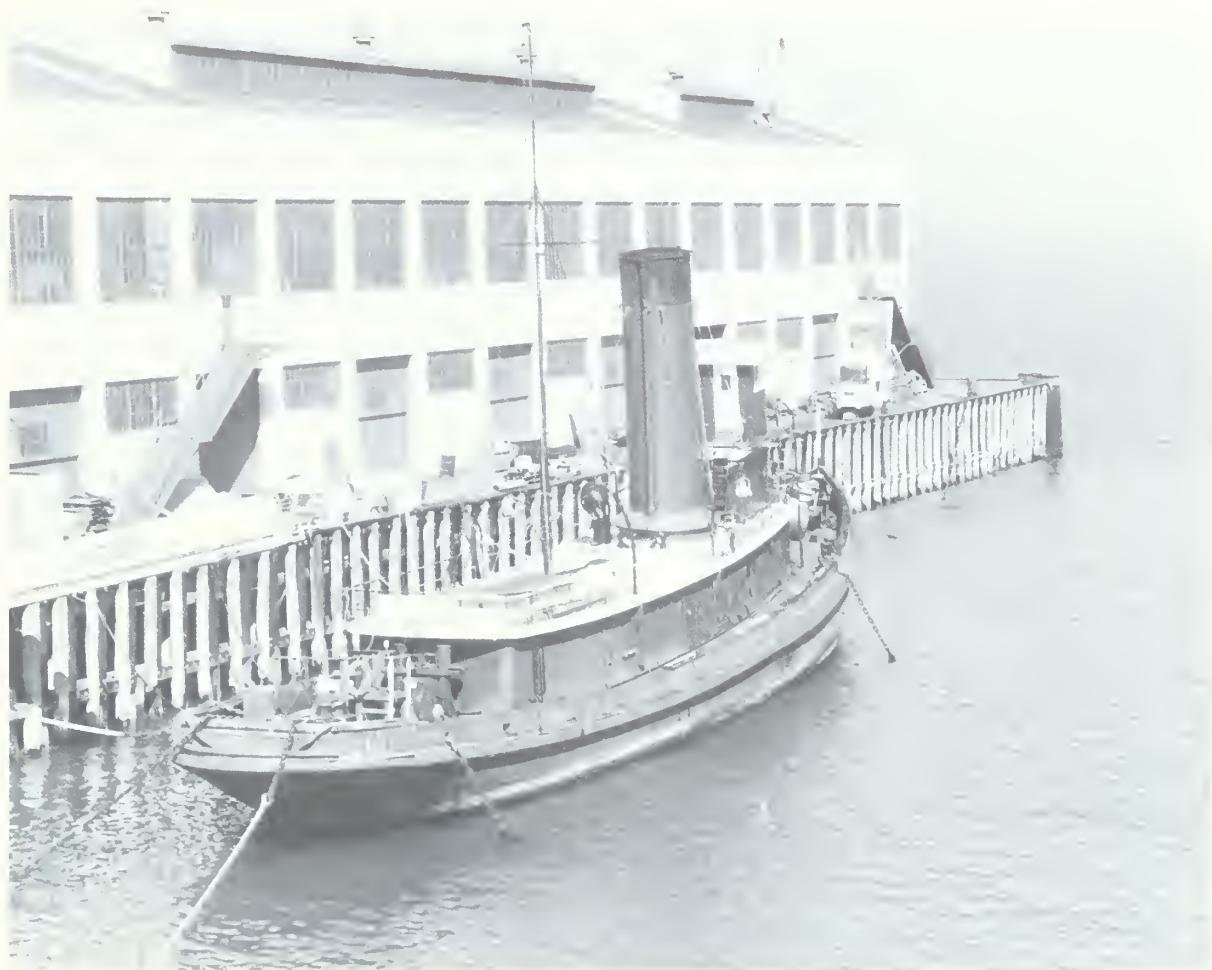
Fig. 20. HERCULES in her temporary restoration berth at Lower Fort Mason.

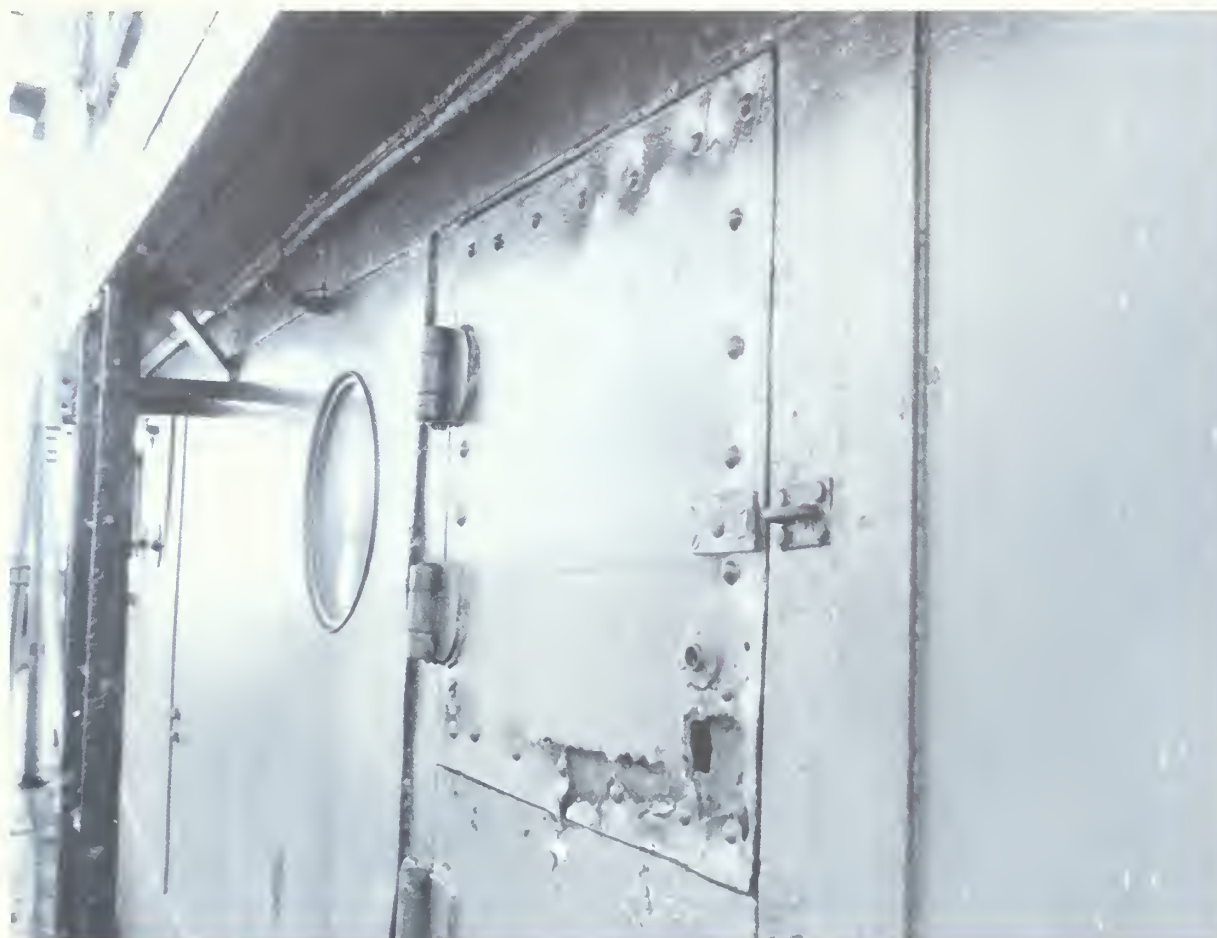
Fig. 21. Wastage typical of that seen in local areas of HERCULES' deckhouse.

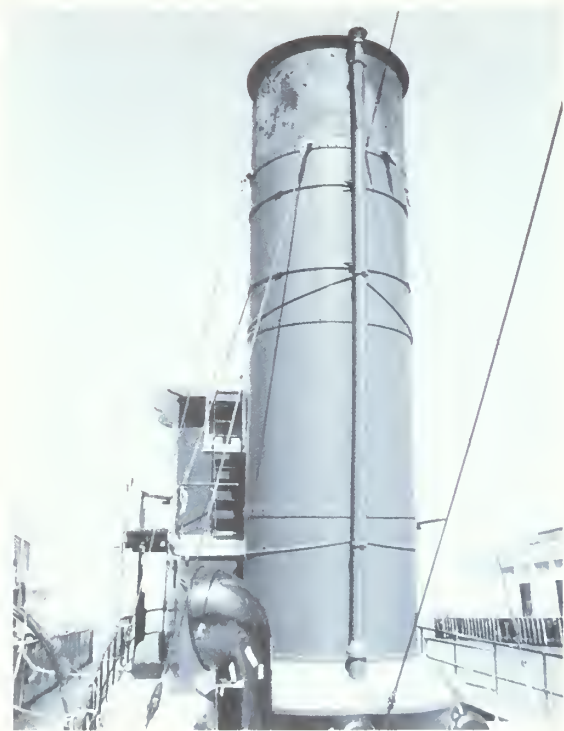
Fig. 25. The smoke stack as viewed from aft. The stack has been rebuilt at least once during HERCULES' working life, as evidenced by a combination of welded and riveted construction, but retains its original form. The tall stack is a significant feature of steam tugs.

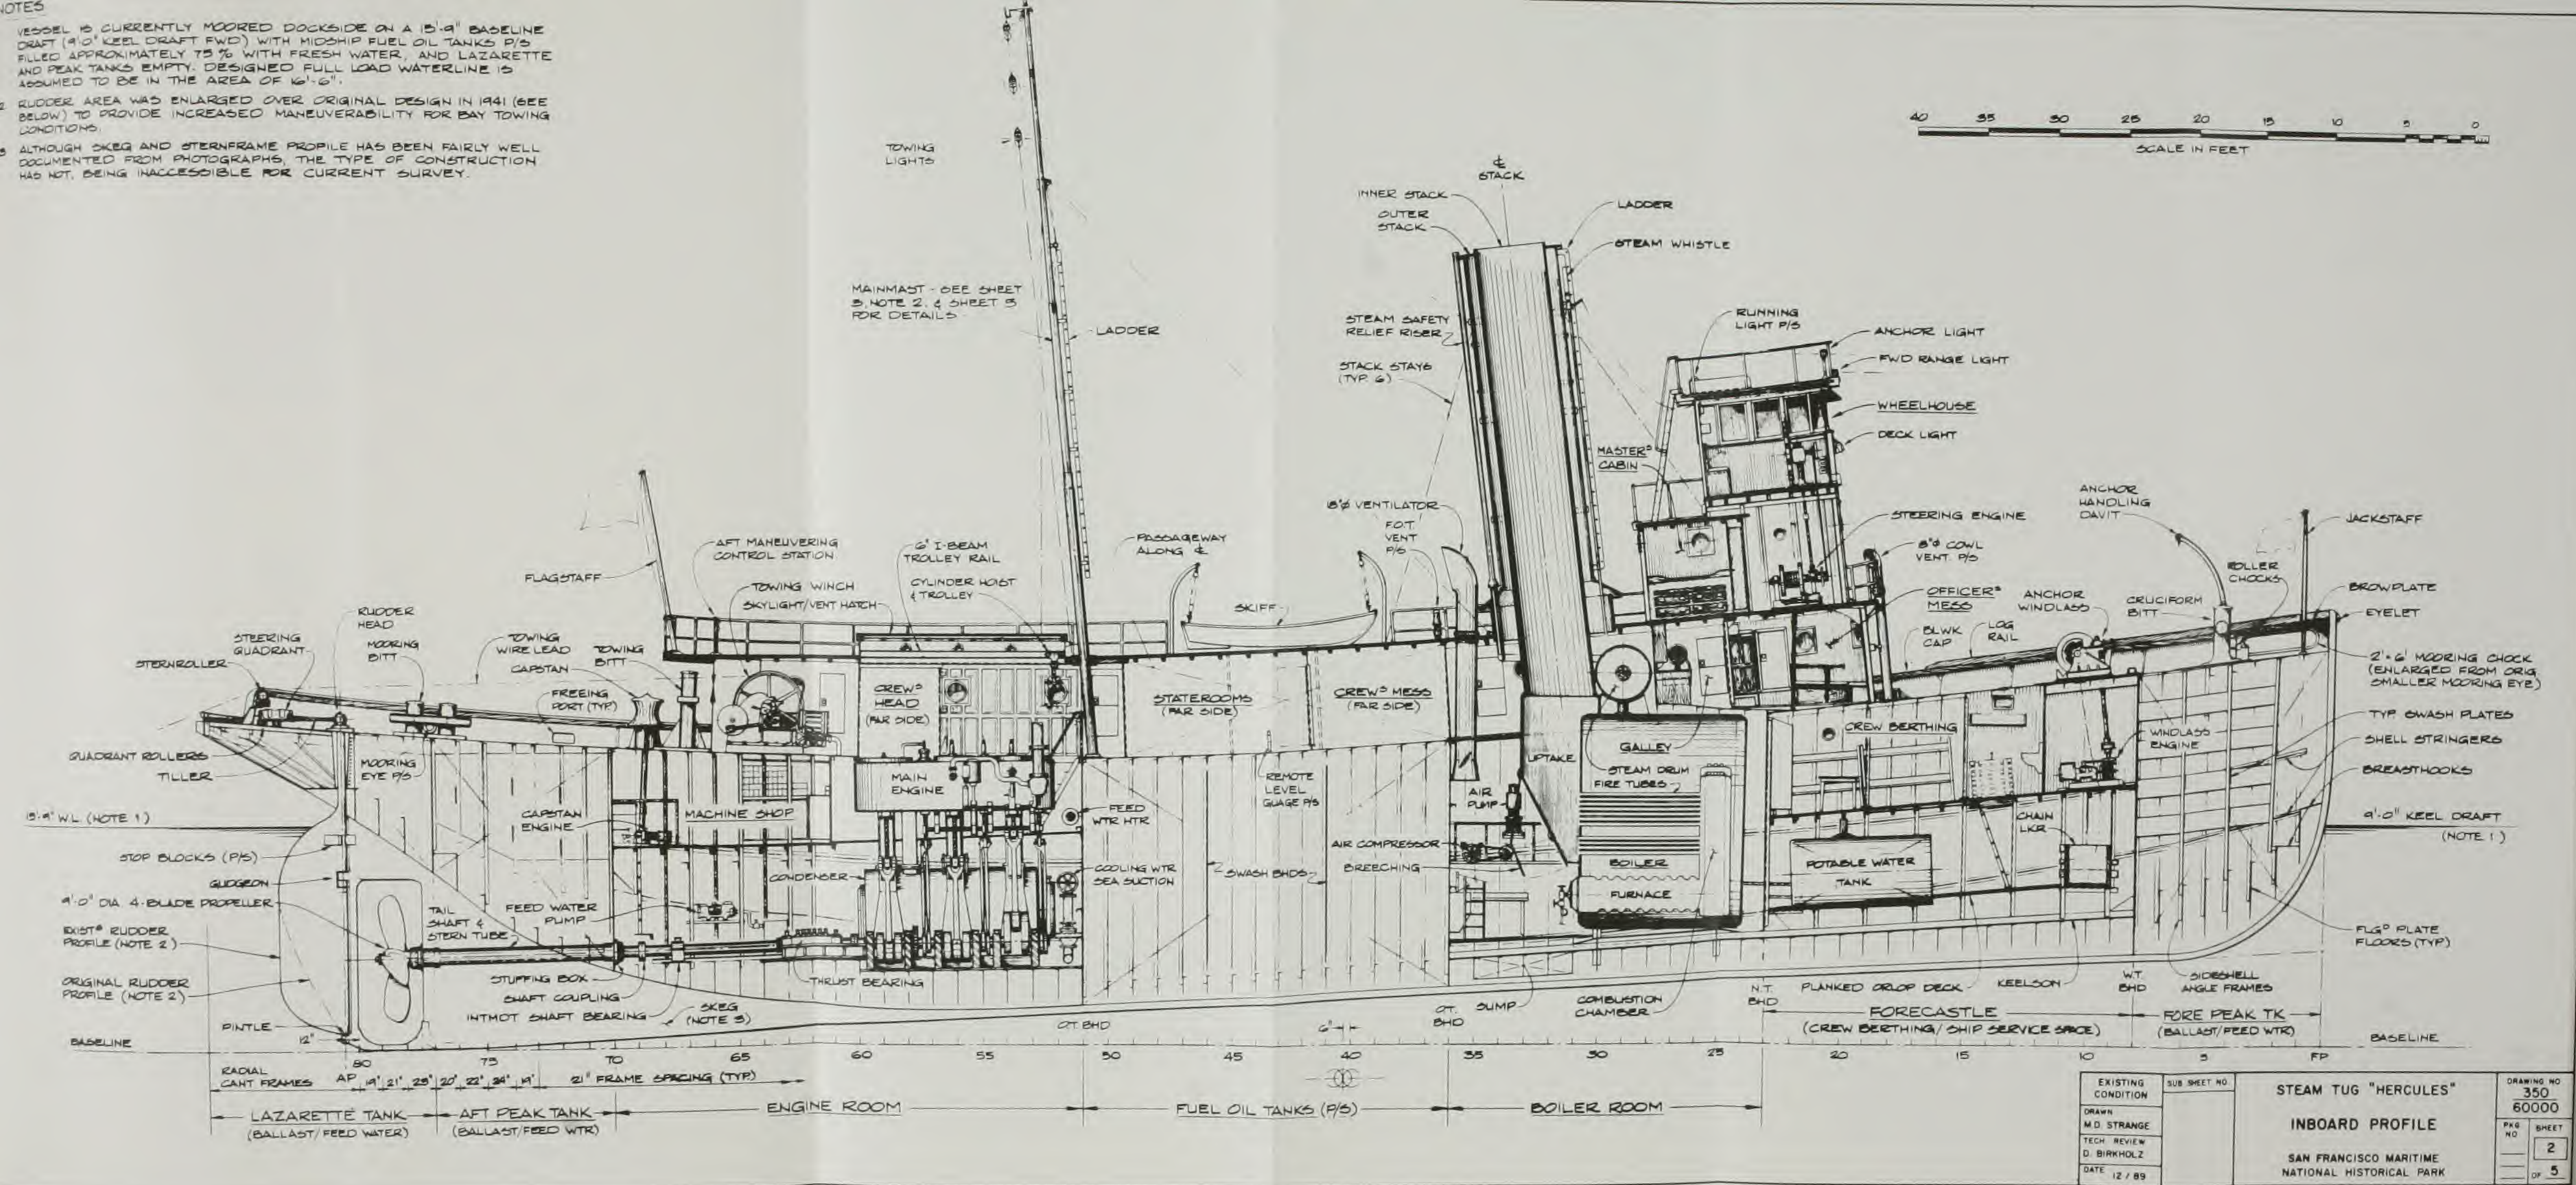
EXISTING CONDITION	SUB SHEET NO.	STEAM TUG "HERCULES"		DRAWING NO.
DRAWN M.D. STRANGE		INBOARD PROFILE		350
TECH REVIEW D. BIRKHOFF		SAN FRANCISCO MARITIME NATIONAL HISTORICAL PARK		60000
DATE 12 / 89		PKG NO.	SHEET	2
			OF	5

VESSEL IS CURRENTLY MOORED DOCKSIDE ON A 15'-9" BASELINE DRAFT (9'-0" KEEL DRAFT FWD) WITH MIDSHIP FUEL OIL TANKS P/S FILLED APPROXIMATELY 75% WITH FRESH WATER, AND LAZARETTE AND PEAK TANKS EMPTY. DESIGNED FULL LOAD WATERLINE IS ASSUMED TO BE IN THE AREA OF 16'-6".

RUDDER AREA WAS ENLARGED OVER ORIGINAL DESIGN IN 1941 (SEE BELOW) TO PROVIDE INCREASED MANEUVERABILITY FOR BAY TOWING CONDITIONS.

ALTHOUGH SKEG AND STERNFRAME PROFILE HAS BEEN FAIRLY WELL DOCUMENTED FROM PHOTOGRAPHS, THE TYPE OF CONSTRUCTION HAS NOT BEEN ACCESSIBLE FOR CURRENT SURVEY.

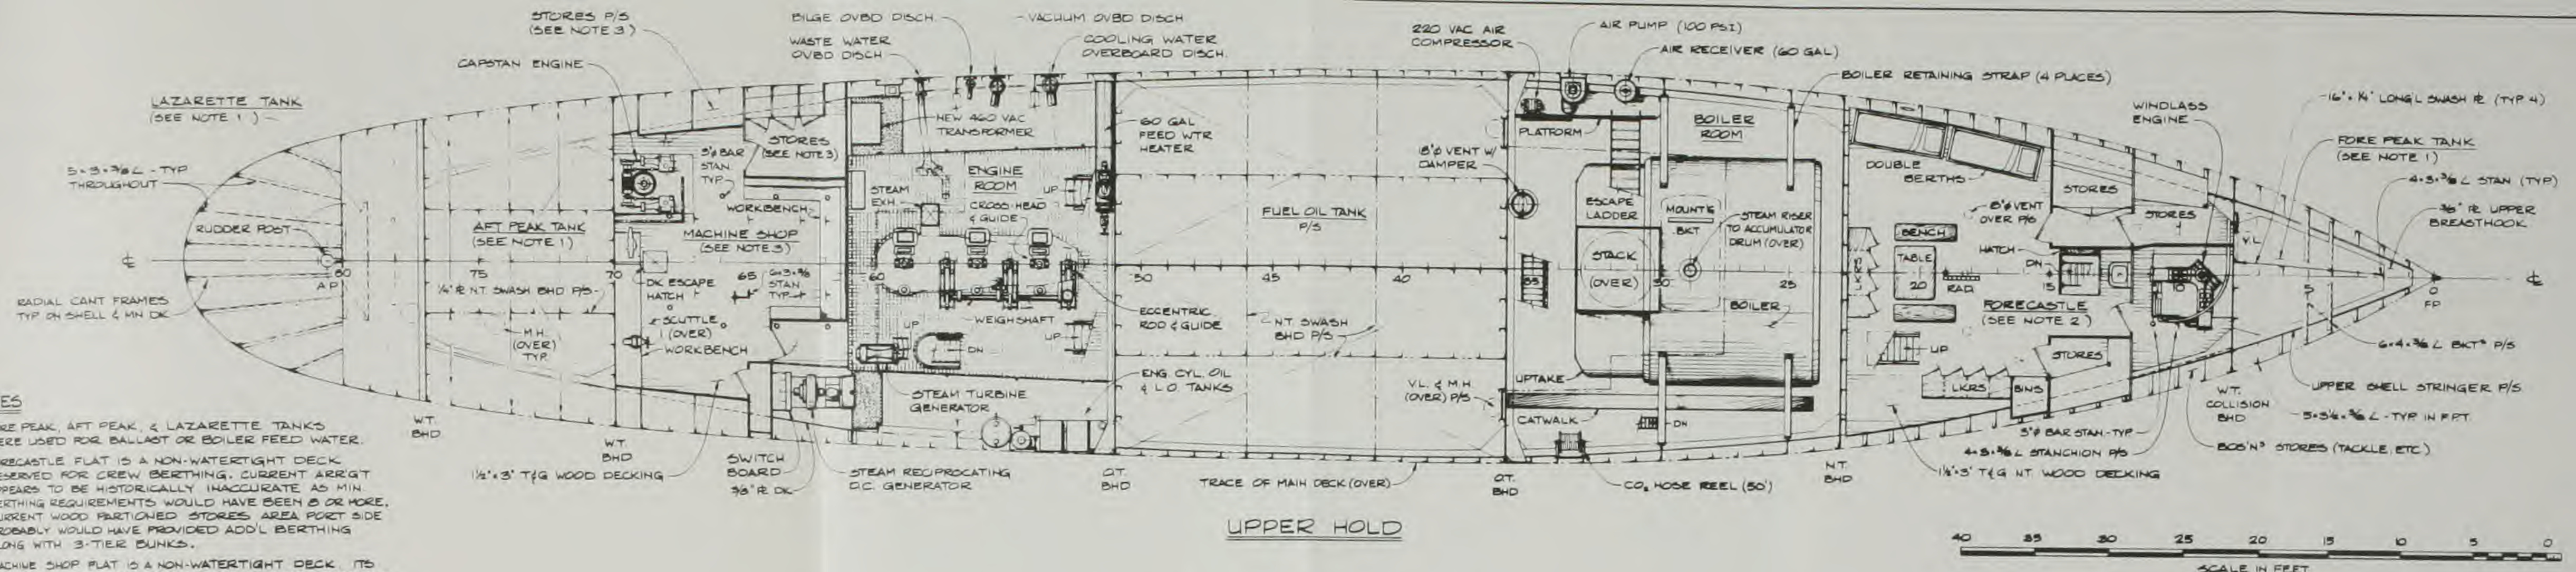
SUB SHEET NO	STEAM TUG "HERCULES"	DRAWING NO	
		350	60000
	HOLD ARRANGEMENT	PKG NO	SHEET
			4
	SAN FRANCISCO MARITIME NATIONAL HISTORICAL PARK	OF 5

- NOTES**
1. FORE PEAK, AFT PEAK, & LAZARETTE TANKS WERE USED FOR BALLAST OR BOILER FEED WATER.
 2. FORECASTLE FLAT IS A NON-WATERTIGHT DECK RESERVED FOR CREW BERTHING. CURRENT ARR'GT APPEARS TO BE HISTORICALLY INACCURATE AS MIN. BERTHING REQUIREMENTS WOULD HAVE BEEN 3 OR MORE. CURRENT WOOD PARTITIONED STORES AREA PORT SIDE PROBABLY WOULD HAVE PROVIDED ADD'L BERTHING ALONG WITH 3-TIER BUNKS.

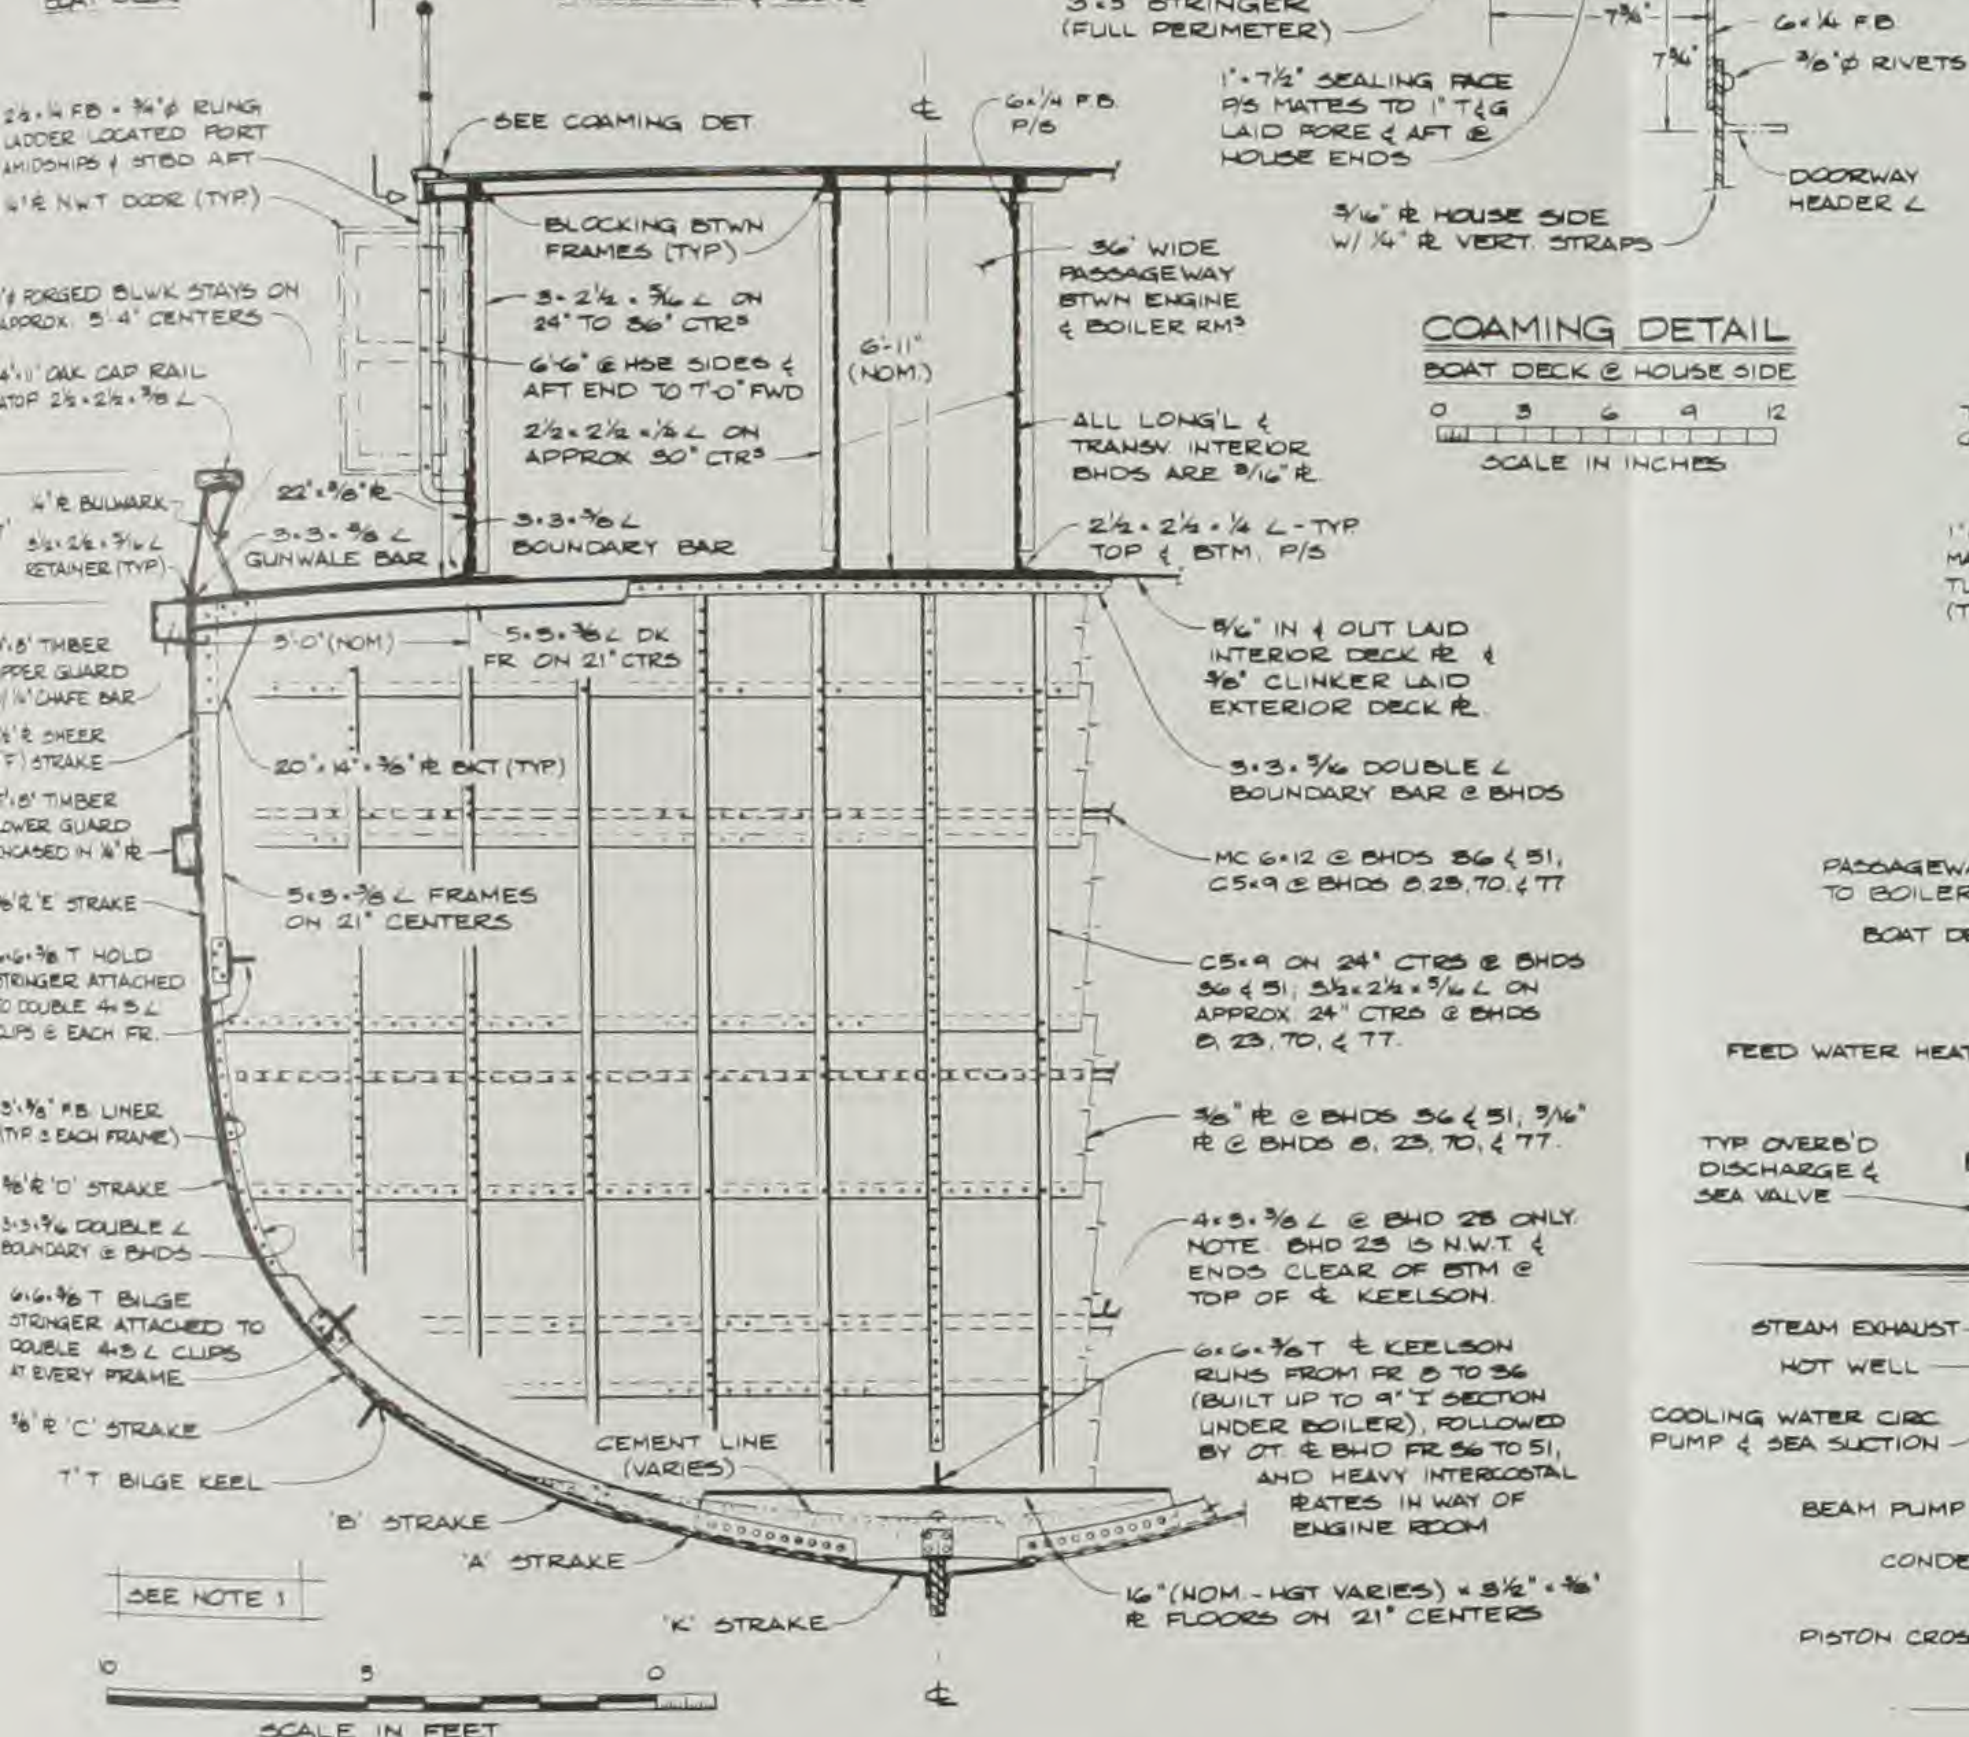
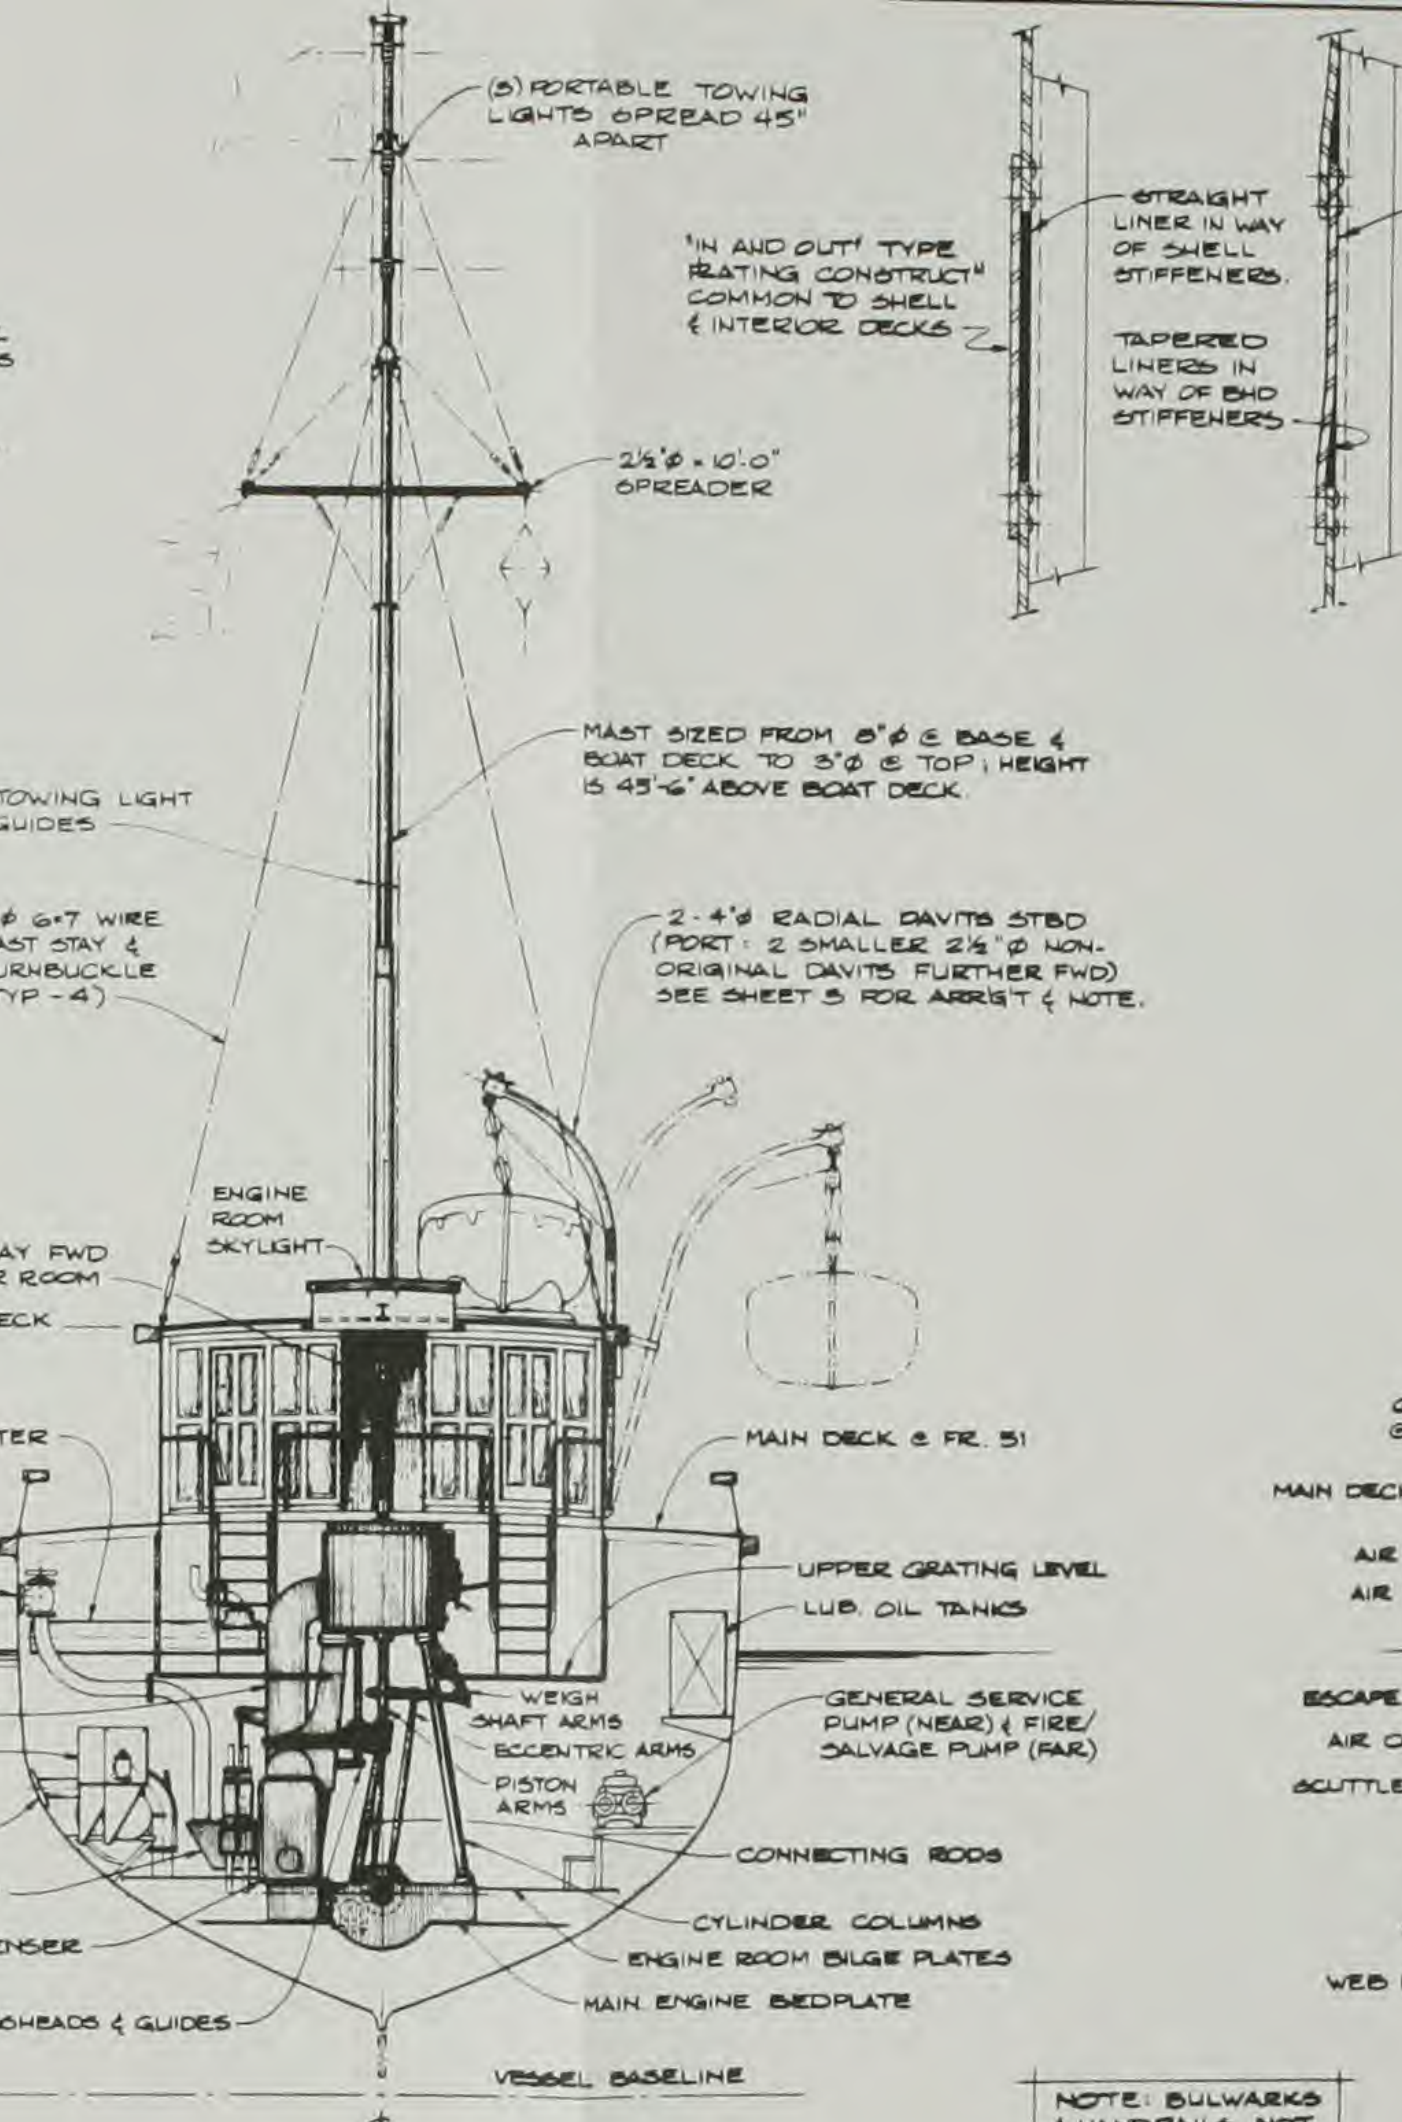
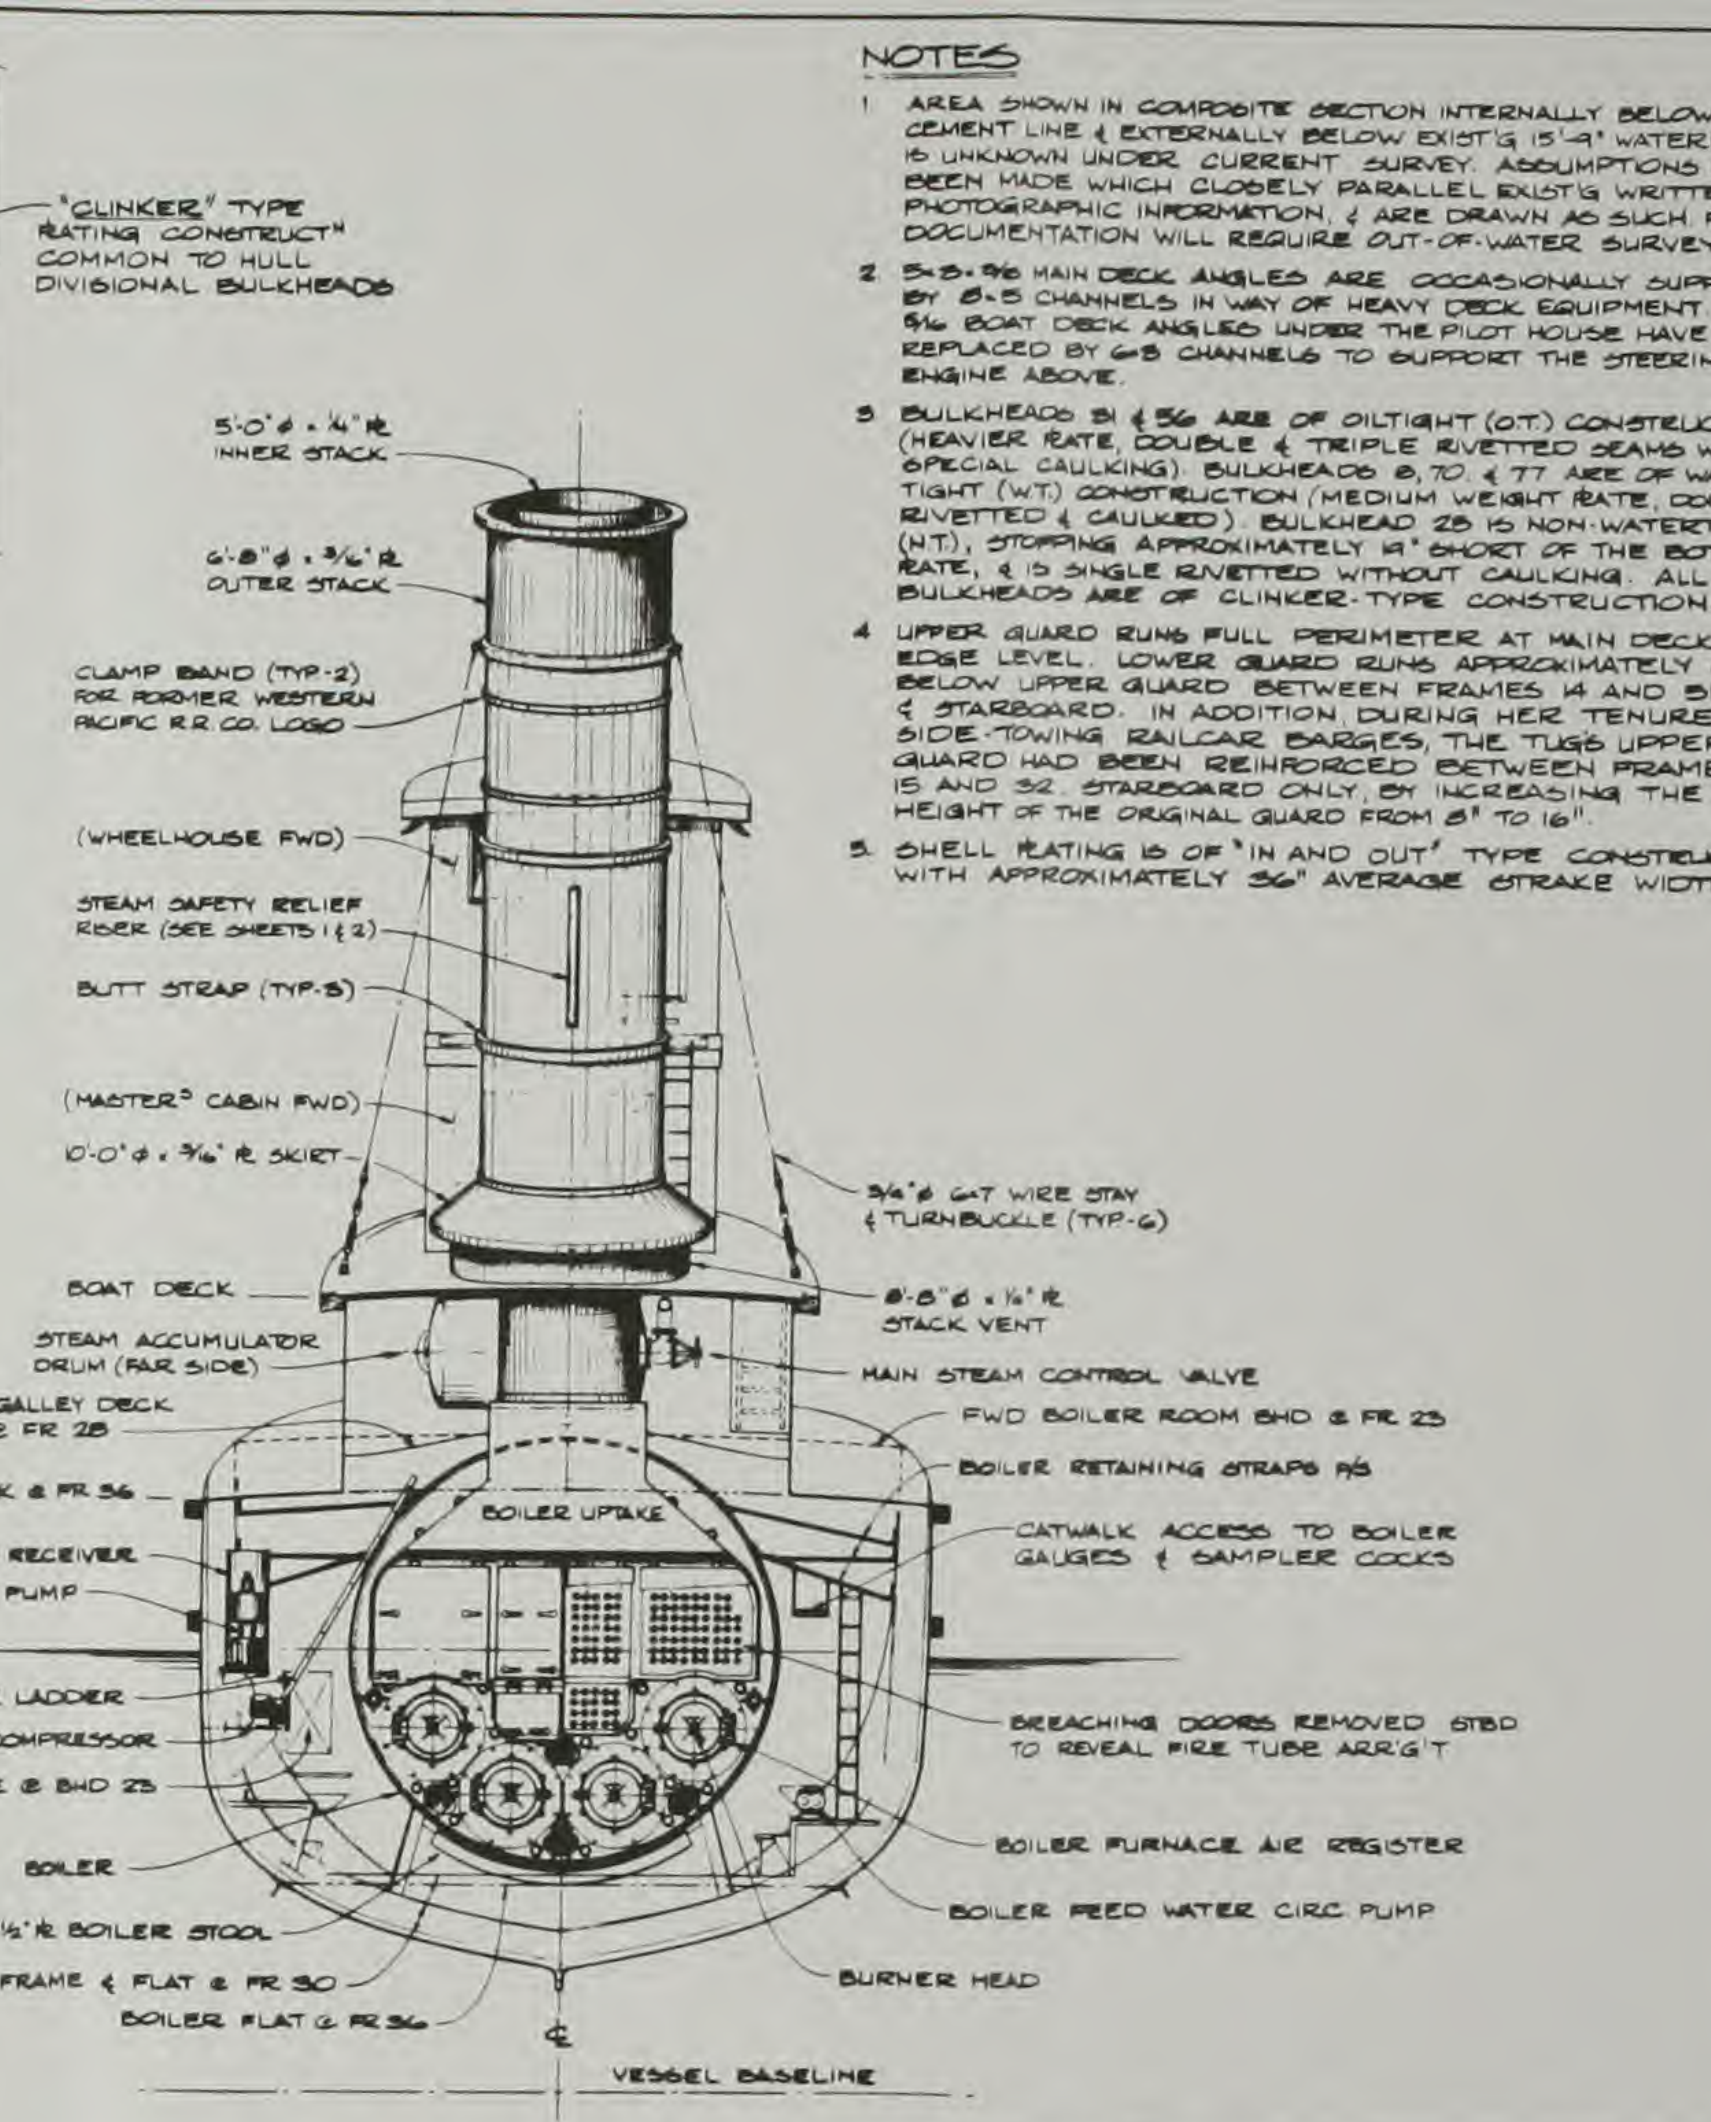
PKG NO SHEET
5
OF 5

- NOTES**
- 1 AREA SHOWN IN COMPOSITE SECTION INTERNALLY BELOW CEMENT LINE & EXTERNALLY BELOW EXIST'G 15'-9" WATERLINE IS UNKNOWN UNDER CURRENT SURVEY. ASSUMPTIONS HAVE BEEN MADE WHICH CLOSELY PARALLEL EXIST'G WRITTEN & PHOTOGRAPHIC INFORMATION, & ARE DRAWN AS SUCH. FURTHER DOCUMENTATION WILL REQUIRE OUT-OF-WATER SURVEY.

- 2 5'-3" x 3/8" MAIN DECK ANGLES ARE OCCASIONALLY SUPPLANTED BY 3'-5" CHANNELS IN WAY OF HEAVY DECK EQUIPMENT. 3'-2" x 3/8" BOAT DECK ANGLES UNDER THE PILOT HOUSE HAVE BEEN REPLACED BY 6'-3" CHANNELS TO SUPPORT THE STEERING ENGINE ABOVE.

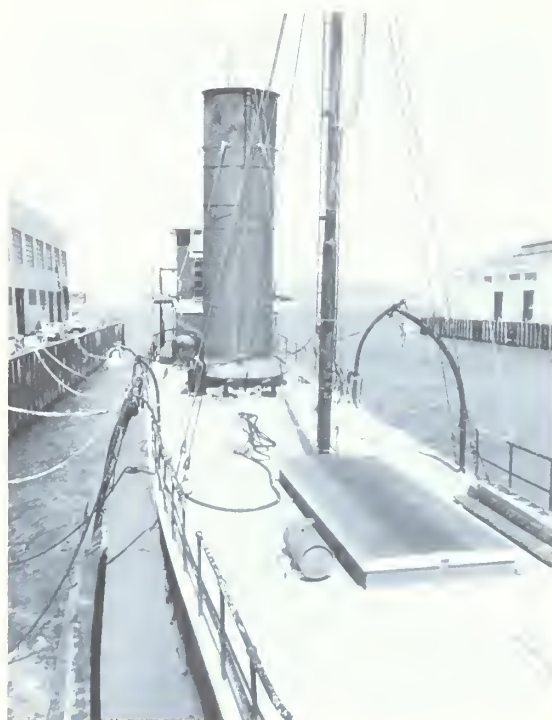
Fig. 26. Boat deck, looking forward from port side, 1989. The lifeboat and skiff normally stowed here have been removed to Museum storage.

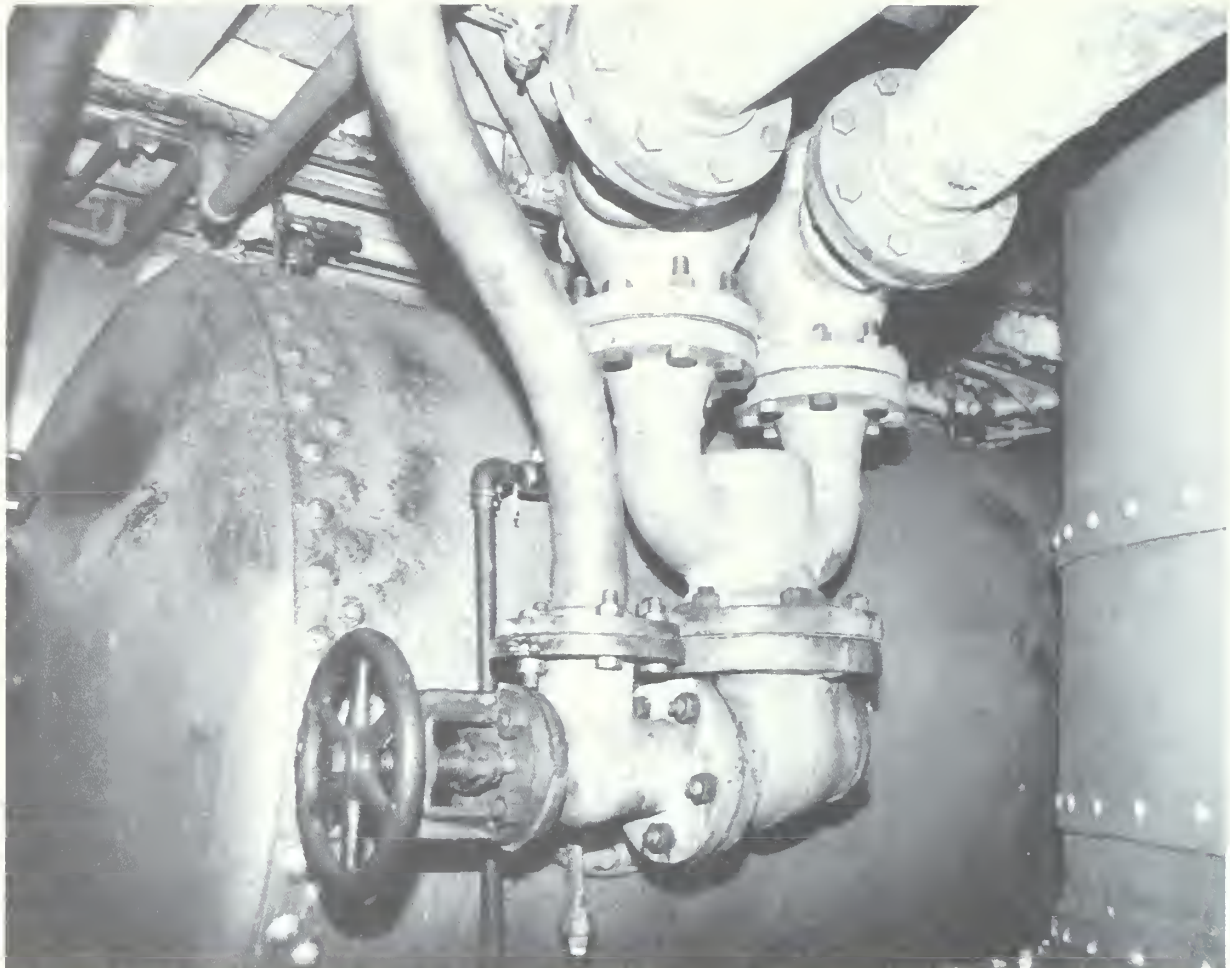
Fig. 27. The boiler safety valves, part of the complex system of steam piping. The riveted steam drum can be seen beyond, and the smoke stack is at right.

Due to safety concerns, the steam piping and fuel oil piping will have additional requirements:

Steam Piping: The potential hazards associated with live steam warrant adherence to established stand-
