Technical Preservation Services
Preservation Assistance Division
National Park Service
U.S. Department of the Interior
Washington, D.C.

Interpreting the Secretary of the Interior's Standards for Rehabilitation

Volume III

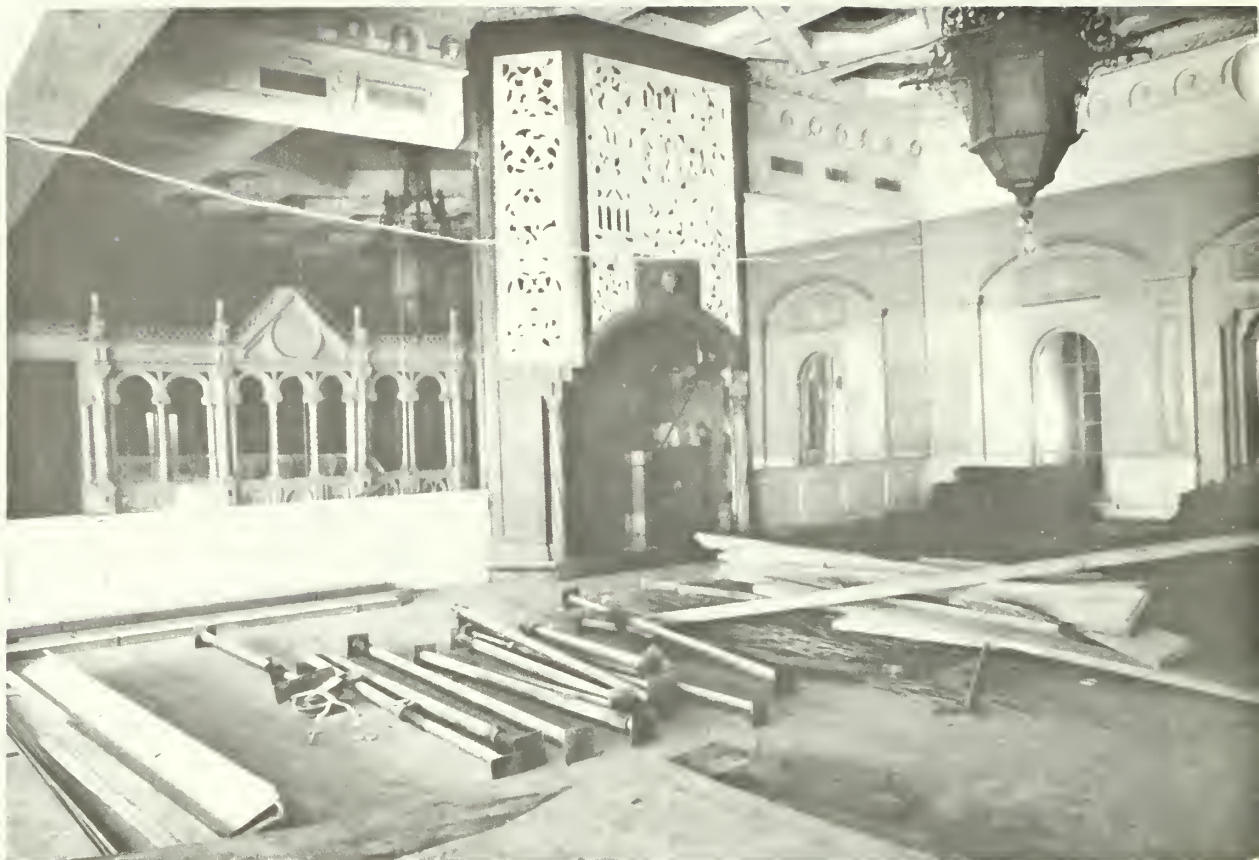
3. Palm court beyond lobby stair. Ornamental screen between the lobby and this room is reflected in mirrored wall at the left of the fireplace. All features were removed from this room in the rehabilitation.

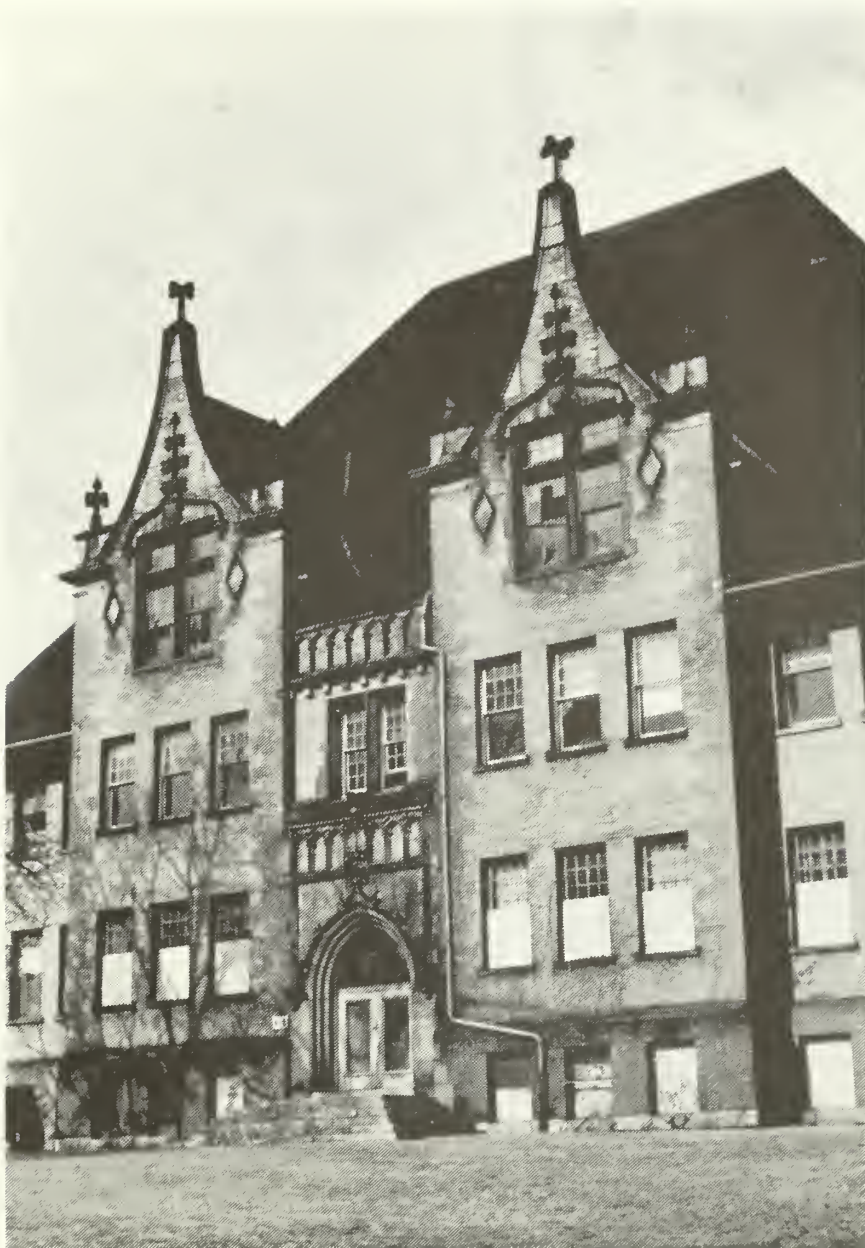
1. The former school building is characterized by its distinctive form--massive yet only three stories in height--its twin towers, unusual arch-shaped entrance and series of large-scale, twelve-over-one windows that were designed to provide maximum daylight in the classrooms.

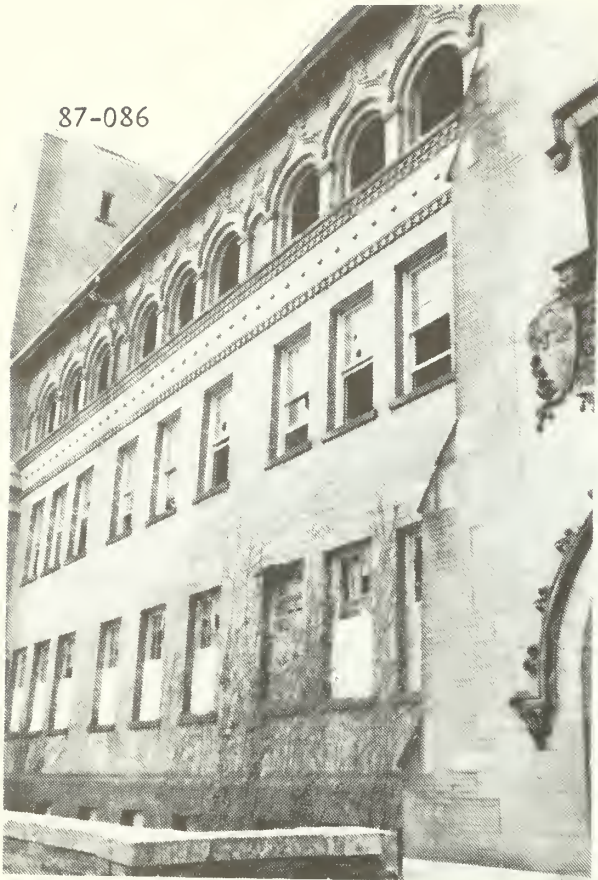
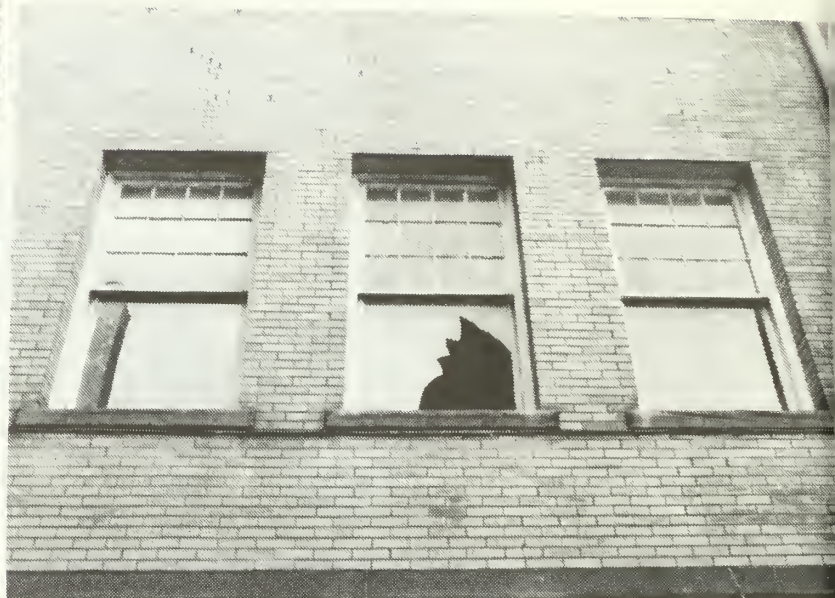
2. and 3. The windows and window openings as one would see them close to the building's walkway entrance establish the importance of their design and detail.

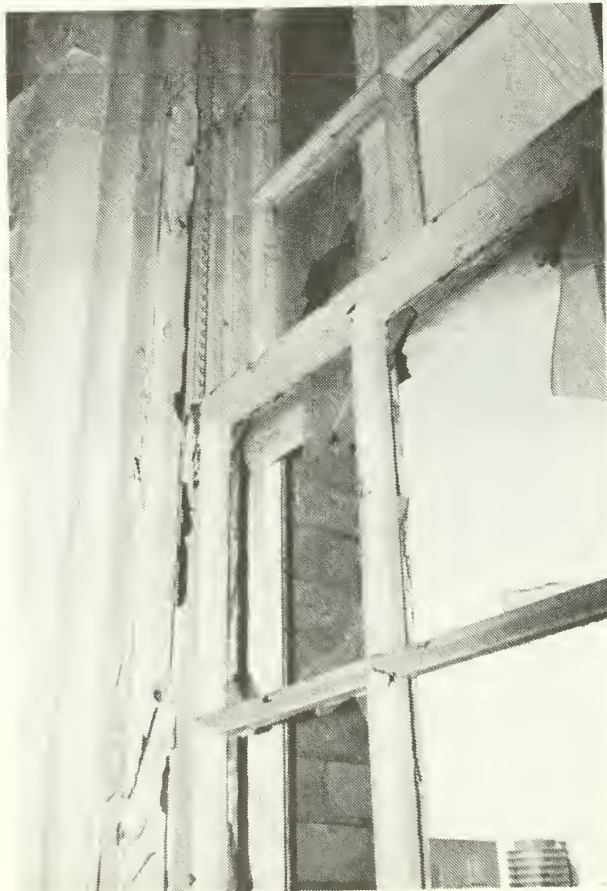
4. From inside as well, the detail, design features, shadow lines and finishes are all part of the character of the window. If a historic window is so deteriorated that it needs to be replaced, a matching replacement window is the most appropriate choice to meet the Secretary's Standards within a rehabilitation project.

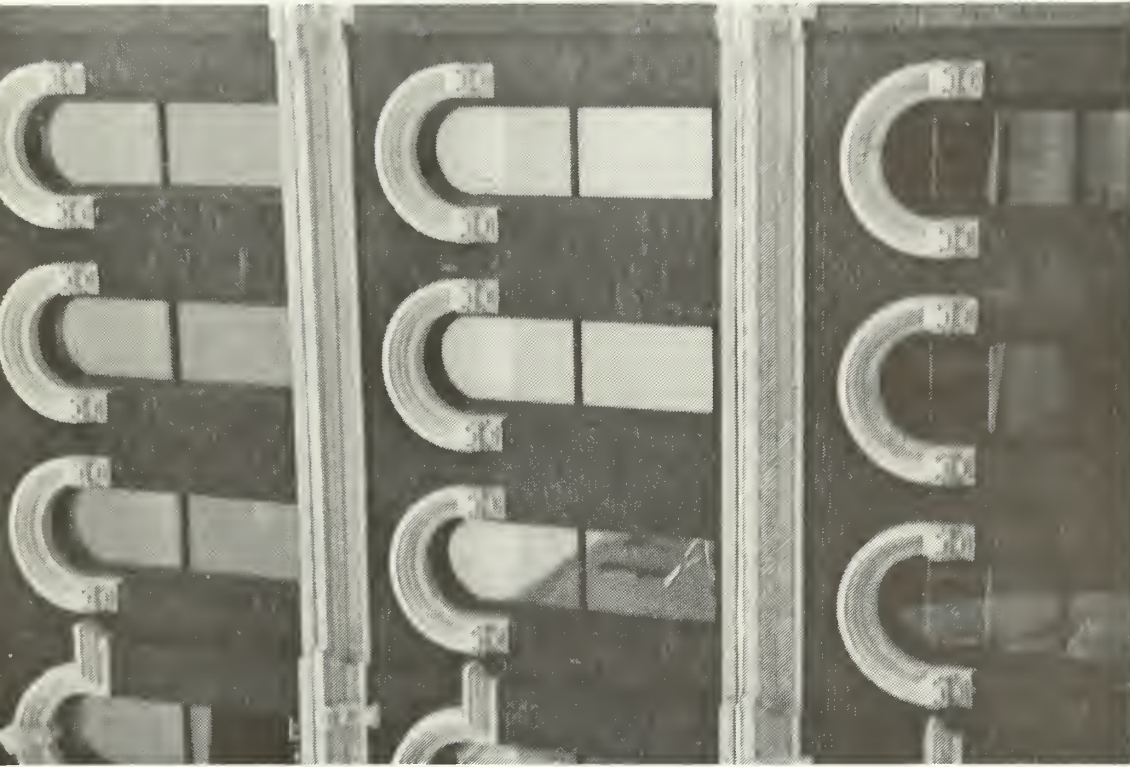
2. After rehabilitation and installation of the new windows, the "eyebrows" seem to float--disconnected--above the dark brown fixed sash.

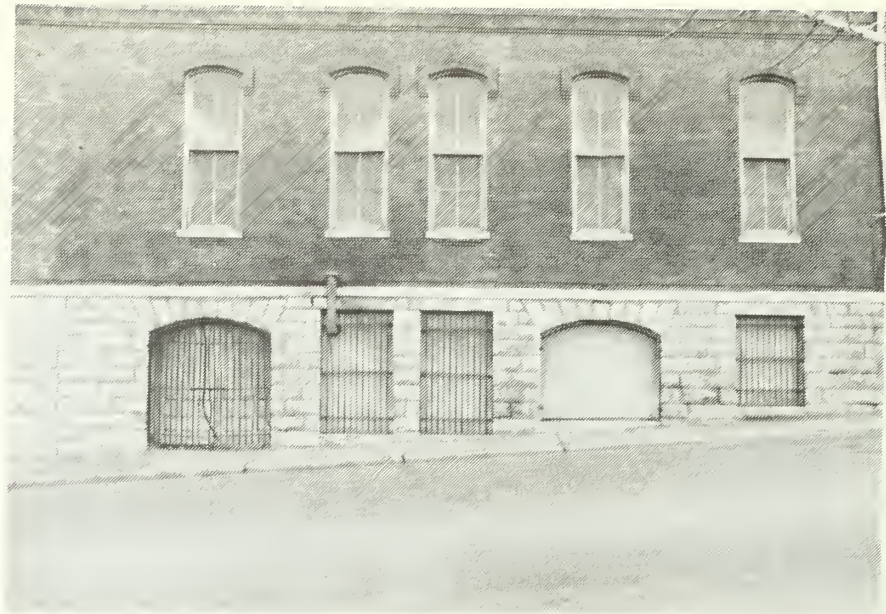
Before and after photographs revealed several design deficiencies in the new window. Where one over one double-hung windows had existed historically on the building's primary facade, the replacement windows were a "fixed" design with both upper and lower sash on the same plane; the horizontal piece applied as a meeting rail is actually flat, and consequently unable to cast the familiar shadow line of the historic window. Finally, there was a dramatic difference in color, from a light cream color to dark brown (see illus. 1 and 2). On another key facade, where there had been historic four-over-four double-hung windows, fixed sash were installed, the light divisions were altered, wider muntins were used, and the color of the windows was changed (see illus. 3, 4 and 5).

3. Before rehabilitation, the windows on another street elevation were four-over-four units that feature delicate, attenuated muntins. The historic window is a double-hung design; the shadow line that the meeting rail casts at the center of the two-part window is a distinctive quality.

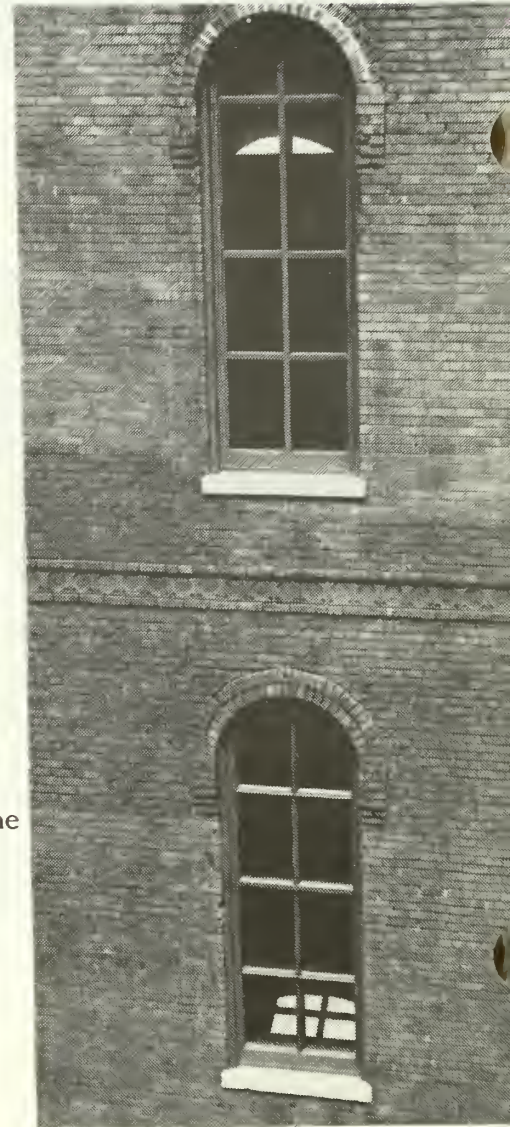
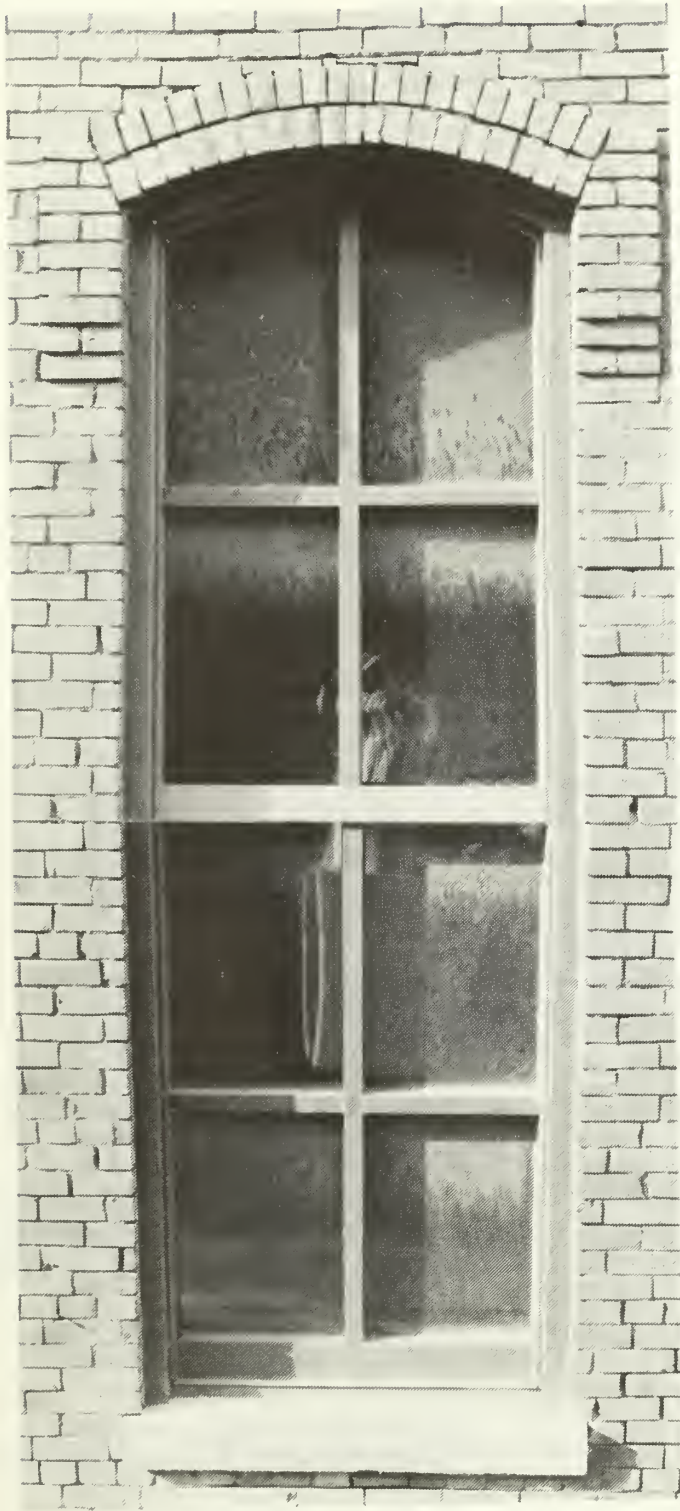
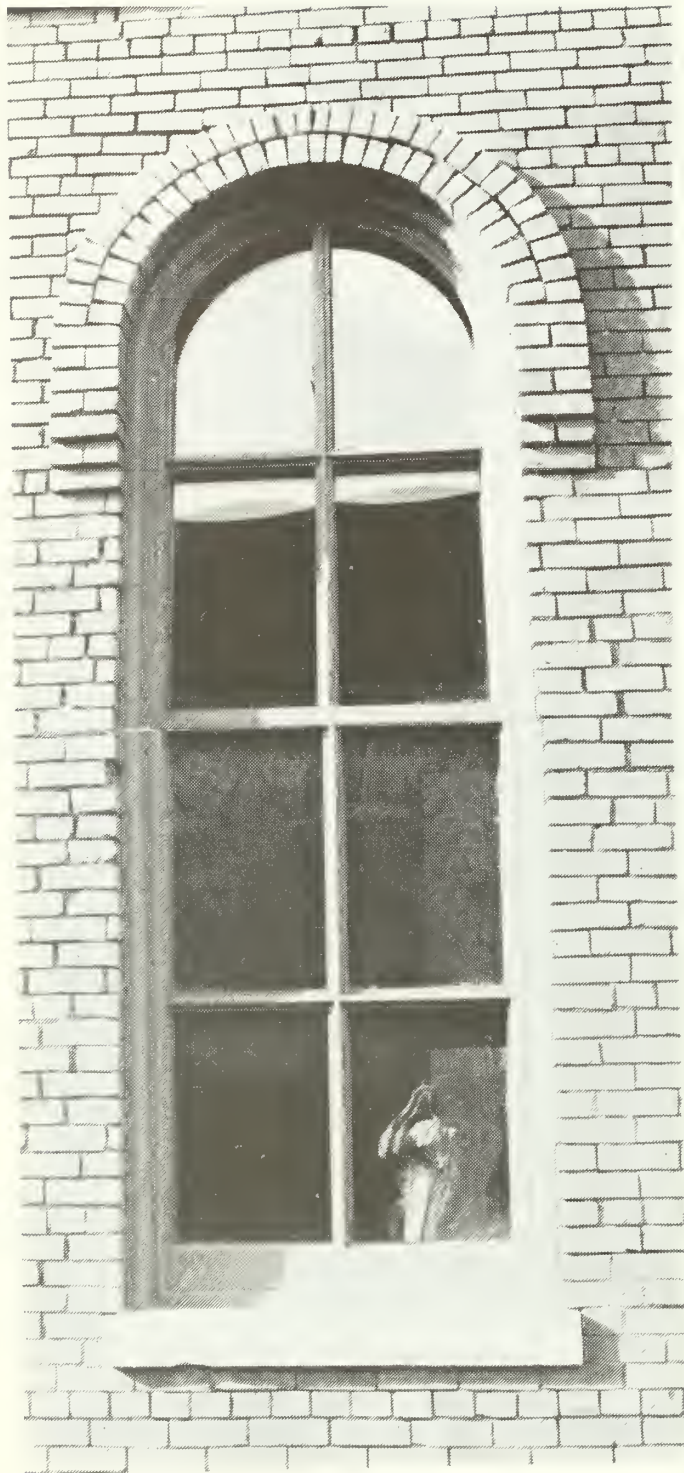
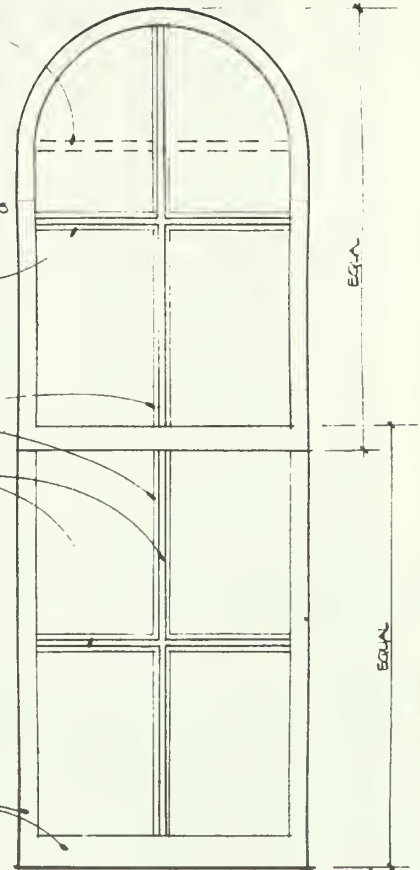
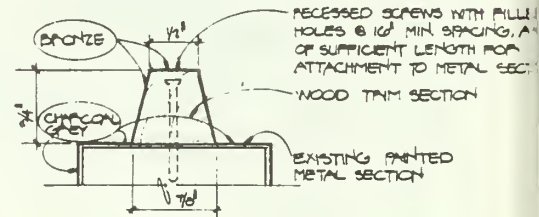
PROPOSED TREATMENT FOR "MEETING RAIL"

6. In an attempt to bring the inappropriate four-over-four replacement units (see 4 and 5.) into conformance with the Standards, two alternatives were proposed. In proposal A, the horizontal muntin at the top would be relocated so that all eight lights would be of equal size like the original. A 3 1/2" wide aluminum strip would be applied in an attempt to recapture some aspects of the meeting rail. Even after these adjustments, however, the upper and lower sash would read as a single, fixed unit; the muntins are also too wide and too flat.

7. In alternative B, proposed changes included installation of a wood brick molding. In an attempt to make the muntin appear thinner and visually recessed, the wide aluminum muntins would be painted a charcoal gray; trapezoidal shaped wood strips would also be applied to the existing flat muntin and painted to match the existing window color. Even making these modifications, the replacement window did not match the detailing of the historic window--the depth of the frame and muntin was still far too shallow, and the muntin profile and width was still inappropriate. This proposal was also rejected.

REMOVE TOP HORIZONTAL MUNTIN & GLASS

RESTRUCTURE WINDOW SO TOP HORIZONTAL MUNTIN IS US MIDWAY BETWEEN TOP SASH SECTION

APPLY WOOD TRIM SECTION TO PAINTED MUNTINS

APPLY 3/4" THICK x FULL WIDTH (OF EXISTING SECTION) WOOD SECTIONS TO HORIZONTAL & VERTICAL PERIMETER SECTIONS & TO HORIZONTAL MEETING PAL COLOR TO BE BRONZE

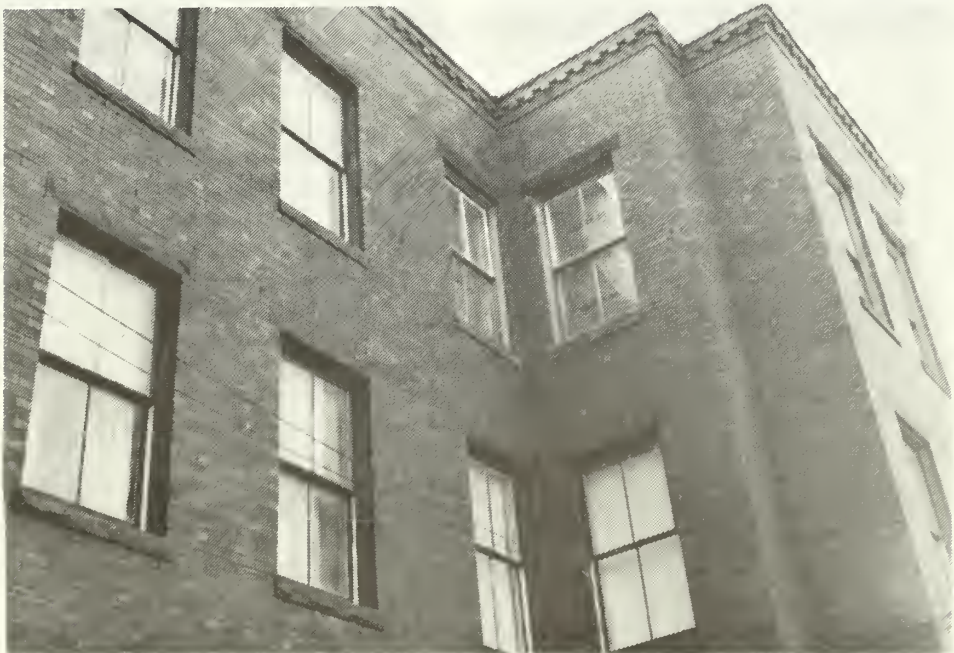
2. Pre-rehabilitation photograph of historic two-over-two double-hung windows that had a thin vertical muntin and wooden molding (brick molding) around the frame.

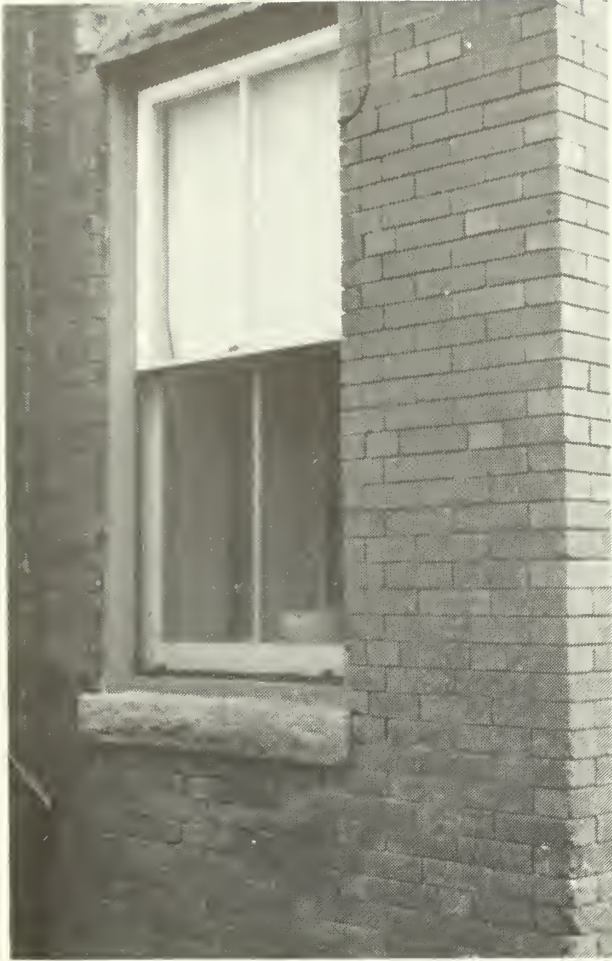
5. New wood replacement window as approved. If possible further refinement (although not required in this case) would have been to install the half screen on the inside rather than on the front of the upper and lower sash.

To bring this rehabilitation into conformance with the Standards, the owner decided to replace the new aluminum windows, which were clearly visible from the street, with new wood sash duplicating the originals in size, profile, muntin configuration, and composition (see illus. 5 and 6). With the new wooden sash in place, the project was subsequently certified.

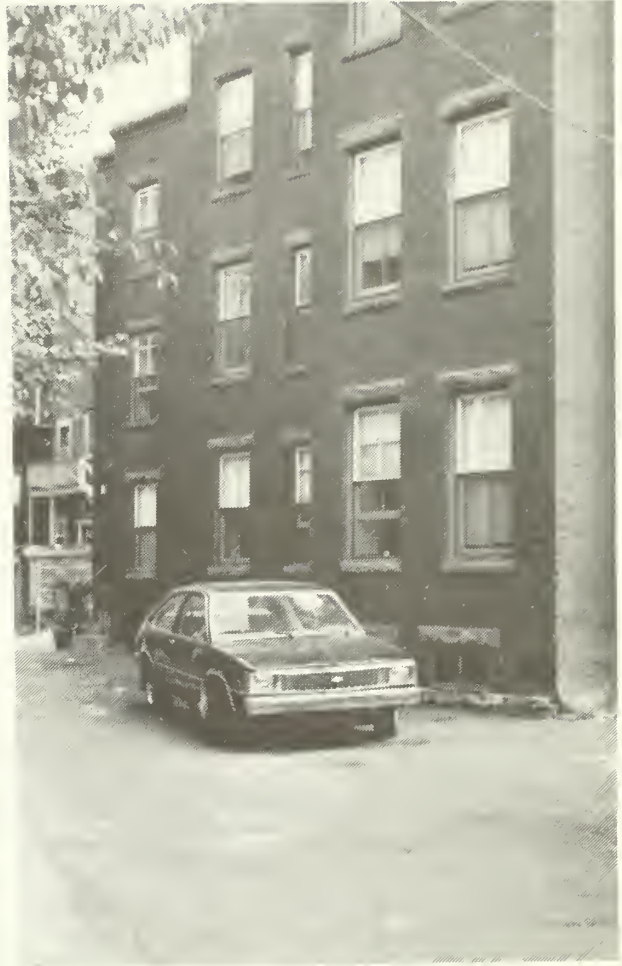
6. Post-rehabilitation photograph of historic rowhouses with matching wood windows.

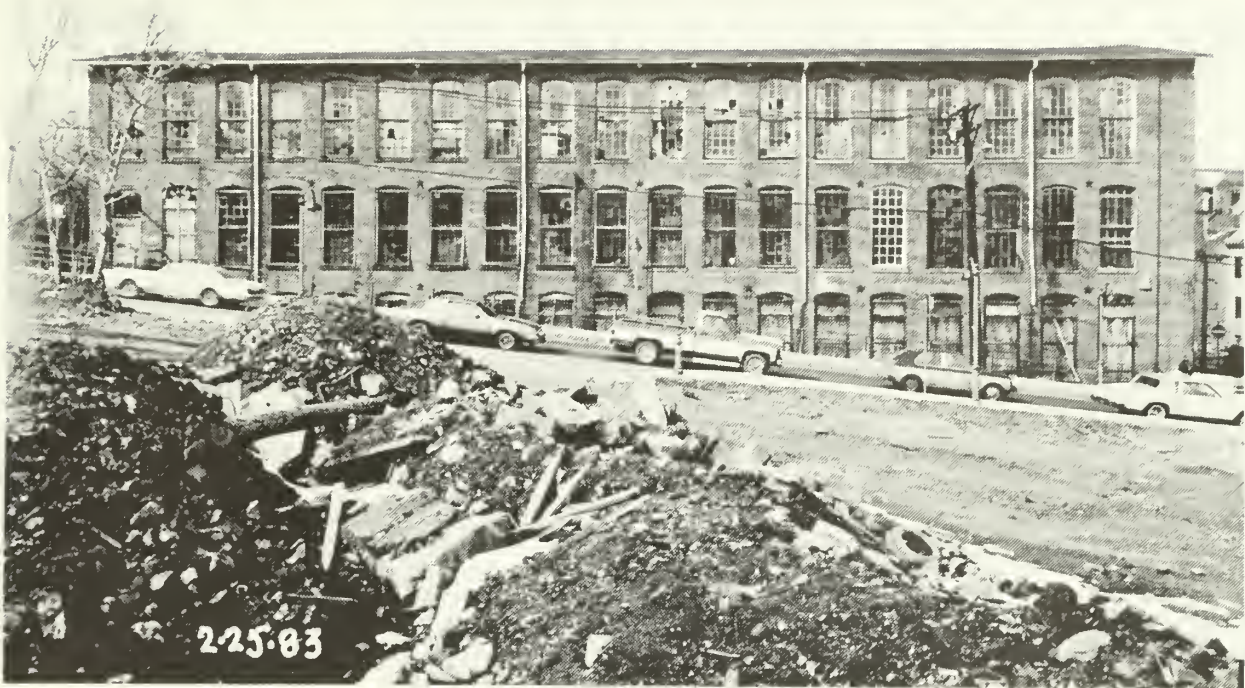
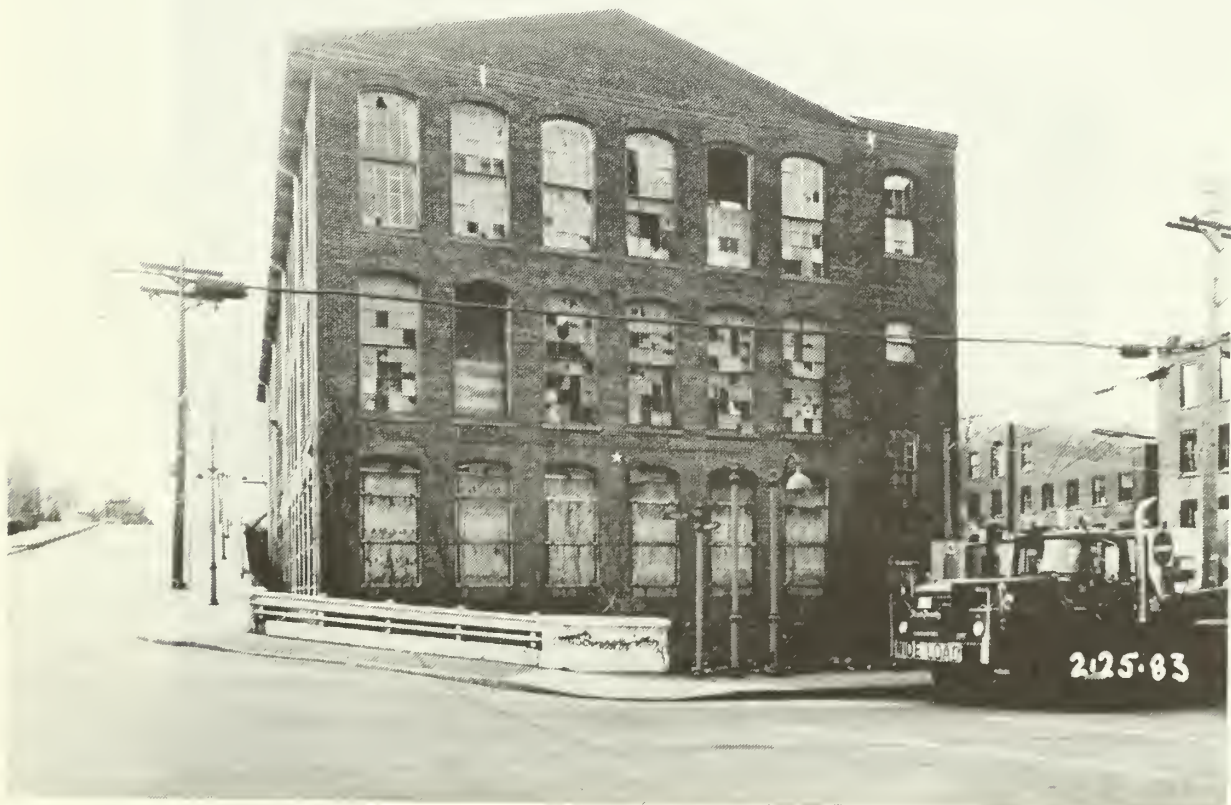
1-2. Pre-rehabilitation view of the building showing deteriorated 16-over-16 windows. Note previous owner's effort to duplicate arch-headed sash with sample unit on 2nd floor. In the view below, note how the upper and lower sash are set on different planes, a characteristic feature of double-hung windows.

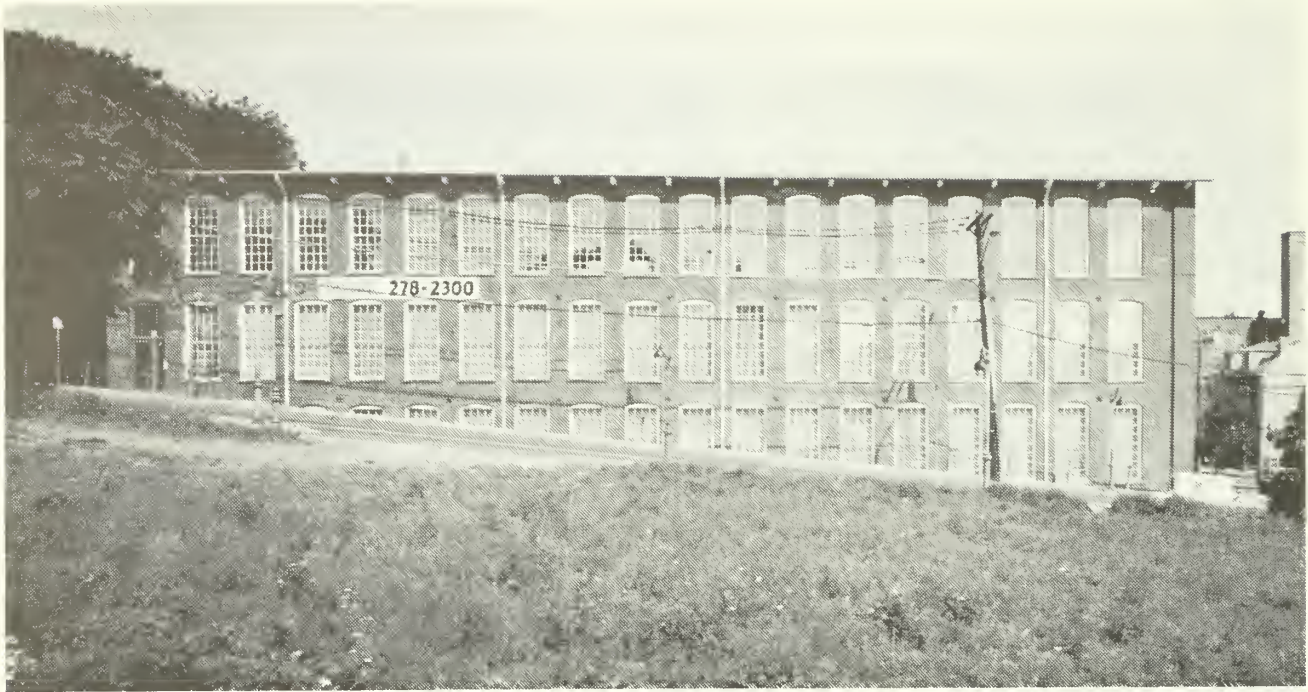
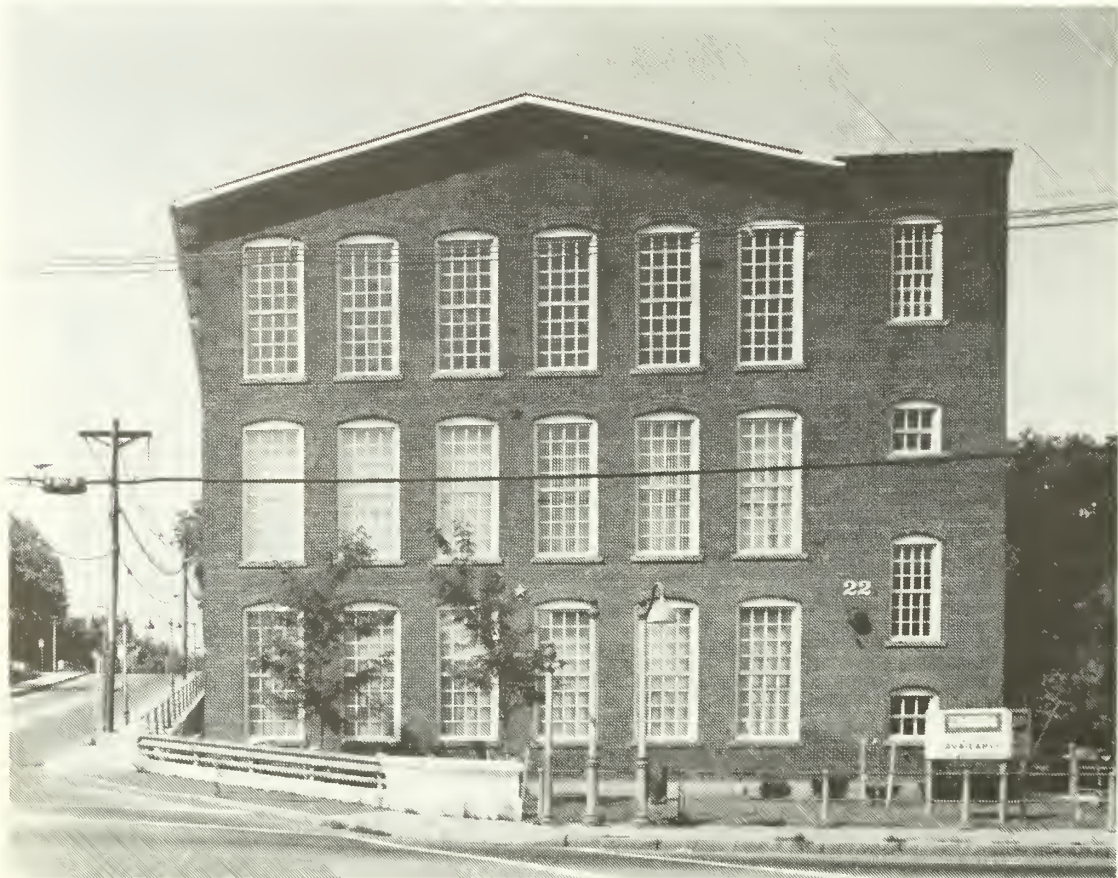
The replacement windows, however, did not adequately duplicate the visual qualities of the historic windows, specifically in appearance, shadow lines, muntin detail and planar qualities. In addition to the change from an arch-headed to a square-headed sash, a number of other distinct changes have occurred to the historic appearance of these windows. The double-hung, historic wood windows have been replaced by fixed metal units with much narrower sash dimensions, noticeably changing the planar relationship of the upper and lower sash. The resultant effect is that at certain angles the replacement windows have the appearance of the upper and lower sash being in the same plane, rather than duplicating the appearance of the historic, double-hung sash (see illus. 3-5).

3-5. Post-rehabilitation view of the building showing replacement windows. In 5, note how the reduction in depth of the meeting rail has produced a flat appearance to the window. The appearance of a historic double-hung window with sash on different planes and a heavy shadow line created by the meeting rail has been lost.

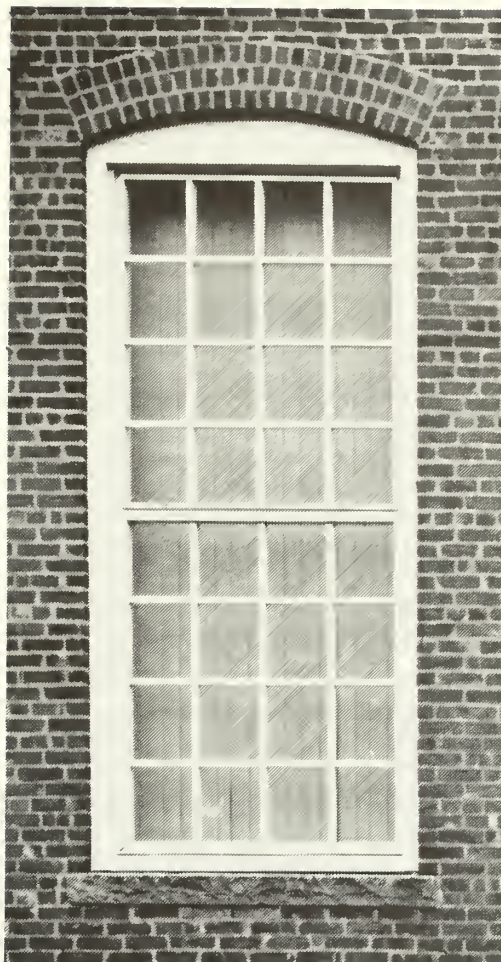
5.

The thickness of the meeting rail so evident in the historic sash has been reduced in depth creating a weaker shadow line (see illus. 5). The use of an applied aluminum muntin grid rather than true 16-over-16 wood muntin divisions has caused significant changes to the appearance of the windows (see illus. 6). The muntin grid clearly does not match the original, since the new muntins have a rectangular rather than trapezoidal profile, it has a ribbed surface, and it extends beyond the plane of the rails and stiles. The projecting grid, furthermore, creates additional shadow lines that did not exist on the historic windows. The historic muntins were flush to the surface of the sash, integral to the sash frame construction and trapezoidal in shape after puttying.

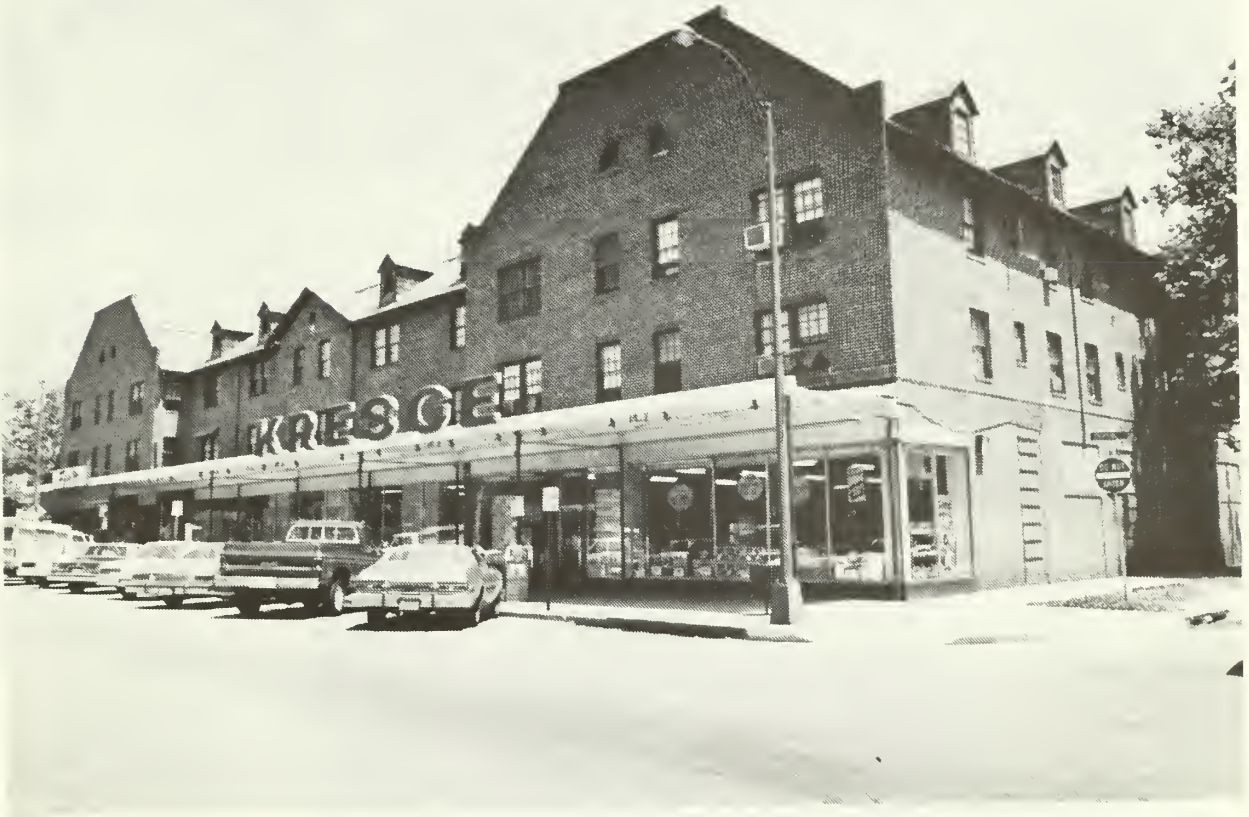
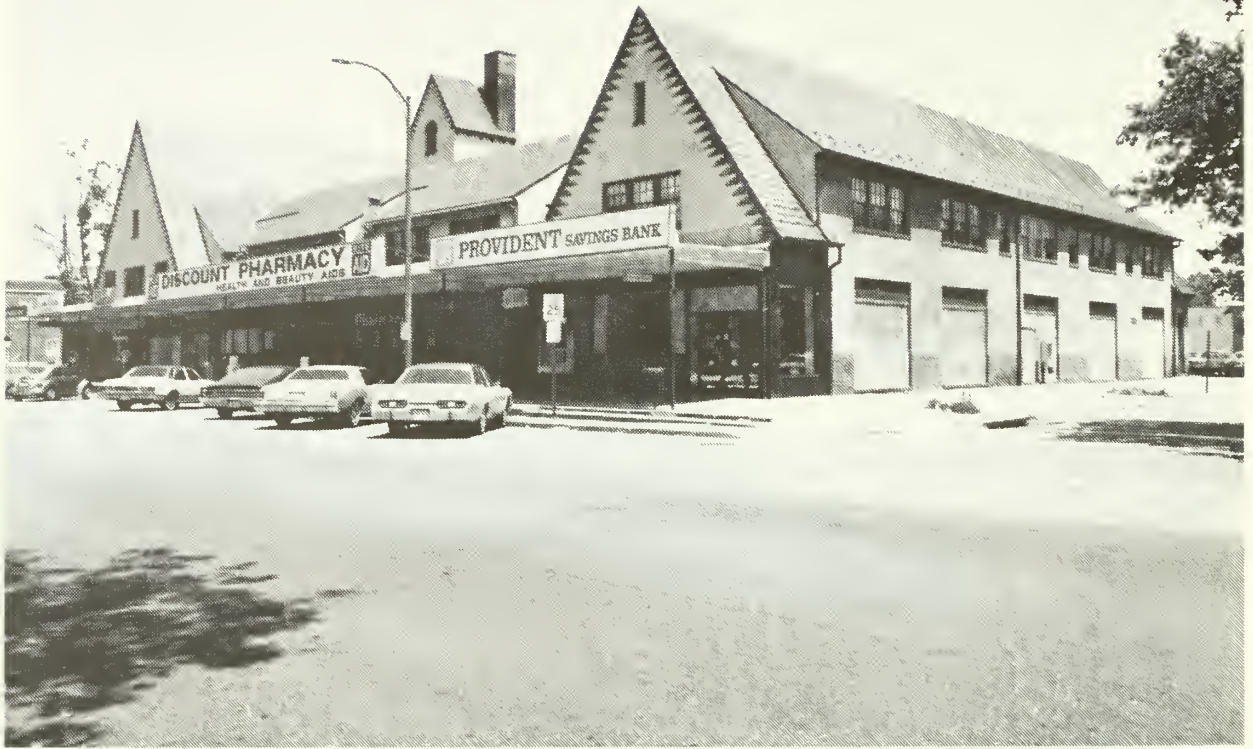
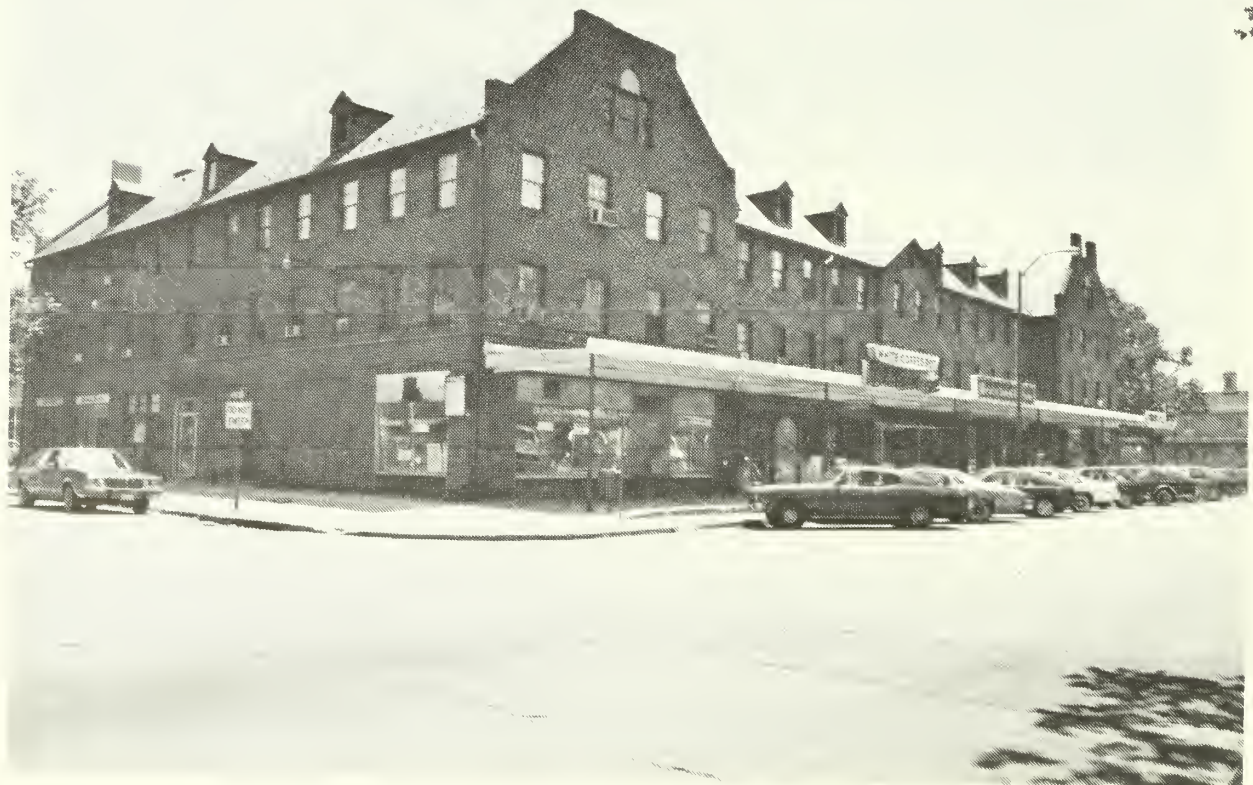
1-3 Pre-rehabilitation views demonstrate the residential scale of the second and third floor windows. Note how the dark color of the window sash and frames makes the windows less prominent on the upper floors of buildings 2 and 3.

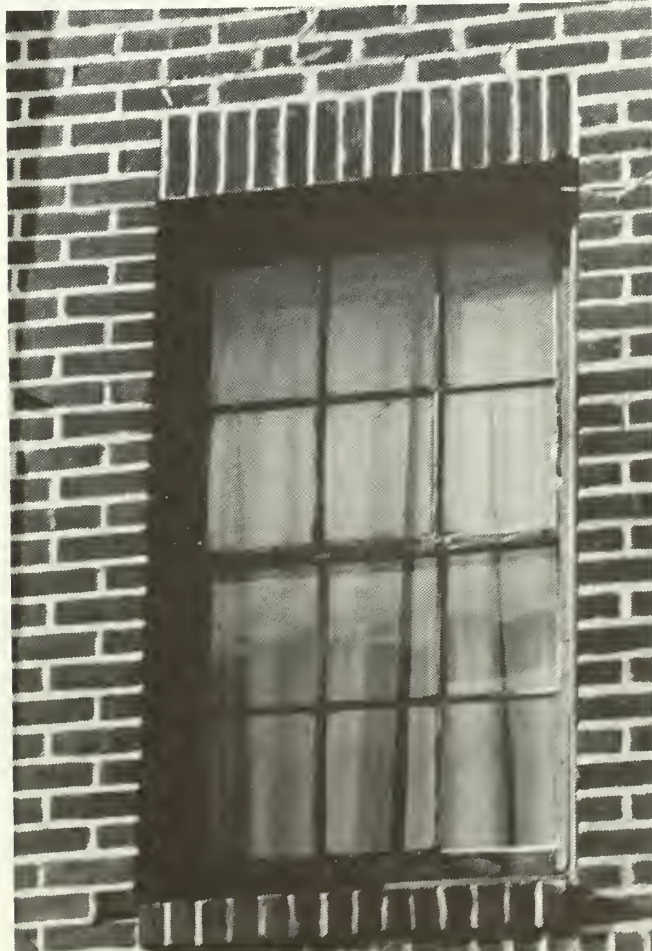
6. Proposed replacement window, exterior. Note rectangular panning, extensive subframe creating additional shadow lines. Compare the meeting rail and muntin dimensions with the historic sash in 4-5.

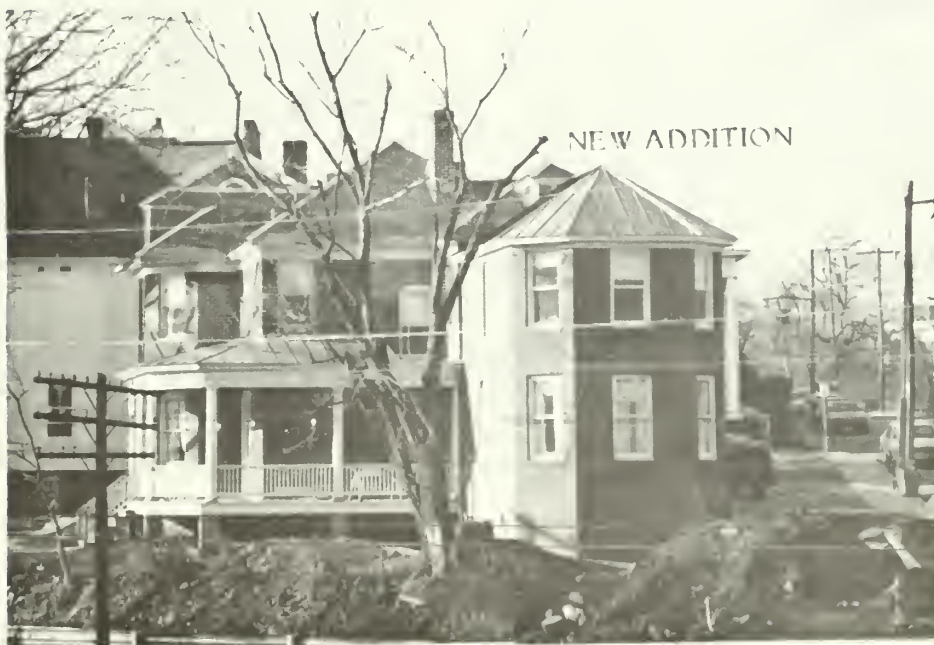
2. A new dormitory wing has been constructed on the side elevation shown in illustration 1. Because of its height, degree of projection, distinctive shape, and high visibility, the new addition has become the dominant feature of the house and has changed the historic character.

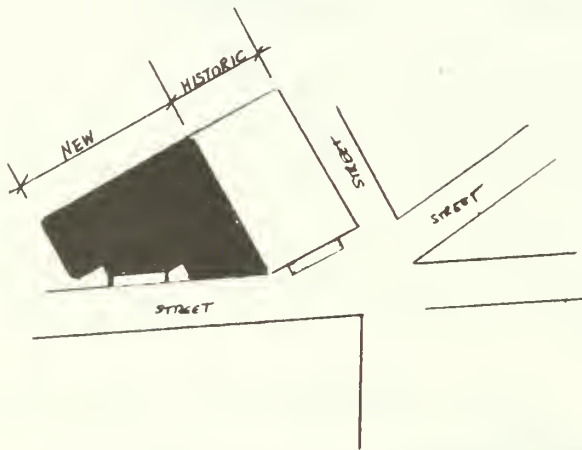
4. The historic bank and new bank addition are shown in relationship to the surrounding streets in the district. The previously rectangular form of the freestanding bank has been dramatically altered by both the size and shape of the addition.

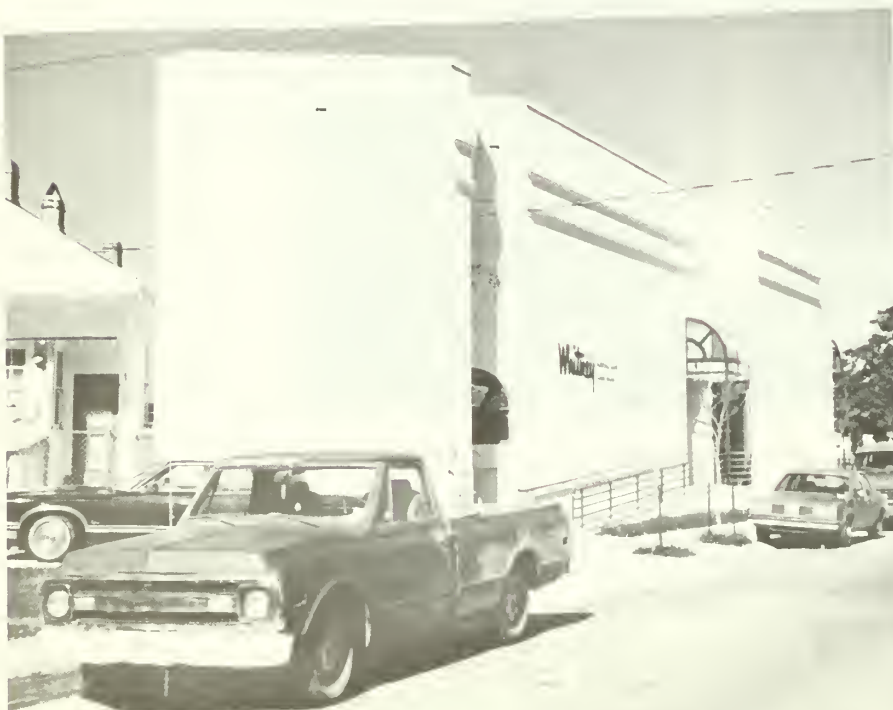
5. Even with a setback, appropriate height, compatible materials, and clear differentiation between new and old, the new work now dominates the resource and the setting. The historic bank can no longer be seen from a major side street.

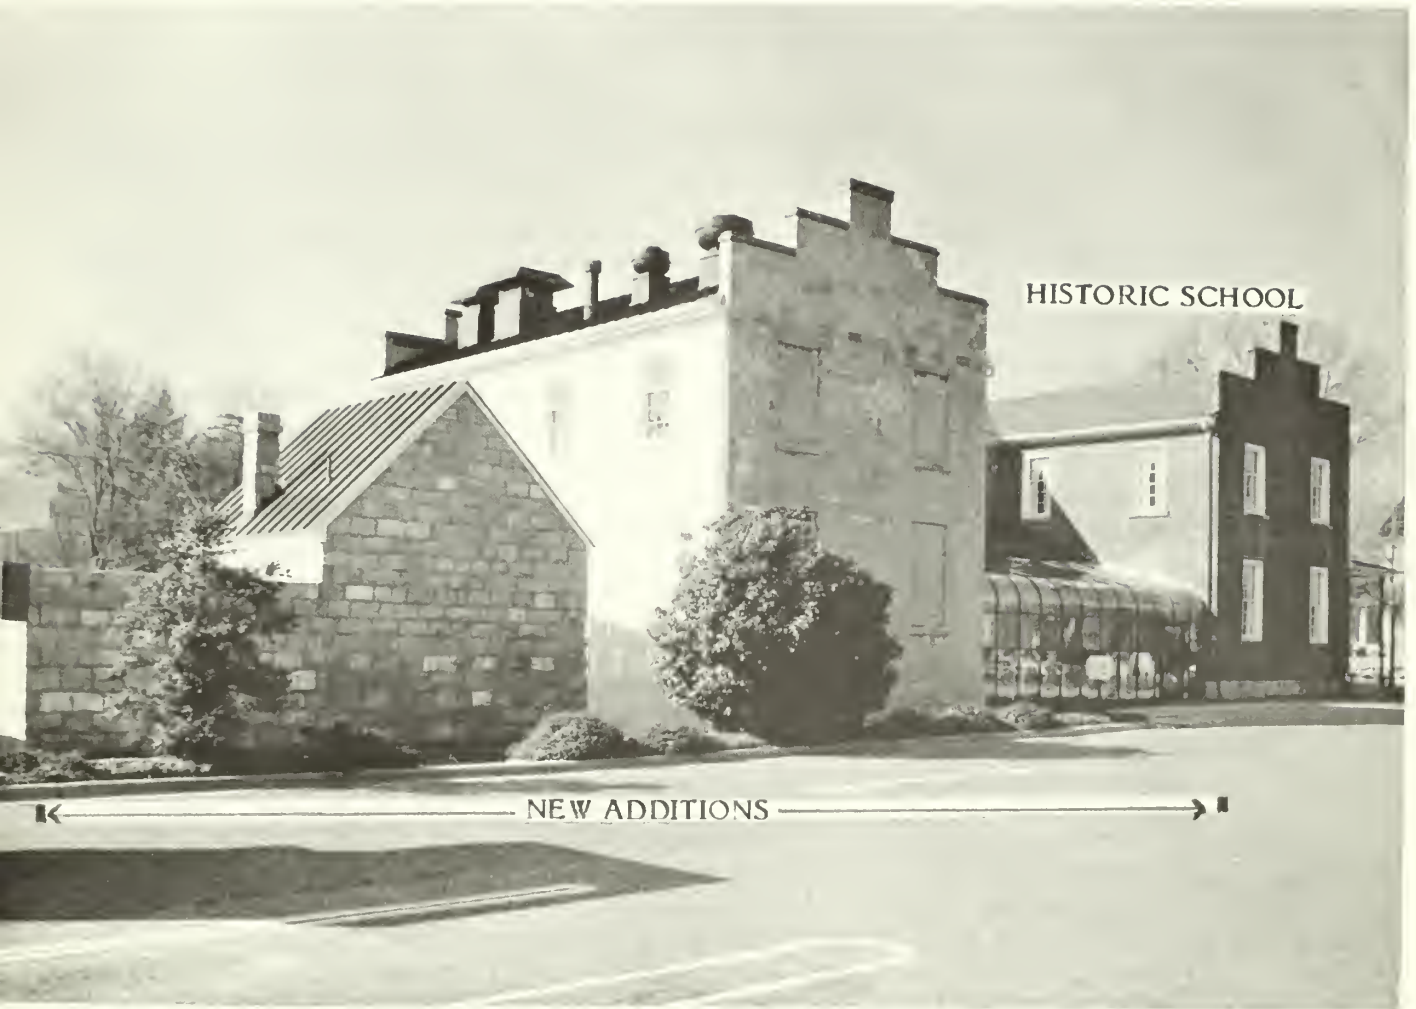
6. The side and rear elevation of the 1839 brick school building are shown here on the far right (the later ell is not visible) together with three new components added as part of the rehabilitation project--a greenhouse, a kitchen building with stepped gables matching the historic building, and a storage building. Because the new addition has changed the historic character to a dramatic degree, the project was denied tax incentives. A smaller kitchen wing--planned and sited differently--could have been in conformance with the Standards. The greenhouse itself was not an issue.
