Technical Preservation Services
Preservation Assistance Division
National Park Service
U.S. Department of the Interior
Washington, D.C.

Interpreting the Secretary of the Interior's Standards for Rehabilitation

Volume III

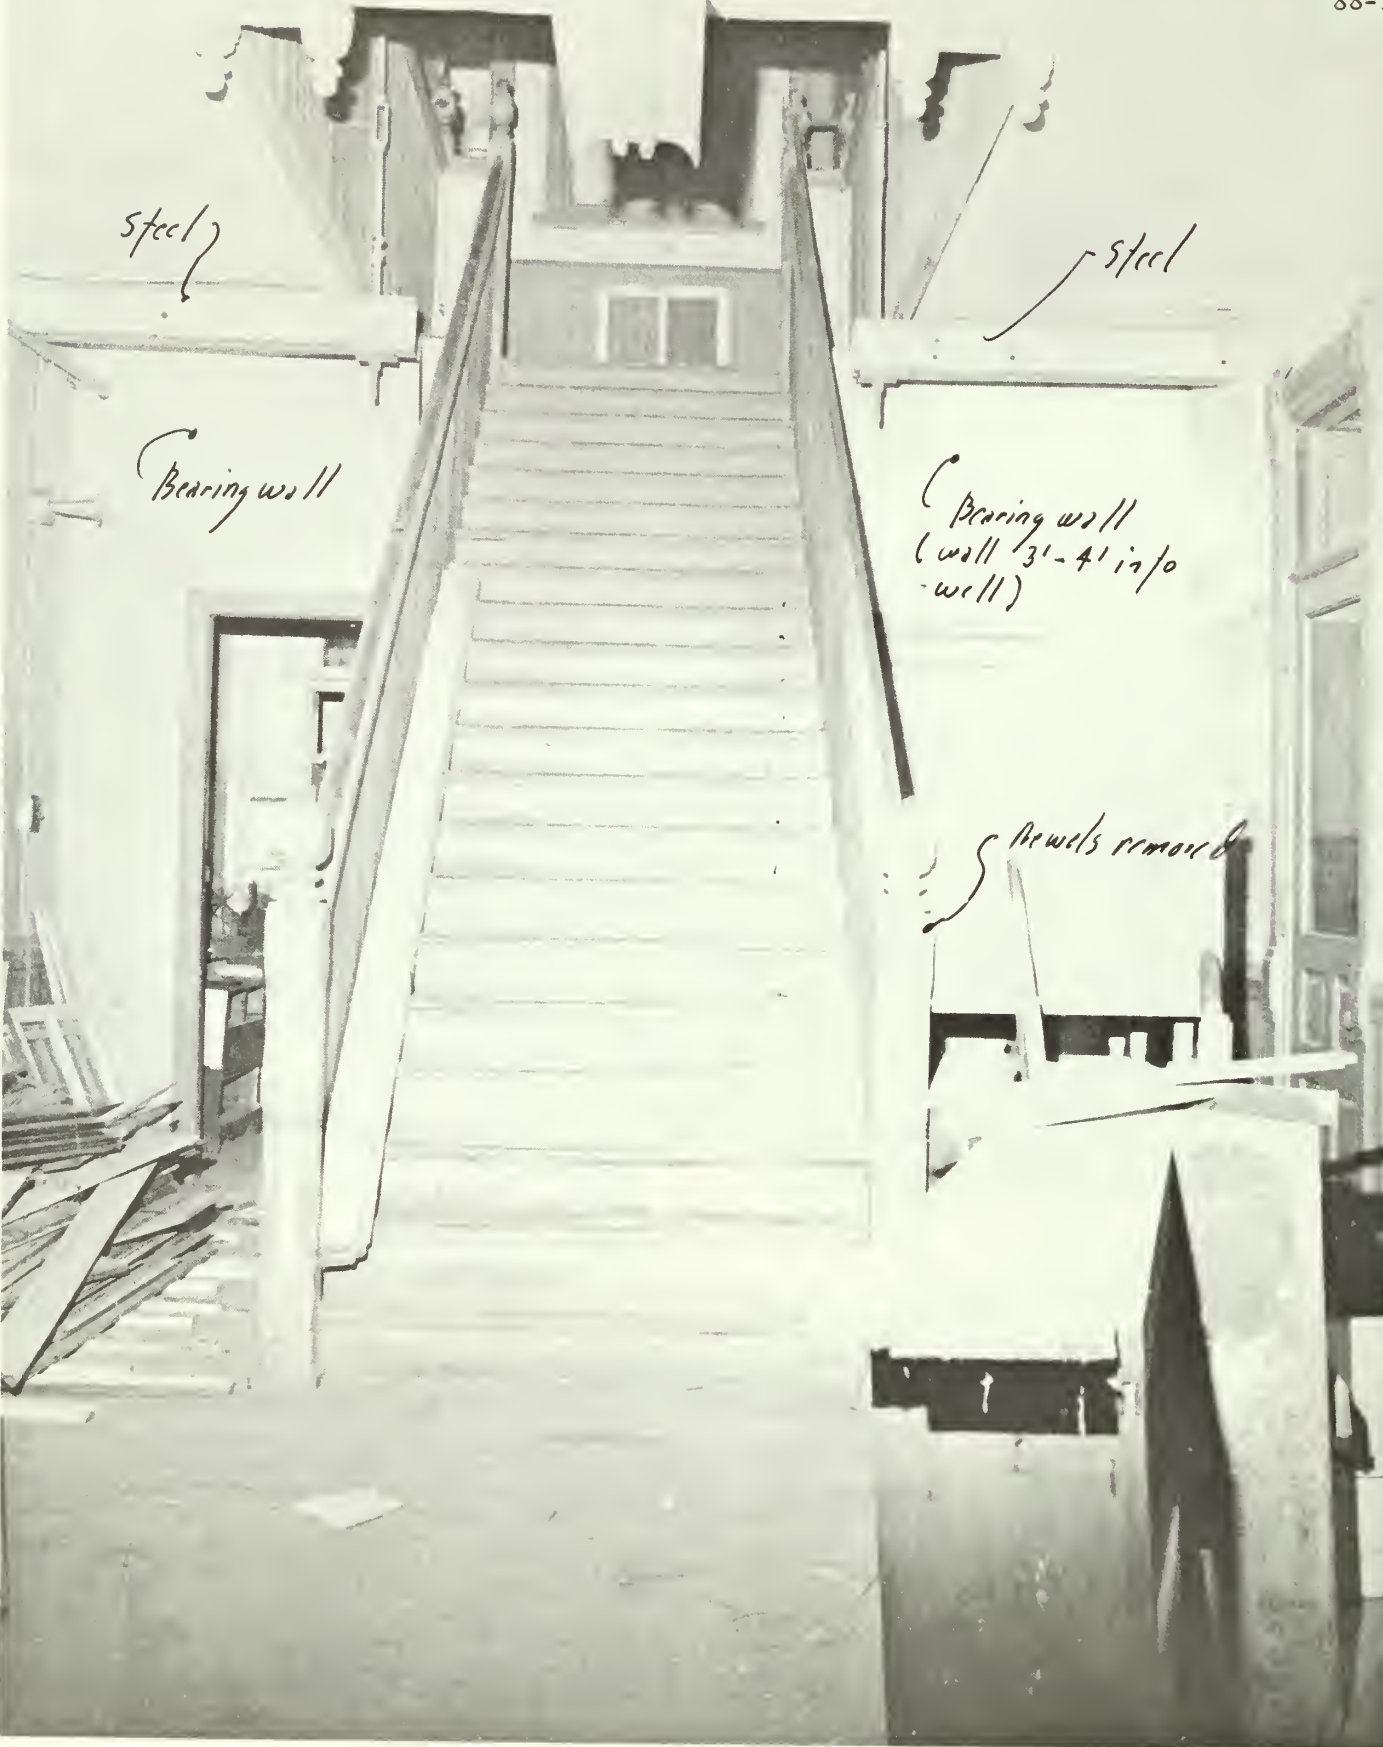
2. Pre-rehabilitation photograph of first floor center stair and hall. This stair was removed in the process of rehabilitation.

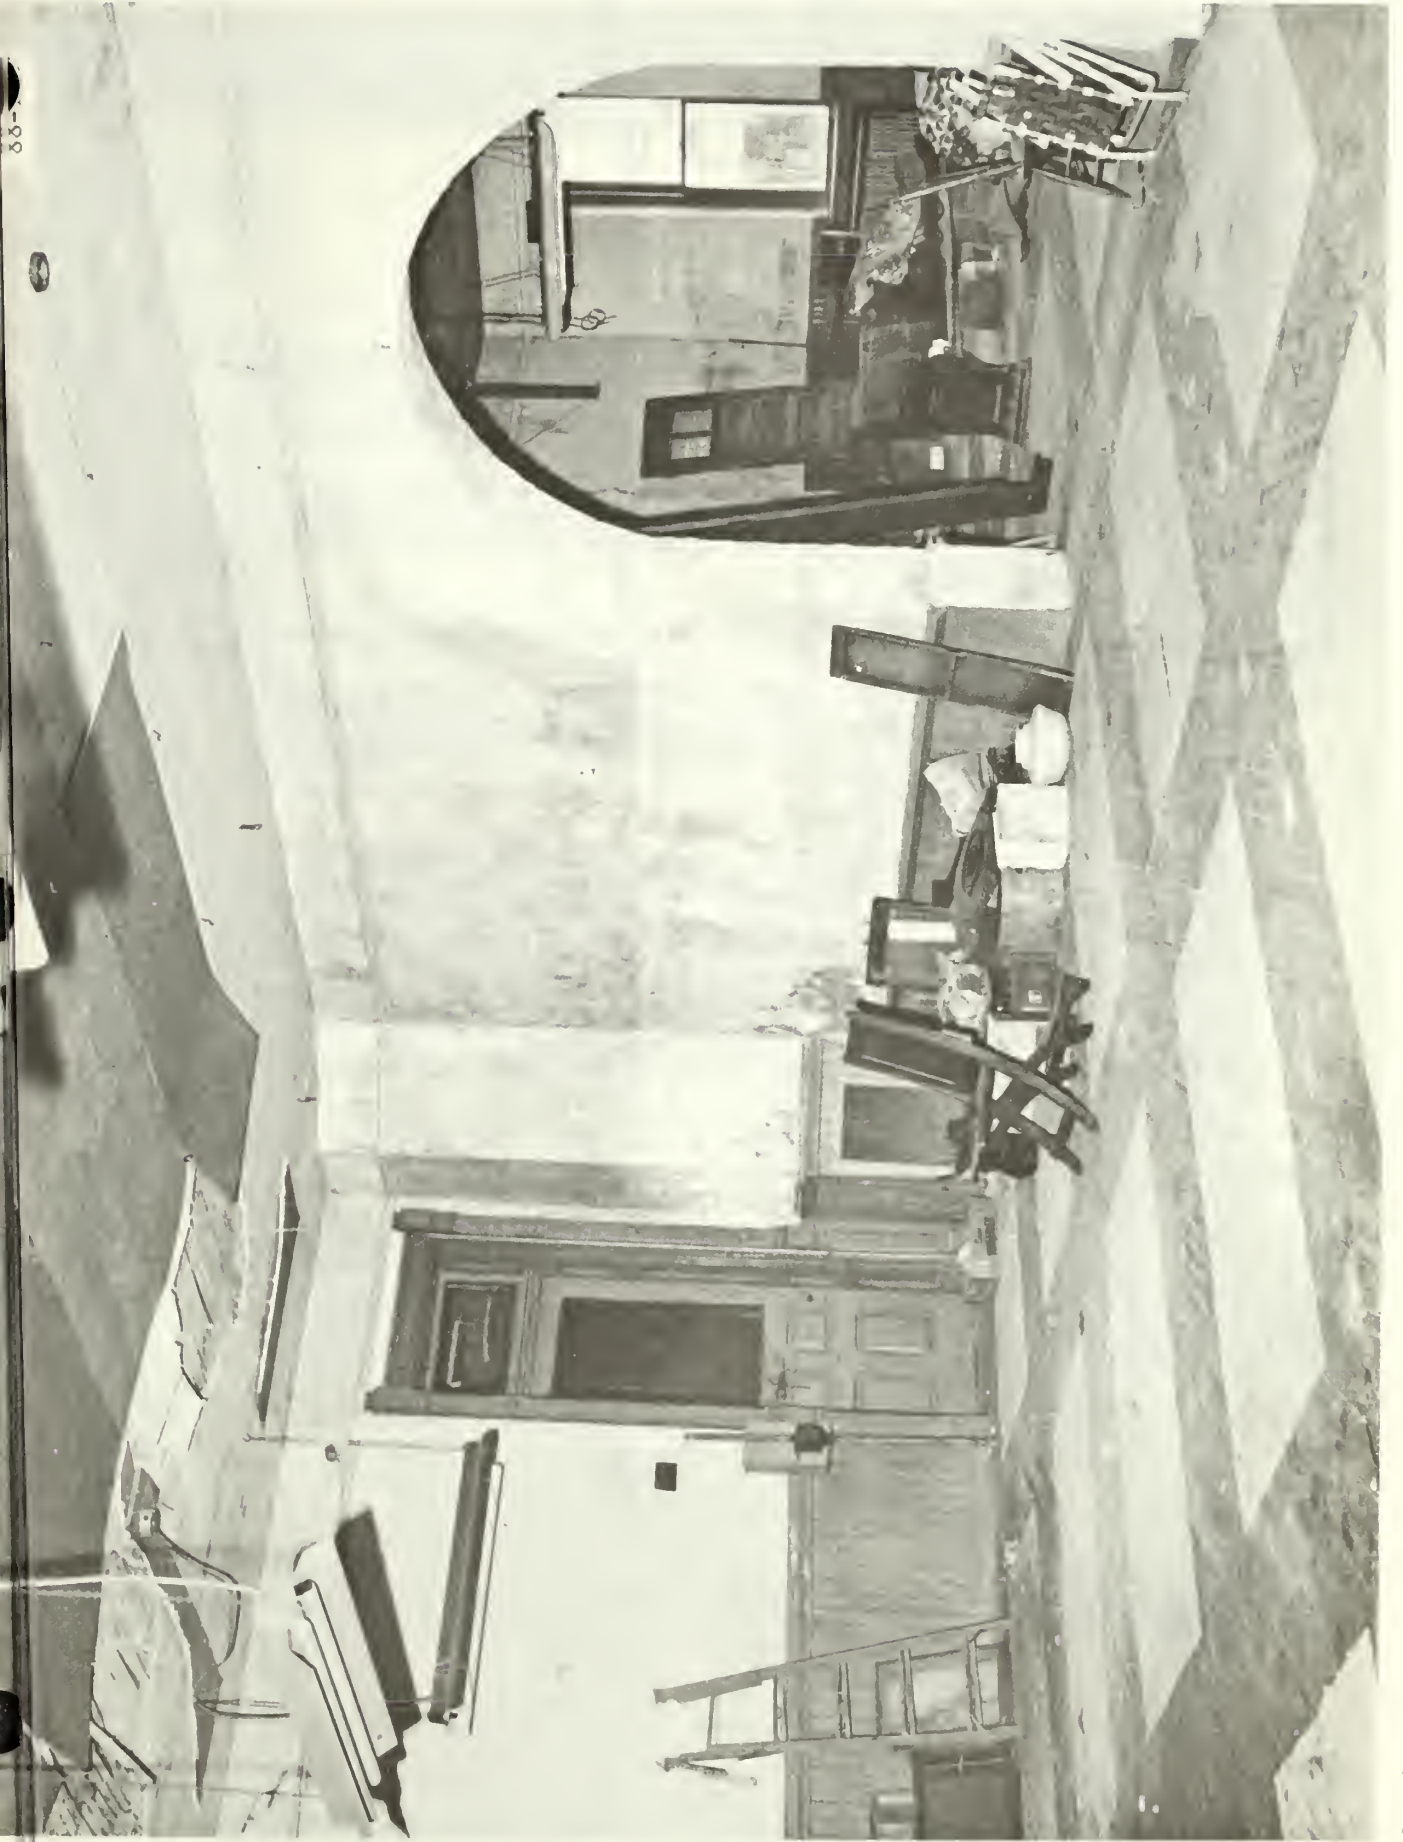
3. View of interior first floor classroom prior to rehabilitation. Arched opening between classrooms was added after original construction.

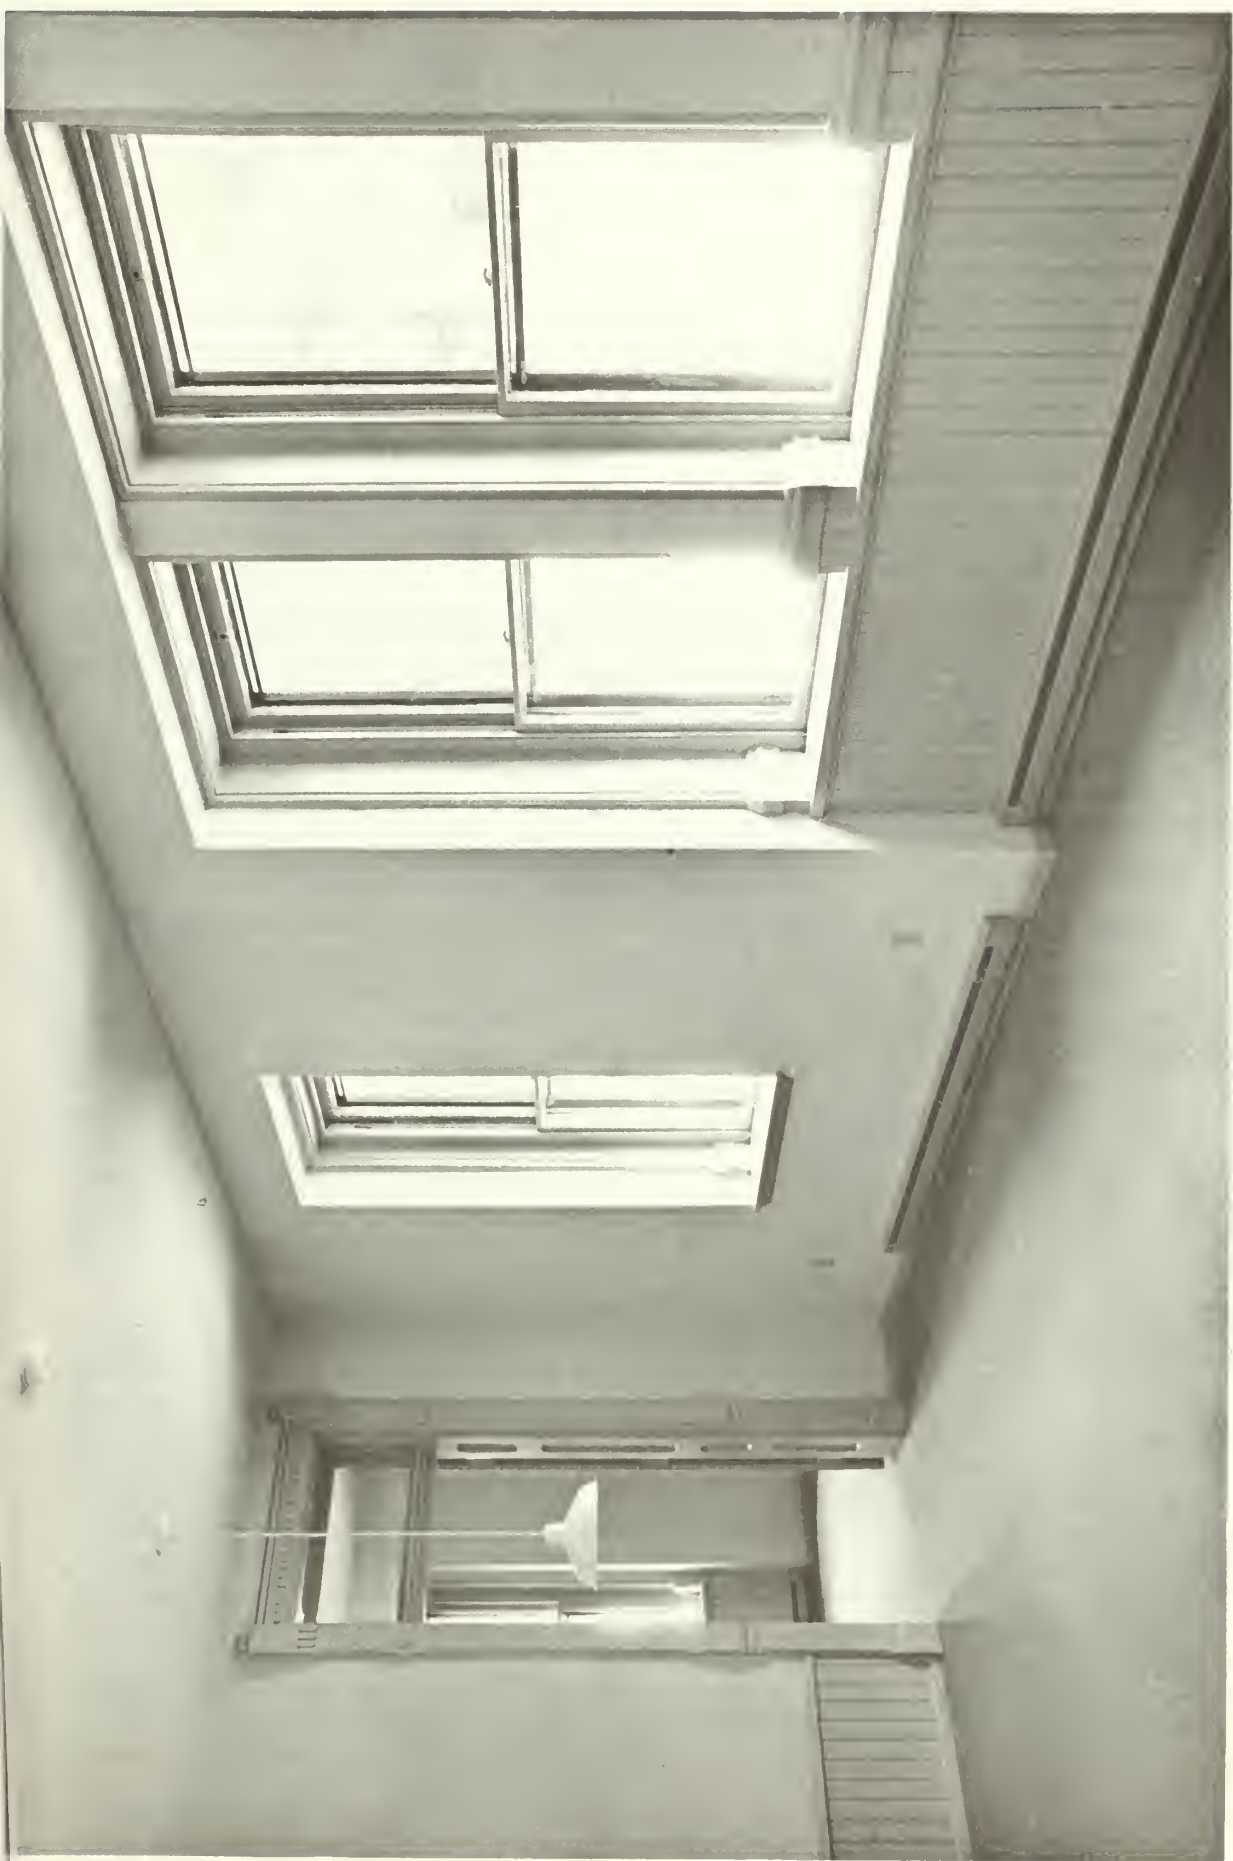
Another distinctive feature that was characteristic to this building type was the panelled wainscotting found throughout the interior. However in the rehabilitation, the interior face of the exterior walls was furred out and significant amounts of wainscotting were subsequently covered (see illus. 6). This treatment has caused the wainscotting to appear fragmented and dis-continuous. The remaining wainscotting appears to be randomly placed, and together with the significant subdivision of the classrooms prevents a clear understanding of the original classrooms' design and space.

6. Third floor classroom as modified for apartments in rehabilitation.

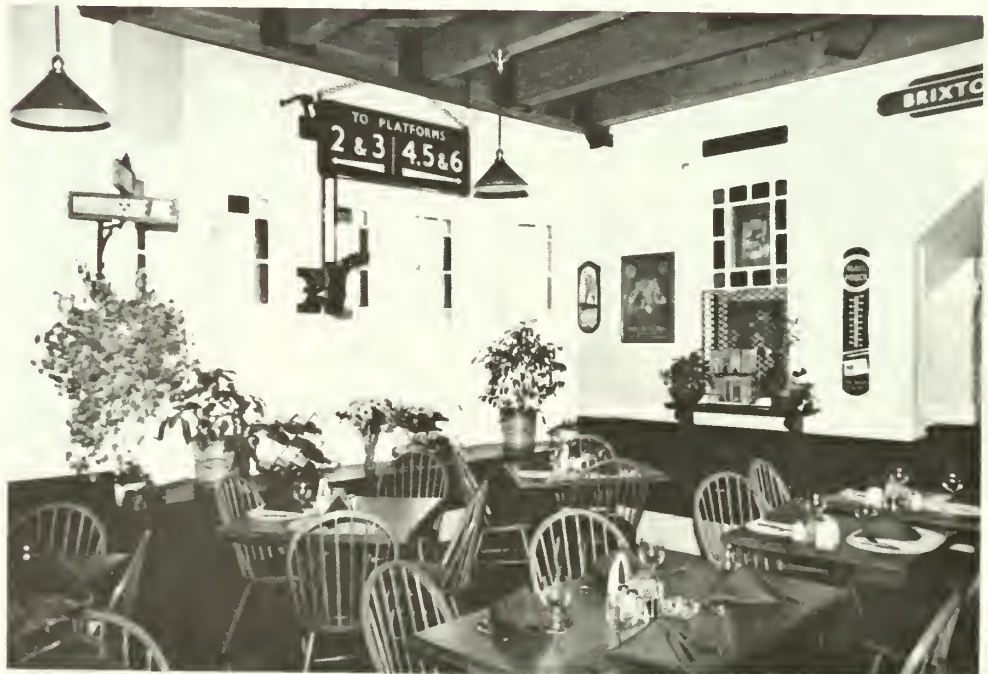
4. Post-rehabilitation view of waiting room after the removal of ticket booth. Note ticket booth window relocated in new stair wall.

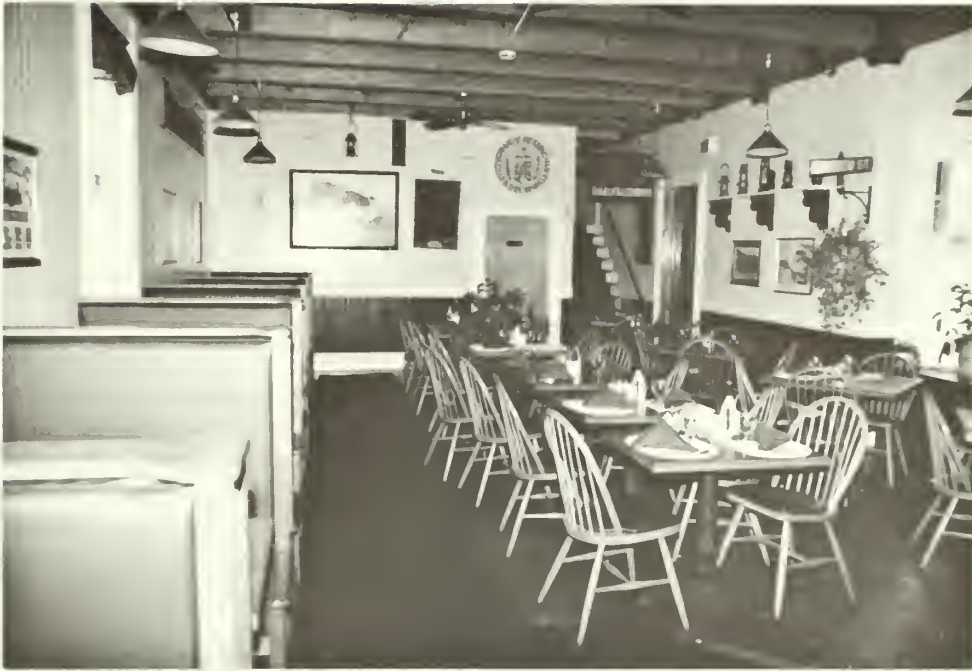
The ceiling of the depot which was removed to install a functional second floor above, was replaced with new ceiling joists dropped below the original first floor ceiling (see illus. 5 & 6). The new unfinished and exposed wood joists are not in keeping with the character of the previously finished waiting room. Further compromising the room was the insertion of restrooms and a staircase at one end of the waiting room; two end windows were obliterated and the distinctive waiting room was reduced by approximately 1/4 to 1/3. Although some detailing was retained on the interior, it was extensively reconfigured, and the new features added were incompatible to the building. As a result, the existing 19th century interior lost its integrity and historic character.

5. Post-rehabilitation view of waiting room. Note the removal of existing ceiling, and the addition of exposed ceiling joists above.

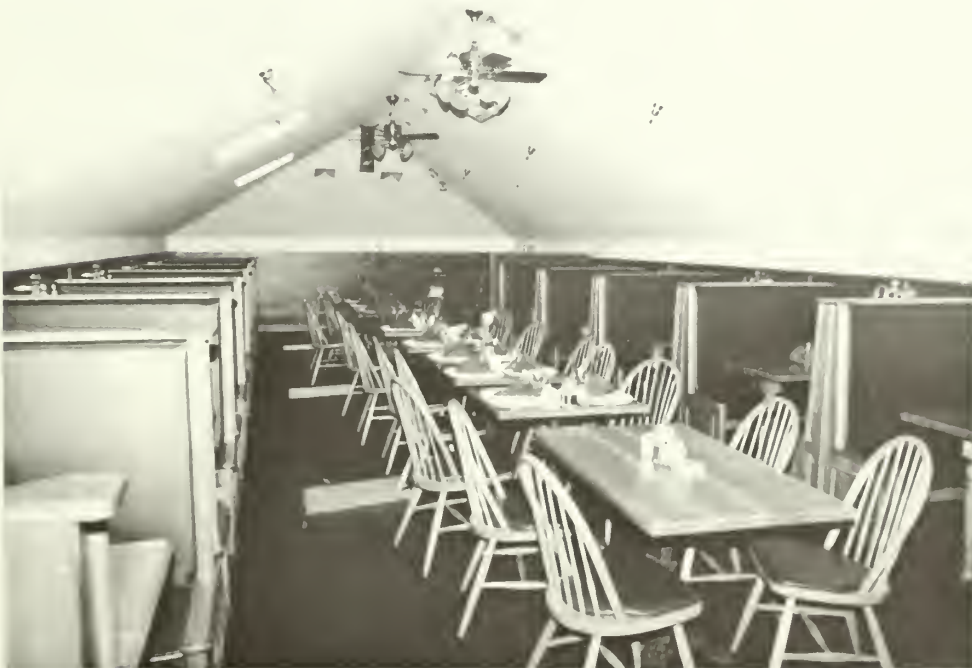
6. Post-rehabilitation view of second floor. Original attic space converted to restaurant space by lowering the ceiling below.

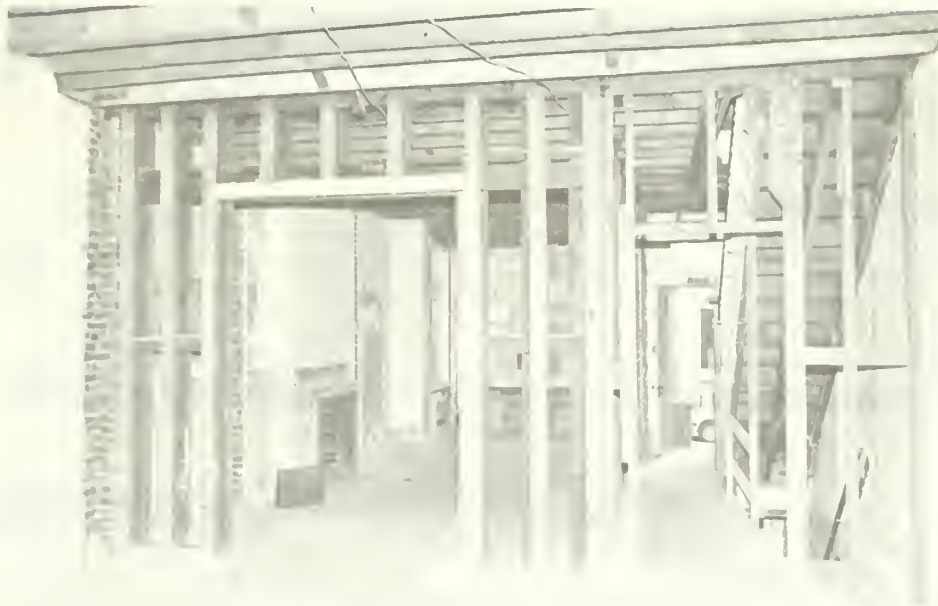
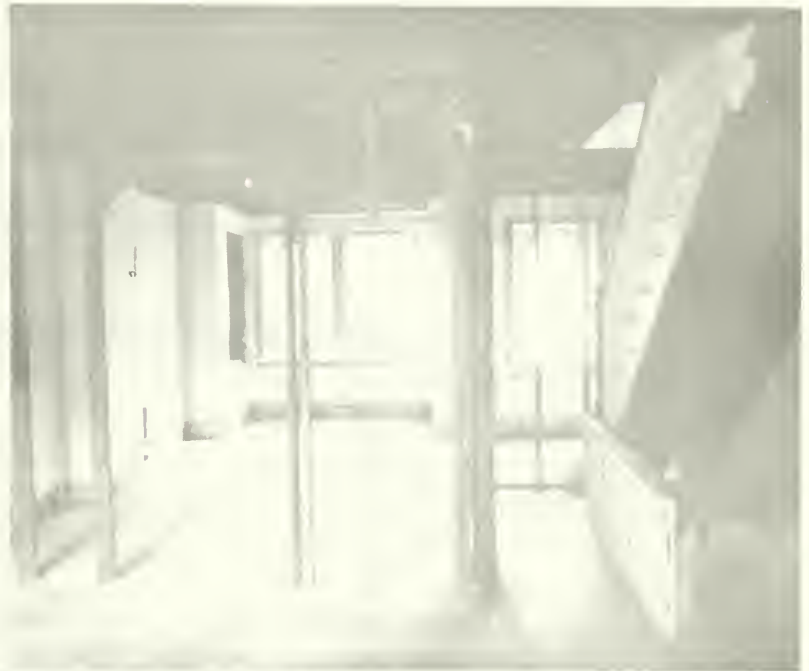
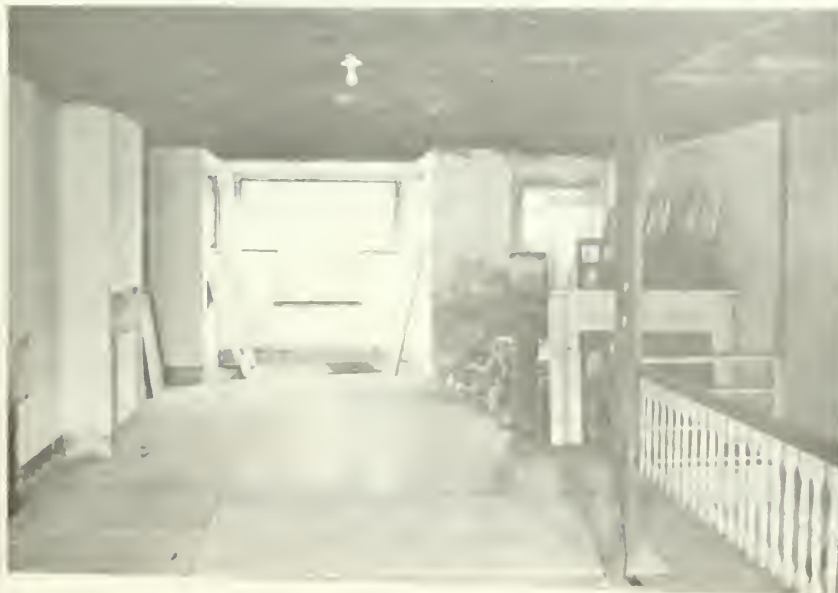
2. The interior of the house after it had been "gutted" by the previous owner. The photographs of all 3 floors are taken from the same location on each floor, and show views toward the front of the house. The new owner was able to repair and reuse wood trim (here, shown piled behind the stairs on the third floor), that had been removed by the previous owner.

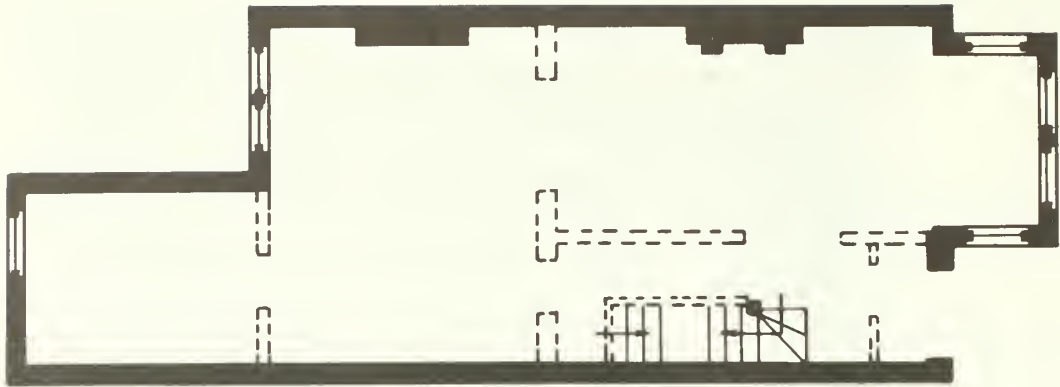
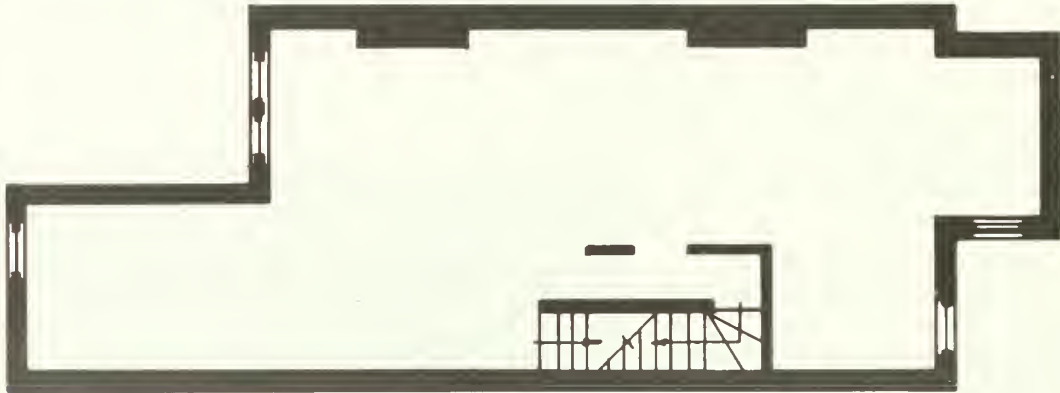
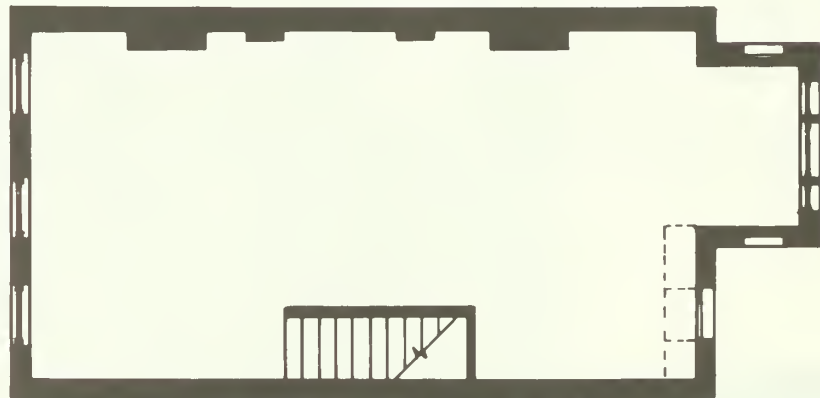
3. Floor plans of the interior prior to rehabilitation. The fireplaces had been removed during previous renovations. Dashed lines represent open stud walls.

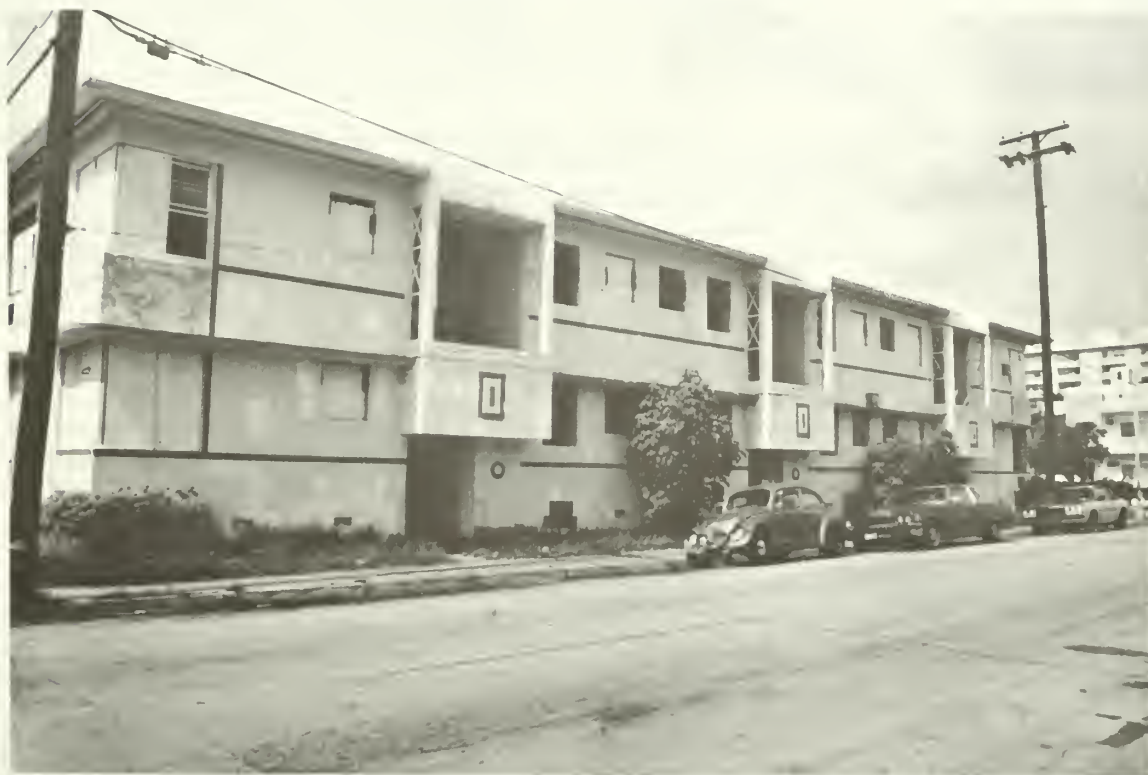
2. The street elevation of the building where patch repair work has already begun shows the decorative panels of local stone under the second story windows at either end of the building.

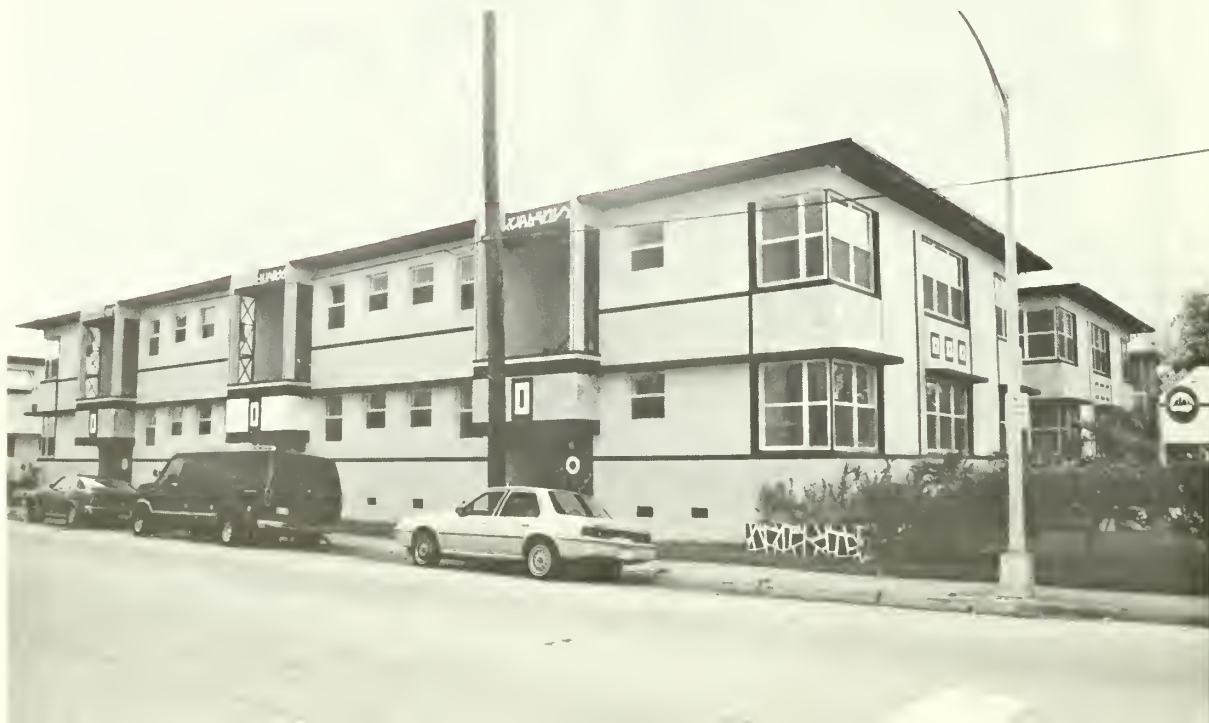
Consequently, as no evidence was presented to indicate that this type of exterior decorative painting had ever existed on this particular building, nor indeed on any building located in the historic district, it was determined that the decorative painted abstract patterns and faux finishes applied during the rehabilitation were inconsistent with the historic character of the building, and the historic district. The plain, unpatterned aqua, yellow, and pink colors on the walls were not considered objectionable, or in violation of the Standards, although it is most unlikely that they would have existed historically either in such a combination, or in such intense colors.

3-5. After rehabilitation the character of the building has been greatly changed by the application of a variety of decorative painted finishes, in particular the "faux" stone surfaces around doors, the contemporary patterned design used above doors and on balconies, and the "cracked tile" pattern on the planters that surround the building.

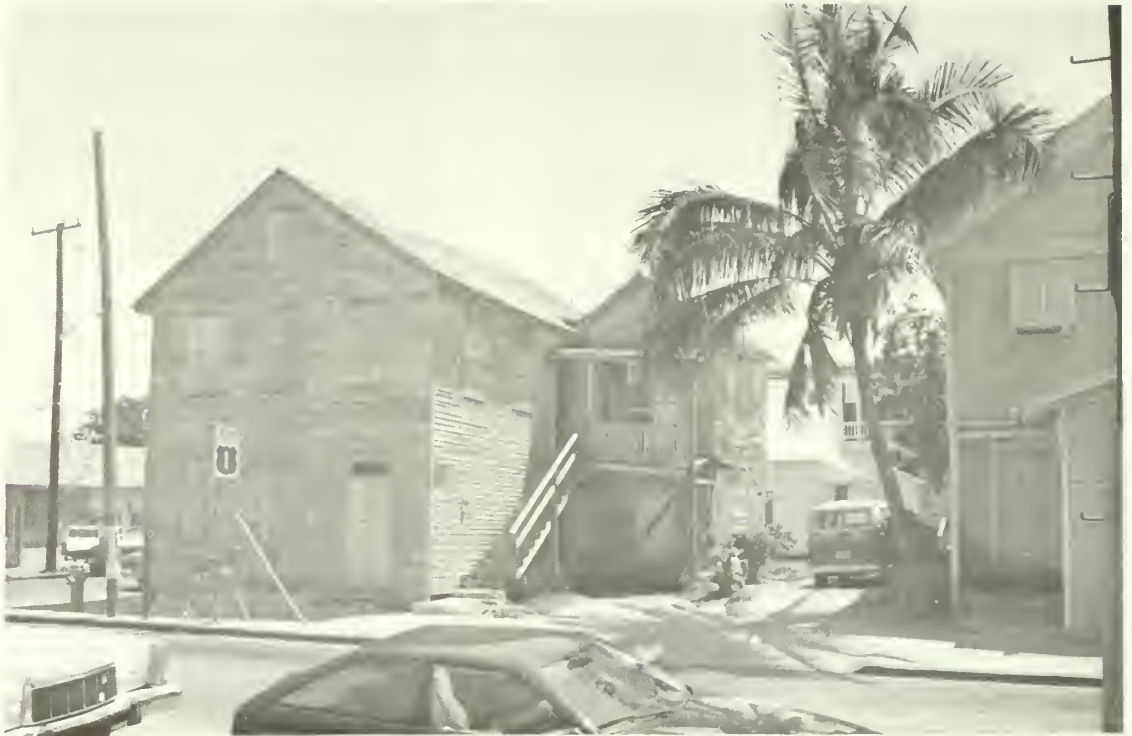
The existing staircase was constructed within the last fifteen years; no remnant of the original feature had survived to guide replication and photographic documentation was unavailable. In view of the Standard's cautions against reproductions which are purely conjectural, the owner maintained that any attempt to reconstruct a staircase would misrepresent the original type. Because the narrow width and deteriorated condition of the staircase made it undesirable to retain, the decision was made to remove the staircase entirely with no attempt at reconstruction.

1. This view shows the exterior staircase in place before rehabilitation. Although this staircase was a replacement of the original, the feature was significant because it had remained in the same location and because it announced a separate use and function for the second floor of the ell.

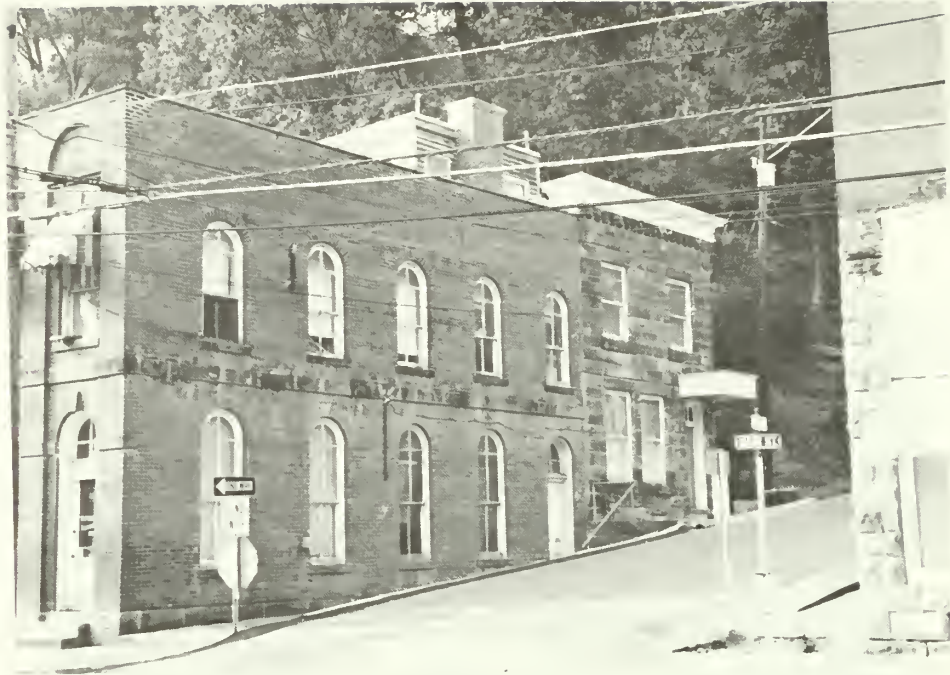
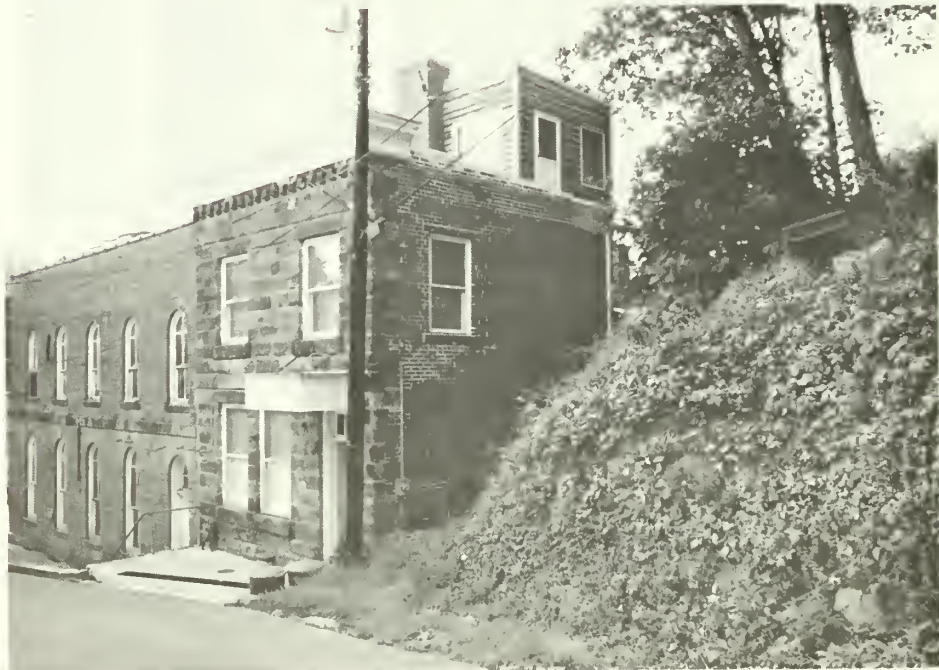
2-3. After rehabilitation, the new rooftop addition is highly visible within the historic district, both from below the building at the main intersection at the foot of the hill, and from above the building higher on the hillside.

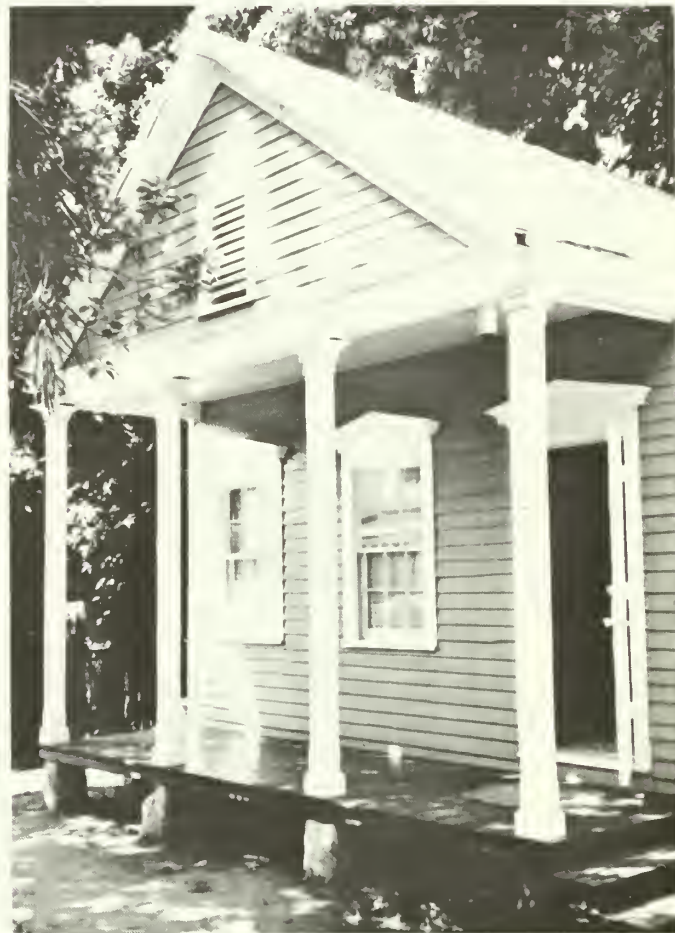
The use of unprecedented details on this small facade is also historically and visually improper because the proportions of the new features create awkward junctures with the existing cornice. For example, the capitals of the posts are improperly scaled and project beyond the gable soffit (see illus 3.) The building's new presentation as a Greek temple is also unsuccessful due to the lack of entablature and requisite Classical cornices and moldings that would normally be found in the overlying gable of a true Greek Revival building.

2. The dramatic shift in appearance from a vernacular structure to a higher style building is achieved with Greek Revival posts and triangular window pediments. The building was not originally fitted with these details, nor is there any occurrence of these features on a facade of this size within the district.

It is not advisable to impose a new stylistic identity onto a facade since attempts will most likely confuse the historic appearance of the building. Although an exterior of any size may lack elaborate detailing and texture, it is important to retain the simplicity which defines the building, realizing that historic character may be expressed only by the few modest details that exist. In this example, violation of the Interior's Standards occurred because the added decorative features caused the removal of historic materials and because the building was given an appearance conflicting with its historic one. By removing the added features and reinstalling the original posts, the visual appearance of the porch and windows can be readily retrieved.

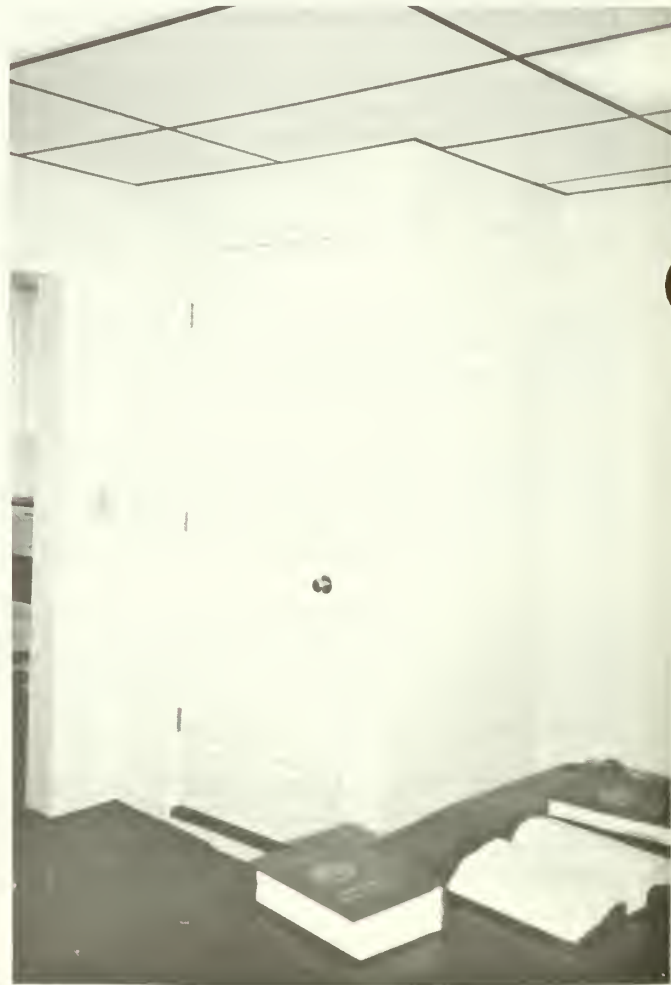
The project did not retain the architectural character and therefore failed to meet the Standards for Rehabilitation. In this particular case, there was no permanent damage to the historic materials, so the rehabilitation could potentially meet the Standards if the owner were to install a plasterboard ceiling more consistent with the original room proportions, preferably at the minimum required clearance for the HVAC system. One method to better integrate HVAC systems is the use of wall and ceiling chases. Failure to minimize the impact of the HVAC system and dropped ceiling may violate Standard 2.

2. This view shows the distracting metal grid and ceiling illumination of the new dropped ceiling.
