REPORT ON TWO WATER SYSTEMS  
ALPINE VISITOR CENTER  
WILD BASIN PICNIC GROUND  
ROCKY MOUNTAIN NATIONAL PARK

DENVER SERVICE CENTER  
NATIONAL PARK SERVICE

CONTRACT NO. CX-2000-3-0021

20 January, 1984

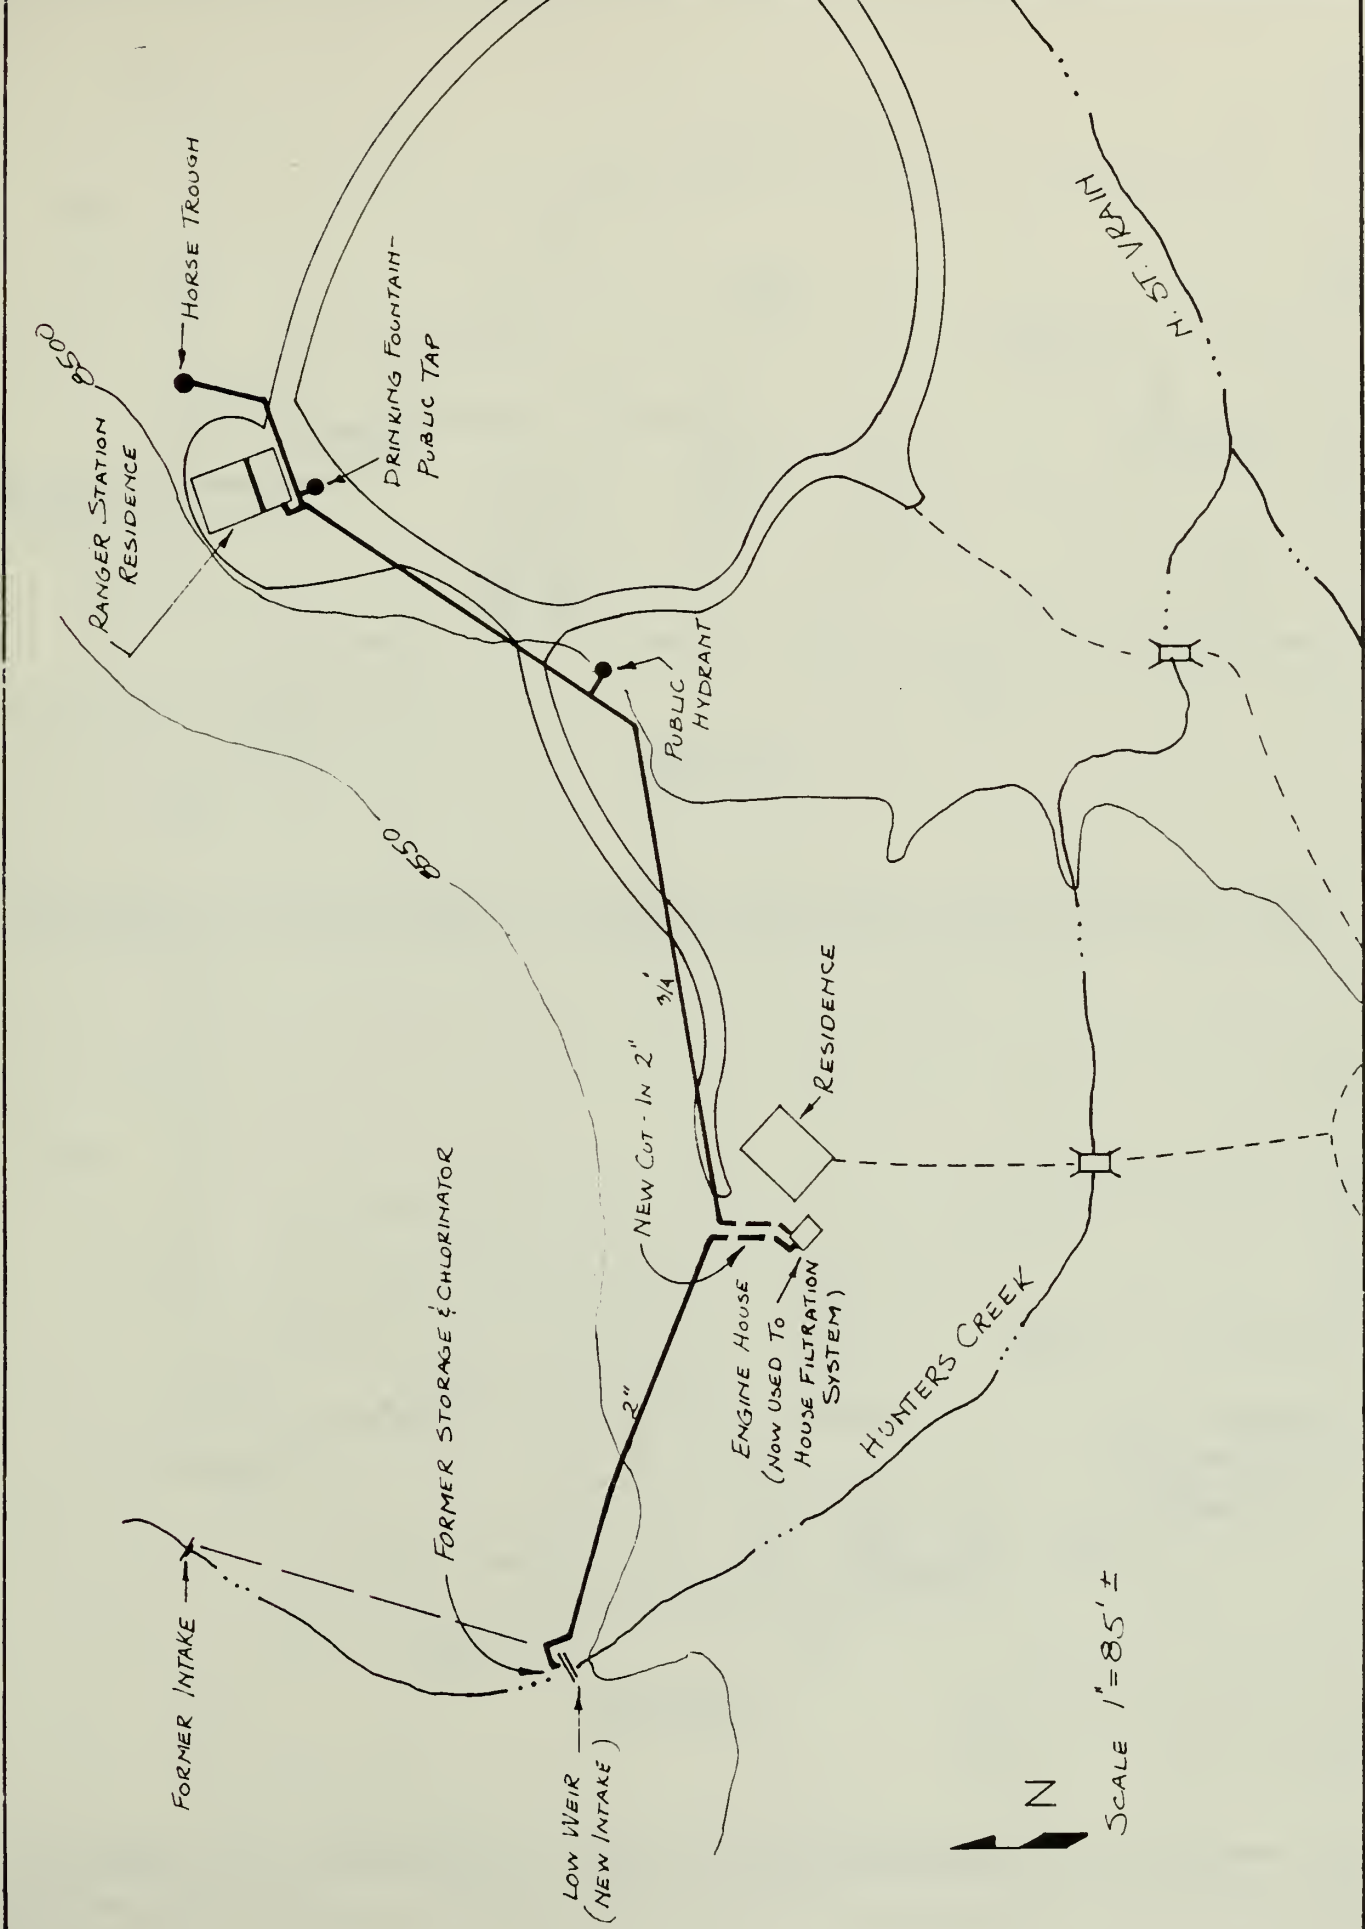
FIGURE 2.1 WILD BASIN - GENERAL ARRANGEMENT OF WATER SYSTEM

placed in a shallow pool formed by a low rock barricade in the main channel of Hunter's Creek. (Figure 2.1) A 2-inch diameter galvanized steel pipe laid on the surface conveyed the water to a 200 gallon storage tank and an aerofeed chlorinator powered by compressed air since no electrical power was available at that point on the system. From the storage, a 2-inch galvanized pipe buried in the cobble and soil matrix carried water to the first residence. A 3/4 inch polyethylene pipe then carried water to the picnic area, the ranger station/residence and the horse stable. The picnic area has one hydrant for public use. A drinking fountain with hose tap on the corner of the ranger station is also available to the public. The on-site staff reported that for the current level of use, the 2 public taps are adequate. The original system operated entirely by gravity.

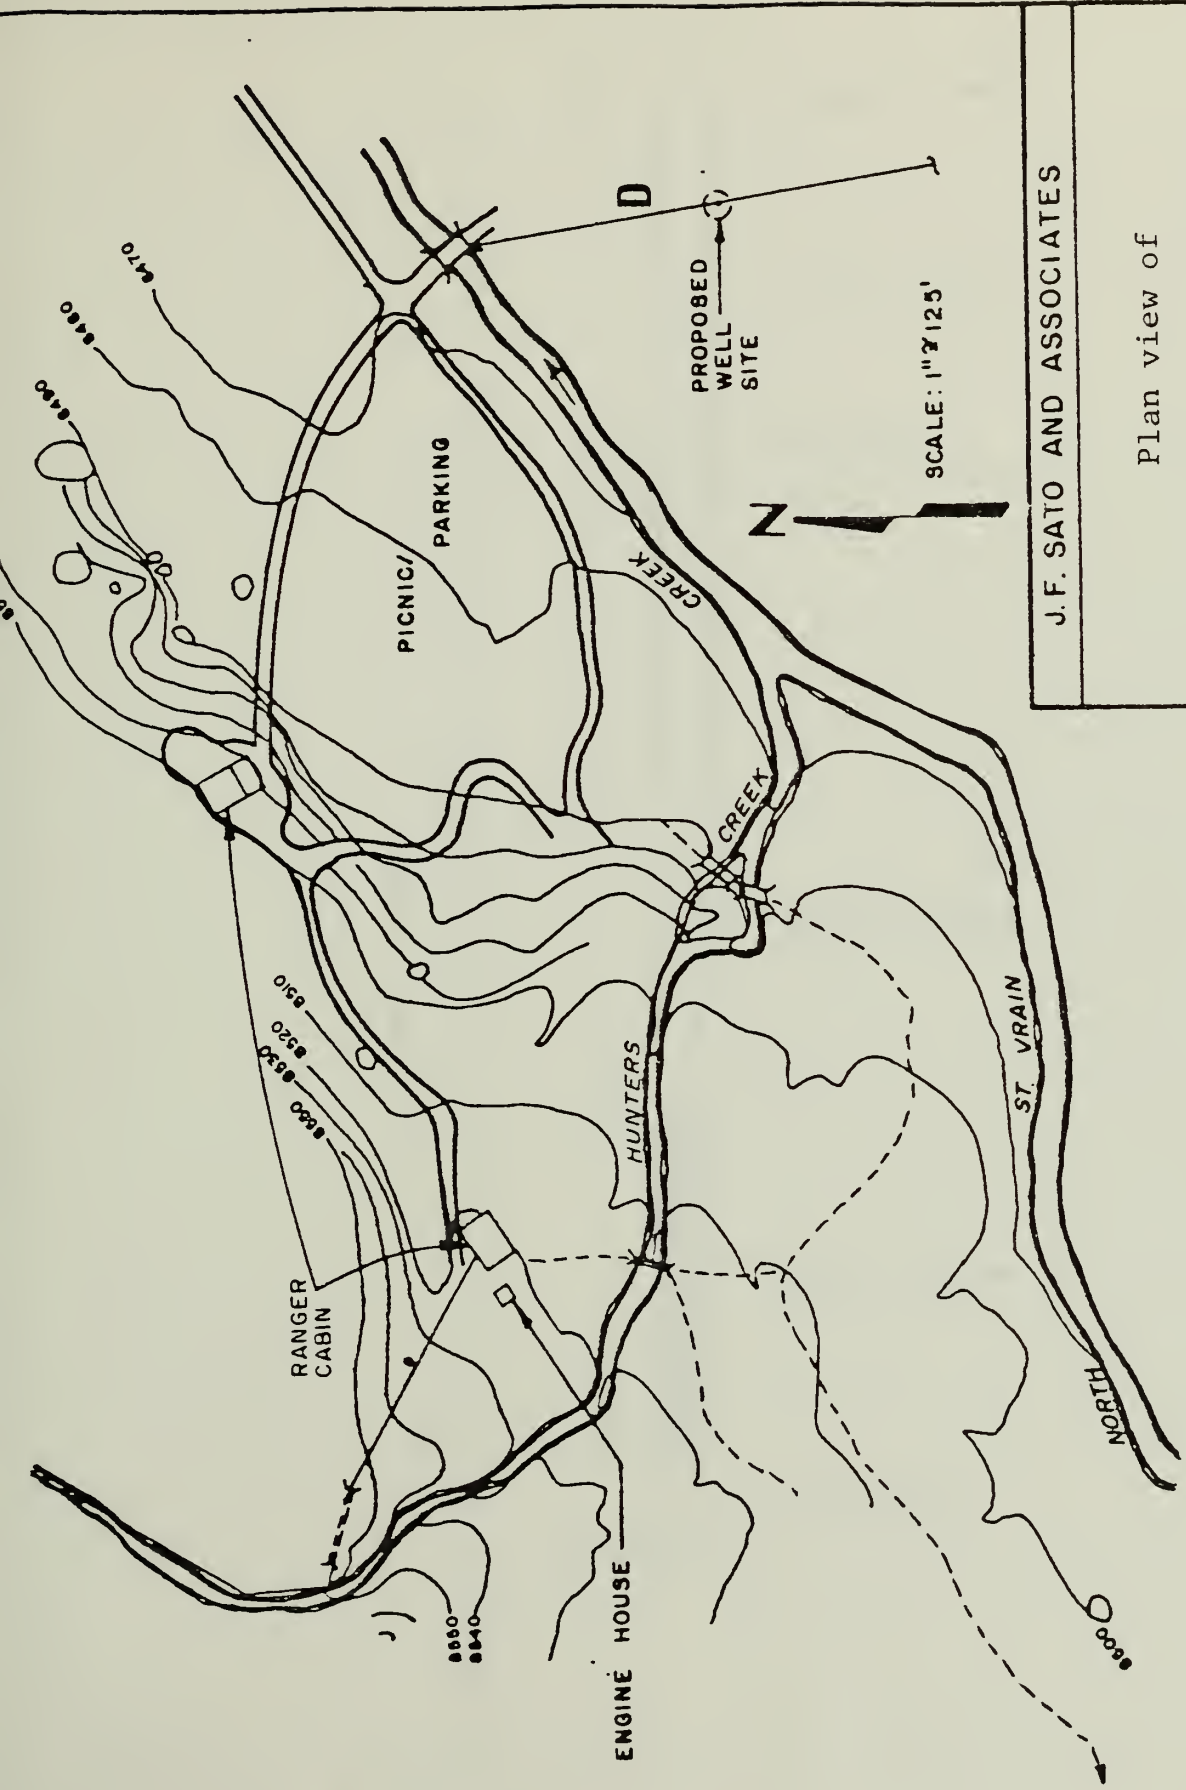
J.F. SATO AND ASSOCIATES	
Plan view of Wild Basin picnic ground	
FIGURE NO. 5	10/83

The site is located 162 feet south from the eastern edge of the bridge and 228 feet in the easterly direction from the confluence of North St. Vrain and Hunters Creek. It is in a natural, dry channel that may have been an earlier course of North St. Vrain but now stands about 3.5 feet above the creek bed.

Figure 4 shows a profile and section of the valley floor south of the bridge crossing North St. Vrain Creek to Wild Basin Ranger Station and picnic ground. A possible site for a water well is shown on this section and in the plan view in Figure 5.

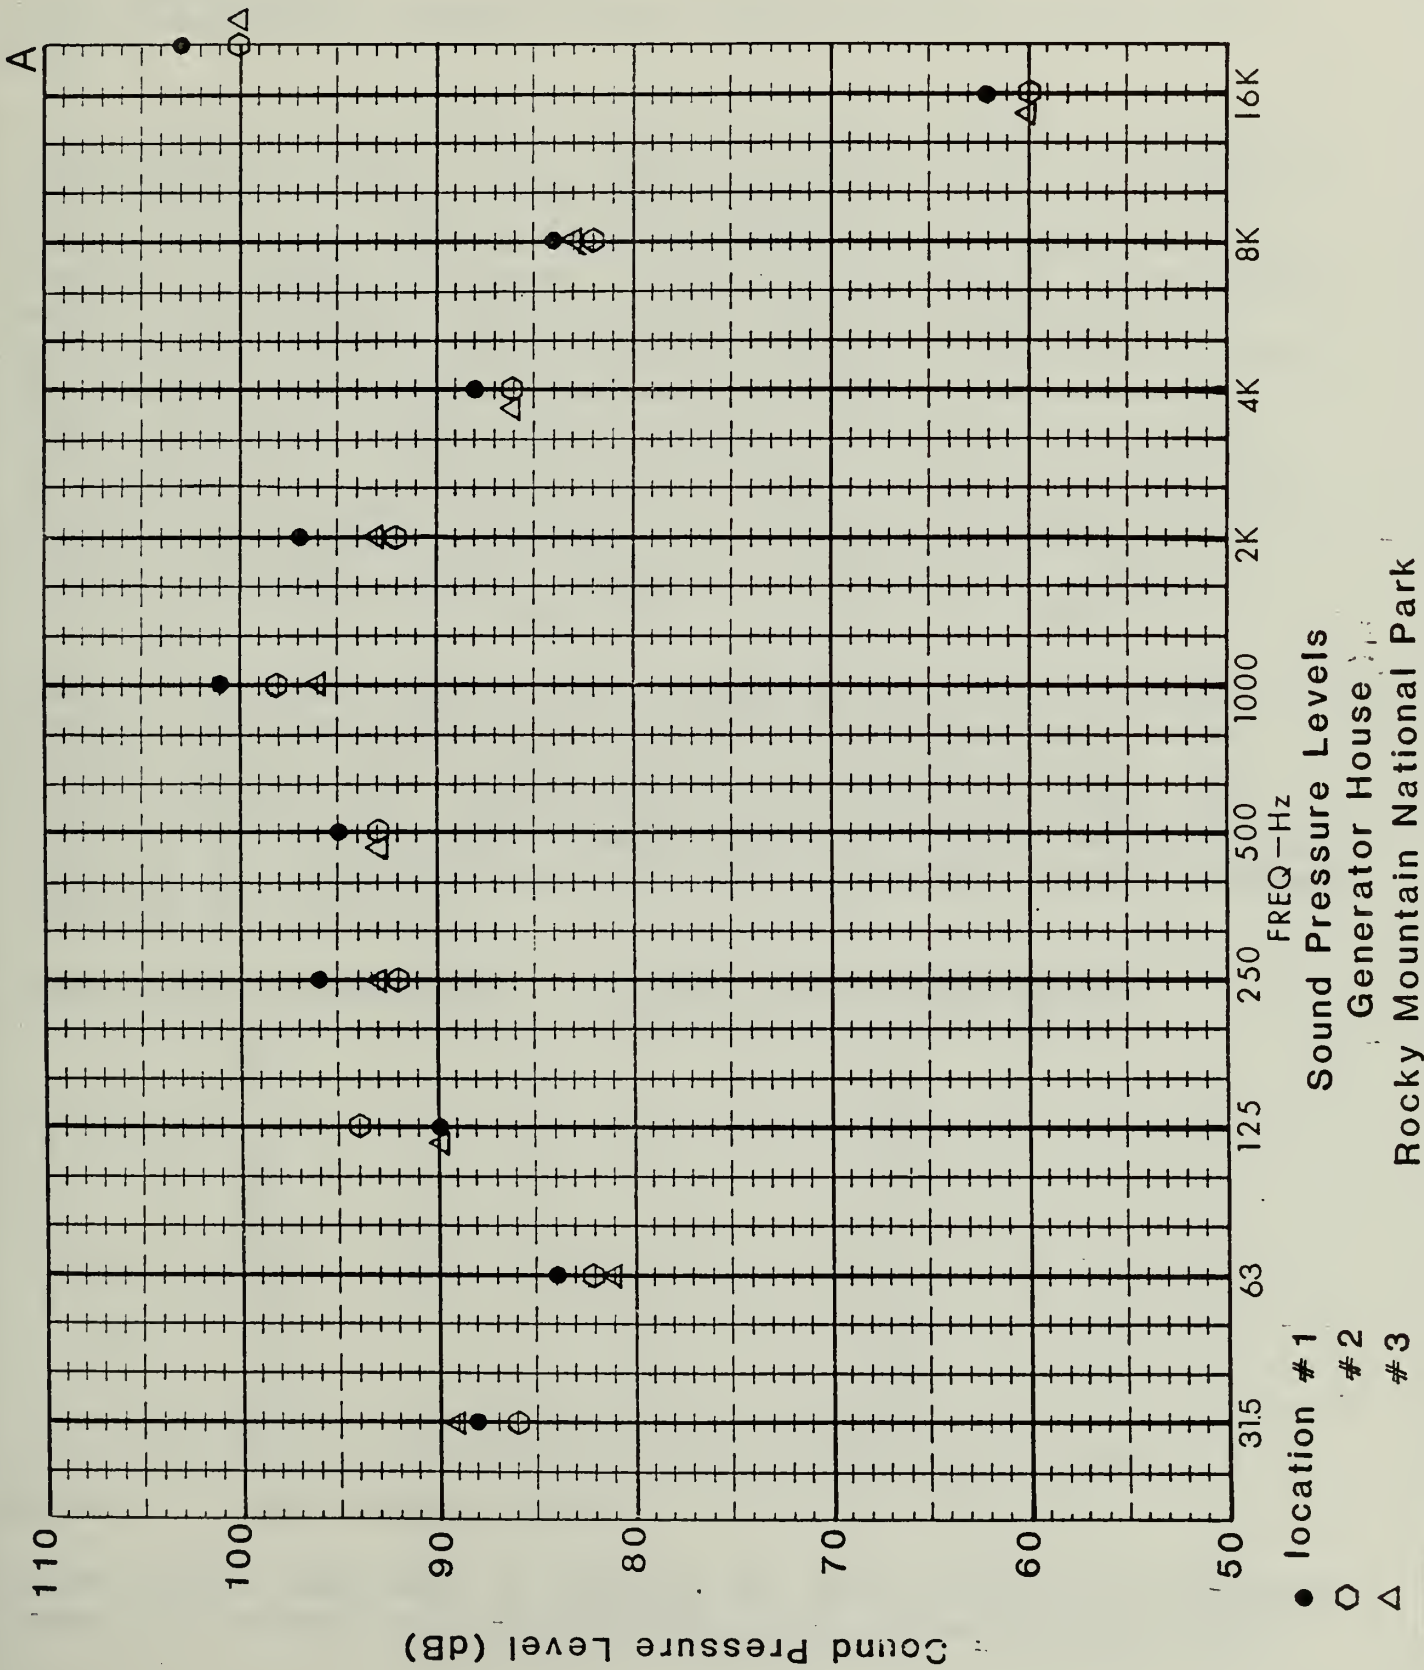
Figure 1

The sound pressure level measurements taken in the interior of the generator house with one generator operational at three locations are given in Table 1 below and are plotted in Figure 1.

As can be seen from the data in Table 1, the internal sound field in the generator house is relatively constant. That is, the noise produced by the motor/generator is diffused evenly through out the building.

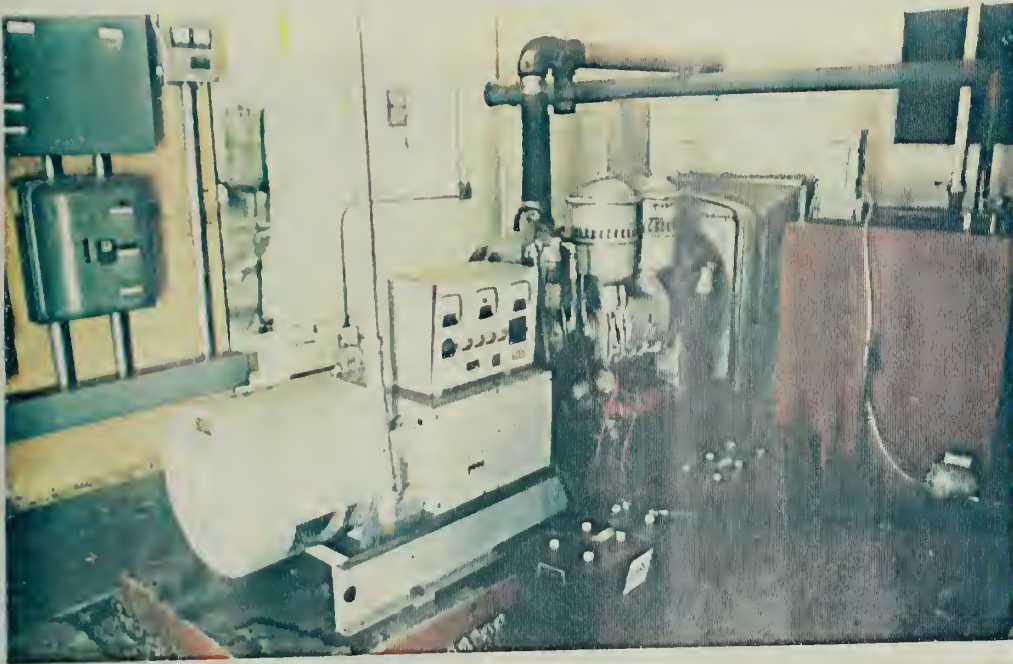
GENERATOR SET

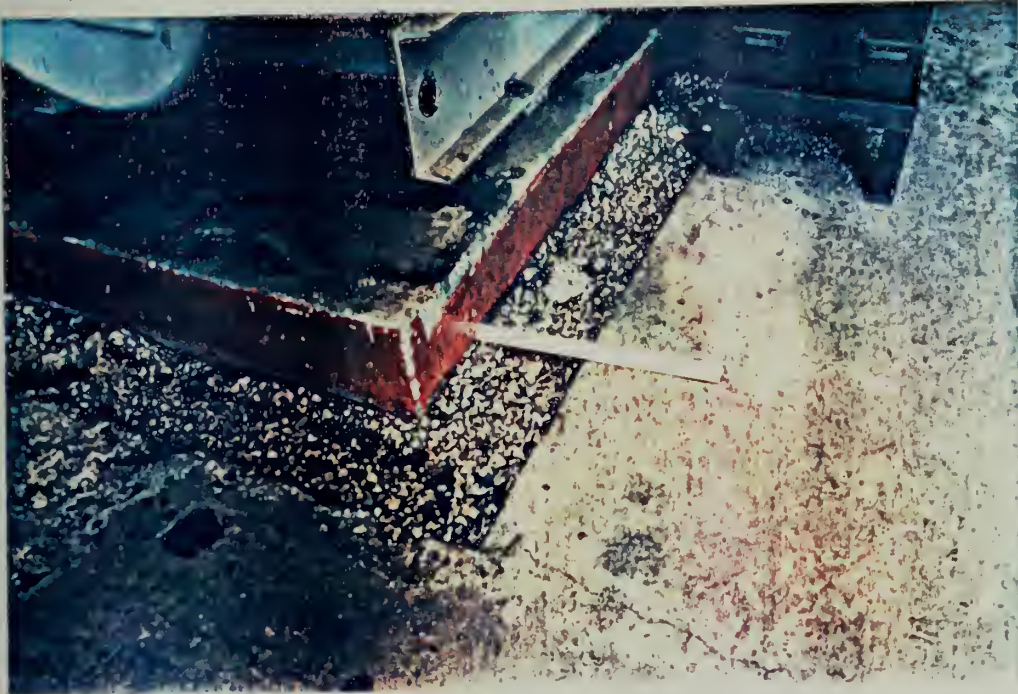
SAND BED FOR  
VIBRATION ISOLATION

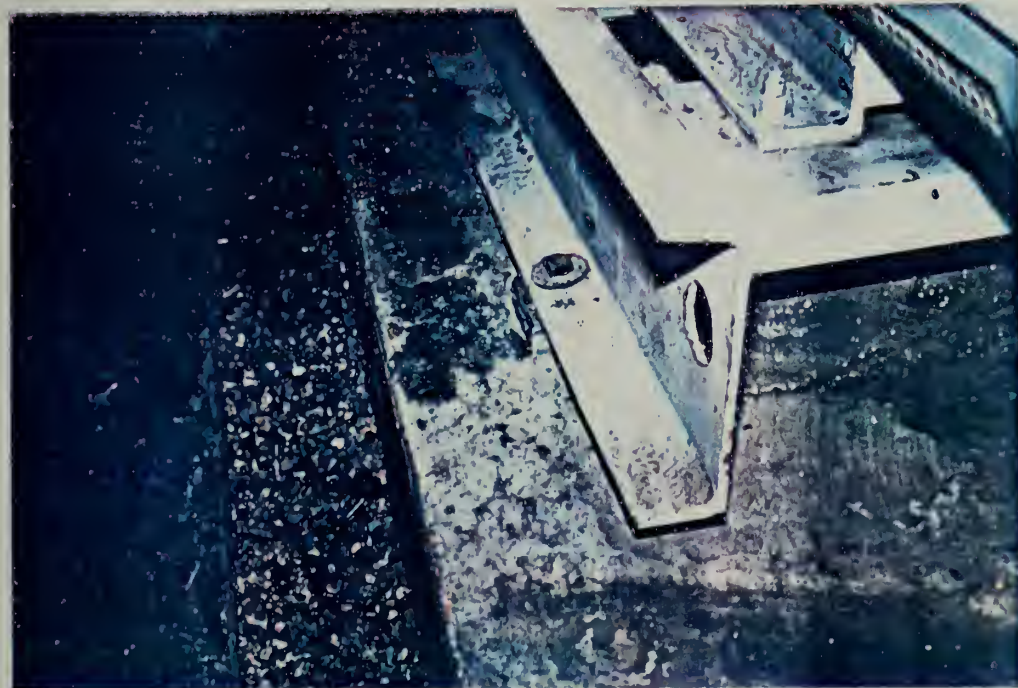
RUBBER STEEL  
COMPOSITE FOR  
VIBRATION ISOLATION
