historic structure report
architectural data section

FORT JEFFERSON
NATIONAL MONUMENT / FLORIDA

BY: LOUIS ANDERSON
APRIL 1988

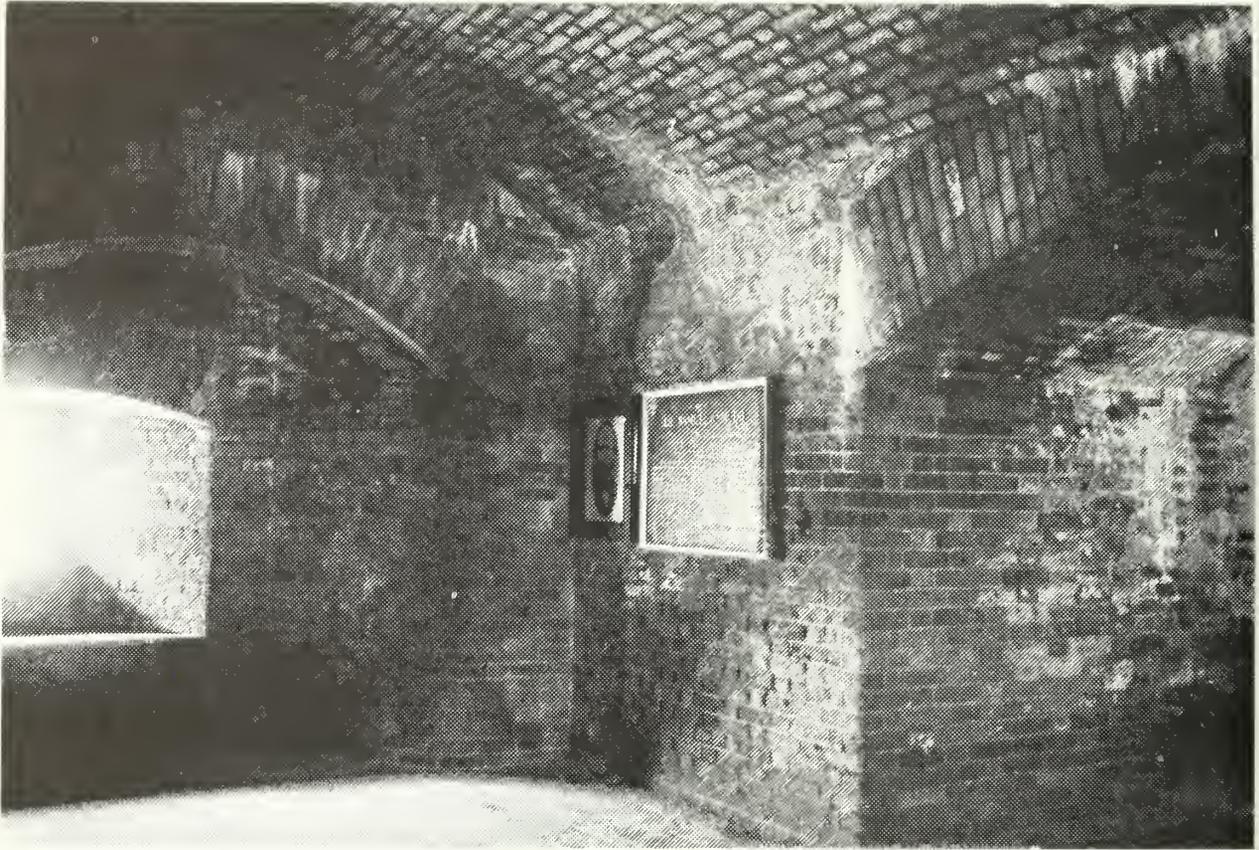
DR. SAMUEL MUDD'S CELL

Dr. Samuel Mudd's Cell, presumed to have been in the lower tier of Bastion 1, is currently in use as an interpretive feature of the fort. It is located near the terminus of the tour route upon descent from the terreplein. There are presently no conditions in this area which demand treatment or detract from its current use. (See Figure 11, Dr. Samuel Mudd's Cell.)

Figure 11 PRESENT CONDITION

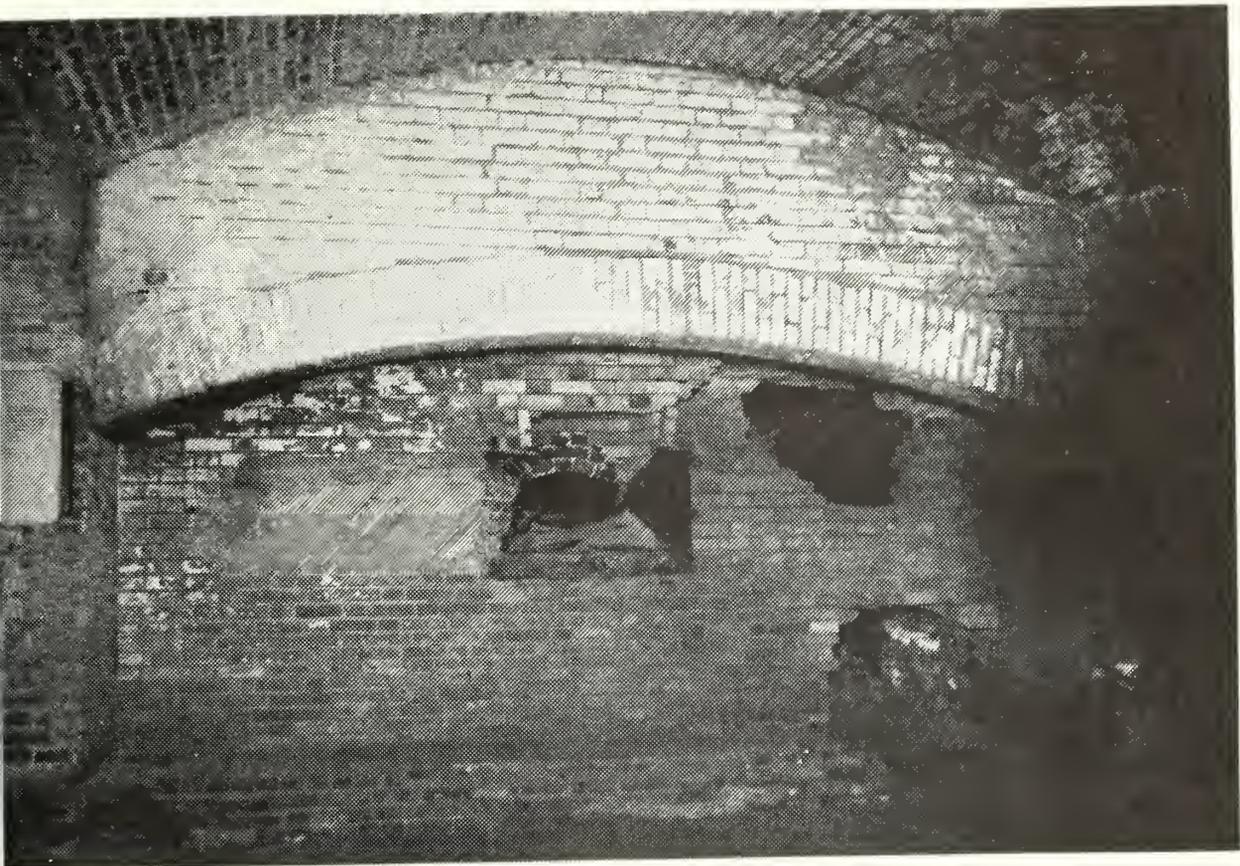
BAKERY

The bakery, located in Bastion 3 of the lower tier, is an important interpretive feature of the fort and an element of the tour route. (See Figure 15, Bakery.)

Figure 15 PRESENT CONDITION

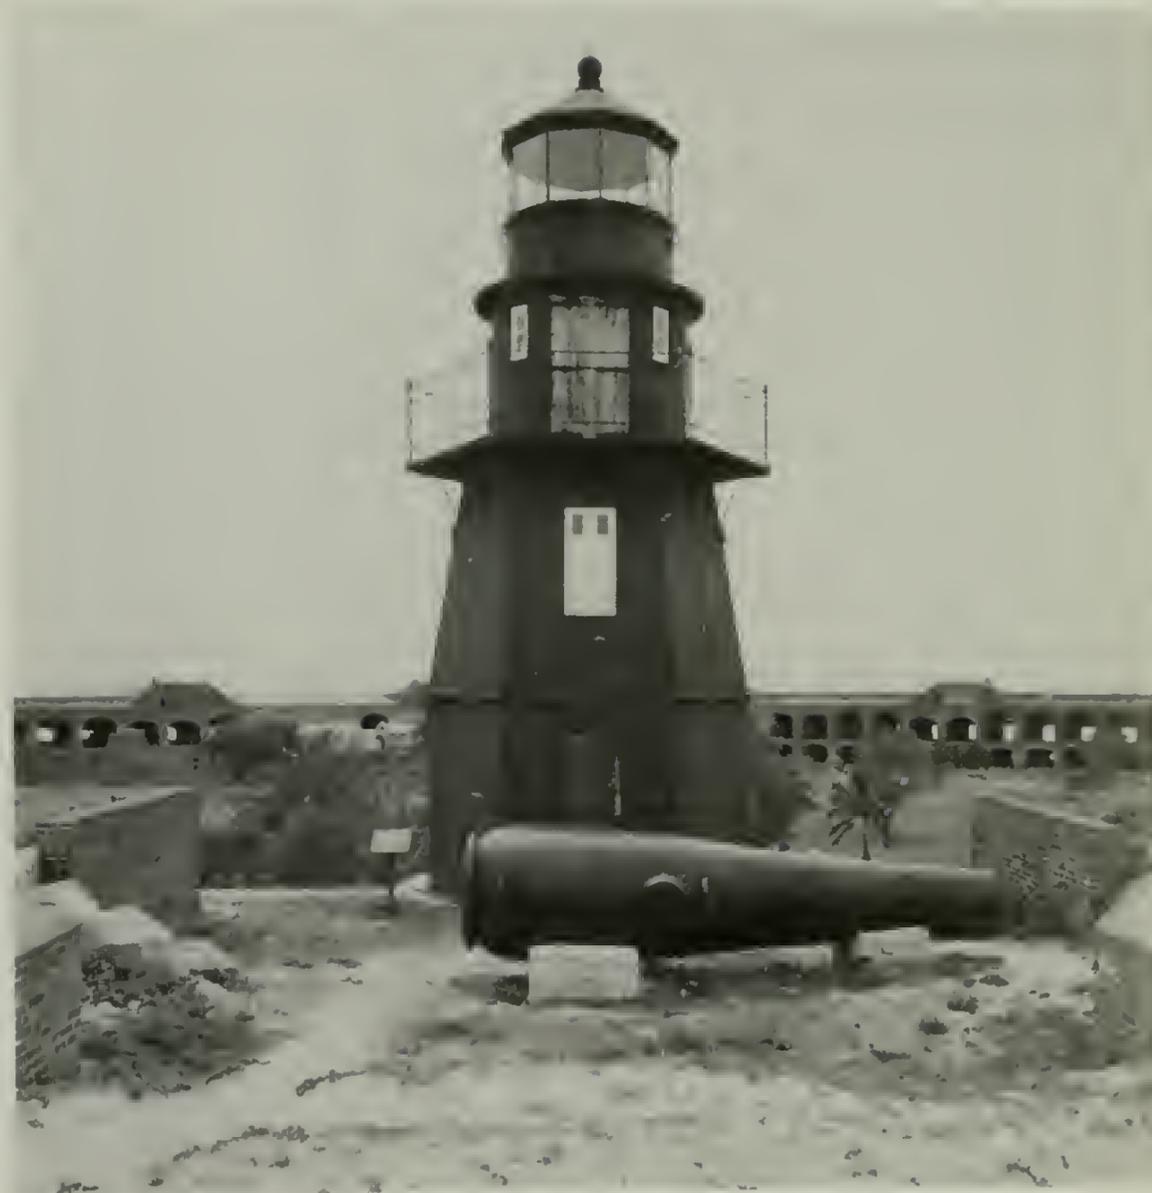
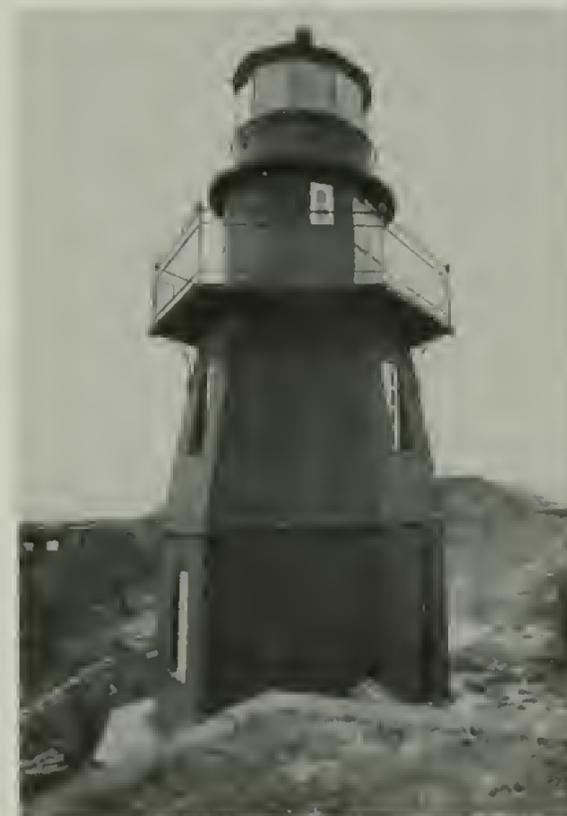
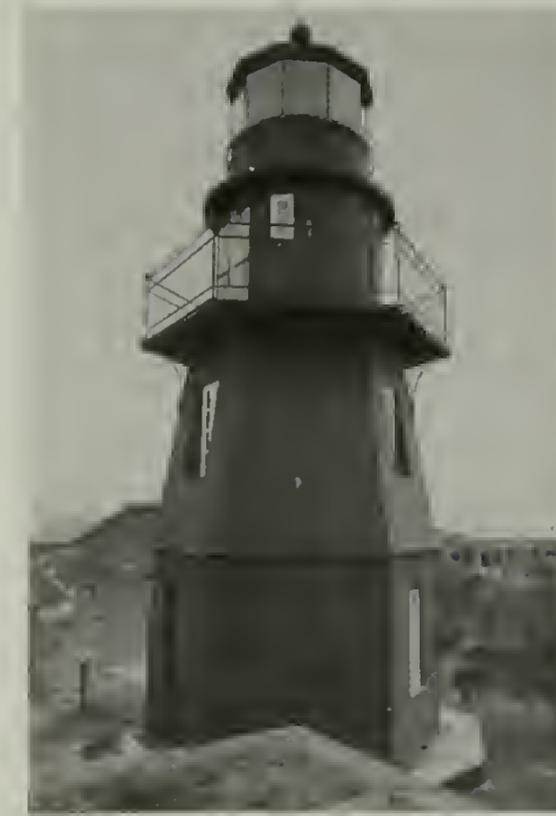
SOUTHEAST ELEVATION
SCALE: 1/4" = 1'-0"

PRESERVATION MAINTENANCE WAS PERFORMED ON THE LIGHTHOUSE IN JULY, 1983. MAJOR ELEMENTS OF THIS WORK INCLUDED: SANDBLAST CLEANING AND REPAINTING THE EXTERIOR, REPLACING ALL LANTERN GLASS, REPAINTING THE LIGHTHOUSE INTERIOR, REPLACEMENT OF DOOR AND WINDOW HARDWARE AND REPAINTING AND REFINISHING LIGHTHOUSE DOORS AND WINDOWS. ELEVATIONS SHOW EXISTING CONDITIONS PRIOR TO ABOVE WORK.

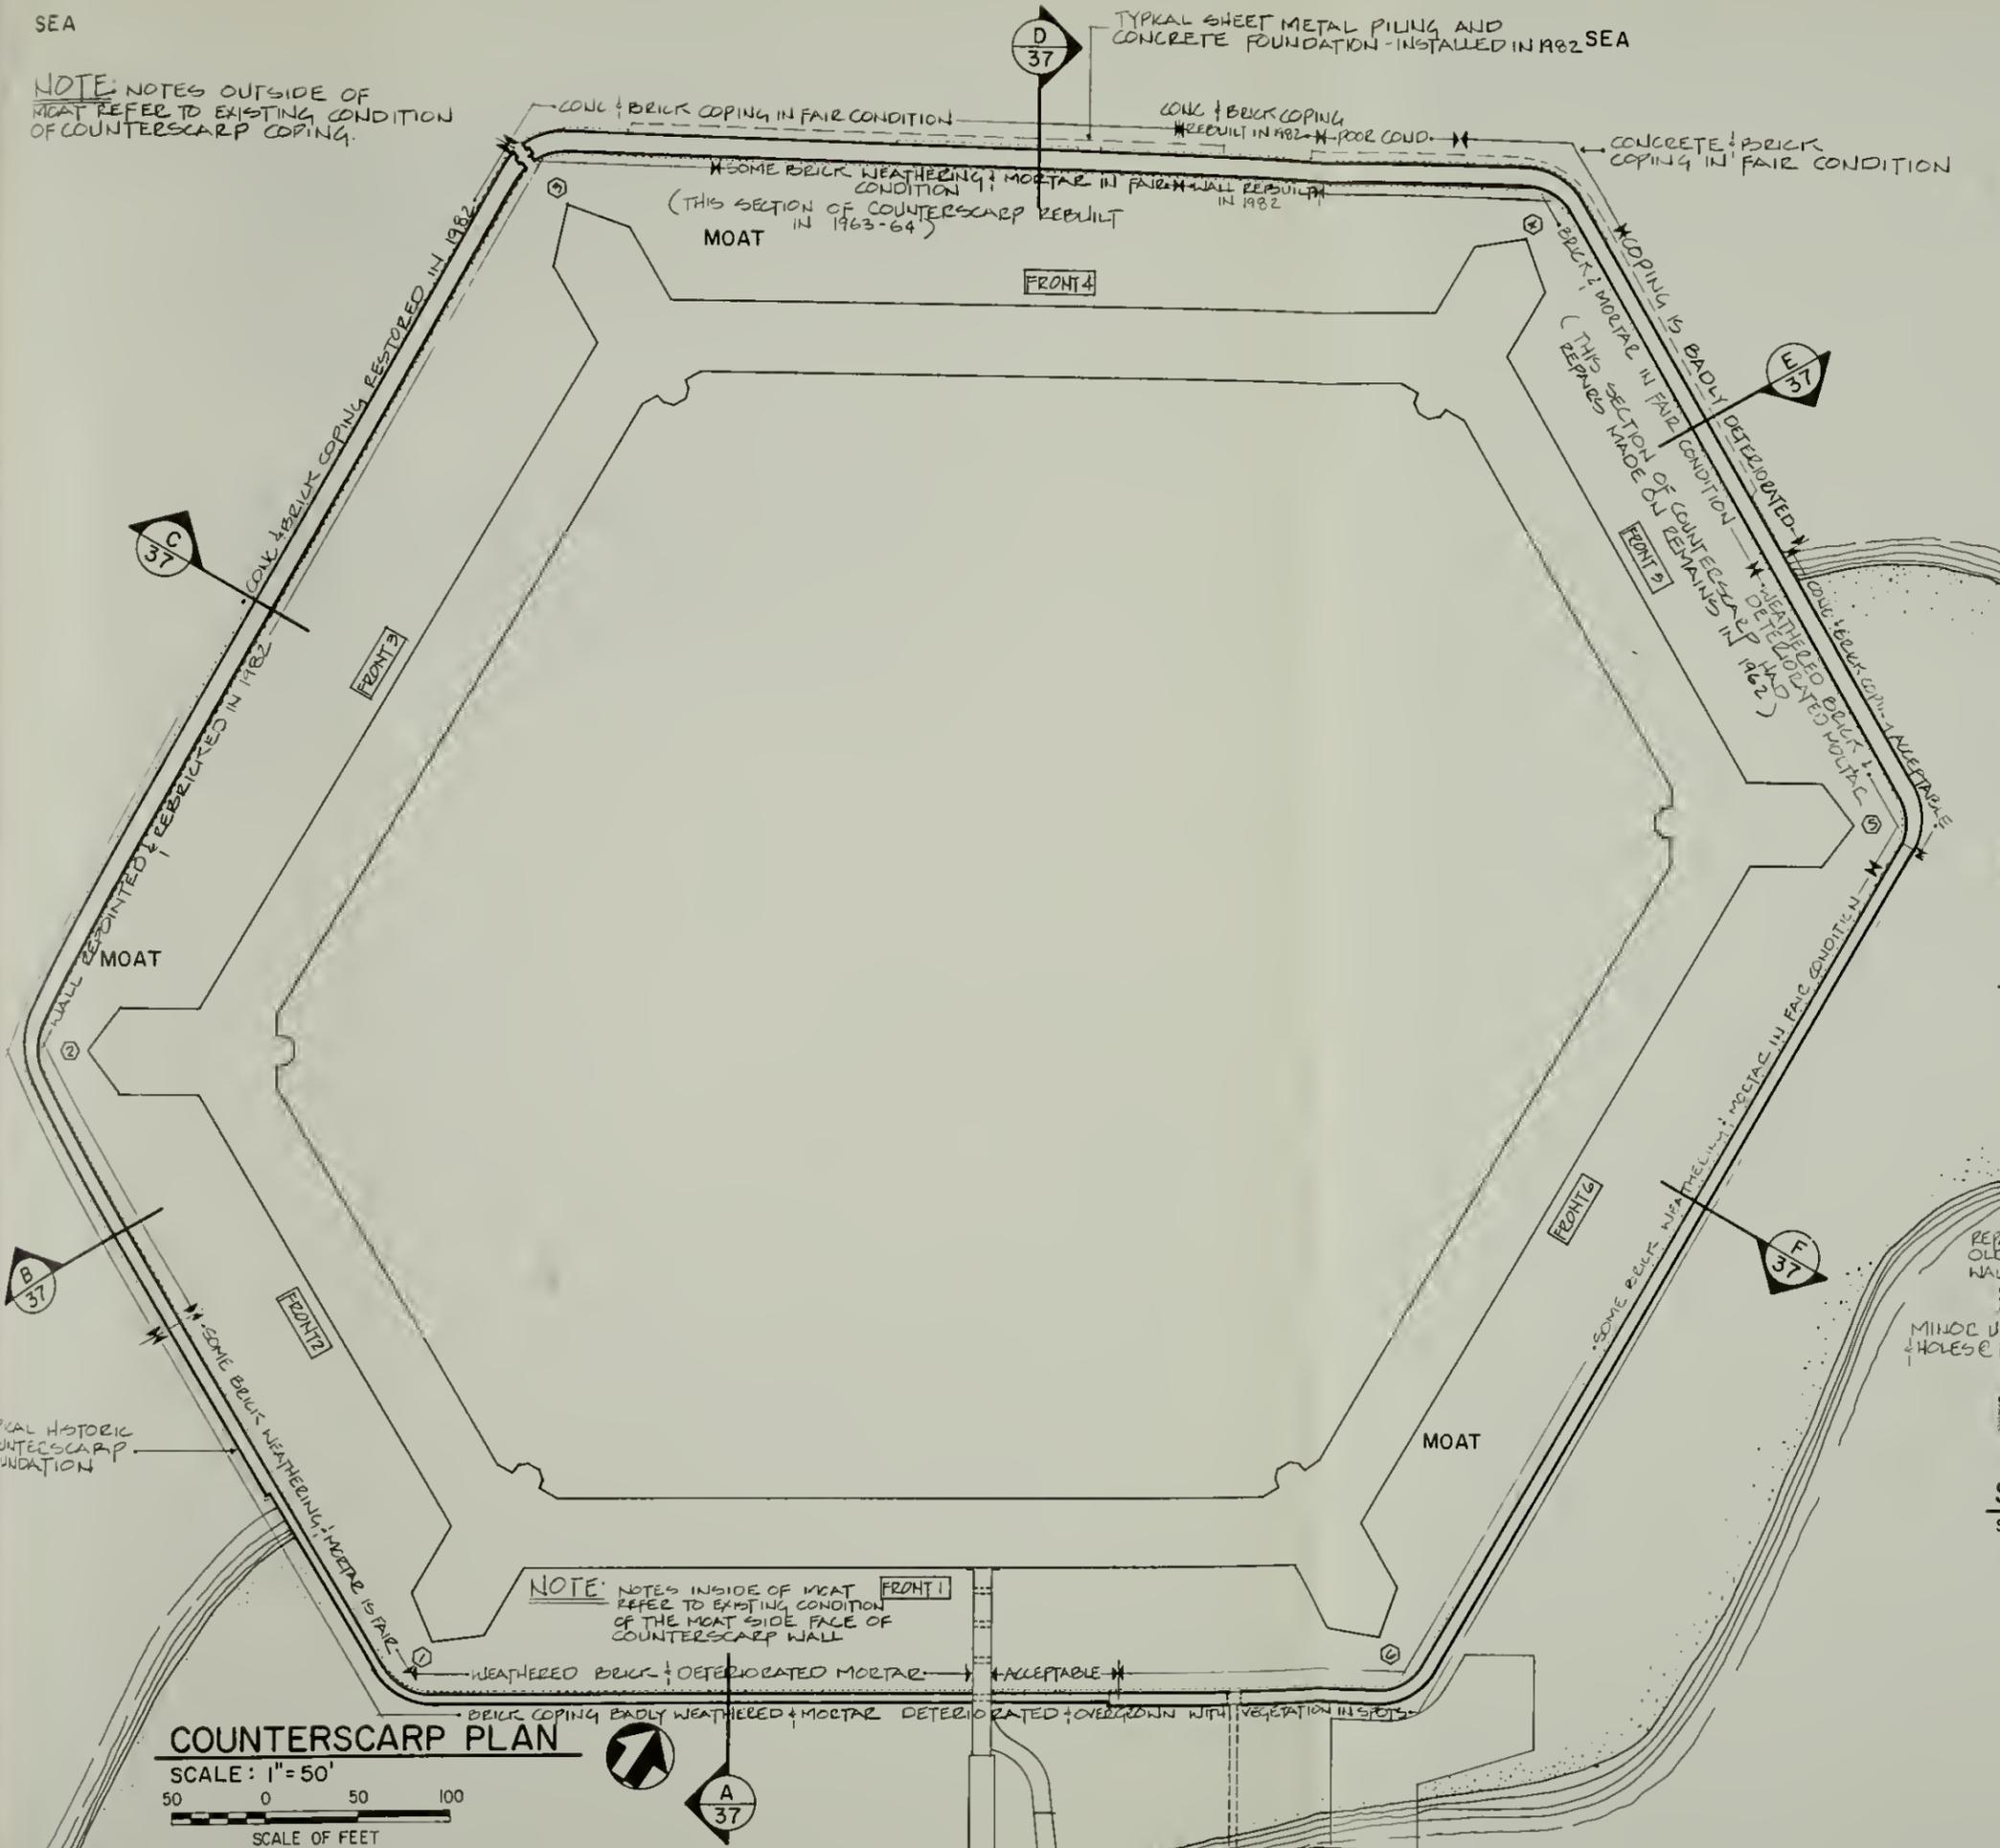
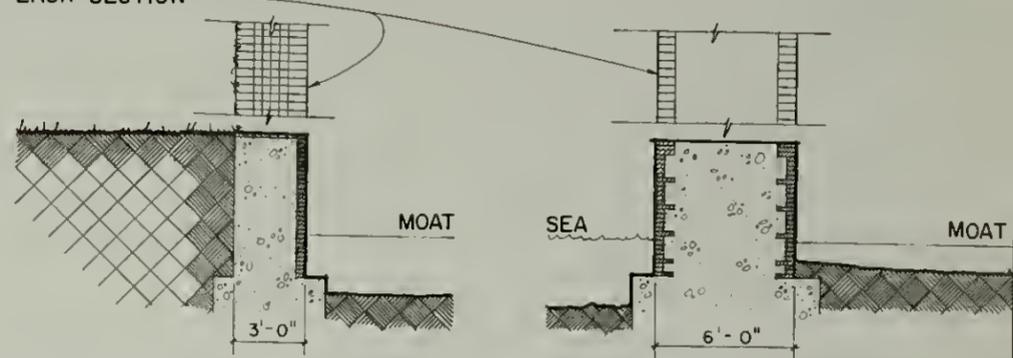
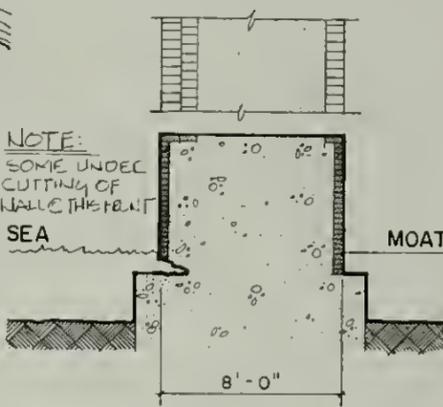
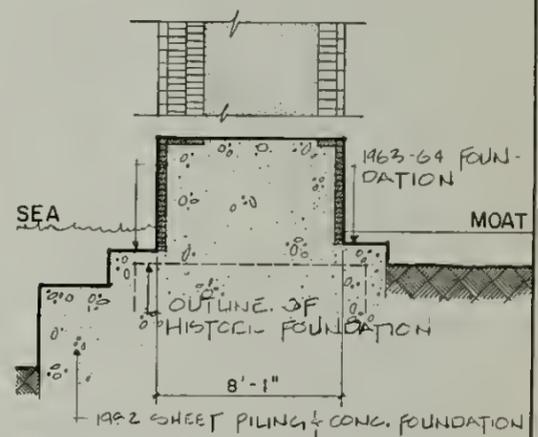
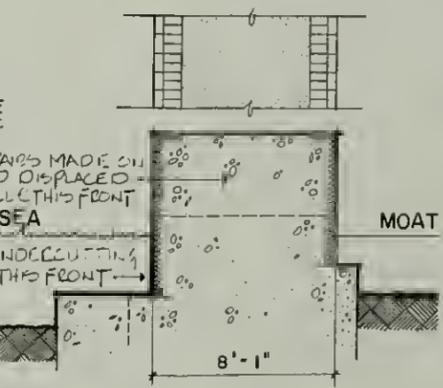
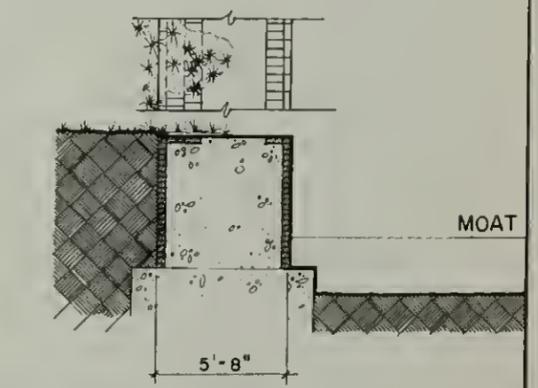
DESIGNED MCGRATH	SUB SHEET NO.	TITLE OF SHEET FORT JEFFERSON N.M. COUNTERSCARP - PLAN AND SECTIONS	DRAWING NO. 364 25,009A
DRAWN ANDERSON		EXISTING CONDITIONS HISTORIC STRUCTURE REPORT	PKG. NO. 103
TECH. REVIEW THORSON			SHEET 31
DATE 10/1/84			OF 47

NOTE: NOTES OUTSIDE OF MOAT REFER TO EXISTING CONDITION OF COUNTERSCARP COPING.

NOTE: NOTES INSIDE OF MOAT REFER TO EXISTING CONDITION OF THE MOAT SIDE FACE OF COUNTERSCARP WALL

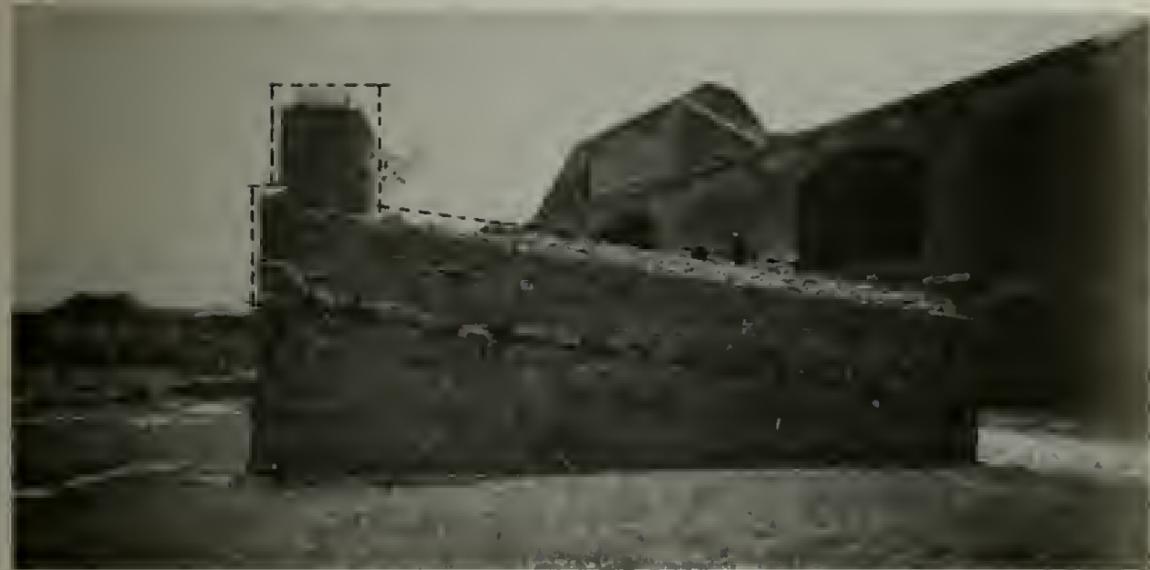
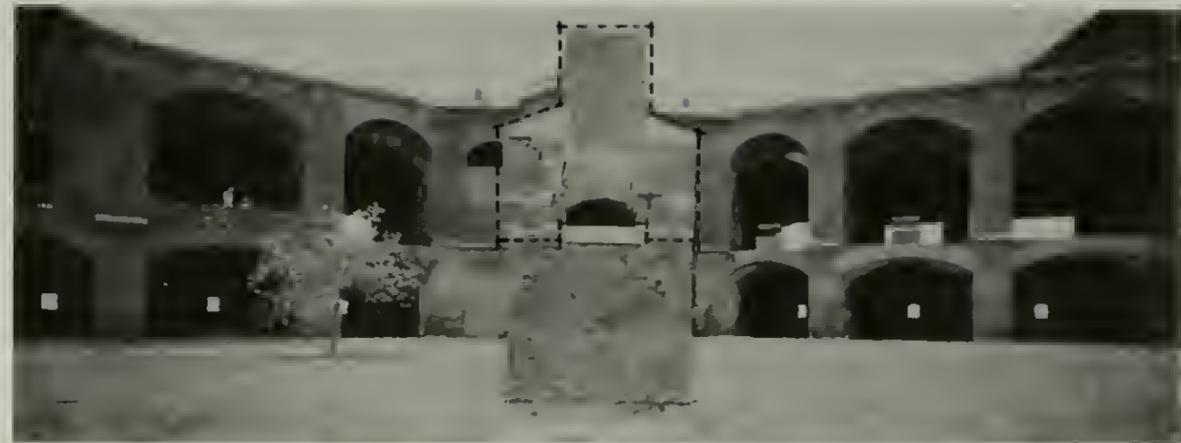
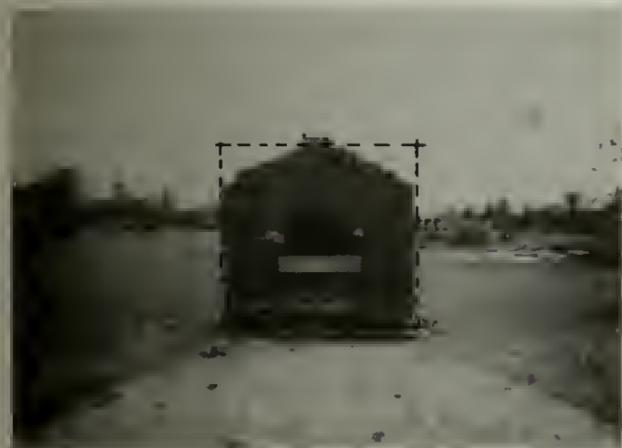
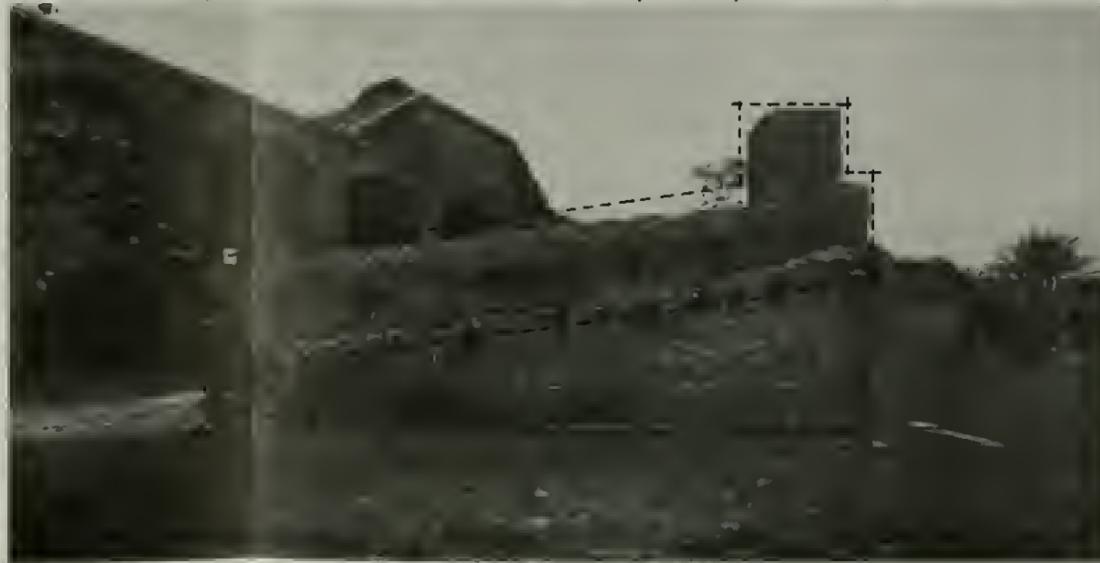
TITLE OF SHEET SHOT FURNACE RESTORATION
PROPOSED WORK HISTORIC STRUCTURE REPORT

HISTORIC DRAWINGS FOR THE SHOT FURNACE HAVE NOT BEEN LOCATED, THEREFORE INTERIOR DETAILS OF THIS STRUCTURE ARE UNKNOWN. THE AREAS WITHIN THE DASHED LINES ARE SEVERELY DETERIORATED AND WILL REQUIRE A MAJOR INTERVENTION TO SAVE THIS STRUCTURE. ANTICIPATED WORK WOULD INCLUDE: CAREFUL DISMANTLING OF ALL AREAS WITHIN DASHED LINES, RECORDING OF EXPOSED DETAILS, REMOVAL OF EXFOLIATED IRON, TREATMENT AND/OR REPLACEMENT OF THE HISTORIC IRON FABRIC, REBUILDING DISMANTLED AREAS; WATERPROOF DETAILING CORAL RUBBLE FURNACE TOP.
