# CULTURAL LANDSCAPE REPORT AQUATIC PARK

SAN FRANCISCO MARITIME NATIONAL HISTORICAL PARK

**CULTURAL LANDSCAPE REPORT, AQUATIC PARK**  
**SAN FRANCISCO MARITIME, NATIONAL HISTORICAL PARK**

**NATIONAL PARK SERVICE**  
**PACIFIC WEST REGION**  
**2010**

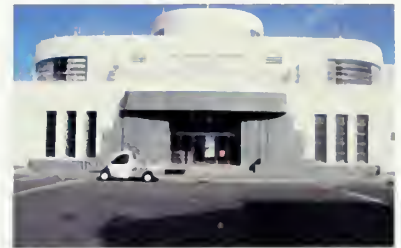
**Figure 86** Front façade of the Bathhouse. View looking north. (NPS, 2006)

- Restore and maintain the historic slate façade on the south side of the building as the primary entrance to the building. (Figure 86)
- Restore the historic planting beds on both sides of the entry (see the section, “Recommendations: Vegetation, Bathhouse Plantings”).

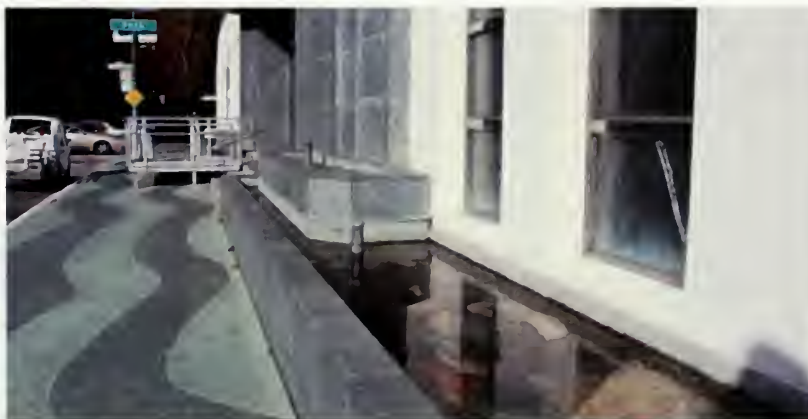
**Figure 87.** One of the two fountains that flank the entrance to the Bathhouse and could be restored as part of an overall landscape rehabilitation. (NPS, 2006)

- Complete rehabilitation of the fountains on the front (south) façade of the building and complete conservation of the stone and mosaics. (Figure 87)

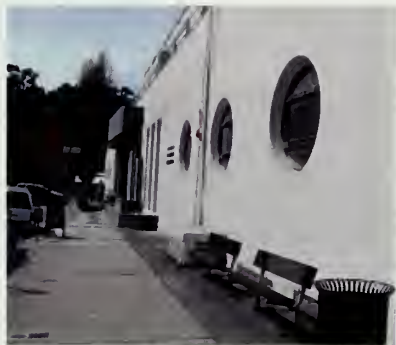
**Figure 88.** Northeast side of the entrance to the Bathhouse with a variety of non-compatible features such as benches, trash cans, city street signs, utilities, and public mailbox. (NPS, 2010)

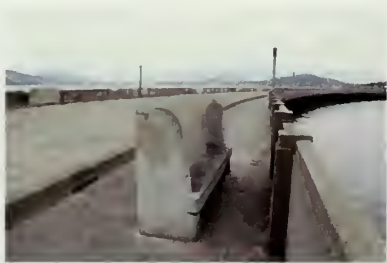
**Figure 91.** Historic concrete bench, parapet walls and curbing, light standards, and other site features associated with the Municipal Pier. (NPS, 2007)

- Consideration should be given to restoring and/or rehabilitating site furnishings along the decking of the Municipal Pier based on the preferred treatment for the structure. Replacement of these features with replica or “period” furnishings is not recommended. (Figure 91)

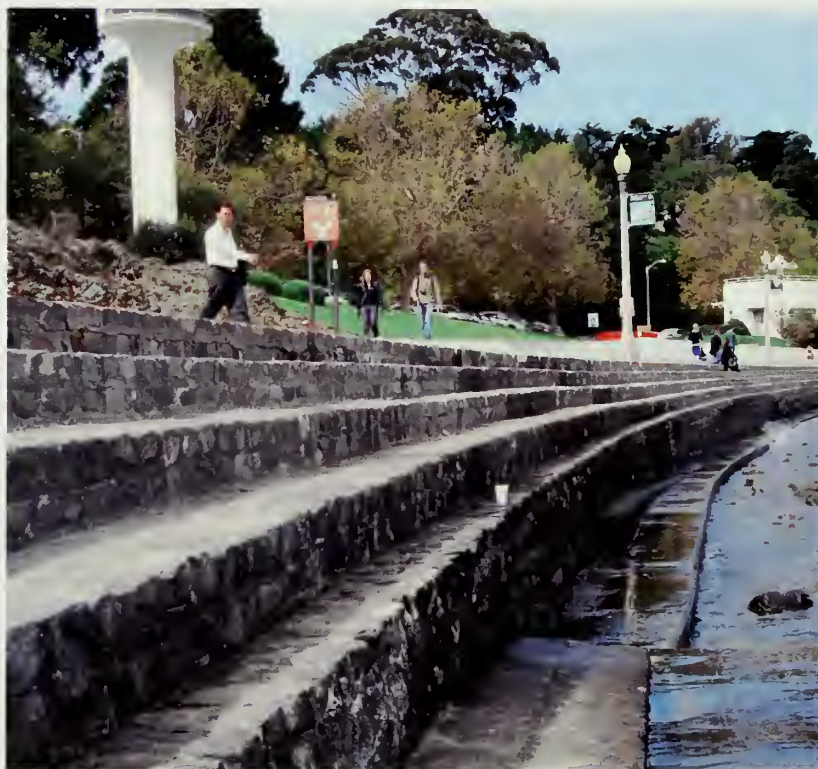
The Seawall and steps that extend the entire length of the cove from the East Convenience Station to the Municipal Pier are generally in good condition, with just a few cracked and missing basalt blocks. Stone curbs throughout the site are also in relatively good condition. Exceptions are a missing section of curb near the Sea Scouts building and damaged curbs near the West Convenience Station. Recommendations address repair and replacement. (Figure 93)

**Figure 94** Missing block curbing at the West Convenience Station should be repaired using in-kind materials. (NPS, 2007)

- Replace the missing portion of the stone curbs as needed using compatible materials and appropriate restoration techniques. (Figure 94)
- Repairs to all historic stonework should be done in consultation with a historical architect or preservation mason.

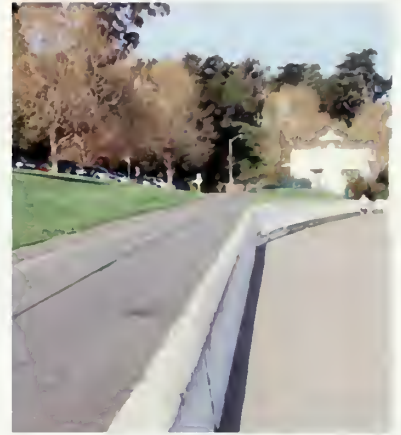
The low concrete retaining wall that borders the Beach Promenade from the West Bleachers to the West Convenience Station shows signs of wear, exposure, and damage resulting from use by skateboarders and bicyclists (“grinders”). Some of the hardware installed on the eastern portion of the promenade wall to discourage skateboarders has broken off, damaging the wall. Recommendations address repair and maintenance.

**Figure 95** Concrete retaining wall between the Beach Promenade and the State Belt Railroad tracks. View looking west (NPS, 2007)

- Preserve and protect the integrity of the Beach Promenade Retaining Wall.
- Discourage recreational use by skateboarders. Maintain the use of deterrent bolts on the wall to prevent damage. Although currently damaged in places, existing bolts appear to deter many skateboarders. (Figure 95)

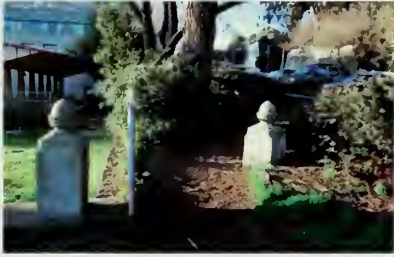
**Figure 97.** Remnant features of the original stone retaining wall as it wrapped around the park to Van Ness Avenue. View looking south. (NPS, 2008)

The stone retaining wall that borders the Bocce Ball Courts was one of the earliest structures built during initial construction of Aquatic Park. It was built to accommodate site grading for the extension of Van Ness Avenue and the State Belt Railroad grade. Based on historic photographs, the original wall was considerably longer than it is today and the grade difference from one side of the wall to the other appears to have been as much as 20 feet. The city water pumping station was located on the lower side of the wall where the Bocce Ball Courts are today. Photographs indicate that the wall was shortened in 1937 when additional grading was done to accommodate construction of new park buildings. Around 1942 the pumping station was removed and the area on the south side of the wall was backfilled, leaving only approximately 4 feet above grade at its highest end. The wall remains distinctive today for its stone construction and the granite acorn bollards on top of the wall. (Figure 97,98)

- Inspect the wall annually to identify potential structural issues and damage to the stone surface. Repair damaged components in kind, matching materials and finish.
- Integrate preservation maintenance activities for inspection and preservation of the wall into FMSS.
- Ensure that any future park development affecting the historic character of the stone retaining wall (such as development of historic

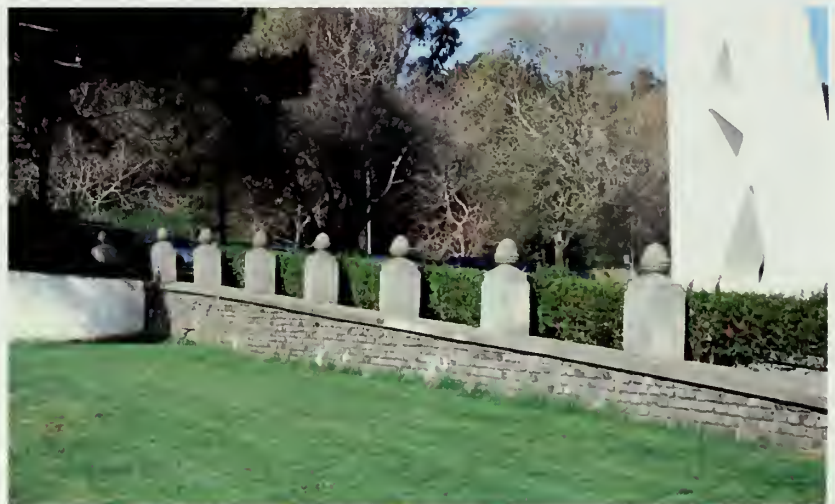
**Figure 98.** View of the stone retaining wall looking northwest from the lawn near the Bocce Ball Courts. The amount of exposed wall visible in the park today generally slopes to the east based on fill added to even the grade when the pump house was removed in the 1940s. (NPS, 2008)

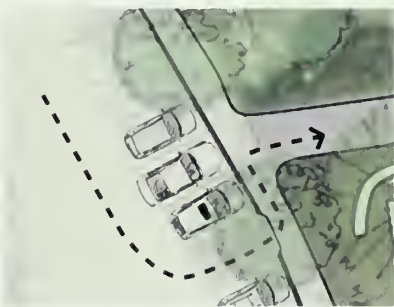
**Figure 99.** A slight realignment on Van Ness Avenue for bicycles routing through Aquatic Park provides a simple mechanism to slow the speed of cyclists and reduce potential conflicts with pedestrians.

- Maintain the current alignment and width of the Upper Promenade, Beach Promenade, and Van Ness Avenue extension as primary historic circulation structures linking the park with adjacent areas. (Figure 99 )

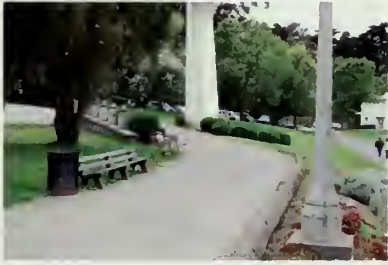
**Figure 101.** Rolled asphalt curbing along the Upper Promenade. View looking west. (NPS, 2008)

- Remove the raised asphalt and pre-formed concrete curbs around the East Speaker Tower and along the Upper Promenade. If curbs are currently needed to control water run-off and drainage, a low, narrow profile concrete curb is more compatible with the historic character and should be used in place of rolled asphalt curbs or pre-form concrete. (Figure 101)

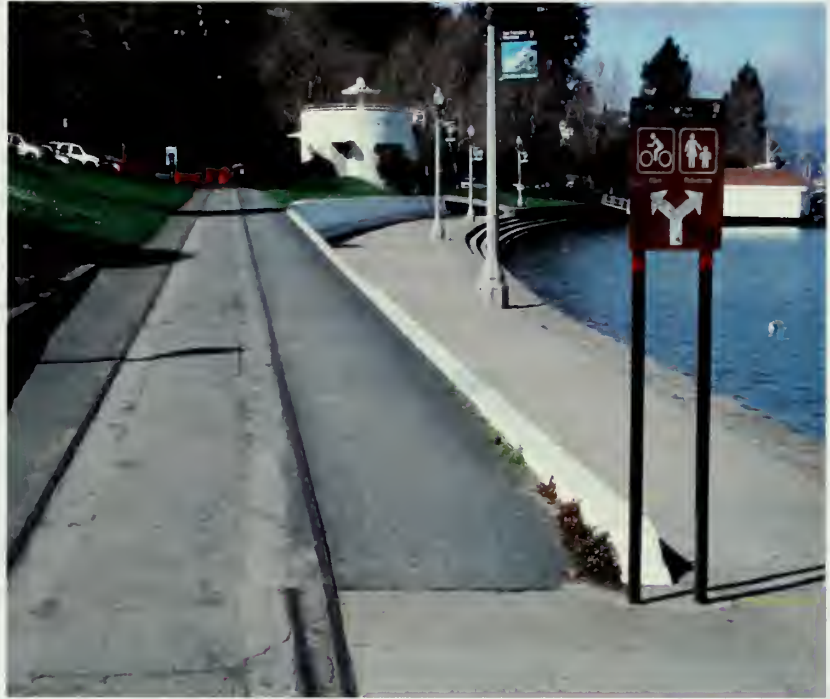
The elastic nature of the asphalt paving has a tendency to make it sag and separate around the rails. Today the uneven character of the rails and the asphalt bedding around them has the potential to create safety issues for bicyclists and other users of the park. Heavy truck traffic and frequent patches to the asphalt exacerbate the safety issue and create an adverse visual impact. (Figure 102)

**Figure 102.** In most cases the separation between bicycles routed on the upper walkway and tracks (left) and pedestrians along the shoreline on the Beach Promenade helps mitigate potential pedestrian/bicycle conflicts. Over the years, asphalt paving and patching around the tracks has created uneven surfaces and in some cases, presents safety hazards. This view looking west. (NPS, 2005)

- Replace existing asphalt paving around the State Belt Railroad tracks with concrete to create a more stable surface and track bed.
  - Ensure that new concrete pavement is finished flush with the top of the rails, without gaps, and the top of the rails are visible on the surface of the pavement.
  - Use a compatible concrete material, and finish for all future repairs and patches to the rail bed along the Beach Promenade, ensuring a smooth and level surface at grade.
- Maintain lawn and/or vegetation adjacent to the rail line to clearly delineate the historic dimension and edge of the alignment.
- Repair areas where impervious surface materials such as asphalt, gravel, or compacted earth have spread beyond the original edge of the walk and prevent the growth of vegetation. Replant with sod with mesh or geo-tech underlay to support edge treatments as needed.

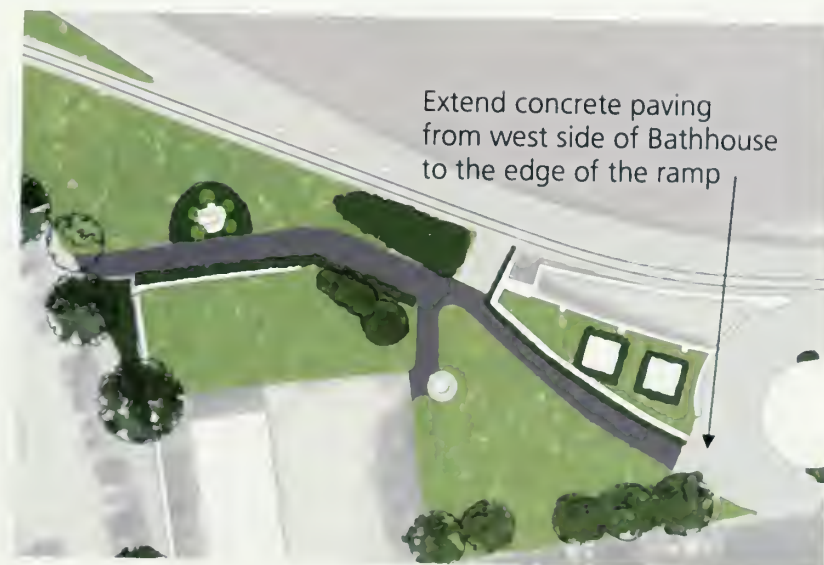
**Figure 103** Plan view showing the extension of concrete paving west of the Bathhouse to the beginning of the Upper Promenade (NPS, 2007)

- Resurface the walkway using concrete paving along the front façade of the Bathhouse (matching the paving on the east side), to the point where the Upper Promenade turns toward Van Ness Avenue (west of the ramp). Date-stamp new paving to differentiate it from existing materials. <sup>2</sup> (Figure 103)

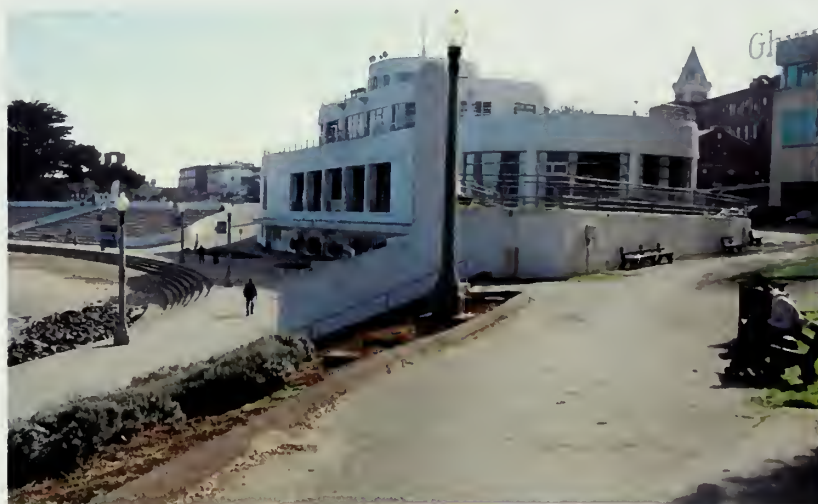
**Figure 104** View of the Upper Promenade showing the rolled curb along the edge of the walkway and planting bed (left), and the patching and expansion of paving leaving a relatively undefined edge on the right side. (NPS, 2006)

- Rehabilitate areas where asphalt, gravel, or compacted earth have migrated beyond the edge of the promenade and are preventing vegetation growth. (Figure 104)
- Ensure that any future park development affecting the historic character of the Upper Promenade, such as development of a streetcar stop in this area, is considered and evaluated within the context of the historic designed landscape and potential impacts to the NHL district.
  - Assess potential adverse effects of new park development affecting the historic design of the Upper Promenade and develop appropriate mitigation measures in consultation with a historical landscape architect and/or cultural resource staff.

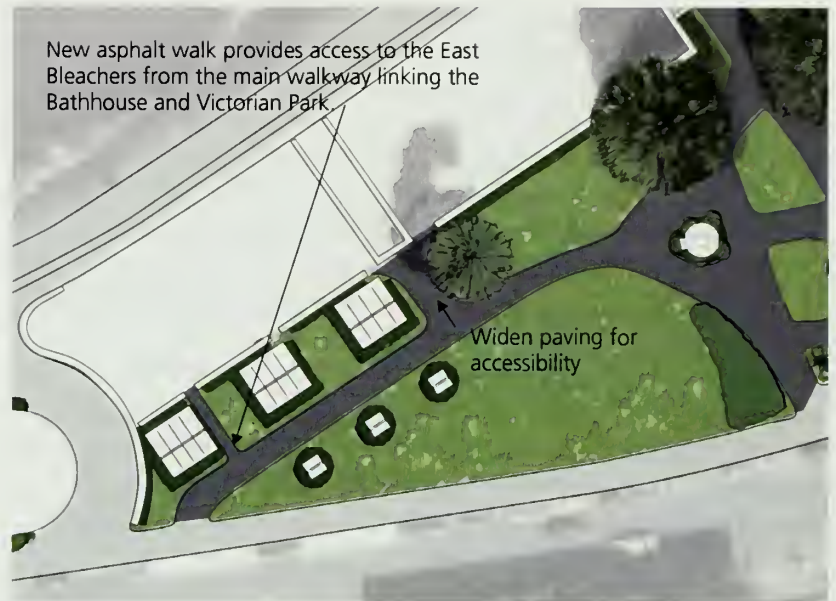
**Figure 105.** Plan view showing the areas behind the East Bleachers. (NPS, 2007)

- Restore the historic configuration, alignment, and width of walkways behind the East Bleachers as part of the rehabilitation of the East Bleachers.
  - Add a new access walkway on the west side of the East Bleachers between the skylights. (Figure 105)

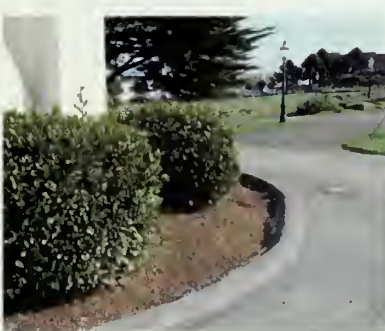
**Figure 106** Raised asphalt curb around the East Speaker Tower planting bed. (NPS, 2008)

- Minimize the future surface patching of walkways in this area. When paving repairs become extensive, consider overall rehabilitation using either a slurry coat and chip seal or other material that is visually compatible with other walkways in the park.
- Remove the raised asphalt curb around the East Speaker Tower and replace with a simple asphalt pavement edge that is flush with the walkway. Correct drainage by re-grading adjacent beds or ground plane. If structure is still required to control runoff, use a low, formed-concrete edging material in a manner consistent with the curbing used on the west side of the site. (Figure 106)
- Remove the asphalt paving in the area of the removed Monterey pine tree (*Pinus radiata*) and reestablish lawn. Plant a new Monterey pine tree (*Pinus radiata*) and add mulch material around the trunk. (See Recommendations: “Vegetation”)

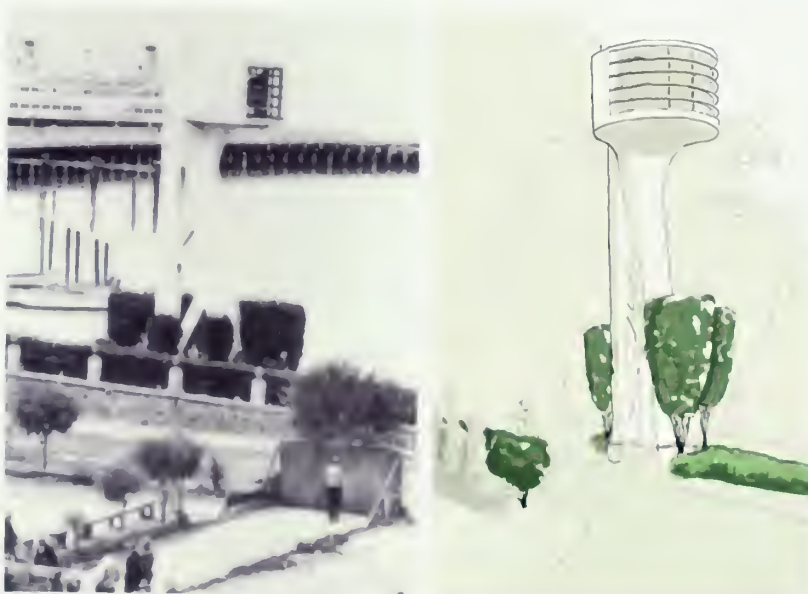
**Figure 110 a&b** During the historic period, Grecian laurels planted around the West Speaker Tower were pruned into an urn-shape, with narrow base and broader top. Recommendations encourage the remaining laurels to be reshaped into a similar form. Left, Detail of historic view looking north from the Bocce Ball Courts, ca. 1952, Right, Concept showing proposed form for pruning existing and newly established laurels.

- Rehabilitate the planting beds around both speaker towers.
  - Amend and replenish soils as needed.
  - Remove and replace in kind existing shrubs in the bed with suitable species.
- Retain the existing Grecian laurels (*Laurus nobilis*) around the West Speaker Tower. Prune and reinvigorate to reestablish the historic character of these materials as a tall, vase-shaped plant. (Figure 110 a&b)

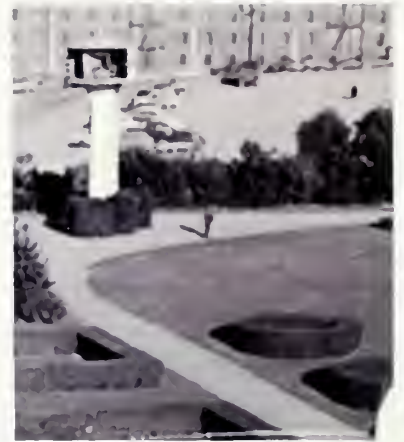
**Figure 112** Detail of photograph showing the historic character of the hedges planted around the skylights on the east side of Aquatic Park, 1953. (San Francisco Maritime NHP, Historic Documents, Photograph Collection, A12 17,546.1)

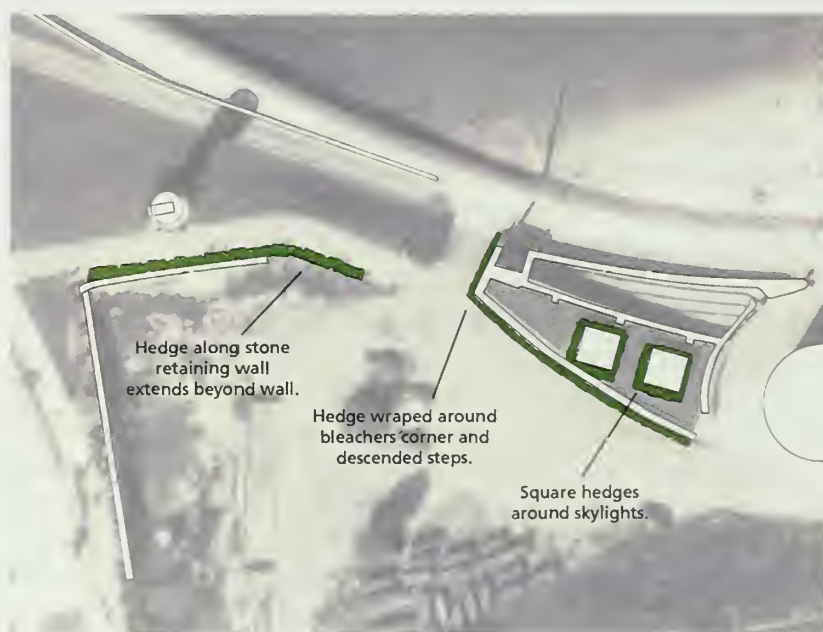
Like the East Bleachers, a broadleaf evergreen hedge extended along the south wall of the West Bleachers. Similar in character to the hedge along the East Bleachers, when the hedge reached the southwest corner of the West Bleachers, it wrapped around the wall and followed the wall along the steps and narrow planting bed leading down to the Beach Promenade. (Figure 113) Today the hedge is gone and the area between the bleacher wall and the Upper Promenade has been paved with asphalt.

**Figure 113.** Graphically overlaid on a 1948 aerial photograph of Aquatic Park are the hedges located on the west side of the park during the historic period. The hedges wrapped around the stone retaining wall and the wall behind the West Bleachers, stepping down to the Beach Promenade. Recommendations call for re-establishing these hedges. (*Pacific Aerial Survey, 3-10-05, 1948*)

- Restore the hedge behind the south wall of the West Bleachers, around the southwest corner of the wall, and down the steps.
  - Remove existing paving and redefine the extent and dimensions using historic photographs and treatment drawings.

- Amend soils as necessary to reestablish a viable planting medium prior to planting.
- Maintain the hedge at a height of 6-10 inches below the top of the wall.
