HISTORIC STRUCTURE REPORT

TUMACACORI NATIONAL MONUMENT  
Arizona

by  
Anthony Crosby

September 1985

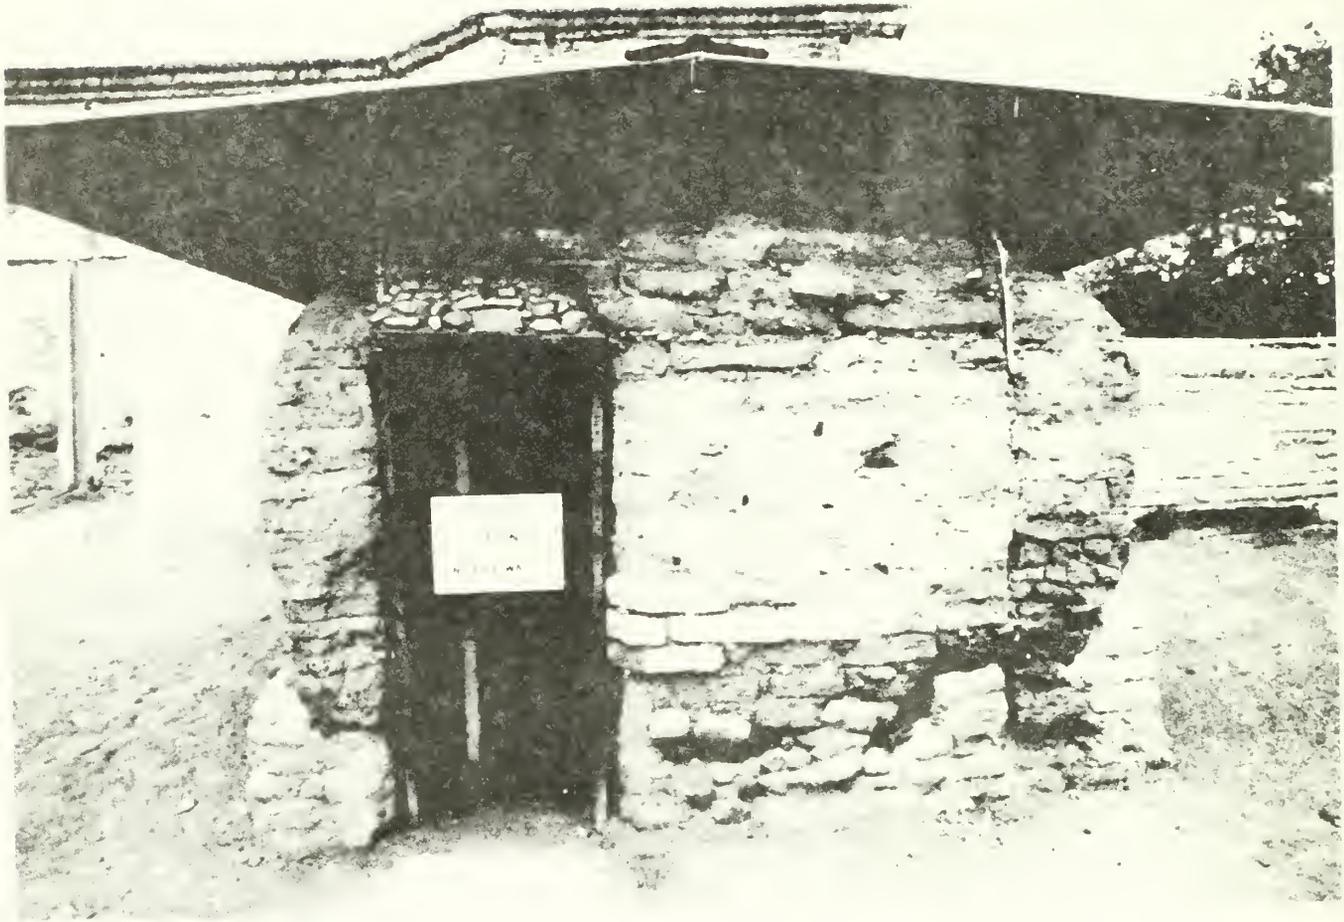
Deterioration from capillary moisture was initially and continues to be most prevalent at the northeast corner and the east wall. The conditions were

4. A view of the corridor prior to the removal of the protective roof. Photograph taken in August 1979.

so critical that repair was undertaken in the fall of 1977. The actual method was simply to fill the major void on the interior, or west side, with mud, fired brick and adobe batts, and rocks. The area was first cleaned of all loose friable material, the surface kept damp, and the fill brought up in successive layers in the deepest concave areas to facilitate drying. The mud, which had a content of approximately 15 percent of nonexpansive clay, was packed in so that it would have more capillary potential than the adobe wall. If properly executed, moisture which will continue to rise in the wall will move, if not be drawn, through the new fill material causing this new material to deteriorate rather than the old. Only the most critical area was repaired at that time, but a similar approach was carried out later on remaining areas.

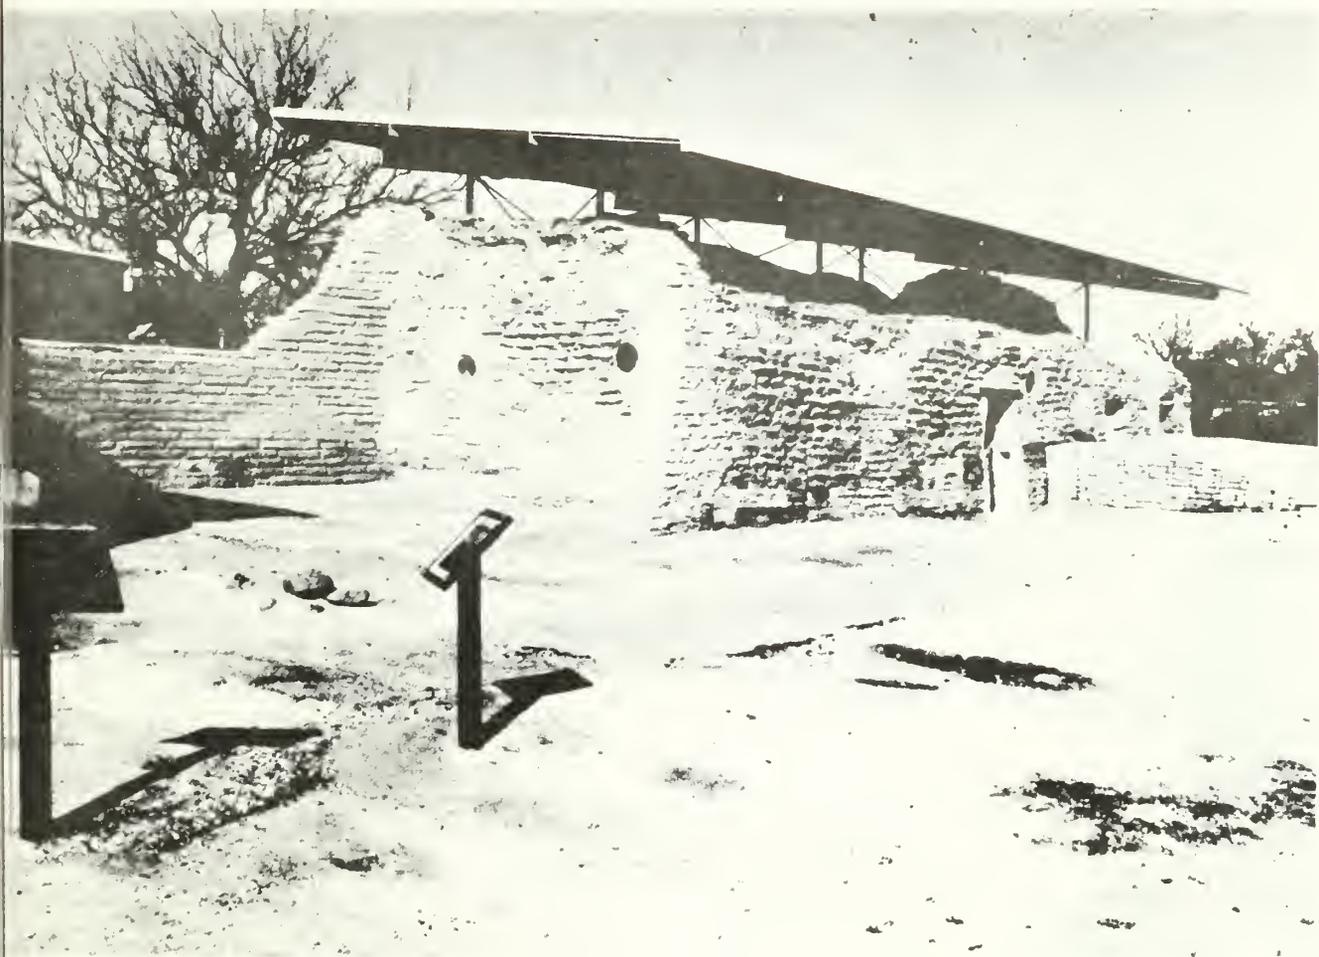
6. The granary from the southeast before the removal of the protective roof.

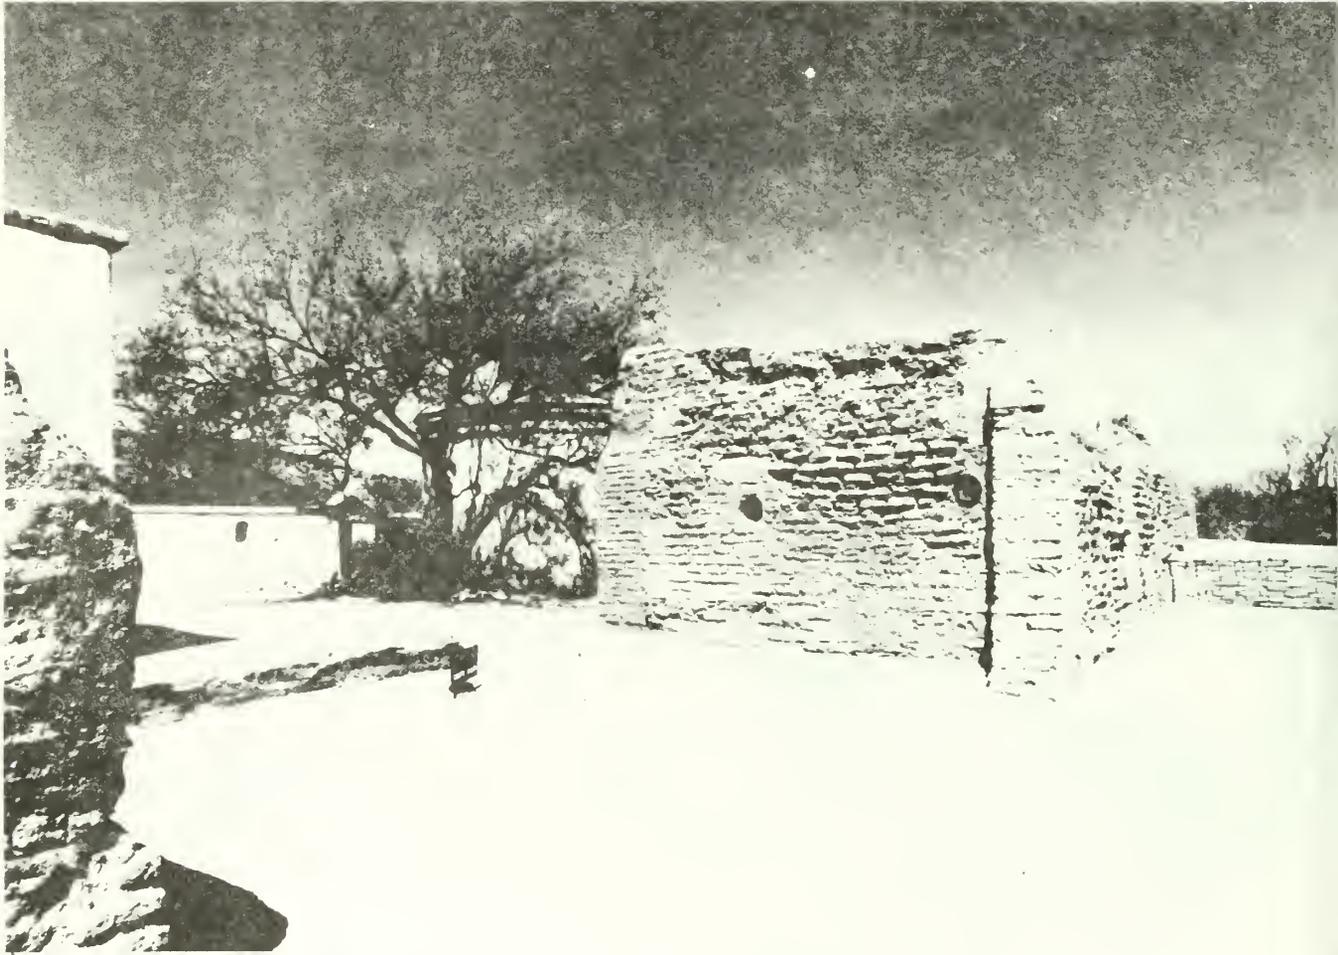
7. The granary from the southeast after the removal of the protective roof.

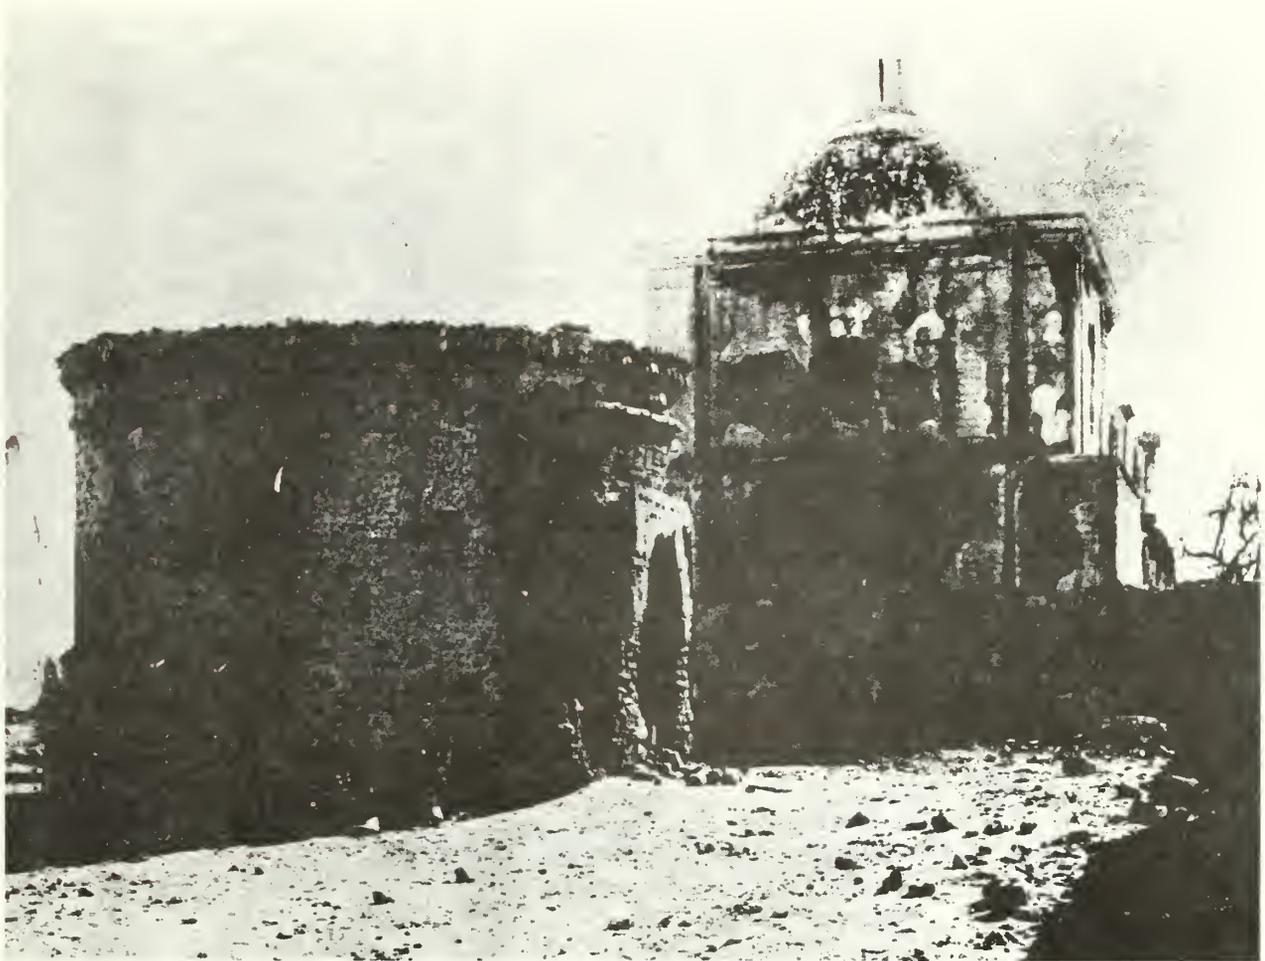
The interior surfaces had been completely replastered with a tinted cement plaster. Much of the exterior surface had also been replastered with the same tinted plaster, but some of the surface of the exterior had been replastered with a cement plaster that attempts to duplicate the

8. A view of the mortuary chapel from the northwest. 1892 International Boundary Resurvey photograph, No. JM-22/3275, Arizona Historic Foundation, Arizona State University Library, Tempe, Arizona.

original finish coat. The original finish coat had small pieces of crushed brick set into the plaster in a random fashion. The physical technique was certainly much the same as was used on the exterior of the camp santo wall and the lower portions of the church, but the result was completely different. It probably reflects a somewhat hurried approach by a less skilled craftsman to a method that had been used previously.

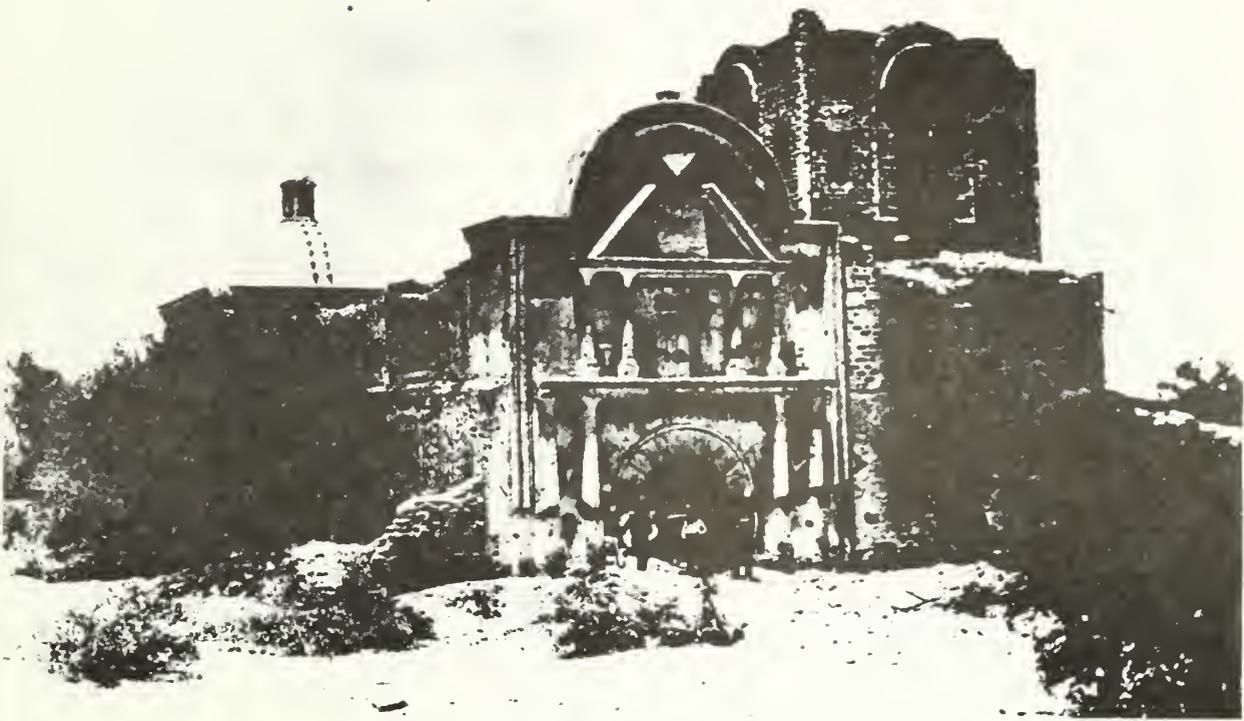
Early photographs of Tumacacori clearly indicated the absence of a roof over the nave. Later photographs show the effects of erosion on the upper portion of the walls (illustration 10). The upper wall erosion suggests that rainwater also percolated down through the walls to further weaken them. Basal erosion to a depth of 12 inches into the walls certainly compromised the structural integrity of the building even more.

10. An 1889 George Roskrige photograph of the church from the south. Photograph is from the Tumacacori National Monument files.

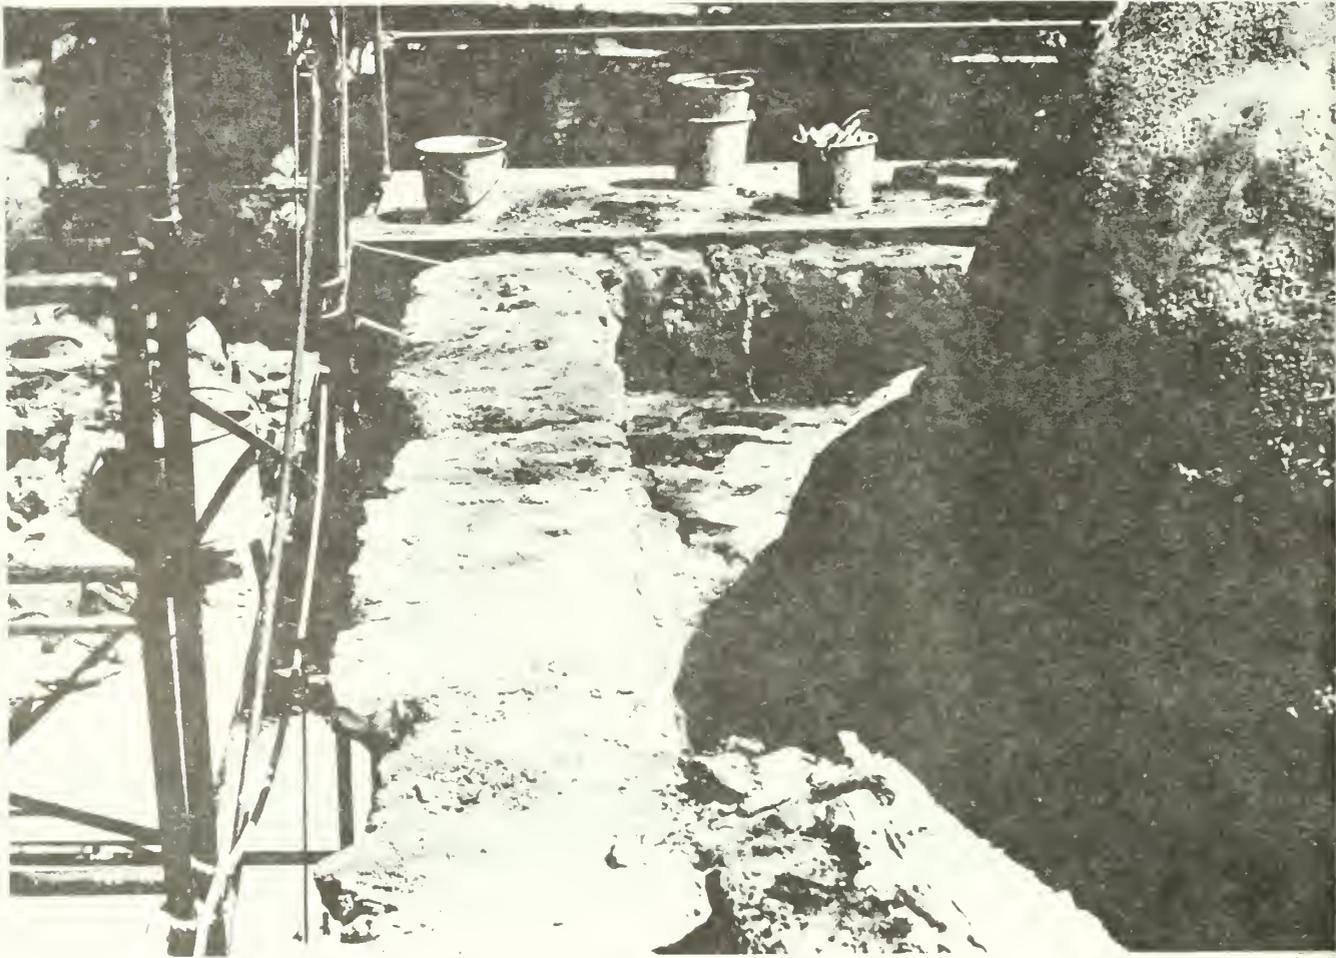
13. A view of the west side of the dome and top of the sanctuary from the south after the removal of the dirt fill.

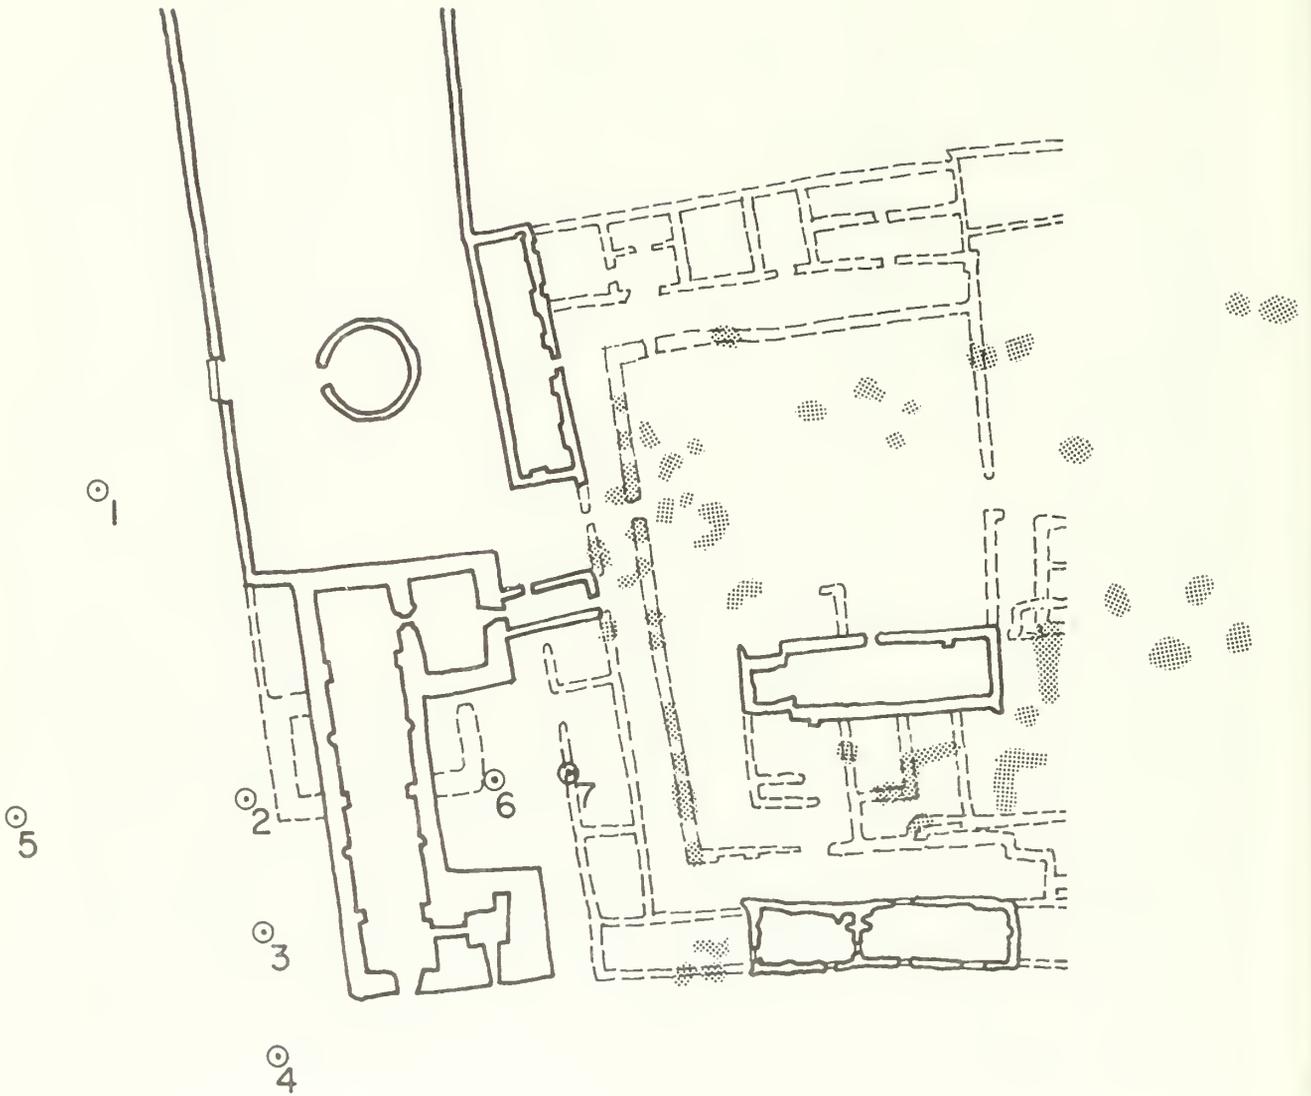
## SOIL MOISTURE MAP

At the time of the subsurface investigation, Doug McCollough, chief of maintenance at Tumacacori, pointed out several spots in the area of the convento patio that appeared to be wet (illustration 22). A continuous monitoring of these spots indicated they remained dark, or stained, and at relatively high moisture contents throughout the year. On May 26, 1977, after a period of two months without rain, the moisture content by weight of the soil only 1 inch below the ground surface in two of these dark spots was 8.6 percent and 6.2 percent. A nonstained area used as a control contained 1.5 percent moisture.

The darkest areas were approximately 40 feet east of the east nave wall of the church, just to the west of the paved walk, southeast of the granary, and just east of the concrete block foundations that mark the apparent foundations of an earlier Jesuit church. The architectonic quality of these stained spots seems to indicate some direct relationship to subsurface architectural remains. The one area that extends parallel to

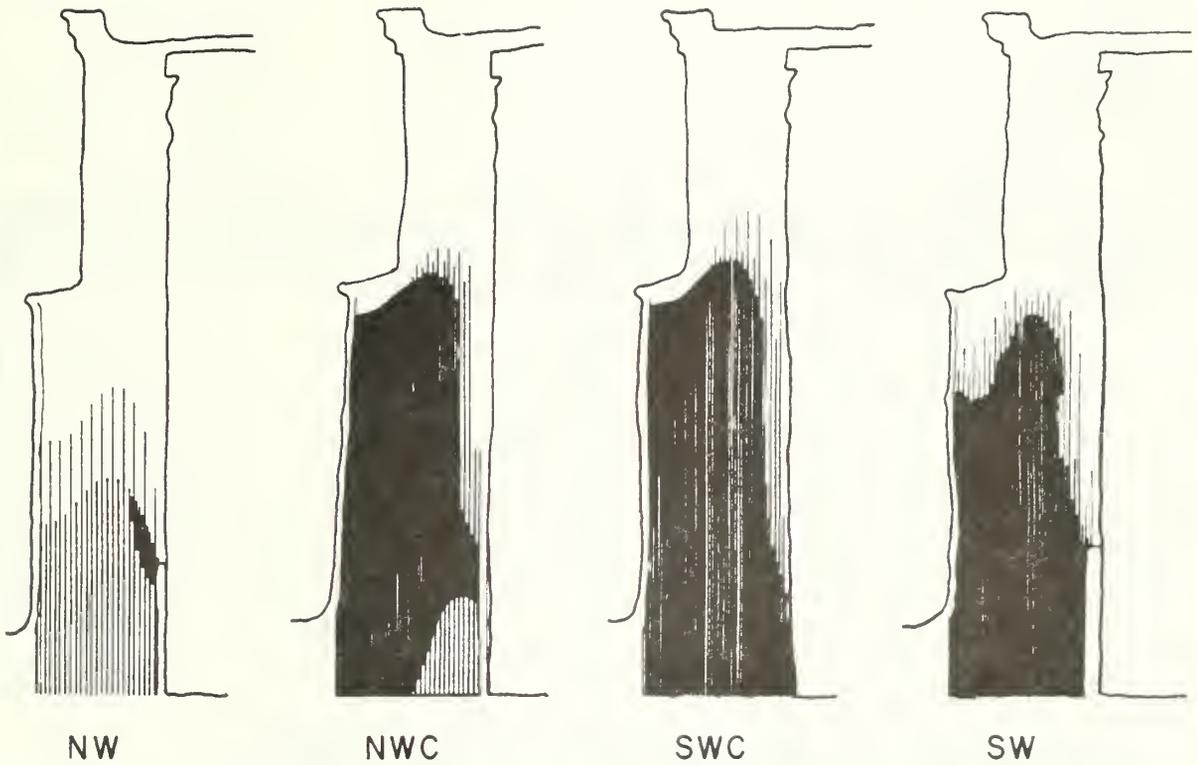
ILLUSTRATION 24

**MOISTURE PROFILES: WEST NAVE WALL**

Based on samples taken 1976.

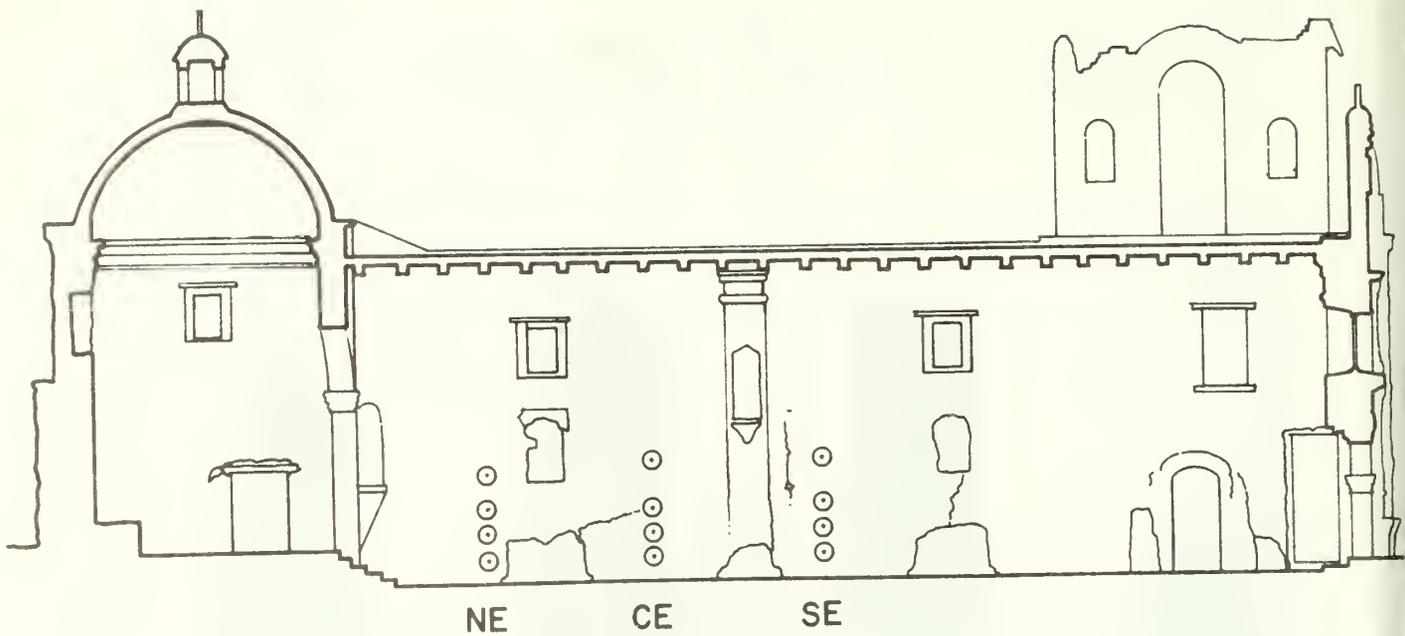
ILLUSTRATION 25.

Profiles based on the actual moisture contents of the seven different locations are shown in illustrations 25 and 26. The profiles at locations SE, CE, and NE are classic capillary moisture profiles with little abnormal moisture occurring higher than 4 feet above the exterior grade.

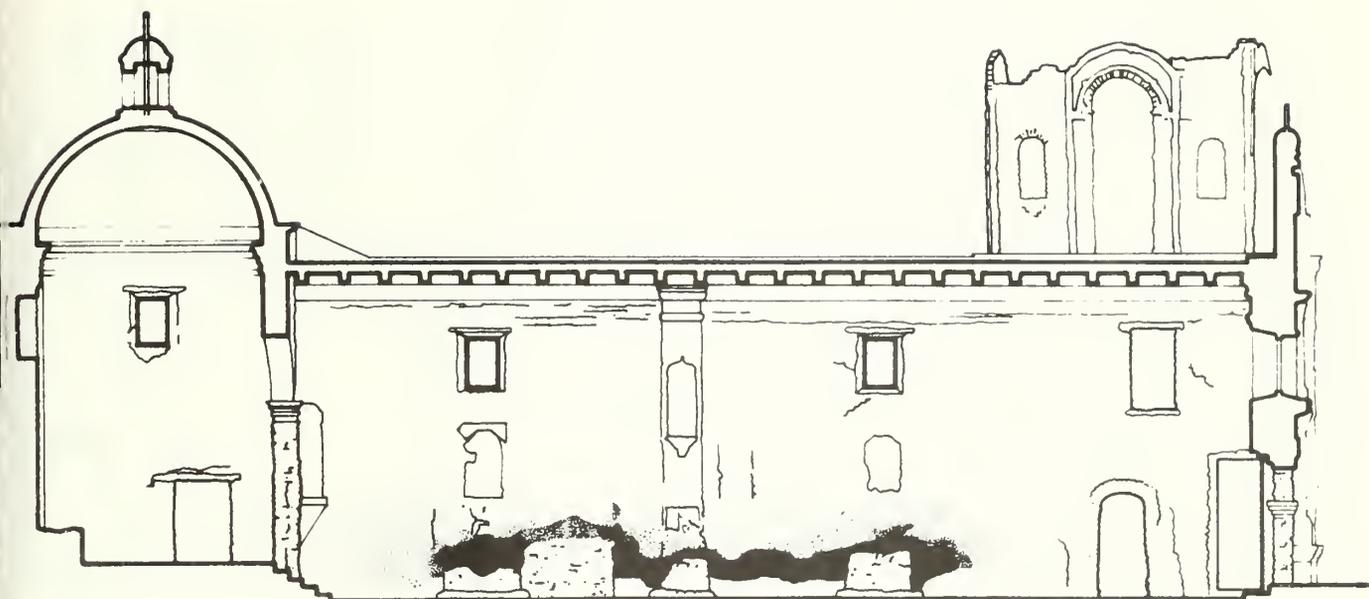
ILLUSTRATION 27.

**SURFACE MOISTURE SURVEY: EAST NAVE WALL**  
Dec. 1, 1976 reading     0-30     30-60     60-85     85-100  
Readings taken with Protimeter Mini.

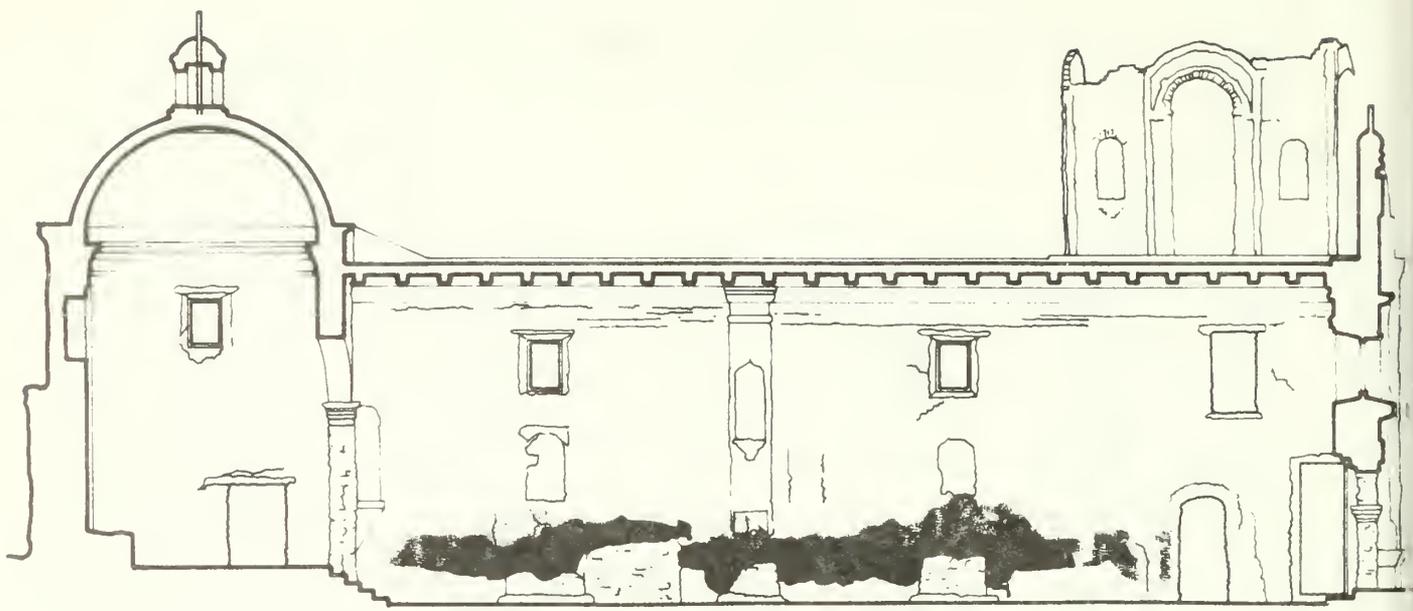
ILLUSTRATION 28.

**SURFACE MOISTURE SURVEY: EAST NAVE WALL**  
**Feb. 11, 1977 reading**    □ 0-30    □ 30-60    ■ 60-85    ■ 85-100  
Readings taken with Protimeter Mini.

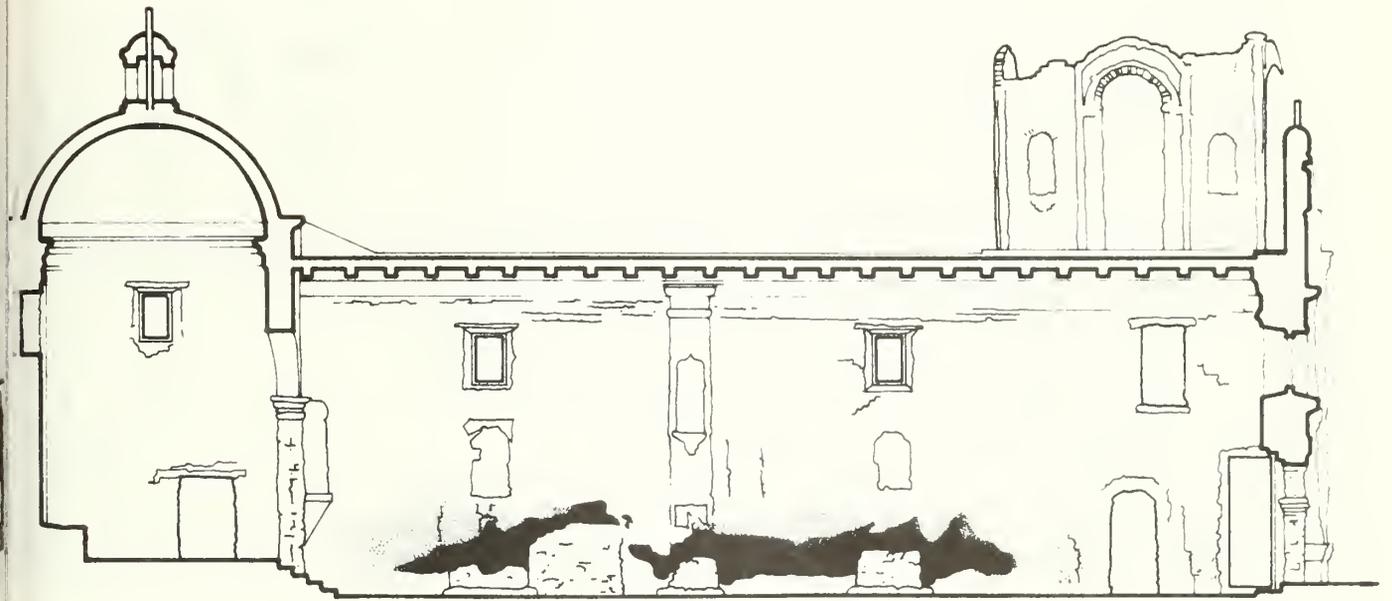
ILLUSTRATION 29.

A surface survey conducted in April 1977 (illustration 29) indicated a relative decrease in surface moisture which, again, probably related directly to the absence of significant rainfall during the period since January. However, a survey conducted on May 14 of that same year showed an apparent increase in surface moisture although there had been no rainfall at all for six weeks (illustration 30). This increase did not relate to any known cause in the cause-effect relationship except an increase in the relative humidity from May 4 to May 10. It is highly unlikely that the increase in ambient moisture would have a continuing effect on the actual surface moisture content several days later.

**SURFACE MOISTURE SURVEY: EAST NAVE WALL**  
April 1977 reading    □ 0-30    □ 30-60    ■ 60-85    ■ 85-100  
Readings taken with Protimeter Mini.

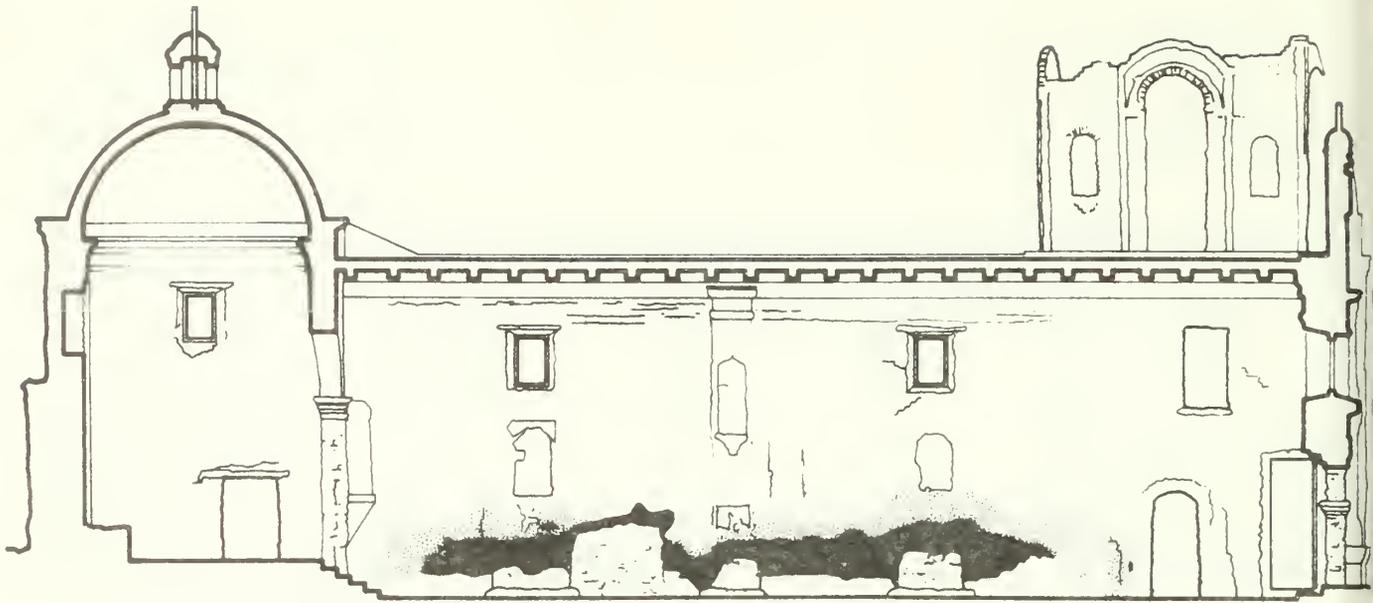
ILLUSTRATION 30.

**SURFACE MOISTURE SURVEY: EAST NAVE WALL**  
**May 14, 1977 reading**  0-30  30-60  60-85  85-100  
Readings taken with Protimeter Mini.
