# historic structure report

## restore historic commissary building to 1897

# FORT SMITH

NATIONAL HISTORIC SITE / ARKANSAS

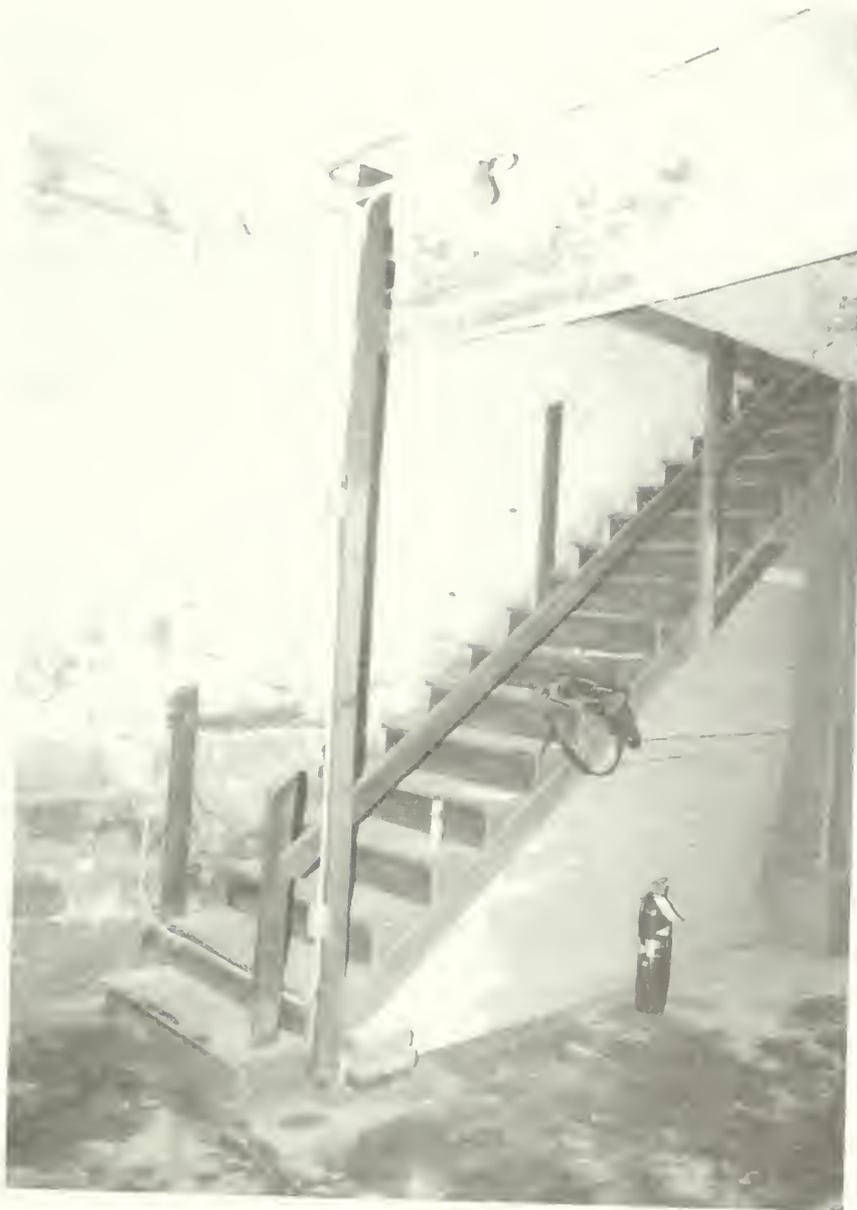
Figure 7. Stair 2 (5/18/82): Built about 1936 to serve the museum function, this stairway enlarged the historic stairwell opening but utilized salvaged material from a former stair in the new stairwell header (see figure 10). This stair was removed along with the washroom and concrete floor below it in 1984.

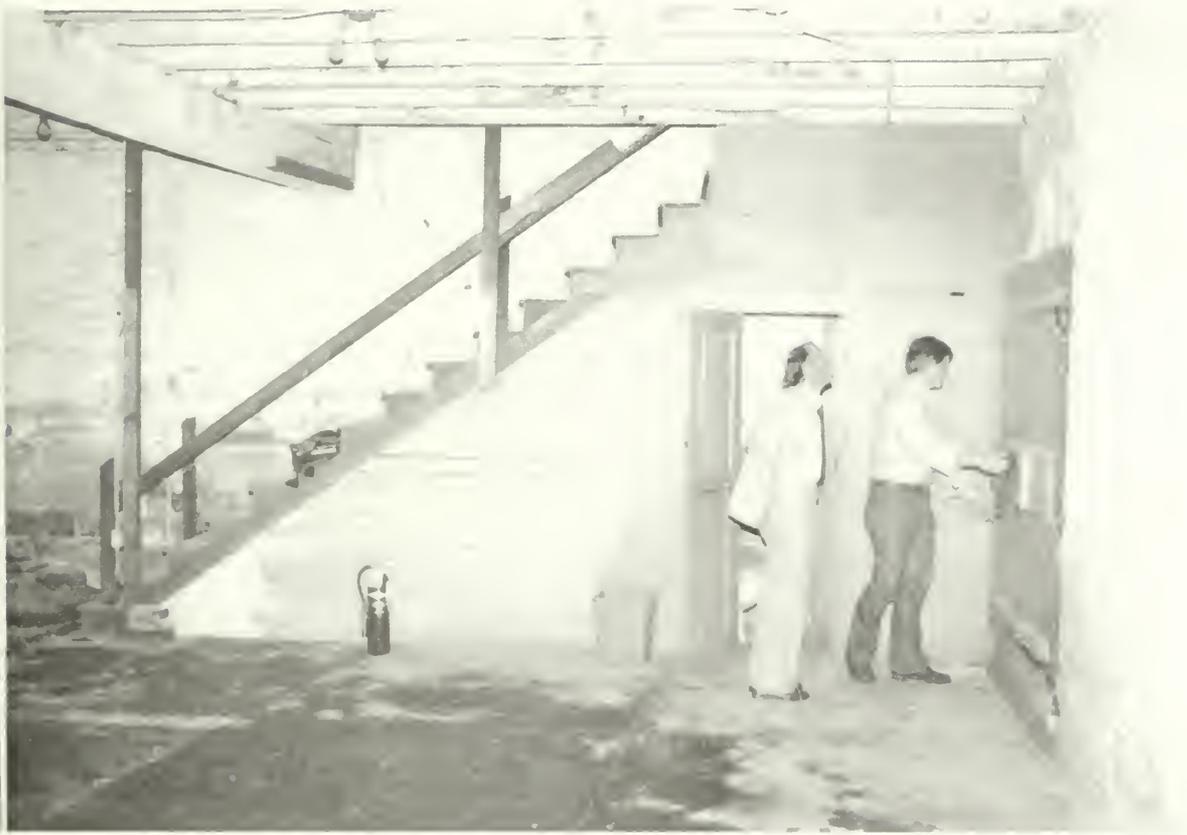
Figure 8. Stair 2 (5/18/82): This stair was 18' long, including the washroom, and 39" wide at the foot. Treads were 3/4"x11-1/2" with 1" nose, and eighteen 7-3/8" risers totalled 11'-3/4", with a total run of 14'-10 1/2". Its structure of 2x4 stock was infested with termites.

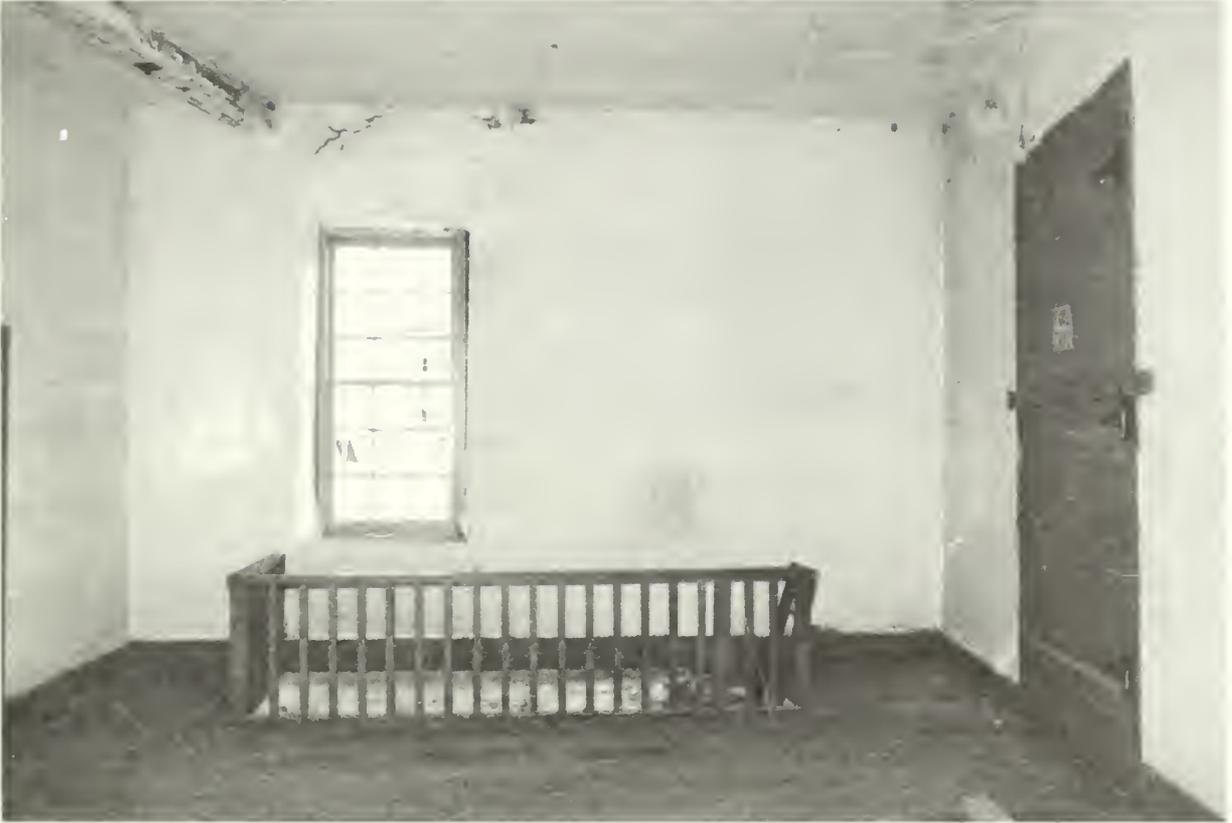
Figure 9. Stairwell Handrail (1/3/85): Undisturbed by the 1983-84 work, the railing shown here is historic--possibly installed in 1866 or during the Judge Parker era (1886). It was extended 19" in length--in photo at right--by two balusters and a new 2x4 end post similar to the original. This extension was done about 1936 when the stairwell was enlarged and new stair installed. The rail appears to have been built contemporaneously with the installation of the 1"x8" baseboard on the east wall--referred to by Parker in 1886, but probably installed earlier (perhaps 1866).

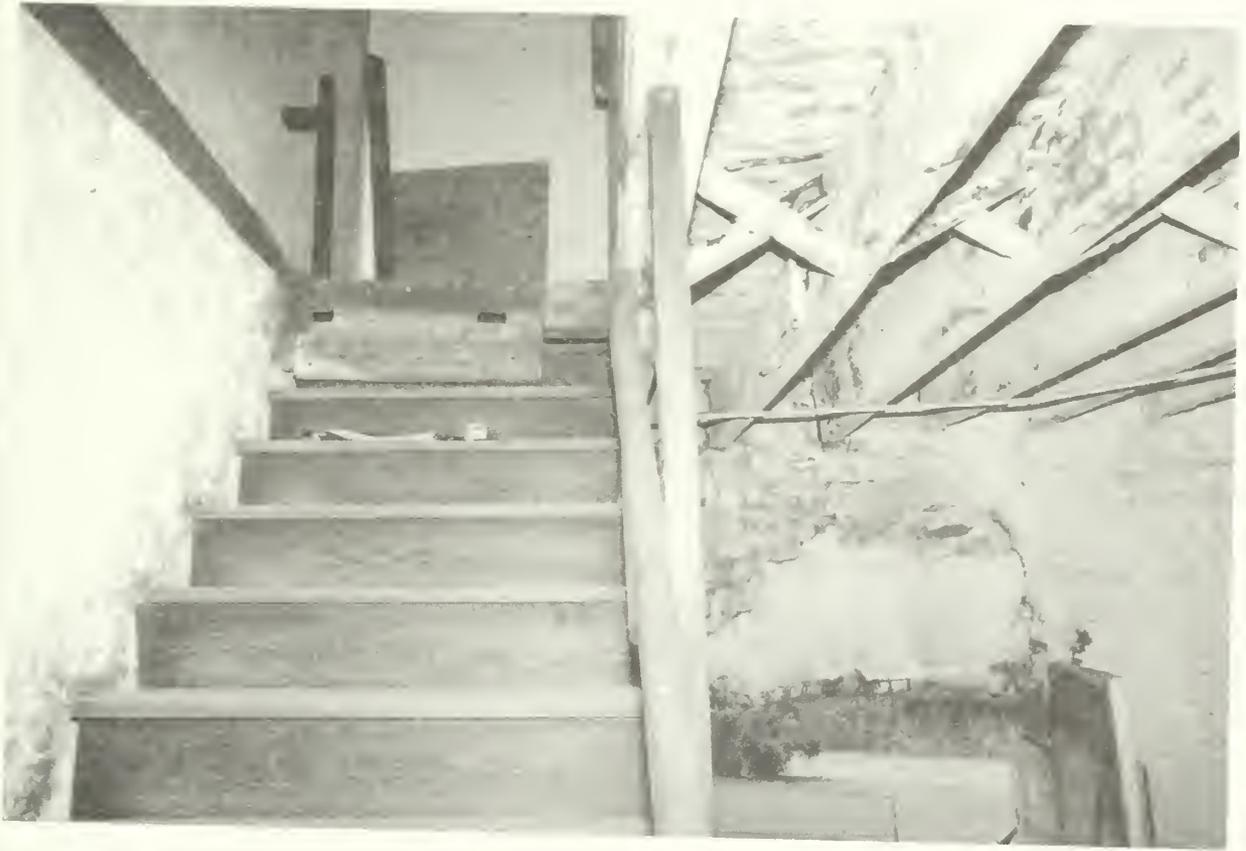
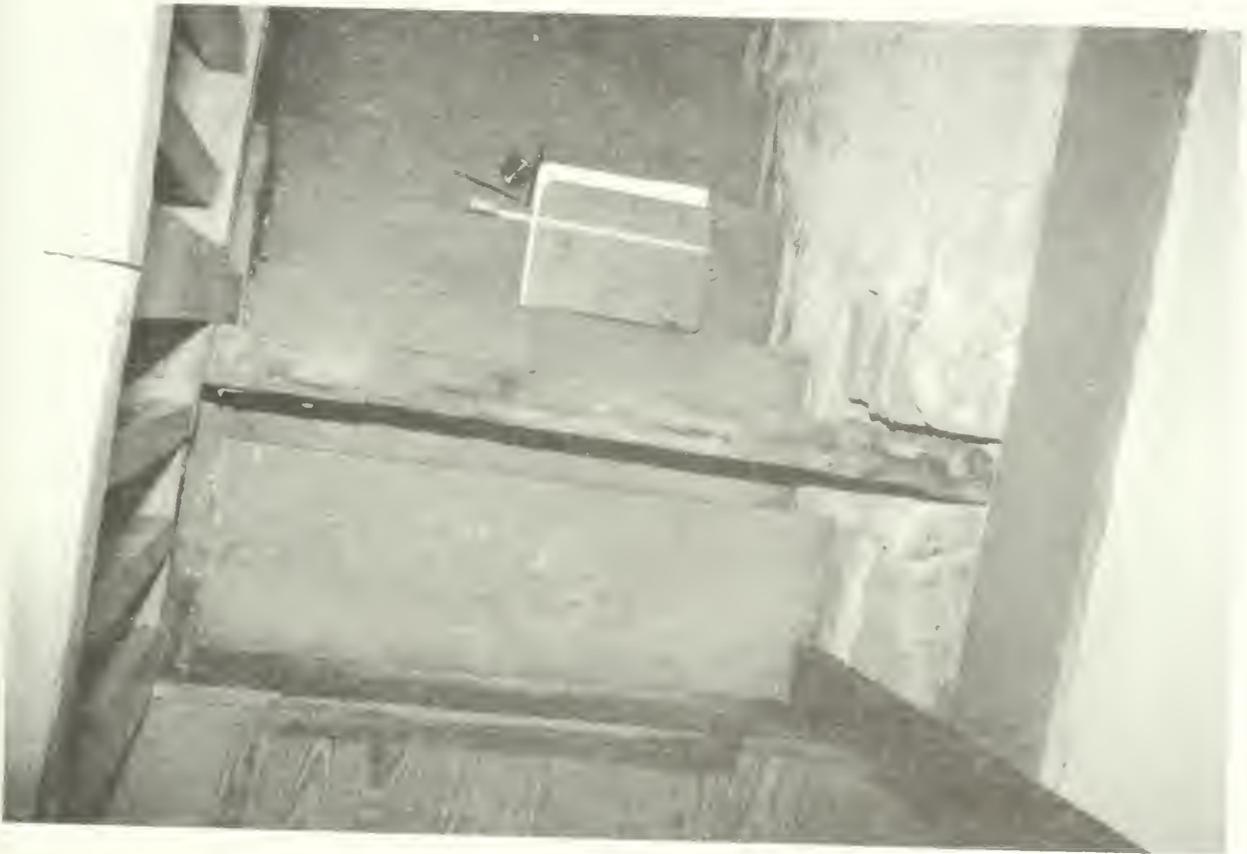
Figure 10. Historic Stairwell Header (5/18/82): Most of the original stairwell header--an architectural relic--is in the possession of the park and shown here in its historic position. The header was notched to rest in the masonry pocket at one side, and a tenon on the other fit into a socket in the first continuous ceiling joist. The two holes in the header received tenons of ceiling joists which ran back to the wall. In the plan view (lower photo) it is clear where the handrailing ended historically and where the floor has been removed to lengthen the stairwell.

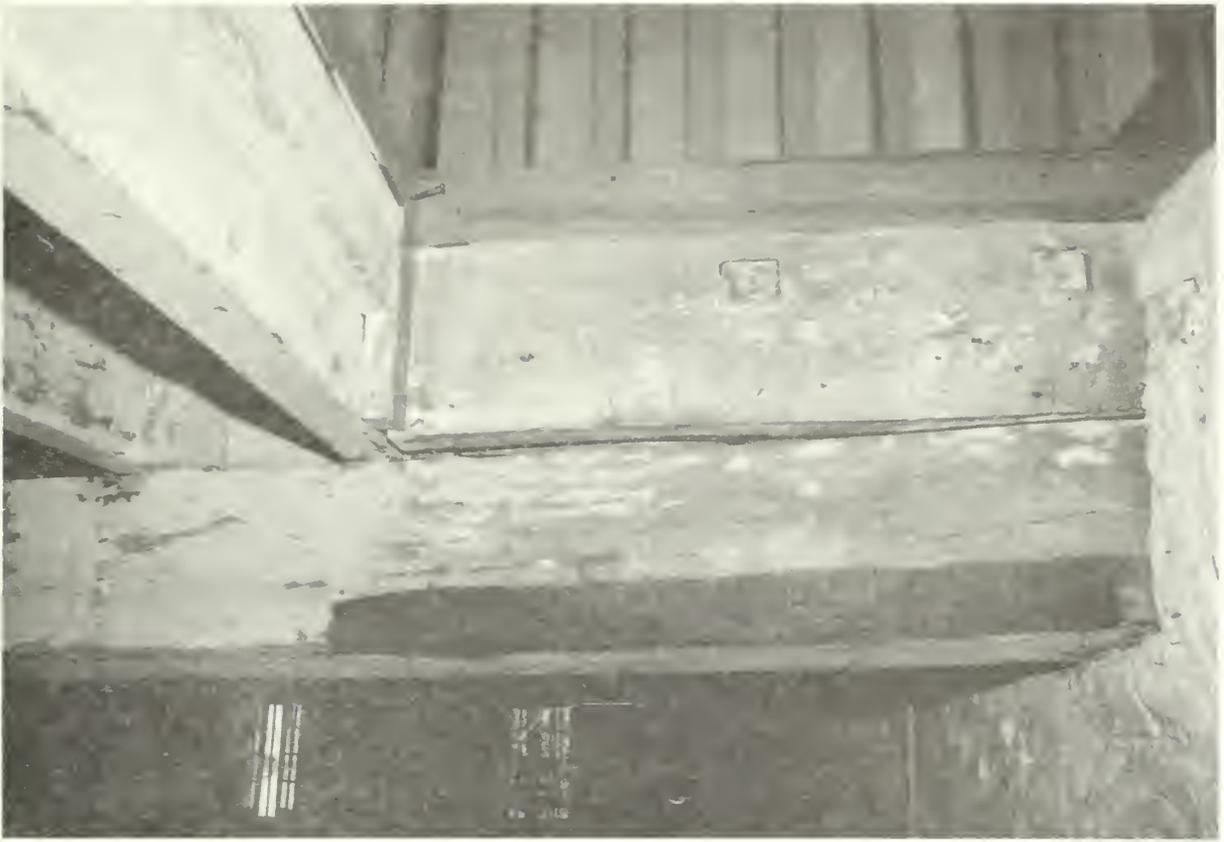
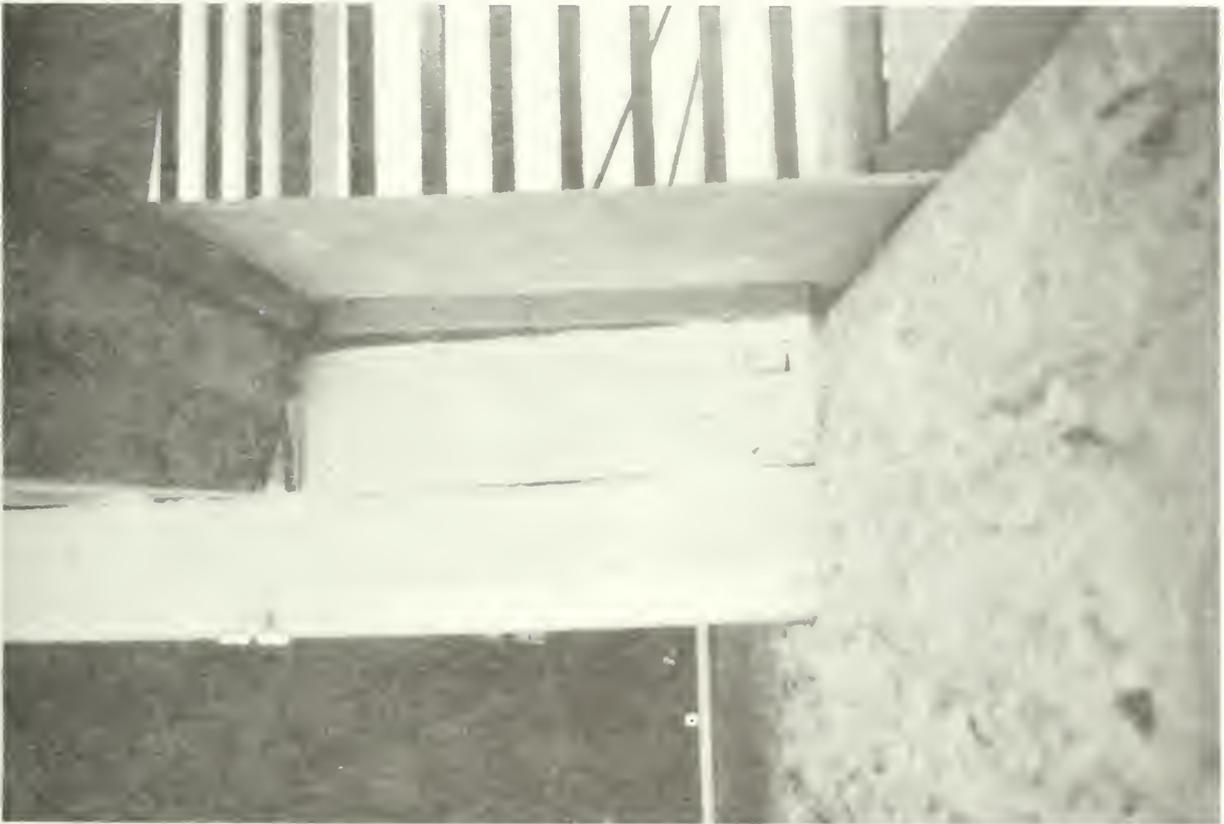
Figure 11: North Header of Stairwell (5/18/82 and 1/3/85). These views of the north end of the stairwell were taken before (above) and after (below) restoration of whitewash. In the upper view it is clear that the transverse beam was notched--probably about 1936--to facilitate stair 2; the notch had never been whitewashed over. The implication is that stair 2 had a longer and/or less steep run than the original stair, requiring additional head clearance. Note, also, the ledger board attached to the joist at the left, which may have been part of a historic stairwell cover when it was not in use.

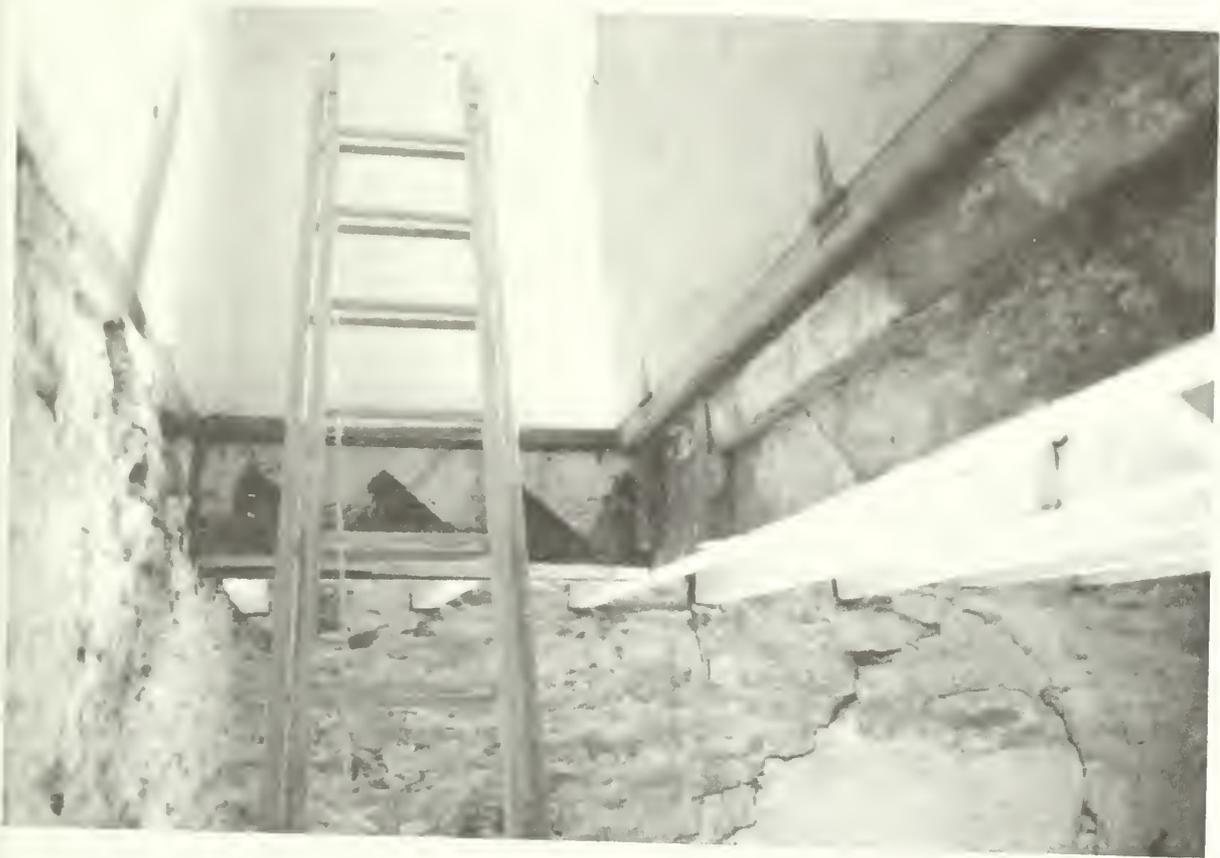
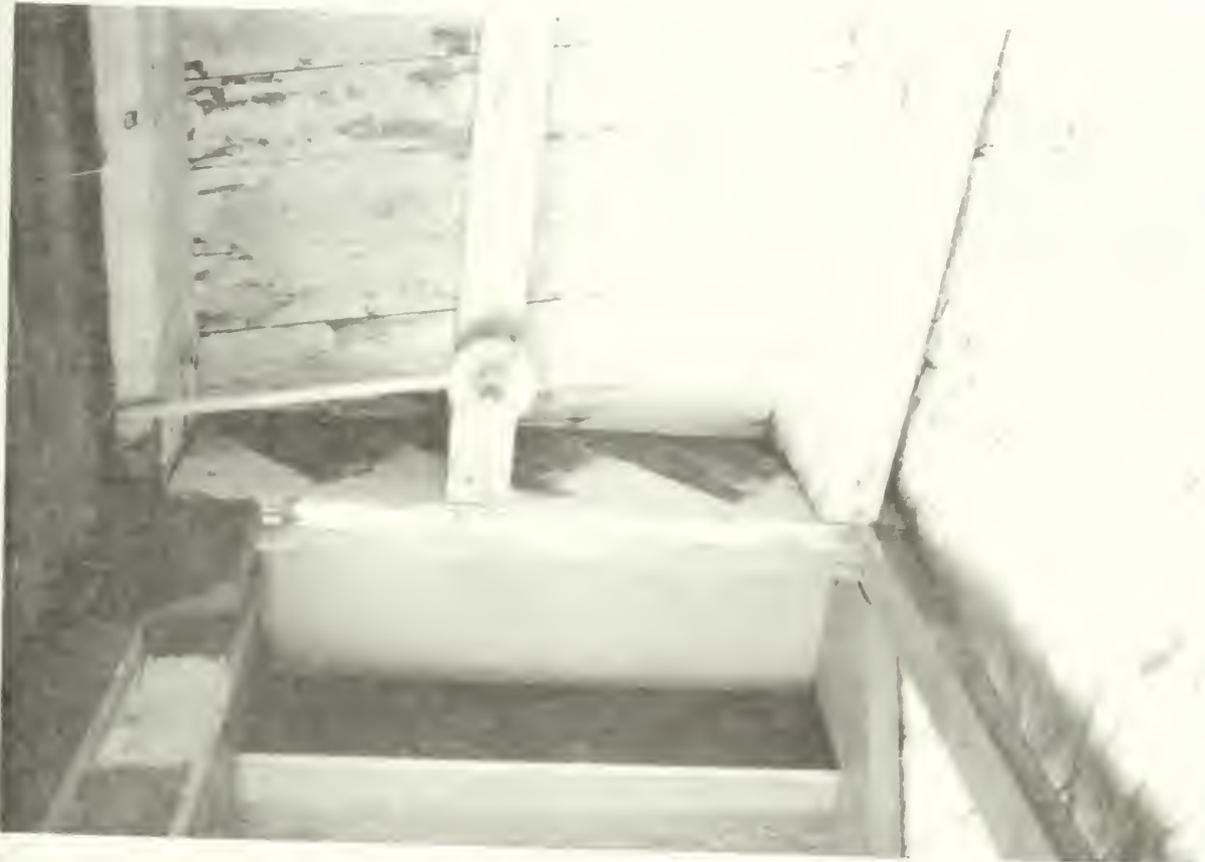
Figure 12. Header of Stair 2 (1/3/85 and 1/31/84): Fragments of a former stair stringer were used by the builder of stair 2 as the new header of the enlarged stairwell. There is no guarantee that these fragments were part of the stair 1 carriage or of some earlier commissary stair; however, they are old, rough sawn lumber with square nail holes. The effort could very well have been made to preserve fragments of a historic stair within the 1936 construction of a new one. Notice, also, ghosts of former handrails in upper photo at right--these were not covered over by the whitewash restoration and could be useful to understanding historic stairs.

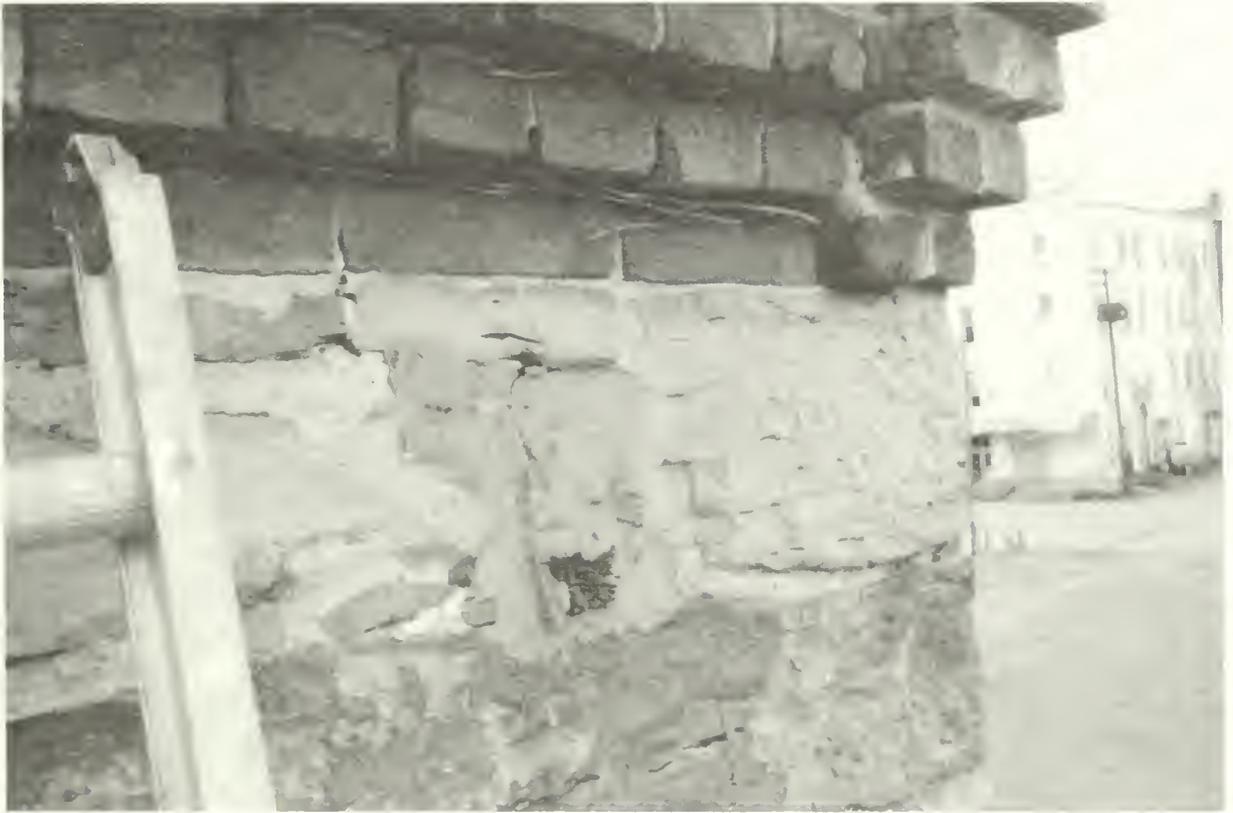
Figure 18. Beam Pocket (6/25/83): Typical upper beam pocket on south facade before restoration. Fragment of wood remains in place. Pocket was filled about 1913 with cement mortar, generously applied. The fragment is a remnant of the roof structure for porches 3 and 5, which hung here from 1866 to approximately 1896.

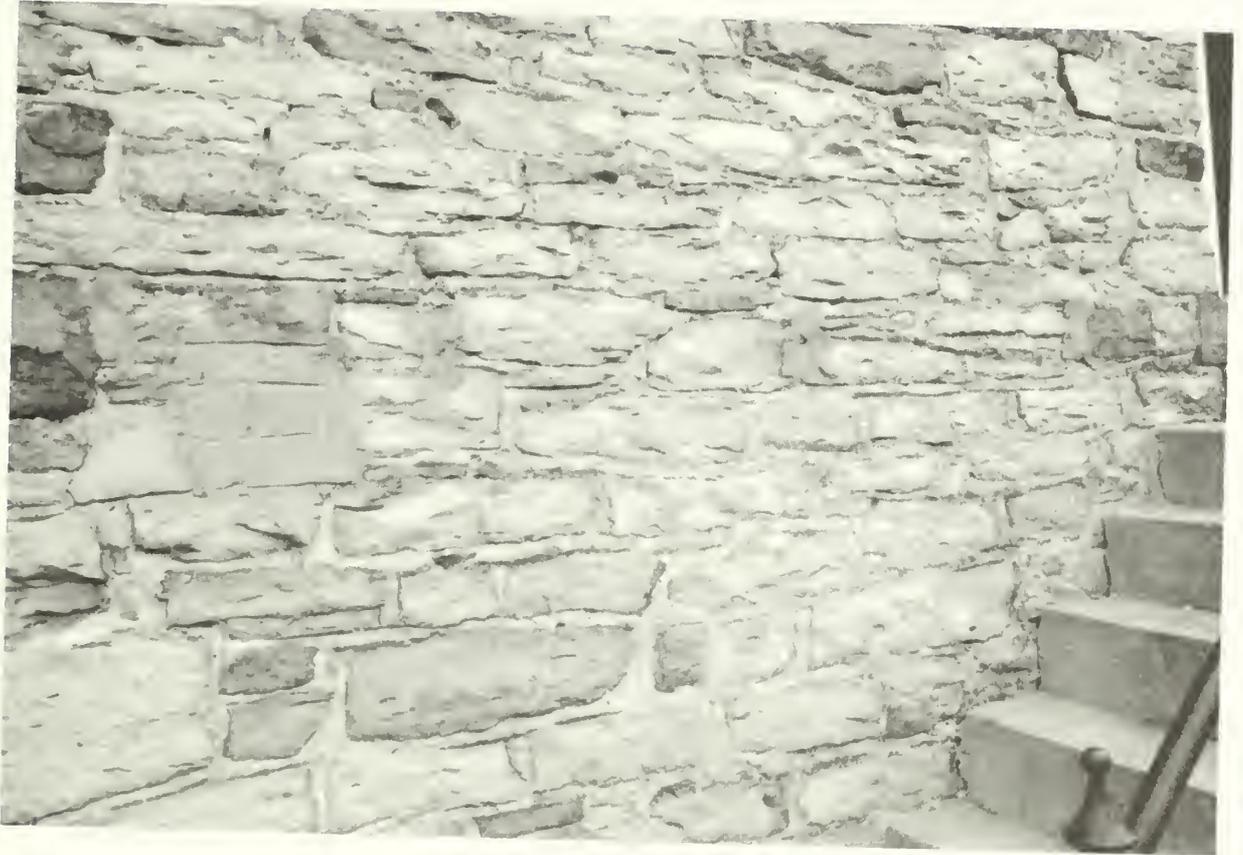
Figure 19. Beam Pocket (6/25/83): The beam pocket at left, filled in about 1913, was scribed to blend with the masonry pattern of the wall. Four smaller cement fills are visible at the level of the door sill stone (at far right). These fills cover up wooden nailers, probably used to attach a porch baseboard or floor header board for porch 5. All of these features were rehabilitated for interpretation.

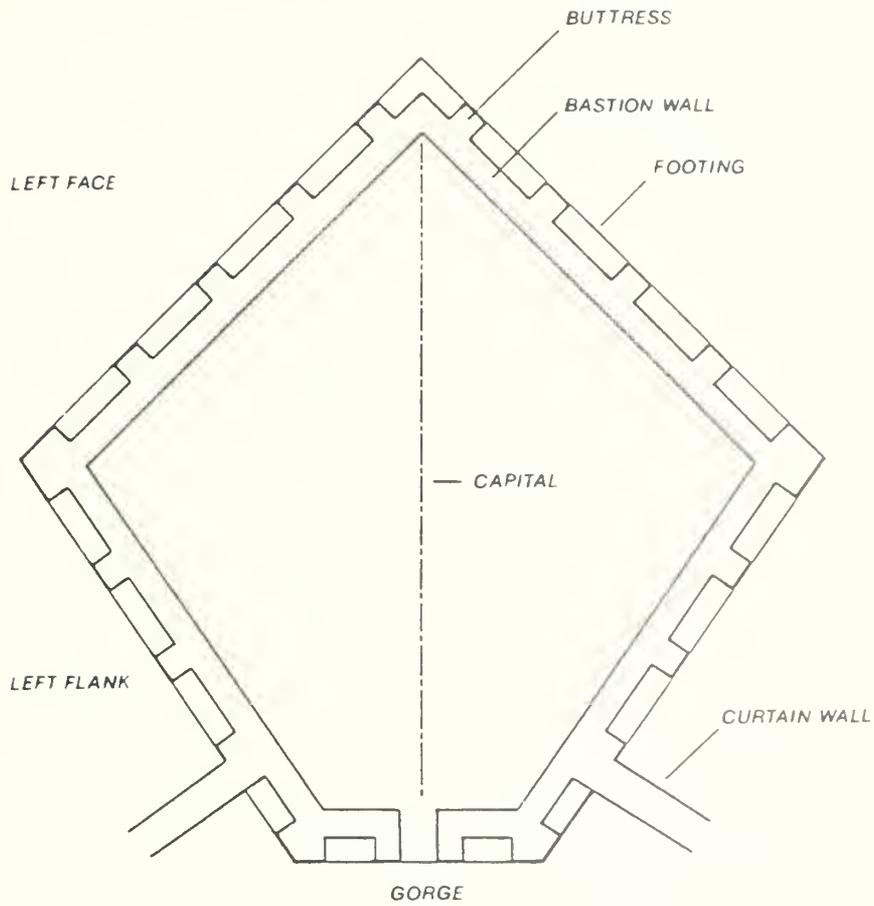
Figure 48. Bastion 1 and descriptive nomenclature--after an original plan

As originally planned, the second Fort Smith was a 7-acre, five-sided stone fort with a bastion at each angle. The foundation of the commissary building was initially bastion 1 of this defensive fortification (fig. 48). Major Charles Thomas, project engineer, reported that prior to October 1840 the foundation of bastion 1 had been raised to the level of the buttresses--about 7.9 feet--as were the adjoining curtain walls.

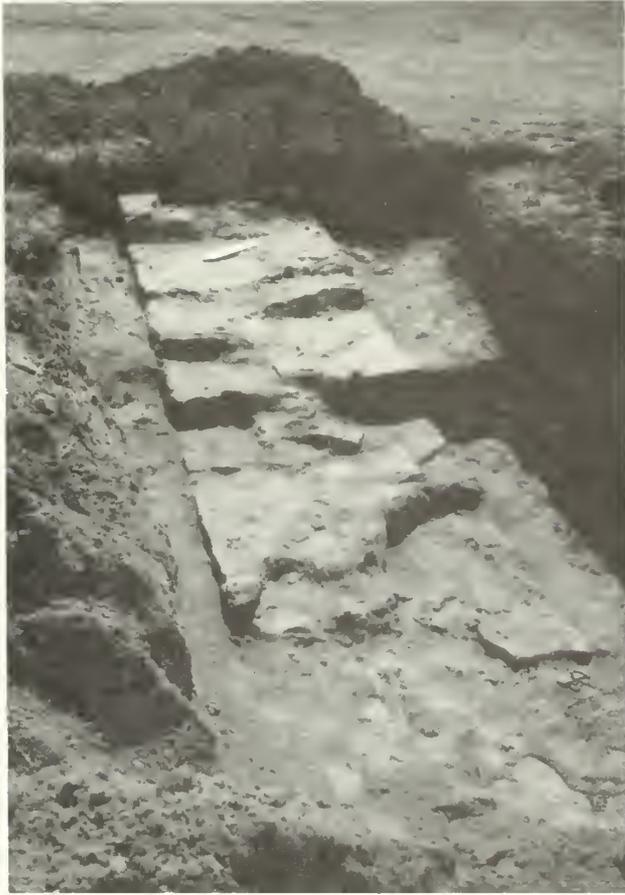
The precise juncture of two curtain wall sections with the foundation of bastion 1 or the commissary has been identified. At least 29.2 feet of surviving wall foundation extends east from the commissary footing (tests 2-3, 31-32, fig. 49). Possibly, the wall remains intact here for a much greater distance, although it has been removed on the eastern end of the commissary lot. In test 1, the curtain wall is represented only by a trench filled with sandstone rubble (fig. 50). Test units excavated south of the commissary yielded further evidence of the curtain wall. At least 4.0 feet of intact foundation was identified in test 17 (fig. 51). However, in test 18, only 8.0 feet to the south, the stone had been entirely removed. Fill in the resulting cavity is a profuse assortment of debris dating to the early 20th century. This material probably provides a good cross section of the rubbish the city once graded from the commissary lawn.

Figure 49: Section of the curtain wall foundation on the east side of the commissary building.

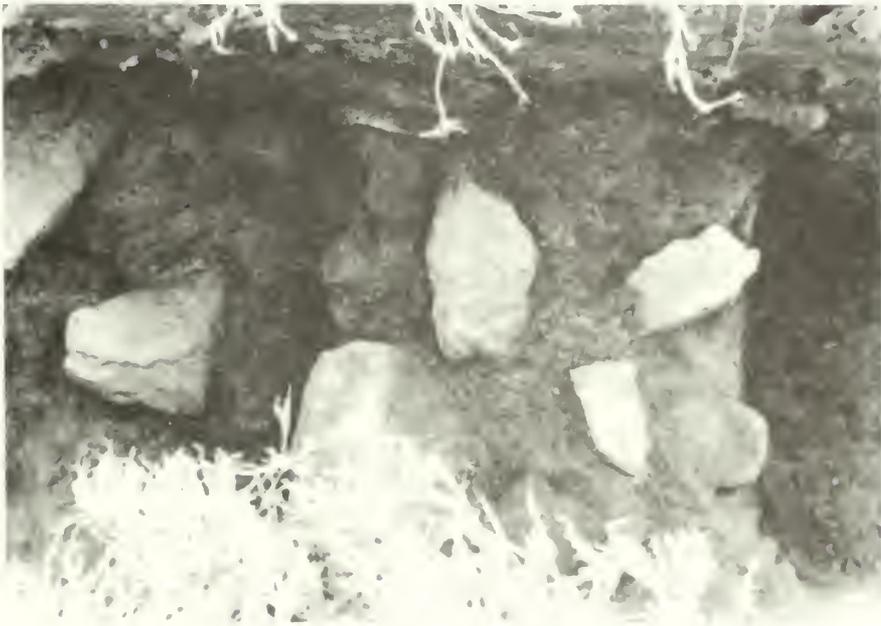
Figure 50: Sandstone rubble marking location of the former curtain wall in test 1.

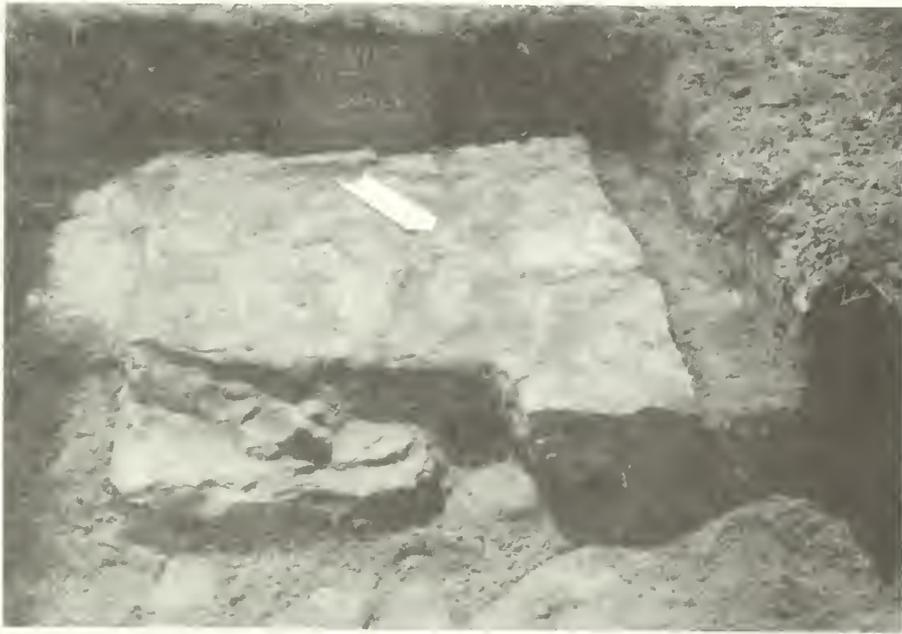
Figure 51. Section of the curtain wall foundation on the south side of the commissary building in test 17.

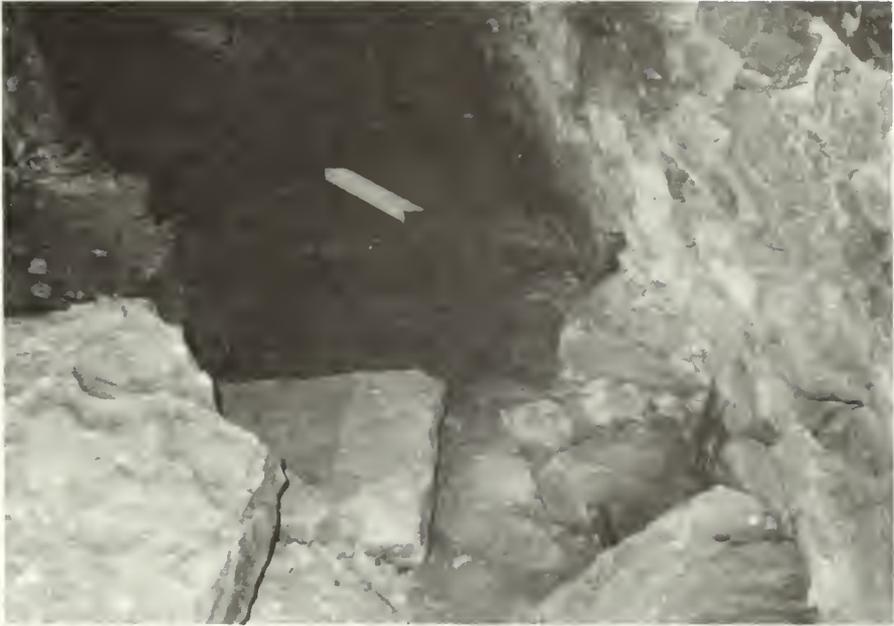
destroyed any trace of the inverted gorge. The original gorge of the bastion, however, remains intact beneath the added corner. Structurally, it is joined to the bastion foundation and curtain walls and therefore was left intact. The gorge is 5.4 feet wide at the point measured, but was probably intended to be 5.5 feet wide like the rest of the bastion foundation (fig. 53). This verified width deviates by 0.5 feet from that specified in historic planning documents.<sup>19</sup>

Figure 53. Gorge of bastion 1, after lifting flagstones from the ground floor of the commissary to insert utility lines.

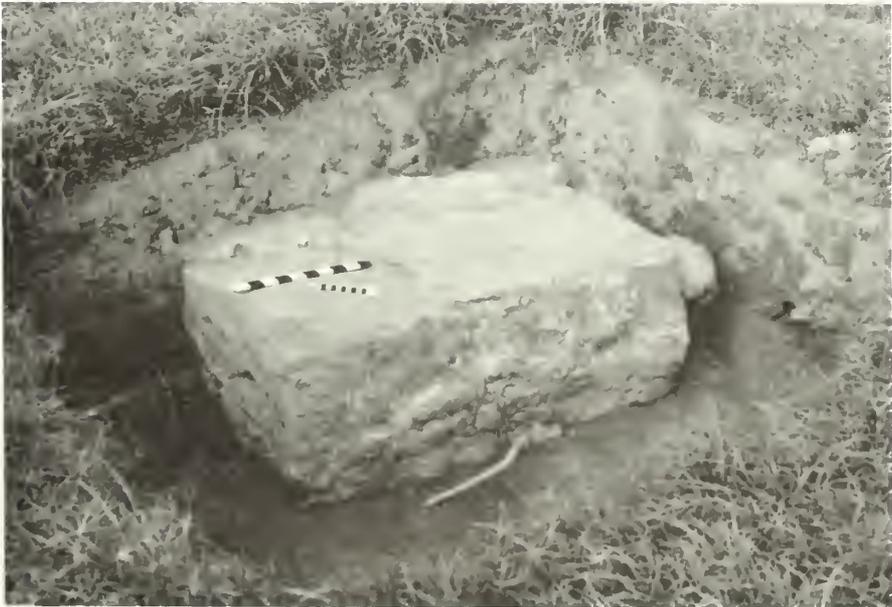
survive (tests 11, 15 and 16). The stone piers consist of several courses of sandstone mortared in place. Both are square in shape, 2.5 feet to a side (fig. 54). Because mortar adheres to their surfaces, it may be assumed that one or more courses of stone were removed in the past, perhaps during the 1911 grading. The piers align perfectly with the beam pockets cut into the southern facade of the building. A third stone pier, visible in a period photograph, was removed sometime in the past.<sup>21</sup> It would have been located in test 14. A fourth support post should have rested on the curtain wall, but may in fact have been offset. A 1.0-foot-square post mold is situated in line with the two surviving piers, immediately adjacent to the curtain wall (test 11). Although evidence of the two easternmost support posts was not discovered, the beam pockets are still in place. A full-length porch, 8.0 x 48.0 feet, is indicated. Both surviving piers are enveloped but not covered by the 1898-1899 fill, suggesting that the porch may have been full-length at the time the fill was deposited.

Figure 54. Stone Pier: This pier was used for a support beam of the south porch in test 15.

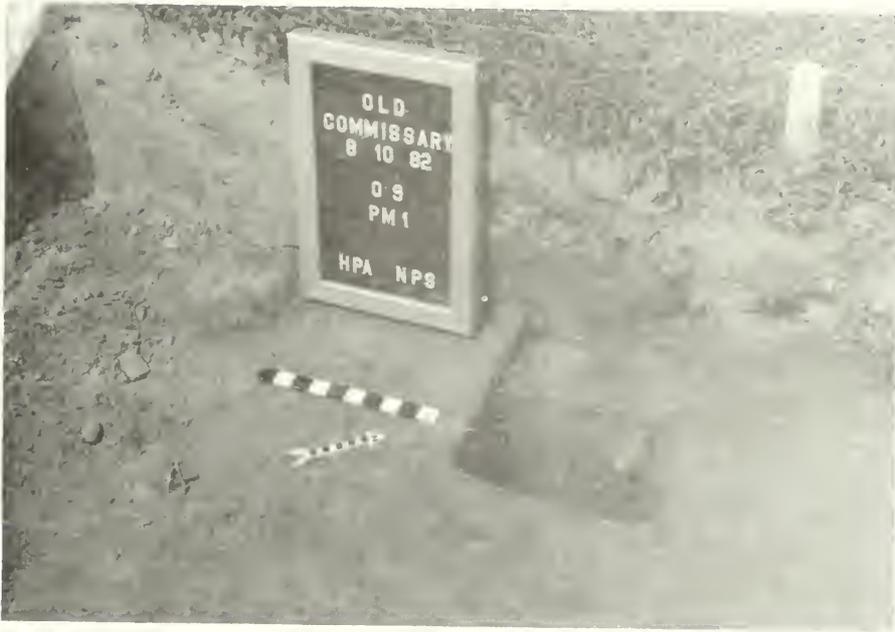
Two post molds, probably related to the 1866-67 porch on the east side of the commissary, were identified in test 4 (fig. 47). The first post mold is 0.4 foot or 5 inches square (fig. 55). It extends 2.0 feet below ground surface into the sterile B22t horizon of Muskogee silt loam. The second post mold is only 4.5 feet to the north. This feature is much disturbed, however, as if a post had been "levered out" of the ground.<sup>22</sup> The second post mold is directly under a beam pocket cut into the east facade of the commissary building and, therefore, is probably the remains of a support post. Both post molds are 8.0 feet from the wall of the building, suggesting a porch width identical to that for the north and south porches constructed the same year.

Figure 55. Square Post Mold: One of the post molds marking a former support beam for the 1866-67 porch on the east side of the commissary.

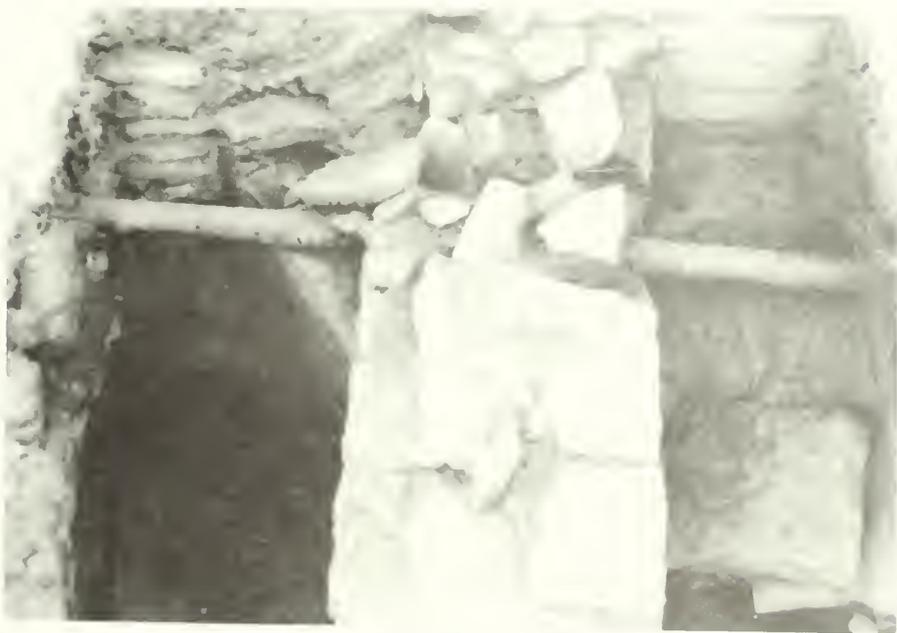
A flagstone walk has been identified on the east side of the commissary (fig. 56). The feature abuts the east curtain wall and parallels the commissary foundation for an unknown distance. The walk is exactly 5.8 feet wide and is approximately 1.5 feet below the surface, placing this feature near the military ground surface. Mortar used in walk construction could shed additional light on the affiliation of this feature, but, unfortunately, this information was not recorded. It is entirely possible that the walk is related to one of the two porches that existed on the east side of the building. Conceivably, the flagstones may have led to the steps on the east end of the north porch. Additional investigation is warranted, however, before making a conclusion.

Figure 56. Flagstone Walk: This feature abuts the curtain wall on the east or right flank of the commissary. Presumably, the walk is associated with one of the historic porches.

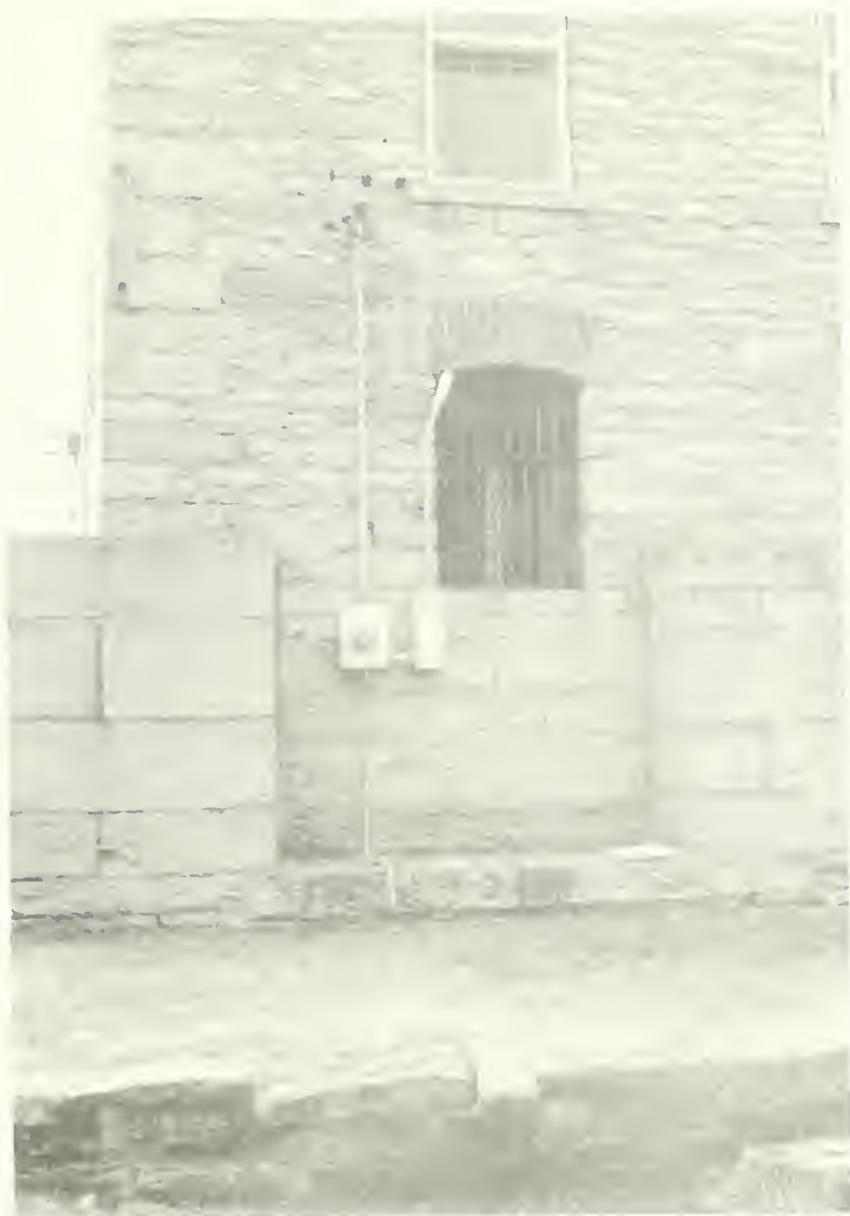
Figure 61. East Corner Detail (10/8/83): The intrusive electrical and telephone entry equipment shown here were removed in 1984, and service entered underground below floor level.

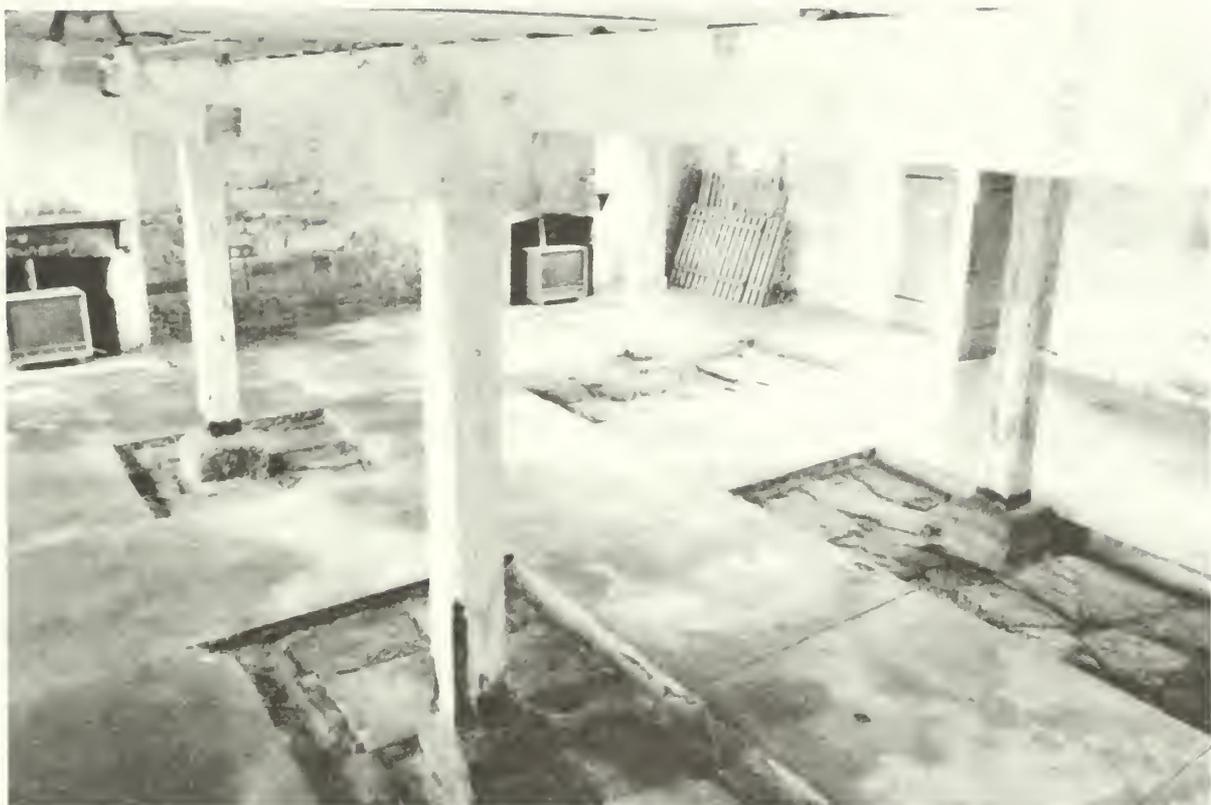
Figure 63. First Floor (6/26/83): General view of first-floor condition before restoration. Note light fixtures, gas stove heaters, and concrete slab floor that were removed, and deteriorated support posts and whitewash that were restored.

The concrete slab tended to act as a moisture barrier. Because groundwater tends to rise, it was forced to rise up the walls or through the stone bases of the main support posts. A rising damp problem and accelerated decay in the lower posts resulted. Removing the slab permits a more generalized release of groundwater vapor, which leaves the building more easily, now that natural ventilation is facilitated by the louvered panels installed at the windows.

Frazier: Souder's description of the posts, bolsters, and transverse beams is good; however, he did not discuss their condition. At their lower 2 feet, the 9-inch by 9-inch oak posts were damp to the touch because of rising groundwater and some decay had occurred. The rotten areas were cut out and filled, restoring the shape of the post and then whitewashed in 1984.

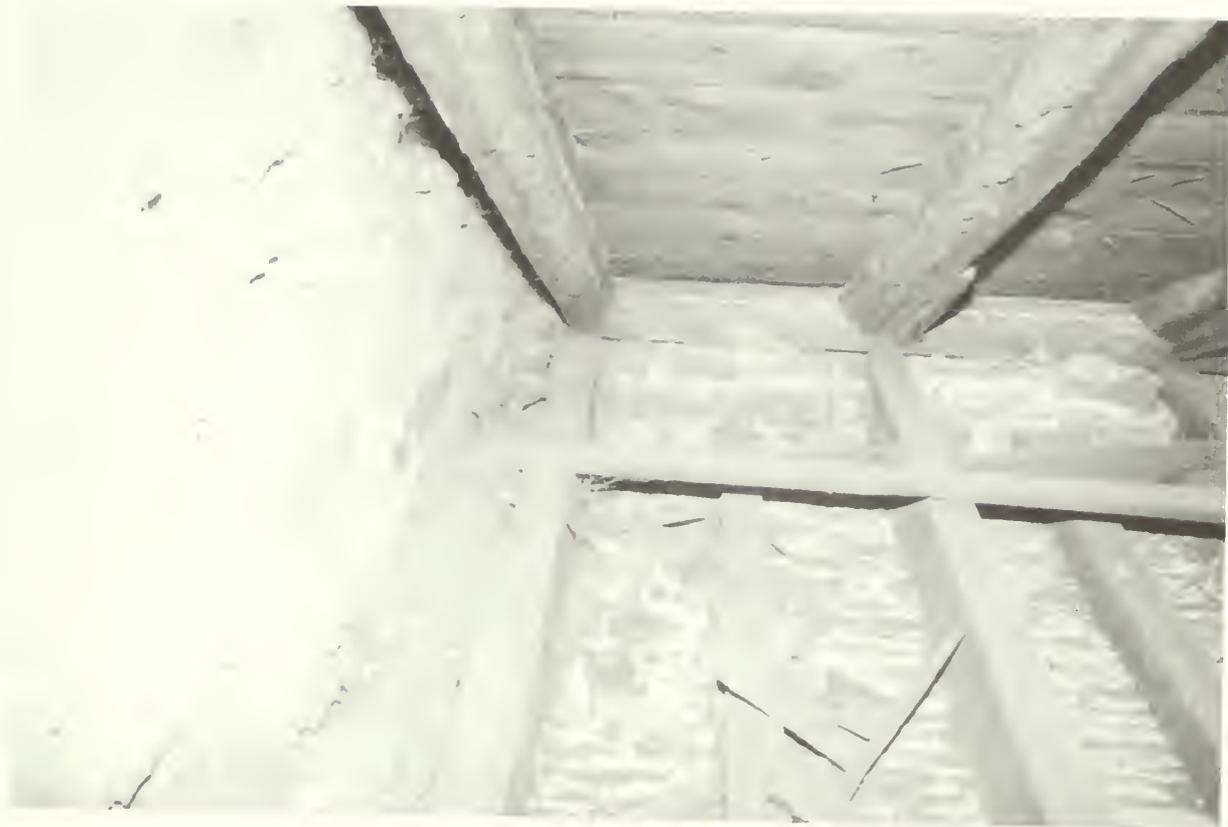
Figure 65. Attic (6/25/83): This photograph shows historic construction details now covered up by new work. Brick nogging filled the space between rough cut 3/8" attic floor joists and provided a backing for the brick cornice and a base for the rafter plate. The 4" by 4" rafters were roughly hewn from poles and notched to sit on the 2" by 6" plate where they were spiked. Rough cut 3" by 3" intermediate joists were set in place in 1866 to help carry the second-floor ceiling lathe and plaster. The gable end walls, of stone, were built 6 inches thinner, as they rise above the attic-floor level. Note also, fragments of slate shingles and the obviously newer roof sheathing that was probably installed in 1938.
