# historic structure report

## restore historic commissary building to 1897

# FORT SMITH

NATIONAL HISTORIC SITE / ARKANSAS

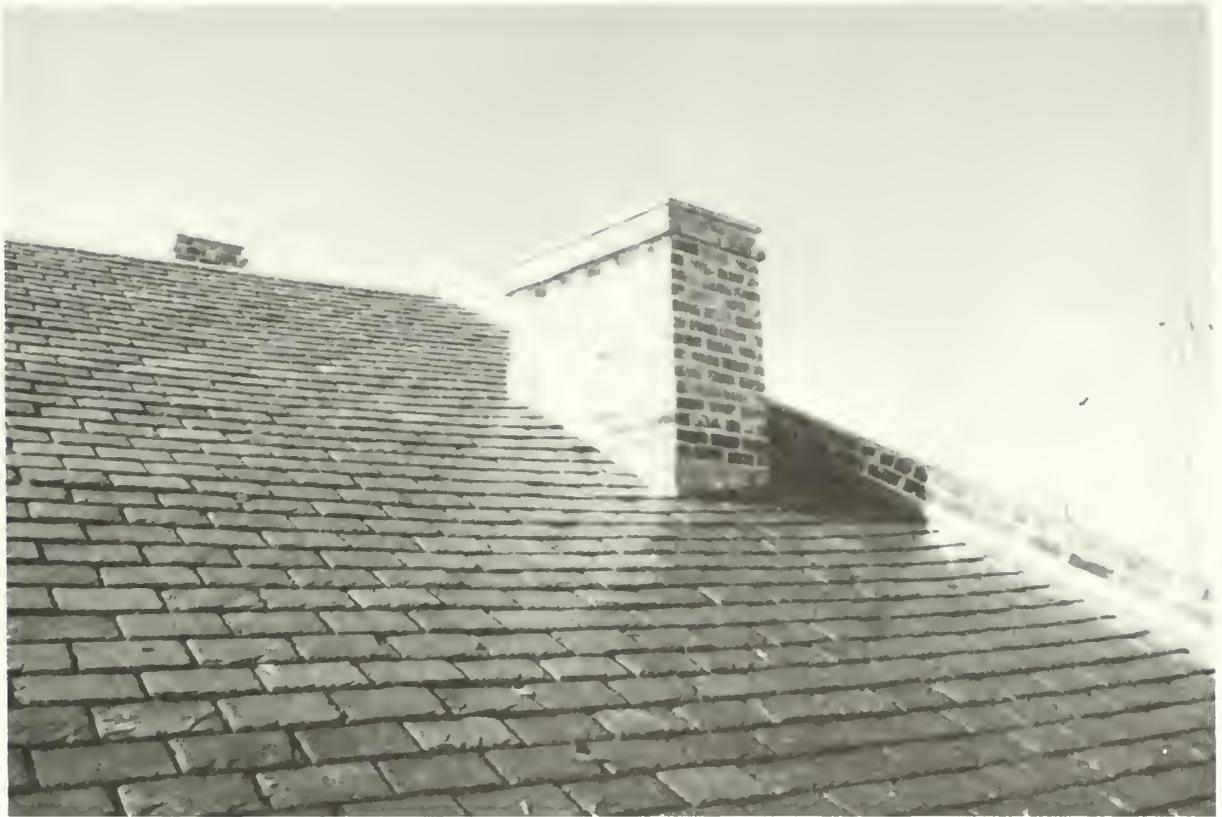
Figure 71. North Chimney (12/14/83): In this view the new slate shingle roof with copper flashing and counterflashing is in place, and the chimneys have been restored to their ca. 1897 appearance. Notice that the chimneys are fitted with slate caps and that bricks have been left out just below the cap corbel to facilitate ventilation of the entire building. By 1894 the north chimney had fallen down to the lower height shown here, compared to the south chimney which, although damaged, was fairly intact.

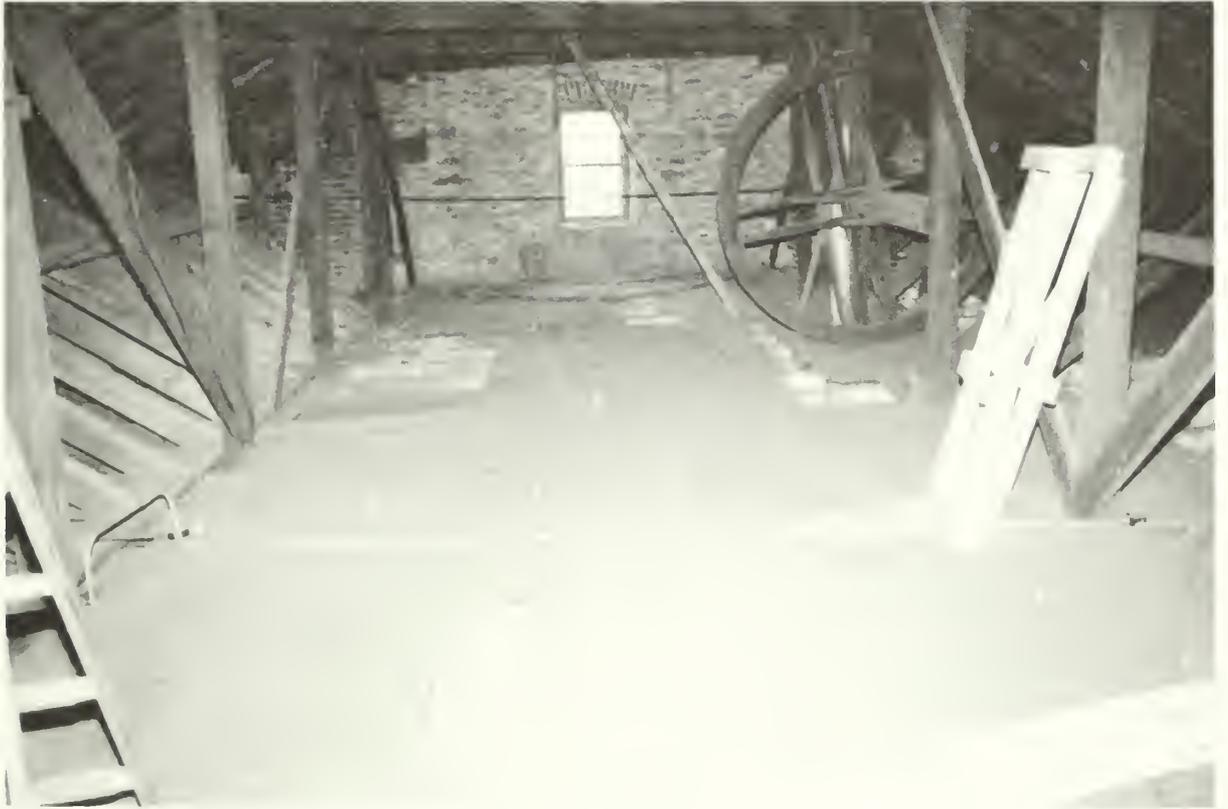
Figure 72. Attic (5/20/82): Besides the reroofing itself, the major work of phase I involved the structural reinforcement and preservation of the attic. The extant hybrid system of rafter braces was removed - note difference between left (south) and right (north) sides - modern electrical and gas service lines were removed and the random sized central flooring planks were taken up, treated, and reinstalled.

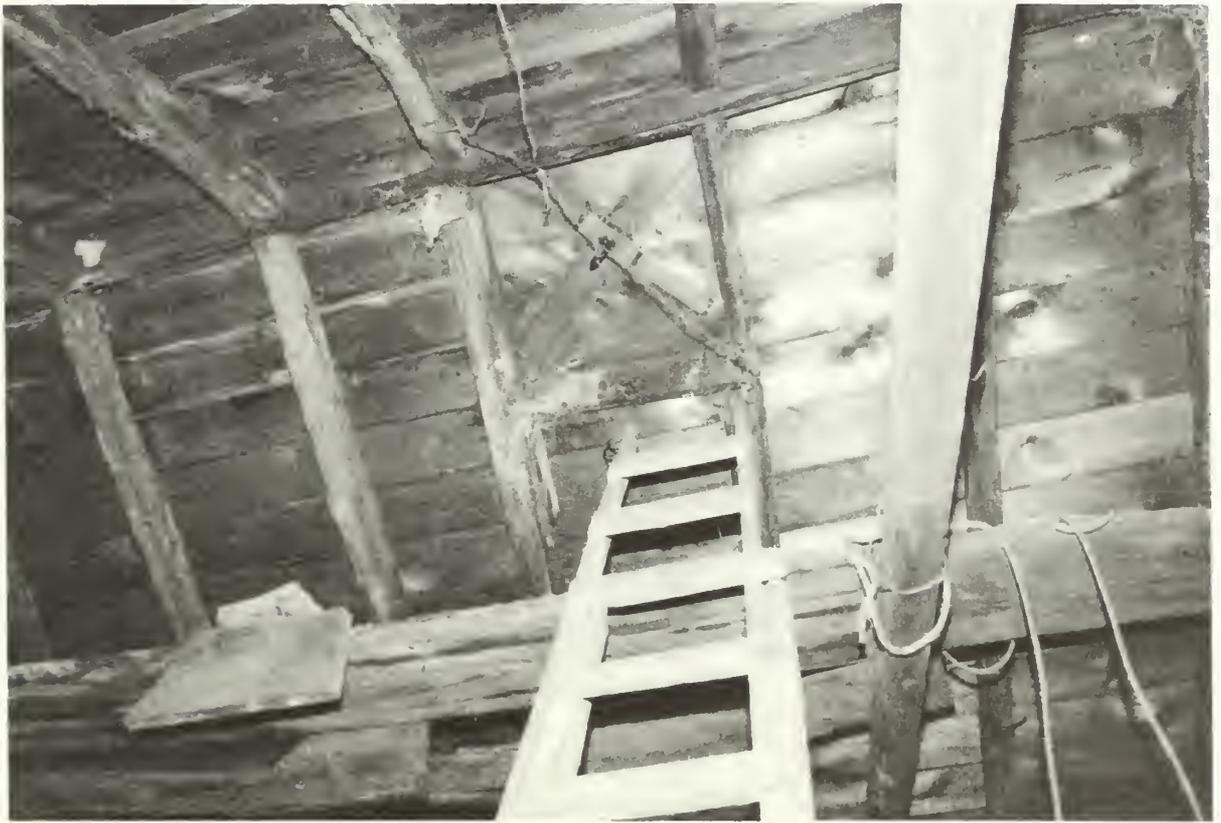
Figure 73. Roof Scuttle (5/20/82): View of sheet metal roof scuttle cover from attic, which was removed and the opening resheathed as part of slate reroofing, fall 1983.

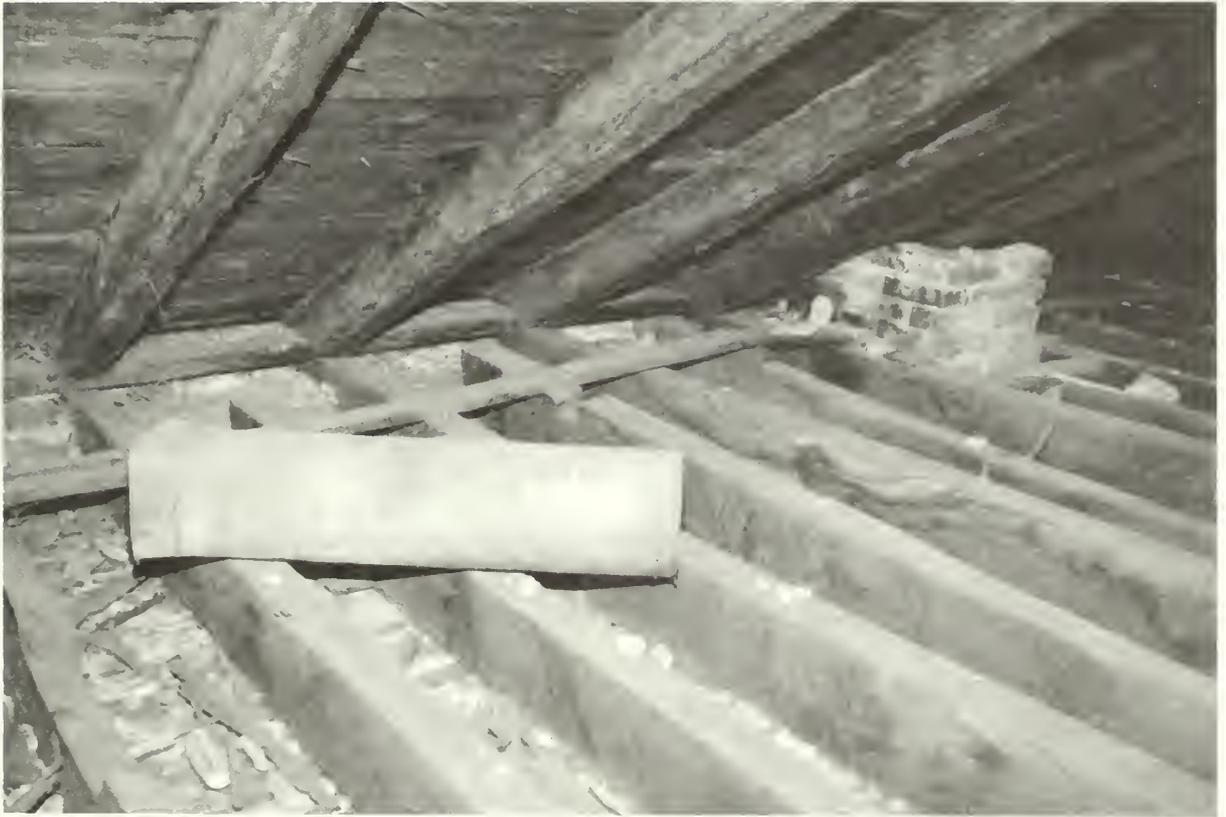
Figure 74. Attic - South Chimney (5/20/82): Existing physical evidence for the design of the south brick chimney and sheet metal flue in conjunction with a close study of figure 31 was sufficient for reconstruction. It was decided, however, not to reconstruct the flue of this chimney because of the maintenance burden it may have required. Sheet 7 of the drawings (421/25,002) document the original chimney/flue for reconstruction.

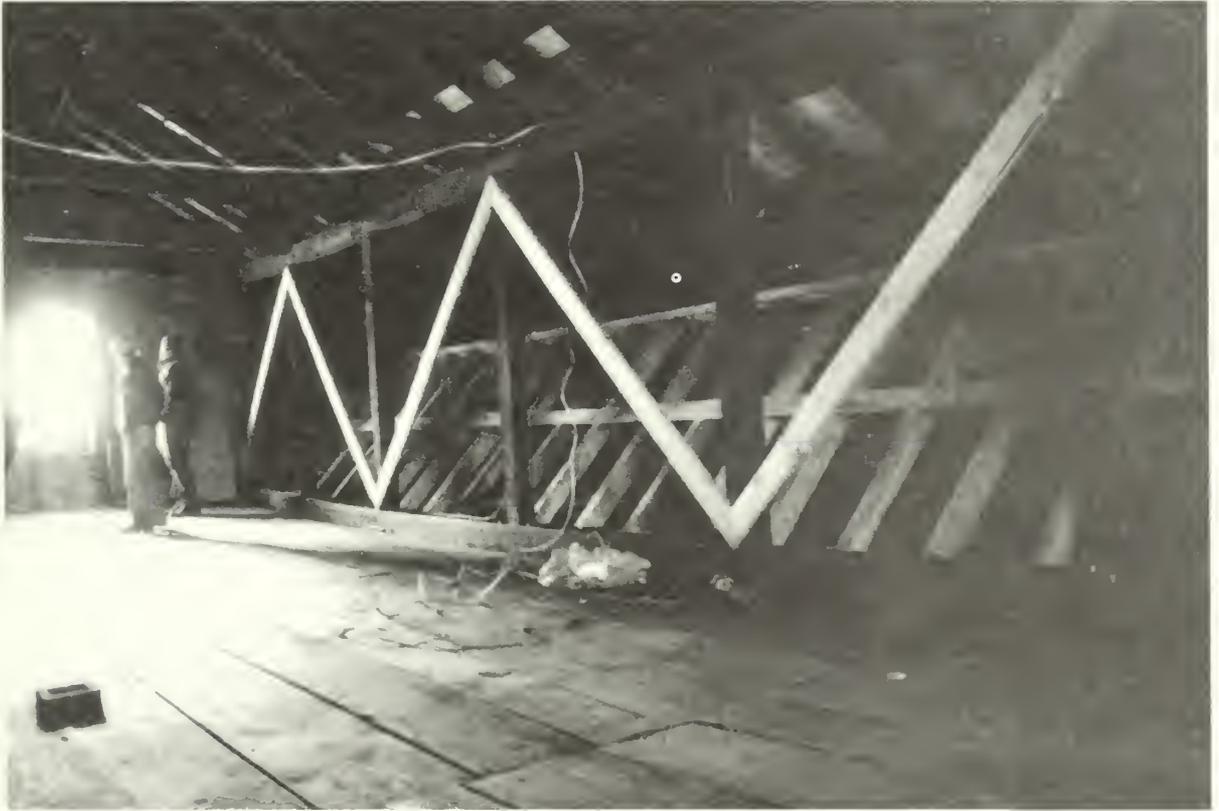
Figure 81. Attic (12/14/83): Looking towards the south corner, in this view, attic structural systems--steel beams at floor level and wooden diagonal struts and braces--have been installed. The historic flooring has been reinstalled. Note hoist cable chase (small square box) at left. Also, light-colored roof sheathing is 1983 replacement material.

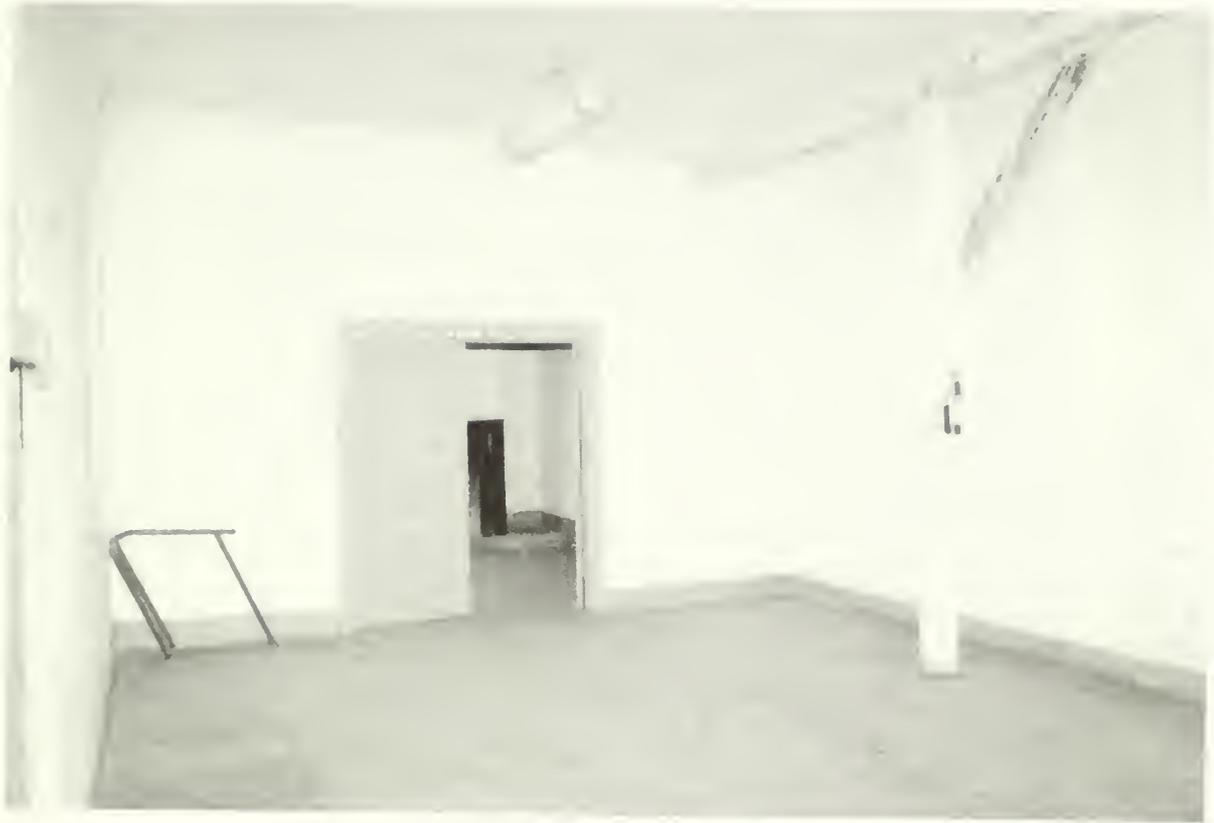
Figure 82. Southeast Room-Second Floor (5/20/82): This area of the second floor has witnessed the most extensive change over the life of the building--see "Historical Data" section. The project treatments focused on removal of intrusions (1930s electrical fixtures) and the reestablishment of structural integrity at the attic floor beam and support post. The 6 x 6 support post shown here, installed at an unknown date, was not located above the support post below and required the diagonal brace to assist in carrying the beam splice above. This had not proven totally effective as the beam has cracked and the splice has fractured.

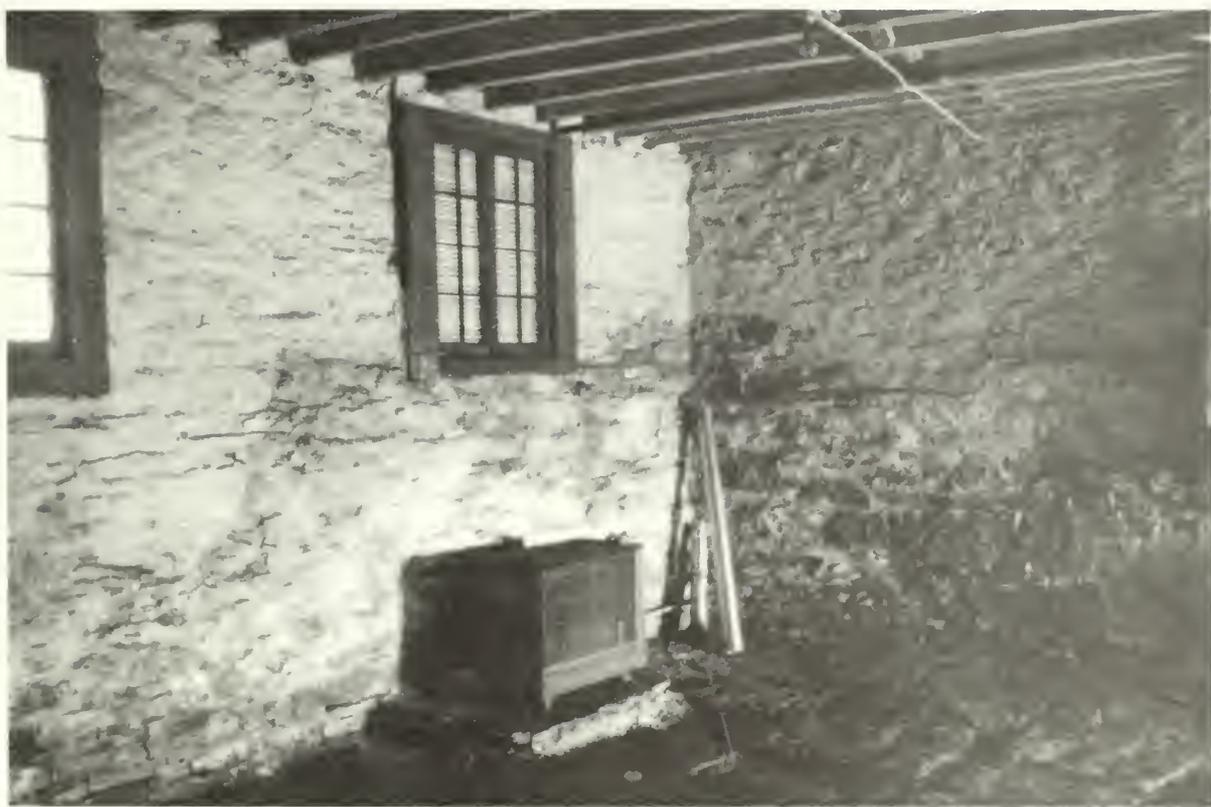
Figure 85. First Floor (1/31/84): Detail of east corner after most of the concrete slab had been removed. Notice shadowy pattern on walls, possibly locating historic furnishing elements. Because of these ghosts, the decision was made not to restore the whitewash on walls, but rather to preserve these shadowy patterns for visitors to observe.

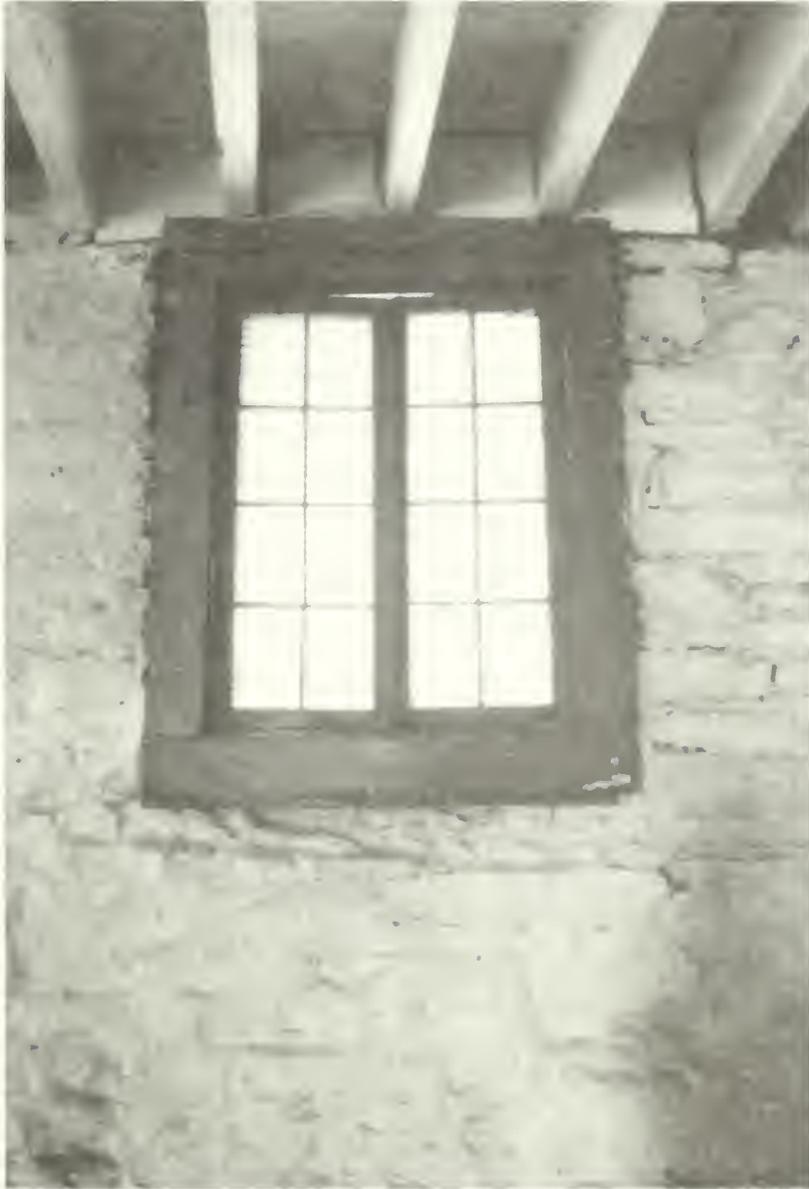
Figure 86. First-Floor Windows (1/31/84): Detail shows typical appearance of four of the six windows at the first-floor level, modified by removing glass and installing louvered panels. This was done to facilitate uninterrupted natural ventilation through the building. Significant drying of the wooden support posts took place within the first year after installation. Natural updraft through all fireplaces and chimneys is also part of the ventilation system.

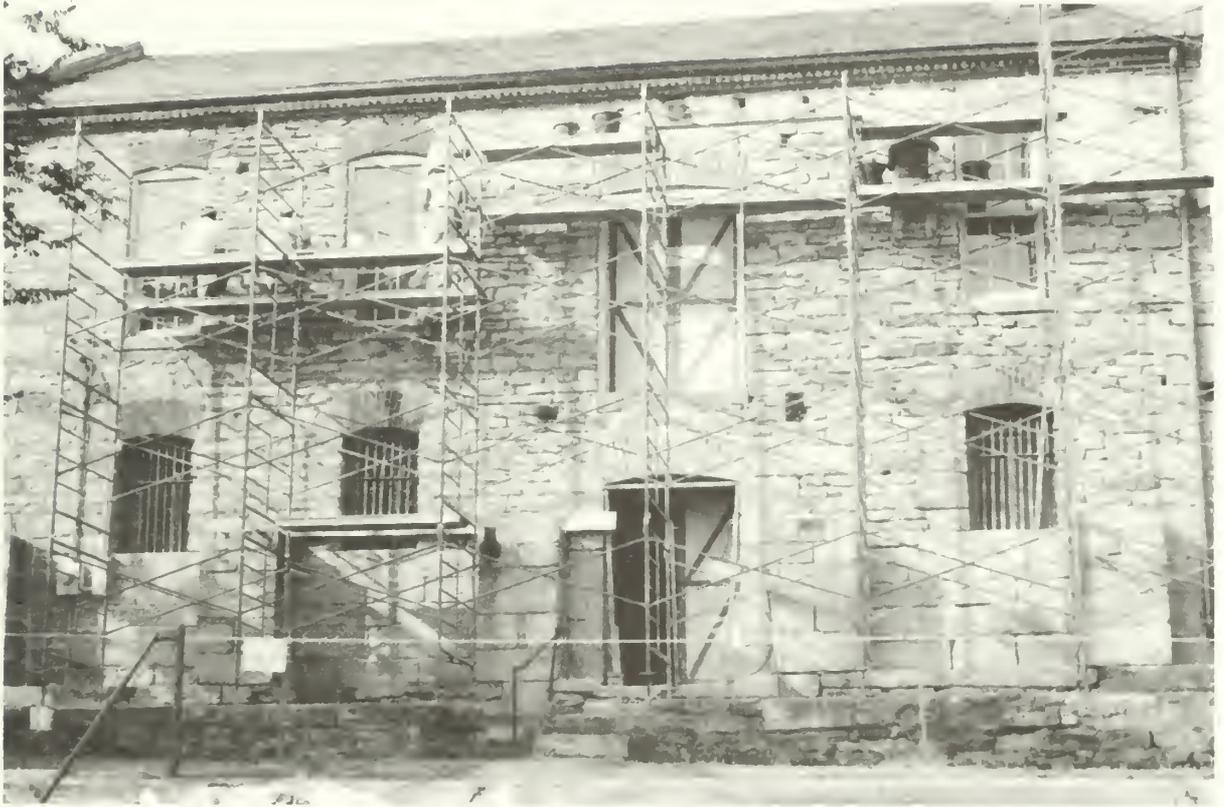
Figure 88. Detail at North Door Area (8/84): This view was taken after the raking phase of masonry treatment; the cement smear has been removed from the brick rowlock arch and beam sockets (for the second floor of porch 4).

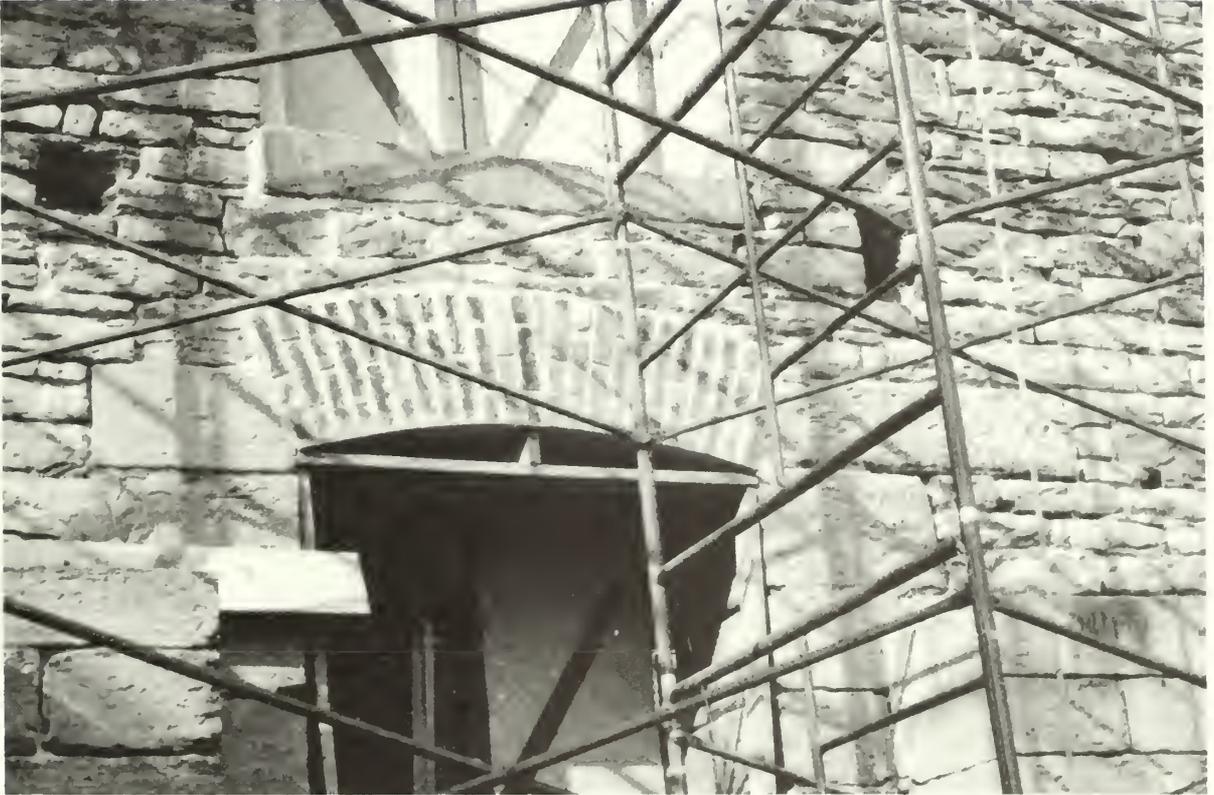
Figure 89. Detail at West Window, North Facade (8/84): In this view, raking has been completed. The texture and quality of historic masonry construction is clear. Also note pockets cut into the wall about 1866 to facilitate installation of porch 4 roof.

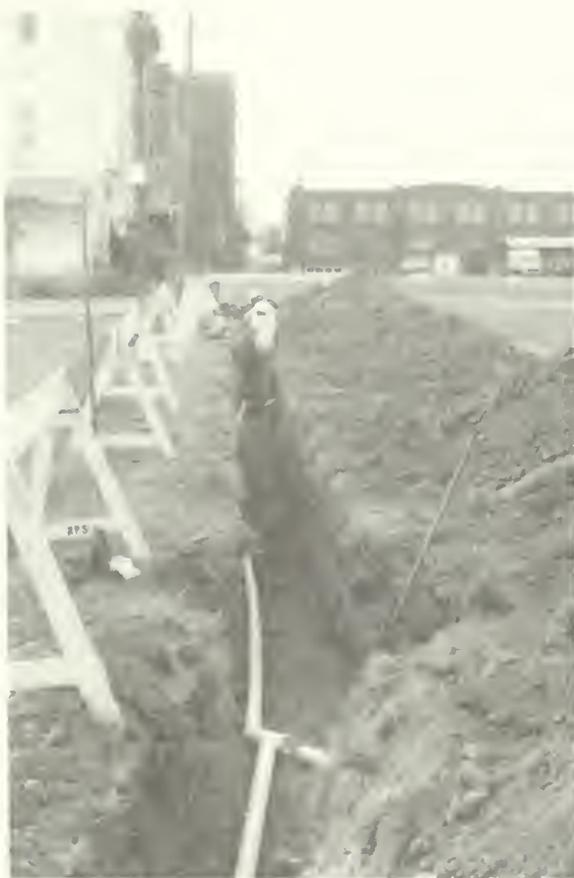
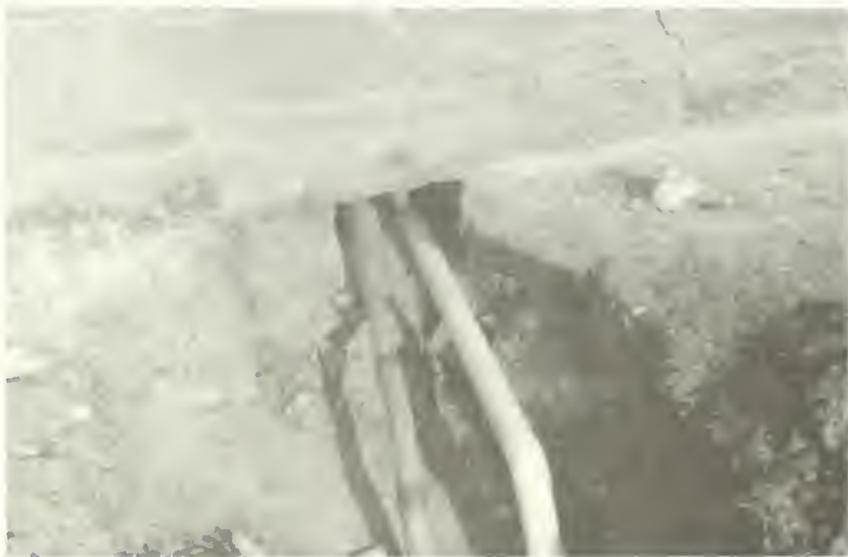
Figure 96. Power and Phone Service (9/84): These photographs show service conduits being installed below the stone slab floor at the south corner of the first floor. In the lower picture, the stone flooring is reinstalled and the sleeper-frame of the visitor platform and panel cabinet has been installed.

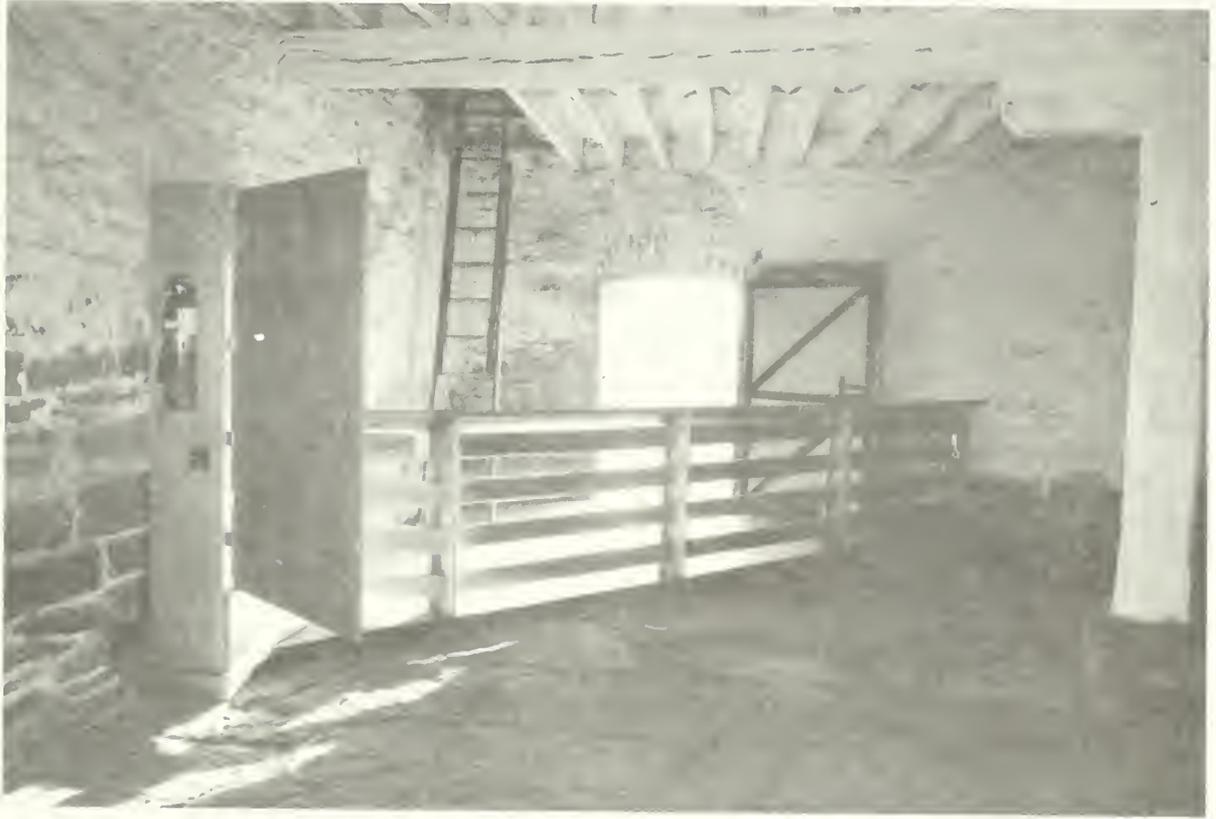
Figure 99. South Corner of First Floor (1/3/85): The visitor interpretive platform is ready to receive interpretive devices. The light switch is operated with a key. All developmental intrusions are concentrated in this corner of the building. Note, the ladder at right will not be present during visitation.

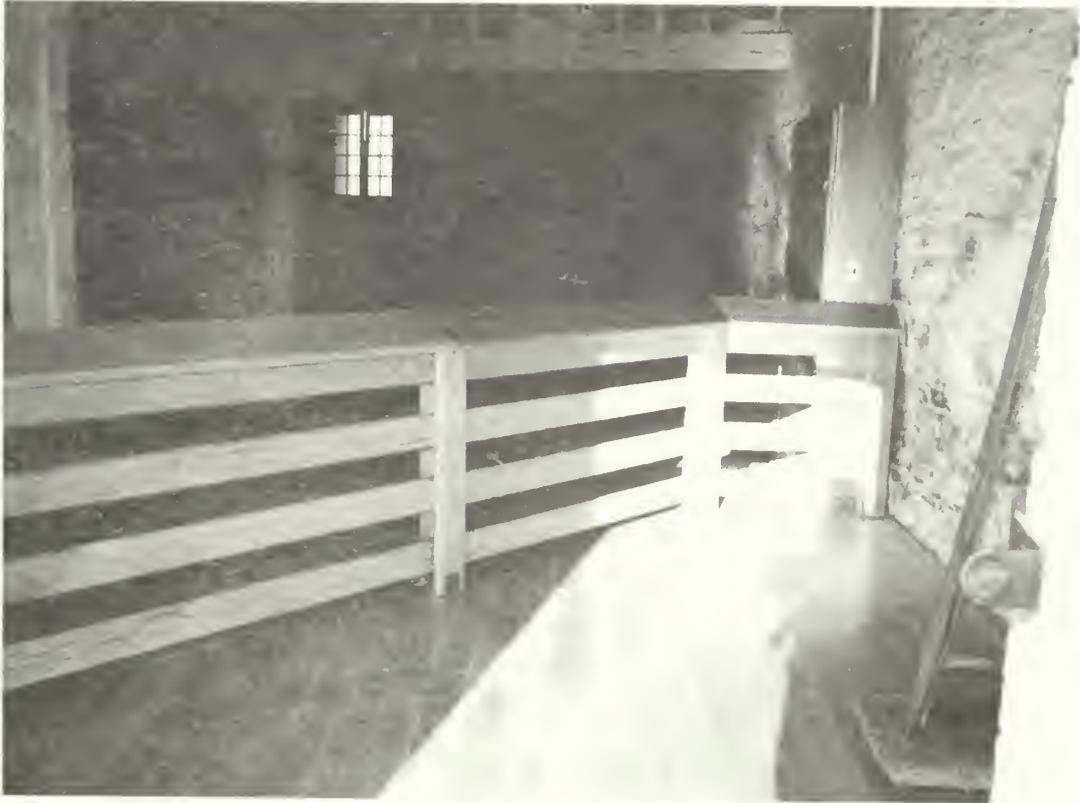
Figure 100. First Floor (1/3/85): This view shows the visitor platform as seen from the restored commissary storeroom - the stone slab floor, repaired and whitewashed support posts, and whitewashed ceiling system are shown. Notice the electrical conduit and light fixtures are placed so as to be imperceivable from the point of view of the visitor platform.

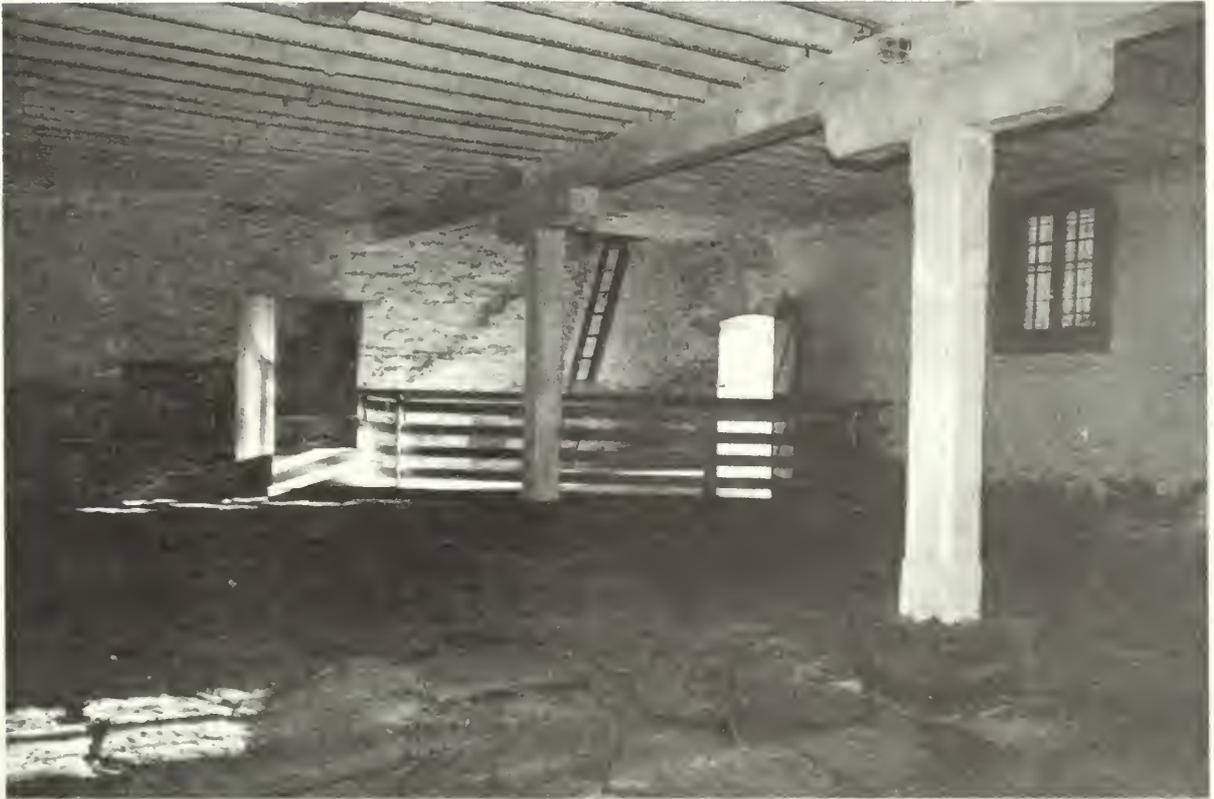
Figure 101. First Floor (1/3/85): Another general view of the restored first-floor room looking towards the south wall. Two windows received the louvered panel modification. The lower wall area was raked and repointed, but walls should not be whitewashed to avoid covering historic ghosts.

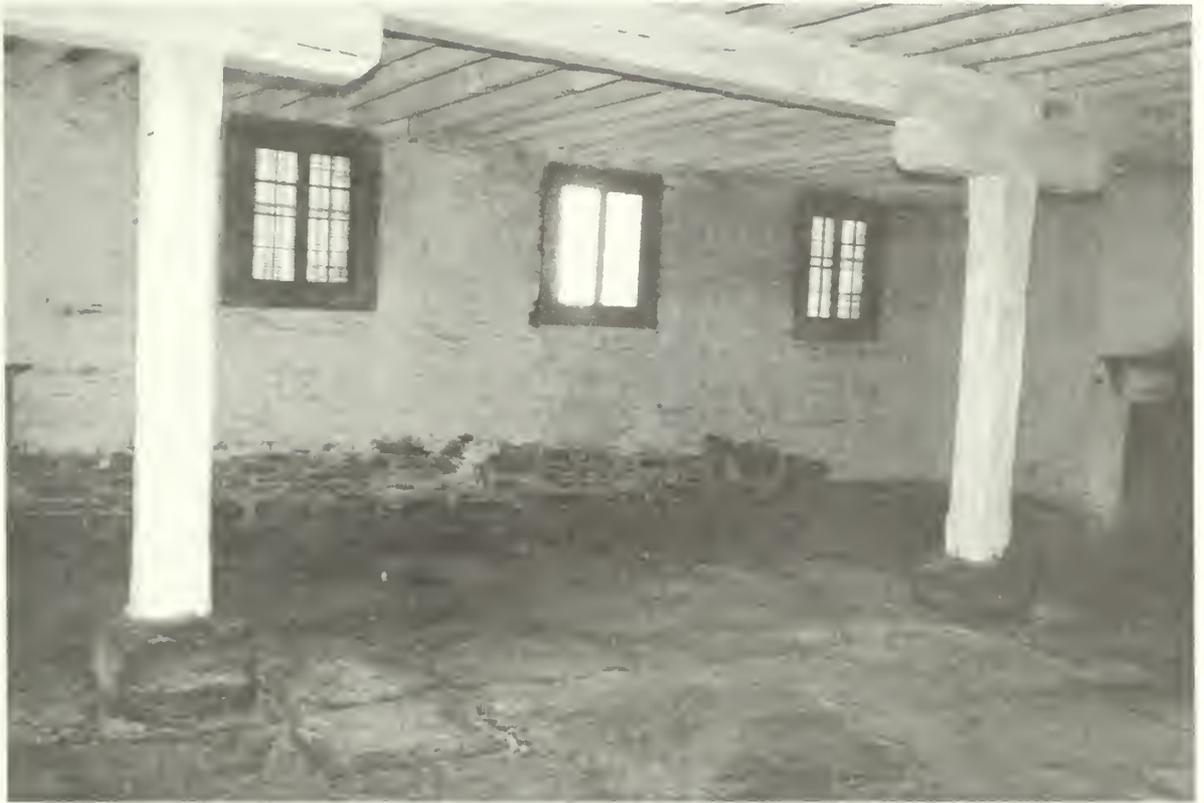
Figure 102. First Floor (1/3/85): Looking at the restored commissary storeroom from the visitor platform, the space is seen as the display. Notice darker pattern on west wall - between fireplaces - that may be a historic ghost, indicating former furnishings. Restoration of the double doors (north entry), including fitting them with an iron crossbar was historic practice. Note, also, that lights, smoke detectors, magnetic intrusion detectors, and associated conduit are imperceivable from the visitor's point of view.

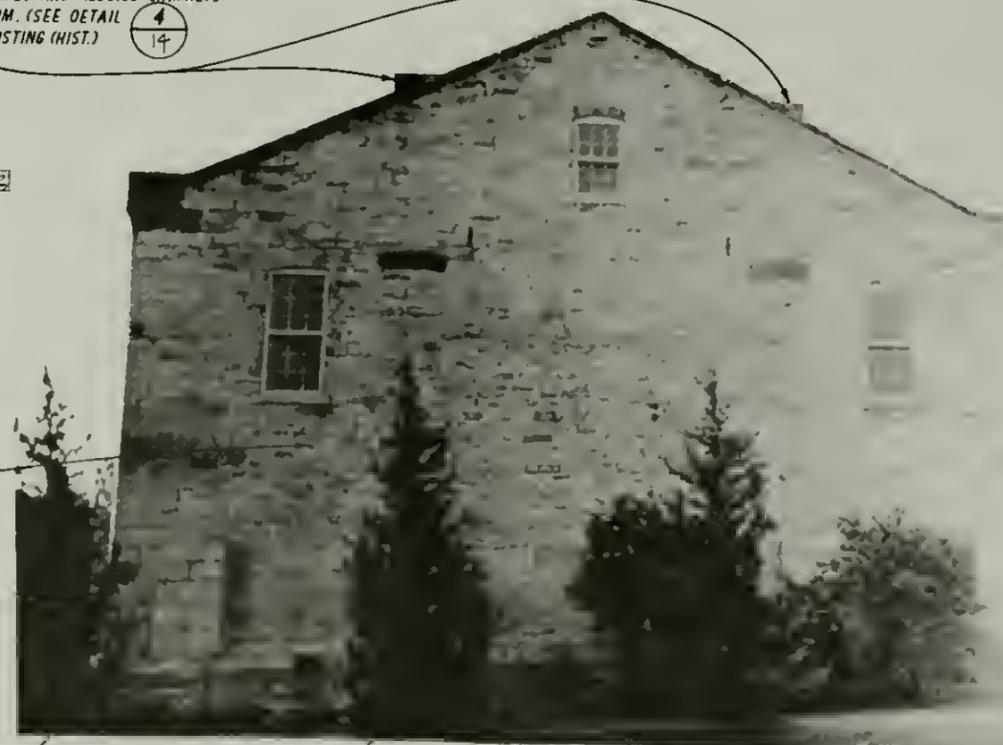
WEST OR NORTHWEST ELEVATION  
NO SCALE

AFTER ARCH RELAY HAIRLINE CRACK APPEARED

REPLACE ASB W/SLATE SHINGLE ROOF AND ALL FLASHING ①

RELAY 4' WALL SECTION & MOVE IN APPROX. 6"

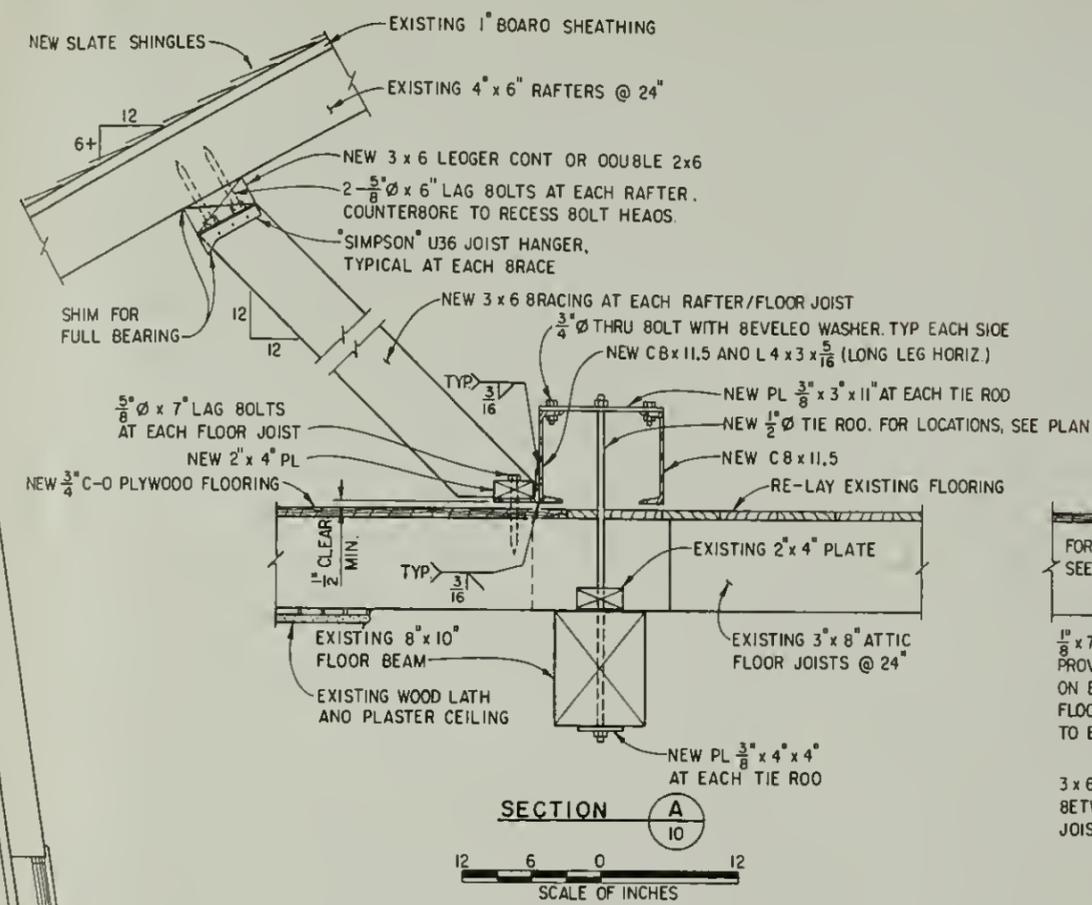
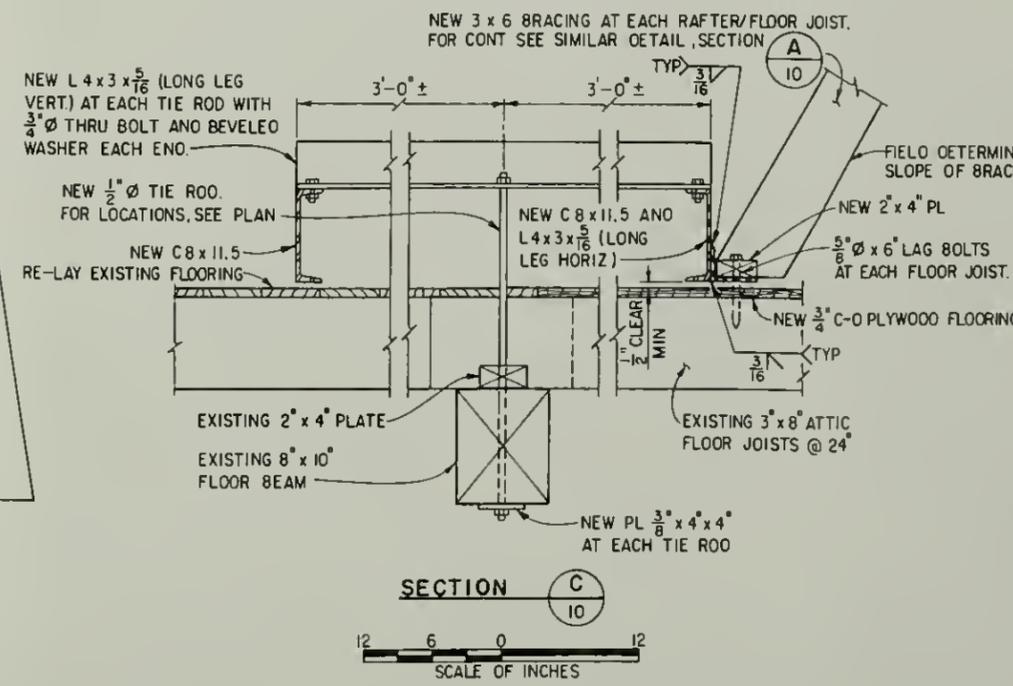
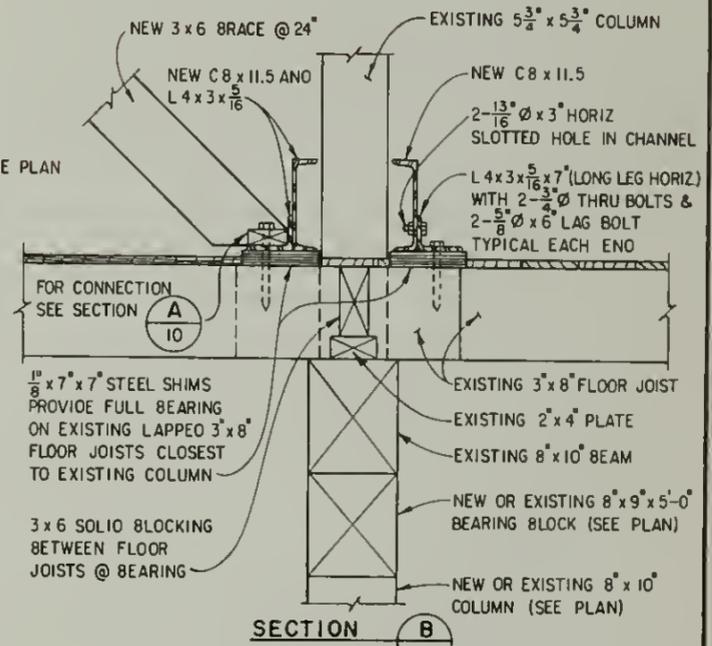
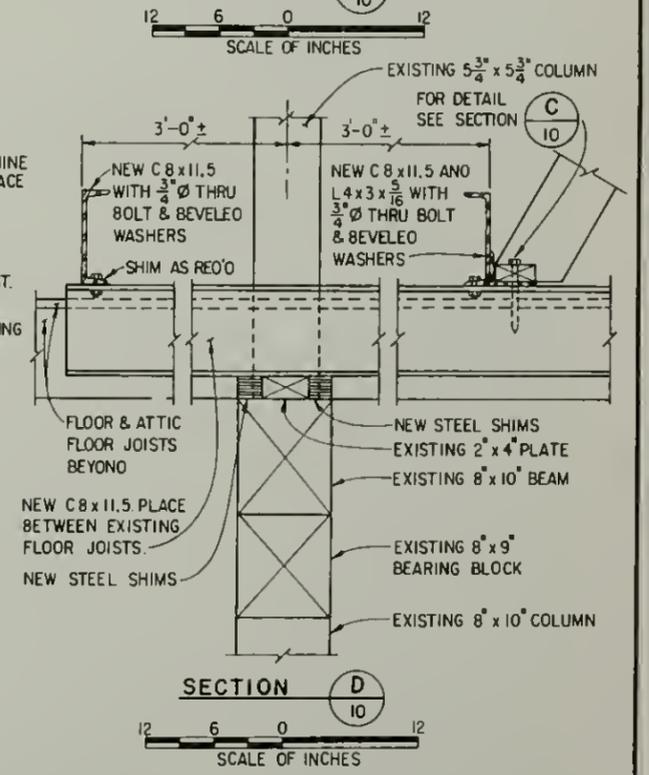
DESIGNED T WONG	SUB SHEET NO.	TITLE OF SHEET <b>ROOF AND ATTIC FLOOR STRUCTURAL MODIFICATIONS ACCOMPLISHED PHASE I</b>	DRAWING NO. 421
DRAWN C. DeL...			PKG. NO. 25,001
TECH. REVIEW THORSON			SHEET 10
DATE 7/85			OF 14

NOTE:  
REMOVE ALL EXISTING BRACING.  
NEW 3/4" C-0 PLYWOOD FLOORING
